5. PERFORMANCE OF IMPROVED GROUND

The performance of four improved ground sites is discussed in this chapter. Three of the sites were treated with stone columns (i.e., Ferrymead Apartment Building, AMI Stadium, and Motorway Bridge Approaches). The last site (i.e., St. Andrews School) was “treated” with screw piles.

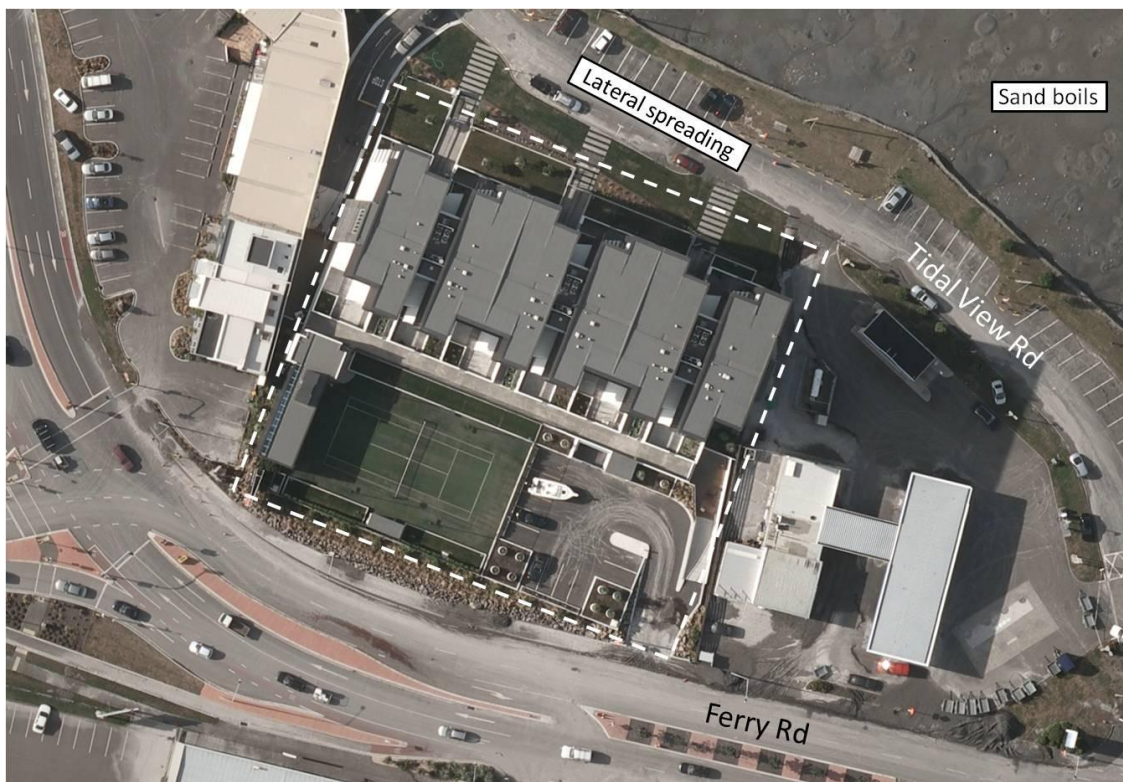
The Waterside apartment building (-43.5577° , 172.7066°), indicated by the dashed white line in Figure 5-1, is situated between the Avon-Heathcote Estuary to the north and Ferry Rd to the south, and immediately west of the Ferrymead Bridge. The structure consists of a 6-story precast concrete panel building with a single basement level carpark (Figure 5-2). The geotechnical engineer for the project indicated that the building is supported on shallow foundations overlying stone columns. Large volumes of ejecta were evident in the area, with sand boils still present in the estuary adjacent to the structure. Two lateral spread cracks were noted on the north side of the building between the water and the building. The crack closest to the water had a maximum width of 13 cm and the crack closest to the building had a maximum width of about 4 cm. The larger crack extended along the top of the embankment north of Tidal View Rd, and additional cracking was present between the road and building.

Figure 5-1. Aerial view of Ferrymead apartment building indicating surrounding ejected material (LINZ 2011). (-43.5577° , 172.7066°)

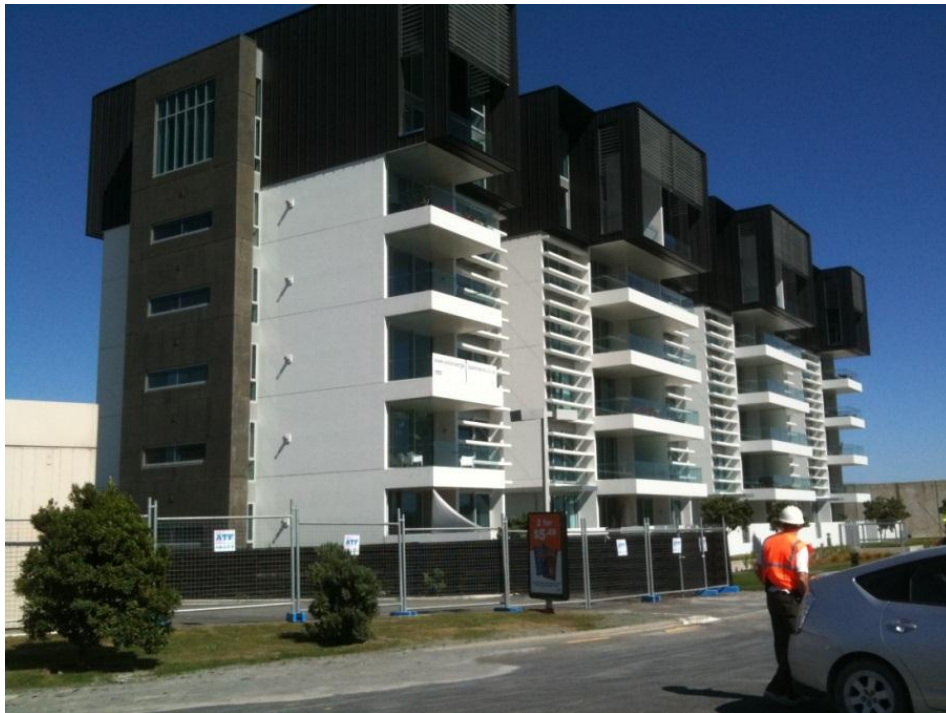
Conversations with the property owner suggested that the building had settled and had a slight tilt toward the water. Measurements by the GEER team indicated that the building has

Figure 5-2. Photograph of apartments looking toward the south west. (-43.5577°, 172.7066°)

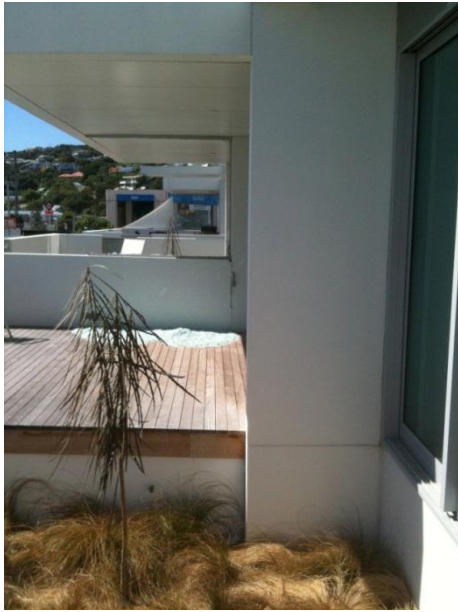
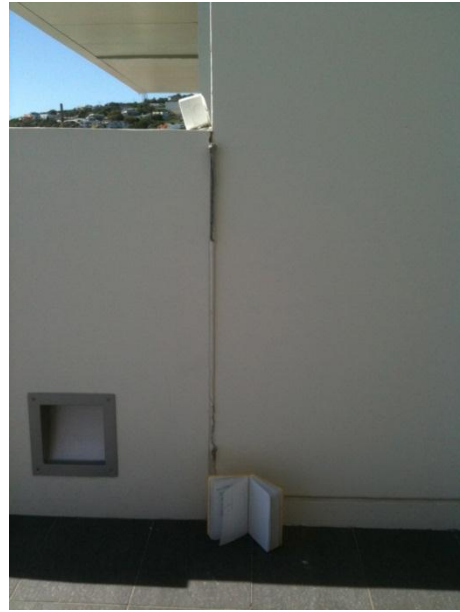
settled between 4 and 8 cm. On the north side of the building, separation walls on the ground surface showed differential movement (Figure 5-3). The separation walls sloped downward towards the building at an angle of about 0.4 to 0.5 degrees (Figure 5-3a). This caused the caulk in the expansion joint to be compressed at the top of the wall (Figure 5-3b). Three of the glass panels that were mounted on top of the separation walls were shattered (Figure 5-3a), likely due to the compression of the glass against the deck above; cracking of the wall connection beneath this was also evident. The separation walls on the south side of the building also sloped downward toward the building at an angle of about 0.8 degrees. Cracking along concrete walkways extending out from the structure also indicated differential settlement of the building relative to the ground north of the building (Figure 5-4).

Figure 5-3. Photograph of separation walls on the north side of the building. Note the (a) sloping of the separation walls and shattered glass panels, and (b) compression of caulk at top of expansion joint. (-43.5577°, 172.7066°)

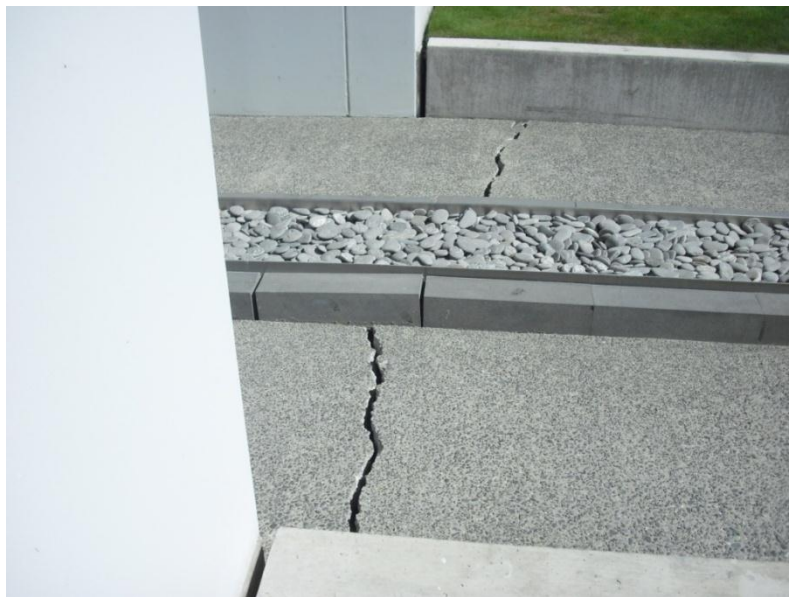
Figure 5-4. Differential settlement along concrete walkway between patios and surrounding ground north of the building. (-43.5577°, 172.7066°)

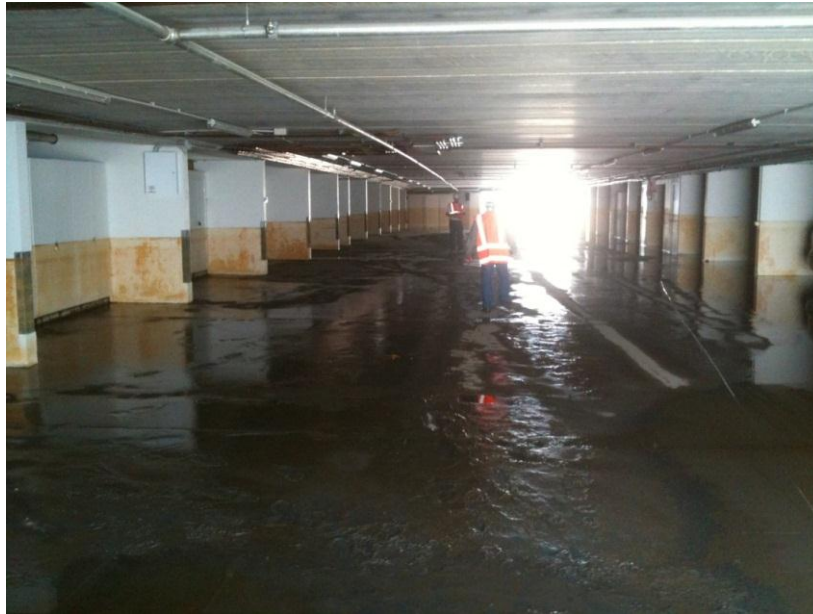
Significant flooding occurred in the basement (Figure 5-4), with sand having flowed up through the drains in the basement slab. Upon the GEER team's arrival on 3 March 2011 a work crew was repairing a ruptured water line on the north side of the building, and a pump was being used to remove water from the basement that had been flooded. Workers were also removing sand from the basement. The water level had dropped to within a few inches at the time of the team's inspection, as indicated by high water marks on the basement wall.

Figure 5-5. Photograph of the basement parking garage. Note the high water mark on the walls. (-43.5577°, 172.7066°)

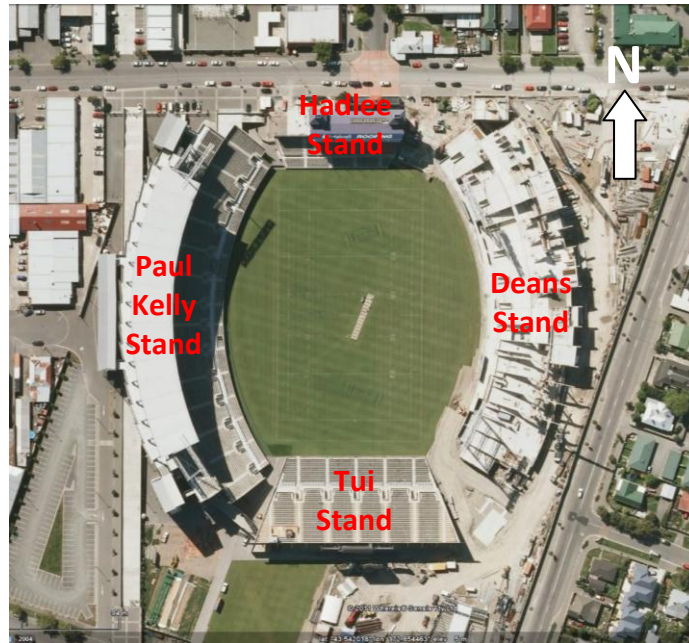
AMI Stadium (-43.5419°, 172.6541°), Figure 5-6, is located in an area that extensively liquefied during the 22 February earthquake. All four stands has shallow foundation systems, and suffered varying levels of damage. The Hadlee Stand, with no ground improvement measures, suffered severe structural damage and has been recommended for demolition. The Tui Stand, constructed on a fill platform to raise its level, and suffered less severe structural damage during the earthquake.

Both the Paul Kelly and Deans Stands were constructed on stone columns installed within their footprint. The Deans Stand has shallow foundations connected by grade beams built upon 8 m deep stone columns, while the Paul Kelly Stand has a slab foundation up to a meter thick founded on 9 m deep stone columns. Both stands suffered structural damage from differential settlements and the ground shaking, which was approximately 30% larger than design levels.

The Paul Kelly Stand, constructed in 2000, settled by up to 400 mm, with settlement variations of approximately 70 mm. The thick slab beneath the structure prevented any ejected material from coming up within the structural footprint. The Deans Stand, built in 2008, developed similar overall settlements, but with much larger variations in settlement across the structure of up to 300 mm.

Figure 5-6. AMI Stadium. (-43.5419°, 172.6541°)

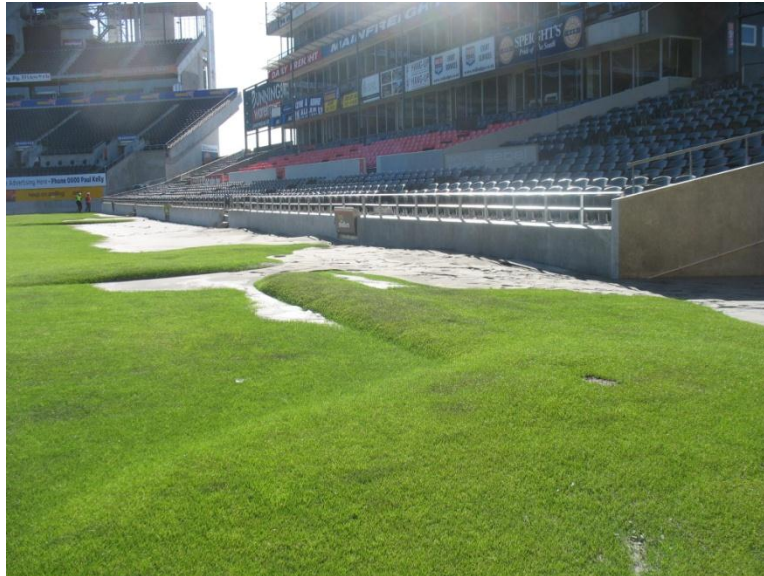
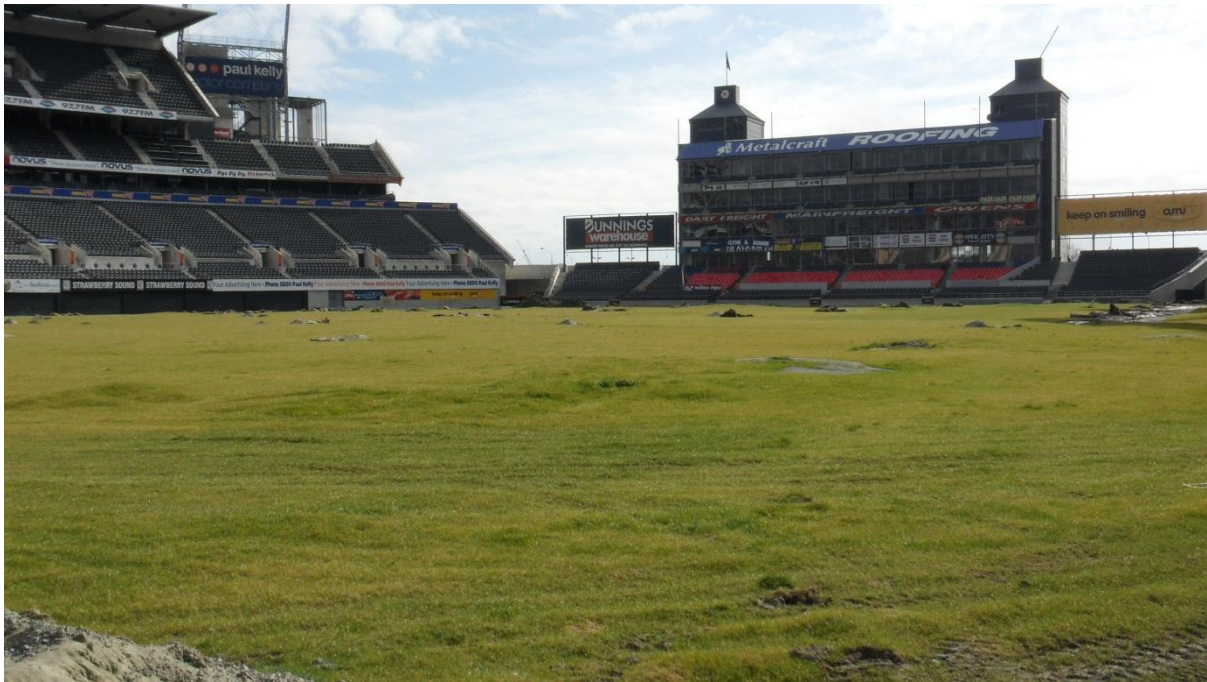
Significant liquefaction occurred on the field. However, due to mesh below the turf liquefaction “blisters” formed, Figure 5-8, more so than sand boils. The blisters formed undulations up to 70 cm high across the field.

Figure 5-8. Liquefaction “blisters” and sand boils on the AMI Stadium field. (-43.541397°, 172. 654521°)

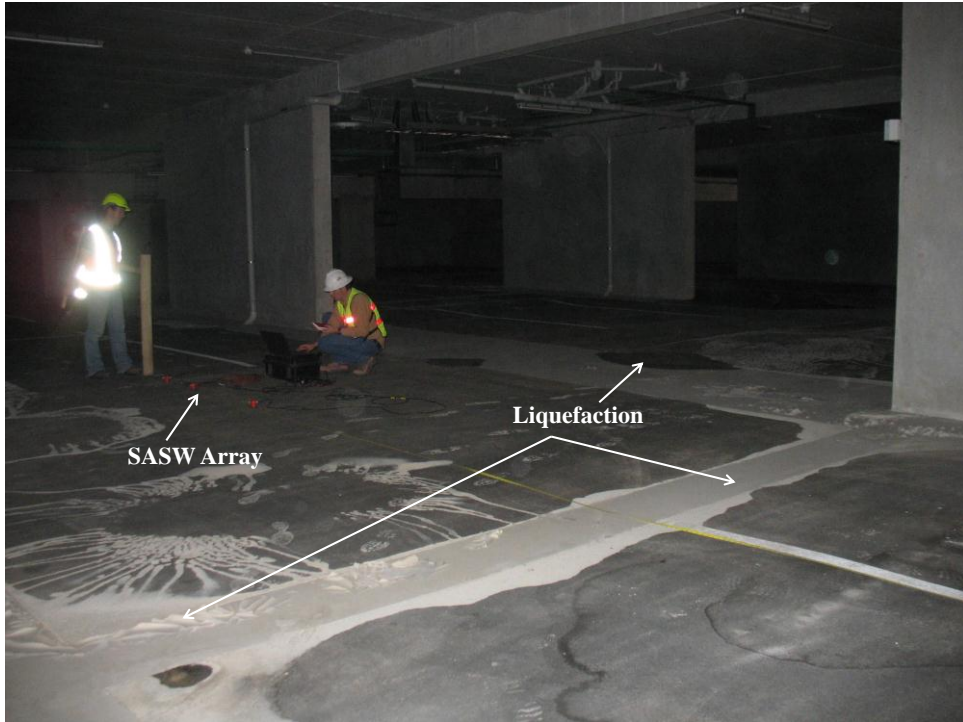
AMI Stone Columns 2 (SC2) test site was located under the south end of Deans Stand. Again, this area was treated with stone columns, as described above. However, significant liquefaction occurred in the area of this test site, as shown in Figure 5-16. The results are presented in Figure 5-17 and Table 5-4.

Figure 5-16. SASW array at AMI SC2 test site. (-43.54236°, 172. 65514°)

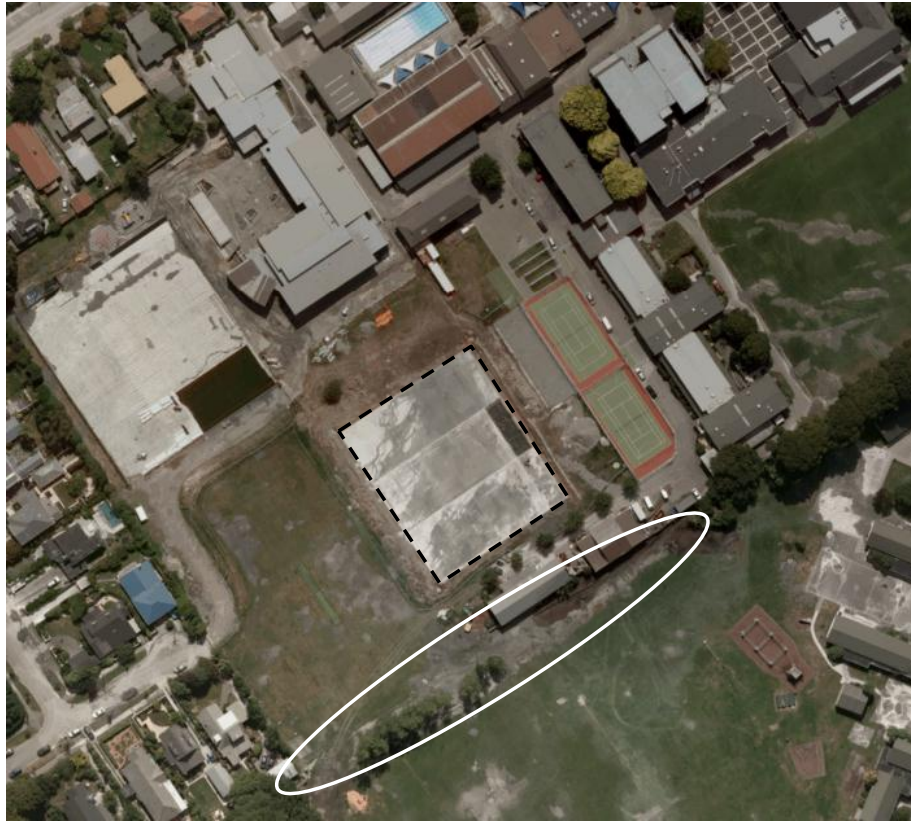
The St Andrews School (-43.508903°, 172.612942°) is located in the suburb of Merivale and was affected by liquefaction during both the 4 September 2010 Darfield and the 22 February 2011 Christchurch earthquakes. Following the Darfield event there was some evidence of liquefaction, with the majority of the ejected material coming to the surface along a depression or old creek bed on the edge of the school grounds (white circled area in Figure 5-21). In this area a small, a two storey building was damaged and subsequently condemned as a result of lateral spreading and settlement. Aerial photographs taken shortly after the February event are shown in Figure 5-21. In this photo, a significant amount of ejecta can be observed, which is from the 22 February event.

During the GEER teams inspection, large amounts of ejecta was still on the school grounds and the surrounding areas, and lateral spreading cracks were evident throughout. Witnesses indicated that a section of the newly poured hockey field slabs (paved area within dashed black square) uplifted by approximately 100 mm due to the ejection of liquefied material, before dropping back down to the original level after the event.

Figure 5-21. Aerial photograph of St Andrews School following 22 February 2011 (LINZ 2011). (-43.508903°, 172.612942°)

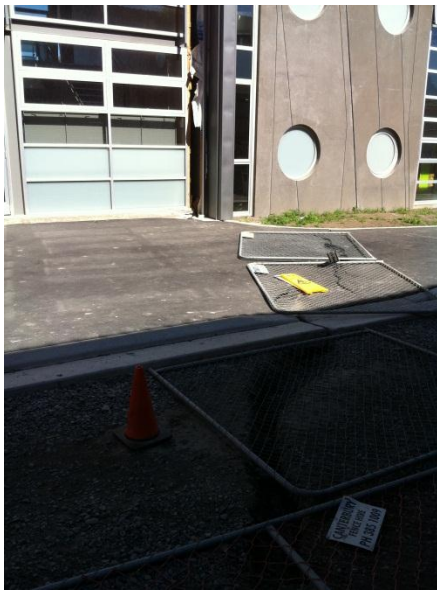
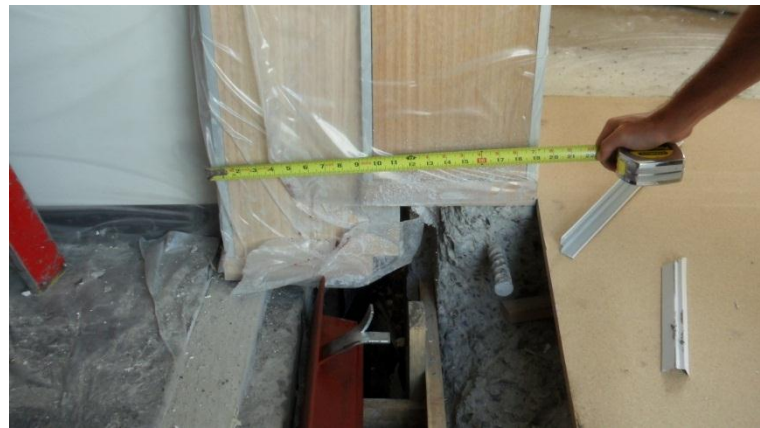
Lateral spreading at the site was evident with movement to the northwest, as illustrated in Figure 5-23. A lateral spread crack passed underneath the building and resulted in the separation of an expansion joint between portions of the building founded on screw piles and raft foundation. The portion of the structure on the shallow foundation moved away from the pile founded portion by ~200 mm and settled by ~200 mm, while the piled portion of the structure remained in place. Internal and external photos of the gap formed by the spreading are shown in Figure 5-24. A ramp was constructed to account for the differential movement, as shown in Figure 5-25.

Figure 5-24. (a) Lateral spread crack propagating through and opening seismic gap in structure (position 1); (b) Opening of seismic gap and settlement between structures on piles and shallow foundation (position 2). (Position locations shown in Figure 5-23.)

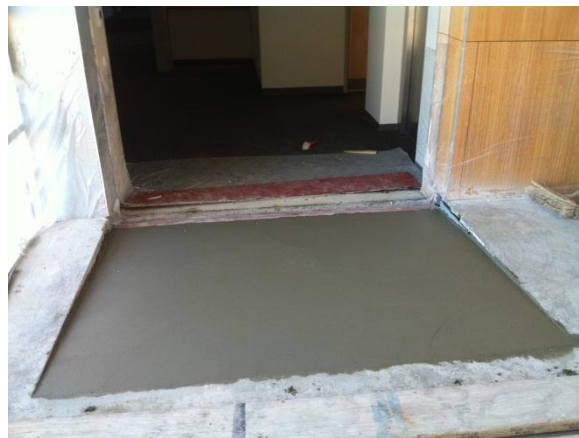
Figure 5-25. Ramp construction to mitigate differential movement between structures (position 2). (Position locations shown in Figure 5-23.)

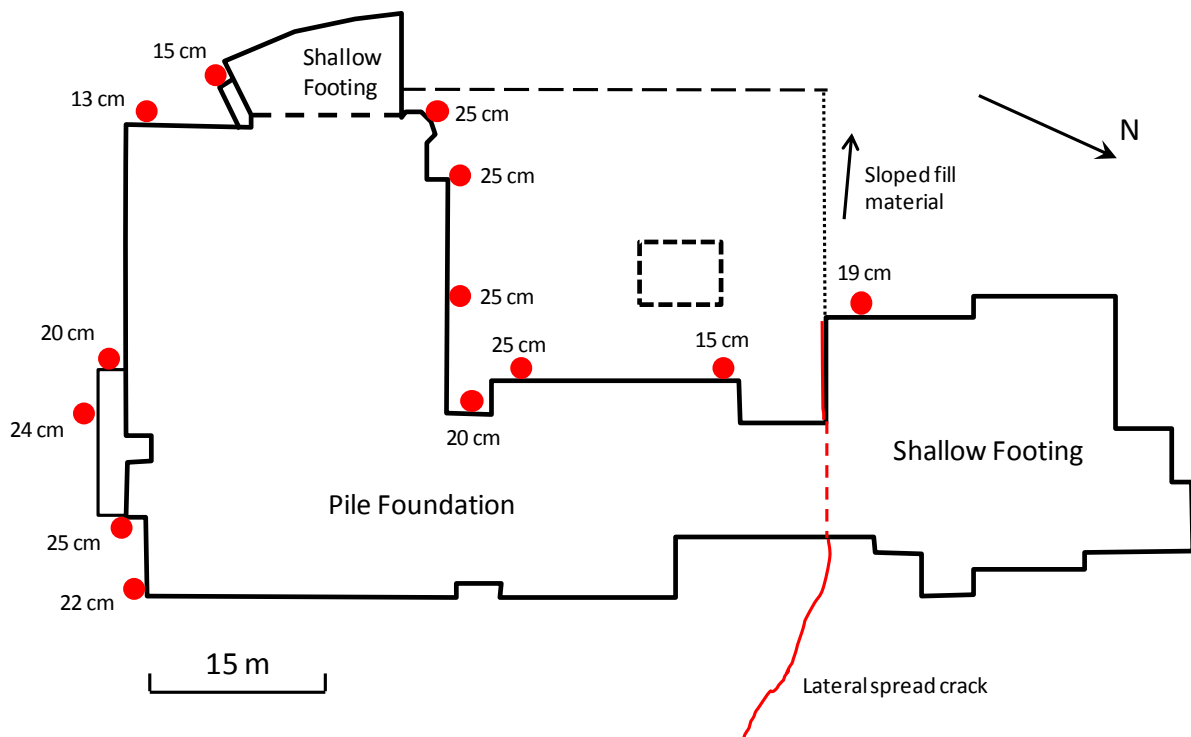
A summary of the differential settlement between the structures and the surrounding ground is shown in Figure 5-26. These measurements show that shallow founded portions of the building settled almost evenly with the surrounding ground, while the pile supported portion did not move, rather the surrounding ground settled by up to 10" (25 cm). Some examples of these movements are shown in Figure 5-27. The settlement of 7.5" on the shallow founded section to the north seems to be due to movement of fill material away from the structure and down the slope, as indicated in Figure 5-23. Other than this position, Figure 5-28 shows that the level of the shallow foundation structure and the surrounds are almost even.

Figure 5-26. Measured ground settlement compared to structure. (-43.508396°, 172.612766°)

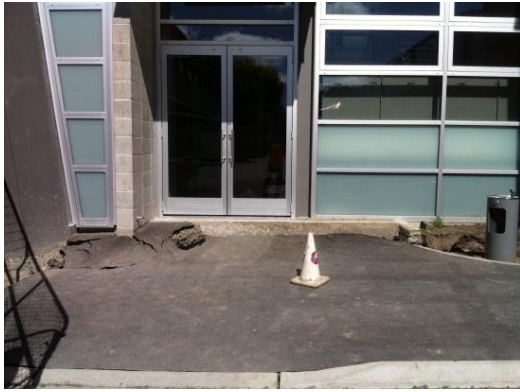
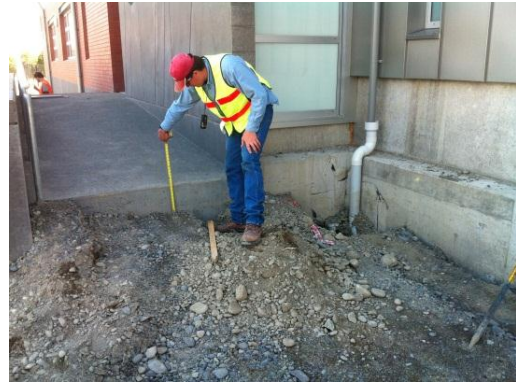
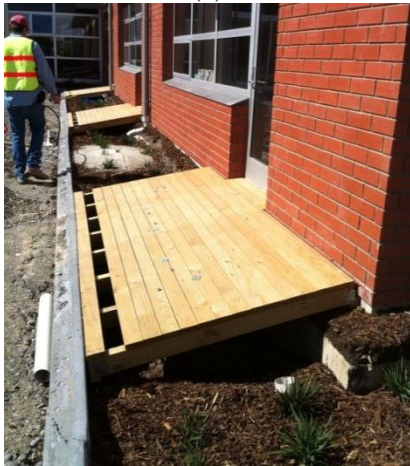
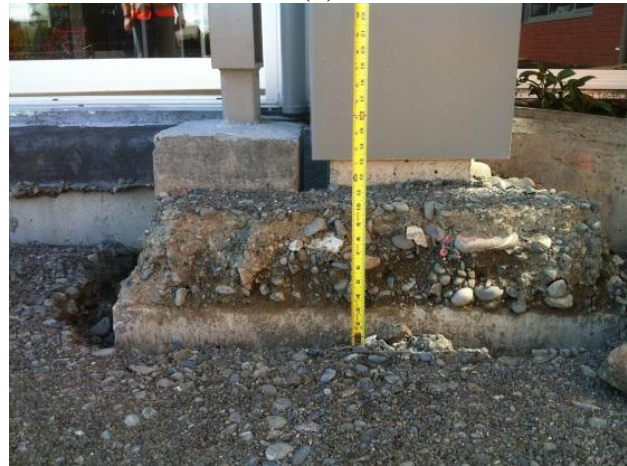
Figure 5-27. Settlement of ground around pile supported structure: (a) 20 cm, position 3; (b) 25 cm, position 4; (c) 25 cm, position 6; (d) 25 cm, position 7. (Position locations shown in Figure 5-23.)

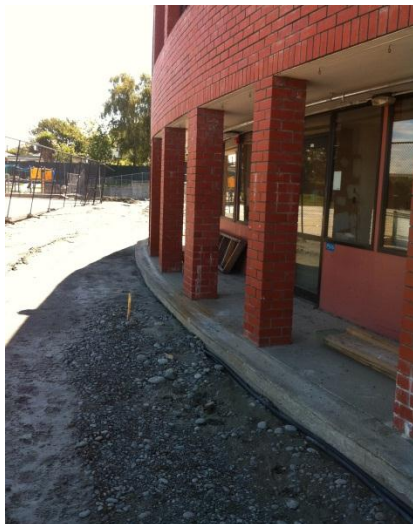
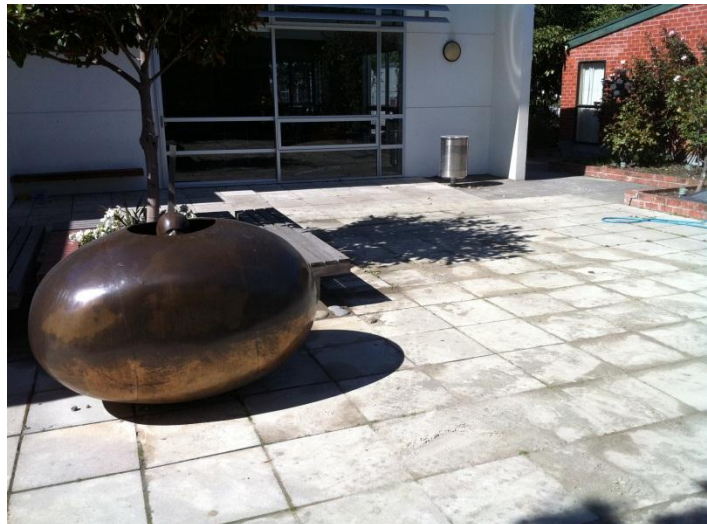
Figure 5-28. The difference between the level of the shallow founded portions of the building and the surrounding ground was minimal: (a) position A; (b) position B. (Position locations shown in Figure 5-23.)

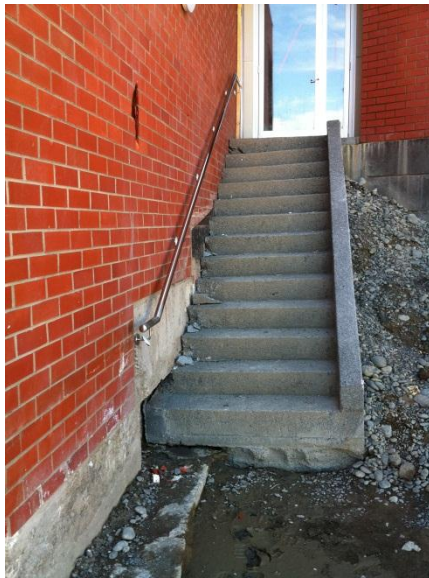
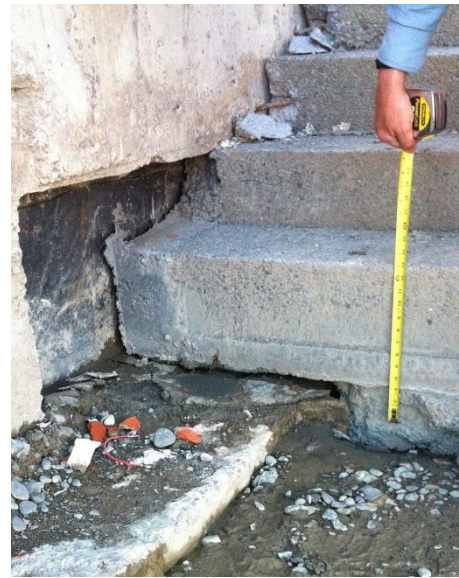
Relative movement of the pile supported portion of the building and the surrounding ground resulted in damage to external stairs shown in Figure 5-29. The stairs were attached to the side wall of the original, shallow founded portion of the structure and lead to an entrance to the new, pile supported structure. When the area settled, the stairs were dragged down by the original structure as it settled, while the top of the stairs were restrained by the piled structure which remained in place. The result was a 7° slope of the stairs towards the original structure as shown in Figure 5-29a. This figure also shows damage to the anchorage reinforcement between the wall and the stairs, indicating both differential vertical and horizontal movement. The shallow founded building seems to have moved away from the stairs.

Figure 5-29. Damage to stairs from differential movement of pile and shallow foundation supported structures at position 5. (Position locations shown in Figure 5-23.)

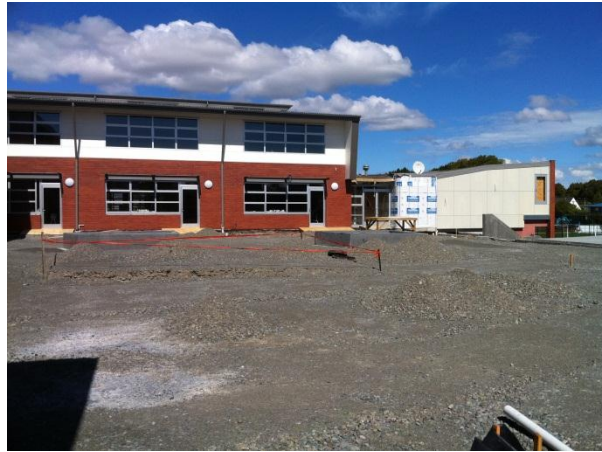
Apart from the gap in the construction joint that widened as a result of lateral spreading and stairs, none of the above ground portion of the structures suffered any distress. Settlements of the shallow founded sections were even, and the only required repair was backfilling of settled areas under and around the piled structure. A buried tank adjacent to the piled structure can be seen in Figure 5-30. As shown in this figure, the ground around the tank settled, exposing the tanks position at the surface.

Figure 5-30. Settlement of ground around the roped off buried tank structure. (-43.508389°, 172.612489°)
