6. PERFORMANCE OF STOPBANKS

Seismic Performance of Stopbanks

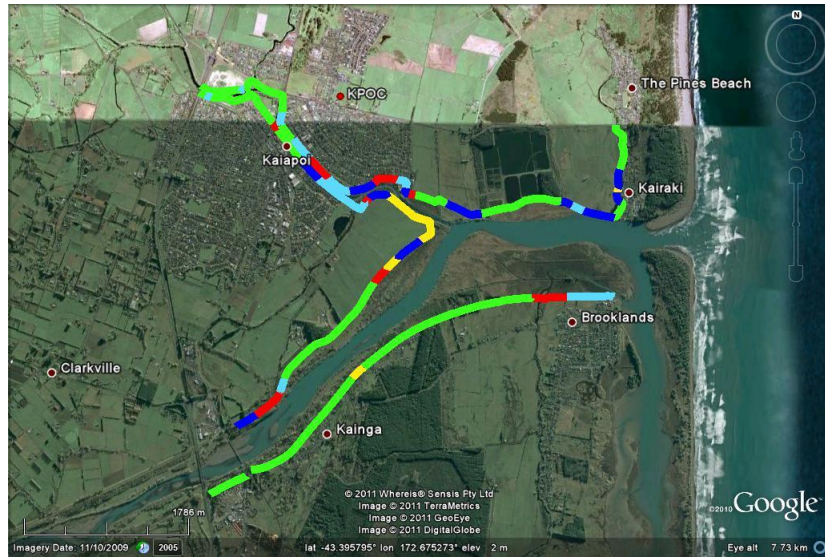
The majority of the damage to the levees resulting from both the Darfield and Christchurch earthquakes occurred east of SH1 as depicted in Figure 6-4 (note, SH1 is shown in Figure 6-7). In Figure 6-4, damage severity is categorized using the scale developed by Riley Consultants (2010, 2011). The scale has five grades that range from No Damage to Severe Damage, as summarized in Table 6-1. As may be observed from Figure 6-4, the damage patterns to the levees following both earthquakes are very similar, but are in general less severe for the Christchurch earthquake as compared to the Darfield earthquake. Note that some portions of the

Figure 6-4. Observed damage to levees following the (a) 4 September 2010, M_w 7.0 Darfield earthquake and (b) 22 February 2011, M_w 6.1 Christchurch earthquake. (Adapted from Riley Consultants, 2010, 2011).

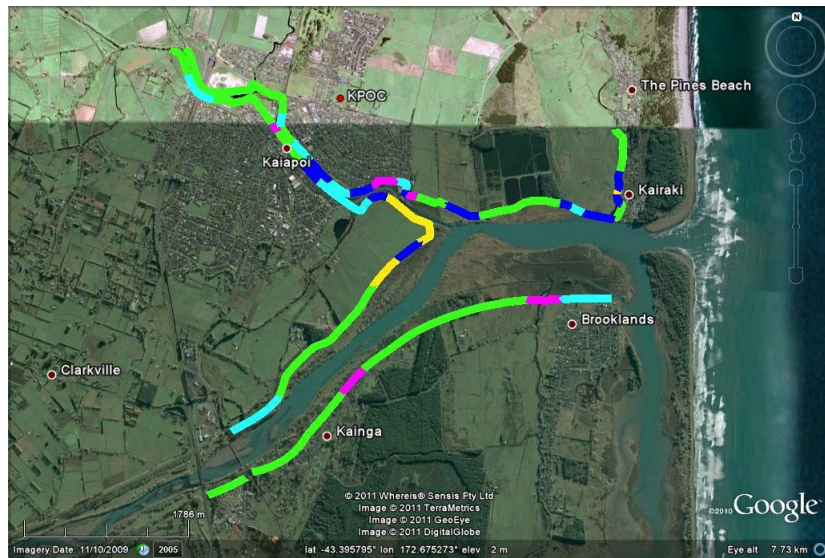
(b)

levees were already under repair by the time the GEER team were able to inspect them following the Christchurch earthquake. In these cases, the GEER team supplemented their field observations, to the extent possible, with both observations from high resolution aerial images taken the day after the Christchurch earthquake and field observations made by ECan consultants (Riley Consultants, 2011).

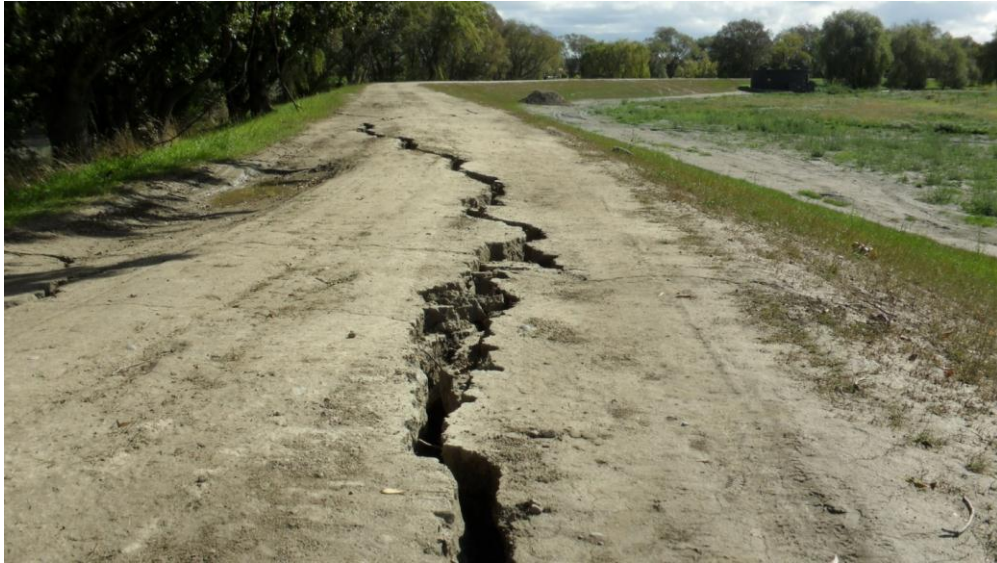
The majority of the damage to the levees was a consequence of liquefaction in the foundation soils that result in lateral spreading, slumping, and/or settlement. The damage mostly manifested as longitudinal cracks running along the crest of the levees (Figure 6-5a). Although not desirable, moderate crack widths for this mode of damage are not believed to be critical to the functionality of the levees because it does not provide a direct seepage path from one side of the levee to the other. However, there is always the potential for these longitudinal cracks to connect undetected transverse cracks or flaws that only penetrate partway through opposite sides of the levee. Such a tortuous seepage path could potentially enlarge rapidly due to internal erosion and piping at high river levels.

Figure 6-5. Cracks in levee: (a) Example of longitudinal cracks running along the crest of the levee; and (b) Example of transverse (or oblique) crack in levee.

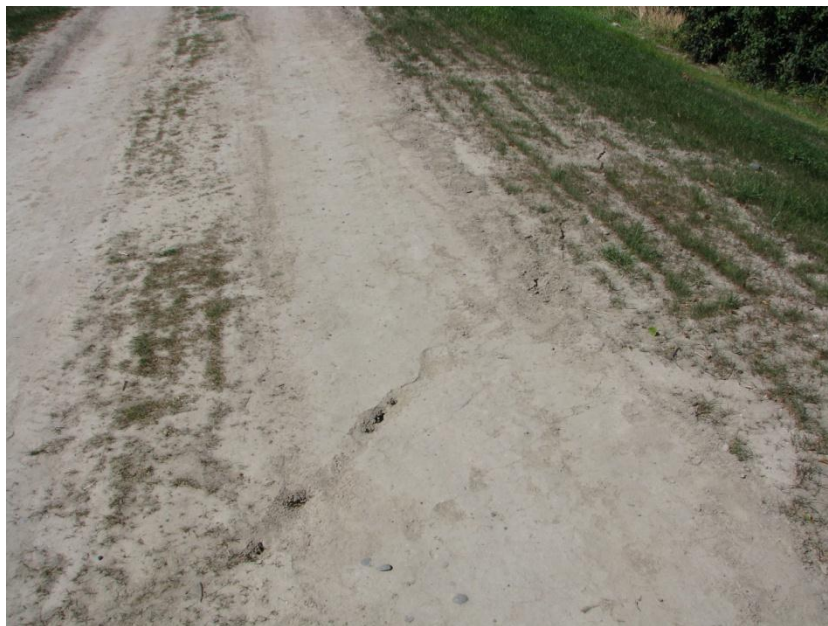
(b)

Transverse cracks in the levees were less commonly observed than longitudinal cracks and were often associated with sharp bends along the length of the levees and/or slumping of the embankment (Figure 6-5b). Because these cracks provide a direct seepage path from one side of the levee to the other, they can severely impact the functionality of the levees. Even transverse cracks having minor widths could potentially enlarge rapidly due to internal erosion and piping at high river levels and lead to the failure of that section of the levee.

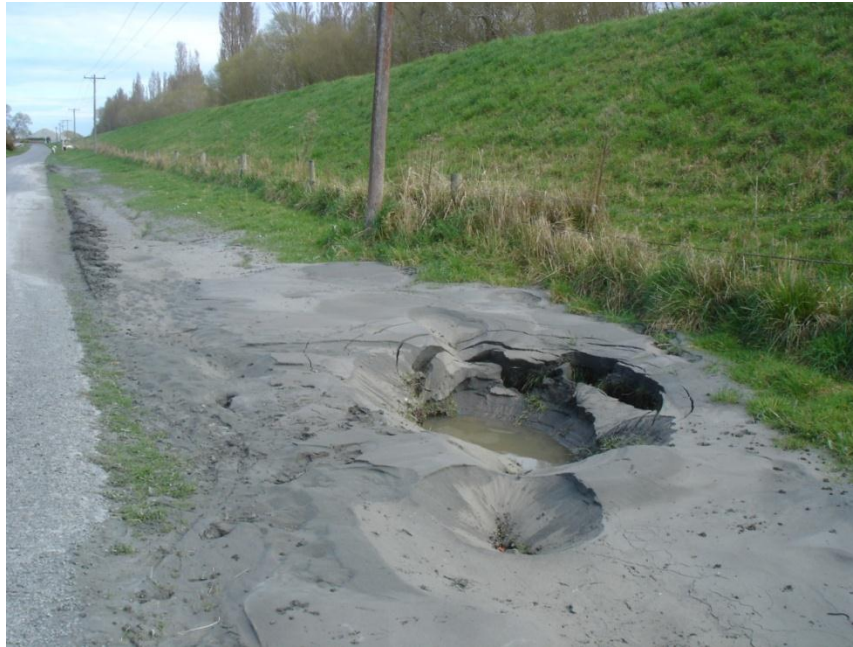
Another liquefaction related mode of degradation to the levees' capacity is where liquefaction and/or lateral spreading formed on both sides of the levee. In these cases a potential flow path is formed down through the vertical feeder dike on the river side of the levee, laterally through the source stratum under the levee, and up through the vertical feeder dike on the other side of the levee. Extensive liquefaction was observed on both sides of the levee along an approximate 0.5 km stretch of the Waimakariri River on Coutts Island Rd (Figure 6-6). From interviews with local land owners and review of maps of the area from 1865, this area was part of an old river channel (Wotherspoon et al., 2011). Additionally, borings performed by the GEER team using a hand auger showed a deep sand deposit along this 0.5 km stretch of levee and buried sticks and logs on both ends, consistent with an old river channel and river channel banks.

Figure 6-6. (a) Large sand boil on landside of the levee on Coutts Island Rd. (b) Large sand boil on riverside of the same section of the levee.
