7. BRIDGES

Christchurch CBD Bridges

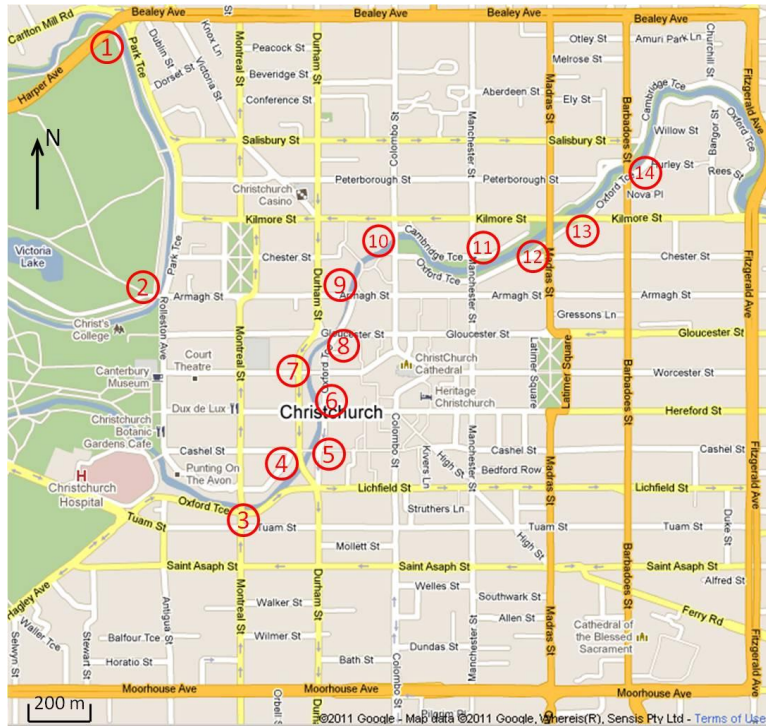
Figure 7-1. Vicinity map showing the locations of CBD bridges that were inspected by the NZ-GEER team (Google 2011).

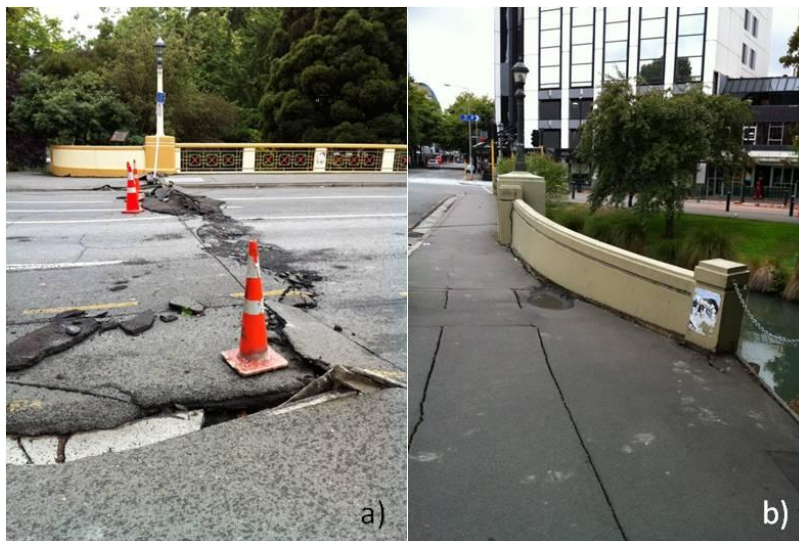
Figure 7-2. a) Damage to the western approach of Hereford Street Bridge (6) due to lateral spreading (-43.532026° 172.633390°); b) Outward rotation of wingwalls on western approach of Gloucester Street Bridge (8) due to lateral spreading (-43.529887° 172.633986°).

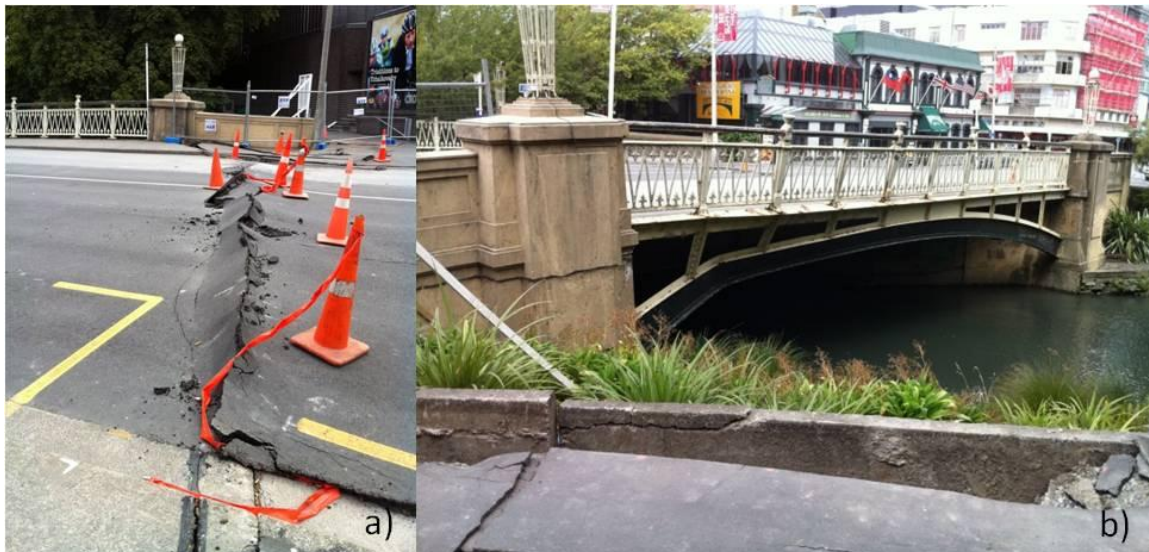
Figure 7-3. a) Moderate approach damage and settlement on northern approach of Colombo Street Bridge; b) Buckling of steel arch and handrail as a result of lateral spreading compressive forces on bridge structure. (-43.5272° 172.6366°)

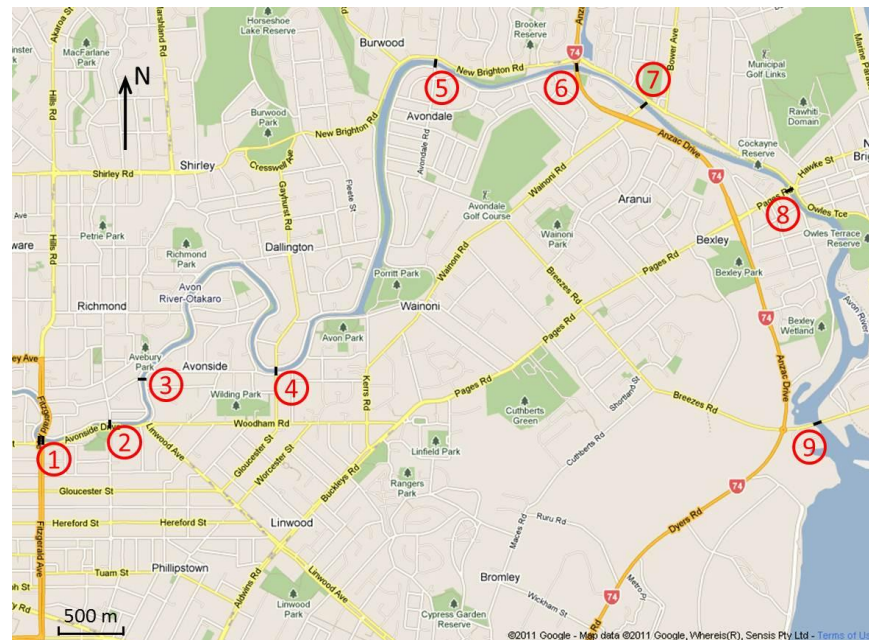
Figure 7-4. Vicinity map showing the locations of the Avon River bridges that were surveyed by the NZ-GEER team (Google 2011).

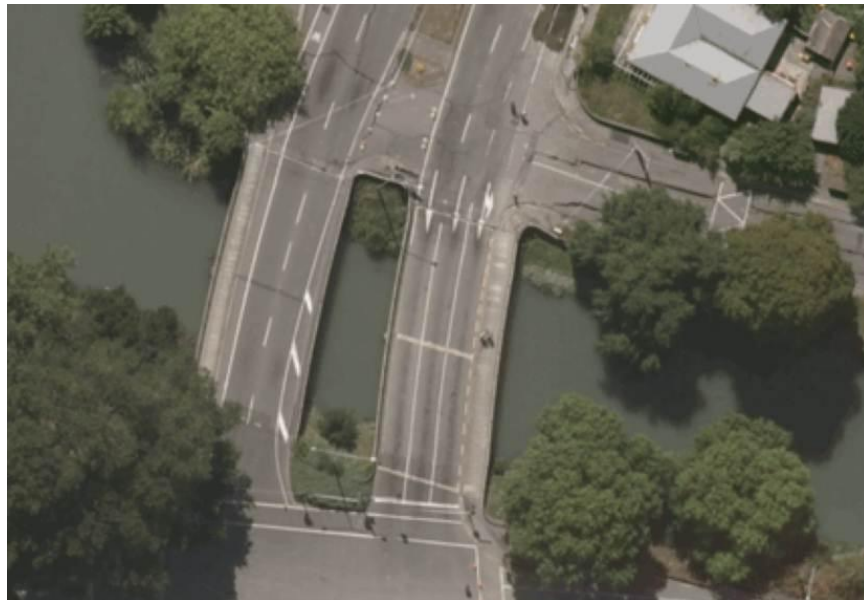
Figure 7-5. Satellite image of Fitzgerald Avenue Bridge post-earthquake (LINZ 2011). (-43.5263°, 172.6506°)

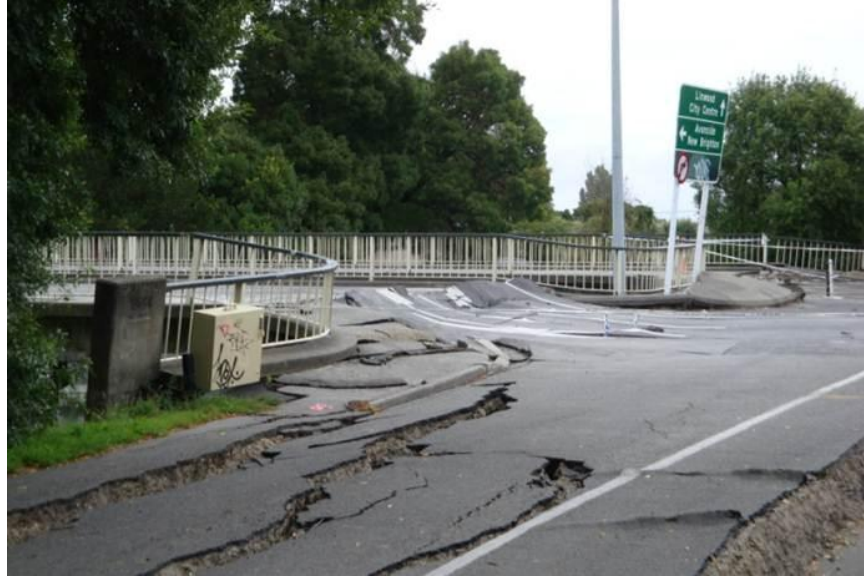
Figure 7-6. Photograph of the north approach of Fitzgerald Avenue Bridge looking toward the southwest. Note the lateral spreading cracks parallel to the river and the settlements at the abutments. (-43.5263°, 172.6506°)

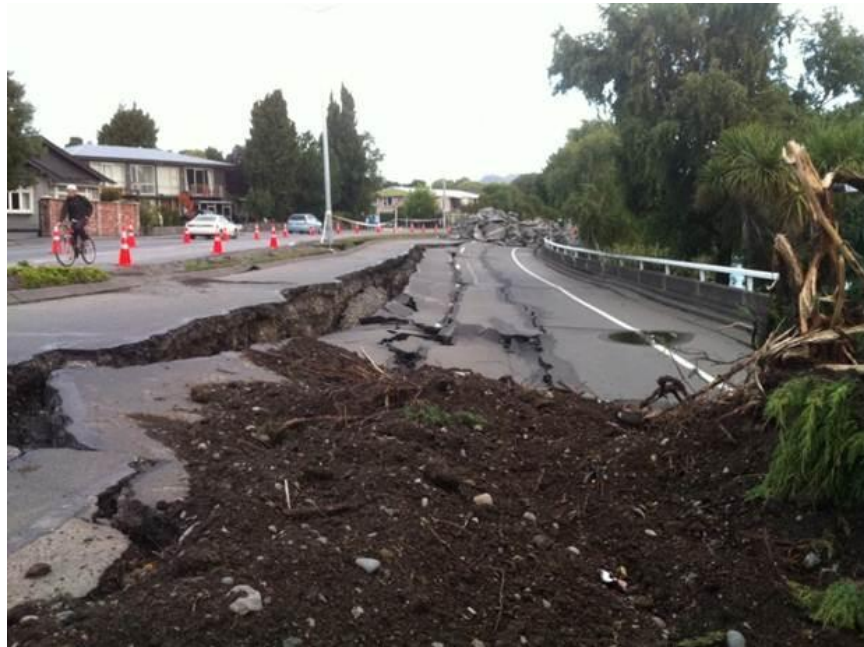
Figure 7-7. Photograph of lateral spreading damage of roadway north of Fitzgerald Avenue Bridge. (-43.524156°, 172.650891°)

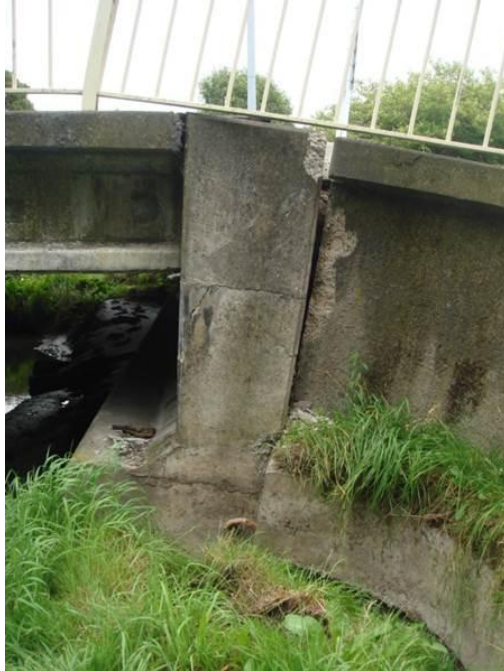
Figure 7-8. Photograph of back rotation of the north abutment of the eastern bridge on the eastern side. (-43.5263°, 172.6506°)

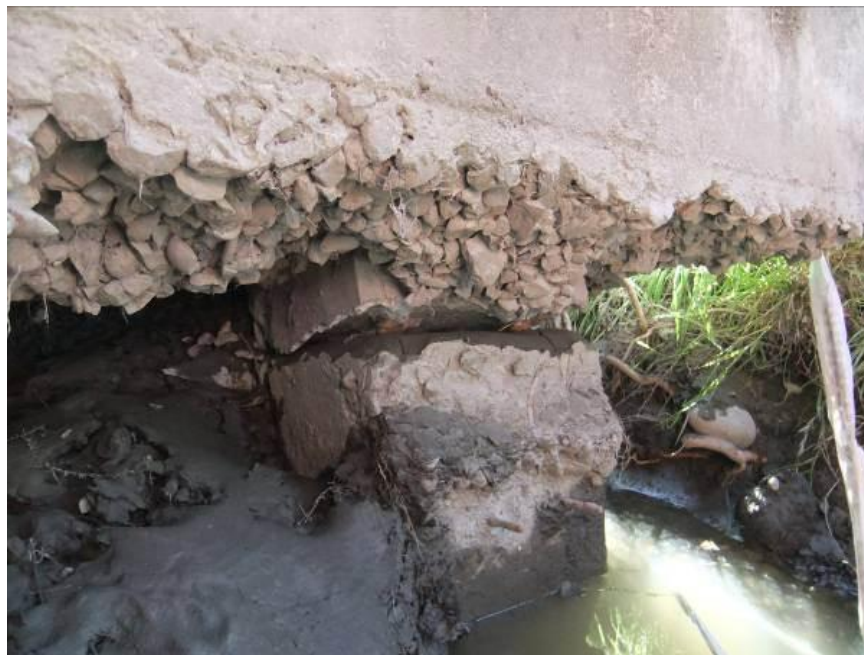
Figure 7-9. Photograph of tension failure and reinforcement elongation at north abutment of the eastern Fitzgerald Avenue Bridge. (-43.5263°, 172.6506°)

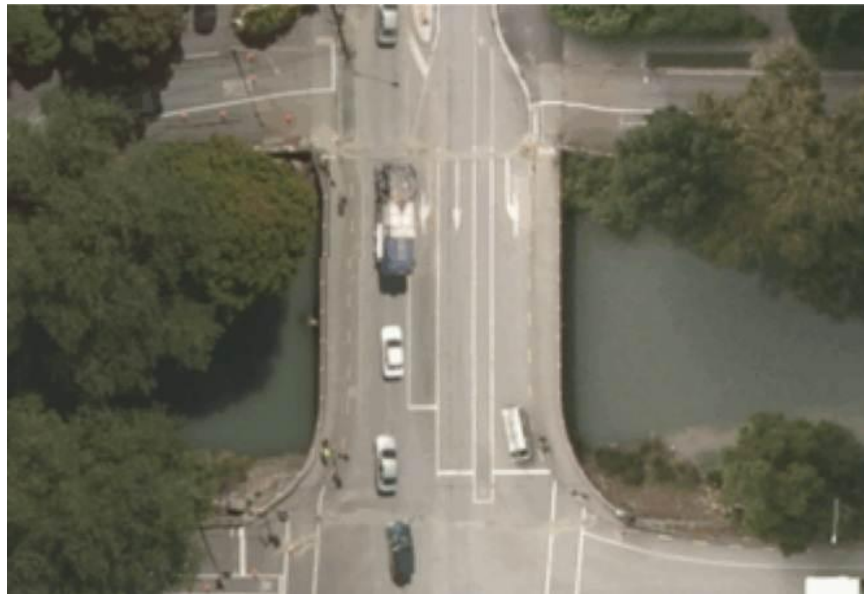
Figure 7-10. Satellite image of Stanmore Road Bridge post-earthquake (LINZ 2011). (-43.5252° , 172.6571°)

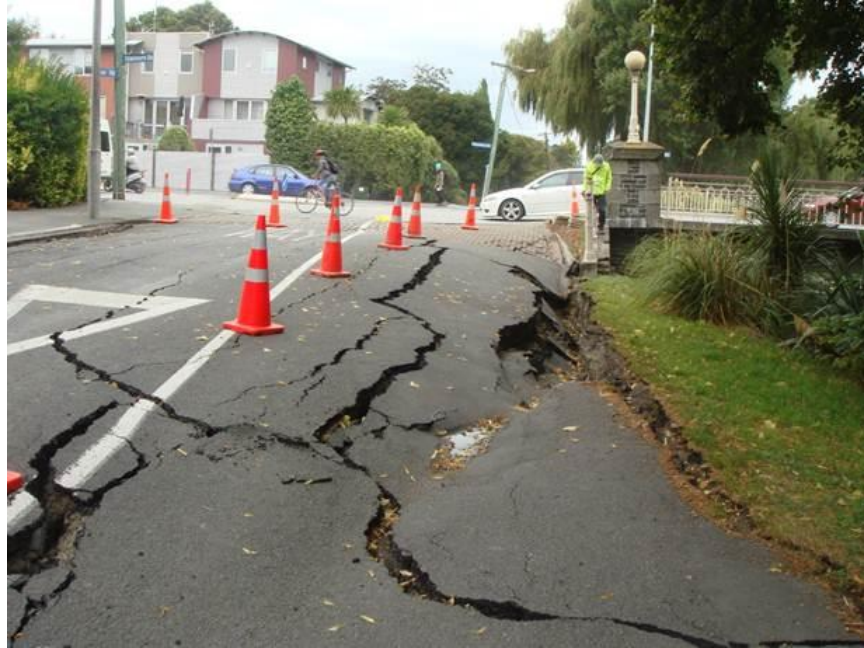
Figure 7-11. Photograph of the west side of the northern approach looking east. Note the lateral spreading cracks running parallel with the river. (-43.5252°, 172.6571°)

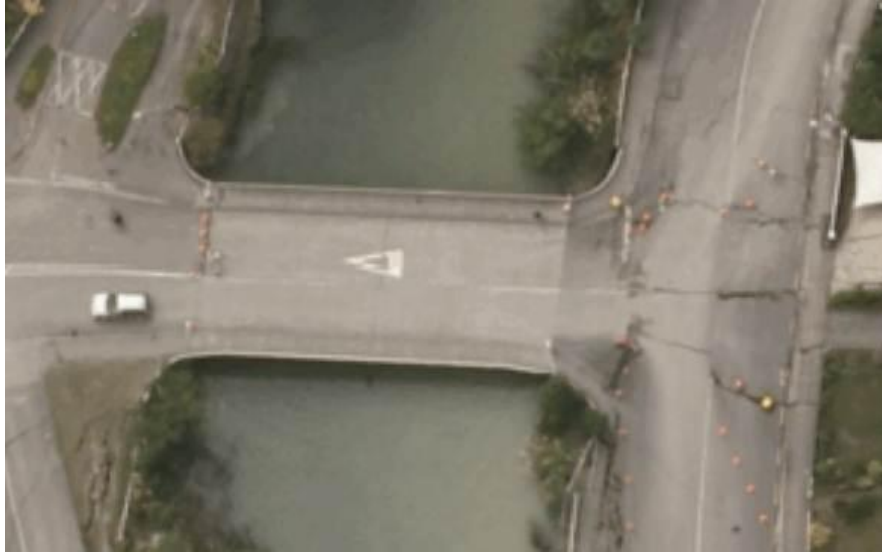
Figure 7-12. Satellite image of Swanns Road Bridge post-earthquake (LINZ 2011). (-43.5222°, 172.6601°)

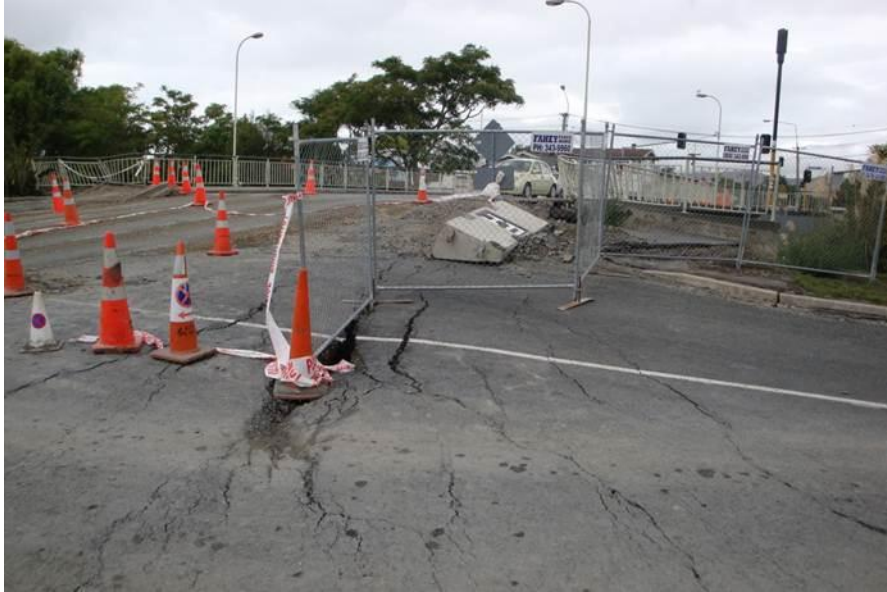
Figure 7-15. Photograph of the approach to the north abutment. Note the aggregate resurfacing and extensive pavement cracking. (-43.5216°, 172.6728°)

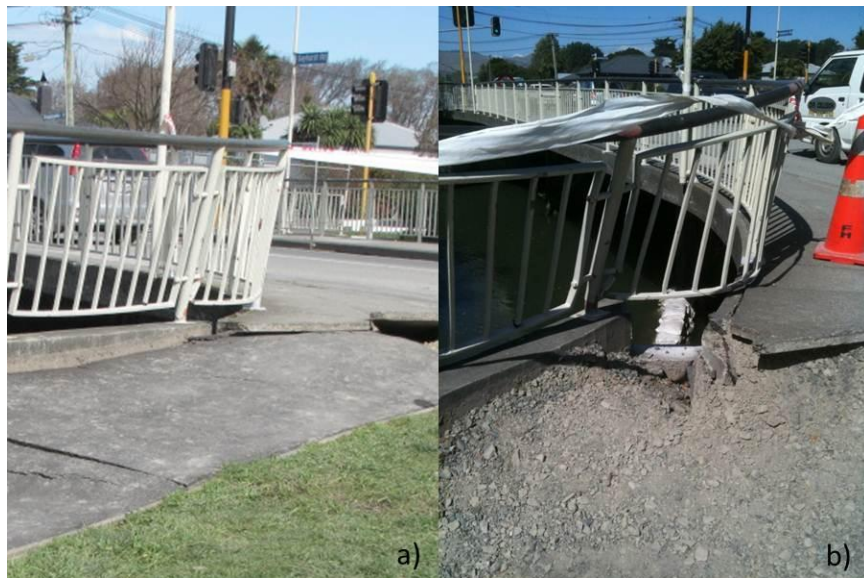
Figure 7-16. Photograph of the north approach of Gayhurst Road Bridge looking southwest. Note the displacement of the wingwall in the (a) Darfield event (GEER 2010) and (b) Christchurch event. (-43.5216°, 172.6728°)

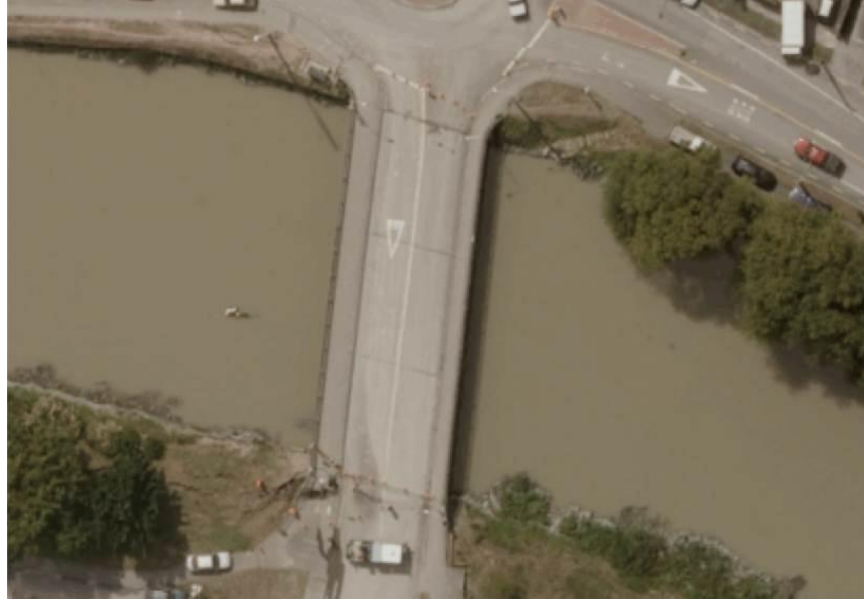
Figure 7-18. Satellite image of Avondale Road Bridge post-earthquake (LINZ 2011). (-43.5005°, 172.6878°)

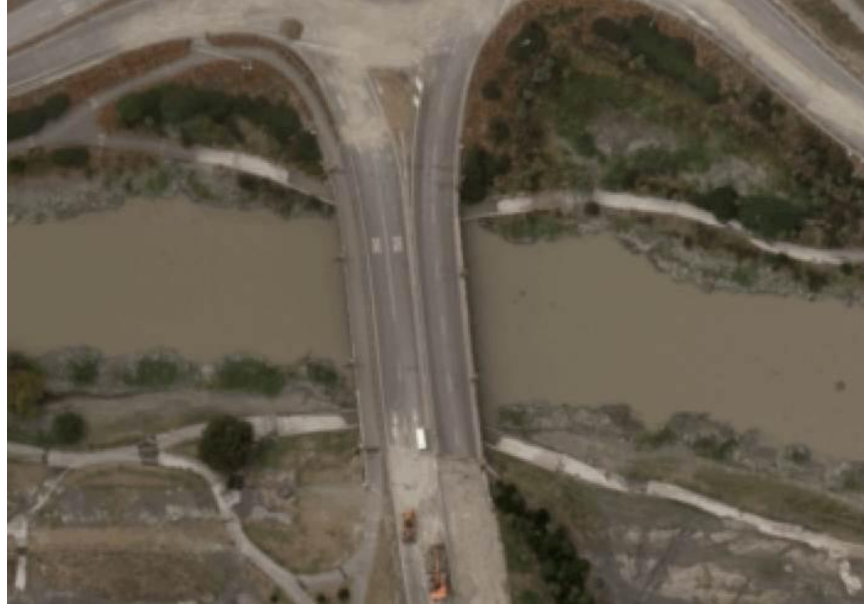
Figure 7-20. Satellite image of Anzac Drive Bridge post-earthquake (LINZ 2011). (-43.5009°, 172.7012°)

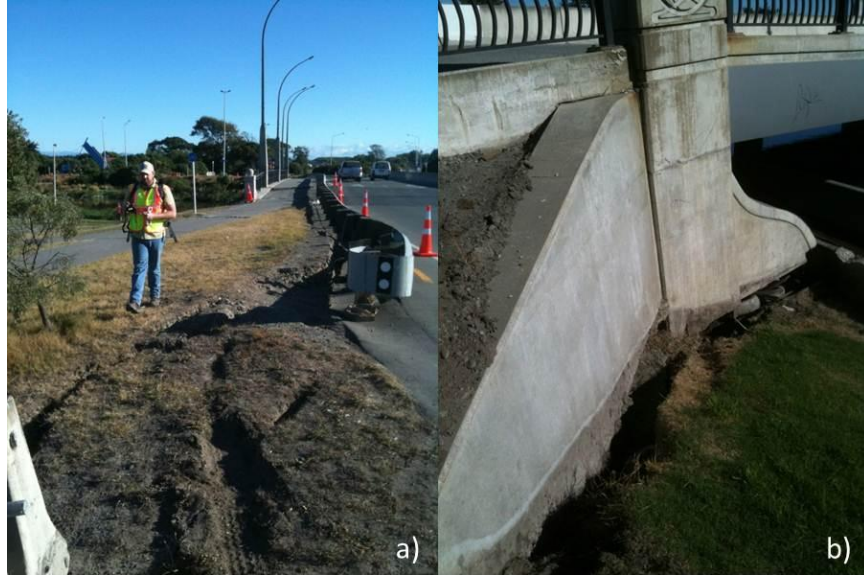
Figure 7-22. Photograph of the south approach and abutment. Note the (a) longitudinal cracks in the approach and (b) back rotation of the abutment and the gap between the soil and the abutment. (-43.5009°, 172.7012°)

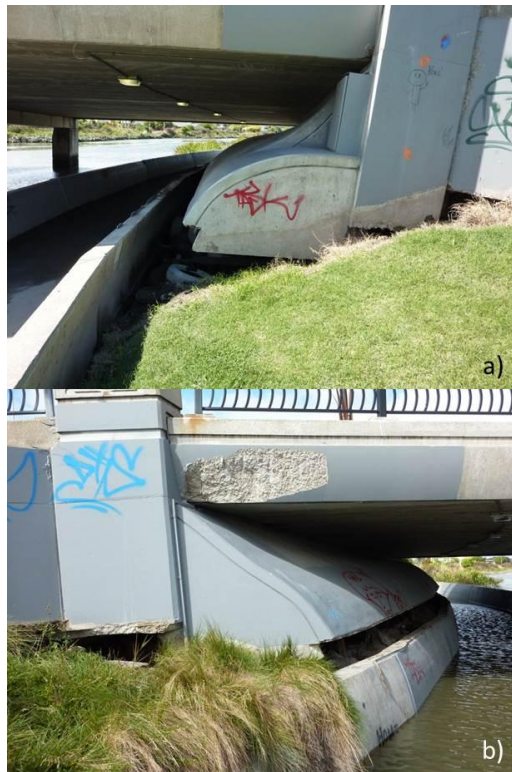
Figure 7-23. Photographs from looking east of the movement of the a) south abutment; b) north abutment. (-43.5009°, 172.7012°)

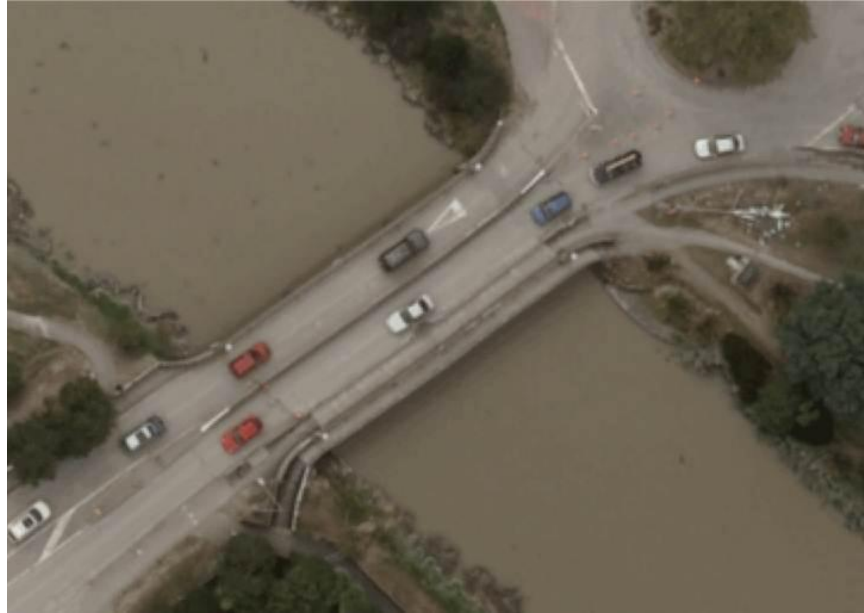
Figure 7-25. Satellite image of Wainoni Road Bridge post-earthquake (LINZ 2011). (-43.5034°, 172.7076°)

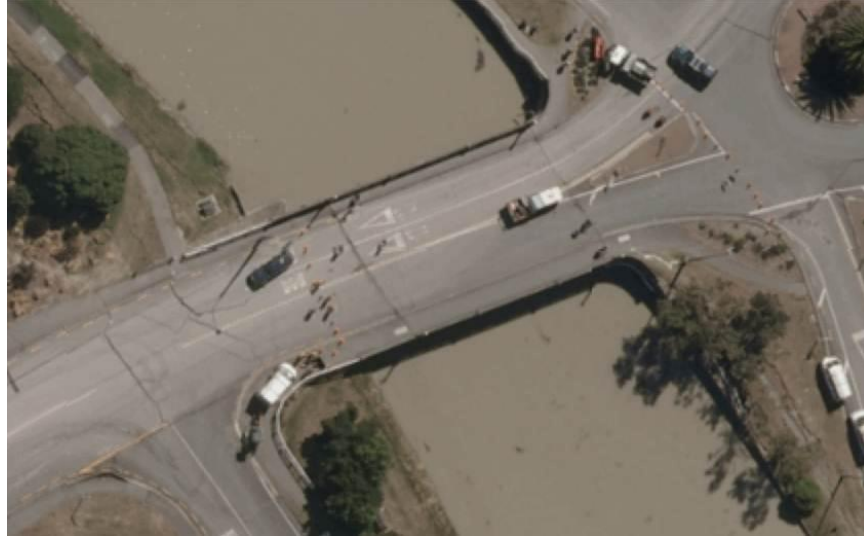
Figure 7-26. Satellite image of Pages Road Bridge post-earthquake (LINZ 2011). (-43.5092°, 172.7214°)

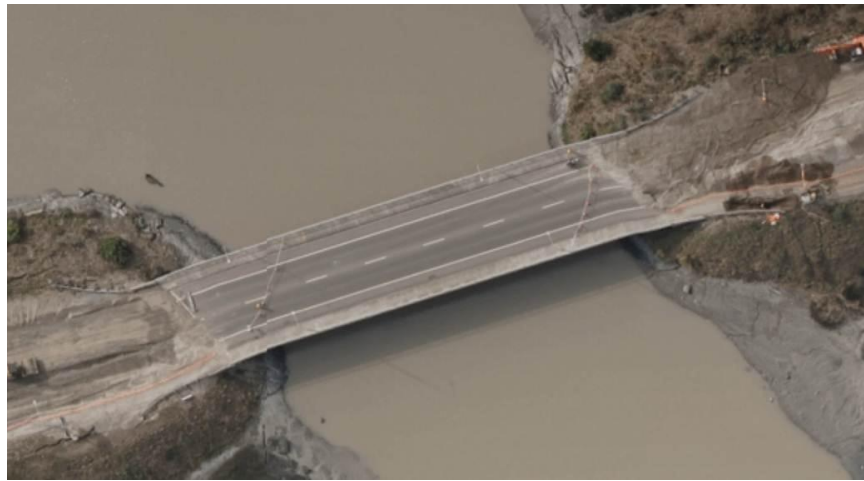
Figure 7-27. Satellite image of South Brighton Bridge post-earthquake (Land Information New Zealand 2011). (-43.5253°, 172.7242°)

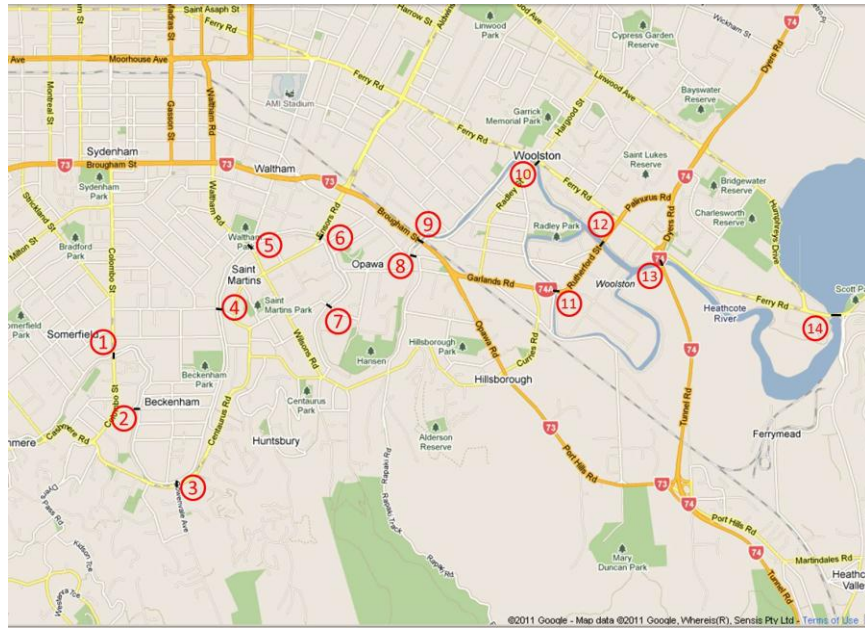
Figure 7-32. Vicinity map showing the locations of Heathcote River bridges that were surveyed by the GEER team (Google 2011).

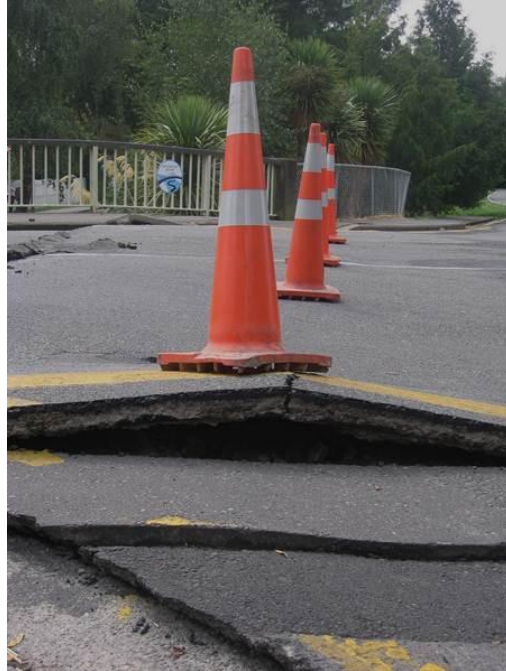
Figure 7-33. Approach damage at Malcolm Avenue Bridge (2) (Flickr 2011). (-43.565073 °, 172.639302°)

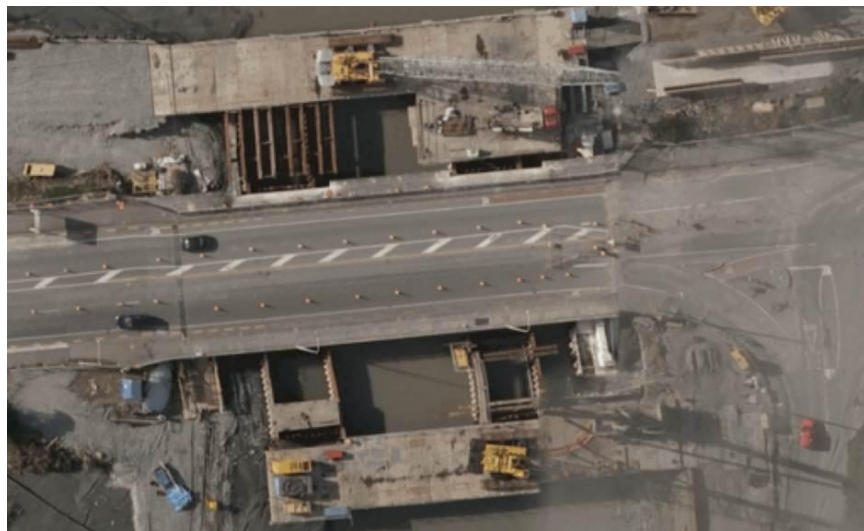
Figure 7-34. Satellite image of Ferrymead Bridge post-earthquake (LINZ 2011). (-43.5584°, 172.7088°)

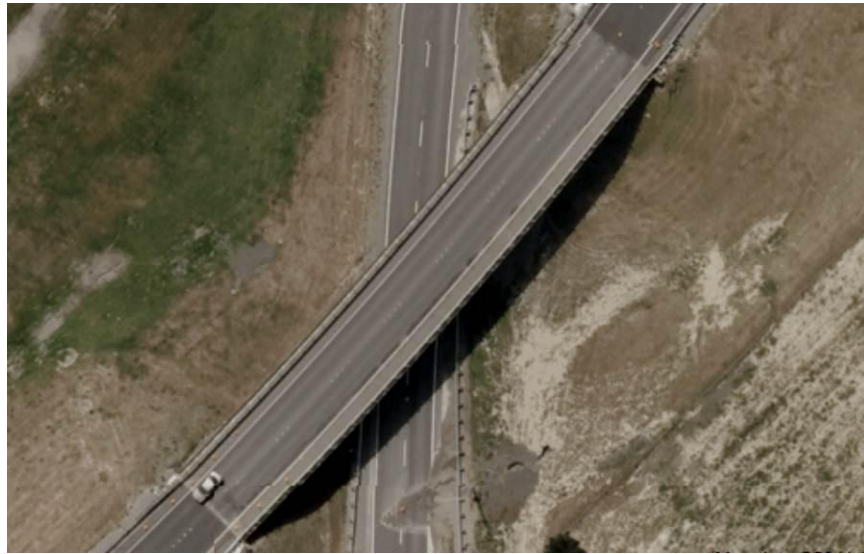
Figure 7-38. Satellite image of Chaney's Overpass Bridge post-earthquake (LINZ 2011).
(1) (-43.4298°, 172.6463°)

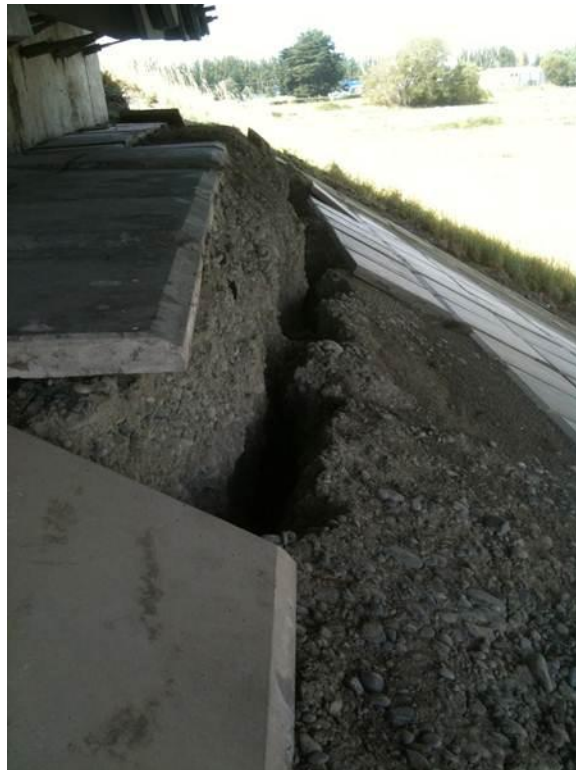
Figure 7-40. Photograph of the top of the slope at the northeast abutment looking southeast. Note the transverse crack. (-43.4298°, 172.6463°)

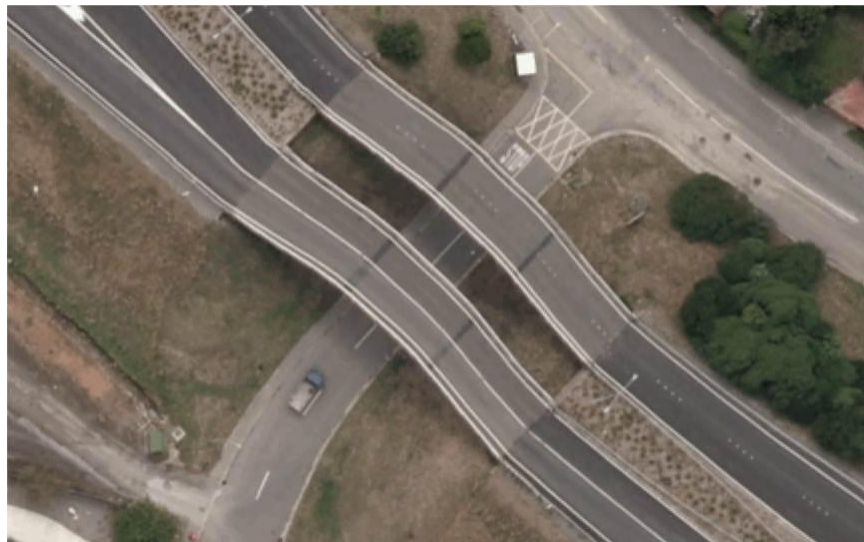
Figure 7-41. Satellite image of Horotane Bridge post-earthquake (LINZ 2011). (-43.5725° , 172.6947°)

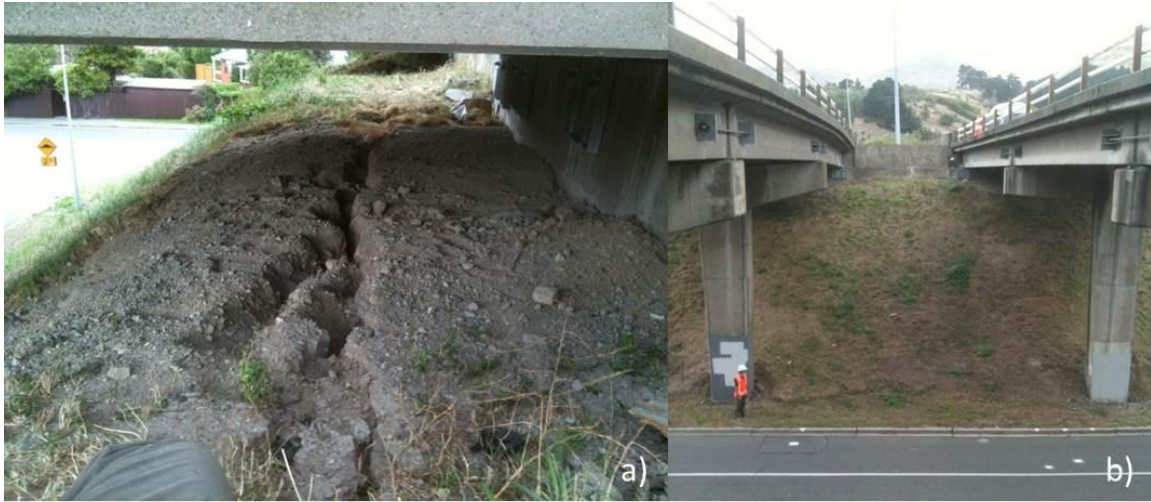
Figure 7-42. a) Transverse crack running along the crest of the slope near the southeast abutment; b) toe scarp running horizontally between the columns of the southeast abutment. (-43.5725°, 172.6947°)

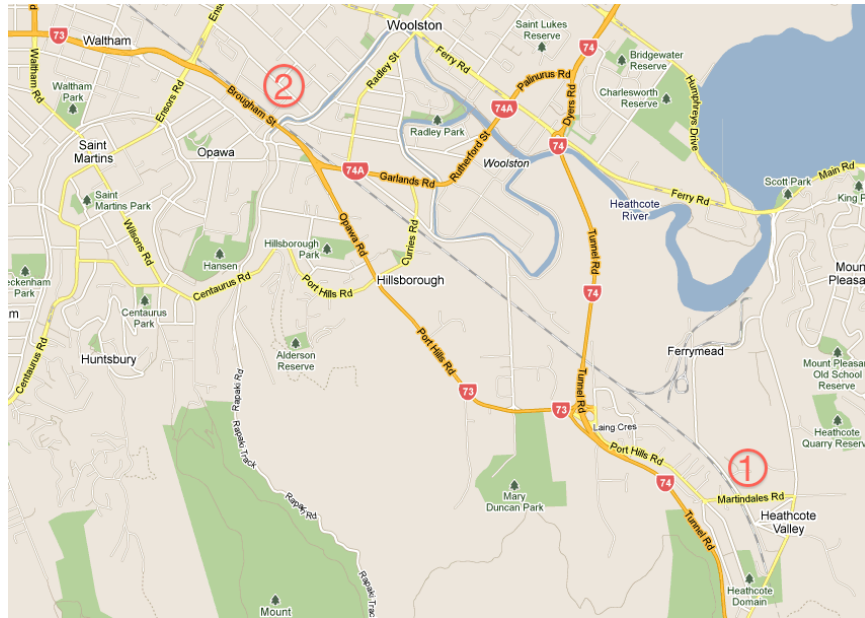
Figure 7-43. Vicinity map showing the locations of the railway bridges that were surveyed by the GEER team (Google 2011).

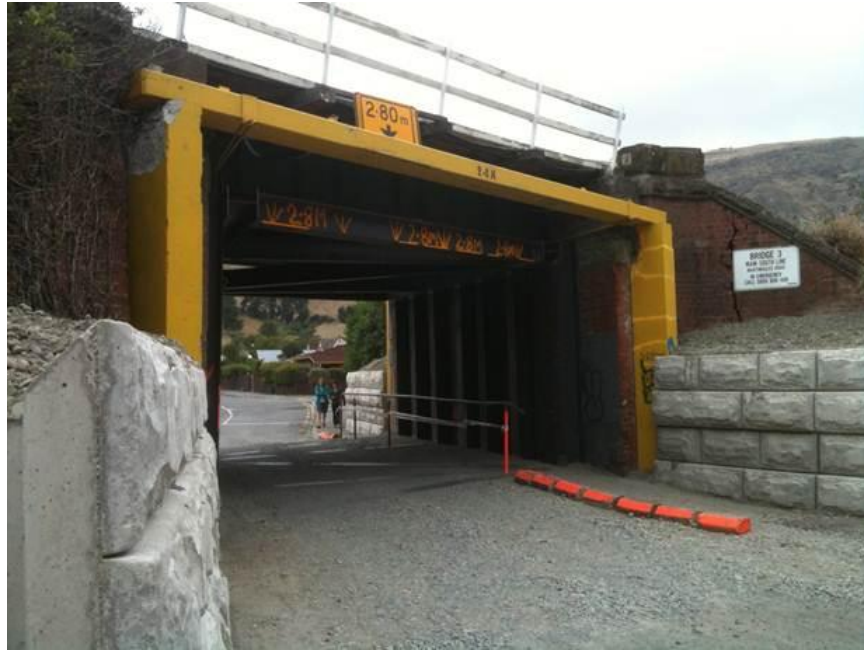
Figure 7-44. Photograph of Railway Bridge 3 after repairs had been made. (-43.575963°, 172.706382°)

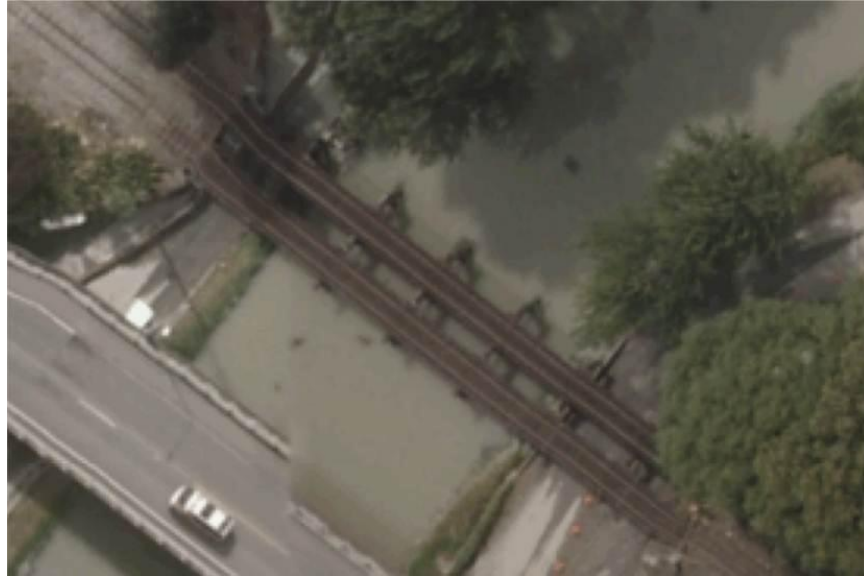
Figure 7-45. Satellite image of Railway Bridge 7 post-earthquake (LINZ 2011). (-43.5529°, 172.6676°)

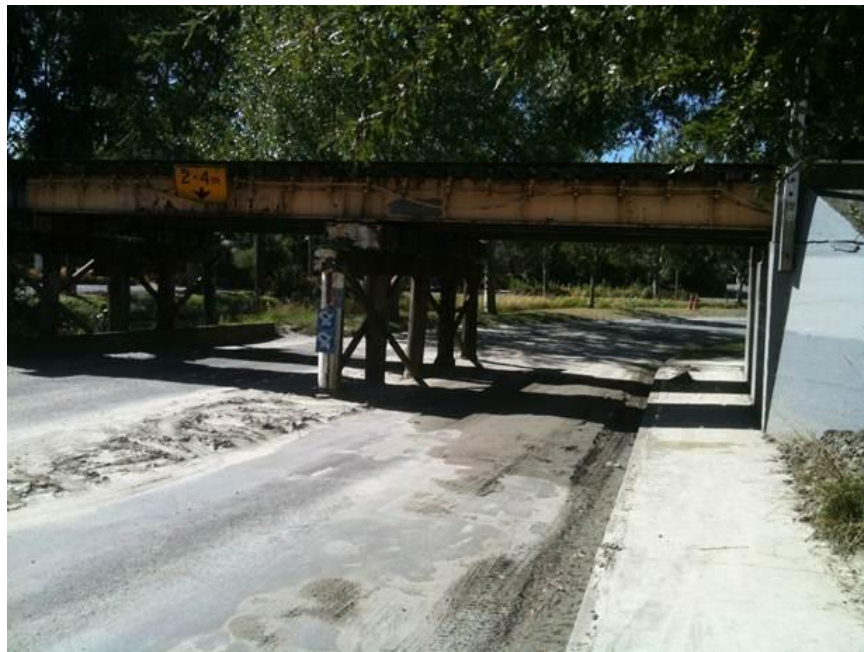
Figure 7-46. Photograph of the northeast abutment looking northwest. Note the sand deposits on the roadway and the horizontal crack at the top of the abutment. (-43.5529°, 172.6676°)
