8. EFFECTS ON LIFELINES

This chapter includes the GEER-NZ Team’s observations for the transportation system (highways and rail and bridges are covered in separate chapters), water and wastewater systems, electric power, and waste management, as well as other lifelines.

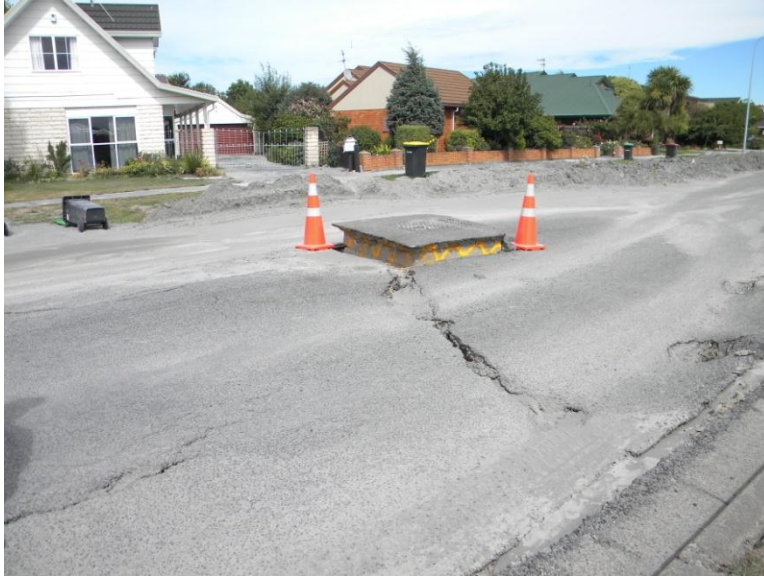
Many surface streets were closed and severely damaged in Christchurch as a result of liquefaction and lateral spreading (Chapter 4). A floated manhole is seen in Figure 8-1 on Orrick Crescent. Figure 8-2 shows a large lateral spread on the north bound lanes of Fitzgerald Avenue and Cambridge Tce.

Figure 8-1. Floated manhole on Orrick Crescent (-43.50174°, 172.696487°).

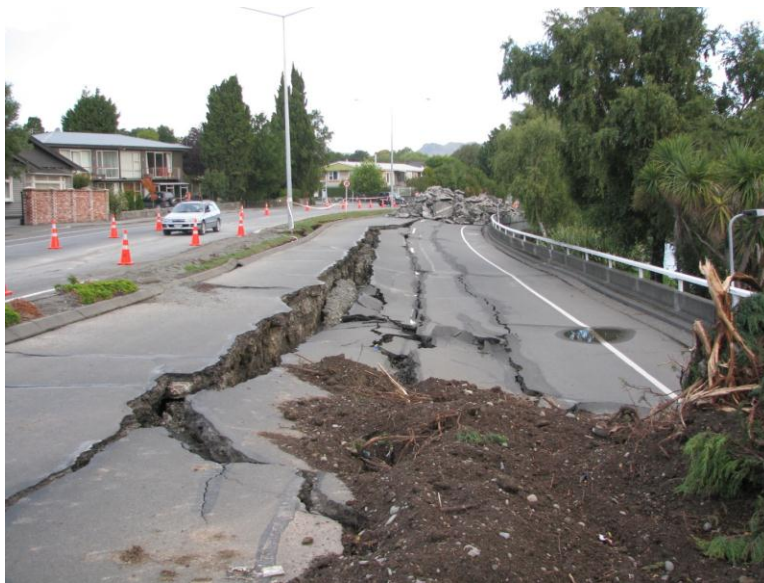
Figure 8-2. Lateral spreading at Fitzgerald Avenue along the Avon River (-43.524048°, 172.650851°).

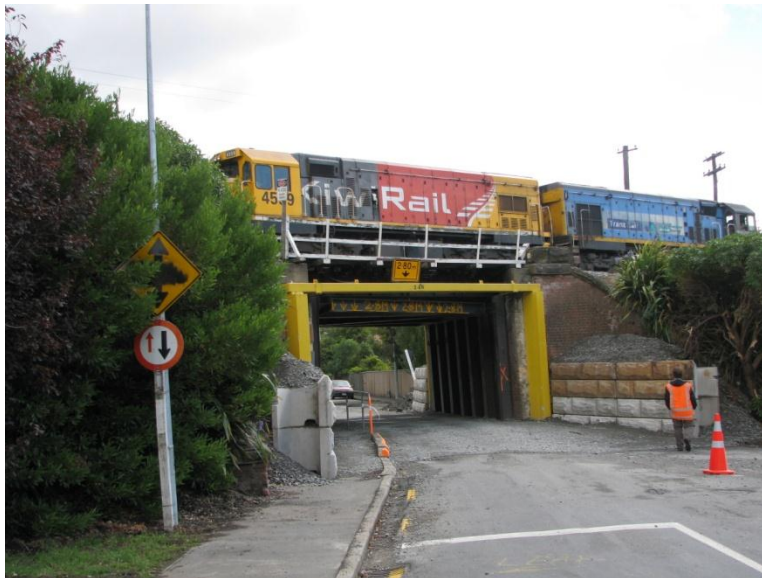
KiwiRail operations in and out of the Port of Lyttelton were halted for 11 days as a result of the 22 February earthquake. KiwiRail sustained damage to two bridges in Christchurch which are described in more detail in the Chapter 7. These bridges are located between the Annex Road rail yard and Heathcote Valley, which resulted in no rail access to the port. Bridge No. 7 sustained minor damage to its abutments and remained operational and did not require repair. Bridge No. 3 at Martindales Road in the Heathcote Valley sustained moderate damage to the abutments and resulted in a six car derailment (Figure 8-3). KiwiRail was able to repair the bridge within two days after the event.

Figure 8-3. Bridge No. 3 at Martindales Road in the Heathcote Valley (-43.576013°, 172.706567°).

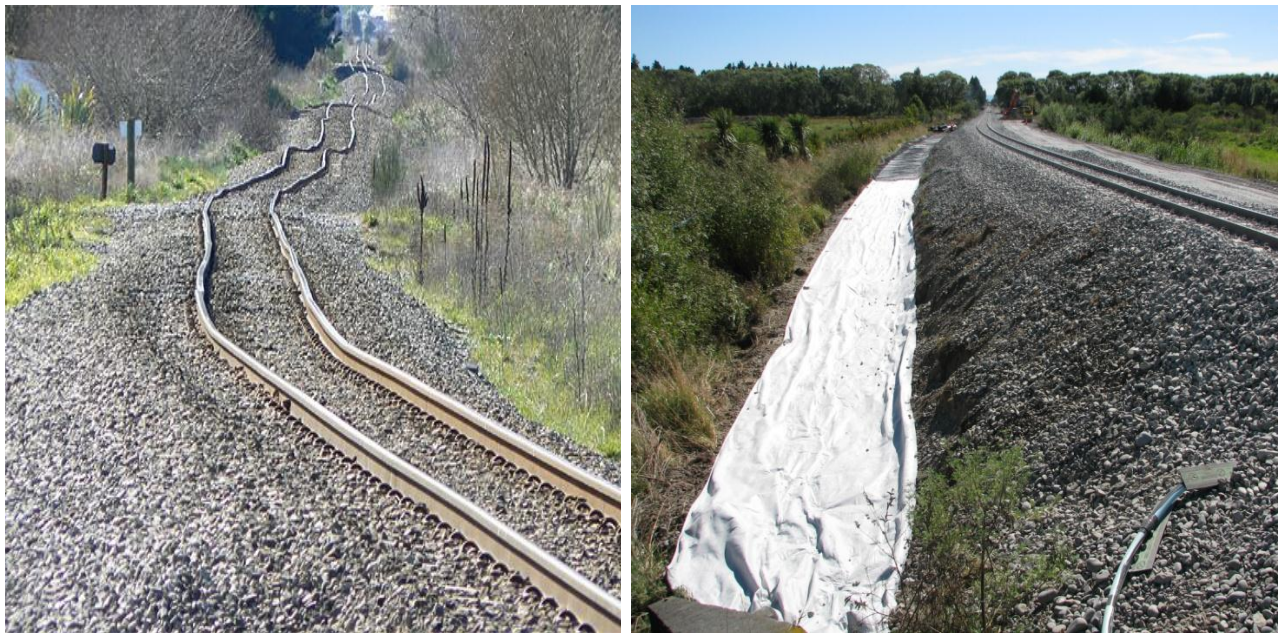
The GEER team visited the section of rail south of Kaiapoi at Woodford Glen that suffered damage during the September 2010 event (Figure 8-4a). Liquefaction was found in the fields adjacent to the damaged area but no damage to the track was reported. KiwiRail was in the processes of widening the ballast over the soft soils as a precautionary measure (Figure 8-4b). The team also found that a separation geotextile and reinforcing geogrid were being installed. Aside from the two damaged bridges no other damage was caused to rail lines.

Figure 8-4. (a) Damage to rail line at Woodford Glen after 4 Sept. event, (b) Rail line at Woodford Glen after 22 Feb. event with additional ballast being added (-43.406114°, 72.649319°)

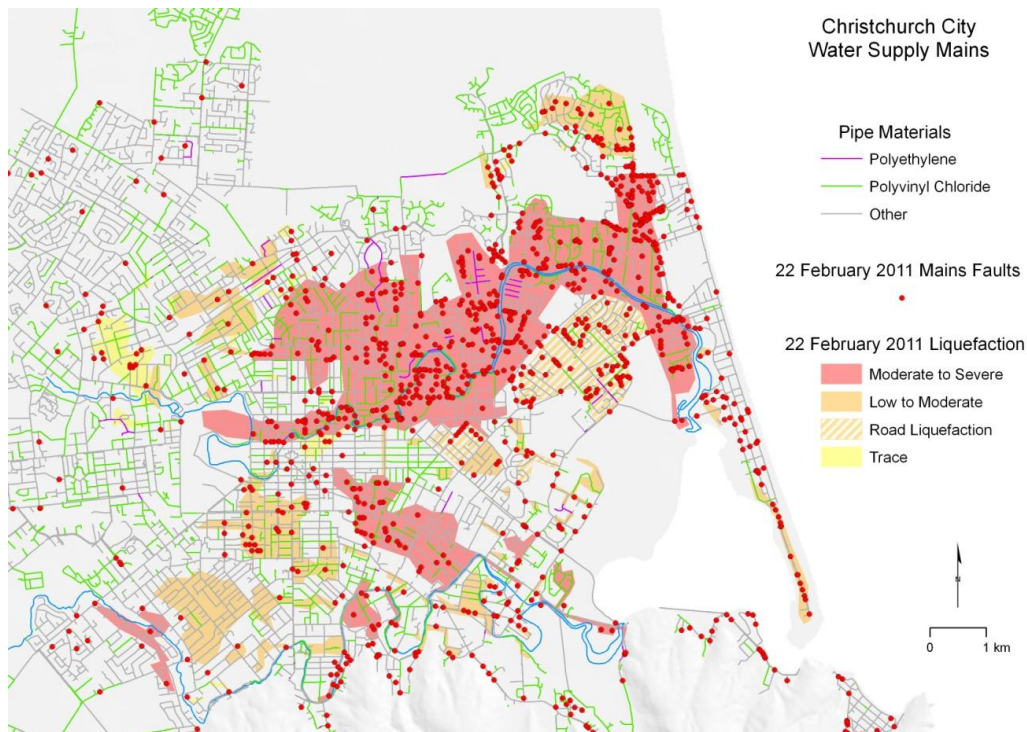
The potable water system is a system of relatively shallow pipe network (mostly in the top 60 cm of the ground). It is a pressurized system composed of mains and sub-mains. Figure 8-5 shows a summary of the water mains network in Christchurch indicating pipe materials (solid lines) and the location of breaks (red solid symbols) caused by the 22 February earthquake. Superimposed in this figure is the liquefaction map (Chapter 4) indicating the areas affected with different severity of liquefaction. It is apparent from this figure that most of the breaks were located in the area affected by liquefaction. A more rigorous preliminary analysis indicates that about 4.6 % of the pipes (pipe segments) were damaged, or about 78 km out of 1676 km total pipe length. About 80% of the damaged pipes were in areas that manifested either moderate-to-severe or low-to-moderate liquefaction. Similar observations and preliminary findings were obtained for the sub-mains system which is dominated by polyethylene (PE) pipes. Despite the relatively large number of breaks, the potable water supply was quickly restored within several days of the earthquake.

Figure 8-5. Water mains pipe network and location of breaks (faults) caused by the 22 February 2011 earthquake; colored lines indicate pipe materials; colored areas indicate liquefaction severity.

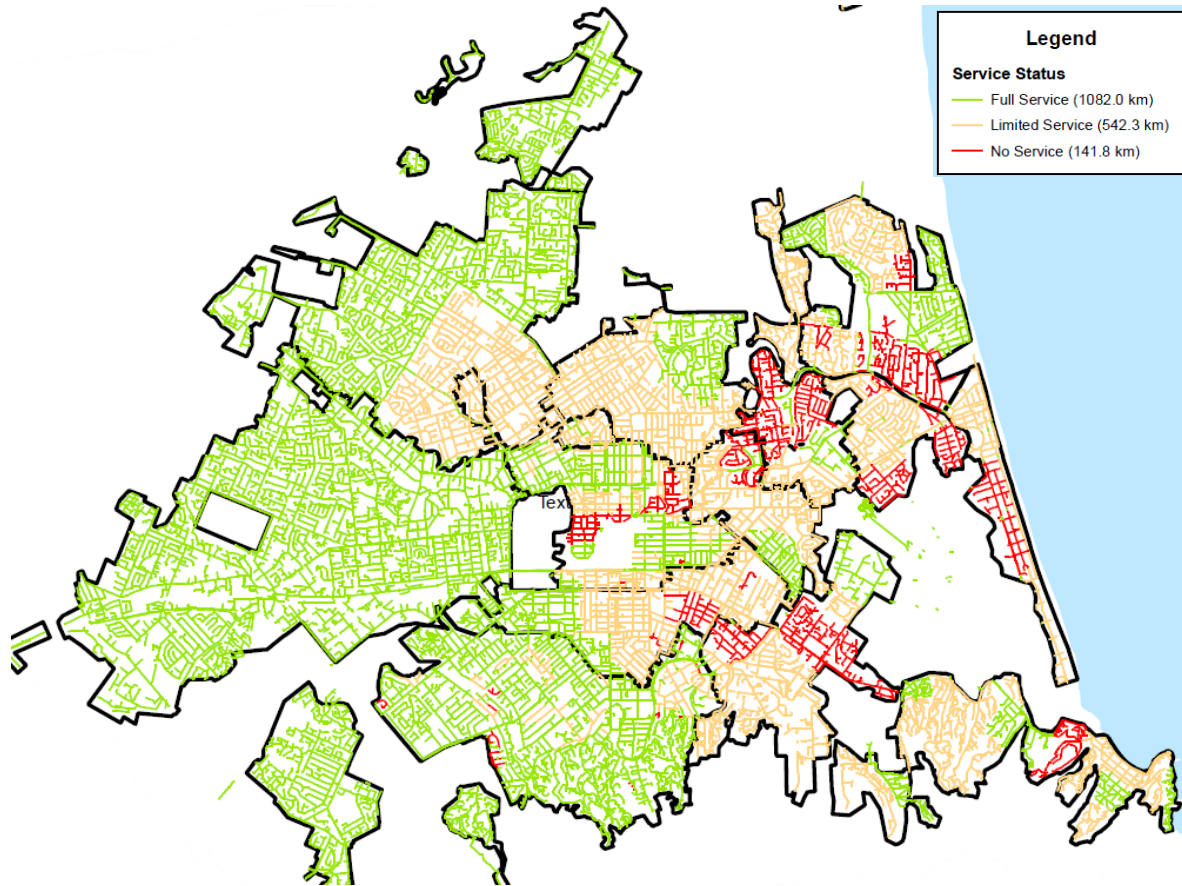
The wastewater system was hit particularly hard in the areas severely affected by liquefaction and lateral spreading. Out of the 1766 km long wastewater network, 142 km (8%) were out of service; and 542 km (31%) with limited service on 16 March 2011 (i.e. three weeks after the February earthquake), as shown in Figure 8-6. A significant part of the network was still out of service even three months after the quake, and it is estimated that it will take two to three years to fully recover the system.

Figure 8-6. Waste water service status on 16 March 2011 (M. Christinson, pers. comm.)

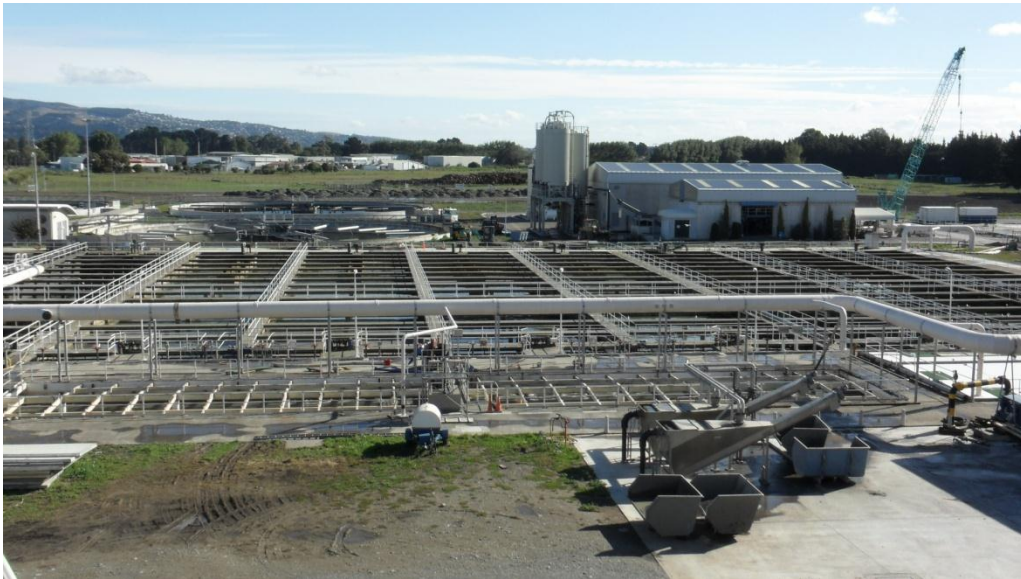
Nearly all components of the Bromley sewage treatment plant were affected by liquefaction, which caused differential settlement of the clarifiers, thereby seriously impairing secondary treatment capabilities. Silt and sand from liquefaction washed into the plant from broken wastewater pipelines, causing damage in the primary settling tanks. Also, the scraper chains in the settling basins (Figure 8-7) had jumped their cogs.

Figure 8-7. Waste Water Treatment Plant Settling Basins (-43.526016°, 172.700922°)

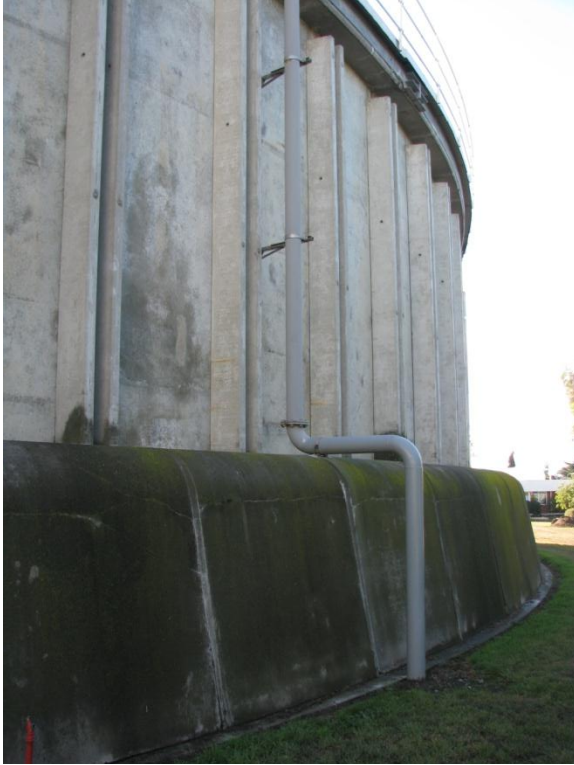
(a)

The trickling filters at Bromley sewage treatment plant appeared to perform well (Figure 8-8a). The team was told that the filters were placed on stone columns. The team also documented 25-50 mm of lateral movement (Figure 8-8b). The filters did suffer some damage in that the distributor was not operating properly.

Figure 8-8. Bromley Waste Water Treatment Plant trickling filters placed on stone columns performed well (-43.52118°, 172.701752°)

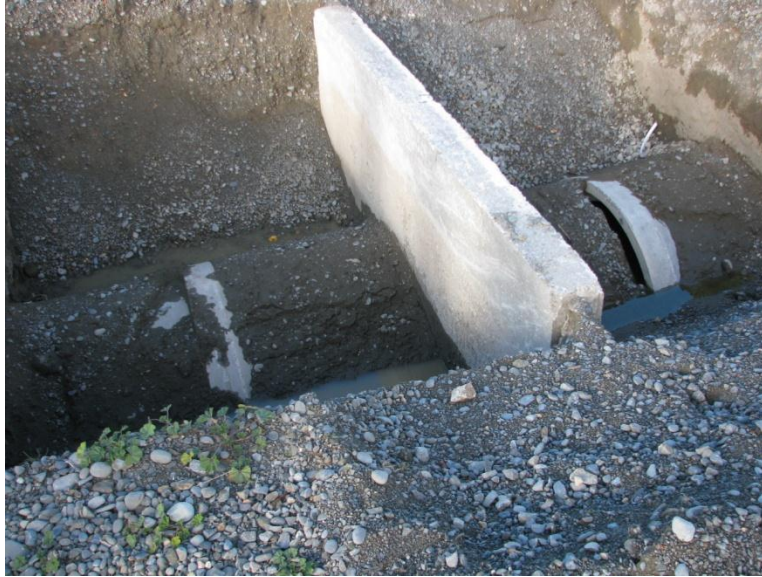
The team completed their reconnaissance of the Bromley sewage station by walking the levees (stopbanks) at the oxidation pond. The team noted several separated concrete pipes that were used to move water from one pond to another during the treatment process (Figure 8-9). Lateral spreading in the stopbank separated pipes.

Figure 8-9. Pipe damage at the oxidation ponds (-43.3145211°, 172.430083°)

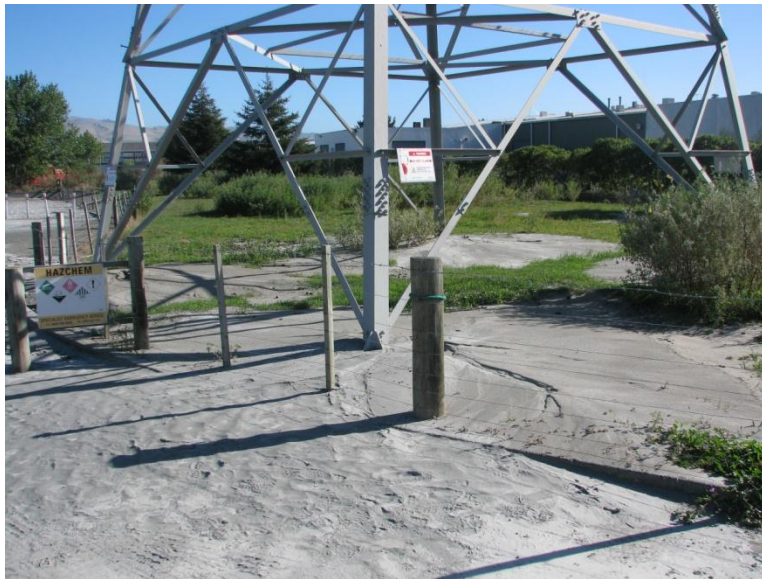
Liquefaction ejecta was found at the substation on both sides of the road. The soils under both power line supports outside of the fence line liquefied (Figure 8-11). Liquefaction ejecta was found around concrete pile groups supporting circuit switchers (Figure 8-12) and earthquake retrofitted transformers. No visible damage or settlement to substation was found by the GEER and it appeared that it performed well.

Figure 8-11. Liquefaction ejecta at the base of an electrical tower (-43.531764°, 172.697467°)

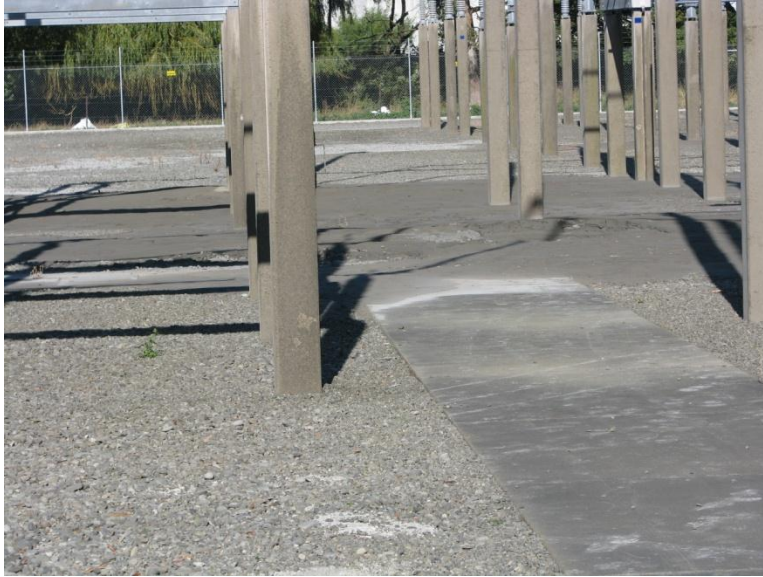
Figure 8-12. Liquefaction ejecta around concrete (-43.532629°, 172.698029°)

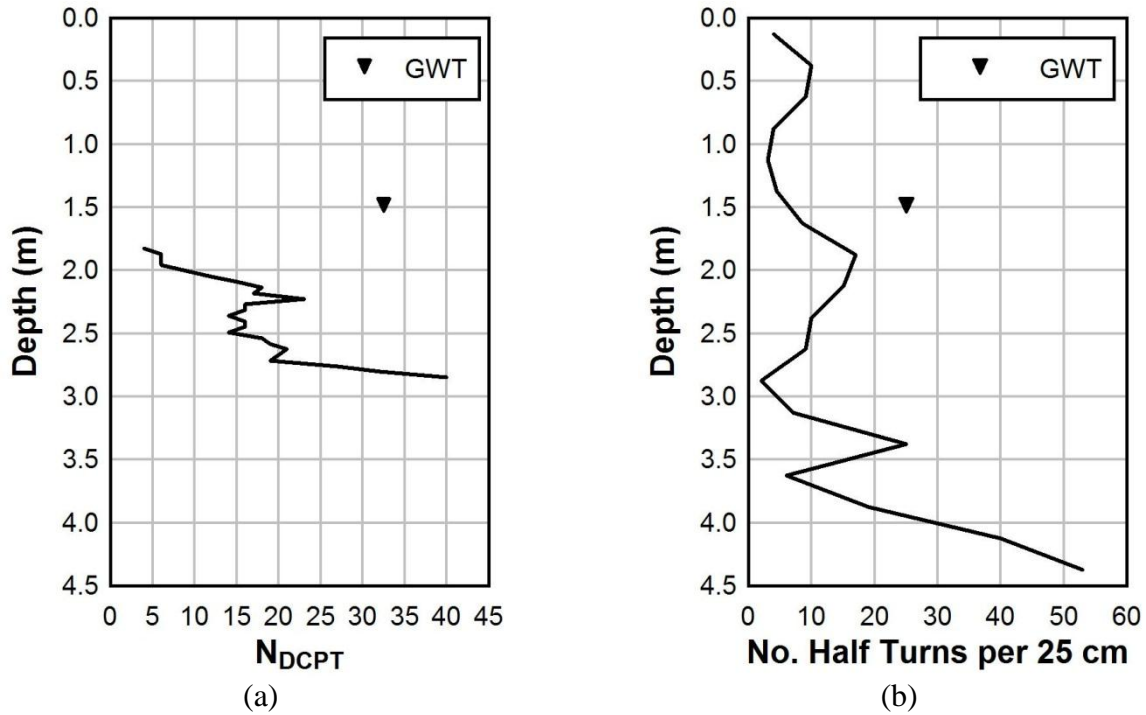
DCP and SWS tests were performed by the GEER team (Figure 8-13) and the data are presented in Figure 8-14. SASW data could not be collected due to the high voltage power line interference. As shown in Figure 8-14, the groundwater table was at depth of ~1.5 m and the top of the liquefied layer was at a depth of ~1.75 m. (Note that a hole was hand augered to the top of the liquefied layer, with the DCP being performed in the hole from then down to refusal).

Figure 8-14. In-situ data from Bromley Substation: (a) DCP test; and SWS test.
