9. ROCKFALL AND LANDSLIDES

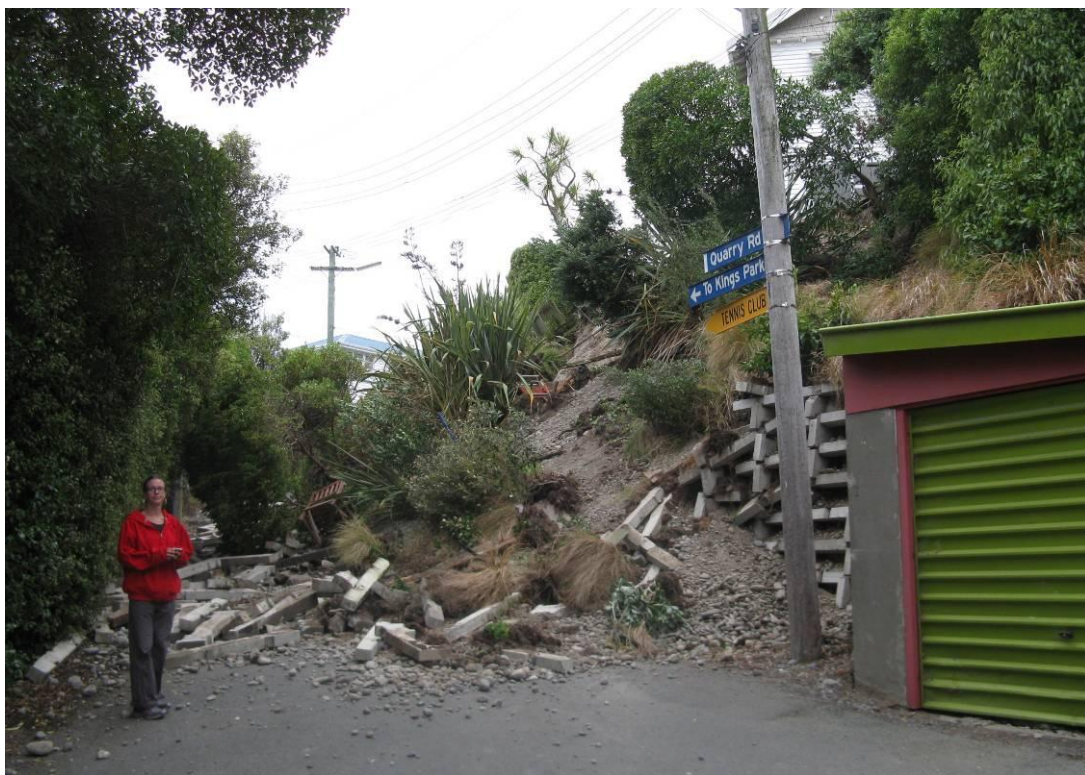
Numerous rockfall, block failures, or slumps were observed in over-steepened road cuts and quarry walls composed of weathered volcanic rocks and overlying loess, even where retaining walls were present, as shown on Figures 9-3 and 9-4 from the upland suburb of Mt Pleasant. These over-steepened cut slopes had approximate inclinations of $\frac{1}{4}H:1V$ or steeper; and were from 1 to 10 meters high for the road cuts in loess and up to 100 m high for quarry faces in the volcanic rocks. For the loess slopes, the failed material formed a debris apron covering half or more of the road.

Figure 9-3. Failed retaining wall and slumping in loess, blocking a road on lower Mt Pleasant (-43.55617°, 172.7156°).

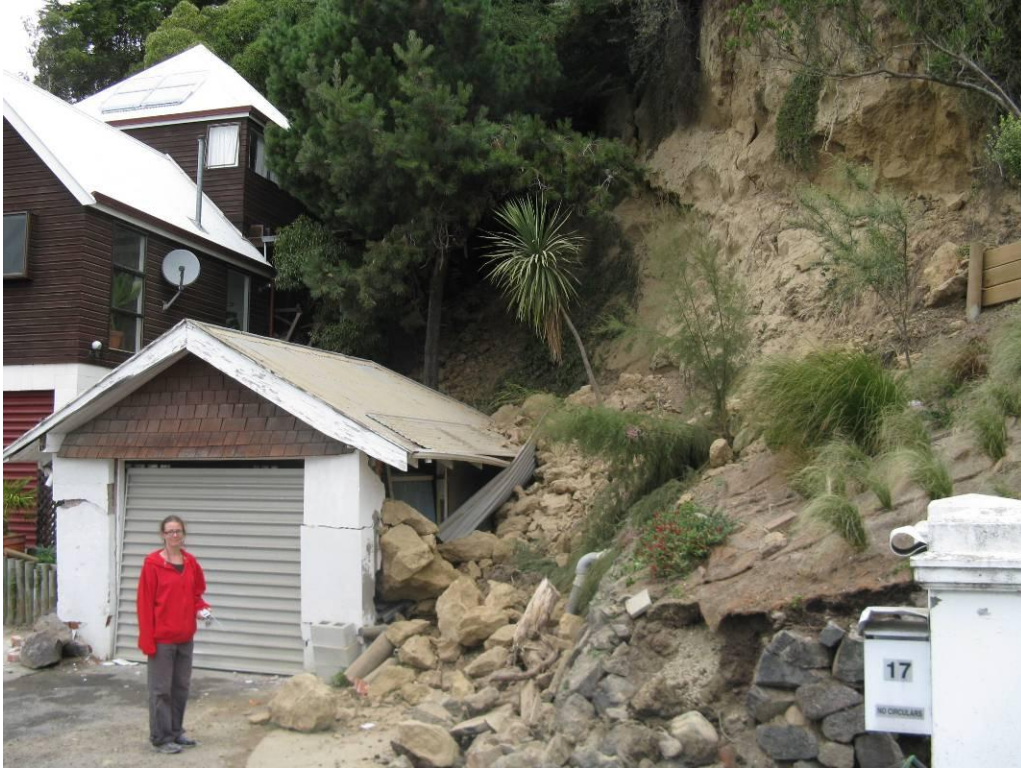
Figure 9-4. Blocks of loess that fell from a 10 m road cut on Mt Pleasant (-43.5565° , 172.7147°).

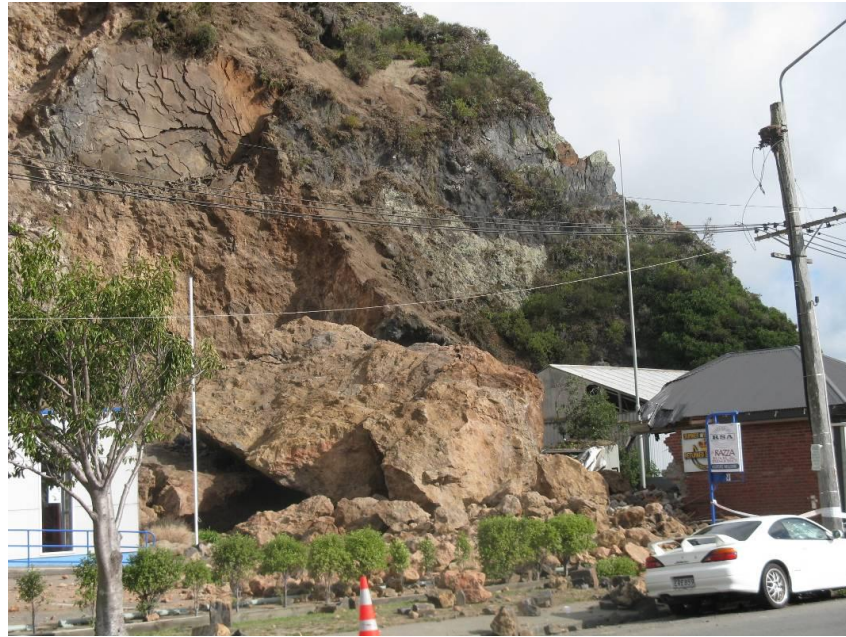
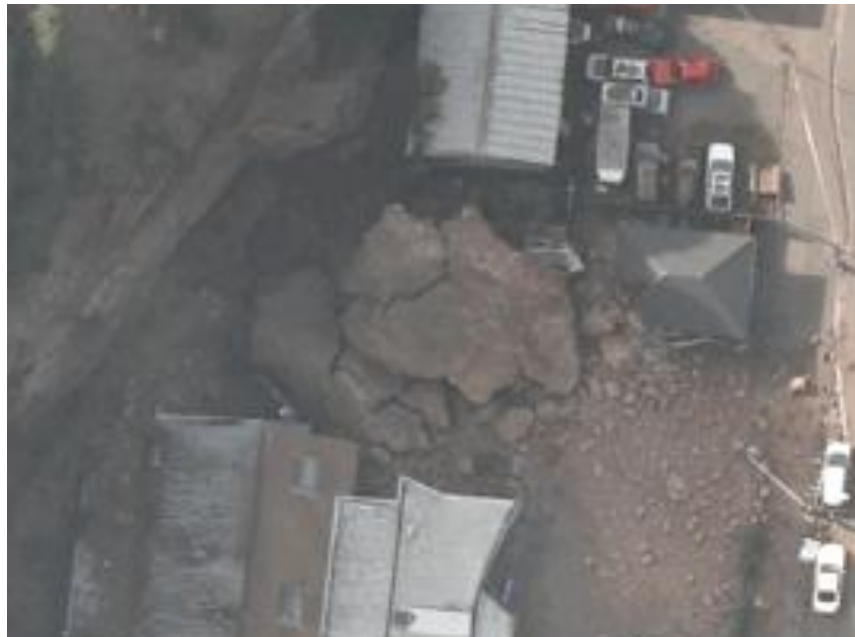
Figure 9-5. The Sumner RSA building was destroyed by a massive block that fell from the cliff-face (-43.5700°, 172.7586°). Top – Street view. Bottom – Aerial view (New Zealand Land Information Post-Earthquake Imagery)

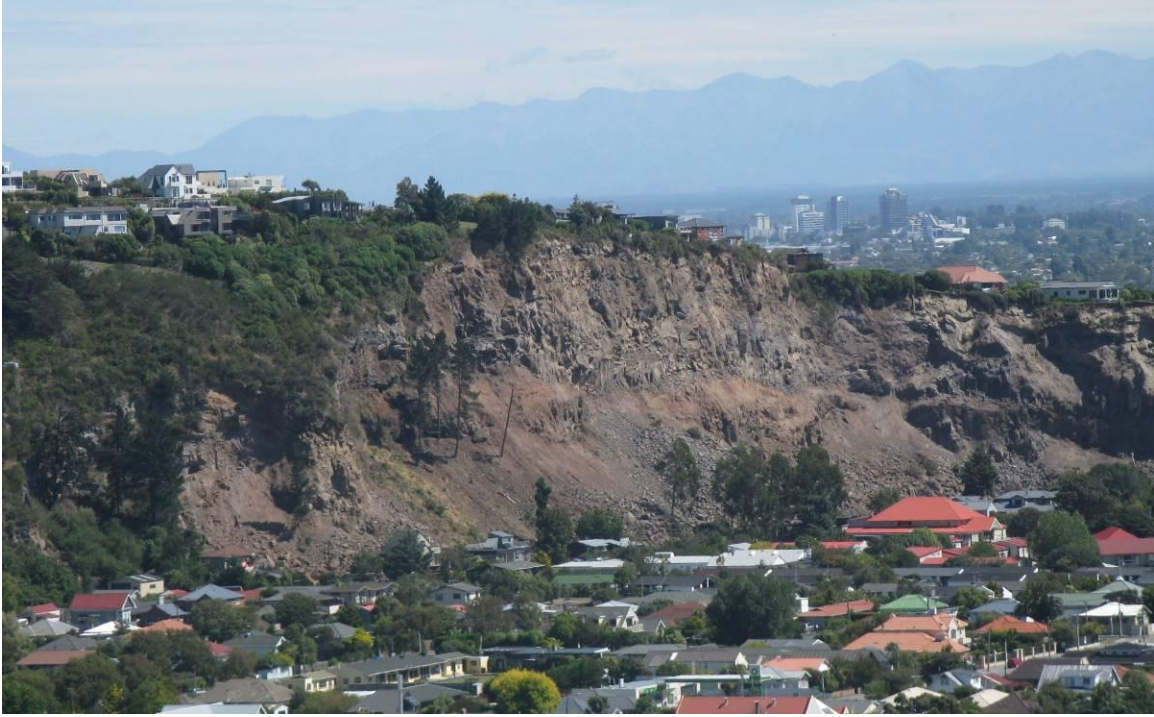
Figure 9-6. Photo showing cliff face in the suburb of Redcliffs, with fresh talus at the base and Christchurch CBD and the Southern Alps in the background (-43.5596°, 172.7374°).

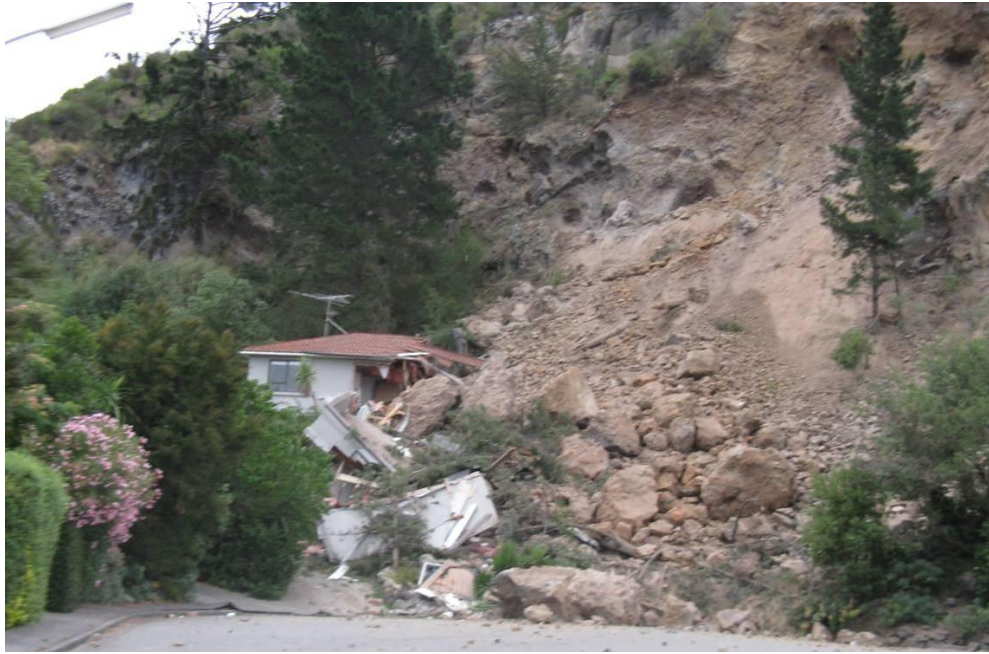
Figure 9-8. Home at the base of cliff in Redcliffs with wedge of talus boulders inundating the structure and roundabout, taken 22 Feb 2011. (-43.5610°, 172.7341°).

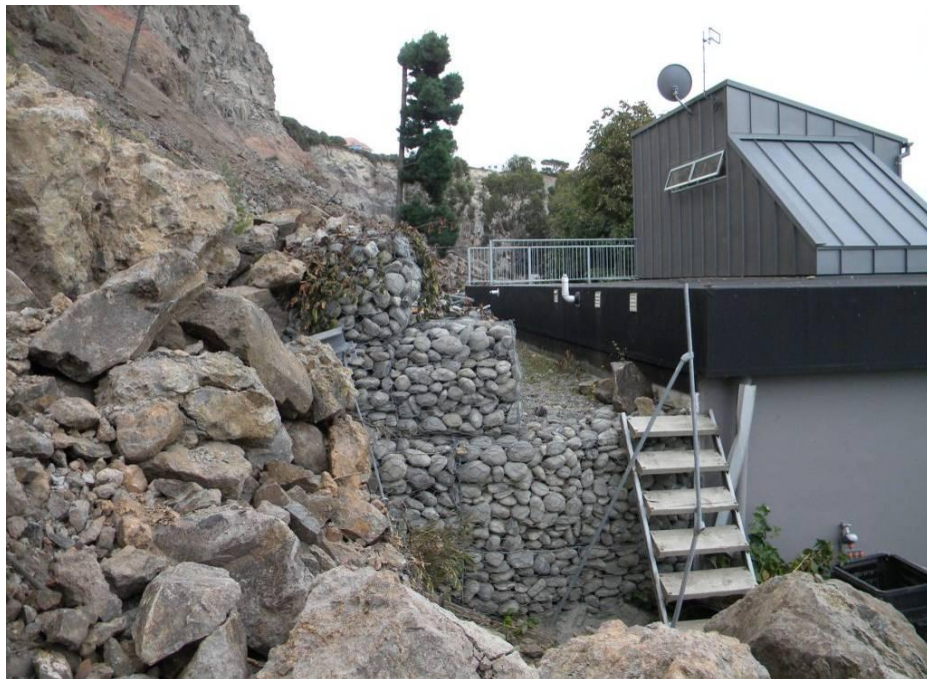
Figure 9-9. Photo showing the gabion behind house at base of cliff in the suburb of Redcliffs. No damage to house from rockfalls was observed (-43.56074°, 172.73379°).

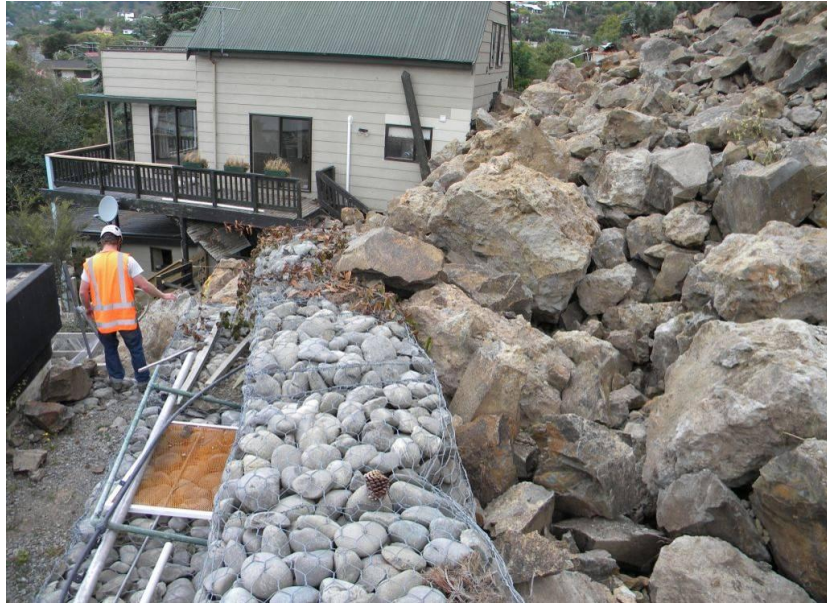
Figure 9-10. Photo showing slight movement of upper part of gabion behind house at base of cliff in the suburb of Redcliffs. Gabion performed well in stopping rockfall and talus from impacting house (-43.56067°, 172.73367°).

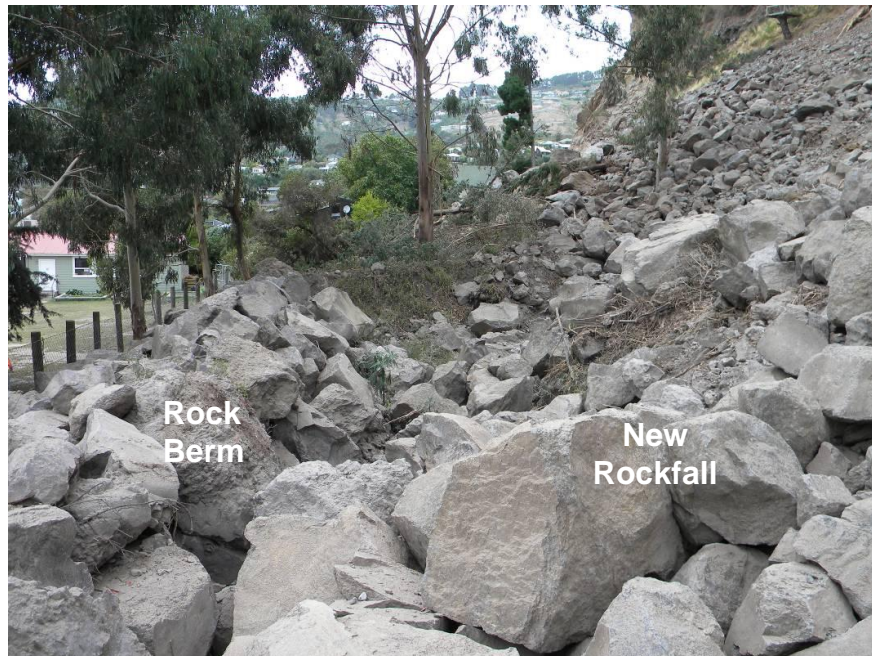
Darfield earthquake (the berm is not present on the 2009 pre-earthquake imagery; Figure 9-7 top). This berm was successful in protecting the schoolyard, as no rocks were observed in the area east of the fence beyond the rock berm (Figure 9-11).

Figure 9-11. Photo showing rock berm constructed to protect schoolyard at base of cliff in Redcliffs. The berm apparently performed well in stopping rockfall and talus as the fence bounding the school field (note wood posts at center left) was not significantly damaged and no rocks were observed on the field (-43.55972°, 172.73298°).

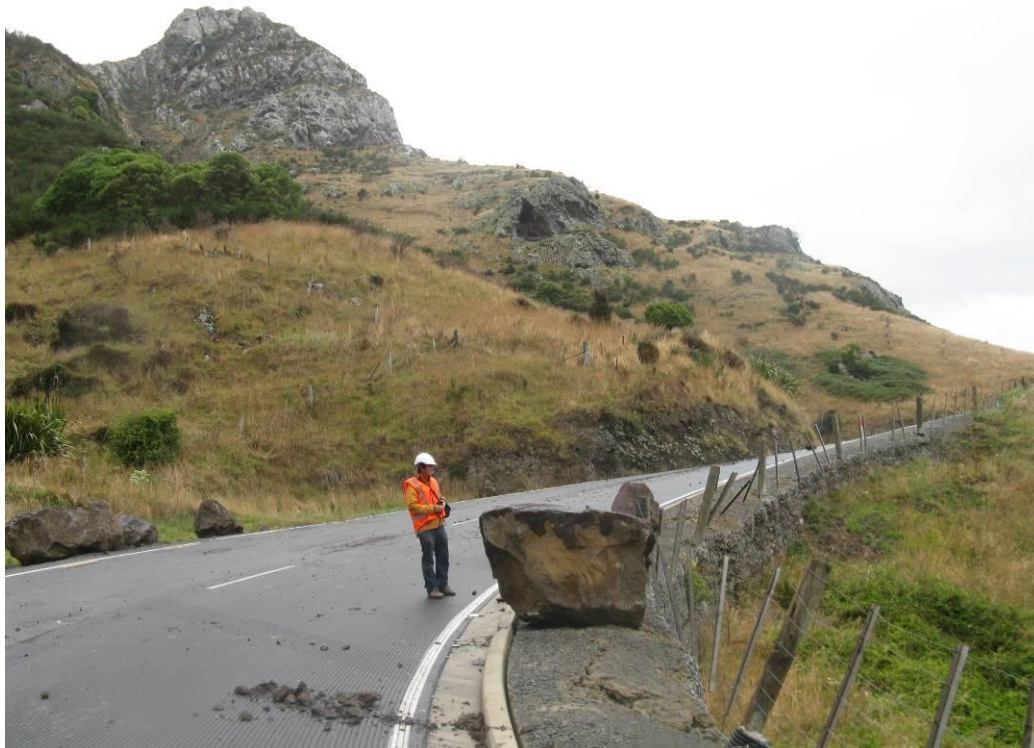
Evan's Pass road, the only direct transportation route and thus a lifeline between Sumner and the Port of Lyttelton, was closed due to rockfall blocking the road and trapping a transport truck. Rockfall and rock topples occurred on many of the over-steepened road cuts and from natural cliffs above the road alignment (Figure 9-12). These failures impeded delivery of relief supplies and critical transport between the port and the southern suburbs. In some locations, rockfalls occurred along bedding planes (e.g. Windy Point), however most rockfall occurred from cliffs composed of jointed columnar basalt and trachyte (Figure 9-13).

Figure 9-13. Rockfall along Evan's Pass Road, with columnar jointed source areas above road in background. (-43.6007°, 172.7354°).

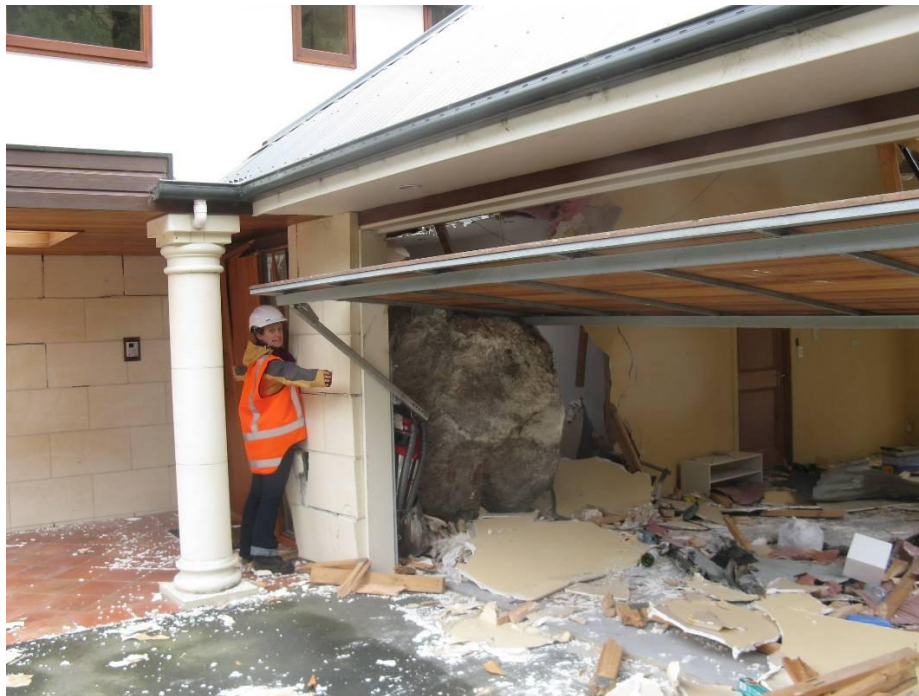
Figure 9-15. Boulder imbedded in house at the top of Morgan's Valley, affectionately known as "Rocky" was sold for charity on the internet for \$60,000 NZ. (-43.58052°, 172.71669°).

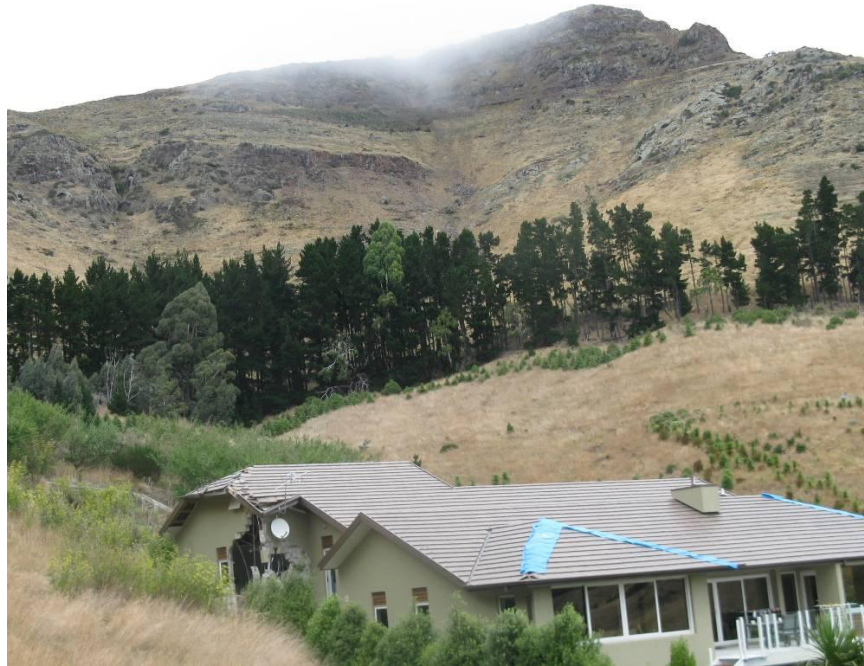
Figure 9-16. House with hole on left side from rockfall, note cliff source areas above with fresh talus. (-43.58126° , 172.71672°).

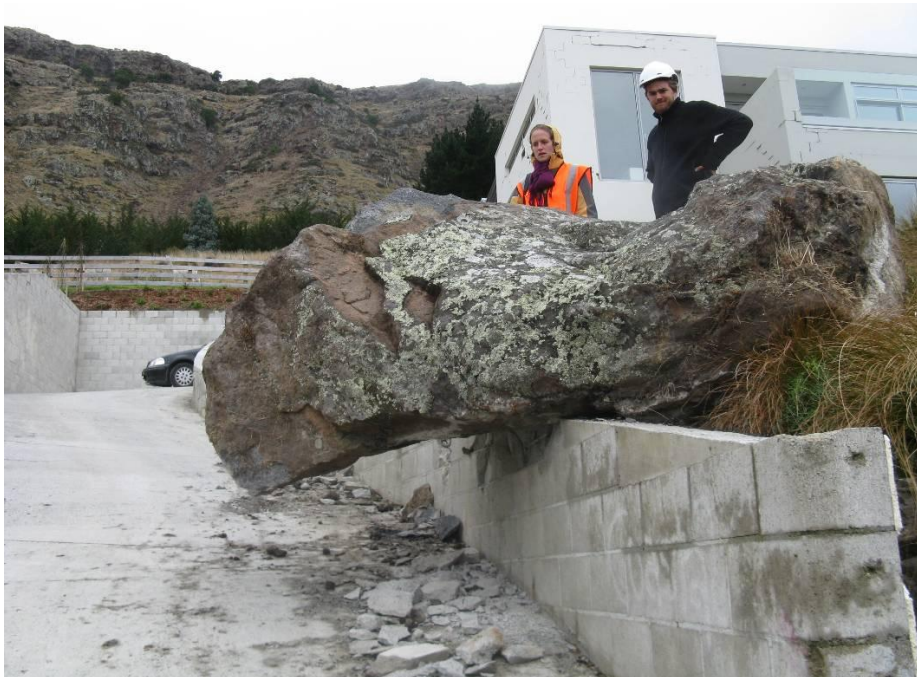
Figure 9-17. Boulder perched on driveway with source area above ~ 400 m away (-43.58202° , 172.7177°).

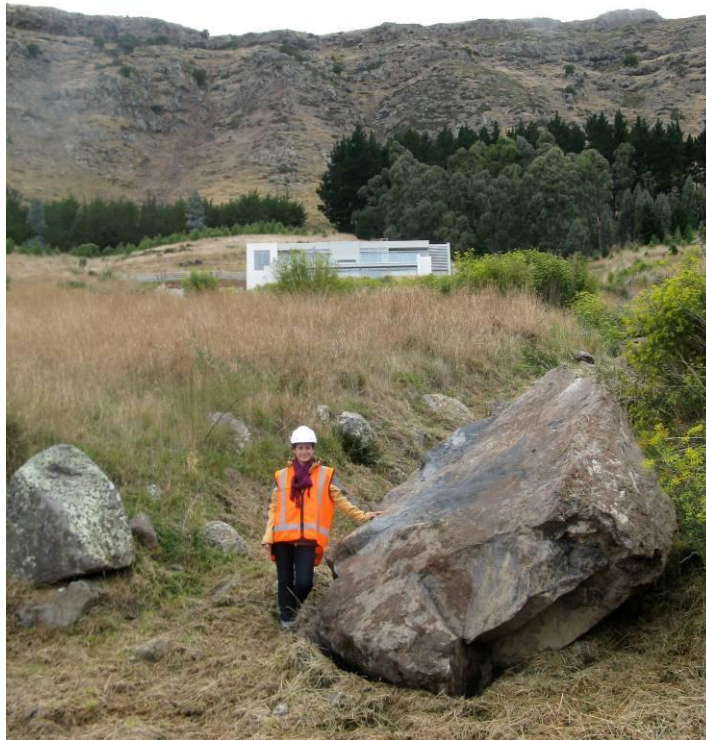
Figure 9-18. Earthquake induced rockfall with geologist for scale. Boulder along left side of photo is lichen-covered in place, and therefore pre-dates the Feb 22, 2011 event (-43.58187° , 172.71632°).

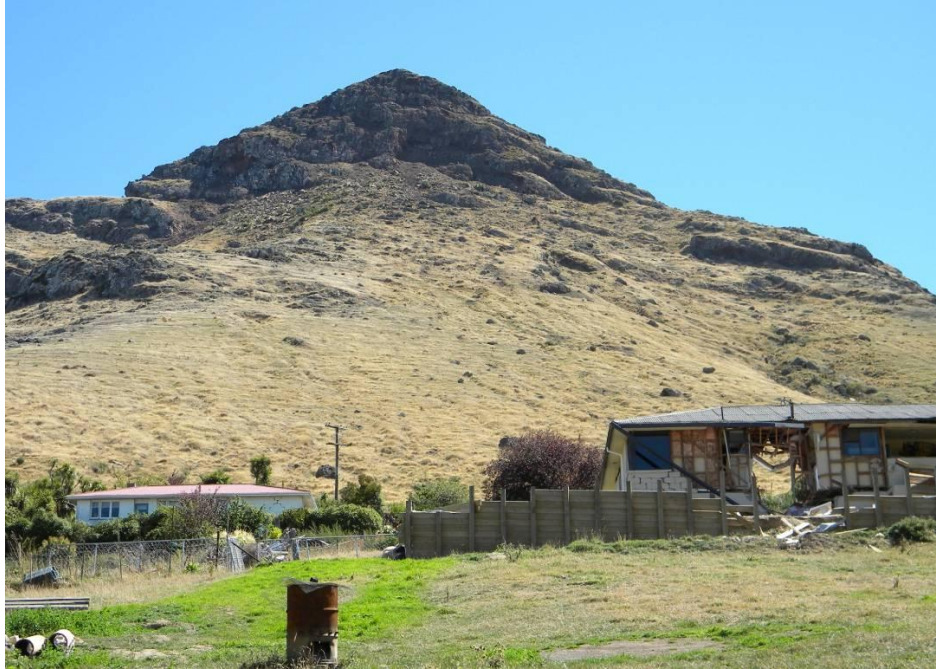
Rockfall in Rapaki from the February earthquake resulted in severe damage to several homes. A massive boulder passed through one house, apparently while airborne as an impact mark is present on the lawn above the house, and the floor in the impact area reportedly was not badly damaged (Figures 9-19, 9-20, and 9-21). Additional rockfall was observed on slopes above Lyttelton.

Figure 9-19. House in Rapaki damaged by rockfall. Rockfall originated from cliffs at an elevation approximately 250 to 300 m above house (-43.60475° , 172.67920°).

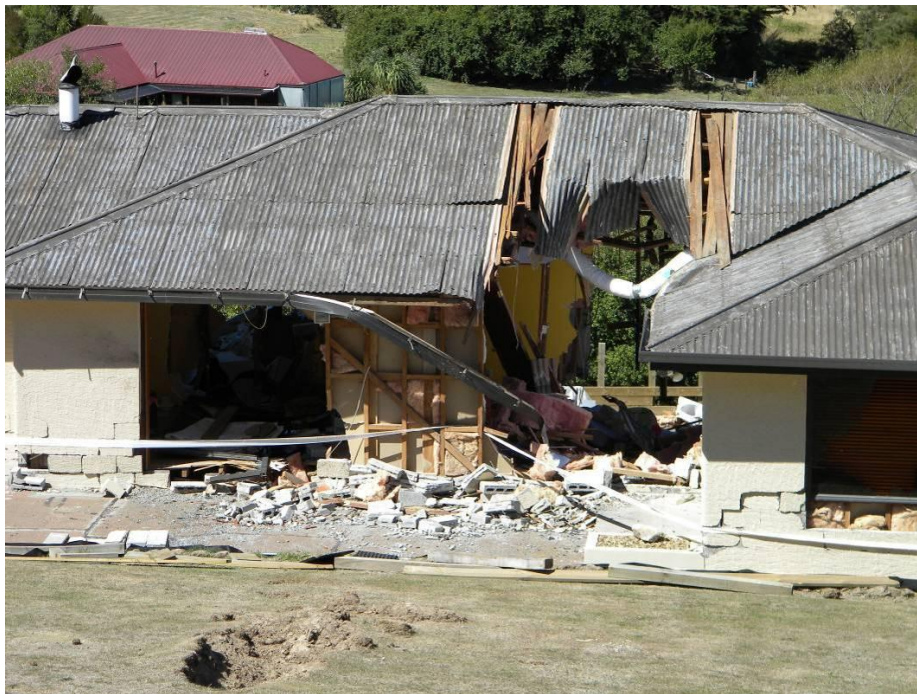
Figure 9-20. House in Rapaki damaged by rockfall. Note impact mark on lawn at bottom of photograph. Boulder may have fractured into two or more blocks as there appear to be two impact areas on the up-slope facing wall of the house (-43.6044° , 172.6780°).

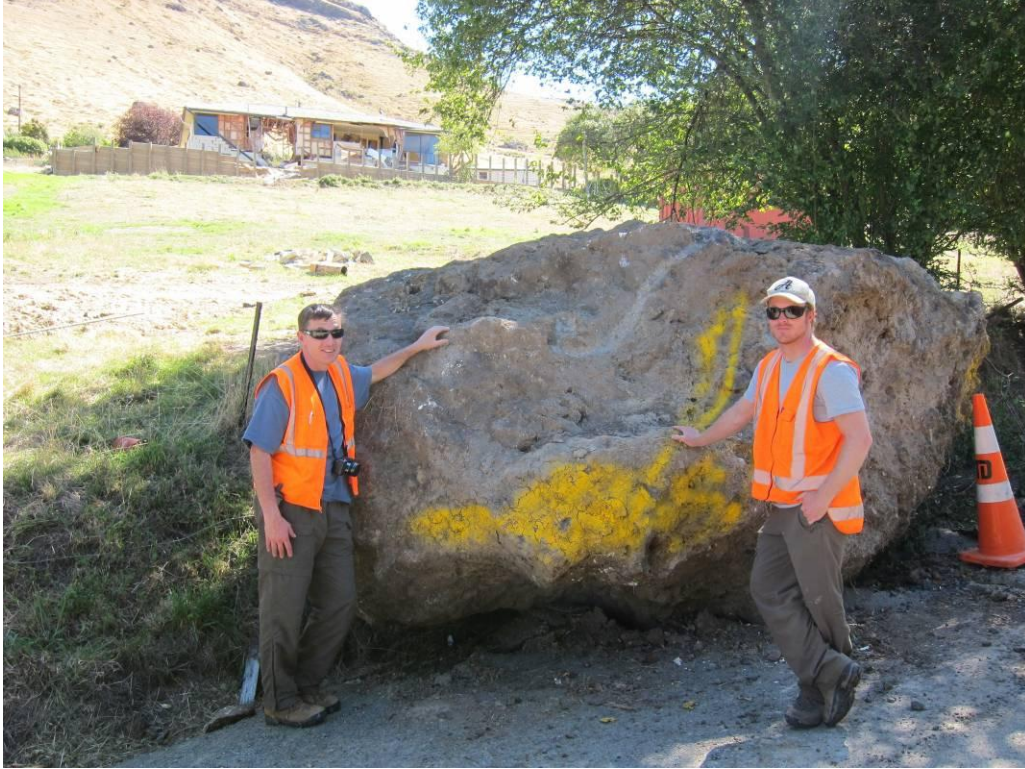
Figure 9-21. Earthquake induced rockfall in Rapaki with geologists for scale. Boulder passed through house at top center of photograph (-43.60478°, 172.67931°).

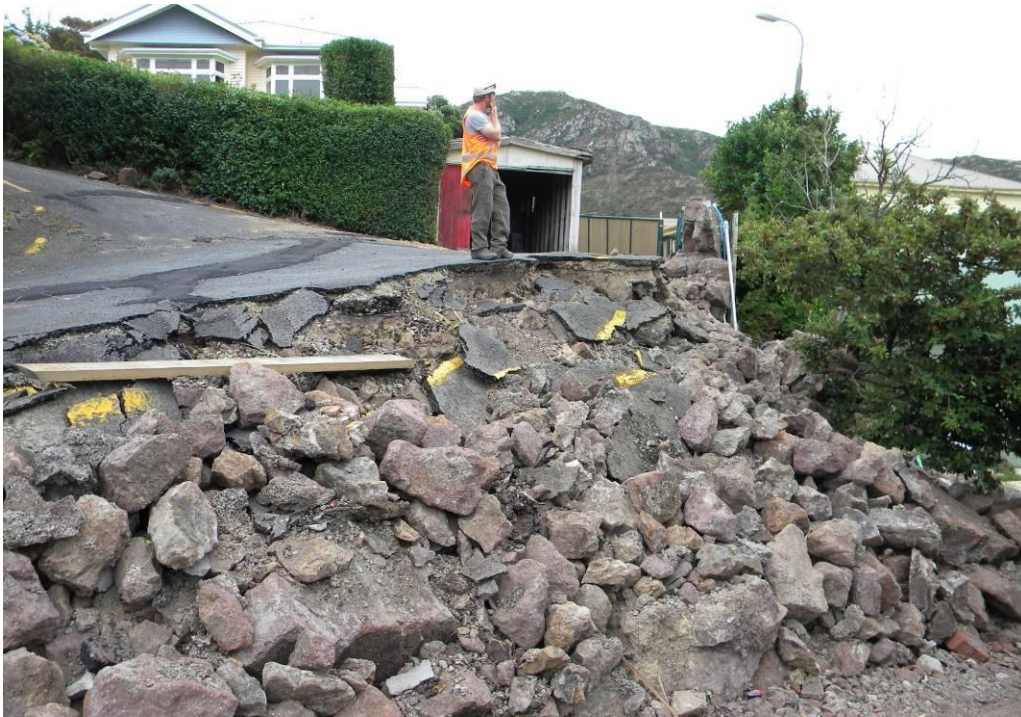
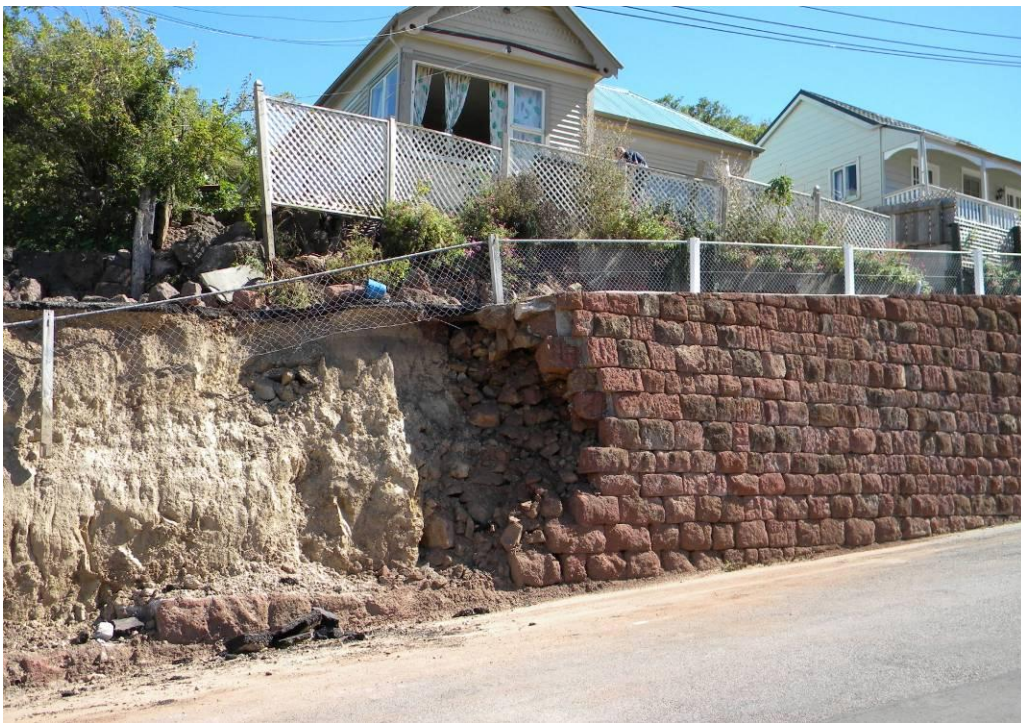
Numerous rock retaining walls in Lyttelton failed as a result of the February earthquake. These walls apparently were constructed of random angular blocks or rectangular blocks, with no reinforcement or mortar (Figure 9-22).

Figure 9-22. Rockwall collapse in Lyttelton. Top: Angular random size block wall (-43.59949° , 172.71717°). Bottom: Rectangular block wall (-43.60069° , 172.71903°).

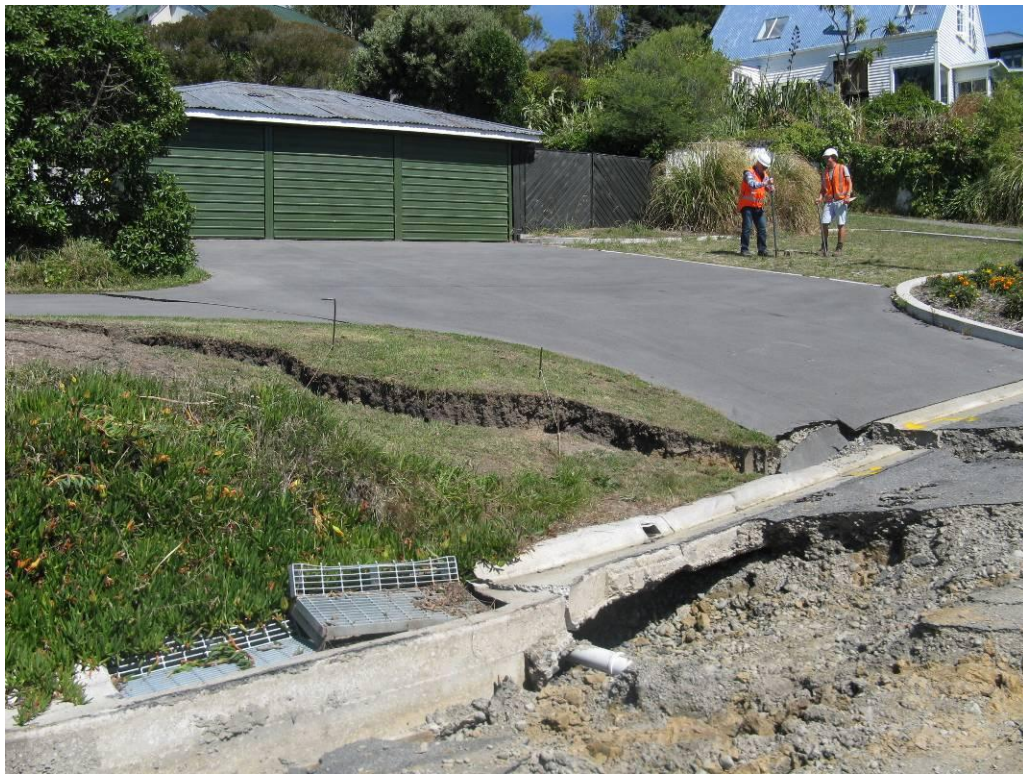
Figure 9-23. Landslide headscarp on Clifton Terrace with monitoring stakes. (-43.56543°, 172.75204°).

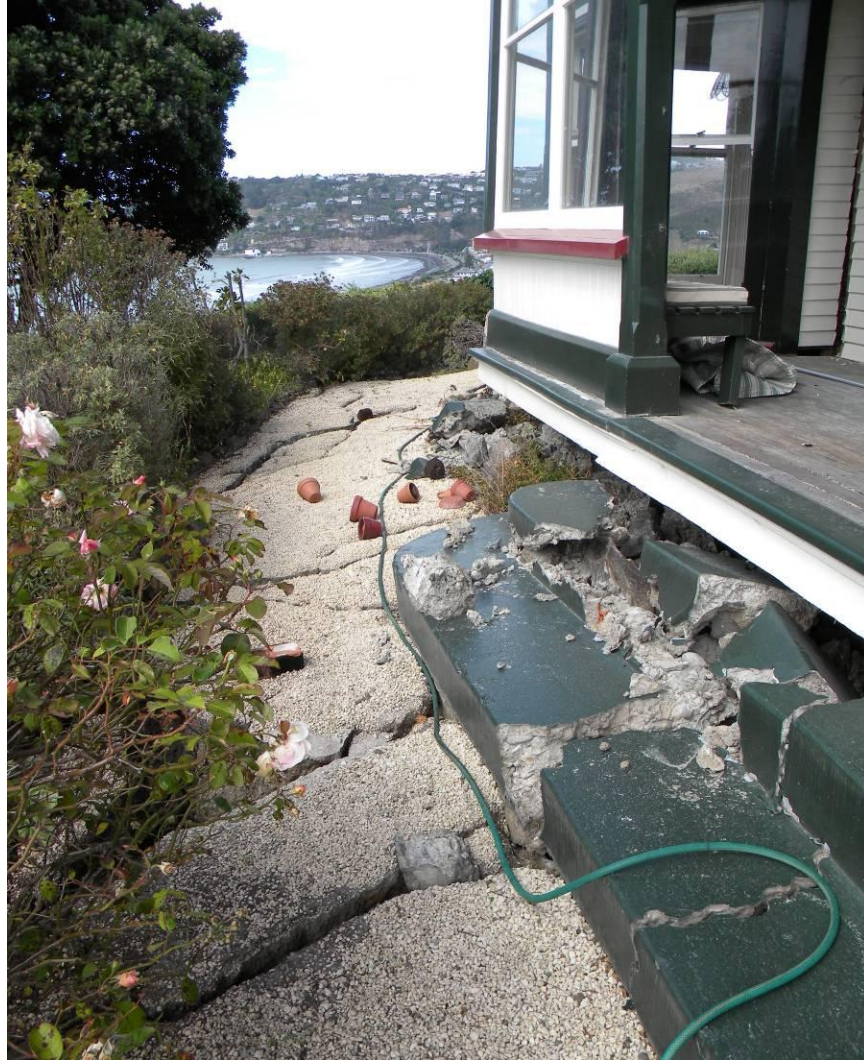
Figure 9-24. Landslide headscarp extending beneath house on Clifton Terrace. House was thrown off foundation, and foundation was cracked in several places along headscarp (-43.56586°, 172.75256°).
