#### **4. LIQUEFACTION AND LATERAL SPREADING**

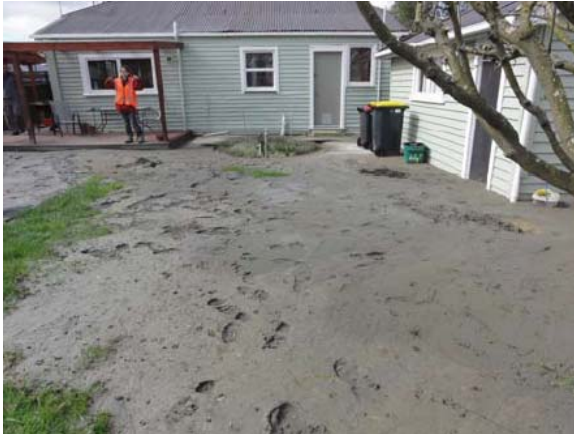
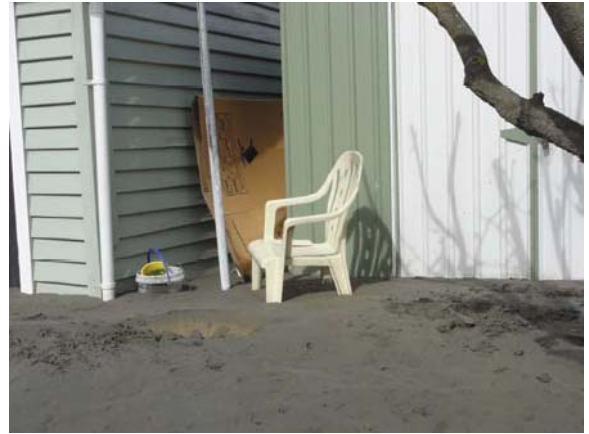
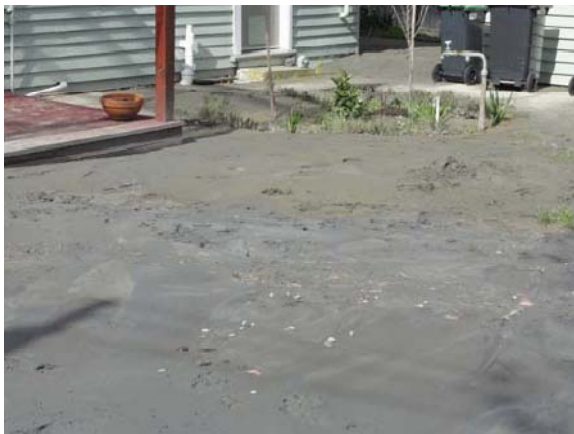
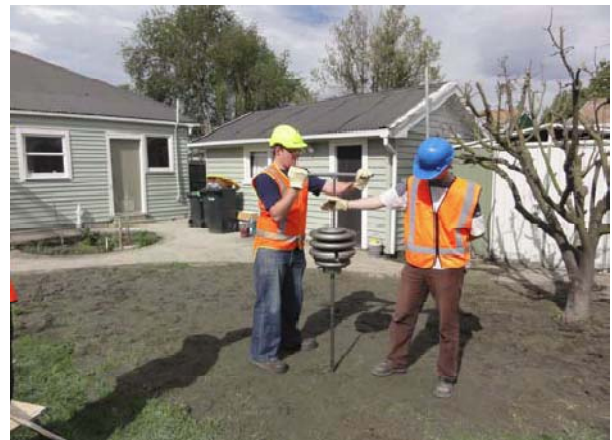
Typical manifestation of liquefaction in the backyard of a residential property is shown in Figure 4.4 (Bracken St, Avonside). Sand boil ejecta covered most of the lawn and was about 20-cm thick in places. There was evidence of massive liquefaction and large surface distortion on Bracken St. The potable water and sewer systems were out of service at the time of the

inspections. Despite significant amounts of liquefaction ejecta and broken utilities throughout the neighbourhood, the house shown in the pictures suffered minor damage in terms of differential settlement and cracking.

Figure 4.4 Evidence of extensive liquefaction in residential areas of Avonside: (a) Massive sand boils in residential area of Avonside (Bracken St); and (b) The sand boil (grey non-plastic silty sand) in the bottom half of the photo to the left was typical of many locations across Christchurch and Kaiapoi where massive liquefaction was observed; at this location, a brown silty sand was also found on the ground surface (upper half of the sand boil); photo to the right: University of Canterbury postgraduate students perform Swedish Weight Sounding (SWS) test (Bracken St:  $-43.520833^{\circ}$ ,  $172.663750^{\circ}$ ).

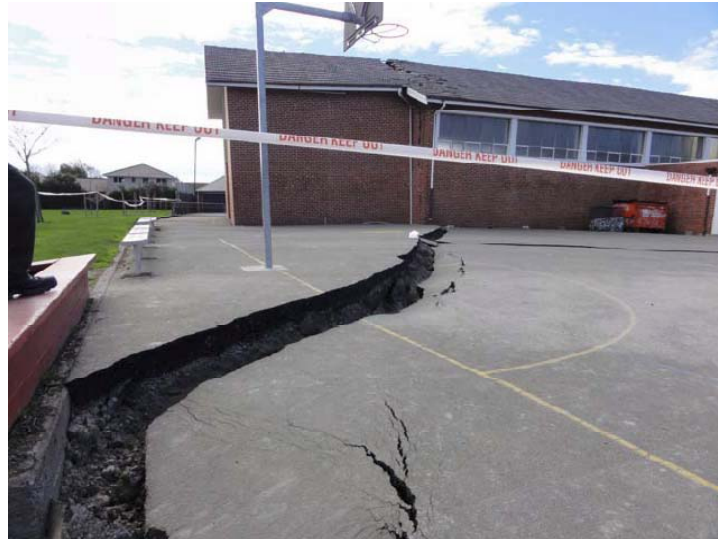
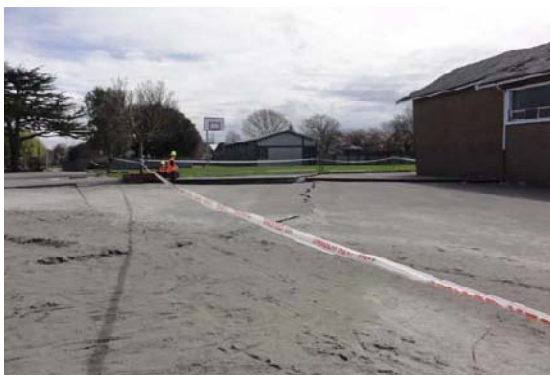
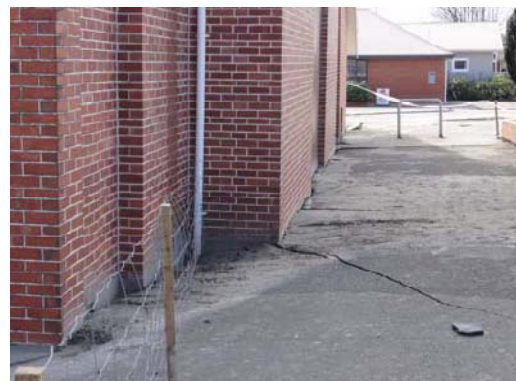
The geotechnical reconnaissance team performed a detailed survey at St Paul's Church (Gayhurst Rd, Dallington), which suffered damage due to liquefaction in the foundation soils (Chapter 5). Figure 4.5 shows a complex pattern of ground distortion including large cracks and vertical offsets around the building. Extensive sand boils covered the paved area around the building, backyard lawn, and around the perimeter of the building and its foundations. The building suffered large differential settlements and severe structural damage.

Figure 4.5 Liquefaction-induced bearing failure at St Paul's Church, Gayhurst Rd, Dallington: (a) Bearing failure in liquefied soils; the crack is 50-90-cm wide with a vertical offset of 33 cm, at its maximum; and (b) Evidence of liquefaction in foundation soils resulting in large total and differential settlements. (-43.519670°, 172.672240°).

Specifically, the northwest side of the building was ripped in half due to a combination of differential settlement and lateral movement. This site is centrally located in a meandering loop of the Avon River and bounded by the river on all sides at distances of about 150-250 m, except to the north/northeast. Lateral spreading was observed in this area, despite being located more than 150 m from the free-face of the river. (Note, however, that this distance is not necessarily anomalous. Evidence of lateral spreading has been found at distances of up to 2 km from a free-face in the New Madrid, Missouri, USA, area (Obermeier, S.F., per. comm.). These features manifested during the 1811-1812 earthquakes that occurred in that region.) The tension cracks and fissures around the building were much bigger than those near the river channel, and hence it is possible that they are not only the result of lateral spreading. Further investigations are required to clarify these details.

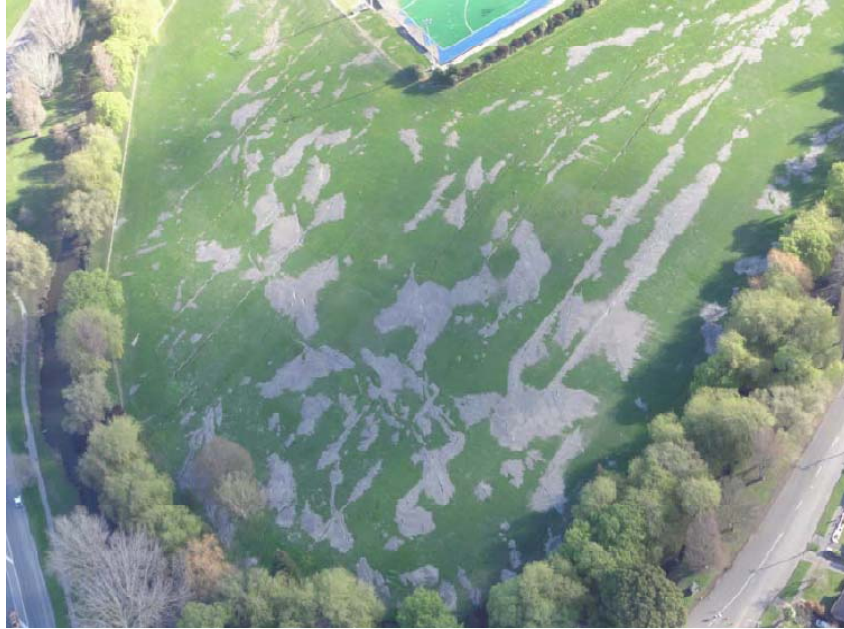
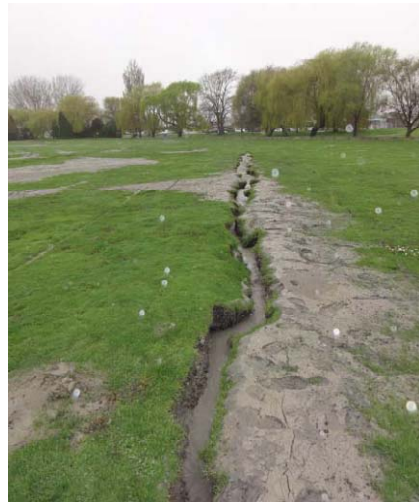
Further to the east of Dallington, extensive liquefaction, including substantial lateral spreading, was observed in Porritt Park (Wainoni), which is enclosed by the Avon River and a diverted stream around the park. Large sand boils covered substantial areas of the park (Figure 4.9). Parallel cracks spaced regularly along drainage lines were indicative of slumping and spreading towards the north and south branches of the stream. Two hockey fields located in the park were severely damaged by the liquefaction, resulting in a very uneven, bumpy surface of the fields.

Figure 4.9 Massive sand boils and lateral spreading cracks at Porritt Park: (a) Aerial view showing massive sand boils with large number of parallel cracks along drainage lines (from a helicopter flyover on the afternoon of Friday, 10 September 2010); and (b) ~ 10 cm wide lateral spread crack. (-43.516278°, 172.689917°).

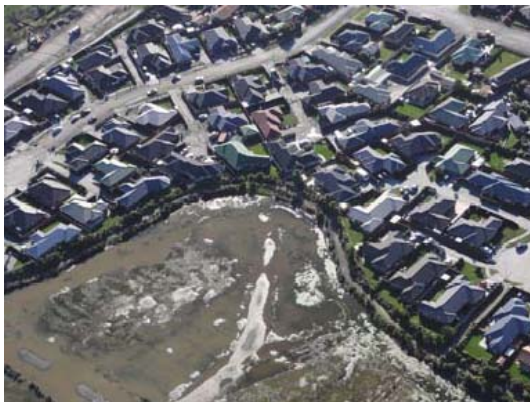
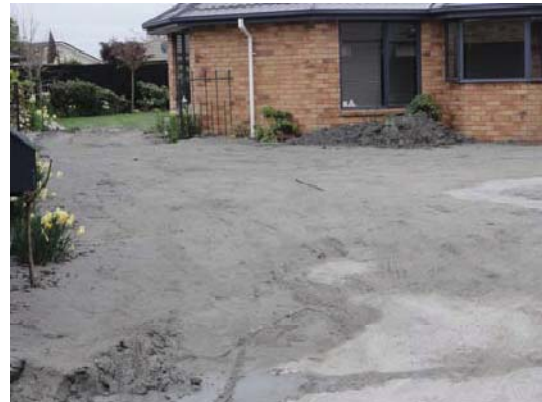
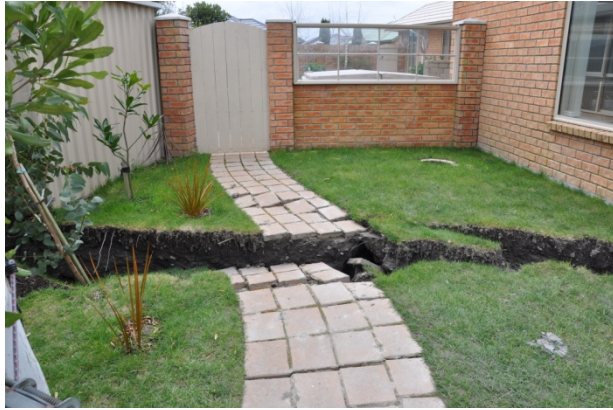
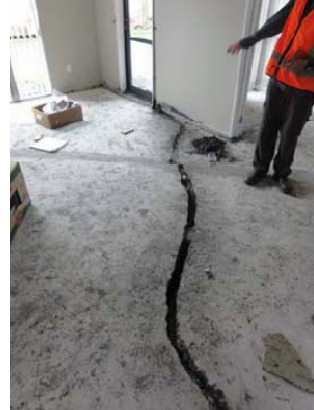
Widespread liquefaction occurred in Bexley, affecting a large number of residential houses (Figure 4.10). Ground distortion (i.e., differential settlement, large ground cracks, deformation of paved surfaces and substantial sand boils) was observed at Seabreeze St and Kokopu Ln. Residential properties along the southern edge of Bexley (along the wetland walkway) were severely affected by lateral spreading. Large movement of the walkway towards the water, slumping of the terrace fill and large ground cracks on residential properties were observed in this area. Similarly, severe manifestation of lateral spreading was observed at the east end of Bexley (Parenga Pl).

Figure 4.10 Evidence of extensive liquefaction severely affecting residential houses in Bexley: (a) Aerial view of the southern edge of Bexley which was severely affected by liquefaction and lateral spreading; (b) Evidence of liquefaction in residential area (Seabreeze St); (c) Large ground cracks due to lateral spreading at Kokopu Pl (-43.5184167°, 172.7221667°); (d) Cracks in unreinforced slab induced by lateral spreading (-43.5193889°, 172.6705555°).

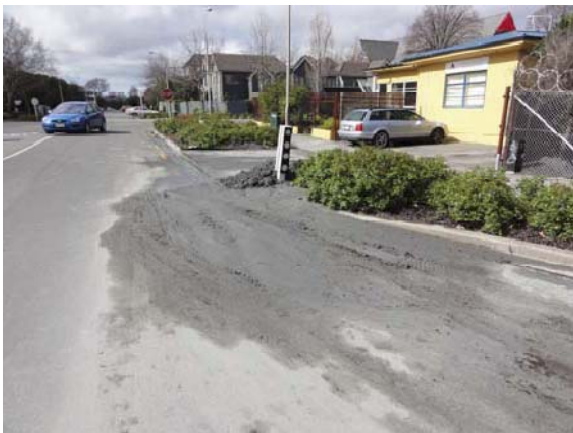
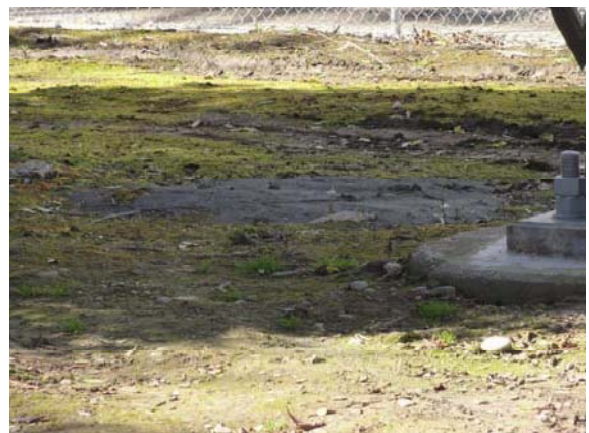
Figure 4.12 Evidence of limited/partial liquefaction in areas of Christchurch: (a) Evidence of liquefaction at Peterborough St - Madras St (CBD) ; (b) Sand boil in the foundation soils of a transmission tower (sub-station northeast of Greers Rd – Ruddenklau Ln, Bishopdale) (-43.4928055°, 172.5918055°).

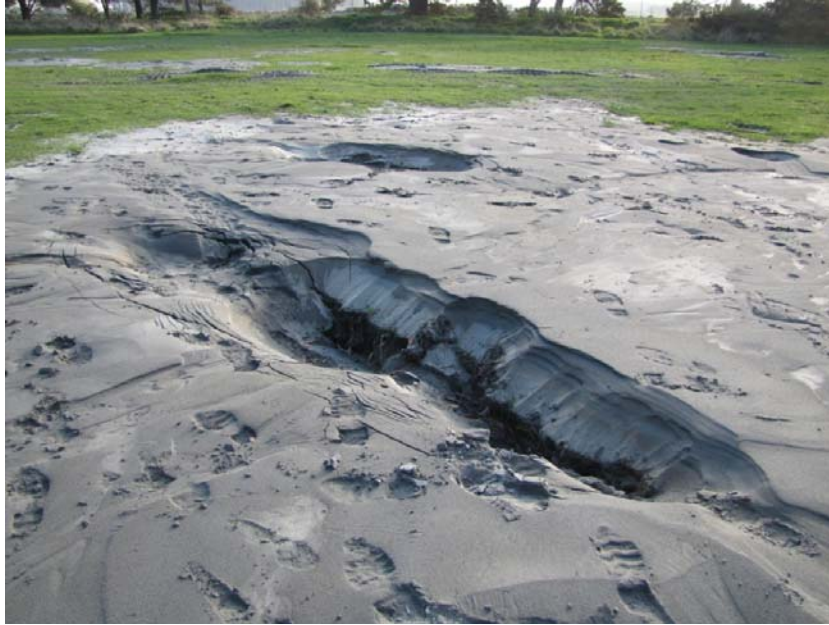
Figure 4.14 Sandboil in the Featherstone Reserve Pines Beach from which sand was taken for electron microscope pictures. (Approximate position:  $-43.381111^{\circ}$ ,  $172.703611^{\circ}$ )

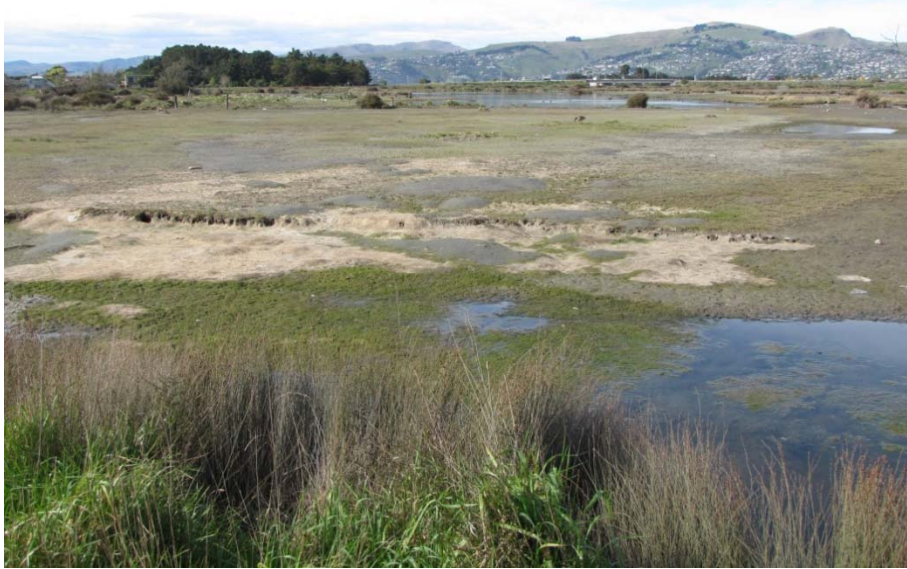
Figure 4.19 View of the Bexley Wetland at near high tide on Wednesday 29 September 2010. Prior to the earthquake this area was inundated at high tide.

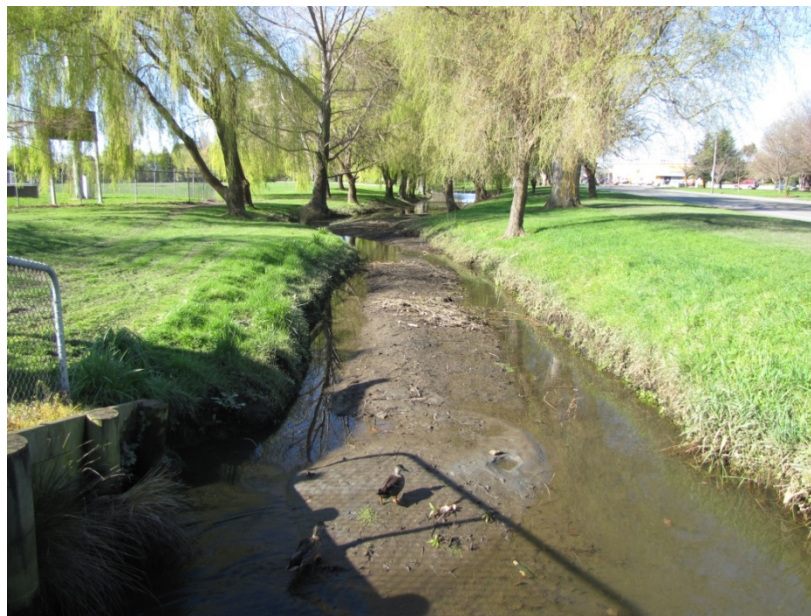
Stream beds were also noticed to be heaved (Figure 4.20). A local resident confirmed that this was not how the stream bed appeared prior to the earthquake. In some places it was necessary to clear the stream bed soon after the earthquake.

Figure 4.20 Photograph of the stream near Porritt Park on Wednesday, 15 September 2010. There is lateral spreading towards this stream from both sides. It is just possible to make out a sand boil in the midst of the stream bed debris to the right of the duck. Several other sand boils were visible along the stretch of heaved stream bed.

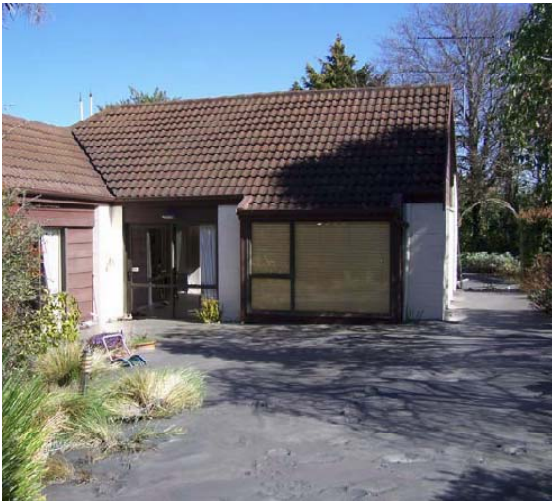
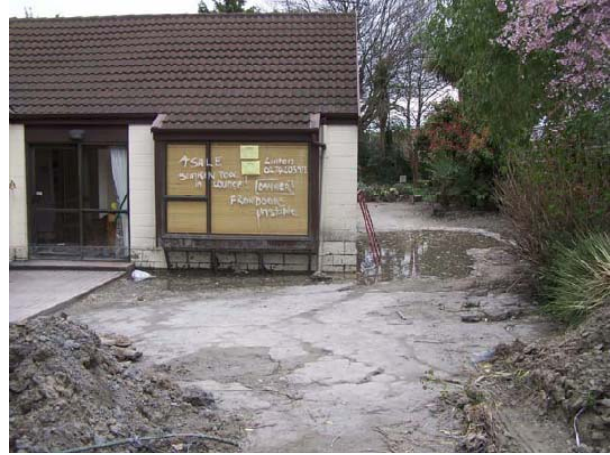
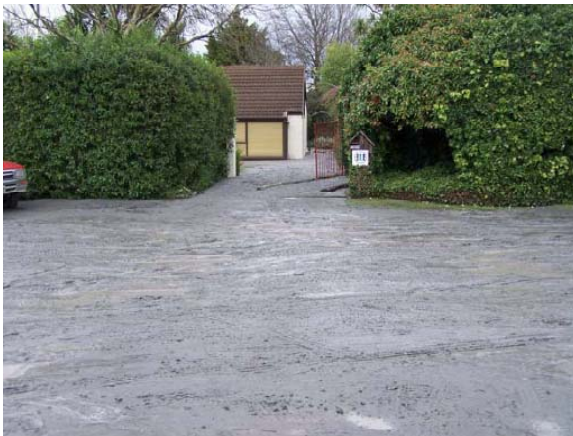
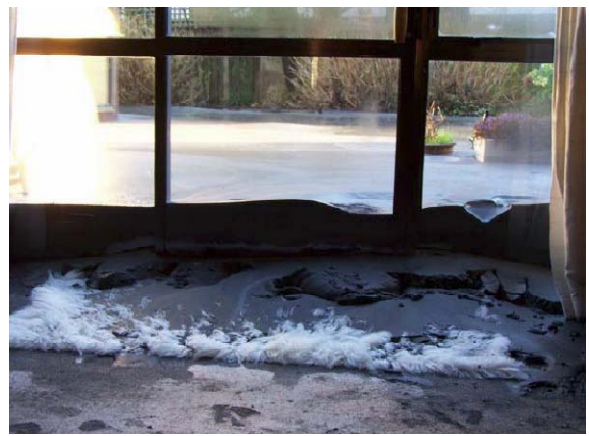
The liquefaction was particularly intense, producing massive sand boils of grey, silty sand, at Cassia Place and at the east end of Charles and Sewell Streets. In the worst hit area, the silty sand ejecta was about 400-mm thick, as shown in Figure 4.25. Some residents reported geysers appearing in the backyard following the earthquake, often forming a small pond near the house that remained for several days after the event. An SWS test and DPTs were performed by the GEER-NZ Team in this area, with the SWS test indicating loose/soft soils up to depths of 8-9 m (Figure 4.26).

Figure 4.25 Manifestation of very severe liquefaction in residential area at Cass Pl, North Kaiapoi (-43.387944°, 172.670111°): (a) ~40 cm thick layer of silt-sand-water mixture covering a residential property affected by very severe liquefaction; (b) same-angle view, but after the clean up of sand boils; (c) View from the street (before clean up); and (d) liquefied silt-sand-water mixture covering the ground outside the house and a rug inside the house (seen through a window from inside the house).

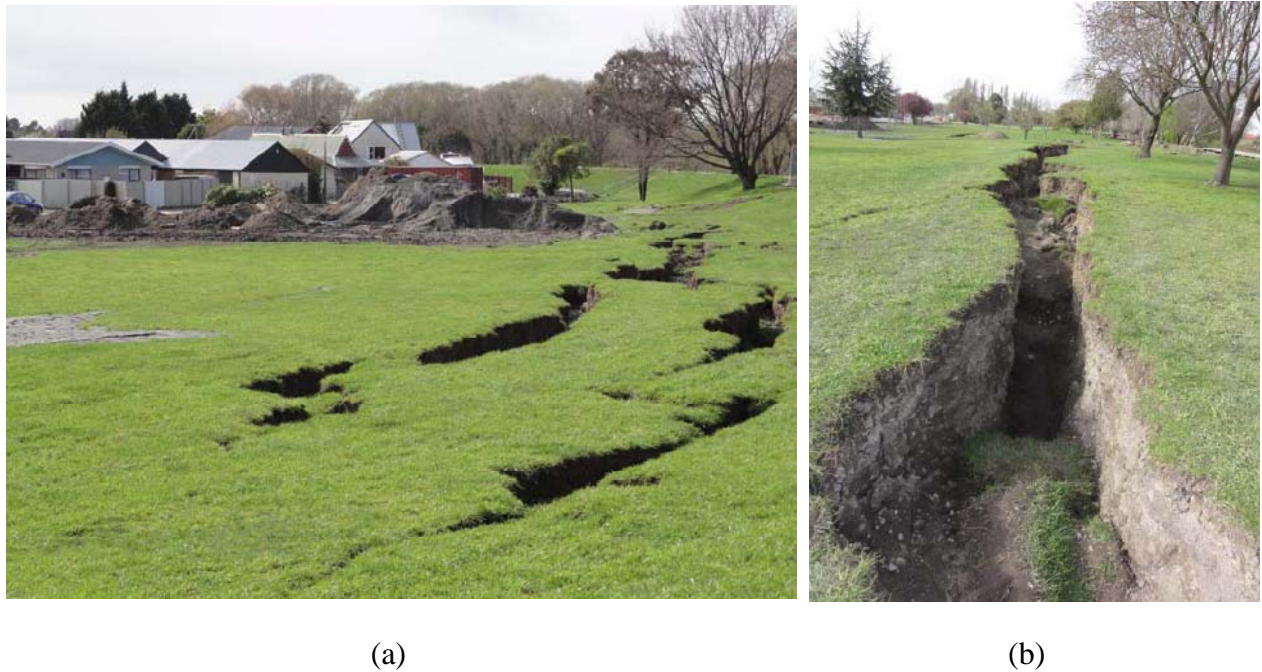
The area along the Pegasus Bay Walkway (from the Kaiapoi Visitor Information Center on the east to Askeaton Park on the west) was affected by significant lateral spreading with large cracks and fissures in the sloping ground towards Charles St (Figure 4.27). Residential houses in this area were affected both by liquefaction and lateral spreading (Figure 4.28). The reconnaissance team carried out detailed ground surveys of lateral spreading along several profiles at this

Figure 4.27 Evidence of liquefaction and lateral spreading along Charles St and the north levee of the Kaiapoi River (-43.384694°, 172.660944°). Note the huge piles of cleaned up sand obstructing the view of the houses in (a).

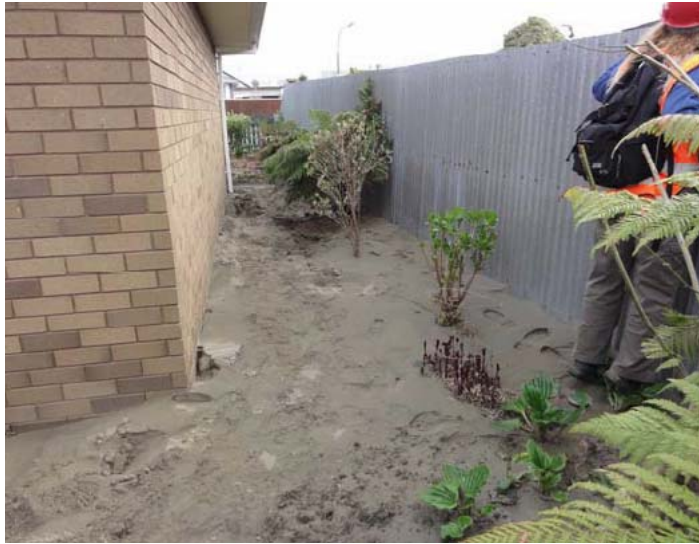
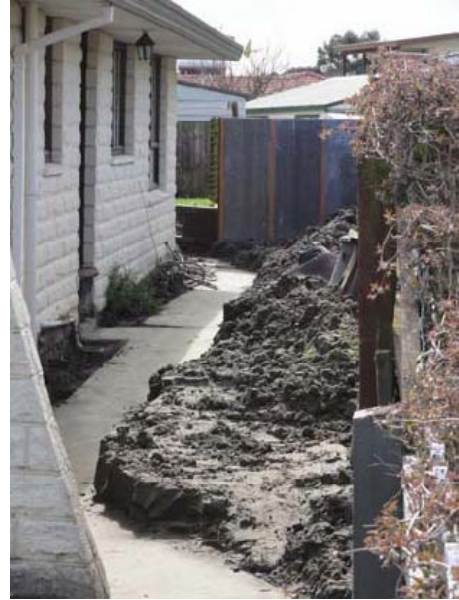
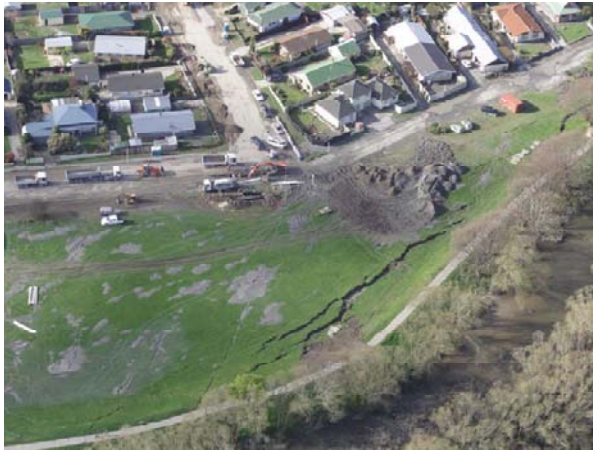
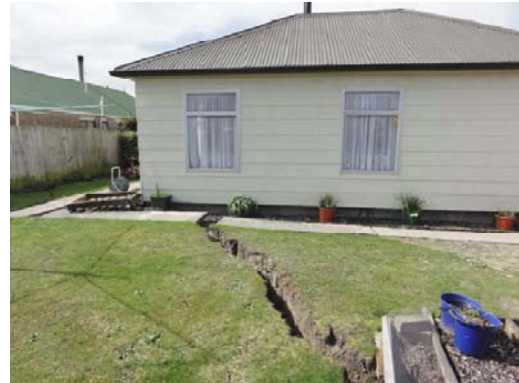
Figure 4.28 Liquefaction and lateral spreading in North Kaiapoi: (a) Evidence of extensive liquefaction at the east end of Charles St ( $-43.386805^{\circ}$ ,  $172.667166^{\circ}$ ); and (b) lateral spreading resulting in a large ground distortion in foundation soils (Charles St) ( $-43.386666^{\circ}$ ,  $172.666111^{\circ}$ )

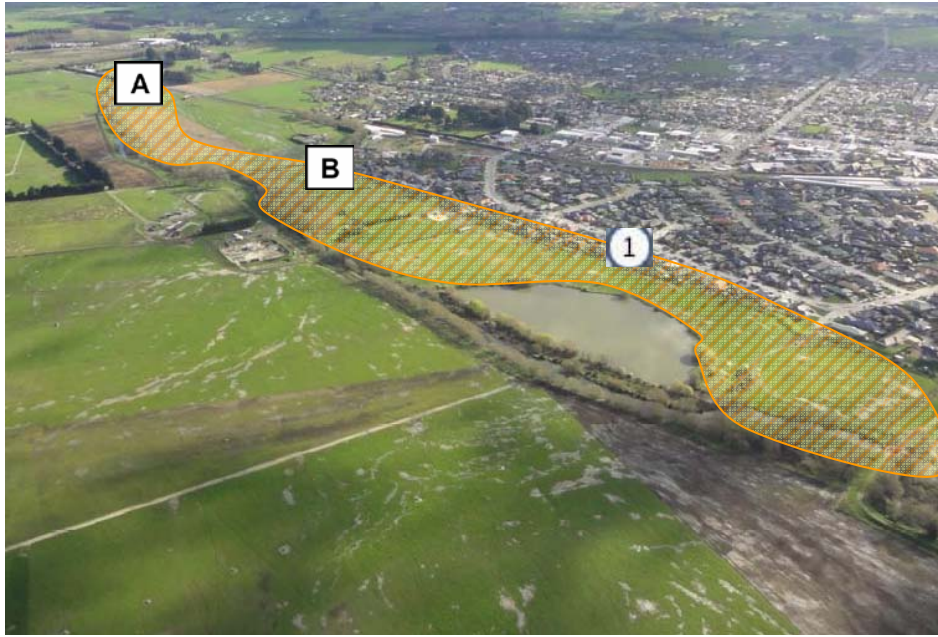
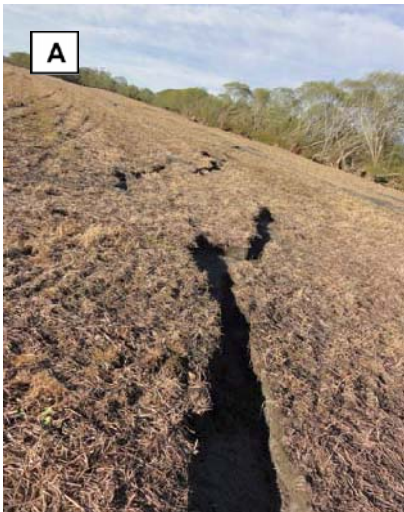
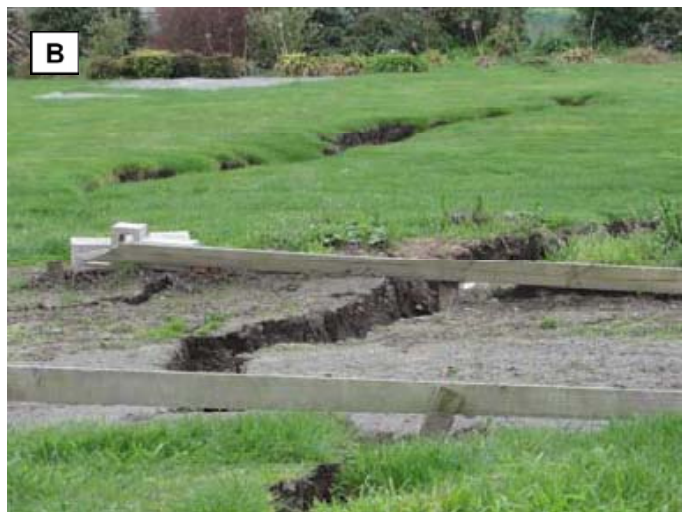
In South Kaiapoi, the most dominant ground failure feature was the liquefaction and massive lateral spreading that affected the eastern branch of Courtenay Drive. The area affected by lateral spreading, shown in Figure 4.29, was approximately 1-km long in the north-south direction and

Figure 4.29 Massive lateral spreading at South Kaiapoi: (a) Sand boils and area affected by lateral spreading around Courtenay Lake (from a helicopter flyover on Friday, 10 September 2010); and (b) Large lateral spread cracks in farm land (at B:  $-43.3941389^\circ$ ,  $172.659750^\circ$ ).

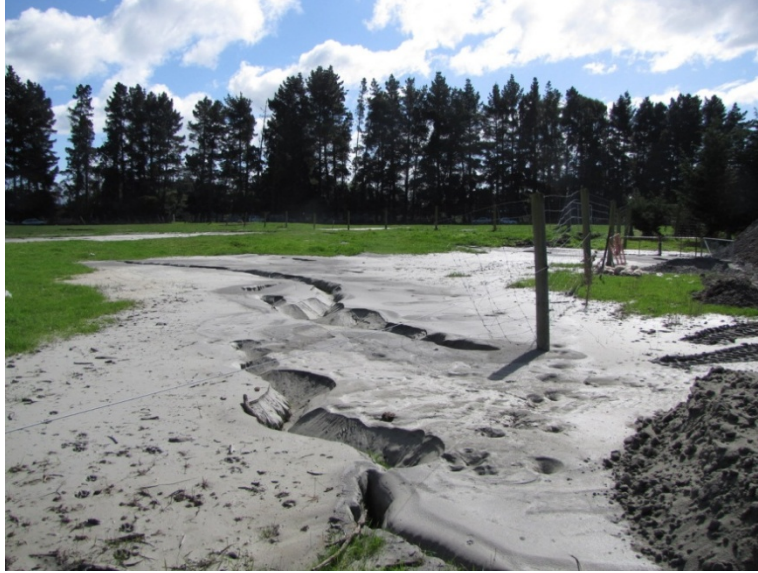
Further south near the train tracks at position 2 (Figure 4.30), large sand boils formed (Figure 4.32). At position 3 (Figure 4.33), liquefaction resulted in damage to the train tracks. The photo in Figure 4.33 was taken from a position on Doubleday's Rd in a NNE direction along the tracks, indicating ground deformation and track movement. Moving north along the train tracks to positions 4 and A (Figure 4.30), Figure 4.31 provides a more detailed aerial view of liquefaction and lateral spreading crossing the tracks just south of Kaiapoi. Using the vehicles in the photo for scale gives a good indication of the significant size of these cracks and the volume of ejecta.

Figure 4.32 Sand boils in fields. (Position 2; -43.4026°, 172.6503°)

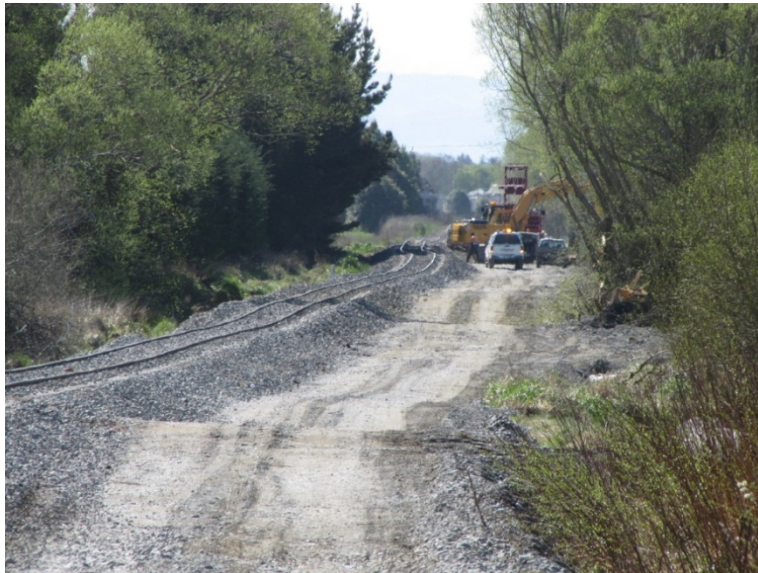
Figure 4.33 Damage to train tracks due to ground movement. (Position 3; -43.4068°, 172.6489°)

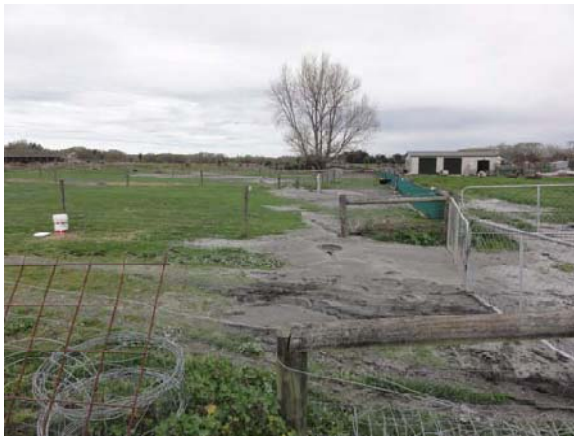
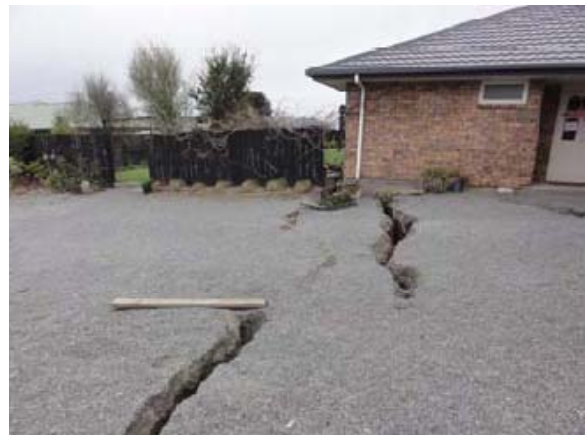
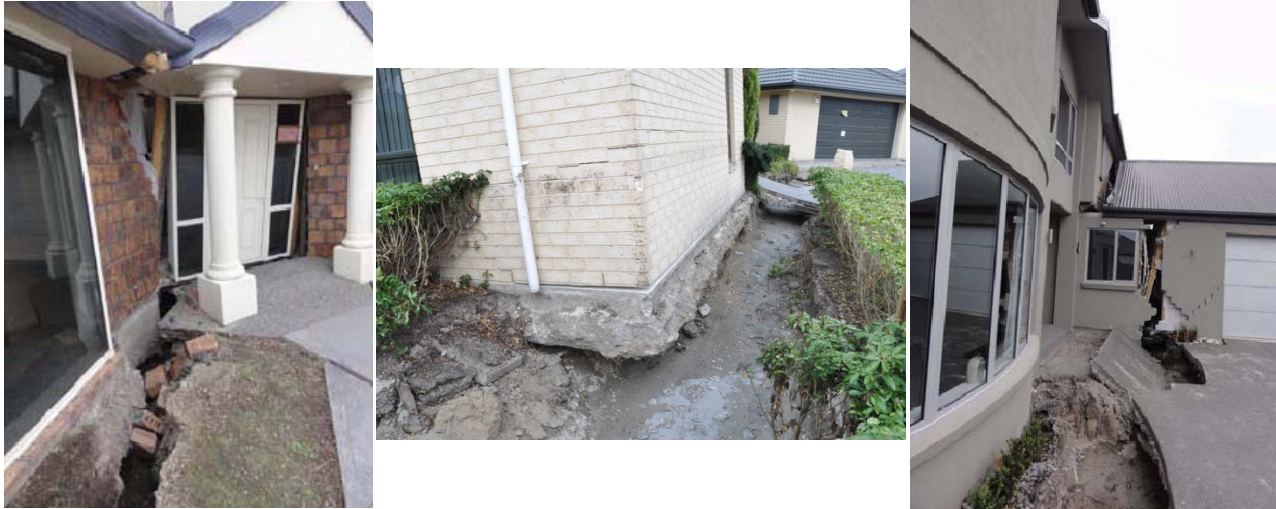
Lateral spreading resulted in large permanent lateral displacements on the order of 1.0-3.5 m with large ground cracks of about 0.5-1.5-m wide running through residential properties and houses along the east branch of Courtenay Dr. In this area, single story and two story houses suffered very severe damage due to large lateral ground movements including large tilt, loss of foundation support, tension cracks in foundations and slabs (Figure 4.34). It was significant that

despite the extreme lateral movement of the immediate foundation soils and the foundations themselves, all houses showed large ductile deformation capacity and continued to carry gravity loads, despite literally being ripped in half in some cases. The reconnaissance team visited the area and conducted detailed inspections and measurements of the distorted houses on several occasions. There was clear evidence that the lateral movement, at least in some parts of the affected area, continued to develop/increase well after the main event. Two consecutive measurements of the width of a large ground crack carried out on 11 and 15 September showed an increase in width of 20 cm over this period ( i.e. from 1.4 m to 1.6 m). The residents of the neighboring property reported new extensive cracks appearing in their house over the same time period. It is believed that this continued deformation was the result of a combination of creep due to static driving shear stresses, significantly softened soils and effects of aftershocks on a structure marginally stable under gravity loads.

Figure 4.34 Lateral spreading at Courtenay Dr, South Kaiapoi: (a) Sand boils and lateral spread cracks; and (b) effects of lateral spreading in residential area.

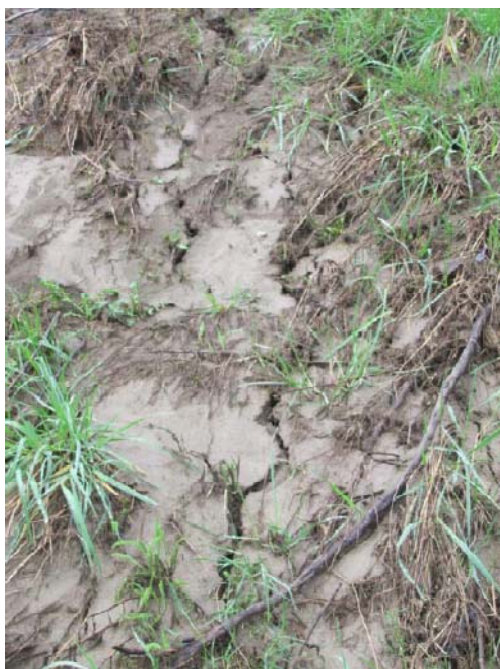
Figure 4.37 Ground damage adjacent to the bank of the Selwyn tributary near the end of Gillanders Rd (Darfield side). (Position marked as Photo 1 in Fig. 4.36;  $-43.596667^{\circ}$ ,  $172.080000^{\circ}$ )

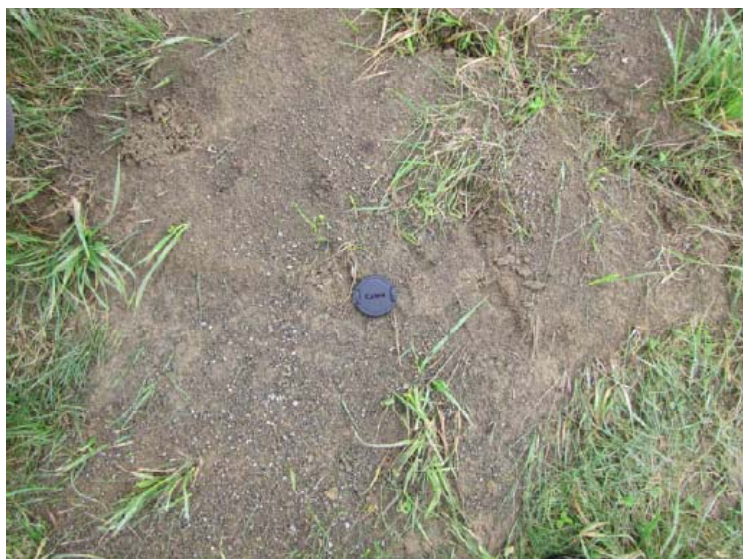
A short distance from here at the end of Gillanders Rd, the team found damage to the unsealed pavement and in the grass verge nearby. Evidence of liquefaction was seen (Figure 4.38). Notable here was the fine gravel on the surface of the sand. Also note that rain had fallen the previous evening so the surface of the ejected material would have been altered somewhat.

Figure 4.38 Liquefaction on the grass verge adjacent to the end of Gillanders Rd (Darfield side). Note the fine gravel particles on the surface and the fissure towards the top right hand side - it was possible to push the sampling spoon to a depth of about 300 mm into the fissure. (Position marked as Photo 2 in Fig. 4.36)

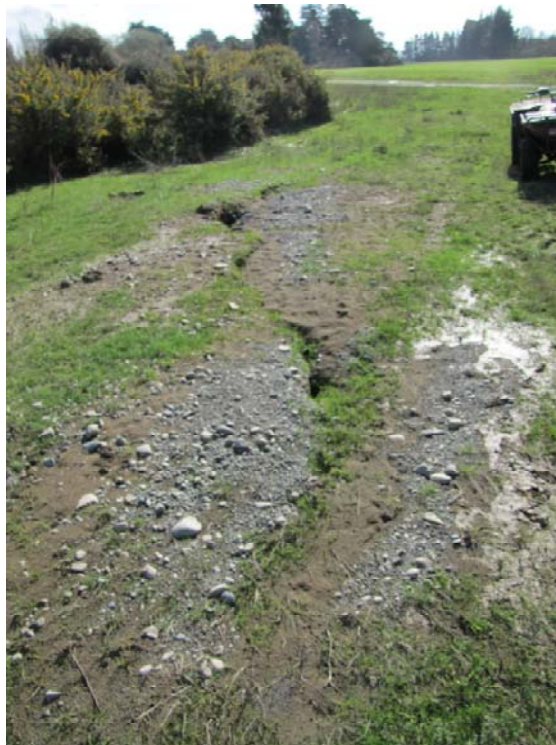
Figure 4.39 Material ejected from a fissure on the Selwyn Forks farm (front paddock). Note the gravel overlying the brown colored sand. This is what was visible after a night of rain. (Position marked as Photo 3 in Fig. 4.36.)

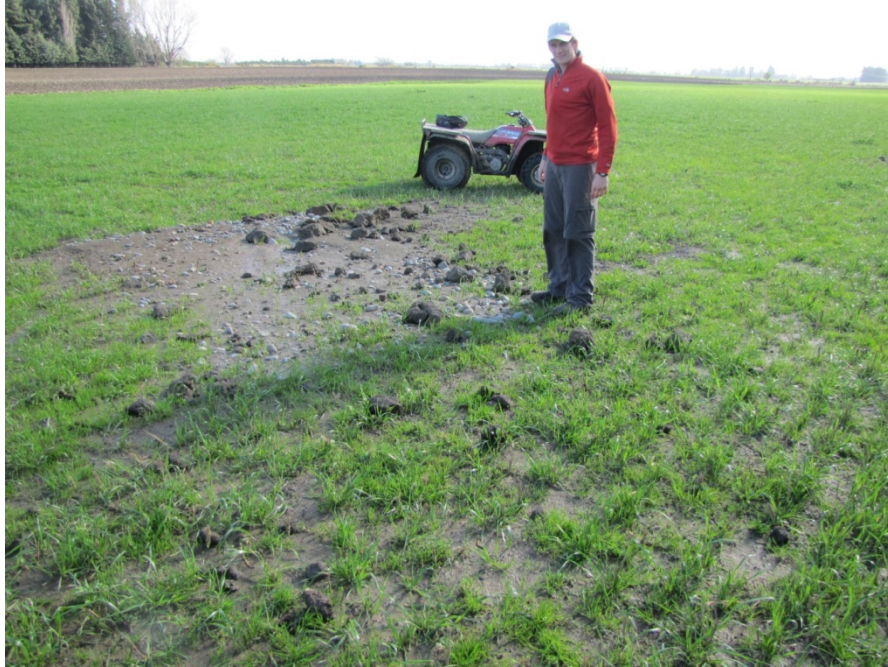
Figure 4.40 Ejected material on another paddock of the Selwyn Forks farm (Sheepyard paddock). As well as sand and gravel the ejecta contain clods of topsoil. (Position marked as Photo 4 in Fig. 4.36.)

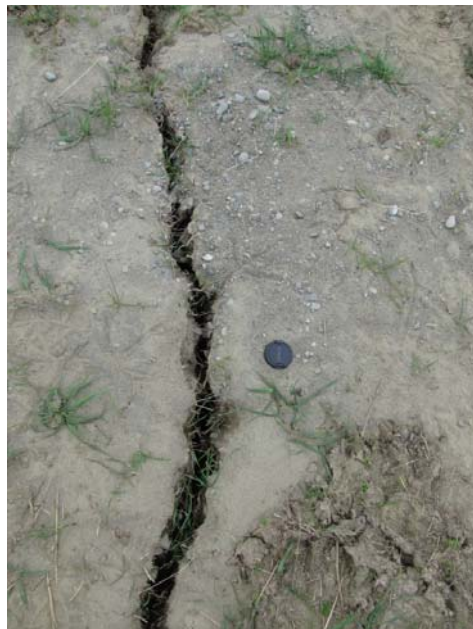
Figure 4.42 Ejected sand and gravel at the Willow Lea property. (Position marked as Photo 5 in Fig. 4.41;  $-43.688056^{\circ}$ ,  $172.353333^{\circ}$ )

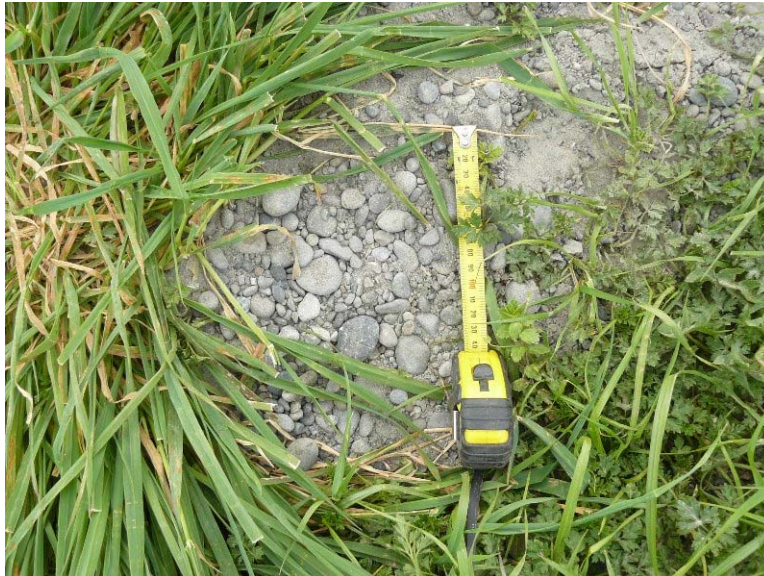
Figure 4.43 Ejected sand and gravel in the Clearwater area. (photo by Ian McCahon)
