5. IMPACT ON BUILDING STRUCTURES

General

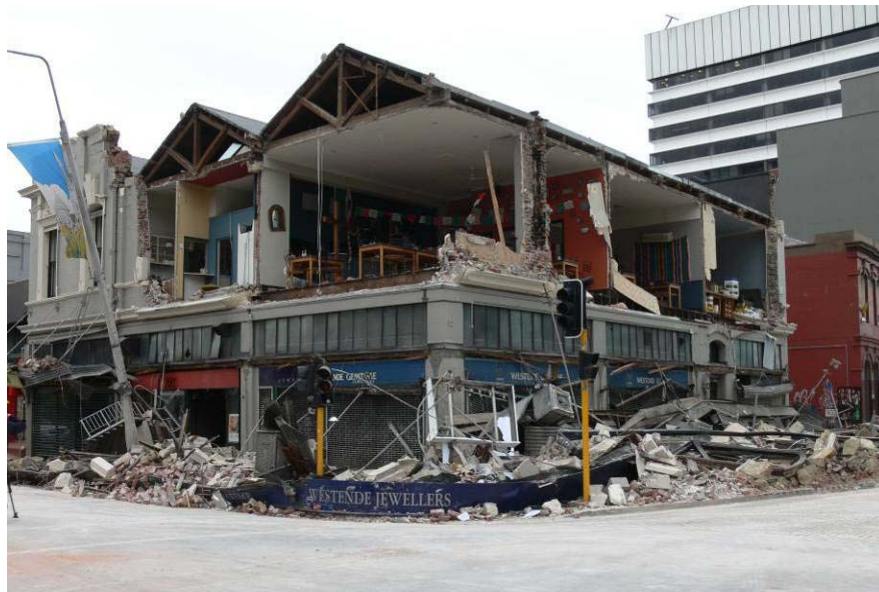
Figure 5.1 Structural collapse of a URM in the Christchurch Business District, 184 Manchester St. (Photograph courtesy of Prof Jason Ingham)

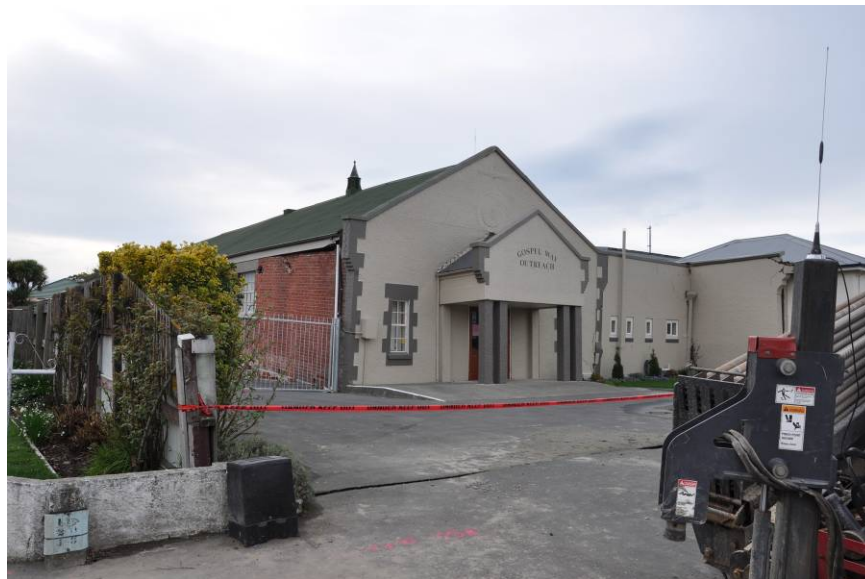
Figure 5.3 Front facing (view looking northeast) of the Gospel Way church in Kaiapoi along Charles St. (-43.3812° , 172.6579° ; 1000 hrs on 11 September 2010)

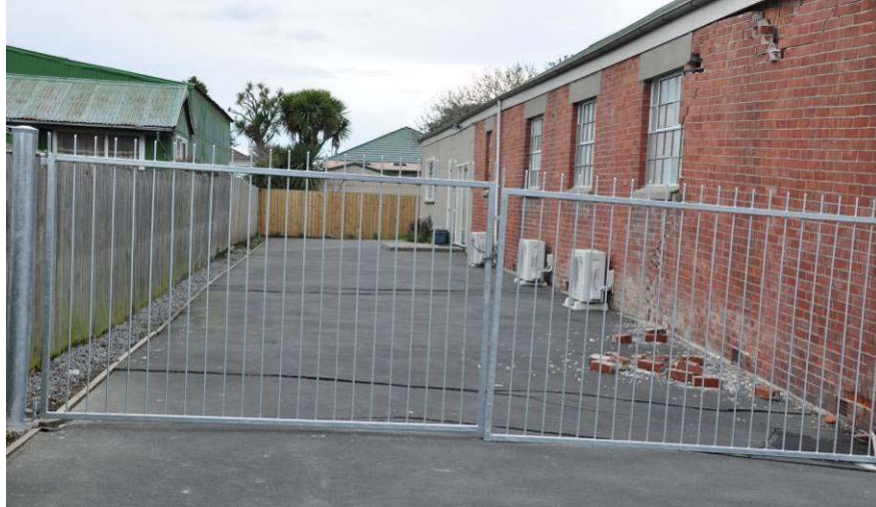
Figure 5.4 Lateral spread patterns extending east along the longitudinal axis of the Gospel Way church in Kaiapoi along Charles St. (-43.3812°, 172.6579°; 1000 hrs on 11 September 2010)

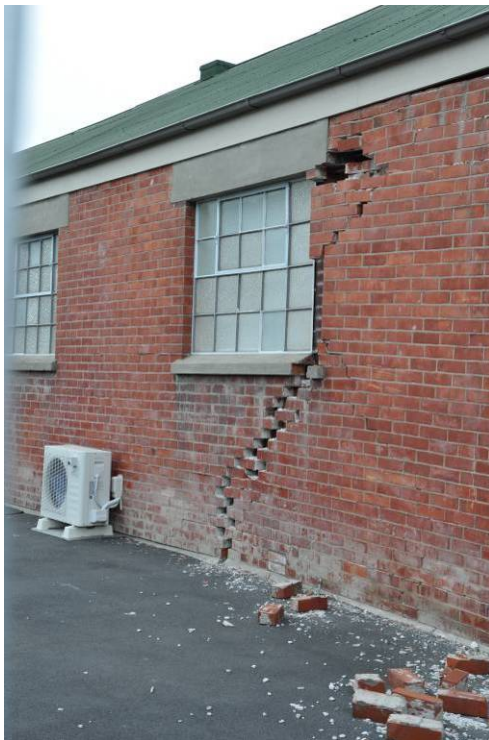
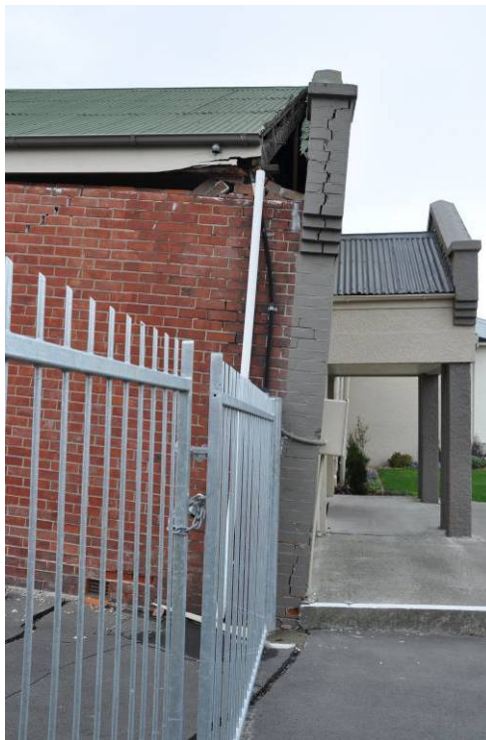
Small businesses line the fronts of Charles St paralleling the Kaiapoi River from approximately Jones St to Davie St (Figure 5.2). The vintage of these structures vary, however, most are single or 2 stories and constructed of light wood framing with brick façade, or stucco, or solely of concrete masonry block. Extensive lateral spreading parallel to the Kaiapoi River extended into the small business and residential regions impacting numerous structures within this community. Liquefaction was evident beyond the lateral spread as discussed in Chapter 4. The most severe damage to structures within the small business community along Charles St is shown in Figures 5.3-5.9. The Gospel Way church for example, a single story structure of brick construction, suffered separation of its heavy front structure from its orthogonal support walls due to lateral movement of the ground towards Charles St (Figures 5.3-5.5). The large lateral ground spreads extended northeast along the longitudinal axis of the building as evident in the adjacent parking area (Figure 5.4). This ground movement manifested into distinct shear cracks at the brick-mortar joints (Figure 5.5a). Structural separation such as that evident in Figure 5.5a was visible at several distinct locations extending along the longitudinal axis of the building. The most severe damage was evident at the front of this building, which settled approximately 15 cm, while the eastern length of the building remained approximately level (Figure 5.5b).

Figure 5.5 Gospel Way Church in Kaiapoi: (a) Shear crack pattern developed at brick-mortar joints along the northern side of the building and (b) separation (settlement and rotation) of the west face of the building. (-43.3812°, 172.6579°; 1000 hrs on 11 September 2010)

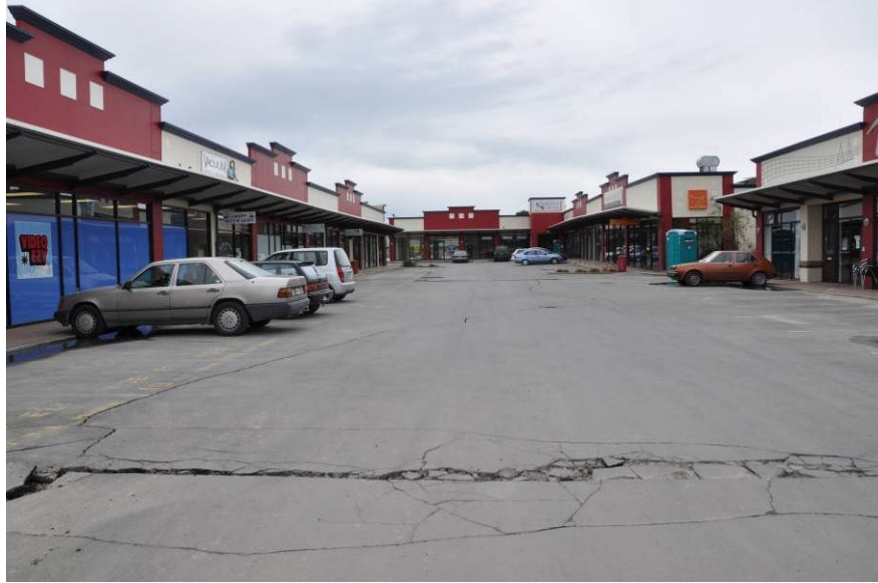
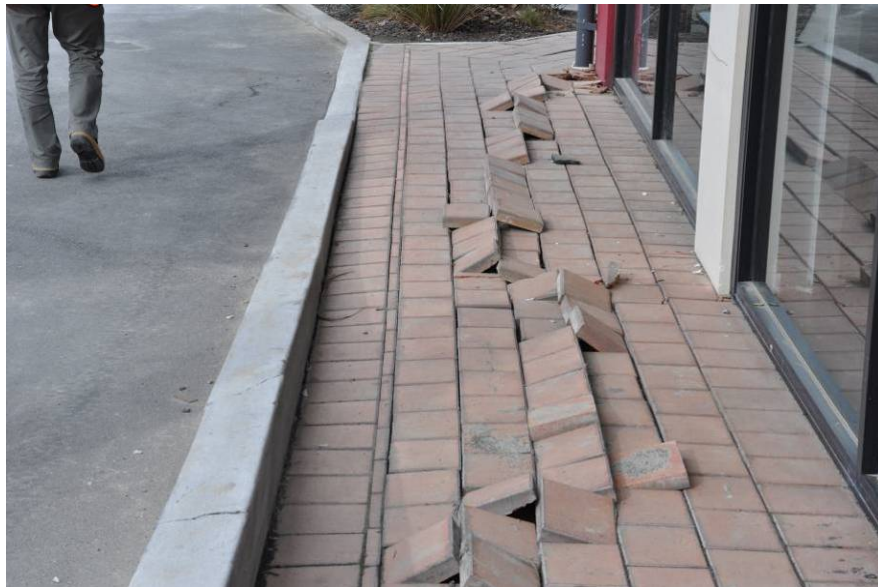
A small shopping area neighboring the New World supermarket in Kaiapoi (between Williams and Jones Streets north-south and Sewell and Charles Streets east-west) showed patterns of extensive ground damage and resulted in many business closures (Figure 5.6a). Closures were primarily prompted by extensive hardscape and interior flooring damage (Figure 5.6b). These buildings attached units of one story wood framed construction supported on slabs on grade and with glass front (open) facing as is common of walking business districts. The tallest structure to suffer damage in the direct adjacency to these business units was a red-tagged 3-story property and family law office constructed of concrete masonry block units (CMU) (Figures 5.7-5.8). This structure is rectangular in footprint with little to no lateral resistance along the longitudinal axis of the building (as evident from the perimeter full facing glass openings – Figure 5.7a). The short axis of the building provides resistance to lateral movement and loads via stiff full length CMU walls at exterior ends of the structure (Figure 5.7b). The front of this building appeared to have settled and rotated towards the direction (southwest) (Figure 5.8). Lateral spread ground failure and liquefaction ejecta were evident directly adjacent to this building (Figure 5.9). A sample of material taken adjacent to this building was tested using laser diffraction scanning (Figure 5.10, denoted WP24).

Figure 5.6 Small business attached units neighboring the Small World supermarket in Kaiapoi (52 Charles St): (a) View looking east showing ground damage pattern and (b) resulting hardscape damage at the front of one business unit. (-43.3827°, 172.6592°; 1045 hrs on 11 September 2010)

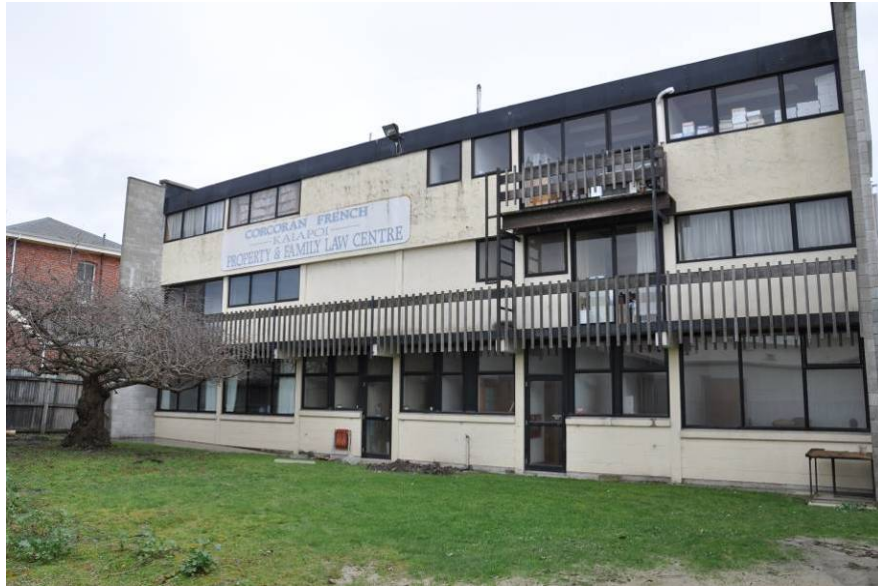
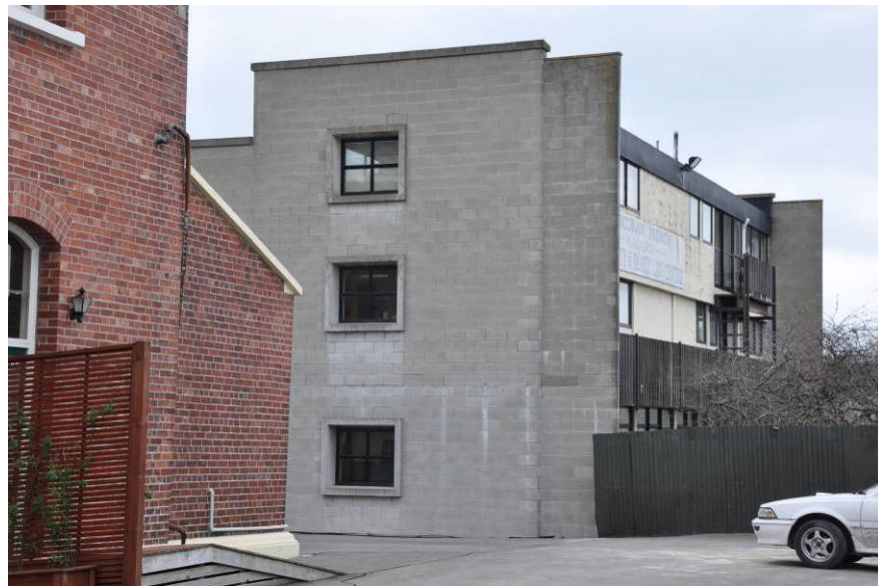
Figure 5.7 Property and Family Law Offices in Kaiapoi business district, 190 Williams St: (a) View looking northwest (at long axis end) of building and (b) view looking northeast showing shearwall ends of short axis of building. (-43.3812°, 172.6579°; 1100 hrs on 11 September 2010)

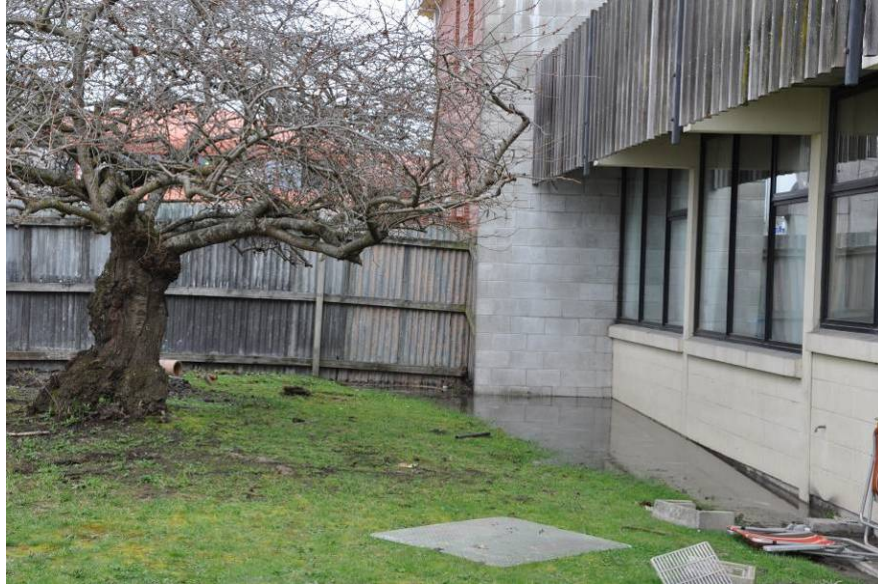
Figure 5.8 Property and Family Law Offices in Kaiapoi business district, 190 Williams St. View looking at west short axis end of the building (-43.3819°, 172.6591°; 1100 hrs on 11 September 2010)

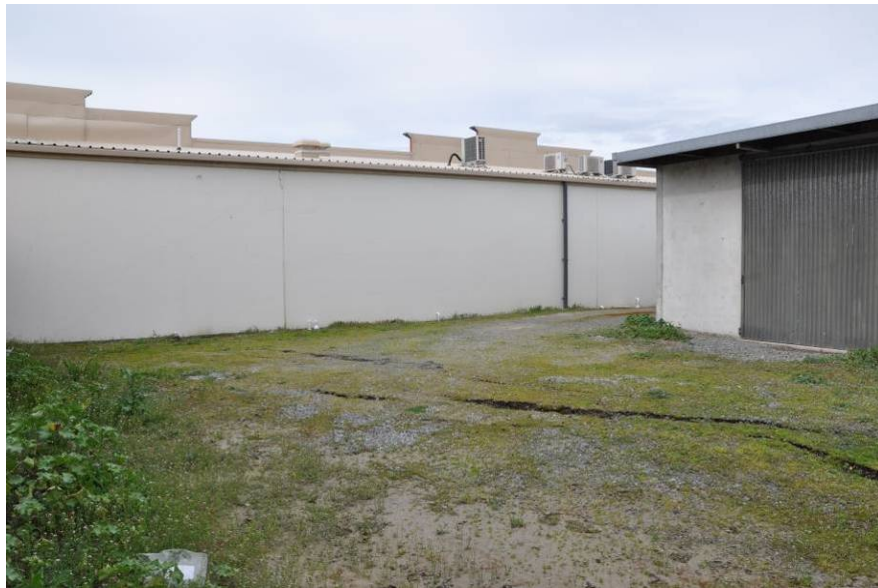
Figure 5.9 Surrounding ground failure patterns directly adjacent to the Property and Family Law Offices in Kaiapoi business district. View looking southeast (43.3819°S, 172.6593°E; 1100 hrs on 11 September 2010)

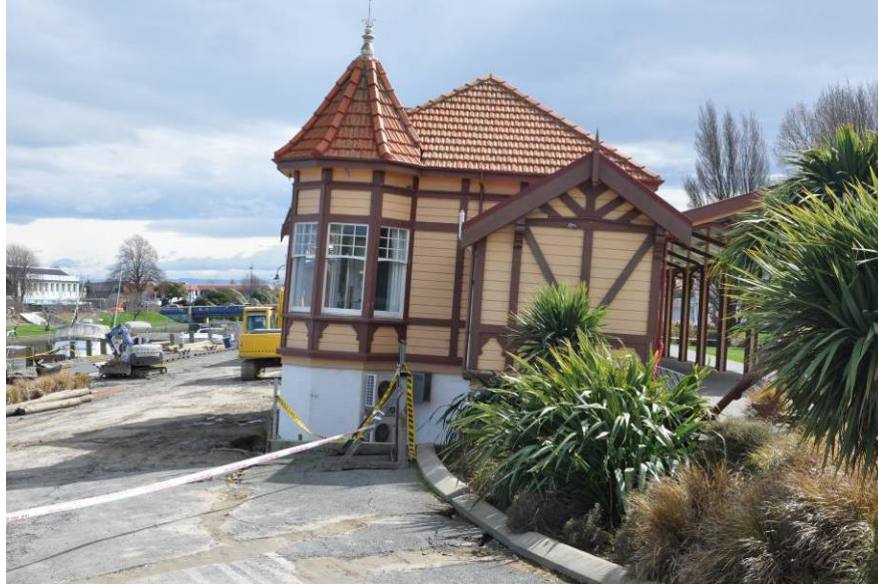
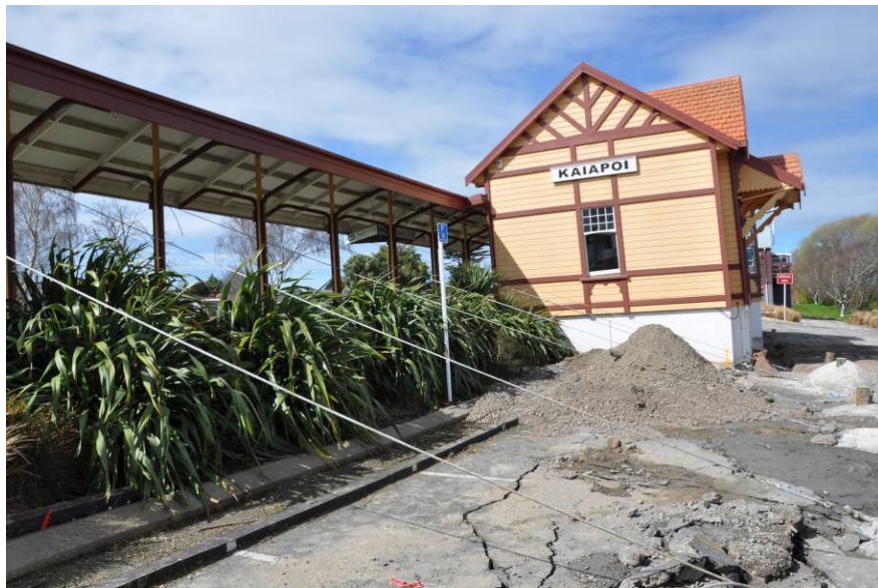
Movement of the Kaiapoi wharf resulted in damage to the historic Kaiapoi Railway Station, which is now renovated and used as the Kaiapoi Information Center (-43.3838° , 172.6596°) and its neighboring Harbor Building (-43.3834° , 172.6591°). The Kaiapoi Information Centre building is a renovated wood framed building on an elevated foundation (Figure 5.11). As a result of loss of ground support, this building tilted approximately 5 degrees northeast (away from the river). Rapid stabilization of the building had been complete by the time of the GEER-NZ Team's visit on 11 September 2010 in the form of concrete footings poured on the exposed (near river) foundation side of the building (Figure 5.11b). In addition, tension tie-backs anchored from newly poured concrete footings to a patio area were used to stabilize the upper pavement during the continuing ground movement. The Harbor building is a one-story masonry block building that suffered tilting towards the river and separation from the wharf of approximately 15-25 cm on its west face (Figure 5.12).

Figure 5.11 Renovated Kaiapoi Railway building now used the Kaiapoi Information Center, adjacent to the Kaiapoi Wharf. (a) View looking northwest and (b) view looking southeast (note the temporary elevated patio support tie-backs and newly poured footings at the front (river side) of the building. (-43.3838°, 172.6596°; 1300 hrs on 11 September 2010).

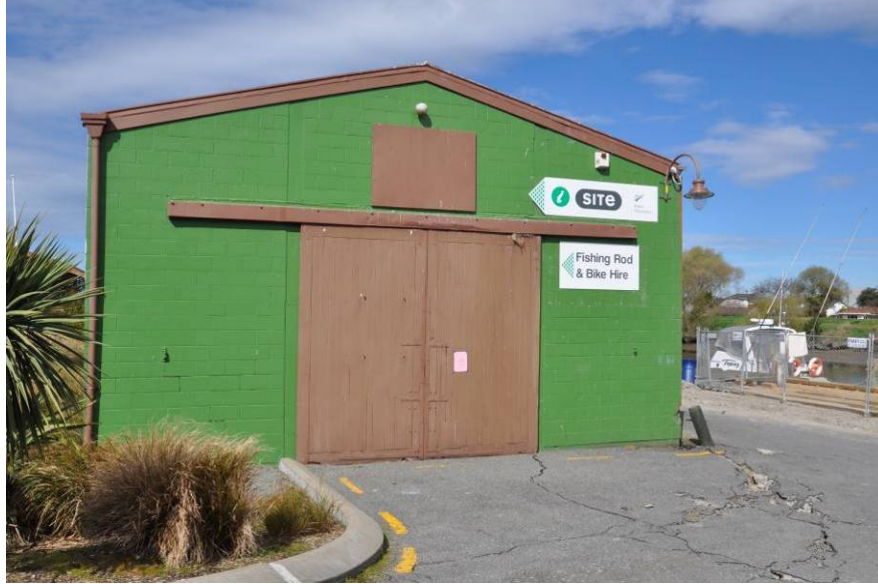
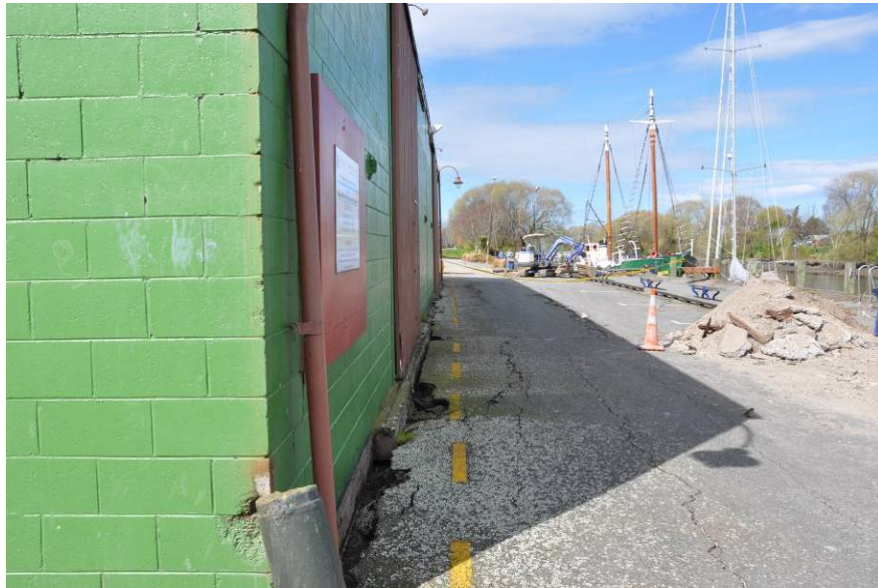
Figure 5.12 Harbor building adjacent to the Kaiapoi River and wharf structures: (a) View looking southeast and (b) view of the northwest corner of the building. Note the approximate 15-25cm gap between the pavement and building. (-43.3834°, 172.6591°; 1345 hrs on 11 September 2010).

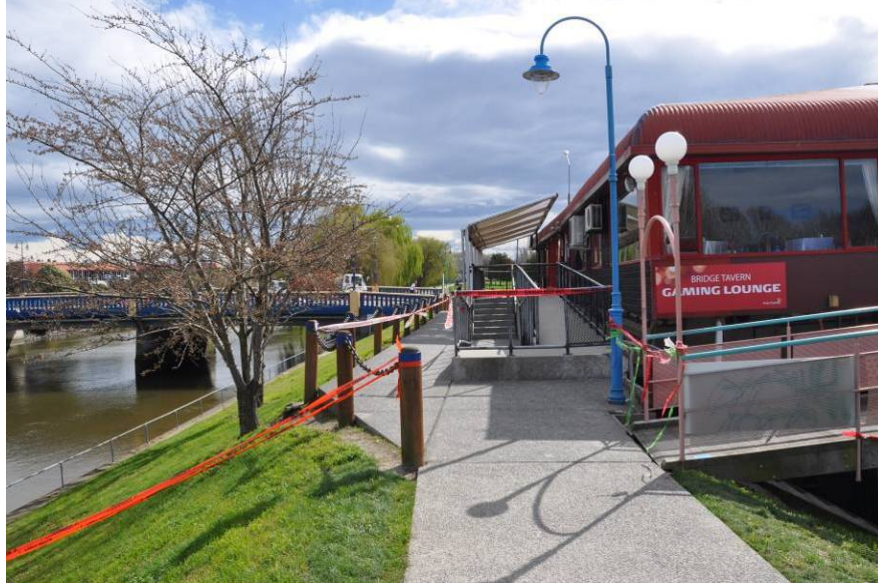
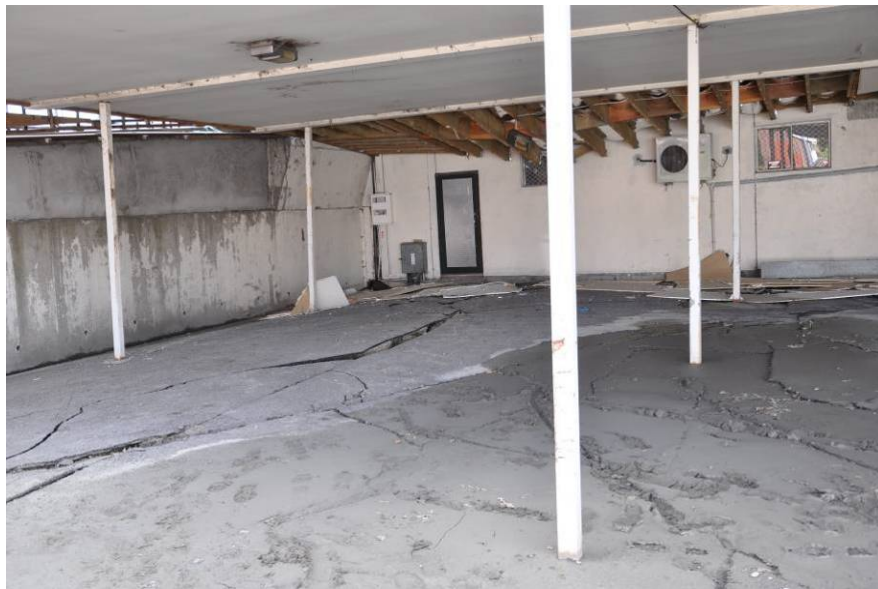
North of the Kaiapoi Information Center and Harbor Buildings, a two story wood frame building with subterranean parking (nearest to river) and a full floor level (nearest to Charles Street) currently housing the Bridge Tavern building was extensively damaged due to ground movement (Figure 5.13). Although movement of the retaining wall adjacent to the Kaiapoi River was not evident, the east embankment side, which supported the first story subterranean parking area showed evidence of ground settlement and cracking. This damage precipitated movement of columns supporting the upper story of the building (Figure 5.13b).

Figure 5.13 Bridge Tavern adjacent to the Kaiapoi River: (a) View looking northwest at Williams St bridge and (b) view looking northwest at subterranean parking. (-43.3826°, 172.6582°; 1345 hrs on 11 September 2010)

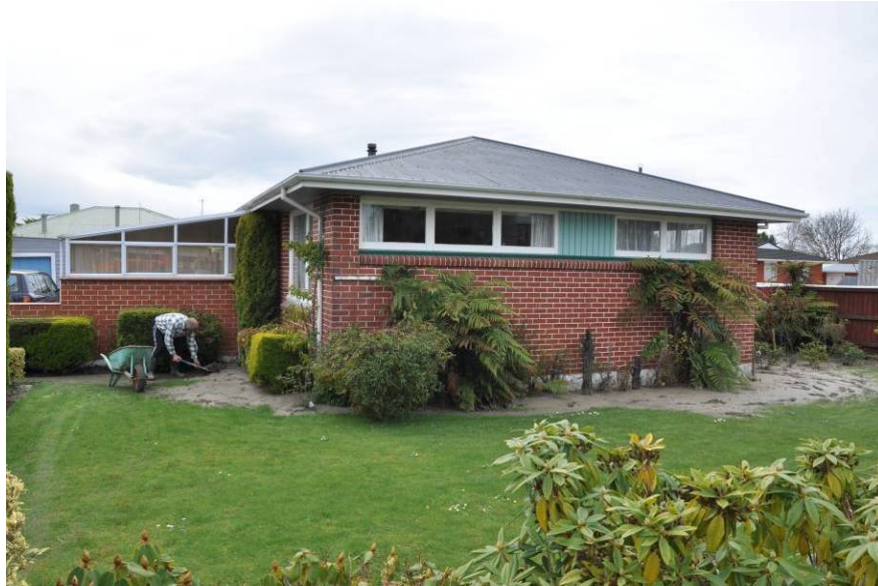
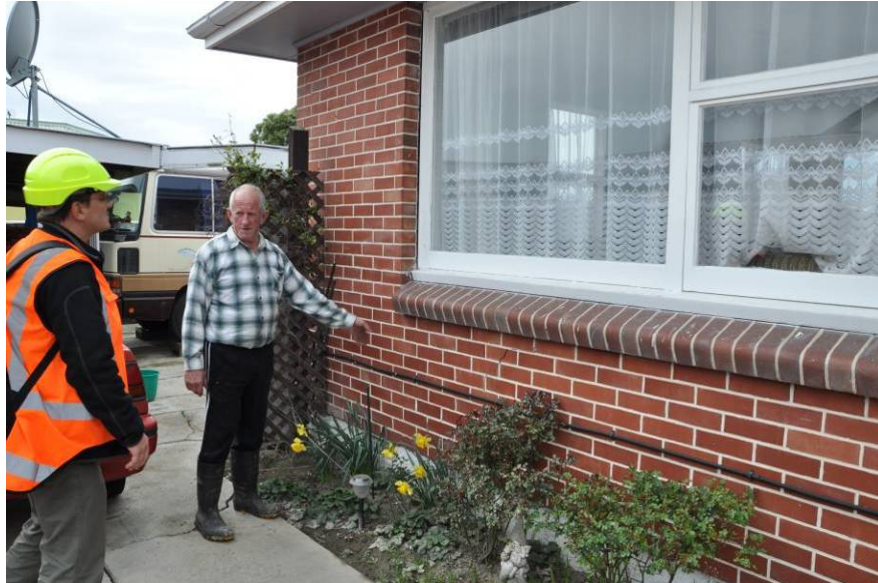
Figure 5.15 Residence along Charles St: (a) Ejecta surrounding home and (b) owner points out shear cracking and gapping developed between window and brick due to structures movement. (-43.3836°, 172.6604°; 1115 hrs on 11 September 2010)

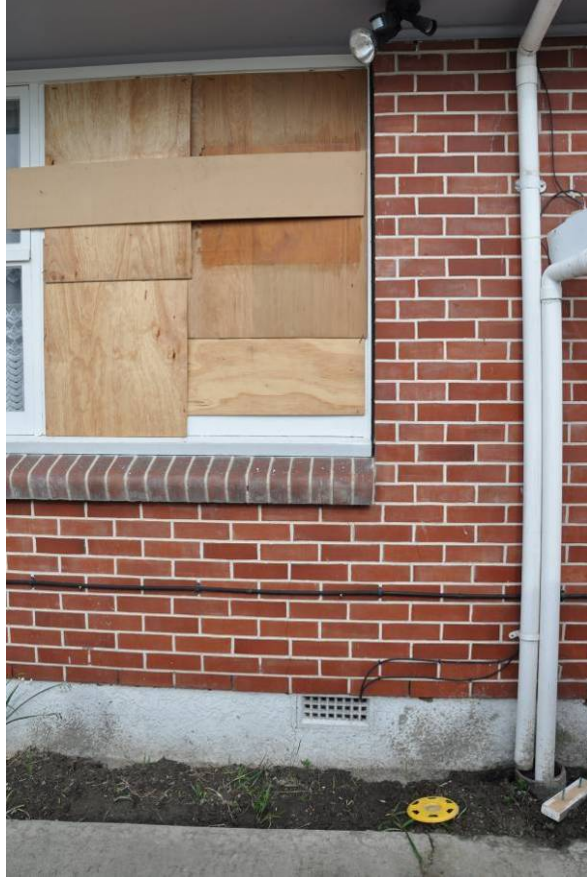
Figure 5.16 Residence along Charles St (same structure as Figure 5.16). Damage to glass windows and between window and wall. (-43.3836°, 172.6604°; 1115 hrs on 11 September 2010)

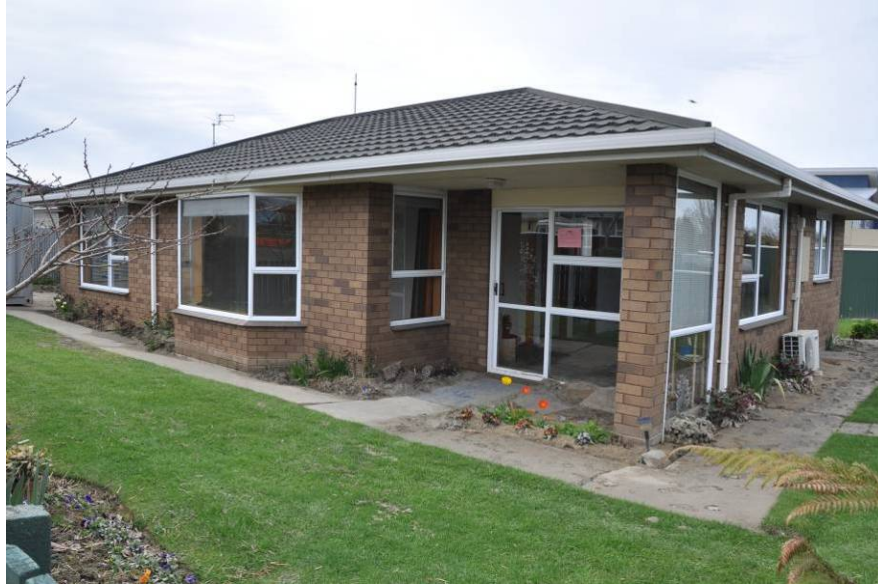
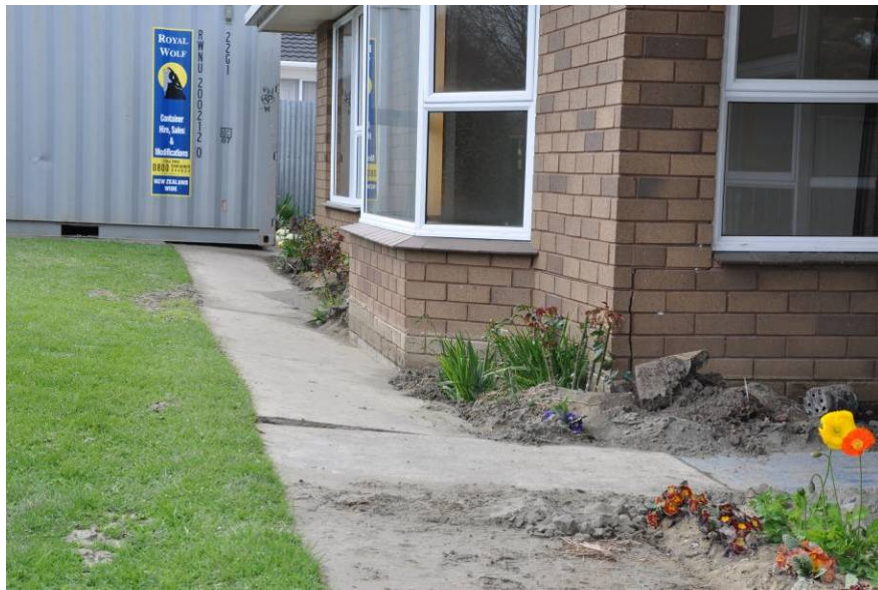
Kaiapoi North – Residential construction within the Kaiapoi North community consists of 1-2 story wood or concrete block framed houses. A number of houses are also constructed of brick or wood with brick façade units. The vintage of these homes appeared to extend as early as 1960's construction, to more recent completely rebuilt or remodeled homes. Uniform settlement of the heavier brick houses in this area, such as shown in Figure 5.15, were measured as large as 20-25 cm. Brick houses consistently observed shear cracking, discontinuities between window and door openings and brick, popped out and/or damaged glass windows, and damage to floor slabs and hardscape (Figure 5.16). Houses along Charles St at the time of the GEER-NZ Team's visit (11 September 2010) were either red or yellow tagged. Very few houses were occupied, with most suffering extensive sand ejecta surrounding the home as well as settlement. In a number of cases, residents of severely damaged homes had moved out completely (e.g. Figures 5.17-5.18). This house at Charles St experienced ~0.4 m of settlement along its North face (Figure 5.17b).

Figure 5.17 Red tagged residence on Charles St: (a) View looking east and (b) north end of house, view looking North-East. (-43.3838°, 172.6607°; 1130 hrs on 11 September 2010)

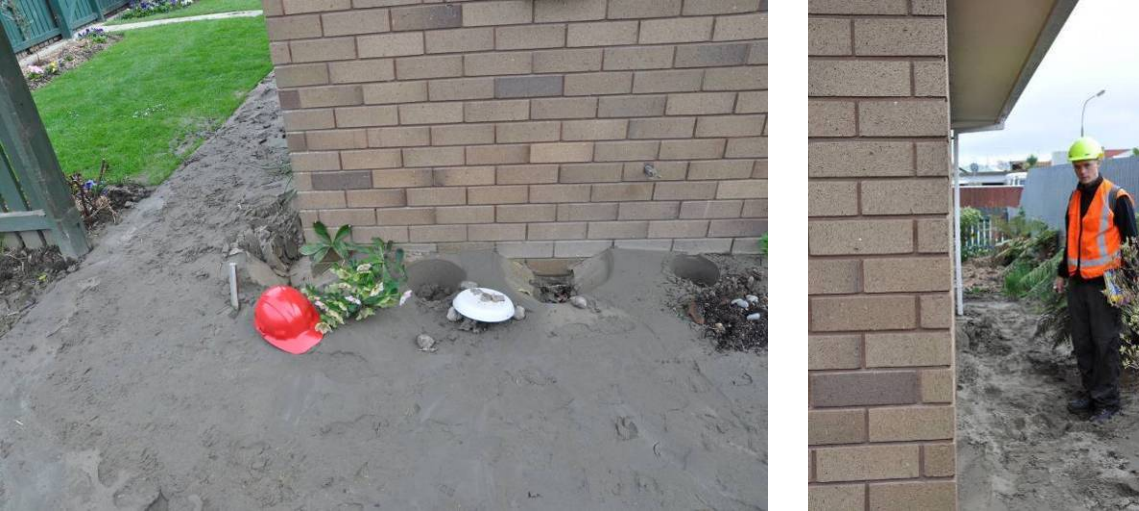
Figure 5.18 Red tagged residence on Charles St. Extensive surrounding ejecta at perimeter of house (43.3838°S, 172.6607°E; 1130 hrs on 11 September 2010)

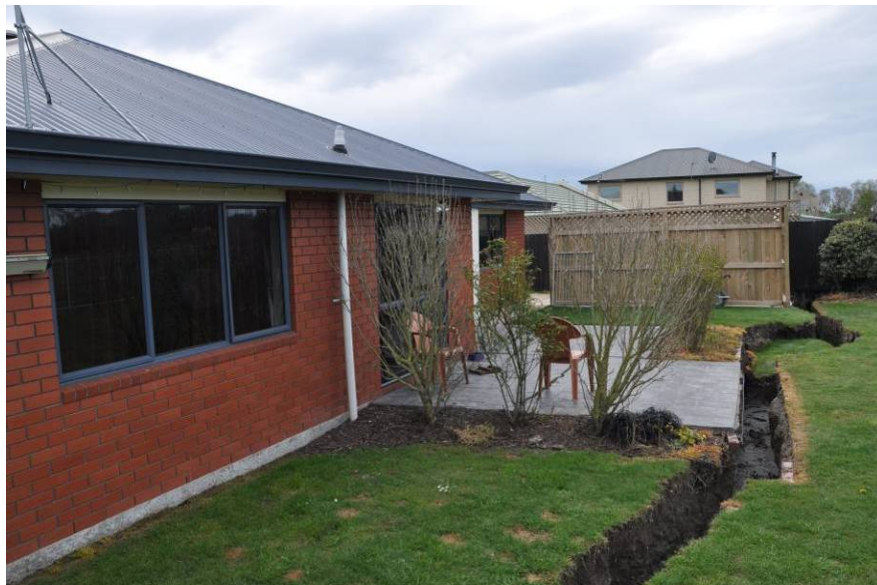
Figure 5.20 Ground failure feature extending through the backyard of a house on the south side of Courtenay Dr in the South Kaiapoi residential community. (-43.3894°, 172.6633°; 1500 hrs on 11 September 2010)

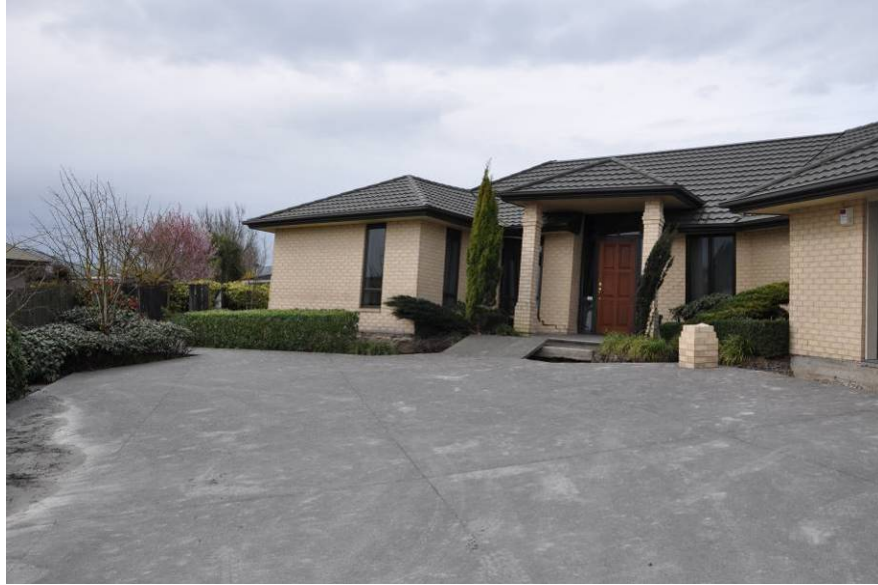
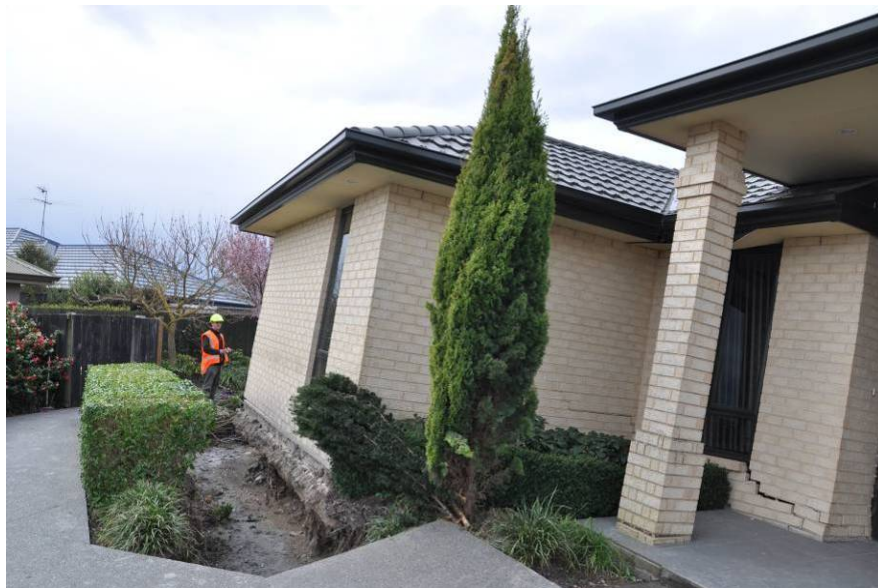
Figure 5.21 Damage to a residence at Courtenay Dr in the South Kaiapoi residential community (front of house articulating excessive tilt and separation of foundation from surrounding hardscape). (-43.390920°, 172.662007°; 1545 hrs on 11 September 2010)

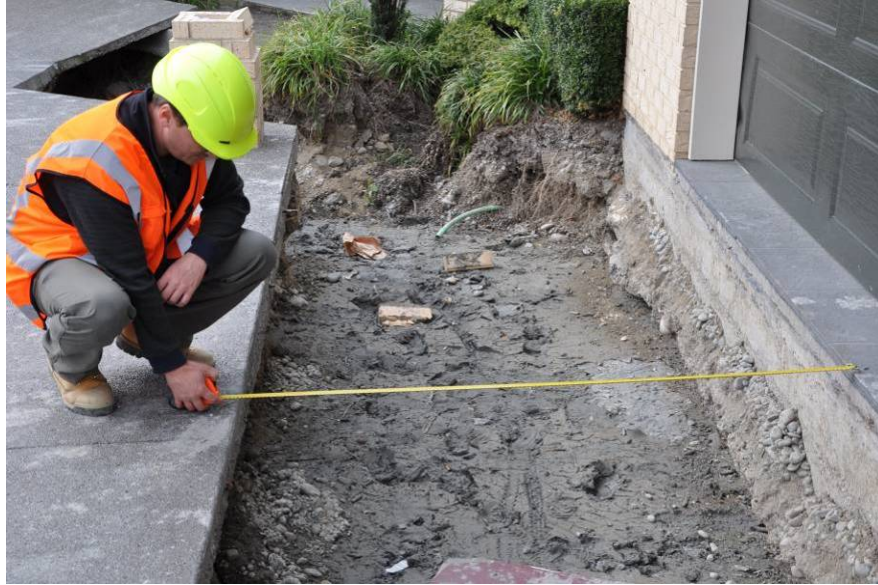
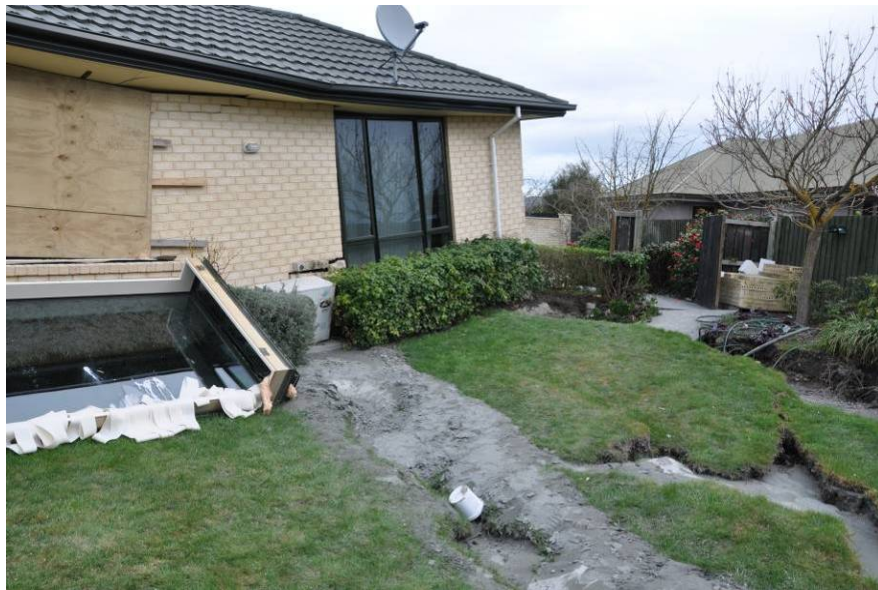
Figure 5.22 Damage to a residence at Courtenay Dr in the South Kaiapoi residential community (a) front of home (1.5-m separation between garage and approach slab) and (b) back of home. (-43.390920°, 172.662007°; 1545 hrs on 11 September 2010)

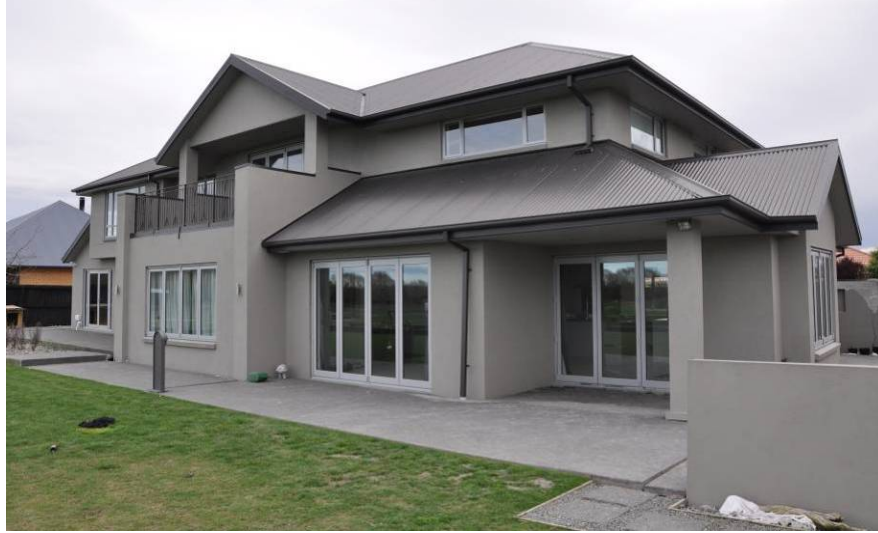
Kaiapoi South – In general damage to building structures in the Kaiapoi South community was limited to Courtenay Dr between Kaikanui St and ending at Parish Ln. This is a residential neighborhood with relatively new homes, all constructed within the last ten years. Most houses are one-story light wood framing or brick supported on unreinforced slabs with perimeter stemwall foundations and light metal roofing. An example of the typical construction style in this area is shown in Figure 5.19. Liquefaction was reported to inundate the neighborhood north of Courtenay Dr towards Charters St, however much of this had been cleaned up by the time of the GEER-NZ Team's visit and appeared to have minimal impact on the houses. The impact to houses along Courtenay Dr however, and particularly those on the east side of the drive, with direct facing to a paddocks' field as well as a branch of the Courtenay Stream, was extensive. Ground failure in this region manifested in large lateral spread zones coupled with liquefaction (Figure 5.20). A manual survey by the GEER-NZ Team indicated that of the 44 houses along this drive 48% suffered severe structural damage induced by ground failure, while 15 (36%) suffered moderate and minor damage, respectively. Laterally spreading ground was observed to extend through the backyards of these houses, with the lack of reinforcement within slab foundations and general light construction styles resulting in severe separation of the home directly in-line with the ground failure. The residences shown in Figures 5.21-5.24 demonstrate the observed damage due to excessive ground movement. The structure shown in Figures 5.21-5.22 suffered excessive tilting and a separation of 1.5 m from its approach driveway to the front of the home (Figure 5.22a), while the rear of the house collapsed inward due to surrounding ground fissures (Figure 5.22b). Similarly, the residence in Figures 5.23-5.24 articulated little to no damage at the backside of the house (Figure 5.23), however the front entry of the house at the interface between

Figure 5.23 Damage to a residence along Courtenay Dr in the South Kaiapoi residential community. Backside of home facing Paddocks field articulates relatively no damage. (-43.391168°, 172.661894°; 1600 hrs on 11 September 2010)

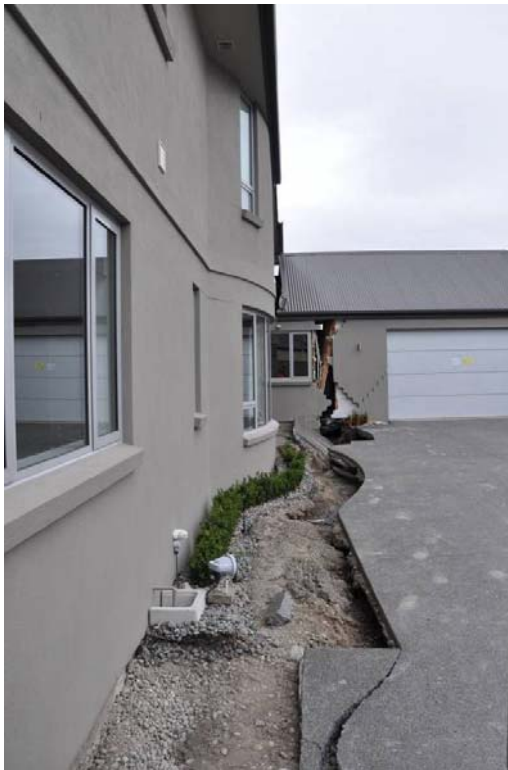
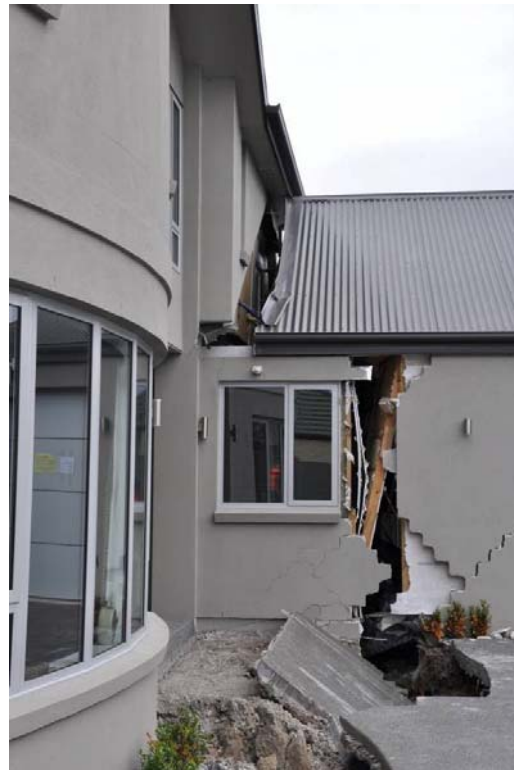
the garage and main portion of the residence suffered a separation of about 1 m due to lateral ground movement (Figure 5.24).

Figure 5.24 Damage to a residence along Courtenay Dr in the South Kaiapoi residential community. Front entry articulates extensive damage as large ground spreading subtends into the superstructure. (-43.391168°, 172.661894°; 1600 hrs on 11 September 2010)

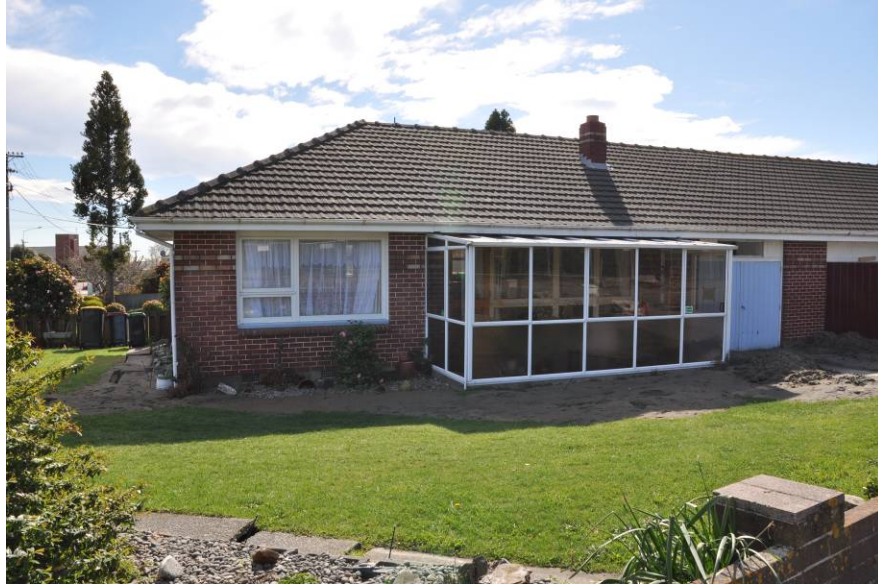
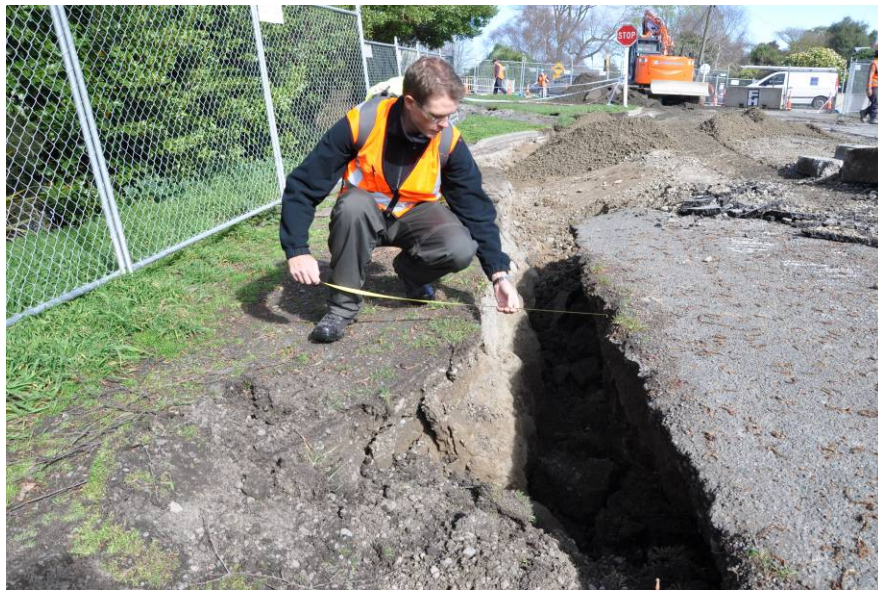
Two common types of damage to residential structures within this community are shown in Figures 5.25 and 5.26. Both of these structures are located near the Avon River. The residence shown in Figure 5.25a directly fronts the Avon River and experienced approximately 3 degrees of rigid body tilt directly south towards the river. Structurally the home was in good condition, though inspection of the interior articulated extensive floor and nonstructural damage. Lateral spreading extension features were observed at the front of the residence at the river and continued north behind this residence (Figure 5.25b). Transects taken by the GEER-NZ Team on 14 September 2010 at this location indicate 85 cm of lateral extension fronted the residence, with vertical offsets in extensions as large as 19 cm and cracks extending as great as 105 cm (T7 in Figure 5.27). Figure 5.26 shows a house in Locksley Avenue, which illustrates a loss of ground support subtended along the structure length. At this location lateral spreading towards the Avon River (behind the position from where the photo was taken) is evident in the driveway. Differential settlement along the length of the house manifests itself as shear cracking and separation of the mortar-brick within the brick veneer wall. This mode of deformation is similar, but less intense, to that imposed on the slab-on-ground foundations of the houses illustrated in Figures 5.20-5.24.

Figure 5.25 (a) Rigid body rotation of a residence in Dallington (Locksley Ave) due to liquefaction and $(-43.5212^\circ, 172.6731^\circ)$; (b) lateral spread features directly fronting the home. Surveys of ground features at this location are associated with T7 $(-43.5212^\circ, 172.6731^\circ)$ (refer to Figure 5.27).

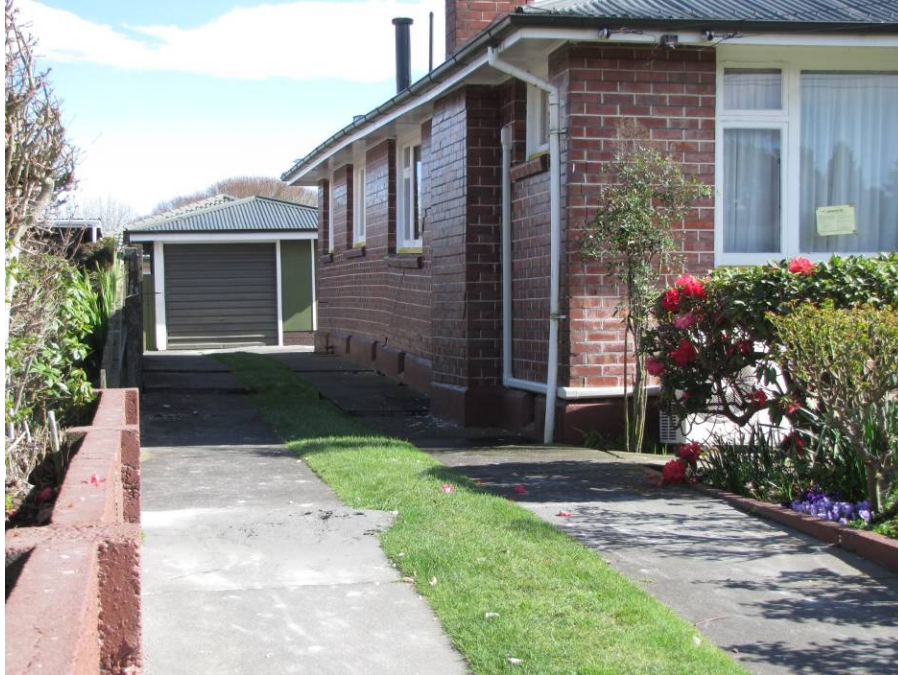
Figure 5.26 Residence affected by lateral spreading along the driveway, which has induced differential settlement between the front and rear of the house. (Note that this is not a slab-on-ground house, and older style of construction with a concrete perimeter beam and the timber floor being supported on shallow foundations; Locksley Ave; -43.5194° , 172.6754° ; 1130 hrs on 14 September 2010)

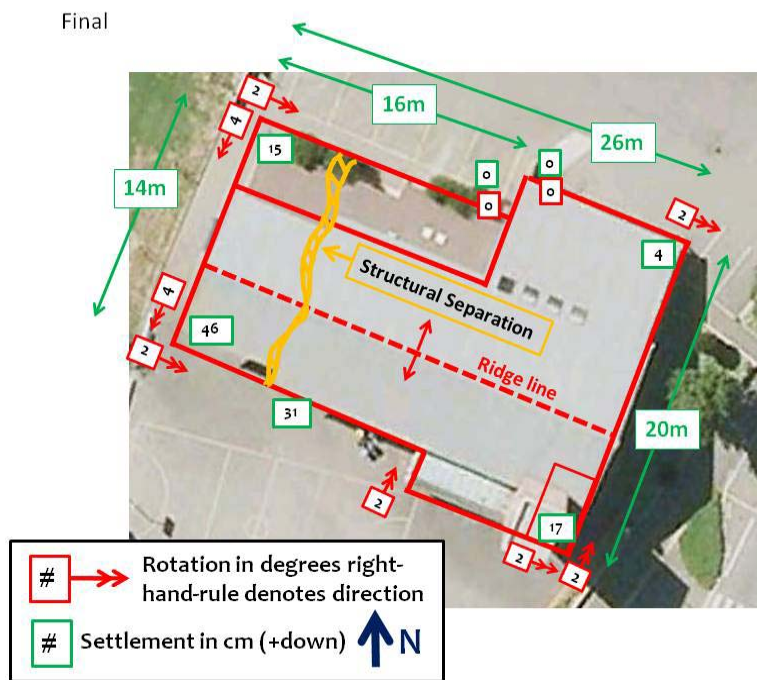
A historically significant feature in the neighbourhood of Dallington is the St. Paul's church and surrounding school (Figure 5.28). St. Paul's church was severely damaged due to surrounding ground movement, which was precipitated by extensive liquefaction within the general area shown in Figure 5.28. Most significantly the structure suffered through building separation due to ground extension and vertical offset subtending north-south approximately one-third of the length along the west end (orange separation location denoted in Figure 5.29). This resulted in separation of the building into two distinct pieces. The West end of the building rotated 2 degrees south and 4 degrees west (Figures 5.30-5.33), resulting in 46 cm of settlement of the south-west corner (estimated with reference to prior ground elevation). No significant lateral translation of the building was measured at its perimeter, rather structural movement was confined to rotation and settlement as described in Figure 5.29. This relatively heavy single story structure was constructed of running bond brick perimeter walls, with a timber (truss) roof. Wall heights were approximately 10 m at the perimeter of the sloping roof and 7m at flat portions. An ~12-m tall tower is articulated at the southeast corner of the structure (Figure 5.33b). The

Figure 5.29 St Paul's church damage map – survey conducted 12 September 2010; Global dimensions approximate (extracted from GoogleEarth image), deformation obtained directly in the field.

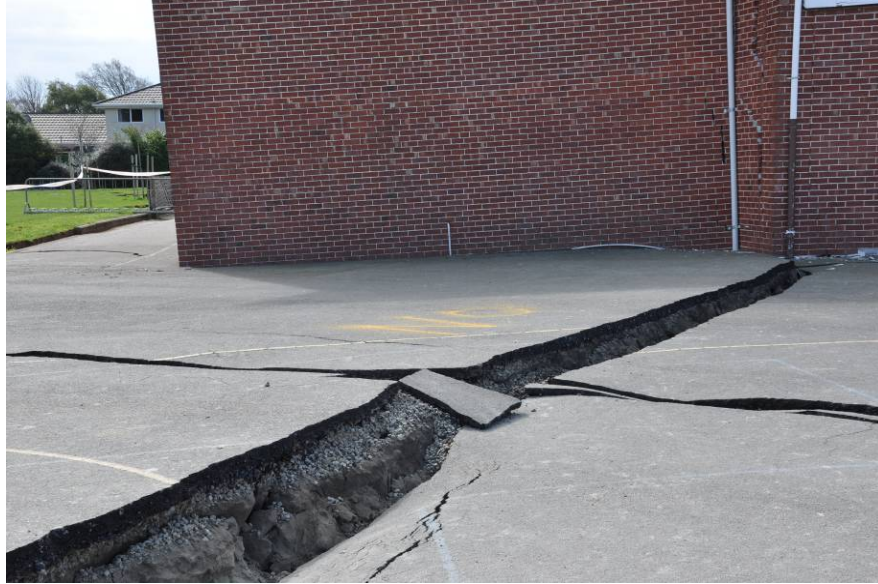
Figure 5.31 St Paul's church in Dallington area - view looking north at ground failure, which continued through building. (-43.5196°, 172.6725°; 1400 hrs on 12 September 2010)
