5. IMPACT ON BUILDING STRUCTURES

General

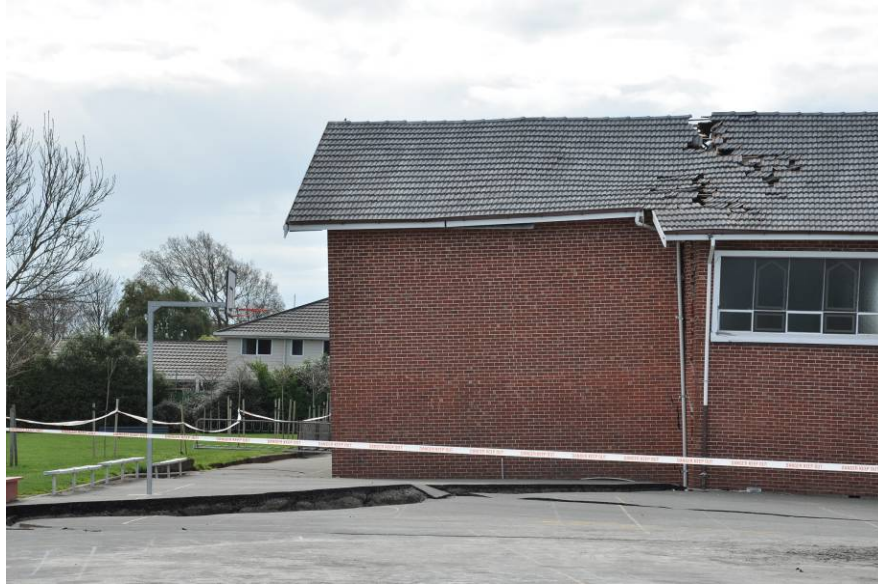
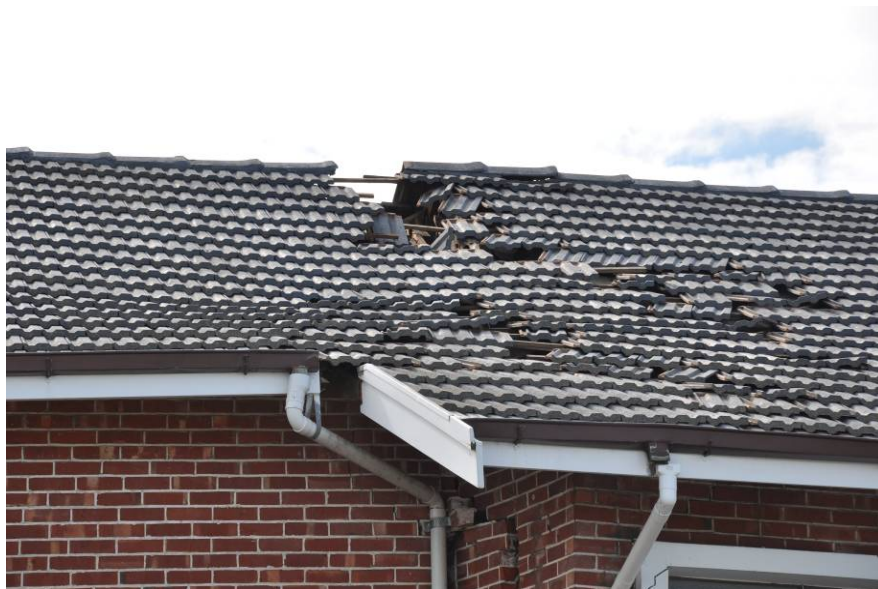
Figure 5.32 St Paul's church in Dallington area - view looking north (a) far view of separated west end of building and (b) close-up view of structural separation. (-43.5196°, 172.6725°; 1400 hrs on September 2010)

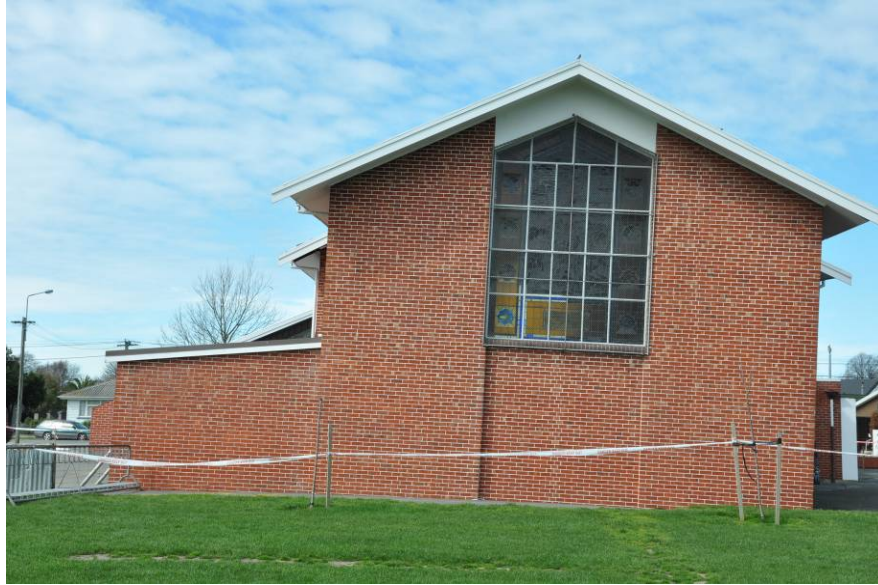
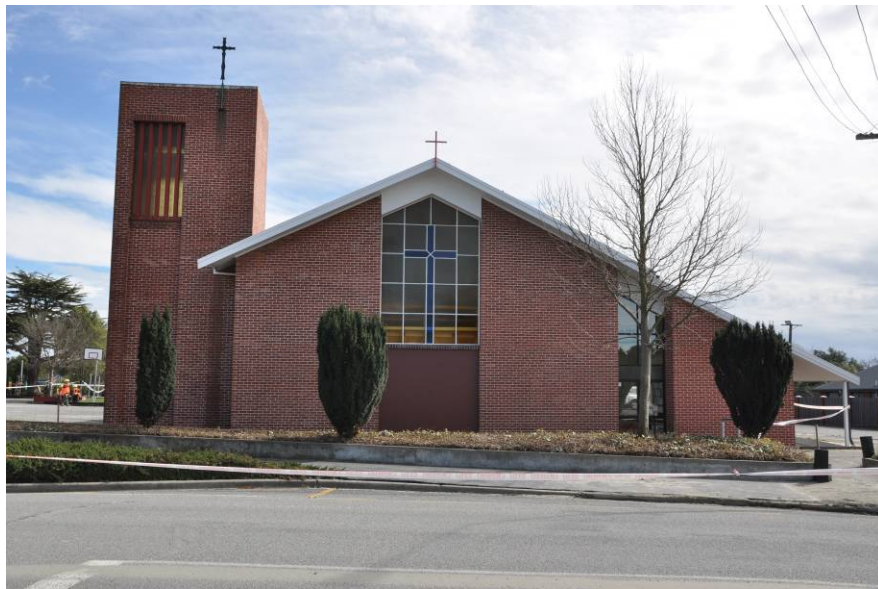
Figure 5.33 St Paul's church in Dallington area: (a) view looking east at the west end and (b) view looking west at the east end (-43.5196°, 172.6725°; 1400 hrs on 12 September 2010)

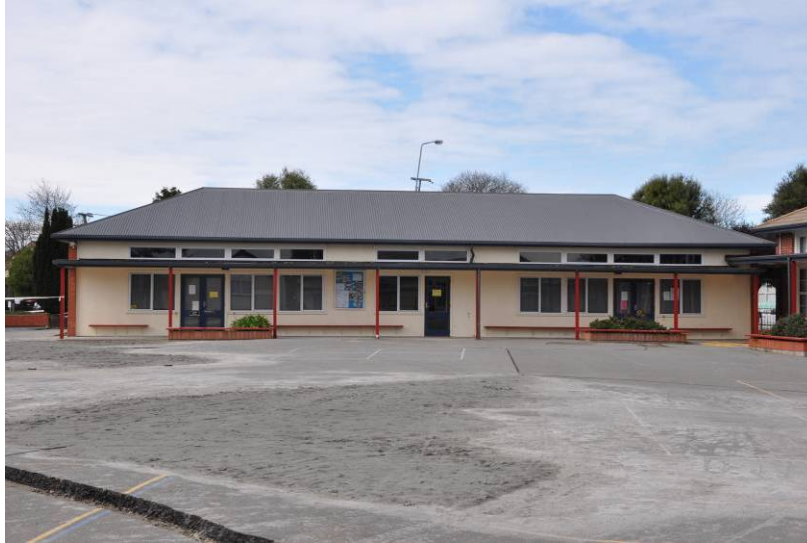
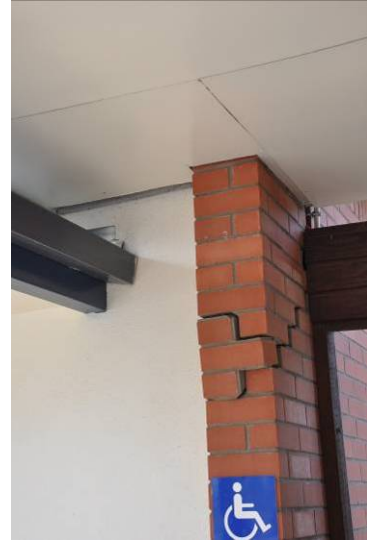
Figure 5.37 St Paul's church and surrounding school - Building B7: (a) view looking east and (b) view of south-west corner of building articulating column damage at wood-brick interface. (-43.5199°, 172.6726°; 1400 hrs on 12 September 2010)

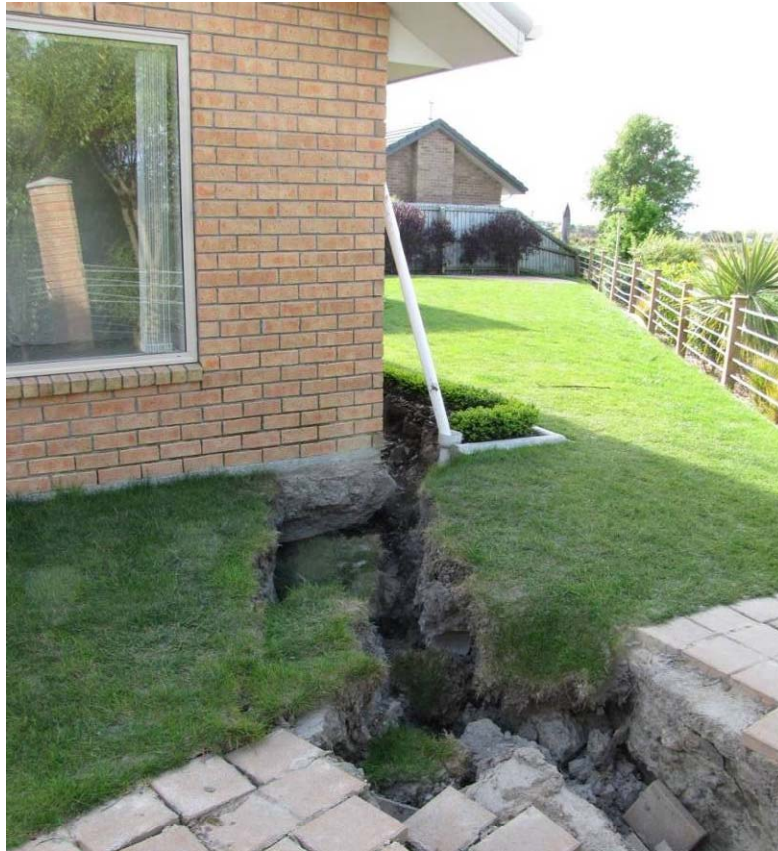
In the residential area of Bexley, houses were significantly affected by lateral spreading (e.g. Figures 5.38-5.39). The lateral spreading was apparent from walking around the path along the southern boundary of the subdivision next to the wetland. Fissures of 300 mm or greater in width traversed the ground of several properties. A floor slab fissure (estimated width 50 to 75 mm, visible because the carpet had been lifted) extended across the full width of one house. Settlement had occurred but with relatively little tilting. Given that the fissure went through the concrete floor slab, there appeared to be relatively little damage to the walls.

Figure 5.38. Lateral spreading compromising ground support beneath the concrete slab-on-grade house foundation. (Kokopu St; -43.5183°, 172.7220°; 1030hrs on 12 September 2010)

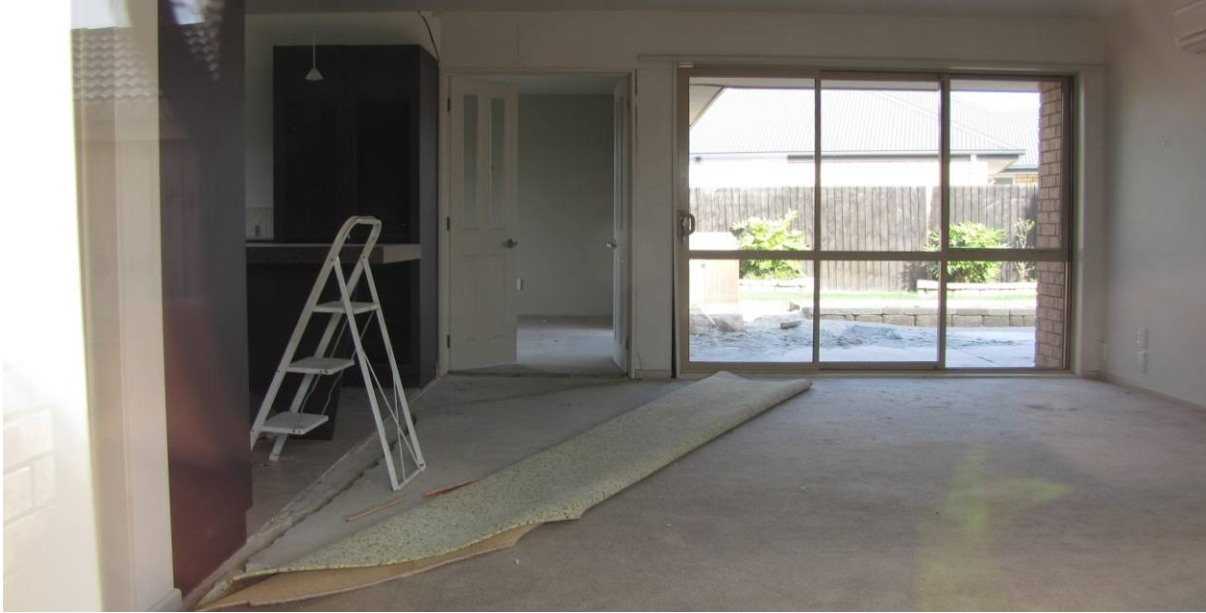
Figure 5.39. Fissure in concrete floor slab (to the left hand side passing beneath the ladder). (Same house as in Figure 5.38.) (Kokopu St; -43.5183°, 172.7220°; 1030hrs on 12 September 2010)

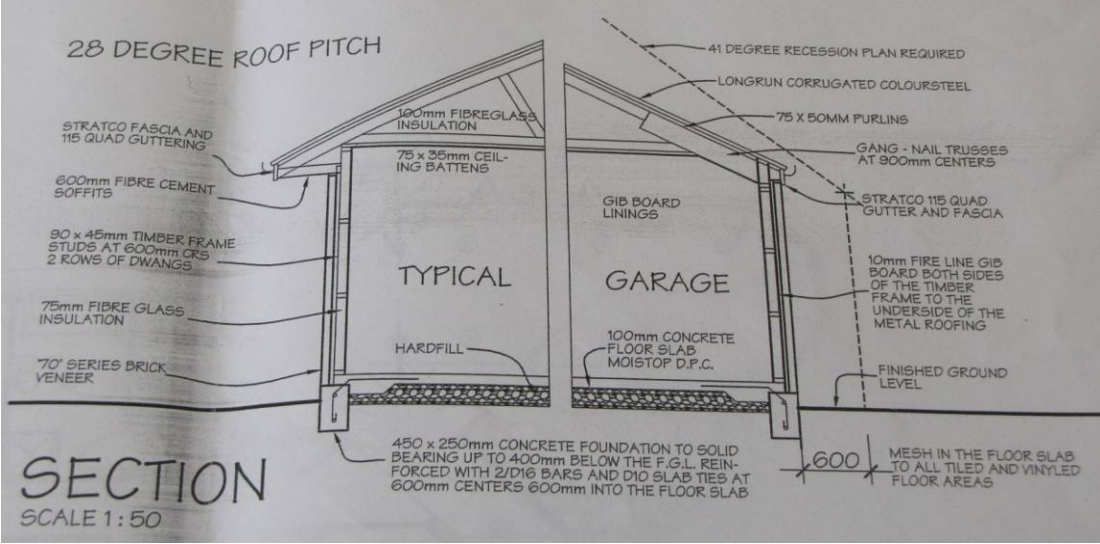
Foundation details for one house in Bexley are shown in Figure 5.40. The system set-out in Figure 5.40 is a perimeter beam with two D16 bars, D10 starter bars 600-mm long at 600 mm centers around the edges. The cavity inside the perimeter beam is filled with coarse gravel, covered with dampcourse, and then topped with a 100-mm thick concrete slab, which, apart from the starter bars, is mostly unreinforced. The drawing in Figure 5.40 specifies mesh reinforcing in areas that are to be tiled or covered in vinyl. Nonetheless, reinforcing was not observed to cross any fissure as noted in the drawing.

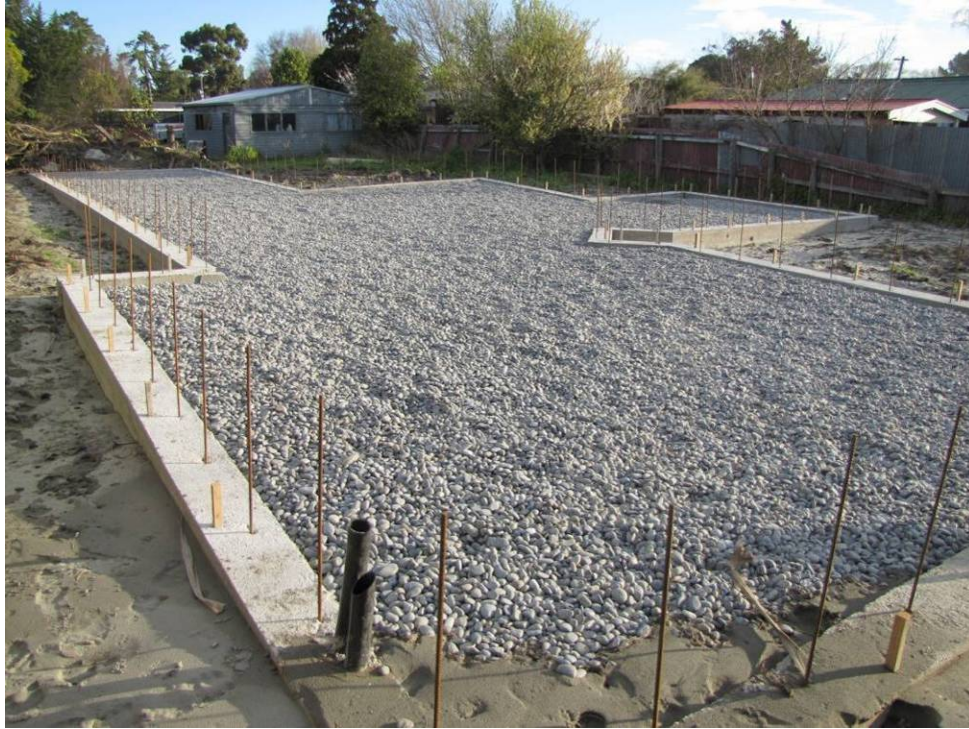
close to level before the event, it was apparent that the footing was not capable of withstanding the ground deformation during the earthquake as the footing was no longer level (Figure 5.41). Two D16 reinforcing bars were observed in this footing where cracking had occurred.

Figure 5.41. Site at Pines Beach which appears to be using the same slab-on-grade system as at Bexley (Chichester St; -43.3877°, 172.70304°; 1800hrs on 12 September 2010)

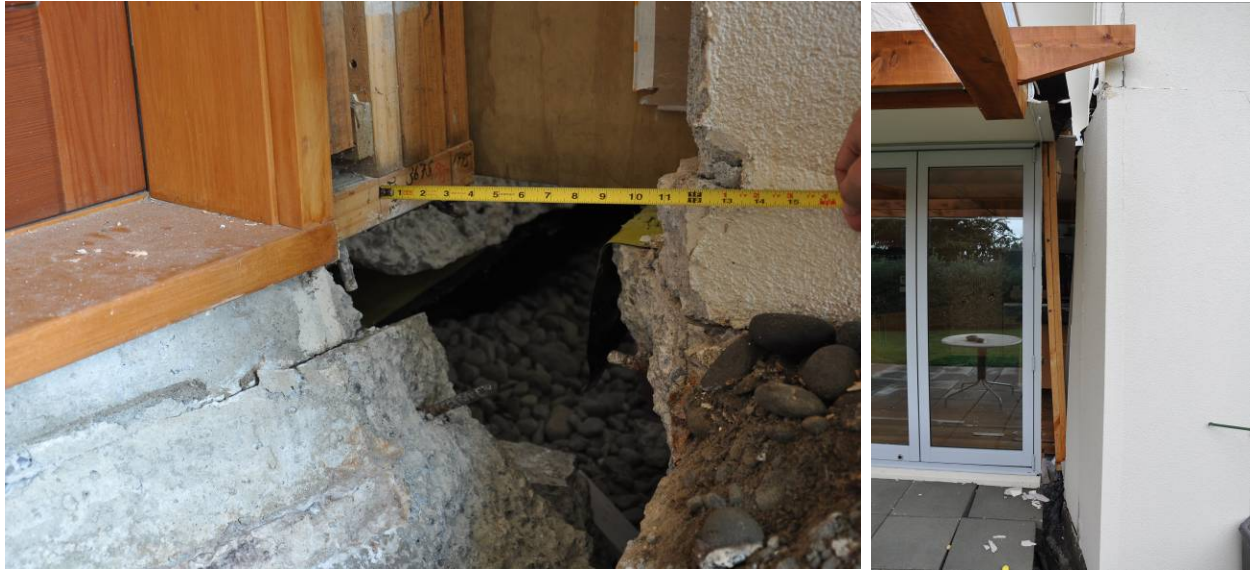
Figure 5.44. Ruptured floor slab near the front entrance of Riverside Ln. Clearly visible is the gravel infill shown in Figure 5.41 (note that there appears to be no ejected sand present). (a) ground fissure separating front entry of the house and (b) same ground feature propagated through the house and departing on opposing side. (-43.43096°, 172.6931°; 1230hrs on 13 September 2010)

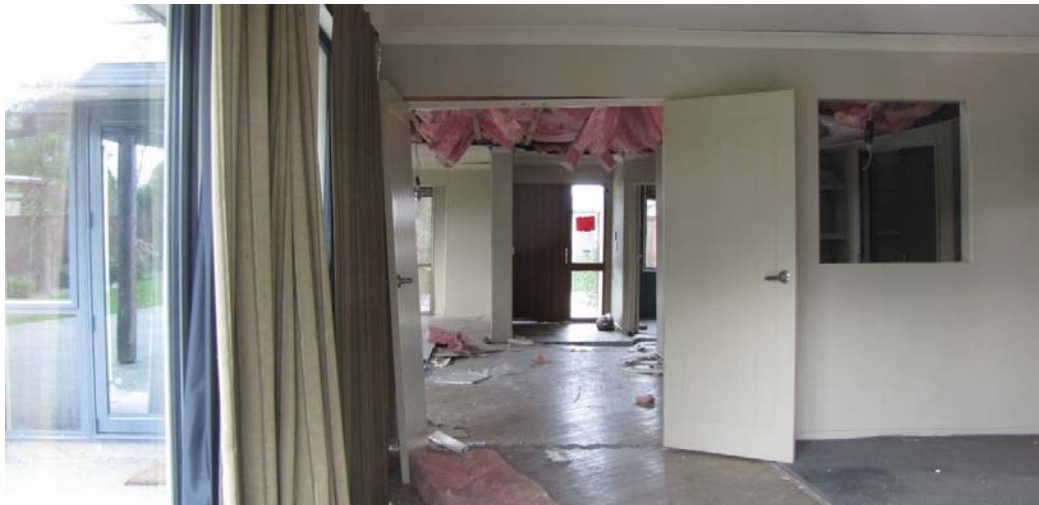
Figure 5.45 Interior view of residence at Riverside Ln. Note the two floor breaks visible in the photograph. (-43.4310°, 172.69319°; 1500hrs on 28 September 2010)

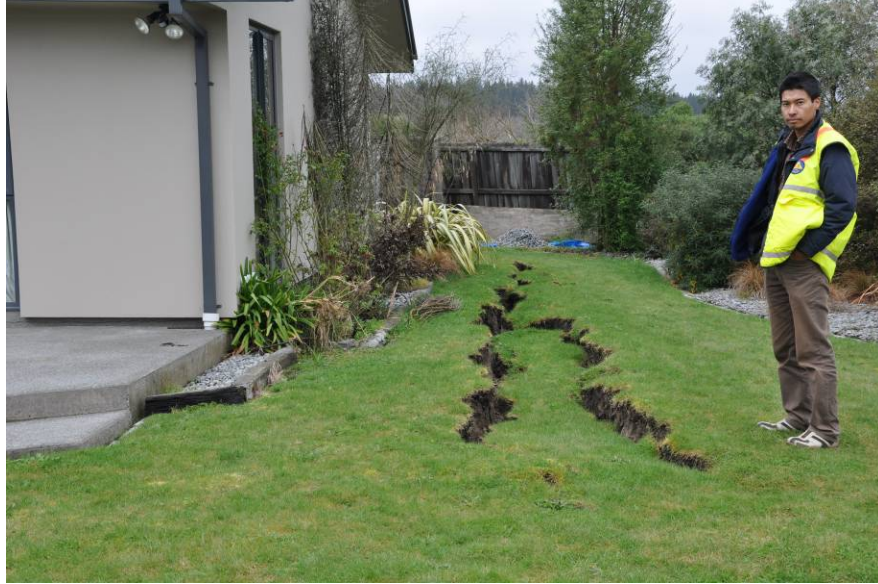
Figure 5.46. Lateral spread adjacent to residence at Riverside Ln. The location of this fissure is ~26 m from the nearby Styx River. (-43.4308°, 172.6930°; 1230 hrs on 13 September 2010)

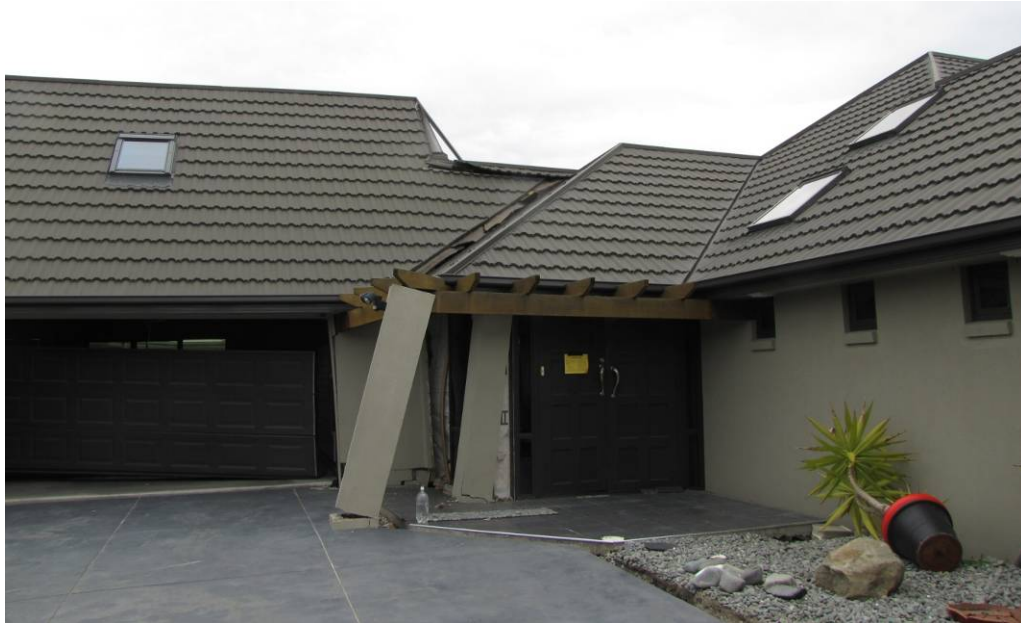
Figure 5.47. House with fissured floor slab with damage carried through to the roof line, which is no longer weather proof. (Riverside Ln, Spencerville). (-43.4311°, 172.6935°; 1600hrs on 28 September 2010)

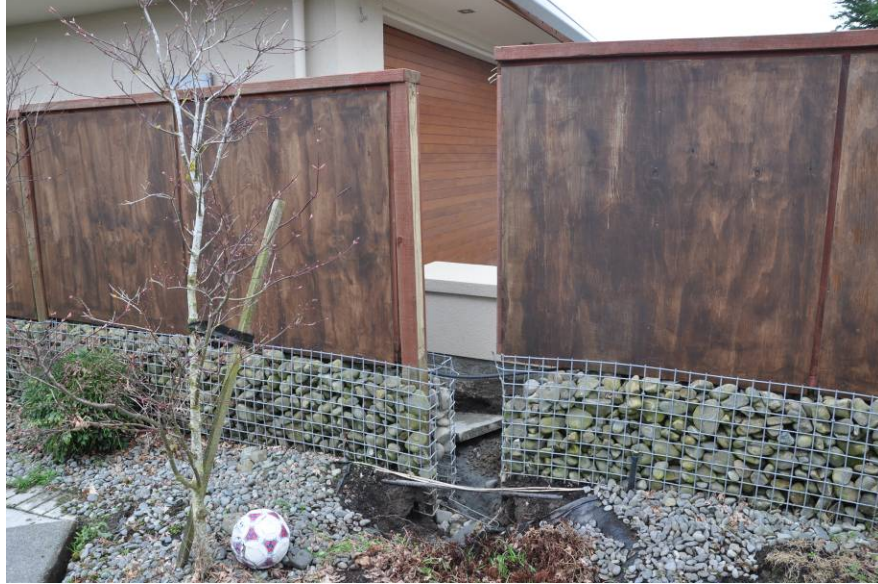
Figure 5.48 Separated fence line due to propagating ground fissure meandering between houses along Riverside Ln. (-43.43096°, 172.6931°; 1230hrs on 13 September 2010)
