6. PERFORMANCE OF LEVEES (OR STOPBANKS) AND OXIDATION POND EMBANKMENTS

Seismic Performance of Levees

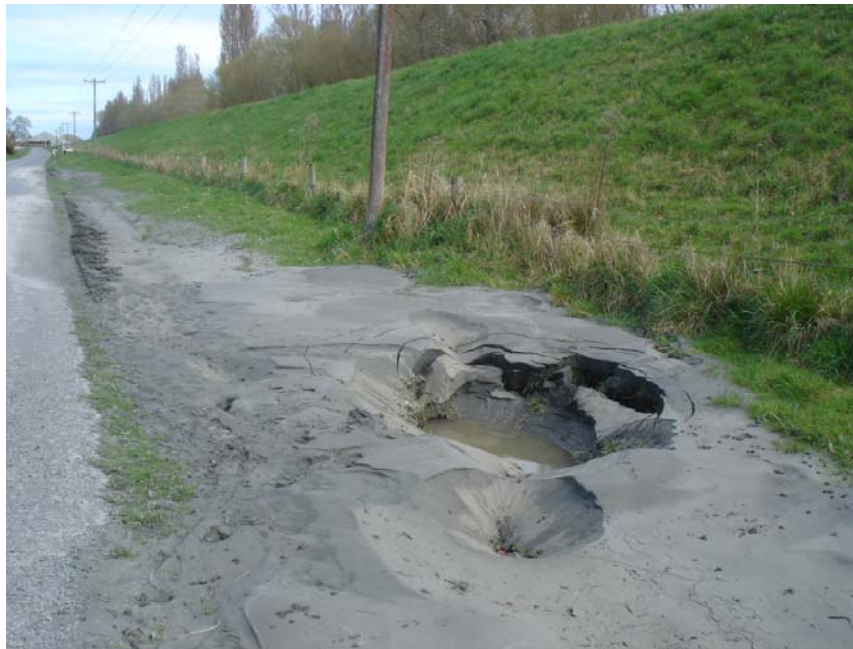
Figures 6.6-6.11 are photographs of the levees for the Waimakariri River along Coutts Island Rd. Numerous sand boils were found along the base of the levee for an ~0.5 km stretch (Figures 6.6-6.8), on both the river and land sides. By the time of the team's damage survey on 11 September 2010, the top of levee along this stretch had already been regraded (Figure 6.9), likely to fill in longitudinal cracks that formed along the crest of the levee. Figure 6.10 is of a ~2-cm wide longitudinal crack in the crest of the levee, located just outside of the ~0.5 km stretch where the crest road had been regraded. It is assumed that the longitudinal cracks in the stretch of levee where the crest road had been regraded were more significant than that crack shown in Figure 6.10, thus warranting the regrading. The liquefaction along the base of the levee and longitudinal cracks in the crest abruptly stopped outside of the ~0.5 km stretch; this may be seen in Figure 6.11, where no damage to the levee could be found.

Figure 6.6 Photo 1: Large sand boil at the base of the landside of the levee on Coutts Island Rd. The location of this photograph is denoted in Figure 6.4. (-43.425018°, 172.628442°)

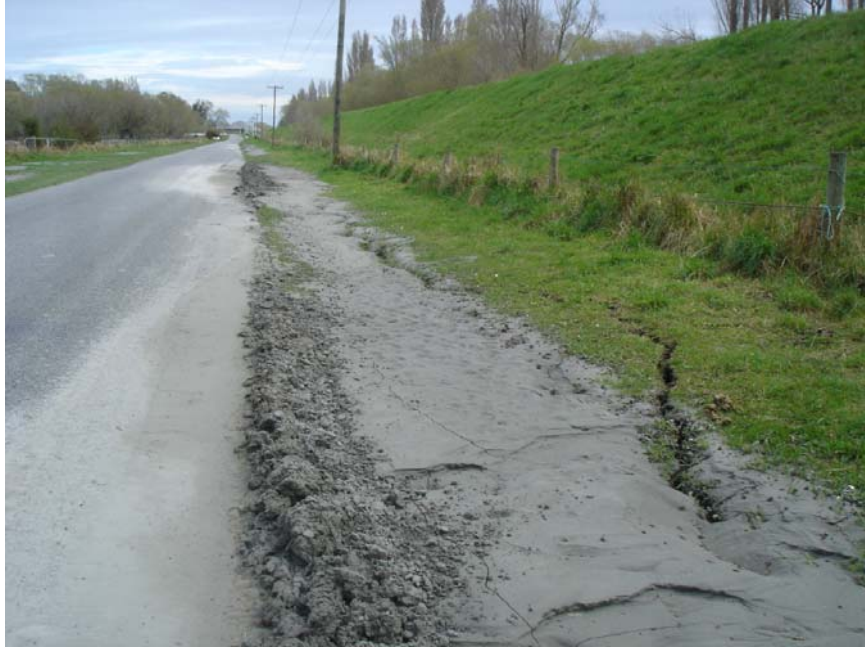
Figure 6.7 Photo 2: Crack running along base of levee on Coutts Island Rd (landside) and liquefaction ejecta. The location of this photograph is denoted in Figure 6.4. (-43.424466°, 172.629907°)

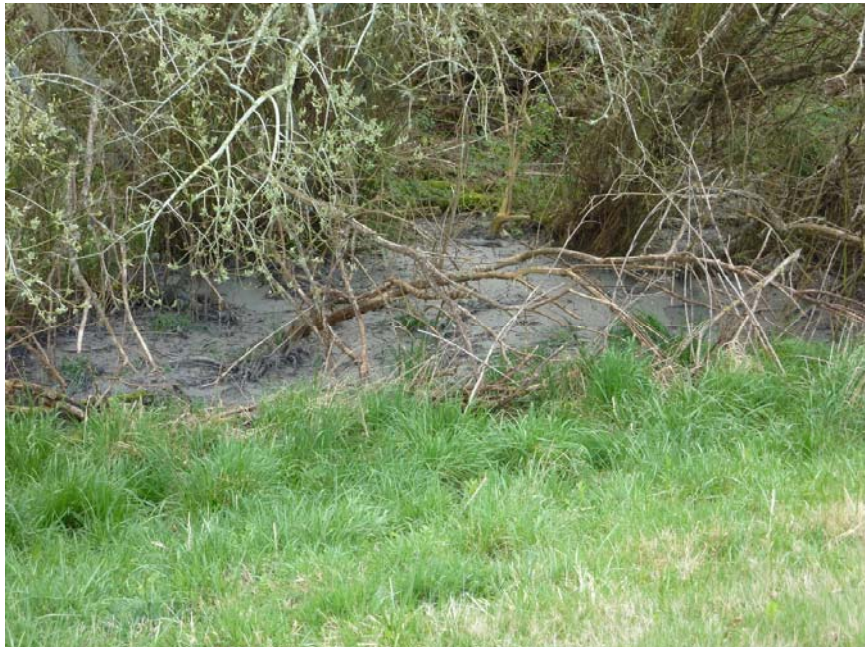
Figure 6.8 Photo 3: Liquefaction ejecta (center of photo) along the base of the levee on Coutts Island Rd (riverside). The location of this photograph is denoted in Figure 6.4. (-43.424093°, 172.630468°)

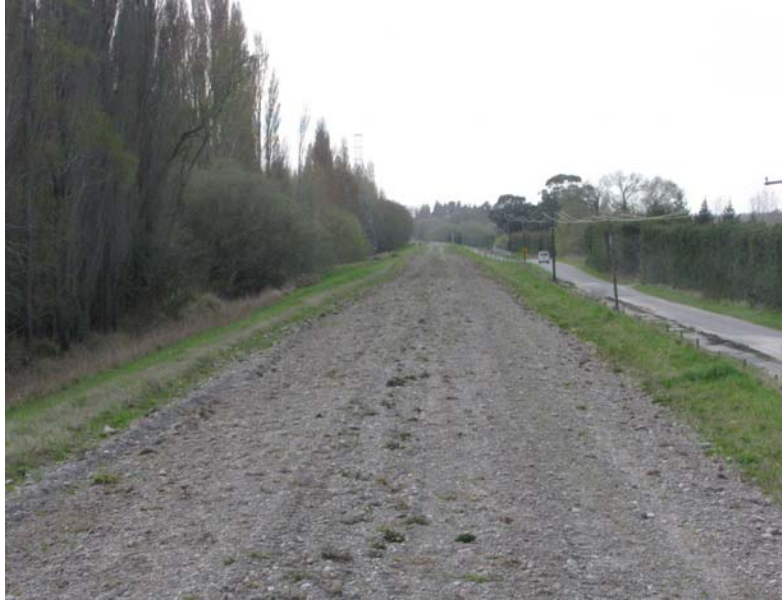
Figure 6.9 Photo 4: Road on top of levee that had recently been reggraded, presumably after the earthquake to fill in longitudinal cracks formed during the earthquake. Liquefaction was observed along the base of both sides of the levee along this stretch. The location of this photograph is denoted in Figure 6.4. (-43.423943°, 172.631045°)

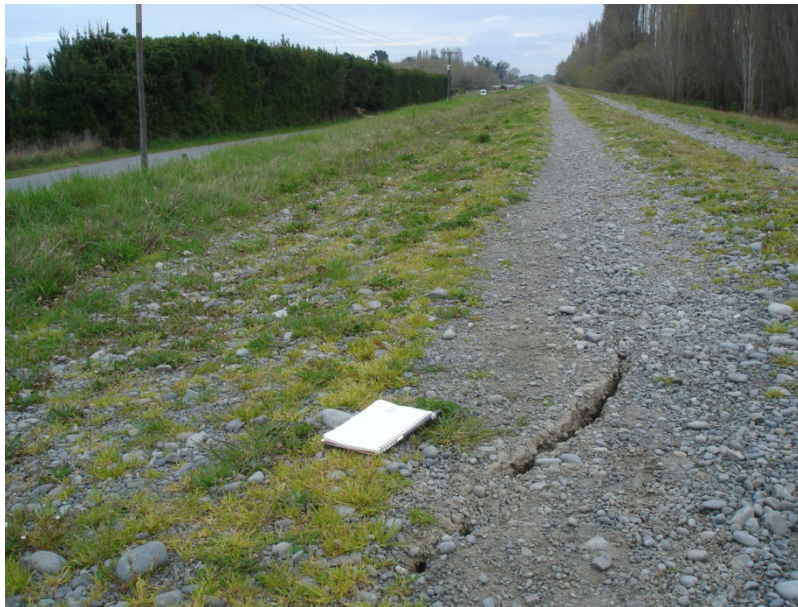
Figure 6.10 Photo 5: ~2-cm wide crack running lengthwise along the top of the levee on Coutts Island Rd. This crack was at the edge of the ~0.5 km stretch of the levee where significant liquefaction was observed. Photo taken looking southwest. The location of this photograph is denoted in Figure 6.4. (-43.423440°, 172.632349°)

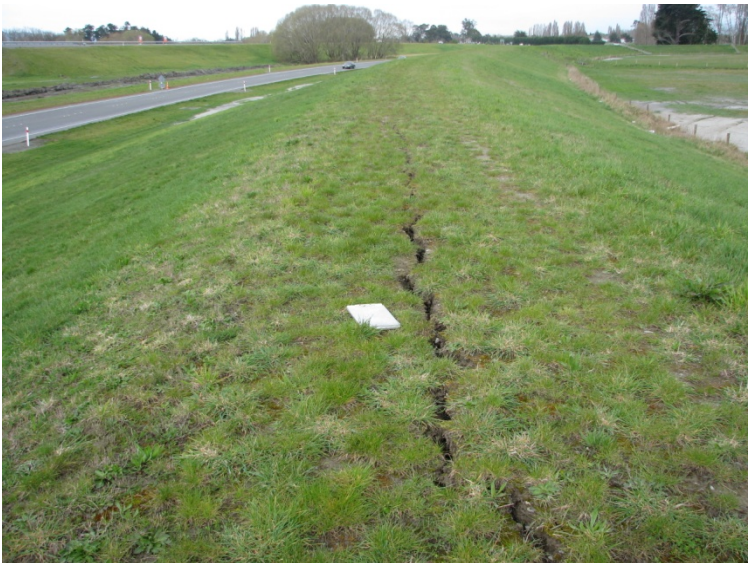
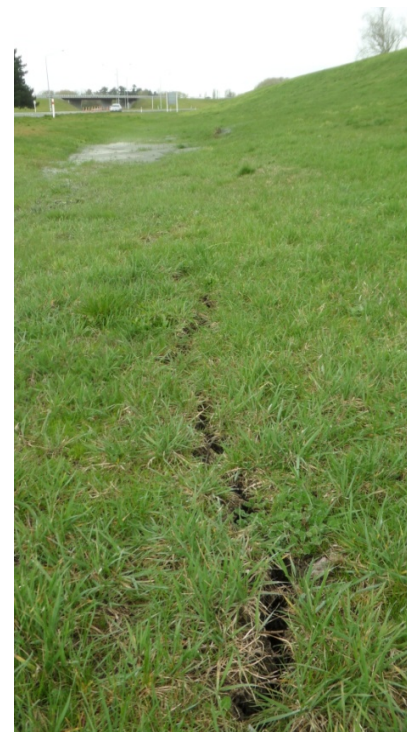
Figures 6.17 and 6.18 are photographs of a secondary levee for the Waimakariri River along State Highway 1. This stretch of levee is denoted by a dashed yellow line (B) in Figure 6.12. Liquefaction was observed on both sides of the levee and longitudinal cracks were observed running along the crest and sides of the levee (Figures 6.17 and 6.18). As may be seen from Figure 6.12, this stretch of the levee lies within the abandoned river channel of the old south branch of the Waimakariri River.

Figure 6.17 Photos 9 and 10: ~5-cm wide longitudinal cracks running along the crest (left) and base (right) of a secondary levee for the Waimakariri River. Photo taken looking southwest; SH1 on left of levee. The locations of these photographs are denoted in Figure 6.4. (-43.430108°, 172.643434°)

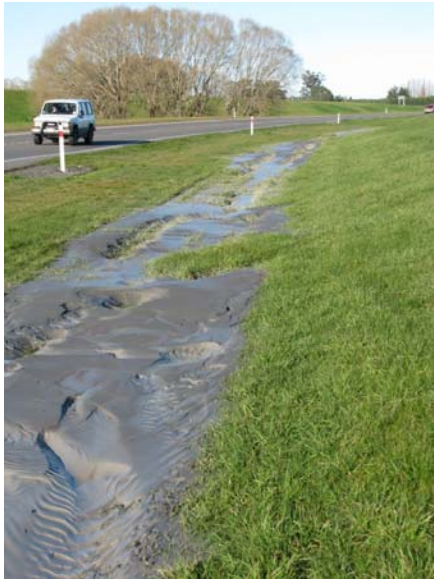
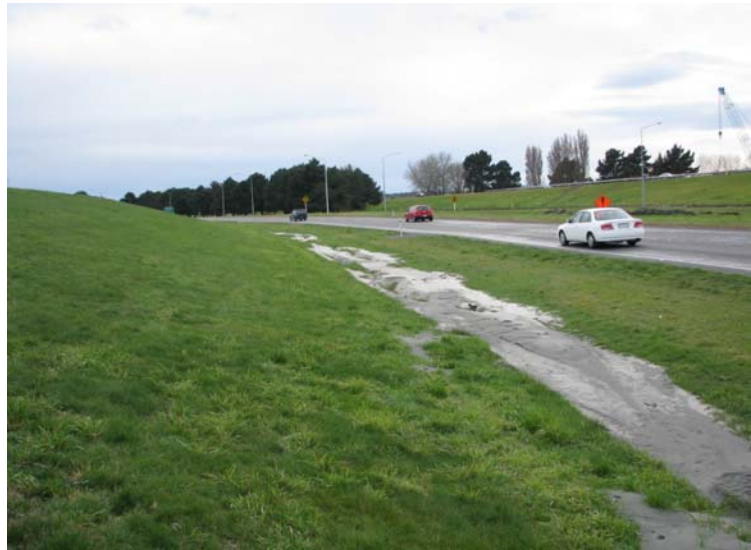
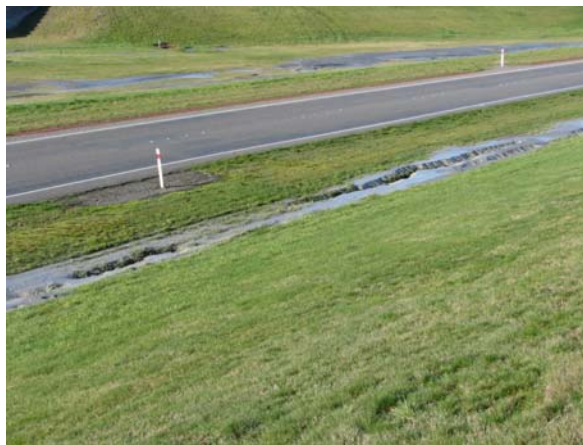
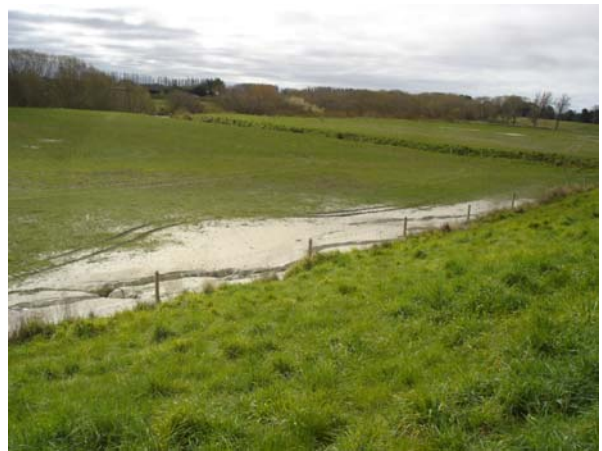
Figure 6.18 Photos 11 - 14: Liquefaction ejecta on both the river and landsides of the levee. The locations of these photographs are denoted in Figure 6.4. (-43.428968°, 172.645435°)

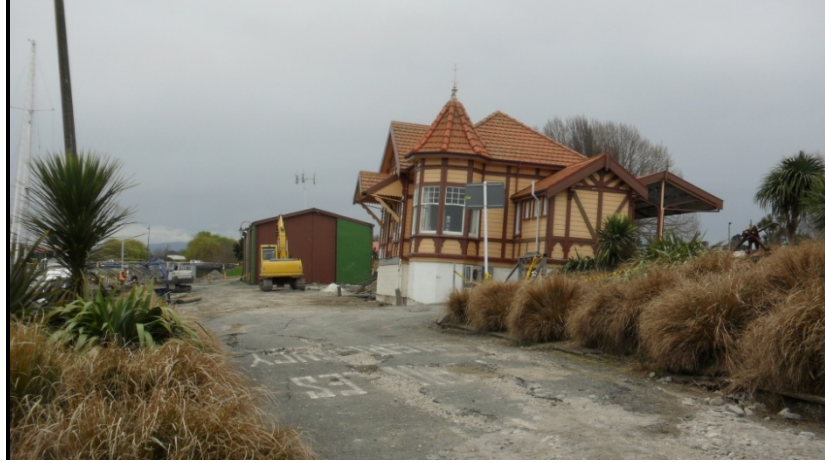
In downtown Kaiapoi adjacent to the river, the Visitors' Information Center on the north side of the river sank and tilted as a result of liquefaction and lateral spreading (Figure 6.19). Ground cracks, as wide as 30 cm and as deep as 100 cm, were observed running parallel to the river near this structure. The two-story Waimakariri-Ashley Coastguard building adjacent to the Visitor Center also suffered the same effects. Just east of this building (~100 m), ground cracks, on the order of 100-cm wide and 185-cm deep were also observed along the gentle inboard (land-side) slope of the levee (Figure 6.20). Lateral spread cracks with massive ejecta were observed at the toe of the embankment (Figure 6.21). Also, a skate park that was located about midway up the gently sloping inboard side of the levee was severely damaged by lateral spreading (Figure 6.22). Settlement/slumping of the foot path on the crest of the levee on the order of 10-30 cm were also noted. Detailed maps of the largest lateral spread cracks will be provided in subsequent versions of this report.

Figure 6.19 Photo 15: Visitors Information Center on the levee on the north side of the Kaiapoi River. The location of this photograph is denoted in Figure 6.4. (-43.387384°, 172.659743°)

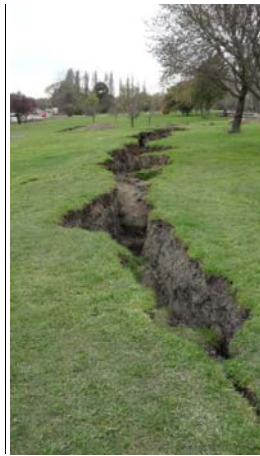
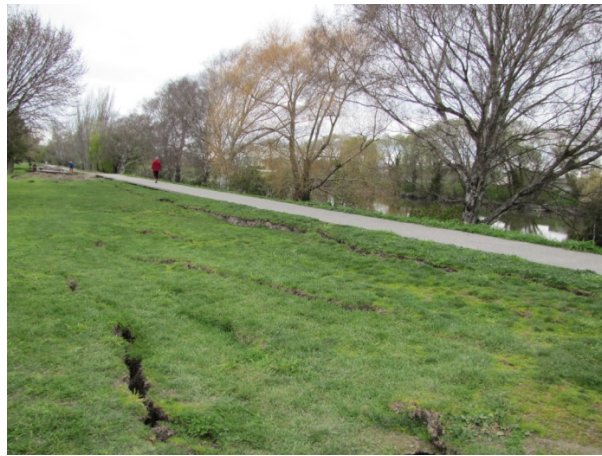
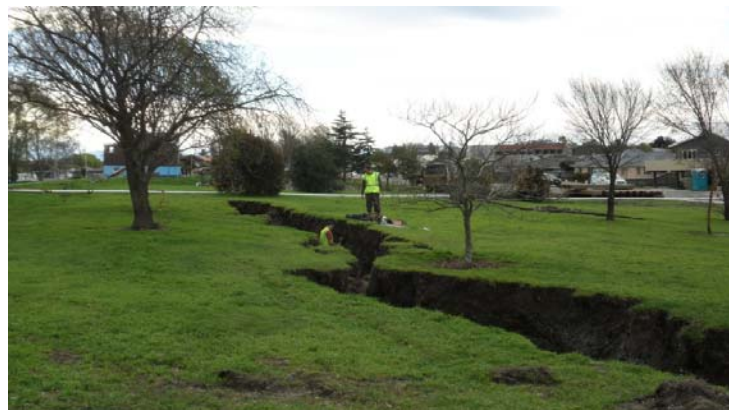
Figure 6.20 Photos 16-18: Lateral spread cracks along landside of the levee on the north side of the Kaiapoi River. The locations of these photographs are denoted in Figure 6.4. (-43.384484°, 172.660653°)

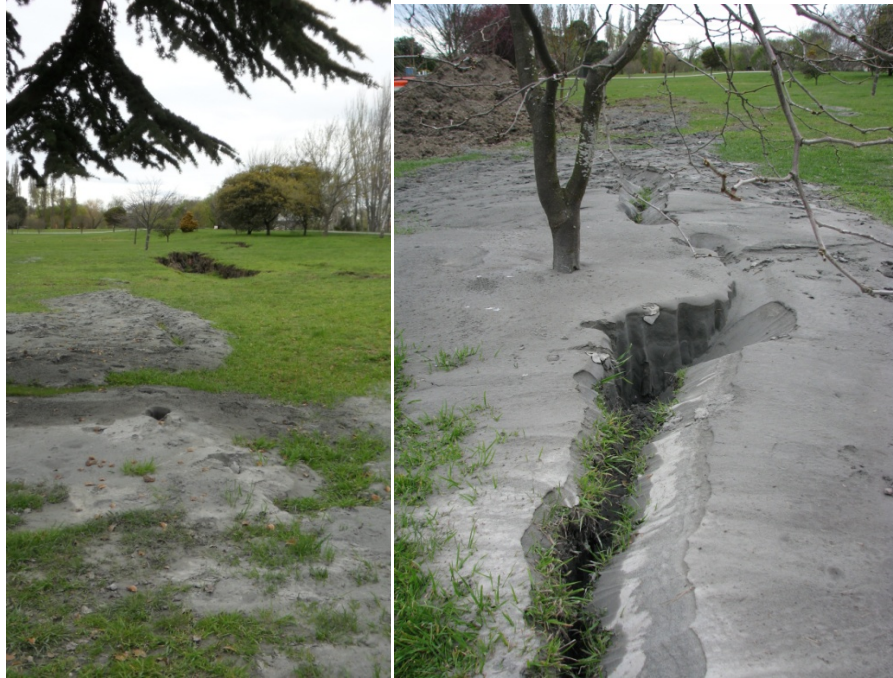
Two bore holes were made using a hand auger near the lateral spread cracks (-43.384767° , 172.661133° and -43.384683° , 172.661350°). However, the profile largely consisted of random fill (gravels/cobbles and wood), making it difficult to advance the auger. One of the bore holes went down to a depth of ~5.5 m, yet a thick layer of soil matching the liquefaction ejecta material could not be found. However, thin (< 10 cm) alternating layers of loose saturated sand and very wet, very soft clay/plastic silt were encountered, particularly near the large lateral spread crack shown in Figure 6.20. This lateral spread crack had no trace of ejecta in and/or immediately near it. This crack was closer to the river than ones that were filled with ejecta at the toe of the levee ~30 m away (Figure 6.21).

Figure 6.21 Photo 19 and 20: Lateral spread cracks along landside of the levee on the north side of the Kaiapoi River. The locations of these photographs are denoted in Figure 6.4. (-43.384633° , 172.661231°)

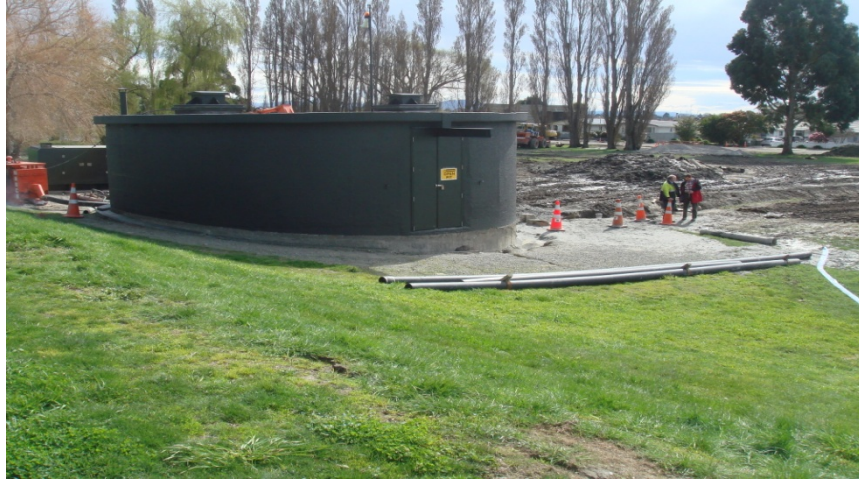
Further east along the Kaiapoi River (~400 m), the ground adjacent to a 6-m diameter structure (containing an underground tank and control equipment) settled by about 30 cm, resulting in damage to pipes attached to the tank (Figure 6.23). Additionally, aerial photographs of lateral spreading along the north bank of the Kaiapoi River going east from the town center are shown in Figure 6.24.

Figure 6.23 Photo 22: Tank that settled ~30 cm resulting in damage to attached pipes. The photograph numbers correspond to the locations denoted in Figure 6.4. (-43.386918°, 172.664412°)

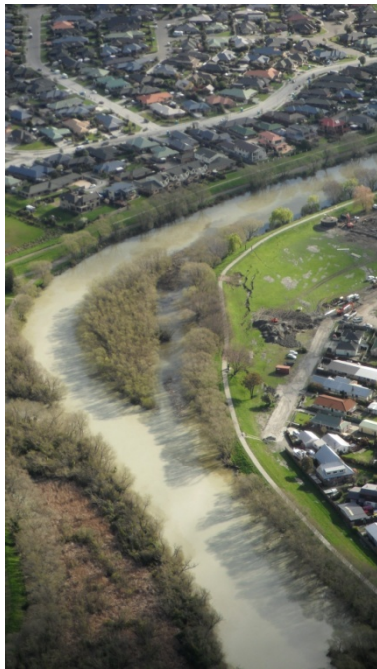
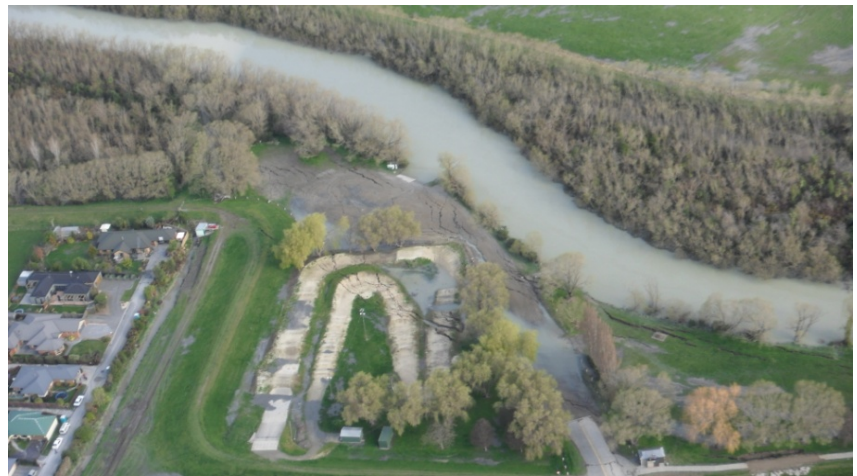
Figure 6.24 Photos 23 and 24: Aerial photographs of lateral spreading of levees on the north bank of the Kaiapoi River. The locations of these photographs are denoted in Figure 6.4. (left: -43.387389°, 172.666173°; right: -43.386875°, 172.672297°)

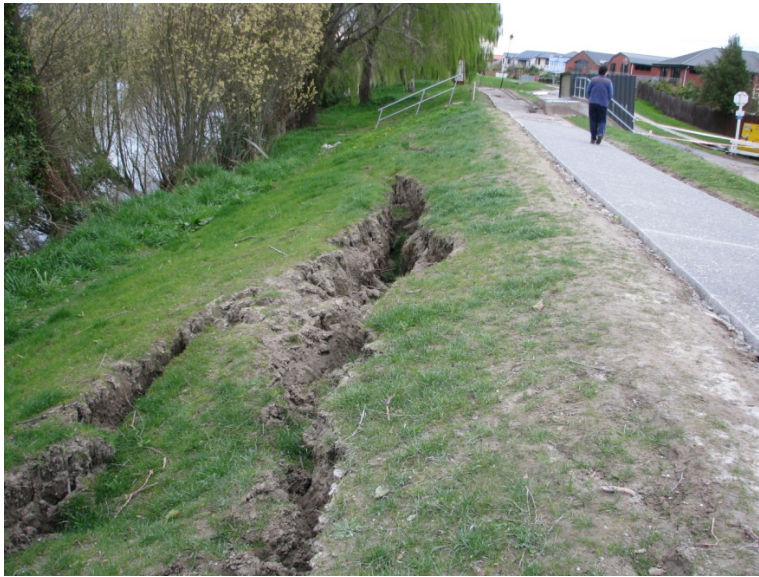
Figure 6.25 Photo 25: Lateral spread cracks along riverside levee on the south side of the Kaiapoi River. The location of this photograph is denoted in Figure 6.4. (-43.385254°, 172.660131°)

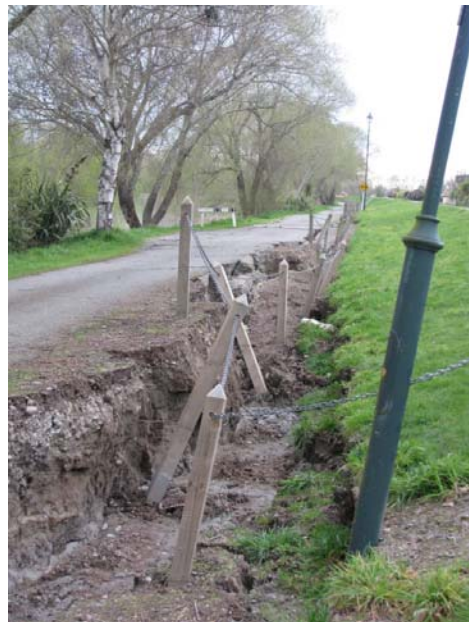
Figure 6.26 Photo 26: Lateral spread cracks along riverside levee on the south side of the Kaiapoi River. The location of this photograph is denoted in Figure 6.4. (-43.385839°, 172.660941°)

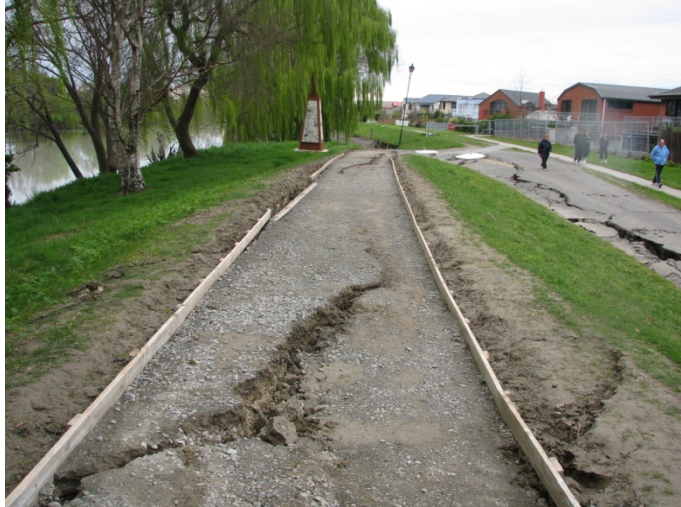
Figure 6.27 Photo 27: Lateral spread cracks along the top of the levee on the south side of the Kaiapoi River. The location of this photograph is denoted in Figure 6.4. (-43.385693°, 172.660688°)

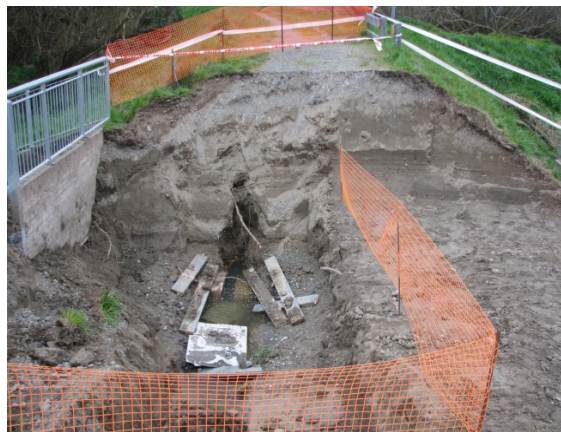
Figure 6.28 Photo 28: Failed drainage conduits running underneath the levee on the southside of the Kaiapoi River. The location of this photograph is denoted in Figure 6.4. (-43.388679°, 172.666203°)

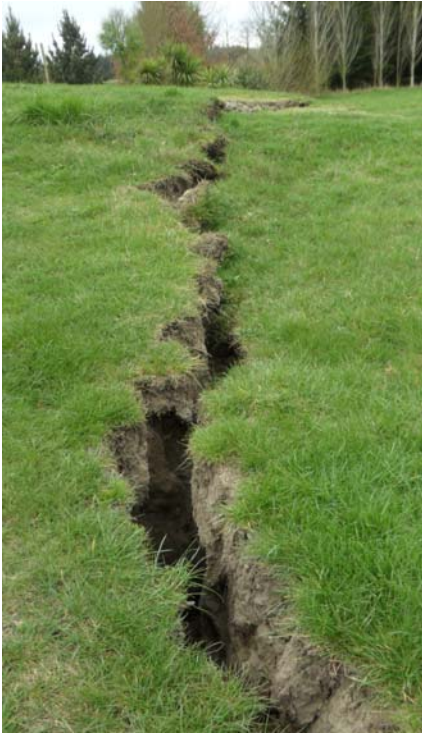
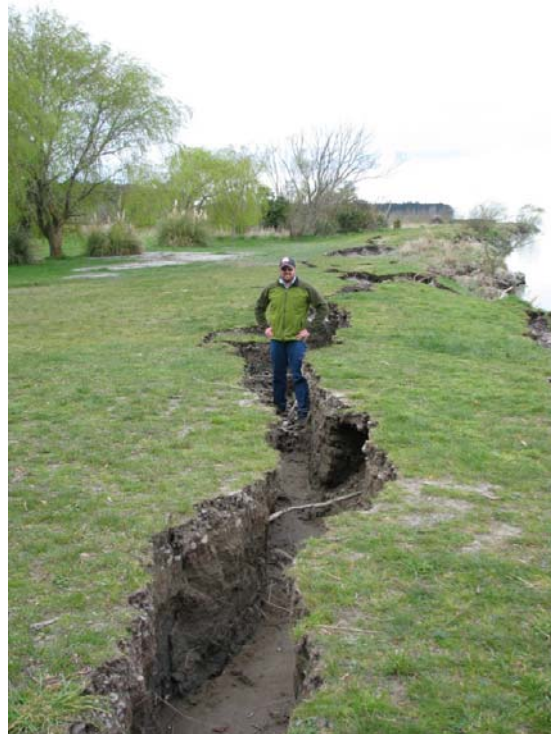
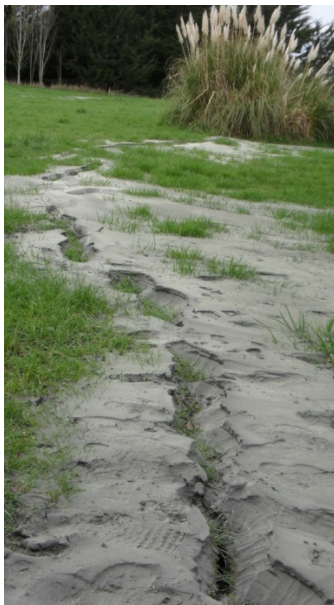
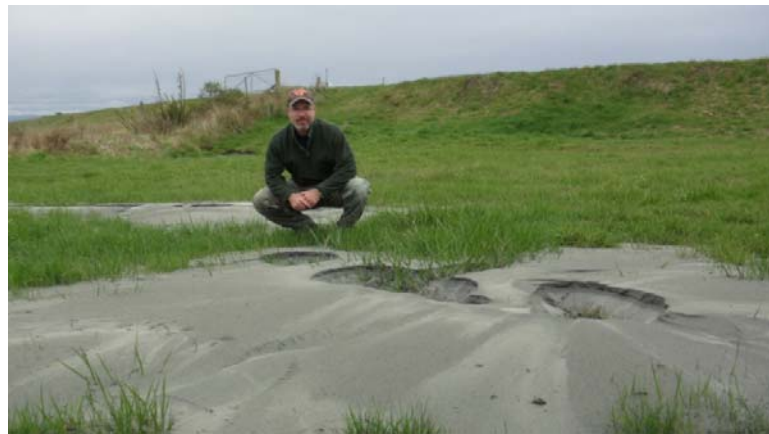
The geotechnical reconnaissance team performed a damage survey on foot of the levees along the southern perimeter of the plant, denoted by the white line in Figure 6.29. No damage was observed along this stretch of the levees, although the team observed large lateral spread cracks (~30-cm wide) in the levees and shoreline about 100 m west of the southwest corner of the plant

Figure 6.30 Liquefaction and lateral spread features on or near levees located about 100 to 200 m west of the Kaiapoi Sewage Treatment Plant. (upper left: -43.389175° , 172.683235° ; upper right: -43.389701° , 172.683390° ; bottom left: -43.389519° , 172.682203° ; bottom right: -43.389432° , 172.6682060°)

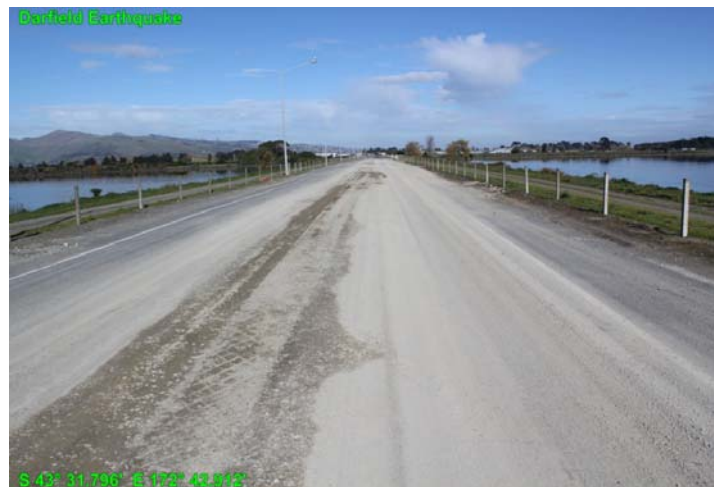
Dyers Road along State Highway 74 cuts through the oxidation ponds and connects the northern approaches to Christchurch with the port of Lyttelton to the south. Road pavements were cracked at the side of the oxidation ponds (between Ponds 2A and 3) and the road was impassable following the earthquake. According to the engineer interviewed at the site, a 50-cm wide crack had opened near the centerline of the road, although it was already filled with compacted dense graded aggregate during the site visit (Figure 6.32). Nevertheless, longitudinal cracks were still evident on the side of the road (Figure 6.33).

Figure 6.32 Repaired Dyers road that runs between Ponds 2A and 3. (-43.529933°, 172.715200°)

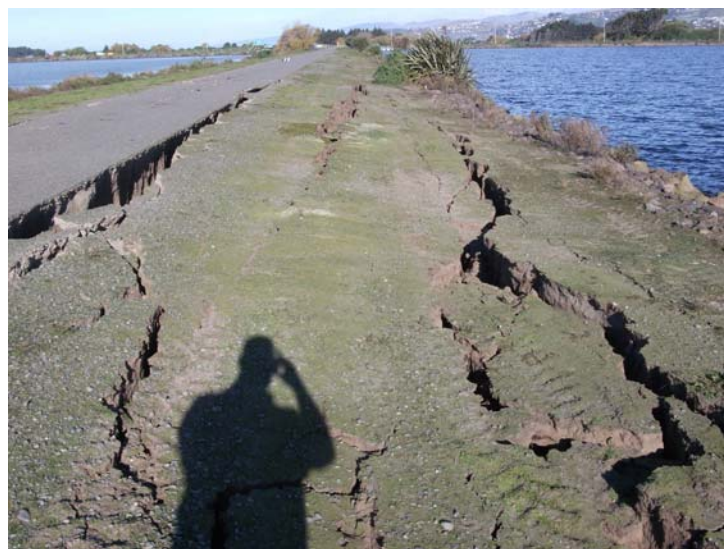
Figure 6.33 Lateral spread cracks running parallel to Dyers Road adjacent to Pond 2A. (-43.531393°, 172.712473°)

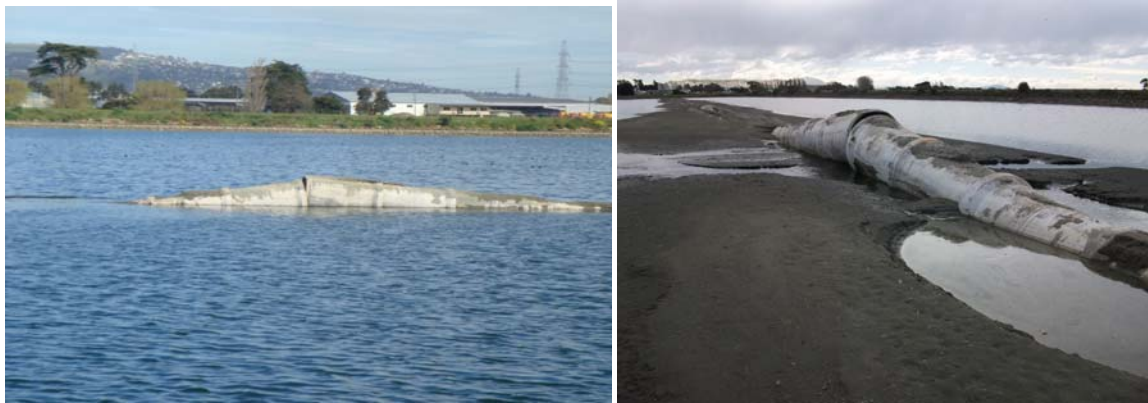
Figure 6.34 Buckled pipe protruding from Pond 1 during pond dewatering, and after pond level was lowered. Pipeline crown was at the pond invert prior to the earthquake. (-43.530867°, 172.705190°)

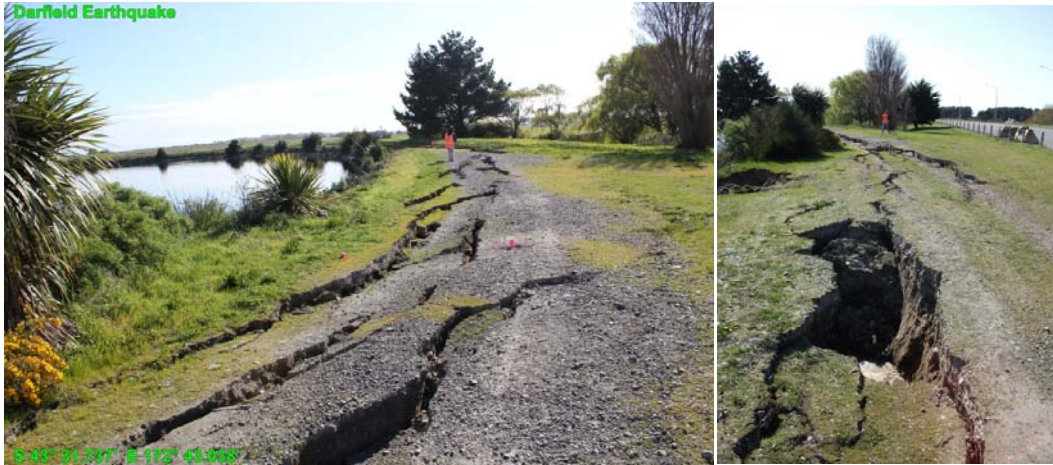
Figure 6.35 Lateral spread cracks at the eastern end of Pond 2B. The sinkhole in the foreground of the photo on the right formed over the top of two outlet pipelines. (-43.52895°, 172.717300°)

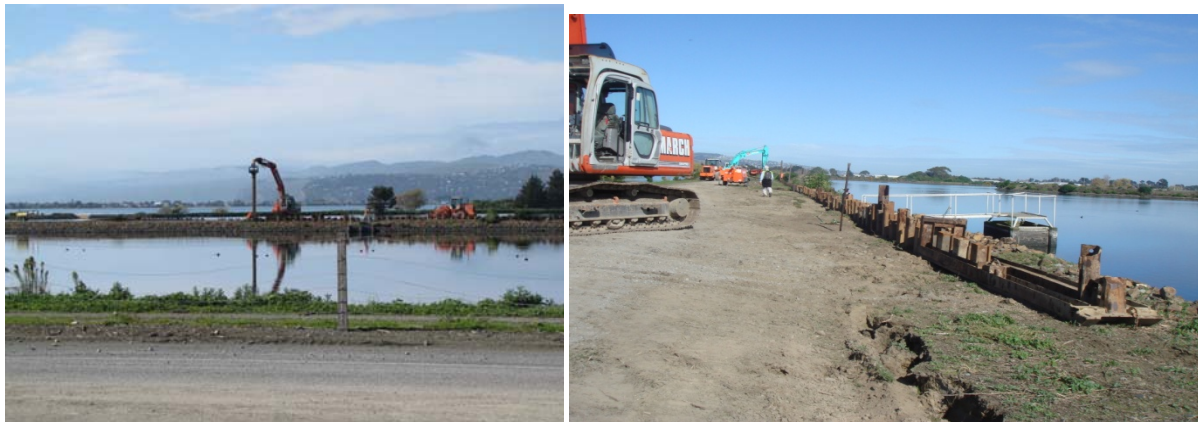
Figure 6.36 Sheet piles being driven to stabilize the pond embankment to arrest further movement. (-43.530563°, 172.718349°)

Because of the slumping of the pond banks, engineers decided to drop the pond water levels and reduce the hydraulic pressures on the embankments. At the time of the reconnaissance team visit, sheet piles were being driven into the Pond 3/6 embankment to stabilize it and arrest further movement (Figure 6.36). Furthermore, the pipelines beneath Dyers Road were being replaced.
