7. EFFECTS ON LIFELINES

This chapter includes the GEER-NZ Team observations for the transportation system (bridges, highways, rail, airports, and ports), water and wastewater systems, electric power, waste management and landfill, as well as other lifelines.

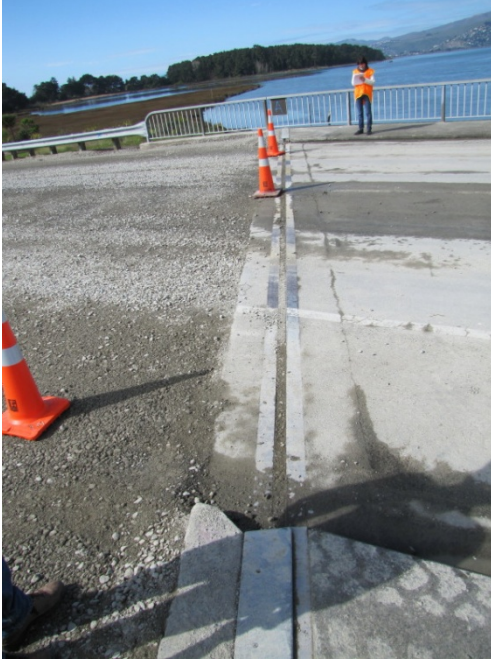
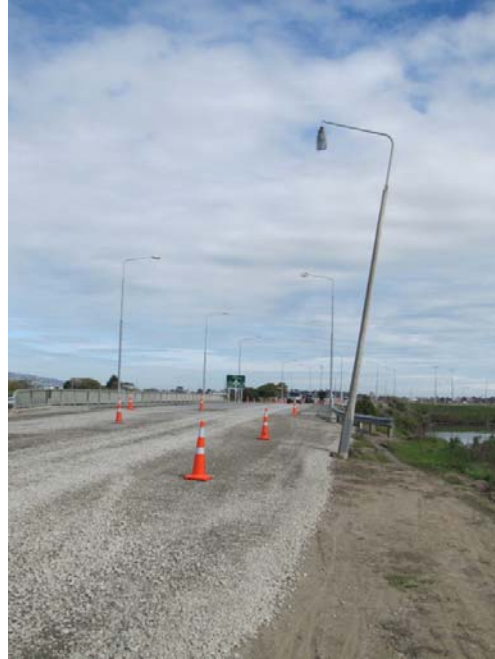
Figure 7.1 Repaired east approach to the Bridge Street Bridge. (-43.5253°, 172.7242°)

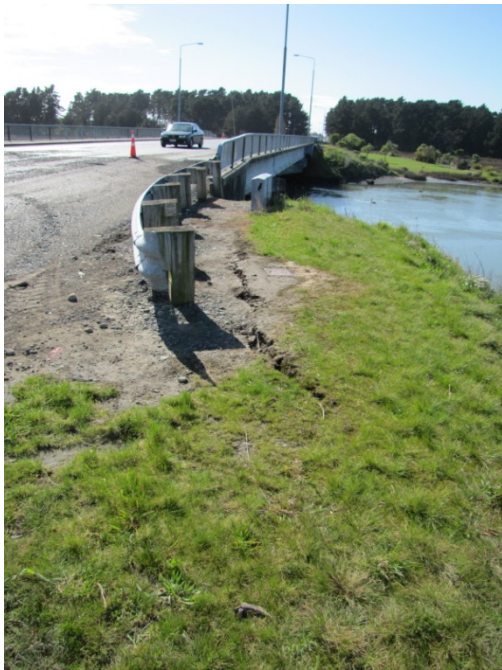
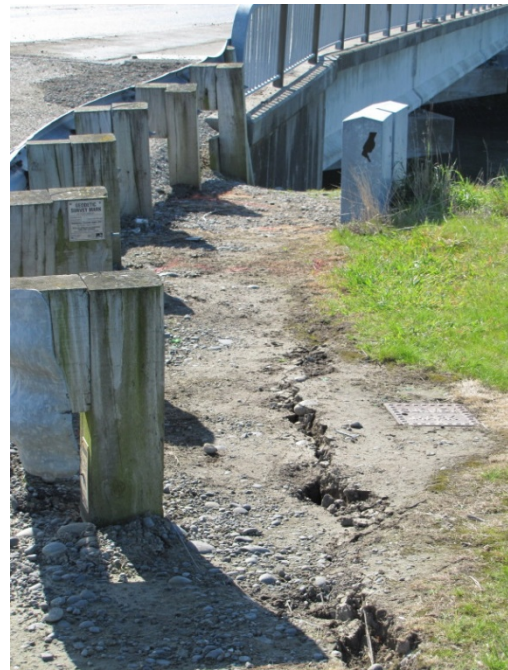
Figure 7.2 Cracking on margins of west approach embankment, Bridge Street Bridge. (-43.5253°, 172.7242°)

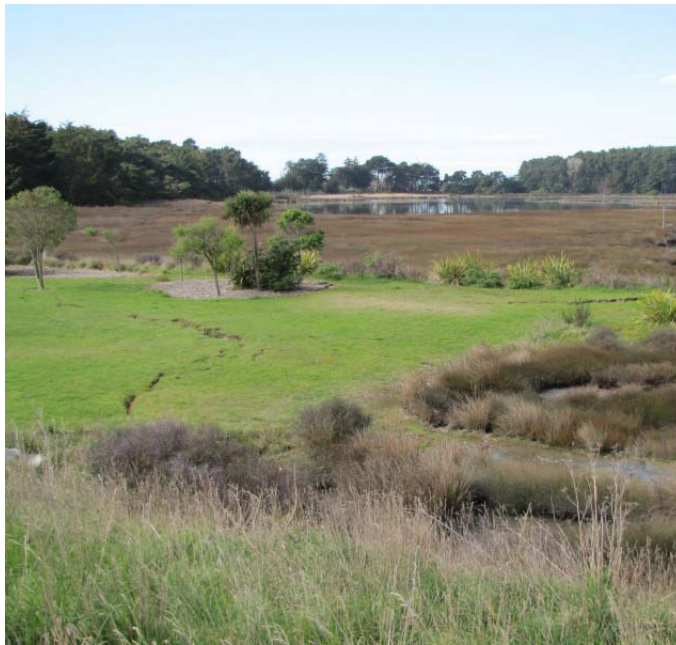
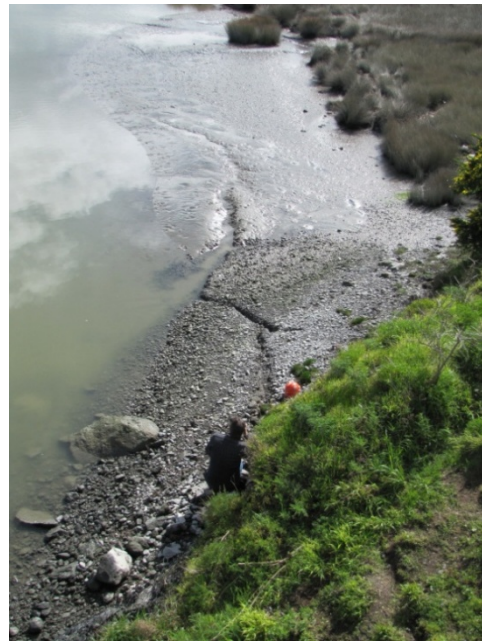
Figure 7.3 Lateral spreading of east banks adjacent to the Bridge Street Bridge. (-43.5253°, 172.7242°)

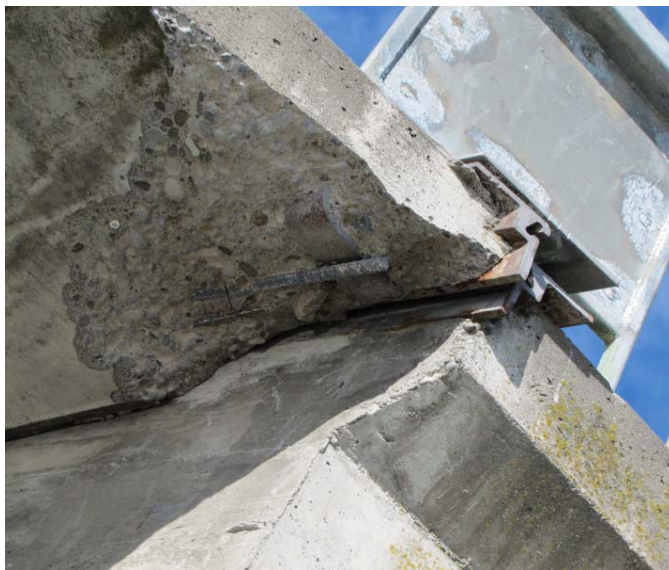
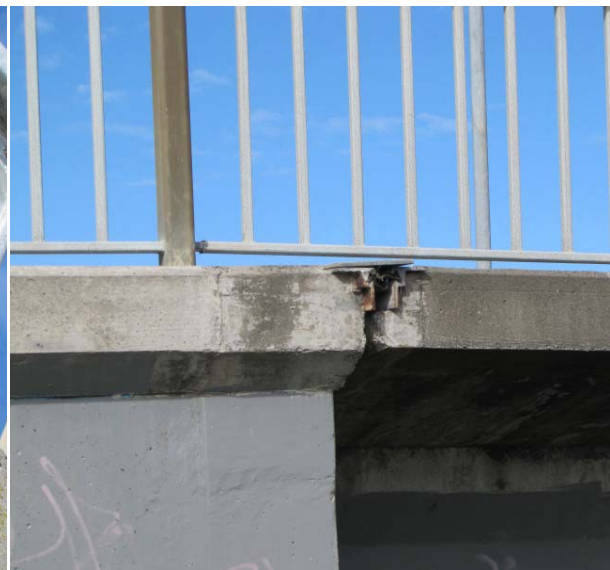
Figure 7.4 Bridge Street Bridge expansion gap closure: (a) West abutment gap closure and spalling; and (b) East abutment gap closure. (-43.5253°, 172.7242°)

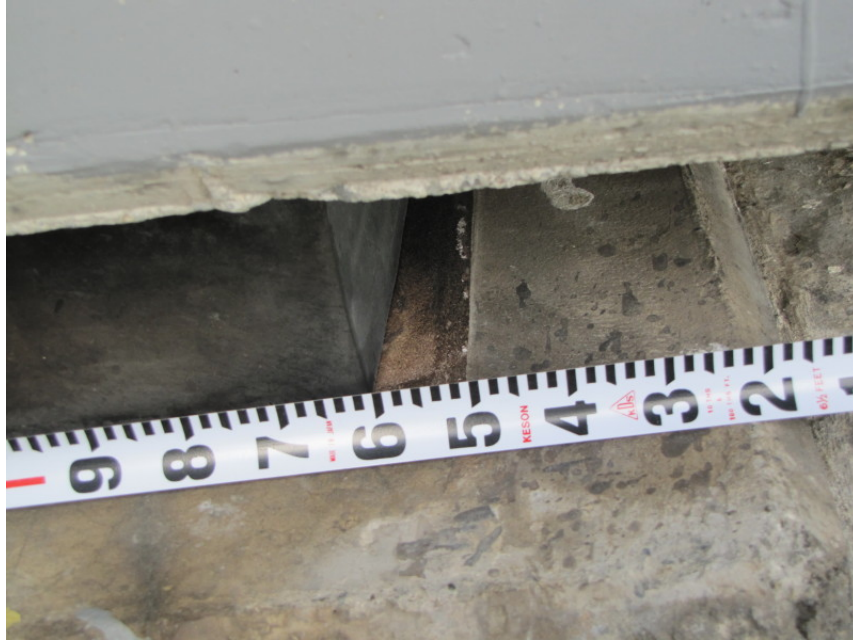
Figure 7.5 West abutment bearing pad displacement, Bridge Street Bridge (scale in Inches). (-43.5253°, 172.7242°)

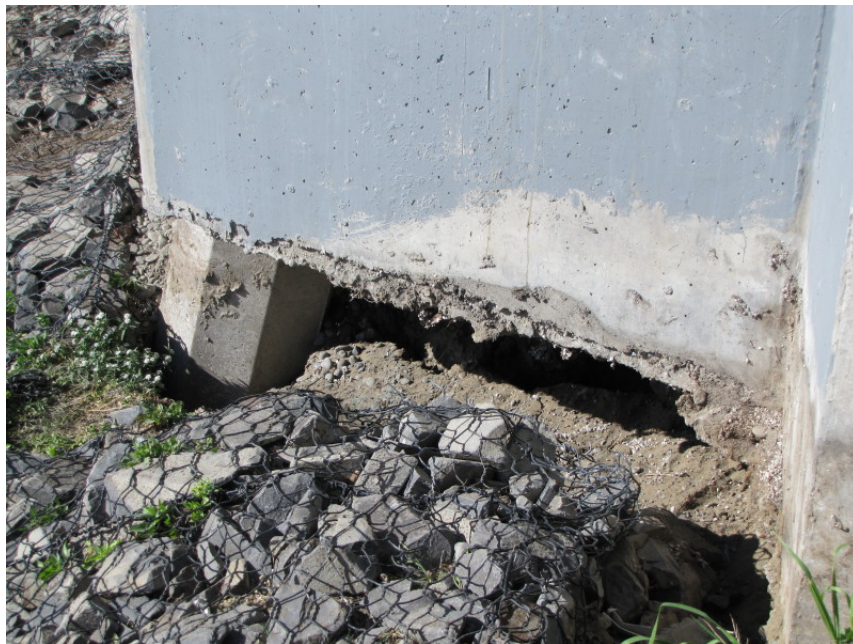
Figure 7.6 West abutment battered pile, Bridge Street Bridge. (-43.5253°, 172.7242°)

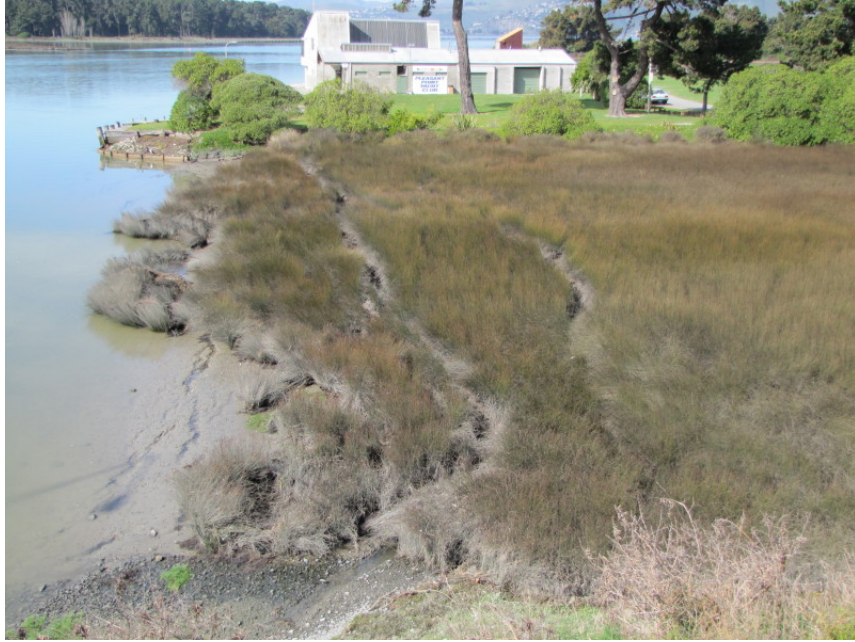
Figure 7.7 Lateral spreading on west bank, Bridge Street Bridge. (-43.5253°, 172.7242°)

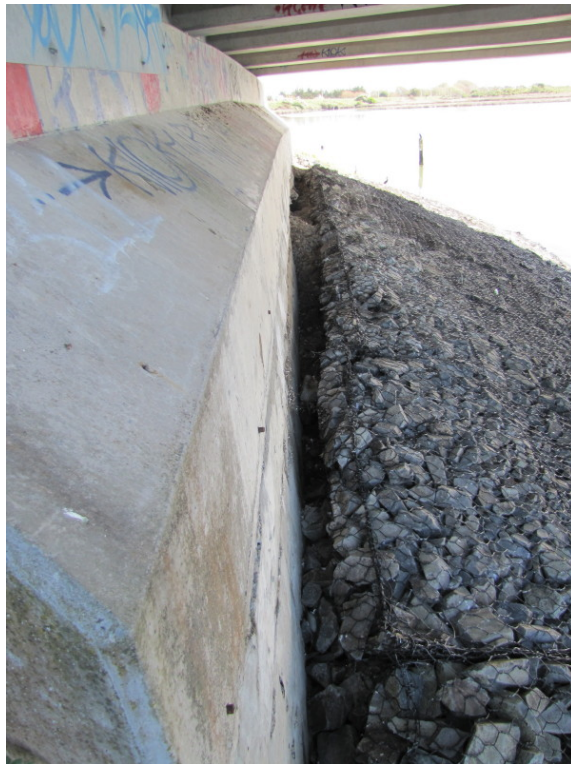
Figure 7.8 Gap between west abutment backwall and end embankment, Bridge Street Bridge. (-43.5253°, 172.7242°)

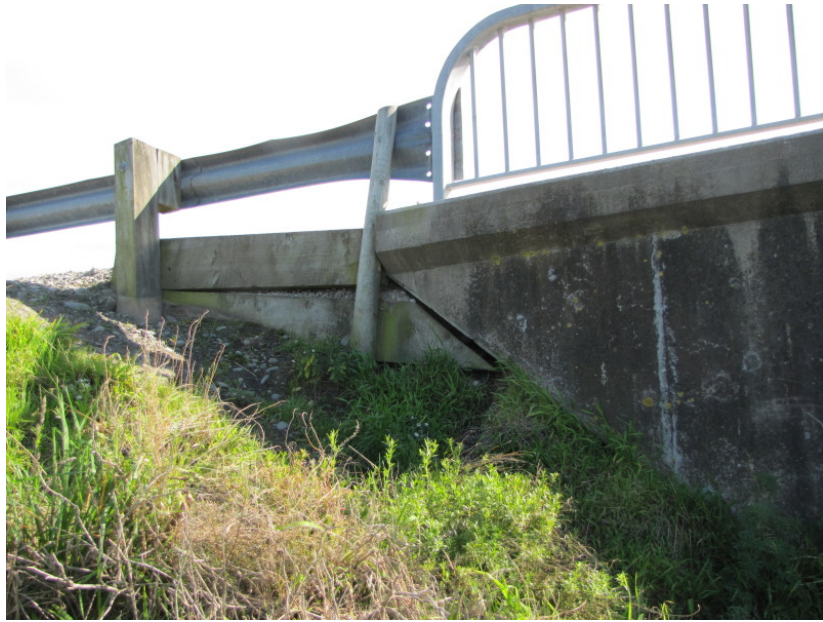
Figure 7.9 Back rotation of west abutment, Bridge Street Bridge. (-43.5253°, 172.7242°)

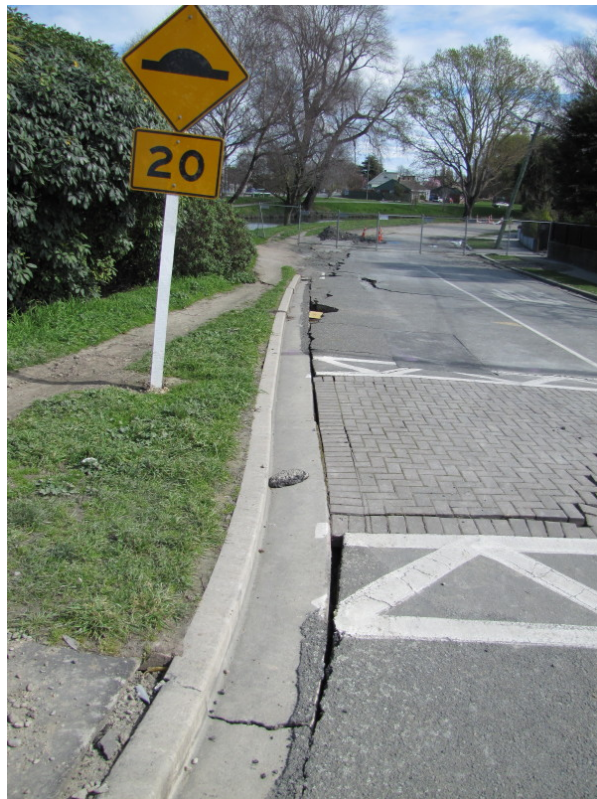
Figure 7.10 Cracking of roadway on west approach fill, Swanns Road Bridge. (-43.5222°, 172.6600°)

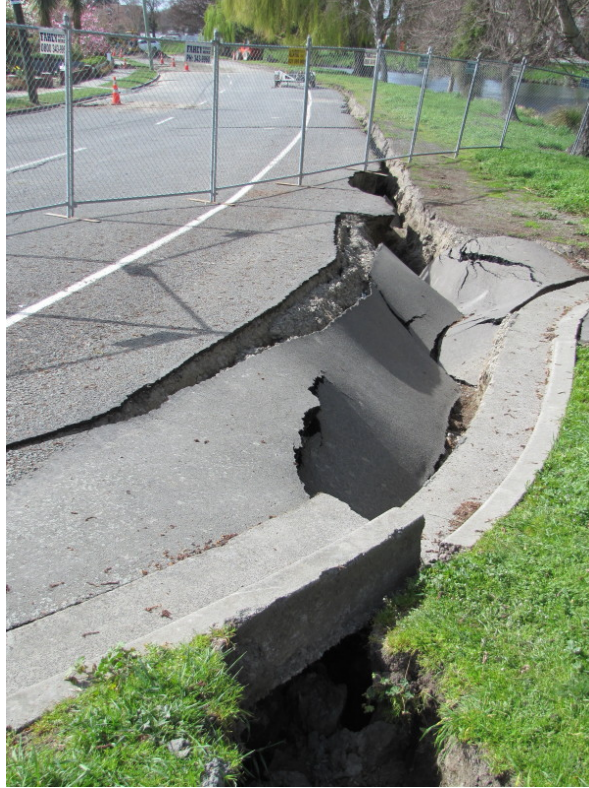
Figure 7.11 Lateral spreading on west approach fill, Swanns Road Bridge. (-43.5222°, 172.6600°)

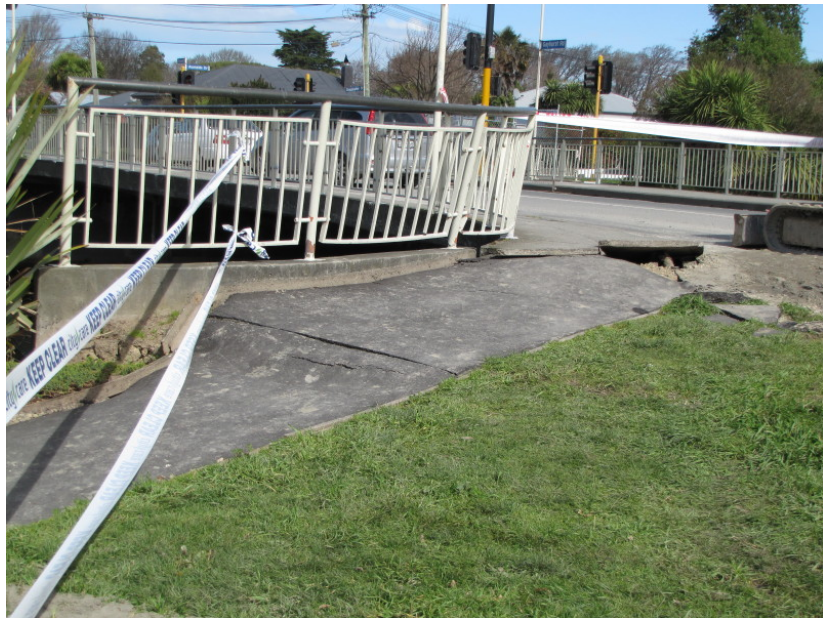
Figure 7.12 Incipient lateral spreading at west abutment, Swanns Road Bridge. (-43.5222°, 172.6600°)

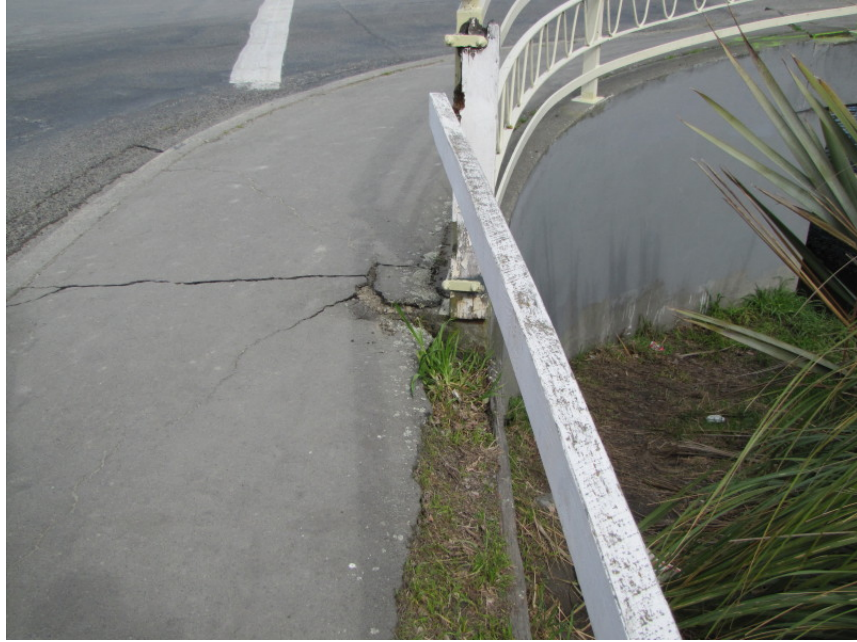
Figure 7.13 Incipient lateral spreading at north abutment, Gayhurst Road Bridge. (-43.52172°, 172.6728°)

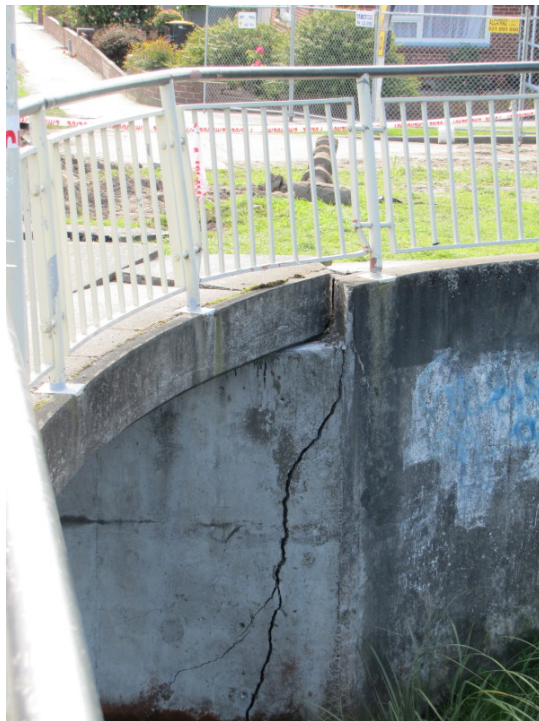
Figure 7.14 Cracking of north abutment, Swanns Road Bridge. (-43.5222°, 172.6600°)

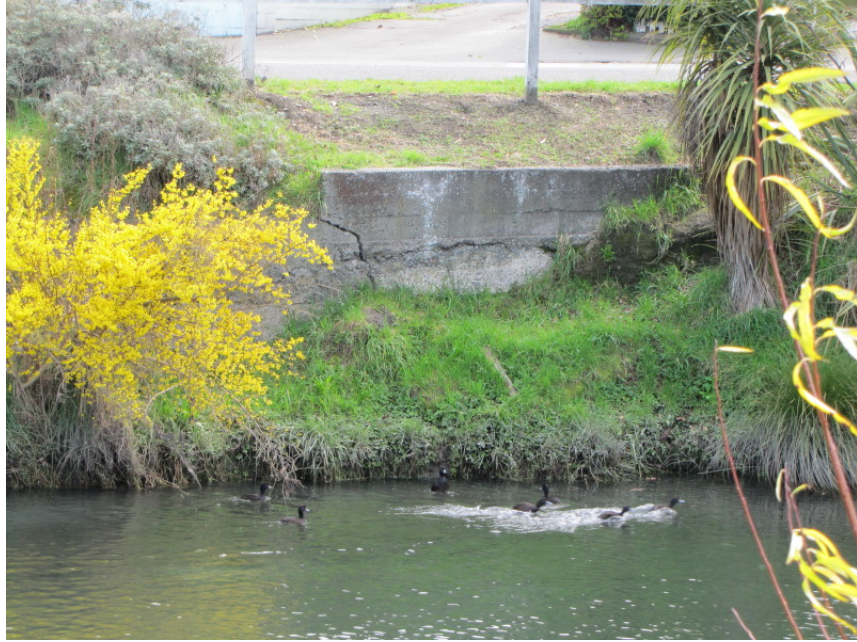
Figure 7.15 Cracking of retaining wall, north bank of the Avon River.

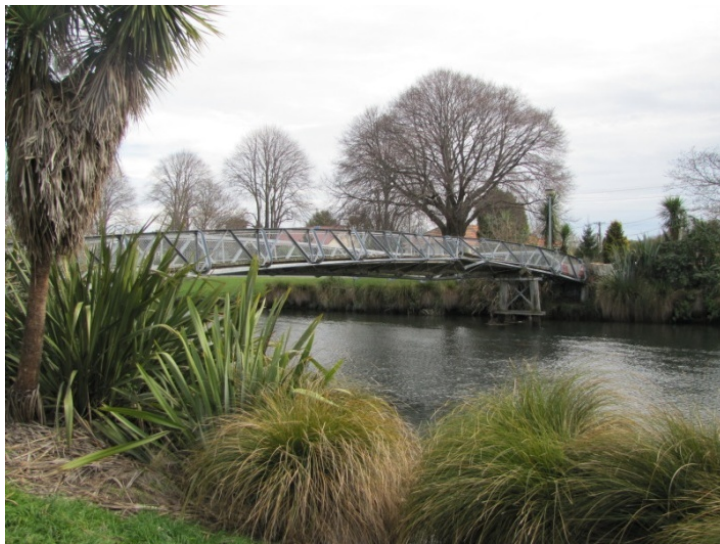
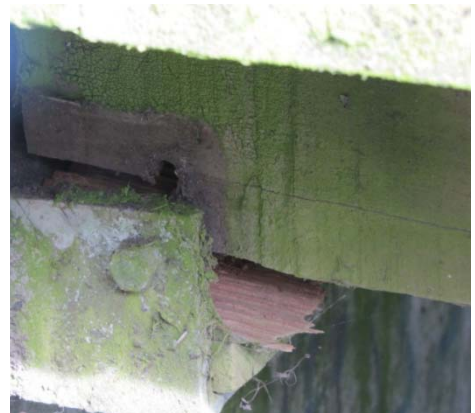
Incipient lateral spreading of the bridge approach fills and abutments walls and cracking of abutment walls were observed at bridges across the Avon River in Christchurch at Swanns Road (-43.5222°, 172.6600°) and Gayhurst Road (-43.5217°, 172.6728°). Both bridges are relative small (approximately 30 m) simple spans with integral abutments constructed in 1954. At both locations cracking in the roadway on the approaches to the bridge (Figure 7.10) and at Swanns Road lateral spreading of the approach fill (Figure 7.11), incipient lateral spreading at the abutments (Figures 7.12 and 7.13), and cracking of the abutment and retaining walls (Figure 7.14 and 7.15) was observed. However, both bridges remained serviceable. At the footbridge crossing over the river approximately midway between the Swanns Road and Gayhurst Road bridges, just south of where Medway Road joins River Road on the west bank of the Avon River (-43.531°, 172.6656°), the rather light deck of the bridge buckled to accommodate the lateral spreading at the abutments (Figure 7.16).

Figure 7.16 Footbridge on the Avon River near Medway Road: (a) Buckled span; and (b) Sheared bearing on east bank. (-43.5310°, 172.6656°)

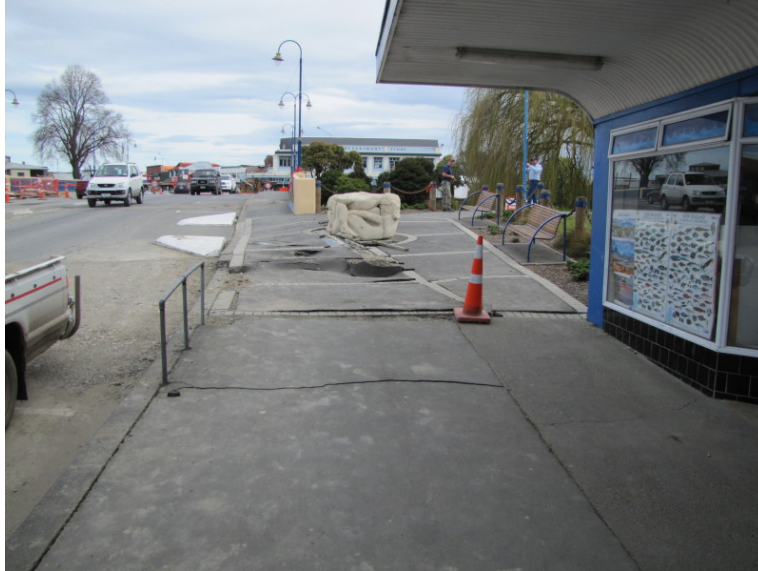
Figure 7.17 Cracking of east approach roadway, Williams Road Bridge. (-43.3825°, 172.6575°)

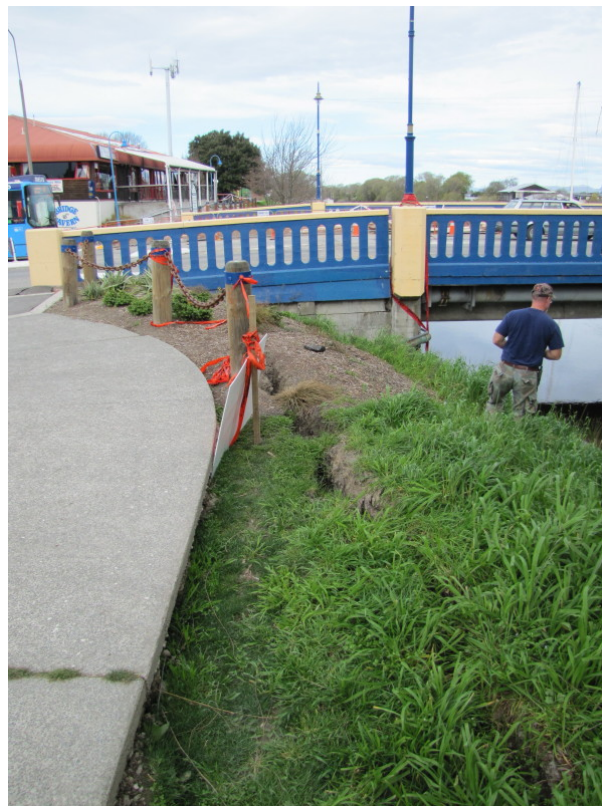
Figure 7.18 Incipient lateral spreading of east abutment, Williams Road Bridge. (-43.3825°, 172.6575°)

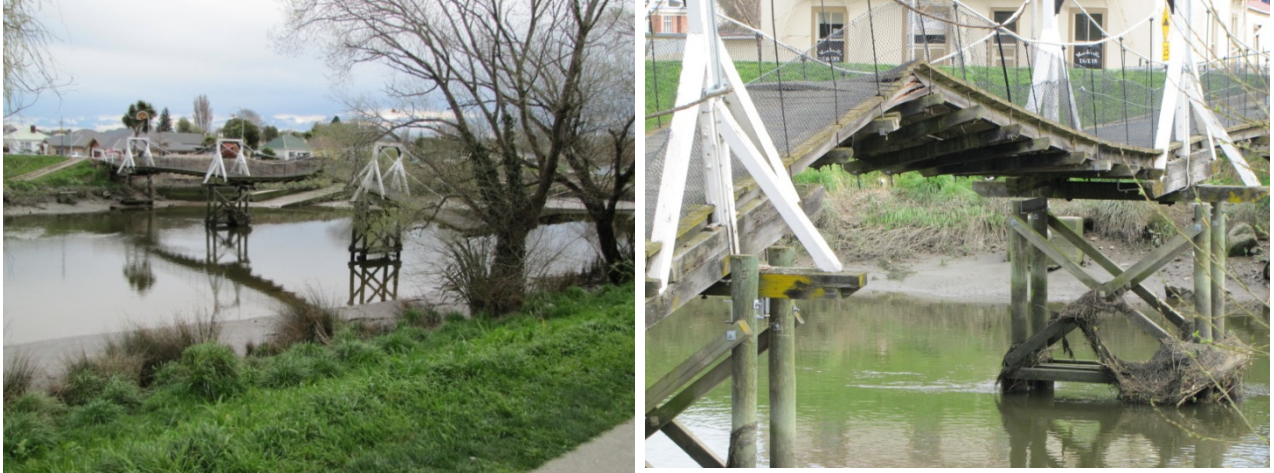
Figure 7.19 Buckling of footbridge near Trousselot Park. (-43.3811°, 172.6558°)

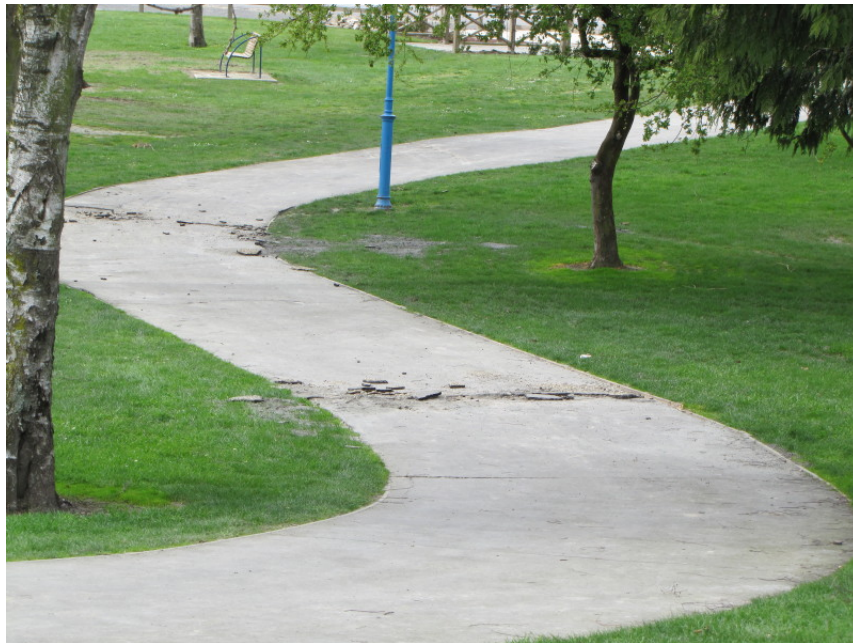
Figure 7.20 Cracking of sidewalk and evidence of liquefaction in Trousselot Park. (-43.3811°, 172.6558°)

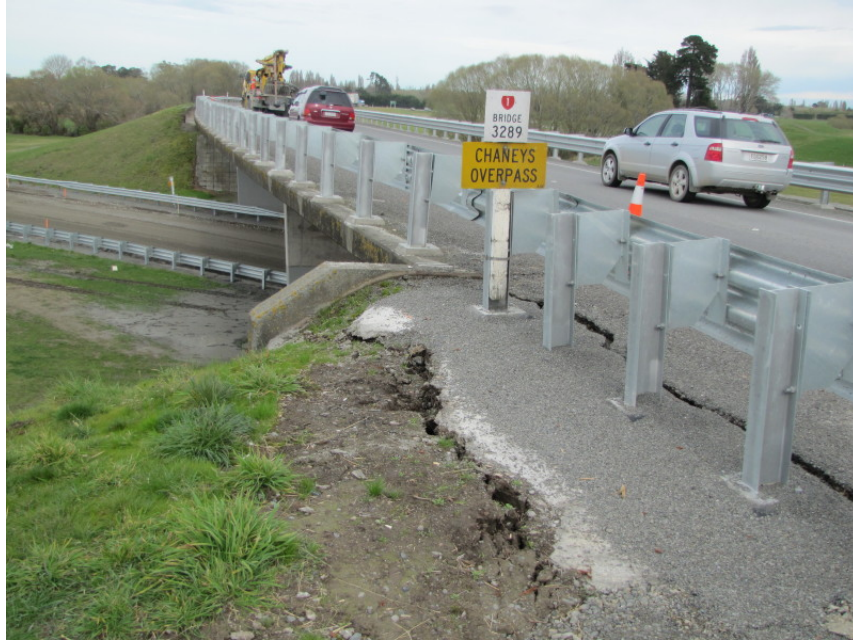
Figure 7.21 Incipient lateral spreading at Chaney's Overpass north abutment. (-43.4300°, 172.6464°)

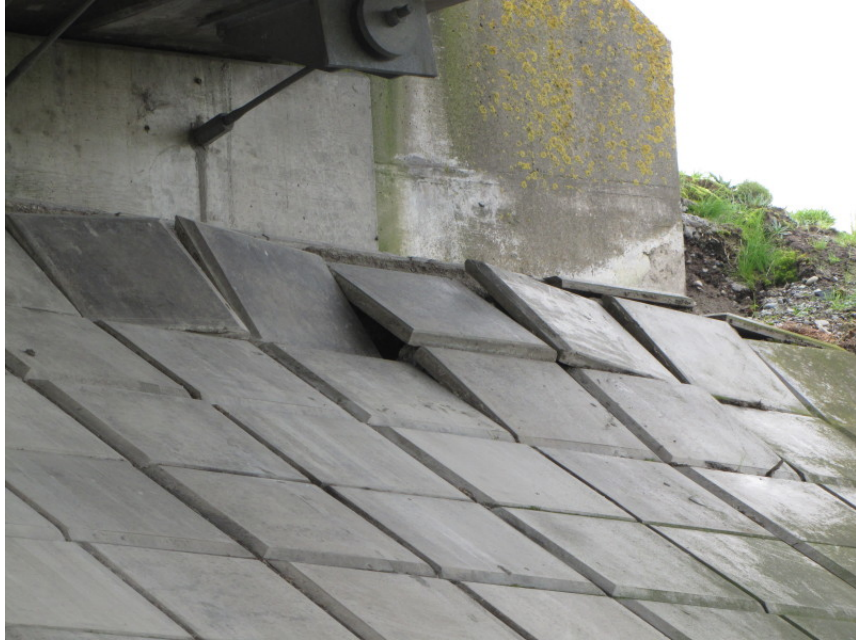
Figure 7.23 Displaced concrete tiles on end embankment for north abutment, Chaney's Overpass. (-43.4300°, 172.6464°)

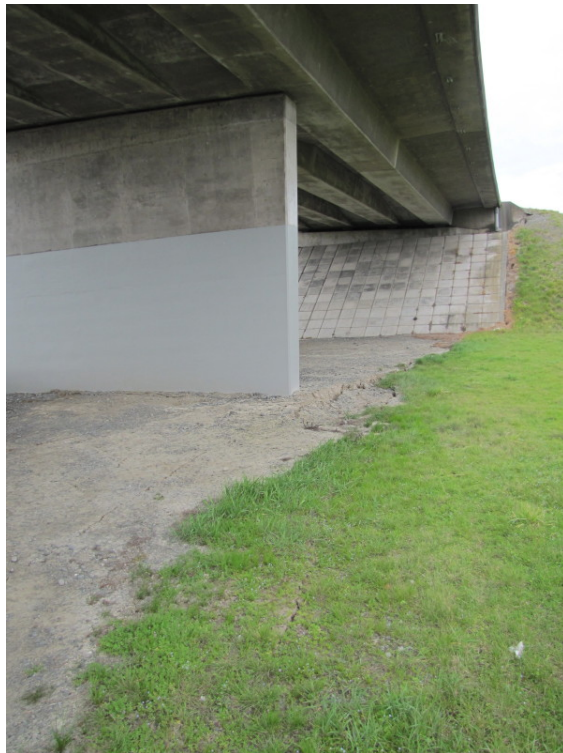
Figure 7.24 Evidence of liquefaction beneath Chaney's Overpass. (-43.4300°, 172.6464°)

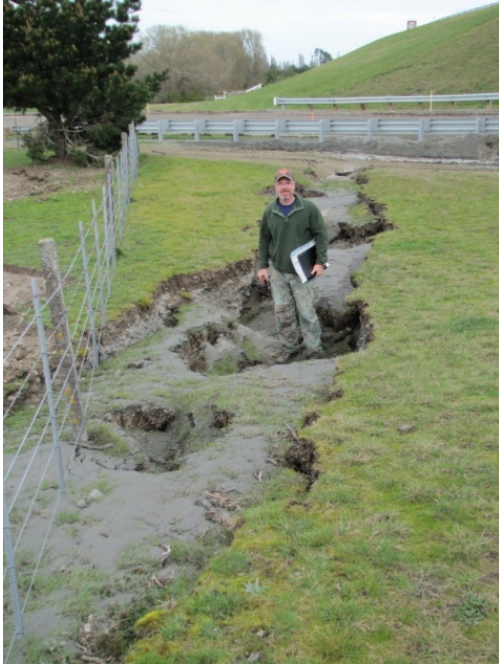
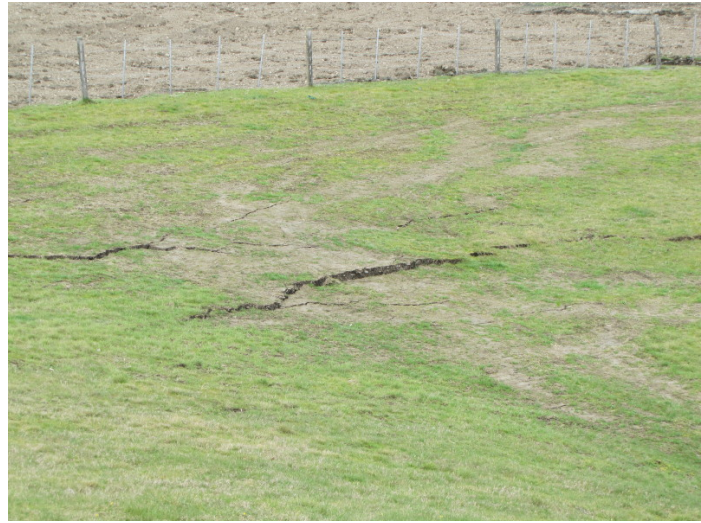
Figure 7.25 Evidence of liquefaction adjacent to Chaney's Overpass. (-43.4300°, 172.6464°)

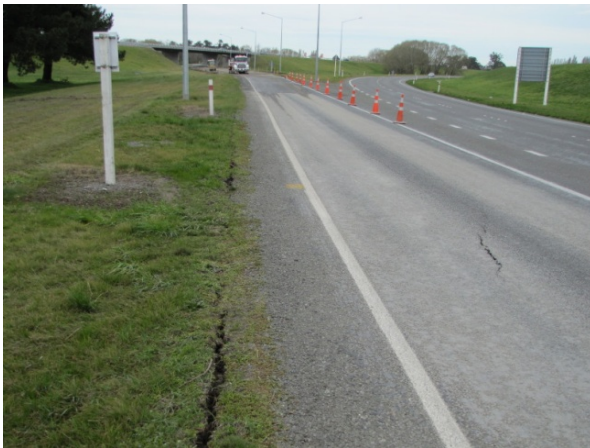
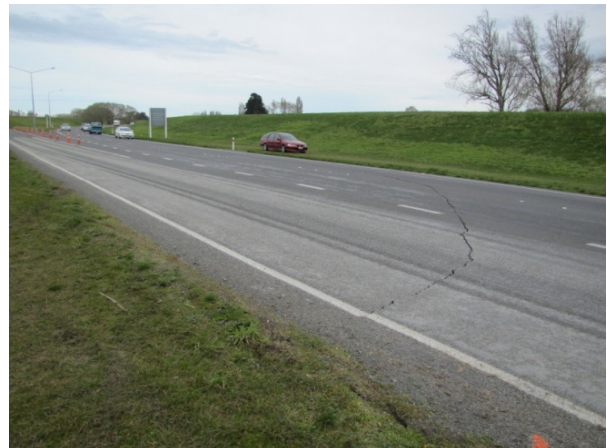
Figure 7.26 Cracking in and along roadway adjacent to Chaney's Overpass. (-43.4300°, 172.6464°)

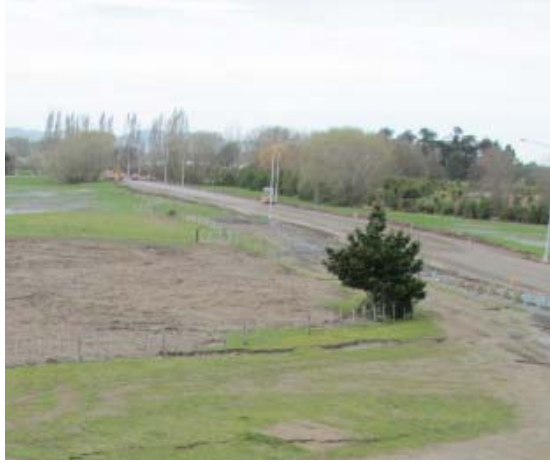
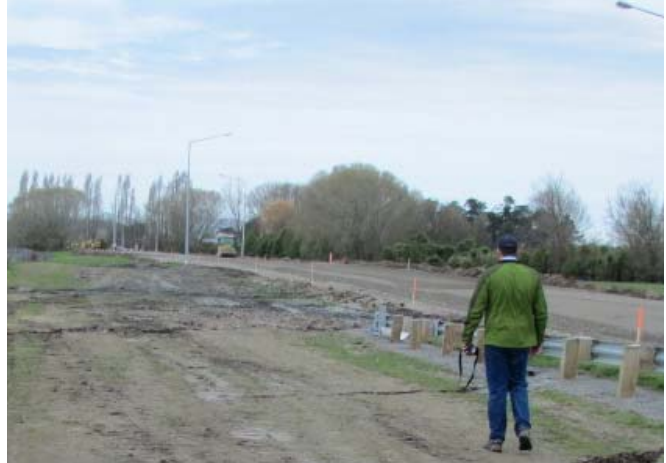
Figure 7.27 Road being repaved adjacent on south approach to Chaney's Overpass. (-43.4300°, 172.6464°)

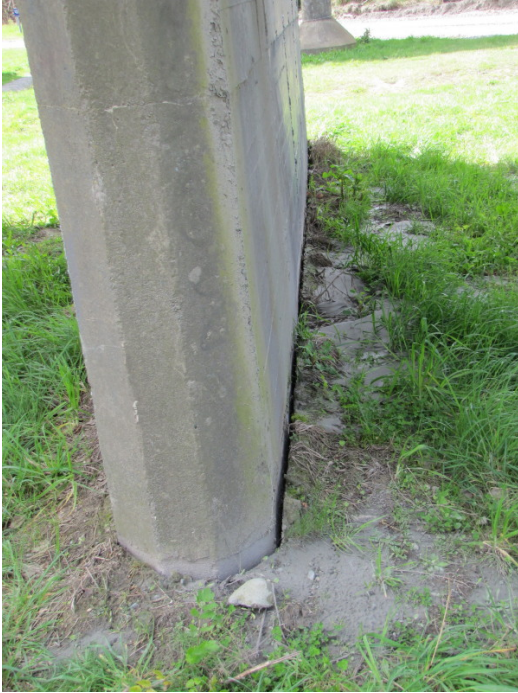
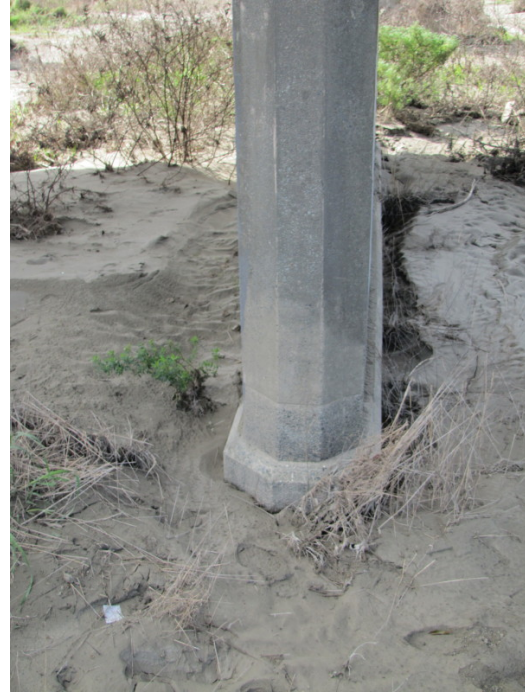
Figure 7.29 Evidence of liquefaction at Highway 1 bridge piers on the north side of the Waimakariri River. (-43.4153°, 172.6467°)

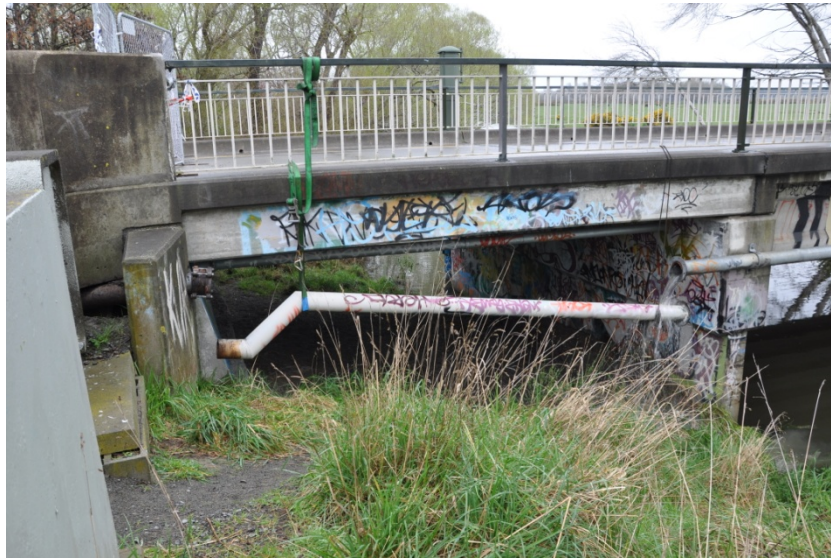
Figure 7.31 Damage to sewage pipe at the Kainga Road Bridge (-43.3997°, 172.6916°)

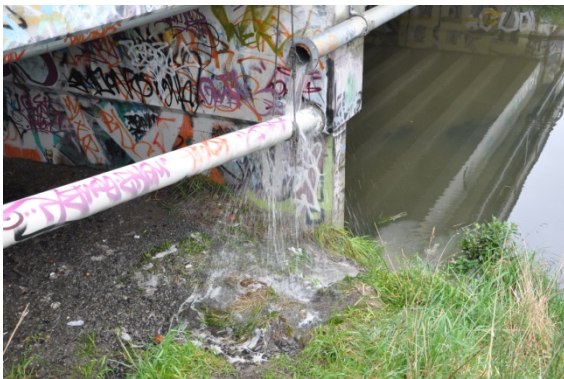
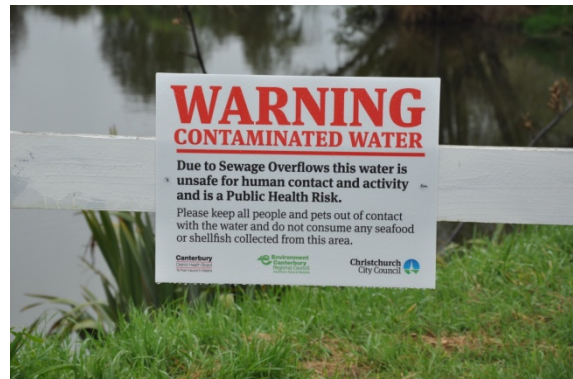
Figure 7.32 Outflow from damaged pipe at Kainga Road Bridge and surrounding warnings to the community. (-43.3997°, 172.6916°)

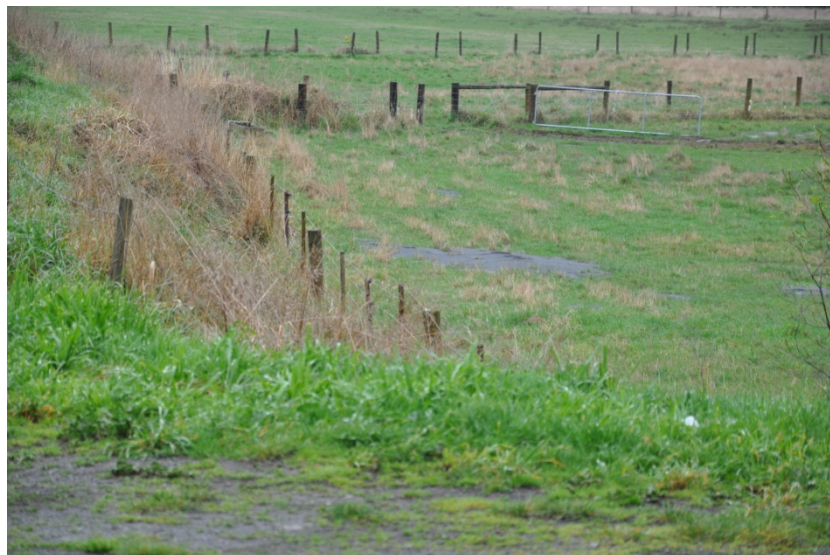
Figure 7.34 Evidence of liquefaction in surrounding low lying marshlands on the east side of the Kainga road bridge (-43.3995°, 172.6917°).

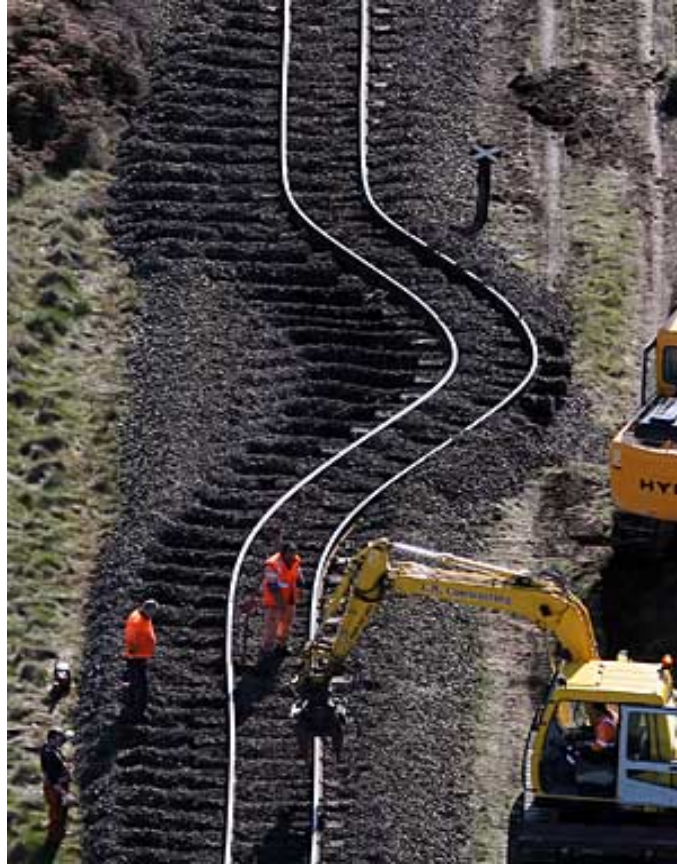
Damage to railways embankments occurred near Rolleston (Figure 7.35) and Woodward Glenn, just south of Kaiapoi (Figure 7.36). In the former case, the damage was due to fault offset, while in the latter case the damage resulted from liquefaction and lateral spreading. By the time the team arrived in Rolleston (13 days after the earthquake), the damage to the tracks had been repaired. The Team was informed that the damaged rail line at Rolleston was fixed the day of or the day after the earthquake and that the slumping rail lines at Woodford Glen had been repaired 4 days after the earthquake.

Figure 7.35 Railway Embankment at Rolleston. (photo by I. McGregor)

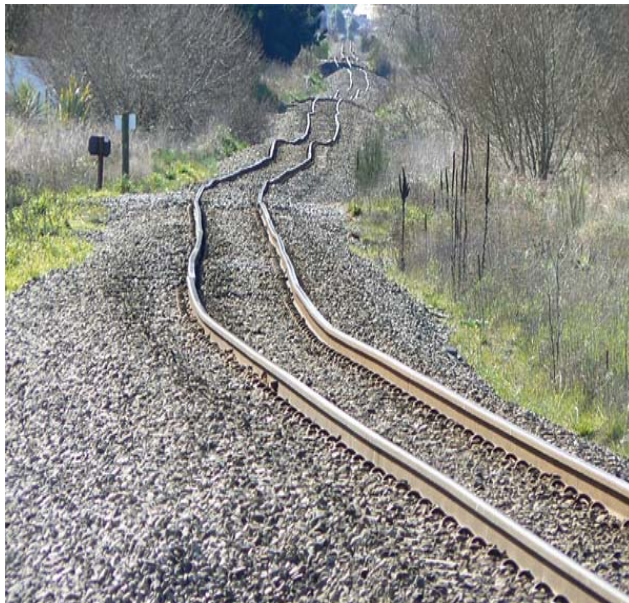
Figure 7.36 Damage to rail line at Woodford Glen. (photo by L. Matthews and J. Overend)

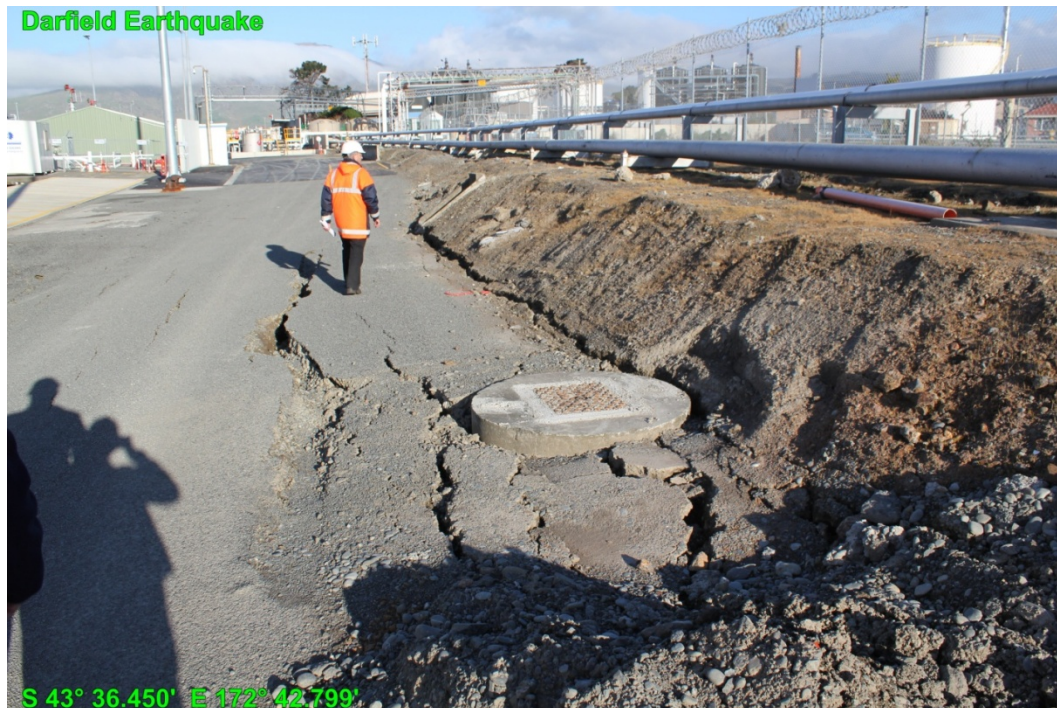
All the wharves underwent limited settlement and lateral deformation, though limited to 0.2 to 0.3 m. Typical damage from settlement and lateral deformation are shown in Figures 7.37-7.39 .

Figure 7.37 Settlement and lateral deformation at fuel transfer facility (-43.60750°, 172.71332°).

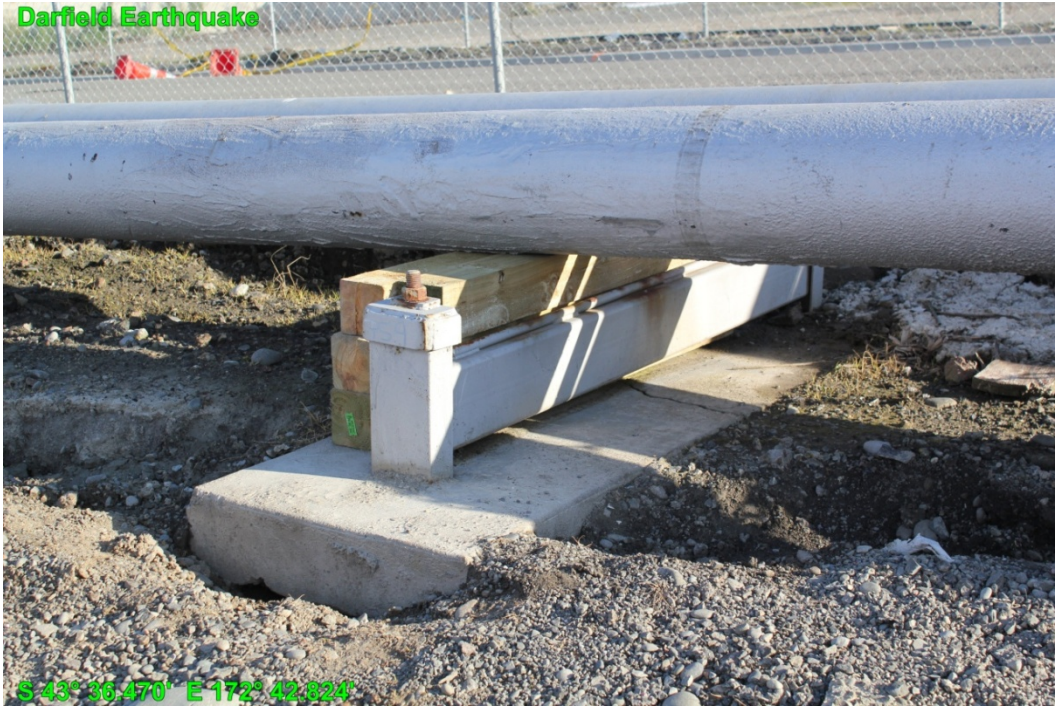
Figure 7.38 Temporary wooden support to accommodate settlement under fuel line (-43.60783°, 172.71373°)

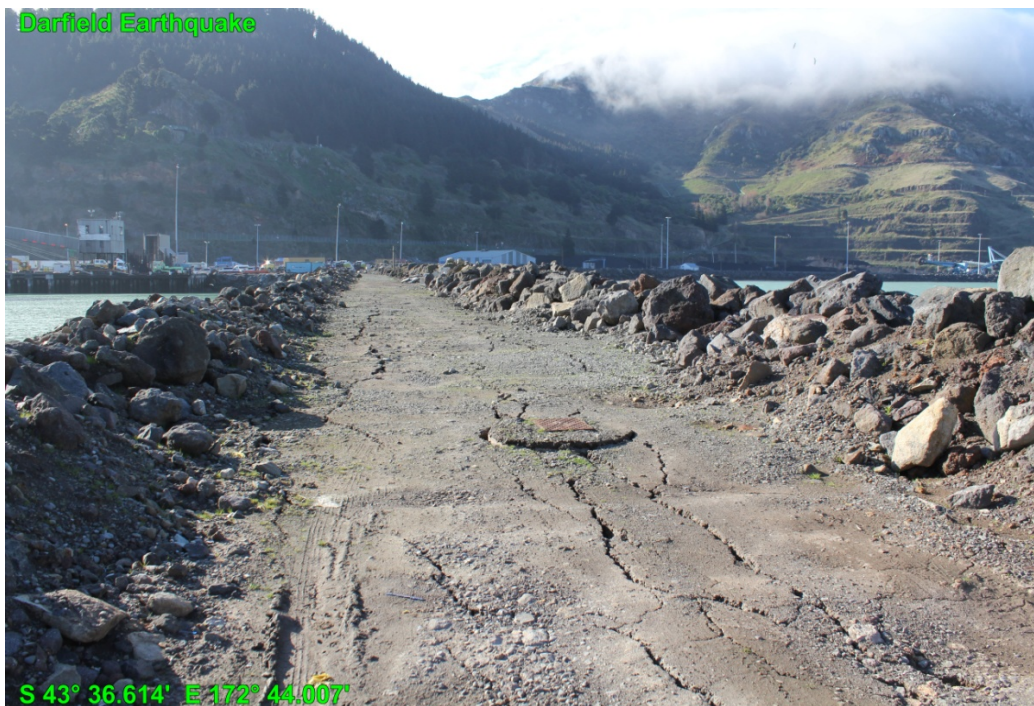
Figure 7.39 Cracking along jetty at eastern end of port (-43.61023°, 172.73345°).

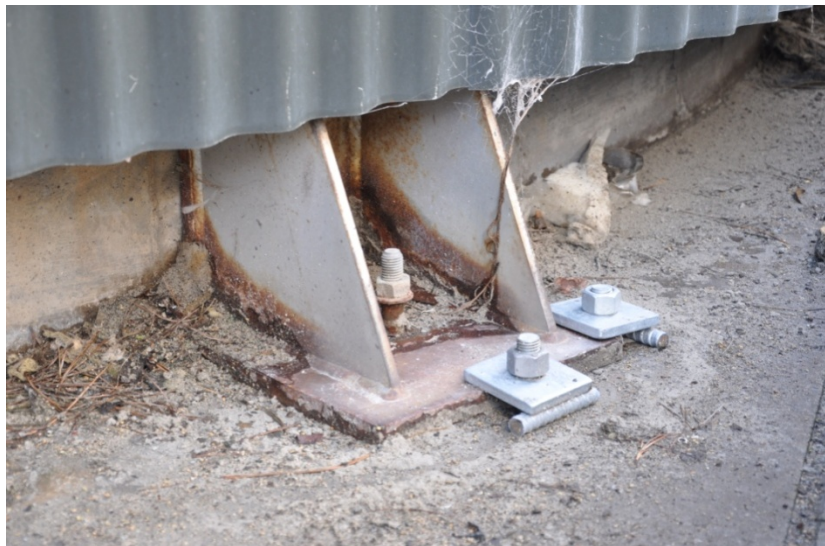
Figure 7.43 Typical repair to Tank 3 and 4 (addition of clamp plates). Note the pullout of the original anchorage. Fulton Hogan Bitumen Plant. (-43.6085°, 172.7149°).

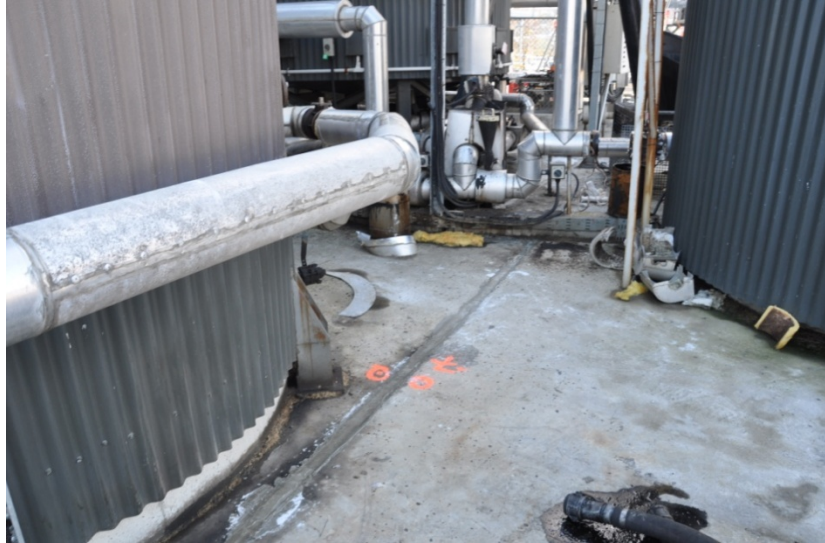
Figure 7.44 Repair of lateral spread cracks within the Fulton Hogan Bitumen Plant, nearby Tank 3. (-43.6085°, 172.7150°)

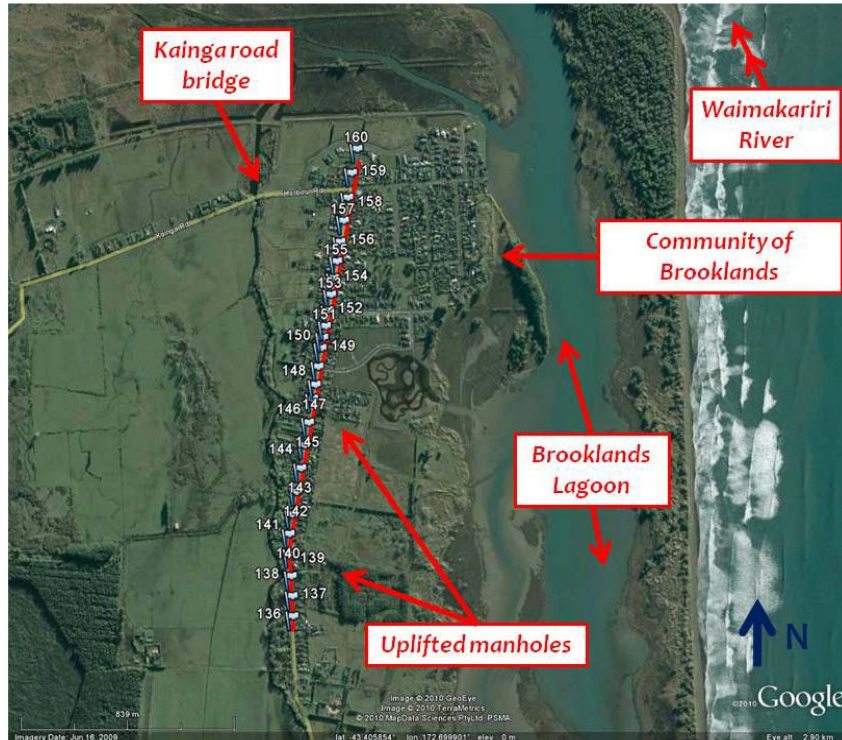
Figure 7.46 Approximately 2 km stretch along Lower Styx Road with observed uplifted manholes. (GoogleEarth image; -43.4059° , 172.6999°). Waypoints 136-160 represent locations of elevated manholes.
