7. EFFECTS ON LIFELINES

This chapter includes the GEER-NZ Team observations for the transportation system (bridges, highways, rail, airports, and ports), water and wastewater systems, electric power, waste management and landfill, as well as other lifelines.

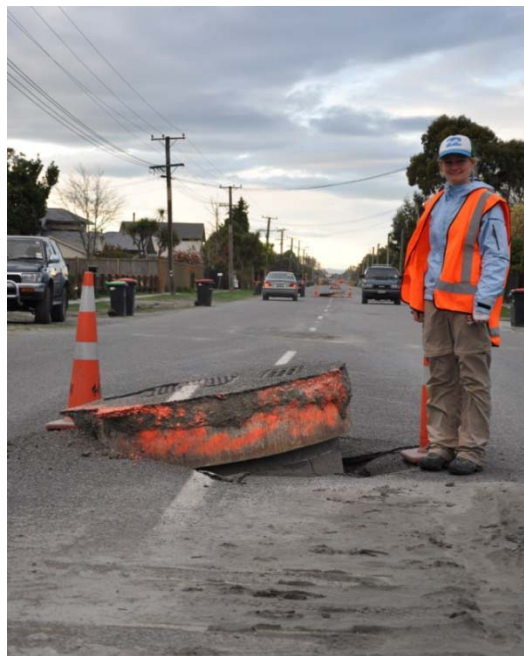
In a number of residential communities, sewage and potable water were problematic immediately following the main shock. Perhaps hardest hit were the communities of Spencerville and Brooklands. At the time of the Team's visit on 13 September 2010, neither community had functioning wastewater collection systems, and Brooklands did not have potable water. Liquefaction along Lower Styx road, the primary connection between these two communities, caused ground subsidence, a rise in the water table, and uplifting of 25 manholes (Figure 7.46). Construction workers were dewatering the region during the Team's visit and informed us that the manholes were 4-m deep. The manholes were approximately 28-46 cm above the existing road surface (Figure 7.47).

Figure 7.47 Uplifted manholes along Lower Styx Road, note the uplifted manholes in the background too. (-43.4113° , 172.6930°).
