Geotechnical Aspects of the 2016 M_w 6.2, M_w 6.0, and M_w 7.0 Kumamoto Earthquakes

Geotechnical Extreme Events Reconnaissance Association

Version 1.0

July 2016

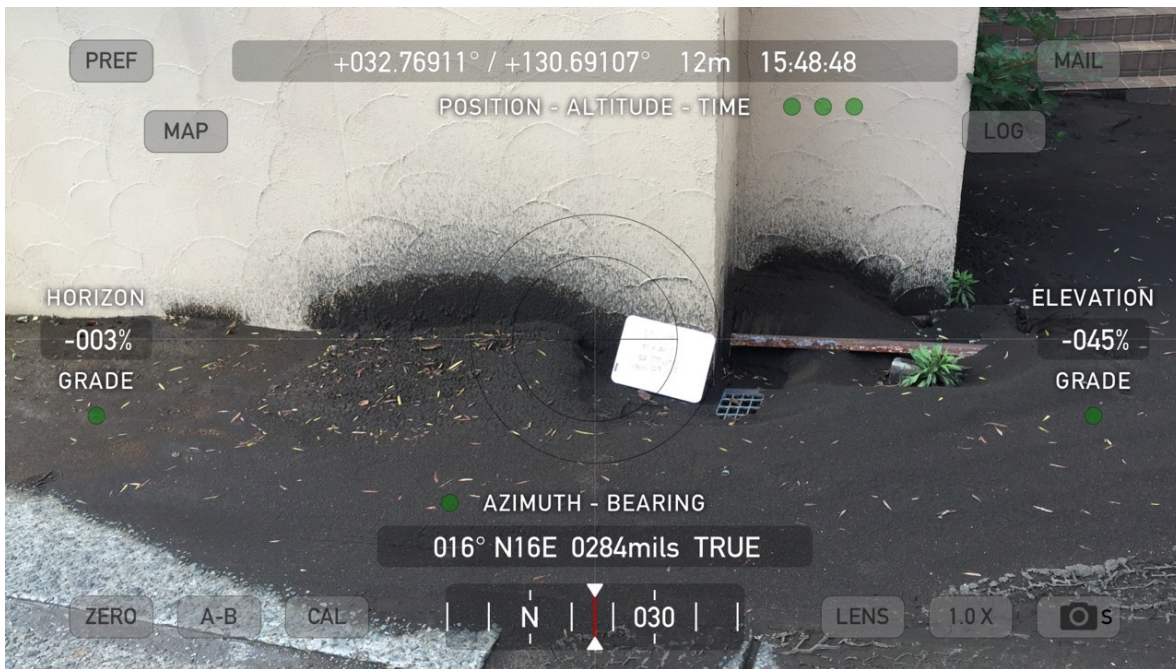
Figure 2-3. Dark sand boils were typical of liquefaction sites in Mashiki town and southern Kumamoto City.

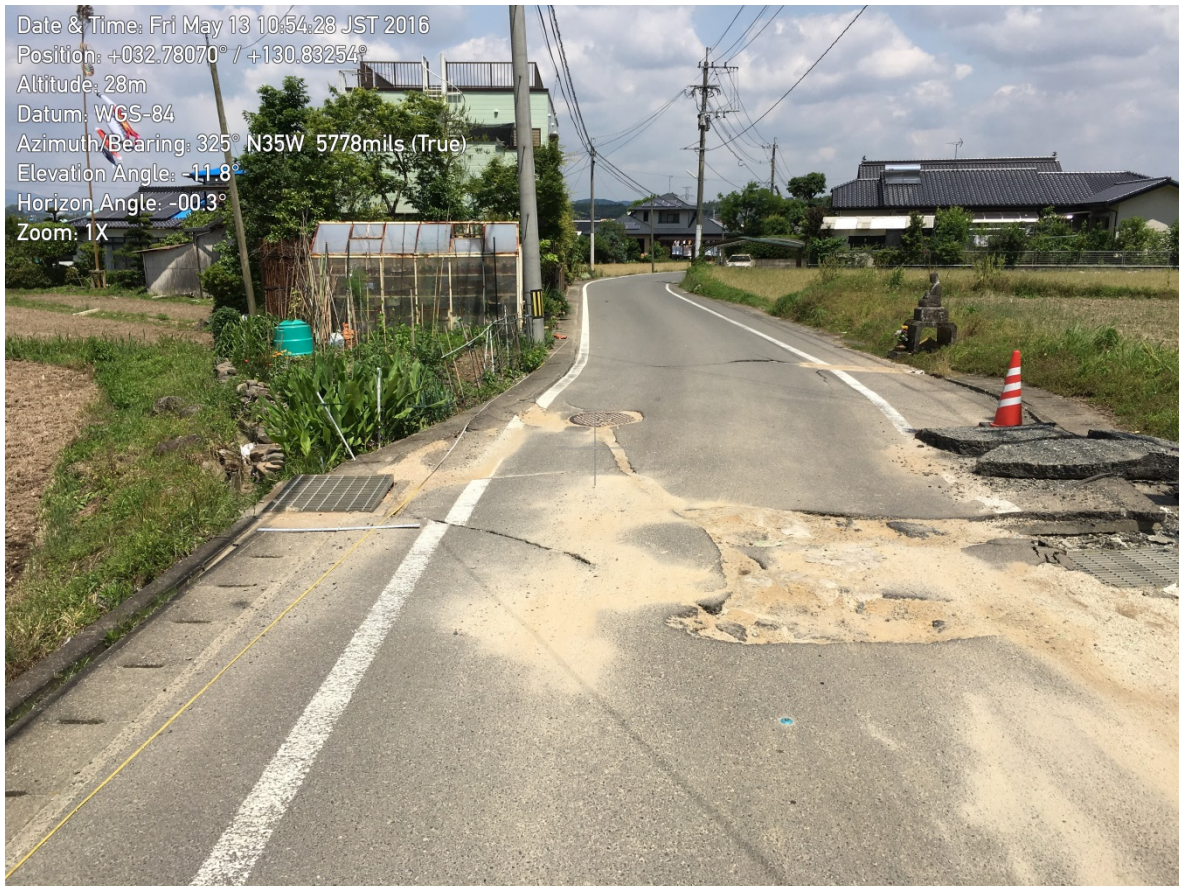
Figure 4-6. Roughly 0.65 m to 0.70 m of right-lateral offset along the Futagawa Fault through a road.

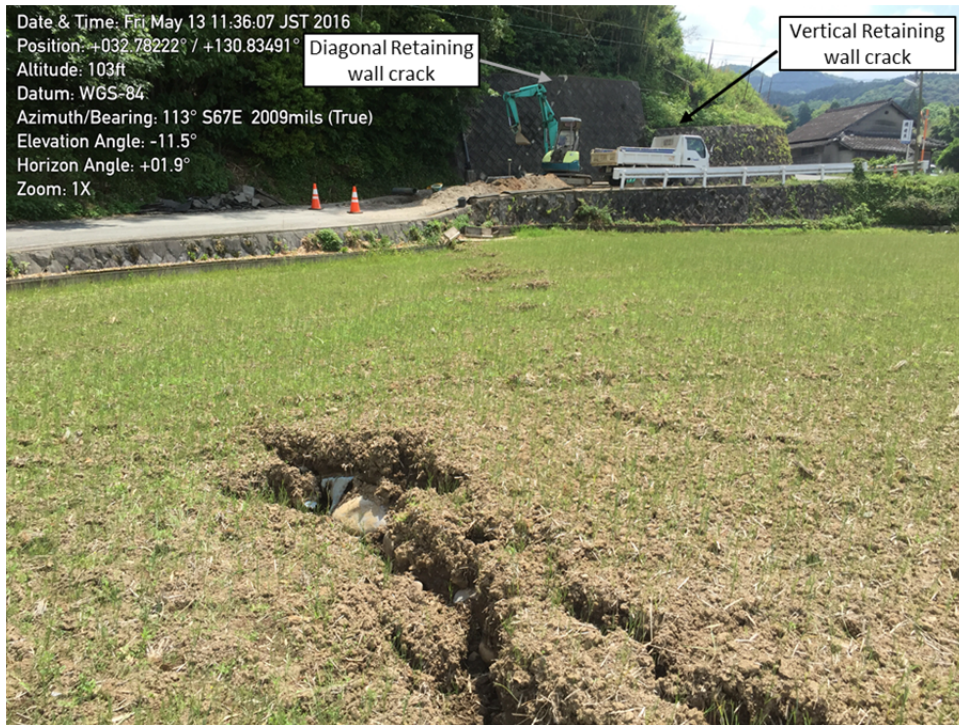
Figure 4-8. Northern strand of the Futagawa surface rupture through a field, road, sewer main, and retaining wall.

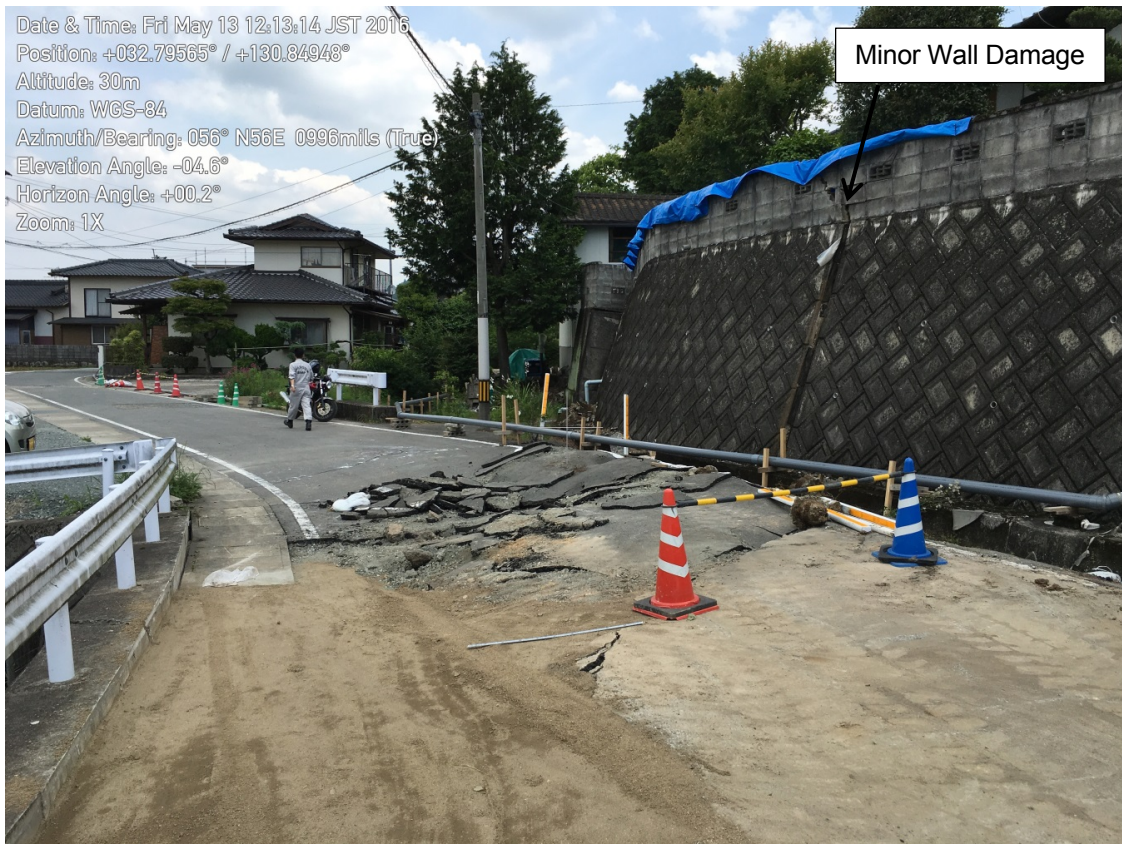
Figure 4-11. Right-lateral offset along the Futagawa Fault through a road and retaining wall, which performed relatively well.

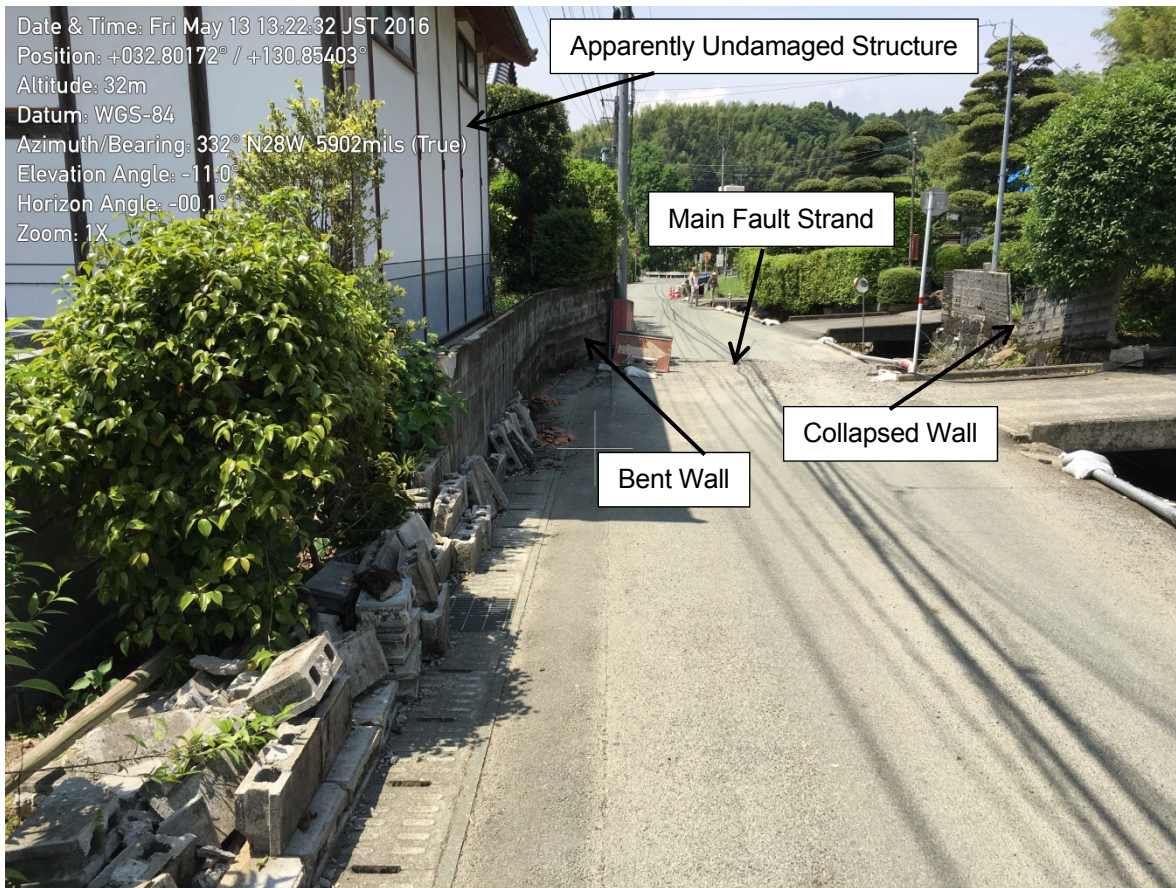
Figure 4-12. Roughly 1.2 m of right-lateral offset along the Futagawa Fault through a road and two walls. The retaining wall on the left was bent but relatively intact, while the wall on the right partially collapsed. The building on the left was immediately astride the fault and suffered no damage visible from the road.

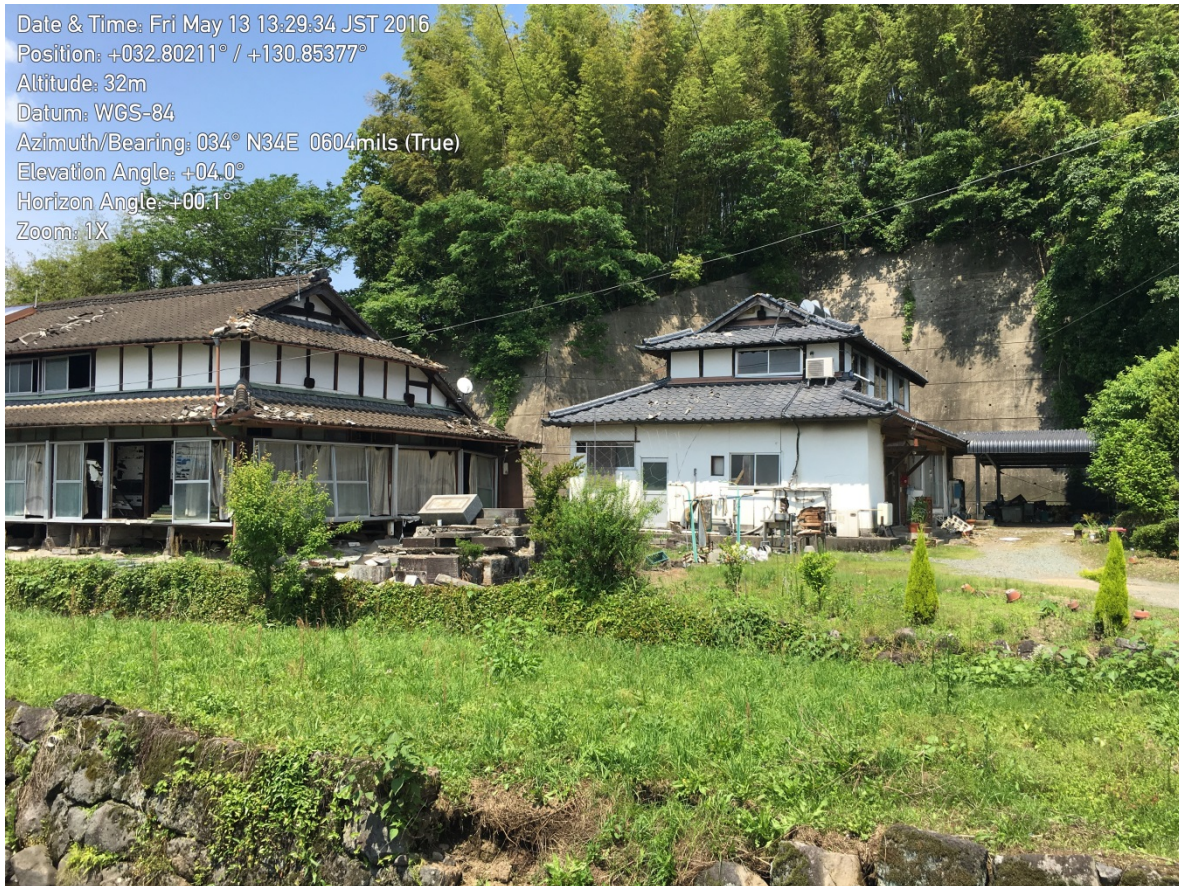
Figure 4-13. Right-lateral offset along the Futagawa Fault likely passed through the large retaining wall behind the residential structures and into the hill behind it; however, we were not able to examine the wall up close and the bamboo jungle behind the wall was too dense to traverse. No visible damage in the retaining wall could be seen from our vantage point.

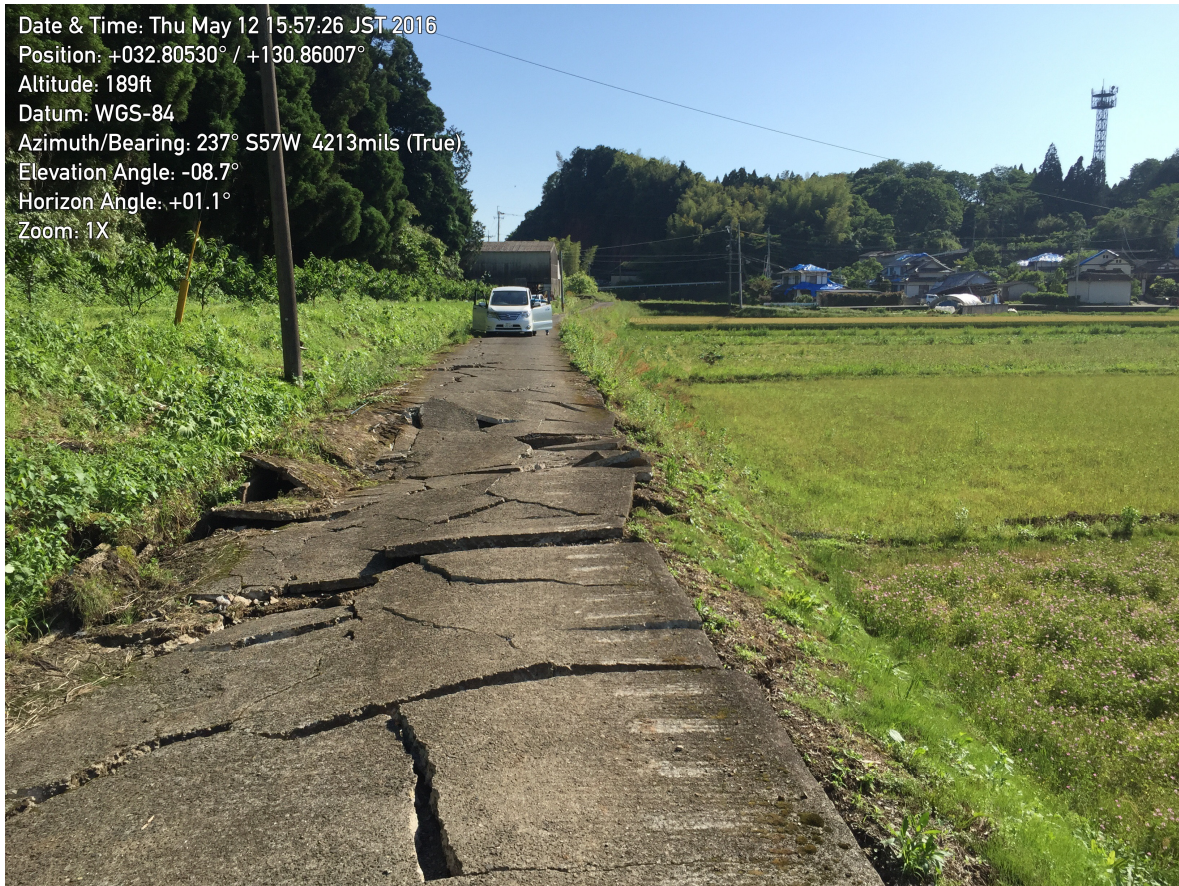
Figure 4-14. Roughly 1.8 m of right-lateral offset along the Futagawa Fault through a concrete road and fields.

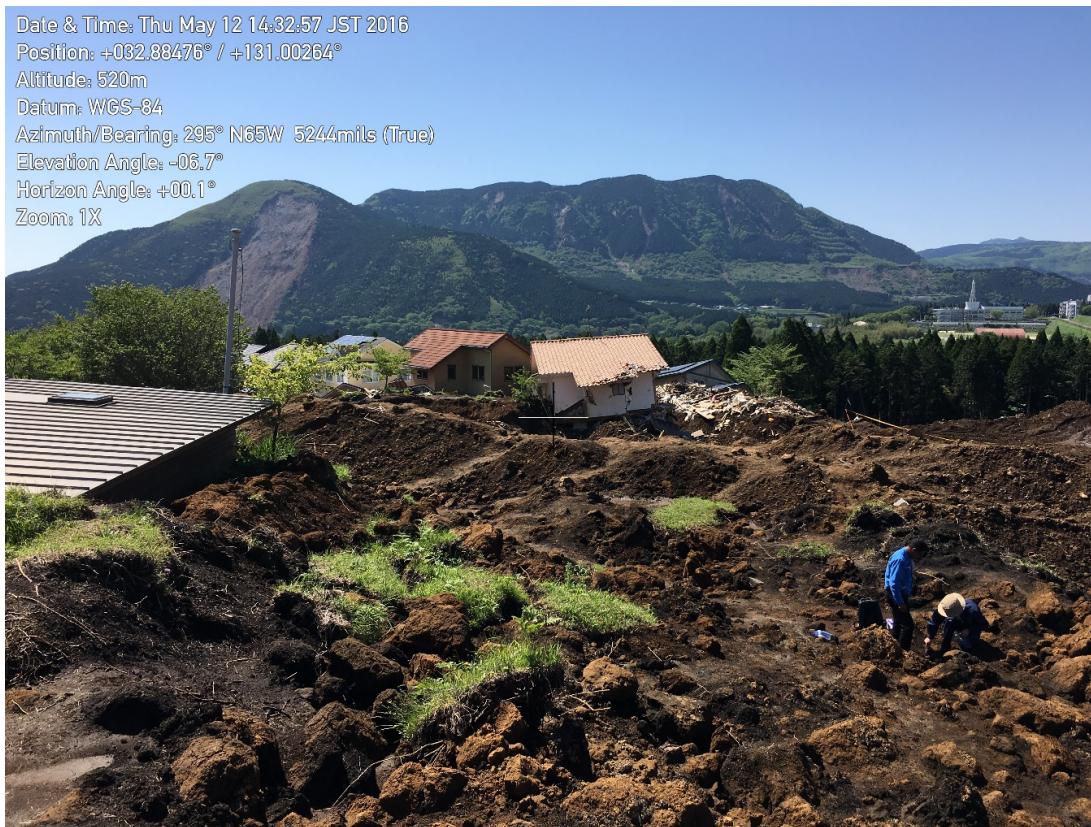
Figure 5-5. Damage to a residential area as a result of the landslide runout. Several structures are missing that would have previously fit within the frame of the photo.

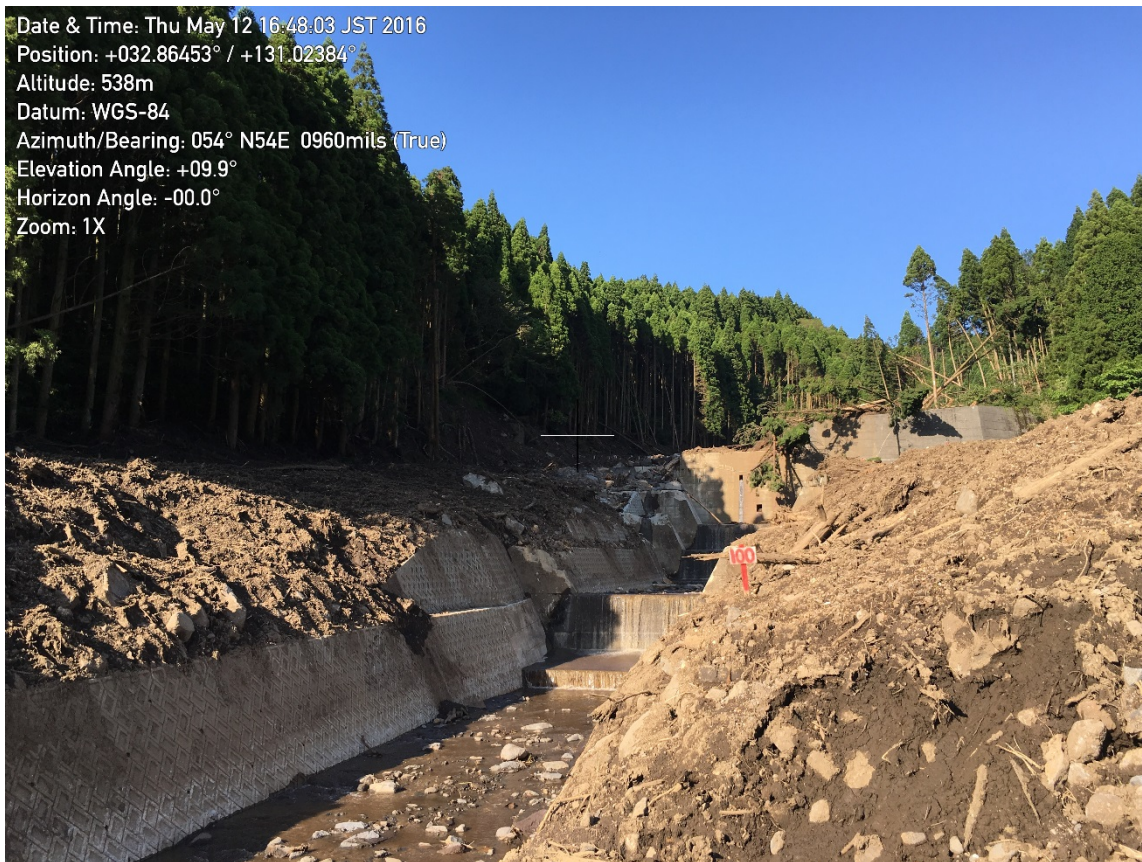
Figure 5-10. Sabo Dam that overflowed and partially collapsed as a result of sediment flows.

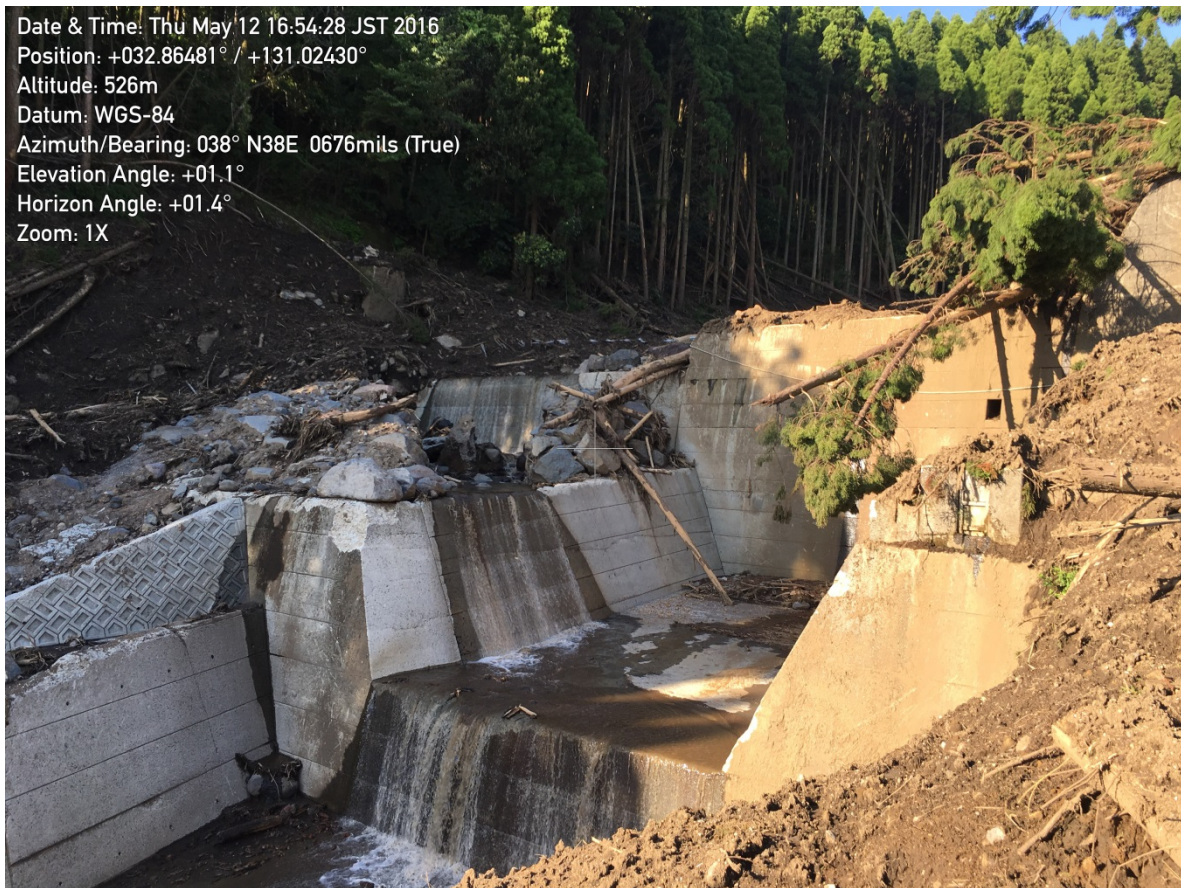
Figure 5-11. Close up of the dam. Note the right side of the dam is missing, in contrast to the left side which is intact.

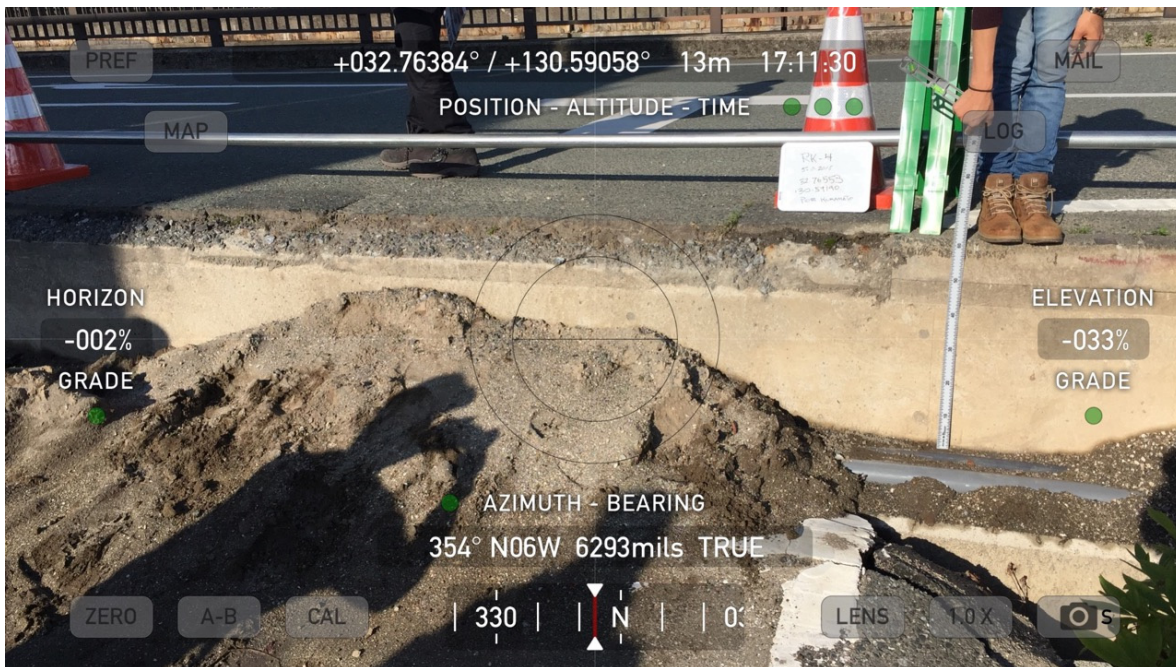
Figure 6-2. Free-field liquefaction settlements at a road intersection on the artificial island west of Kumamoto. Settlement of nearly 58 cm were observed at this location.

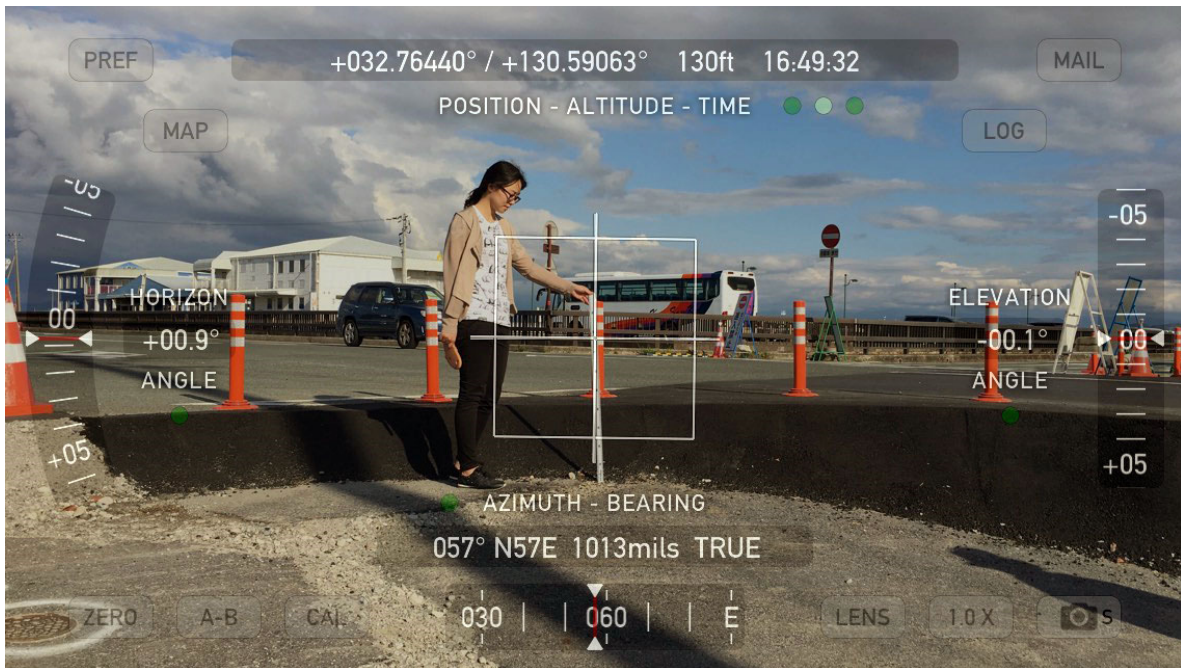
Figure 6-3. Post-liquefaction settlement of road on the artificial island between 30 cm and 40 cm

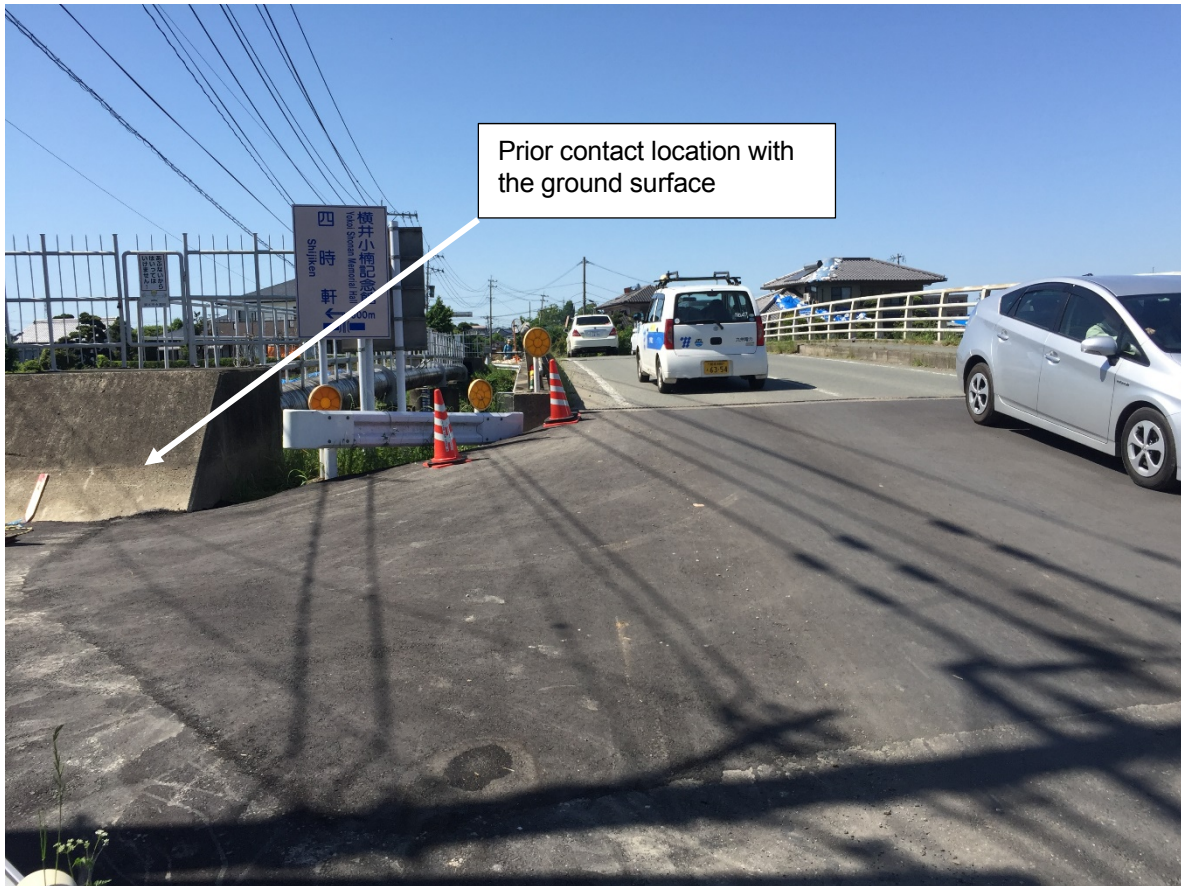
Figure 6-8. Liquefaction-induced settlement at bridge approach. Estimated settlements of 36 cm were observed at this site. Location: 32.77322° N 130.78433° E

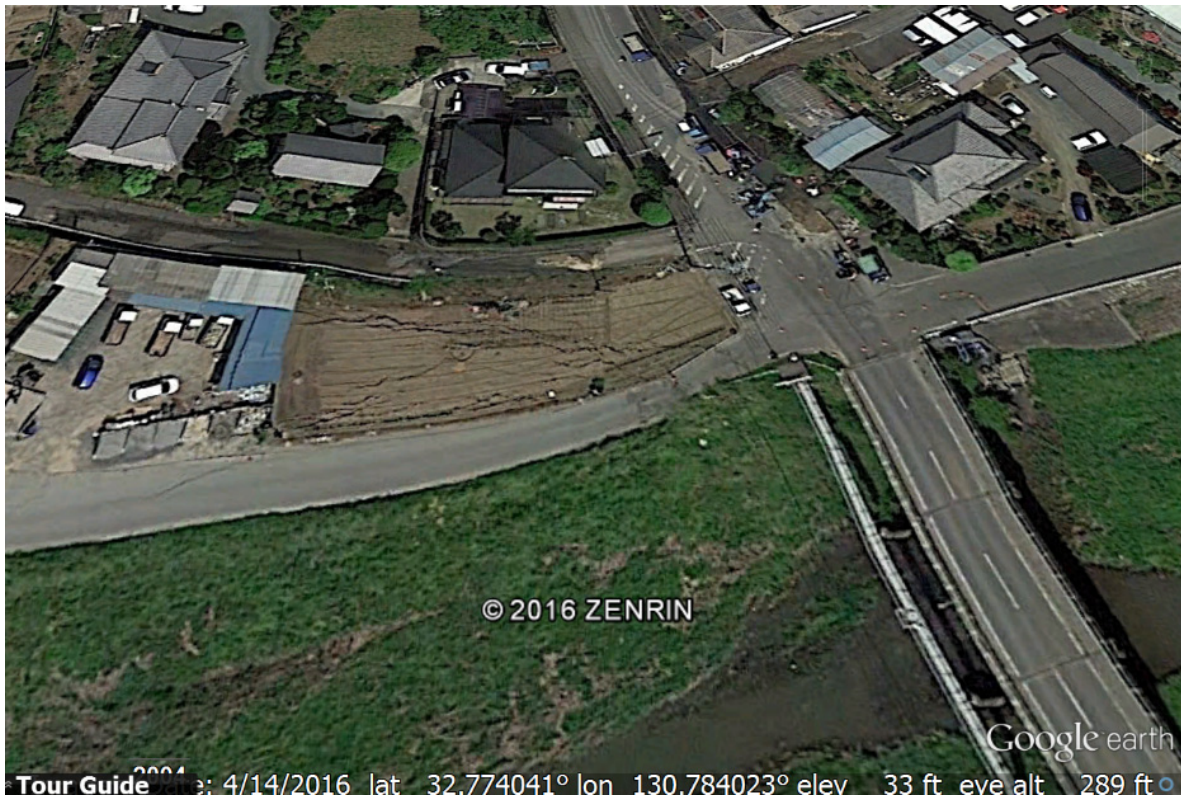
Figure 6-14. Lateral spread feature identified adjacent to a bridge.

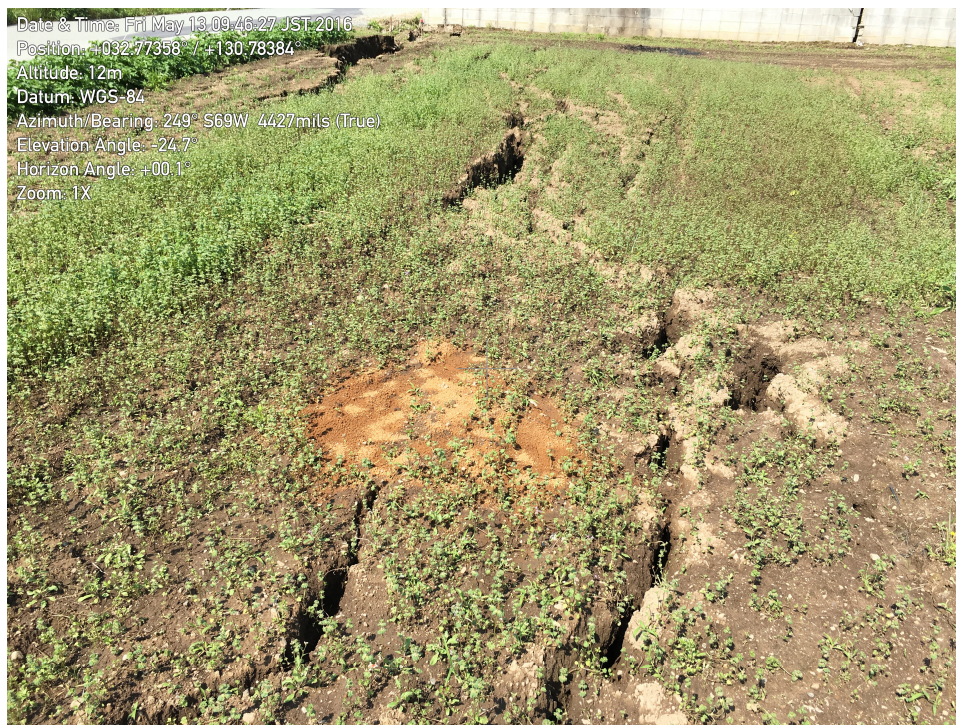
Figure 6-16. Ground cracking from lateral spread and observed ejecta.

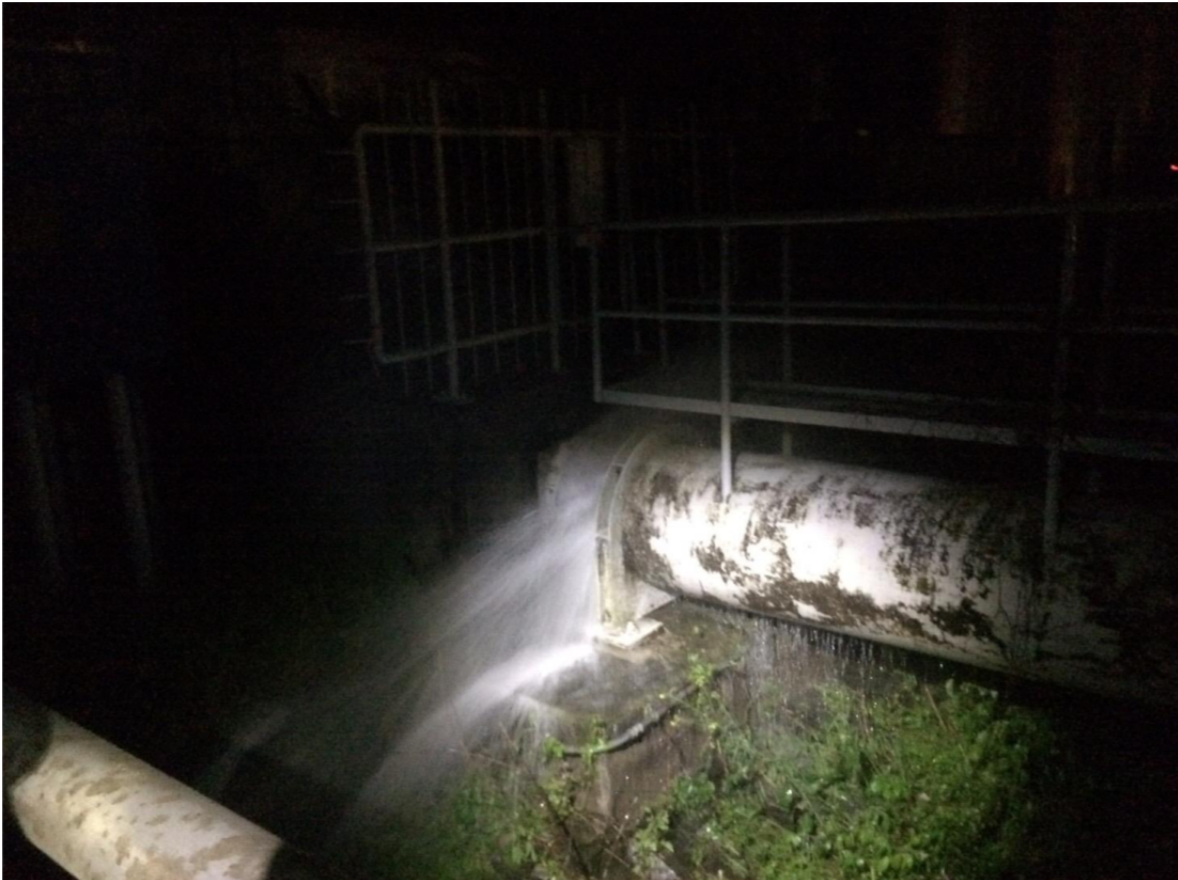
Figure 7-3. Leakage of 800 mm diameter bridge pipeline (courtesy of Kumamoto City Water and Sewer Bureau) (32.77326, 130.78428).

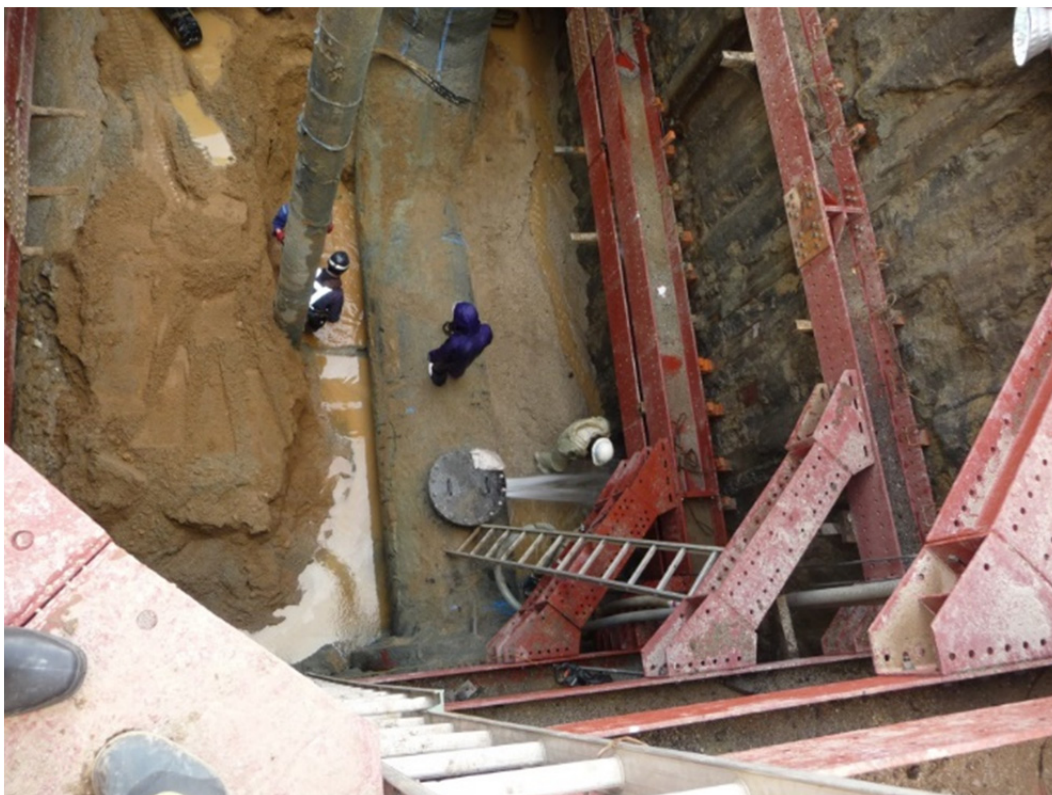
Figure 7-4. Repair of a 1350 mm transmission main with leakage from 600 mm flange cap (courtesy of Kubota Corp) (32.76382, 130.75117).

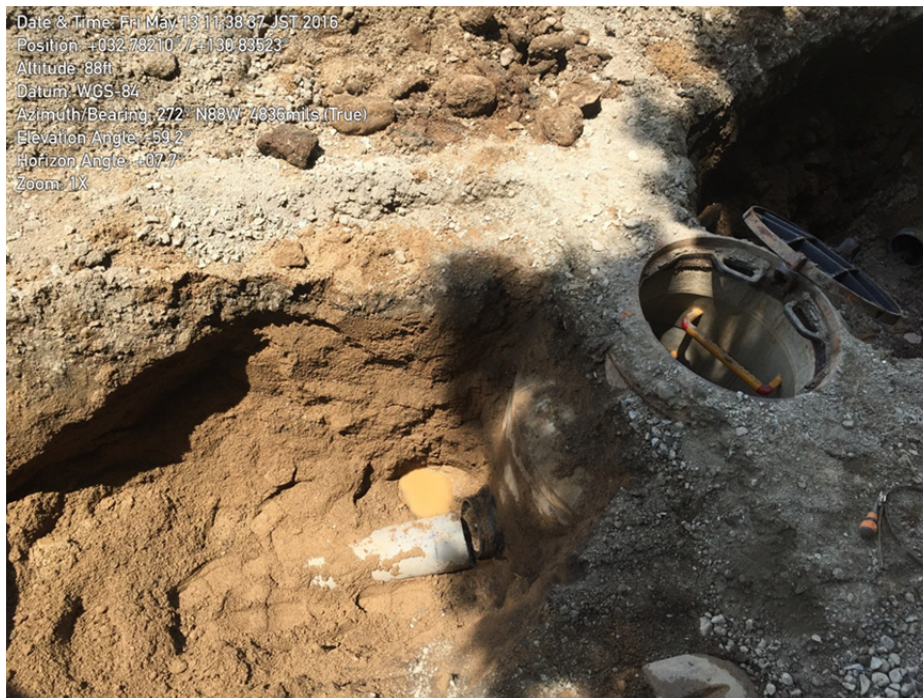
Figure 7-6. Ongoing repairs of a sewer main where surface rupture caused differential movement and disengagement of a 200-mm PVC main at both the north and south sides of a concrete manhole structure. (32.78212, 130.83507).

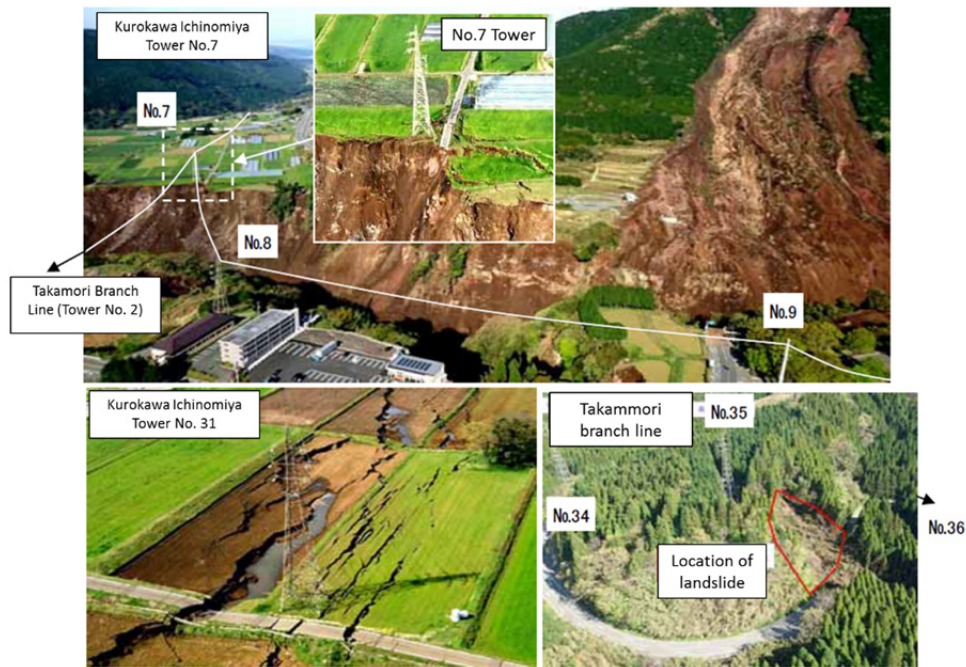
Figure 7-8. Earthquake-induced damage near the 66-kV transmission towers (courtesy of Kyushu Electric Power Co.) (No. 7 Tower: 32.879237, 130.985245) (No. 31 Tower: 32.928217, 130.999955).

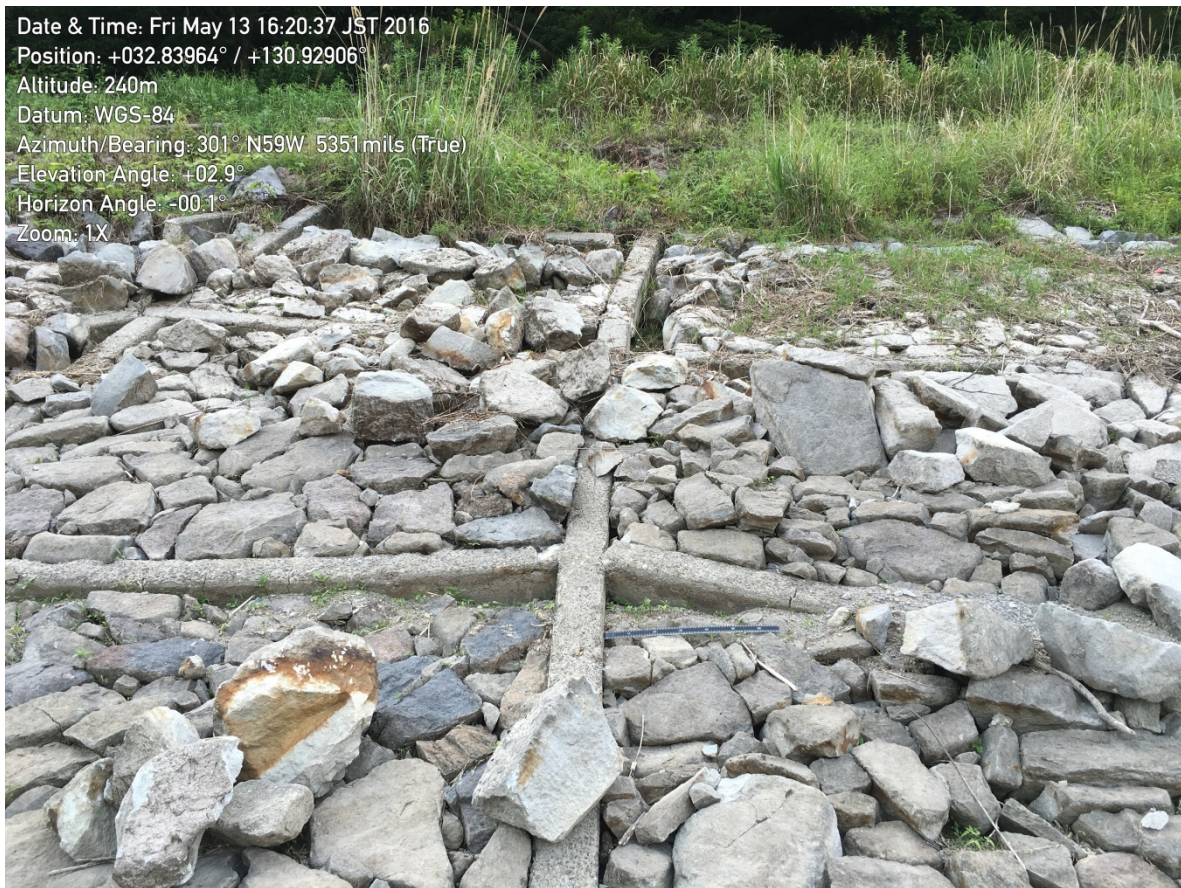
Figure 9-8. Deformation caused largely by the fault at the location of the fault entrance into the reservoir, as seen by the riprap dilation and bending of the concrete gridwork.

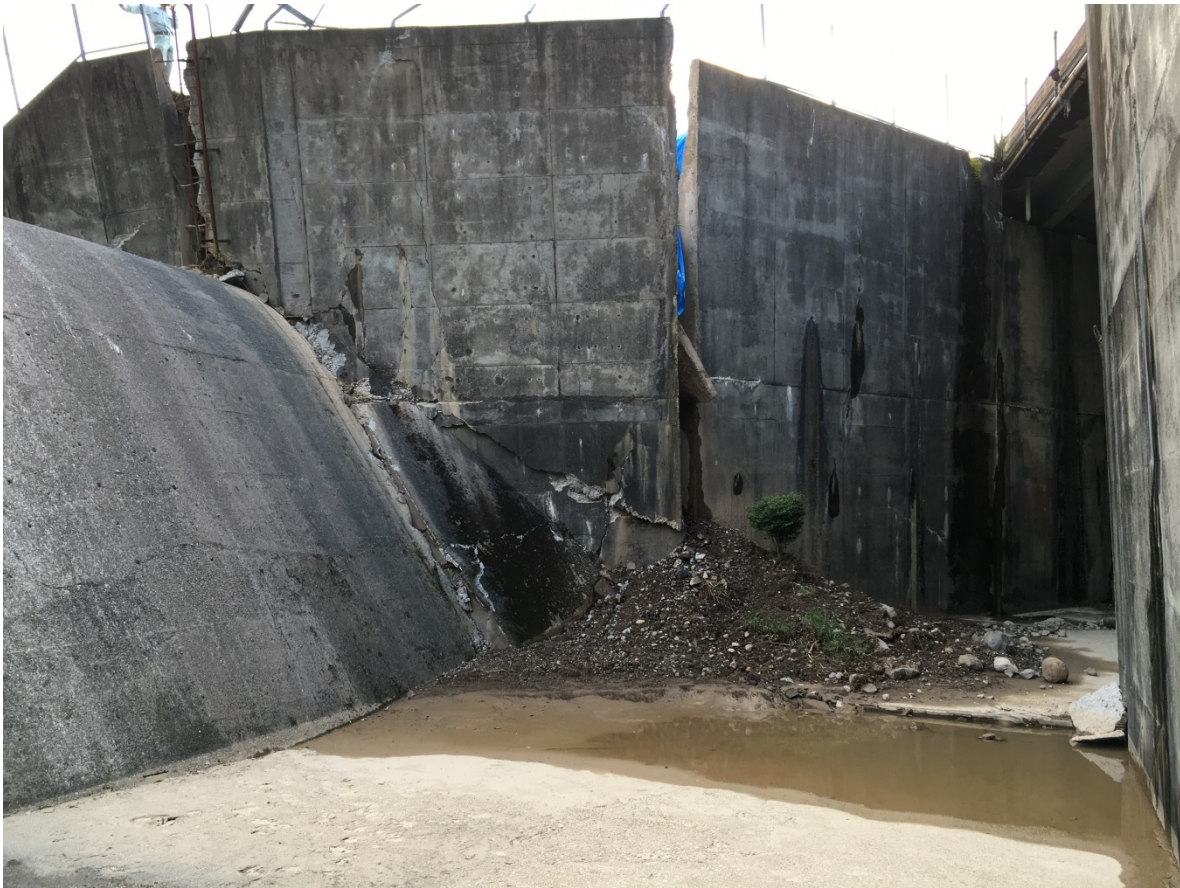
Figure 9-10. Damage and offsets at the location of fault rupture, between the spillway and the spillway outlet channel.

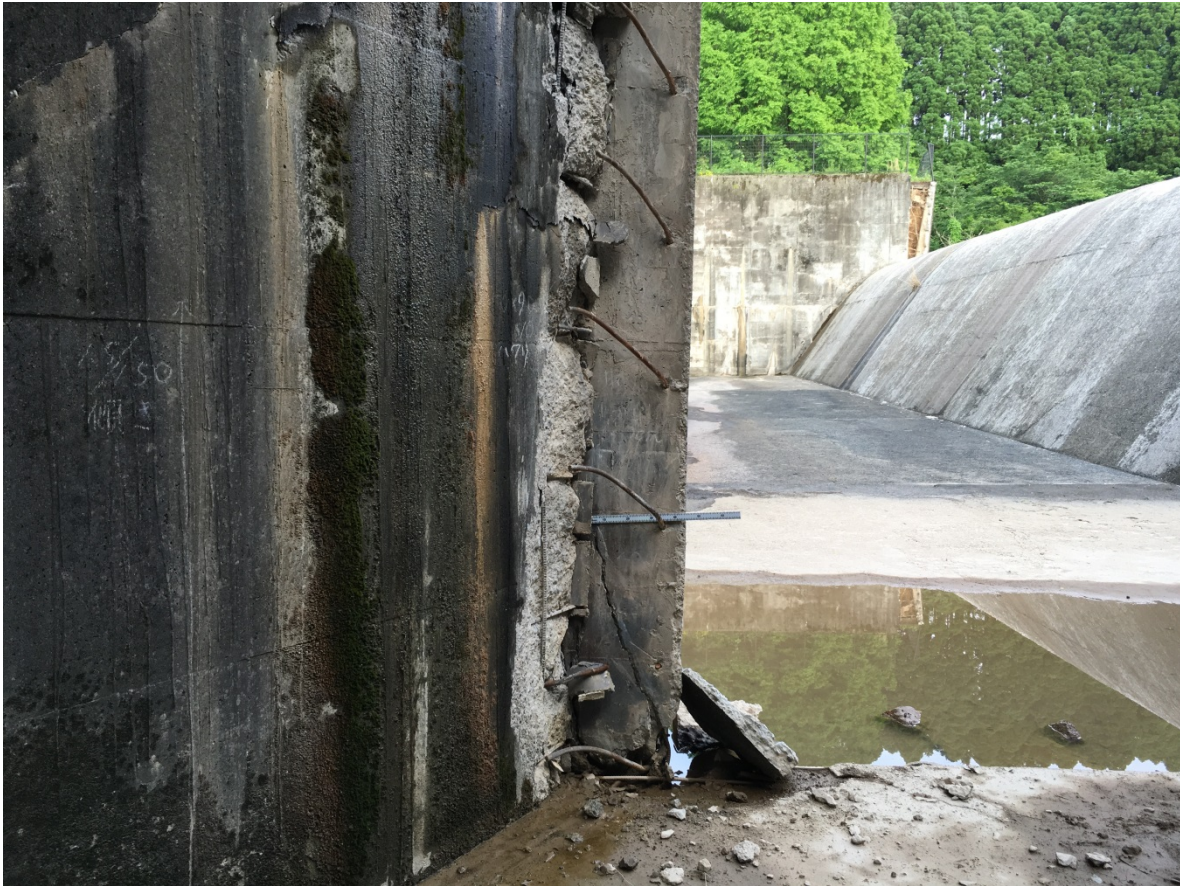
Figure 9-11. Detail of the main fault offset, through the intersection of the spillway and spillway outlet channel.

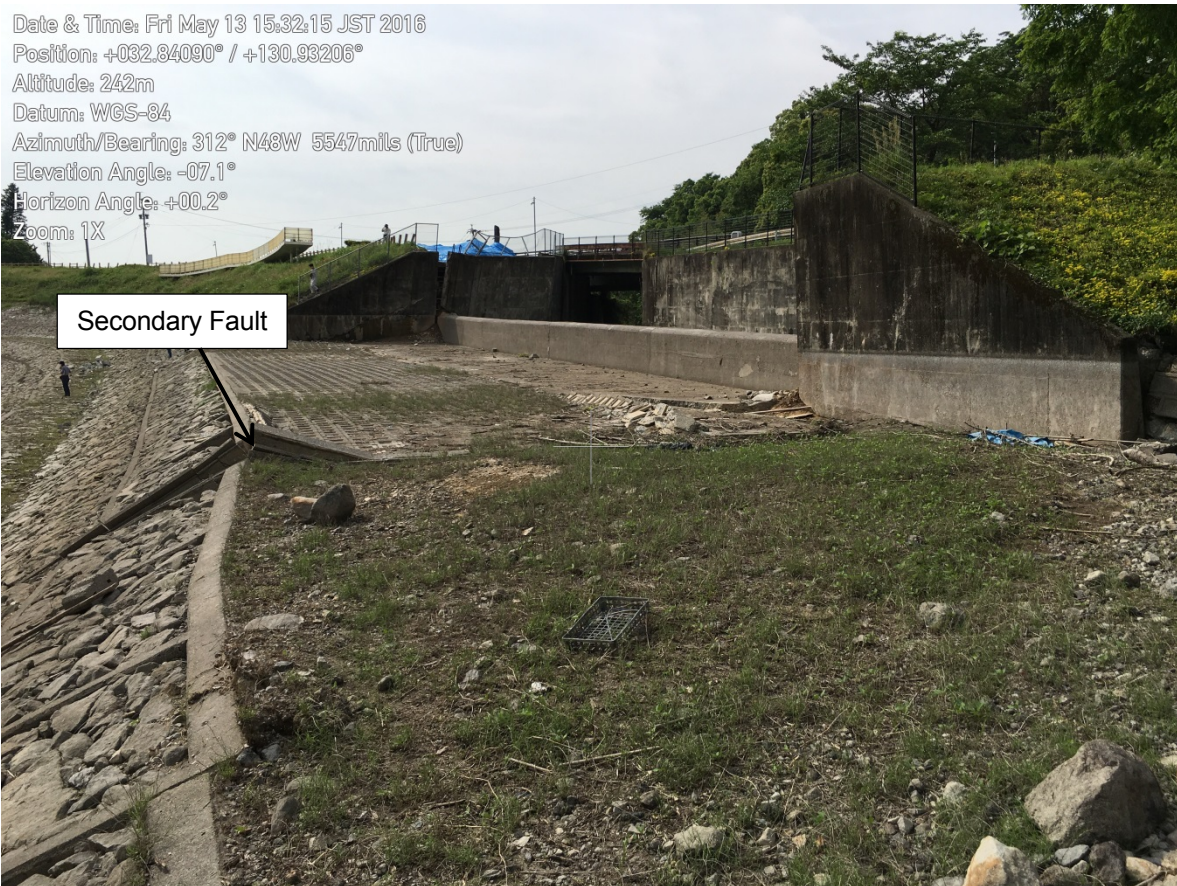
Figure 9-18. Side view of the spillway, with an apparent secondary rupture in the foreground running through the right side of the spillway.

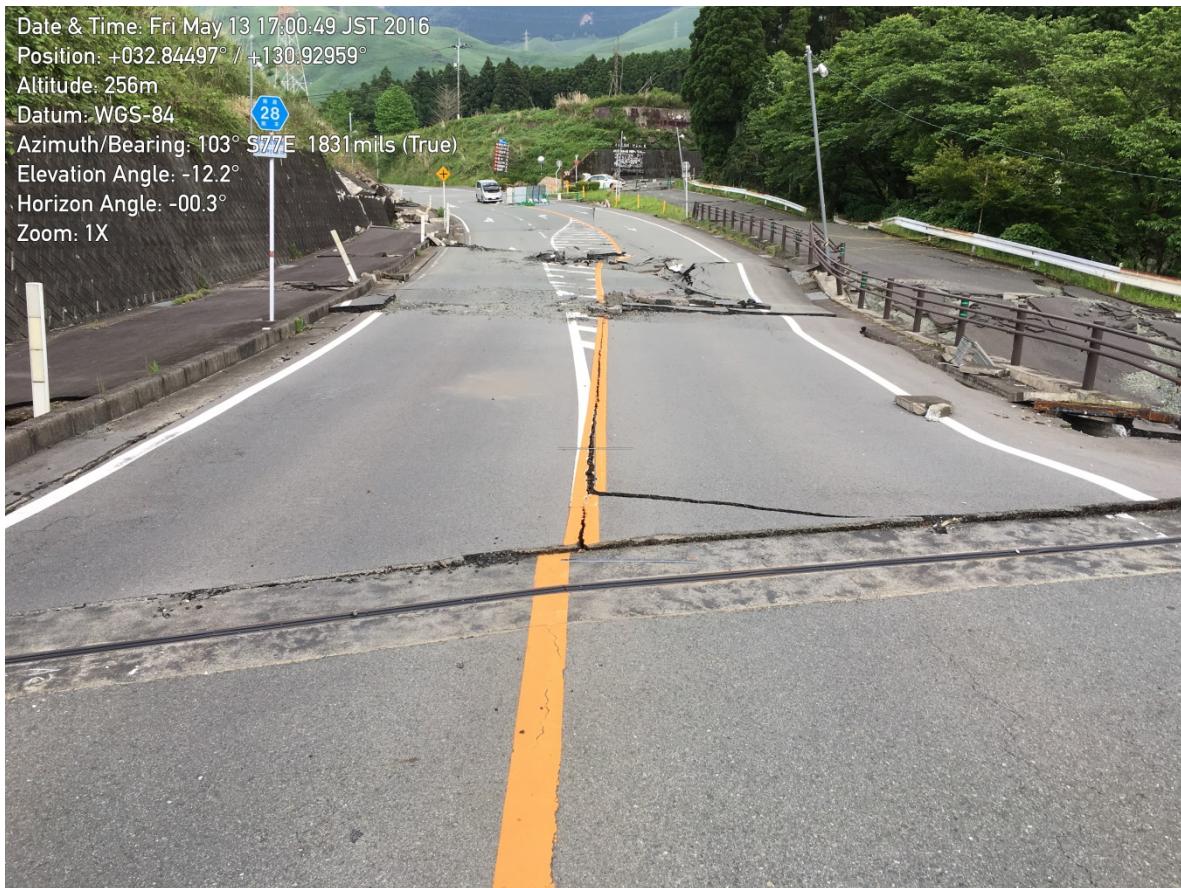
Figure 9-19. Fault rupture through the highway above the dam spillway.
