Geotechnical Aspects of the 2016 M_w 6.2, M_w 6.0, and M_w 7.0 Kumamoto Earthquakes

Geotechnical Extreme Events Reconnaissance Association

Version 1.0

July 2016

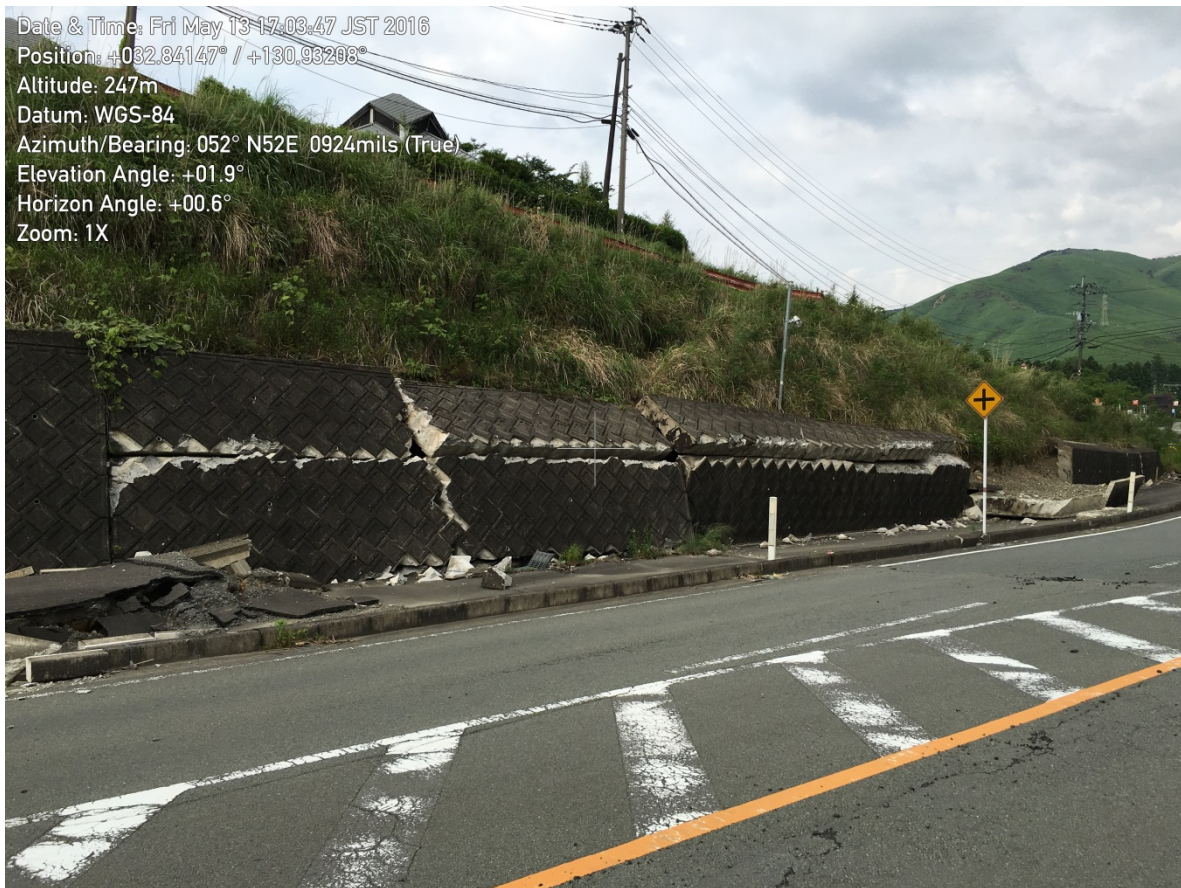
Figure 9-20. Partial collapse of an unreinforced concrete block retaining wall at the location of fault rupture, above the spillway.

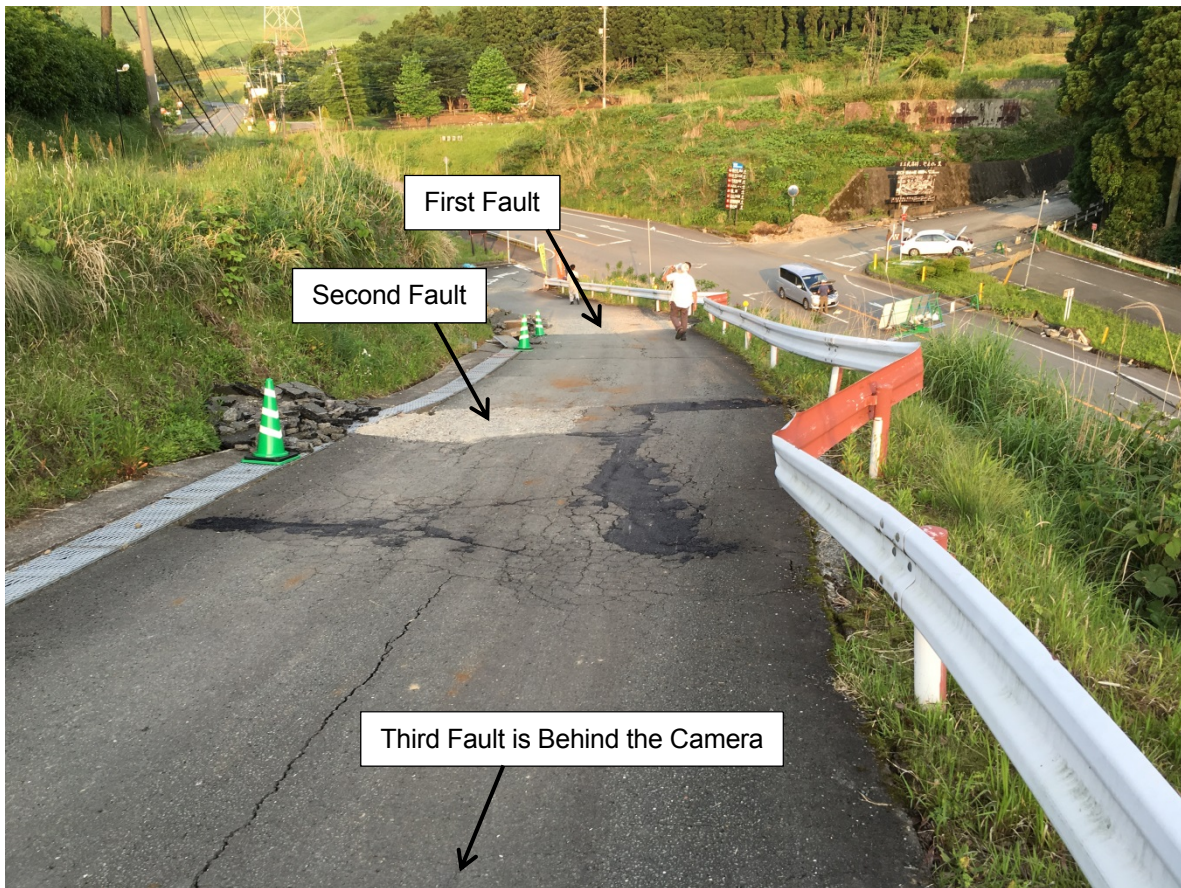
Figure 9-21. Fault ruptures in the hill above the highway and above the spillway. Note the compressions in the guardrail and road patches.

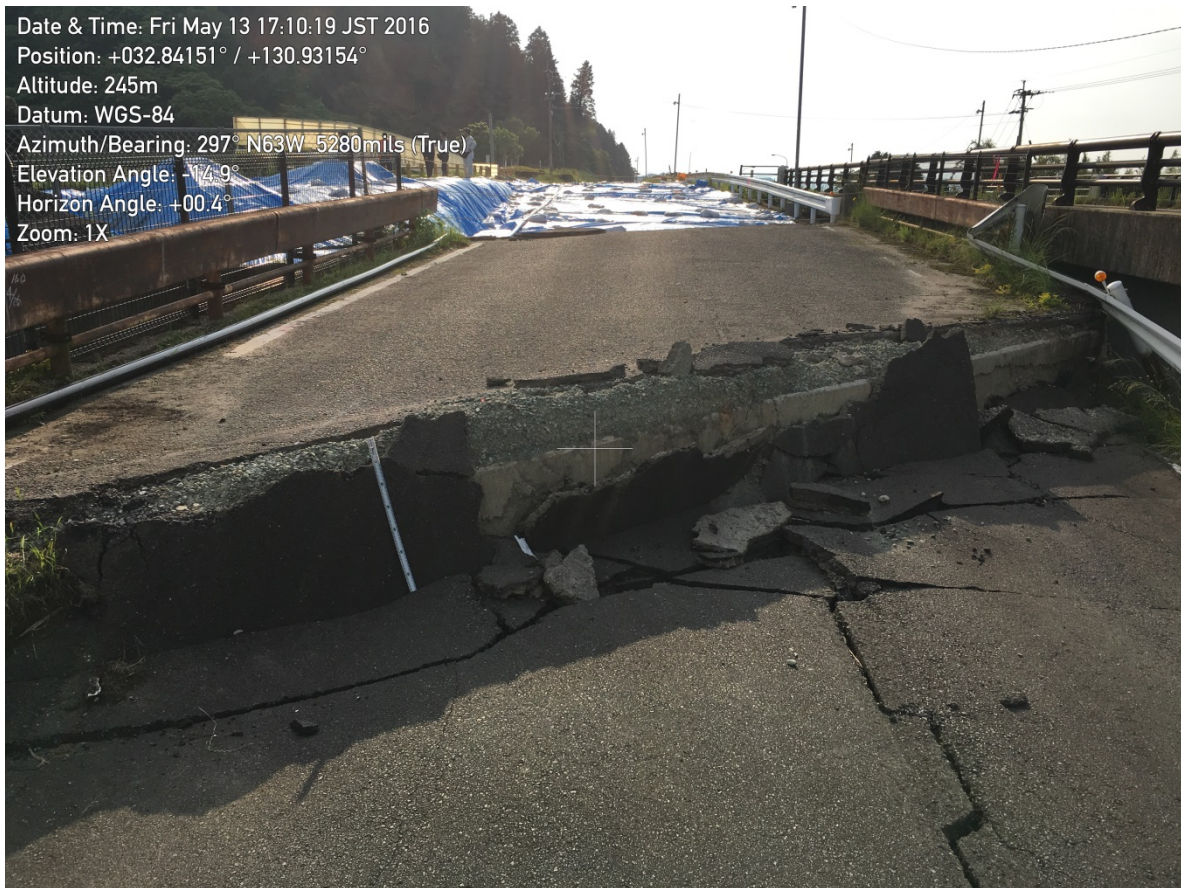
Figure 9-22. Differential settlement at one of the bridges crossing the spillway outlet channel, possibly caused by movement of the spillway walls in response to fault displacement.

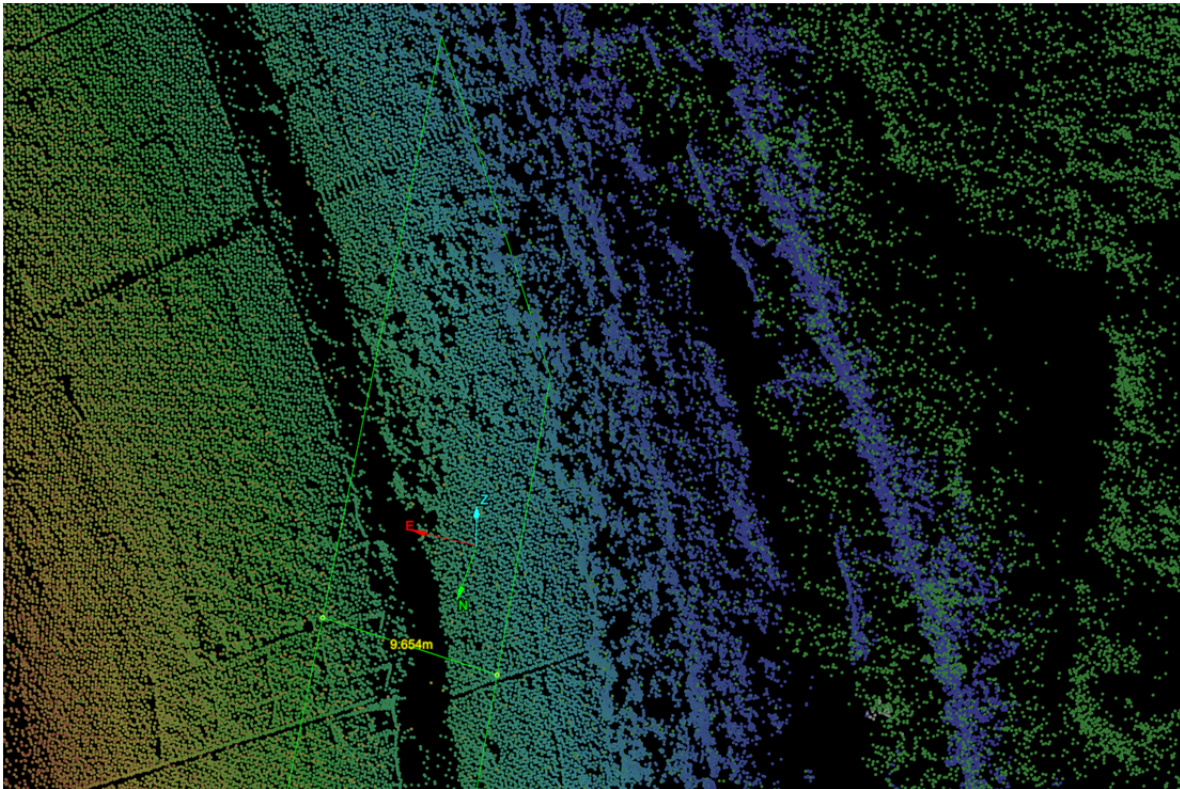
Figure 9-24. Evidence of fault rupture beneath the reservoir wall rock facing: disruption of the rock blanket, here visible in the roughened topography of the wall (32.84123, 130.93158).

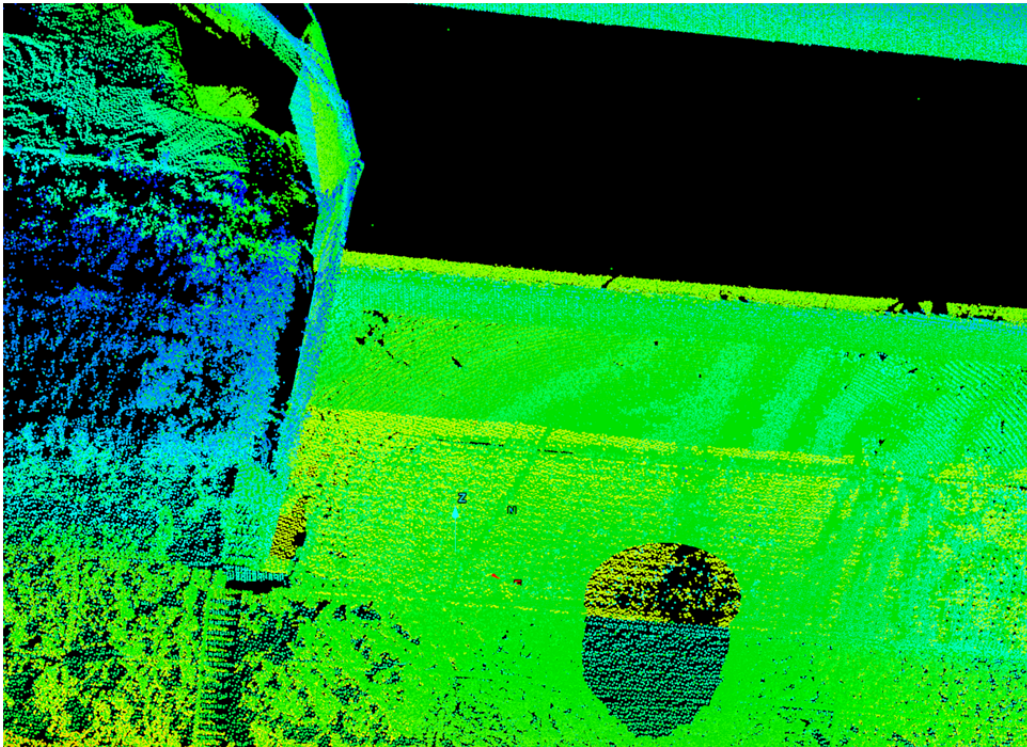
Figure 9-25. Detail of damage to the spillway along the western side of the structure (32.84123, 130.93158).

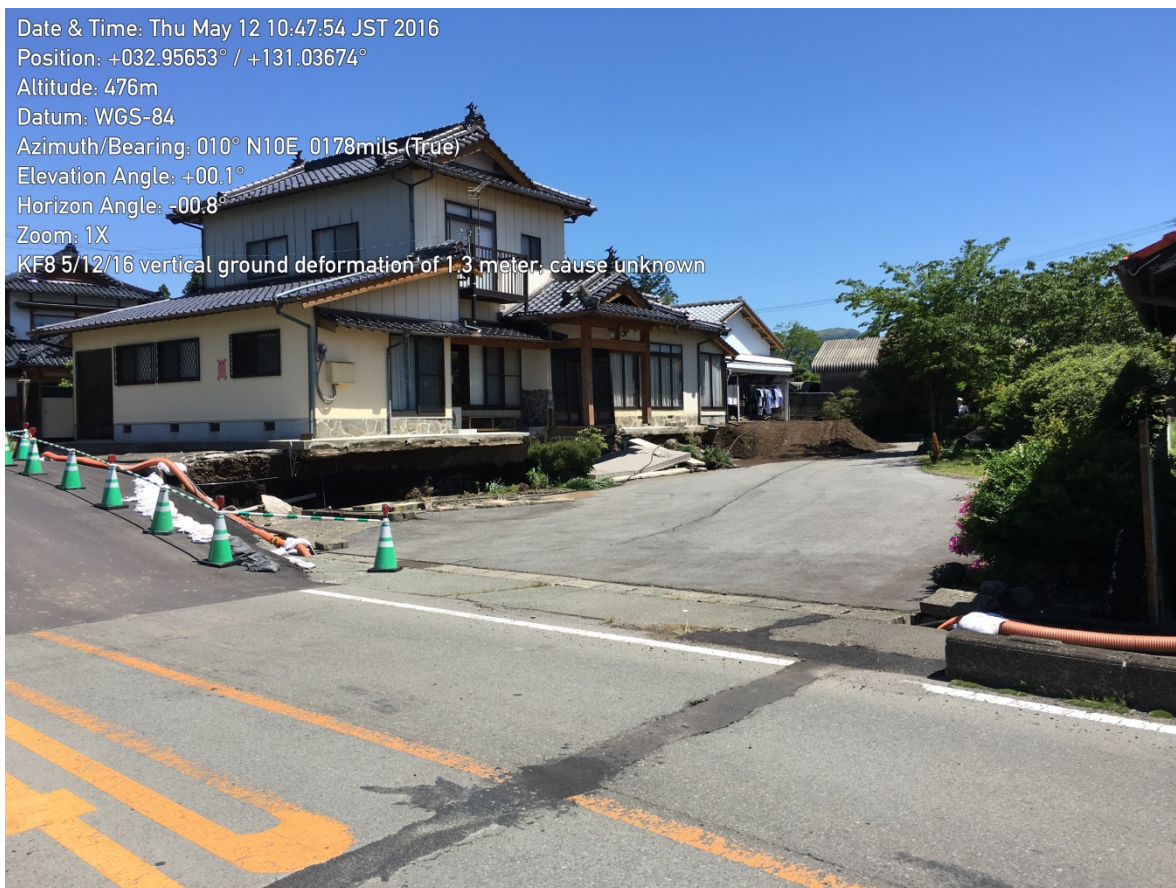
Figure 9-31. One edge of the zone of depression caused a large grade change immediately adjacent to a residential structure.

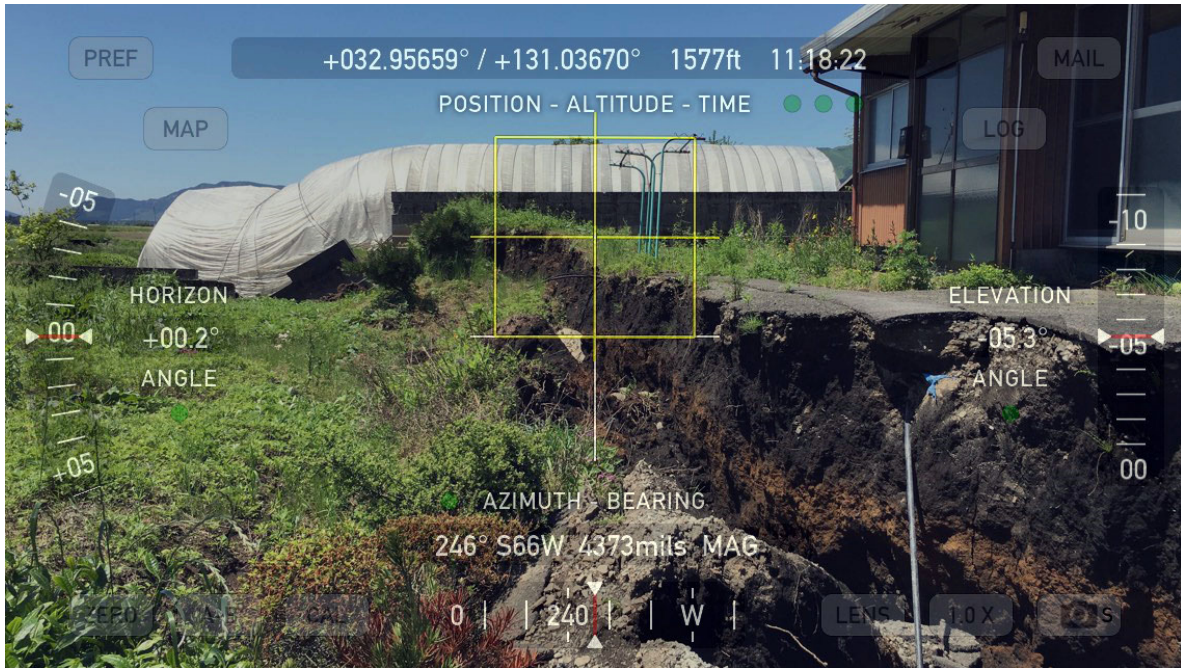
Figure 9-32. One edge of the zone of depression crosses next to a residential structure and beneath a greenhouse structure.

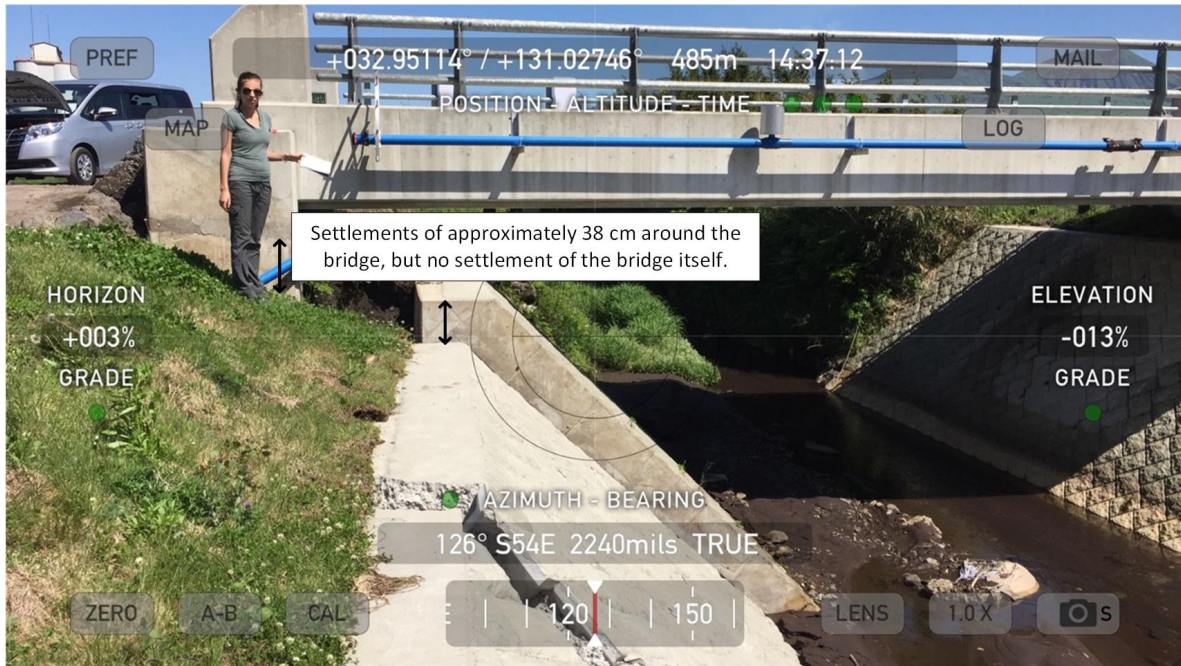
Figure 9-34. No foundation settlement at the west bridge abutment located in the depression zone.

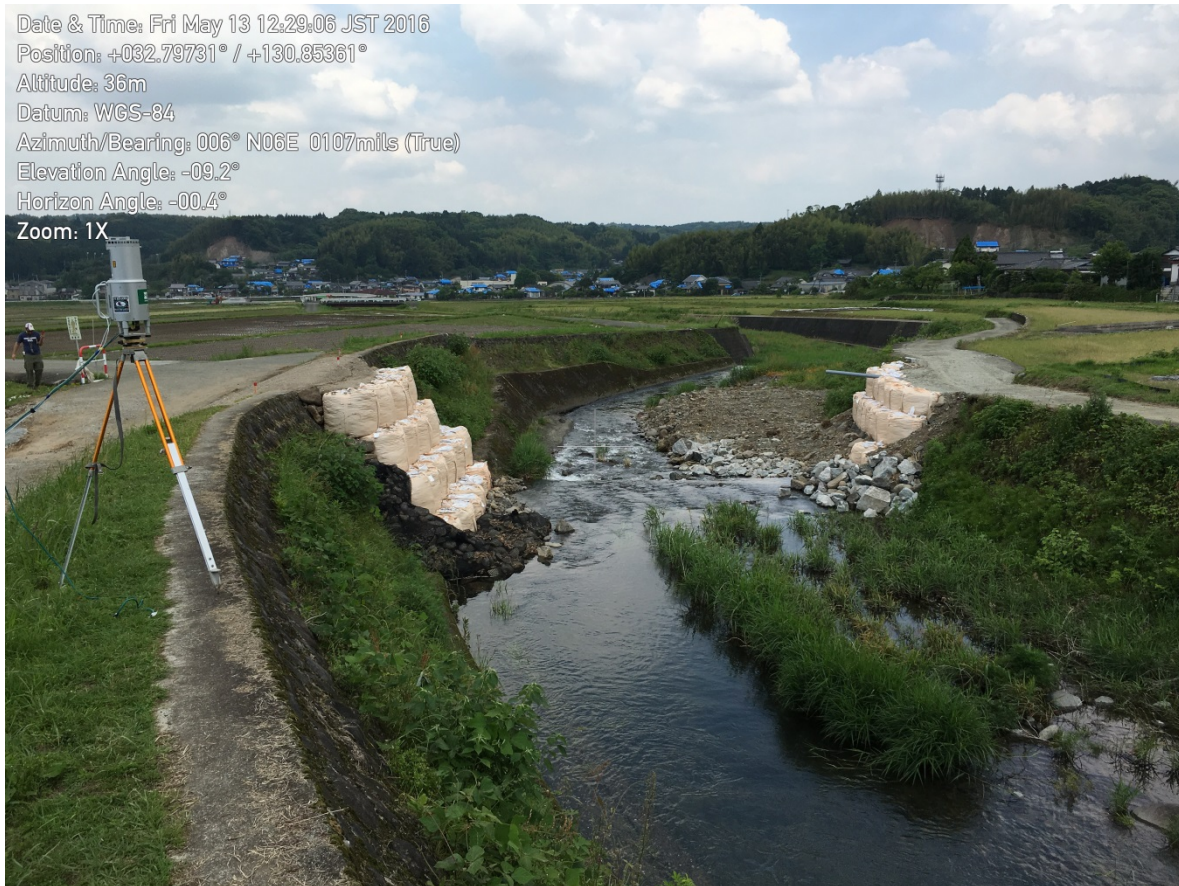
Figure 9-47. Terrestrial LIDAR setup at the fault crossing of the canal. Vertical movement of the fault strands and the associated popup block can be seen in the photo. Repair work is evident at the location of the main southern strand fault crossing.

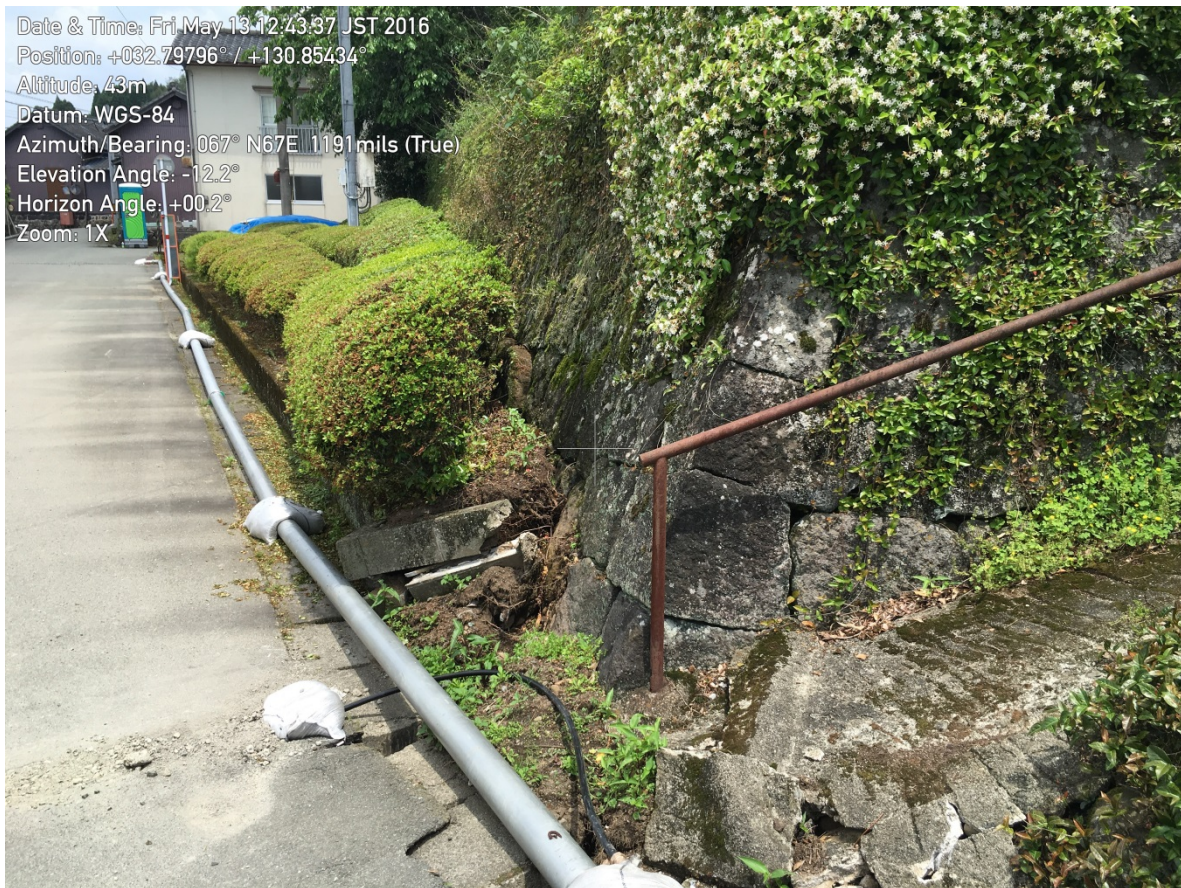
Figure 9-48. Fault rupture through a road and a retaining wall on the Futagawa Fault. No significant damage observed in the stone block retaining wall.

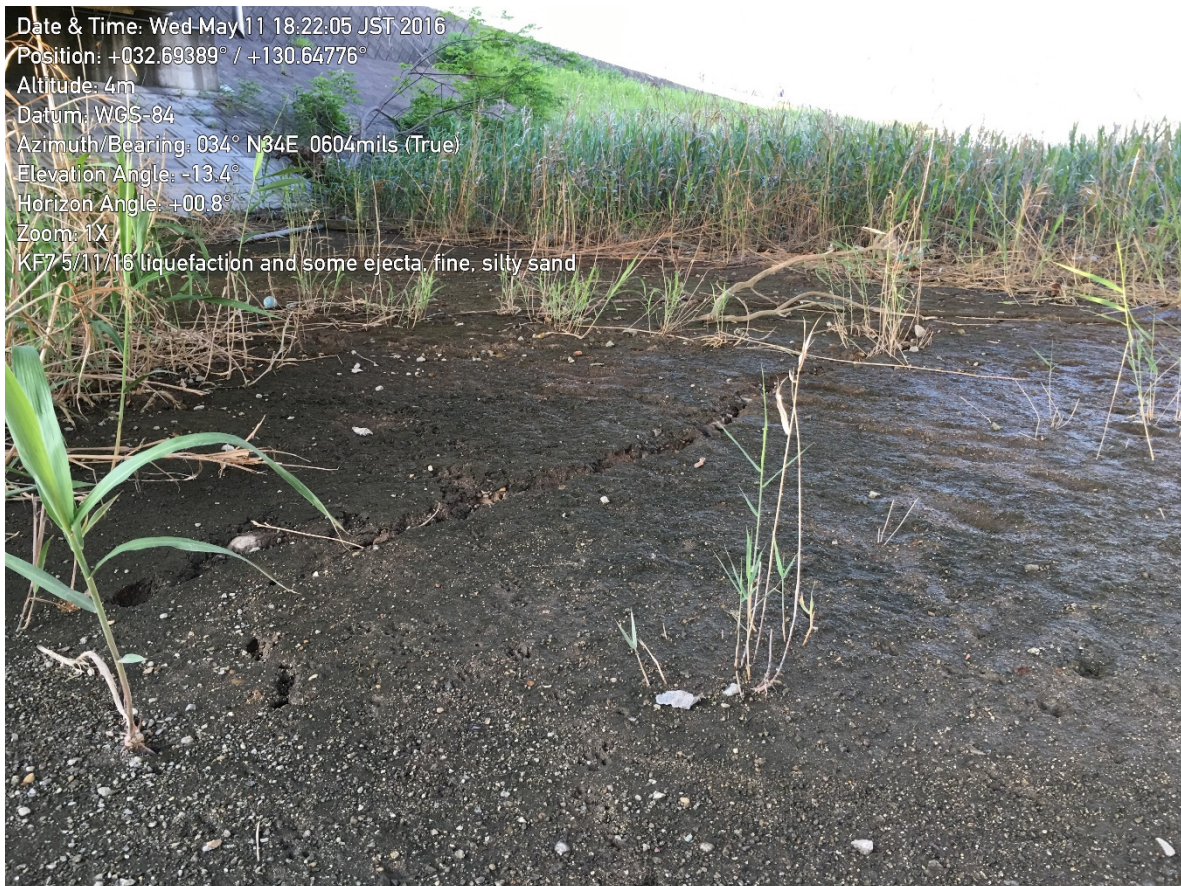
Figure 9-55. Evidence of liquefaction beneath the northern abutment of the Route 501 bridge. No evidence of significant lateral spread was observed by the research team.
