GEOTECHNICAL EXTREME EVENTS RECONNAISSANCE (GEER) ASSOCIATION

Geotechnical Reconnaissance of the 2016 M_w 6.3 Meinong Earthquake, Taiwan

GEER Association Report No. GEER-046

Version 2: July 14, 2016

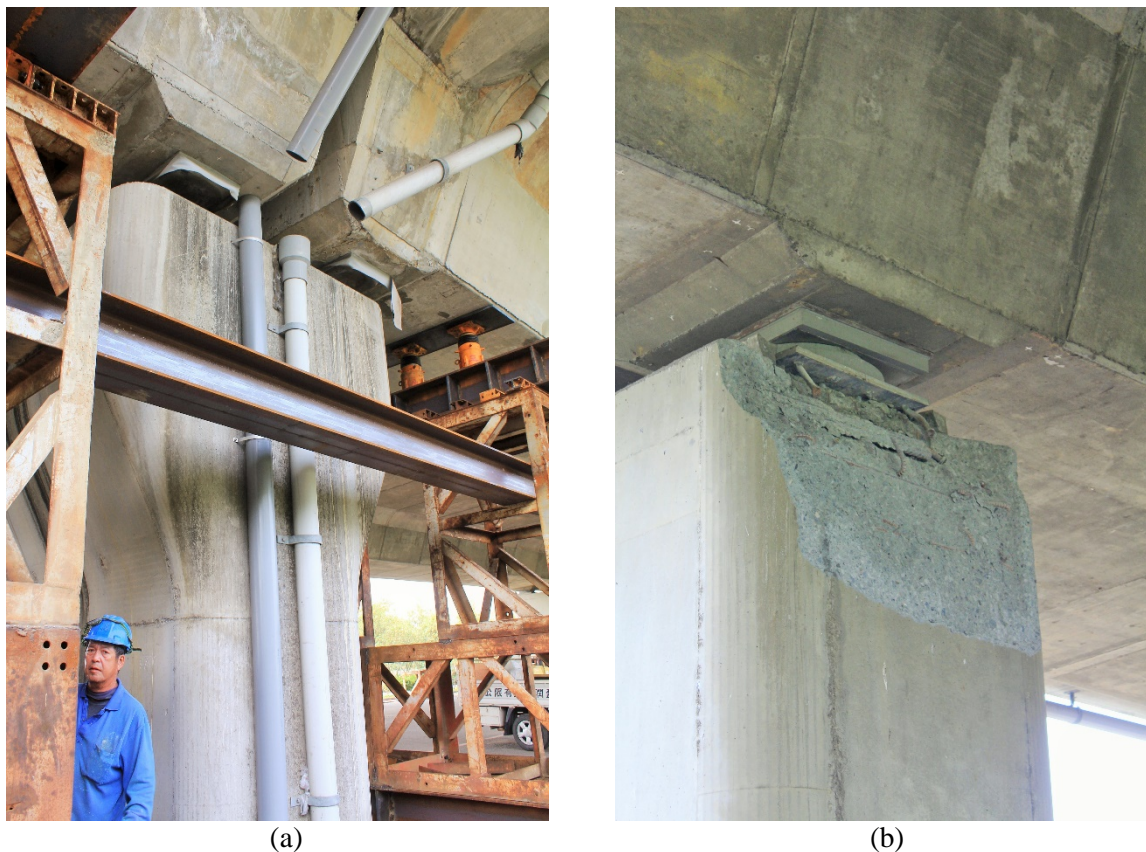
Figure 6-2: Provincial highway 86 bridge # 24: (a) east bound direction support repair (note separation of drainage lines and sheared hinges) and (b) failure of hinge and concrete support for west bound direction.

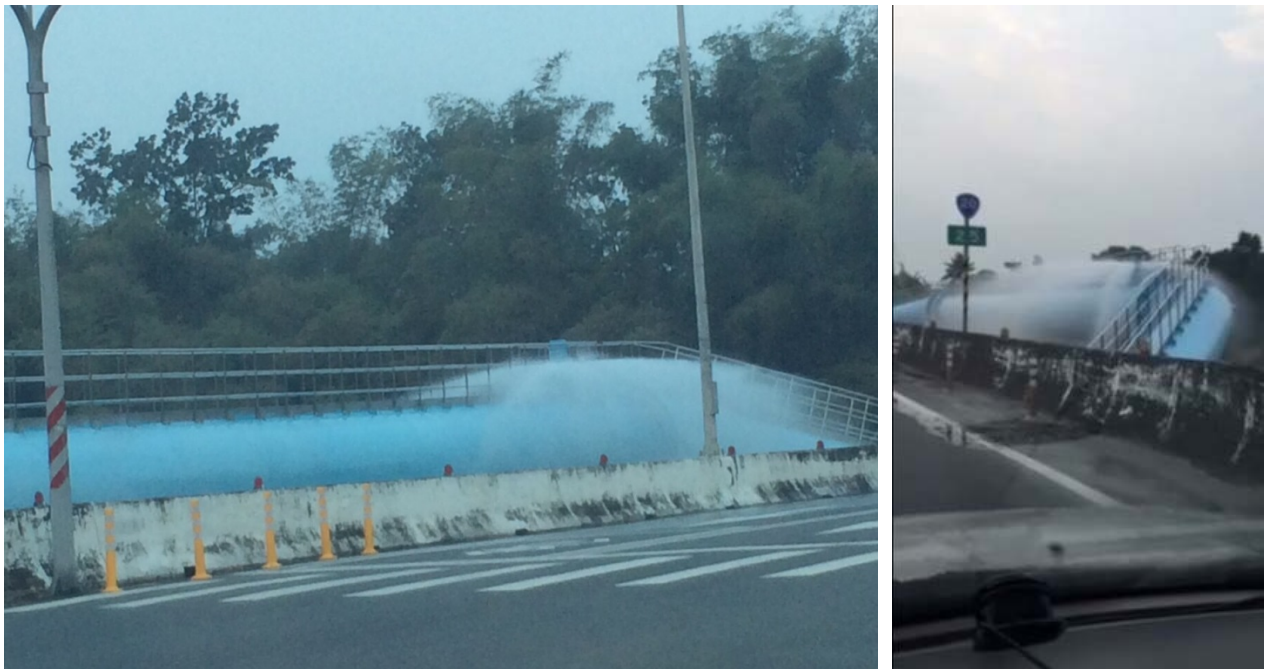
Figure 6-4: Damaged 2000 mm Water Pipeline near Bridge in Yung Kang District (開運橋頭永康側) (23.034244, 120.286719).

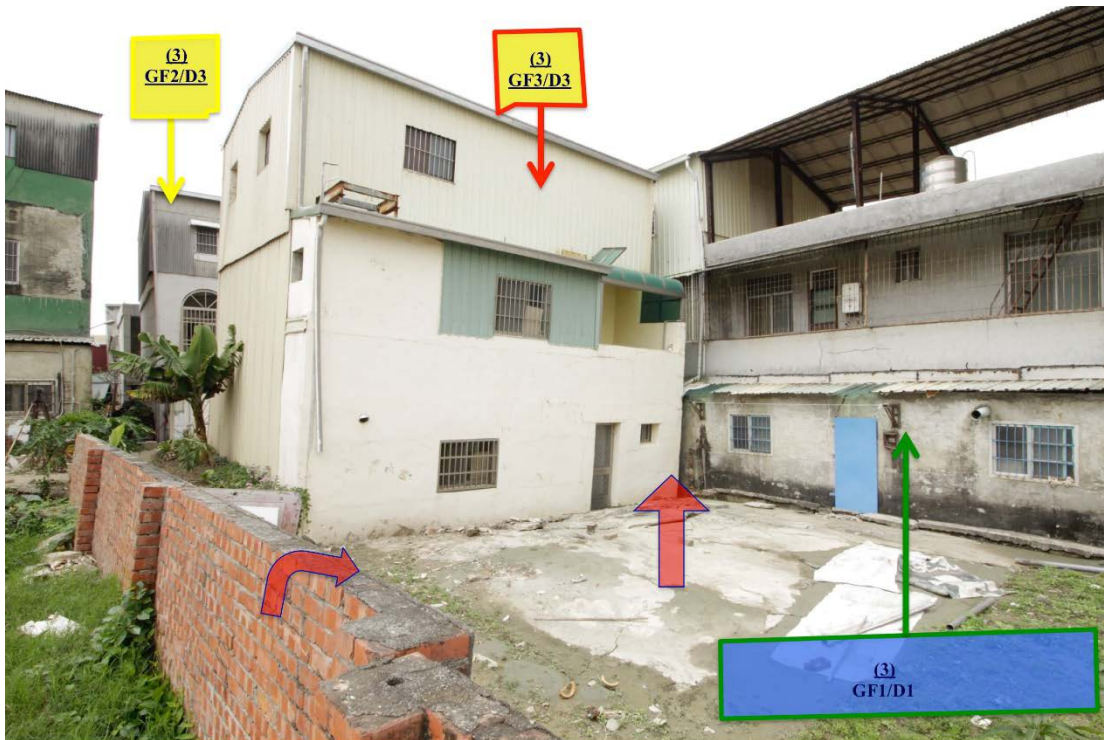
Figure 7-8: Example of mapping GF1 through GF3; demonstrating various structural damage states. (23.025409°, 120.207565°).

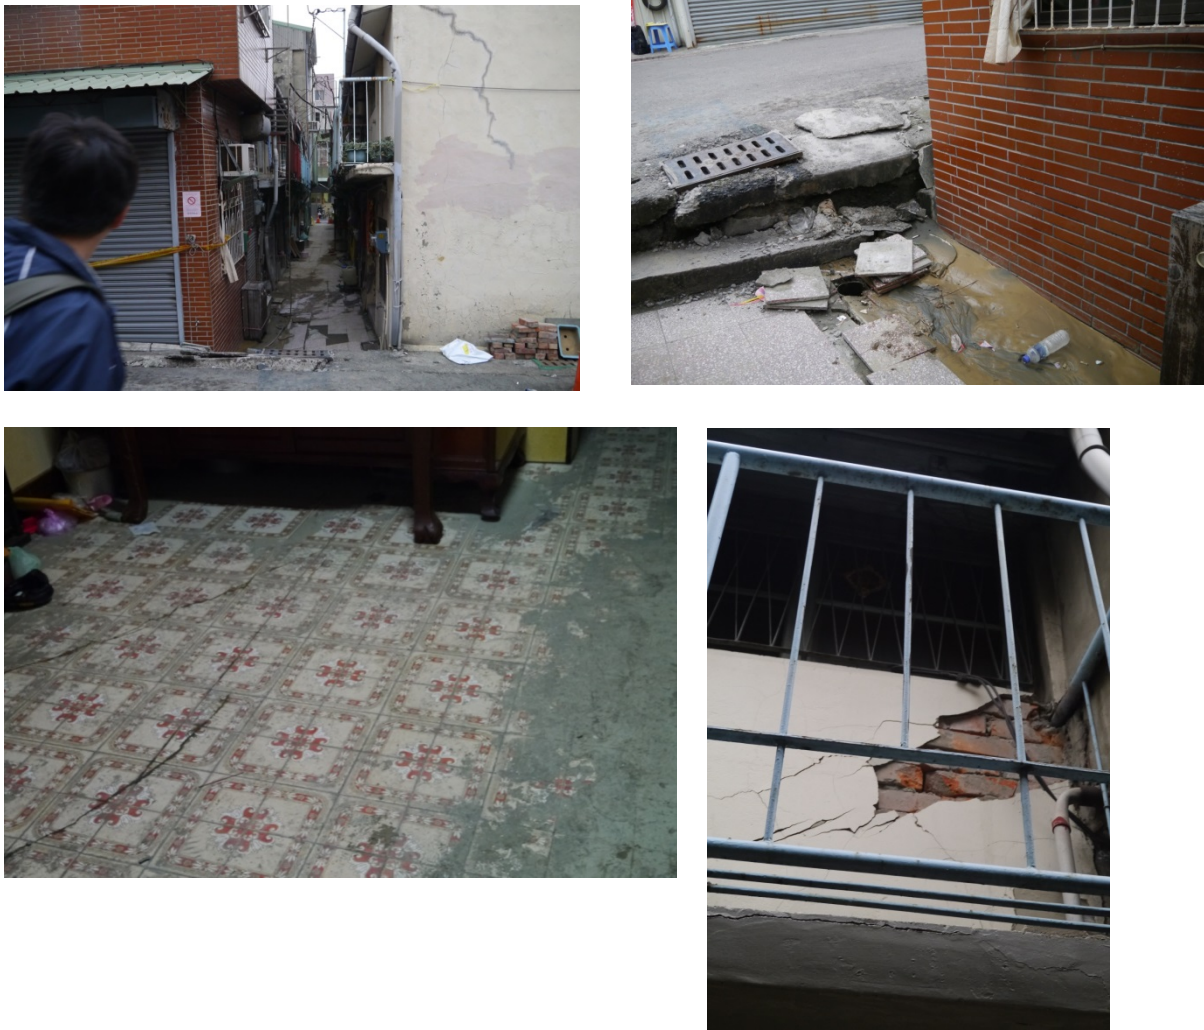
Figure 7-16: Damage features at the Wenhe site ([23°00'12.7"N 120°11'30.5"E](#)).

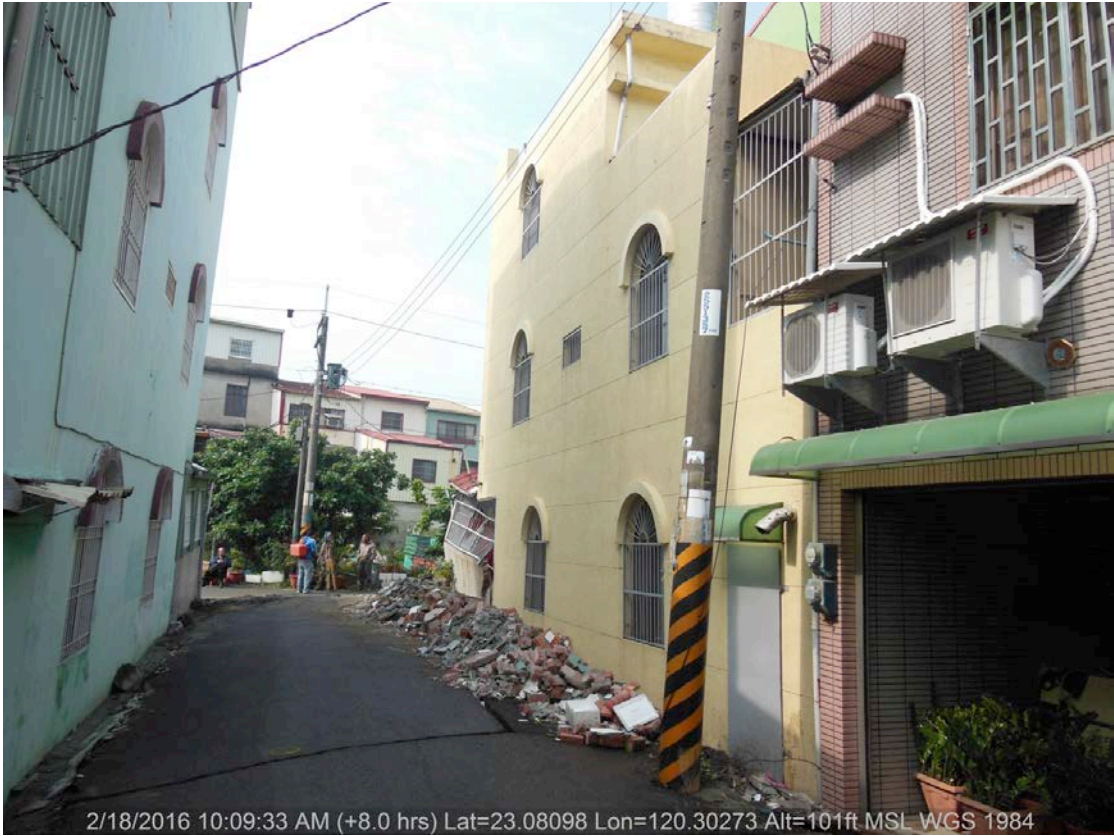
Figure 7-23: Ground heave along an alley between two settling buildings ([23.08098, 120.30237](#)).

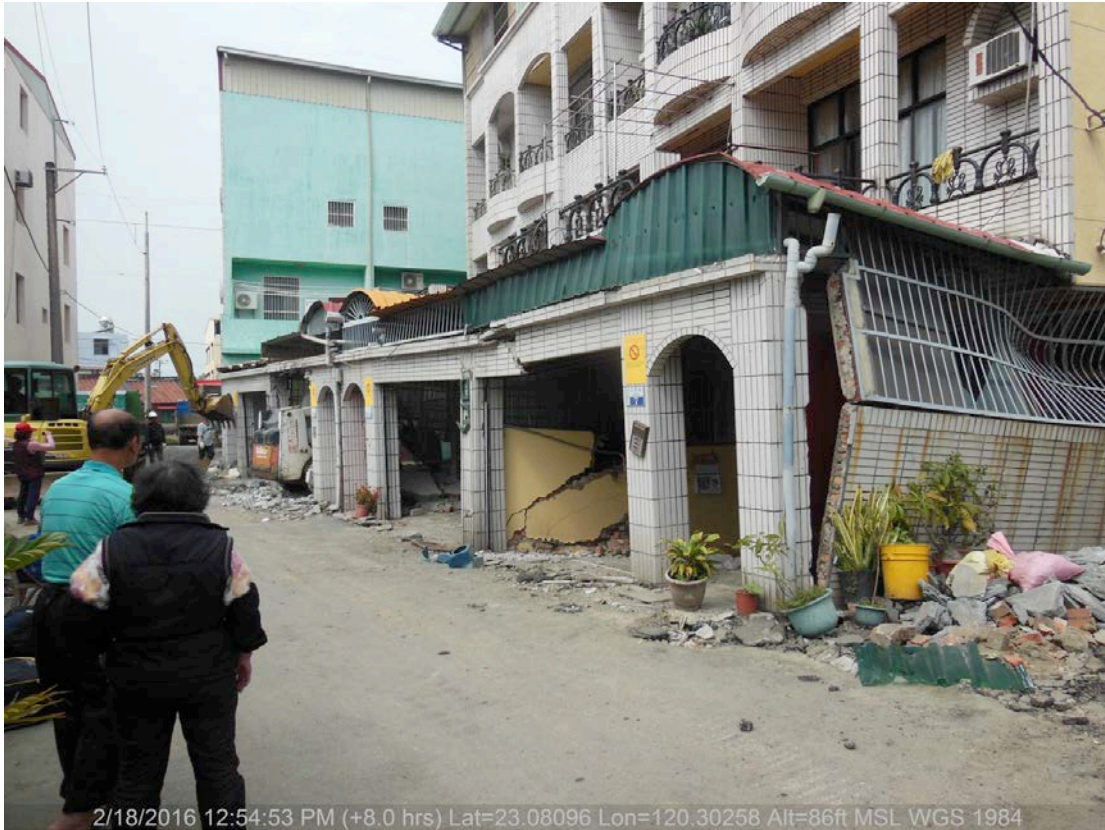
Figure 7-24 Damage to illegal add-on car port ([23.08096, 120.30258](#)).

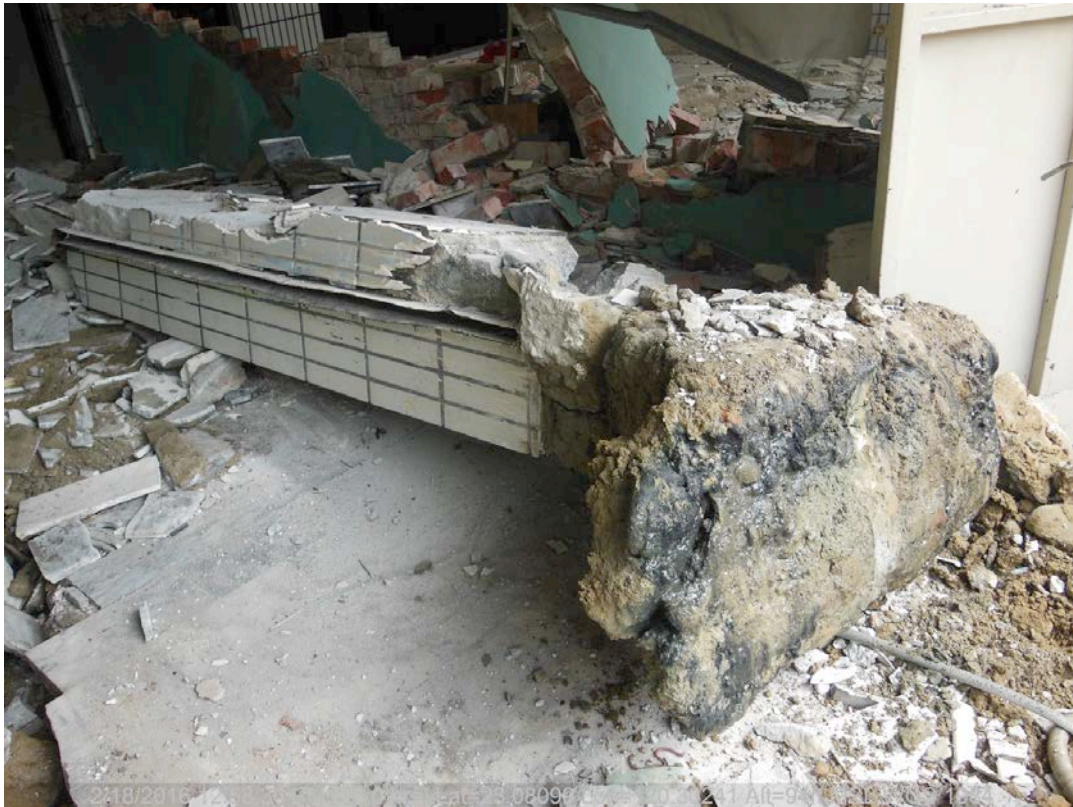
Figure 7-26: Structural column at the interior of a garage, note the lack of foundation support ([23.08096](#), [120.30258](#)).

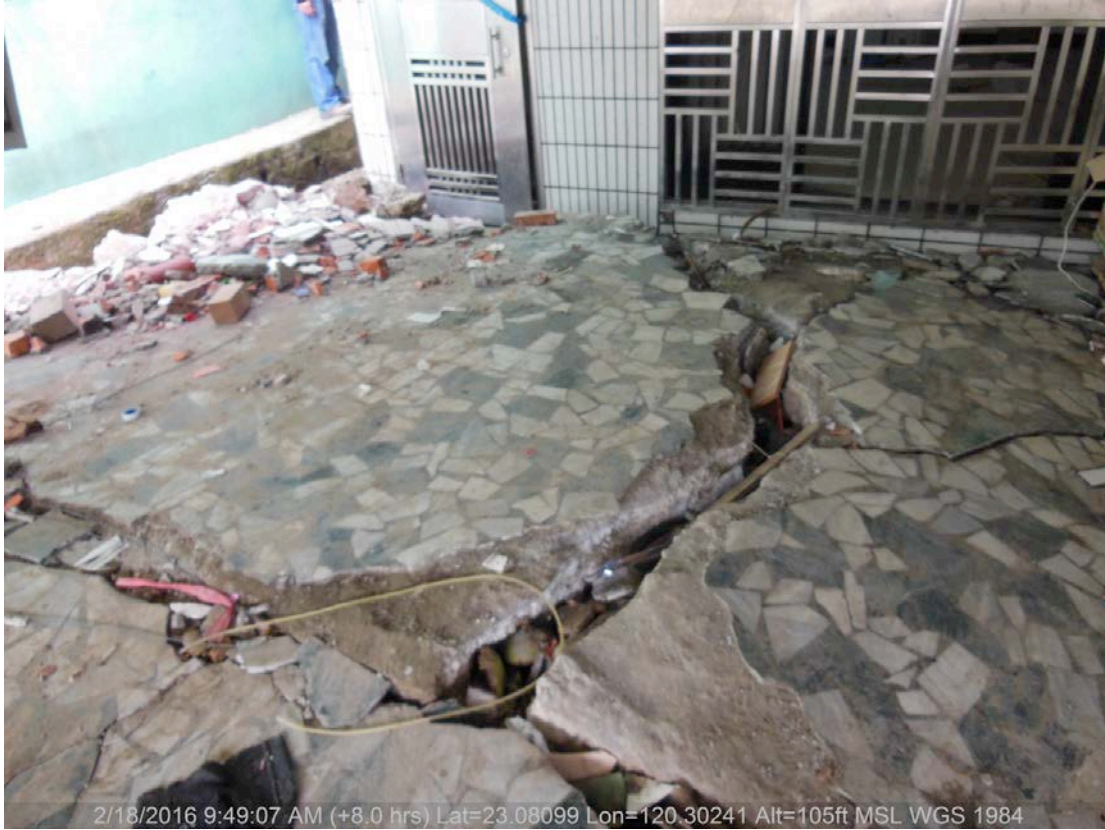
Figure 7-27: Damaged unreinforced car port slab due to ground heave ([23.08099, 120.30241](#)).

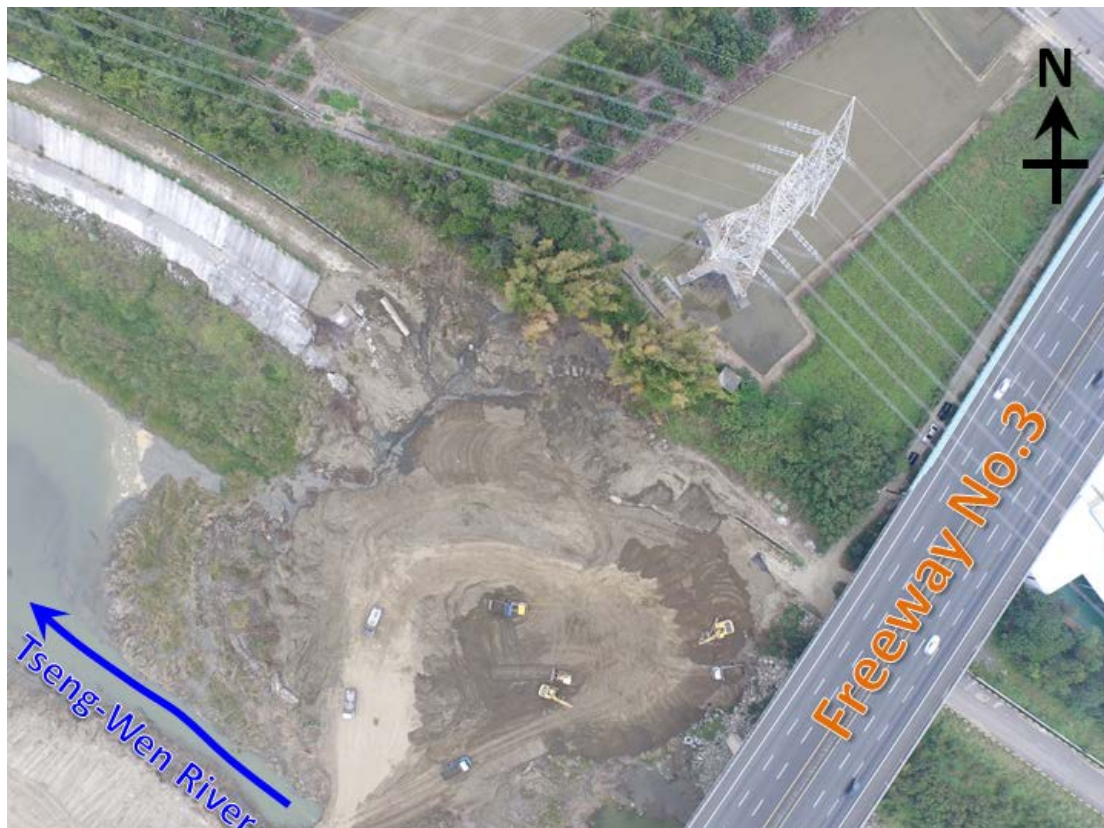
Figure 8-3: Aerial View of Failure No.1. (Photo provided by W.-K. Huang) ($23^{\circ} 9'12.40''$, $120^{\circ}20'37.68''$). Note the construction repair operation underway.

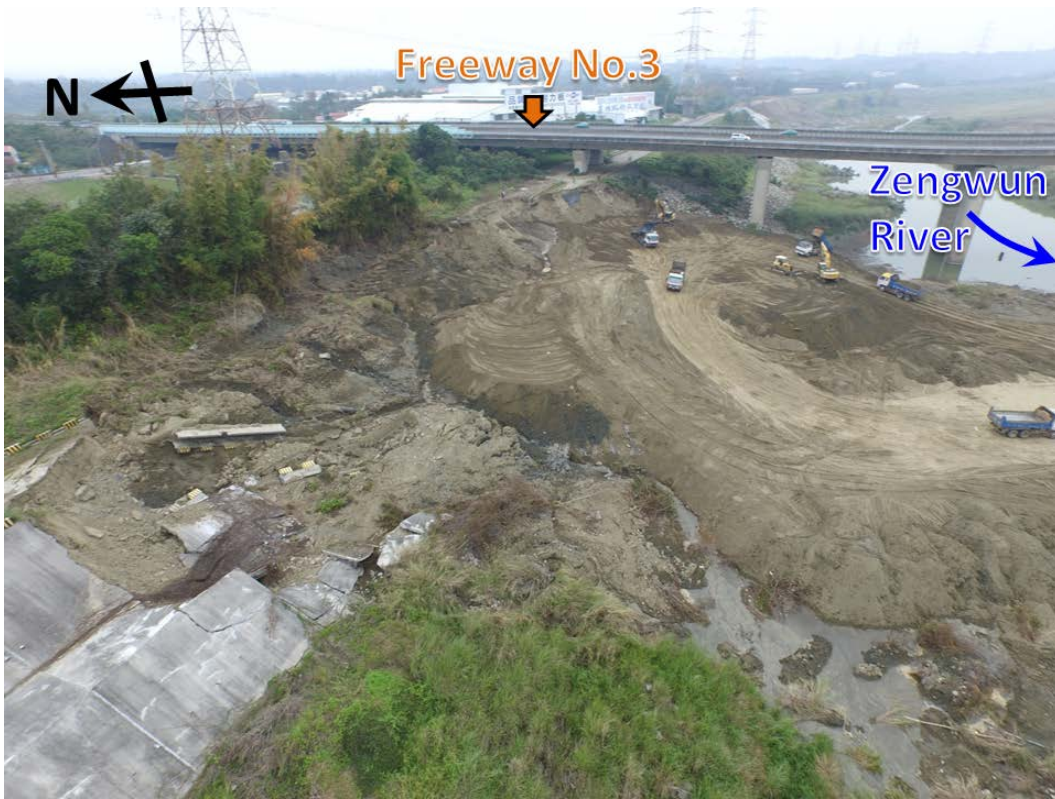
Figure 8-4: Bird's View of Failure No.1. (Photo provided by W.-K. Huang) (23.154135, 120.342255).

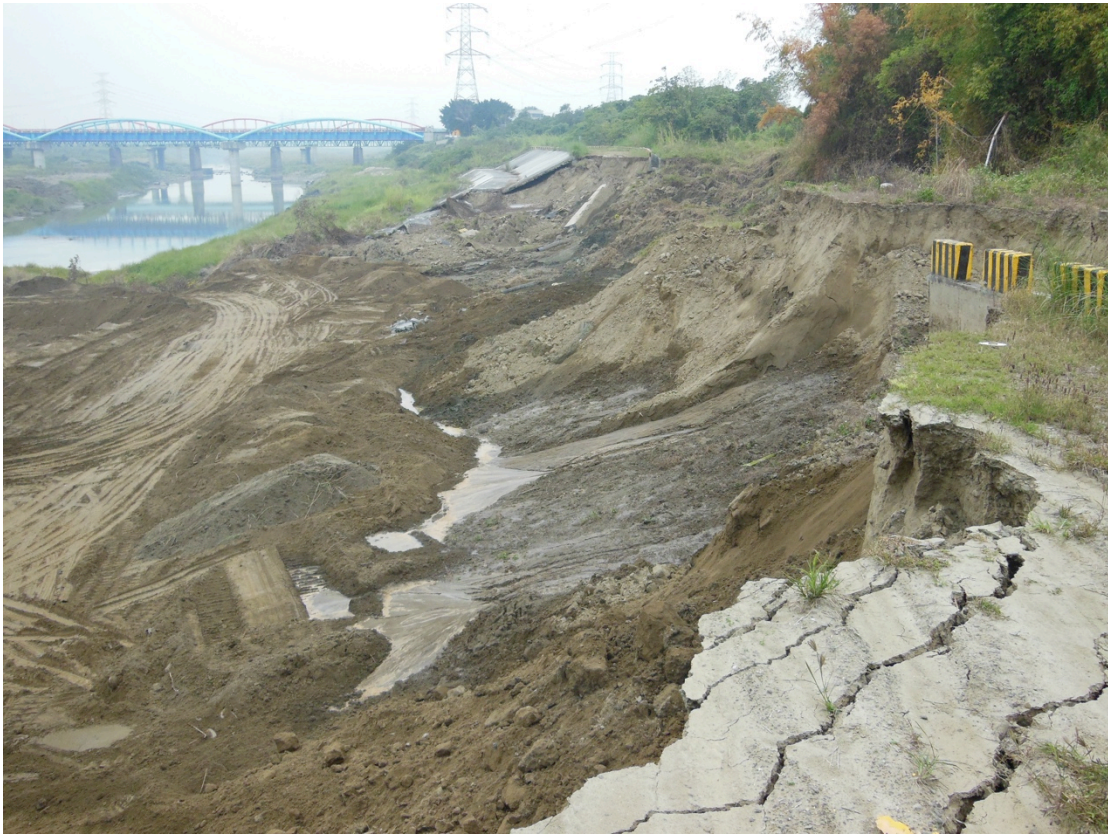
Figure 8-6: Failure 1 Looking Northwest (23.1537, 120.3434).

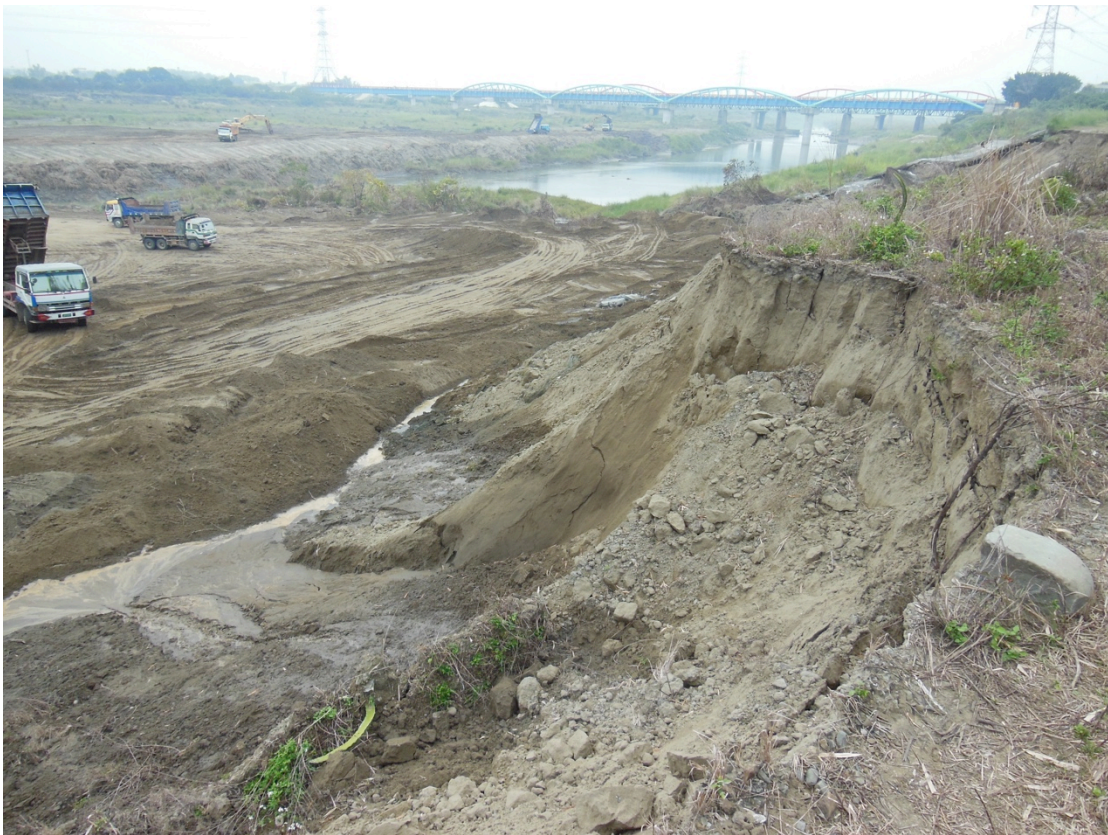
Figure 8-8: Seepage at Base of Scarp at Impervious Contact (23.1537, 120.3434).

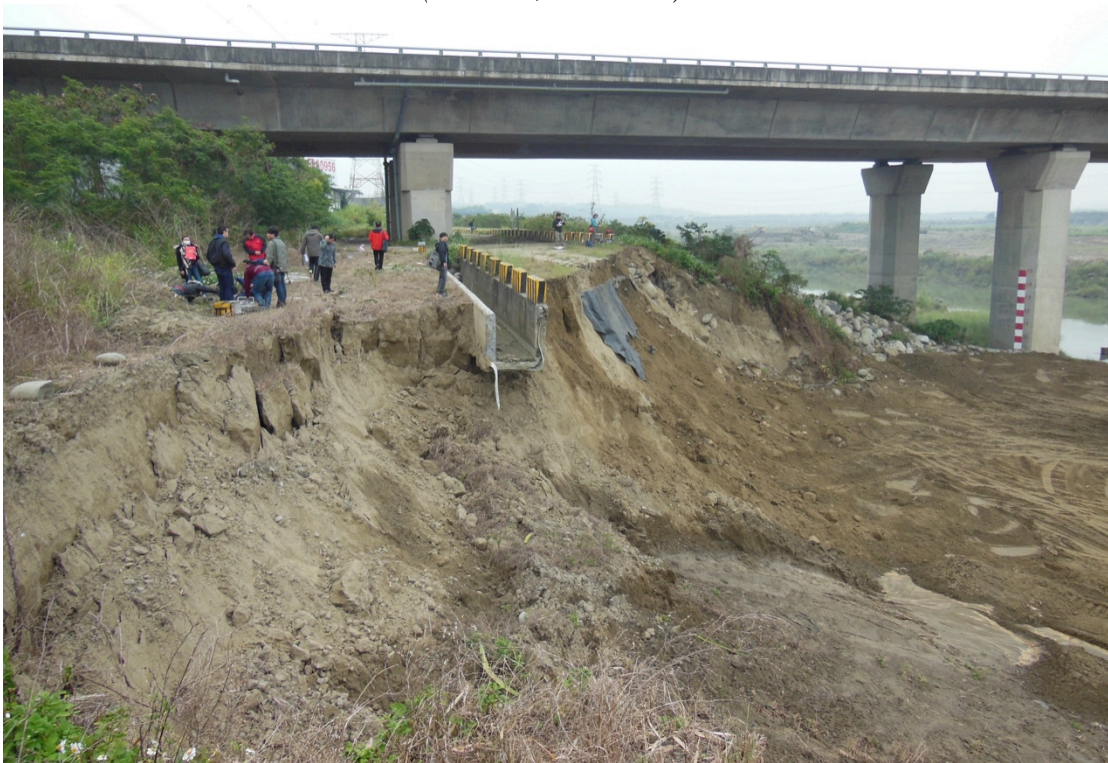
Figure 8-9: Southwest Margin of Failure 1 (23.153889, 120.343178).

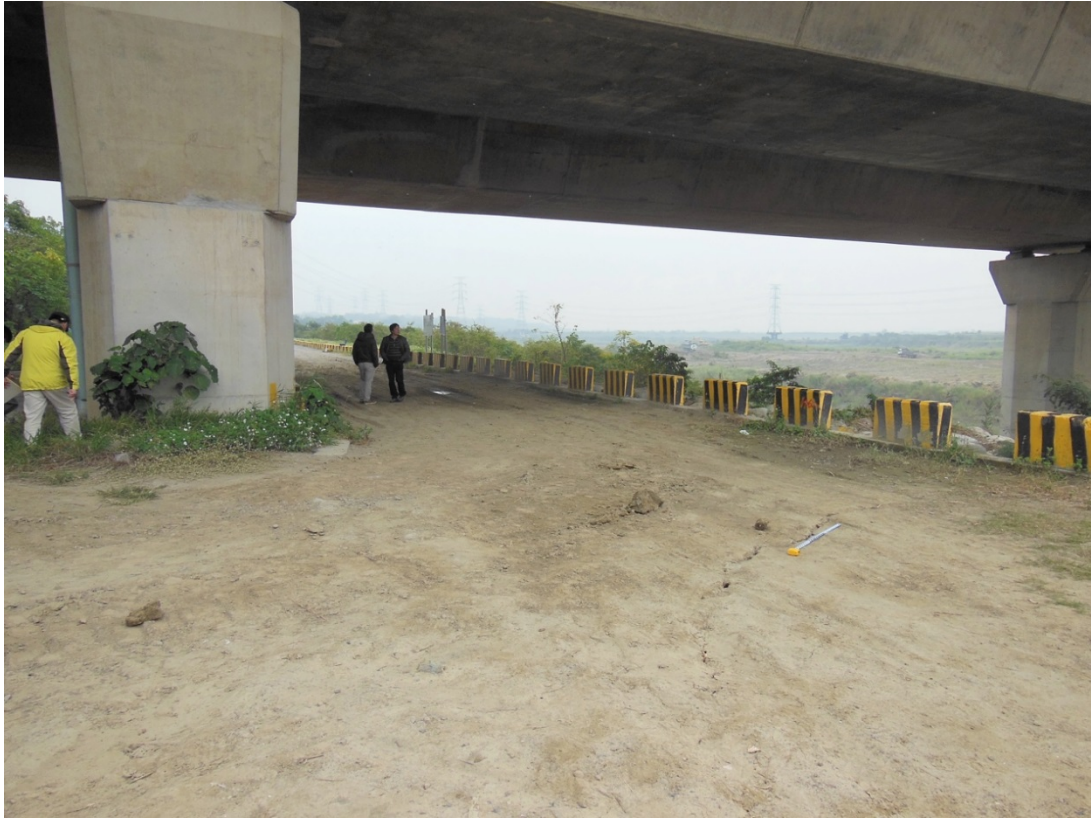
Figure 8-10: Arcuate Crack Extending to the Bridge Piers (23.153583, 120.343650).

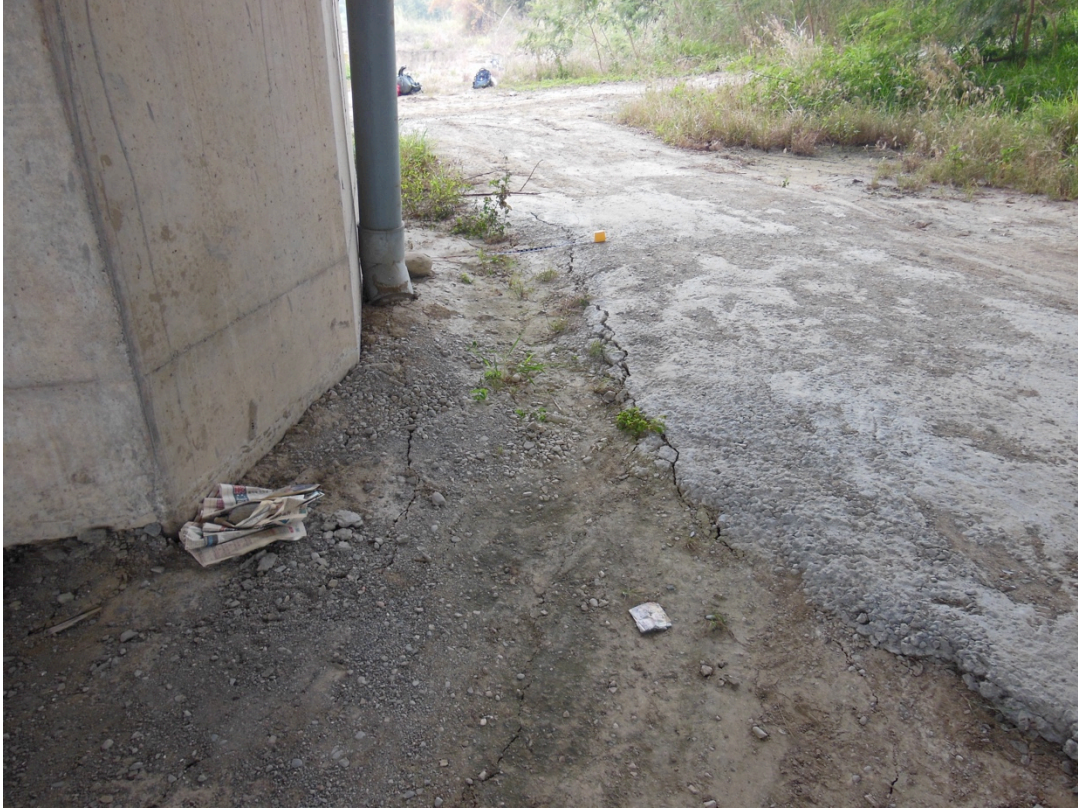
Figure 8-11: Nested Arcuate Cracking Behind the Piers (looking northwest) (23.153514, 120.343736).

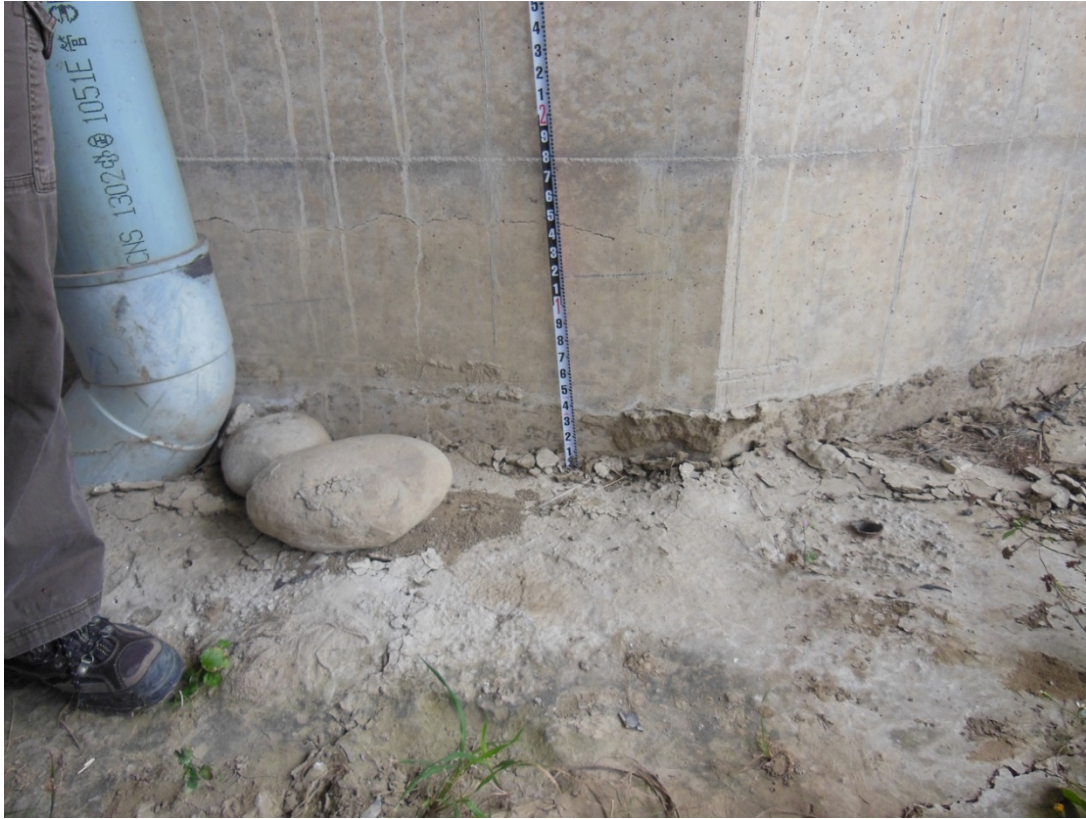
Figure 8-12: Settlement Around Bridge Prier is about 4 to 5 inches (23.153514, 120.343736).

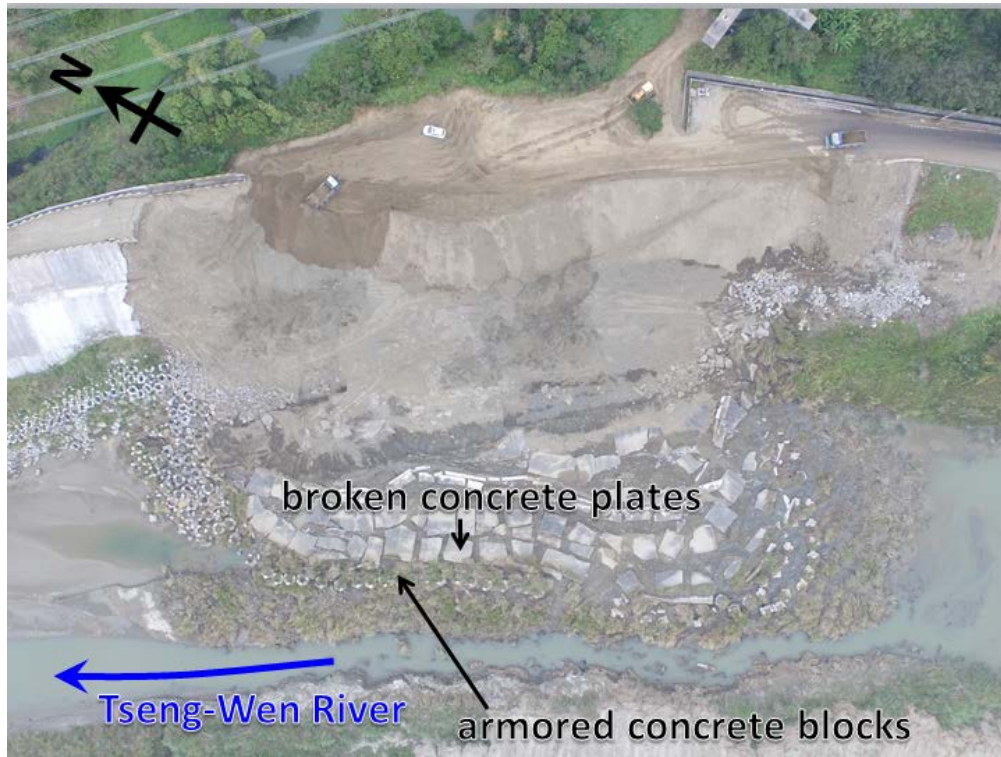
Figure 8-14: Aerial View of failure No.2. Notice the long runout distance of the materials.
 (Photo: W.-K. Huang) ($23^{\circ} 9'3.26''$, $120^{\circ}20'47.59''$).

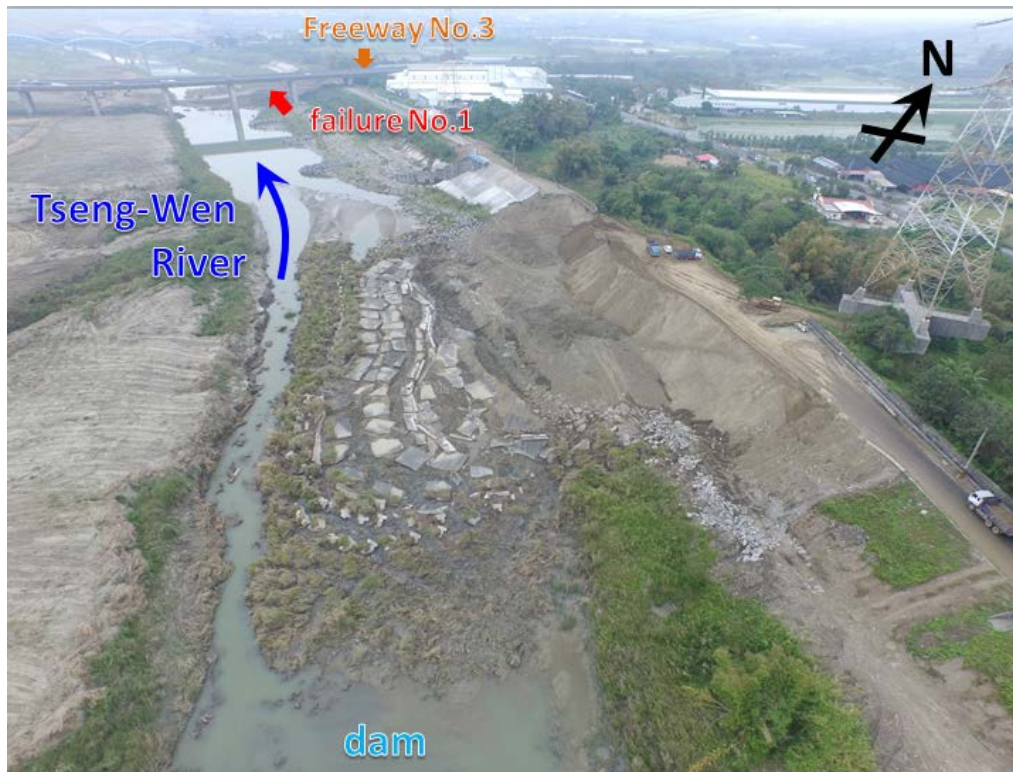
Figure 8-15: Bird's View of failure No.2. (Photo: W.-K. Huang) ($23^{\circ} 9'3.26''$, $120^{\circ}20'47.59''$).

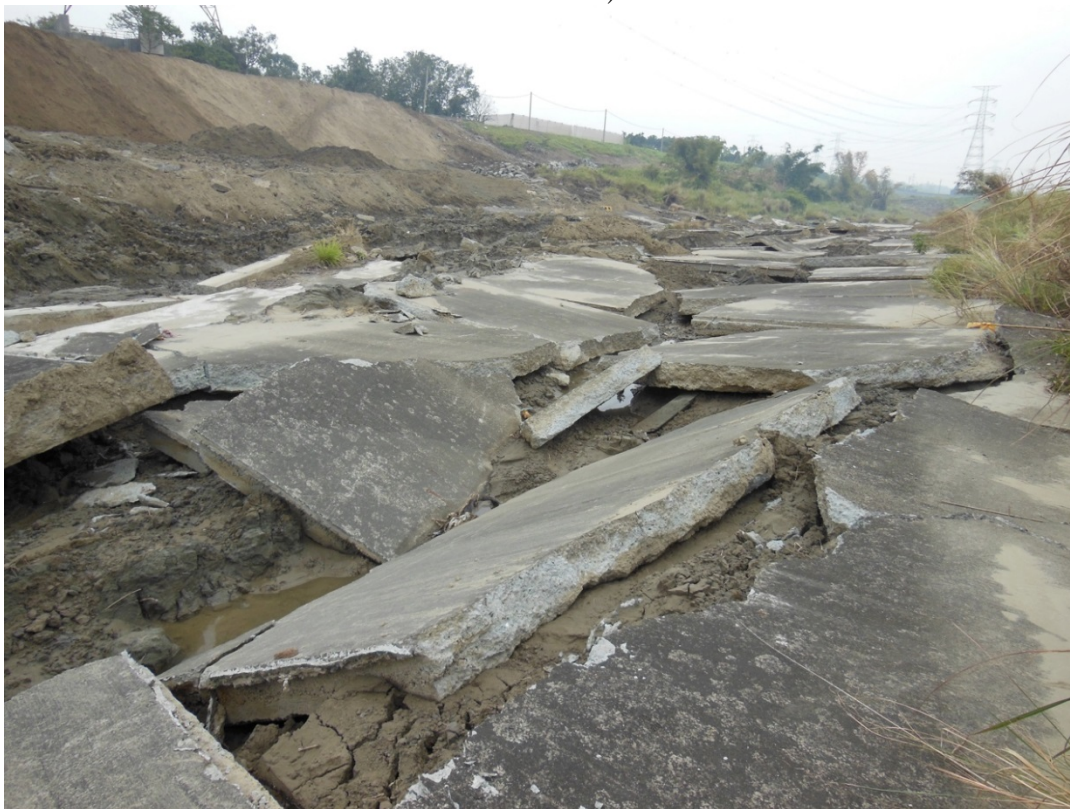
Figure 8-17: Area of the Pushed Out Toe (23.150801, 120.345807).

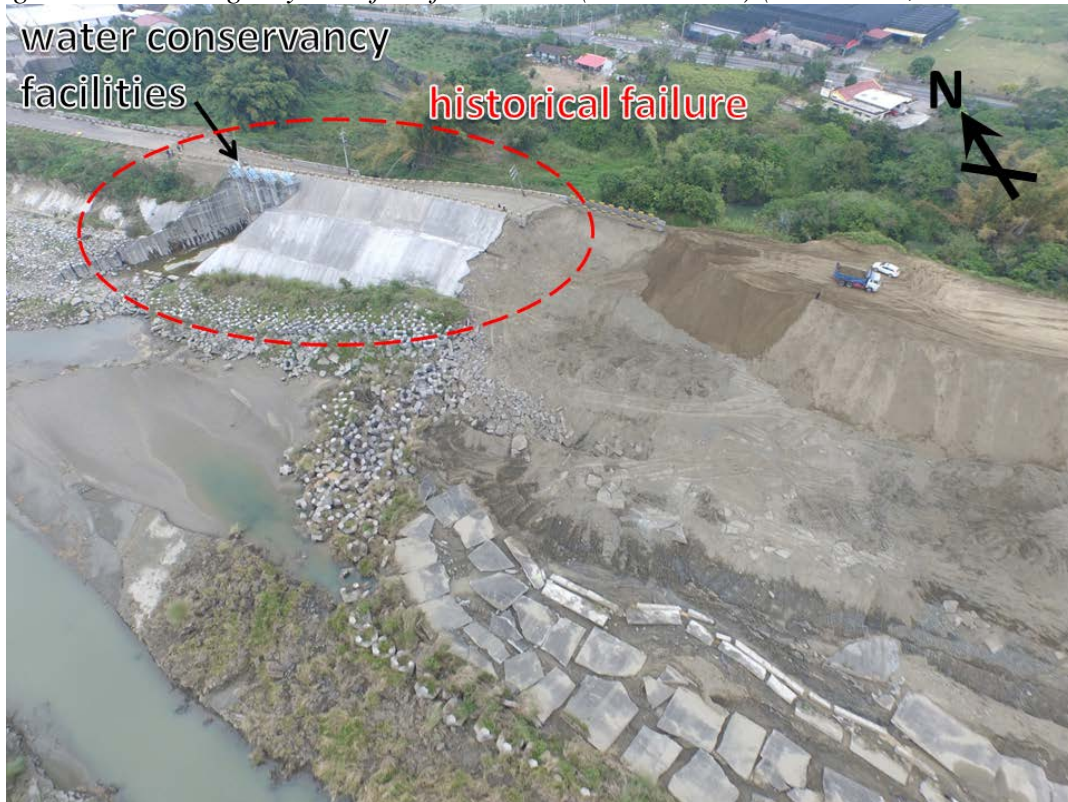
Figure 8-25: Historical Failure Near Failure No.2. (Photo: W.-K. Huang). (23.150949, 120.346590).

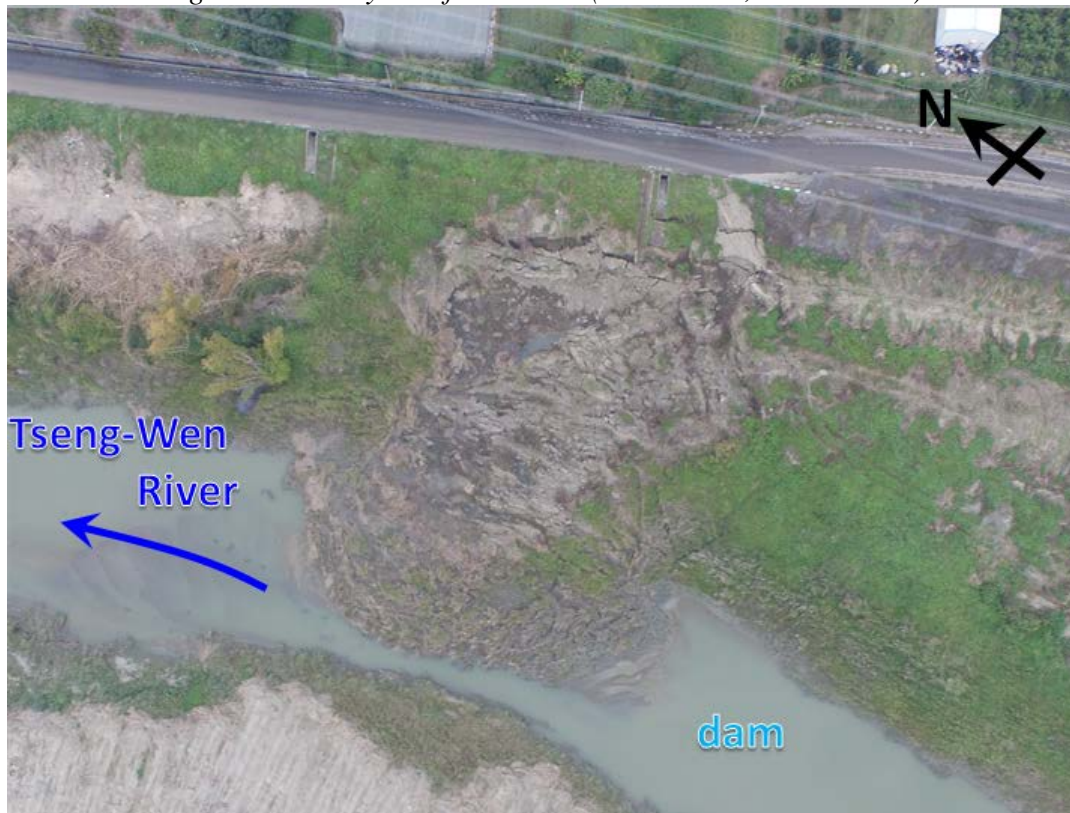
Figure 8-27: Aerial view of failure No.3. (Photo: W.-K. Huang). (23.148325, 120.347631)

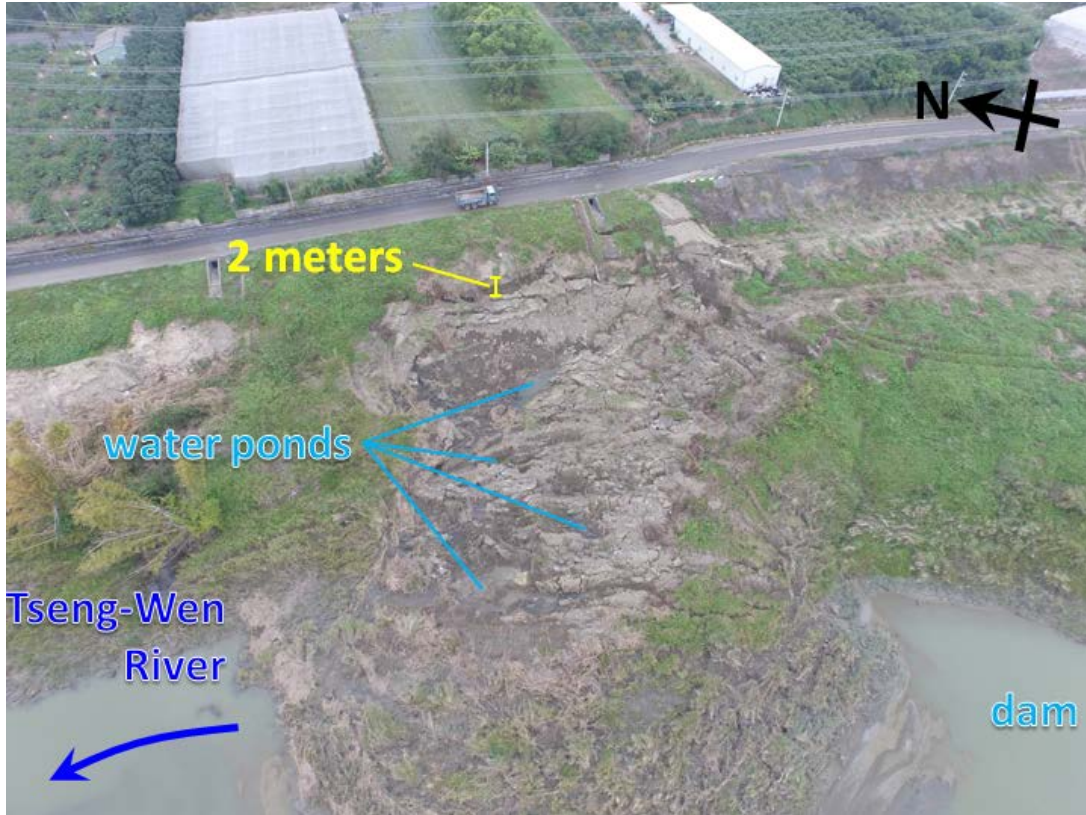
Figure 8-28 Bird's view of failure No.3. (Photo: W.-K. Huang). (23.148325, 120.347631)

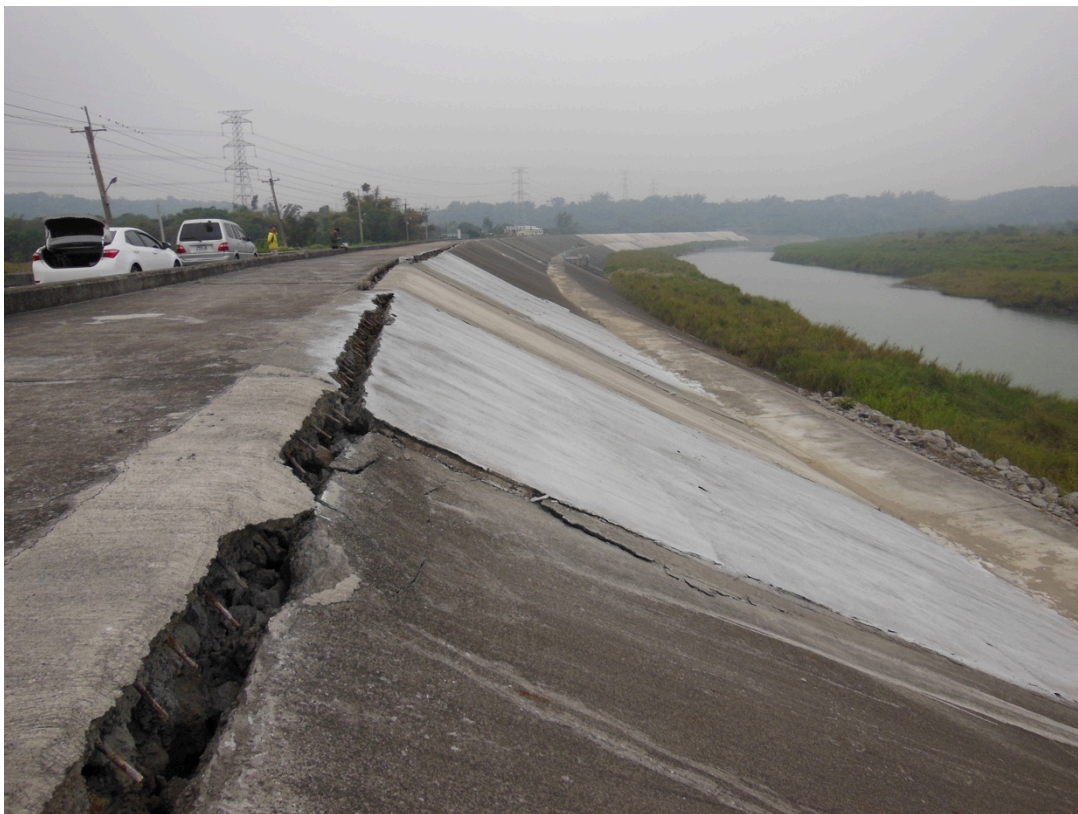
Figure 8-31: Distress of Concrete Slab Bank Protection (23.121176°,120.379569°).

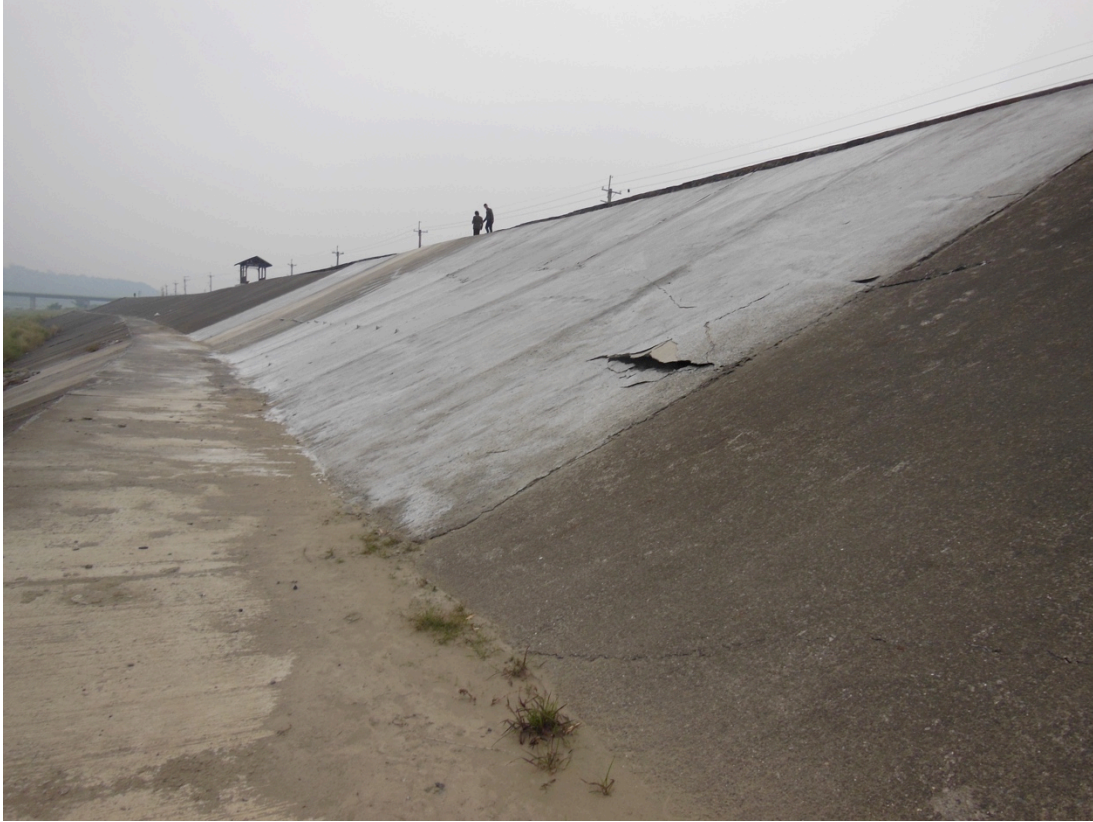
Figure 8-32: Buckling of Repaired Slab (23.121176°,120.379569°).

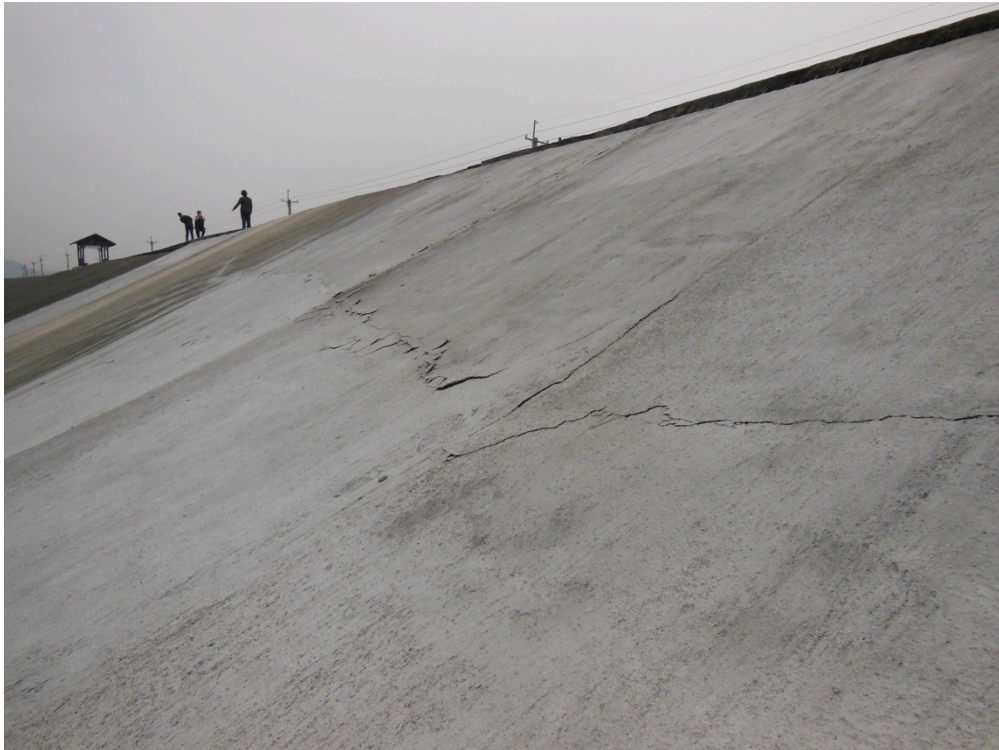
Figure 8-33: Shear Cracking of the Repaired Concrete Slab (23.121176°,120.379569°).
