GEOTECHNICAL EXTREME EVENTS RECONNAISSANCE (GEER) ASSOCIATION

Geotechnical Reconnaissance of the 2016 M_w 6.3 Meinong Earthquake, Taiwan

GEER Association Report No. GEER-046

Version 2: July 14, 2016

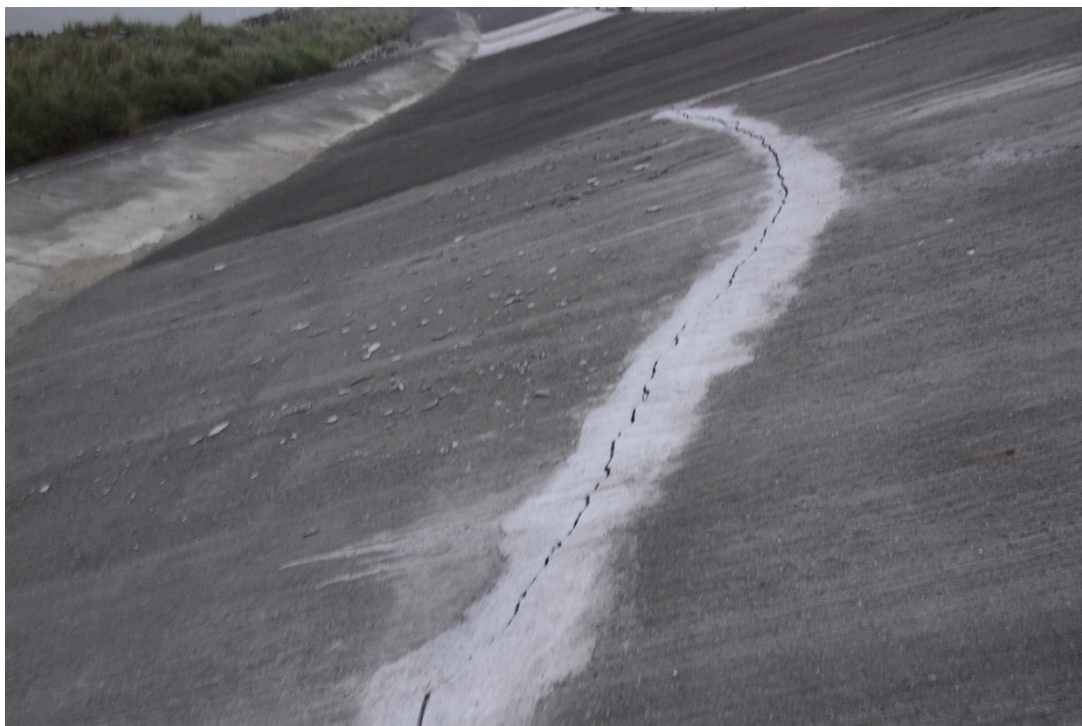
Figure 8-34: Re-cracking of Recently Repaired Cracking (23.121176°,120.379569°).

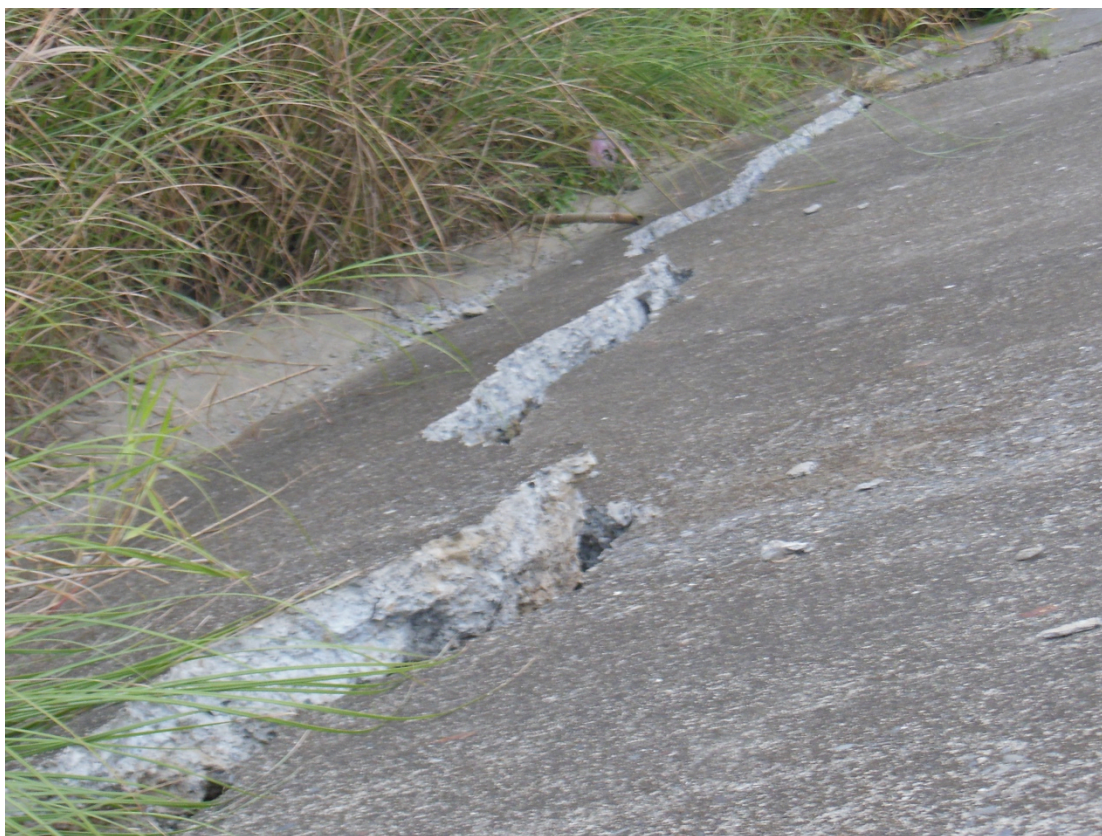
Figure 8-35: Slab Damage at Levee Toe (23.121176°,120.379569°).

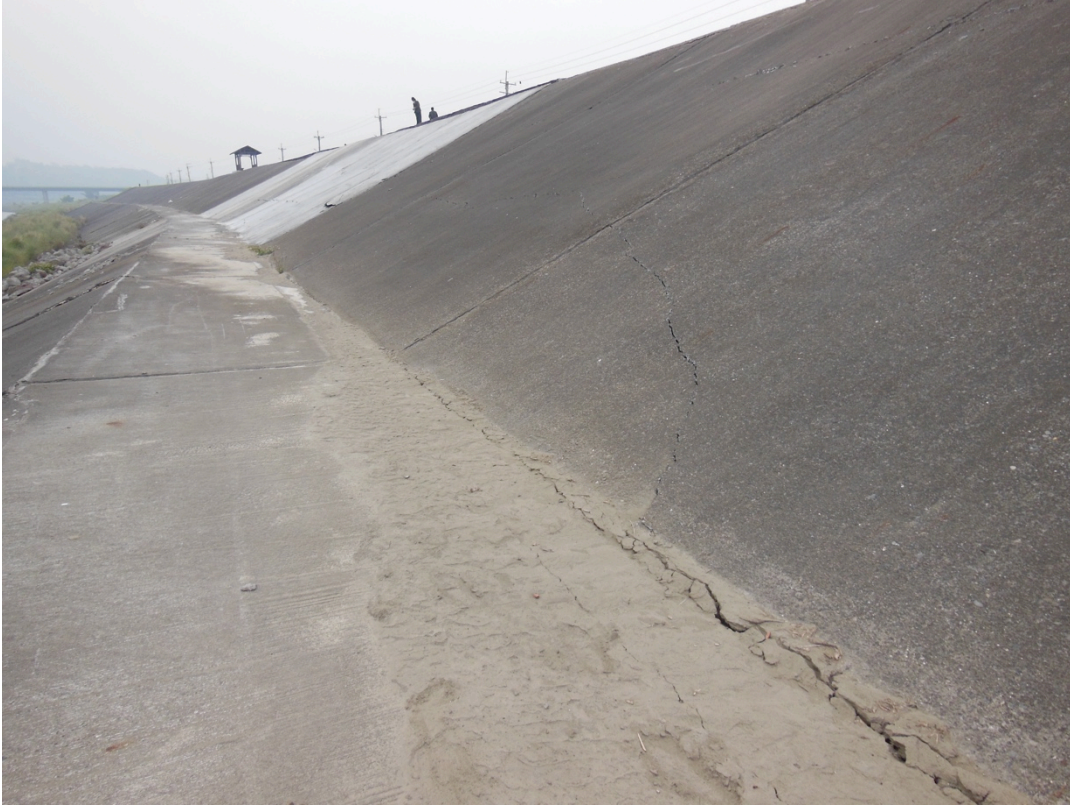
Figure 8-36: Patches of Sand Deposited on Bench (23.121329, 120.379284).

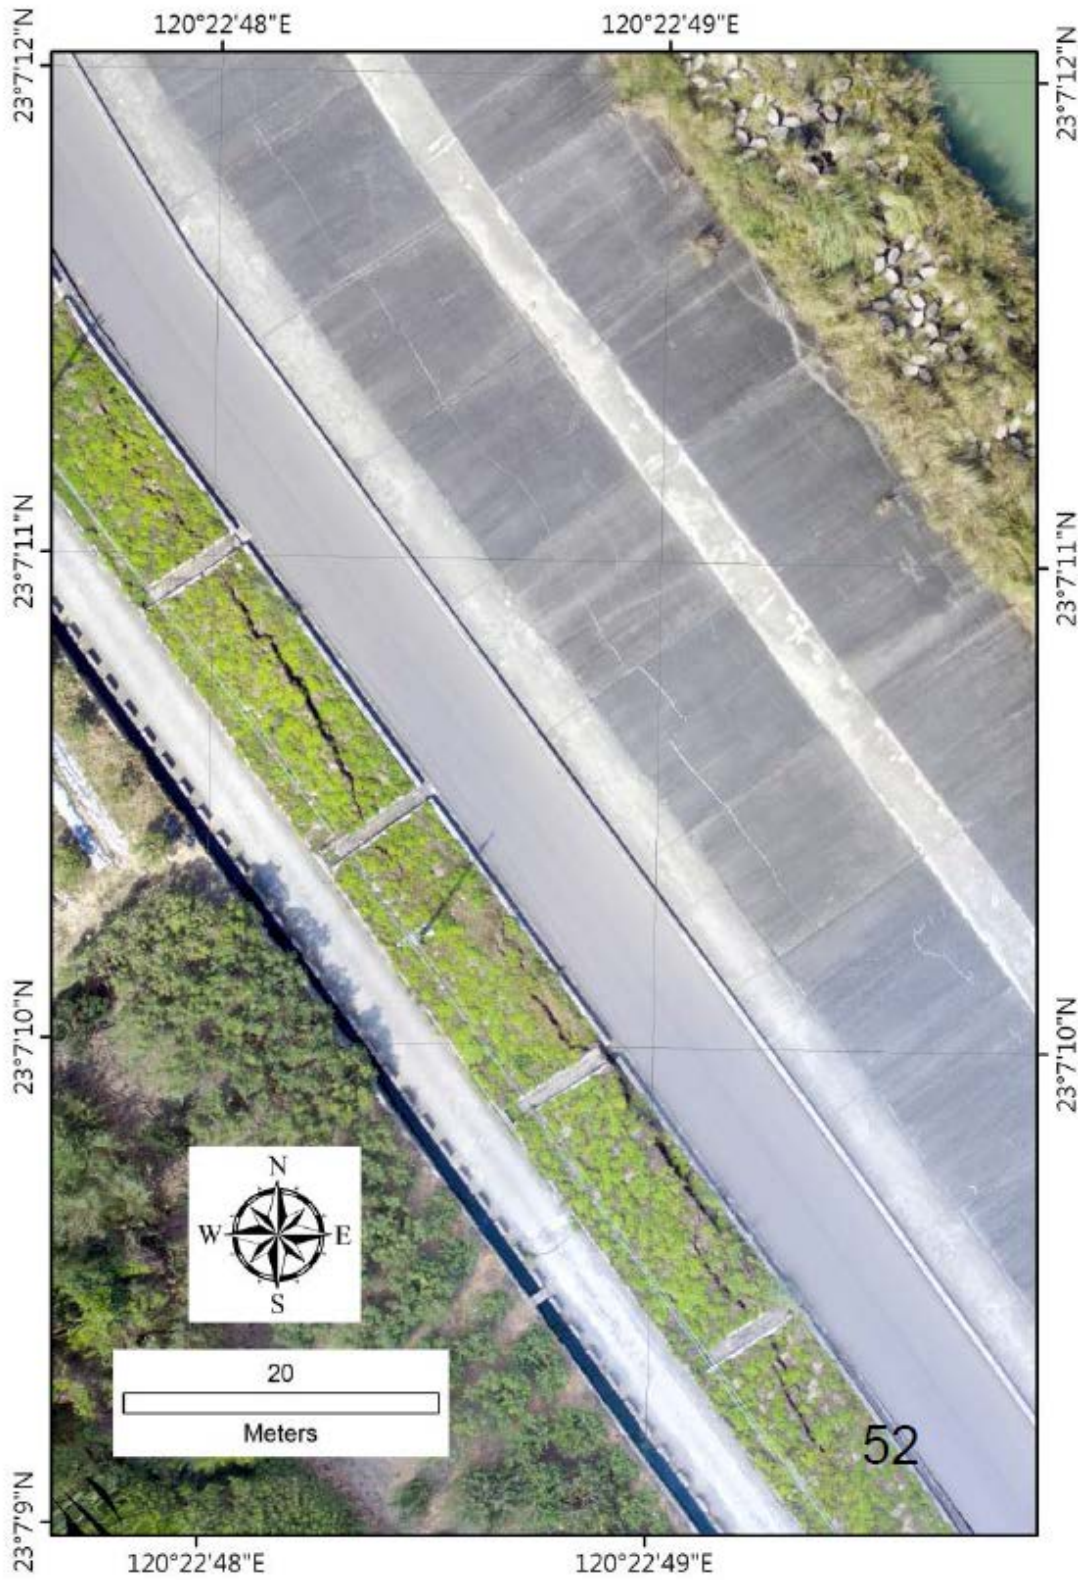
Figure 8-39: Cracking Occurring along Landslide Toe (Photo from NCREE).

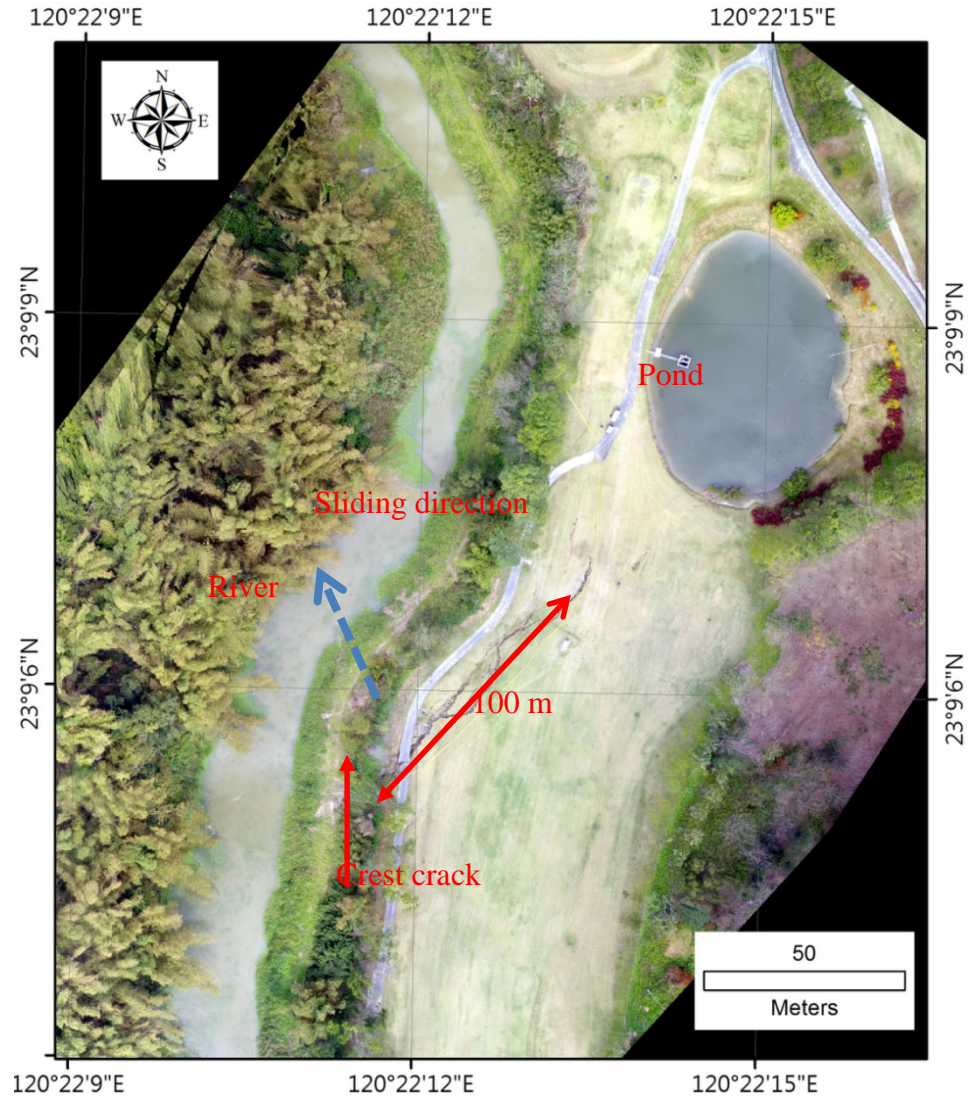
Figure 8-40: Overview of slope failure at Nan-Bao golf course (source: NCREE field survey on 2016/02/13).

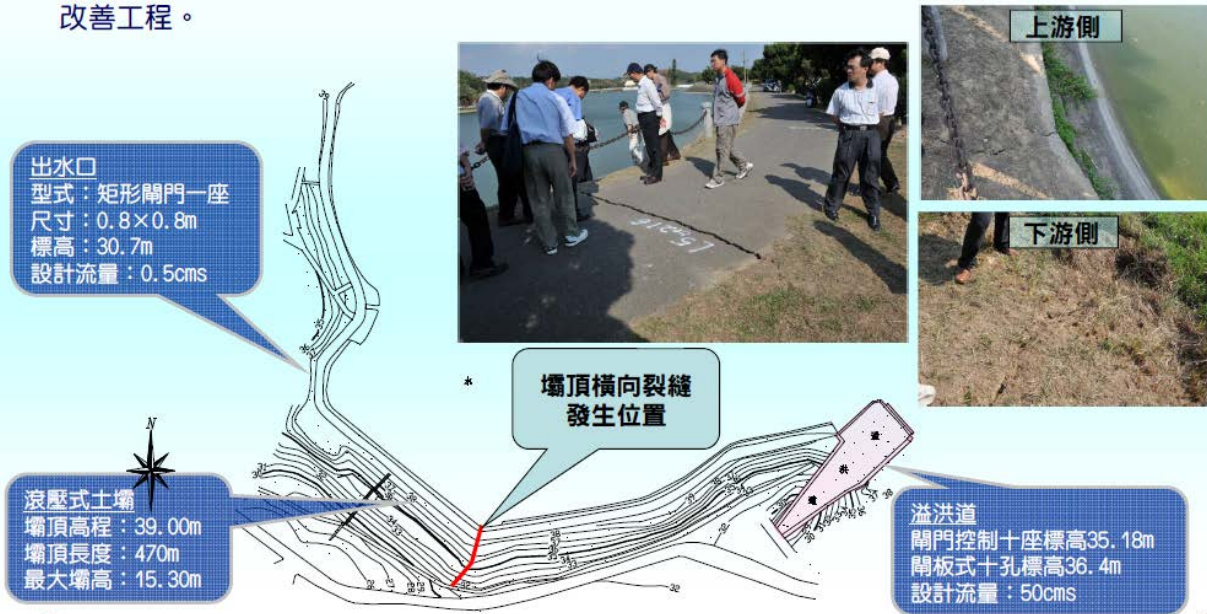
Figure 9-12: Earthquake Induced Transverse Crack from 2010 Jiasian Earthquake.

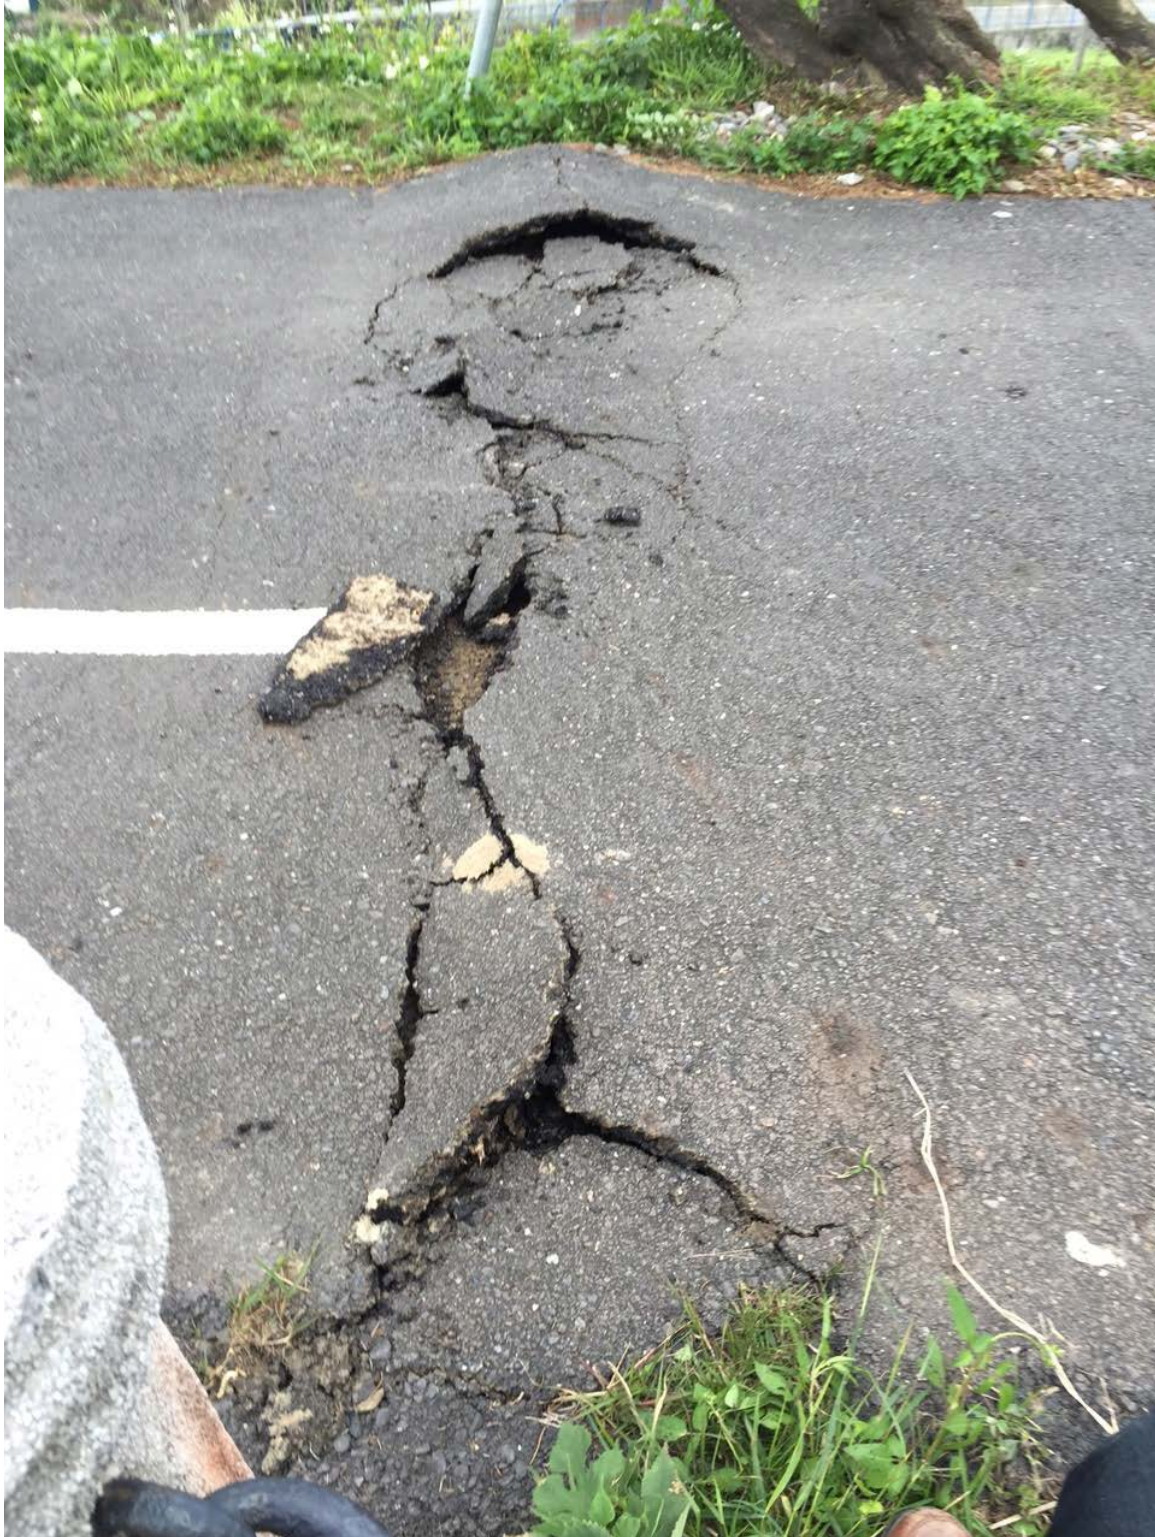
Figure 9-14: Cracking of the AC Pavement (Lat: 23.025606, Long: 120.337445).

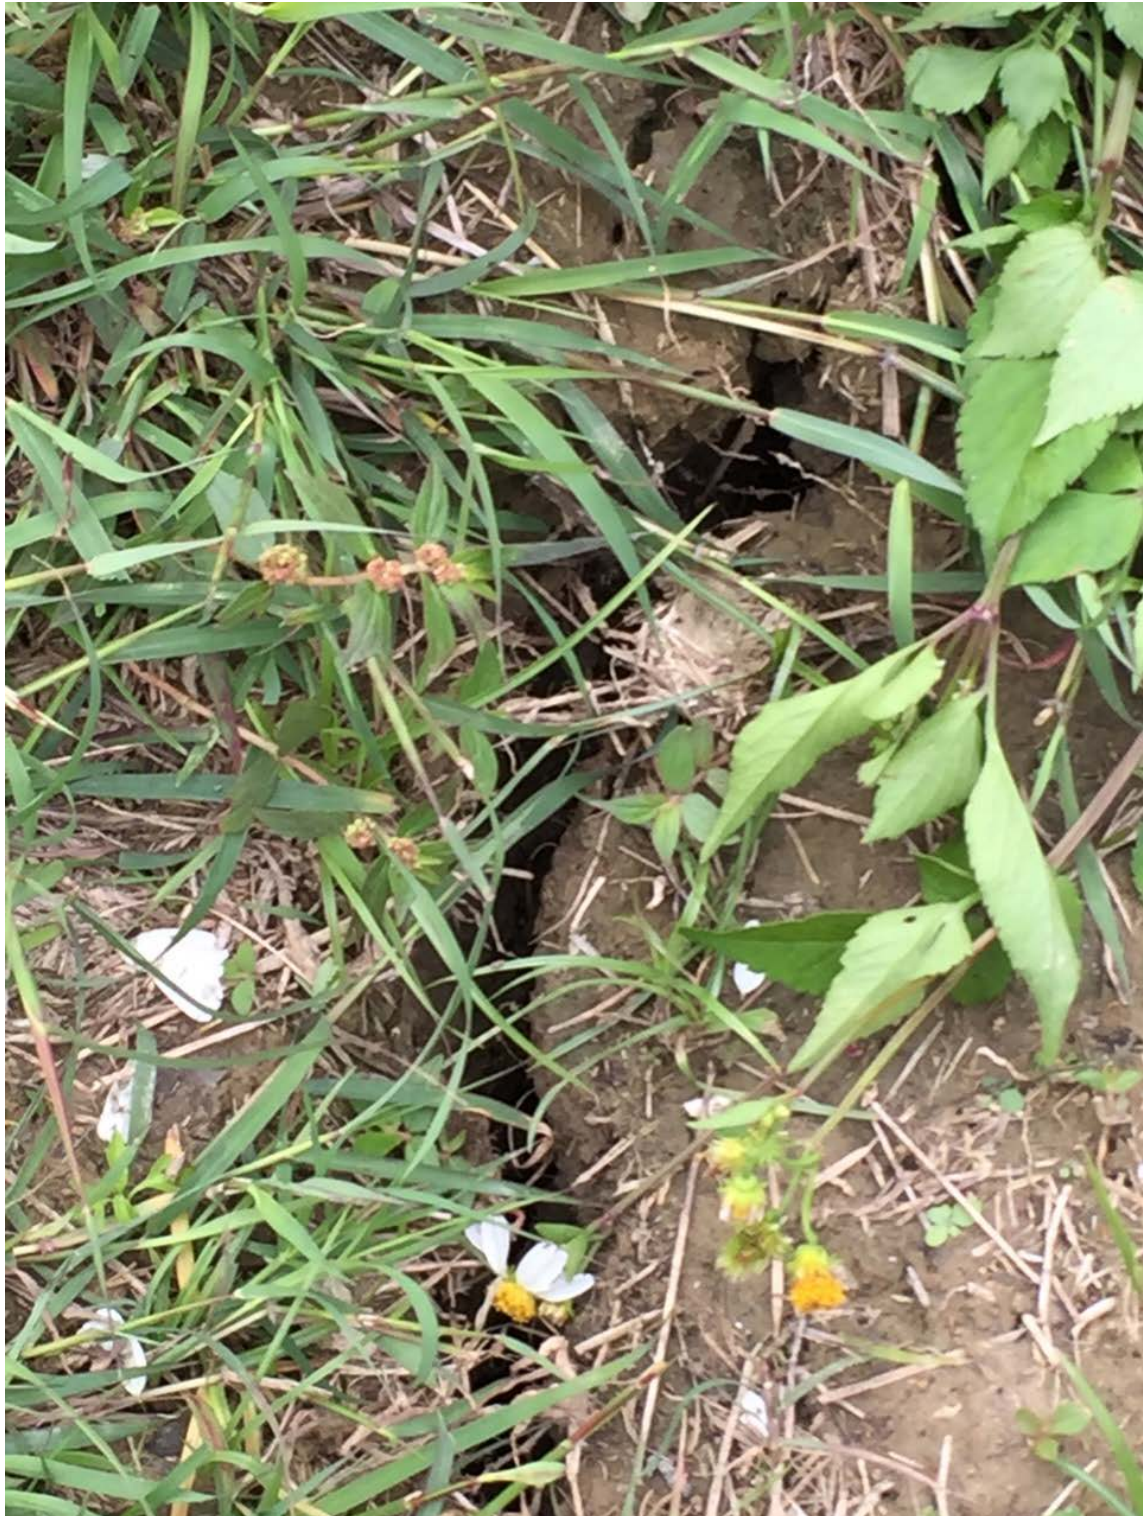
Figure 9-15: Cracking Developed in the Downstream Embankment (Lat: 23.025497, Long: 120.337569).

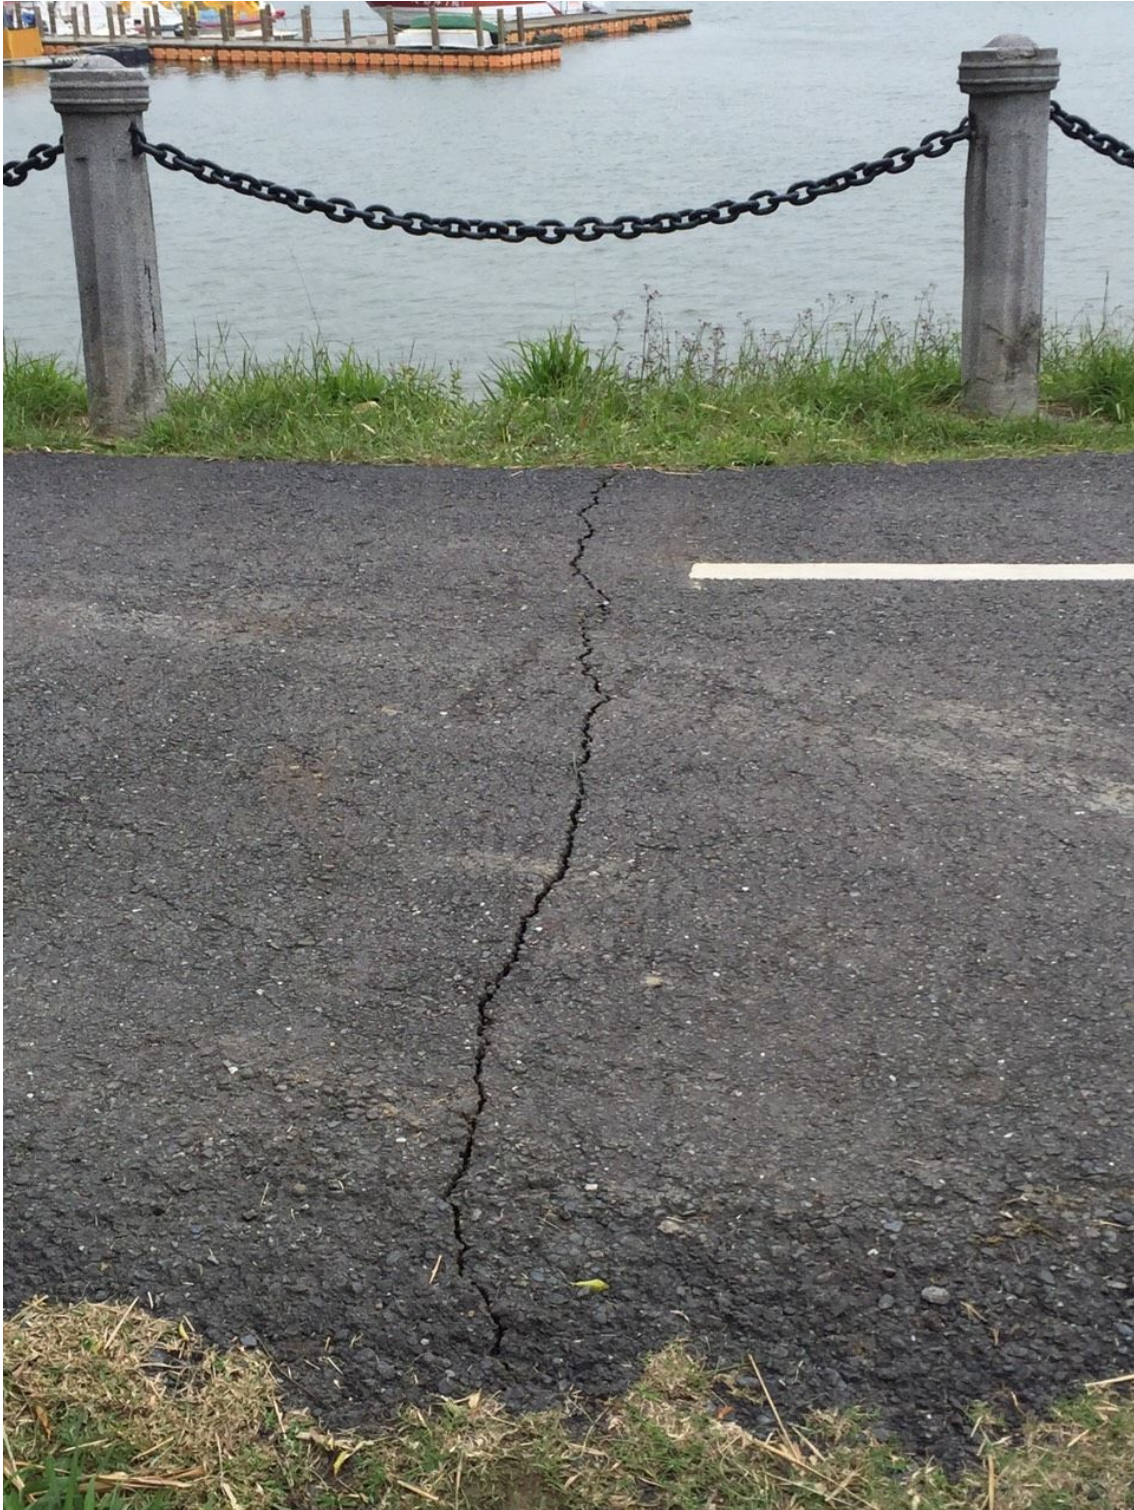
Figure 9-16: Cracking Developed in the Embankment (Lat: 23.026056, Long: 120.336966).
