## GEOTECHNICAL EXTREME EVENTS RECONNAISSANCE (GEER) ASSOCIATION

*Turning Disaster into Knowledge*

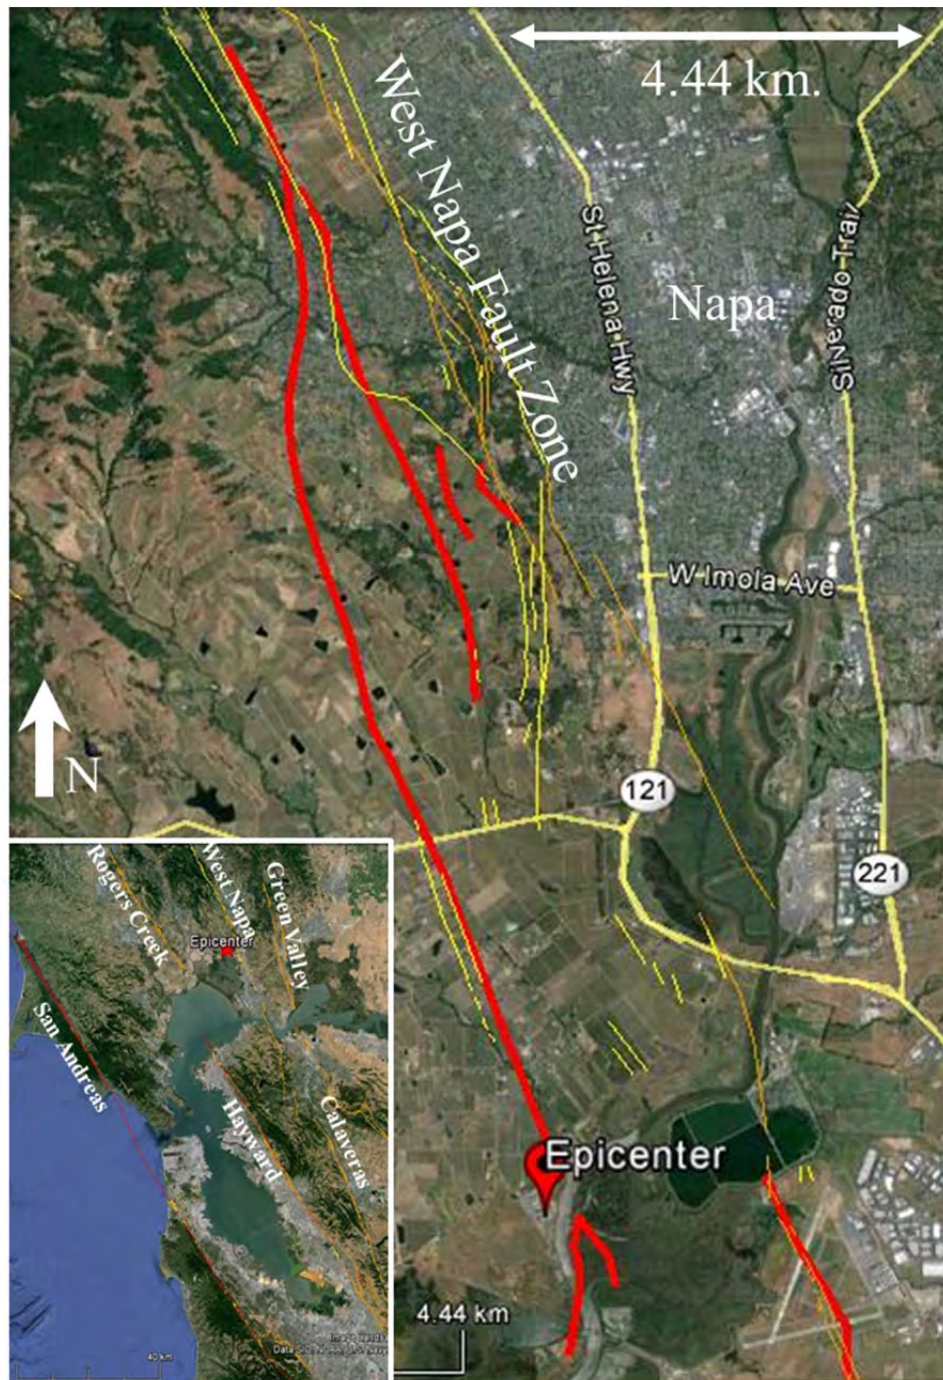
Figure 1.1 Map of the approximate tectonic rupture trace for the August 24, 2014  $M_w = 6$  South Napa Earthquake with Regional Fault Map of the San Francisco Bay Area. [NSF-GEER; J. Cohen-Waeber; 09/14/2014]

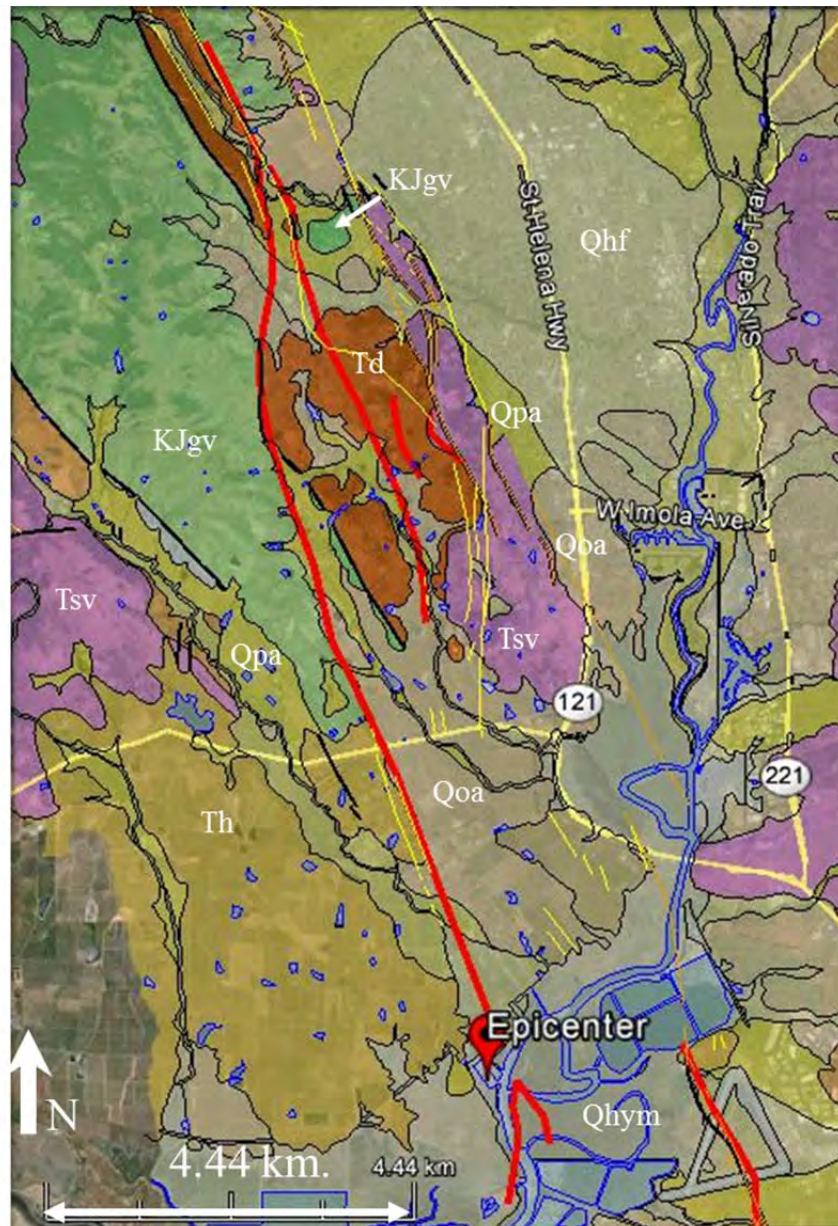
Figure 1.2 Geologic map and approximate trace of tectonic rupture (red) for the August 24, 2014  $M_w = 6$  South Napa Earthquake. Qhym - Holocene Bay Mud Deposits, Qhf - Holocene Alluvial Fan Deposits, Qpa/Qoa - Pleistocene Alluvium, Th - Pliocene/Pleistocene Huichica Fm. Sedimentary, Tsv - Miocene/Pliocene Sonoma Volcanics (Mafic flows and Tuffs), Td - Eocene/Miocene Domengine Sandstone, KJgv - Cretaceous/Jurassic Great Valley Sequence Sedimentary. [NSF-GEER; J. Cohen-Waeber; 09/14/2014]

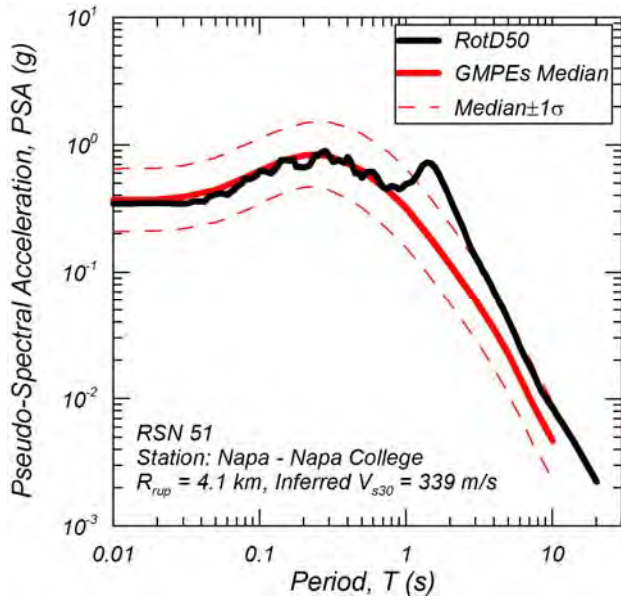
Figure 8 shows the vertical PSA compared with the GMPE by Bozorgnia and Campbell (, 2014). The comparisons show a general satisfactory agreement between recorded and estimated values, especially at the short vertical periods that are important for the vertical component, with the following exceptions. Figure 8 shows that PGA are underestimated for Carquinez Br Geotech Array #1 and #2 in Figure 8(c) and (d). Similarly, PSA greater than 1 s are underestimated at Lovall Valley Loop Rd and Napa Fire Station No. 3 in Figure 8(e) and (f). These trends observed in vertical PSA are similar to those observed in horizontal PSA.

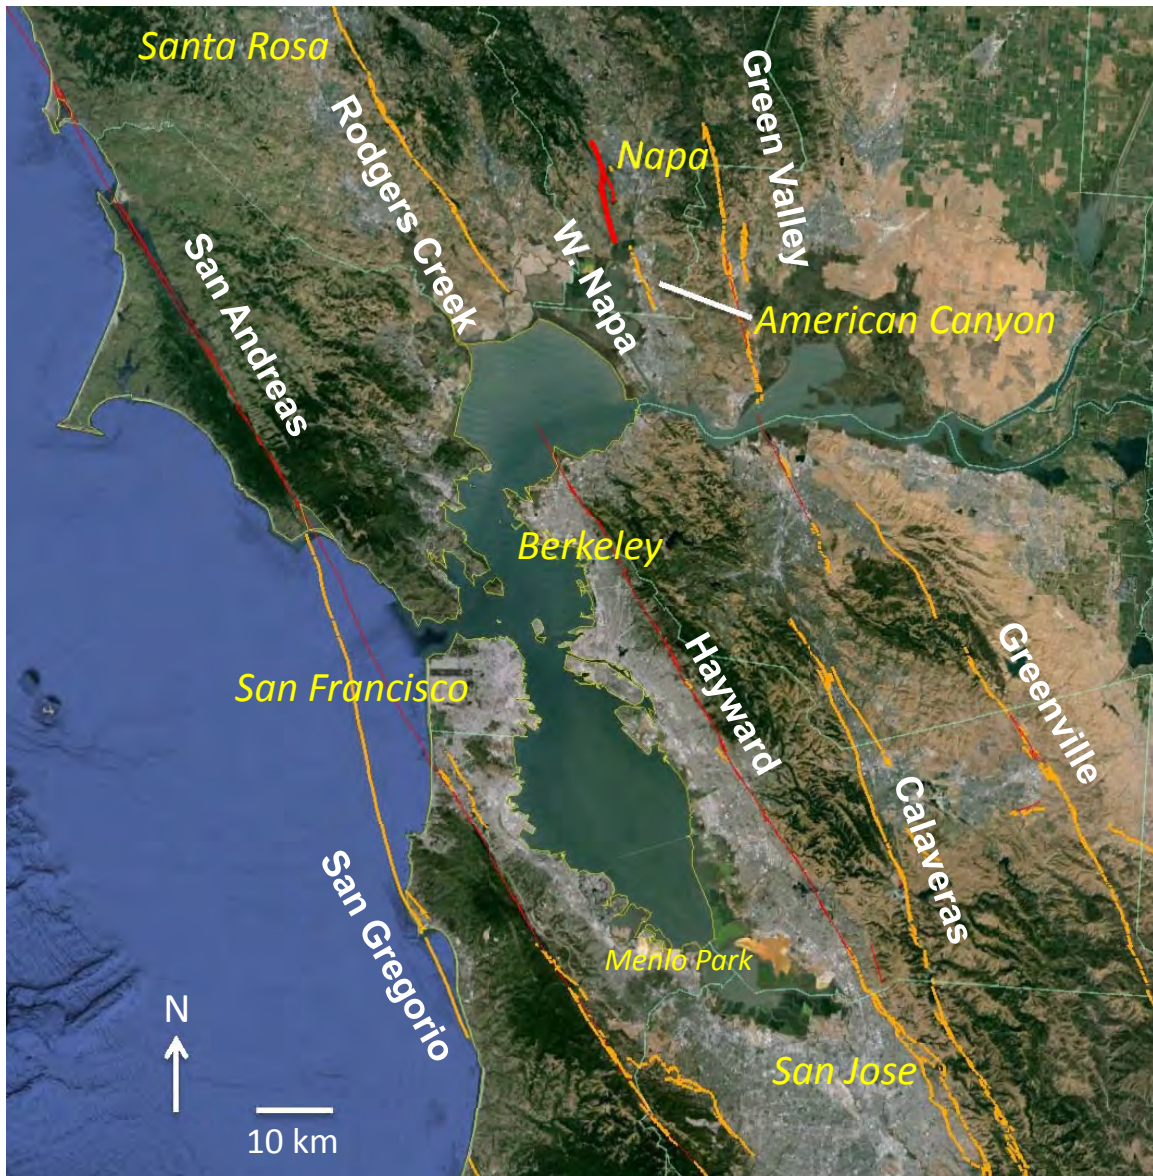
Fig. 3-1 Map showing historic and Holocene mapped traces of the various right-lateral branches of the San Andreas Fault system. Red lines are historic surface ruptures, orange lines are Holocene faults. Those traces recently activated in association with the M 6.0 South Napa earthquake have been added, and are included as an update to previously mapped faults for the region. Faults from USGS Quaternary Fault and Fold Database, base from U.S. Geological Survey.

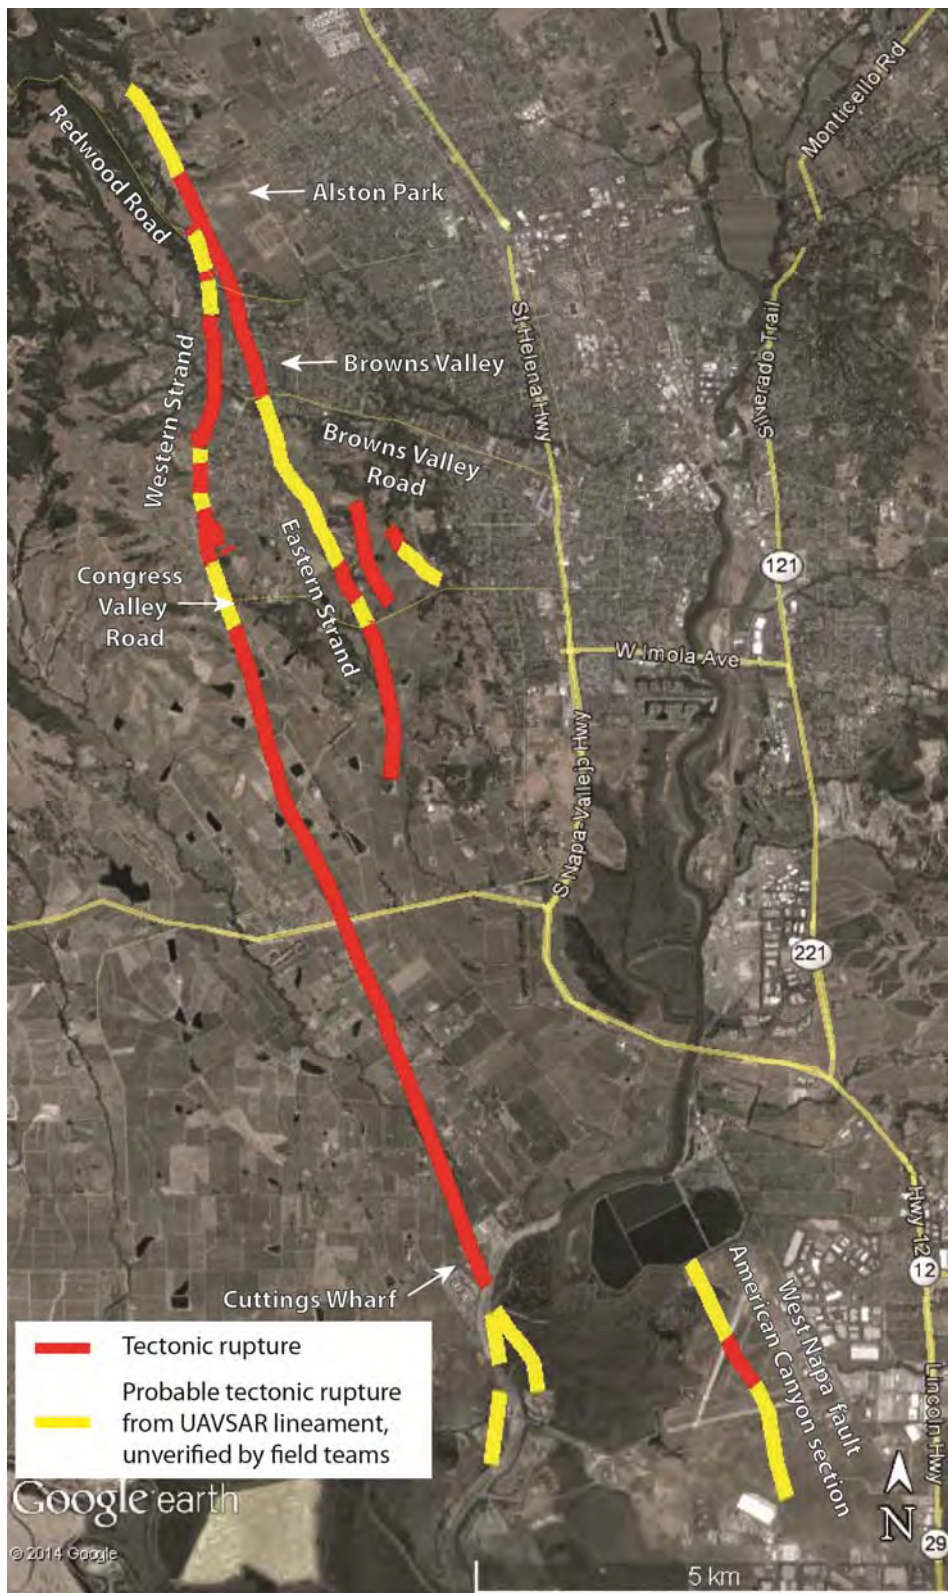
Figure 3-2. Map showing location of observed and inferred South Napa Earthquake fault rupture. Note: Due to scale issues, not all roads and place names listed in text are labeled. Readers are encouraged to use published road maps and online map resources for locating place names not included on Figures 3-2 and 3-4. Image base from Google Earth.

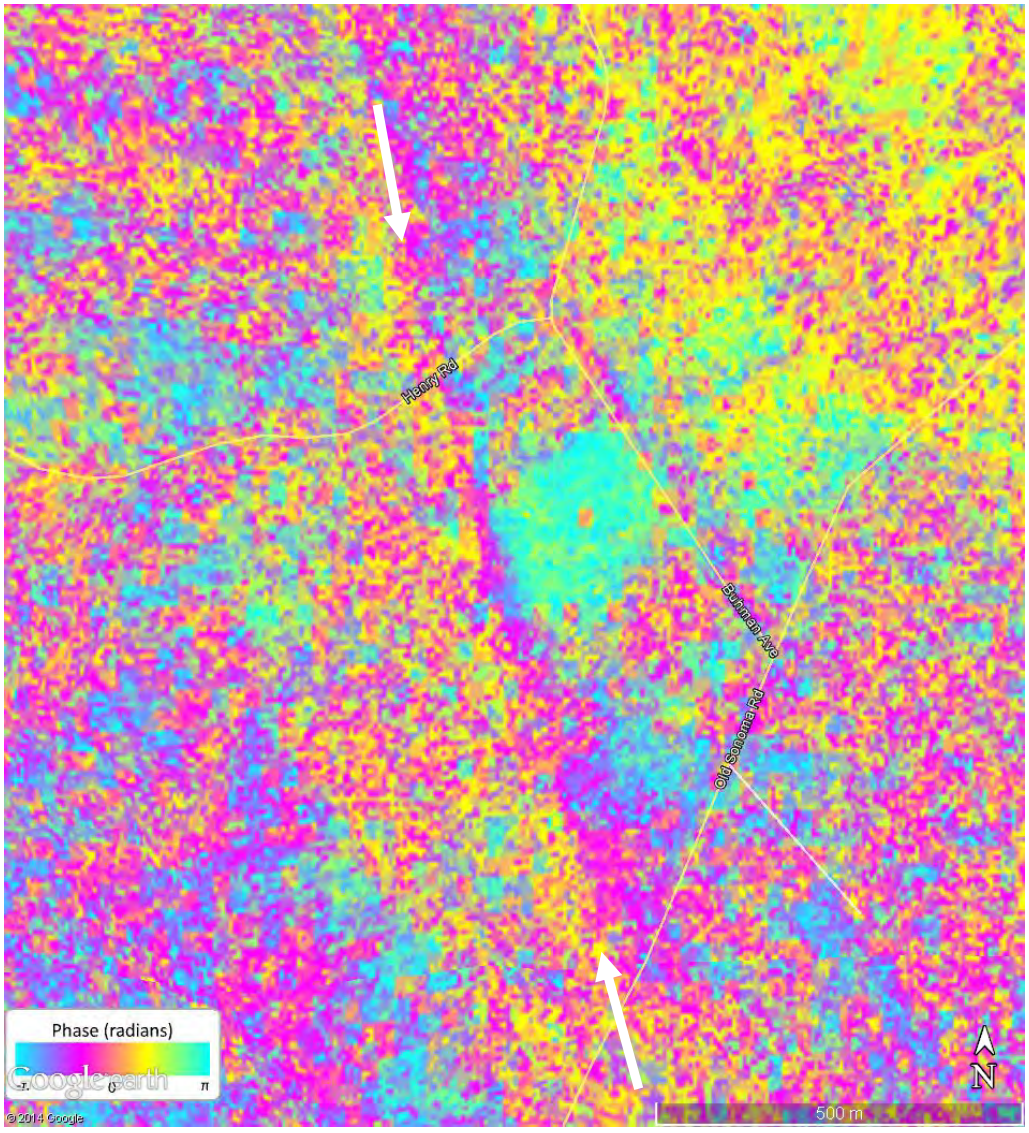
Figure 3-3. Image showing lineament observed on UAVSAR (denoted by white arrows) coincident with surface rupture in the vicinity of Old Sonoma and Henry Roads (UAVSAR image provided by NASA/Jet Propulsion Laboratory, California Institute of Technology).

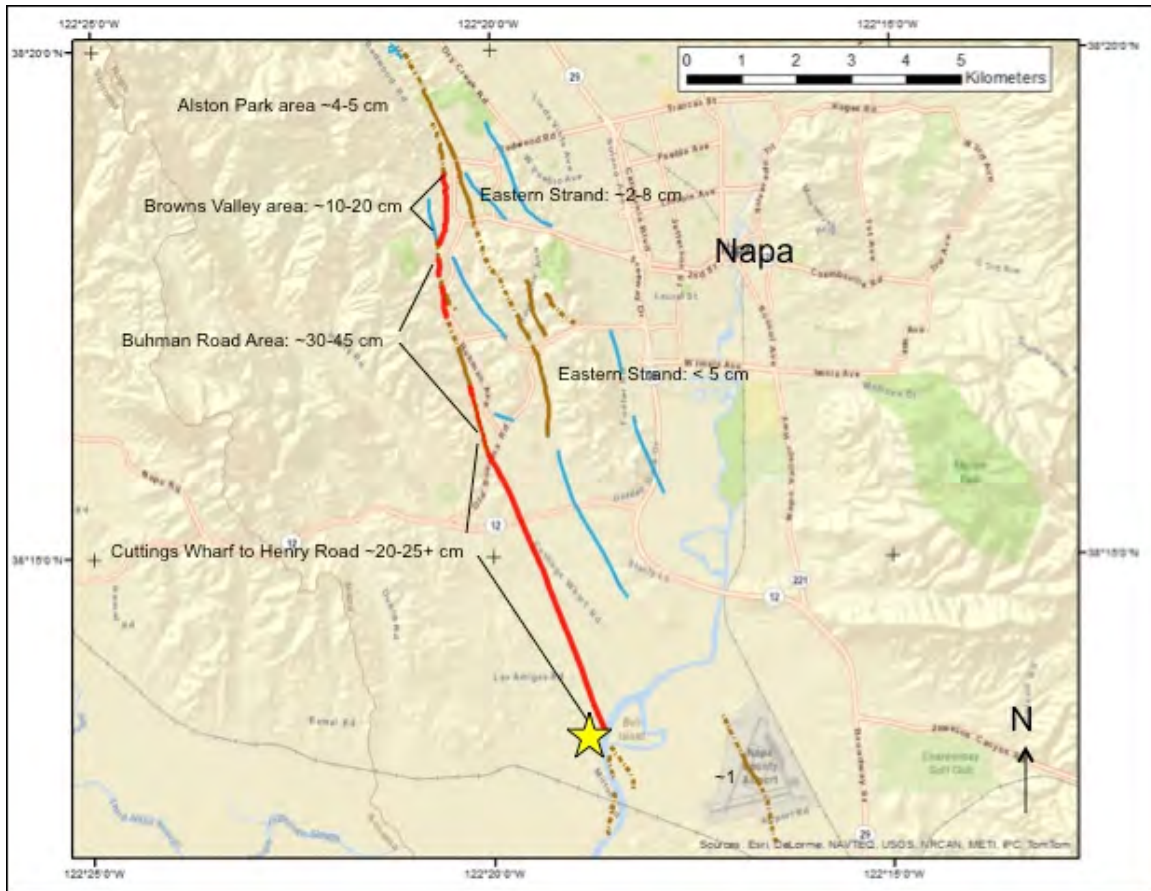
Figure 3-4. Map showing generalized right-lateral offsets along the surface rupture (in cm), measurements may include afterslip. Ruptures shown as red and brown lines, brown lines show areas of lesser, or distributed slip, or areas not yet field verified, but are likely areas of rupture, based on UAVSAR. Blue lines are lineaments identified from UAVSAR, and are still being field verified. Star shows approximate location of epicenter. Note how the surface rupture is located at, and north of the epicenter, and that the majority of the rupture involves about 20 to 25 cm of right-lateral offset at the surface, with slip decreasing in the vicinity of Browns Valley as the fault steps to the east.

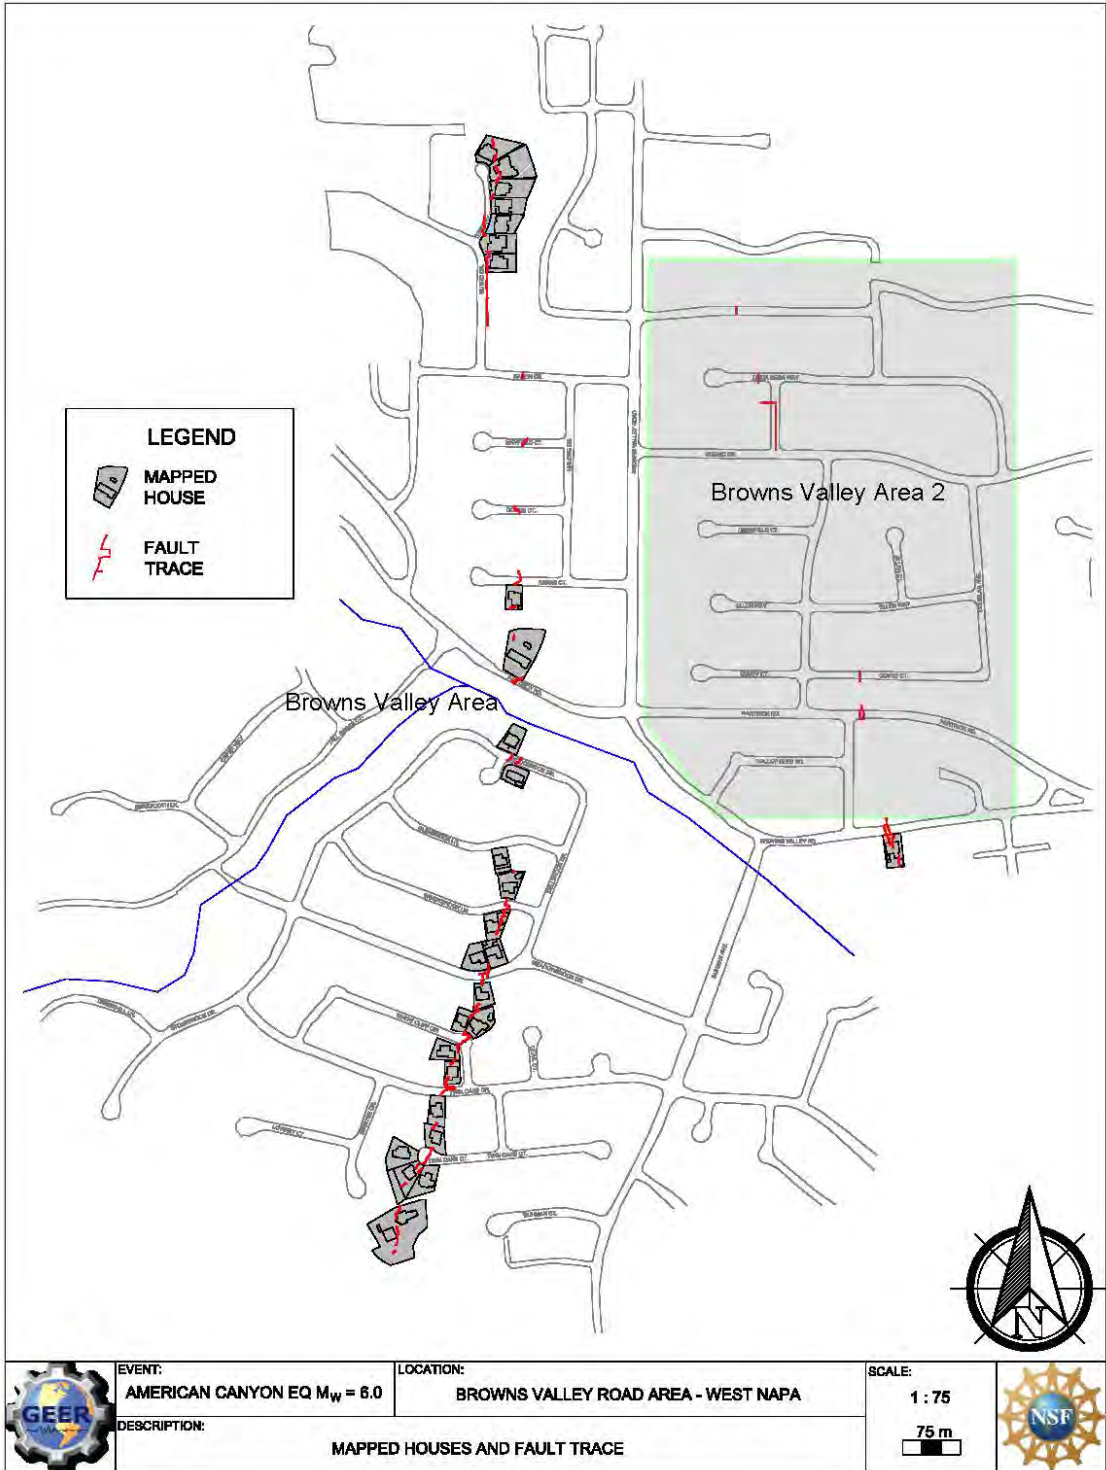
Figure 4.1 Location of mapped properties and surface fault rupture in the Browns Valley area. [NSF-GEER; J. Cohen-Waeber, R. Luque, R. Lanzafame, N. Wagner; 09/12/2014]

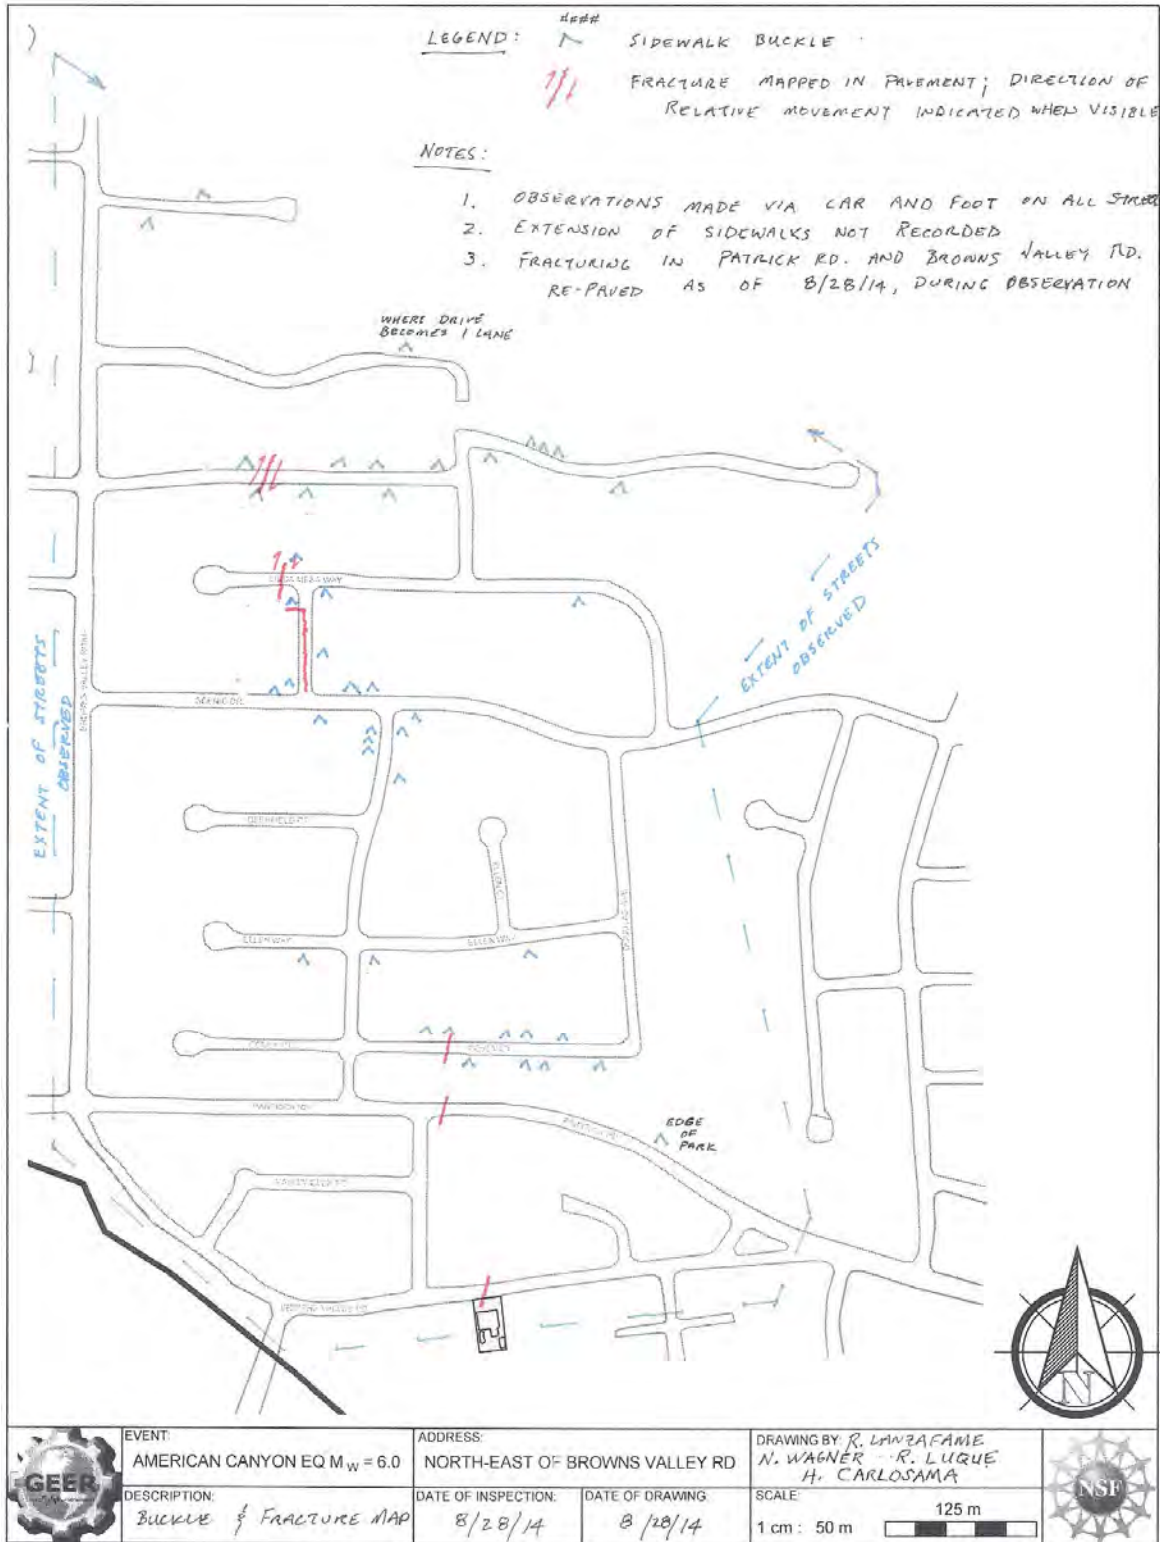
Figure 4.2 Map of surficial damage in the Browns Valley Area 2, Northeast of Browns Valley. [NSF-GEER; H. Carlosama, R. Luque, R. Lanzafame, N. Wagner; 09/12/2014]

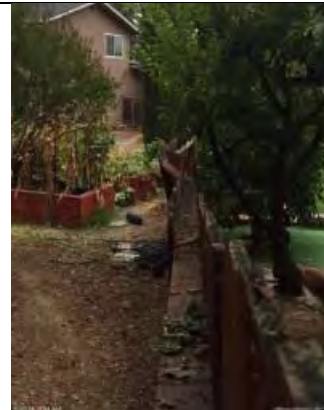
Table 4.3 Observed types of ground rupture.

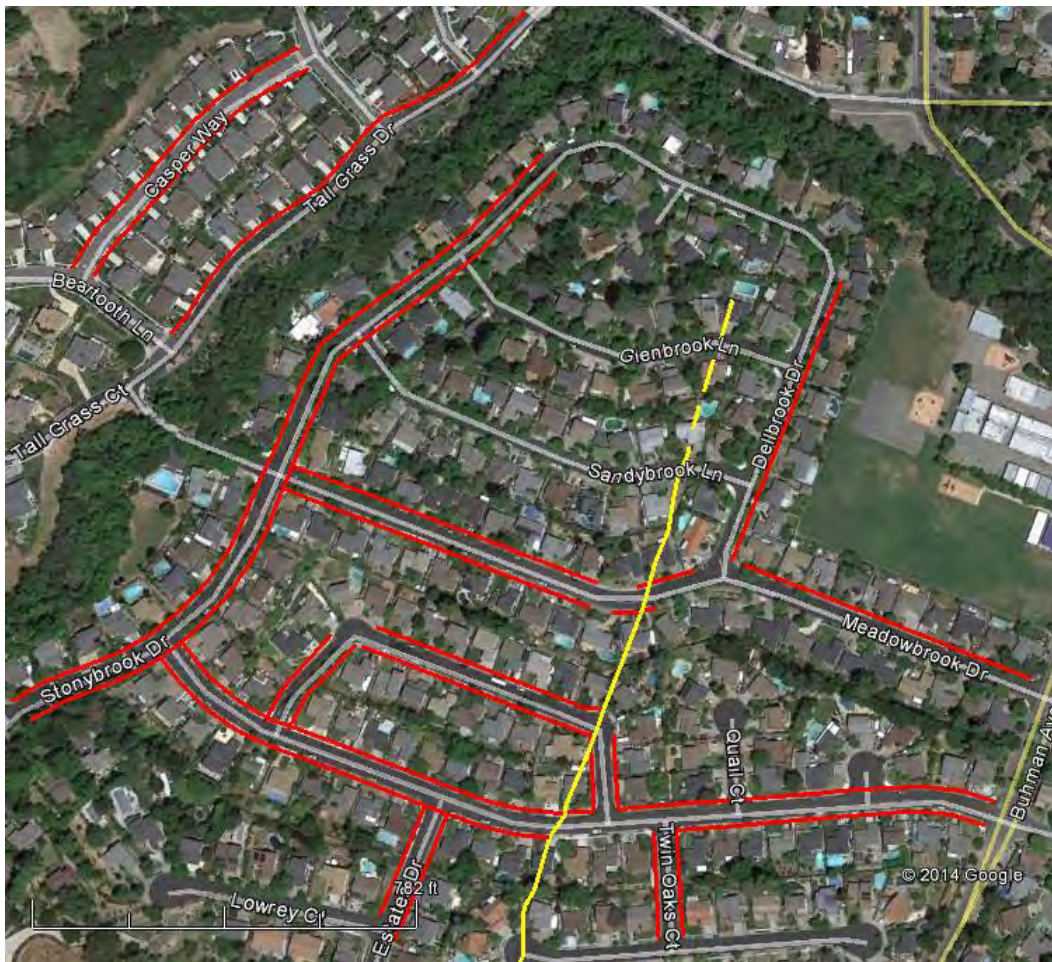
Figure 5.1: Observation and measurement sections of ground strain (red lines) and approximate observed fault trace (yellow line); produced in Google Earth; [NSF-GEER; Napa, CA; N 38.3040 W 122.3443; 8/26/14 - 8/28/14]

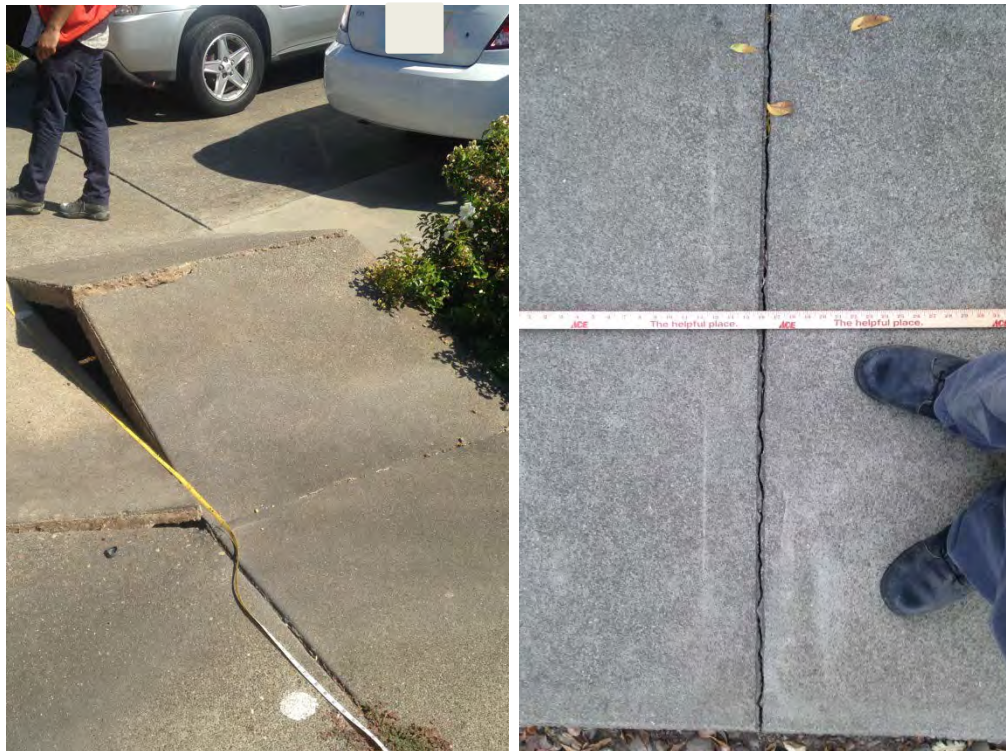
Figure 5.2: Typical buckled compression zone (left) and extension crack (right) [NSF-GEER; N 38.3037 W 122.3433; 8/26/2014 15:41 (left); N 38.3055 W 122.3455; 8/26/2014 18:34 (right)]

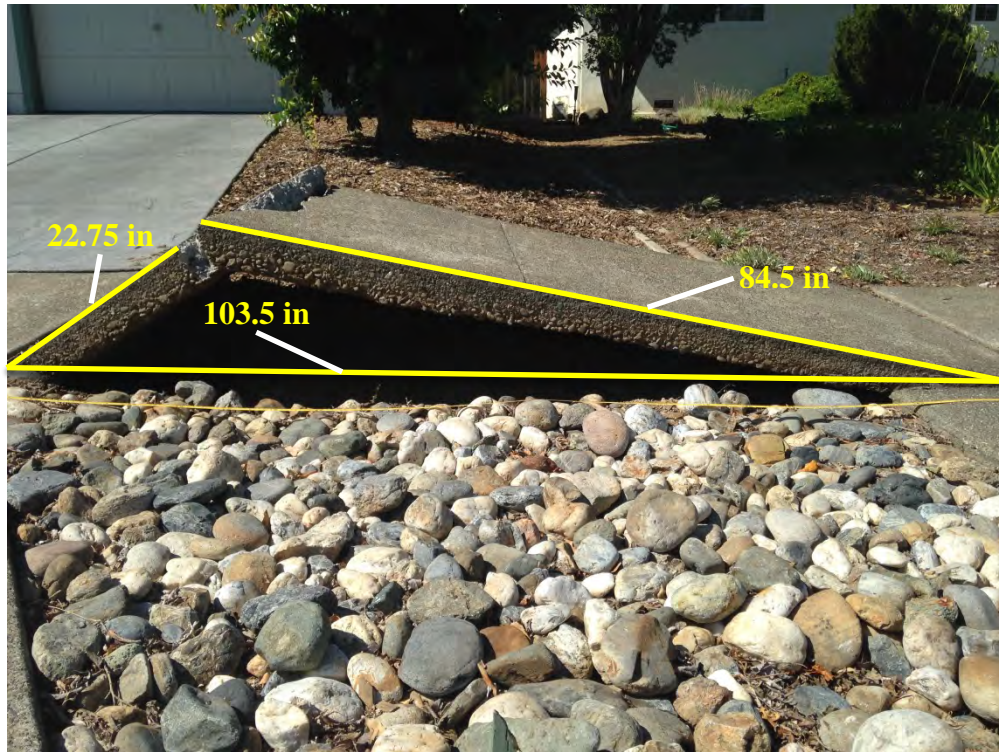
Figure 5.3: Measuring a typical buckled compression zone in sidewalk pavement [NSF-GEER; N 38.3039 W 122.3430; 8/26/2014 15:24]

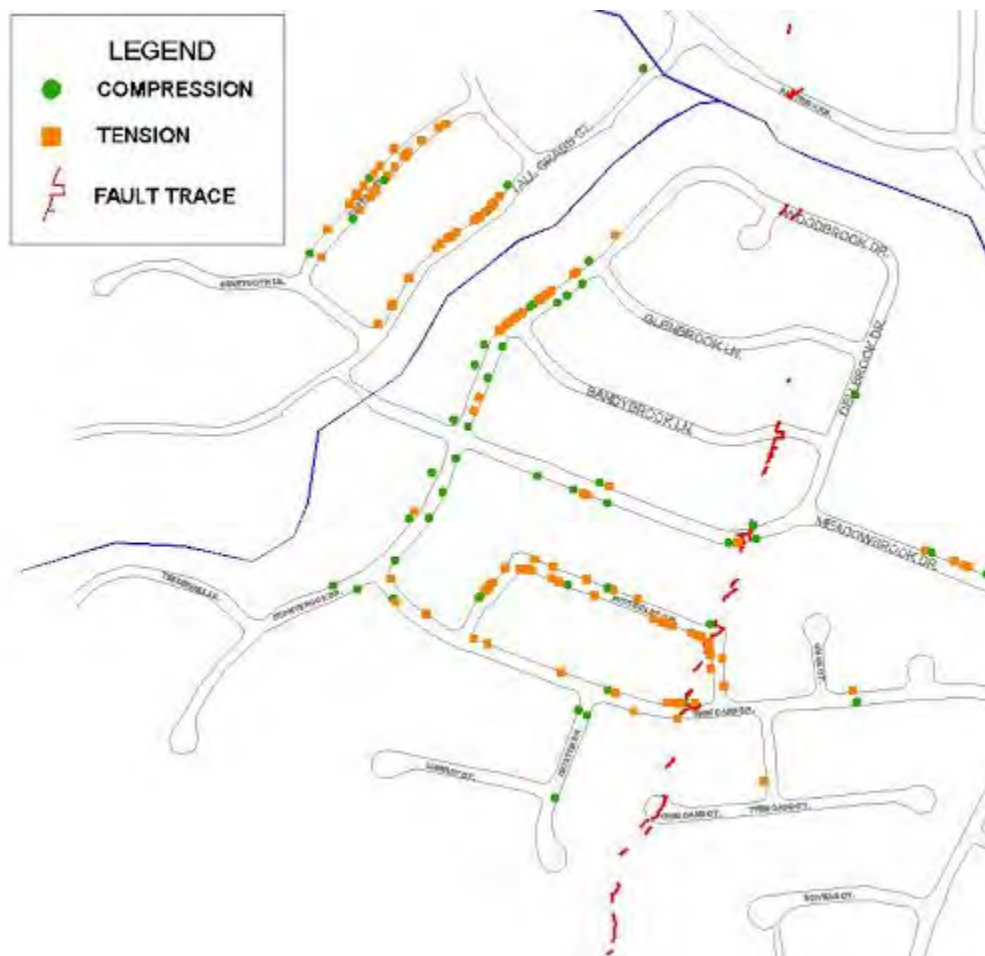
Figure 5.6: Observed and measured tension (orange) and compression (green) locations; produced in AutoCAD; [NSF-GEER; Luque, R.; Wagner, N.; processed 9/5/14]

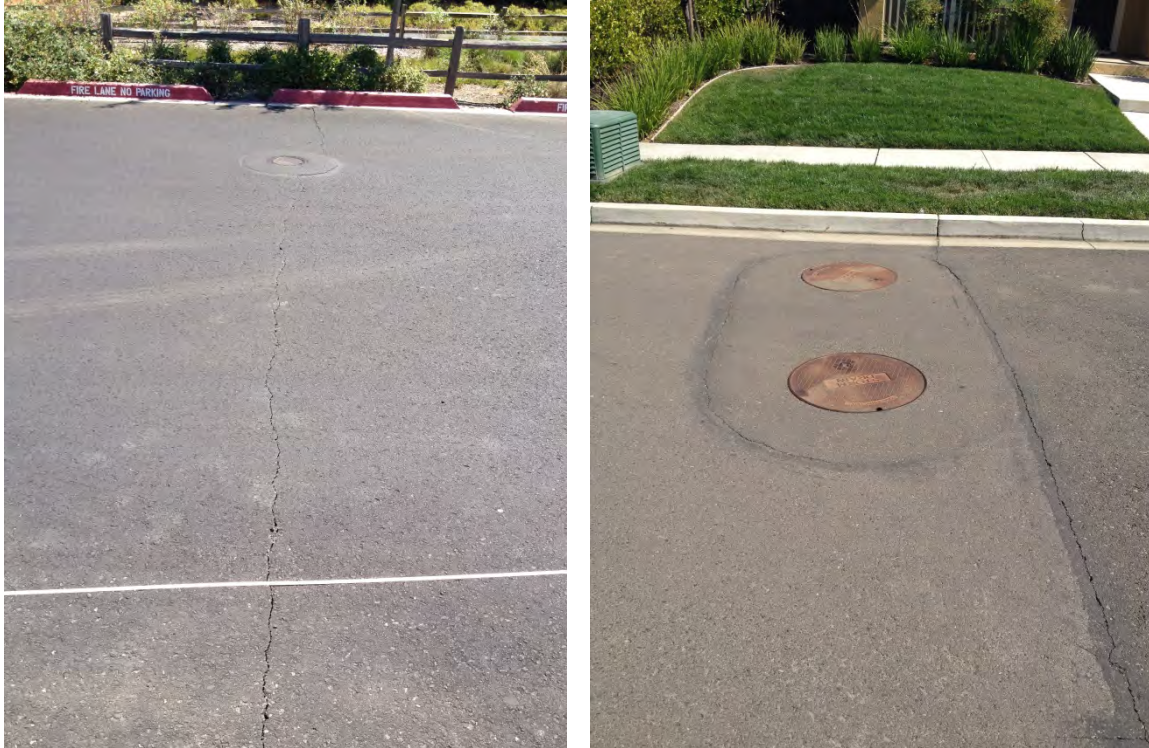
Figure 5.10: Cracks in asphalt perpendicular to fault trace near manhole covers [NSF-GEER; N 38.3063 W 122.3458; 8/28/2014 14:15 (left); N 38.3068 W 122.3465; 8/28/2014 15:19 (right)]

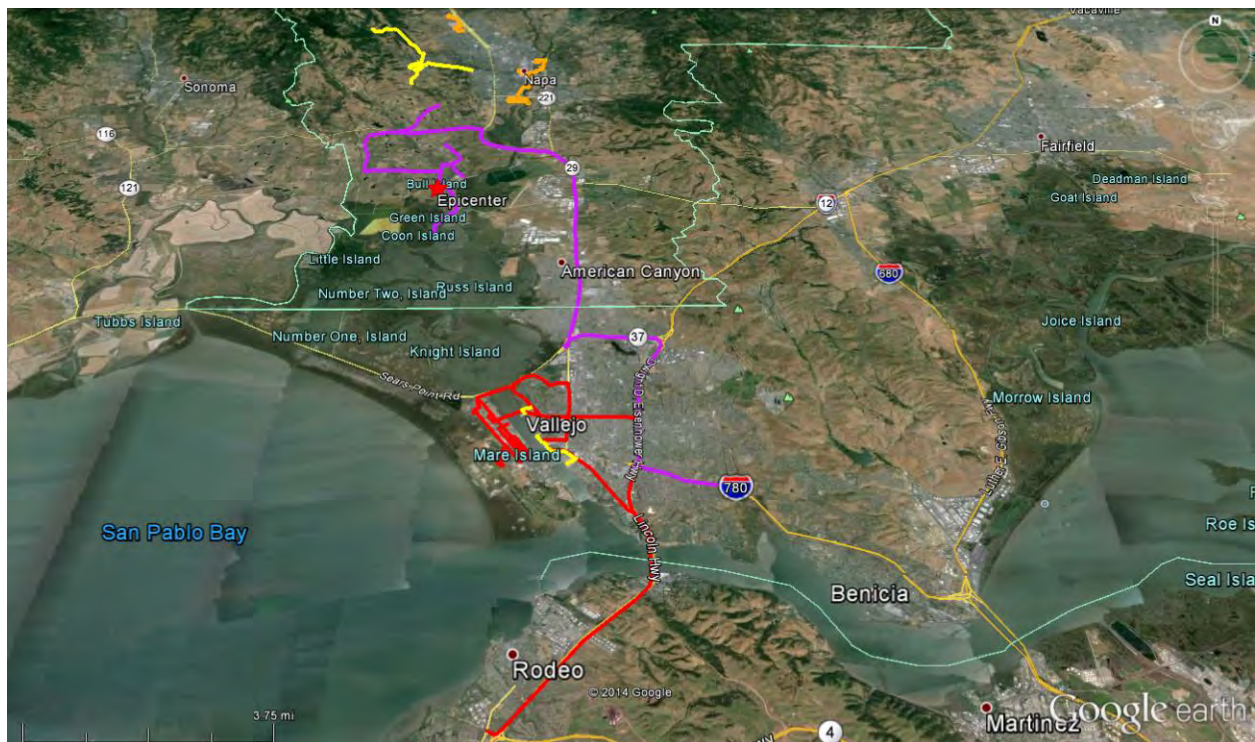
Figure 6.1: GPS tracks for GEER reconnaissance teams that focused on ground failure observations; produced in Google Earth; [NSF-GEER; Vallejo, CA and Napa, CA; 8/24/14]

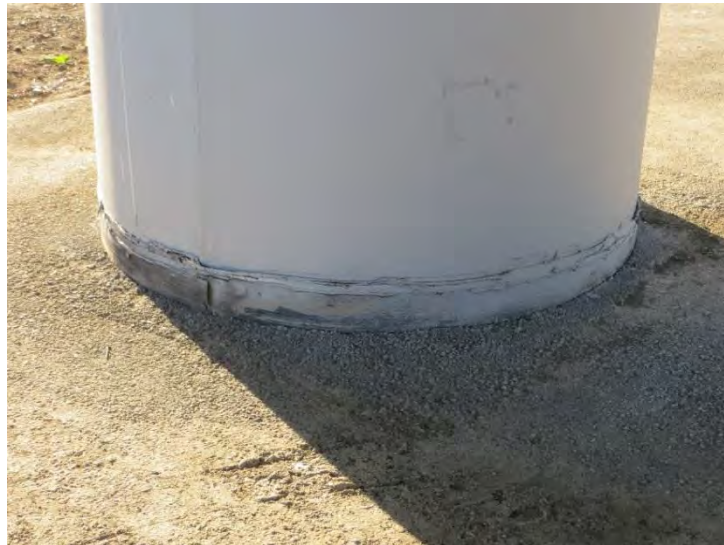
Figure 6.2: Highway 37 Bridge pier with no significant ground damage; [NSF-GEER; Mare Island, Vallejo, CA; GPS N38.122 W122.276; 08/24/14; 18:24]

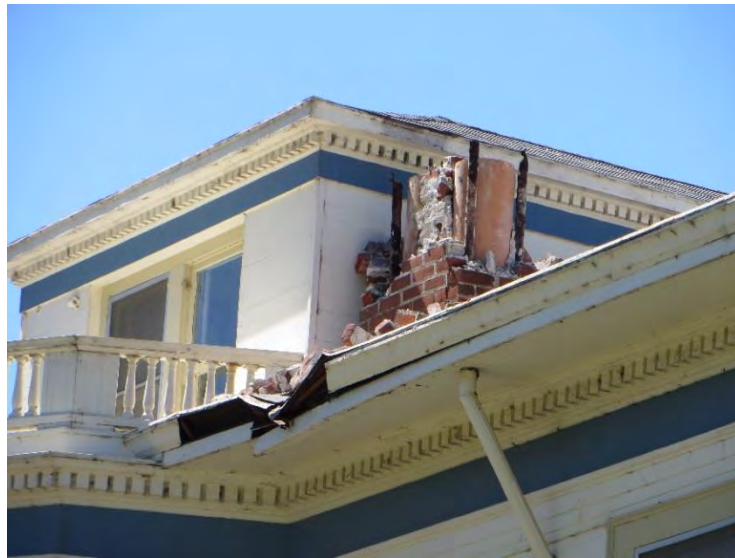
Figure 6.3: Brick chimney damage; [NSF-GEER; Mare Island, Vallejo, CA; GPS N38.099 W122.273; 08/24/14; 14:19]

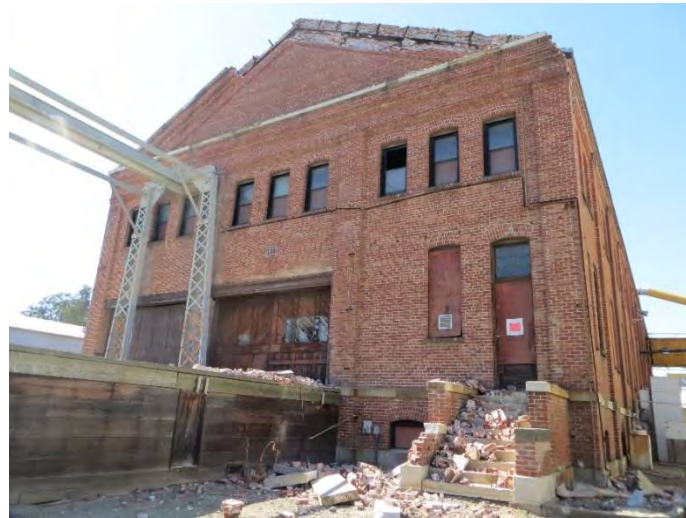
Figure 6.4: Brick facade damage; [NSF-GEER; Mare Island, Vallejo, CA; N38.095 W122.268; 08/24/14; 15:38]

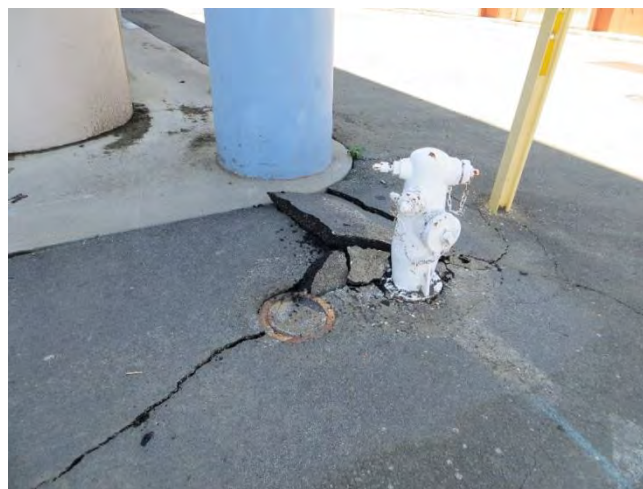
Figure 6.5: Pavement damage at hydrant; [NSF-GEER; Mare Island, Vallejo, CA; GPS N38.098 W122.269; 08/24/14; 14:37]

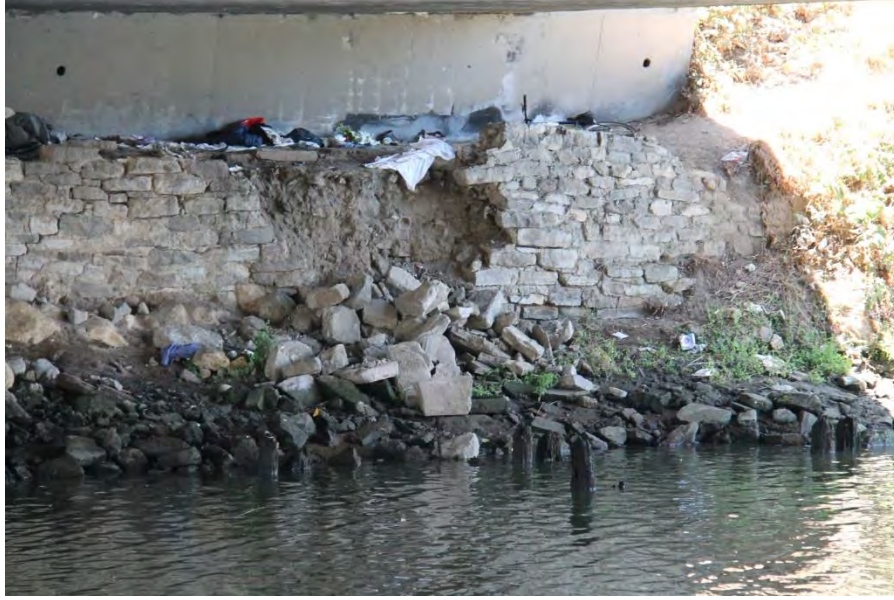
Figure 6.6: Failure of masonry retaining wall below the south abutment of Soscol Bridge [NSF-GEER; N 38.2997 W -122.2834; 08/24/14 13:09]

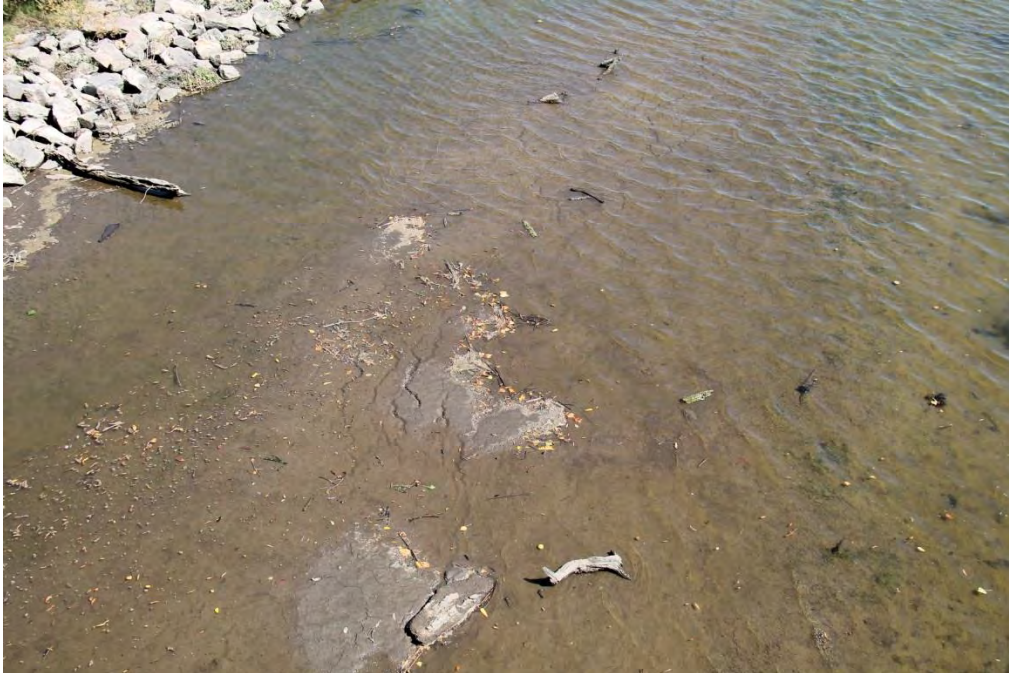
Figure 6.7: Ground cracking and submerged sand boils due to liquefaction in Napa River point bar, east bank, south of 3<sup>rd</sup> St. Bridge [NSF-GEER; N 38.2980 W -122.2830; 08/24/14 14:44]

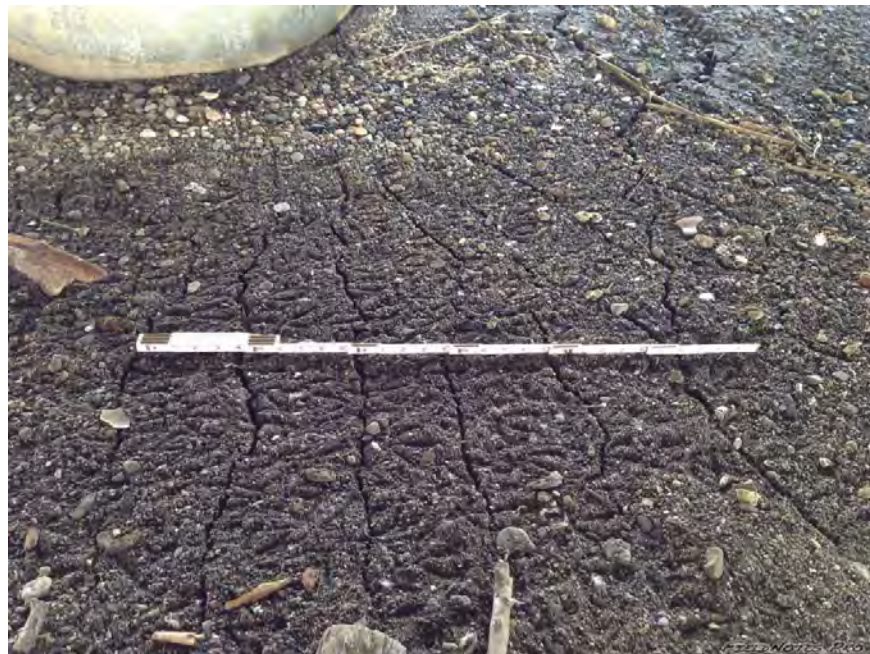
Figure 6.8: Ground cracking due to liquefaction in Napa River point bar below 3<sup>rd</sup> St. Bridge, between the two columns of the eastern pier. [NSF-GEER; N 38.2980 W -122.2840; 08/24/14 14:44]

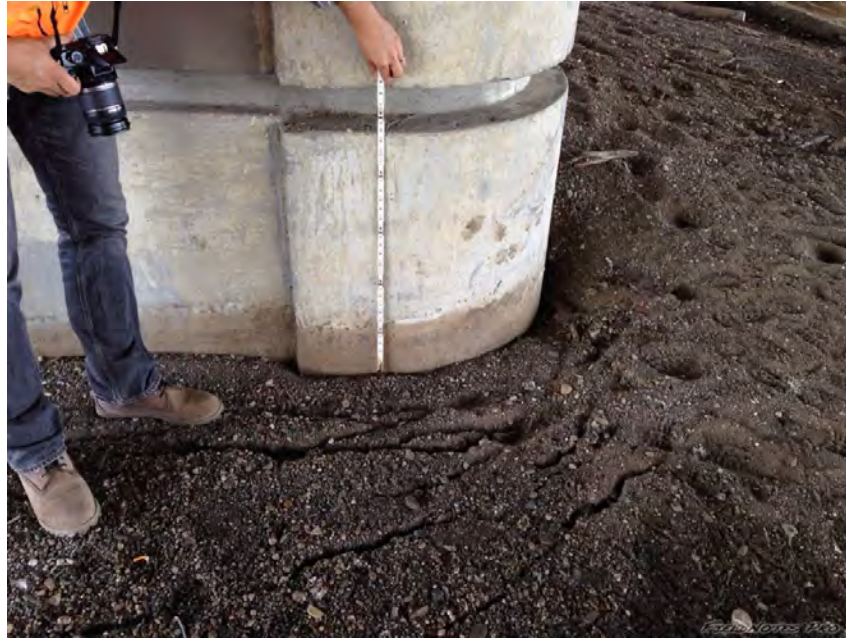
Figure 6.9: Ground cracking and settlement due to liquefaction in Napa River point bar below 3<sup>rd</sup> St. Bridge [NSF-GEER; N 38.2980 W -122.2840; 08/24/14 14:44]

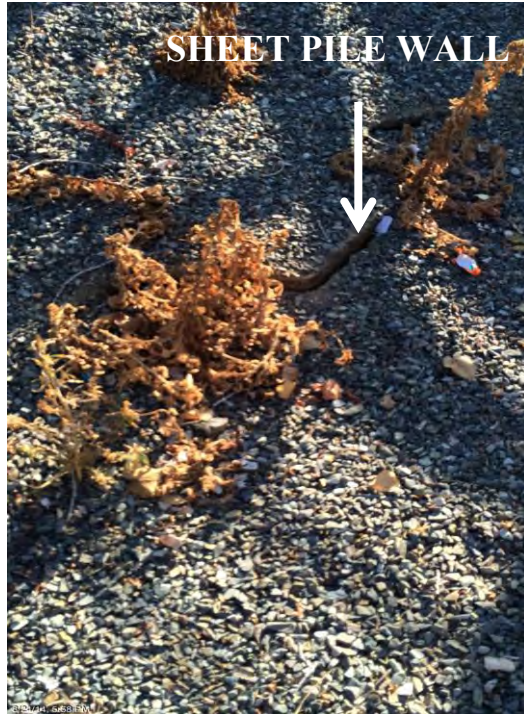
Figure 6.10: Crack along sheet pile wall behind the retaining wall in the Pedestrian Bridge [NSF-GEER; N 38.3003 W -122.2881; 08/24/14 17:58]

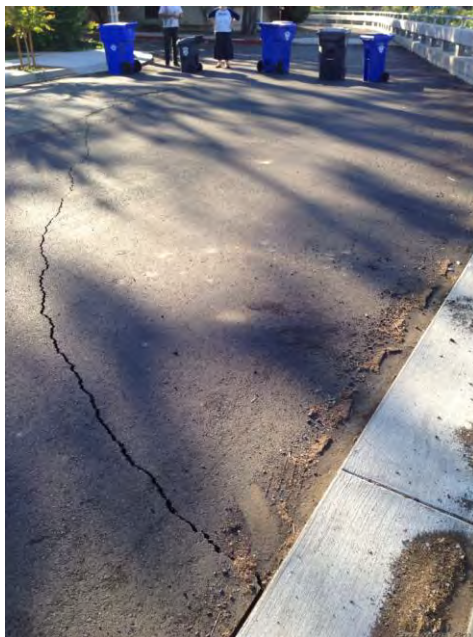
Figure 6.11: Crack in pavement behind the retaining wall in the pedestrian bridge [NSF-GEER; N 38.3003 W -122.2881; 08/24/14 17:58]

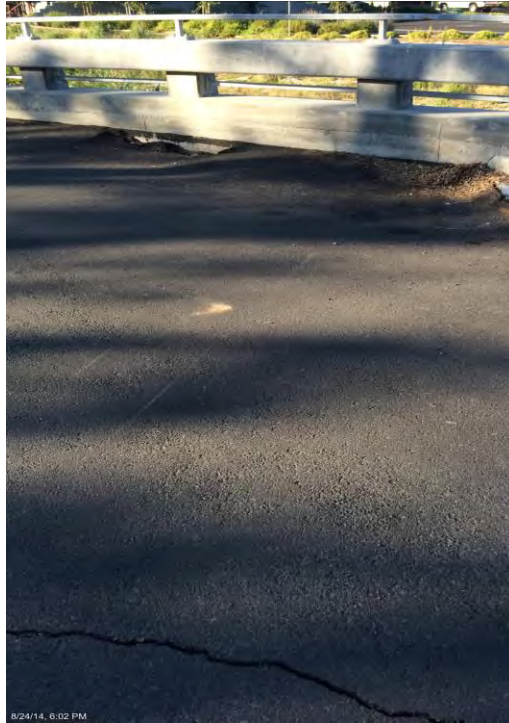
Figure 6.12: Settlement of backfill near the retaining wall in the pedestrian bridge [NSF-GEER; N 38.3003 W -122.2881; 08/24/14 17:58]
