## GEOTECHNICAL EXTREME EVENTS RECONNAISSANCE (GEER) ASSOCIATION

*Turning Disaster into Knowledge*

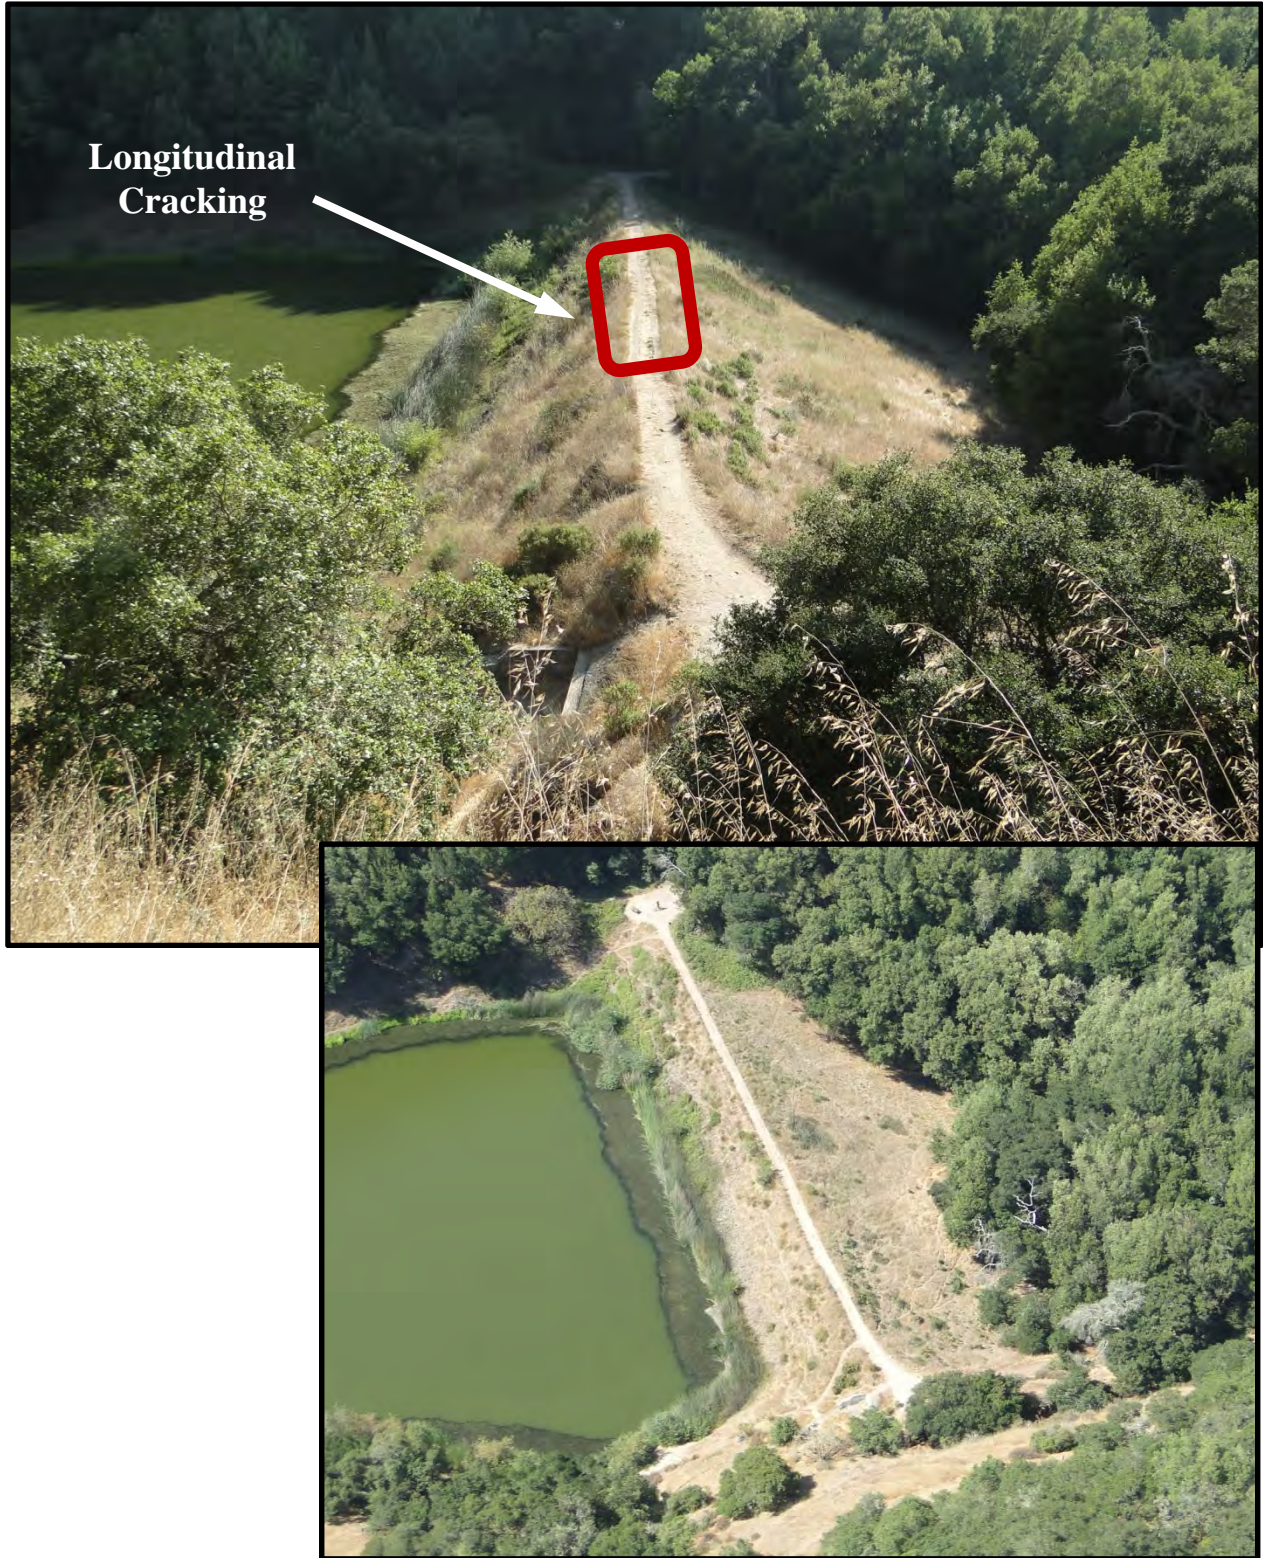
Figure 7-2: Ground and aerial photographs of Lake Marie Dam looking southeast  
[NSF-GEER; Napa, CA; N38.260 W 122.230; Harder, L. F.; 09/01/14]

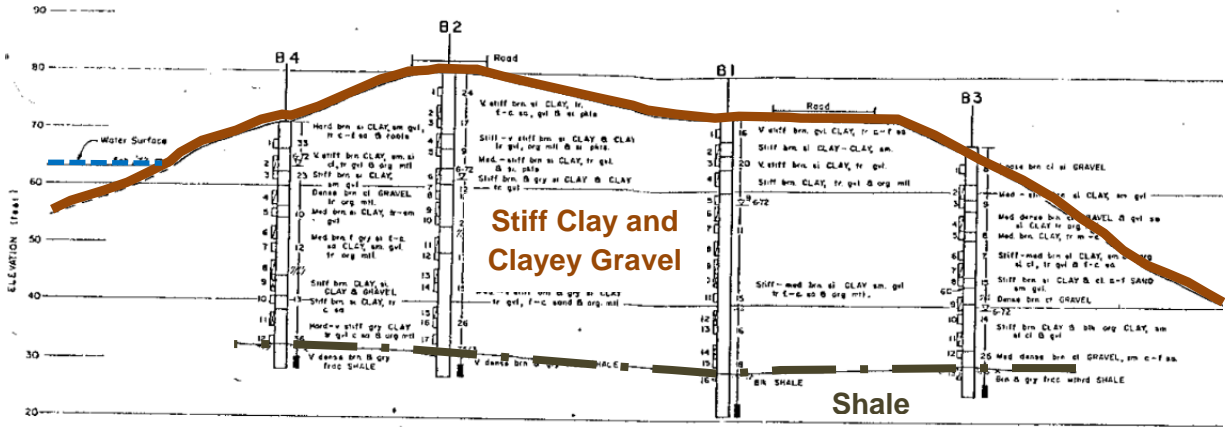
Figure 7-5: Cross section of Lake Chabot Dam [Vallejo, CA; N38.141 W 122.241; from DSOD files]

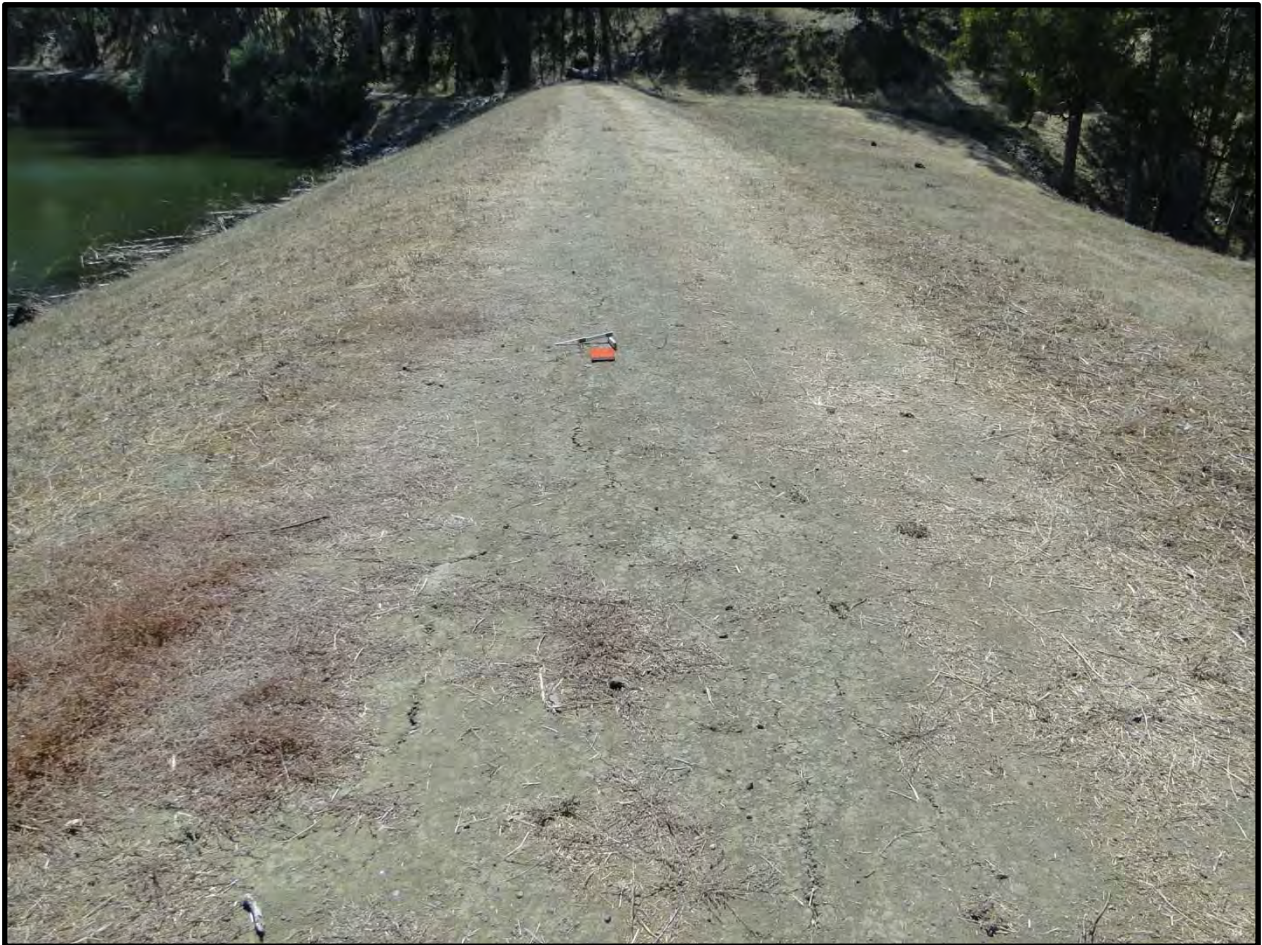
Figure 7-6: Photograph of minor longitudinal cracking on the crest of Lake Chabot Dam looking southeast [NSF-GEER; Napa, CA; N38.141 W 122.241; Harder, L. F.; 08/27/14]

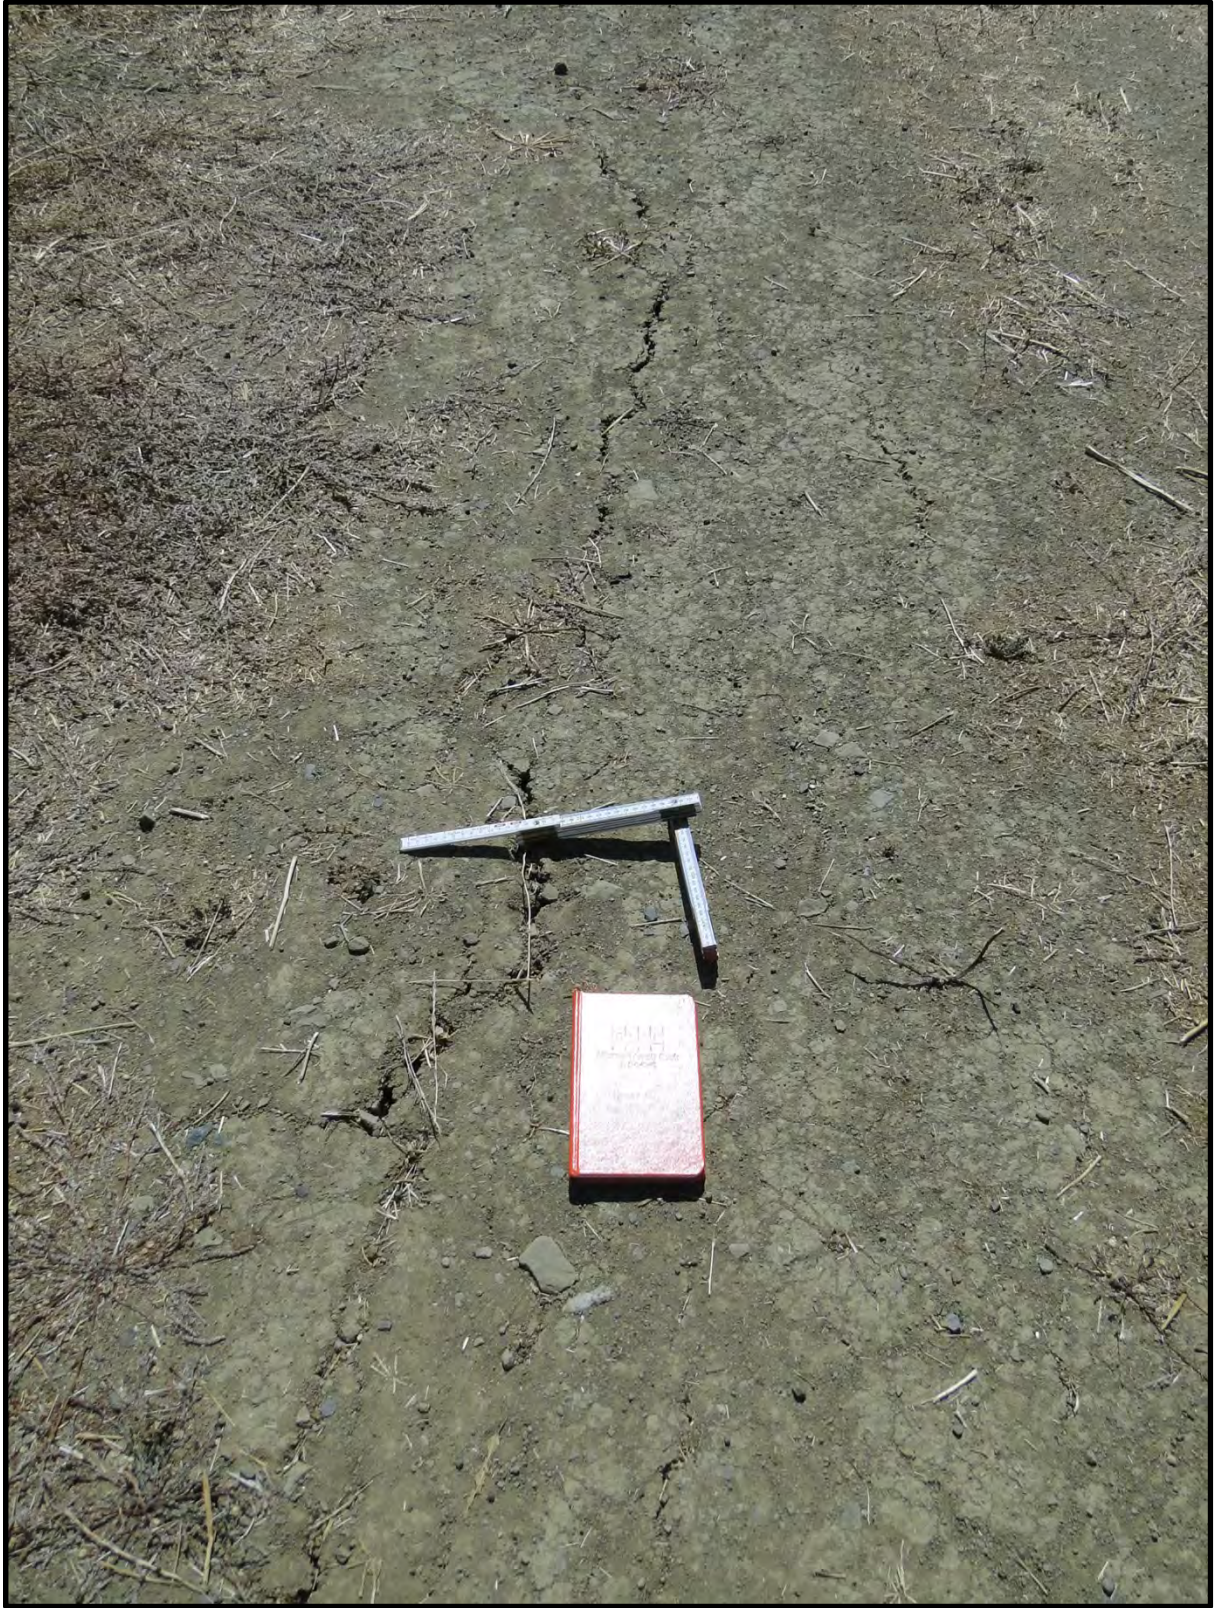
Figure 7-7: Close-up photograph of minor longitudinal cracking on the crest of Lake Chabot Dam looking southeast [NSF-GEER; Napa, CA; N38.141 W 122.241; Harder, L. F.; 08/27/14]

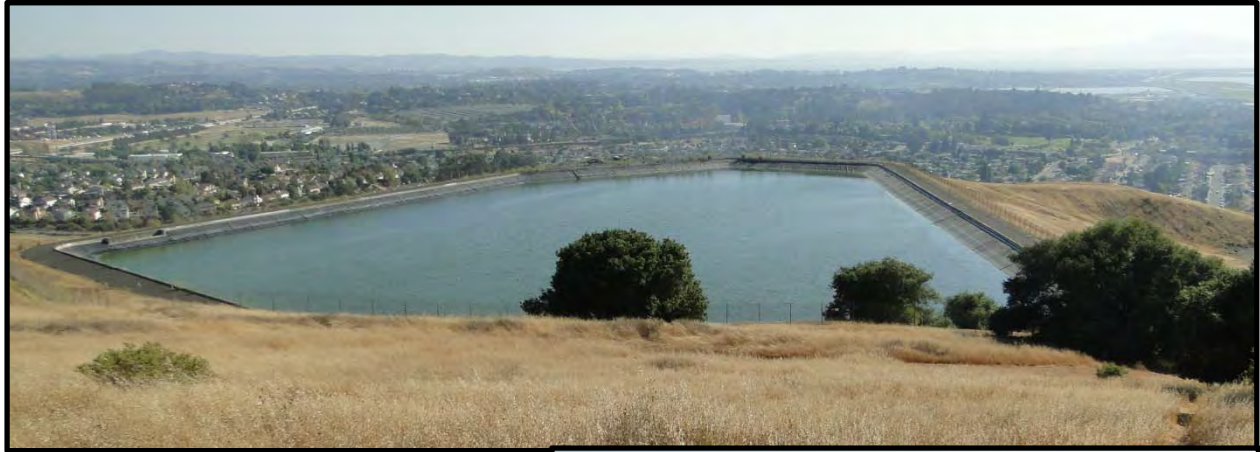
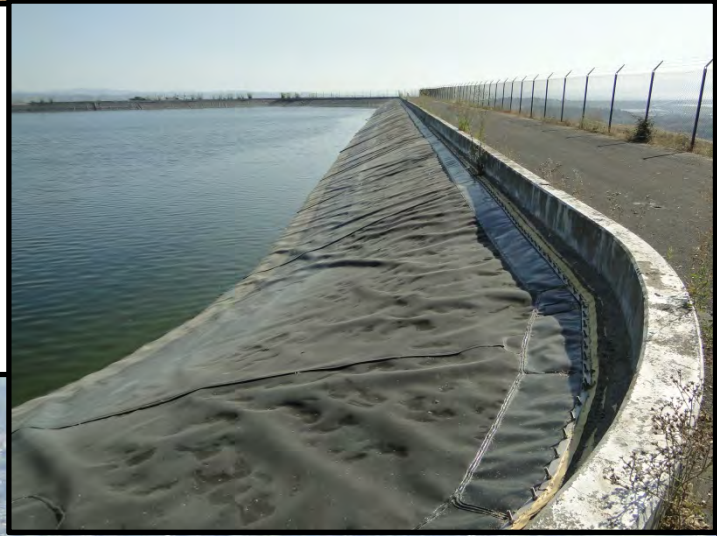
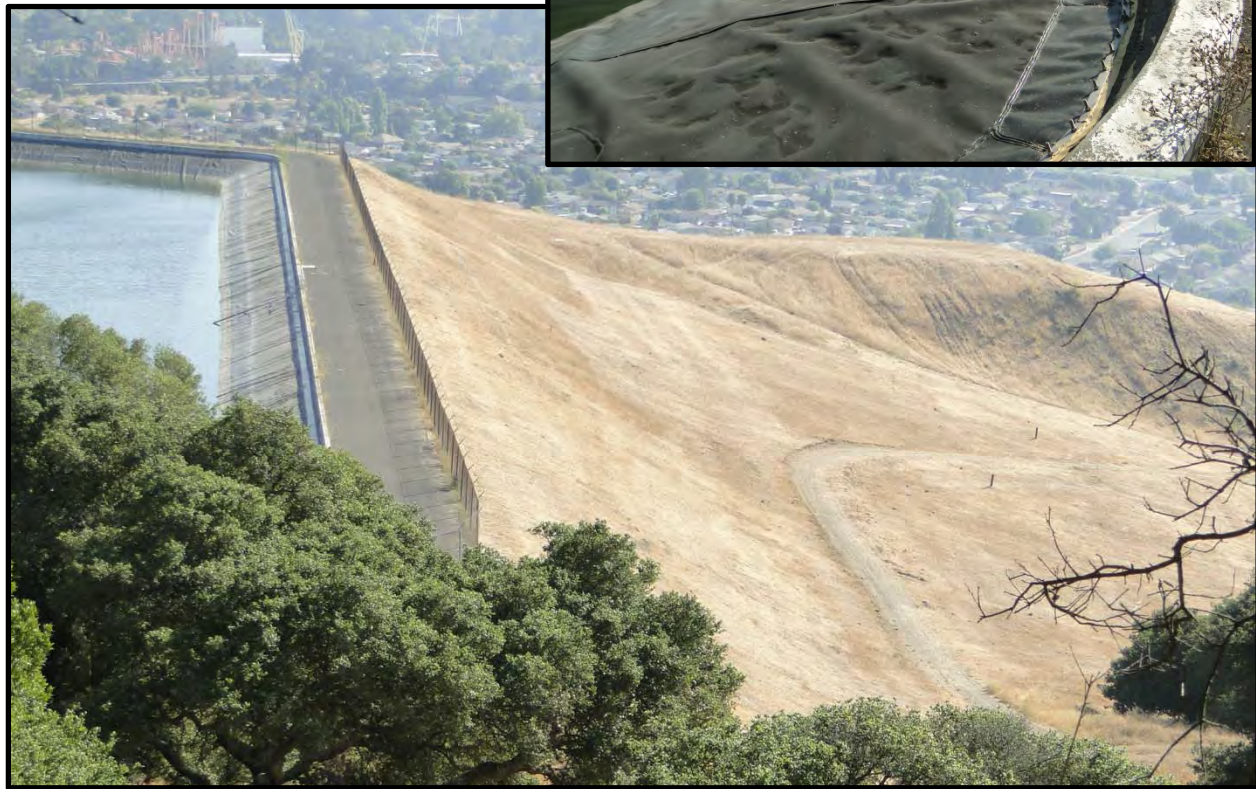
Figure 7-8: Views of Summit Reservoir Dam looking southeast  
[NSF-GEER; Napa, CA; N38.153 W 122.225; Harder, L. F.; 08/27/14]

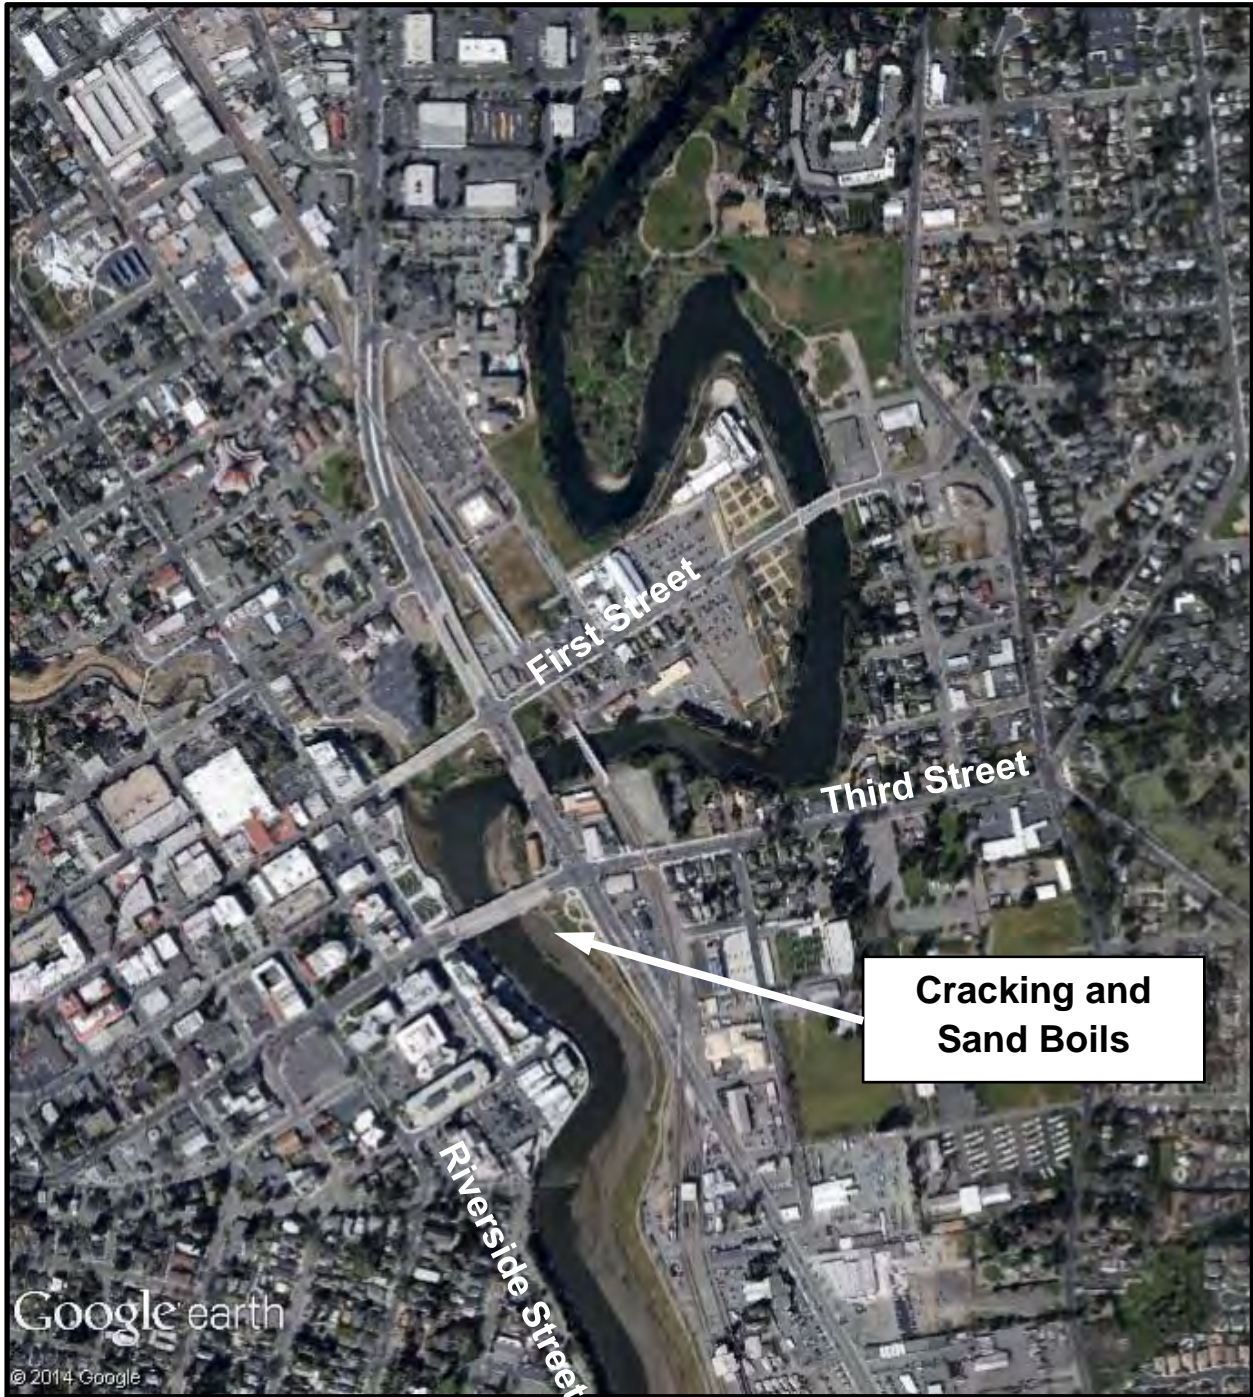
Figure 7-11: Google Earth Plot of Downtown Napa  
[NSF-GEER; Napa, CA; N38.308 W 122.281; Harder, L. F.; 09/11/14]

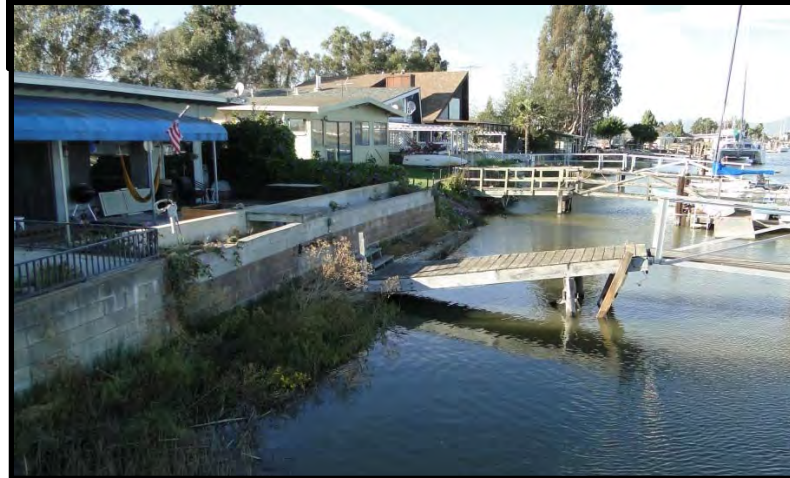
Figure 7-16: Photographs of cracked asphalt pavement on Milton Road, cracked cinderblock retaining wall, and damage to waterside floodwall/boat dock on Edgerley Island south of the epicenter [NSF-GEER; Napa, CA; N38.198 W 122.316; Harder, L. F.; 09/01/14]

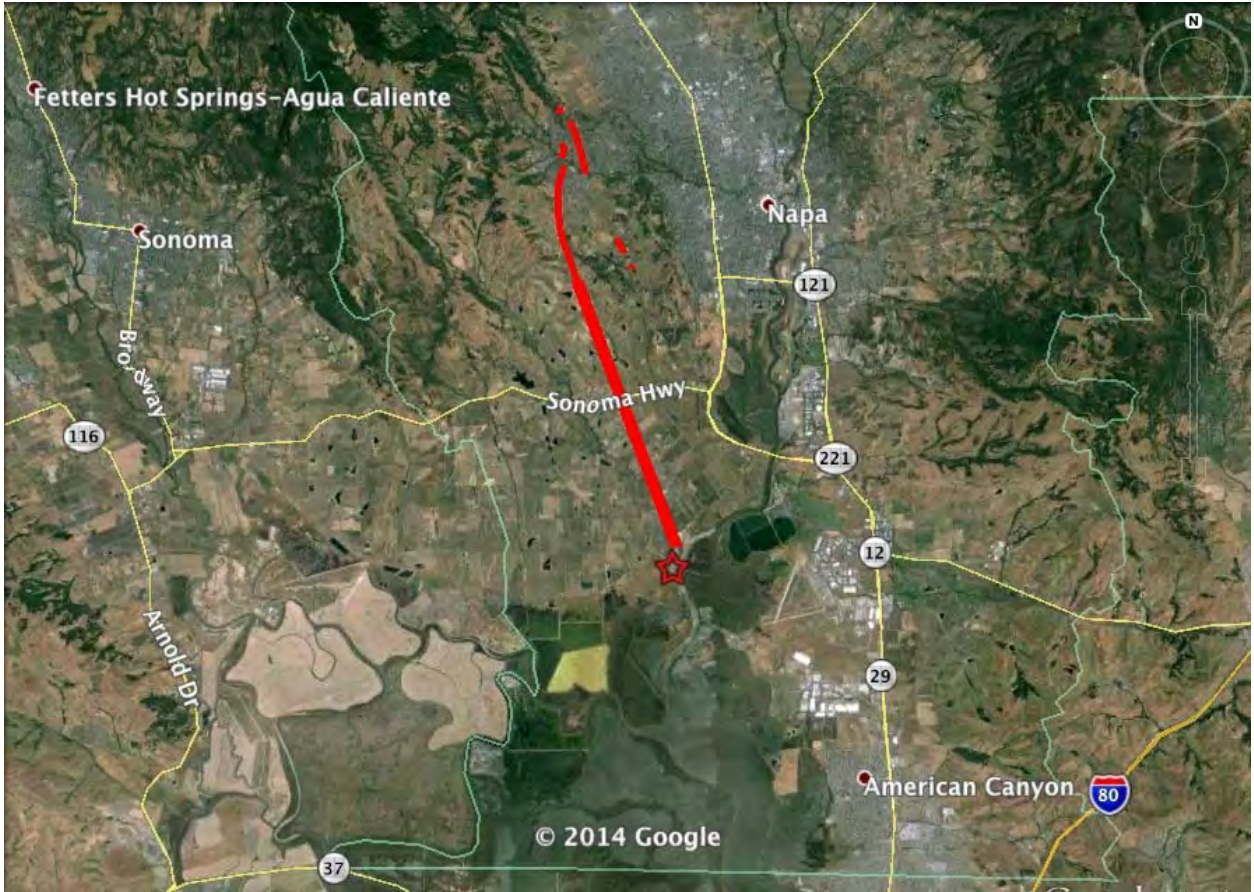
Figure 1. General map of surface fault rupture associated with the M6.0 South Napa earthquake of August 24, 2014.

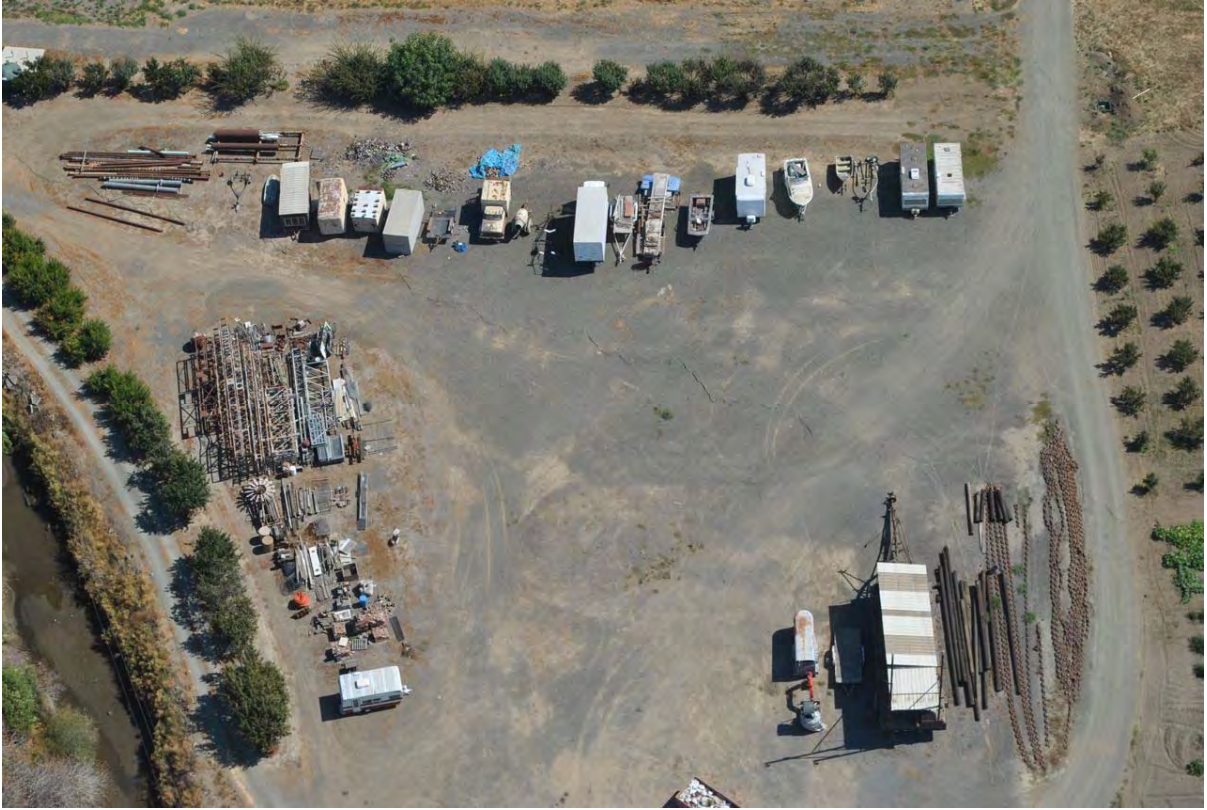
Figure 2. Surface fault rupture at Napa Sea Ranch (0.5 km NW of epicenter), showing left-stepping pattern of transensional cracking. Near-vertical view to the east. [NSF-GEER; GPS N38.225 W122.312; 08/25/14: 11:57 am]

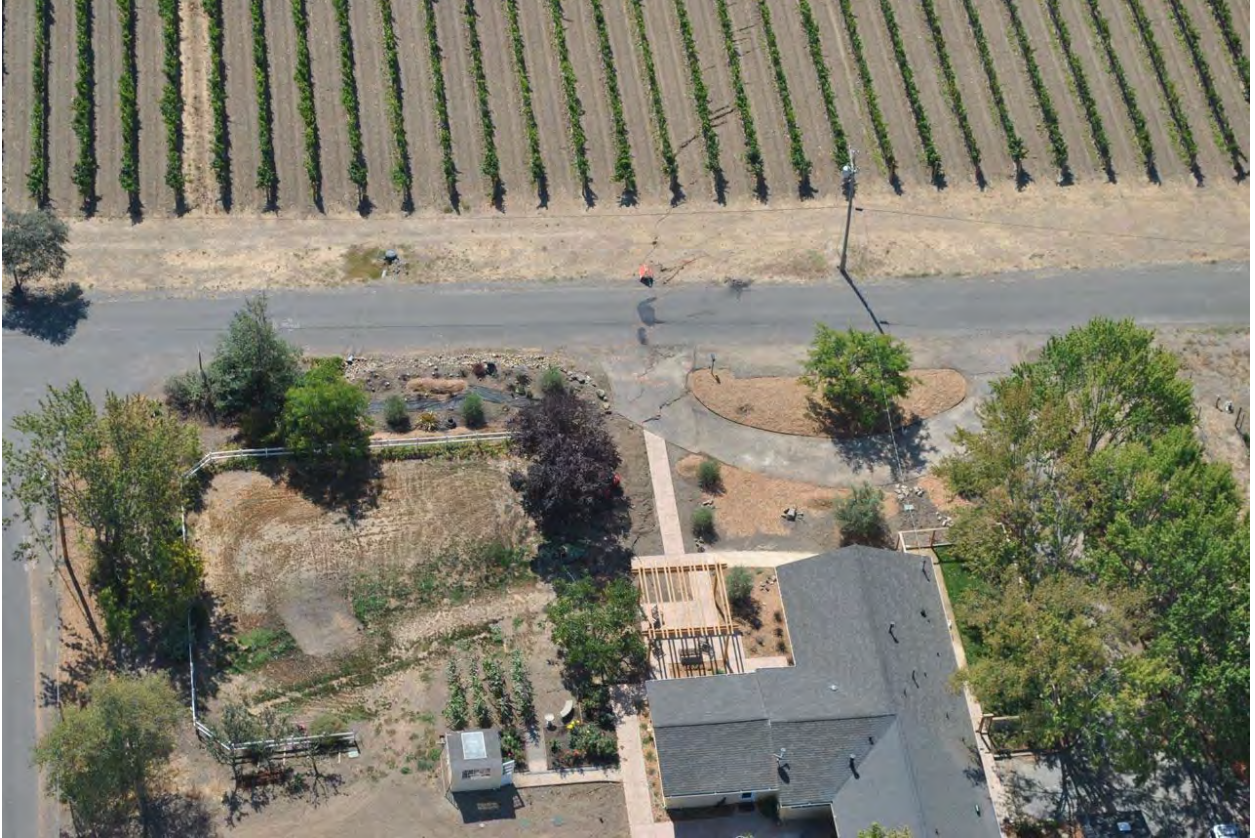
Figure 3. Surface fault rupture at South Avenue (2.5 km NW of epicenter), showing left-stepping pattern of transensional cracking within vineyard, across asphalt, and directly east of residence. Oblique view to the south. [NSF-GEER; GPS N38.242 W122.320; 08/27/14: 11:59 am]

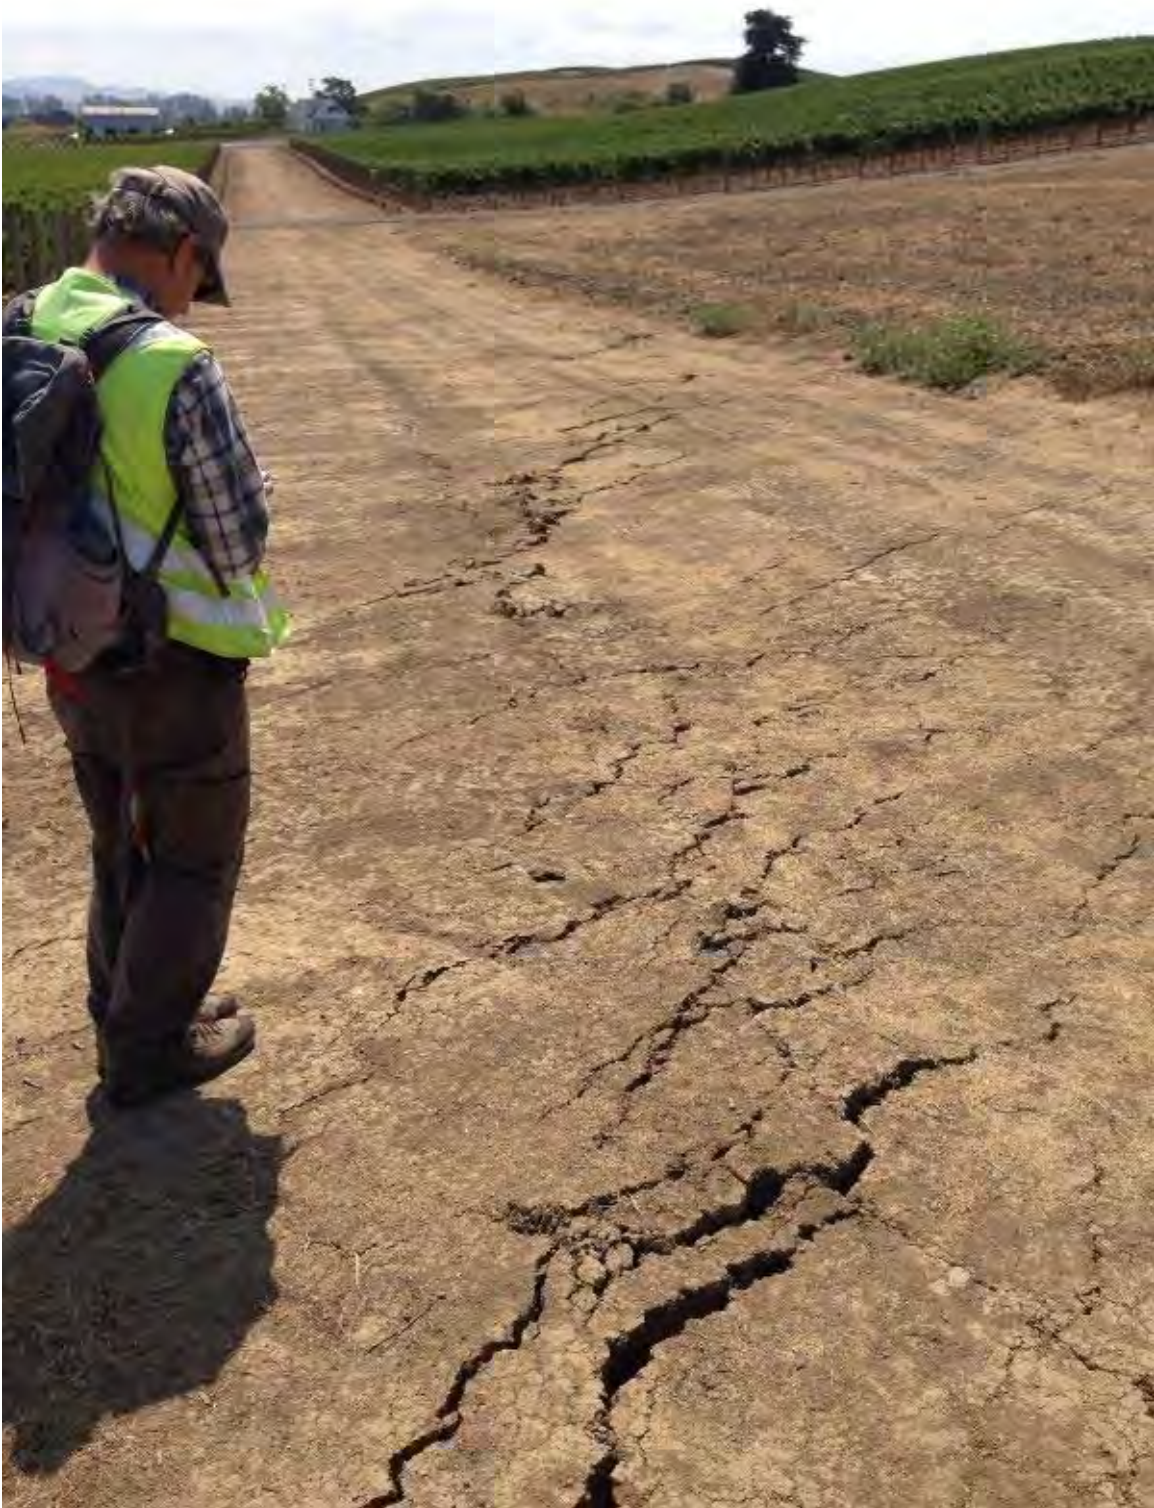
Figure 7. Surface fault rupture at central part of Clos du Val Vineyard (5.9 km NW of epicenter), showing left-stepping pattern of transensional cracking within compacted dirt farm road. View to south-southeast. [NSF-GEER; GPS N38.271 W122.335; 08/25/14: 12:10 pm]

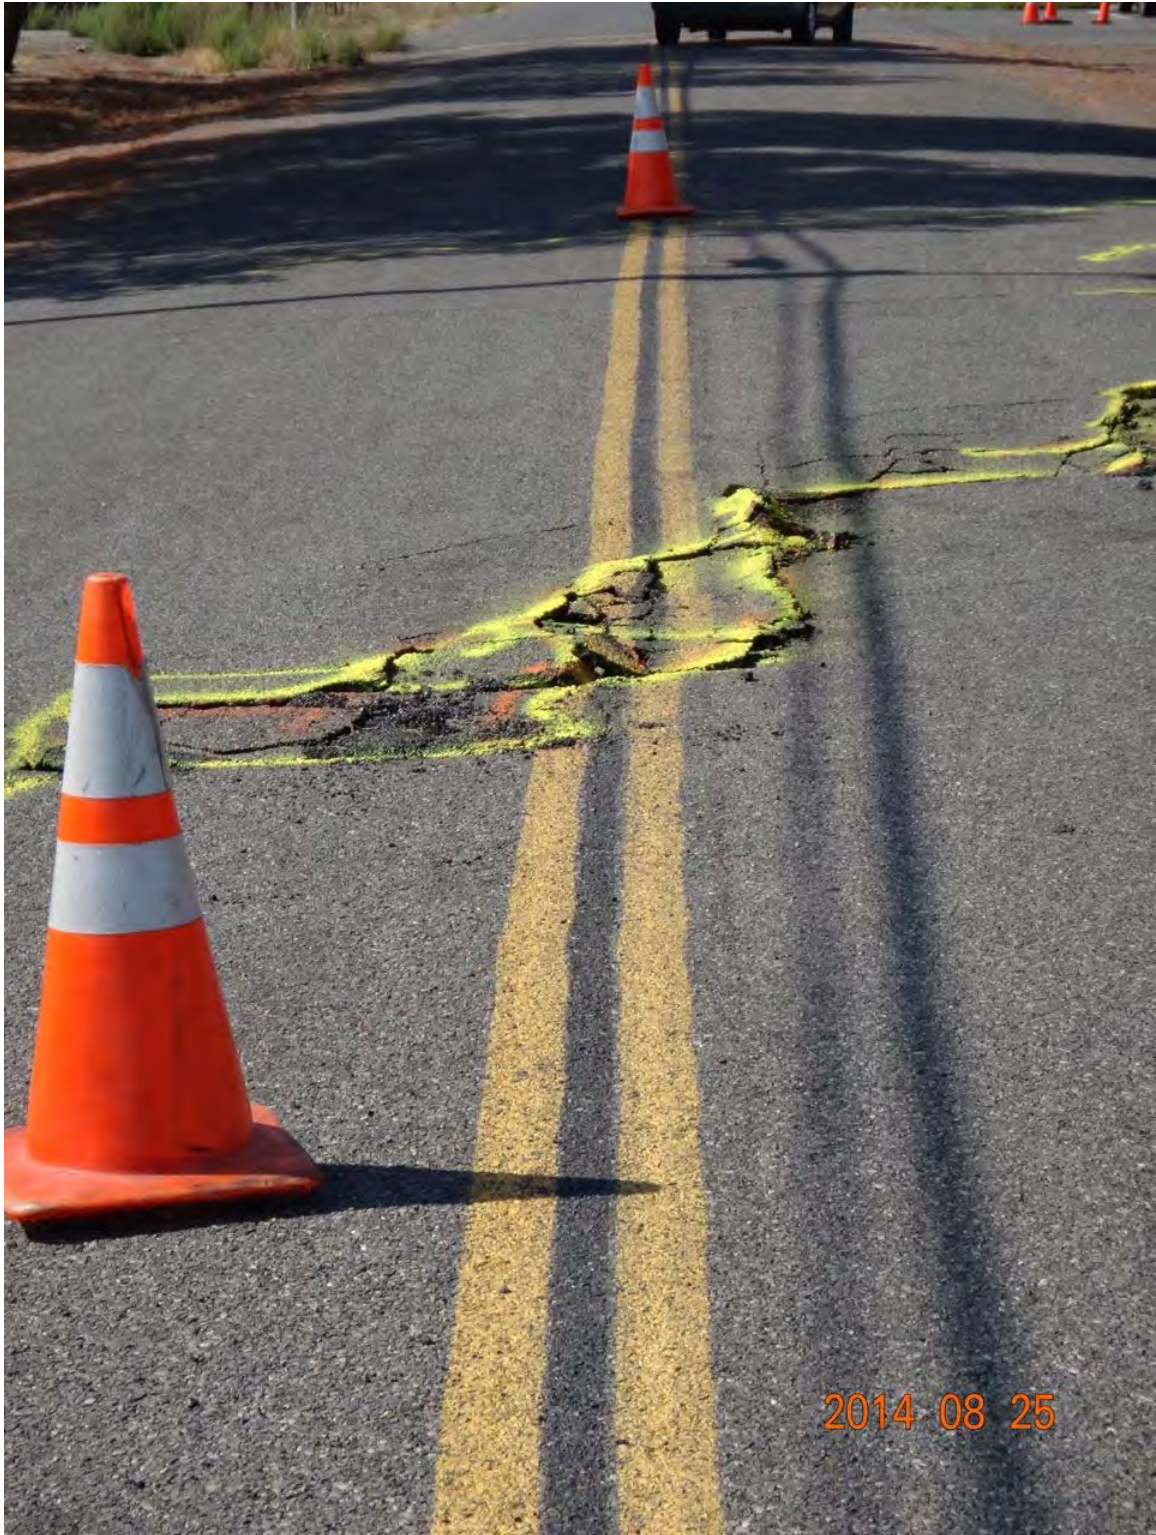
Figure 10. Surface fault rupture at Los Carneros Road (2.5 km NW of epicenter), showing offset of centerline and complex, small-scale deformation in ductile asphalt. View to north. Compare with close up of centerline in Figure 11. [NSF-GEER; GPS N38.2432 W122.3209; 08/25/14: 3:31 pm]

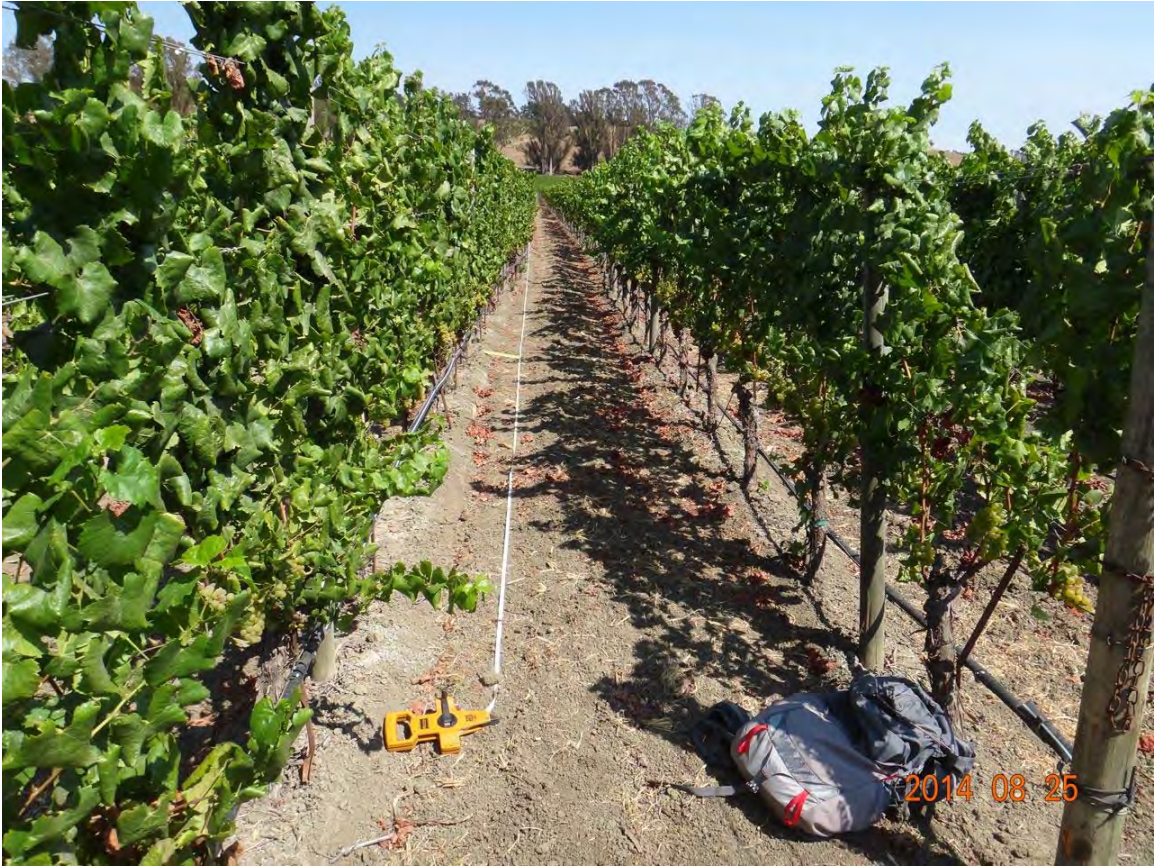
Figure 12. Surface fault rupture at northern part of Clos du Val Vineyard near 2121 Buhman Avenue (6.7 km NW of epicenter), showing measurement alignment along azimuth 090. Yellow engineer's scale is located west of fault zone; offset location is also discernible via offset of vine shadow within the vineyard row. [NSF-GEER; GPS N38.2776 W122.32377; 08/25/14: 2:23 pm]

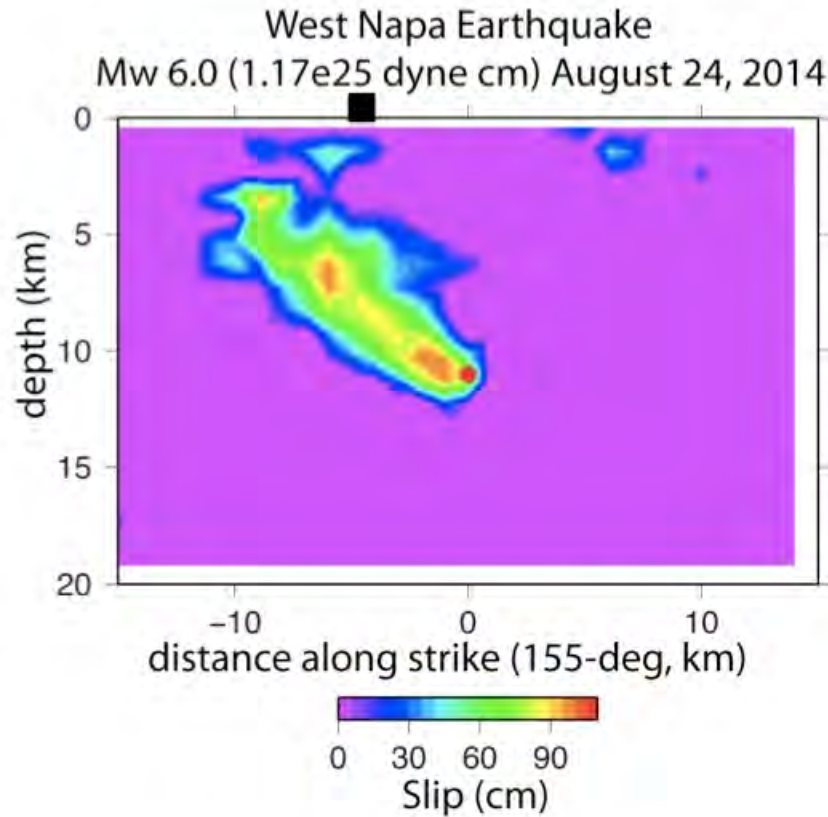
Figure 14. Cross section of slip distribution of the South Napa earthquake, from USGS ([http://earthquake.usgs.gov/earthquakes/eventpage/nc72282711#scientific\\_finite-fault](http://earthquake.usgs.gov/earthquakes/eventpage/nc72282711#scientific_finite-fault); accessed September 14, 2014; 1800), modified to show approximate location of largest field measurement of right-lateral offset at northern Clos du Val vineyard (black square at surface added by authors).

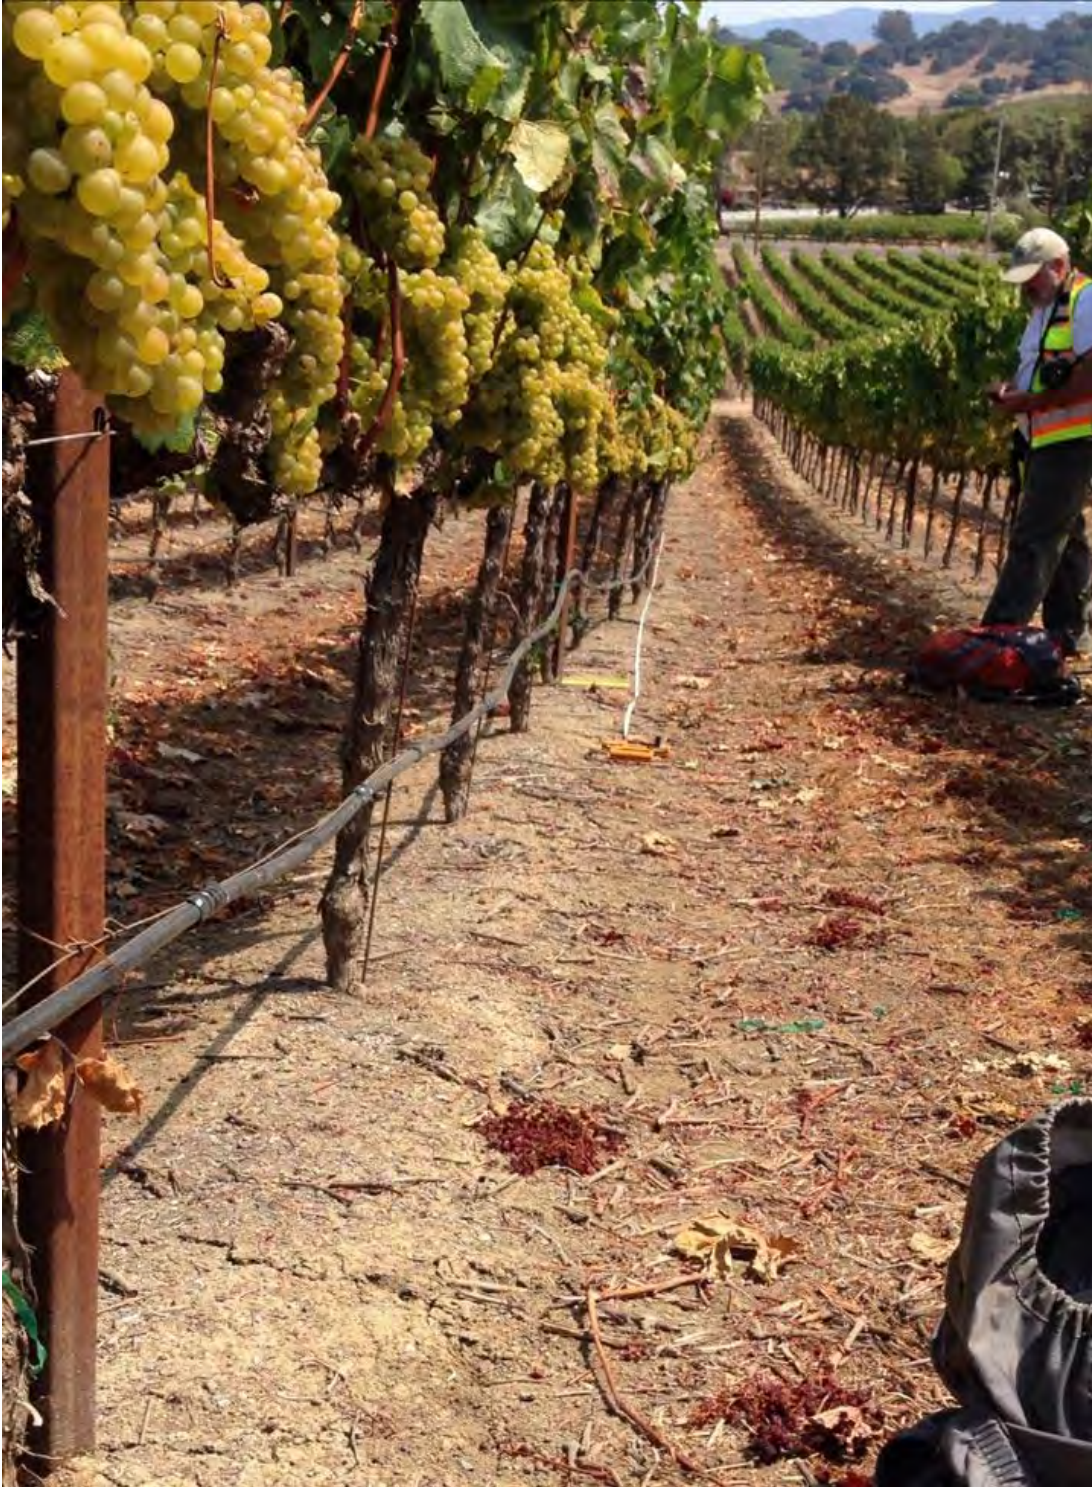
Figure 16. Surface fault rupture at southern part of Clos du Val Vineyard near Old Sonoma Road (5.6 km NW of epicenter), showing measurement alignment along azimuth 058. This vineyard row is about 40 m northwest of similar row shown on Figure 12; also shows 20 to 25 cm of apparent lateral offset. Geologist Wesling standing on fault zone [NSF-GEER; GPS N38.2672 W122.3343; 08/25/14: 11:51 am]

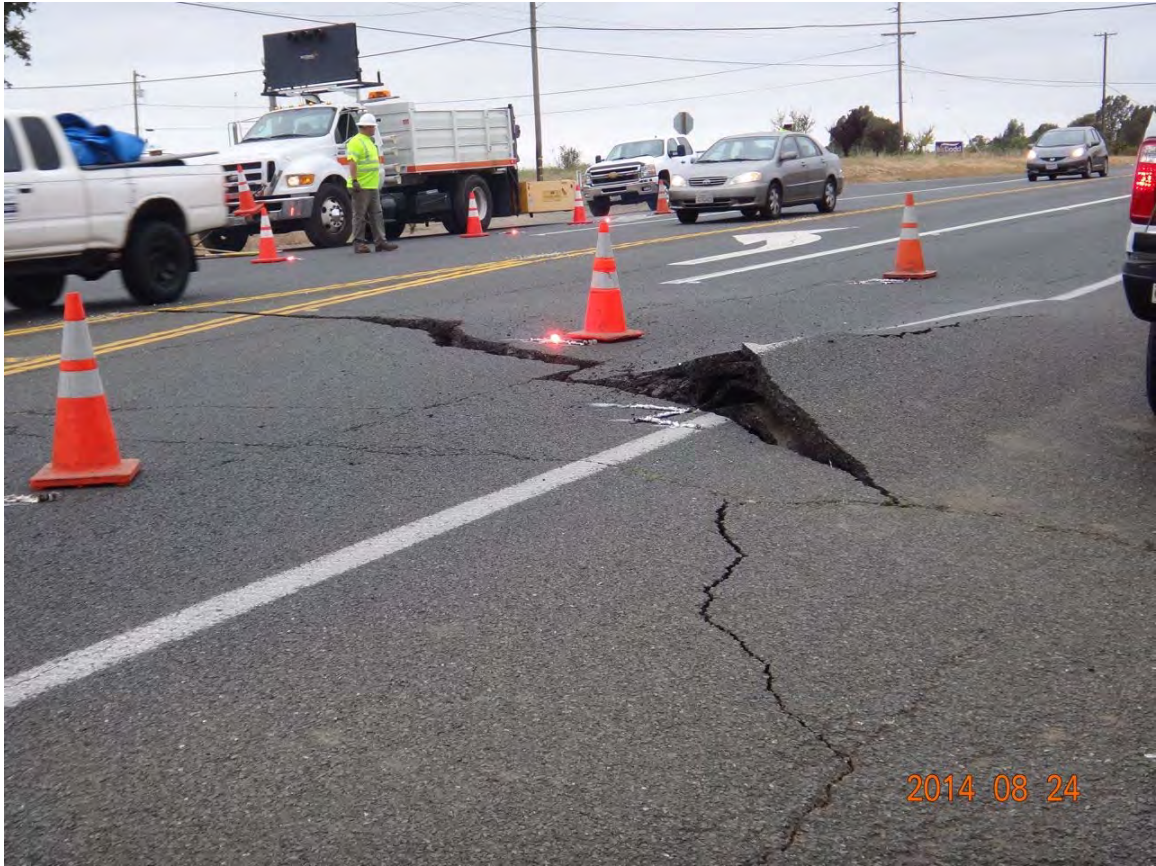
Figure 20. Surface fault rupture at Highway 12 (4.2 km NW of epicenter), showing increased buckling of asphalt on northern margin and lateral offset. Taken at 0746 local time, this photograph precedes road repairs. [NSF-GEER; GPS N38.256 W122.327; 08/24/14: 7:46 am]
