## GEOTECHNICAL EXTREME EVENTS RECONNAISSANCE (GEER) ASSOCIATION

*Turning Disaster into Knowledge*

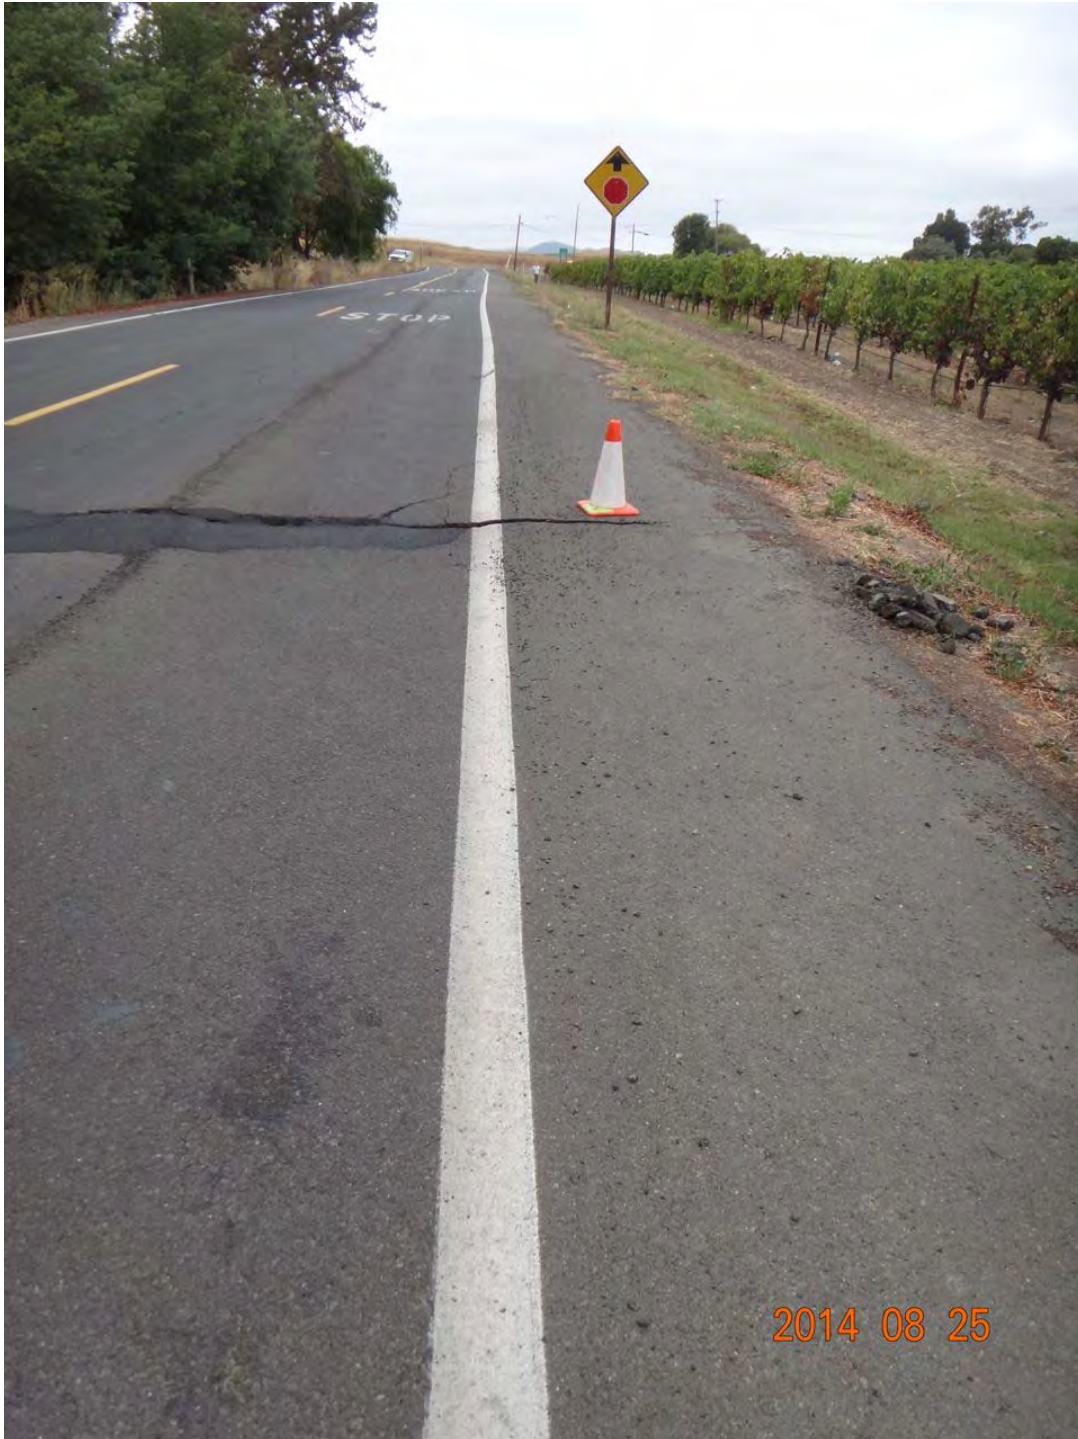
Figure 21. Surface deformation at Cuttings Wharf Road (4.0 km NW of epicenter), showing recent development of scarp across asphalt (photograph taken at 1000). Field reconnaissance at 0600 on August 24, 2014 observed no deformation along the road at this site. [NSF-GEER; GPS N38.2544 W122.3265; 08/25/14: 9:57 am]

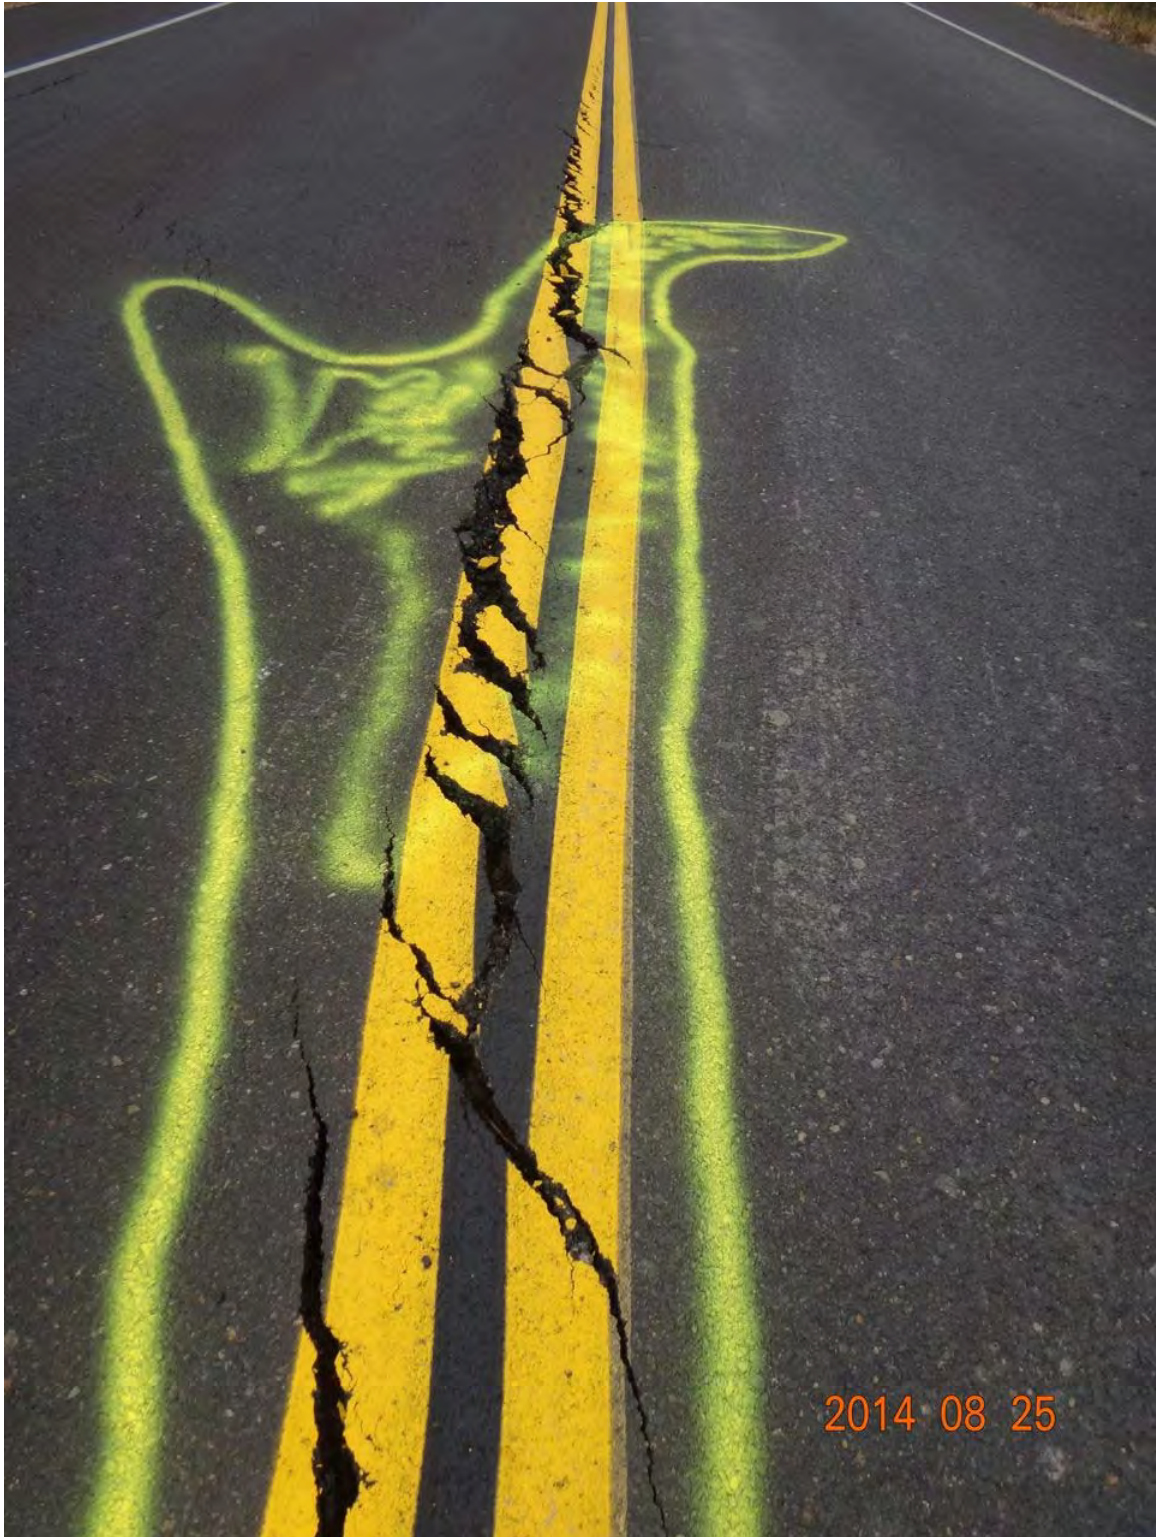
Figure 23. Surface deformation at Old Sonoma Road (5.4 km NW of epicenter, photograph taken on August 25 at 1036, about 29 hours after main shock). Compare with photograph in Figure 22 [NSF-GEER; GPS N38.2659 W122.3338; 08/25/14: 10:36 am].

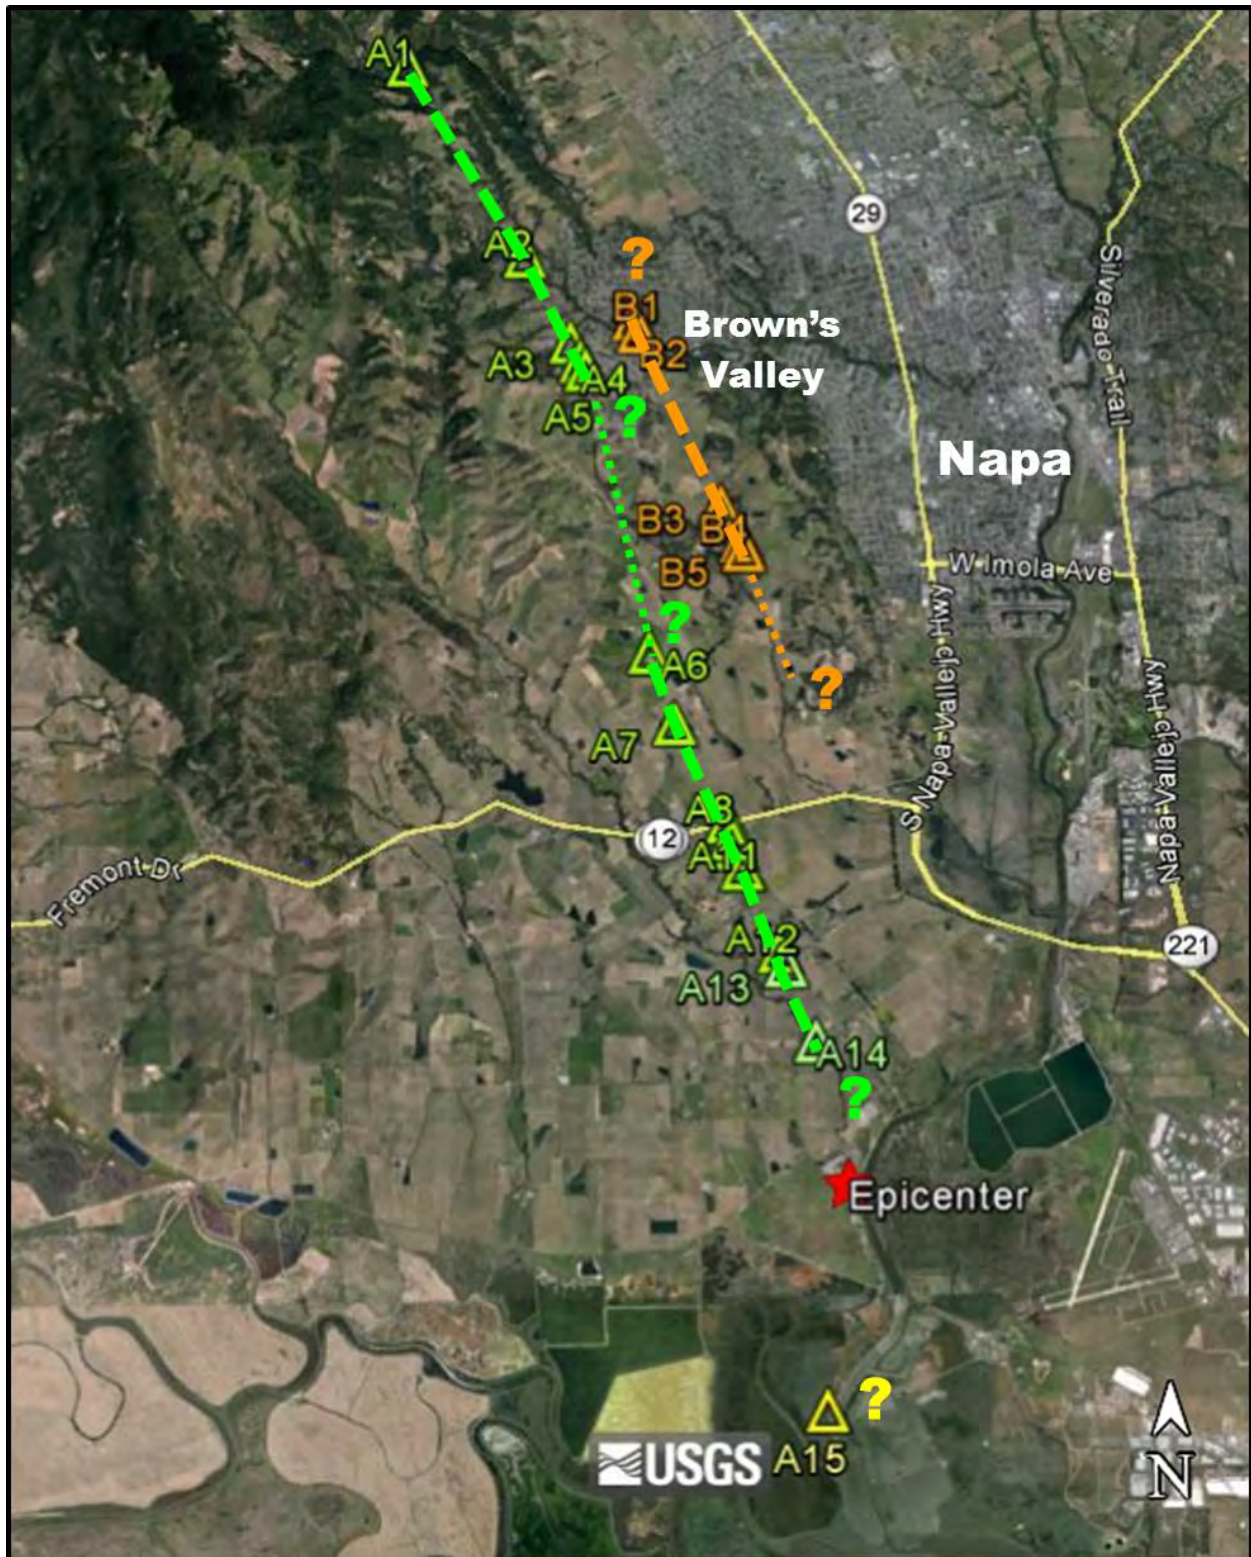
Figure 1: Alignment of surface cracking observed following August 24, 2014 Magnitude 6 Napa Earthquake (adapted from Google Earth [NSF-GEER; Napa, CA, processed 09/03/14])

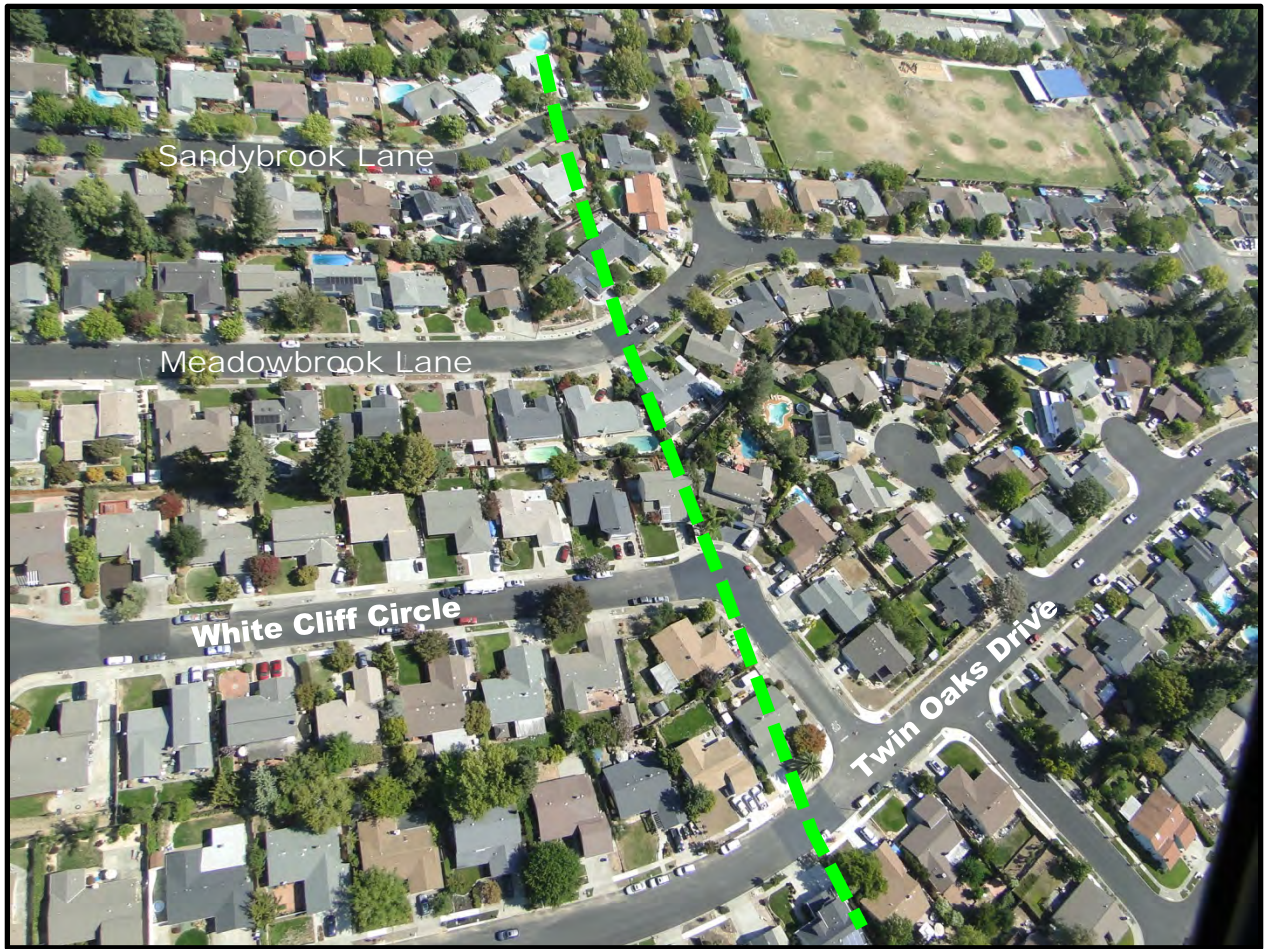
Figure 2: Alignment of surface cracking observed along Alignment A in Browns Valley following August 24, 2014 Magnitude 6 Napa Earthquake - see dark asphalt patches [NSF-GEER; Napa, CA; N 38.304 W 122.344; Harder, L. F.; 09/01/14]

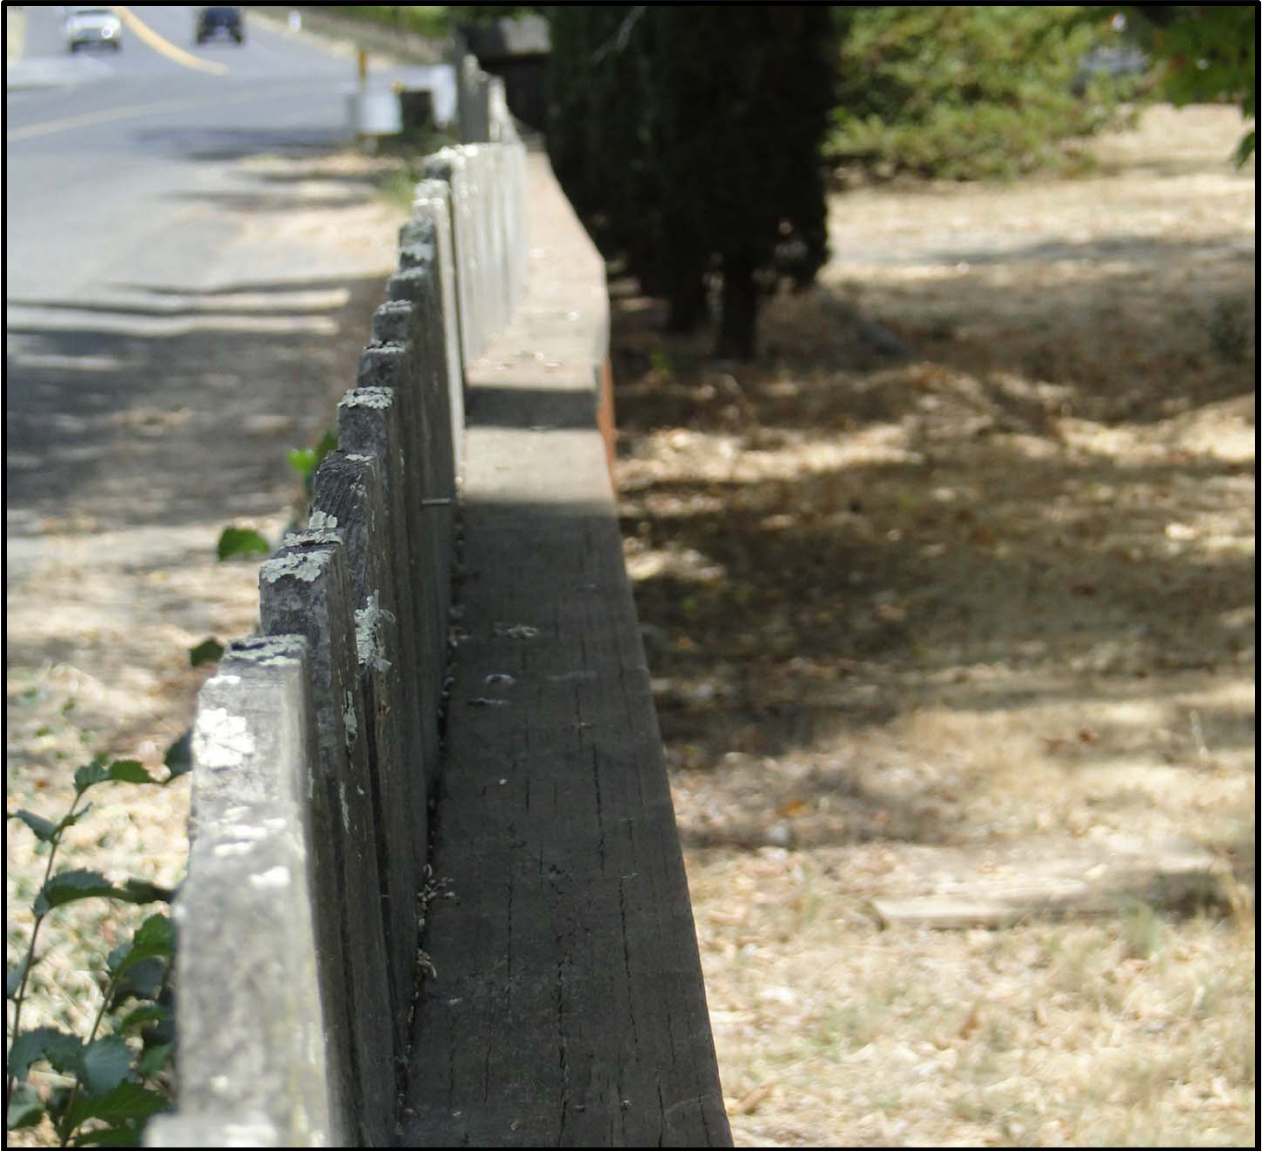
Figure 5: Photograph of wooden fence displaced by ground cracking in front of residence (Congress Valley Road, Point B4) – looking easterly  
– right lateral fence displacement across ground cracking is approximately 5 to 8 centimeters  
[NSF-GEER; Napa, CA; N 38.284 W 122.325; Harder, L. F.; 08/29/14]

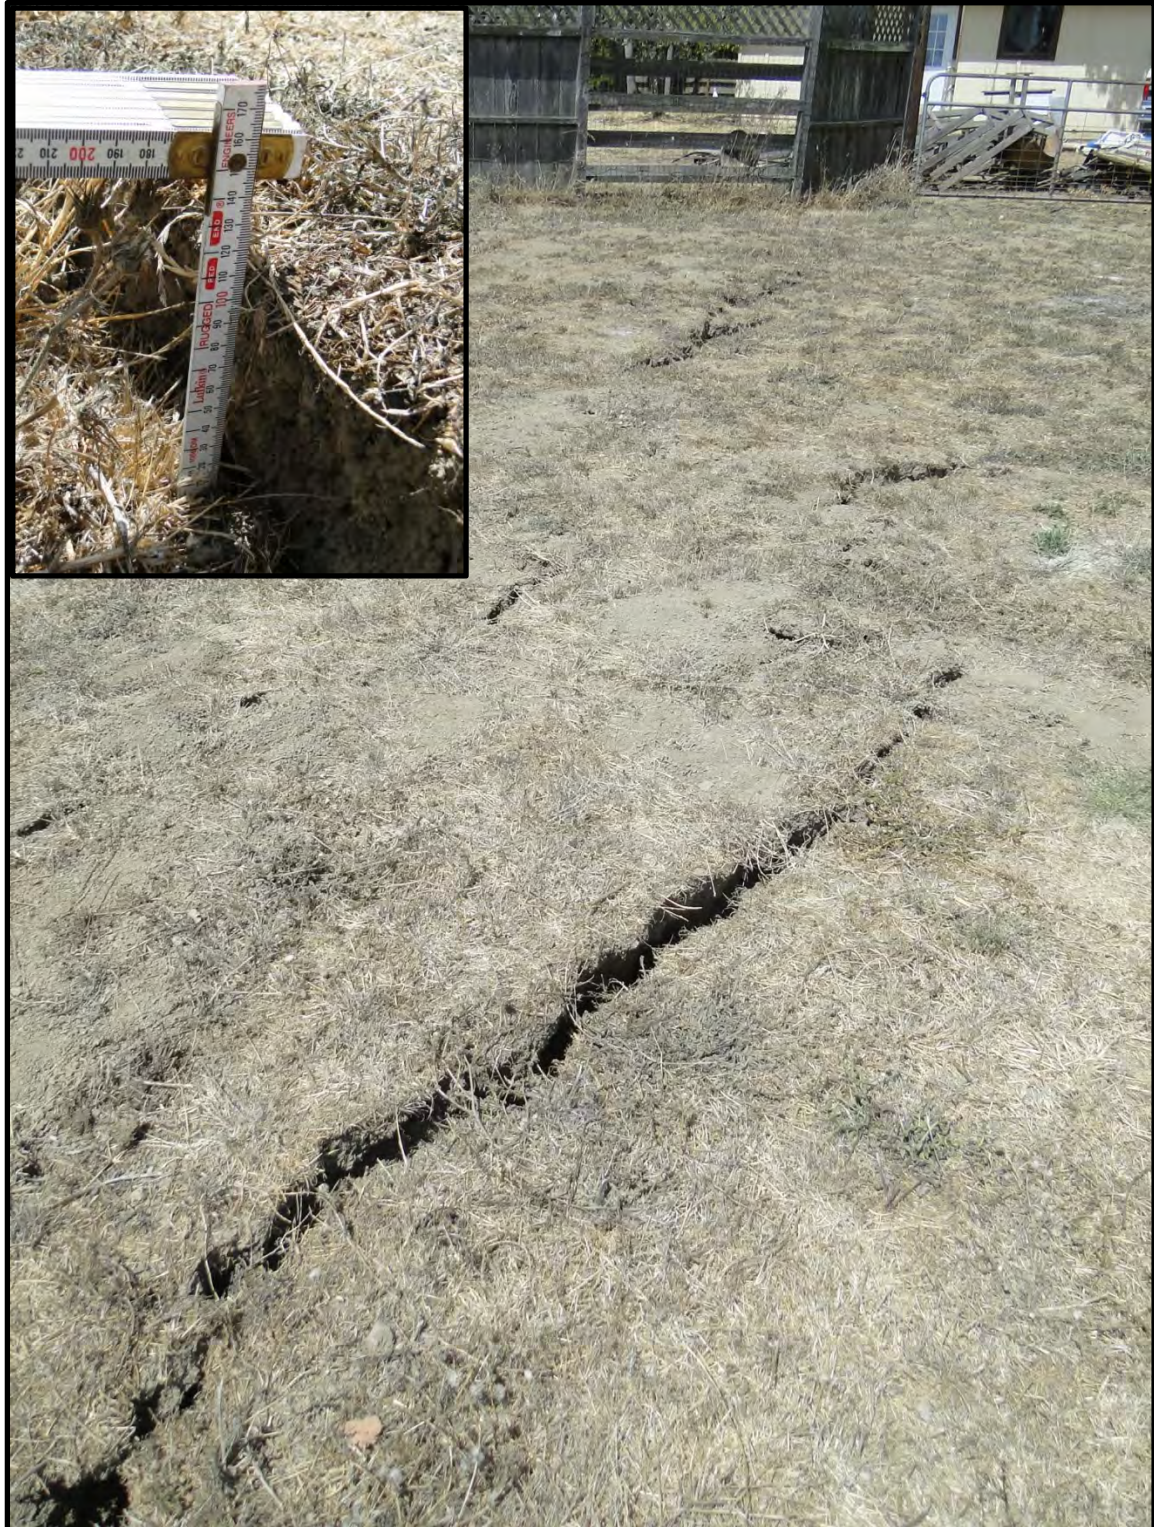
Figure 7: Photograph of ground cracking on property  
(Congress Valley Road, Point B4) – looking northerly from damaged Old Sonoma Road  
(Point 5) - vertical offset up to 12 centimeters with west side up  
[NSF-GEER; Napa, CA; N 38.284 W 122.325; Harder, L. F.; 08/29/14]

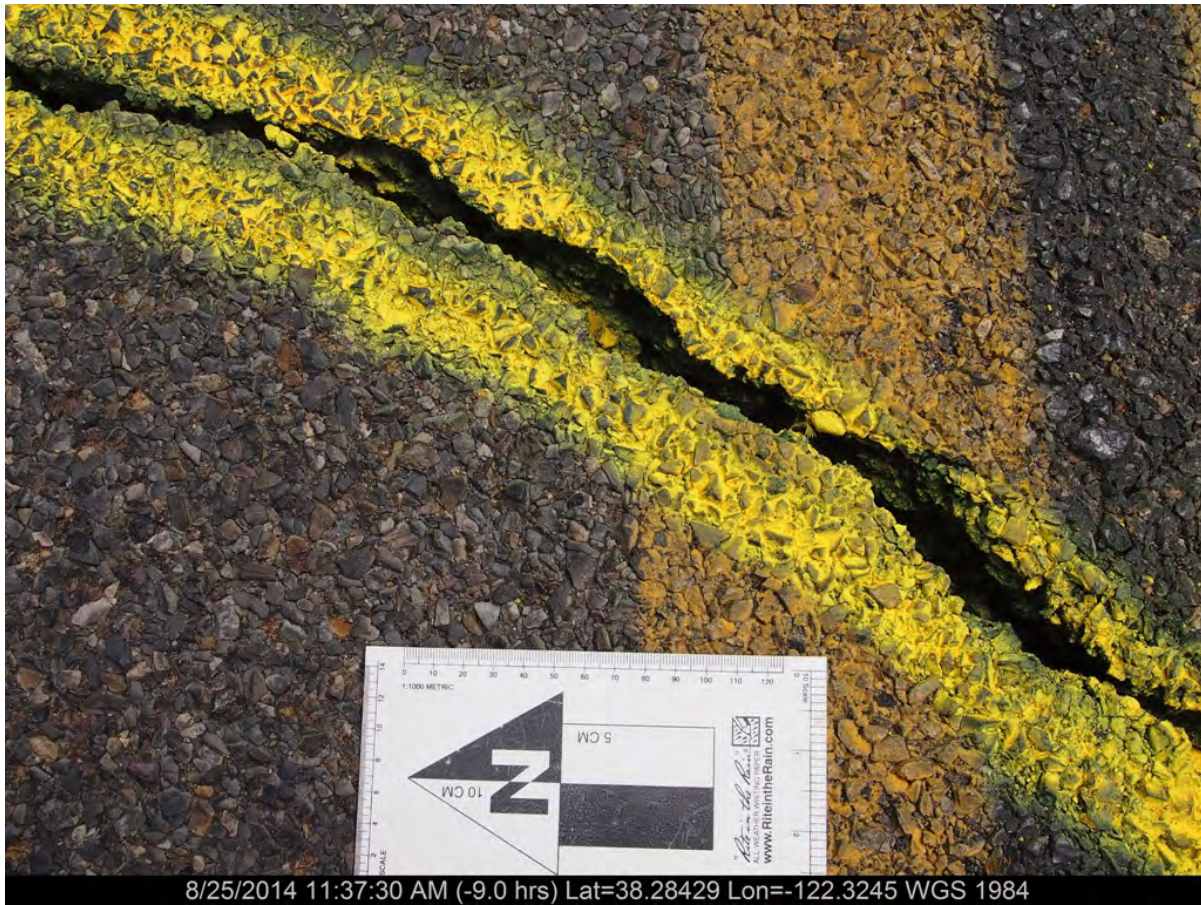
Figure 2. Photograph showing approximately 3.5 cm of right lateral separation of NW margin of yellow centerline on Congress Valley Rd. [NSF-GEER; N38.2842, W122.3245; 08/25/14; 11:37 AM]

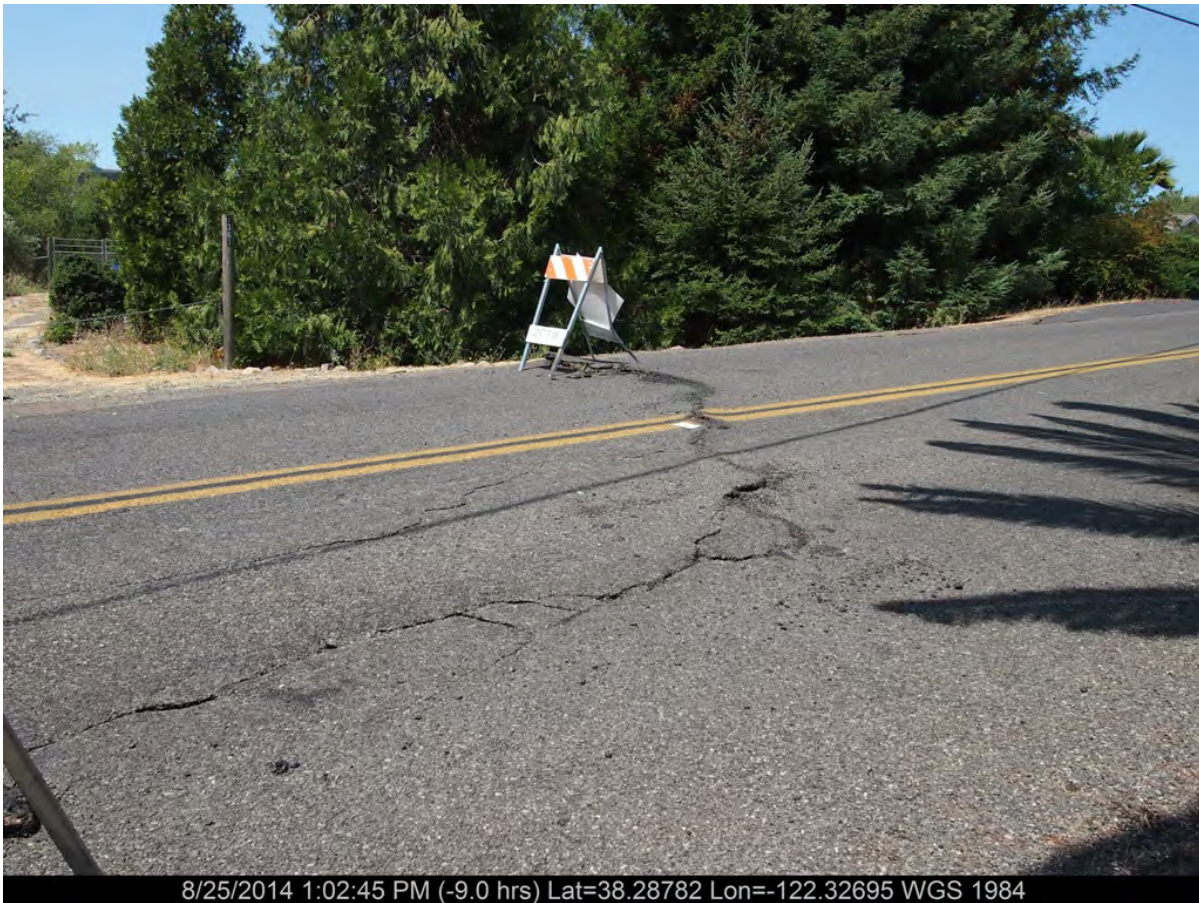
Figure 3. Photograph showing cracking in paved surface of N-S oriented Thompson Rd. [NSF-GEER; N38.2878, W122.3269; 08/25/14; 1:02 PM]

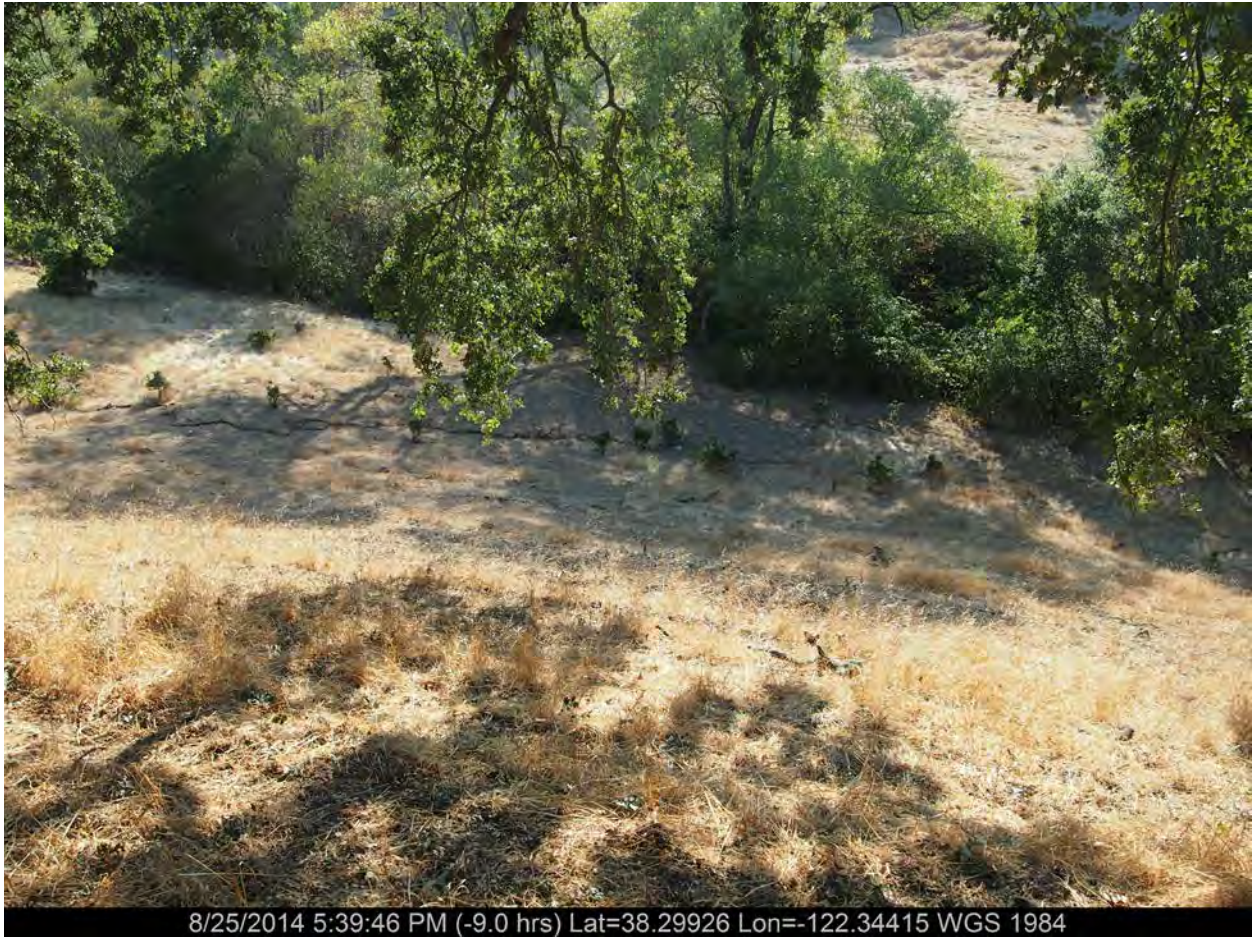
Figure 7. Photograph showing linear mole track in alluvial surface adjacent to unnamed creek. Location is along trend with deformation shown in Figures 5 and 6. Feature estimated at appx.20 m long, with apparent vertical displacement of appx.3-4 cm. [NSF-GEER; N38.2992, W122.3441; 08/25/14; 5:39 PM]

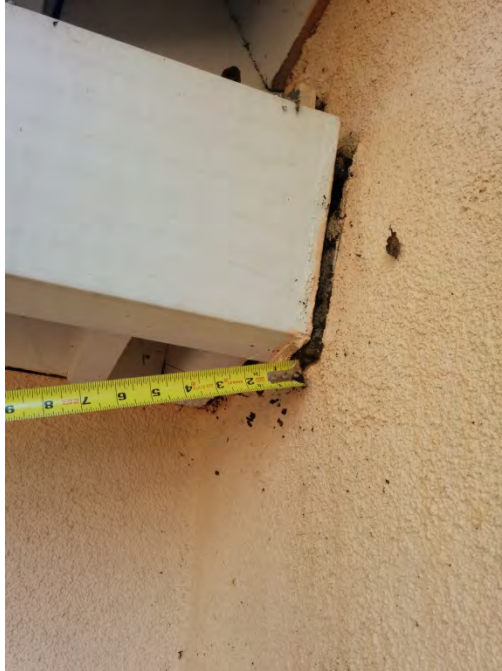
Figure C-H01-2: Roof Beam separated from wall due to shearing. [NSF-GEER; N 38.3135 W 122.3431; 08/28/14 17:08]

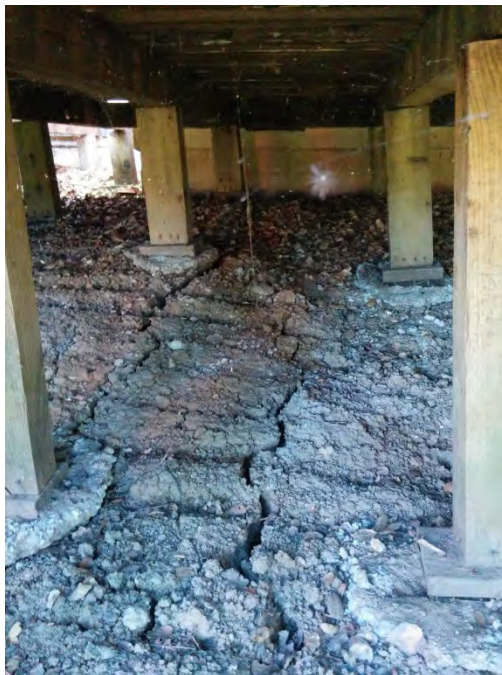
Figure C-H01-3: South looking view of ground rupture under deck coming from under severely damaged house on pier foundations. [NSF-GEER; N 38.3135 W 122.3431; 08/28/14 17:15]

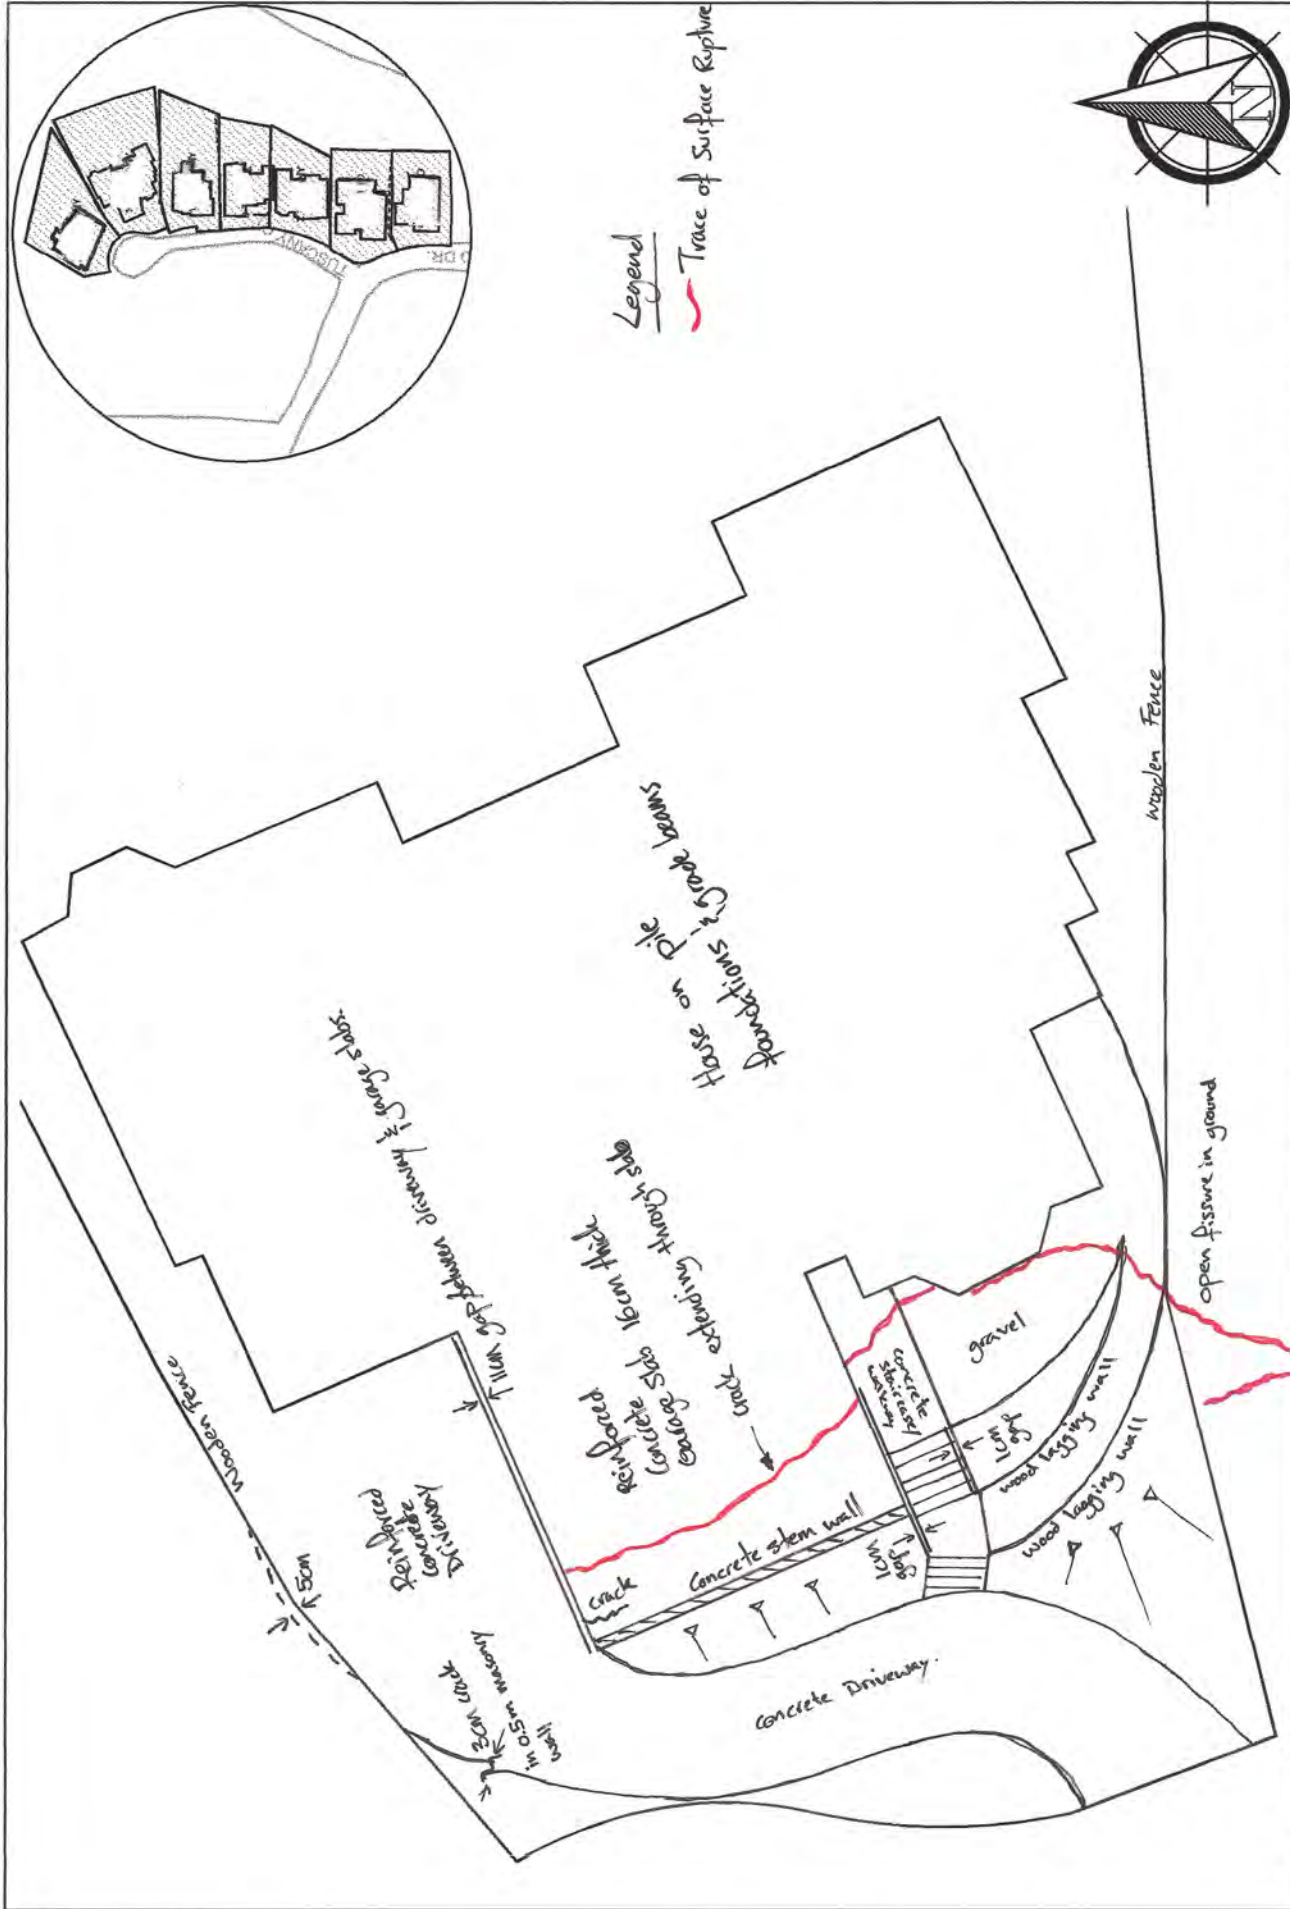
EVENT: AMERICAN CANYON EQ $M_w = 6.0$	ADDRESS: 38.3133 -122.3431	HOZ	DRAWING BY: J. Cohen-Weber J. Weber, G. Harris, S. Fosti
	DATE OF INSPECTION: 08/28/2014	DATE OF DRAWING: 08/28/2014	
DESCRIPTION: Surface fault rupture through private residence.		5 m

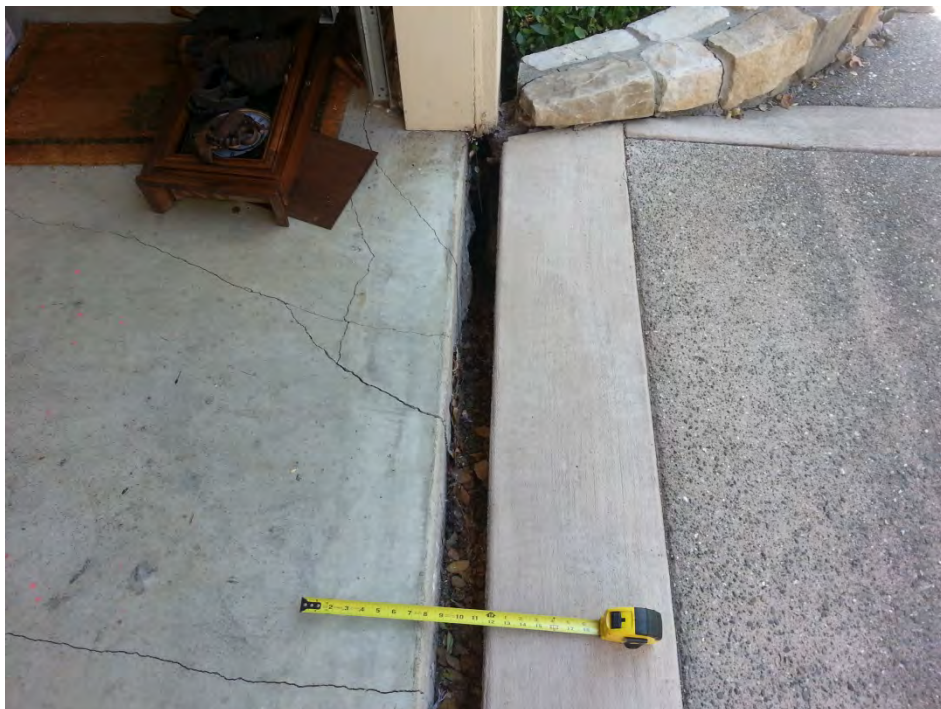
Figure C-H02-3: West looking view of driveway/garage slab separation and crack extending through 6 inch reinforced slab. [NSF-GEER; N 38.3133 W 122.3431; 08/28/14 12:44]

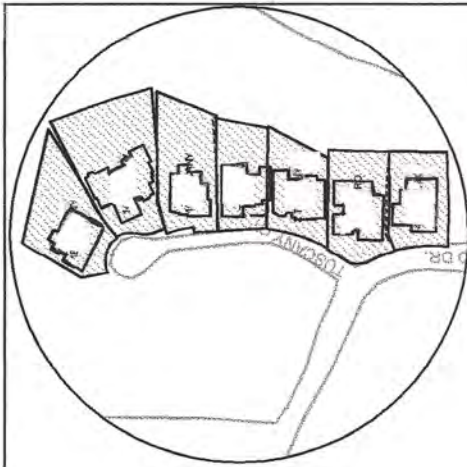
Legend  
 ~ Trace of surface Rupture

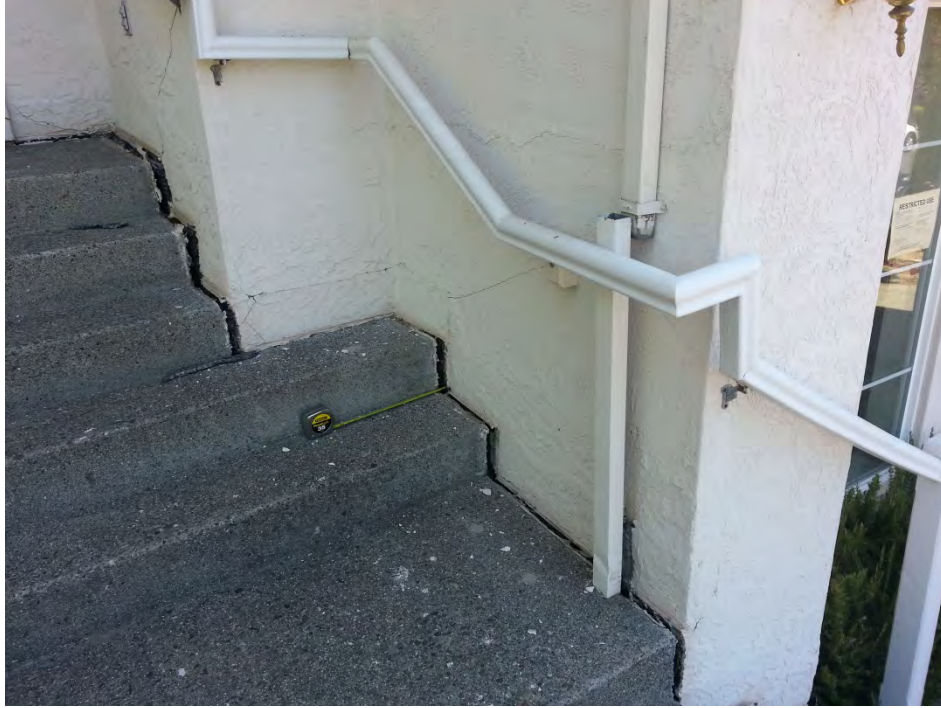
Figure C-H03-2: SE looking view of stair case/structure separation and cracks. [NSF-GEER; N 38.3131 W 122.3431; 08/28/14 11:52]

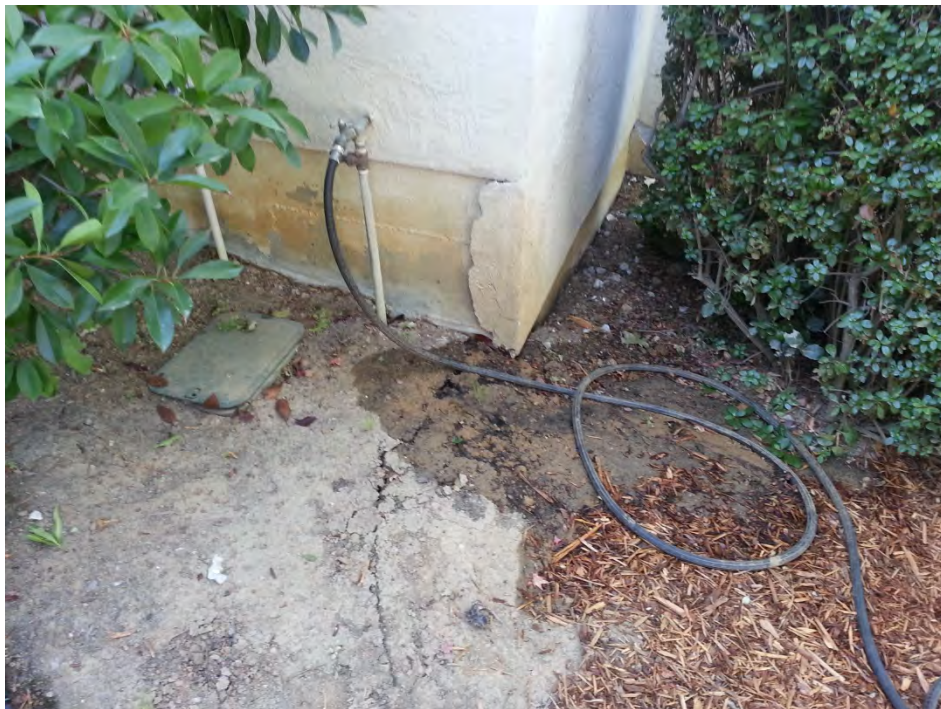
Figure C-H03-3: SE looking view of structure pushed off of foundation. [NSF-GEER; N 38.3131 W 122.3431; 08/28/14, 11:54]

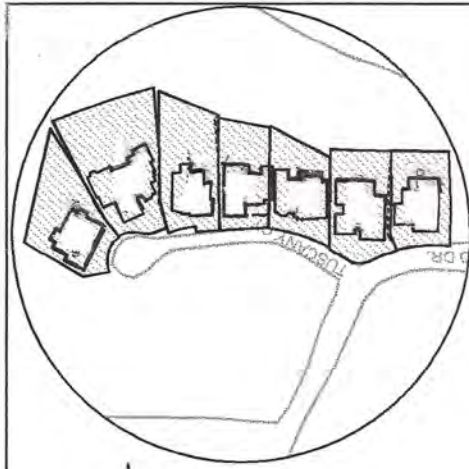
Legend  
 Trace of surface Rupture

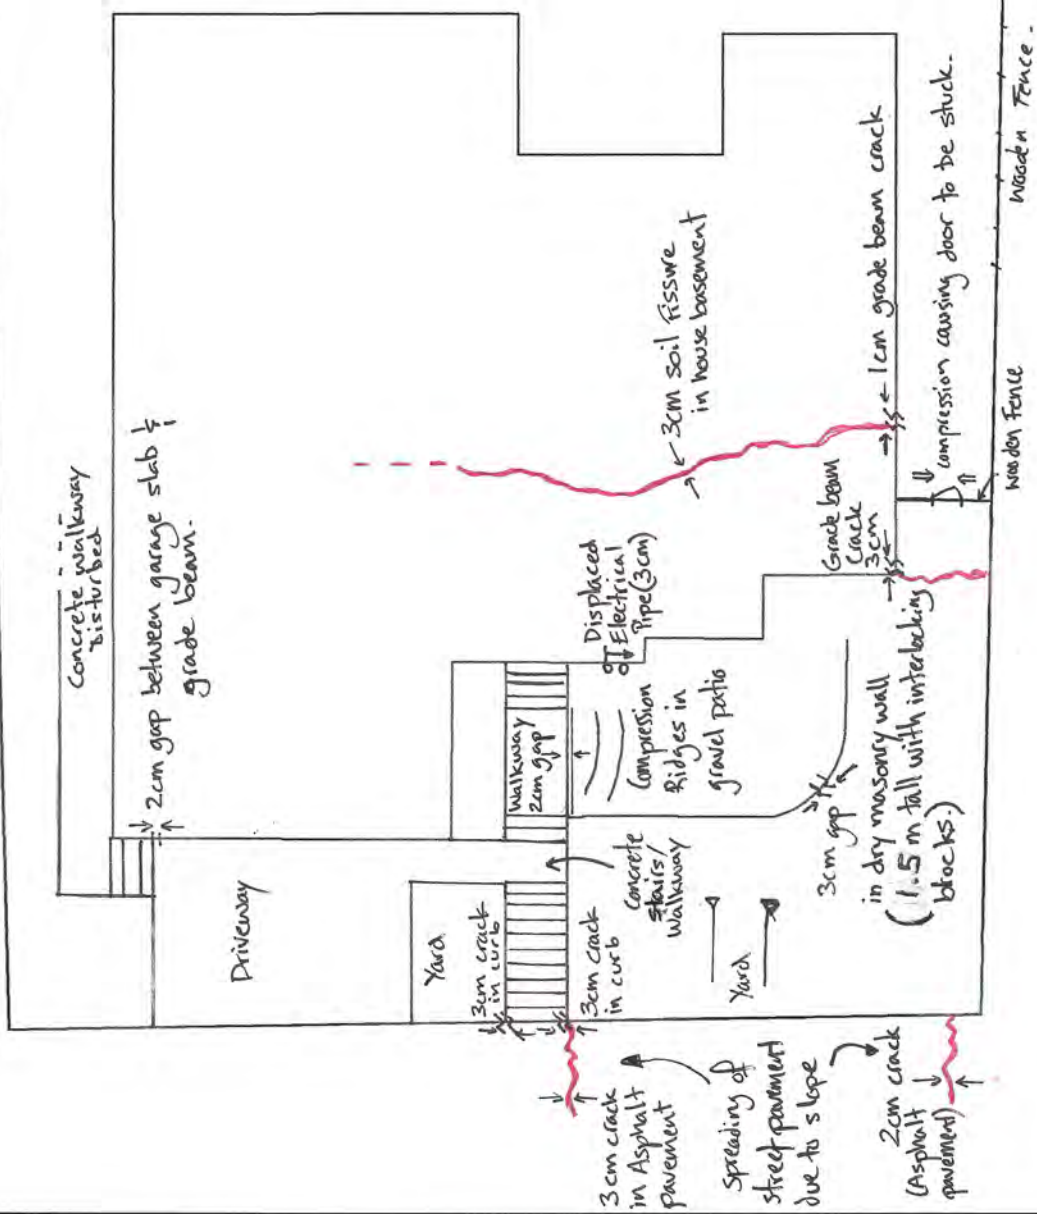
EVENT:	AMERICAN CANYON EQ Mw = 6.0	ADDRESS:	38.3128 - 122.3431	(404)	DRAWING BY:	J. Cohen-Weber
	DESCRIPTION:	Surface fault rupture through private property.	DATE OF INSPECTION:	08/28/2014	DATE OF DRAWING:	08/28/2014	J. Weber, G. Harris, S. Fati
			SCALE:	1 cm : 2 m			
							5 m

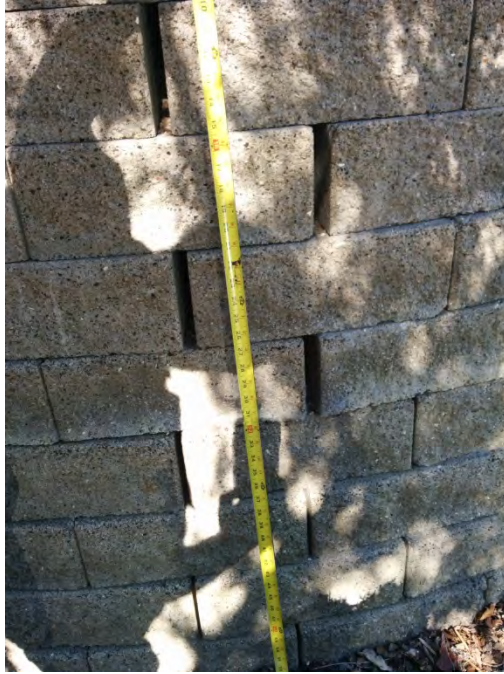
Figure C-H04-2: Displaced masonry wall. [NSF-GEER; N 38.3128 W 122.3431; 08/28/14, 16:32]

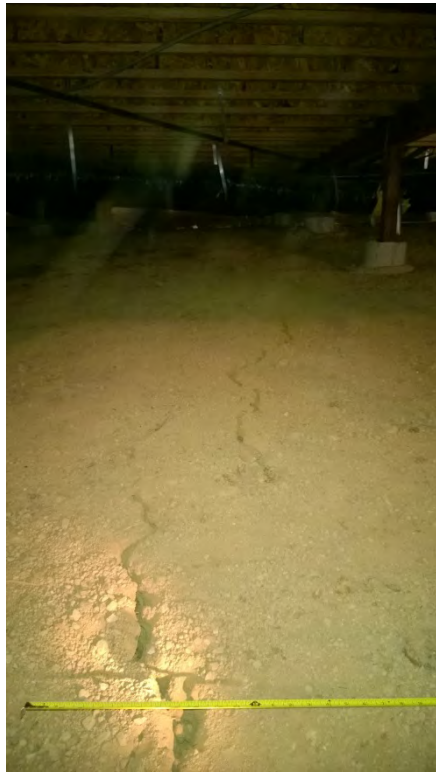
Figure C-H04-5: Soil fissure in basement. [NSF-GEER; N 38.3128 W 122.3431; 08/28/14, 12:08]
