## GEOTECHNICAL EXTREME EVENTS RECONNAISSANCE (GEER) ASSOCIATION

*Turning Disaster into Knowledge*

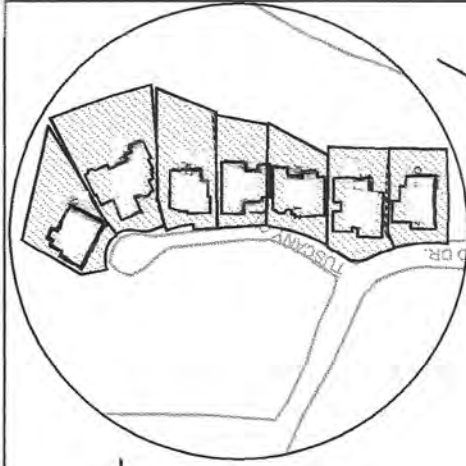
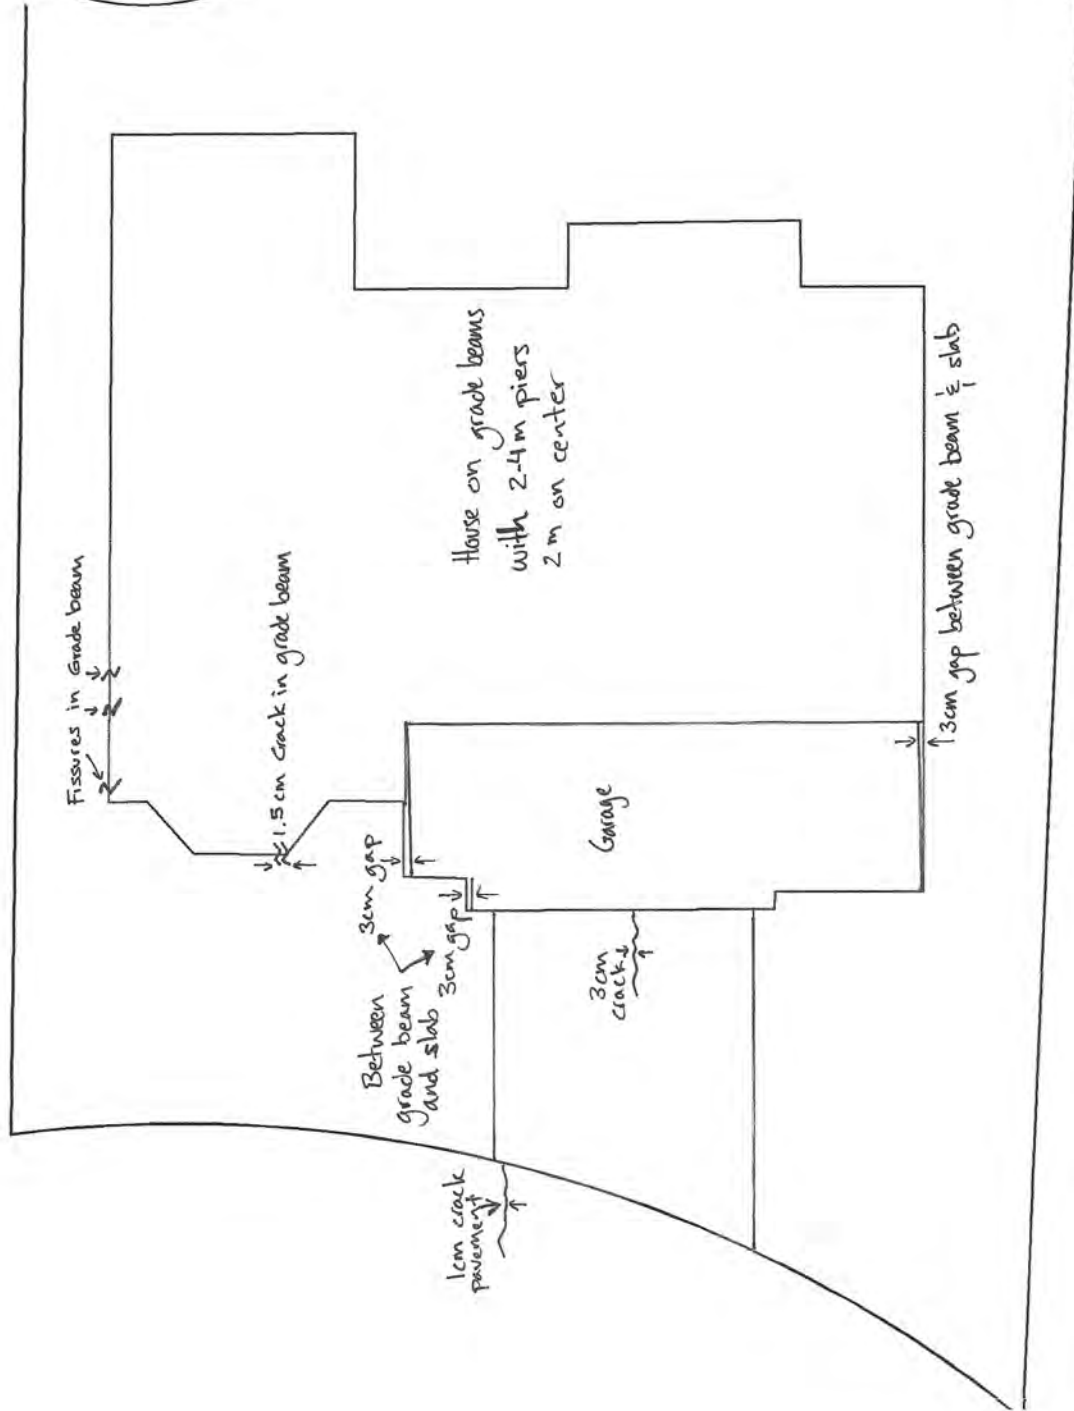
EVENT: AMERICAN CANYON EQ Mw = 6.0 DESCRIPTION: Surface fault Rupture through Private property.	ADDRESS: 38.3126 -122.3431 DATE OF INSPECTION: 08/28/2014	DRAWING BY: J. Cohen-Waerber J. Waerber, G. Harris, S. Foti SCALE: 1 cm : 2 m 	
--	--	--	---	--

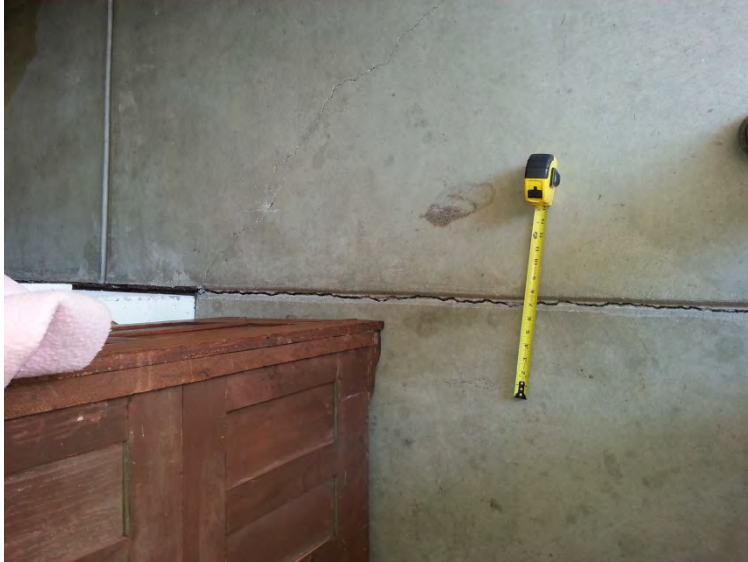
Figure C-H05-2: Cracked slab foundation in garage. [NSF-GEER; N 38.3126 W 122.3431; 08/28/14, 15:20]

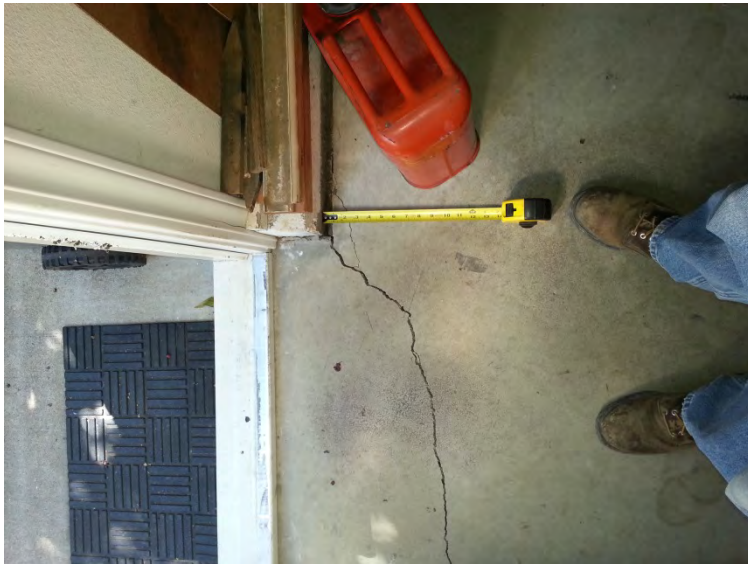
Figure C-H05-3: Cracked slab and separation from footing. [NSF-GEER; N 38.3126 W 122.3431; 08/28/14, 15:20]

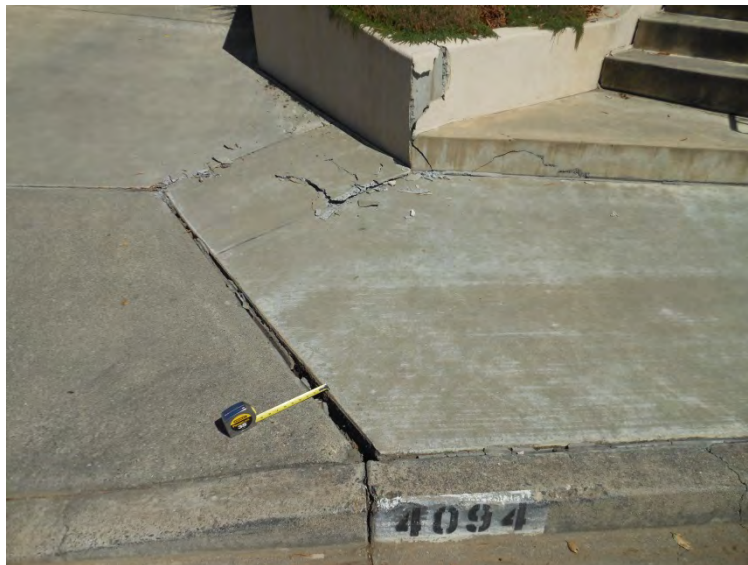
Figure C-H07-3: Crack extending along stair case and joint. [NSF-GEER; N 38.3122 W 122.3432; 08/28/14]

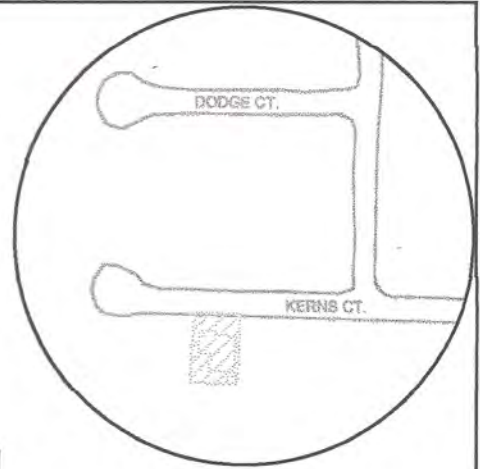
Legend  
Trace of surface rupture.

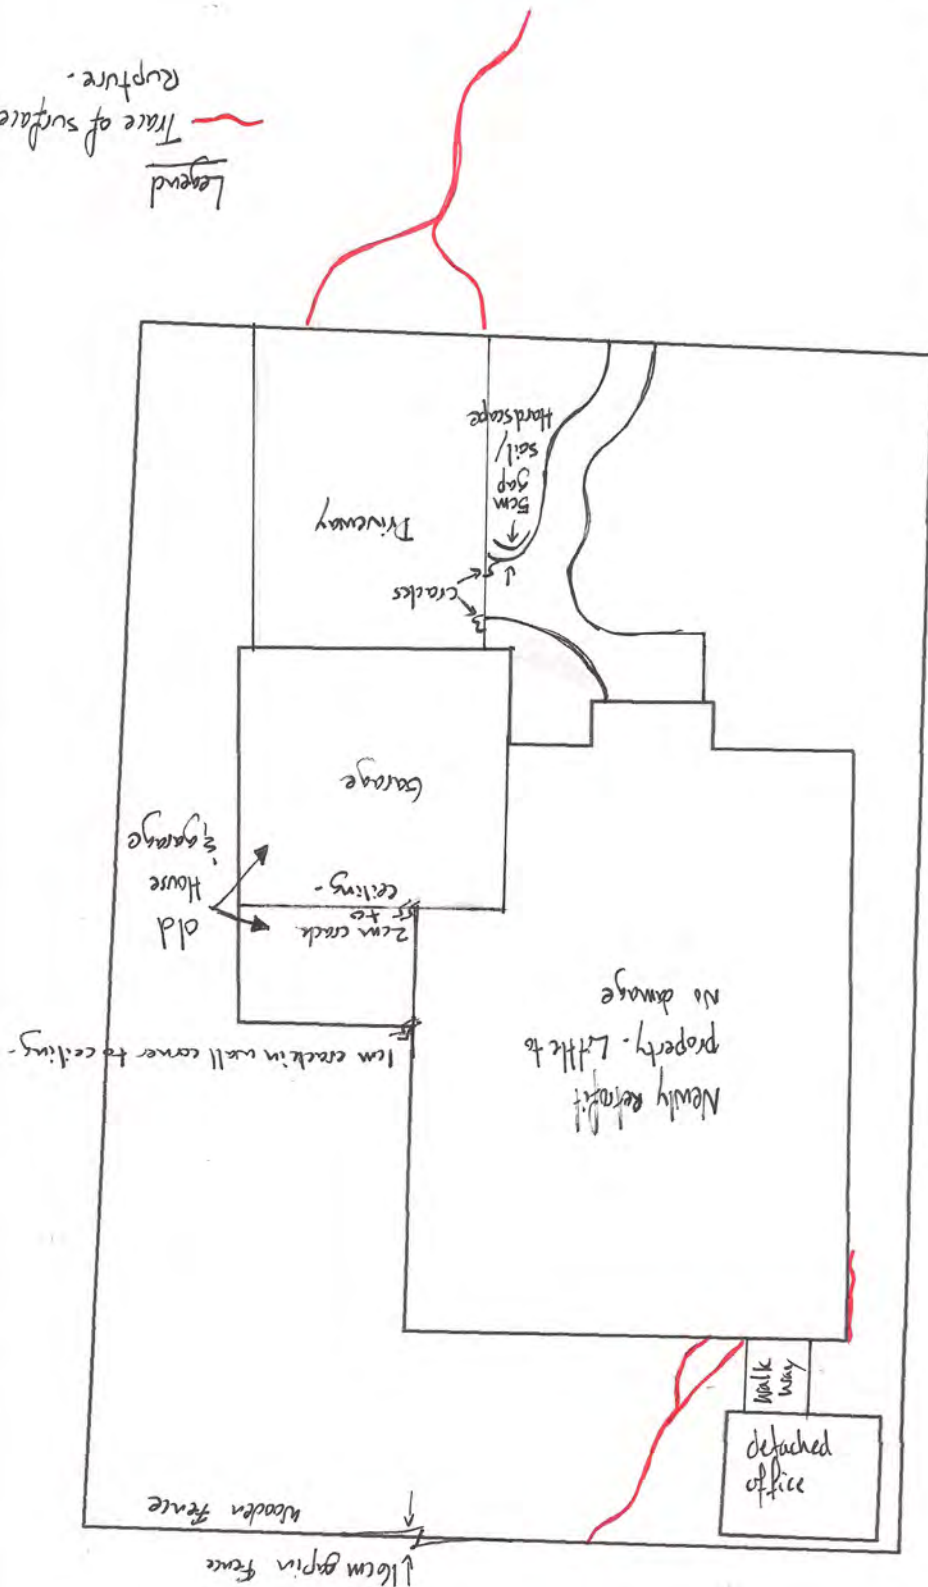
EVENT: AMERICAN CANYON EQ $M_w = 6.0$	ADDRESS: 36.3082 -122.3427	(H14)	DRAWING BY: J. Cohen-Waeber	
	DESCRIPTION: Surface fault + Rupture through Private Property.	DATE OF INSPECTION: 08/28/2014	DATE OF DRAWING: 08/28/2014	SCALE: 1 cm : 2 m

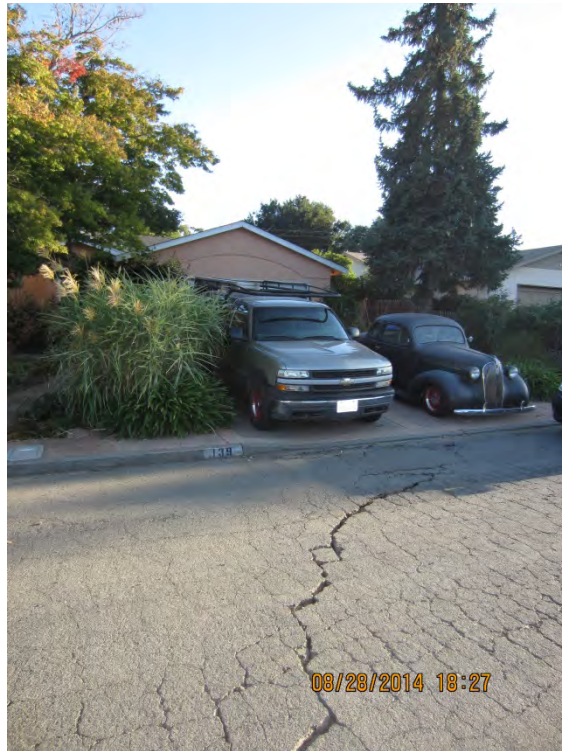
Figure C-H14-3: Street Crack. [NSF-GEER; N 38.3082 W 122.3427; 08/28/14, 18:27]

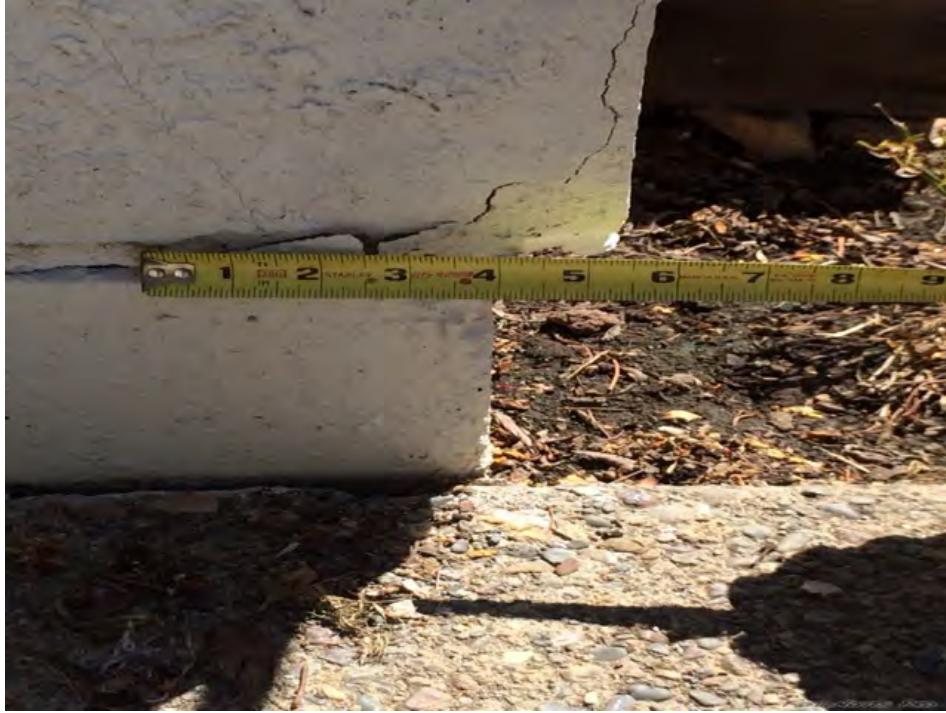
Figure C-H17-2: Movement of the ground and foundation with respect to the wall [NSF-GEER; N 38.3066 W 122.3427; 09/05/14 16:01]

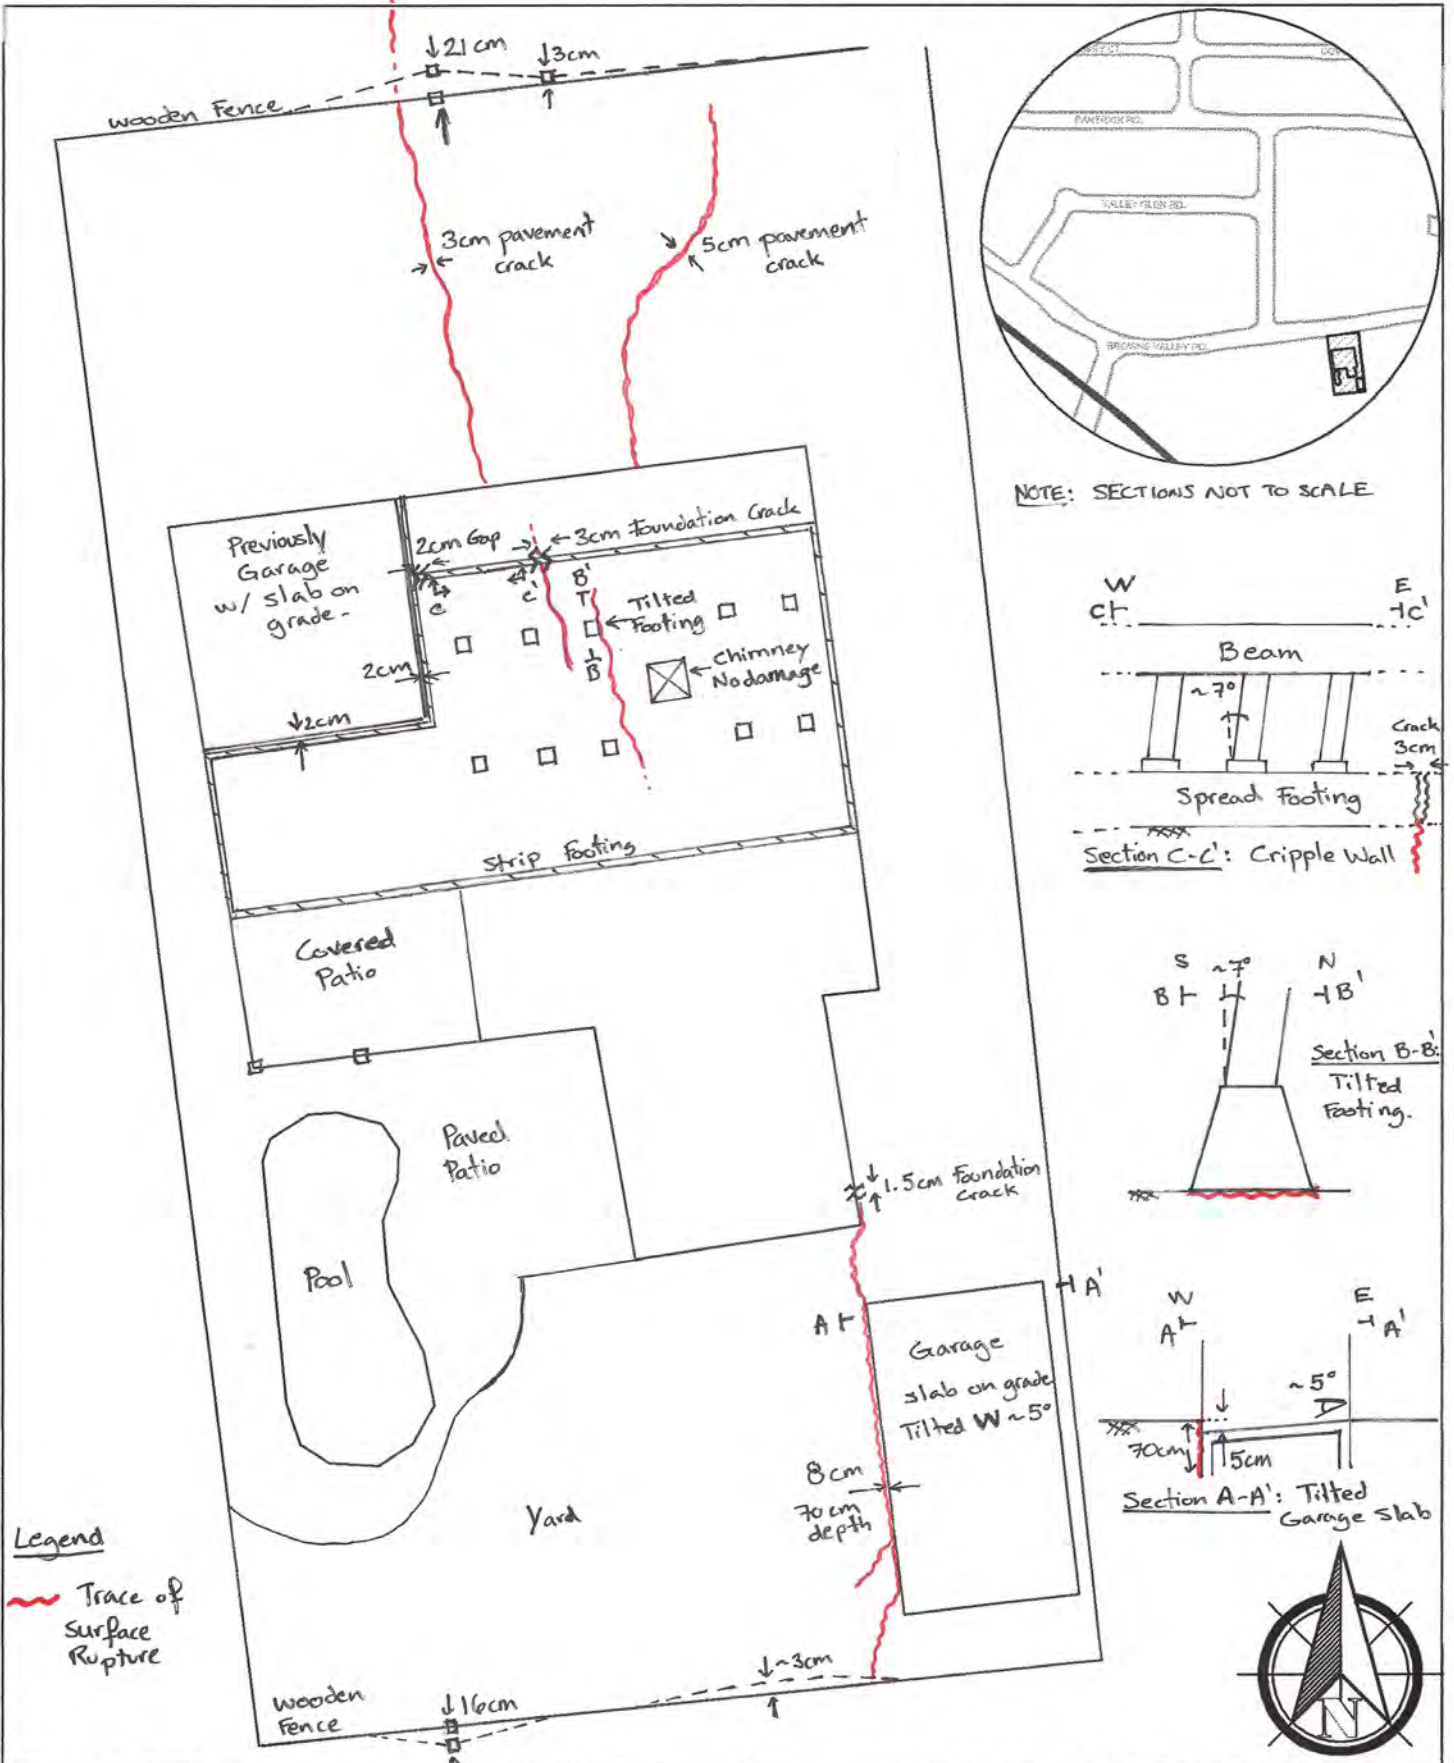
EVENT: AMERICAN CANYON EQ $M_w = 6.0$	ADDRESS: 38.3052 -122.3369 (H21)		DRAWING BY: J. Cohen-Waeber J. Weber, G. Harris, S. Foti
	DESCRIPTION: Surface Fault rupture through private property.	DATE OF INSPECTION: 08/28/2014	DATE OF DRAWING: 08/28/2014	SCALE: 1 cm : 2 m

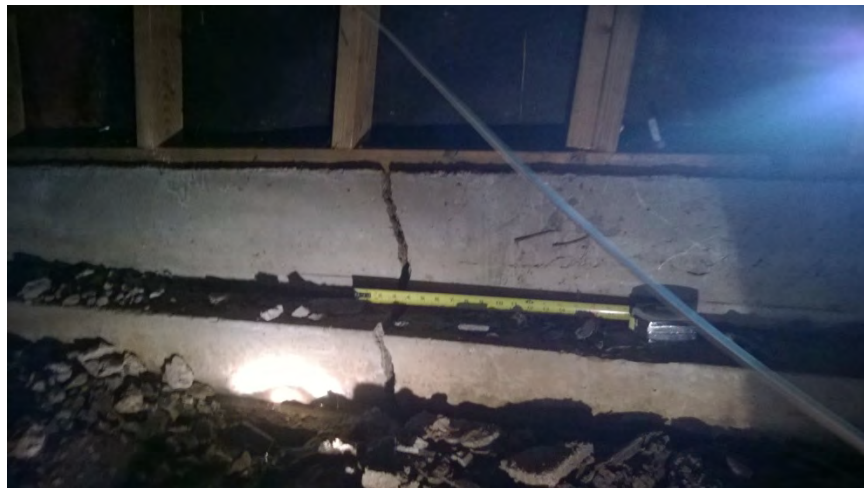
Figure C-H21-3: Strip footing crack and tilted cripple wall (E-W) [NSF-GEER; N 38.3052 W 122.3369; 08/28/14, 10:15]

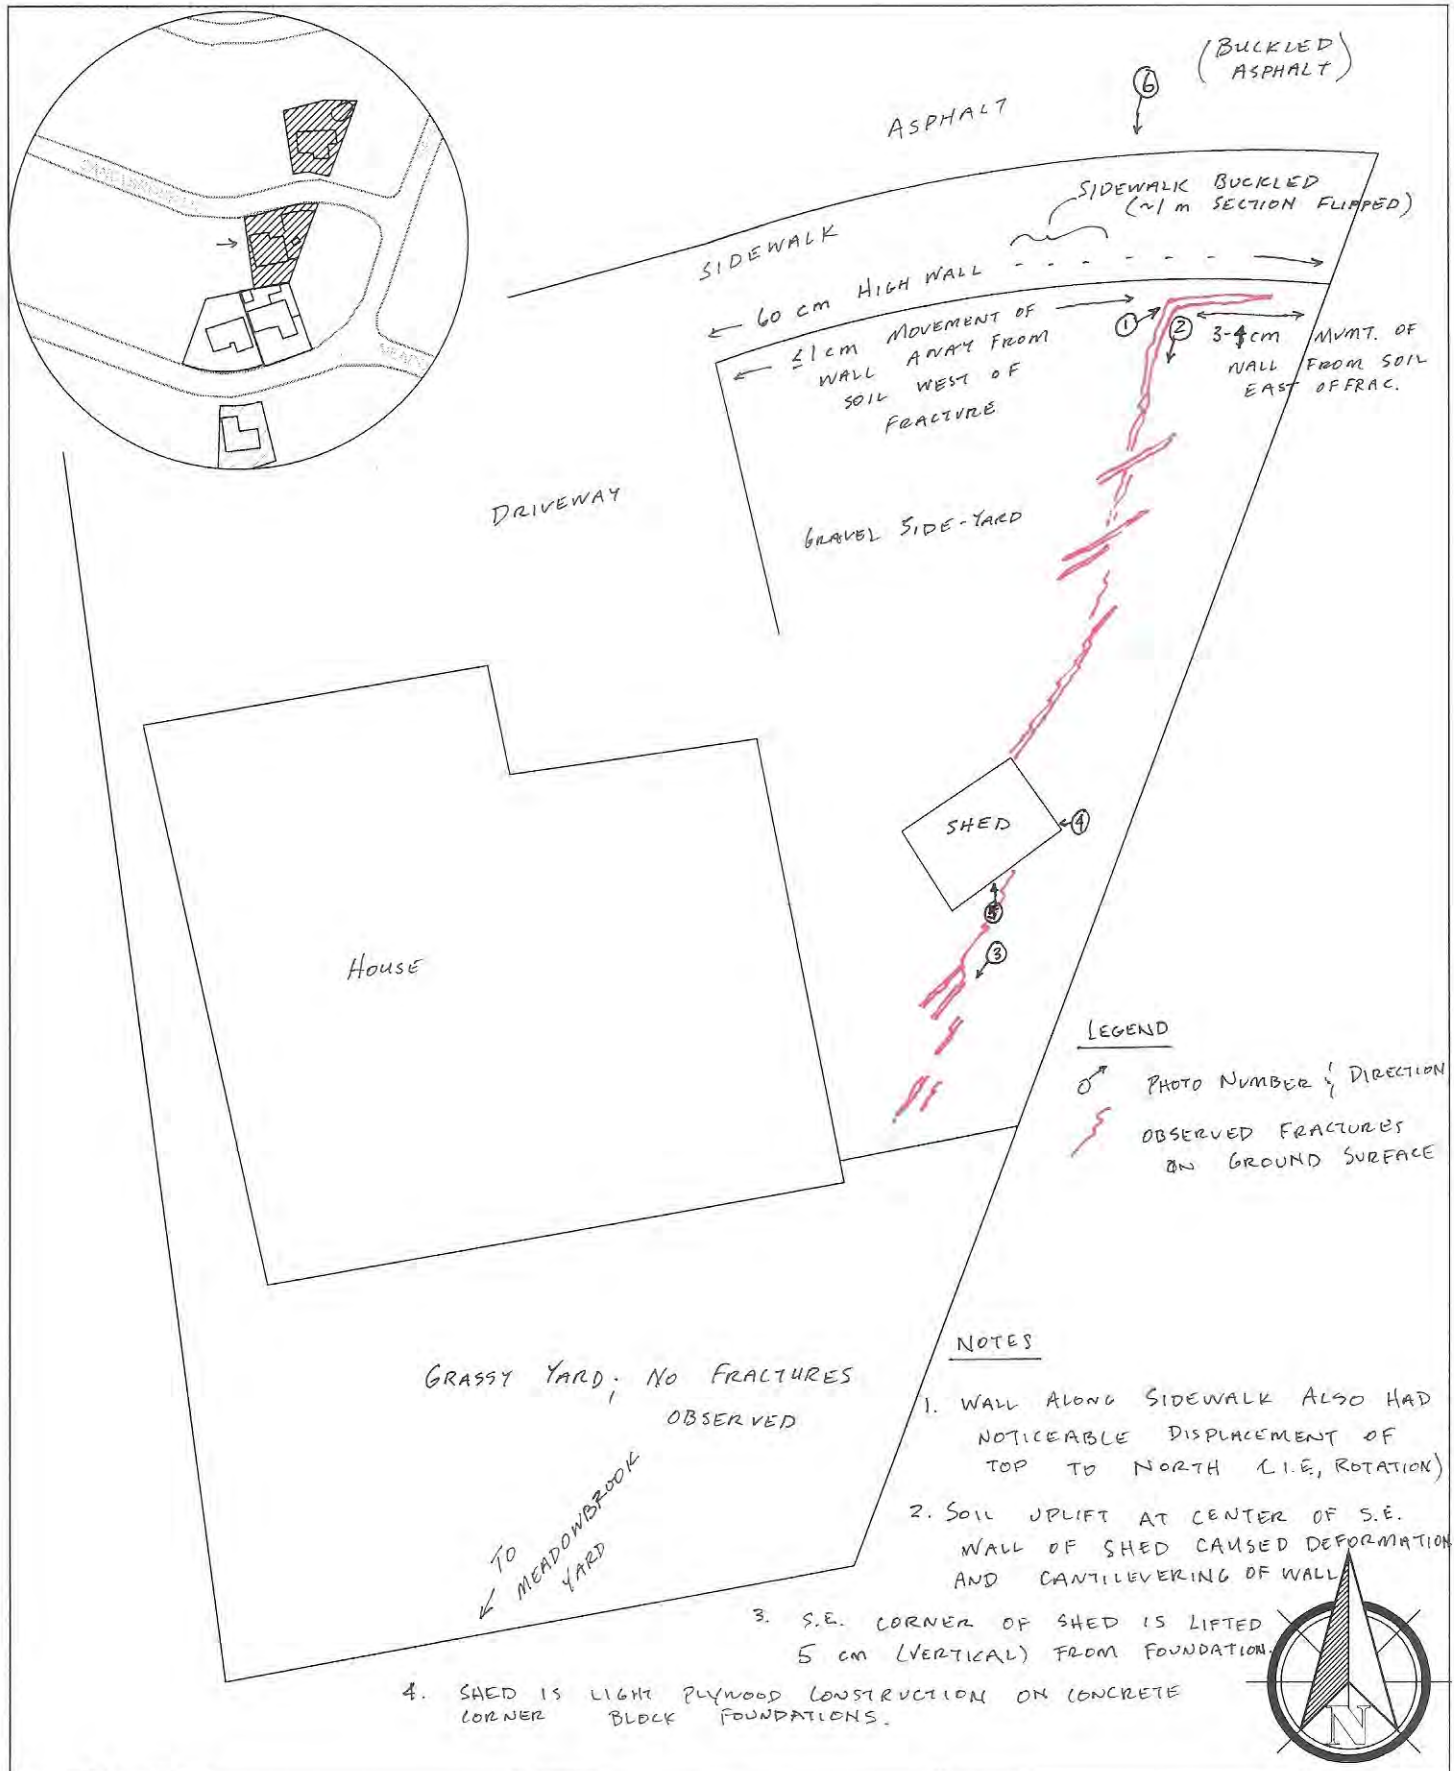
EVENT: AMERICAN CANYON EQ $M_w = 6.0$	ADDRESS: N 38.3045° W 122.3429°	DRAWING BY: R. LANZAFAME N. WAGNER
	DESCRIPTION: HOUSE MAPPING (23)	DATE OF INSPECTION: 8/25/14	DATE OF DRAWING: 8/25/14
		SCALE: 1 cm : 2 m

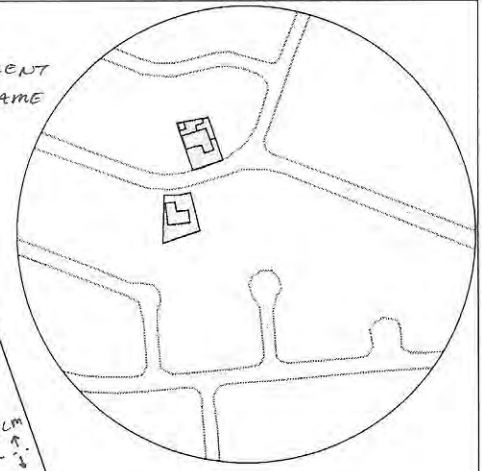
OFFSET OF HOUSE FRAME RELATIVE TO FDN.

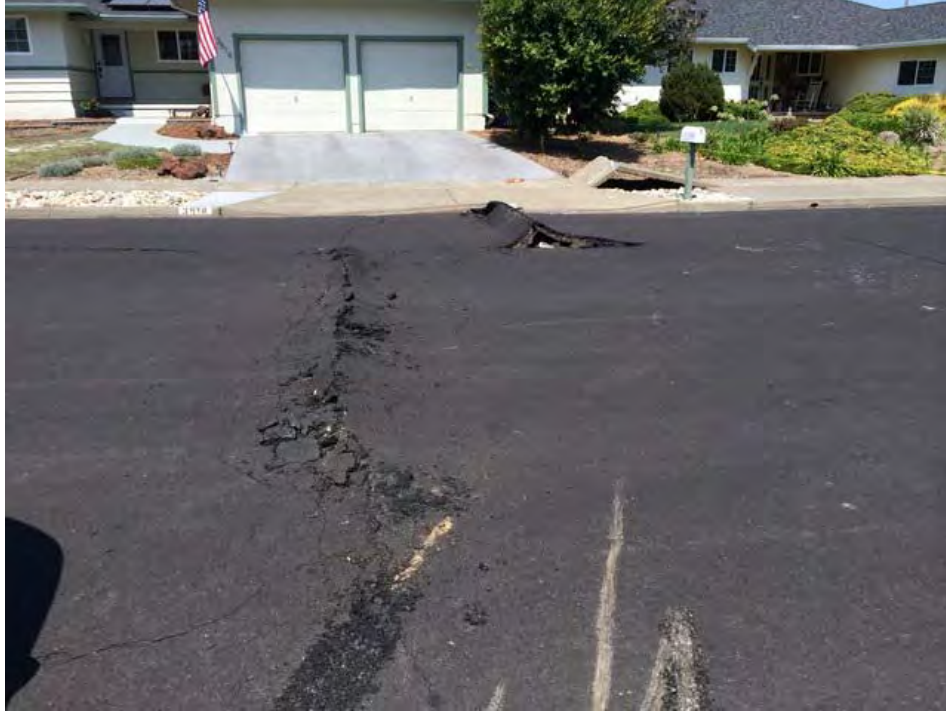
Figure C-H24-3: Asphalt rupture and front of residence (building on right) [NSF-GEER; N 38.3038 W 122.3430; 08/25/14 14:02]

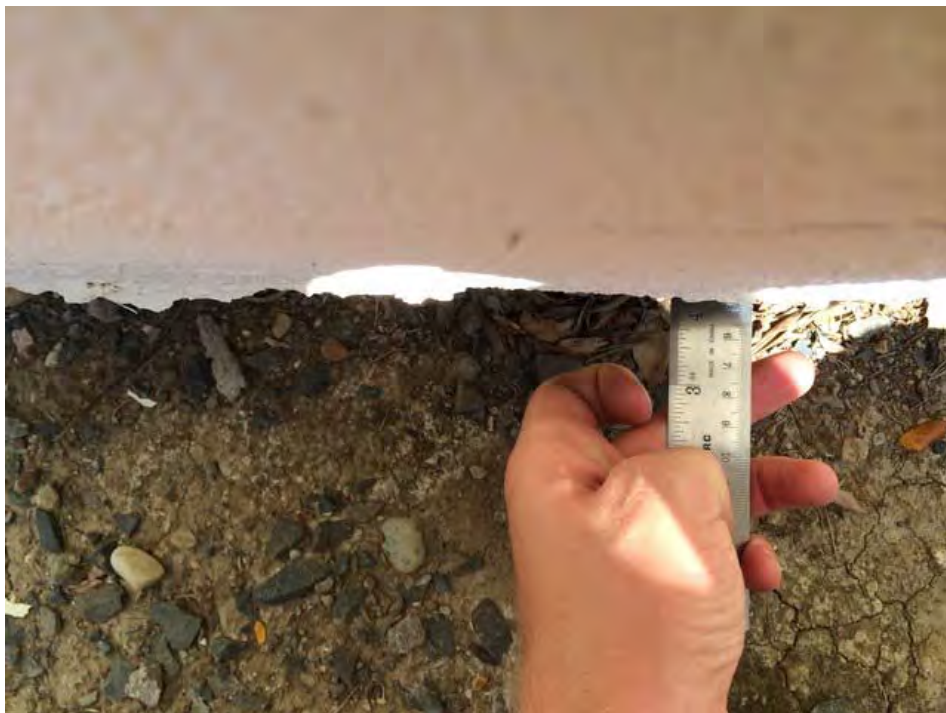
Figure C-H24-4: Offset of wall frame relative to foundation (view from top) [NSF-GEER; N 38.3040 W 122.3431; 08/25/14 14:15]

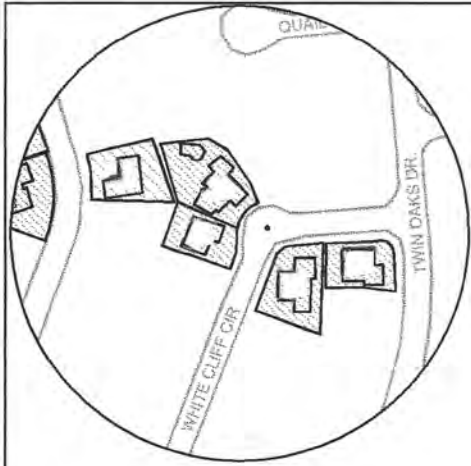
Legend  
 Trace of surface rupture

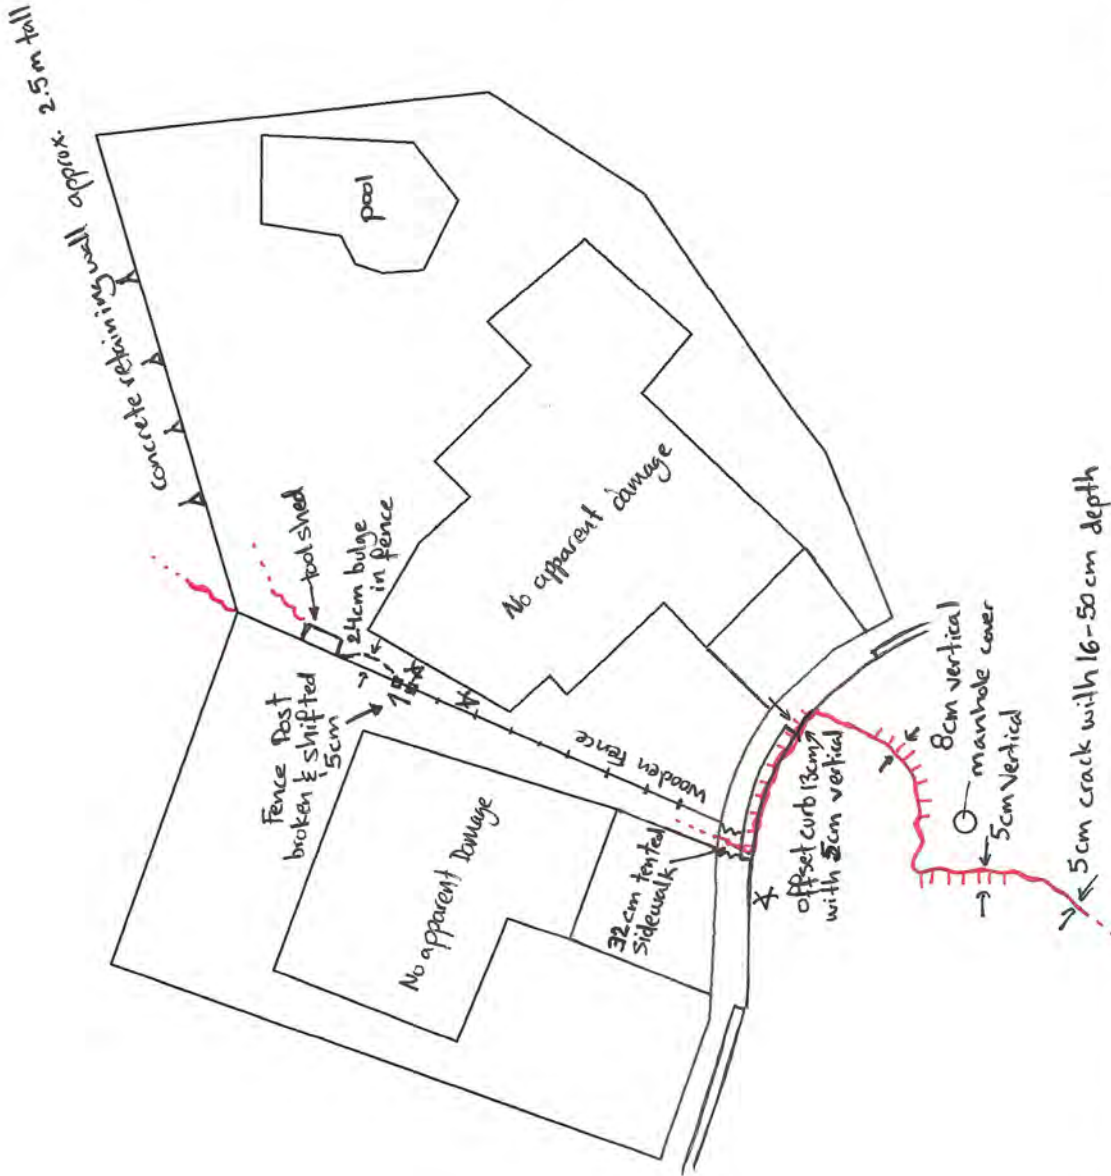
EVENT:	AMERICAN CANYON EQ Mw = 6.0	ADDRESS:	38.3033 -122.3434	DATE OF INSPECTION:	08/25/2014	DRAWING BY:	C. Markham, J. Bray Julien Cohen-Waerber
	DESCRIPTION:	Surface Fault Rupture through private property			DATE OF DRAWING:	08/25/2014	SCALE:	1 cm : 4 m
								10 m

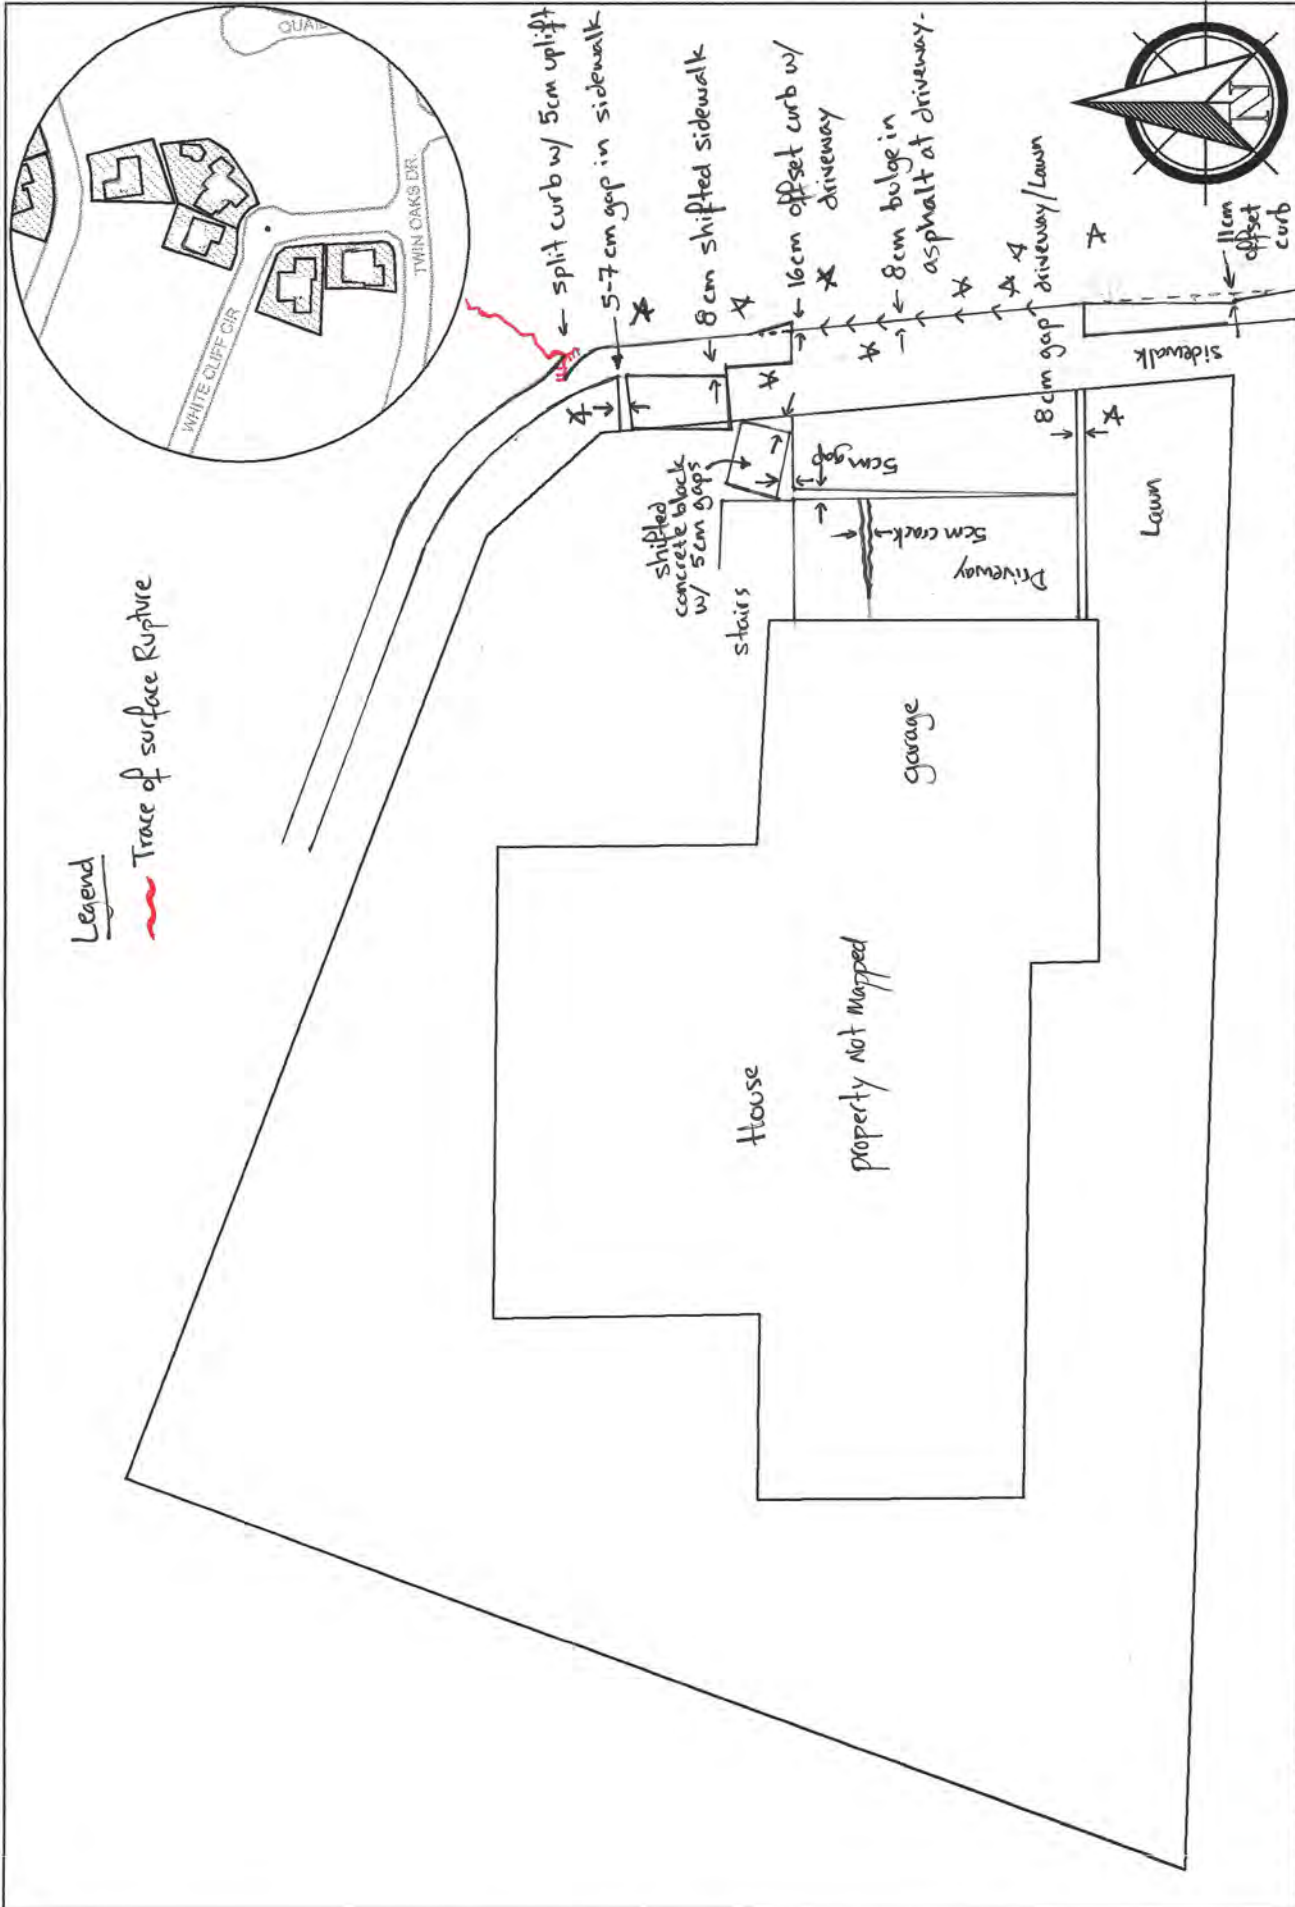
Figure C-H28-H29-3: Buckling of wooden fence showing post displacement [NSF-GEER; N 38.3033 W 122.3434; 08/25/14 09:52]

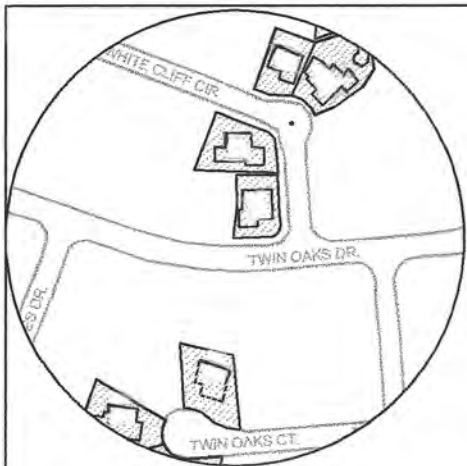
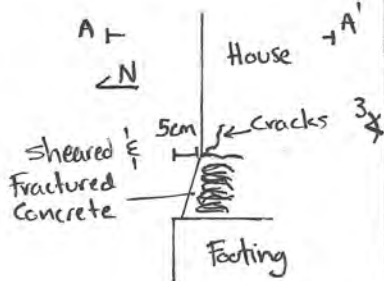
Note: section not drawn to scale

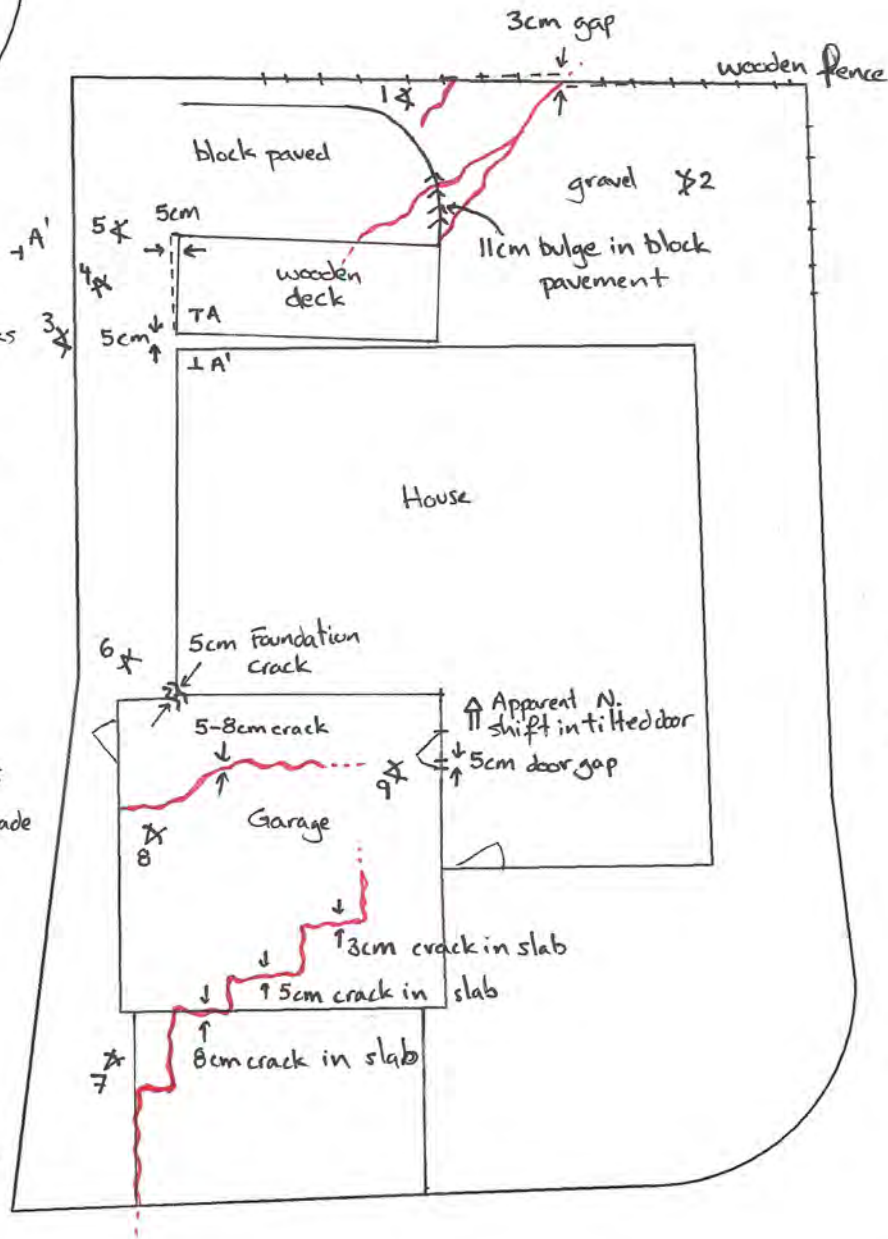
Surface Rupture Trace

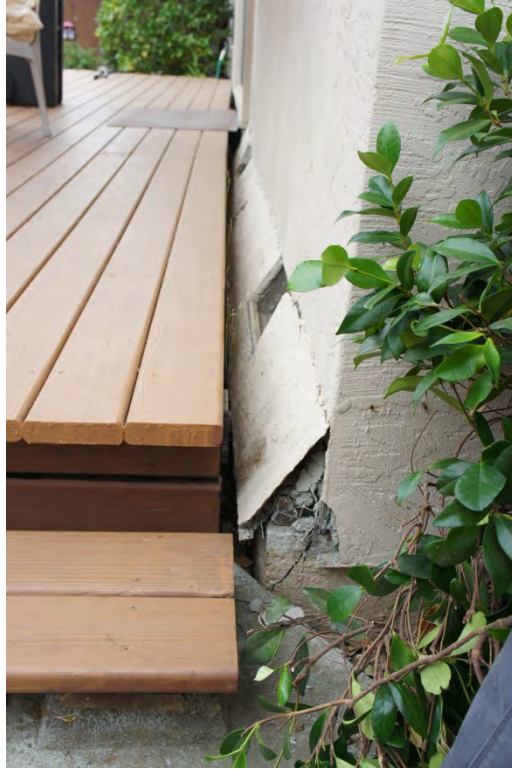
Figure C-H31-2: Structure shifted on foundation. [NSF-GEER; N 38.3027 W 122.3436; 08/25/14 10:11]

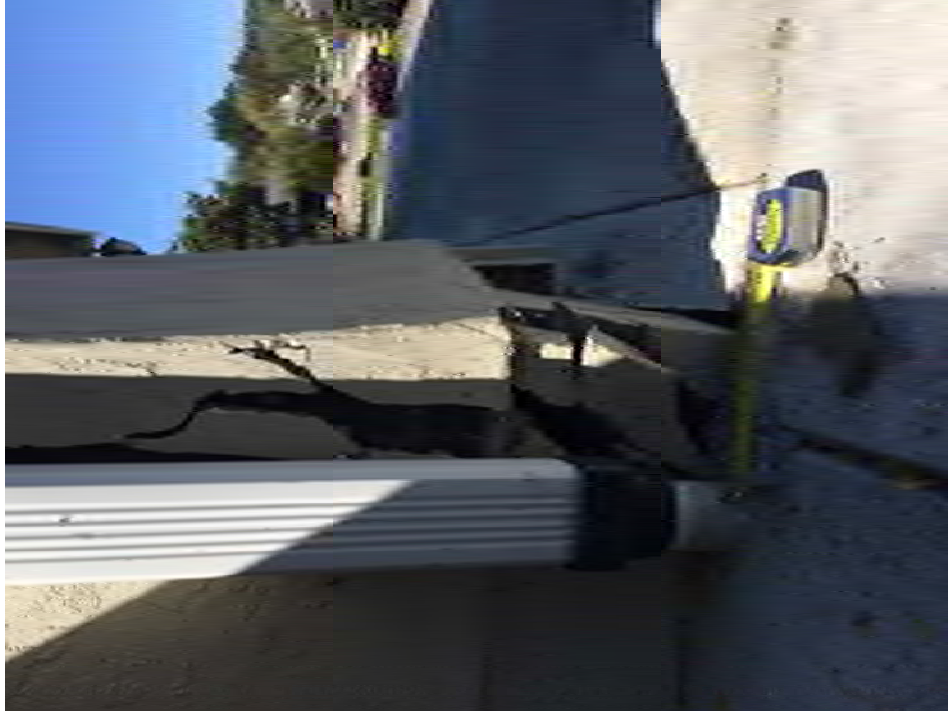
Figure C-H32-4: Damage to strip footing at garage corner [NSF-GEER; N 38.3023 W 122.3438; 08/27/14 11:47]

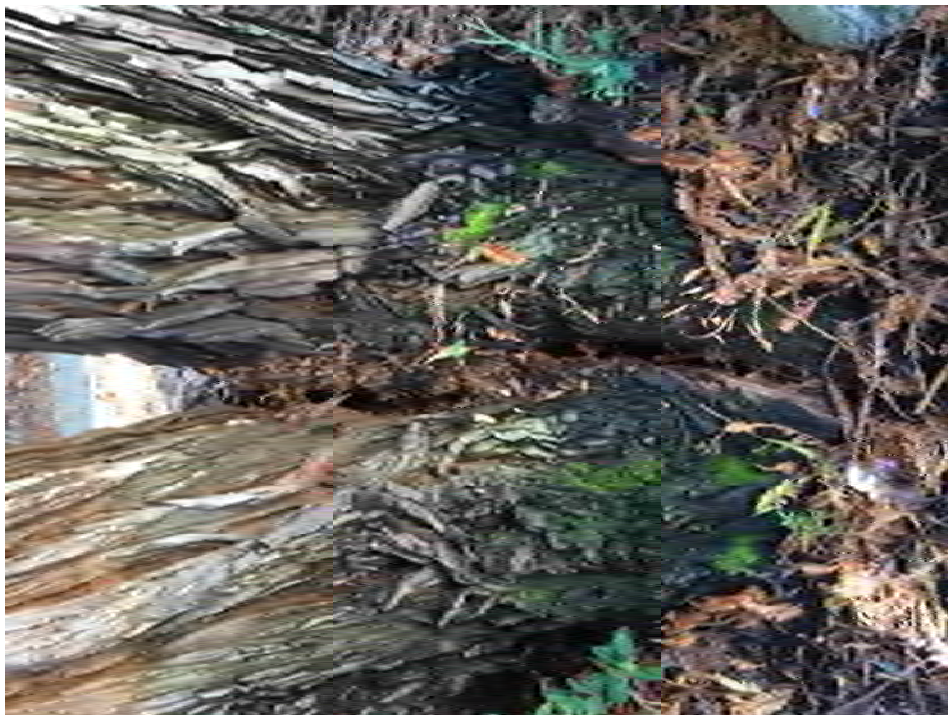
Figure C-H32-5: Split tree trunk adjacent to rupture alignment [NSF-GEER; N 38.3021 W 122.3439; 08/27/14 15:13]

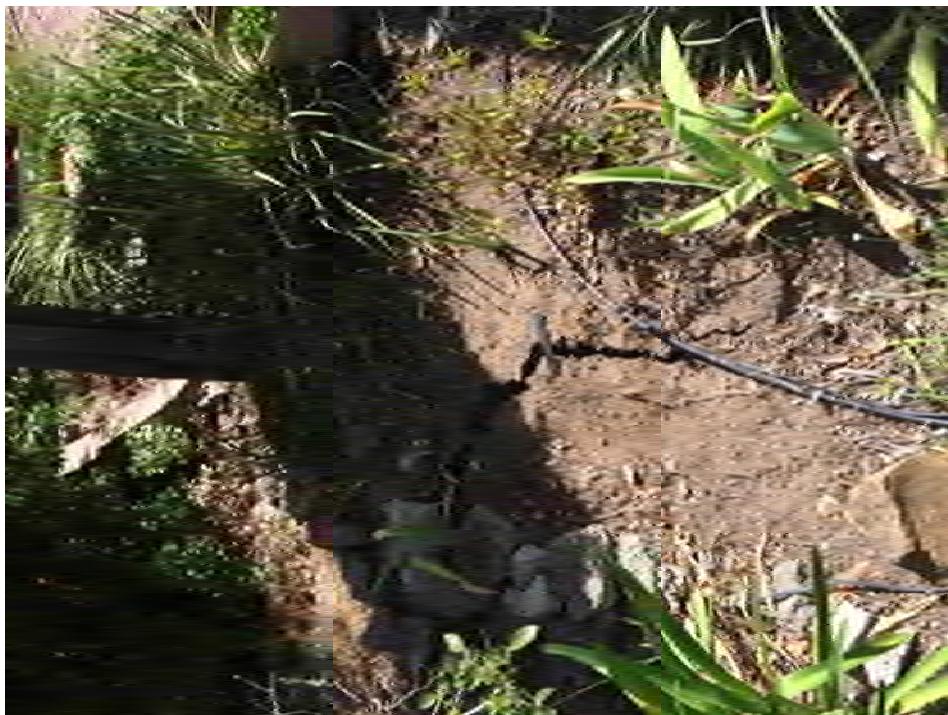
Figure C-H33-3: Fracture along backyard slope [NSF-GEER; N 38.3020 W 122.3439; 08/25/14 11:22]

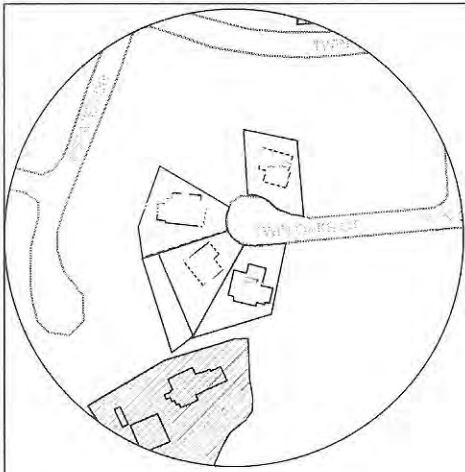
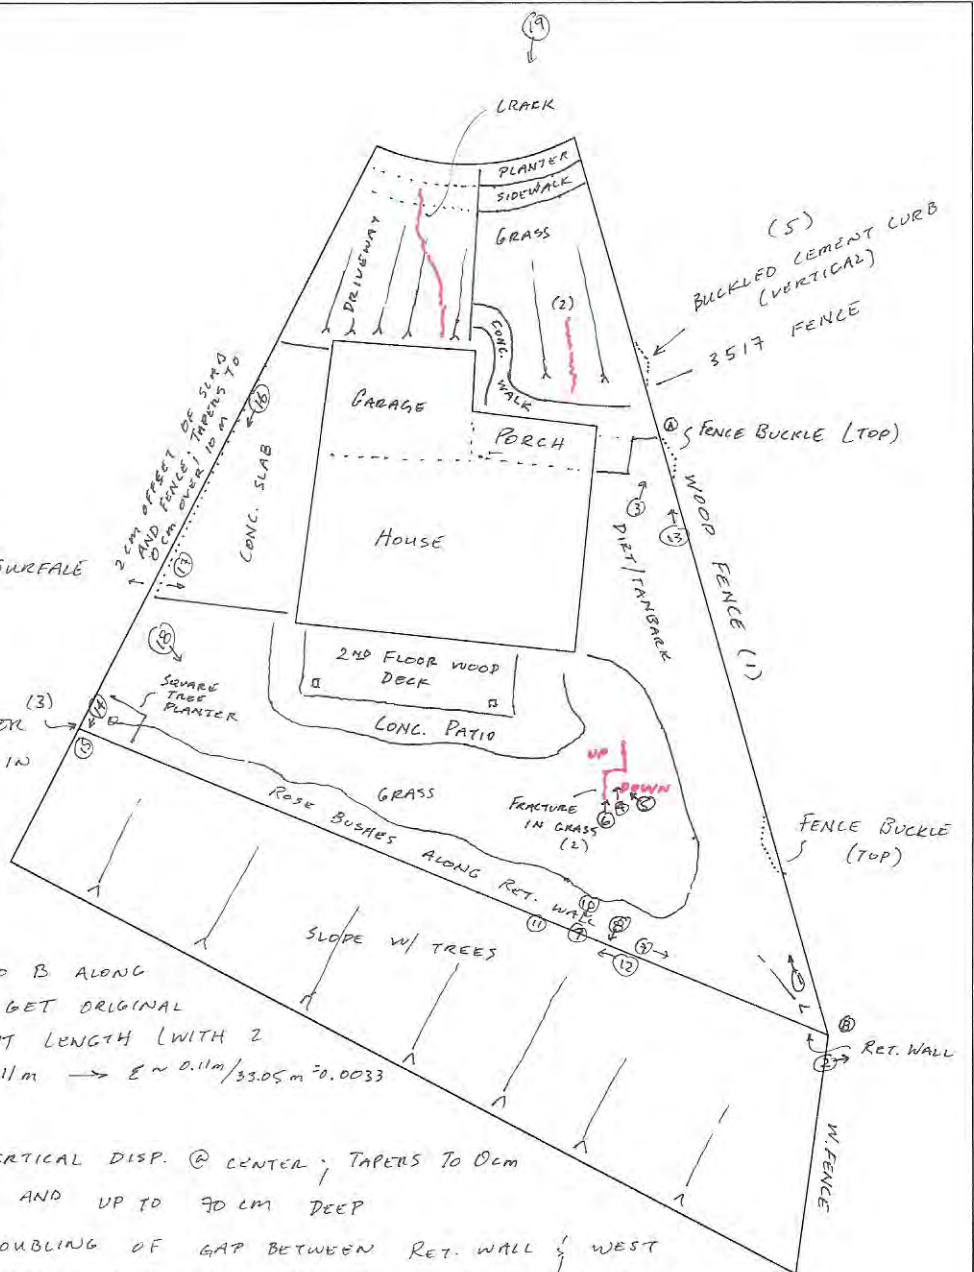
[NSF-GEER; N 38.3016 W 122.3443; 08/25/14 11:05]
