## GEOTECHNICAL EXTREME EVENTS RECONNAISSANCE (GEER) ASSOCIATION

*Turning Disaster into Knowledge*

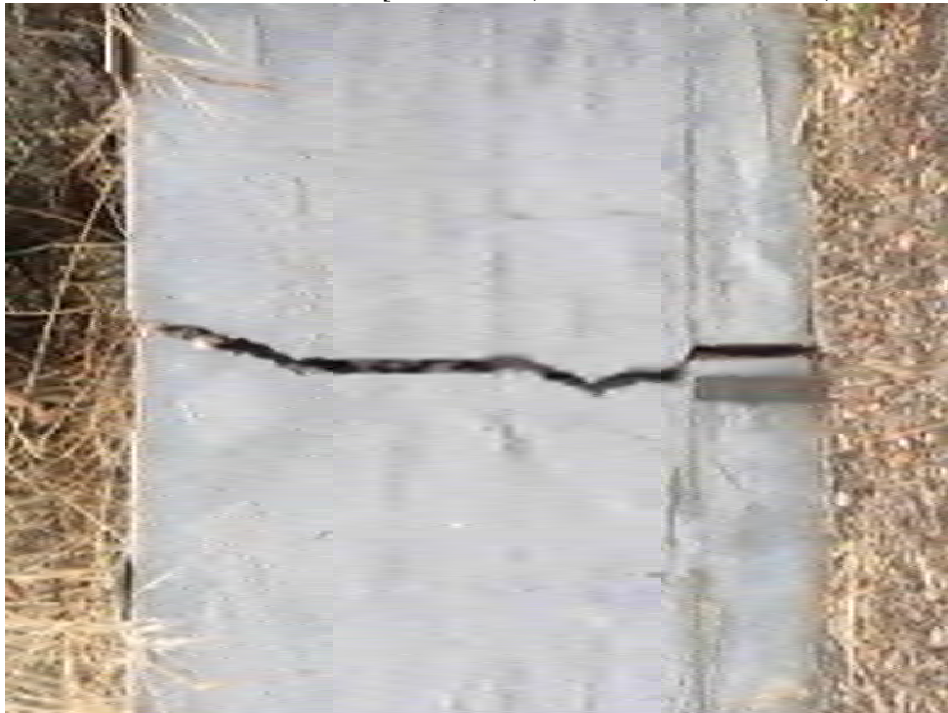
Figure C-H35-4: Retaining wall crack [NSF-GEER; N 38.3015 W 122.3440; 08/25/14 10:58]

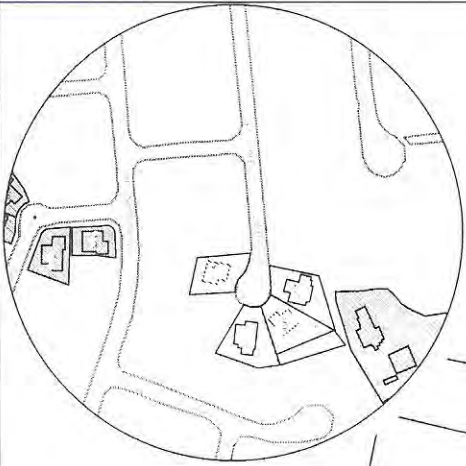
LEGEND:  
 ~~~~~ FRACTURE ON GROUND SURFACE  
 (A) NOTE ANNOTATION  
 ↗ PHOTO NUMBER AND DIRECTION

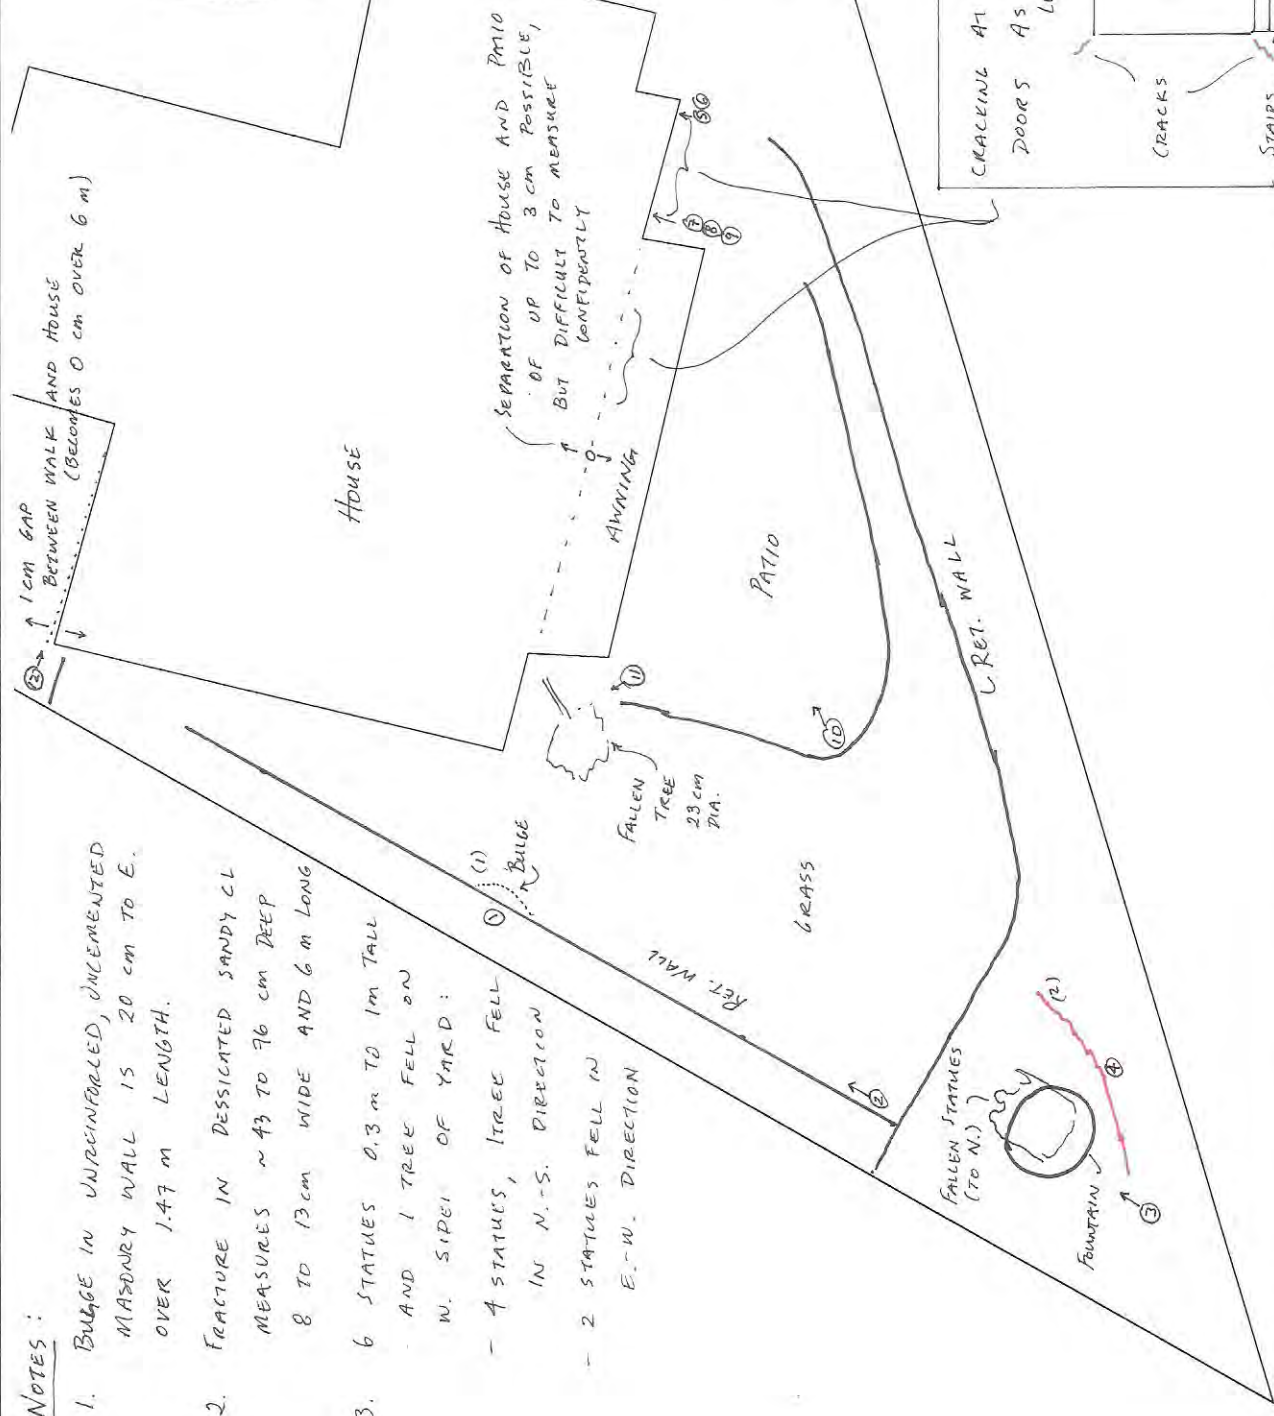
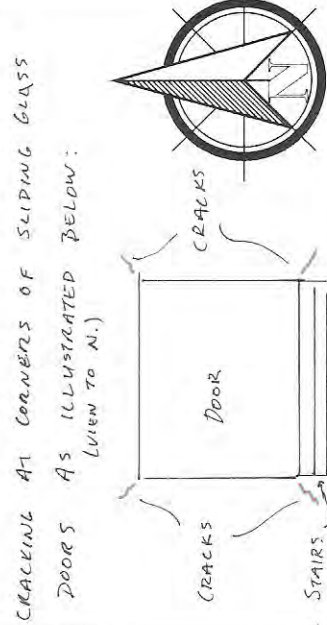
| | EVENT: AMERICAN CANYON EQ M <sub>w</sub> = 6.0 | ADDRESS: N 38.3015° W 122.3440° | DRAWING BY: R. LAUZAFAME<br>N. WAGNER | |

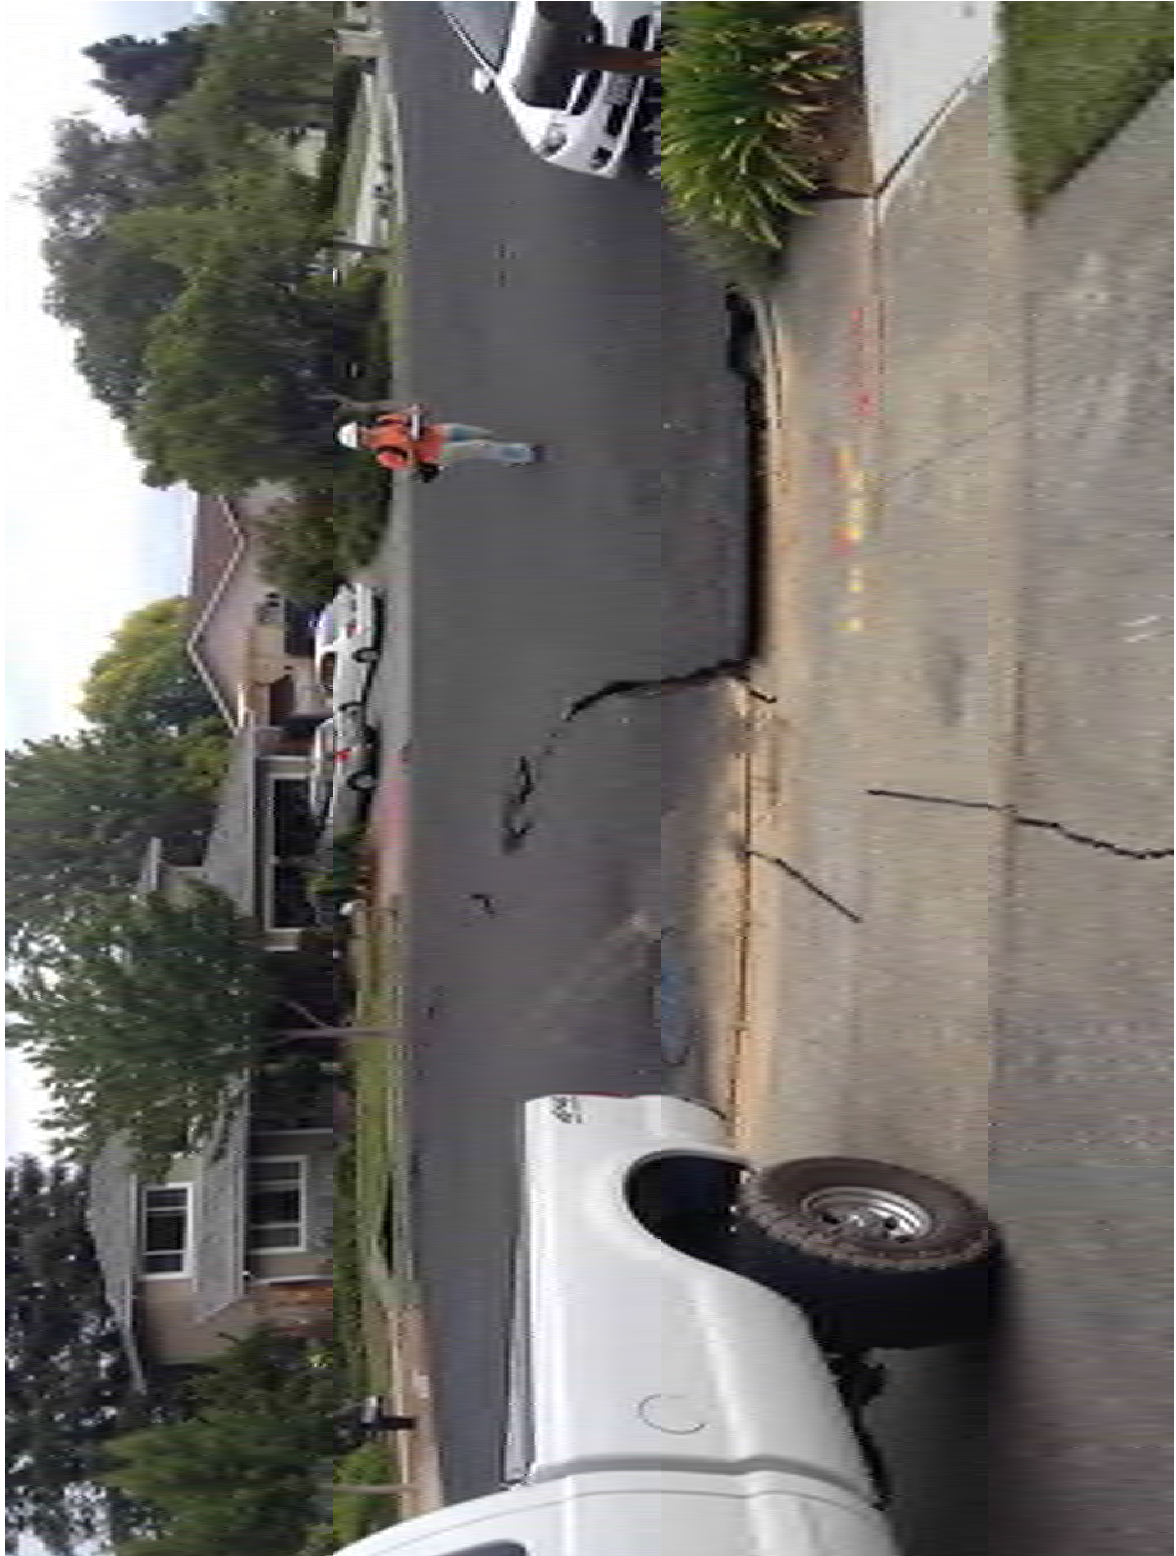
Figure C-P1-2: General view of fracturing [NSF-GEER; N 38.3016 W 122.3441; 08/25/14 10:24]

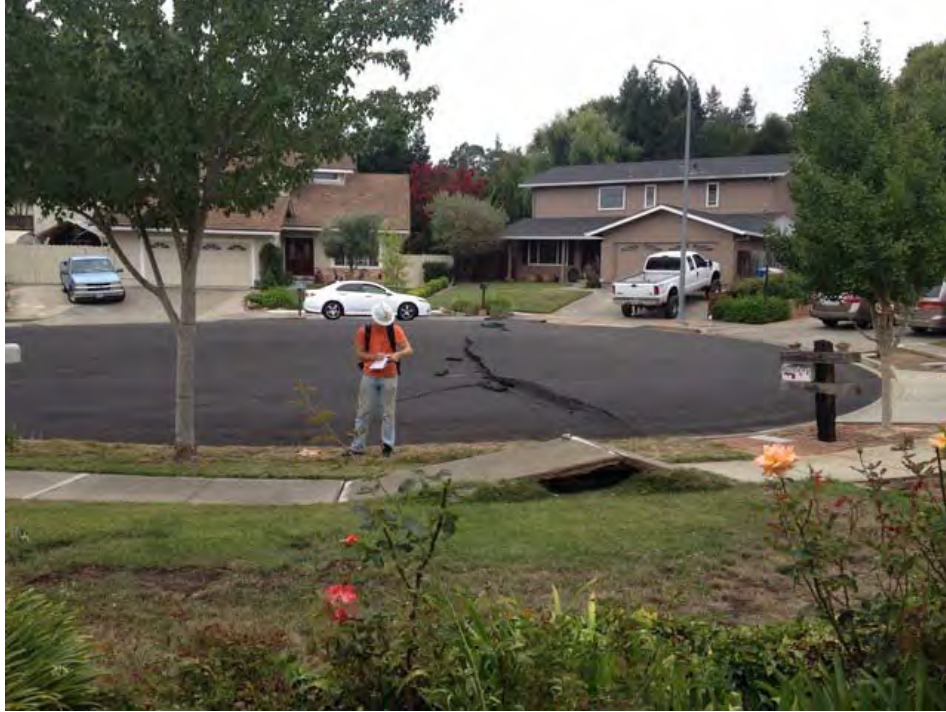
Figure C-P1-3: General view of fracturing [NSF-GEER; N 38.3018 W 122.3437; 08/25/14 10:42]

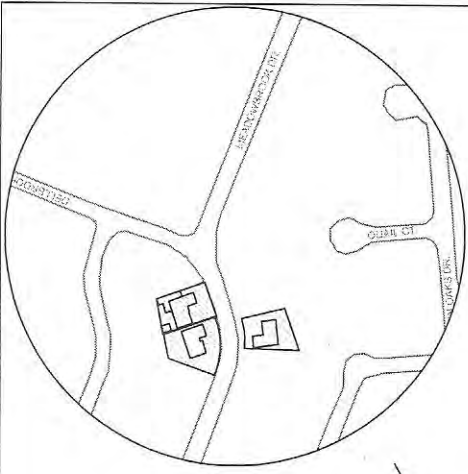
DRAWING BY: A. LANZAFAME  
N. WAGNER

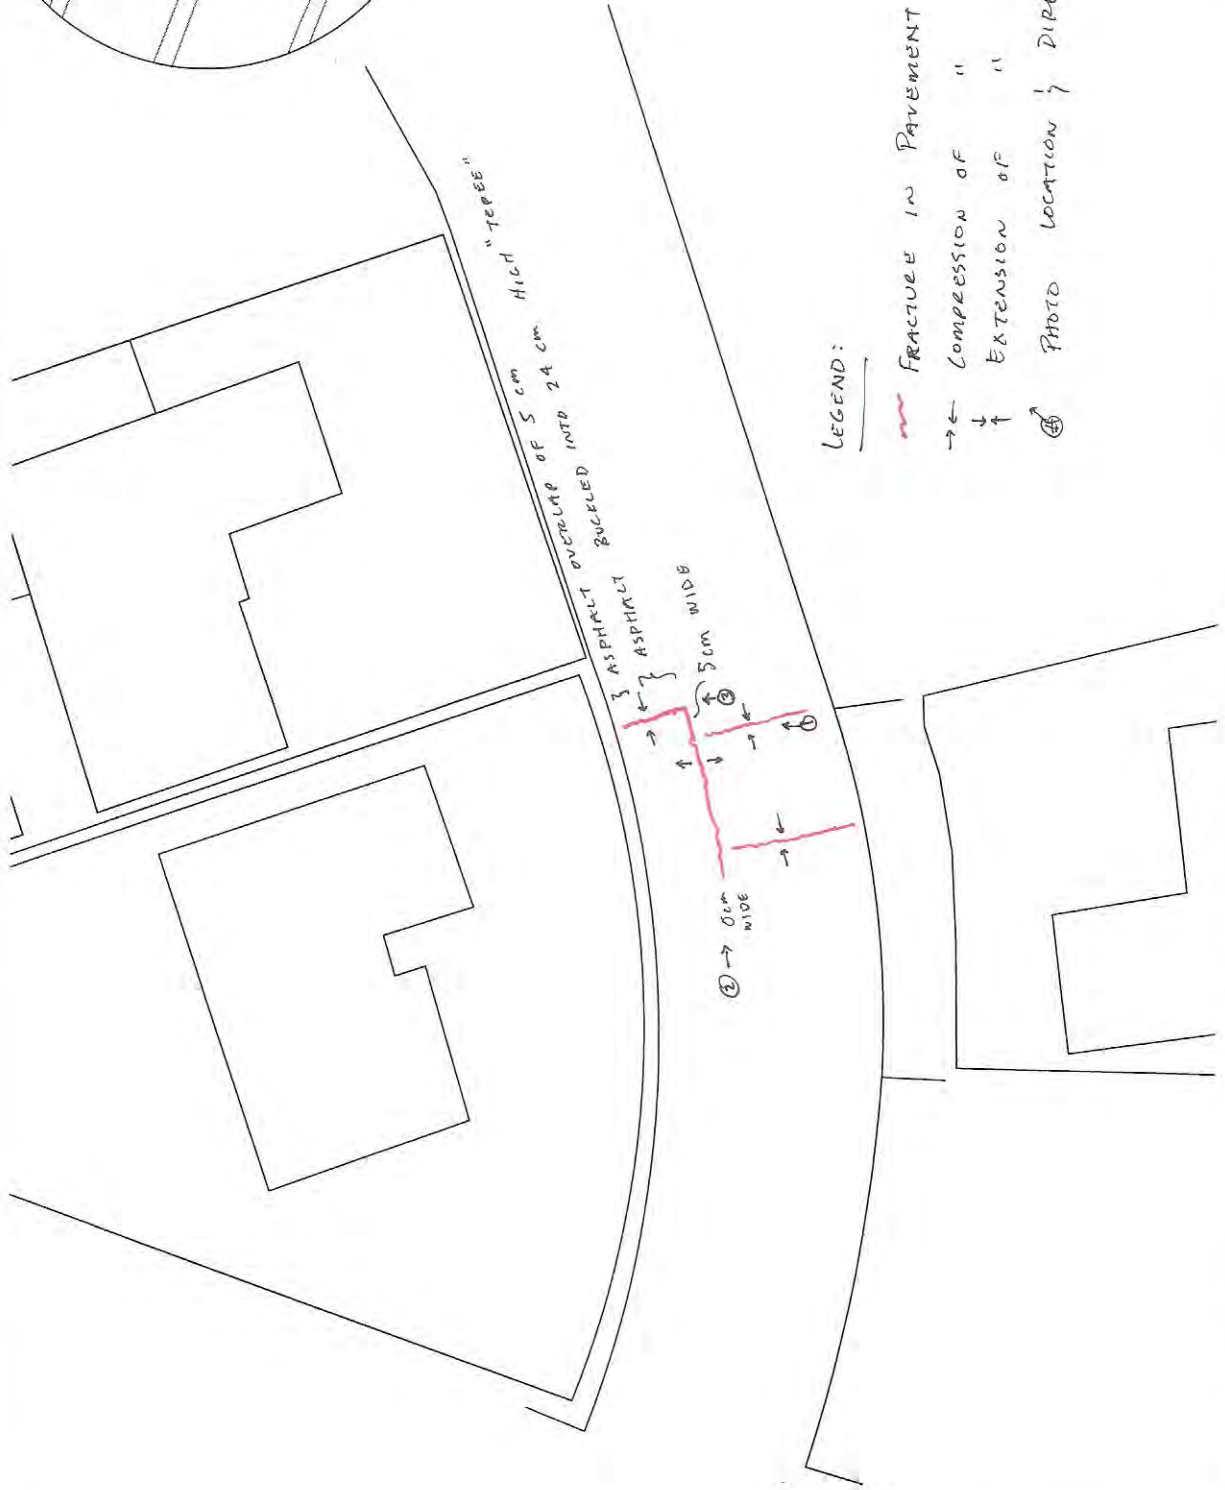
DESCRIPTION: HOUSE DAMAGING (P2)

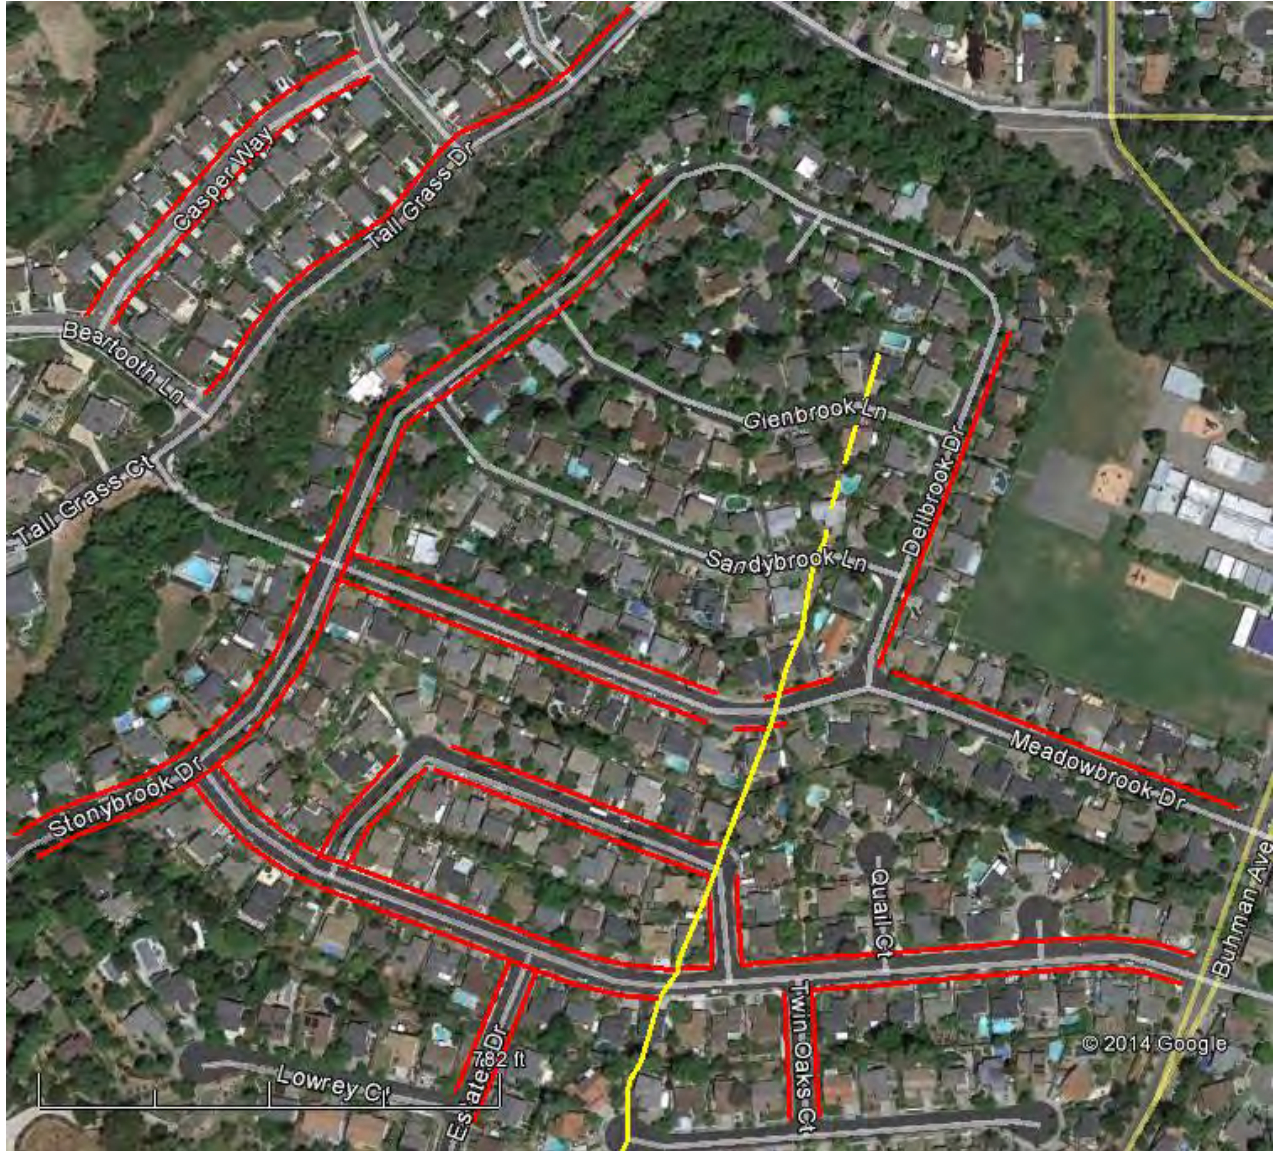
Figure D-1: Observation and measurement segments of ground strain (red lines) & approximate observed fault trace (yellow line); produced in Google Earth; [NSF-GEER; Napa, CA; N 38.3040 W 122.3443; 8/26/14 - 8/28/14]

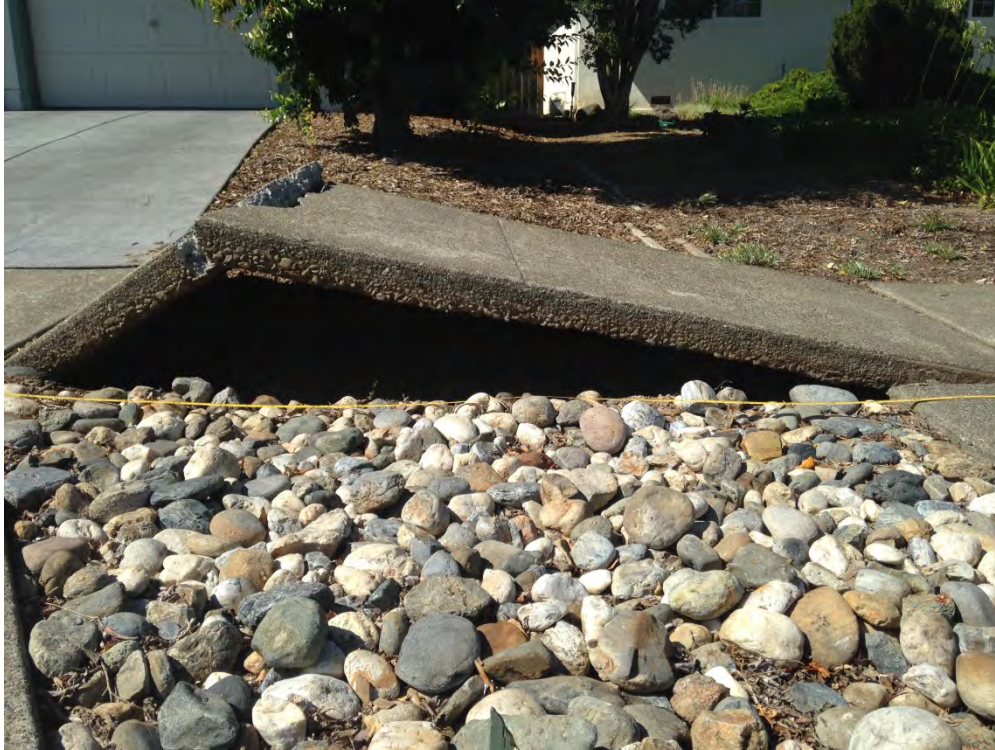
Figure D-3: Typical buckled compression zone in pavement perpendicular to fault, near observed fault trace [NSF-GEER; N 38.3039 W 122.3430; 8/26/2014 15:24]

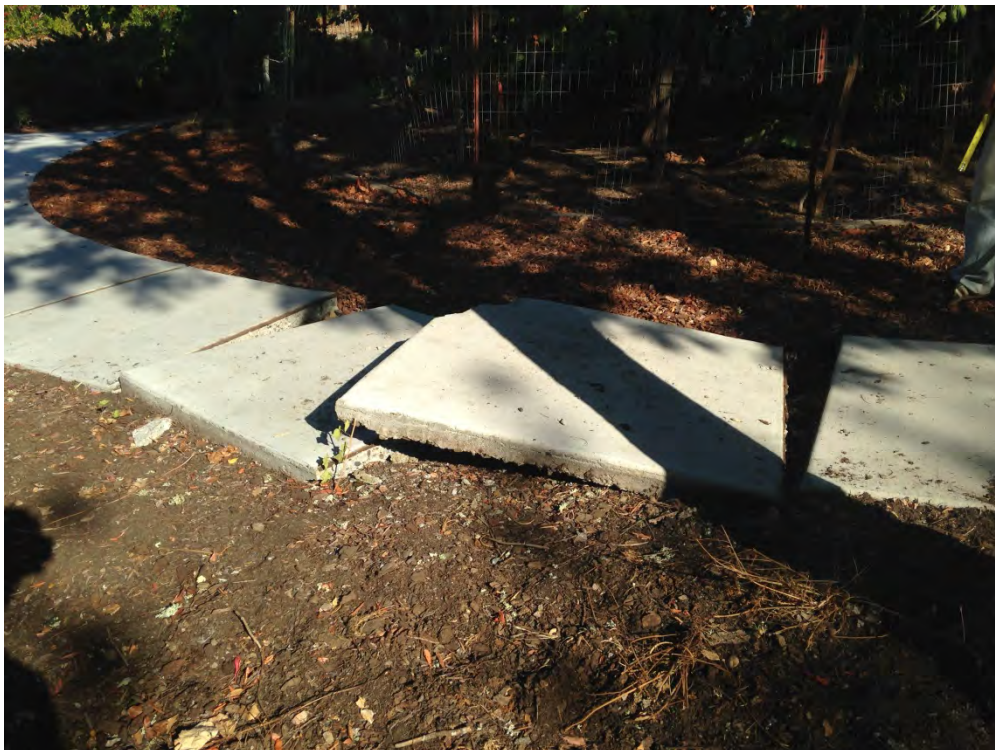
Figure D-4: Overlapping compression zone in pavement parallel to fault, near road crossing [NSF-GEER; N 38.3054 W 122.3455; 8/26/2014 17:20]

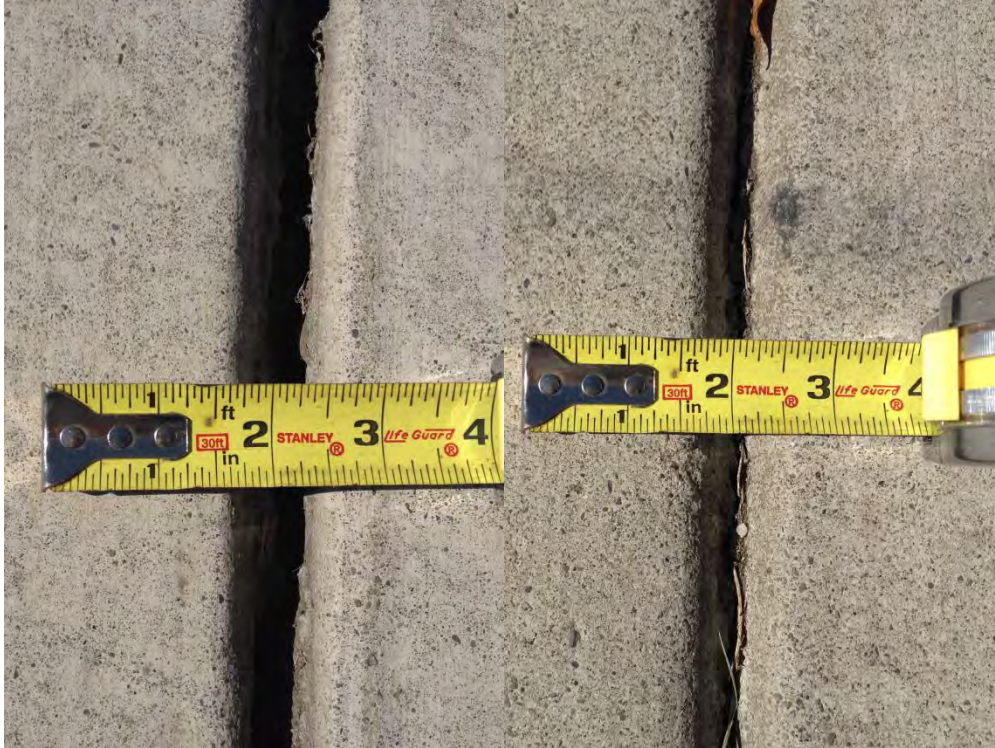
Figure D-9: Typical extension cracks in thermal joints of sidewalk pavement parallel to fault; ~13mm gap (left), ~7mm gap (right) [NSF-GEER; N 38.3067 W 122.3464; 8/28/2014 15:18]

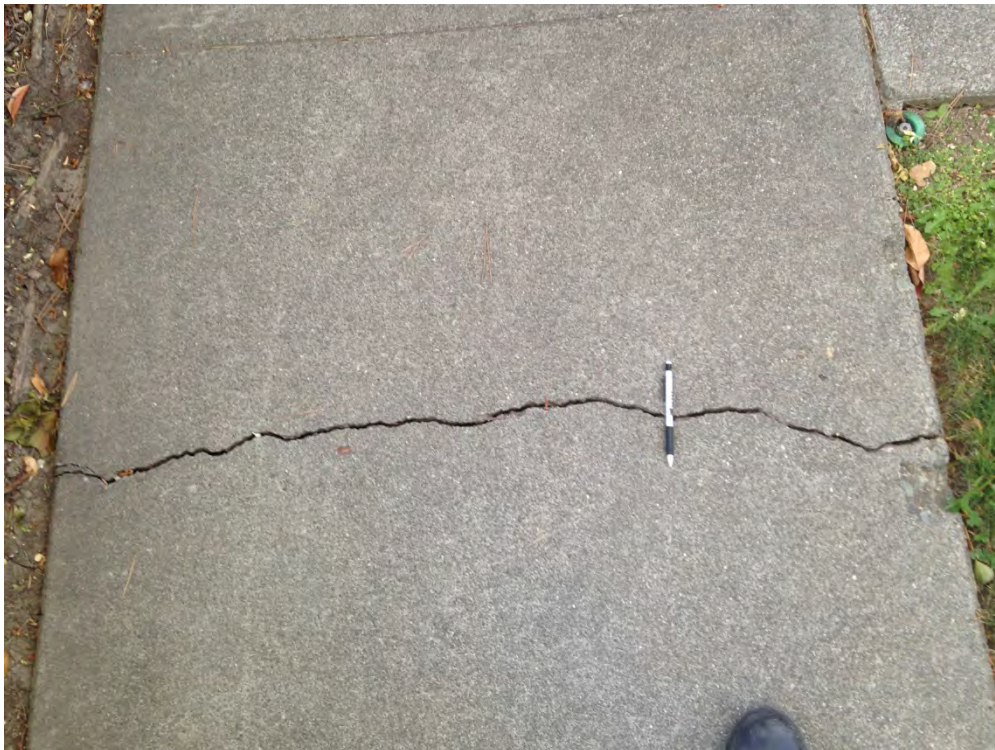
Figure D-10: Extension crack in sidewalk pavement parallel to fault; ~3mm gap [NSF-GEER; N 38.3055 W 122.3454; 8/26/2014 18:30]

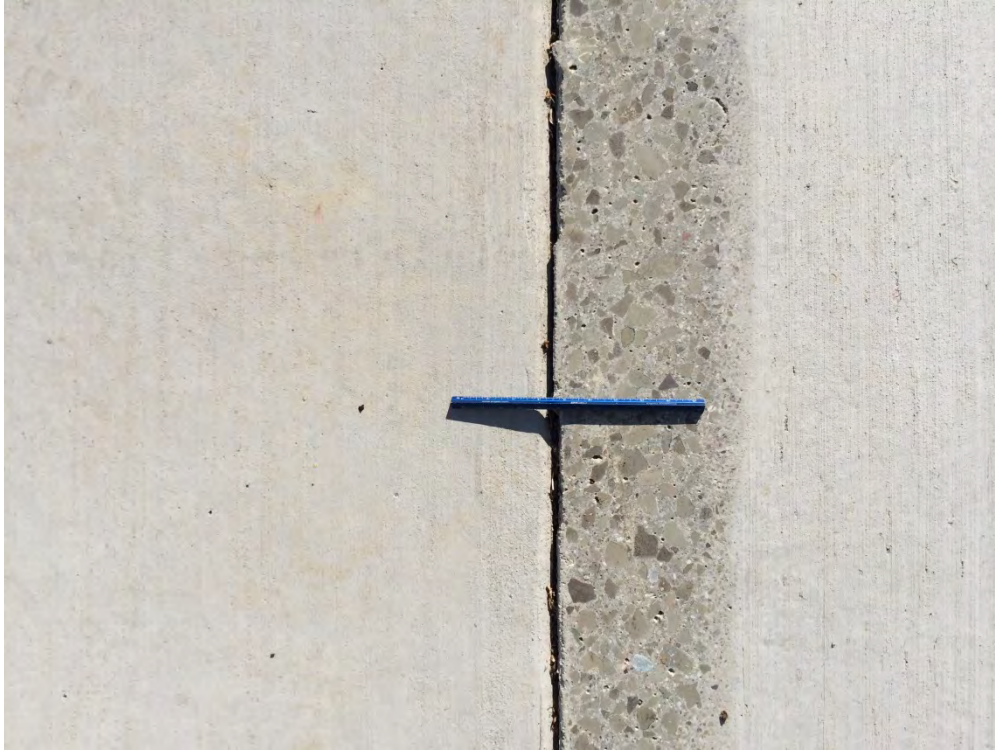
Figure D-11: Example of extension crack not considered due to shaved concrete [[NSF-GEER; N 38.3021 W 122.3430; 8/28/2014 09:17]

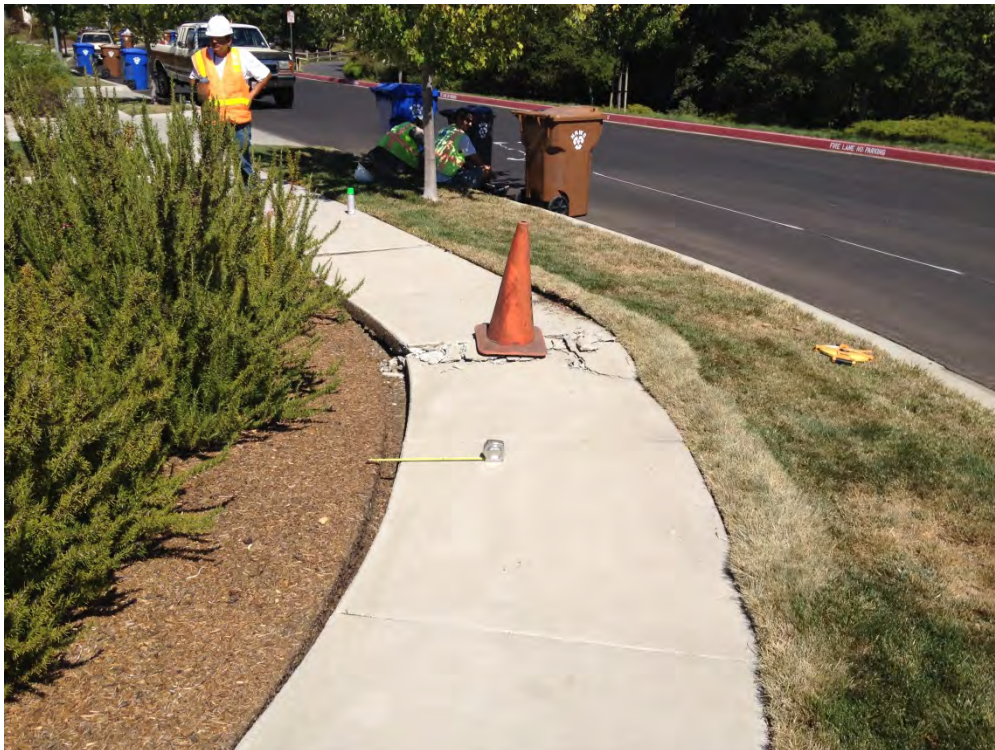
Figure D-12: Crushed section in pavement parallel to fault with compression features in curb strip perpendicular to fault, across from creek [NSF-GEER; N 38.3055 W 122.3467; 8/28/2014 14:30]

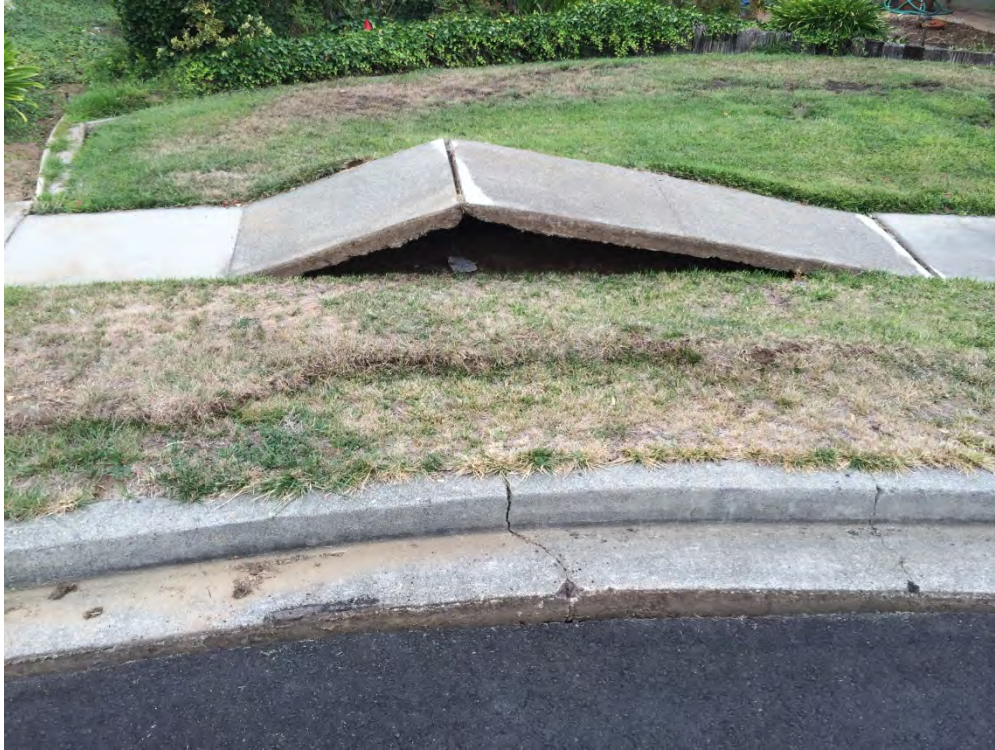
Figure D-13: Buckled section in pavement perpendicular to fault with compression features in curb strip and lawn parallel to fault, near observed fault trace [NSF-GEER; N 38.3018 W 122.3439; 8/25/2014 10:38]

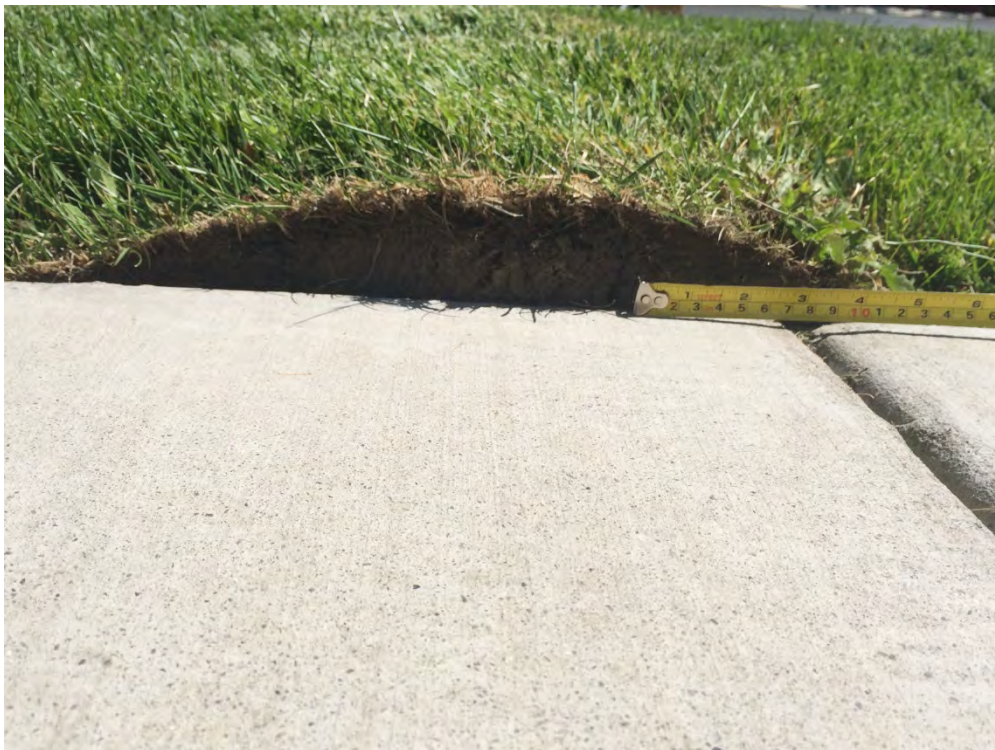
Figure D-14: Compression feature in curb strip perpendicular to fault, across from creek [NSF-GEER; N 38.3065 W 122.3455; 8/28/2014 13:52]

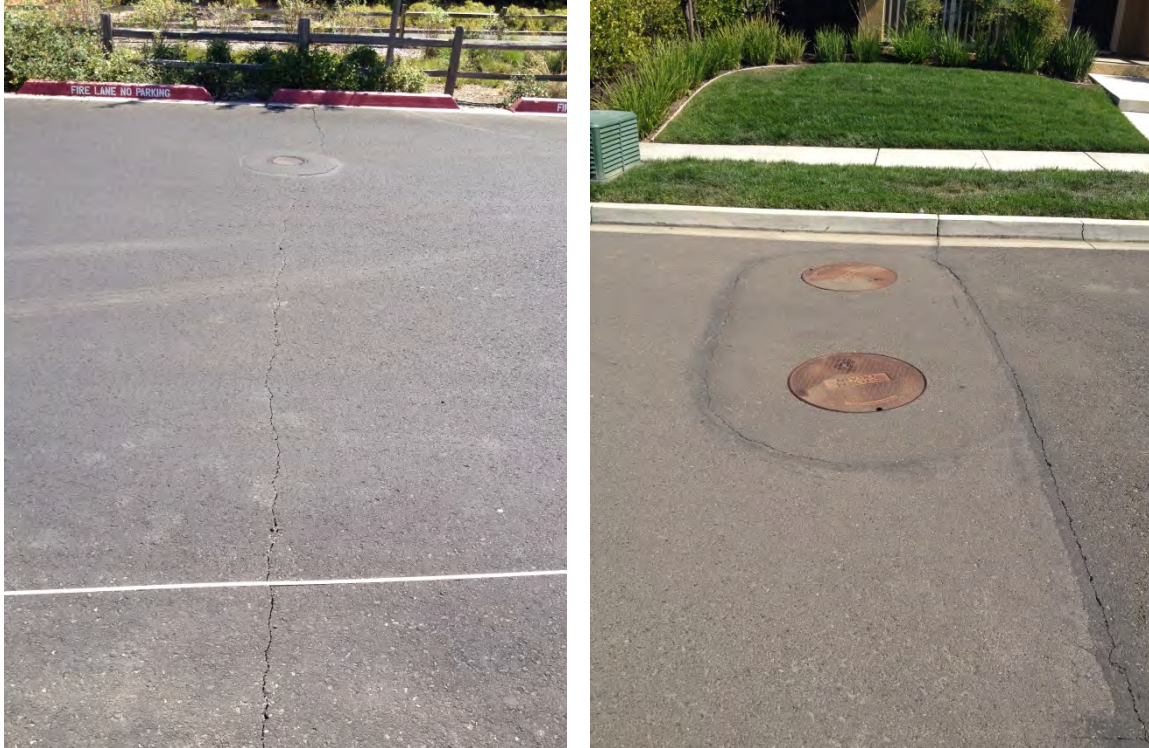
Figure D-15: Cracks in asphalt perpendicular to fault trace near manhole covers [NSF-GEER; N 38.3063 W 122.3458; 8/28/2014 14:15 (left); N 38.3068 W 122.3465; 8/28/2014 15:19 (right)]

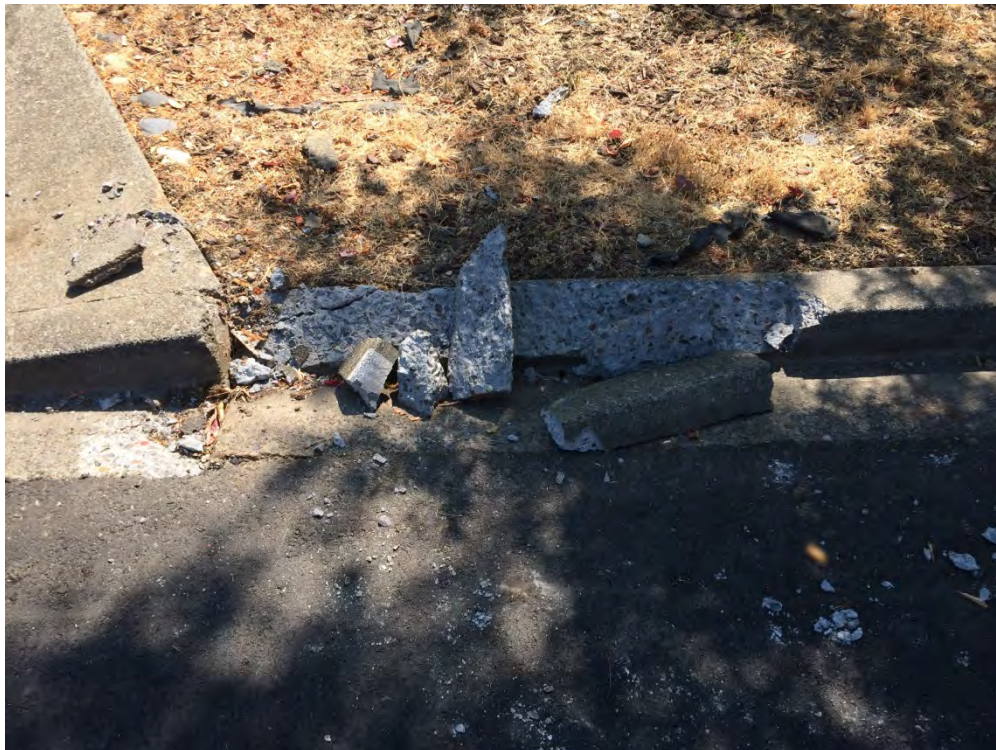
Figure D-16: Crushed curb perpendicular to fault trace [NSF-GEER; N 38.3035 W 122.3411; 8/25/2014 14:47]

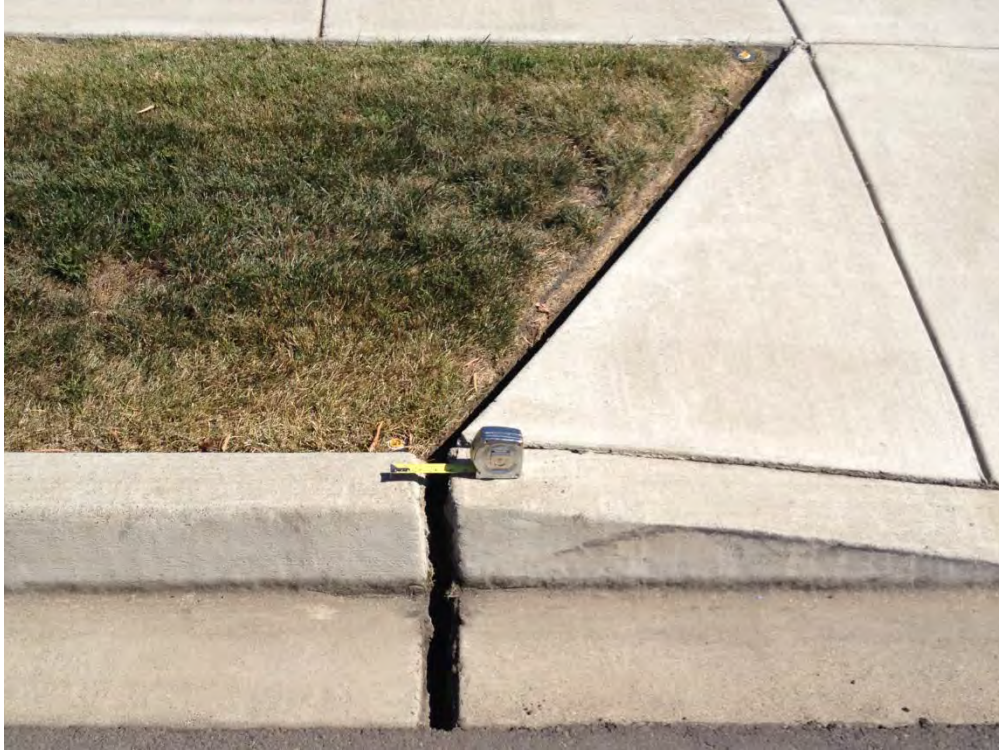
Figure D-17: Extension crack in curb parallel to fault trace [NSF-GEER; N 38.3066 W 122.3465; 8/28/2014 15:08]

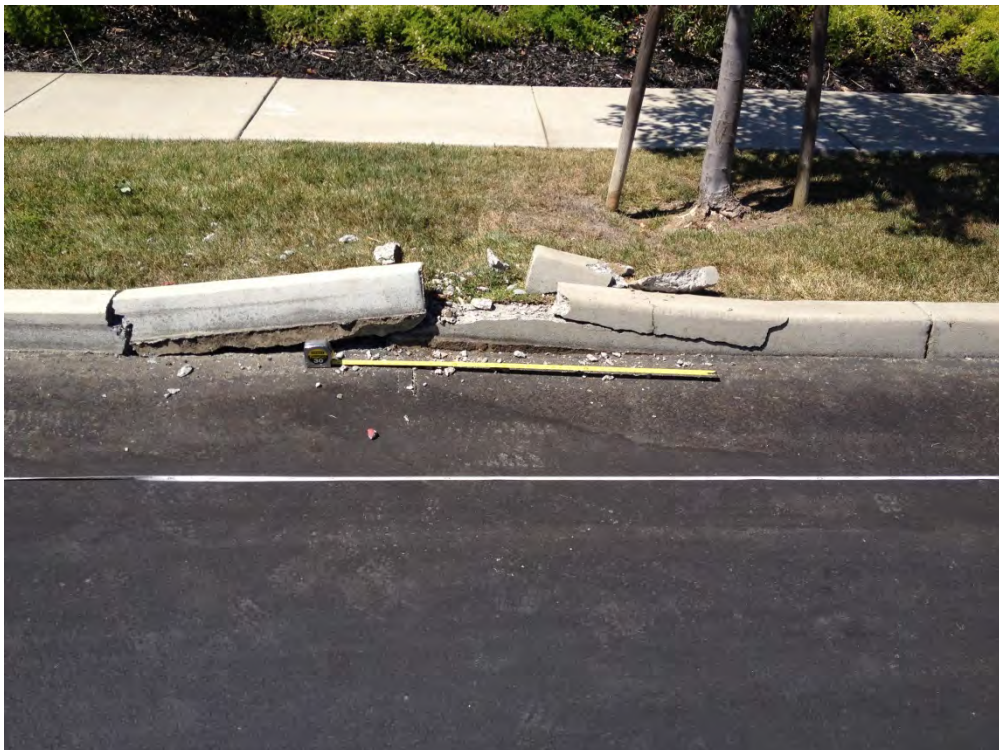
Figure D-18: Buckled curb parallel to fault trace [NSF-GEER; N 38.3073 W 122.3443; 8/28/2014 13:41]

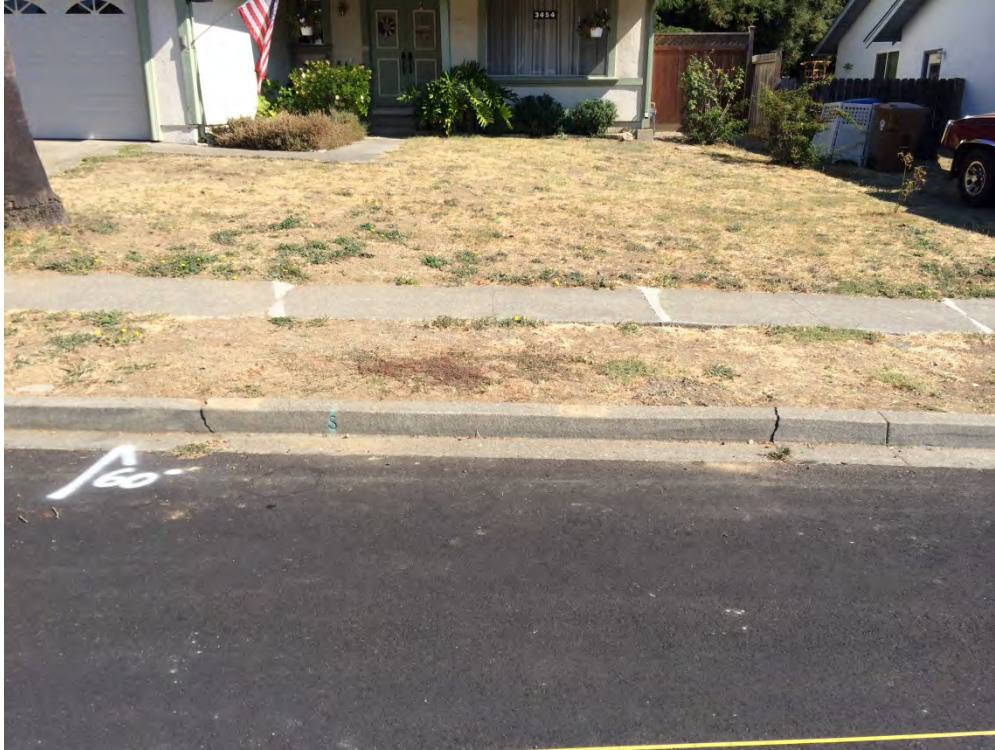
Figure D-19: Buckled curb adjacent to pavement perpendicular to fault trace; visible cracking in soil aligns with cracks in curb [NSF-GEER; N 38.3027 W 122.3407; 8/28/2014 10:25]

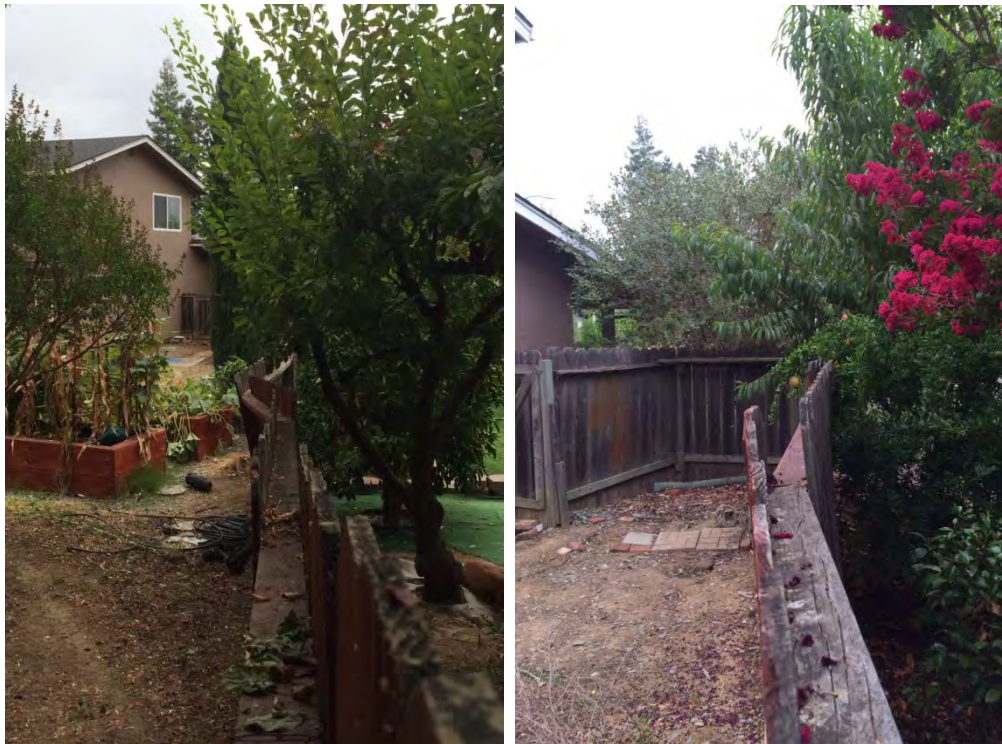
Figure D-20: Buckled section of fence for strain measurements [NSF-GEER; N 38.3015 W 122.3442; 8/25/2014 09:57]

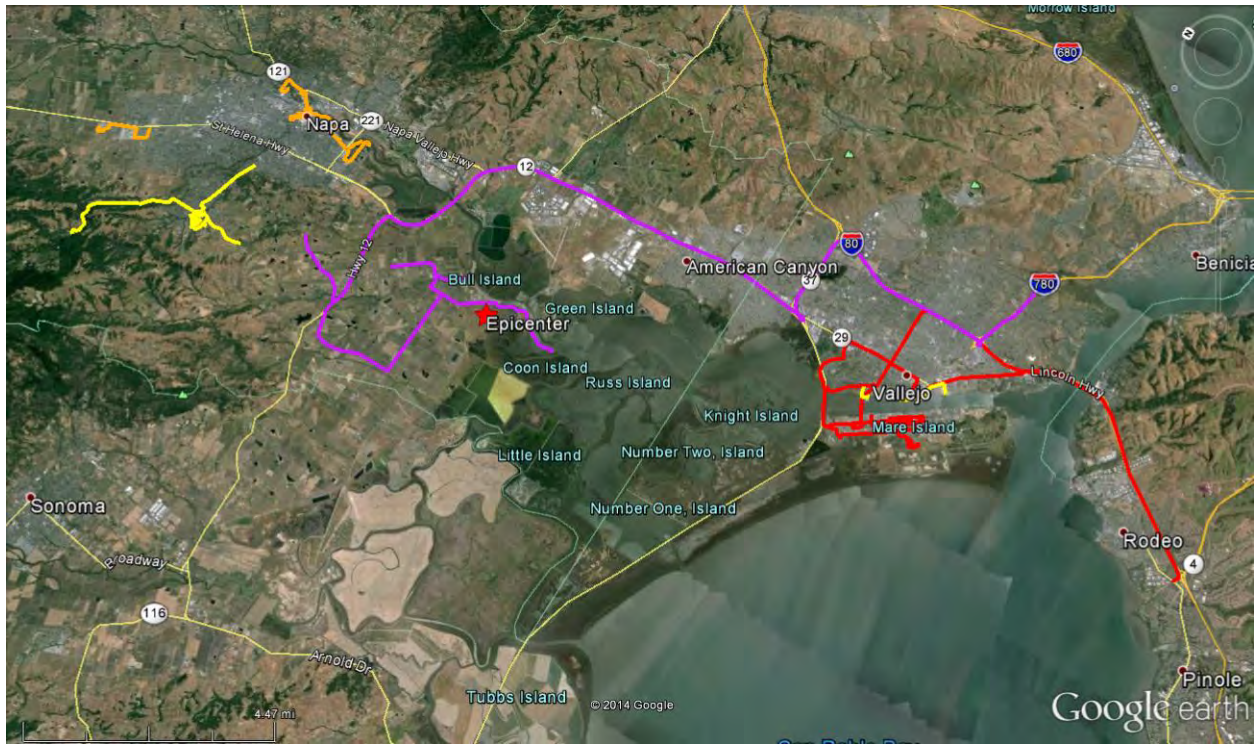
Figure E.1: GPS Track for all GEER teams outside near-fault region [NSF-GEER; 08/24/14]

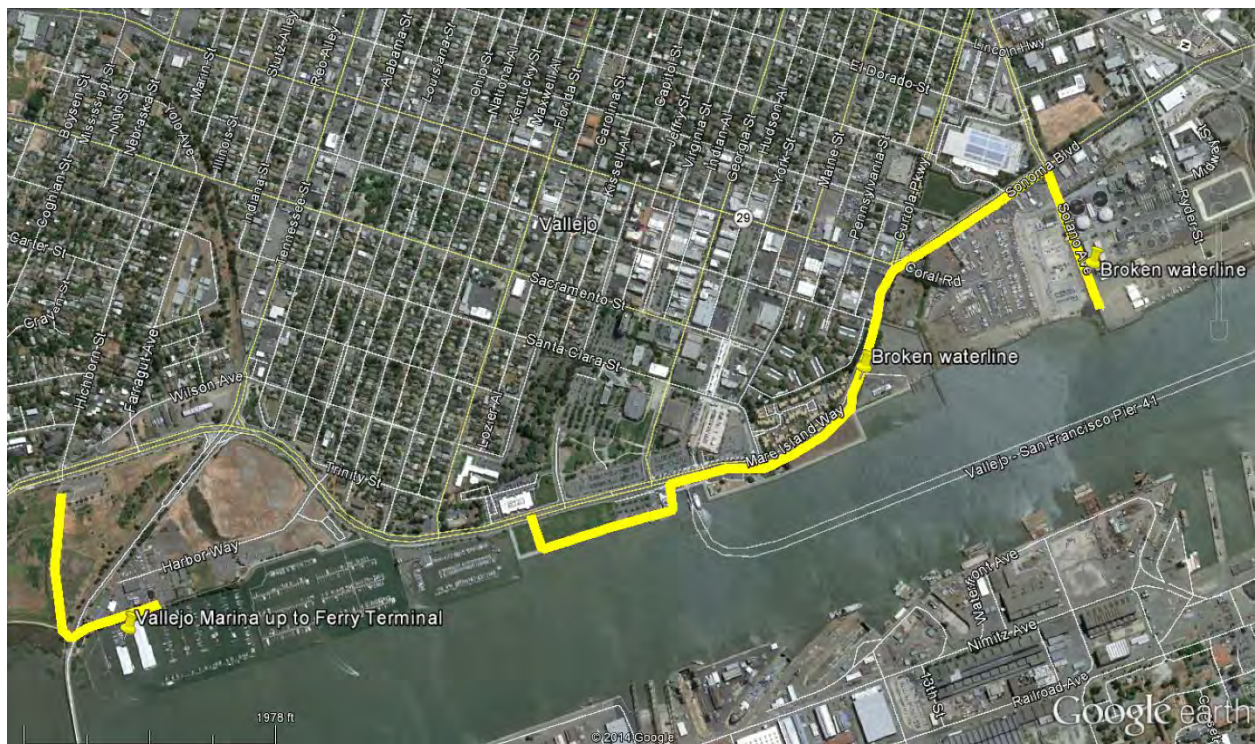
Figure E.5: Vallejo Waterfront Observation Locations [NSF-GEER: Gardner and Markham; 08/24/14]

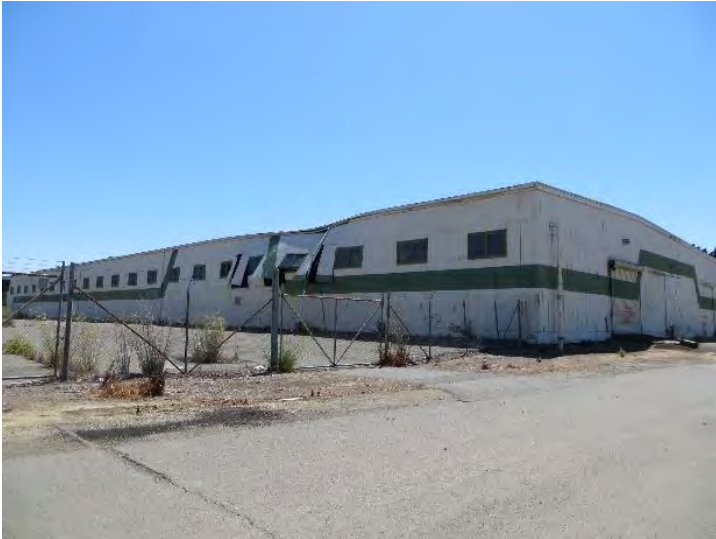
Figure E.6: Corrugated siding damage [NSF-GEER; GPS N38.111 W122.282; 08/24/14; 13:53]

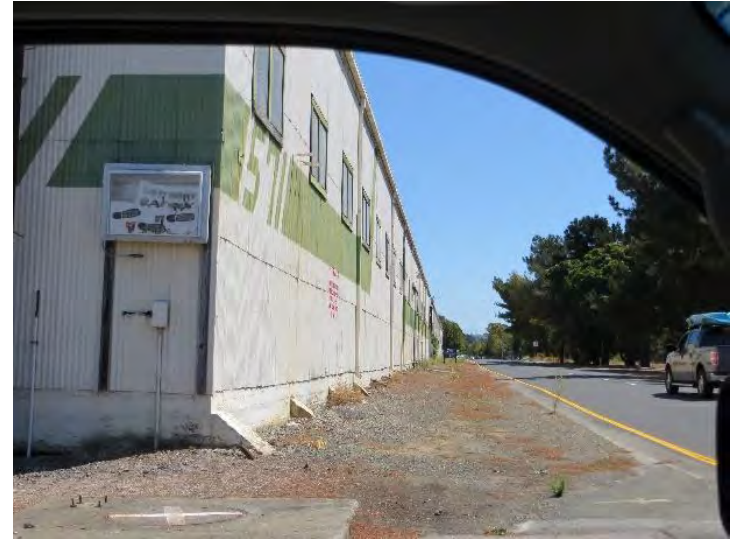
Figure E.7: Corrugated siding, no damage [NSF-GEER; GPS N38.110 W122.283; 08/24/14; 13:54]

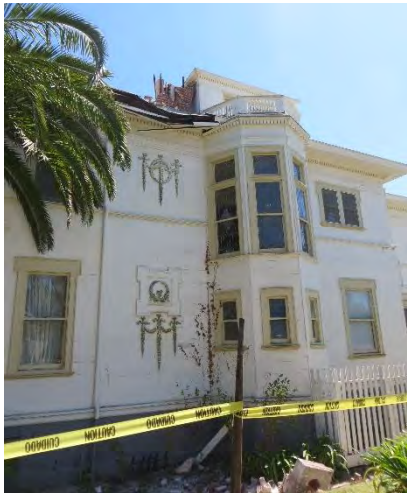
Figure E.8: Brick chimney damage [NSF-GEER; GPS N38.100 W122.274; 08/24/14; 14:13]
