## GEOTECHNICAL EXTREME EVENTS RECONNAISSANCE (GEER) ASSOCIATION

*Turning Disaster into Knowledge*

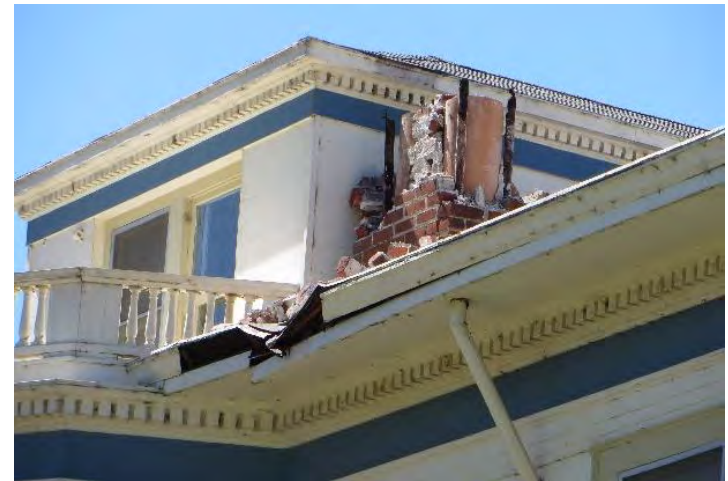
Figure E.9: Brick chimney damage [NSF-GEER; GPS N38.099 W122.273; 08/24/14; 14:19]

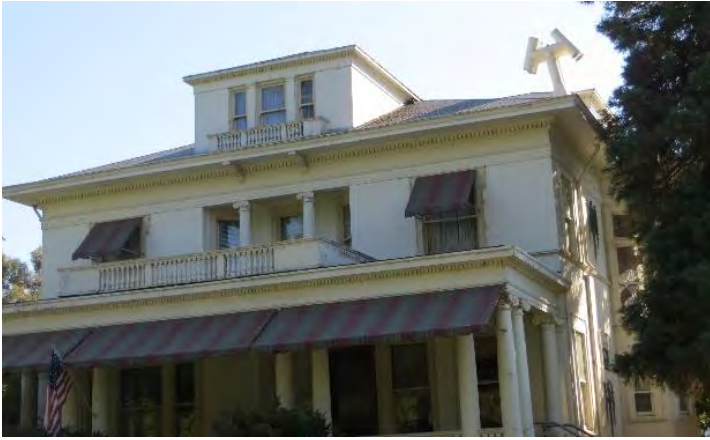
Figure E.10: Metal chimney, no damage [NSF-GEER; GPS N38.097 W122.272; 08/24/14; 17:06]

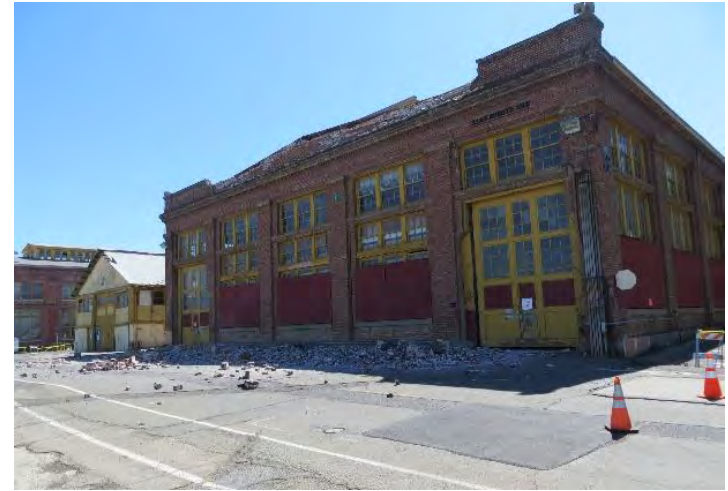
Figure E.11: Brick facade damage [NSF-GEER; GPS N38.097 W122.268; 08/24/14; 14:43]

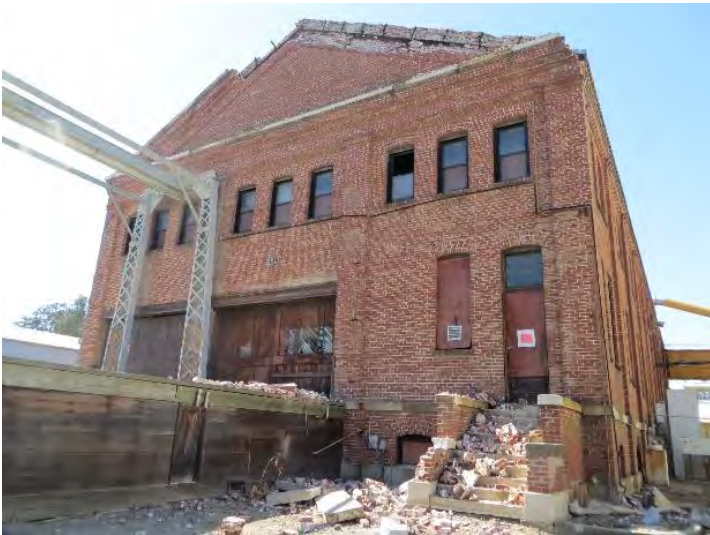
Figure E.12: Brick facade damage [NSF-GEER; GPS N38.095 W122.268; 08/24/14; 15:38]

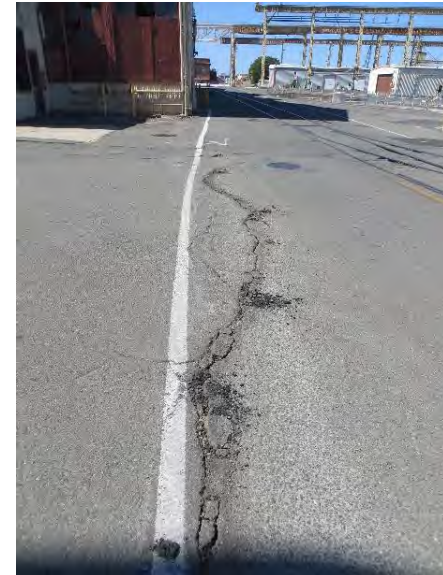
Figure E.13: Possible earthquake damage [NSF-GEER; GPS N38.098 W122.269; 08/24/14; 14:37]

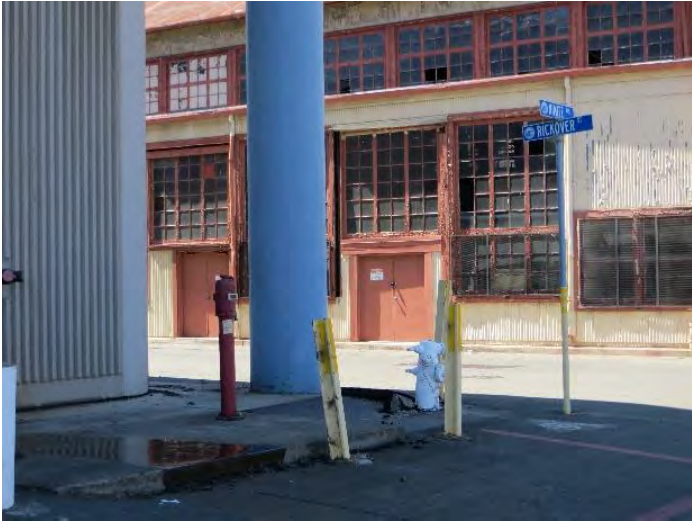
Figure E.14: Pavement damage at hydrant [NSF-GEER; GPS N38.098 W122.269; 08/24/14; 14:39]

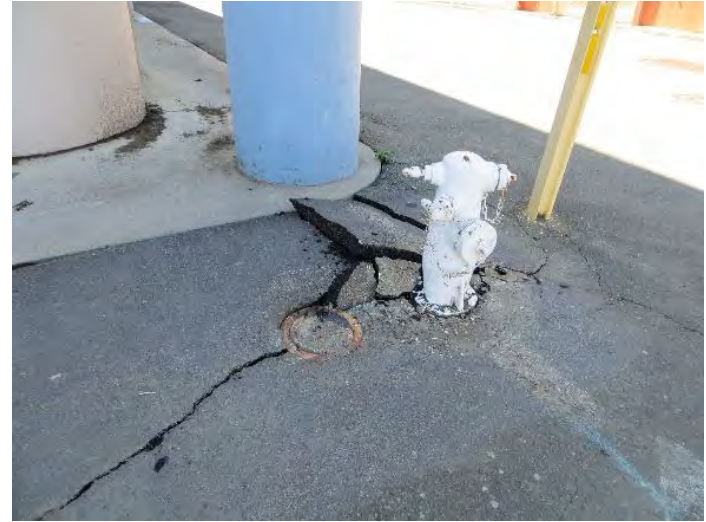
Figure E.15: Pavement damage at hydrant [NSF-GEER; GPS N38.098 W122.269; 08/24/14; 14:37]

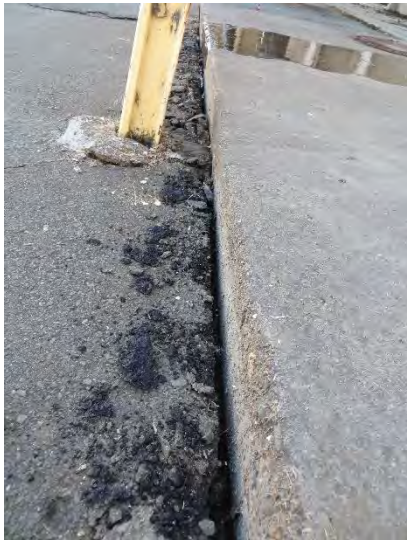
Figure E.16: Pavement damage along concrete [NSF-GEER; GPS N38.098 W122.269; 08/24/14; 14:38]

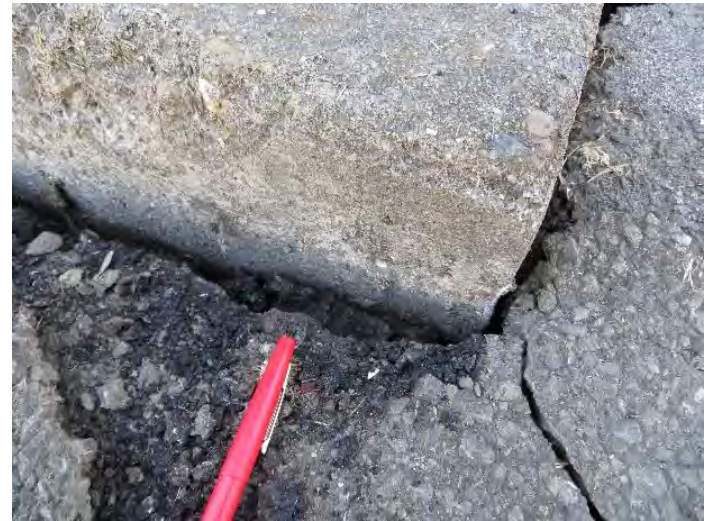
Figure E.17: Pavement damage at concrete corner [NSF-GEER; GPS N38.098 W122.269; 08/24/14; 14:38]

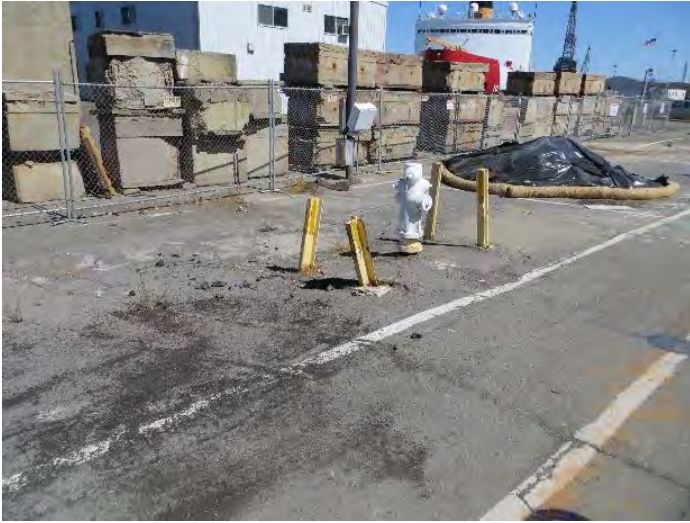
Figure E.18: Hydrant, no damage [NSF-GEER; GPS N38.097 W122.268; 08/24/14; 14:51]

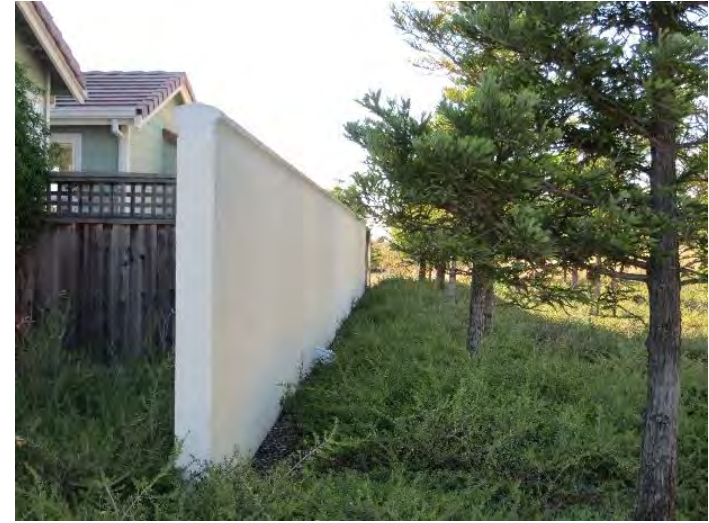
Figure E.19: Soundwall alignment, no deformation [NSF-GEER; GPS N38.096, W122.276; 08/24/14; 17:31]

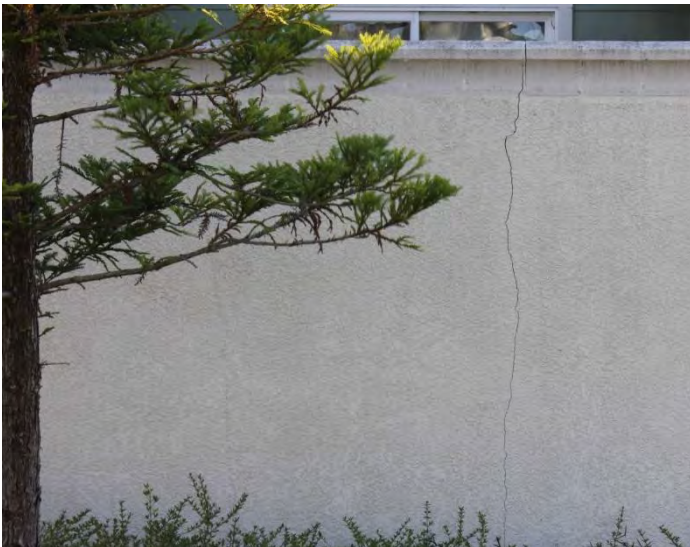
Figure E.20: Soundwall, minor crack [NSF-GEER; GPS N38.096 W122.276; 08/24/14; 17:31]

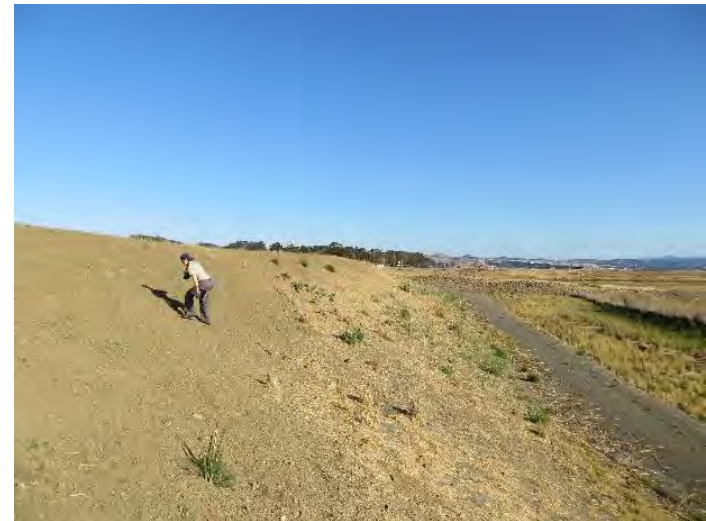
Figure E.21: Surcharge slope, no damage [NSF-GEER; GPS N38.092, W122.277; 08/24/14; 17:49]

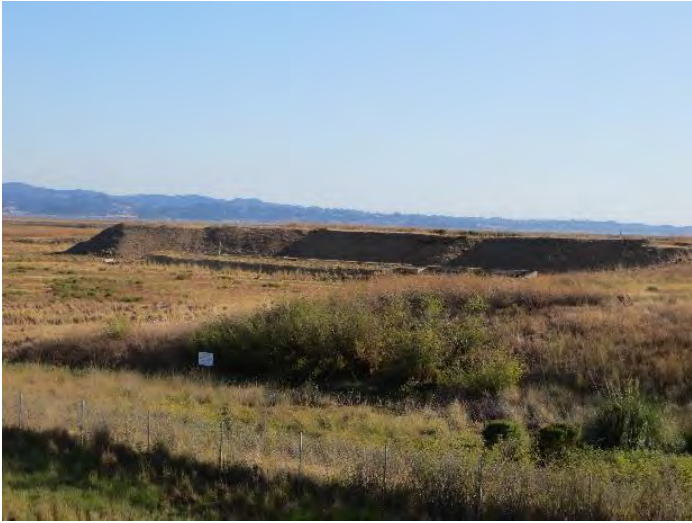
Figure E.22: Slope, no damage [NSF-GEER; GPS N38.092 W122.277; 08/24/14; 17:50]

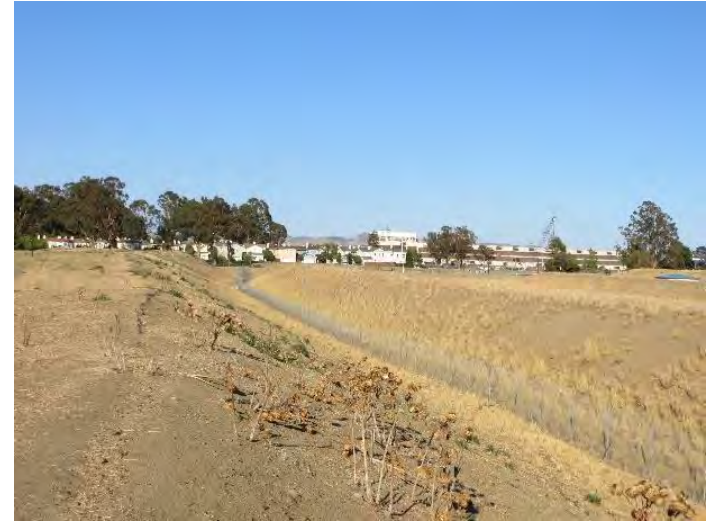
Figure E.23: Slopes, no damage [NSF-GEER; GPS N38.092 W122.277; 08/24/14; 17:53]

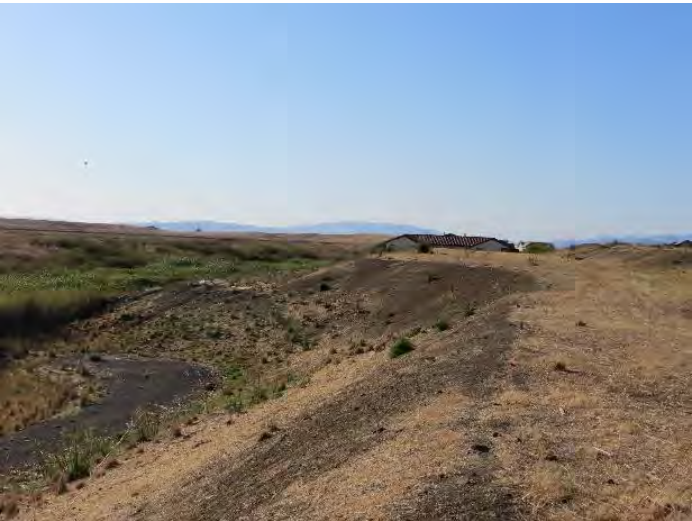
Figure E.24: Surcharge slope, no damage [NSF-GEER; GPS N38.092 W122.277; 08/24/14; 17:51]

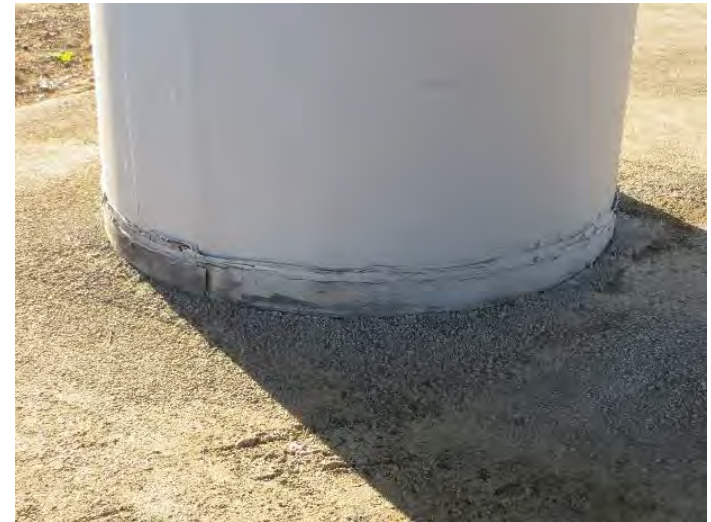
Figure E.25: Highway 37 Bridge pier, no damage [NSF-GEER; GPS N38.122 W122.276; 08/24/14; 18:24]

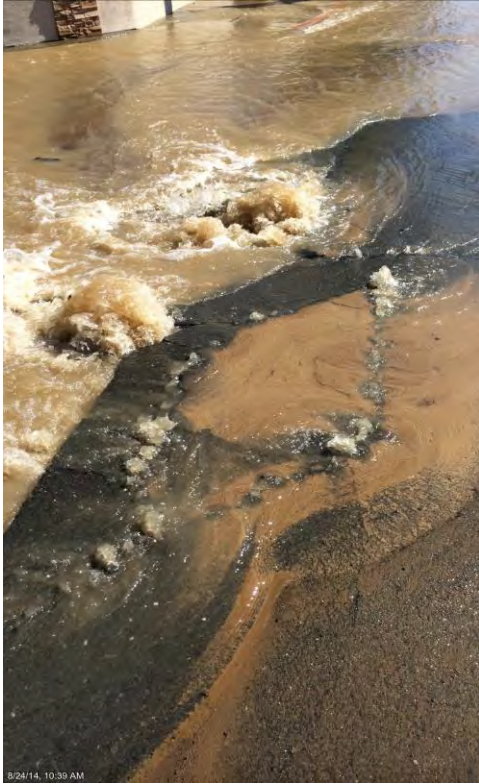
Figure E.26: Water main break at Napa Valley Mobile Home Park [NSF-GEER; N 38.3465 W -122.330; 08/24/14 10:39]

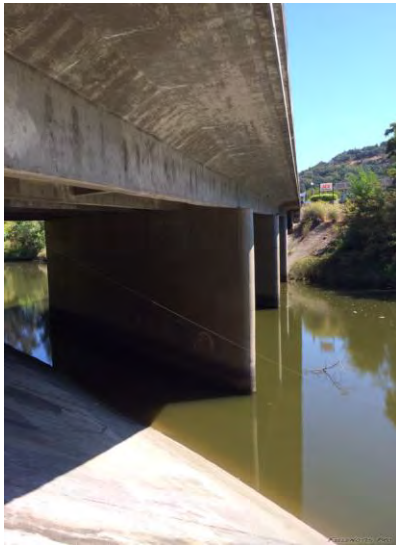
Figure E.29: Lincoln Bridge. No damage was observed. [NSF-GEER; N 38.311 W -122.278; 08/25/14 12:02]

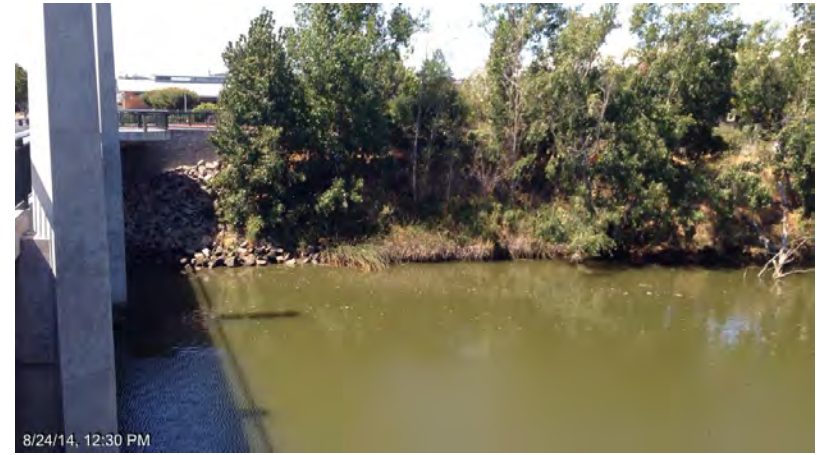
Figure E.30: 1<sup>st</sup> St. Bridge. No damage observed. [NSF-GEER; N 38.3023 W -122.2794; 08/25/14 12:26]

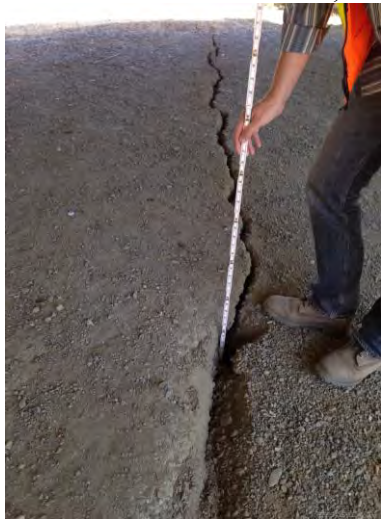
Figure E.31: Railroad Bridge. Crack observed in the interface between the North abutment foundation and the soil. [NSF-GEER; N 38.3002 W -122.282; 08/25/14 12:41]

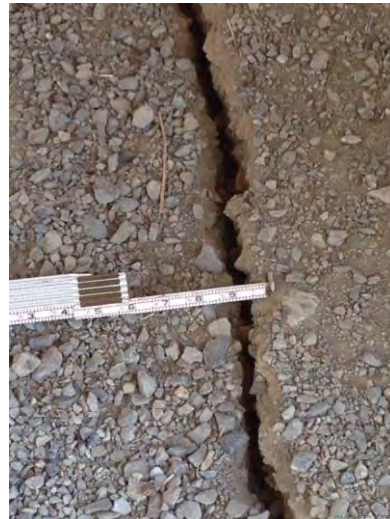
Figure E.32: Railroad Bridge. Crack observed in the interface between the South abutment foundation and the soil. [NSF-GEER; N 38.2995 W -122.2821; 08/25/14 13:28]

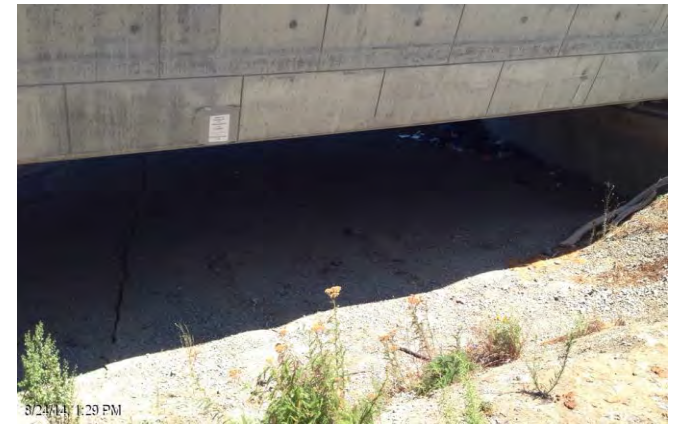
Figure E.33: Railroad Bridge. Crack observed in the interface between the South abutment foundation and the soil. [NSF-GEER; N 38.2995 W -122.2821; 08/25/14 13:28]

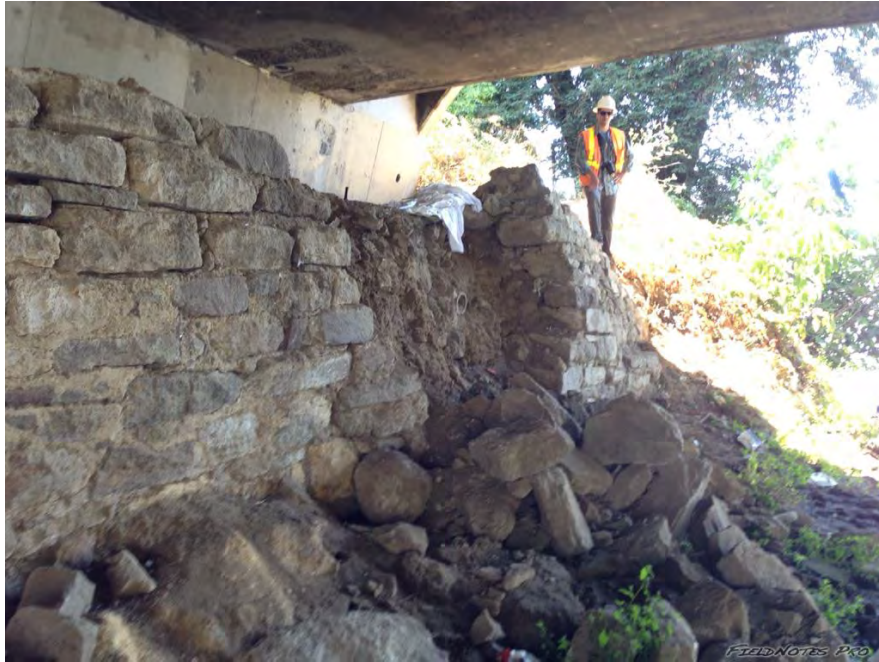
Figure E.34: Failure of the stone retaining wall in South abutment of Soscol Bridge [NSF-GEER; N 38.2994 W -122.282; 08/24/14 13:44]

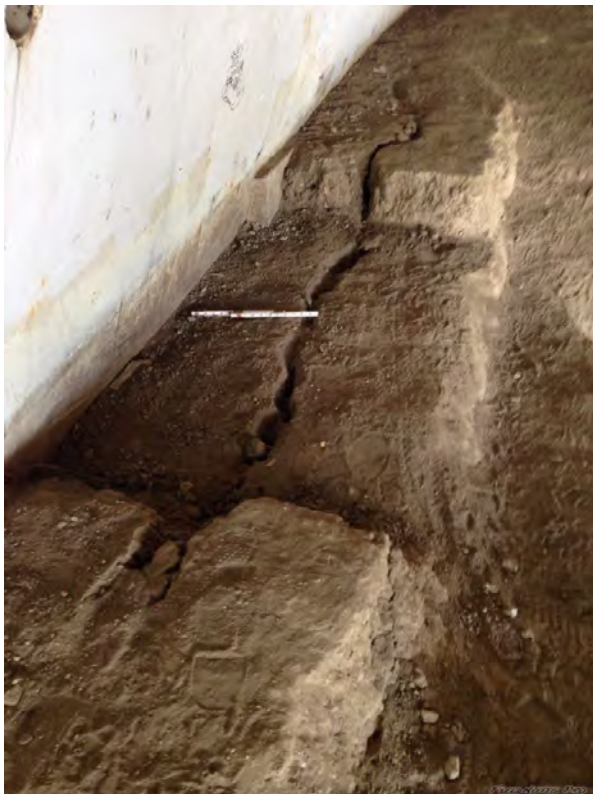
Figure E.35: Crack parallel to the River in North abutment of Soscol Bridge [NSF-GEER; N 38.2997 W -122.283; 08/24/14 13:09]

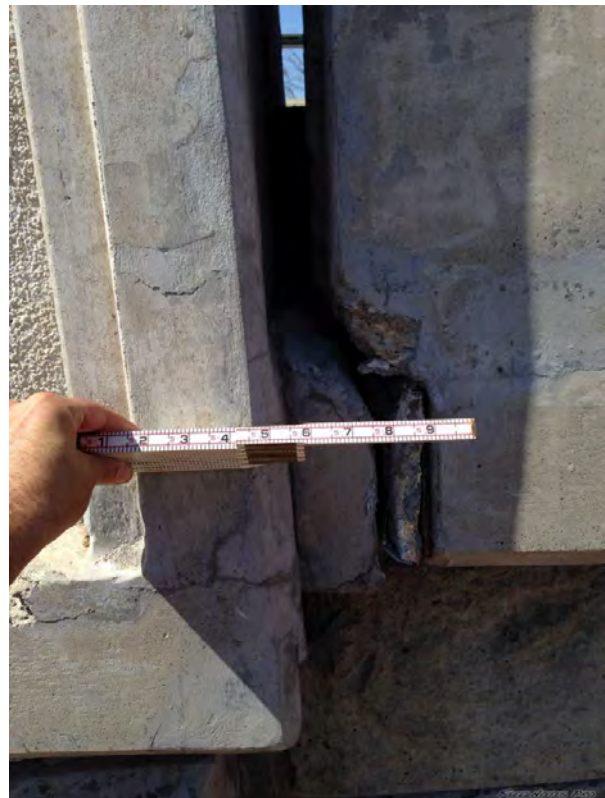
Figure E.36: Movement of the deck in 3rd St. Bridge East abutment [NSF-GEER; N 38.2981 W -122.284; 08/24/14 14:44]

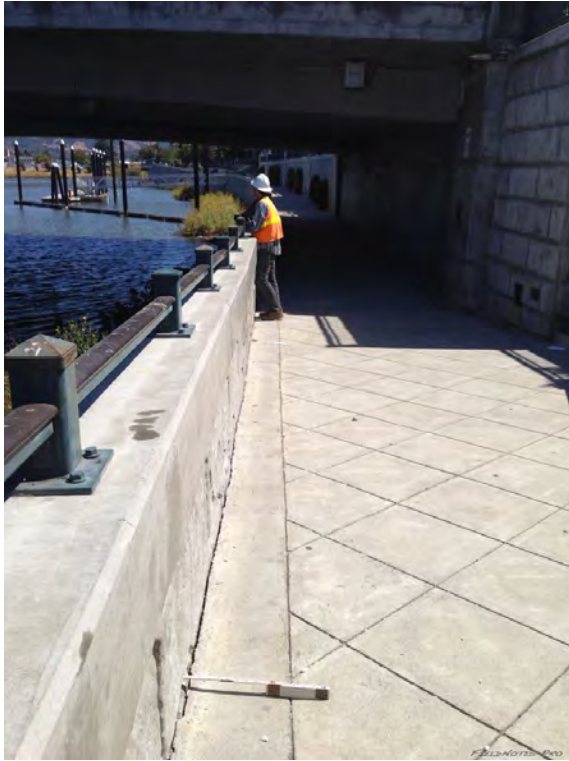
Figure E.37: Crack parallel to the River in West abutment of 3<sup>rd</sup> St. Bridge [NSF-GEER; N 38.2980 W -122.2840; 08/24/14 14:44]

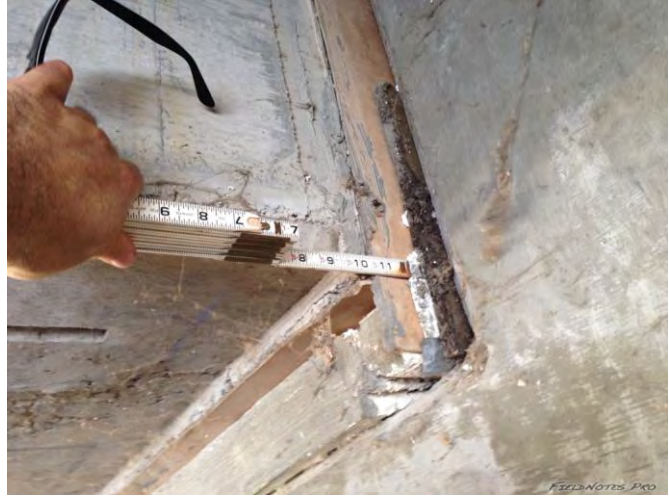
Figure E.38: of the deck in 3<sup>rd</sup> St. Bridge East abutment [NSF-GEER; N 38.2981 W -122.284; 08/24/14 14:44]

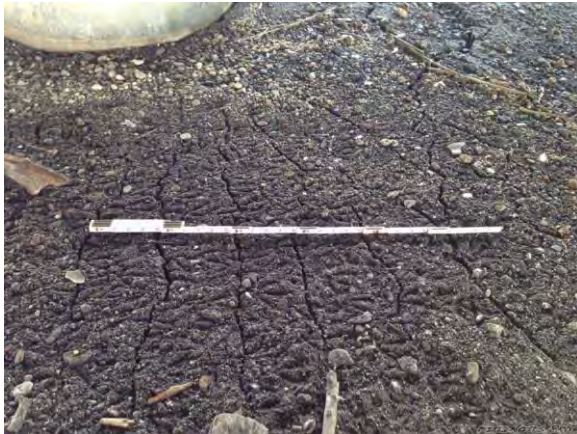
Figure E.39: Ground cracking due to liquefaction in Napa River point bar below 3<sup>rd</sup> St. Bridge, between the two columns of the eastern pier. [NSF-GEER; N 38.2980 W -122.2840; 08/24/14 14:44]

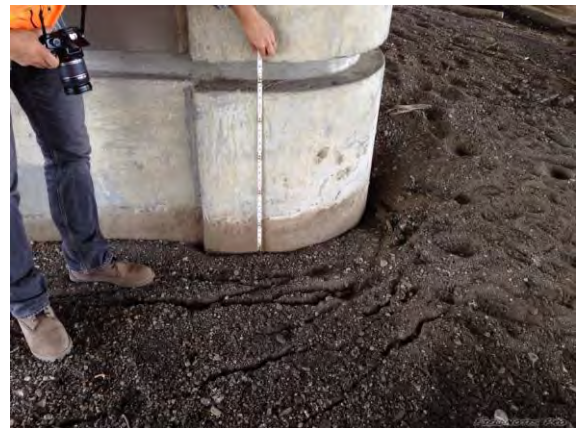
Figure E.40: Ground cracking and settlement due to liquefaction in Napa River point bar below 3<sup>rd</sup> St. Bridge [NSF-GEER; N 38.2980 W -122.2840; 08/24/14 14:44]

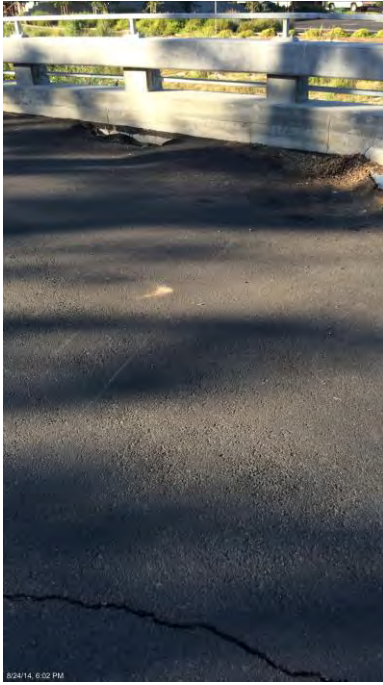
Figure E.41: Settlement of backfill near the retaining wall in the Pedestrian Bridge [NSF-GEER; N 38.3003 W -122.2881; 08/24/14 17:58]

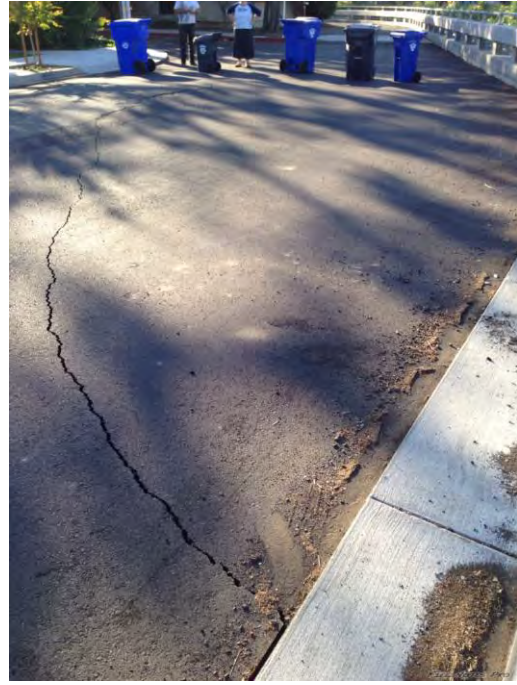
Figure E.42: Crack in pavement behind the retaining wall in the Pedestrian Bridge [NSF-GEER; N 38.3003 W -122.2881; 08/24/14 17:58]

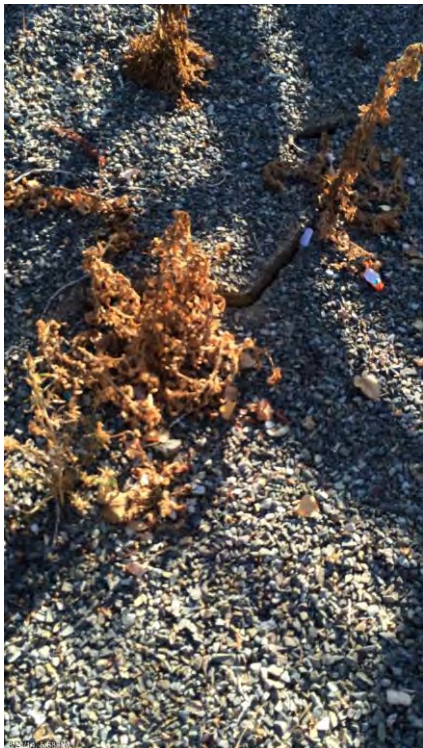
Figure E.43: Crack along sheet pile wall behind the retaining wall in the Pedestrian Bridge [NSF-GEER; N 38.3003 W -122.2881; 08/24/14 17:58]

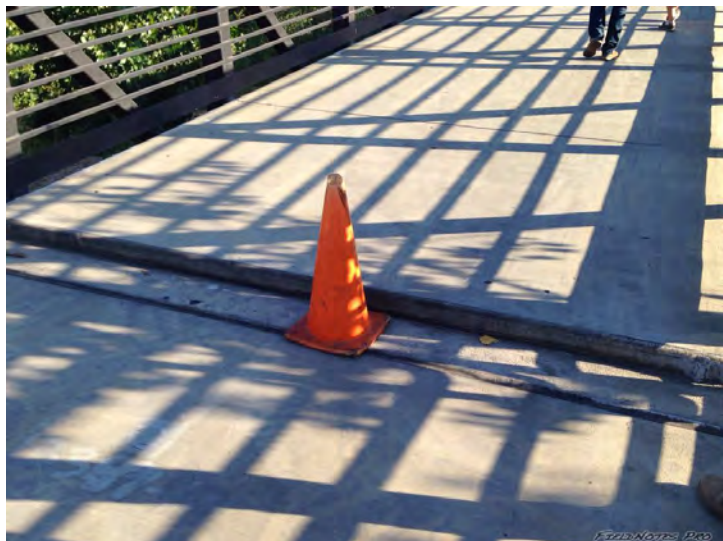
Figure E.44: Step between bridge's deck and access ramp in North abutment. [NSF-GEER; N 38.3003 W -122.2881; 08/24/14 17:58]

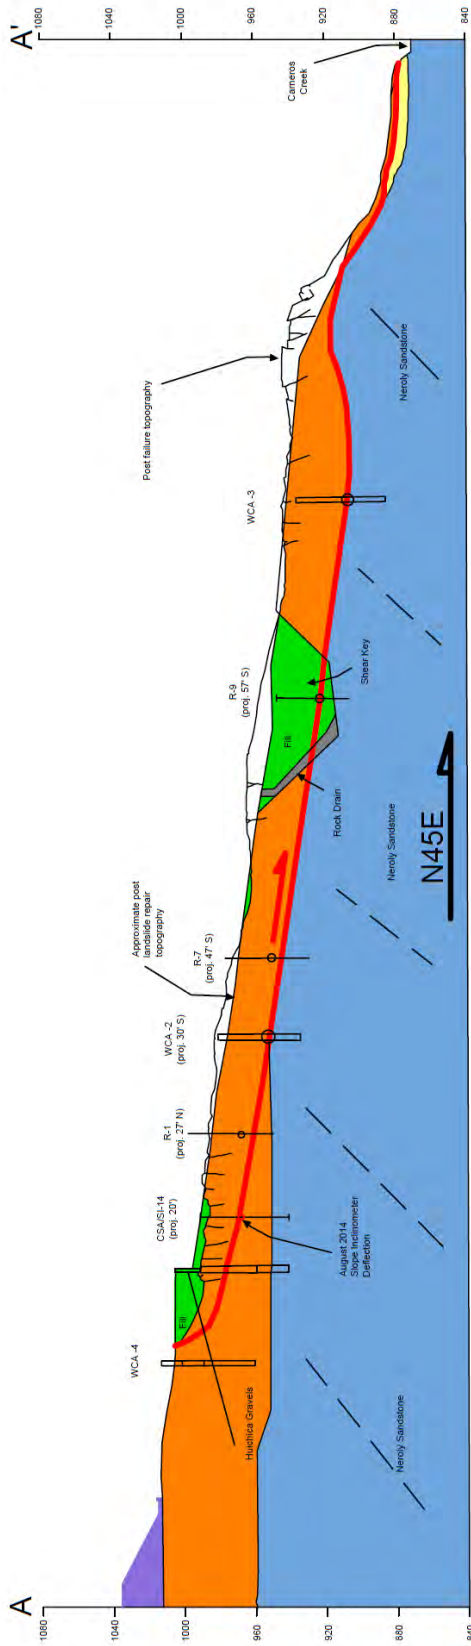
Figure E.45: Napa winery cross-section

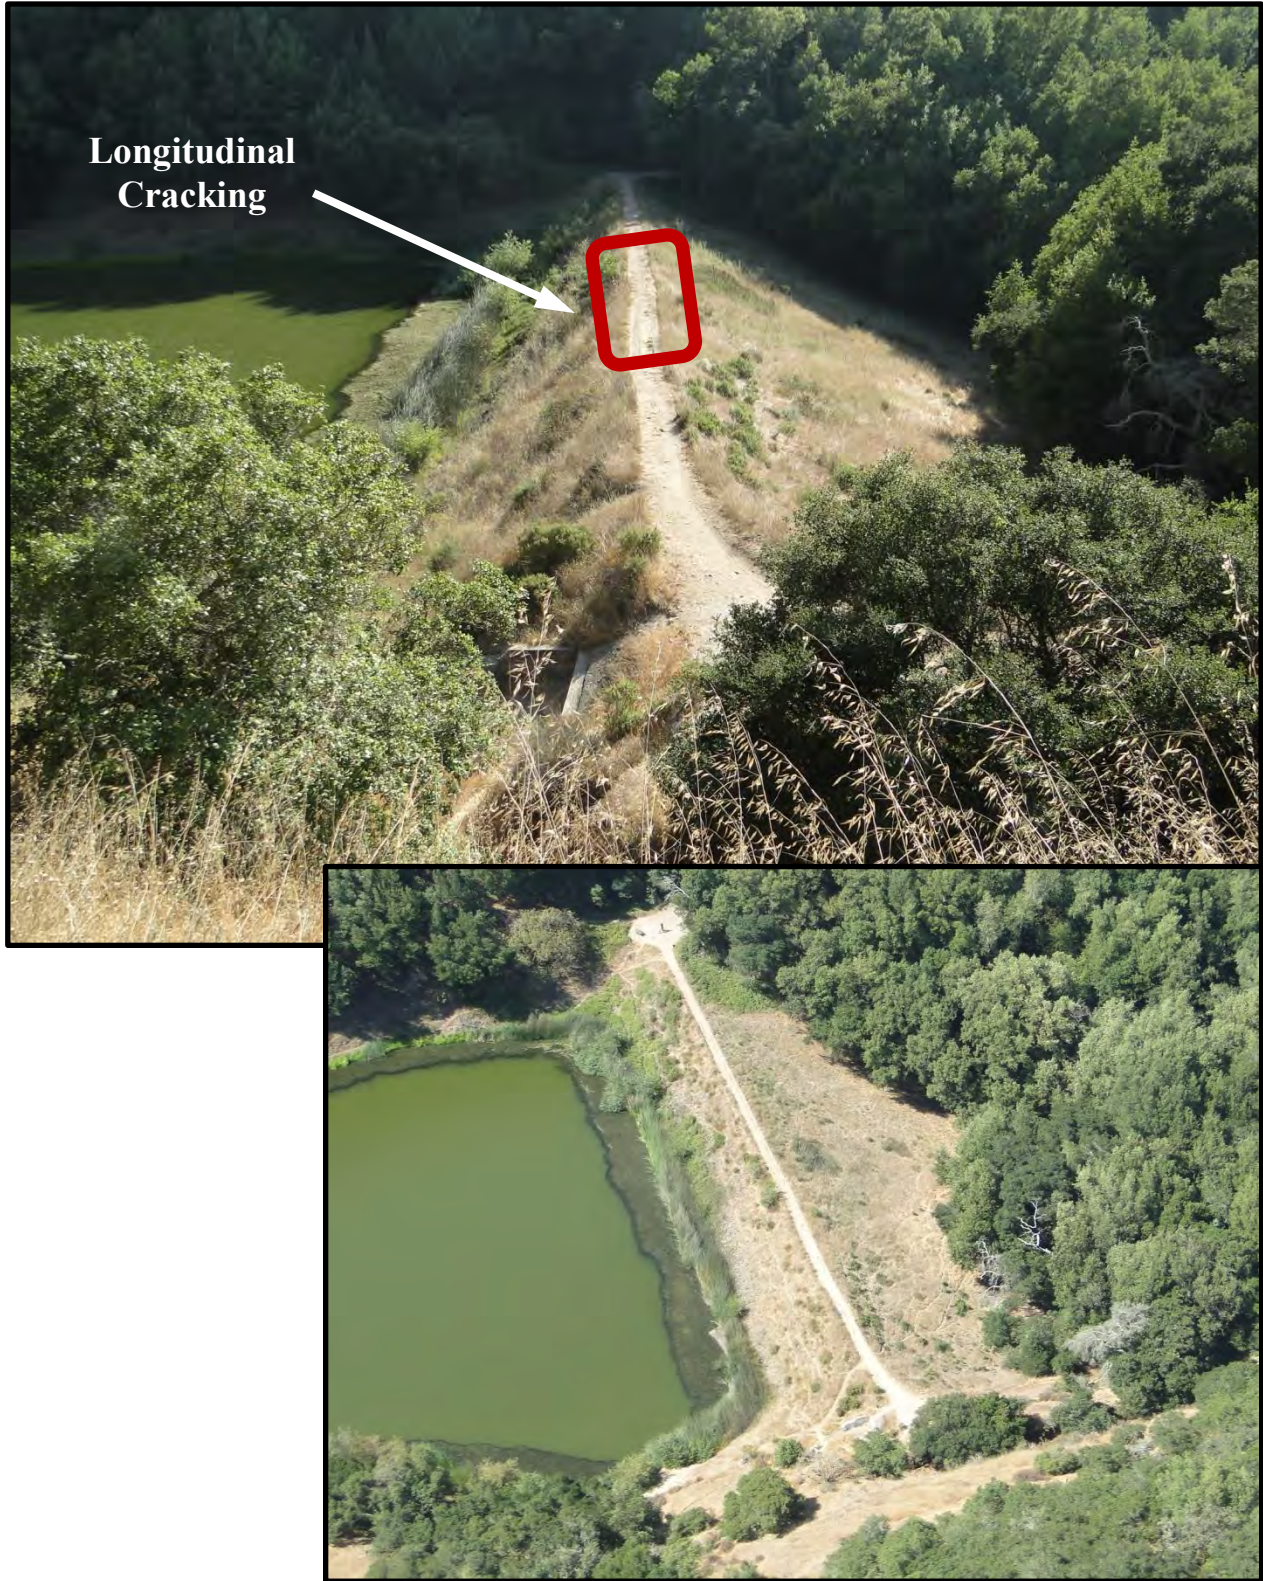
Figure F-2: Ground and aerial photographs of Lake Marie Dam looking southeast  
[NSF-GEER; Napa, CA; N38.260 W 122.230; Harder, L. F.; 09/01/14]

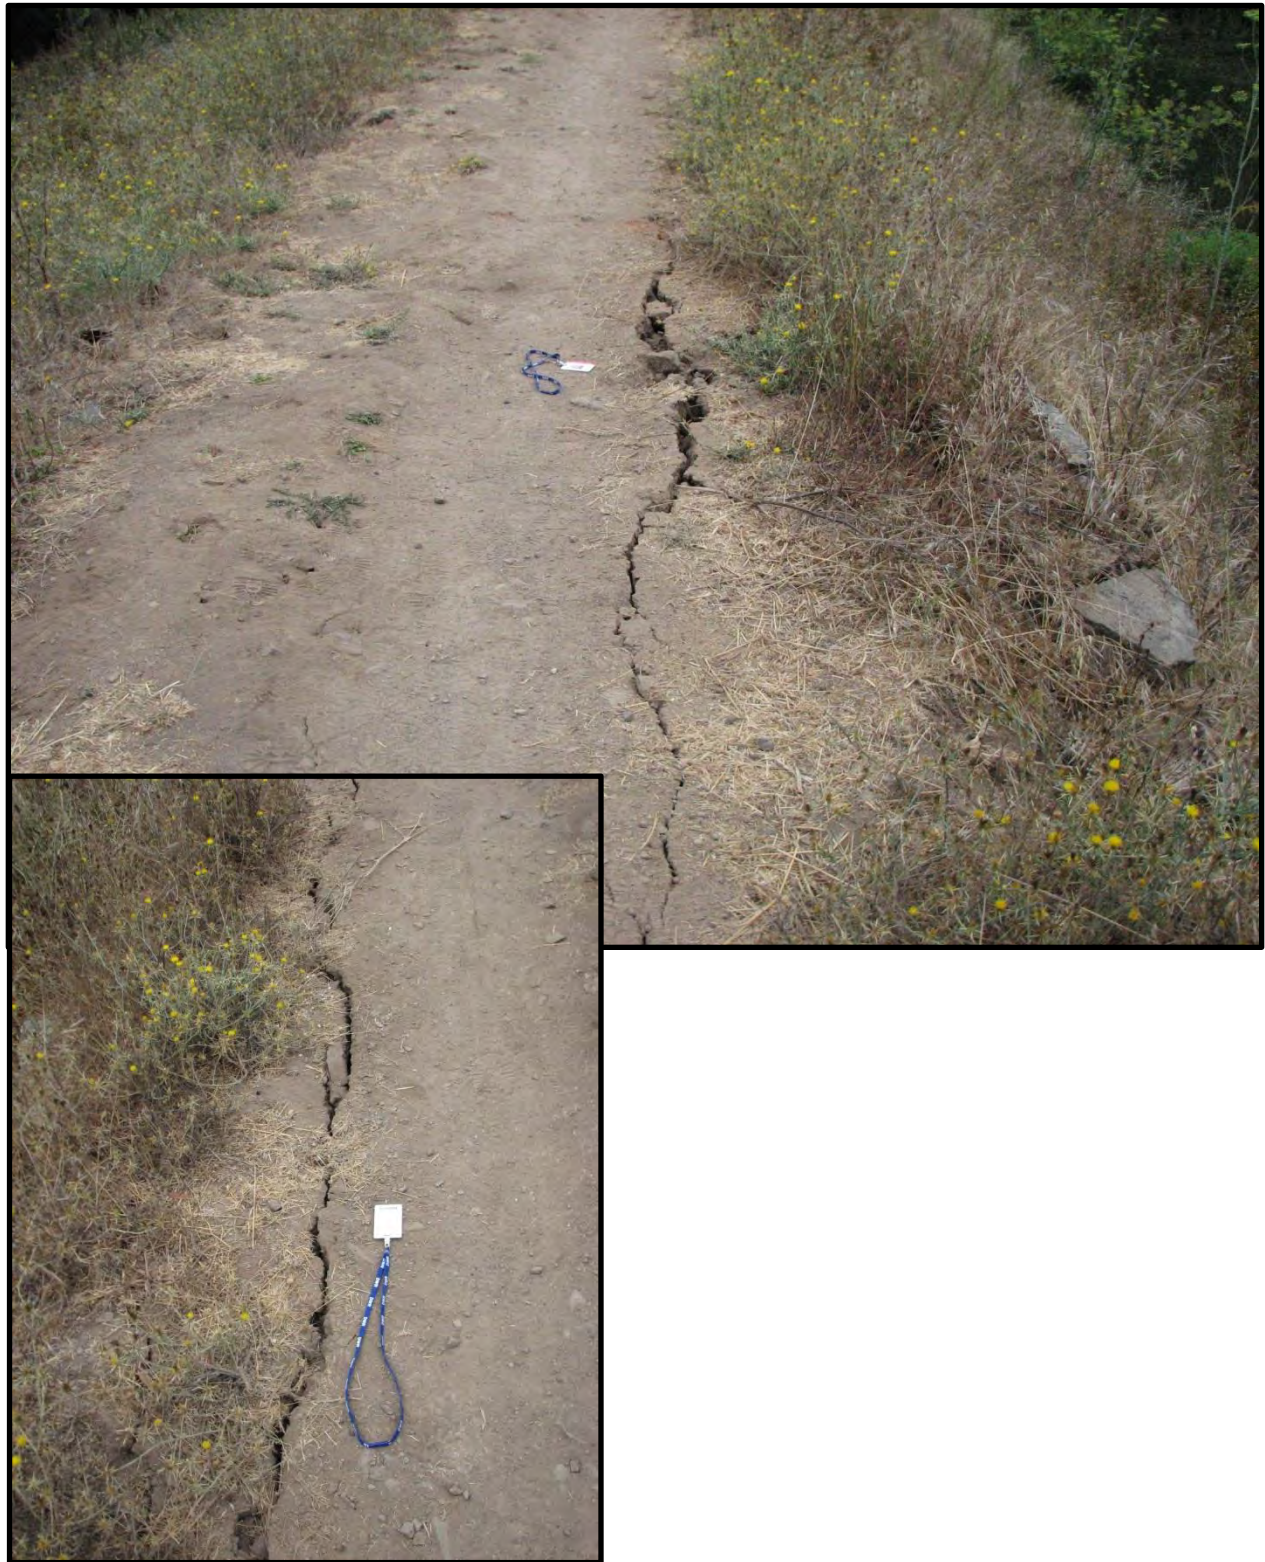
Figure F-3: Photographs of longitudinal cracking on the upstream edge of the crest of Lake Marie Dam [Napa, CA; N38.260 W 122.230; from DSOD files; 08/24/14]

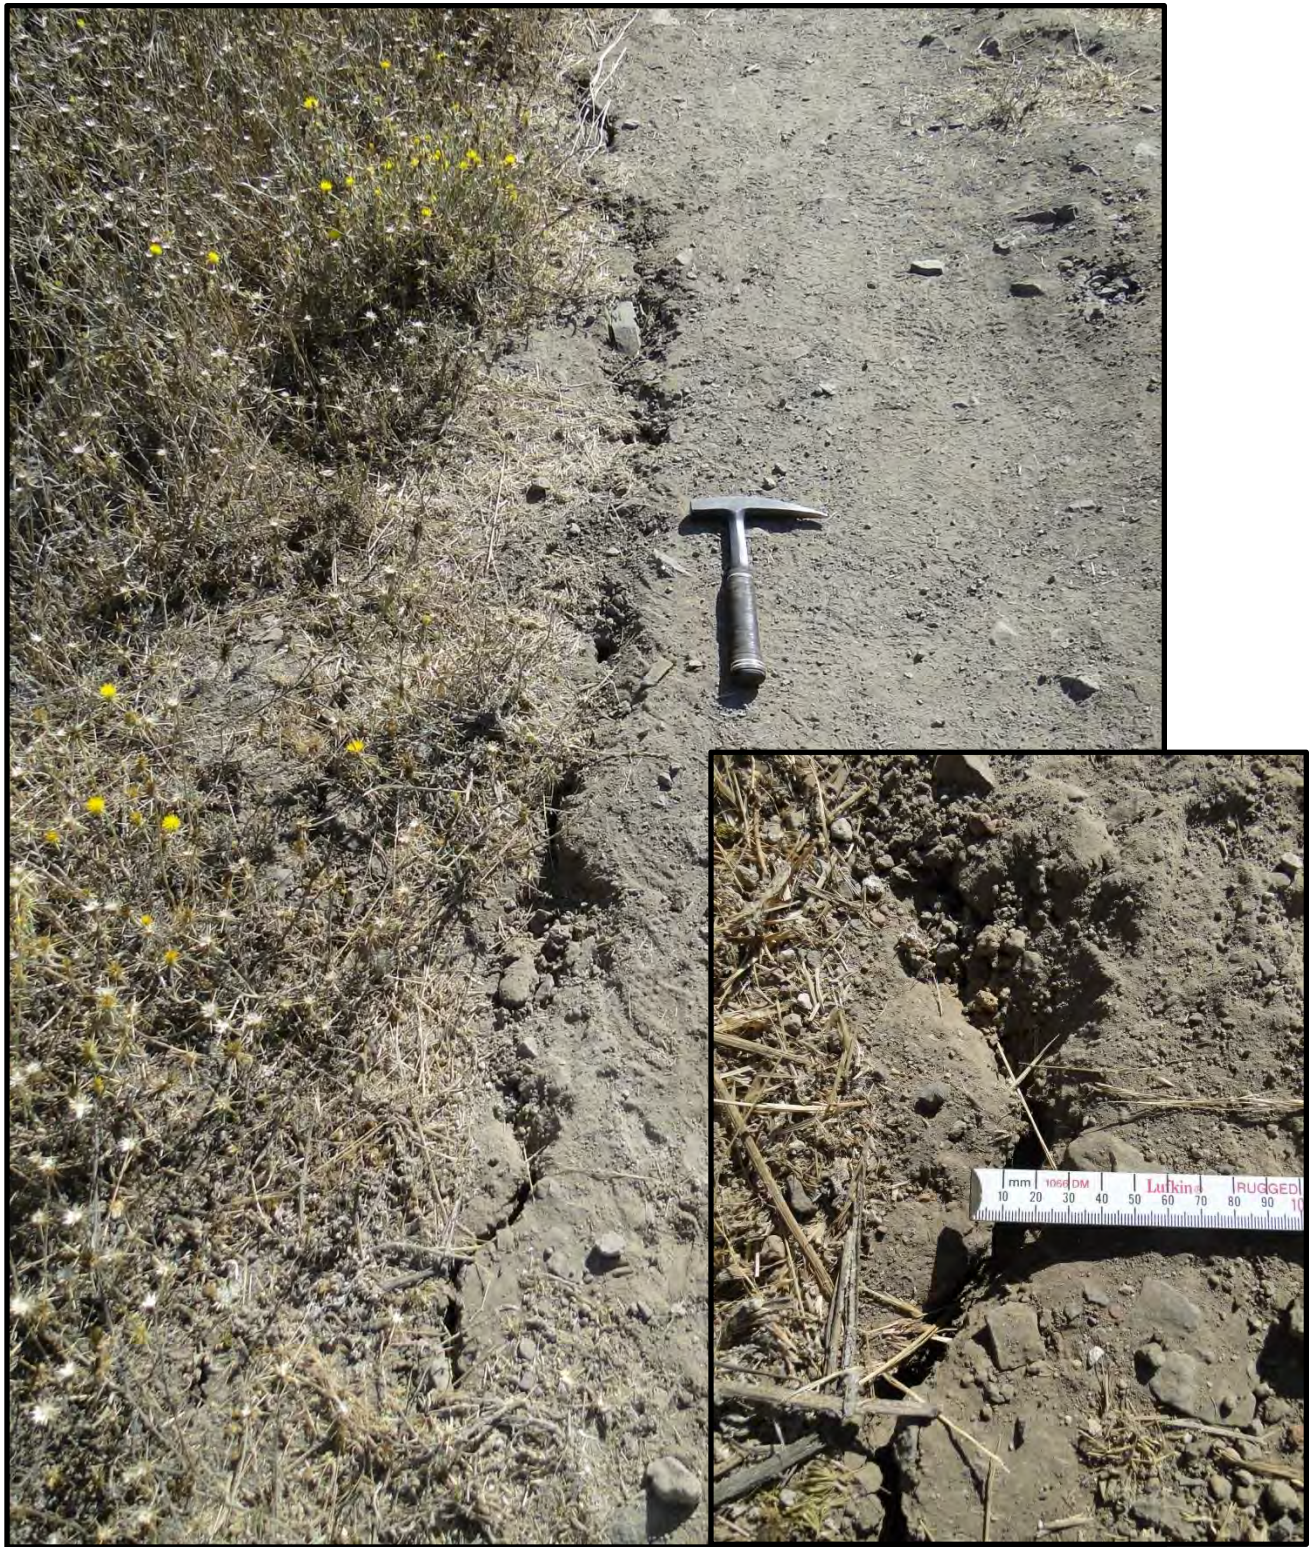
Figure F-4: Photograph of cracking on the upstream edge of the crest of Lake Marie Dam looking southeast [NSF-GEER; Napa, CA; N38.260 W 122.230; Harder, L. F.; 09/01/14]

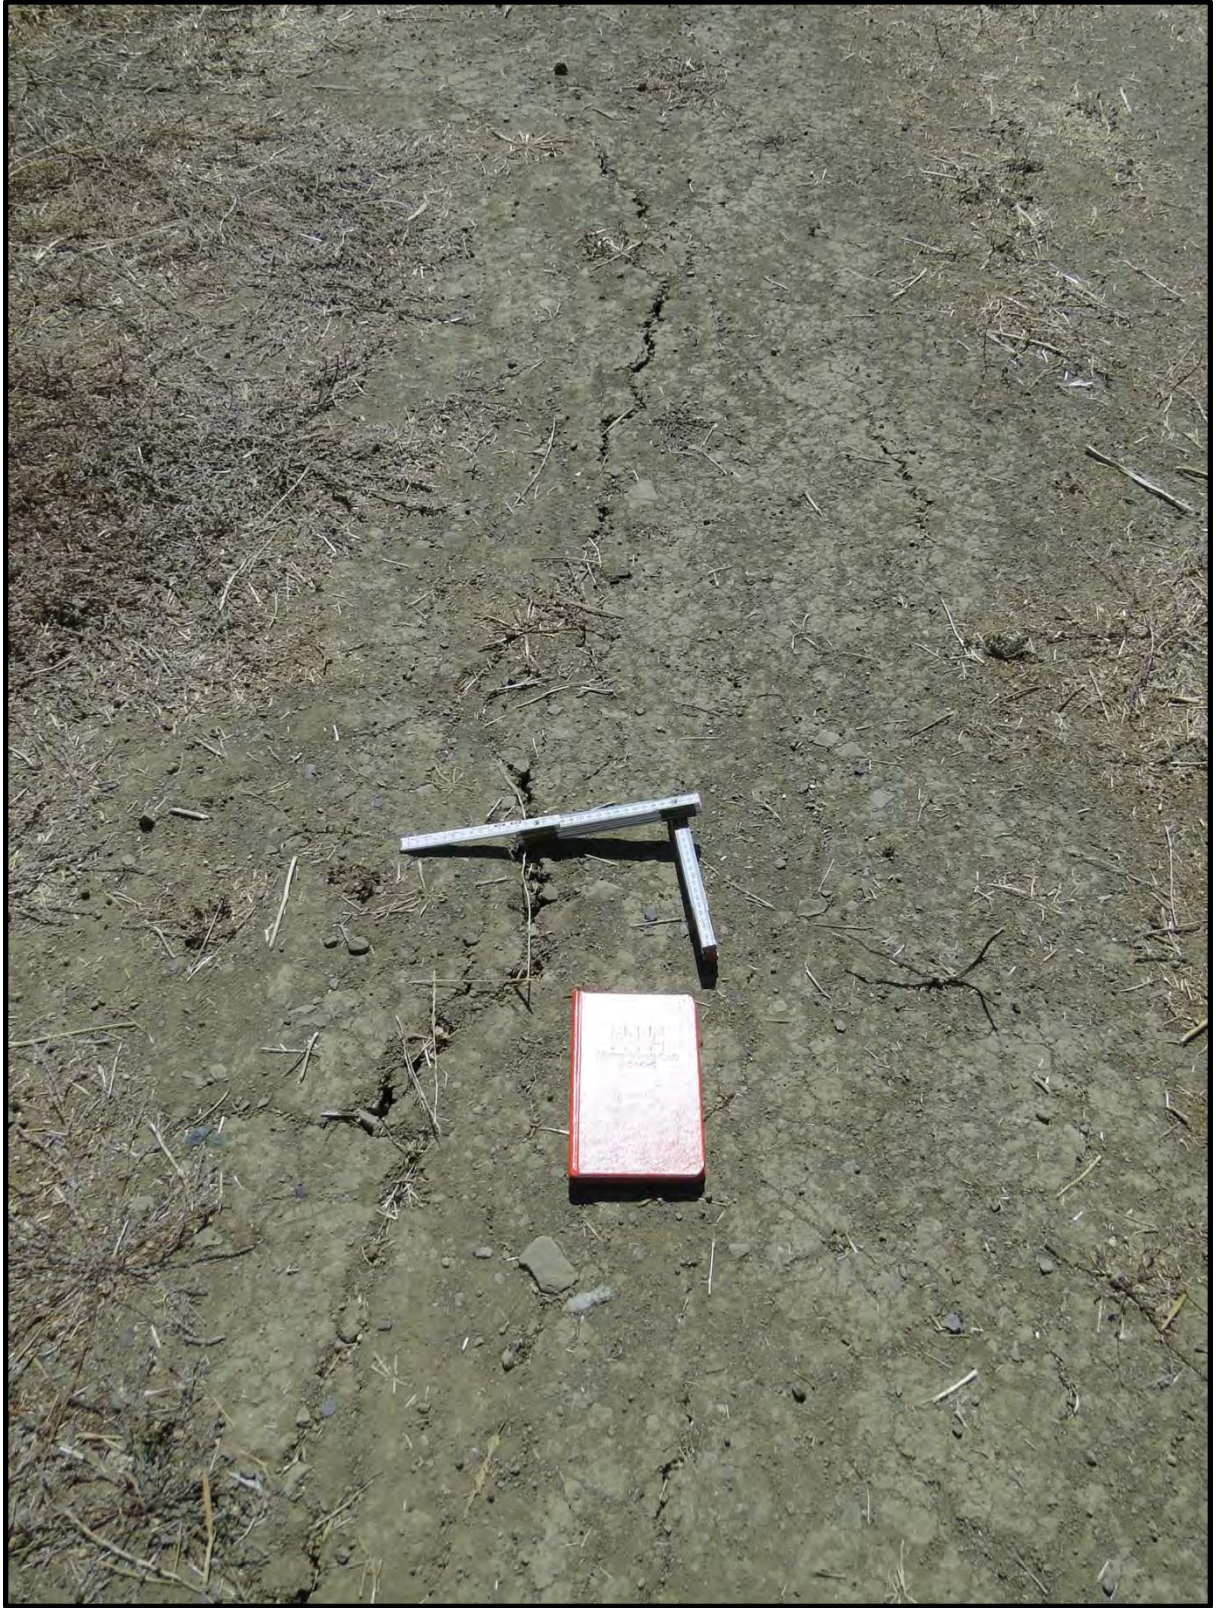
Figure F-7: Close-up photograph of minor longitudinal cracking on the crest of Lake Chabot Dam looking southeast [NSF-GEER; Napa, CA; N38.141 W 122.241; Harder, L. F.; 08/27/14]
