## GEOTECHNICAL EXTREME EVENTS RECONNAISSANCE (GEER) ASSOCIATION

*Turning Disaster into Knowledge*

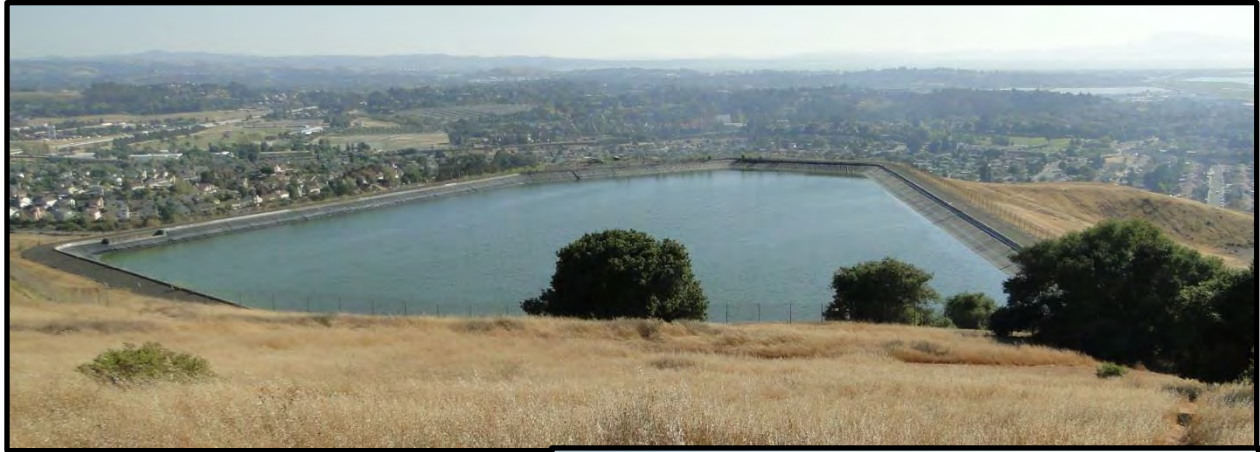
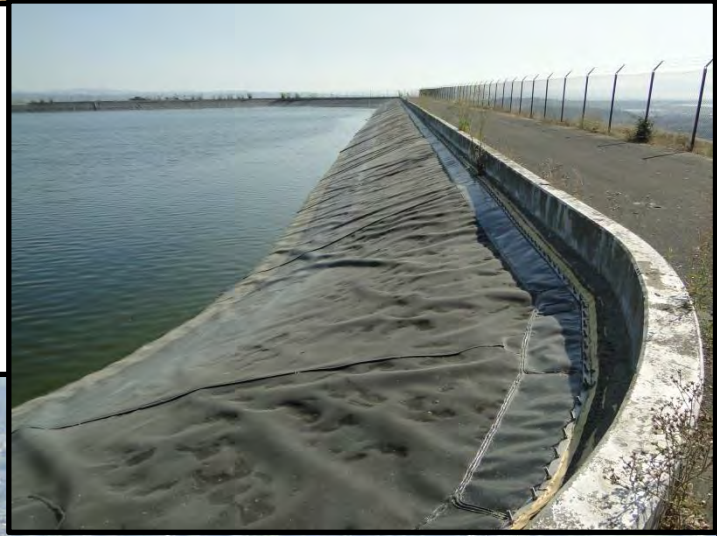
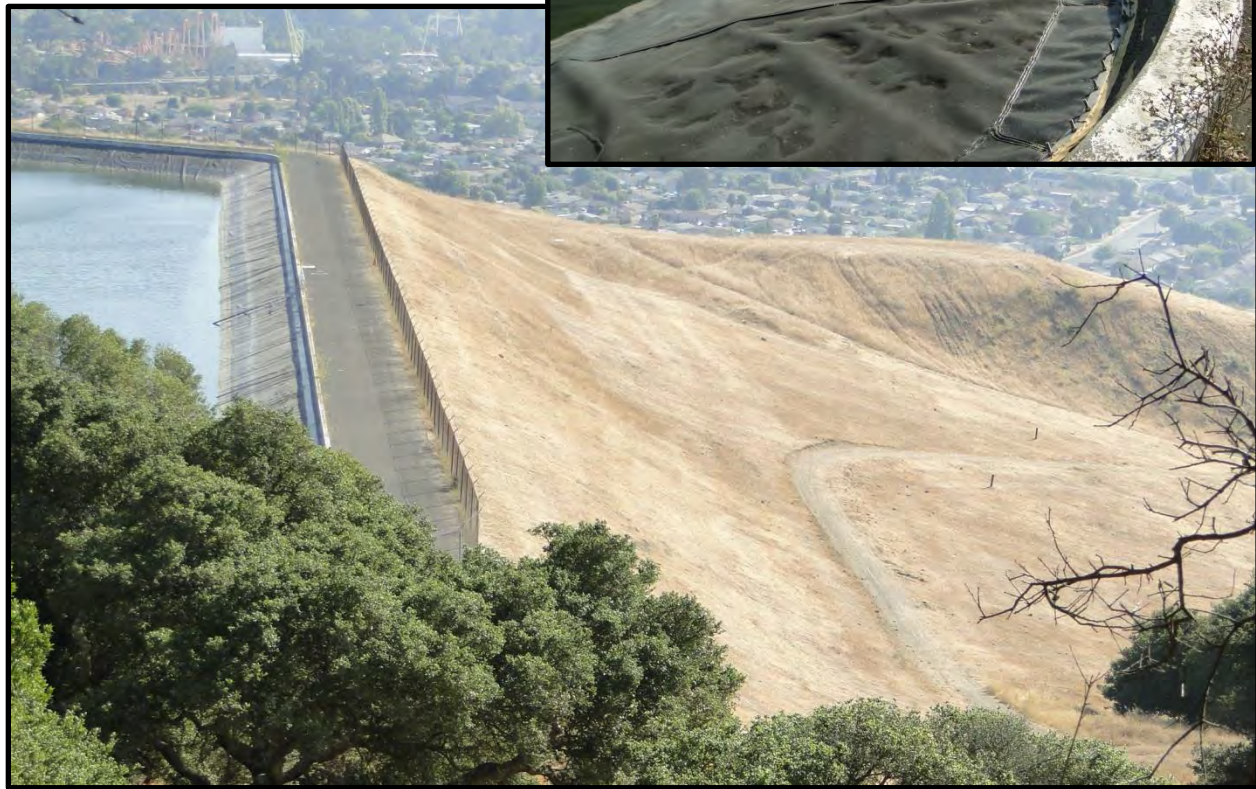
Figure F-8: Views of Summit Reservoir Dam looking southeast  
[NSF-GEER; Napa, CA; N38.153 W 122.225; Harder, L. F.; 08/27/14]

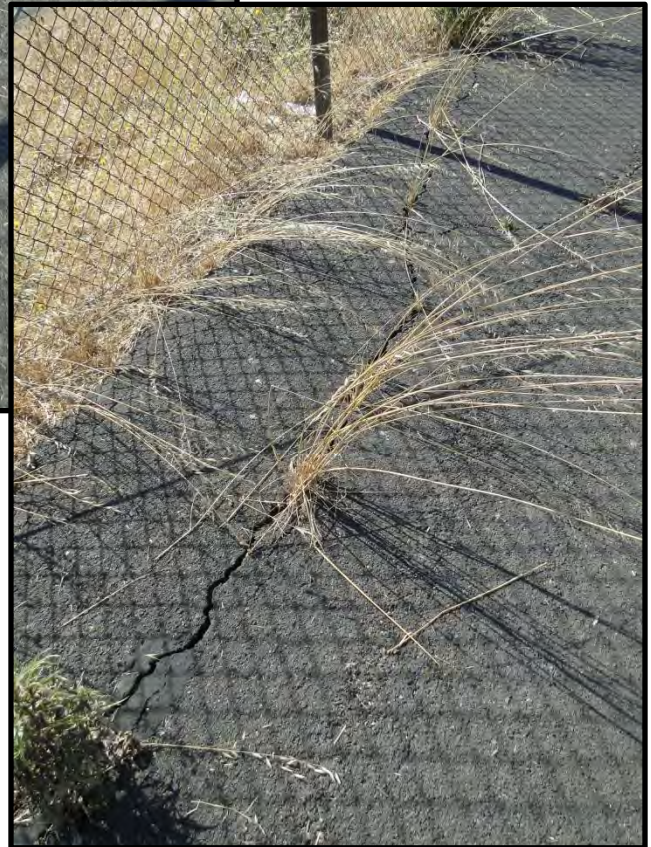
Figure F-9: Photographs of pre-existing longitudinal cracks on the crest of the maximum section of Summit Reservoir Dam  
[NSF-GEER; Napa, CA; N38.153 W 122.225; Harder, L. F.; 08/27/14]

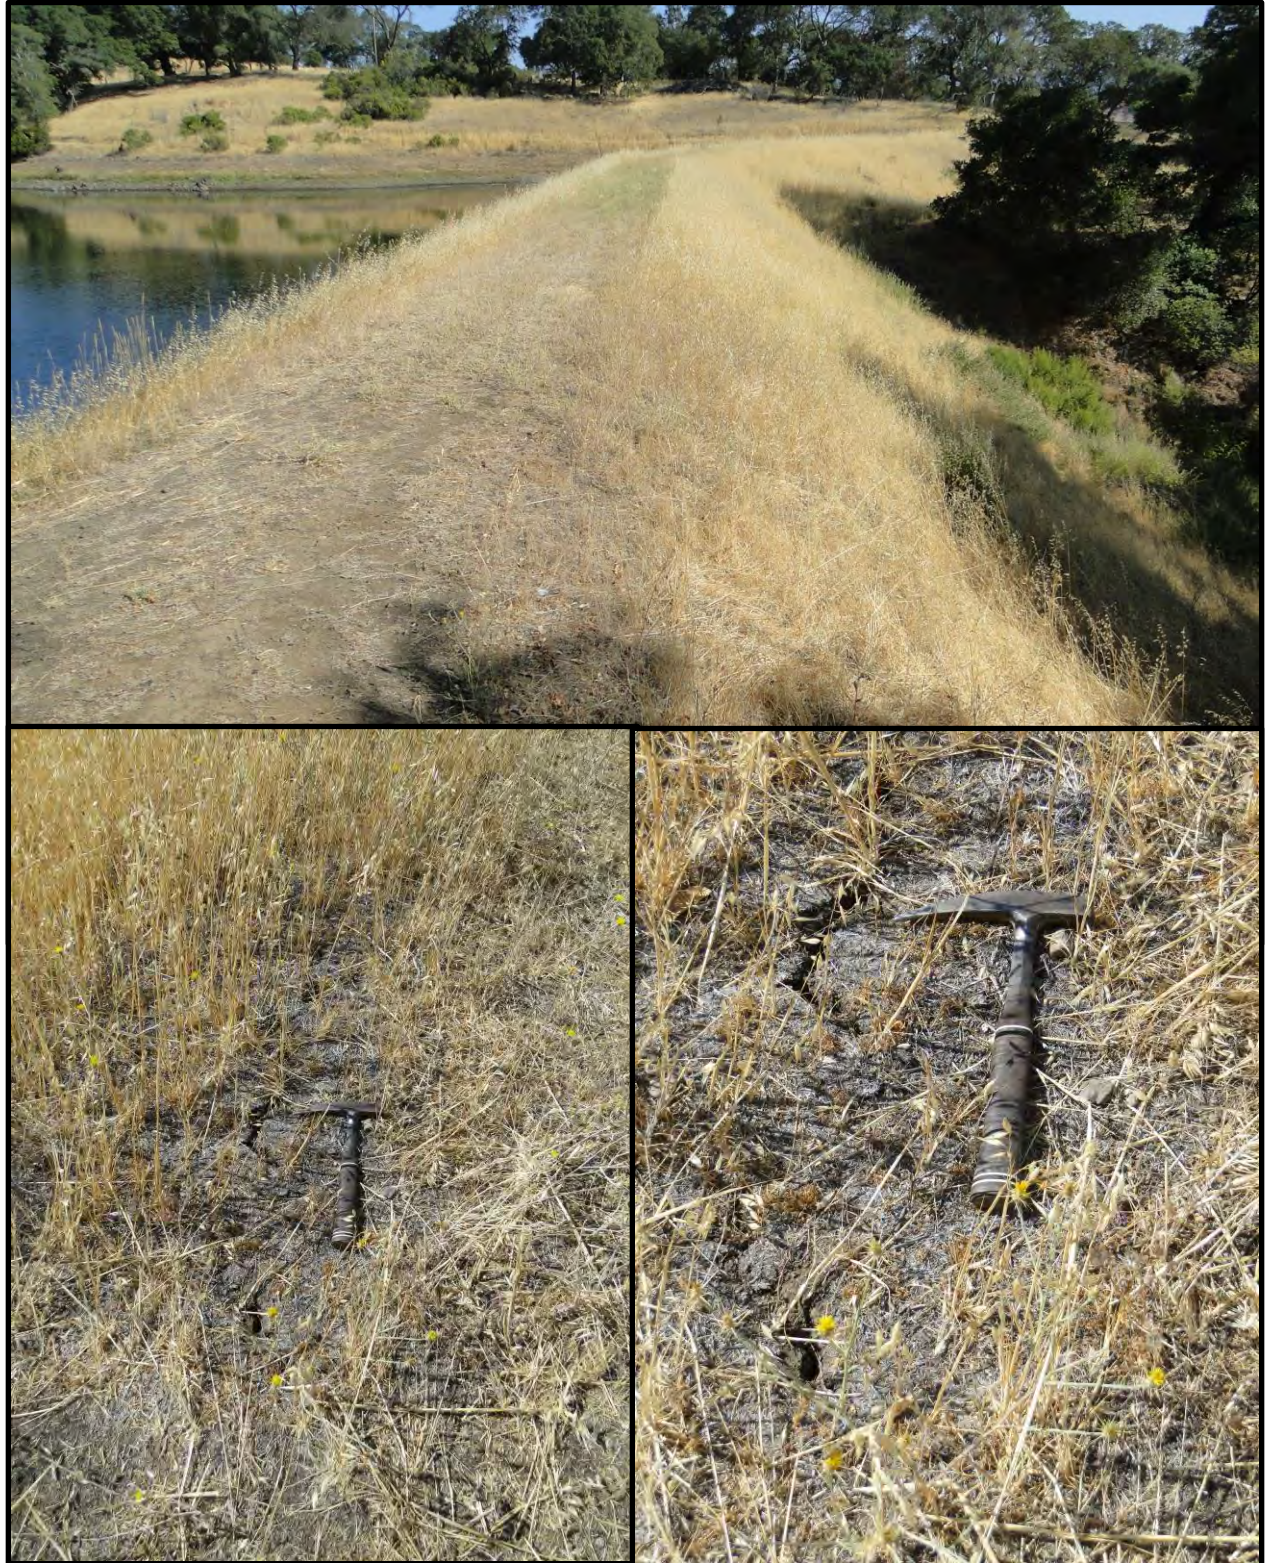
Figure F-10: Photographs of Municipal Dam and longitudinal cracks observed along the downstream edge of the crest of Municipal Dam  
[NSF-GEER; Napa, CA; N38.298 W 122.144; Harder, L. F.; 08/27/14]

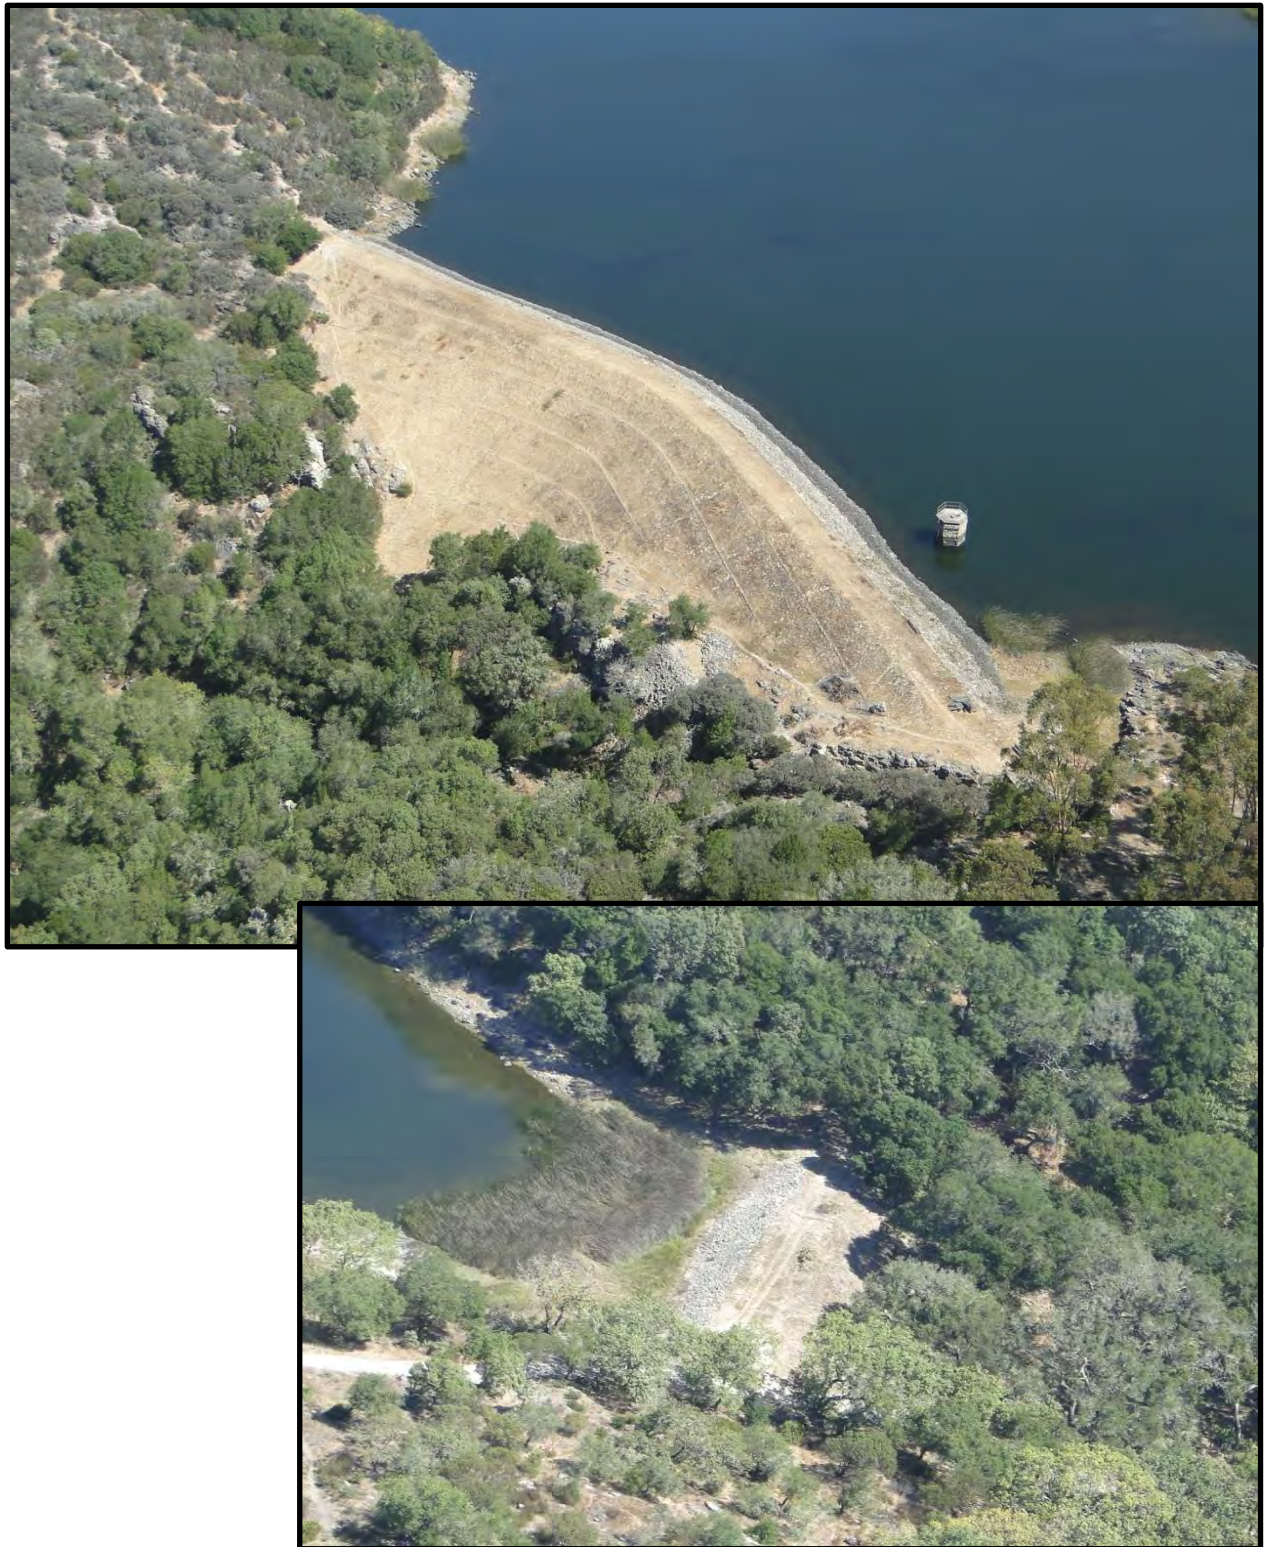
Figure F-11: Aerial Photographs of Lake Frey Dam – main dam and auxiliary dam  
[NSF-GEER; Napa, CA; N38.292 W 122.192; Harder, L. F.; 09/01/14]

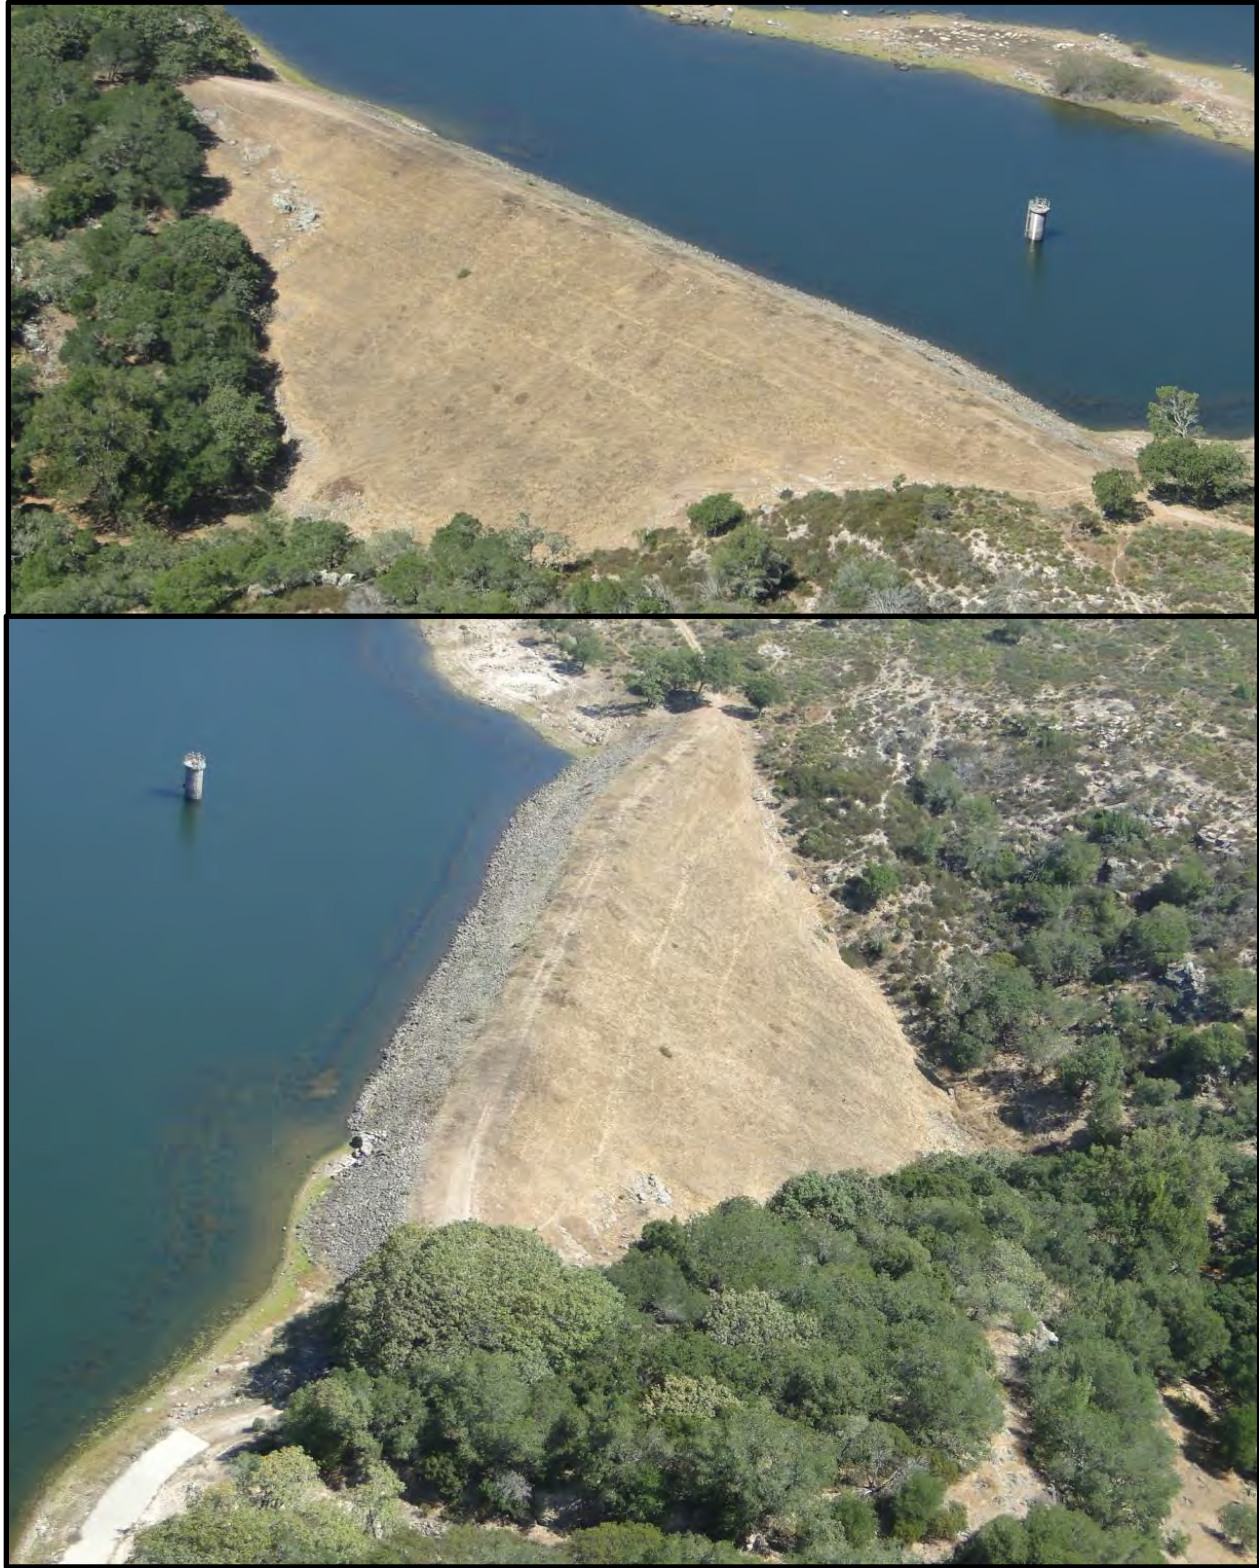
Figure F-12: Aerial Photographs of Lake Madigan Dam  
[NSF-GEER; Napa, CA; N38.308 W 122.193; Harder, L. F.; 09/01/14]

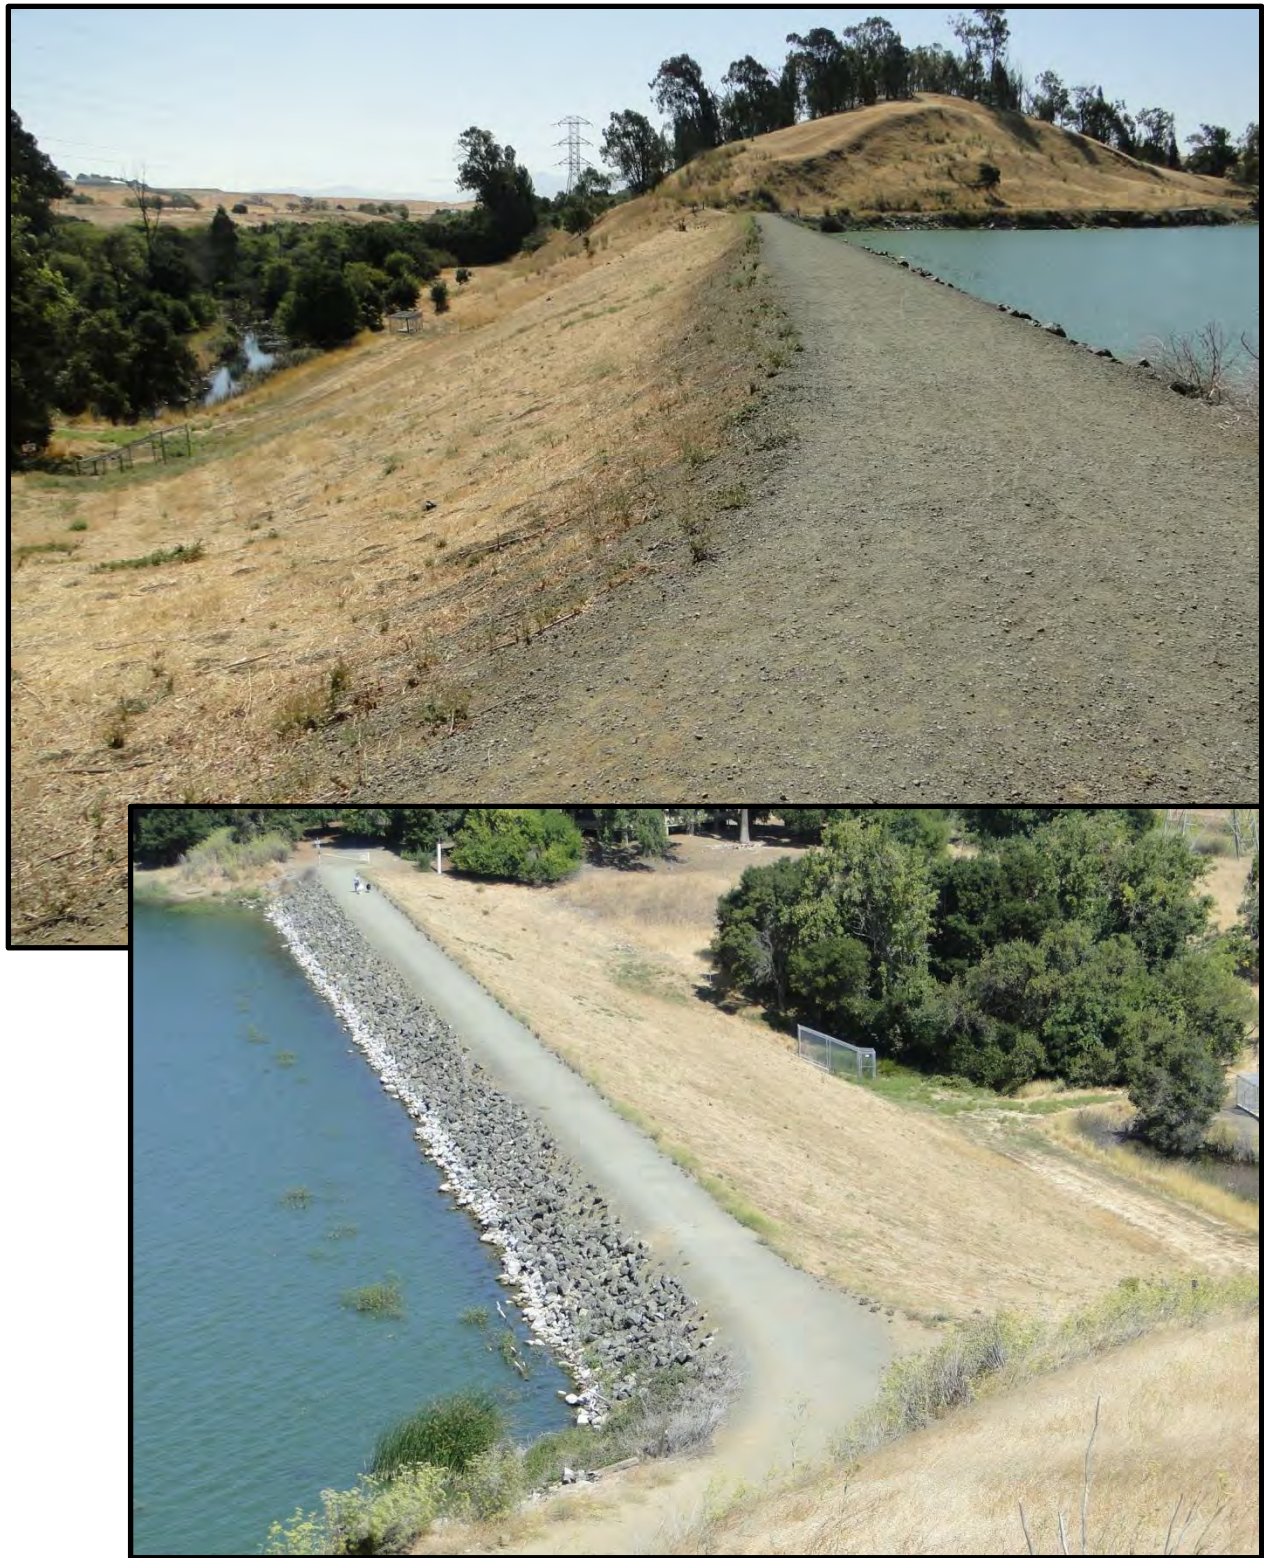
Figure F-14: Photographs of Lake Herman Dam  
[NSF-GEER; Napa, CA; N38.097 W 122.150; Harder, L. F.; 08/27/14]

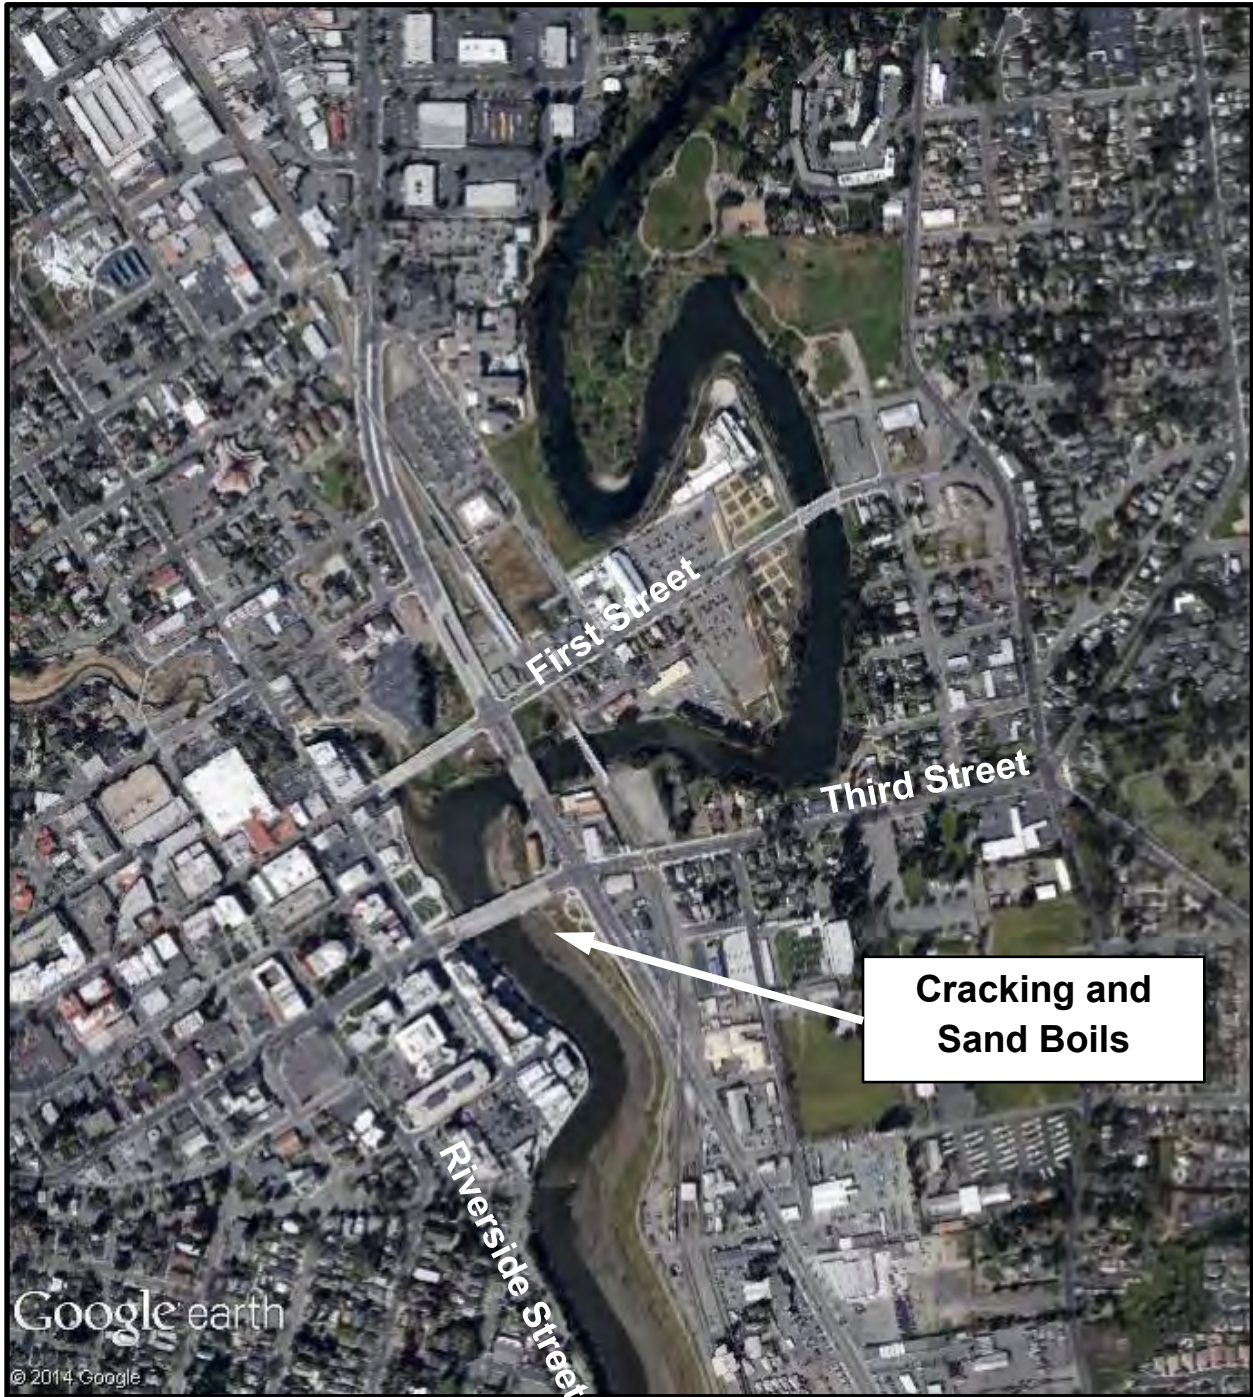
Figure F-16: Google Earth Plot of Downtown Napa  
[NSF-GEER; Napa, CA; N38.308 W 122.281; Harder, L. F.; 09/11/14]

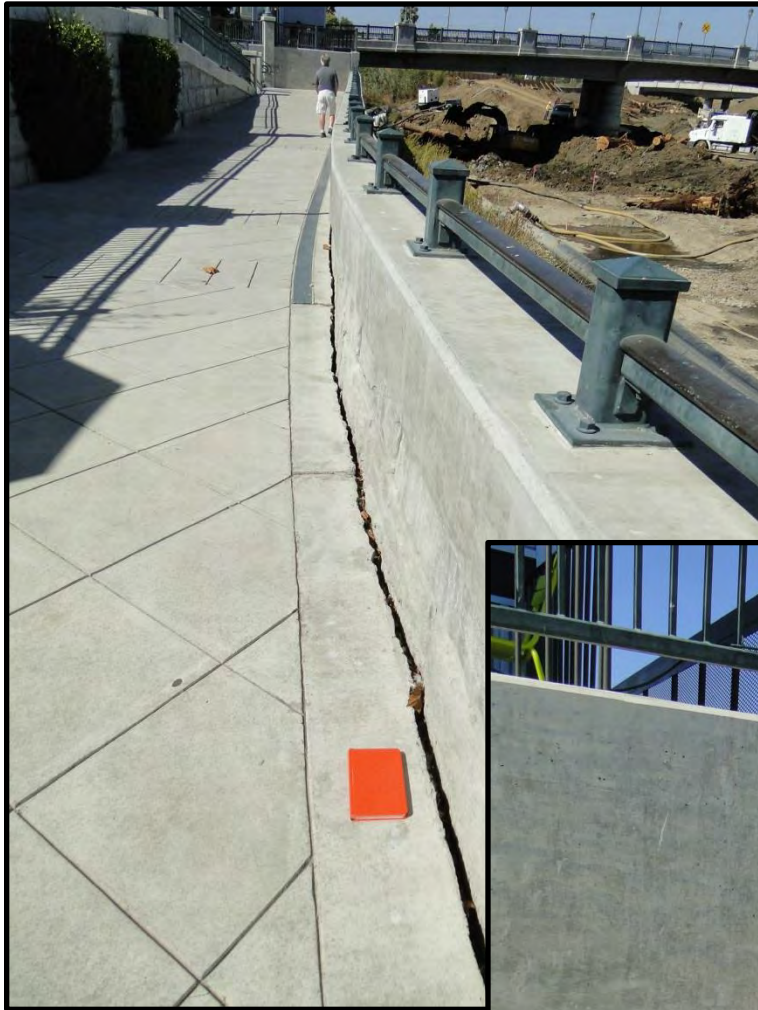
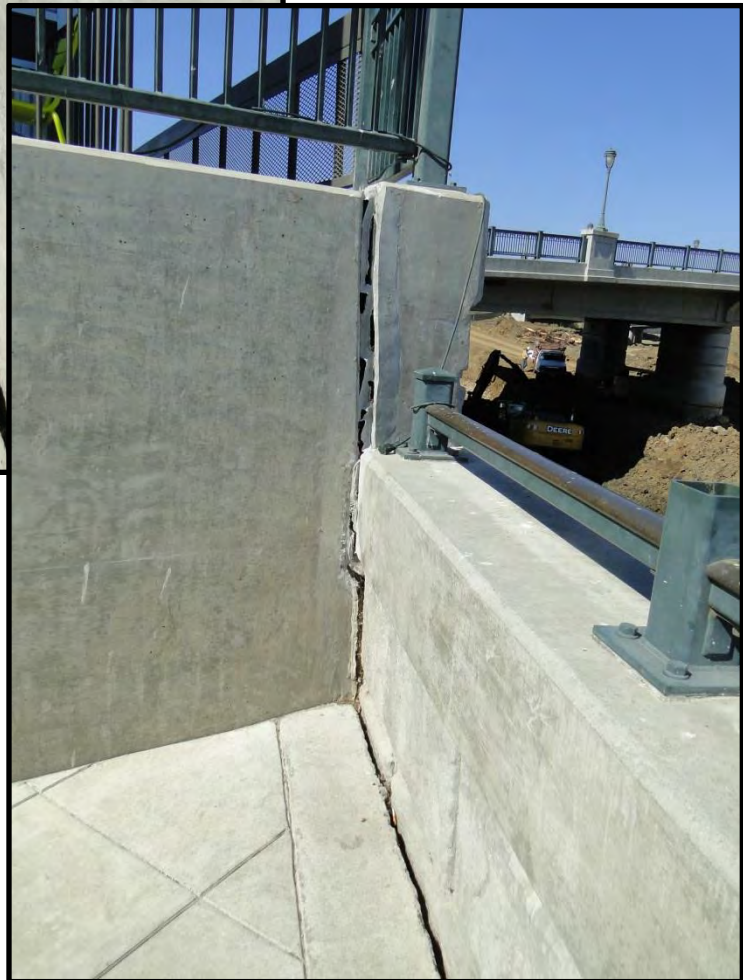
Figure F-19: Separation of concrete slab and retaining wall from Napa River floodwall along right bank of Napa River looking upstream from Third Street Bridge [NSF-GEER; Napa, CA; N38.299 W 122.285; Harder, L. F.; 09/04/14]

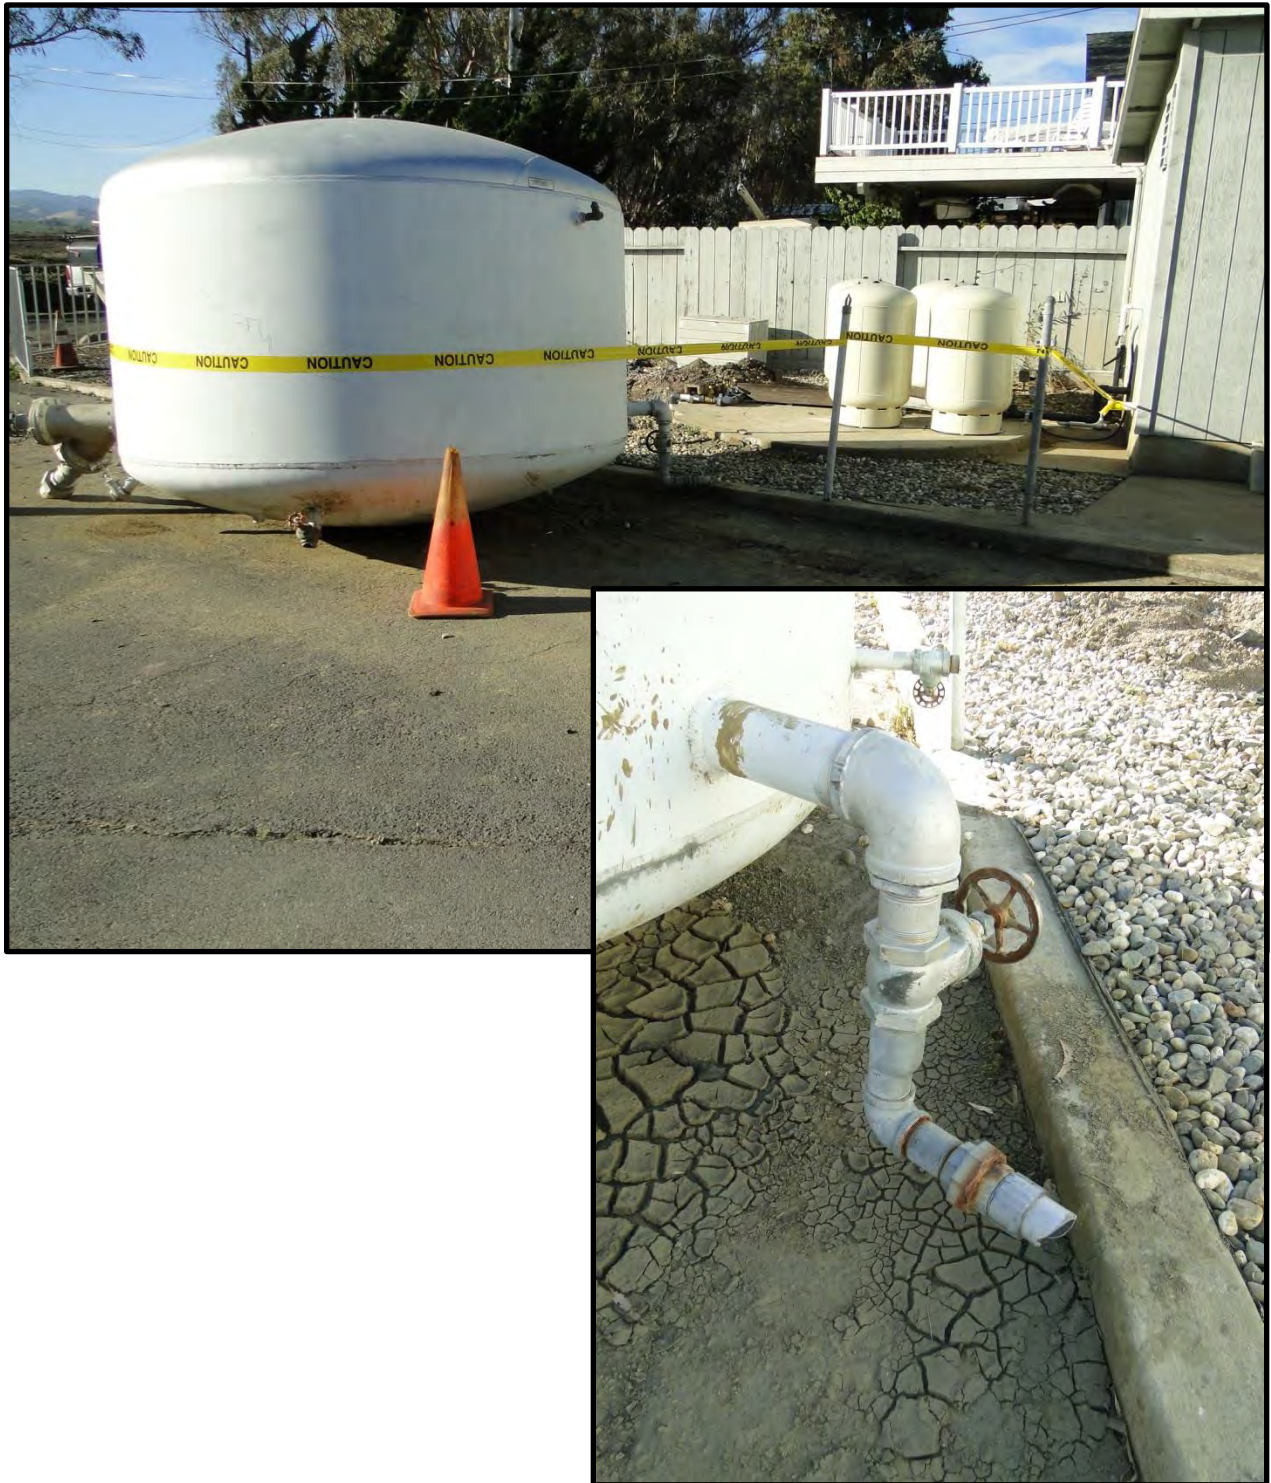
Figure F-22: Photographs of displaced water tank moved off its concrete pad and sheared pipe connection – note replacement tanks on pad in its place - on Edgerley Island south of the epicenter [NSF-GEER; Napa, CA; N38.198 W 122.316; Harder, L. F.; 09/01/14]

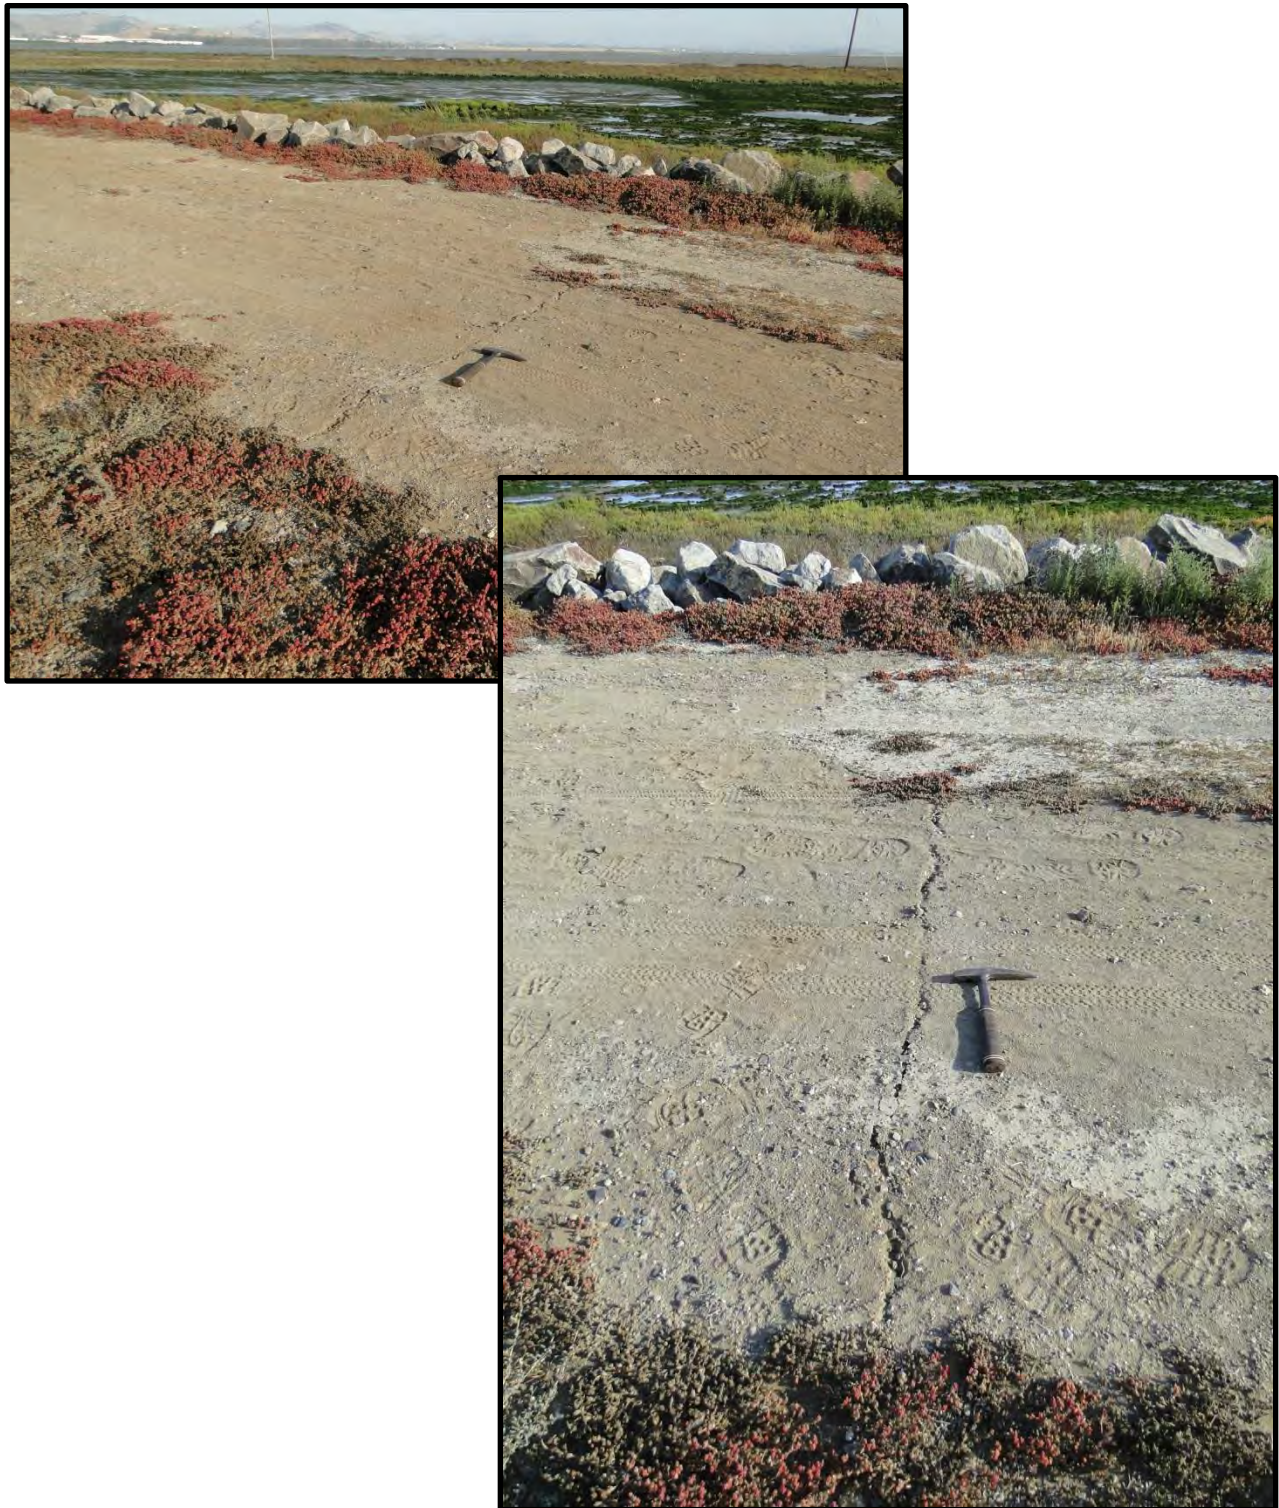
Figure F-24: Photographs of transverse cracking on crown of salt pond retaining dike on western edge of Green Island south of the epicenter  
[NSF-GEER; Napa, CA; N38.201 W 122.302; Harder, L. F.; 09/04/14]
