4.0 SURFACE FAULTING AND COASTAL UPLIFT

4.2 Fault Rupture Investigations

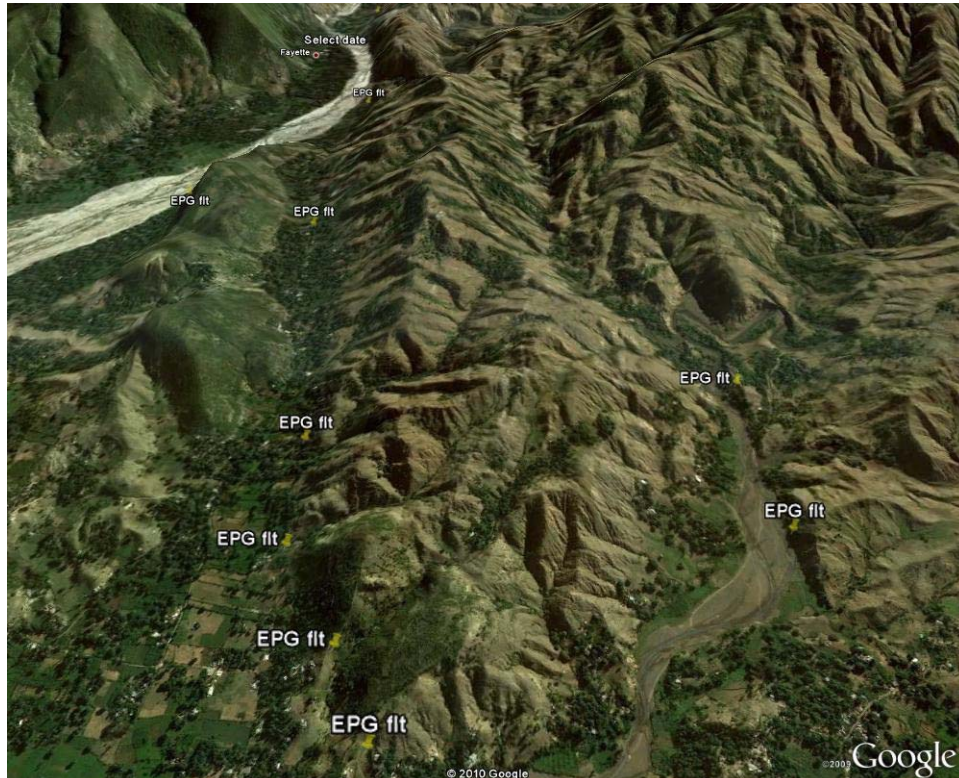
Figure 4.1. View east towards Fayette and Leogane along parallel east-northeast trending traces of Enriquillo Plantain Garden fault. Fault trace marked by push-pins labeled “EPG flt”. Fault trace at right (left offset of river along prominent north-facing scarps) apparently steps north to linear valley of Momance River at top left of picture.

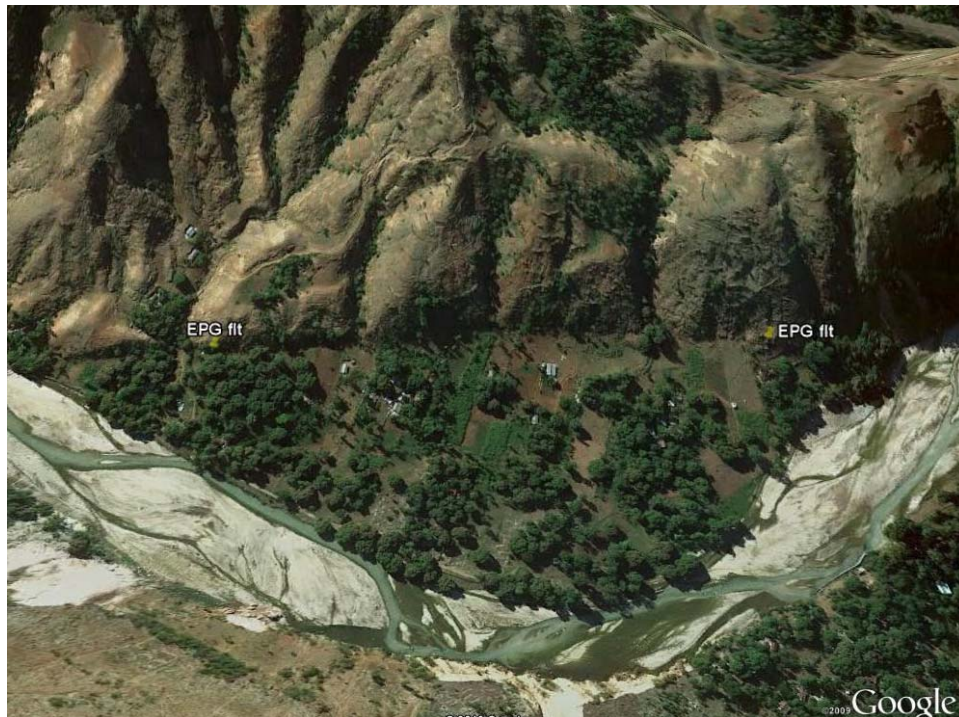
Figure 4.2. View south of prominent fault scarp crossing fluvial terrace on Momance River east of Fayette. Fault trace marked by push-pins labeled “EPG flt”.

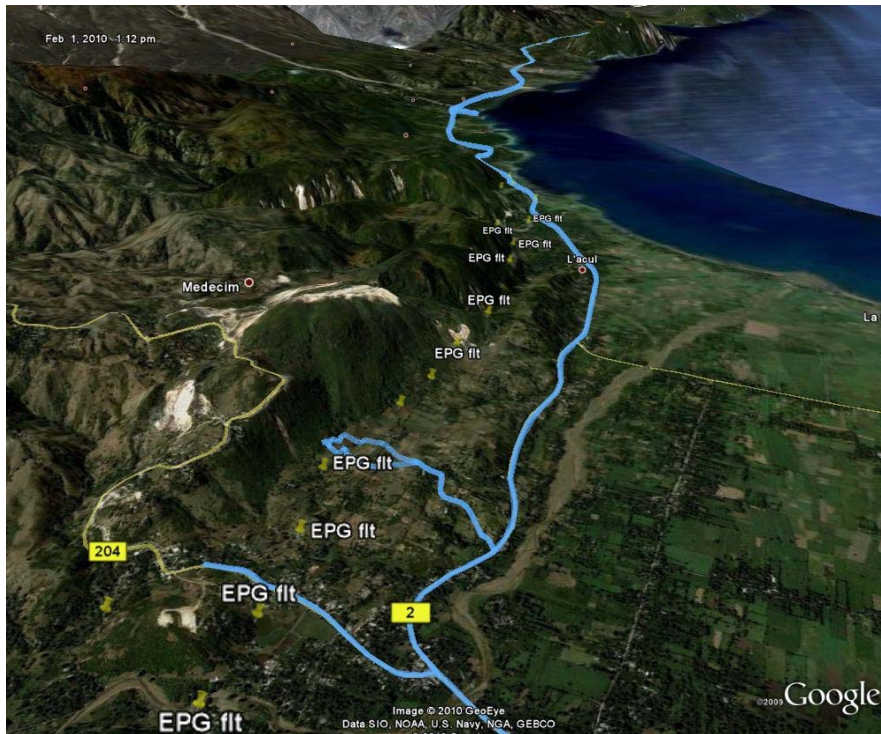
Dr. Mann and Dr. Koehler identified several locations near Dufort where the location of the EPG fault was well constrained and accessible, and the combined team visited these sites on February 1. These sites are located along Road 204 (Jacamel Road) and west of Road 204 (Figure 4.3). Road 204 passes south from the intersection with Road 2 across the plain and up the slope of the east-west trending mountain range. The EPG fault lies along the base of the range, at a prominent break-in-slope from the plains to the lower part of the range. The team confirmed that Road 204 is not displaced where it crosses the fault and range front. A distinct linear valley and shutter ridge occur at the base of the hills about 0.75 km west of Road 204, providing a well-constrained location of the active trace of the EPG fault. The team inspected the fault over a distance of several hundred meters across the small valley, along several transects extending across the shutter ridge and through the valley bottom to bedrock areas exposed on the hillslope above the valley. The fault is constrained to lie at the prominent break-in-slope at the base of the hill or within a few tens of meters east in the valley bottom (Figure 4.4). South of this valley, the EPGFZ is marked by the prominent break-in-slope and a series of side-hill benches (Figure 4.5). The team observed minor cracking in the valley floor at one location, and a linear north-facing scarp at the base of the hillslope. It was concluded that the minor cracking in the valley floor likely represented effects of shrink-swelling in the soil and that the north-facing scarp was the result of hoeing/tilling for agricultural purposes (Figure 4.6). Therefore, the team concluded that the fault did not rupture at the ground surface through the small valley.

Figure 4.3. View southwest along EPG fault west of Dufort. Reconnaissance track marked in blue shows location of fault traverses on and west of Road 204. Fault trace marked by push-pins labeled “EPG flt”.

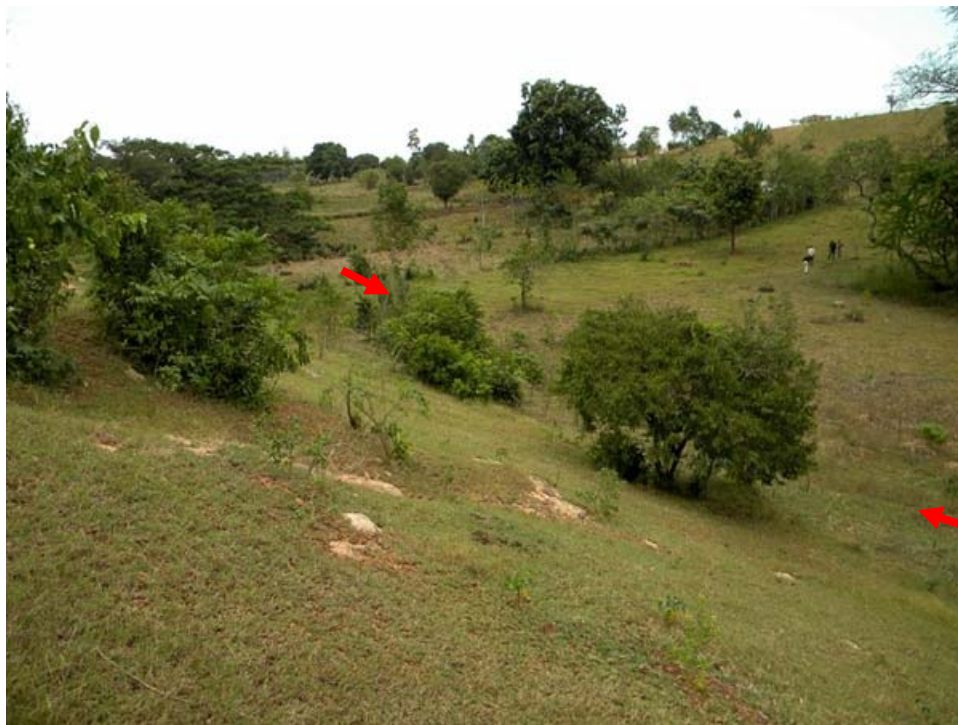
Figure 4.4. View west along trace of EPG fault at linear valley southwest of Dufort (west of Road 204). Fault trace likely between base of slope (between red arrows) and center of linear valley. No fractures or other evidence for fault rupture observed at this site (N18.444306, W72.643722,).

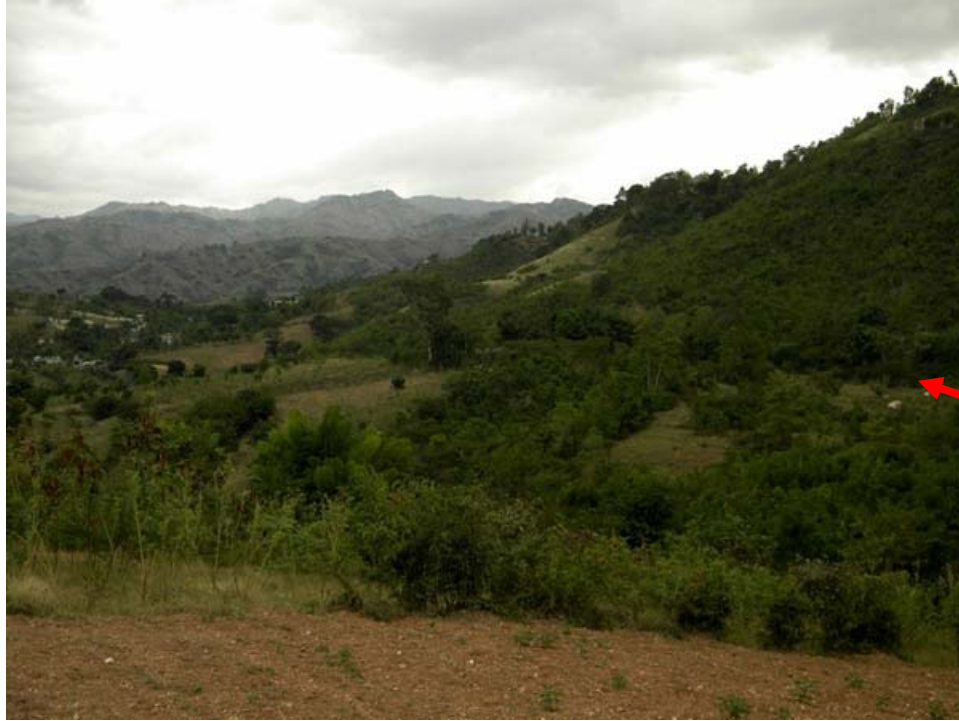
Figure 4.5. View east along trace of EPG fault from hill above linear valley west of Road 204 (along red arrow) (N18.445819, W72.6431718).

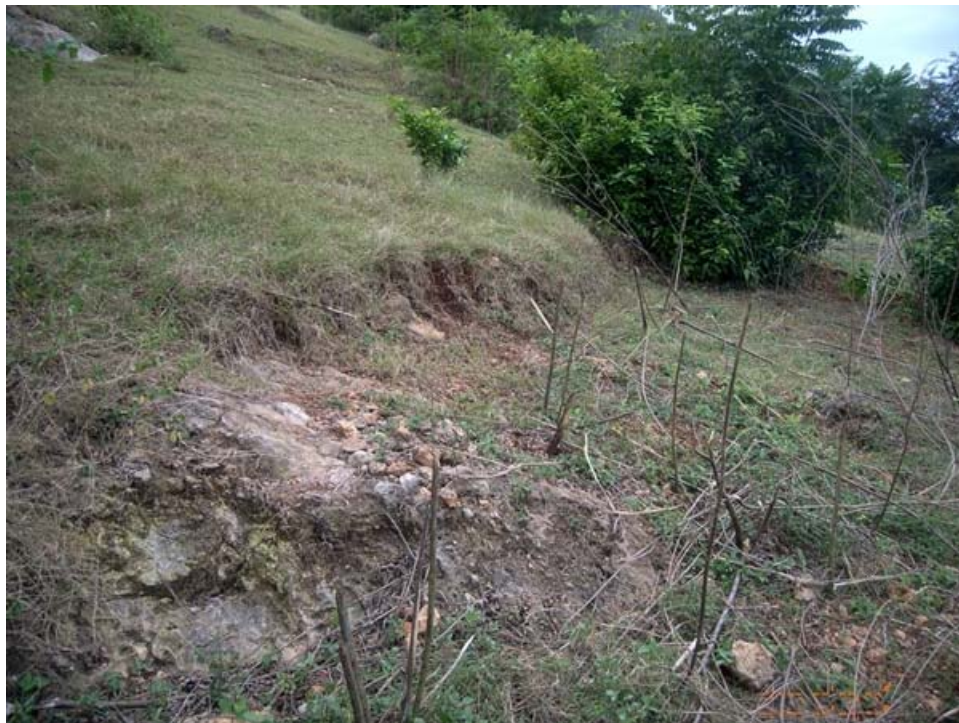
Figure 4.6. View west along agricultural scarp in linear fault valley west of Road 204 (N18.444527, W72.643777).

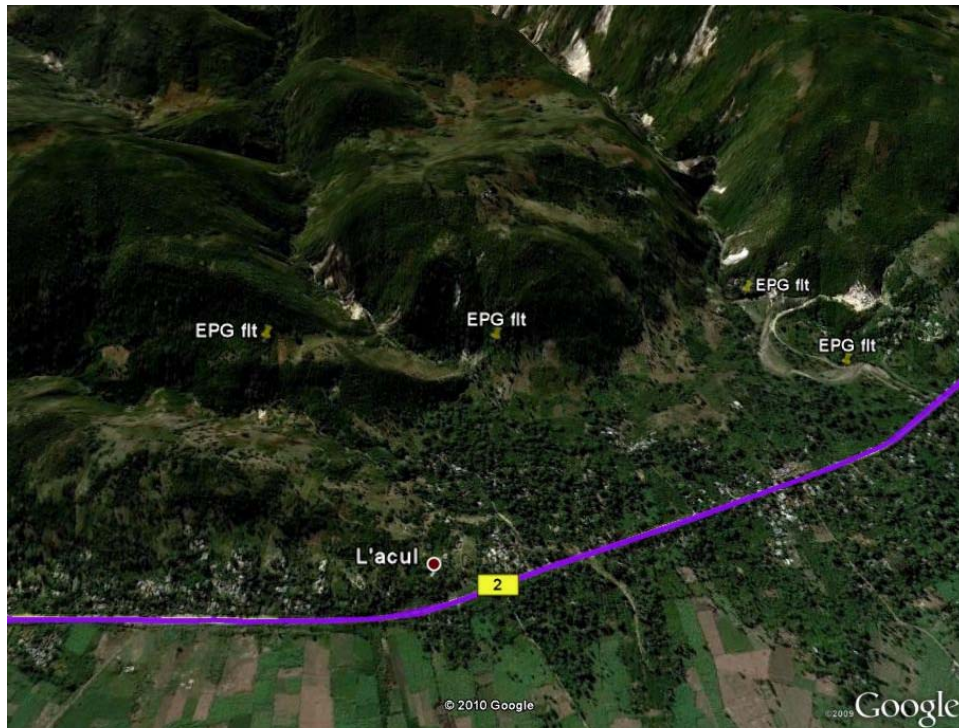
Figure 4.7. View south of shutter ridge blocking drainage (center) and offset stream channel (center right) along fault south of L’acul. Fault trace marked by push-pins labeled “EPG flt”.

The GEER team traversed Road 2 west of Road 204, where Road 2 is parallel to and crosses over the EPGFZ near L’acul, on several occasions between February 1 and 4 during additional reconnaissance investigations (Figure 4.7). No evidence of lateral road displacements or equivocal shear cracks was found on the roads across the fault crossing areas. However, a number of cracks and areas of settlement were observed along the road. These features were evaluated and we concluded to be the result of settlement of the road fill/embankment settlement over soft subgrade soils (see Section 8.0 Road Fill Performance), and possibly in some cases due to localized liquefaction. None of these features were found to represent surface fault rupture.

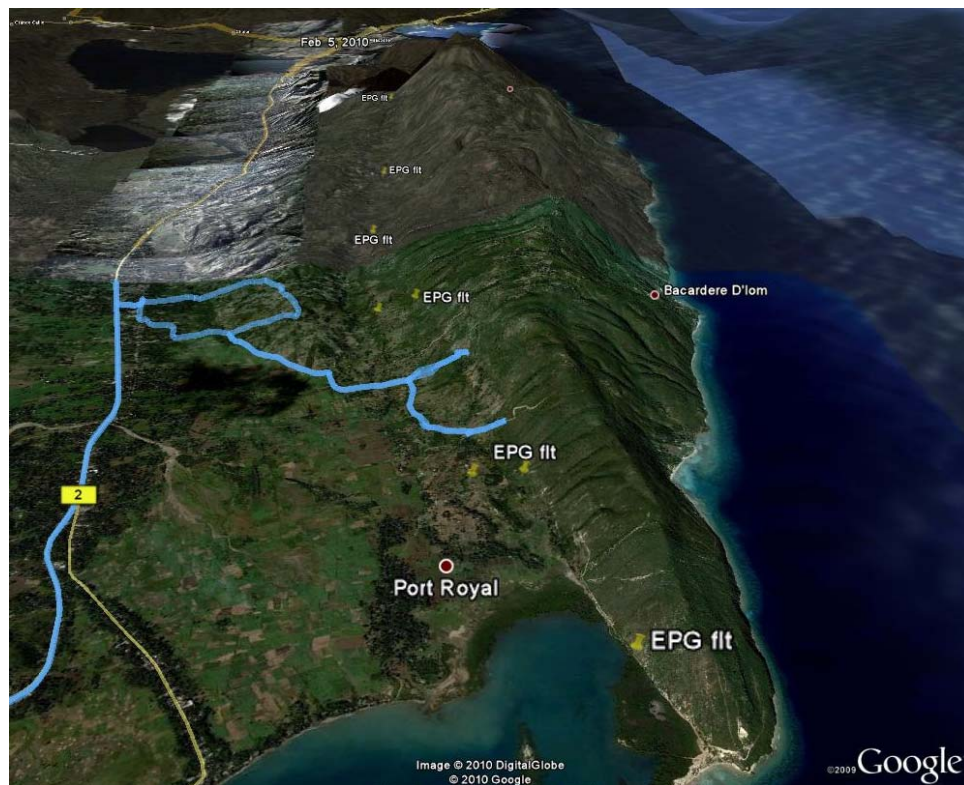
With the assistance of a local resident to guide the team along un-improved cart and horse paths off the paved road, the GEER team conducted traverses across the fault on February 4 at two locations in the area north and west from Port Royal (Figure 4.8). At the two sites, which were located along about a $\frac{3}{4}$ km length of the range front, two parallel fault traces are marked by prominent side hill benches, offset drainages, and a sharp steeply dipping contact between colluvium and limestone bedrock (Figures 4.9 to 4.11). The team traversed footpaths that extended north upslope across the fault at both sites. No fracturing or evidence for fault rupture

Figure 4.8. View west of prominent parallel west-southwest trending fault traces along south-facing slope of hills west of Petit Goâve Bay and Port Royal. Reconnaissance track marked in blue shows location of fault traverses west of Port Royal. Fault trace marked by push-pins labeled “EPG flt”.

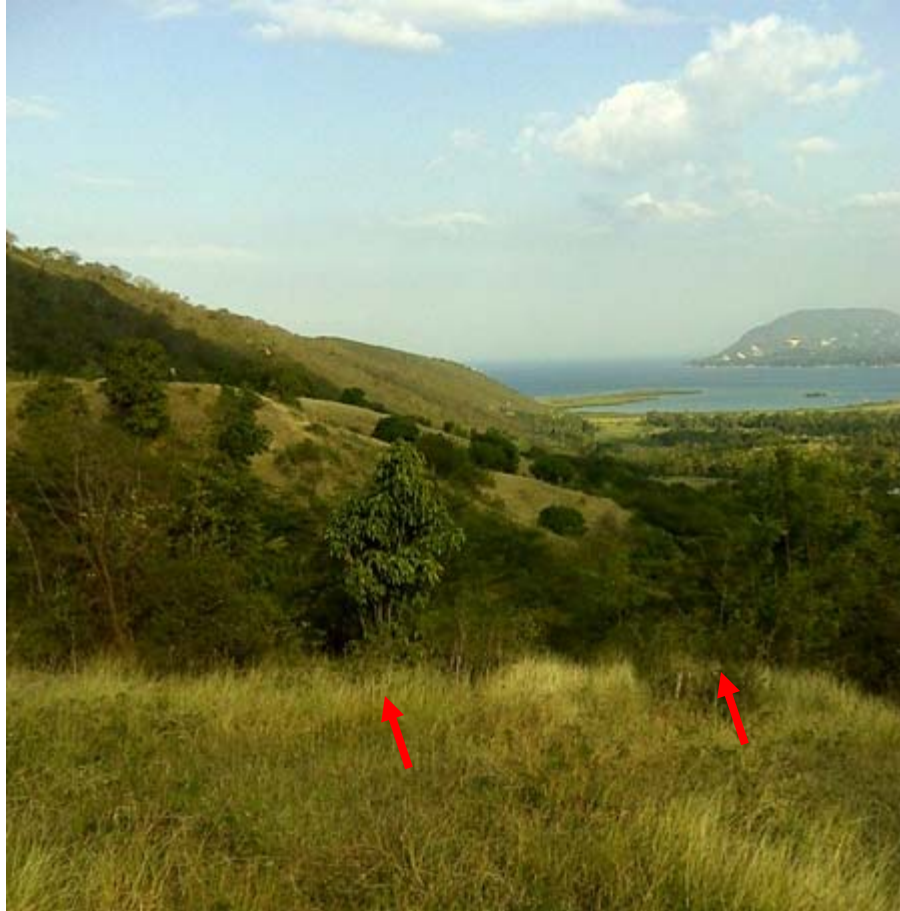
Figure 4.9. View east-northeast along fault west of Port Royal. Side-hill bench bounded by two fault traces at left and center of photo (above red arrows). No fractures or other evidence for fault rupture observed at this site (N18.440027, W72.923304).

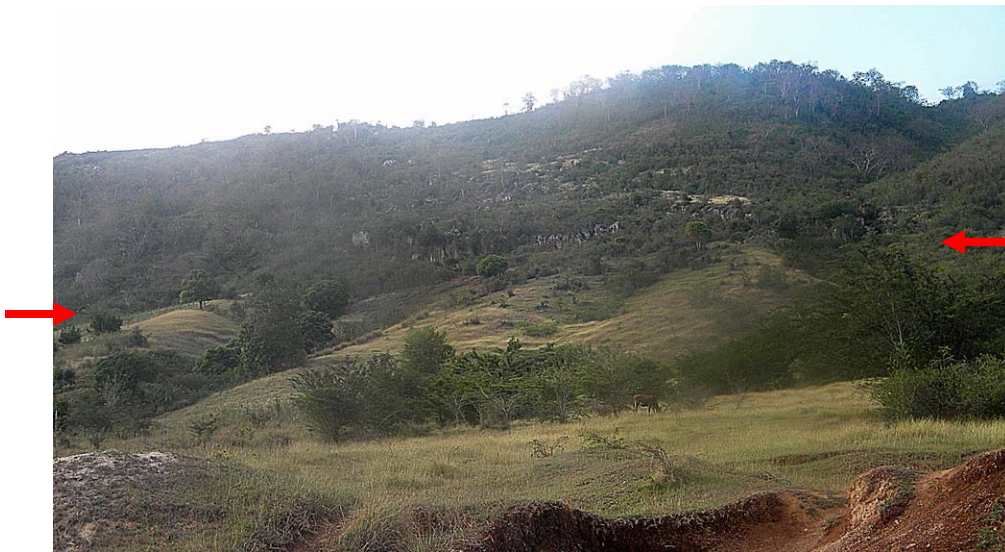
Figure 4.10. View north across fault (at upper break in slope) west of Port Royal. Side-hill bench and blocked drainages at center of photograph (between red arrows) (N18.439666, W72.916444).

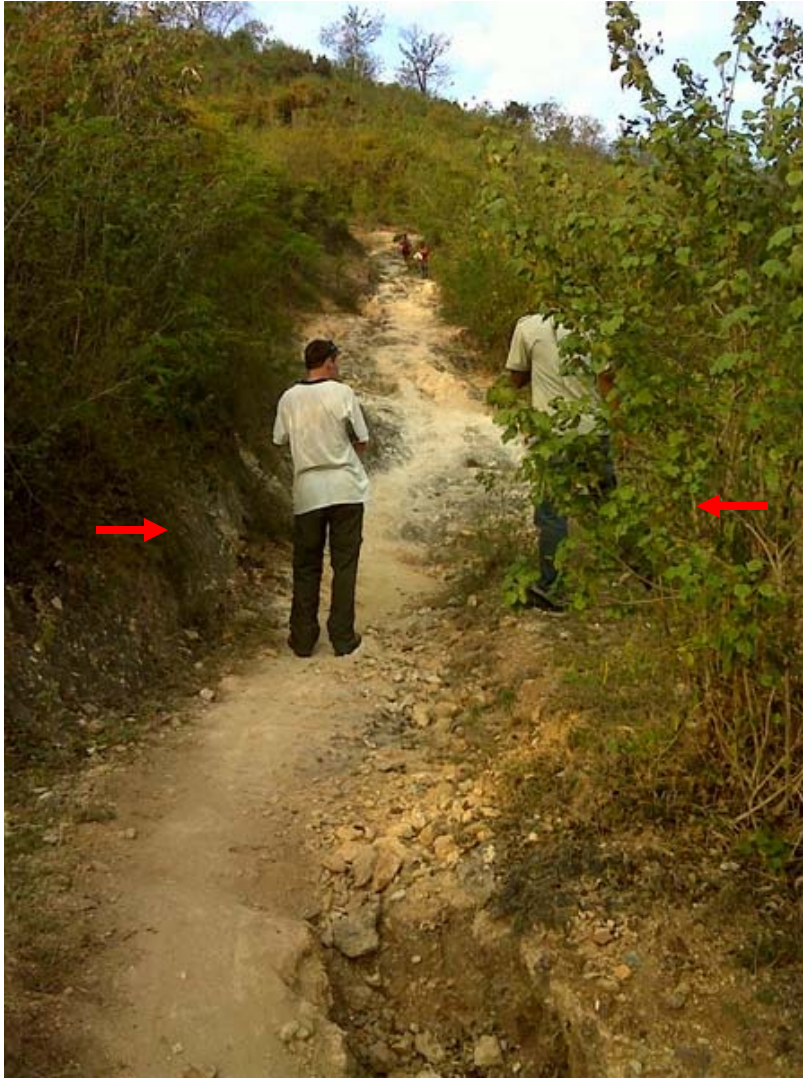
Figure 4.11. View north across fault at west of Port Royal. Fault passes perpendicular to track in middle of photograph at colluvium-bedrock contact (at red arrows upslope from team members). No fractures or other evidence for fault rupture observed at this site (N18.44150, W72.916389).

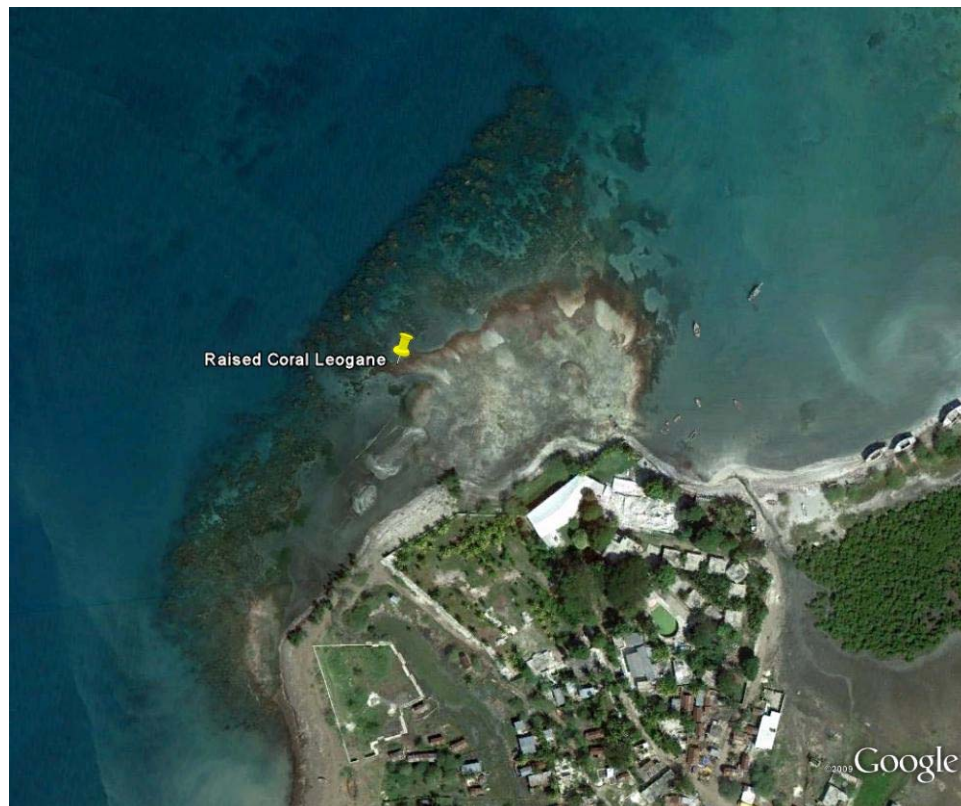
Interpretation of aerial imagery and reports from Haitians in the coastal area of Léogâne indicated that several areas along the coast were uplifted as a result of the 12 January earthquake. The GEER team traveled to the Ca Ira area west of Léogâne on 1 February to observe one area where coastal uplift had been observed. At this site, the team observed an area of exposed coral and subtidal Turtle grass extending for more than 100 m seaward from the shoreline (Figure 4.12). Key observations from this area are as follows.

Figure 4.12 Aerial view of coastal uplift in Ca Ira, near Legwane.
(See GEER Haiti Report.kmz for location)

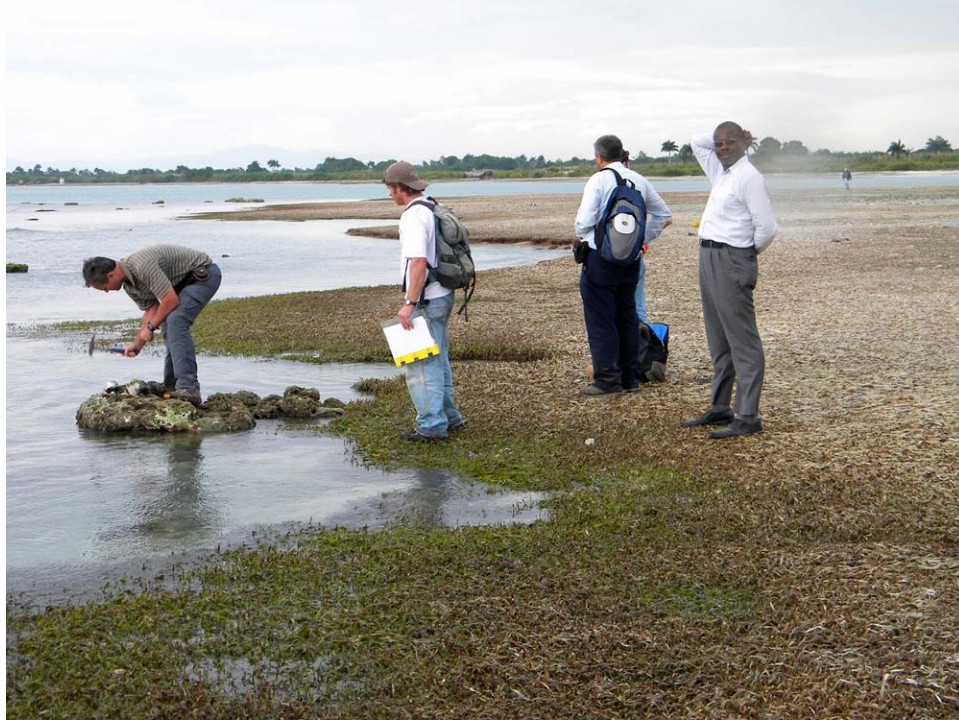
Turtle grass is a subtidal plant, and apparently does not grow in areas exposed at low tide. As observed during our reconnaissance, an extensive area of this grass was exposed above the water level (which was at or close to low tide during our reconnaissance). Much of the exposed grass was brown and appeared to be dying as a result of exposure to air/direct sunlight (Figure 4.13). The length of the grasses was about 10 cm, possibly indicating the minimum submergence depth at low tide prior to the 12 January earthquake.

Figure 4.13. Reconnaissance team inspecting exposed grass and coral at Ca Ira, Léogâne. An extensive area of mud flats, grasses, and coral was exposed at low tide. (18.525333°N, 72.652008°W).

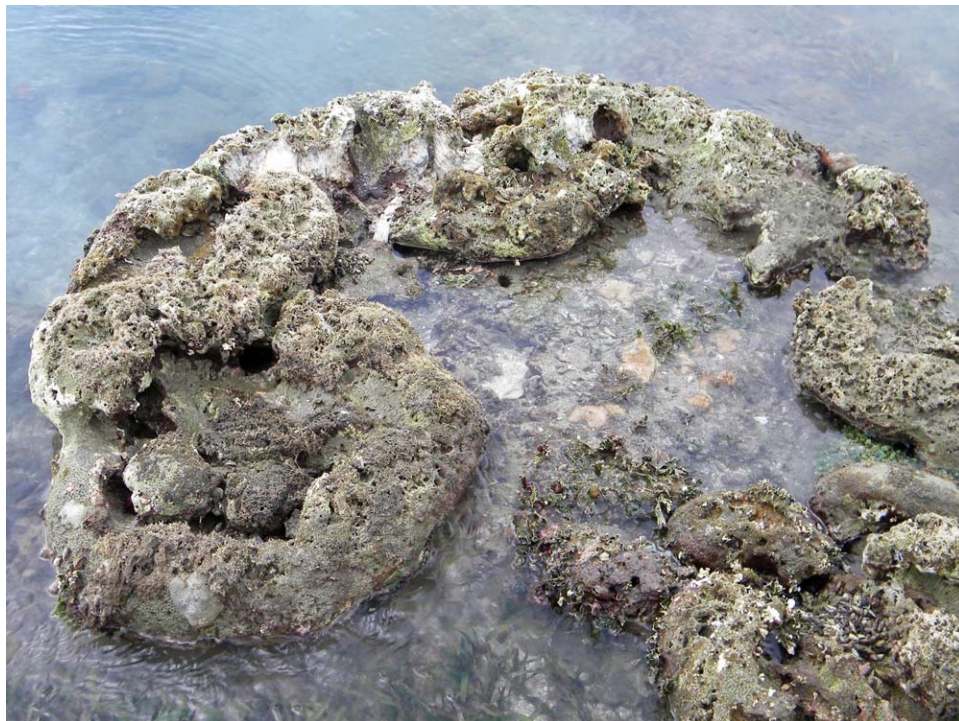
The coral reef exposed at low tide consisted of largely dead coral heads (Figure 4.14), with small areas of new living coral at the top of the heads (Figure 4.15). The outer coral head is dead, which appears to indicate that uplift occurred previously at this site, followed by submergence and growth of new coral. The minimum subtidal depth at which coral grows is dependent on the specific coral species and other factors, but may be on the order of several tens of centimeters.

Figure 4.14 Coral head (~1.0 m diameter) with living coral at center exposed at low tide at Ca Ira, Léogâne (N18.525333, W72.652008).

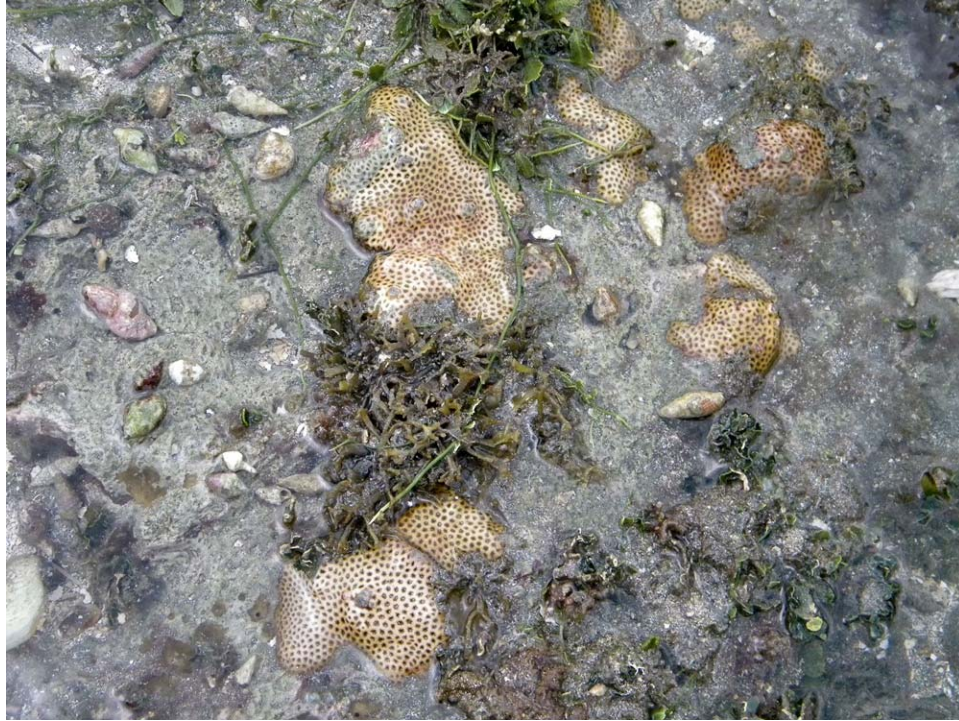
Figure 4.15 Living coral in coral head exposed at low tide at Ca Ira, Léogâne. (N18.525333, W72.652008)

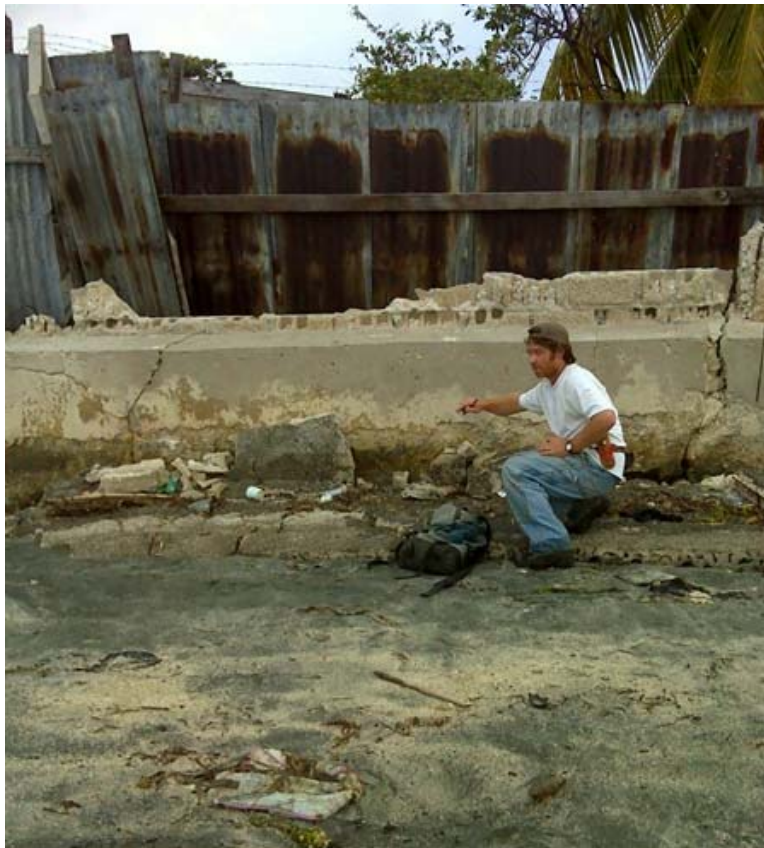
Local villagers indicated that the grasses and mud flats were not exposed at low tides prior to the 12 January earthquake, and that the high tides no longer extended to the sea wall as indicated by the water marks on these walls (Figure 4.16). The current tide chart for Port-au-Prince indicates the tidal range typically is about 0.4 to 0.6 m.

Figure 4.16. Water mark for high tides on sea wall at Ca Ira, Léogâne. Residents indicate high tides no longer extend up the wall to the former high tide level (N18.524924, W72.650871)

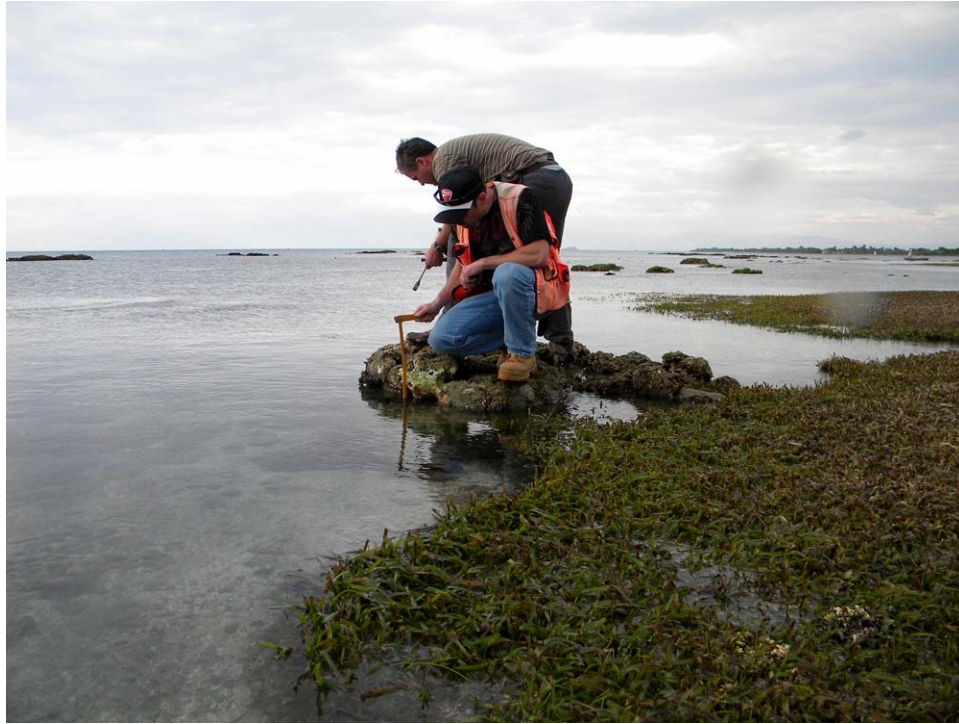
Figure 4.17. Exposed coral head at Ca Ira, Léogâne. Team members measuring uplift of coral head. (N18.525333, W72.652008)

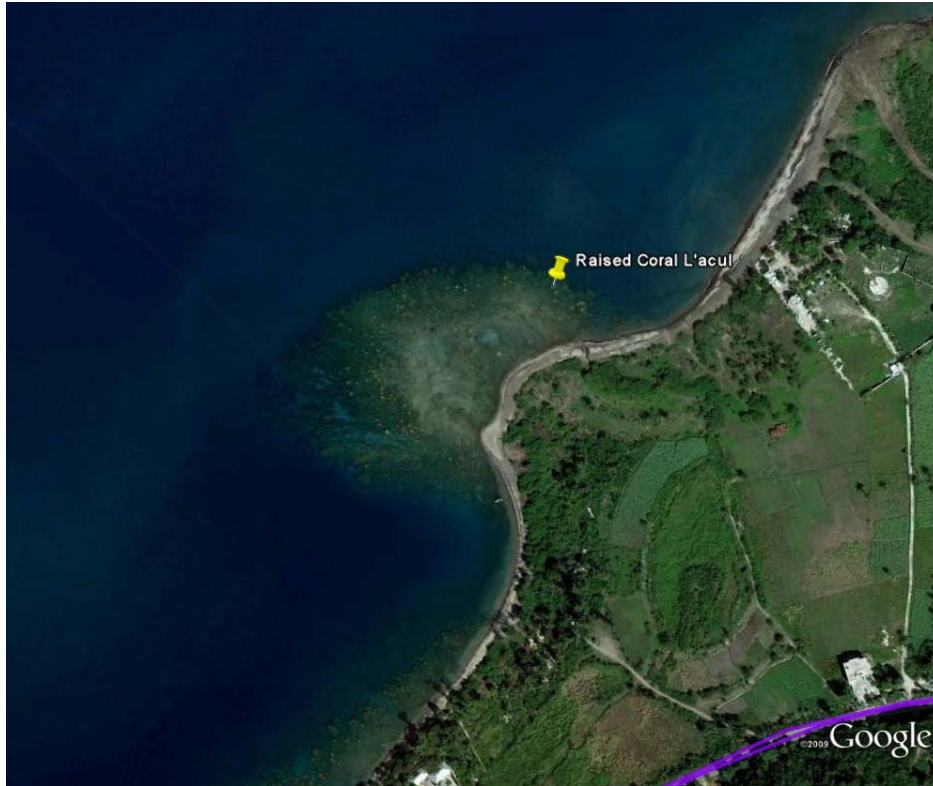
The GEER team also conducted reconnaissance along the coast near L'acul on February 4, where aerial imagery showed additional areas of exposed coral reefs (Figure 4.18). We note that the L'acul site is 0.5 to 0.75 km north of the Enriquillo-Plantain Garden fault zone (EPGFZ) which trends west-northwest to the coast (west of L'acul). Small areas of coral heads were exposed above the water at the time of our visit (Figures 4.19 and 4.20), and the water level apparently was approximately one hour prior to high tide. The team observed a much larger area that apparently is now exposed at low tide, based on the height (3 to 5 cm) of living coral exposed above the water level during our visit and the approximate tidal range of 0.4 to 0.6 m. In general, the amount of uplift estimated at the L'acul site appears to be approximately the same order of magnitude as that observed at Ca Ira. Dr. Mann is working with a team from the U.S. Geological Survey (including Dr. Carol Prentice) to further document and quantify uplift recorded by corals along the coast.

Figure 4.18 Aerial view of coral uplift near L'acul.
(See GEER Haiti Report.kmz for location)

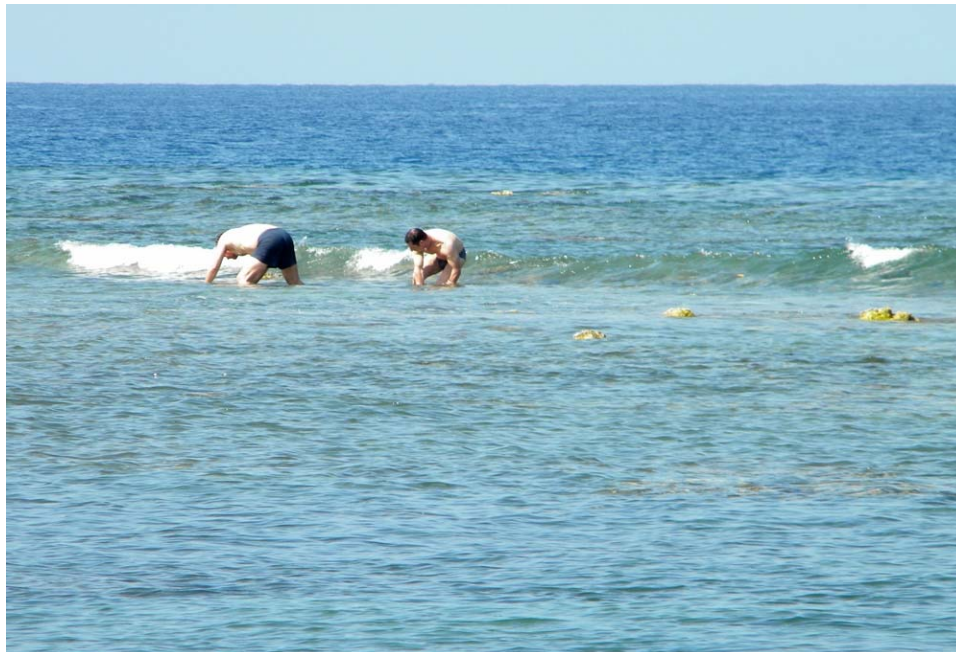
Figure 4.19 GEER team members inspecting uplifted coral reef near L'acul Coral heads are exposed above water at right, approximately one hour prior to high tide. (N18.446463, W72.688354).

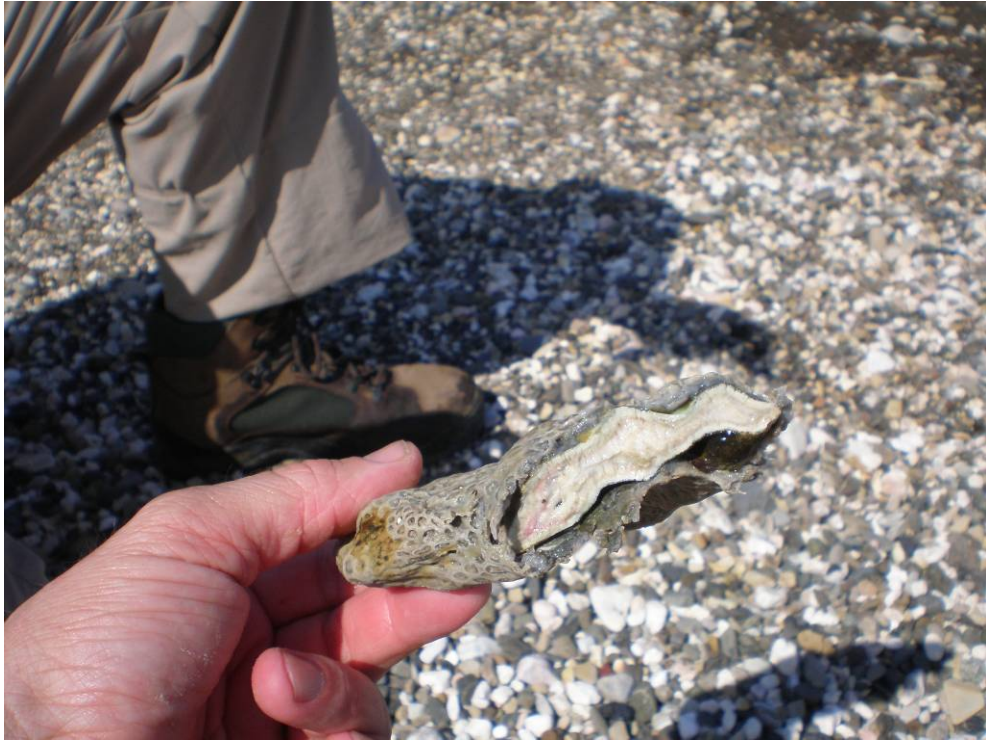
Figure 4.20 Fleshy living, or recently living, coral collected from the top of a coral spire projecting about 3 to 5 cm above water level at the time of the GEER field visit. (N18.446463, W72.688354)
