**Figure 6.2** Pre- and post-earthquake satellite/aerial imagery (top and bottom, respectively) of the port at Port-au-Prince, Haiti (N18.555058°, W72.351144°). Imagery courtesy of Google Earth.

**Figure 6.5** Annotated aerial image of Port de Port-au-Prince showing locations of damage due to the earthquake. Imagery courtesy of Google Earth. (N18.555058°, W72.351144°)

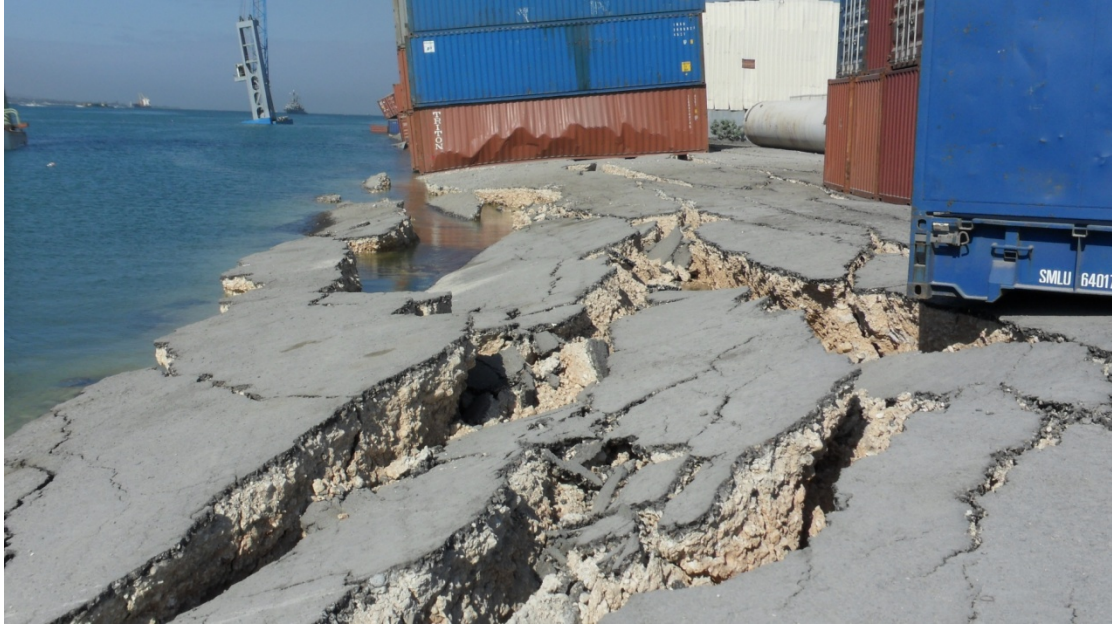
The North Wharf collapsed, most likely due to liquefaction-induced lateral spreading. Numerous surface manifestations of liquefaction and lateral spreading were present in the vicinity of the North Wharf. By the time the GEER Team arrived at the port (G. Rix on 27 January and 2 February for the rest of the team), the US Navy construction teams had already placed fill over large portions of the road that ran adjacent (on the North side) to the warehouses. The Navy construction workers told the GEER Team that the fill was needed because the lateral spread cracks made the road impassable by vehicles. The presence of these cracks was confirmed by post-earthquake satellite/aerial imagery taken between 13 and 21 January, and re-grading had removed them by the time a 25 January image was taken. Nonetheless, numerous manifestations of liquefaction and lateral spreading were untouched at the time of the GEER Team's inspection (Figures 6.6 through 6.11).

**Figure 6.6** Lateral spreading adjacent to the collapsed North wharf. Note the crane in the water in the background and the metal warehouses on the right. (N18.55622, W72.34787)

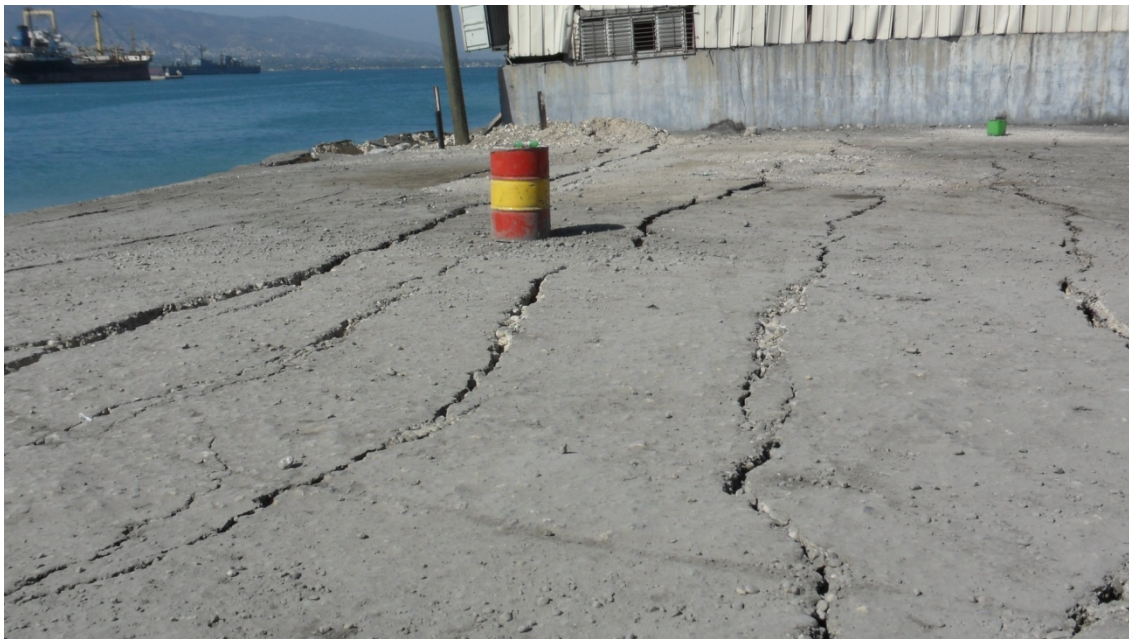
**Figure 6.7** Lateral spreading between the two metal warehouses, adjacent to the collapsed North wharf (left). A cumulative total of 89 cm of horizontal movement (determined by crack width) was measured in a zone extending inland approximately 30 m from the post-earthquake shoreline. Post-earthquake imagery indicates lateral spread cracking extended 50 m inland. (N18.556696, W72.34787)

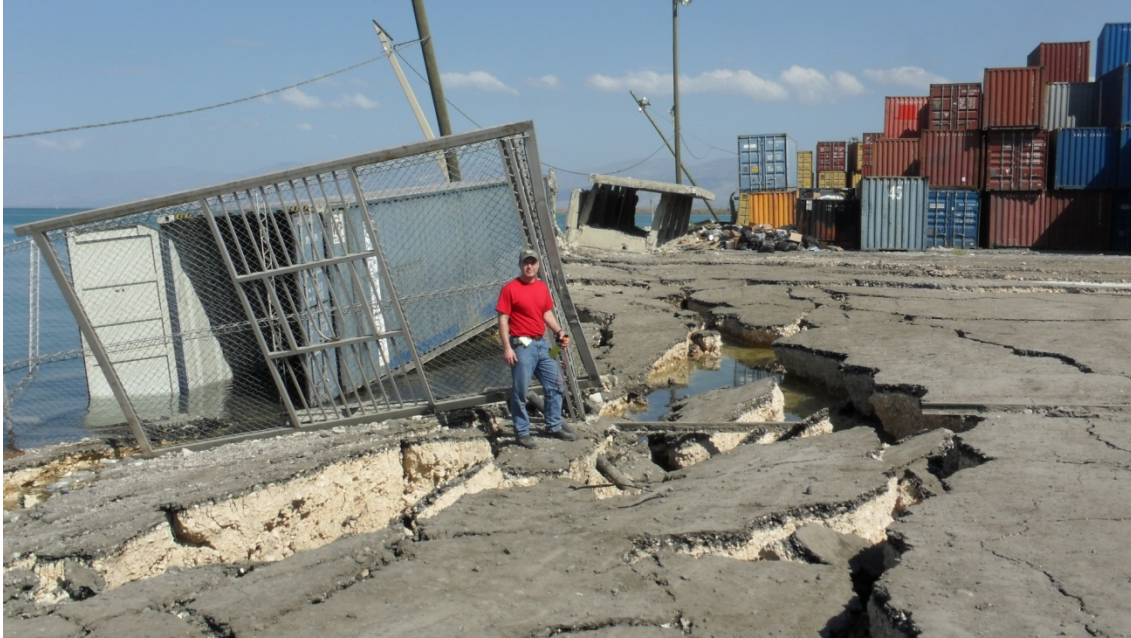
**Figure 6.8** Lateral spreading west of the two metal warehouses. Photo taken facing north with the metal warehouses to the right. (N18.557075, W72.352045)

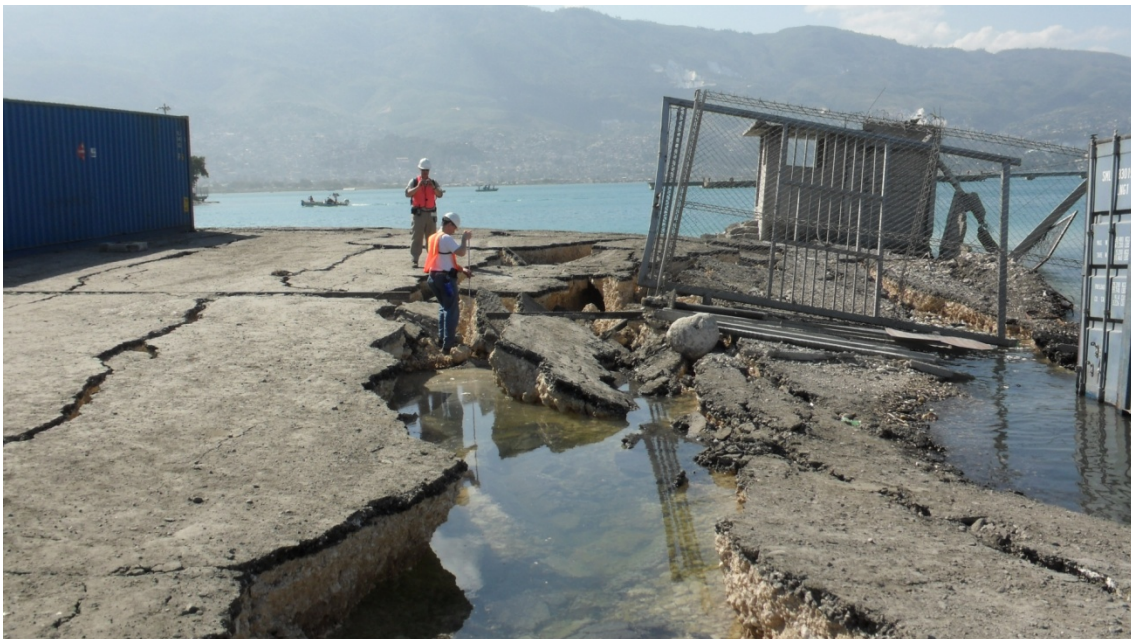
**Figure 6.9** Lateral spreading west of the two metal warehouses. Photo taken facing south with the metal warehouses to the left. (N18.557075, W72.352045)

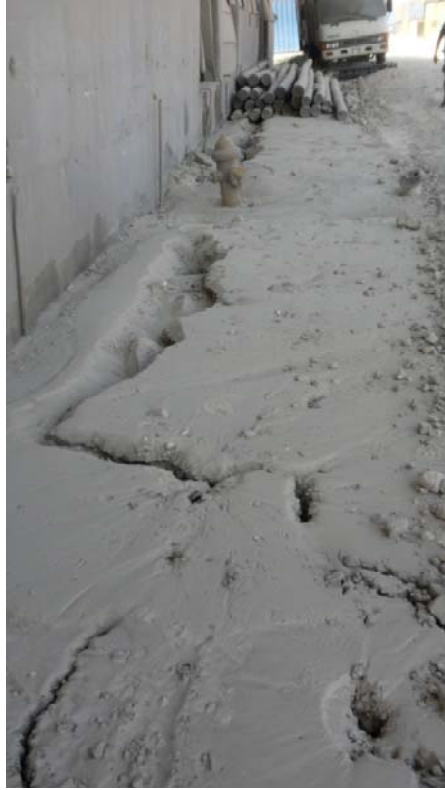
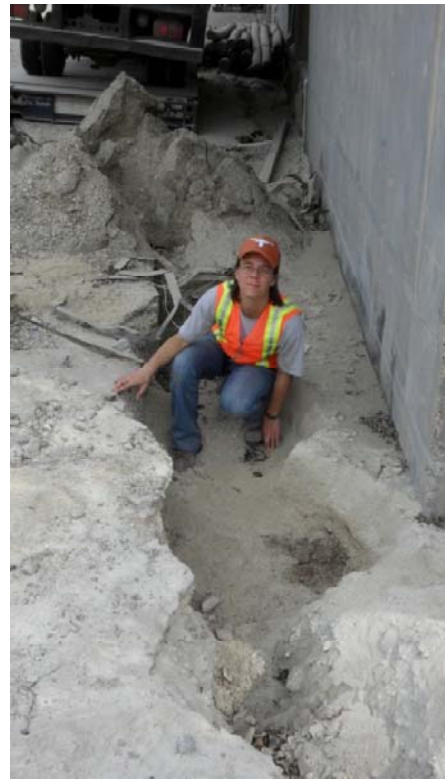
**Figure 6.10** Liquefaction and lateral spreading adjacent to the north side of the metal warehouses. Photo on top taken facing west, photo on bottom taken facing east. (N18.556961, W72.349751)

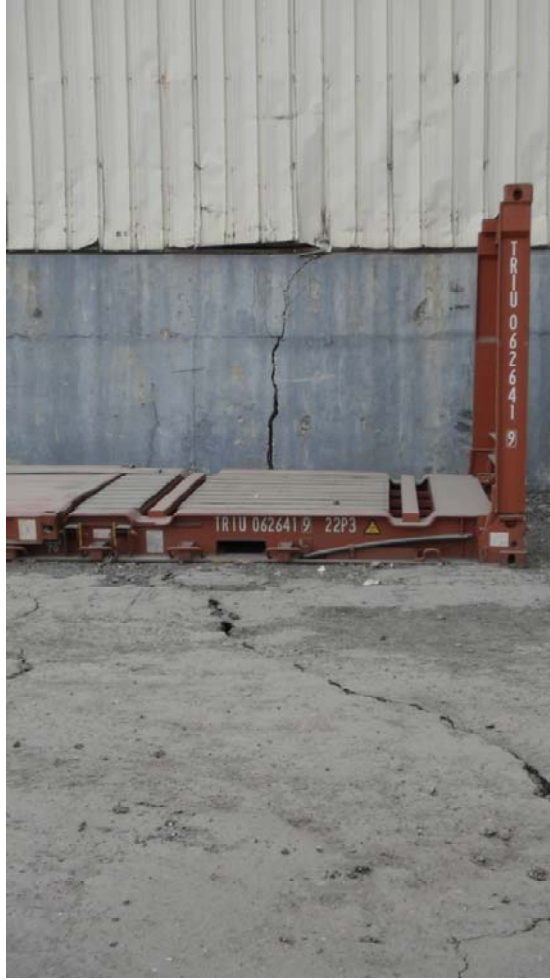
**Figure 6.11** Lateral spreading crack extending into the western foundation wall of the west warehouse. Photo taken facing east. (N18.55721, W72.35179)

The warehouses suffered severe damage as a result of the lateral spreading and settlement, and will likely have to be torn down. As shown in Figure 6.11, lateral spreading cracks running in the East-West direction cut through each warehouse foundation wall. A detailed survey of the relative elevations and lateral movements of the west warehouse slab is shown in Figure 6.14. The interior slab consisted of 14 separate slabs, two abreast and seven long. Due to lateral spreading, the south wall (adjacent to the shoreline) moved approximately 0.7 to 1.4 m laterally towards the shoreline (i.e., the width of the warehouses increased). The relative elevations across the slab are more difficult to interpret because it was clear that the slab was constructed with a significant slope and/or curvature towards the seaward edge. Without knowledge of the relative elevation differences before the earthquake, these movements cannot be converted to relative settlements due to liquefaction. Nonetheless, the relative elevations across the interior were variable, with the some areas almost 1 m lower than others. It appeared that the

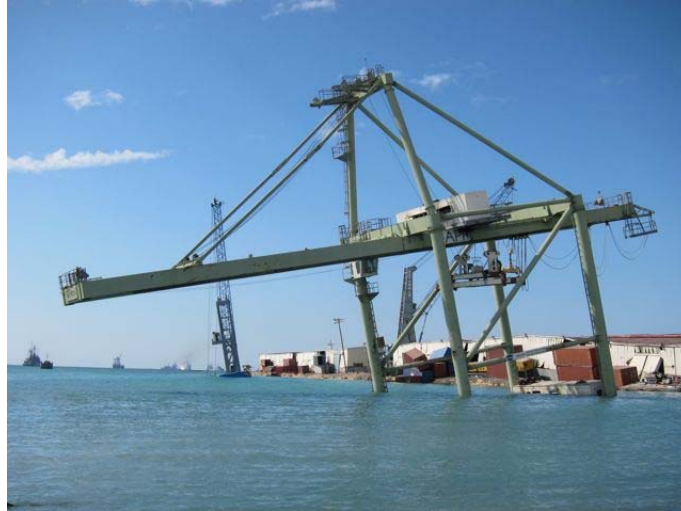
Two of the three cranes were apparently on the North Wharf at the time of the earthquake and are now partially submerged. Figure 6.12 shows the A-frame container crane in the foreground and a submerged mobile crane in the background. There was no obvious structural damage to the container crane. Interestingly, a photo taken by an unknown photographer (apparently aboard a ship docked at the eastern end of the wharf) immediately after the earthquake (Figure 6.13) shows that the landside legs of the A-frame crane were still above water, with the crane in its most eastwardly position. However, a U.S. Coast Guard photo taken during an overflight of the port at mid-day on January 13, 2010 shows the crane in the same position as in Figure 6.12 (i.e., moved westward about 60 m from its position in Figure 6.13) and with the base of the crane fully submerged. Also, the January 13 photo shows that additional subsidence occurred at the eastern end of North Wharf (i.e., the location of the crane in Figure 6.12). The National Earthquake Information Center reports no fewer than 45 aftershocks ranging from  $M_w$  4.0 to 6.0 following the main shock until 1:54 pm EST on January 13, 2010. This raises the likelihood that a portion of the observed permanent displacements caused by liquefaction occurred as a result of aftershocks. The second mobile crane was parked between the two warehouses and appears to be undamaged.

**Figure 6.12** Submerged 15-m gauge container crane (foreground) and mobile crane (background). Photo taken facing west. (N18.55598, W72.348564)

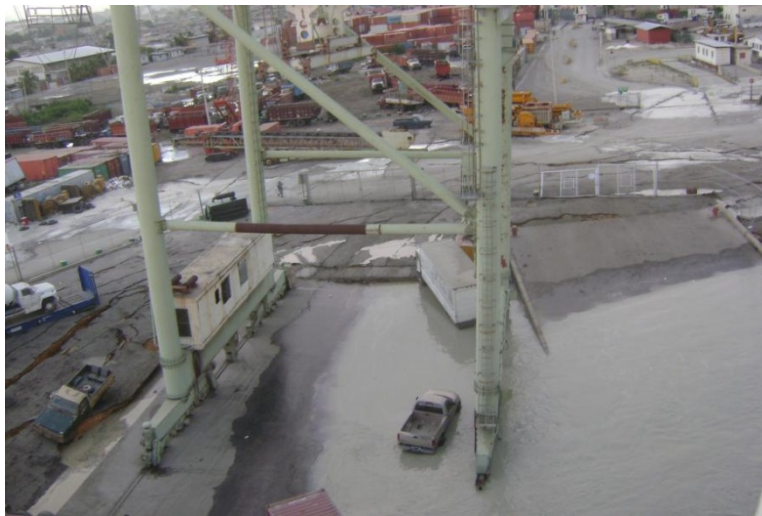
**Figure 6.13** Photo taken immediately after the earthquake with the crane in its most eastward position and with the landside legs of the crane above water. Photo taken facing east. Source: unknown (N 18.556056, W72.347981)

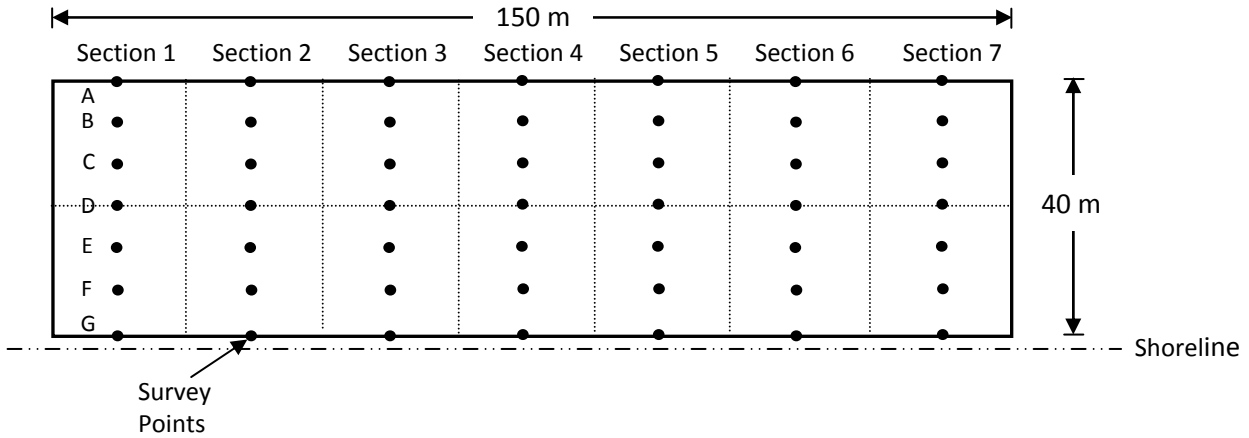
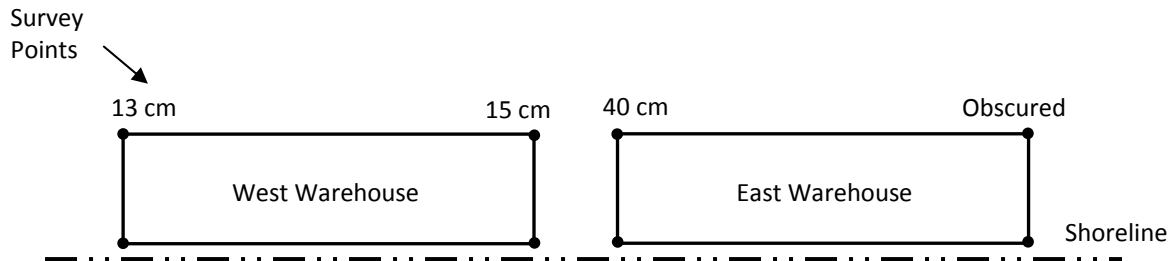
warehouses were founded on strip footings around their perimeters, which settled significantly. Settlements measured at the inland corners of the warehouses are also shown in Figure 6.14. The west warehouse appears to have settled approximately 15 cm relative to the ground surface, while the east warehouse settled more than 40 cm

Survey Pt	Section 1	Section 2	Section 3	Section 4	Section 5	Section 6	Section 7
Vertical Settlement (cm)	A	0.0	-6.1	27.5	42.7	-7.6	32.0	-4.6
	B	-7.3	-4.3	-2.7	24.7	-14.9	24.7	-5.8
	C	-20.4	-20.4	-25.0	-32.6	-23.5	-43.3	-0.6
	D	-24.4	-18.3	-21.4	-2.7	-13.7	-47.3	0.0
	E	-6.7	-32.6	-8.2	-11.3	-5.2	-23.5	-15.9
	F	-16.5	-25.6	-25.6	-34.8	-19.5	-27.1	-25.3
	G	-48.8	-63.4	-74.7	-79.3	-67.1	?	-58.0
Displacement of south wall towards south (cm)		71.1	94.9	119.9	104.6	141.5	131.8	84.8

**Figure 6.14** Results of a detailed survey of the relative settlements of the west warehouse slab, and the total settlements at the inland corners of the warehouses

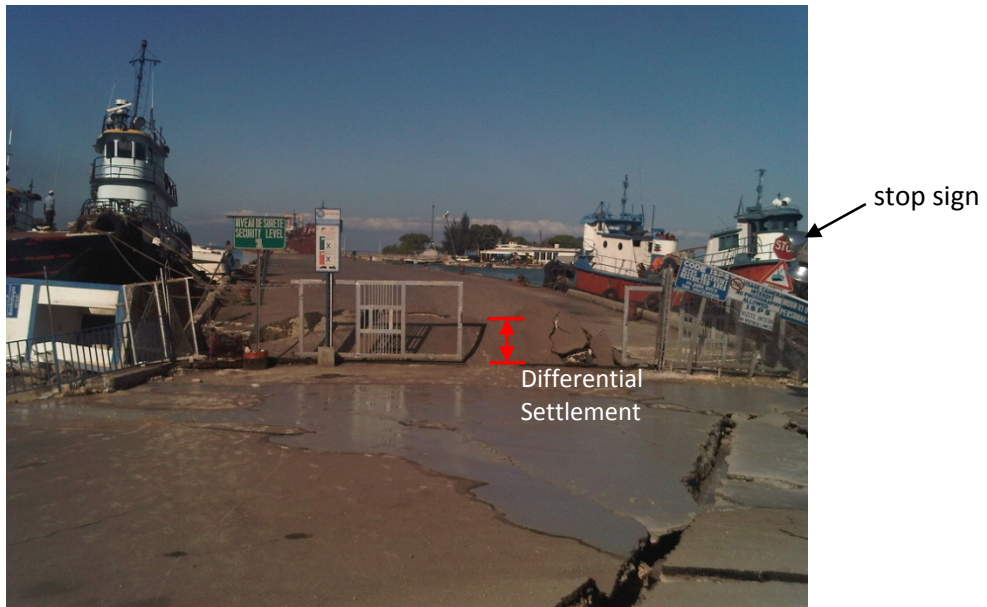
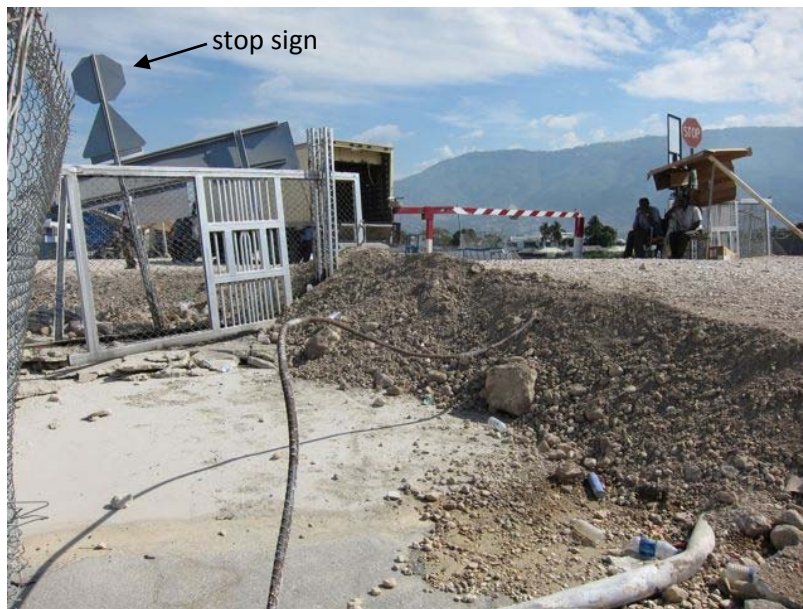
In addition to the damage to the piles supporting the South Pier, the abutment also experienced liquefaction-induced lateral and vertical displacements. Approximately 1 m of fill was required to re-level the approach to the pier as shown in Figure 6.15. Also, the piles supporting the small pedestrian bridge connecting the South Pier to the island could be readily observed. Figure 6.16 shows the damage to these piles, including the extensive damage to the landward row of piles.

**Figure 6.15** Approach to the South Pier immediately after the earthquake (top photo: Source unknown; photo taken facing South-East) and after approximately 1 m of fill was placed (bottom photo: photo taken facing West). (N18.554028, W72.348658)

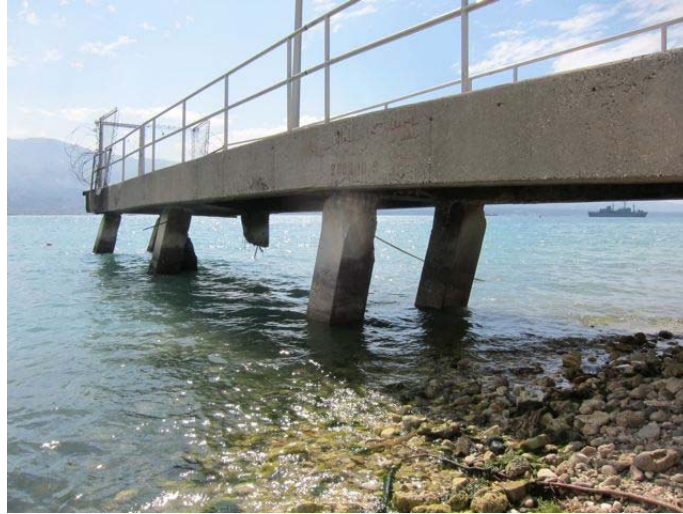
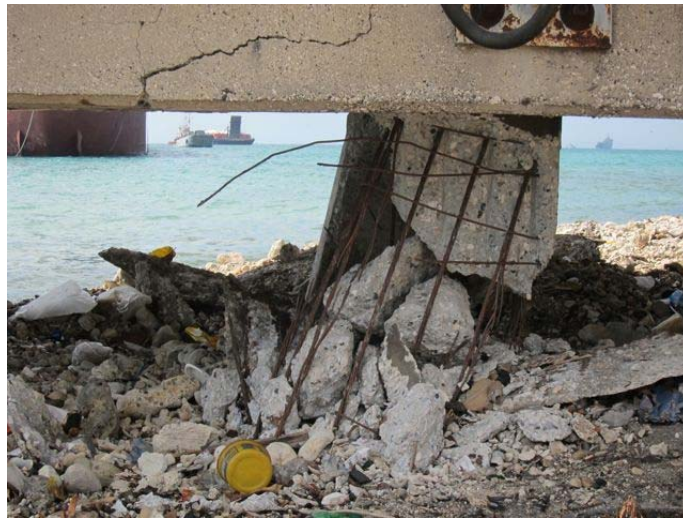
**Figure 6.16:** (top) Damage to piles supporting the pedestrian bridge connecting the South Pier to the island (photo taken facing South) and (bottom) extensive damage to the landward row of piles (photo taken facing West) (N18.554628, W72.351492)

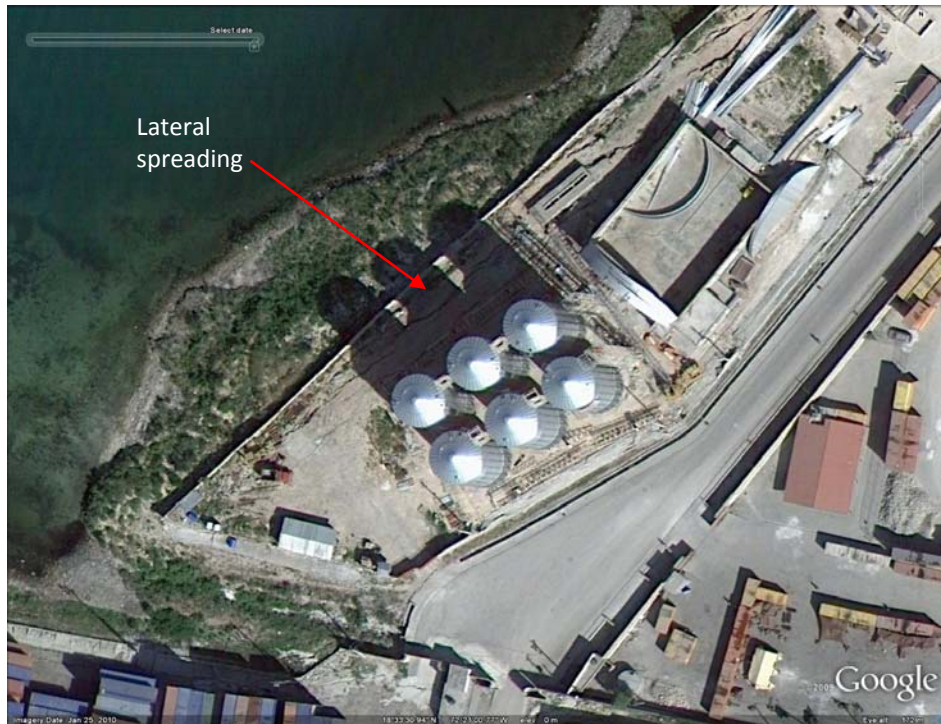
North of the main port facility along the shoreline, there were six steel grain hopper silos and two storage yards (Figure 6.17). From aerial imagery, it was determined that the grain silos were built sometime between March 2008 and January 2010. As shown in Figure 6.18, lateral spreading occurred behind the silos (westward side), but the silos and their foundation system showed no visible signs of distress (Figures 6.18 and 6.19). The amount of grain in the silos at the time of the earthquake is unknown. Also, the foundation system for the silos is unknown at this time. Extensive lateral spreading occurred in the two storage yards that are just north of the silos (Figures 6.20 through 6.24). Approximately 2.4 m of cumulative lateral displacement was measured at the northern storage yard. A unique feature of these lateral spreads is that the fill is garbage overlain by cobbly soil (Figure 6.24). However, it is believed that sand underlying the garbage fill liquefied and caused the lateral spreading.

**Figure 6.18** Lateral spreading behind (westward side) steel grain hopper silos. However, the foundation system for the silos showed no visible signs of distress.  
Imagery courtesy of Google Earth.

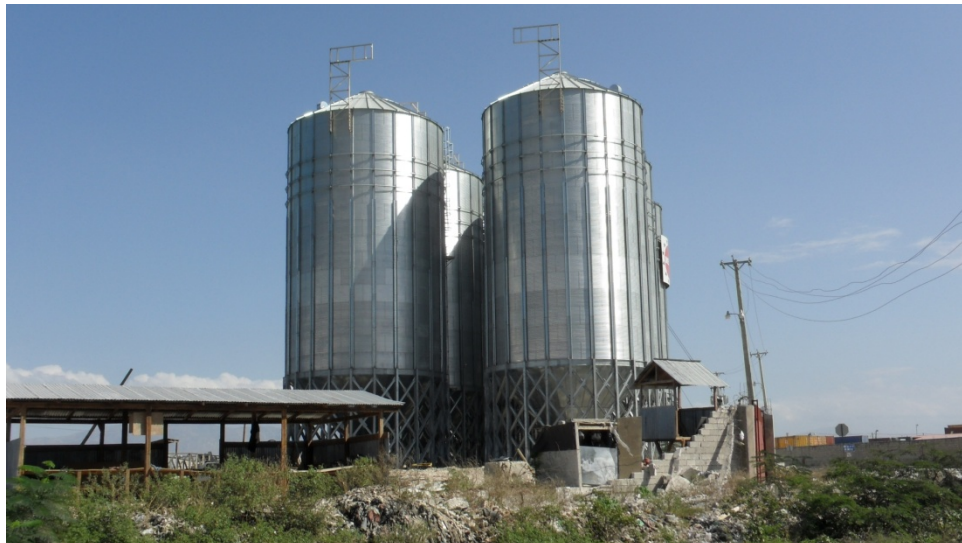
**Figure 6.19** Post-earthquake photo of steel grain hopper silos (photo taken facing North). The silos showed no visible signs of distress.  
(N18.558431, W72.350350)

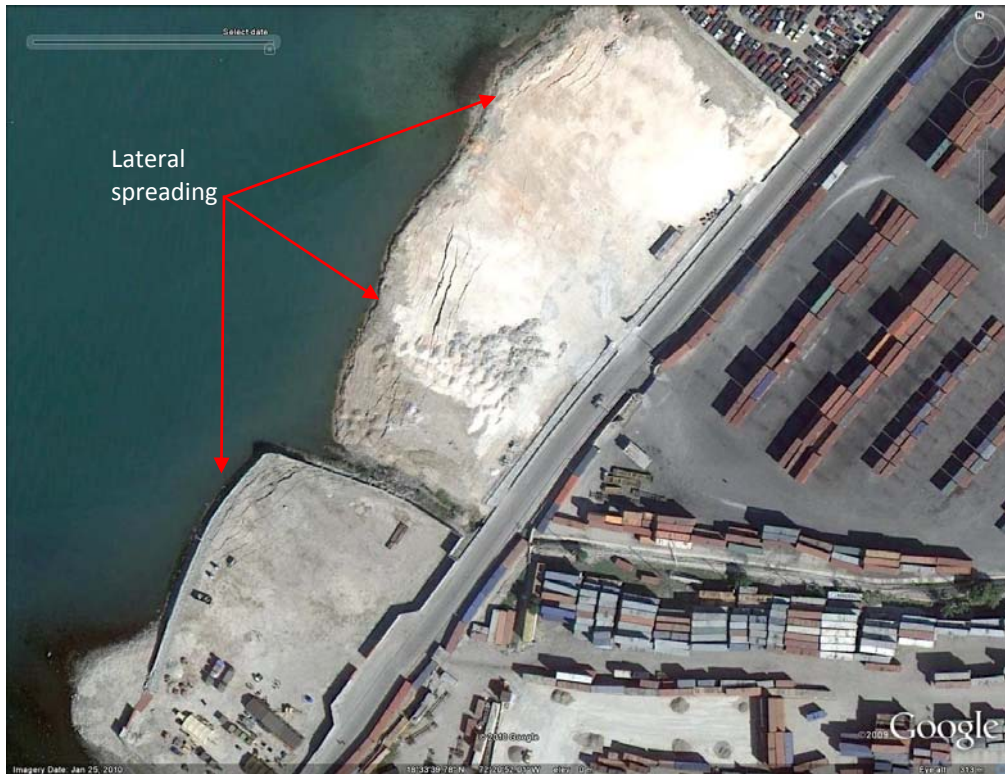
**Figure 6.20** Lateral spreading in the storage yards in the northern part of the port facility. Imagery courtesy of Google Earth. ( $18^{\circ}33'40.23''\text{N}$   $72^{\circ}20'52.33''\text{W}$ )

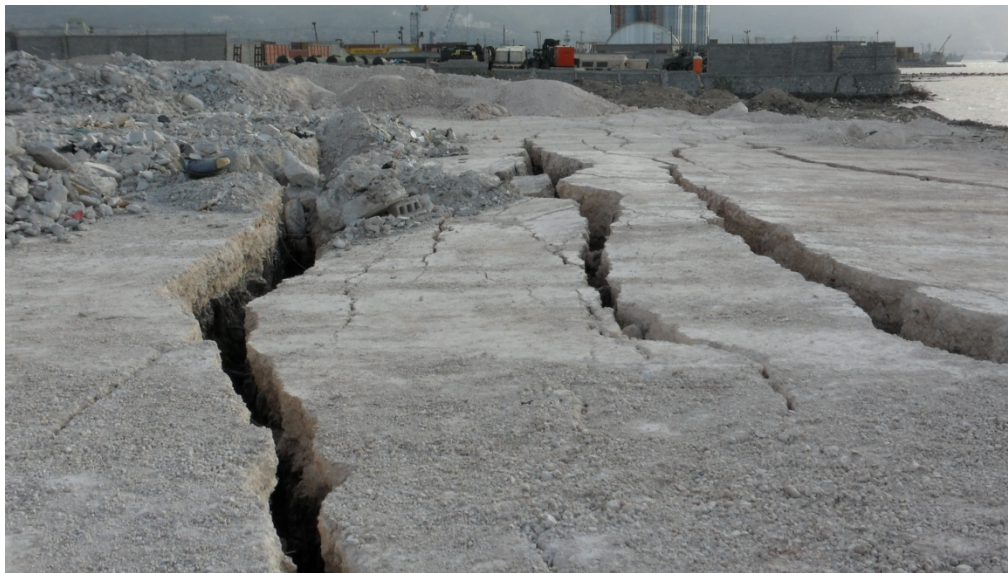
**Figure 6.21** Lateral spreading in the storage yards in the northern part of the port facility. Photo taken facing South. ( $18^{\circ}33'41.39''\text{N}$   $72^{\circ}20'52.51''\text{W}$ )

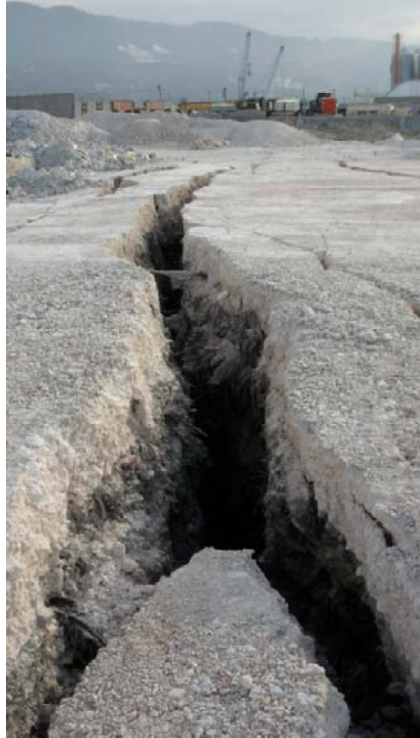
**Figure 6.22** Lateral spreading in the storage yards in the northern part of the port facility. Photo taken facing South. ( $18^{\circ}33'41.76''\text{N}$   $72^{\circ}20'52.25''\text{W}$ )

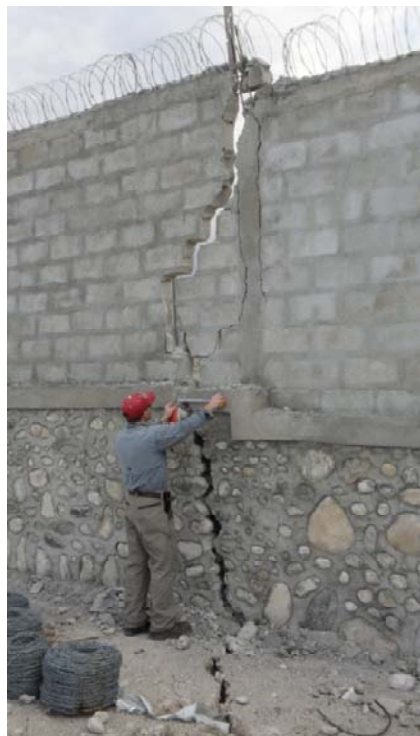
**Figure 6.23** Lateral spreading in the storage yards in the northern part of the port facility. Lateral spread crack passes through a stone/masonry wall. Photo taken facing South. (Approximate long. and lat. of photo:  $18^{\circ}33'35.15''\text{N}$   $72^{\circ}20'56.18''\text{W}$ )

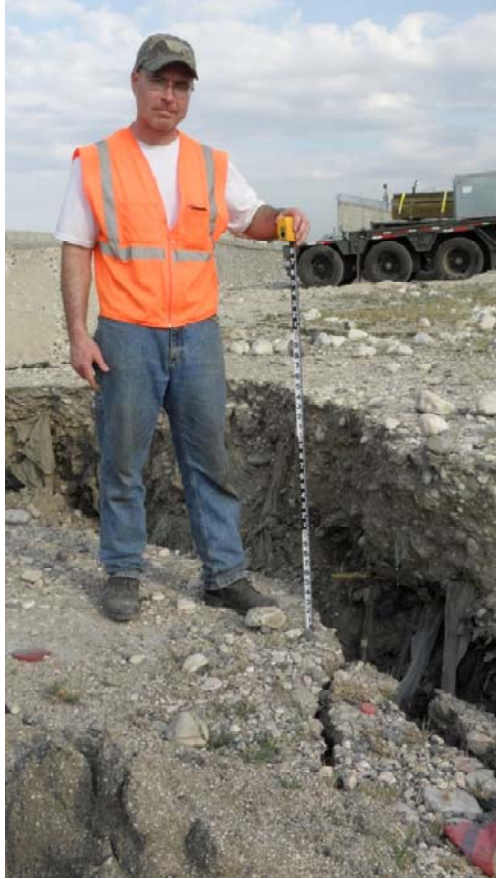
**Figure 6.24** Lateral spreading in the storage yards in the northern part of the port facility. A unique feature of this lateral spread is that the fill is garbage. However, it is believed that the liquefaction of the sand below garbage is the cause of the lateral spreading. Photo taken facing North-East. (Approximate long. and lat. of photo:  $18^{\circ}33'38.93''\text{N}$   $72^{\circ}20'54.89''\text{W}$ )

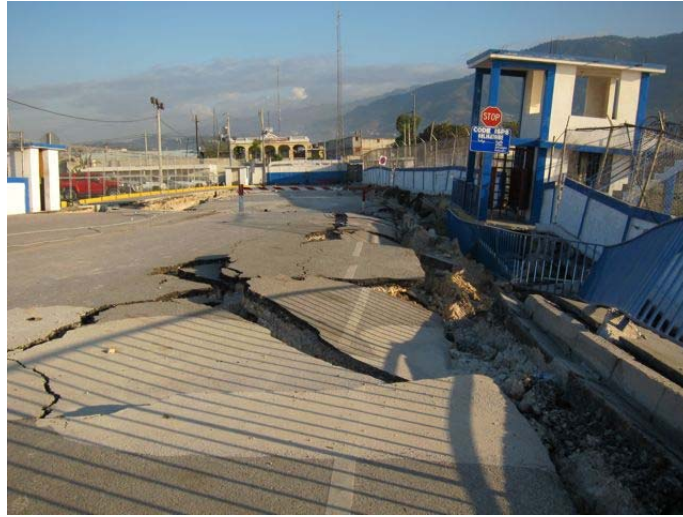
Finally, one of the main entrance roads to the port was heavily damaged by liquefaction-induced lateral spreading, as shown in Figure 6.25.

**Figure 6.25:** Damage to entrance road caused by lateral spreading. Photo taken facing South-East. (Approximate long. and lat. of photo: 18°33'11.61"N 72°20'52.50"W)

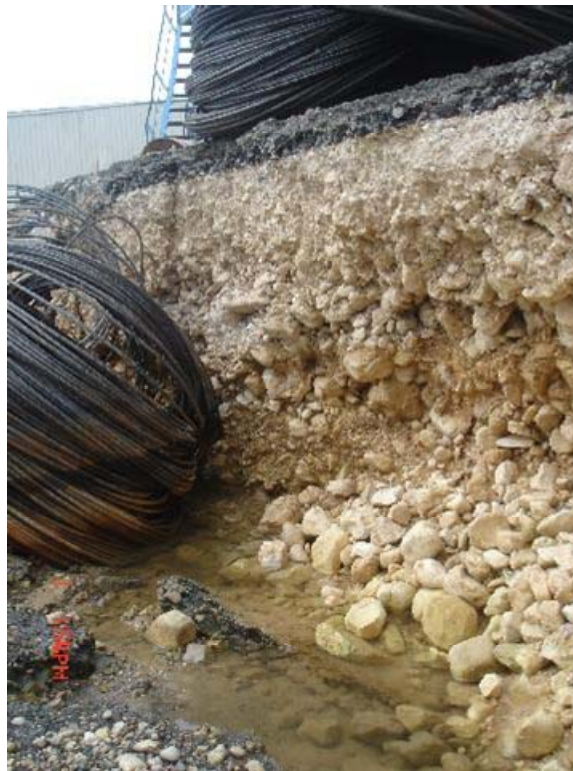
**Figure 6.29** Near-surface soil layering at the wharf as observed on the free-face of the lateral spread that collapsed the wharf deck. This picture was taken just south of SASW 1 (refer to Figure 6.26), facing East. (N18.556635°, W 72.350202°).
