7.0 LIQUEFACTION AND LATERAL SPREADING

7.3 Coastal Failure west of L'acul

7.4 Coastal Failure near Fouche

7.5 Coastal failure near Grand Goâve.

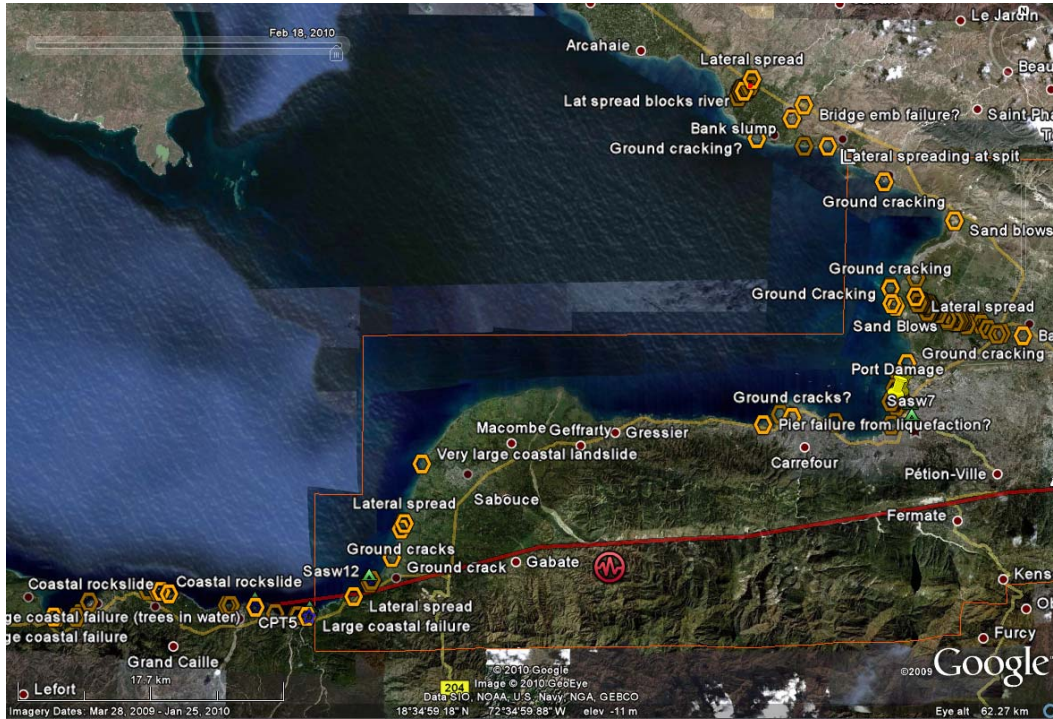
Prior to arrival in Haiti, GEER team members identified numerous potential liquefaction-induced failures near the coastline, as shown in Figure 7.1. Potential liquefaction-induced failures were identified up to 38 km from the epicenter and up to 26 km from the fault trace. These data plot well within the boundaries for most distal liquefaction sites proposed by Ambraseys (1988) using worldwide data (Figure 7.2). As discussed by Olson et al. (2005), this suggests that the natural coastal and alluvial soils near Port-au-Prince Bay are only moderately susceptible to liquefaction, although liquefiable Quaternary sediments were generally noted only within short distances from the coast. Additionally, without any strong motion recordings from this event, the level and duration of shaking is unknown. The slip inversions for the event (see Section 2.0 Seismological Aspects) indicate that most of the earthquake energy was released in 6 to 8 seconds, which is relatively short for a M 7 earthquake. This short duration of shaking would have limited the number of cycles of loading and minimized the zones that experienced liquefaction.

Figure 7.1. Potential liquefaction, lateral spreading, and coastal failure sites identified from post-earthquake aerial photography (sites identified as open hexagons). Imagery courtesy of Google Earth.

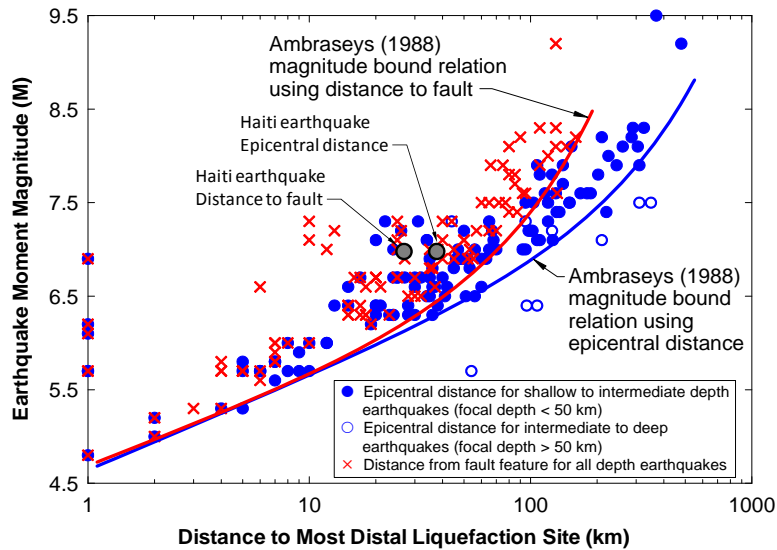
Figure 7.2. Comparison of most distal liquefaction sites identified in Haiti from aerial photography with worldwide data collected by Ambraseys (1988)

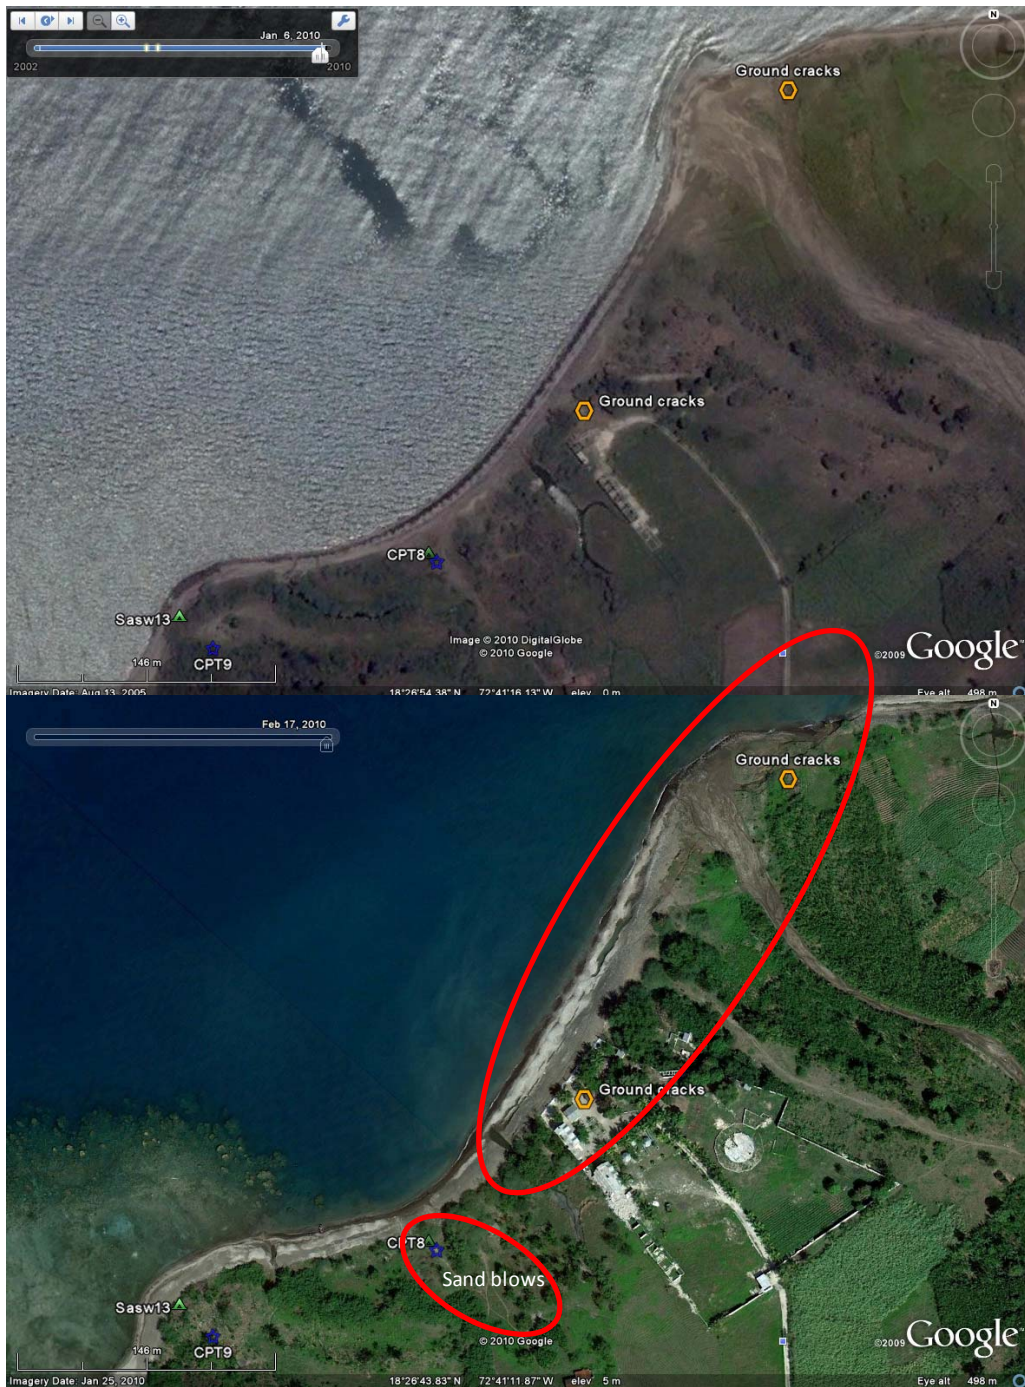
Approximately 400 m of coastline at the mouth of a stream experienced significant translational movement west of the village of L'acul, as illustrated by the pre- and post-earthquake imagery in Figure 7.3. Also evident near the south end of the failure are uplifted coral beds, as described Section 4.0 Fault Rupture and Coastal Uplift. The primary manifestations of failure included cracking subparallel to the coastline (Figure 7.4 and Figure 7.5), a slump block near the northern extent of the failed zone, and sand blows near the southern extent of the failed zone (Figure 7.6). It is important to note that lateral spreads typically occurred in delta fan lobes or beach deposits adjacent to major stream discharge/delta zones. Lateral spread failures were rare or absent at points where coral has developed and "buttressed" the shoreline.

Based on the subparallel cracking, the formation of sand blows, and the results of the in-situ tests, the team attributed this failure to liquefaction and lateral spreading. Liquefaction likely occurred within the loose to medium dense sands below the watertable between depths of about 0.75 m and 2.3 m (2.5 to 7.5 ft). Below 2.3 m in the failed zone, the DCPT encountered much denser sands. The extent of the failure to the south was limited by the presence of fine-grained soils and peat overlying the denser marine sands.

Figure 7.3. Pre- and post-earthquake images of coastline near village of L'Acuil. Note in the lower, post-earthquake image the significant cracking subparallel to the coast and the arcuate slump in the northern end of the failure. SASW and DCPT testing was performed near several large sand blows located near the south end of the failure zone, as well as farther south outside of the failed reach. Imagery courtesy of Google Earth. Approximate center of image at $18^{\circ}26'51.17''\text{N}$, $72^{\circ}41'11.06''\text{W}$.

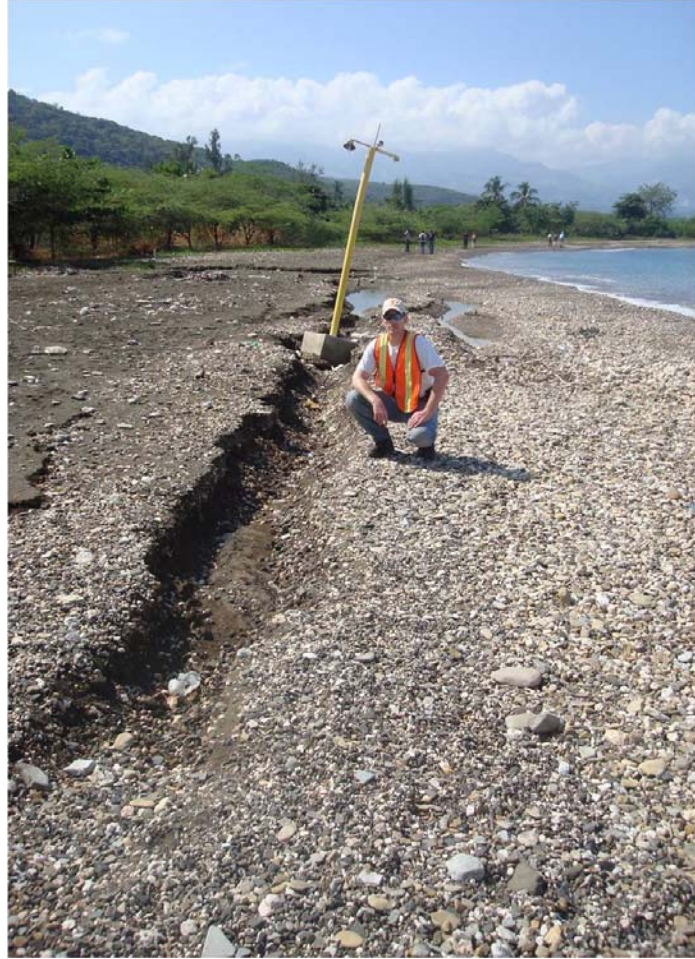
Figure 7.4. Cracking and lateral spread along coastline near village of L'Acul.
($18^{\circ}26'48.81''\text{N}$, $72^{\circ}41'11.92''\text{W}$ looking west).

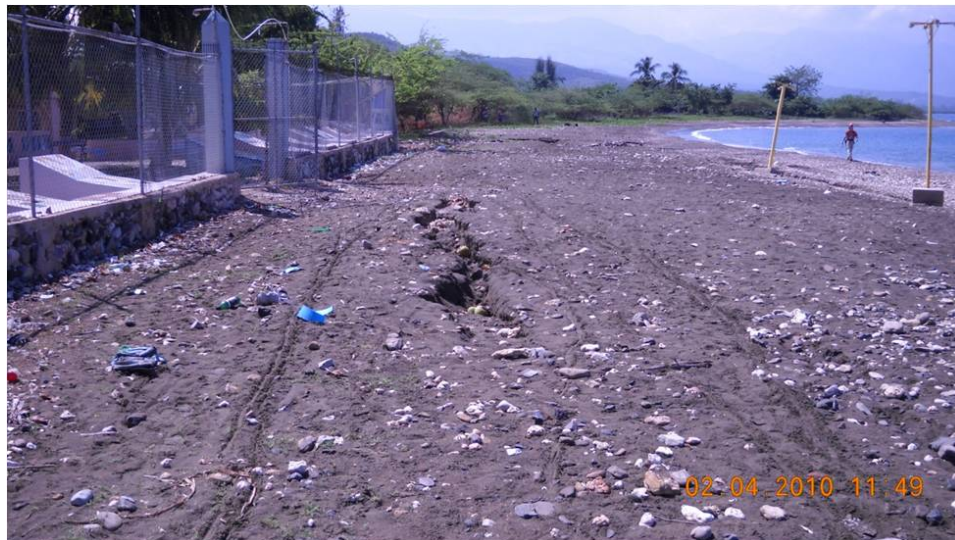
Figure 7.5. Ground cracking along coastline near village of L'Acul.
($18^{\circ}26'48.83''\text{N}$, $72^{\circ}41'11.39''\text{W}$ looking west).

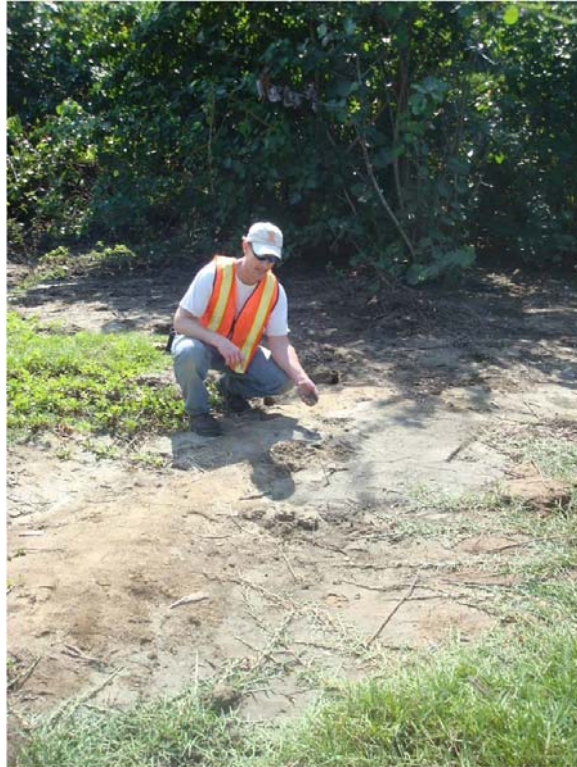
Figure 7.6. Sand blow formation to the south of the main cracks along coast near village of L'Acuil. ($18^{\circ}26'44.27''N$, $72^{\circ}41'12.05''W$ looking south).

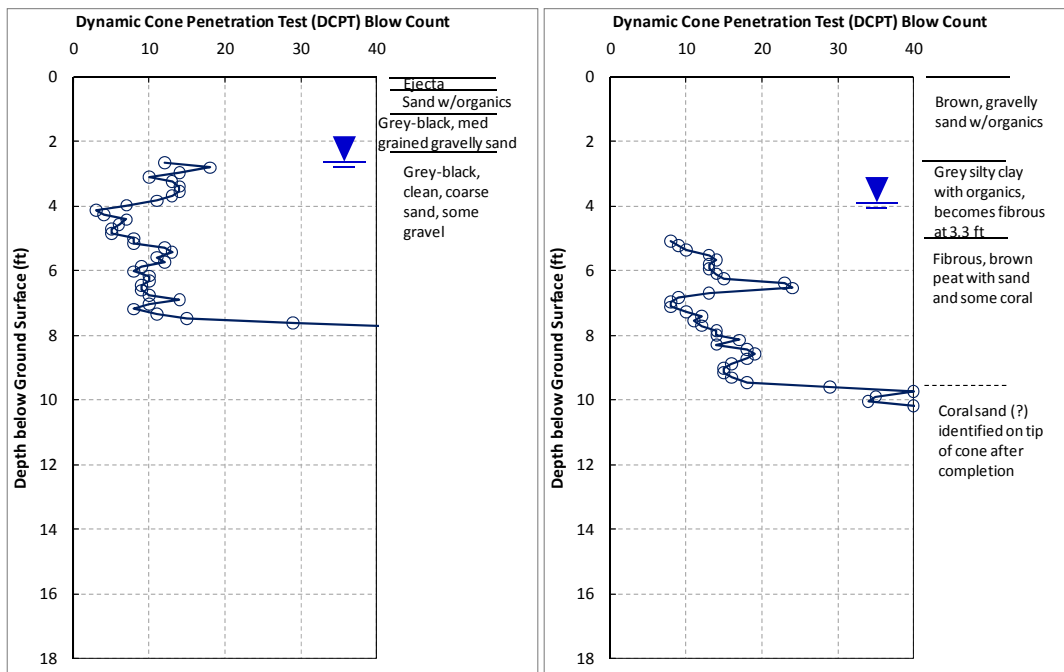
During reconnaissance efforts, the team conducted two dynamic cone penetration tests (DCPT) and two spectral analysis of seismic waves (SASW) lines at the site, one set near the sand blows at the southern end of the failed zone and one set outside of the failed zone to the south (Figure 7.3). Figure 7.7 presents the results of the DCPTs. As illustrated in Figure 7.7, the stratigraphy changes dramatically between the failed and non-failed zones, with loose sands being encountered near-surface within the failed zone and clays and peats being encountered near-surface outside of the failed zone. The fine-grained stratigraphy is expected because of its significant distance from the active mouth of the stream to the north. The results from SASW testing are still being processed and will be included in future versions of this report.

Figure 7.7. Results of DCPTs performed near coastline near village of L'Acuil. Sounding on left performed at south end of failed zone (DCPT-8), and sounding on right performed outside of failed zone (DCPT-9).

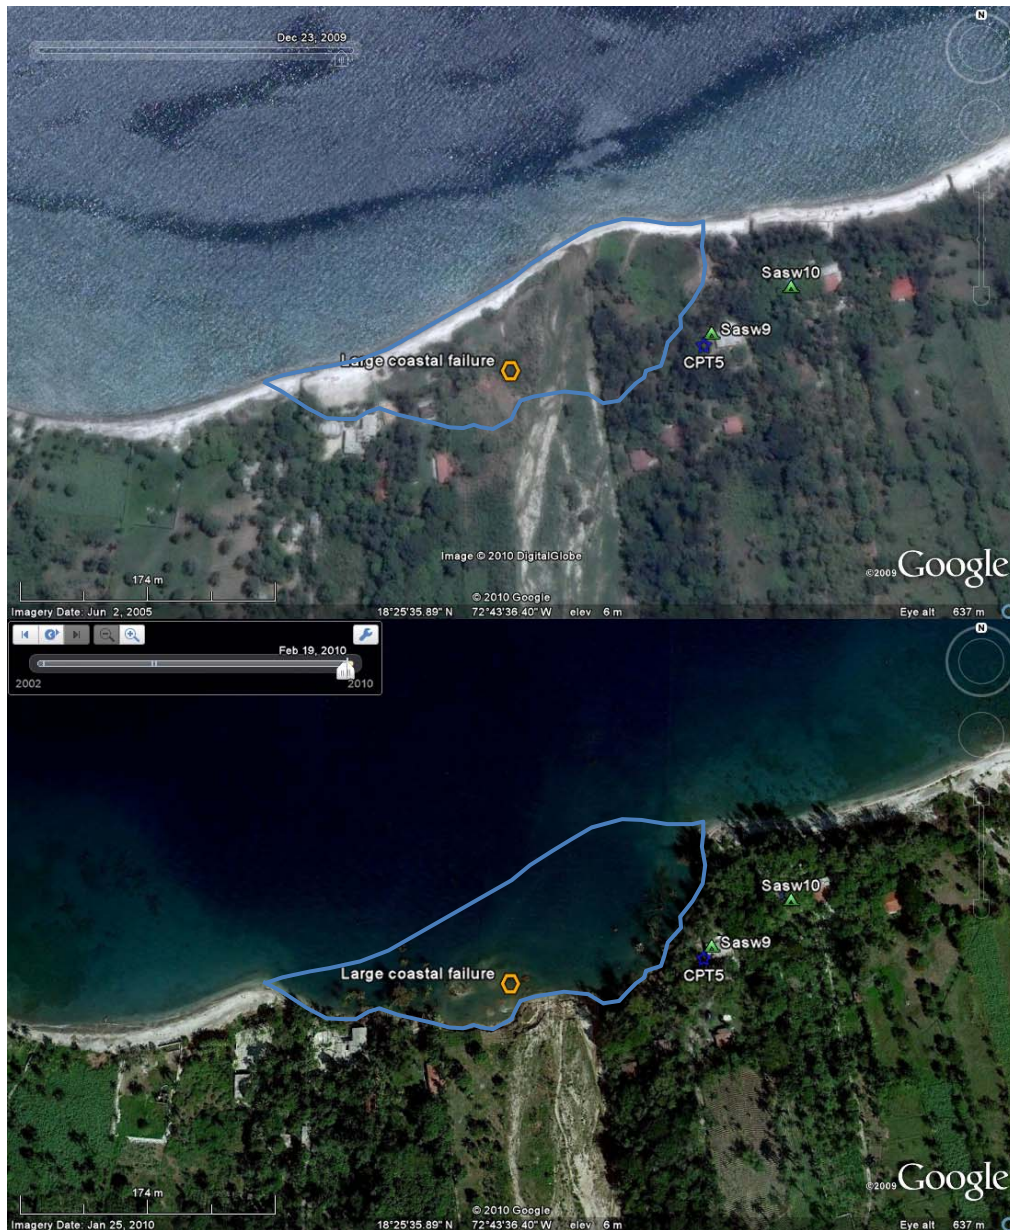
Approximately 330 m of coastline failed near the village of Fouche, as illustrated in pre- and post-earthquake imagery in Figure 7.8. At this site, as much as 100 m of land (perpendicular to the coast) was lost as a result of the failure. The primary manifestations of failure included scarps, cracking, and graben formation in an arcuate path along the coastline (Figure 7.9 and Figure 7.10), as well as substantial damage to a stone wall running perpendicular to the coast and parallel to a braided stream that emptied into the bay (Figure 7.11 and Figure 7.12) and moderate-sized sand blows along the inland extent of the failure (Figure 7.13). One sand blow area included gravel clasts of up to about 2.5 cm in maximum dimension. The gravels may have been plucked from the sidewalls of the liquefaction feeder dike/fissure, or could have been entrained in the actual liquefied sediments.

Based on the arcuate scarp, graben formation, sand blows development, and the results of the in-situ tests, the team attributed this failure to liquefaction and lateral spreading of the loose to medium dense sands below a depth of 0.7 m (2.5 ft). Headscarps and slump block scarps were up to 1.5 m high in the central parts of the failure, suggesting that failure extends perhaps 1.5 to 2 m below the original ground surface. Liquefaction likely extended to a depth of 1.6 m and may have occurred at greater depth, but penetration with the DCPT was limited in these denser sands. Similar to the coastal failure near the village of L'acul, this failure appears to coincide directly with the presence of the braided stream dumping loose sand into the sea, rather than in the marine sands present along the coast.

Figure 7.8. Pre- and post-earthquake images of coastline near village of Fouche. Note in the lower, post-earthquake image the significant loss of coast as outlined in blue. SASW-9 and DCPT-6 were performed near several moderate-sized sand blows located near the southeast end of the failure zone, while SASW-10 was performed outside of the failure zone. Imagery courtesy of Google Earth.

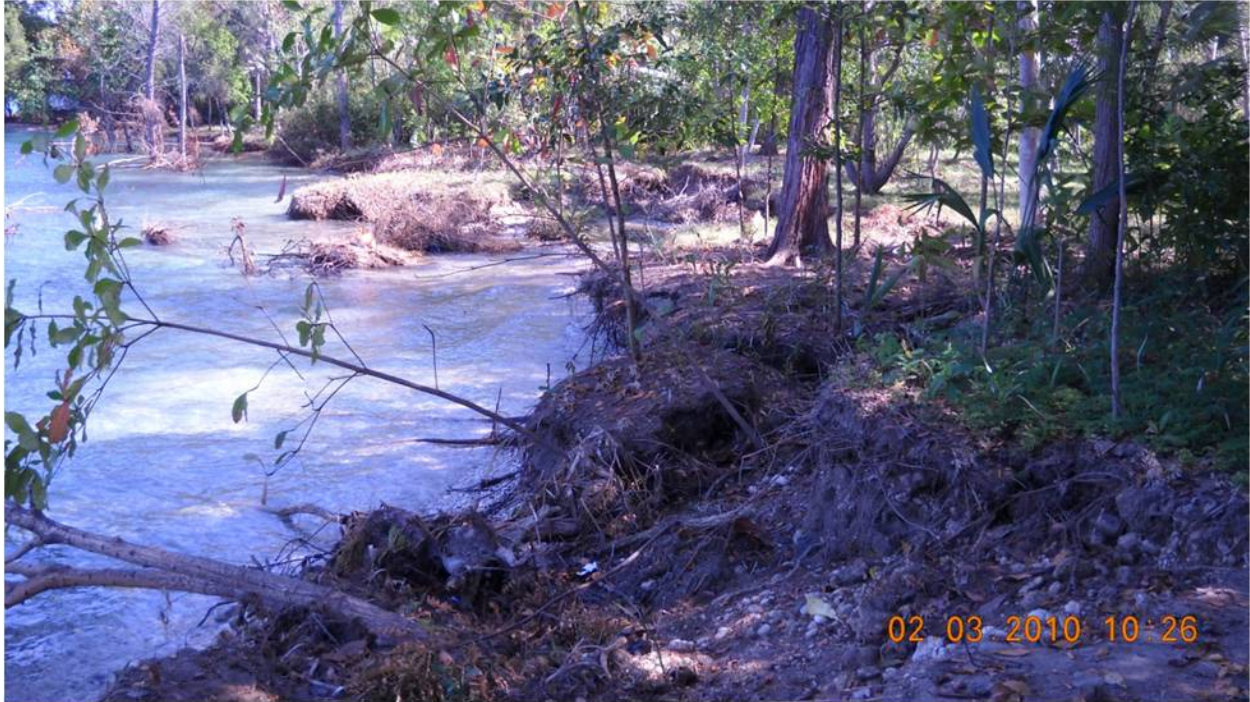
Figure 7.9. Scarp of coastal landslide near village of Fouche.
($18^{\circ}25'34.23''\text{N}$, $72^{\circ}43'33.61''\text{W}$ looking northeastward)

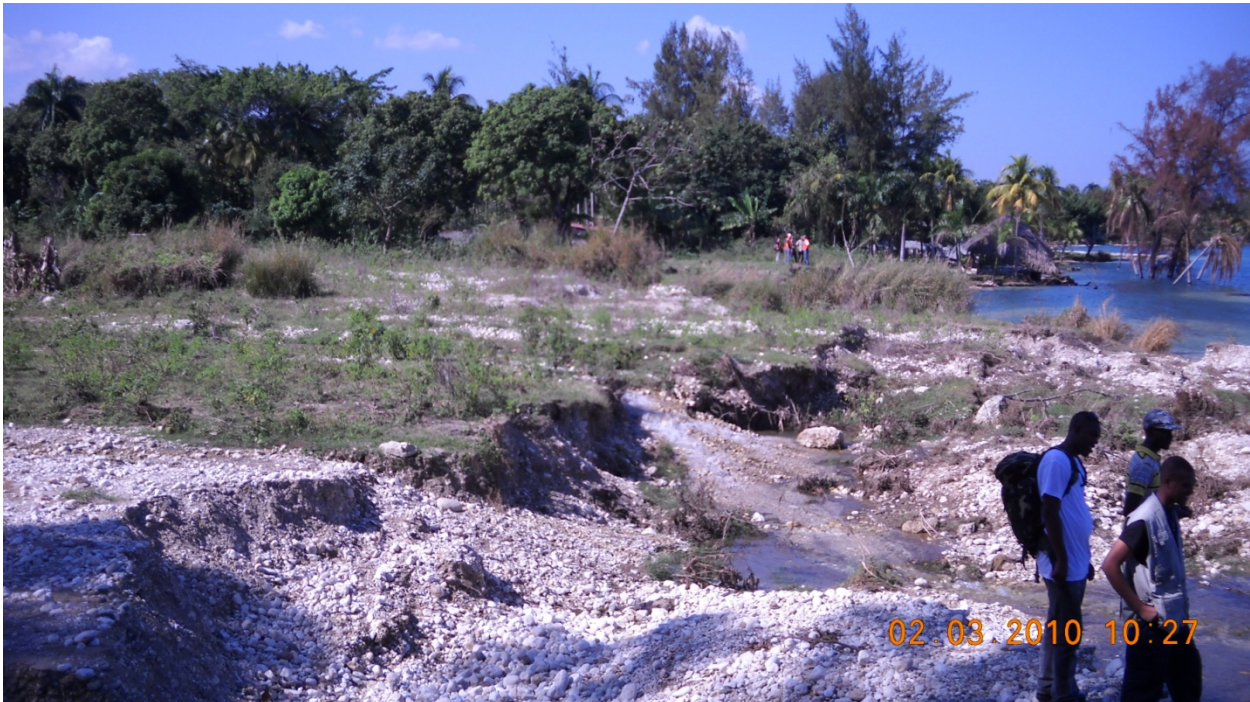
Figure 7.10. Scarp of coastal landslide near village of Fouche.
($18^{\circ}25'34.01''\text{N}$, $72^{\circ}43'34.60''\text{W}$ looking westward).

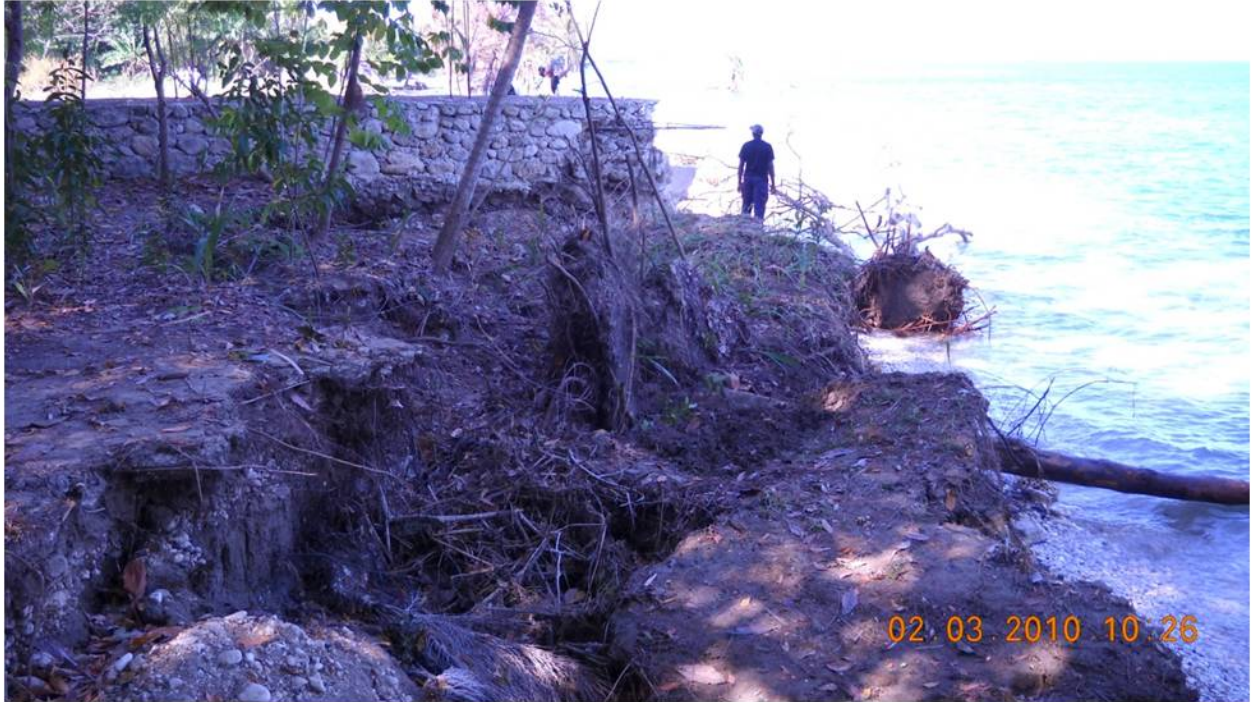
Figure 7.11. Damage to stone wall resulting from coastal failure and lateral spreading. (18°25'33.94"N, 72°43'34.27"W looking westward).

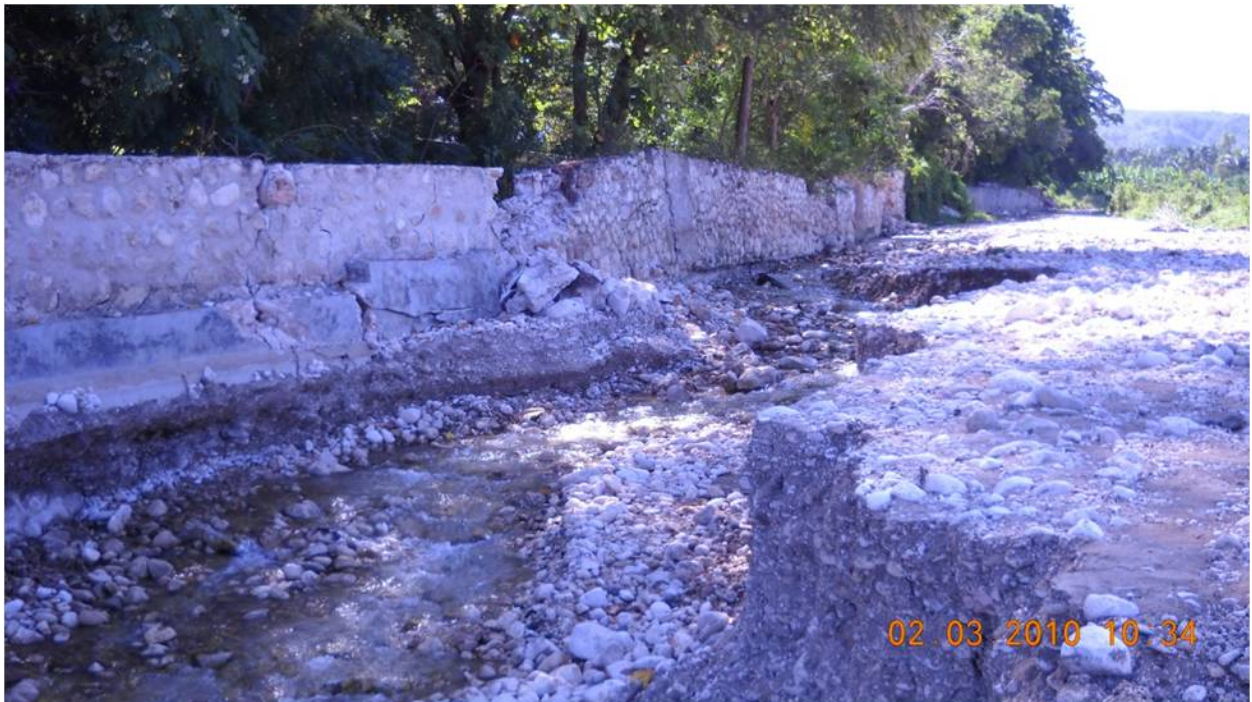
Figure 7.12. Damage to stone wall resulting from lateral spreading. Note the surficial cobbly material revealed by the failure scarp in the foreground. (18°25'33.31"N, 72°43'34.58"W looking southward away from coast).

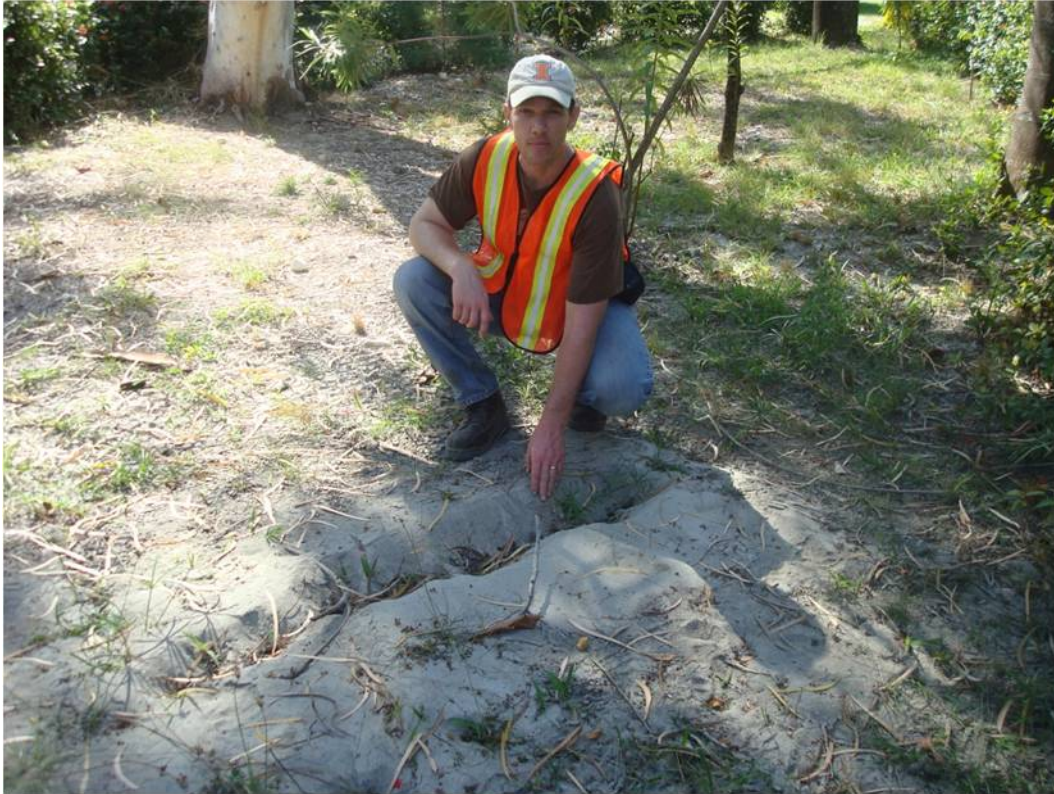
Figure 7.13. Sand blow and ejecta formed at coastal failure site near village of Fouche. Approximate image coordinates: $18^{\circ}25'35.08''\text{N}$, $72^{\circ}43'31.70''\text{W}$.

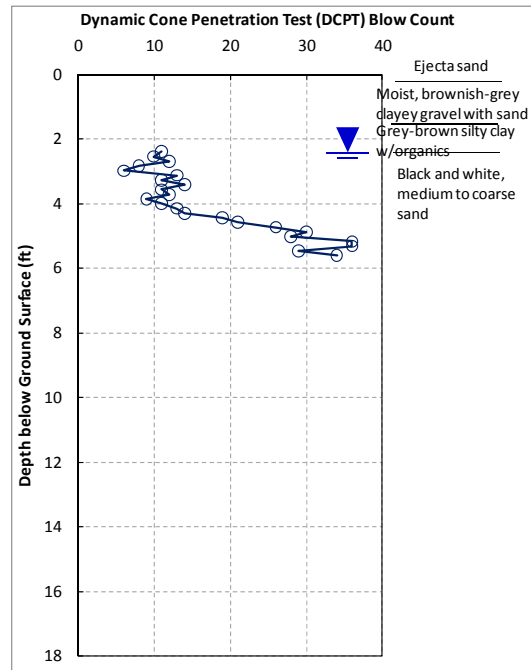
During the reconnaissance efforts, the team conducted one DCPT and one SASW line near several sand blows at the eastern end of the failed zone (Figure 7.8 and Figure 7.14), and one SASW line outside of the failed zone to the east (Figure 7.8). A second DCPT was attempted in this non-failed area but a thick layer of fill precluded augering beyond a few inches. Figure 7.15 presents the results of the DCPT in the failed zone. As illustrated in Figure 7.15, loose sand was encountered at a depth of about 0.7 m (2.5 ft), underlying a low permeability cap layer consisting of clayey sand and silty clay. The sands became medium-dense to dense at a depth of about 1.6 m (5.5 ft). The results from SASW testing are still being processed and will be included in future versions of this report.

Figure 7.15. Results of DCPT-5 testing at coastal failure site near village of Fouche.

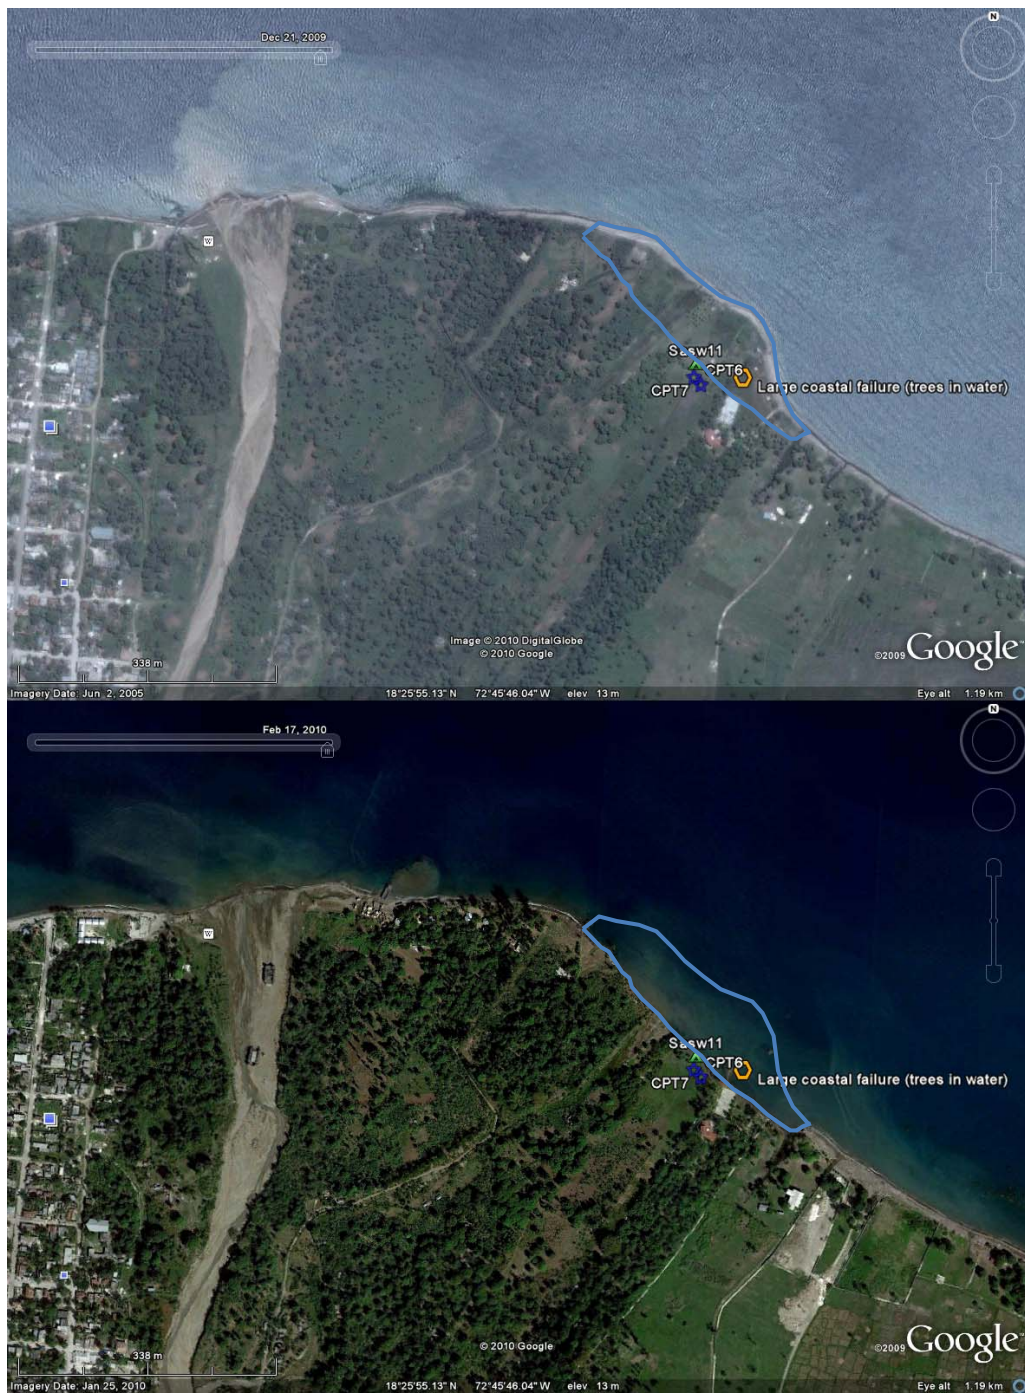
Approximately 400 m of coastline failed near the village of Grand Goâve, as illustrated in pre- and post-earthquake imagery in Figure 7.16. At this site, nearly 100 m of land (perpendicular to the coast) was lost as a result of the slide. The primary manifestations of failure included scarps (Figure 7.17 and Figure 7.18), cracking, and graben formation subparallel to the coastline (Figure 7.19), substantial damage to a unreinforced block wall running perpendicular to the coast (Figure 7.20), and small- to moderate-sized sand blows along the inland extent of the failure (Figure 7.21).

Based on the arcuate scarp, graben formation, sand blows development, and the results of the in-situ tests, the team attributed this failure to liquefaction and lateral spreading of the loose to medium dense sands and silty sands below a depth of 0.9 m. Liquefaction likely extended to a depth of 1.6 m and may have occurred at greater depth, but penetration with the DCPT was limited in these denser sands. Similar to the coastal failures near the villages of L'acul and Fouche, this failure occurred adjacent to a braided stream dumping loose sand into the bay (probably in a former channel of the stream), rather than in the marine sands present along the coast.

Figure 7.16. Pre- and post-earthquake images of coastline near village of Grand Goâve. Note in the lower, post-earthquake image the significant loss of coast as outlined in blue. SASW-11, DCPT-7, and DCPT-8 were performed just inland of the backscarp of the failed zone. Imagery courtesy of Google Earth.

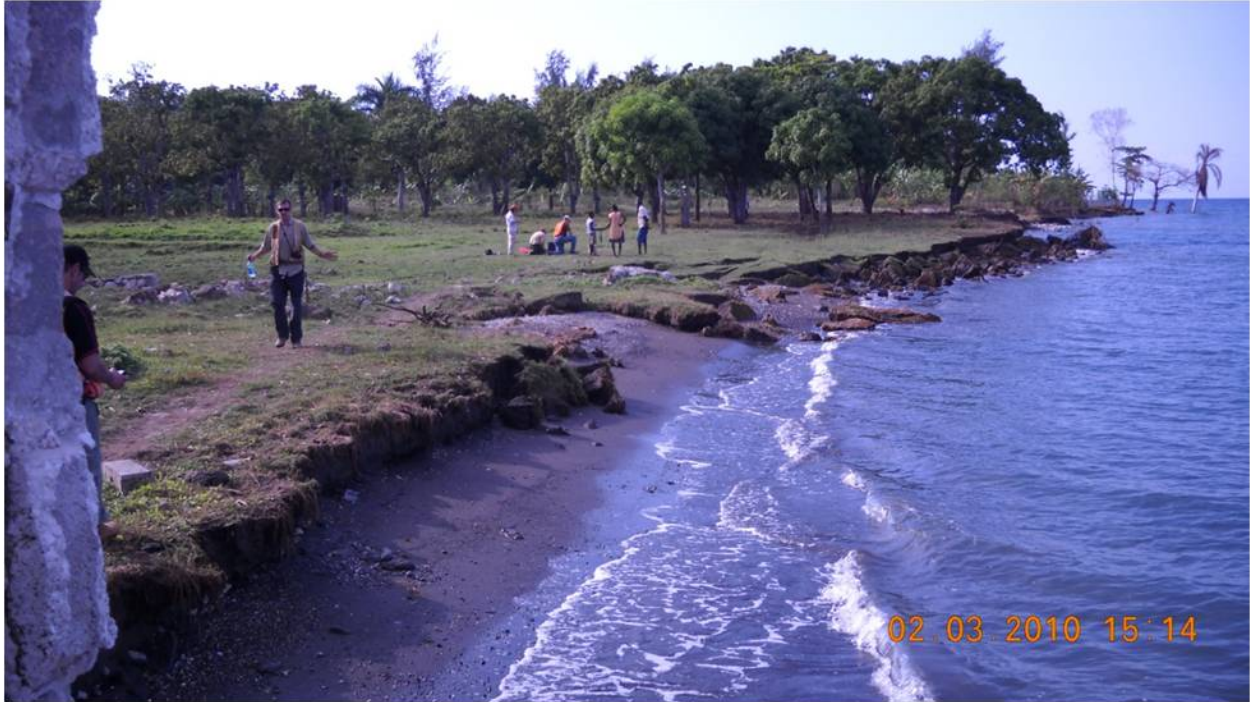
Figure 7.17. Scarp formed along northern portion of coastal failure near village of Grand Goâve. ($18^{\circ}25'53.82''\text{N}$, $72^{\circ}45'37.16''\text{W}$ looking northwest).

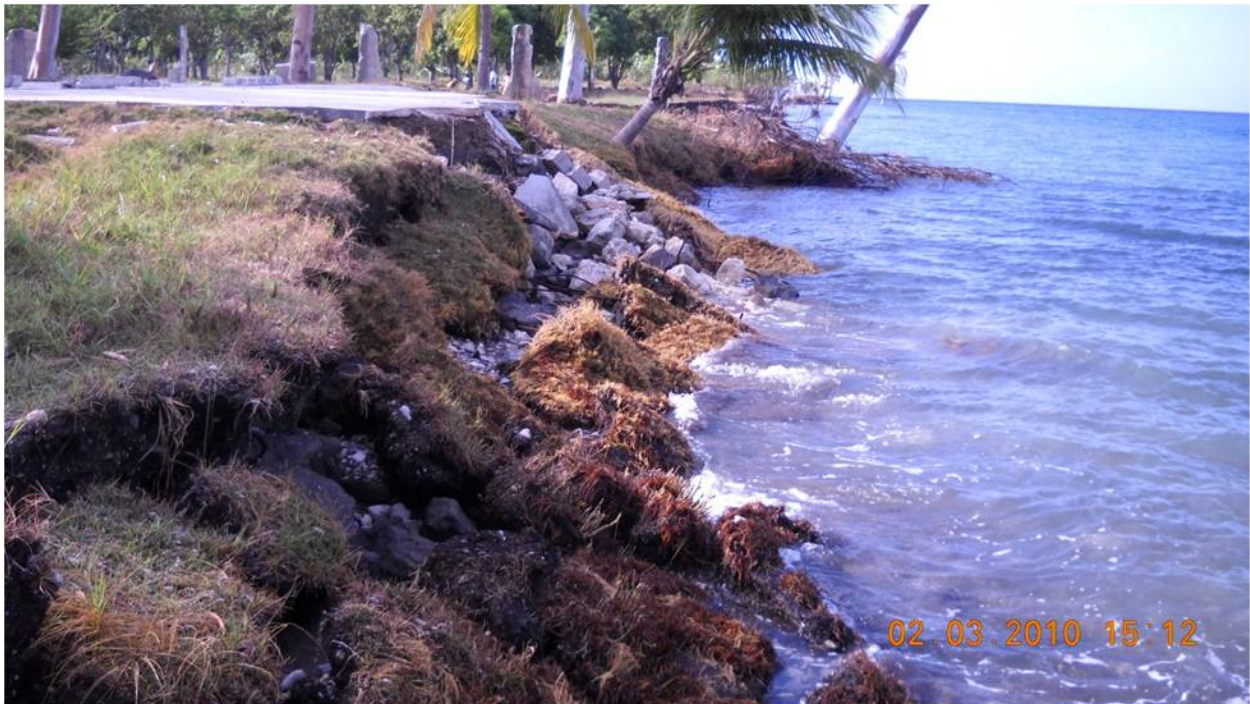
Figure 7.18. Scarp formed along southern portion of coastal failure near village of Grand Goâve. ($18^{\circ}25'52.91''\text{N}$, $72^{\circ}45'35.92''\text{W}$ looking northwest)

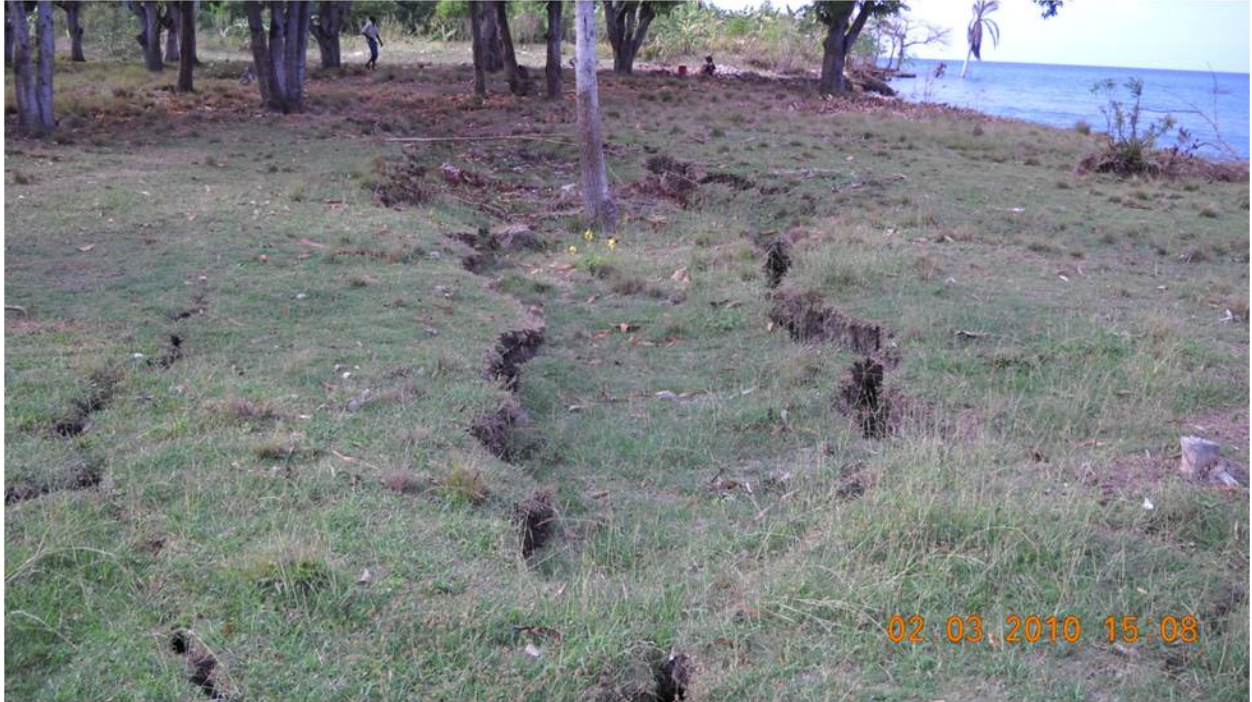
Figure 7.19. Graben formation subparallel to coastline at coastal failure near village of Grand Goâve. ($18^{\circ}25'54.43''\text{N}$, $72^{\circ}45'37.99''\text{W}$ looking northwest).

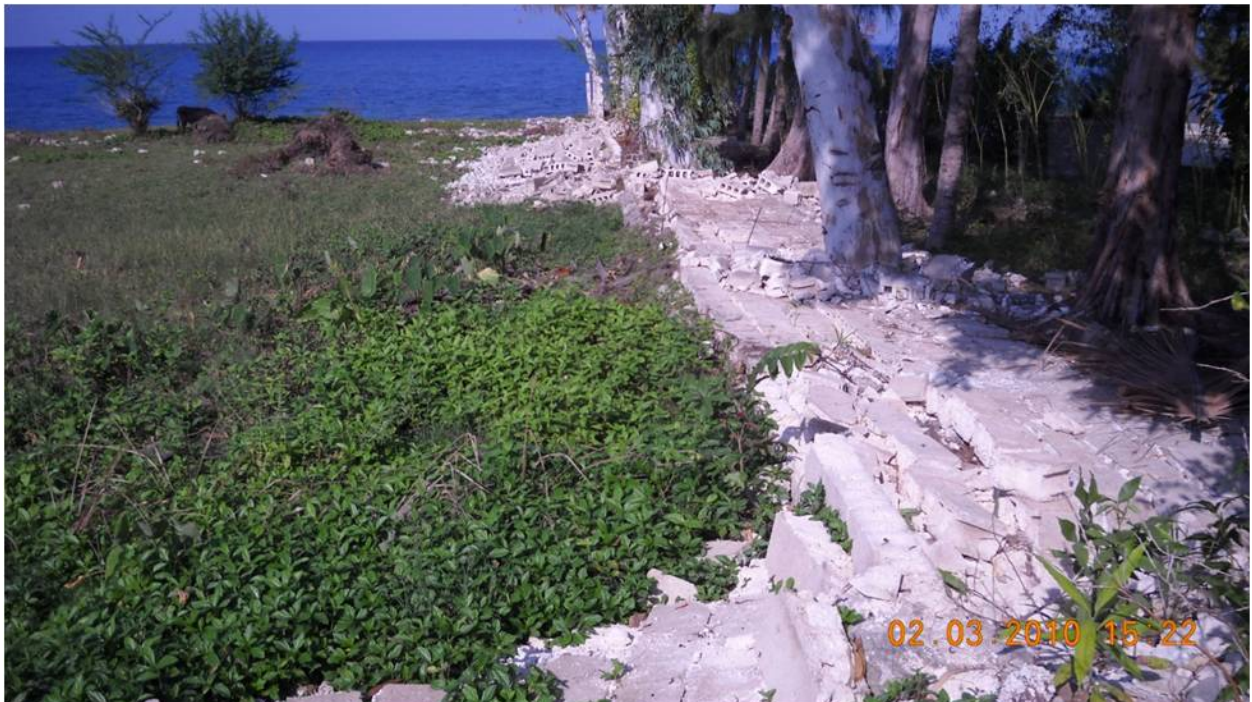
Figure 7.20. Damage to unreinforced block wall running perpendicular to coast near village of Grand Goâve. ($18^{\circ}25'51.84''\text{N}$, $72^{\circ}45'38.06''\text{W}$ looking northeast).

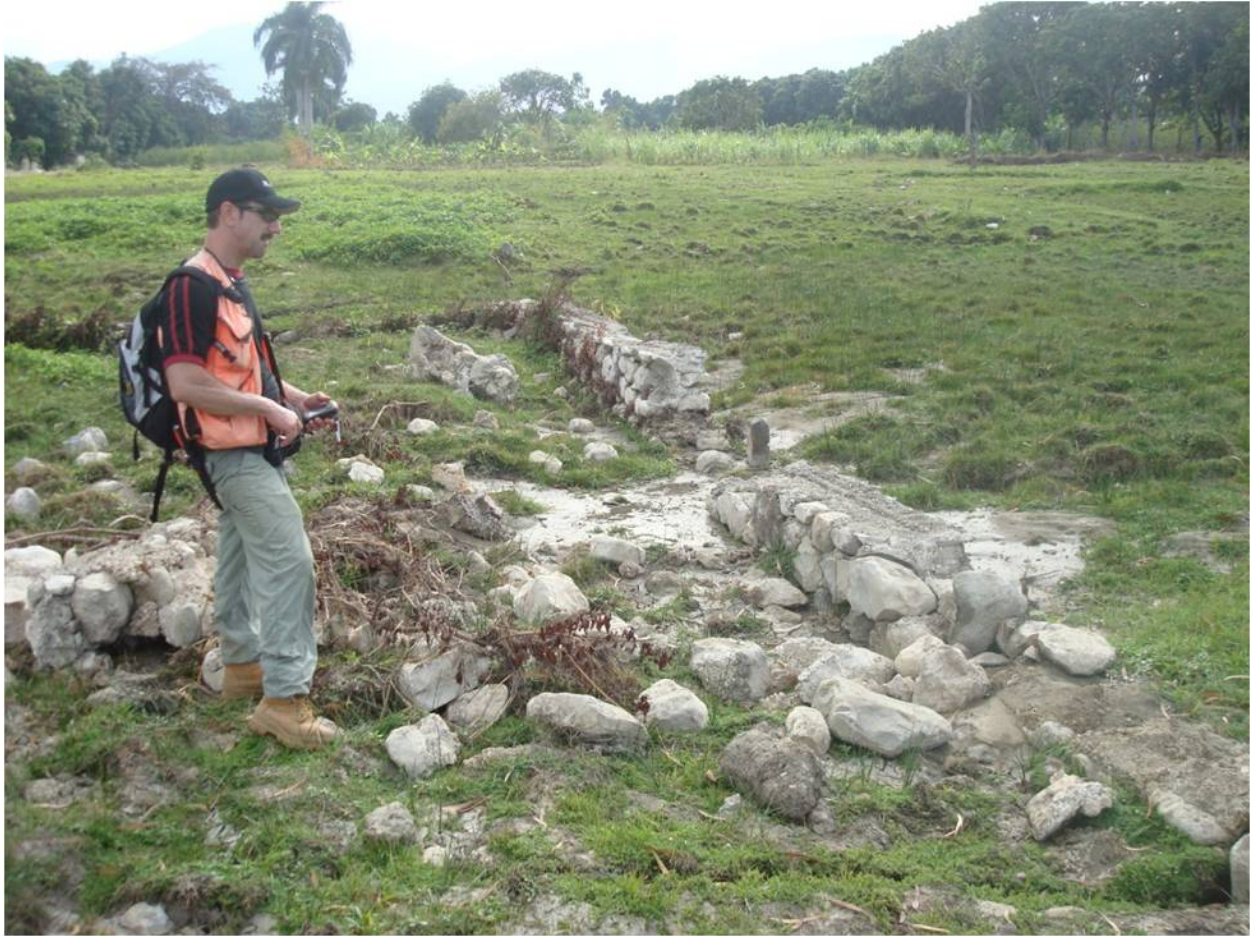
Figure 7.21. Sand blow formation along inland extent of coastal failure near village of Grand Goâve. ($18^{\circ}25'53.73''\text{N}$, $72^{\circ}45'37.65''\text{W}$)

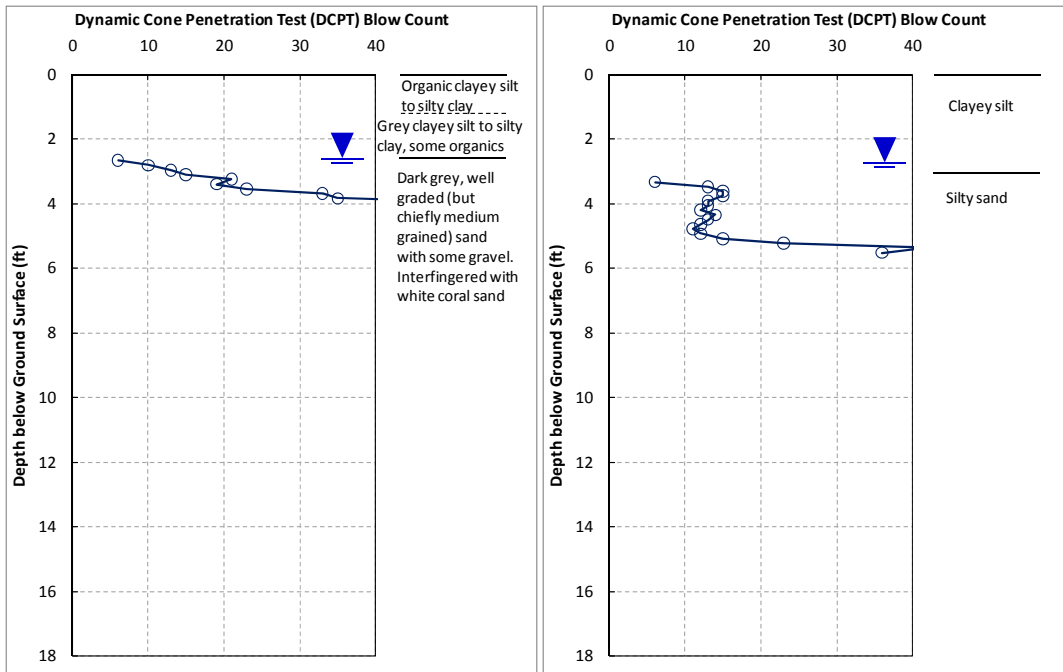
During reconnaissance, the team performed two DCPT and one SASW line near several sand blows at the inward end of the failed zone (Figure 7.16 and Figure 7.22). Figure 7.23 presents the results of the DCPT. As illustrated in Figure 7.23, loose sand to silty sand was encountered at a depth of about 0.8 to 0.9 m (2.6 to 3.0 ft), underlying a low permeability cap layer consisting of clayey silt. The sands became medium-dense to dense at a depth of about 1.1 to 1.6 m (3.6 to 5.3 ft). The results from SASW testing are still being processed and will be included in future versions of this report.

Figure 7.23. Results of DCPT-6 (at left) and DCPT-7 (at right) performed at coastal failure near village of Grand Goâve.
