8.0 ROAD FILL PERFORMANCE

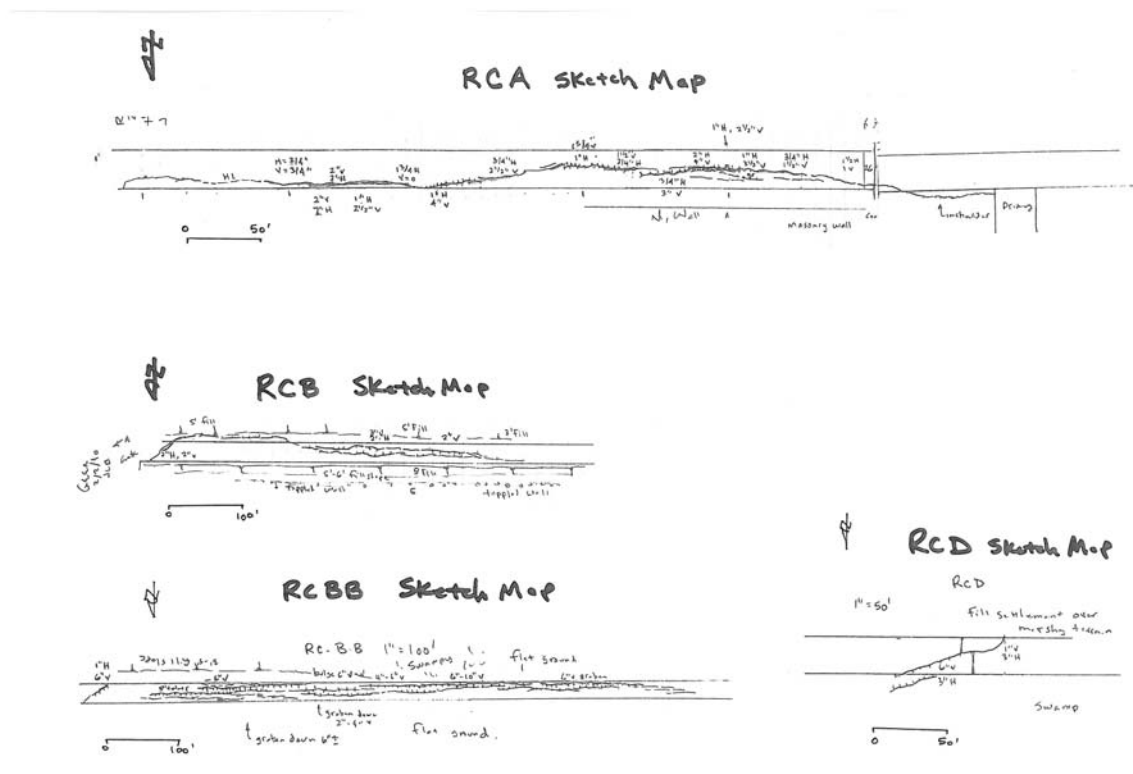
Five locations of poor road fill performance were investigated along Route 2 (Figure 8.1). Figures 8.2 and 8.3 are sketch maps of the crack patterns and fill failures for the investigated sites (note that RCD in Figure 8.2 represents RCC in Figure 8.1). These sketches will be improved in the next version of this report. At each location cracks and deformation extended completely through the asphalt pavement, which is typically 3 to 5 cm thick (Figure 8.4), and apparently through the compacted fill subbase and fill. Many of the road cracks exhibit an arcuate pattern typically associated with lateral spread or slump failures. Our team inspected the natural ground adjacent to the road/fill, and found no extension of cracks, liquefaction features, or cracks/deformation indicating global lateral spreading, deep-seated slumping, or major liquefaction. Rather, cracking appeared restricted to the road bed and adjacent fills, and reflects localized settlement and differential cracking/movement of the road fill and underlying subgrade soil. Most of the failures occur in areas where the road crosses small alluvial drainages/valleys and/or marshy areas. In some cases, the road is underlain by thick fill with steep fill slopes that underwent a degree of creep and possible discrete slumping. Based on observed conditions, the road failures appear to be the result of deformation of soft, organic and saturated alluvial and marsh soils. The magnitude of damage will require extensive regrading and paving to restore a stable and safe roadway.

Figure 8.2. Road fill failure sketch maps for sites RCA through RCD.

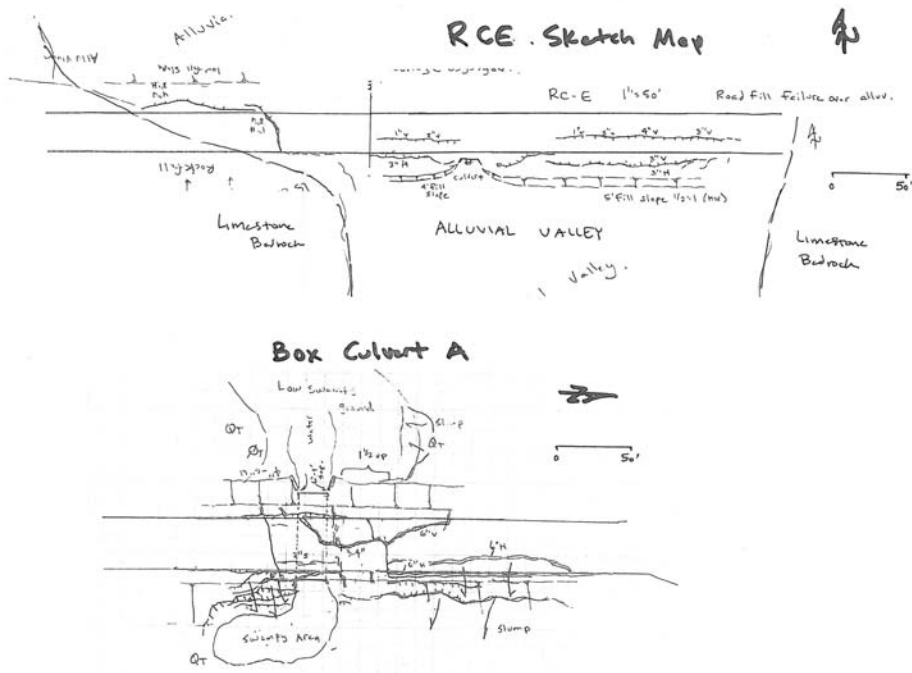
Figure 8.3. Road fill failure sketch maps for site RCE and BOXCLVTA.

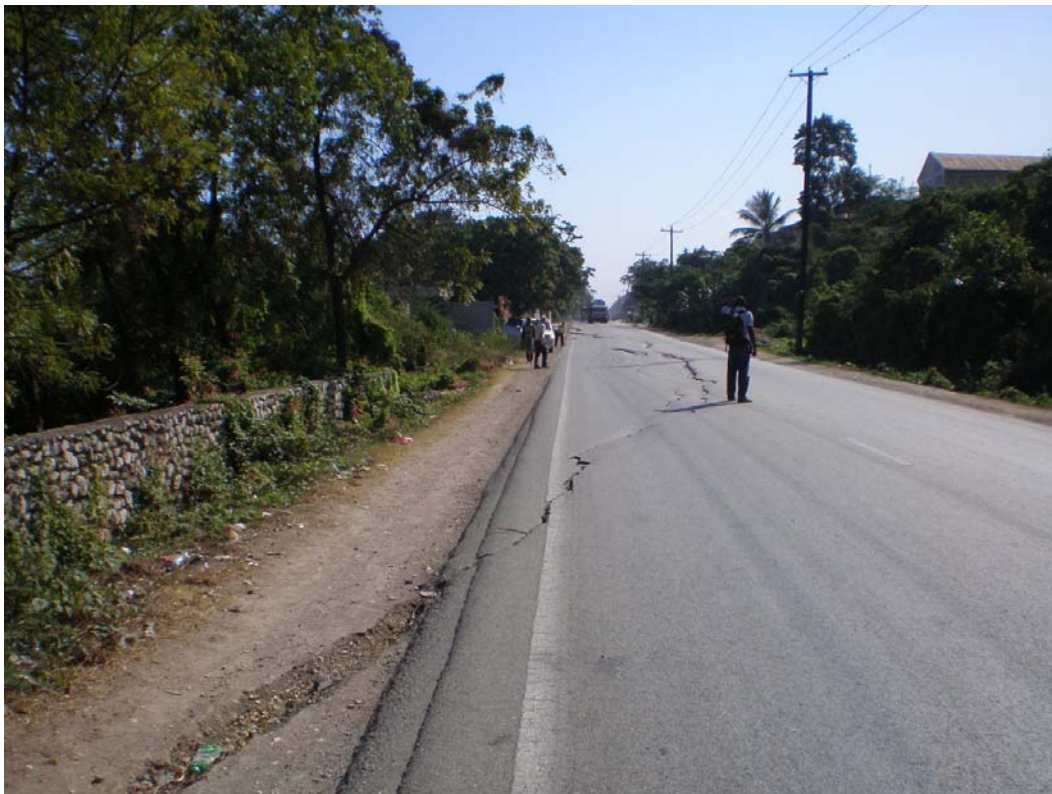
Figure 8.4 Typical arcuate road cracks at road failure site RCA west of Carrefour.

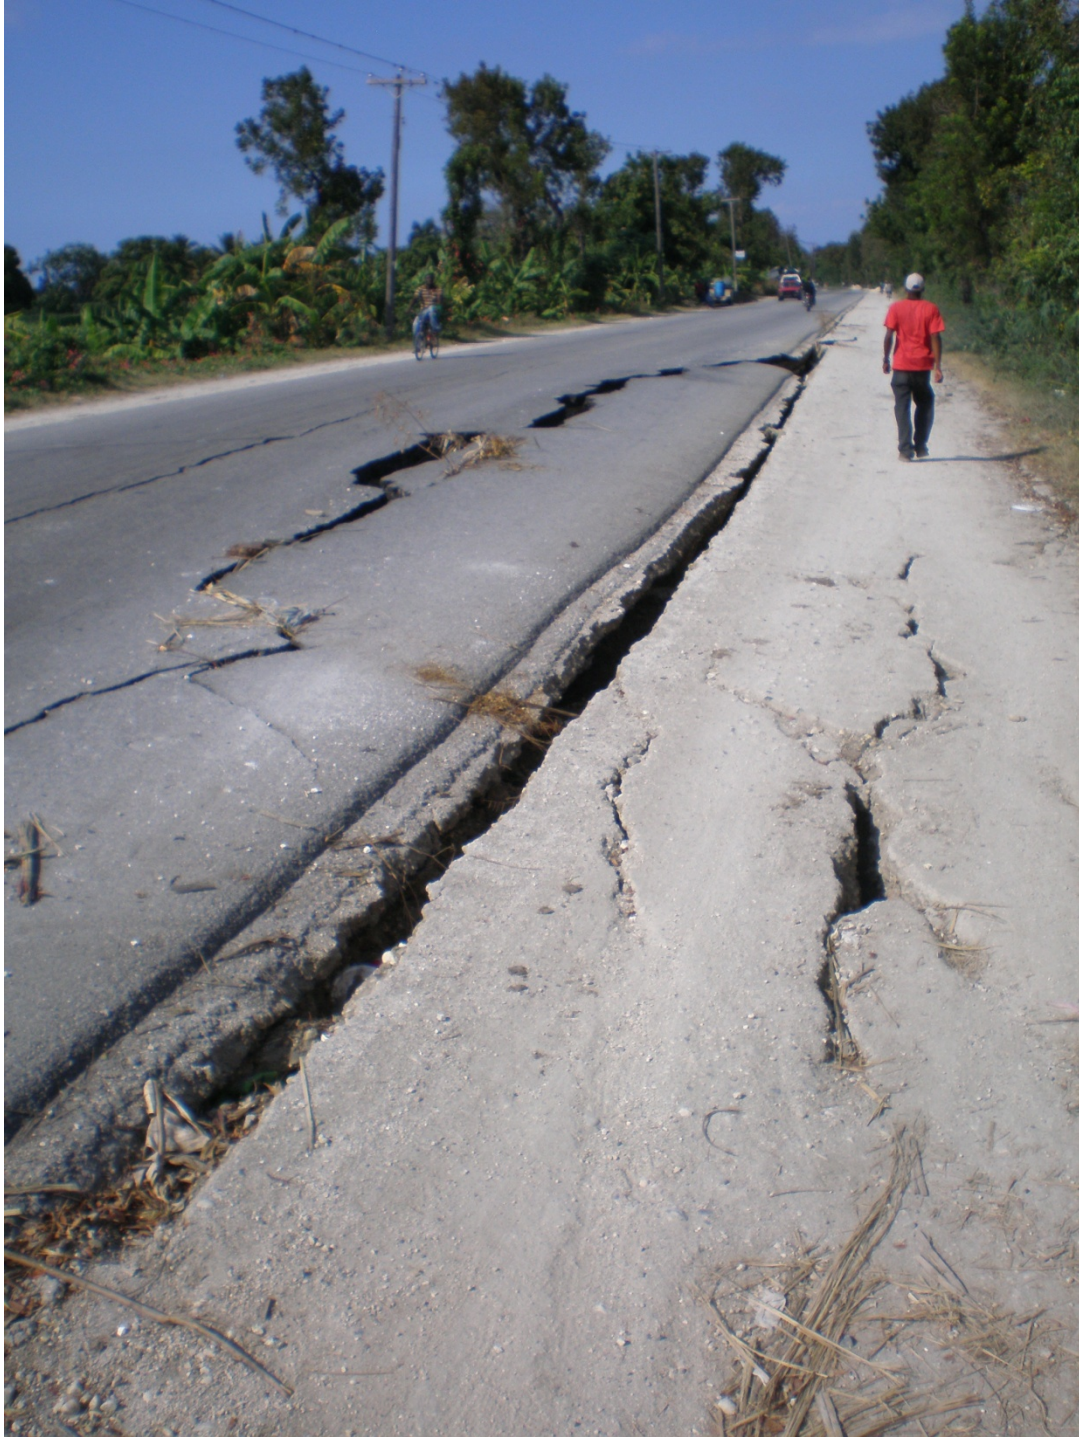
One notable site (BOXCLVT A) of road damage occurred between Leogane and Dufort, where a masonry box culvert passes under the roadway along a swampy area. The portion of the road bed over the culvert did not settle notably, but the prisms of fill against the culvert settled up to 30 cm. Discrete slumping of the road fills north and south of the culvert (Figure 8.5) damaged the outboard edges of the fill, contributing to the road failure. Fill exposed in large cracks (up to 30 cm wide) and slump headscarps consisted of well-compacted granular fill (Figure 8.6), and appeared to be suitably compacted. The settlement appears to have been caused by deformation in the soft, organic subgrade soils of the swampy zone, and slumping failure of the steep 1:1 to 1.5 :1 (horizontal to vertical) fill slopes that range from about 3 to 4.5 m high. This particular failure was previously reported to possibly represent surface fault rupture, as it occurs westward of the general trend of the Enriquillo-Plantain Garden fault trace. However, the reconnaissance team found no evidence of surface fault rupture west or east of the site, or along the fault trace in this area.

We did observe possible liquefaction features in a stream channel about 150 to 300 m south of the box culvert damage site. It is possible that liquefaction-induced soil failure or deformation contributed to the failure of the road subgrade, but liquefaction features were not observed at the box culvert site that instead were underlain by fine-grained organic soil.

Figure 8.5 Cracks induced by fill slope slumping at road damage site BOXCLVTA.

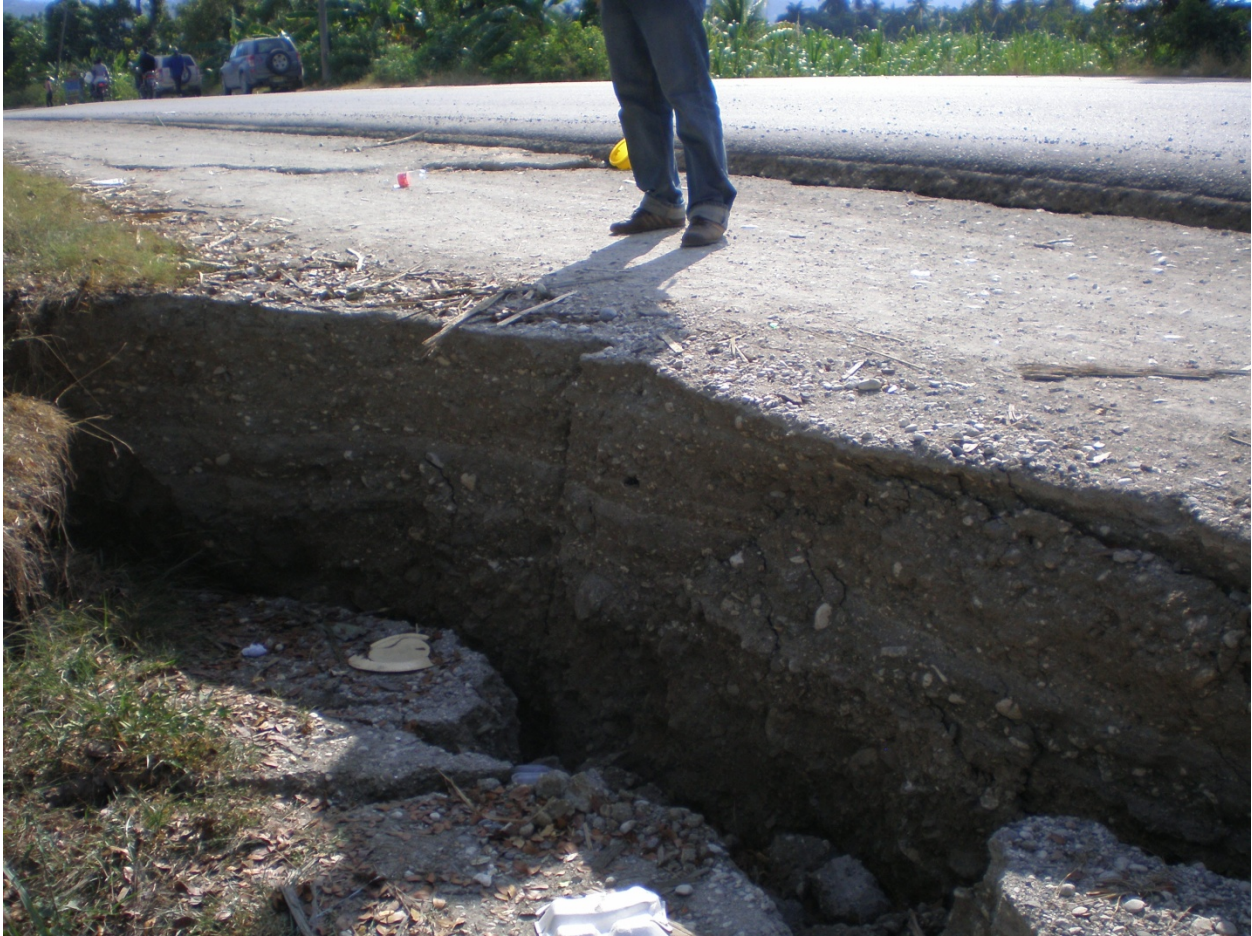
Figure 8.6 Well-compacted granular fill at road damage site BOXCLVTA.
