9.0 LANDSLIDES

9.1 Introduction

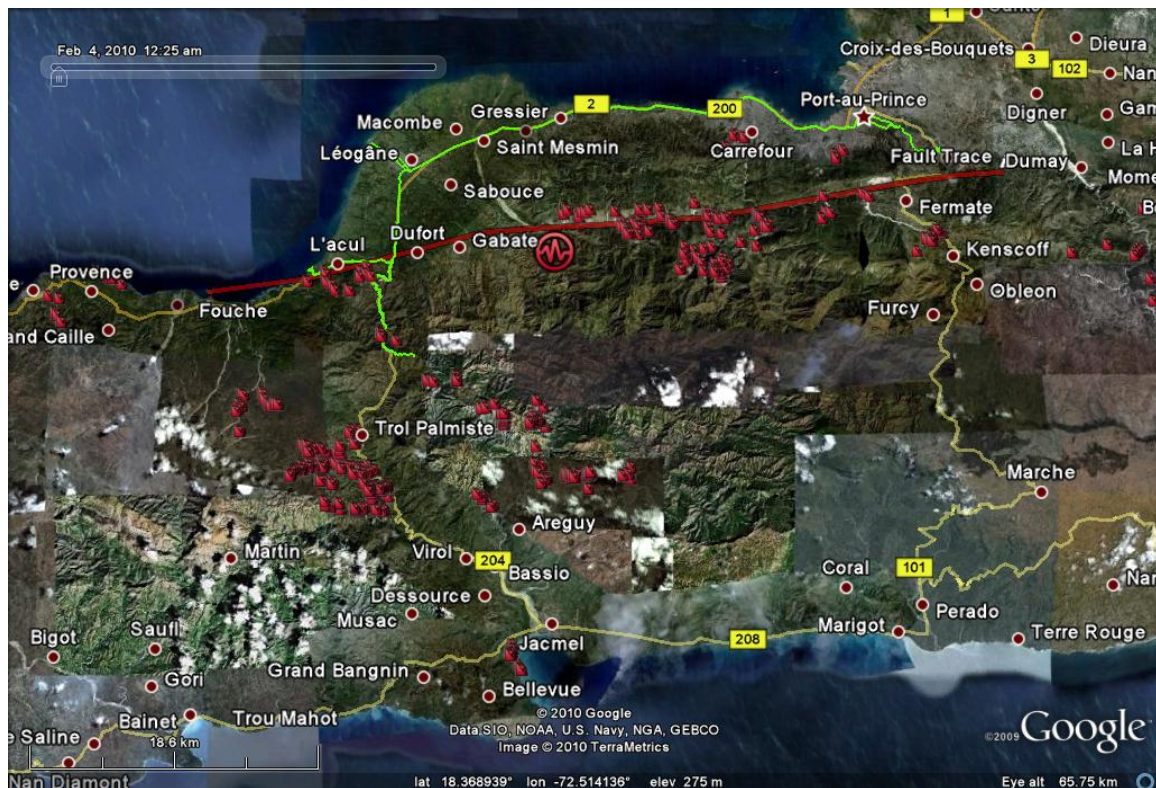
Figure 9.1 shows the landslides identified from aerial imagery by Dr. Ed Harp of the USGS. These landslides are concentrated in several regions: (1) along the deep, incised river valley that follows the fault trace, (2) along Route 204 about 15 km northwest of Jacmel, and (3) east of Route 204 about 10 km north of Jacmel. Smaller concentrations of landslides were observed near Provence in the west (Figures 9.2 and 9.3) and near Jacmel in the south. Failures observed in satellite imagery generally represent shallow slides (1 to 3 m thick) in which the overlying vegetation is stripped from the hillside. These types of failures have distinct features (i.e., bright, light colored areas surrounded by vegetation) that are easily identified in satellite imagery, but they must be large enough to be observed in the imagery.

Figure 9.1 Landslides (red) identified by aerial imagery by Ed Harp of the USGS. Green track is route traveled by GEER team on day of landslide investigation. (Imagery from Google Earth)

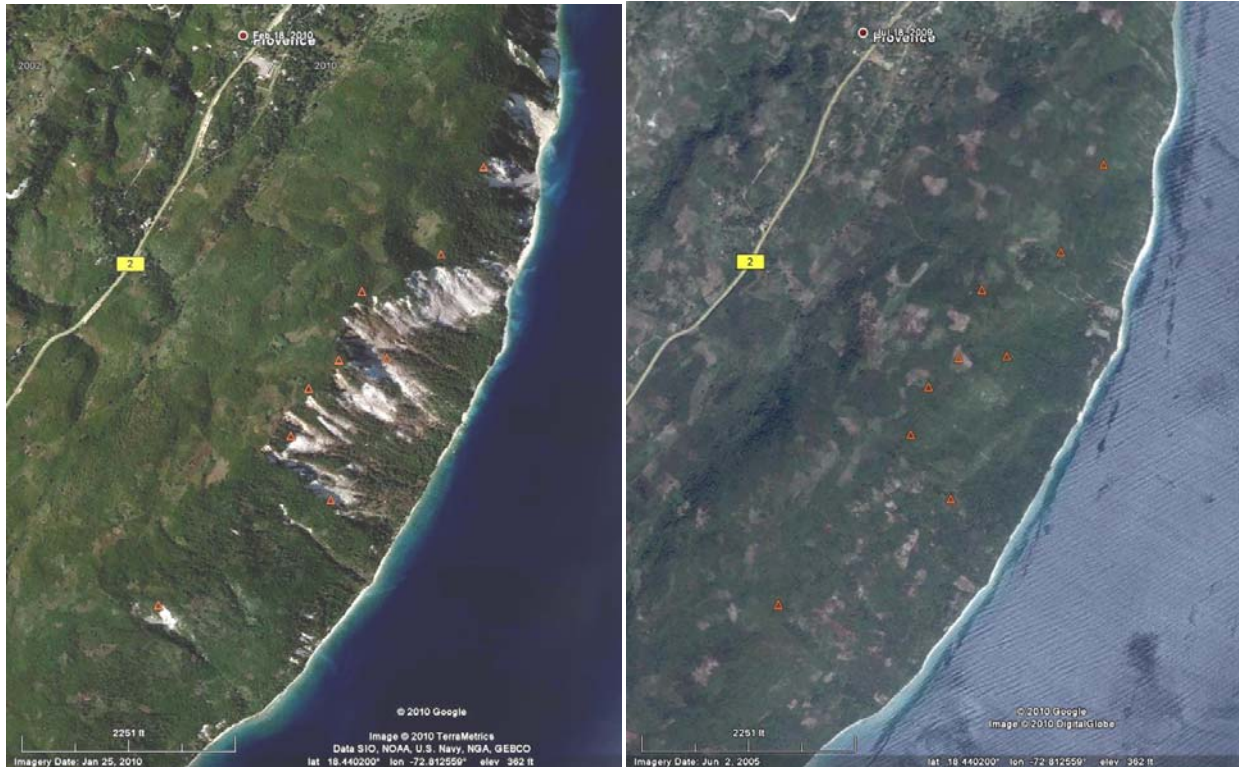
Figure 9.2 Post-earthquakes denuded slopes due to landslides near Provence (left) along with pre-earthquake image (right). These are relatively steep ocean bluffs. (Scarp locations mapped by Ed Harp. Photos provided by Google Earth)

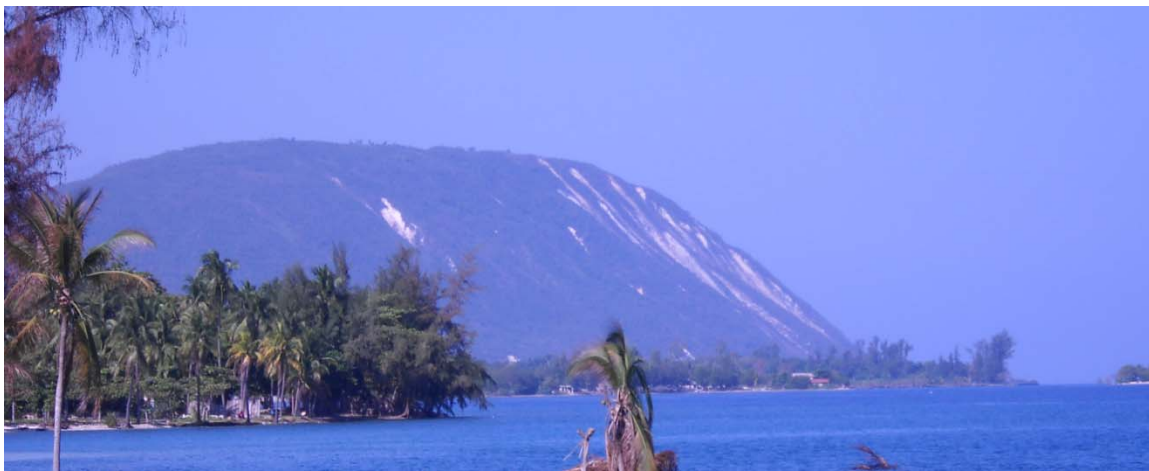
Figure 9.3 Landslide scars near Provence in distance. (18.426166°N, 72.725825°E).

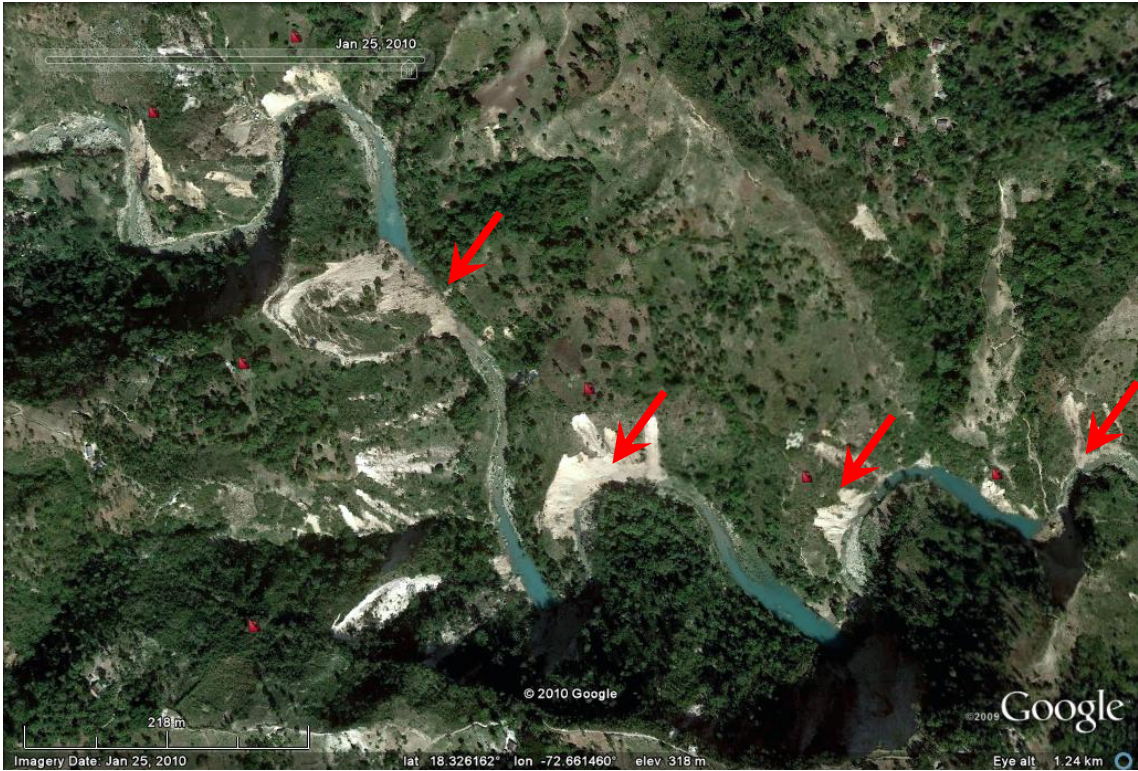
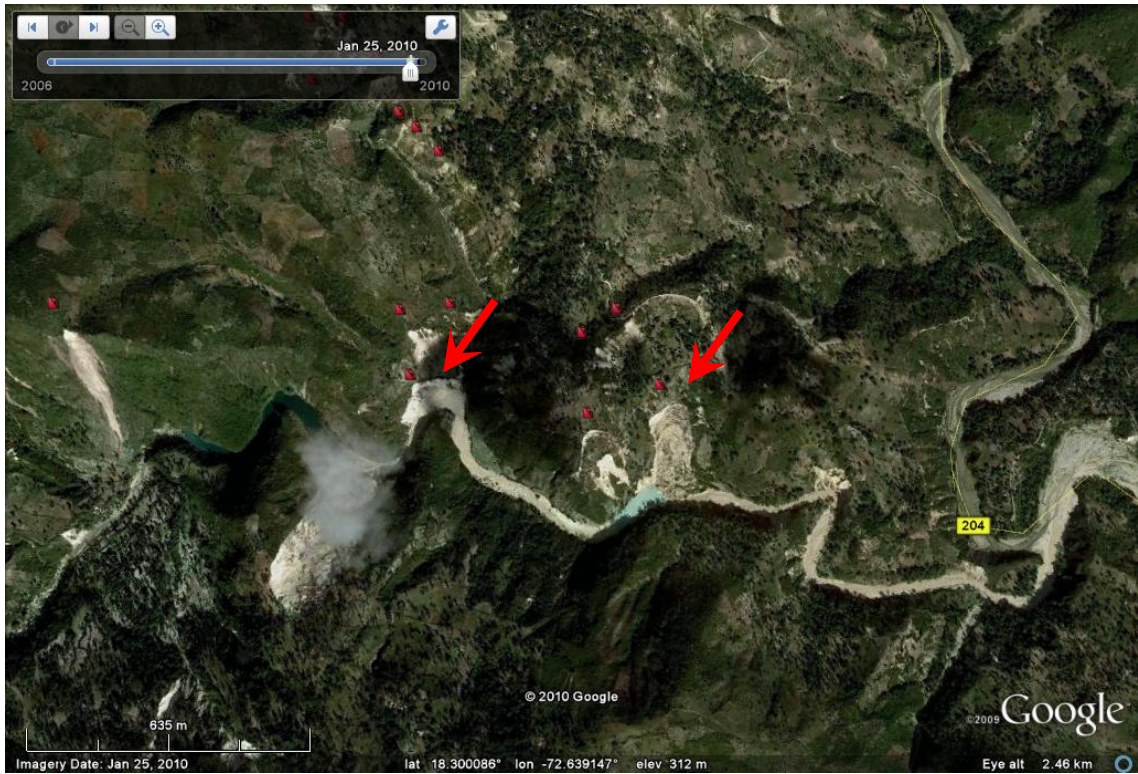
The concentration of landslides along Route 204 included many landslide dams that blocked two streams that flow east towards the road (Figure 9.4). These landslide dams were generated both by the debris of shallower soil slips, as well as deeper seated failures that appear to have been controlled by bedding. At least a few of these landslide dams breached in the weeks after the earthquake (Ed Harp, personal communication), but villages downstream were spared any inundation because the river valley was broad enough to accommodate the additional water.

Figure 9.4 Landslide dams (red arrows) and retained lakes west of Route 204 and approximately 15 km northwest of Jacmel (top: N18.326162, W72.66146, bottom: N18.300086, W72.639147).

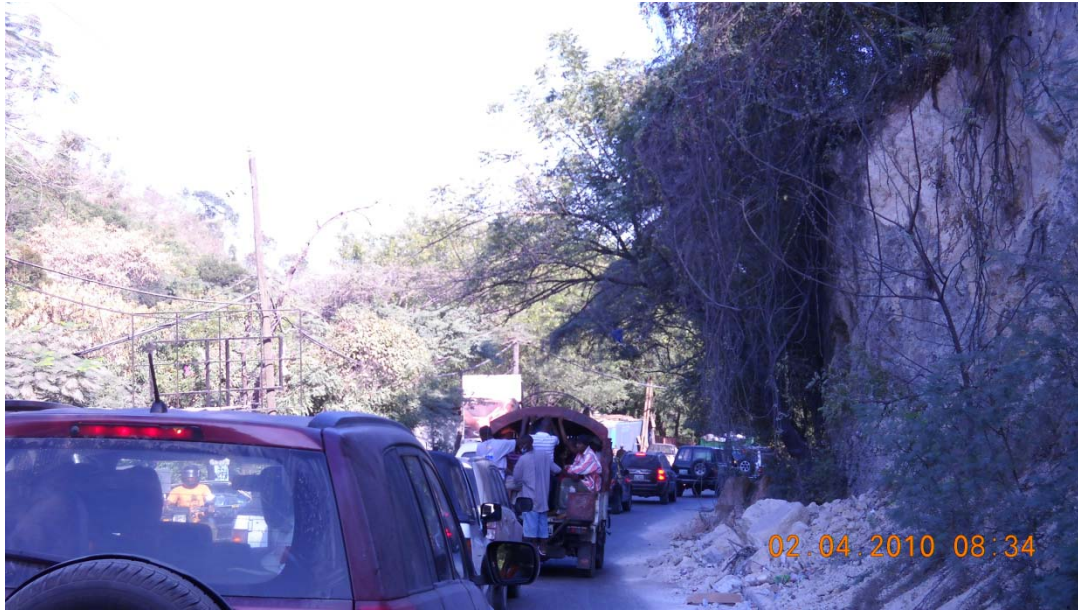
Numerous topples or falls were observed in over-steepened road cuts in weathered and sheared bedrock within the hills of Pétiion-Ville (Figure 9.5), an upland suburb to the southeast of Port-au-Prince. These over-steepened cut slopes had estimated inclinations of $\frac{1}{4}H:1V$ or steeper; many were nearly vertical and some remaining un-failed cuts were actually locally overhanging. These slopes had estimated heights on the order of 1.5 to over 6 m. The falls generally included relatively slender slivers, typically involving 0.3 to 1.0 m thick of material. The material fell to the base of the slopes, forming a wedge on the roadside or sidewalk, and frequently encroaching onto the roadway.

Figure 9.5 Vertical cut remaining relatively stable with minor rock fall/topples.

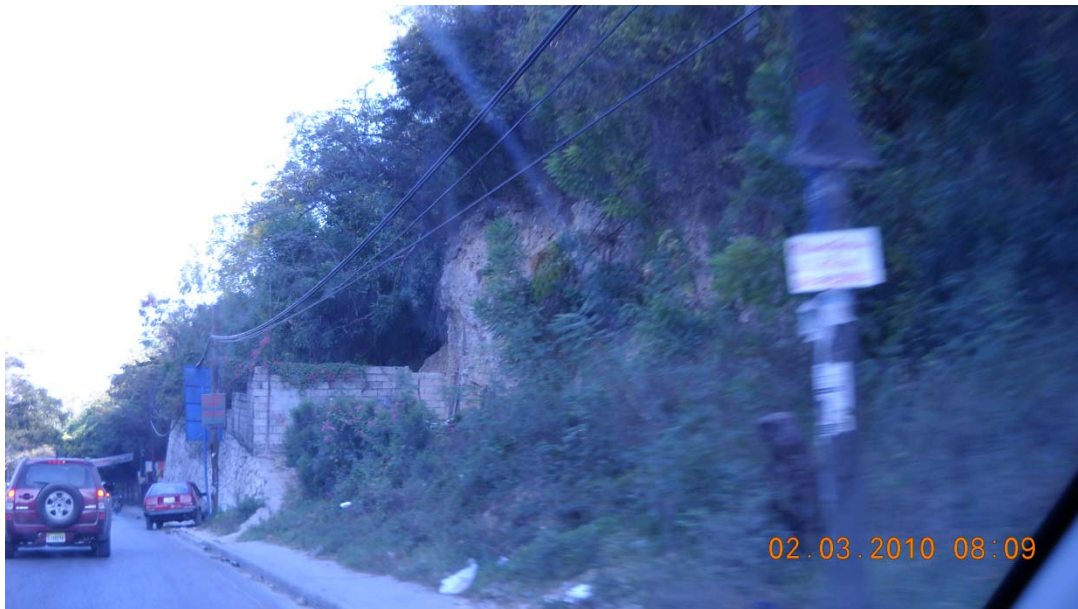
There were also many of these very steep road cuts that remained unfailed following the earthquake, as evidenced by the presence of vegetation, dust, and debris on the faces of the slopes (Figure 9.6). However, most of the unfailed slopes exhibited a wedge of raveled material at the base of the slope with established vegetation, suggesting the raveling had been occurring for some time and was not related to the recent earthquake, or with only minor toppling in the recent earthquake (e.g., Figure 9.5).

Figure 9.6 Stable near-vertical road cut and masonry wall. (N18.531873, W72.313045).

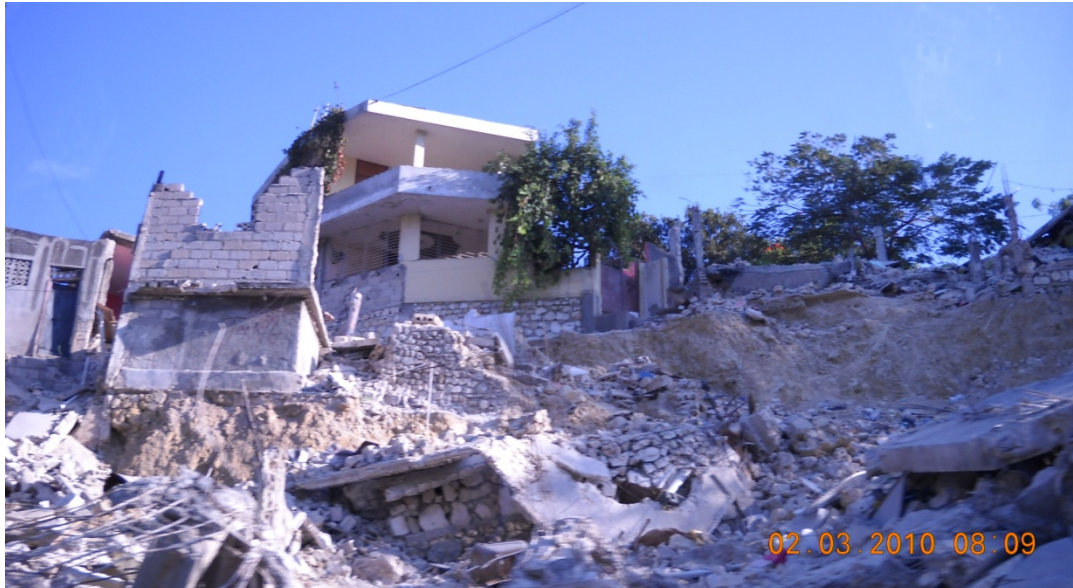
One area of more significant landslides was observed downhill from Petion-Ville along Rue Fernand. This landslide contained the rubble of several adjacent structures that had collapsed (Figure 9.7). There were scarp-like, near vertical surfaces near the top of slope, which could suggest that a rotational failure occurred beneath the now-collapsed structures. However, scarps of the observed height generated through a rotational failure would require a large volume of soil to be pushed out near the toe of slope. This volume of material did not appear to be present or to have been removed from the site. Furthermore, the soils are conglomeratic and likely have high friction angles, which would make the site an unlikely candidate for a rotational failure mechanism. It is more likely that the failure was initiated by basement/retaining walls for the overlying structures.

Figure 9.7 Several buildings have collapsed in this location. Although there are scarp-like near vertical surfaces near the top of slope that may suggest the possibility of a deeper rotation failure, in our opinion the observed conditions are likely due movement of soils adjacent to failed walls, as discussed in the text. (N18.528406, W72.309920).

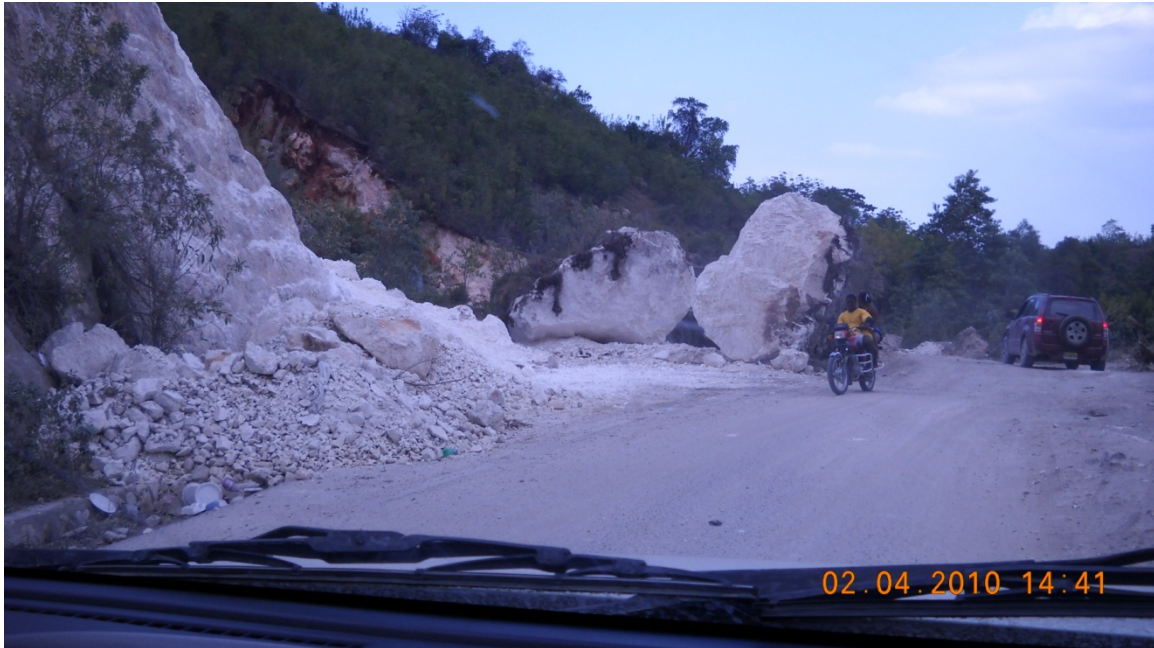
Some chalky limestone quarries (recent activity of the quarries was not checked) had moderately high steep slopes that also failed in rock topples or rock falls. Occasionally these resulted in large boulders rolling onto roadways (Figure 9.8). Similar failures occurred in over-steepened road cuts through chalky limestone.

Figure 9.8 Topple or fall included several large boulders in this old quarry.
(N18.439010, W72.646168).

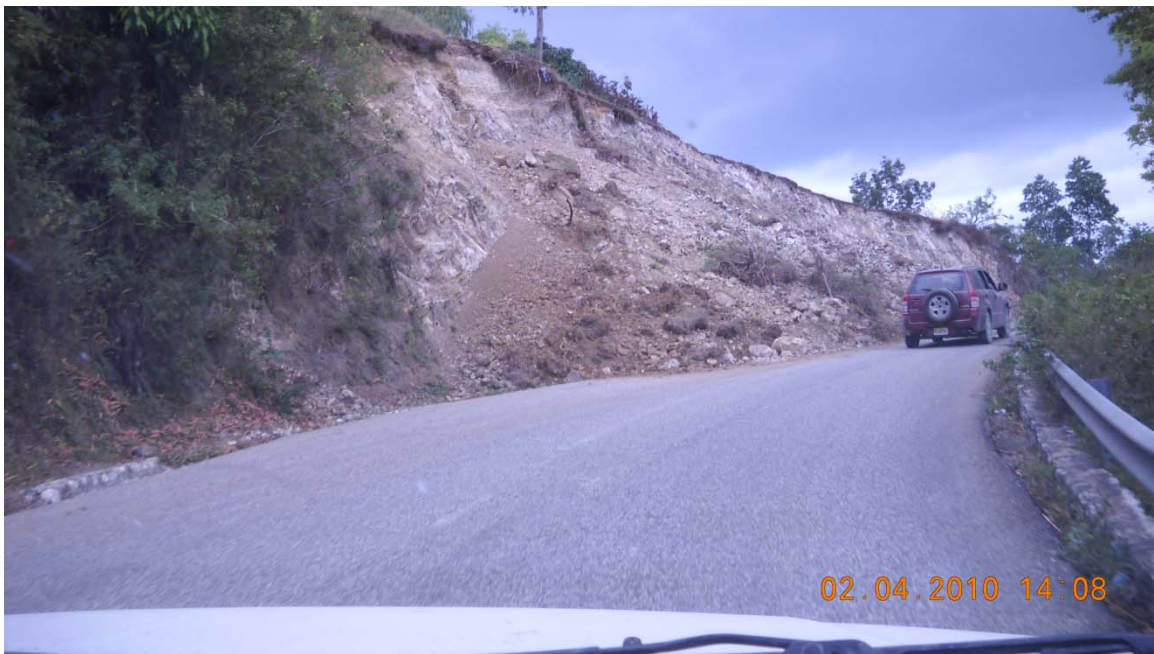
Figure 9.9 Rock topple or rock fall from over-steepened road cut.
(N18.412741, W72.638576).

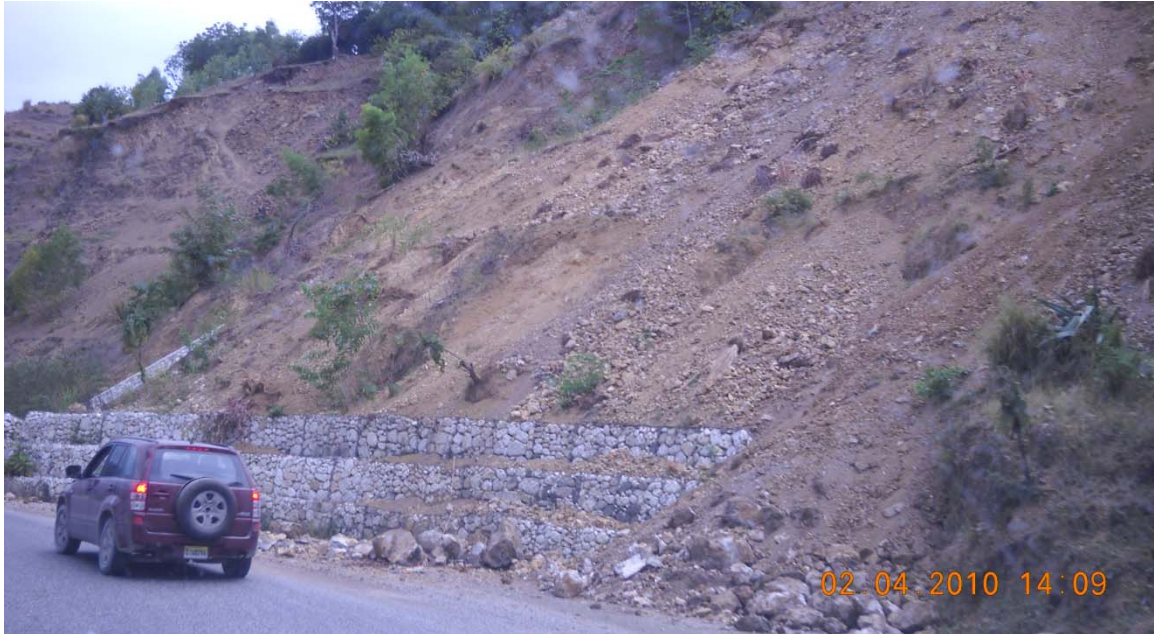
Figure 9.10 Shallow rock topple or rock fall from over-steepened road cut. Debris slid over the top of stable gabions at the toe of the slope. (N18.409159, W72.638815).

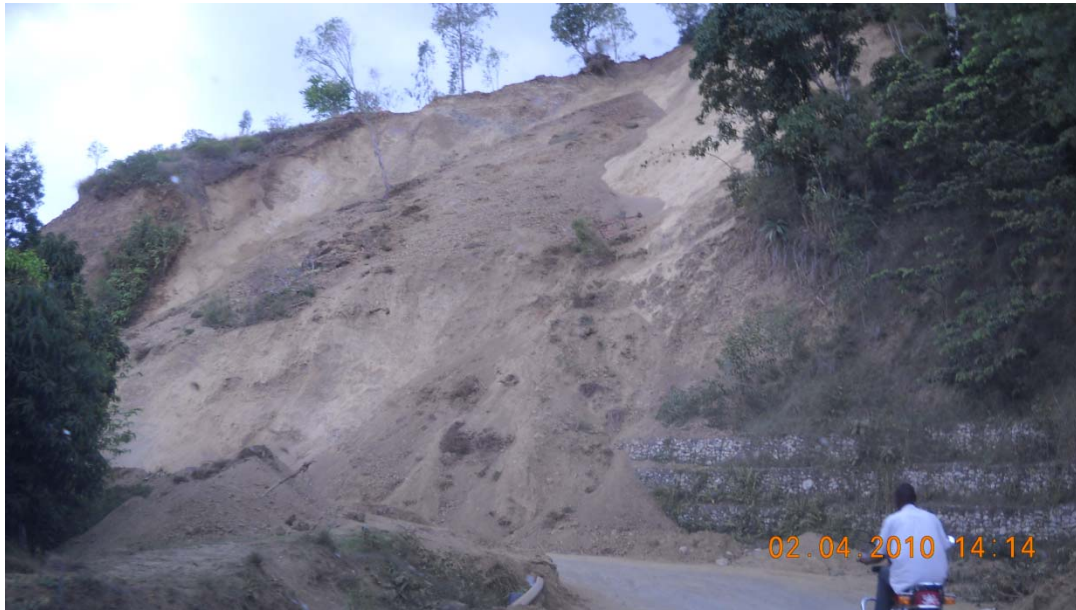
Figure 9.11 Relatively shallow slip-out of regolith. Disaggregated material flowed over stable gabions and blocked over half the road. (N 18.409159, W72.638815).

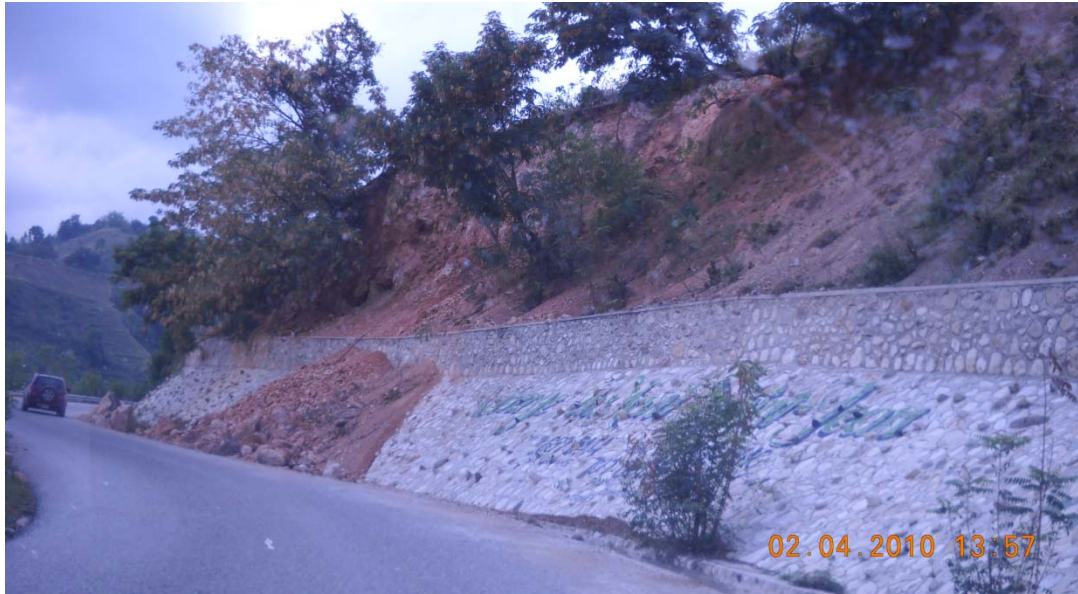
Figure 9.12 Shallow slip-out of soil in upper road cut. Soil slid over the top of the surviving masonry wall and slope protection. (N18.440270, W72.636207).
