**THE KFARNABRAKH LANDSLIDE OF NOVEMBER 30TH, 2015:
*A Geological and Geotechnical Evaluation of the Landslide
and Risk of Future Failures***

Report of the NSF Sponsored GEER Association Team

GEER Association Report No. GEER-047

March 16, 2016

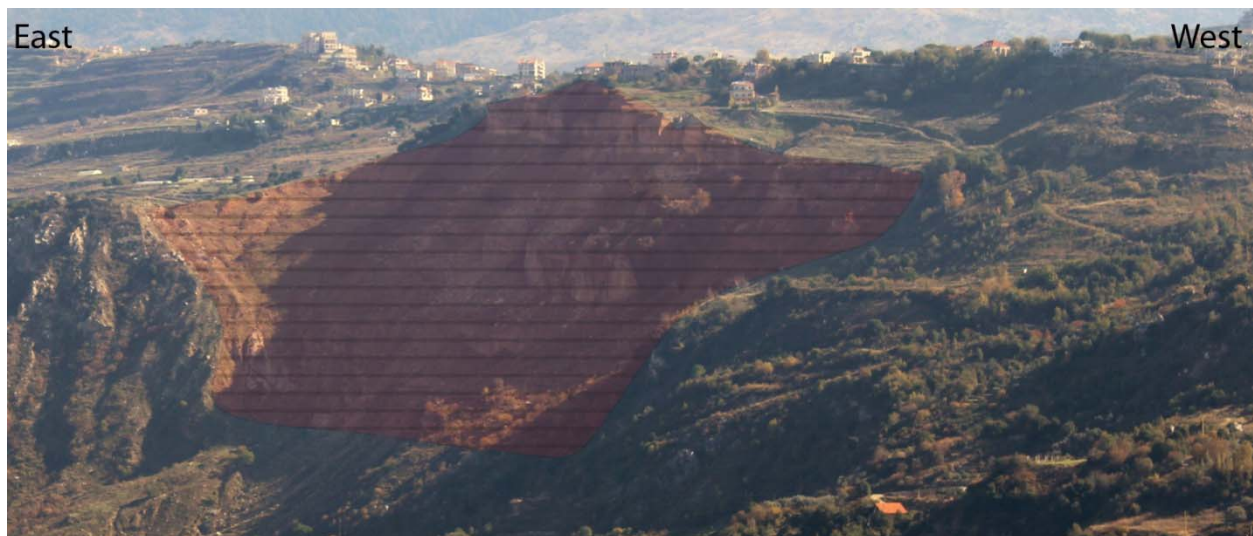
Figure 2: Interpreted field image of the historical 1767 Kfarnabrakh Landslide (picture take at 33°42'22"N 35°37'25"E).

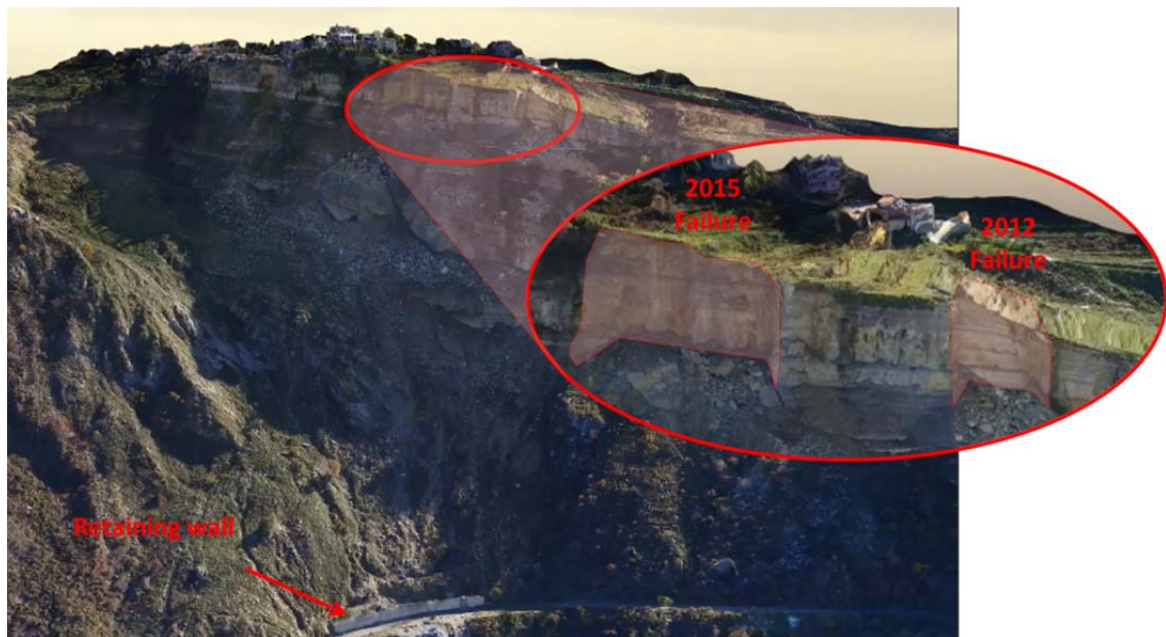
Figure 3: Location of the 2012 and 2015 landslides (Picture generated form Point cloud 3D representation)

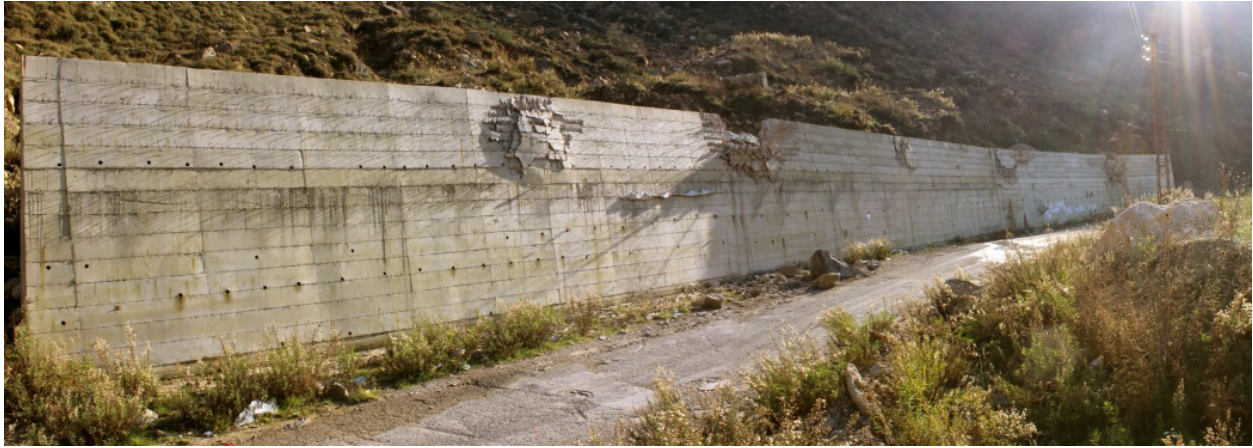
- The retaining wall constructed following the 2012 landslide was able to block the debris during the Nov. 2015 landslide; however, it did sustain punctures and detachment damage from rolling stones as can be seen in Figure 4 after the first site visit. The wall backside was filled up with detriments showing a lack of maintenance. That explains why the damage occurred on the upper part of the wall.

Figure 4: Damage to the Retaining wall following Nov. 2015 landslide (Picture taken at from 33°42'13"N 35°37'36"E)

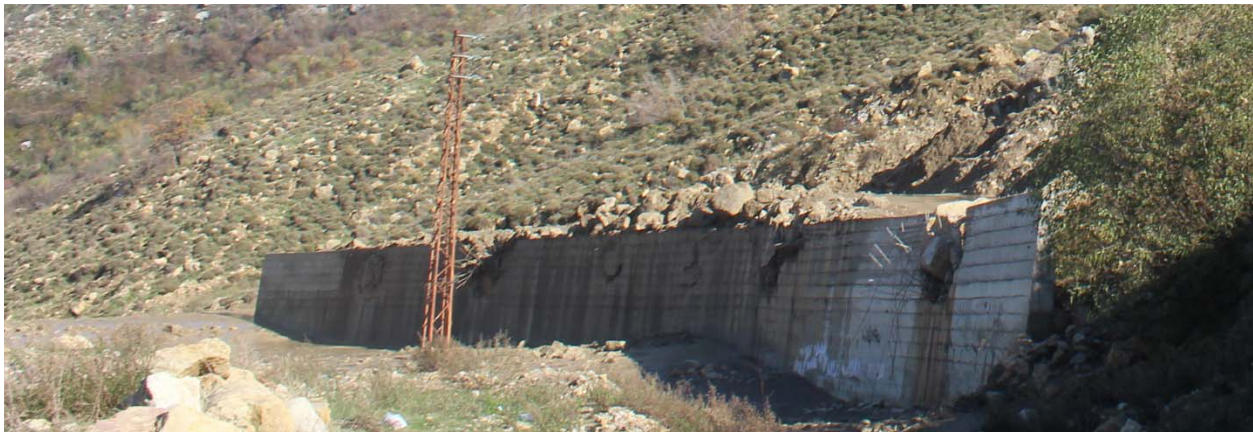
- The retaining wall didn't fare well in terms of protecting the road on January 3rd, 2016 after having 116 mm of rainfall over 3 days (Figure 5). The fresh debris from the November landslide were mobilized again and caused complete closure of the road adjacent to the retaining wall. The inspected stones were ranging from weak and poor weathered limestones to very stiff dolomitic stones. For reference, the elevation change between the top of the cliff and the base of the wall is about 250 m.

Figure 5: Overtopping of wall due to debris flow following heavy rainfall in January 3rd, 2016 (Picture taken at 33°42'10"N 35°37'33"E)

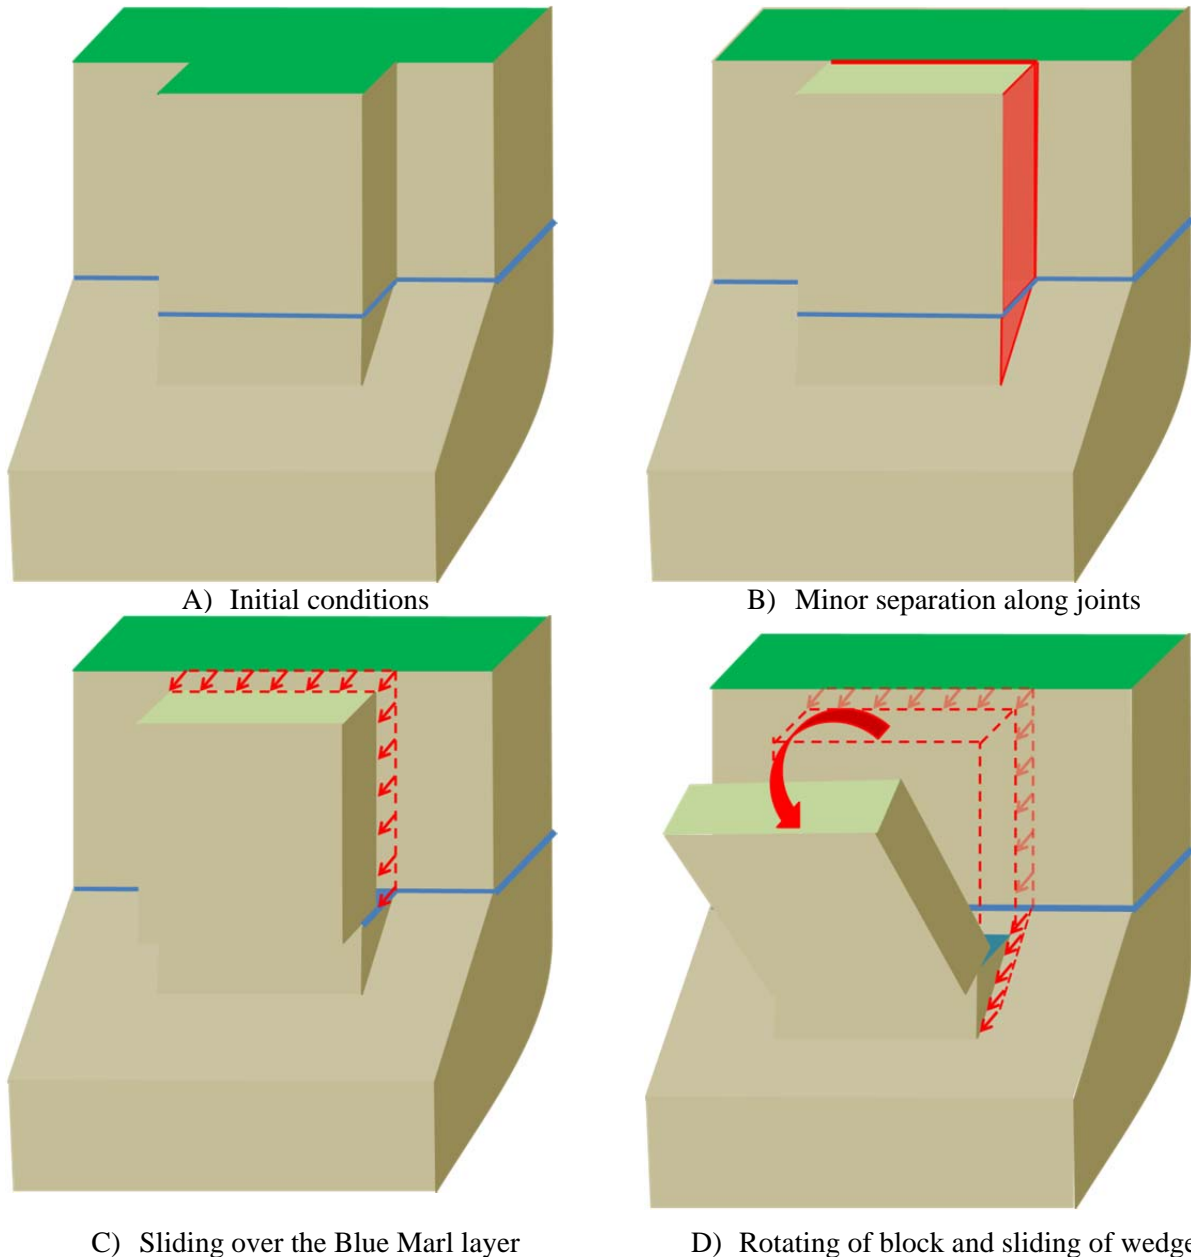
Figure 13: Proposed failure mechanism

Figure 13-A shows that a block of the rock mass, defined by the existing joints, represents the initial conditions. Figure 13-B shows the initial limited movement of the rock mass causing

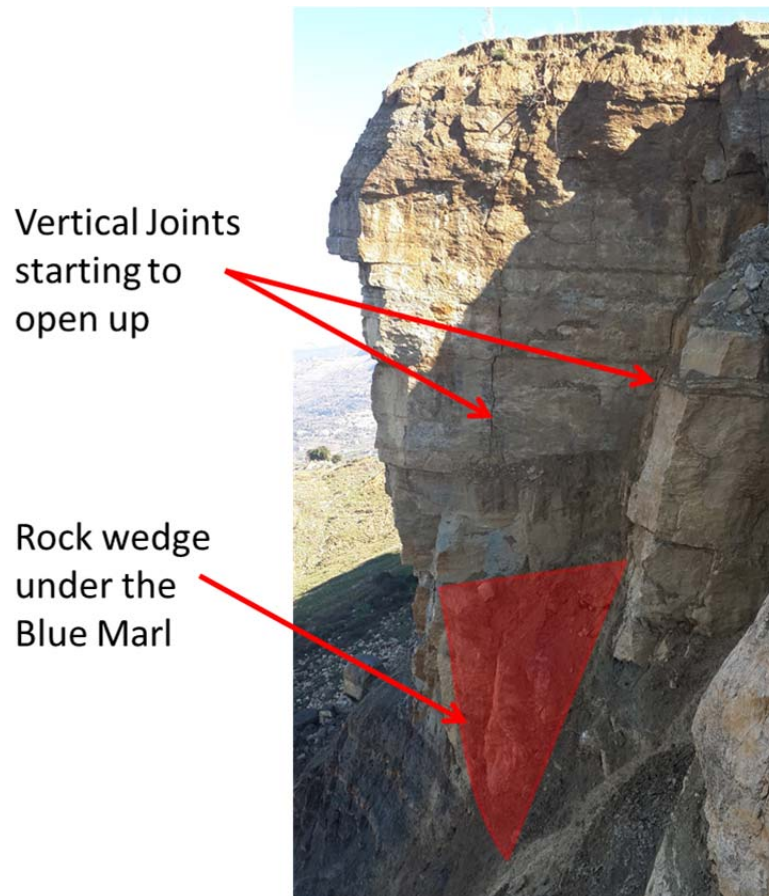
separation between the block and surrounding rock. This behavior was evident during the site visit when looking at the cliff sides as can be seen in Figure 14. The surface crack shown in Appendix Figure A-4 is located on ground surface right above the vertical corner joint shown below. As a result of these cracks, water flow through the joints is cutoff and the grass on the surface exhibits a change in color from green to yellow. This can be seen by observing images taken from Google Earth at dates prior to the 2015 failure (Figure 15). Notice the change in the grass color.

Figure 14: Side view of the cliff showing the highly jointed rock mass with some vertical joints starting to open up (Picture taken at 33°42'00"N 35°37'38"E)

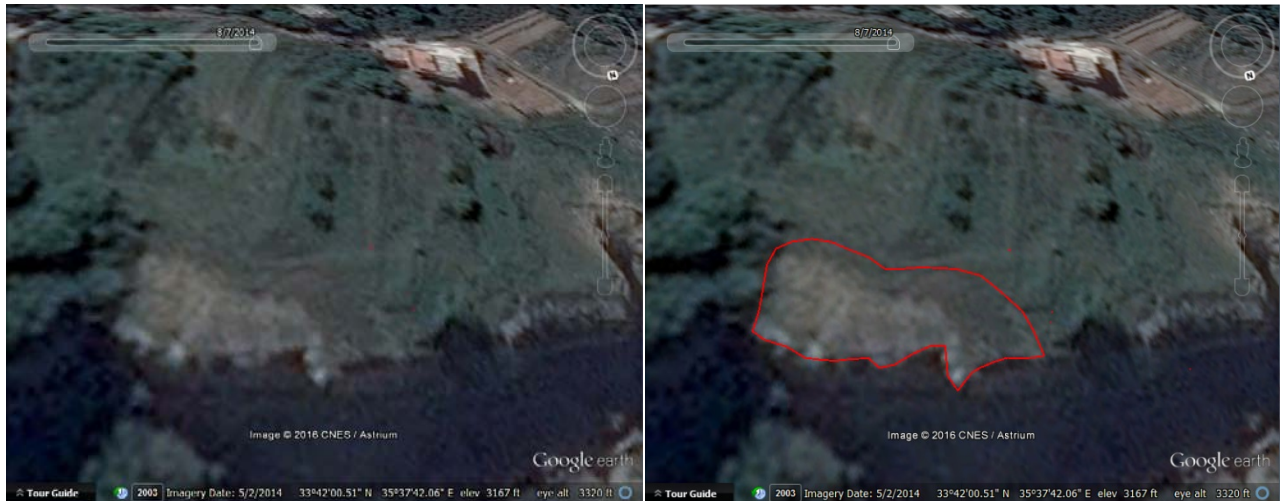
Figure 15: Change in color of grass as joints open and cut water supply prior to failing in August 2014- Red line presents 2015 failure zone (pictures form Google Earth Pro)

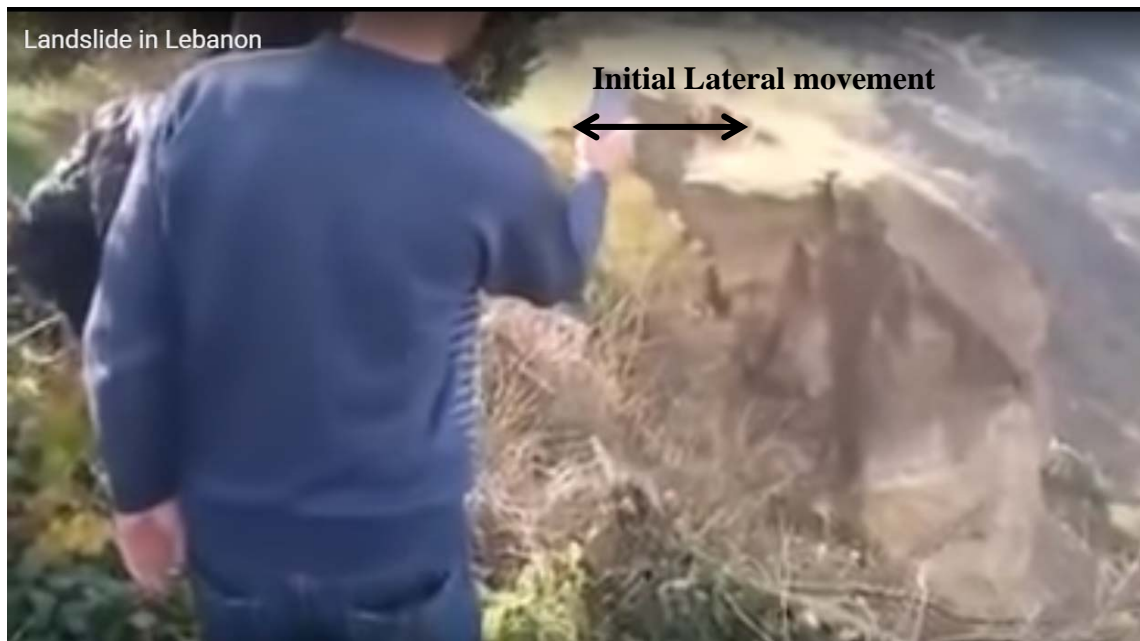
As the joints open, the water starts flowing down the joints (rather than across it) in addition to allowing more surface water to seep into the ground since the joint expansion is usually accompanied by cracks in the top soil extending to the surface. The water seeping through the vertical joints can now reach the Blue Marl layer (a high plasticity-low friction strata) causing its top portion to get saturated. The saturated Blue Marl, like all high plasticity clays, loses significant portion of its unsaturated strength once it gets saturated which creates a layer acting almost like a lubricant underneath the already mobilized rock mass, and thus facilitating its horizontal slippage (Figure 13-C). The horizontal slippage during the early stage of the rock mass failure can be seen during the video recordings (Figure 16). This theory can also help

Figure 16: Snapshot from video of landslide showing a lateral displacement of the rock mass with a gap created between it and the stable ground

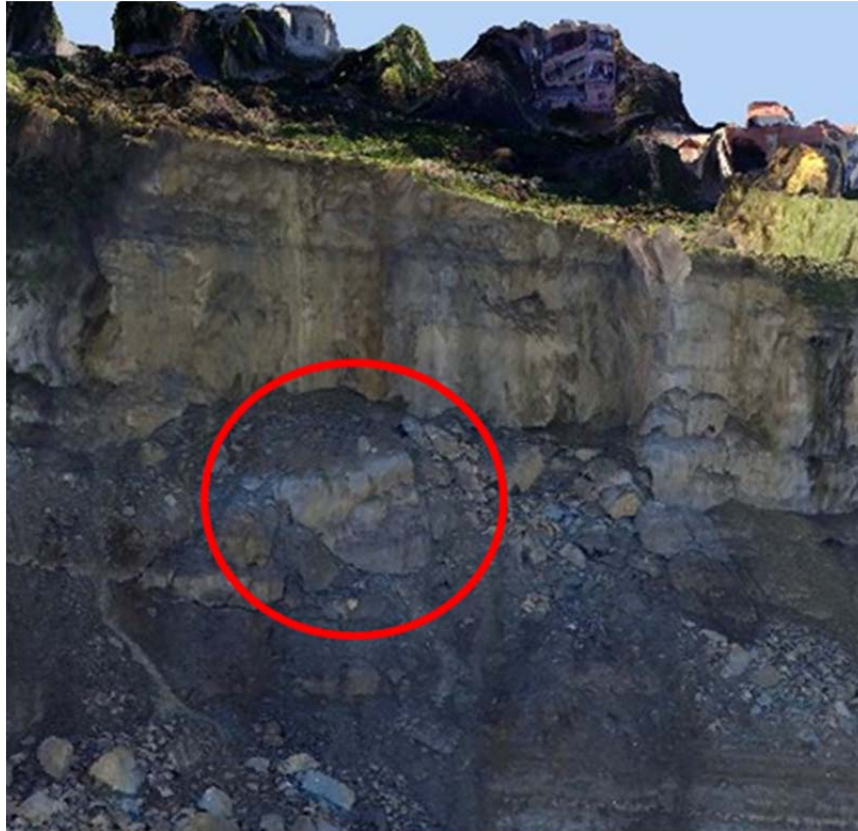
As the block slides further, it starts creating a moment due to the overhanging portion of it resulting in rotational movement accompanied by failure in the edge of rock supporting the Blue Marl. The rotational movement after the initial sliding can be seen in the video referenced in the

earlier link starting at the 1:11 mark. This failure results in the wedge sliding down the slope after tensile cracks develop on along the backside. The rock wedge can be seen in the images of the site as shown in Figure 17.

Figure 17: Wedge previously supporting the Blue Marl (Picture generated form Point cloud 3D representation)

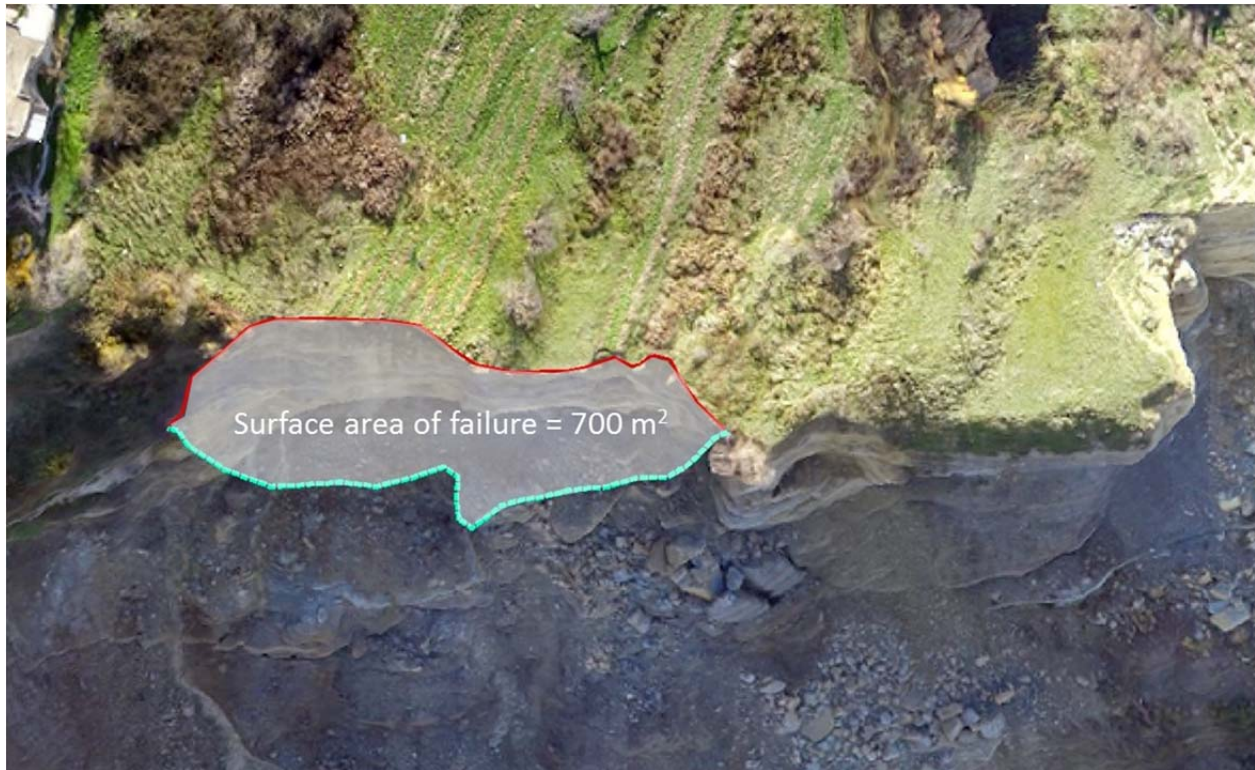
The pre-failure outline of the cliff was extracted from GoogleEarth's latest data (August 2014) and added to the DSM model created from the drone images. Coordinates of local fixtures (corner of buildings) were used to correct for any offset between the two. Figure 18 shows the resulting footprint of the failure area with an approximate cross-section of 700 m^2 . The average thickness of the failed mass was estimated at 25 m and accounting for the angled back joint along which the rock block separated, the approximate volume of the failed material is estimated at $15,000 \text{ m}^3$ ($165,000 \text{ yd}^3$).

Figure 18: Cross-sectional area of 2015 failure (Picture generated form Point cloud 3D representation)

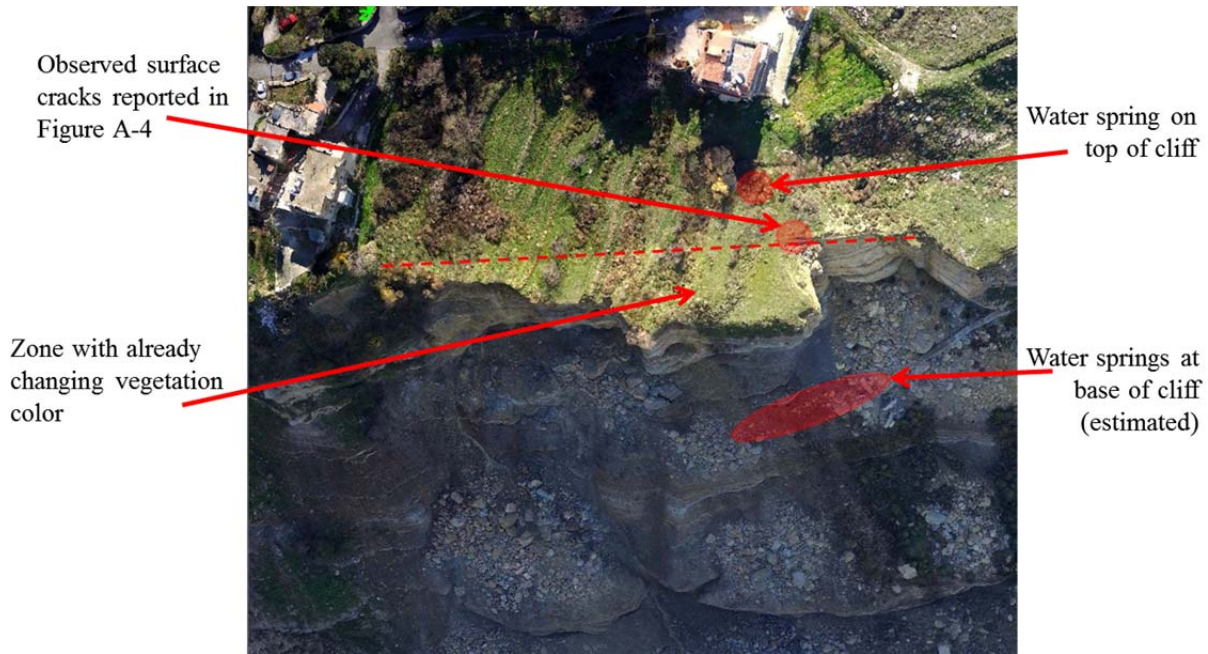
Using this information and studying the images of the area near the 2012 and 2015 landslides, the highest risk area was identified. Figure 19 shows a zone (below the dashed line)

that clearly marks a lighter shade of green vegetation compared to the vegetation further away from the cliff. This line falls on top of the extrapolated projection of the main NorthEast – SouthWest joint that generated the 2012 landslide. This high risk zone extends to the SouthWest corner of the house closest to the cliff and should be a major reason for concern for the overall stability of this house (which has been already evacuated).

Figure 19: High risk area based on vegetation color change, observed surface cracks and location of existing joints (Picture generated form Point cloud 3D representation)

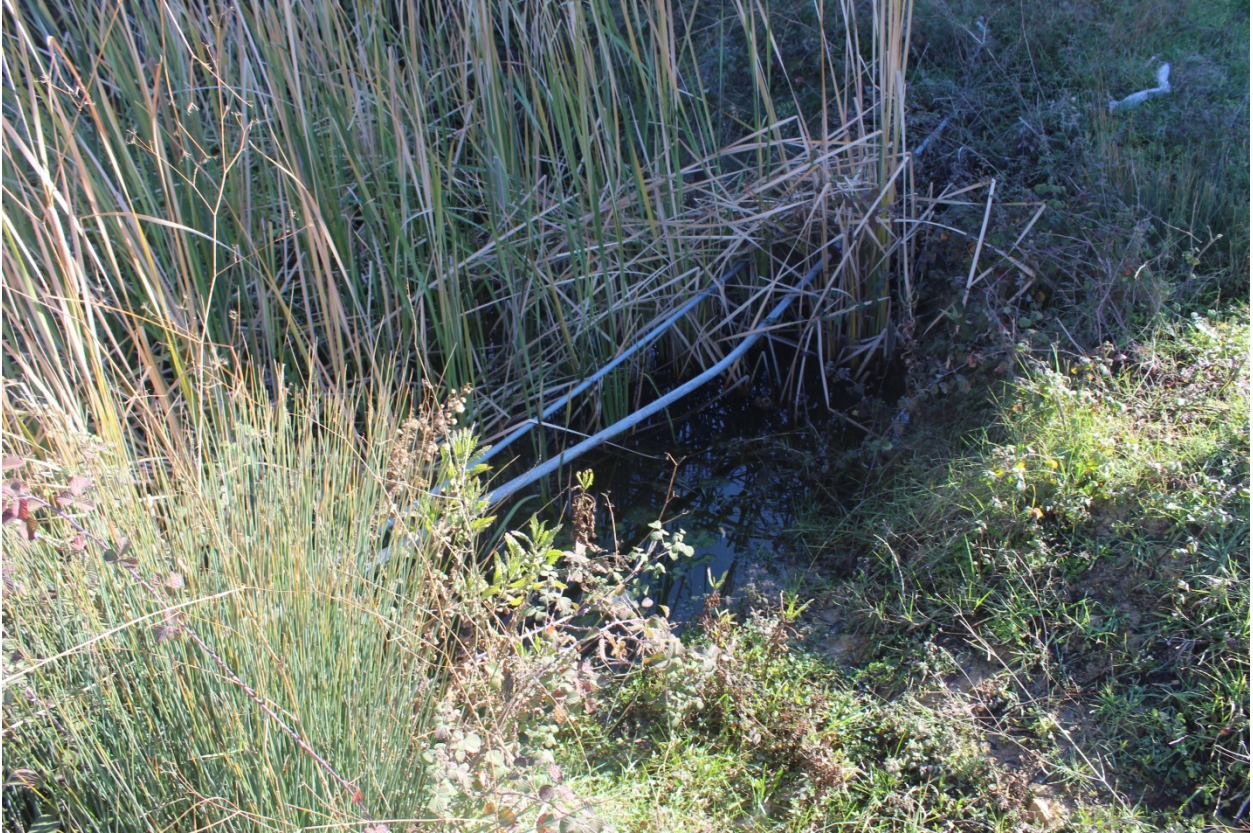
- The top soil has a very low hydraulic conductivity and there is a local “spring” that residents described as a year round spring with no seasonal change in water supply (Appendix Figure A.1).

Figure A.1: local water spring at the top of the cliff, about 30m. from the face of the cliff and 20m. from the southeast corner of the 2012 failure.

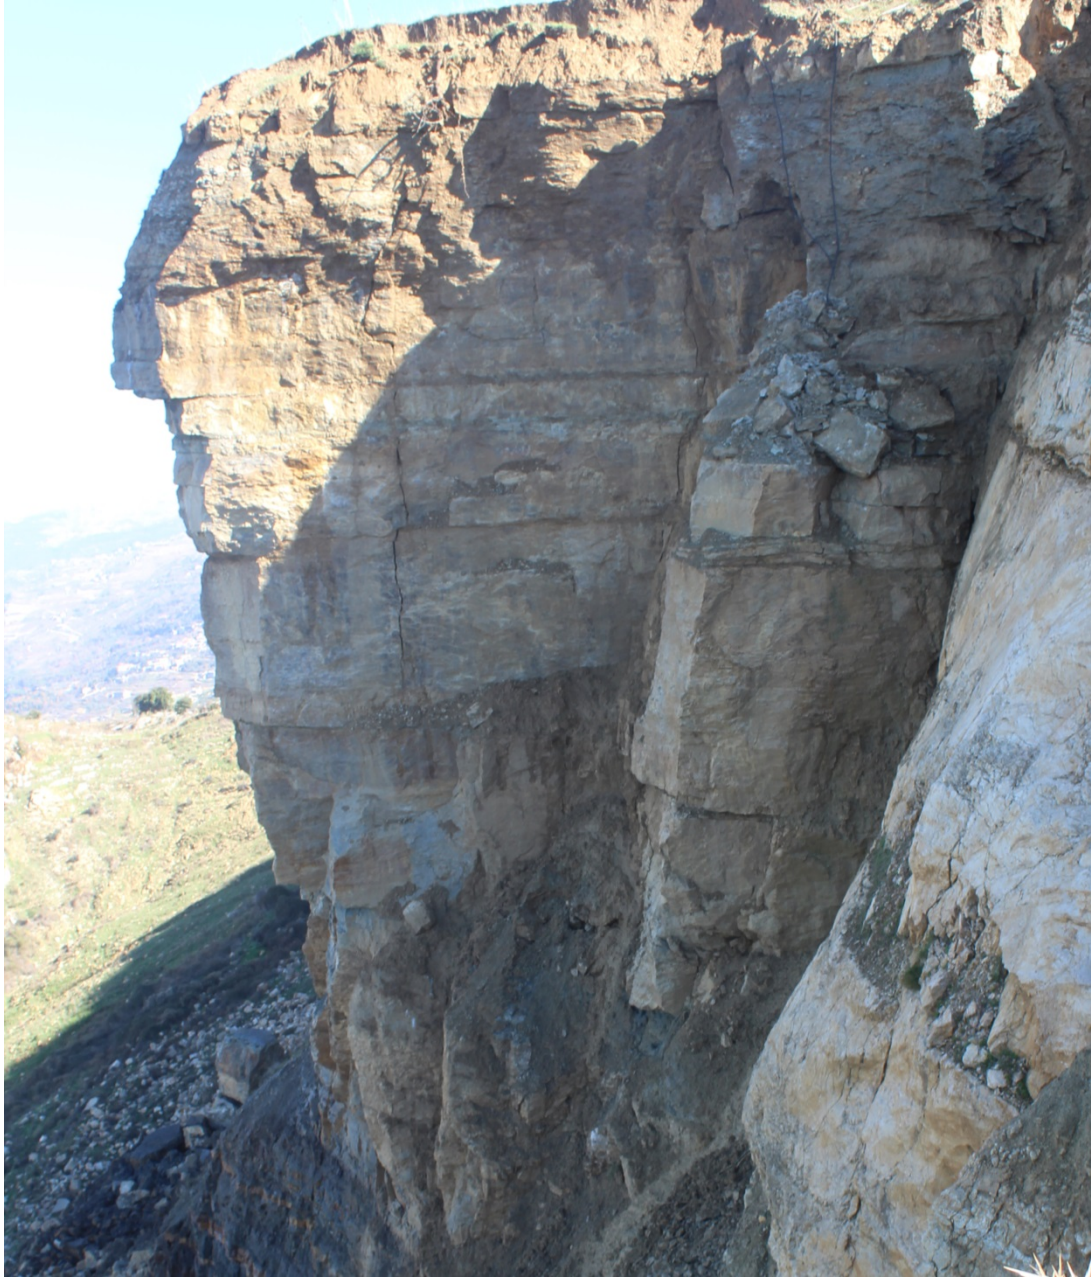
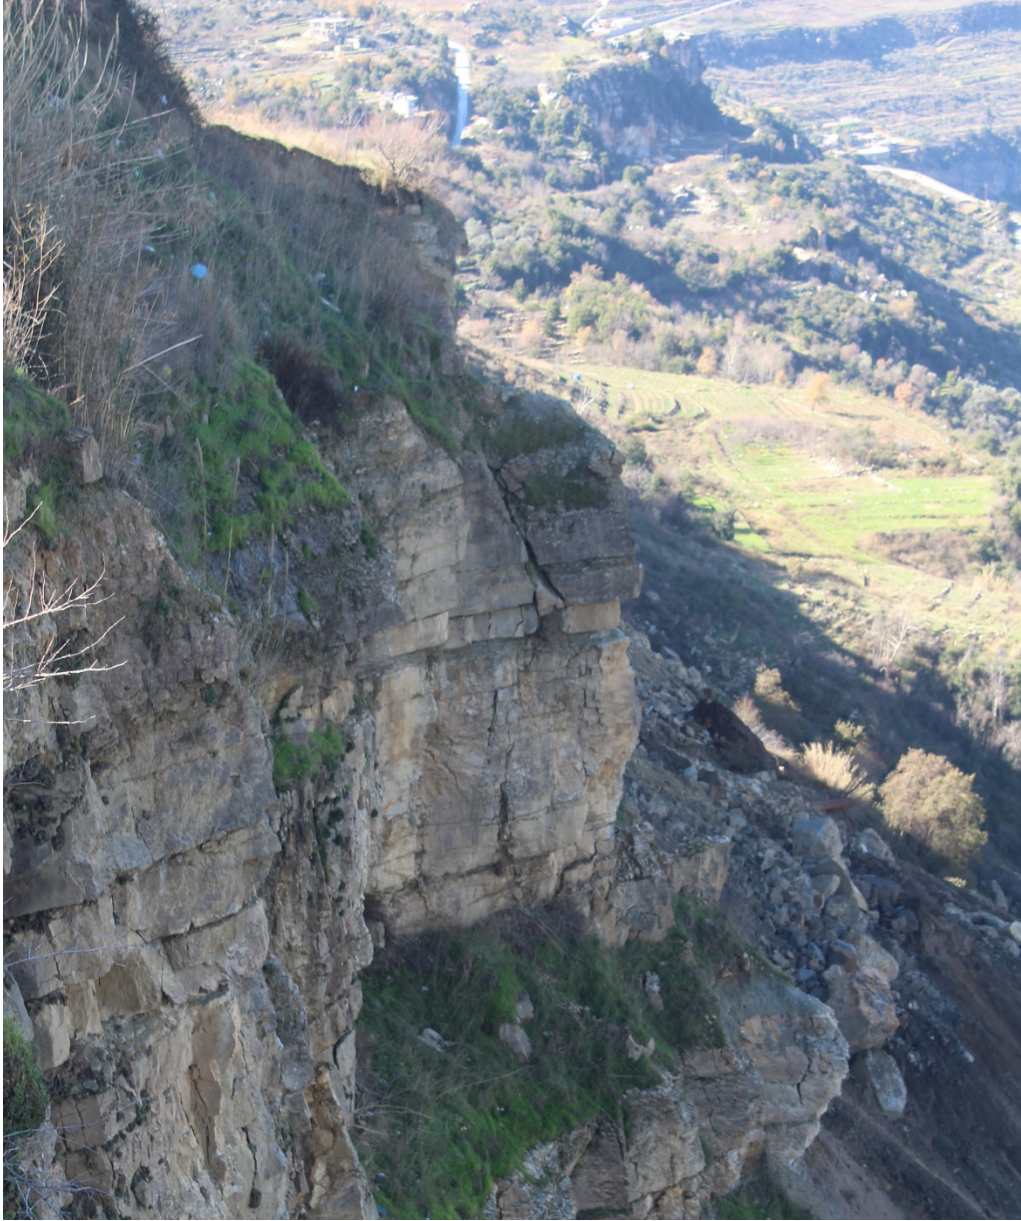
- The rock mass is highly jointed with joint spacing of less than 1m even in the top portion of the cliff that appeared as a massive rock (Appendix Figure A.2 and 3).

Figure A.2: Highly jointed rock mass.

Figure A.3: Highly jointed rock mass.

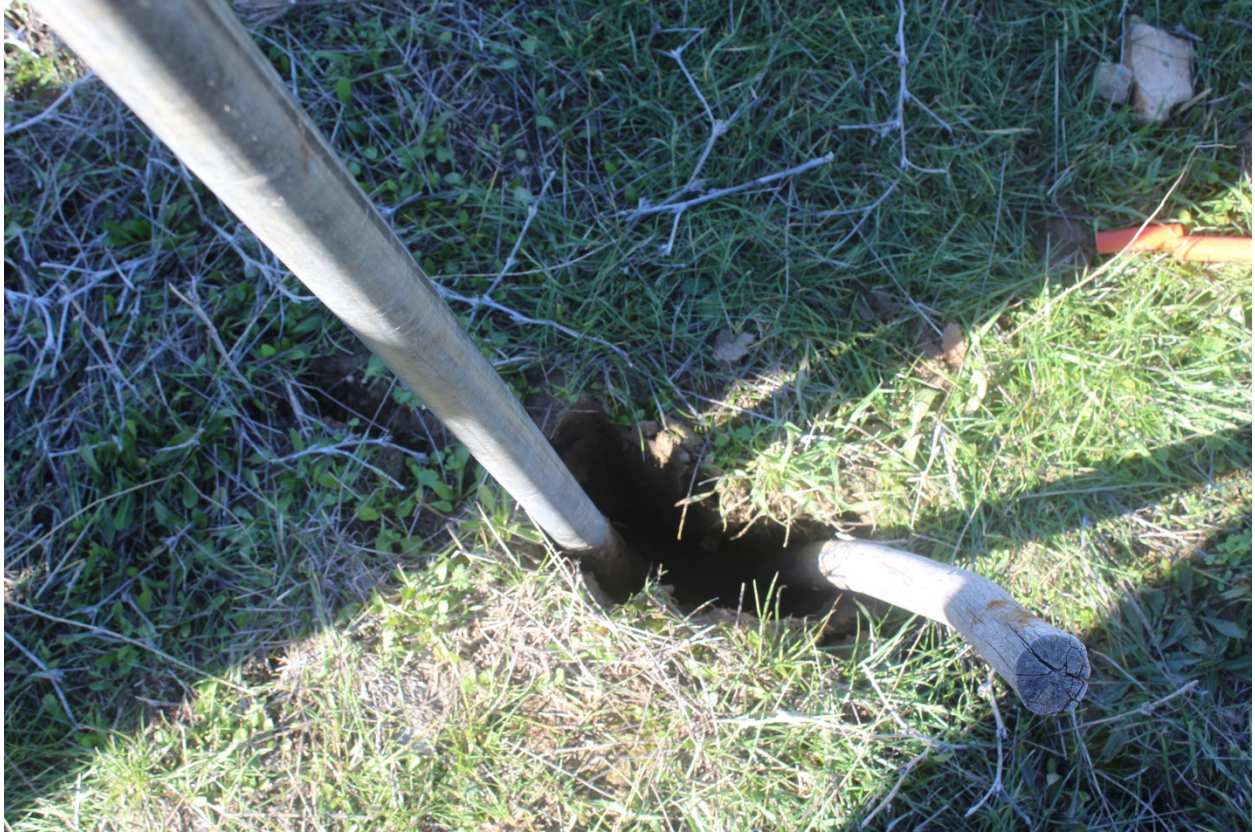
- There are new cracks that started to form at a new location between the 2012 and 2015 failures which is a clear indication of possible near future failures (Appendix Figure A.4).

Figure A.4: Surface cracks already well developed in the area between 2012 and 2015 failure.

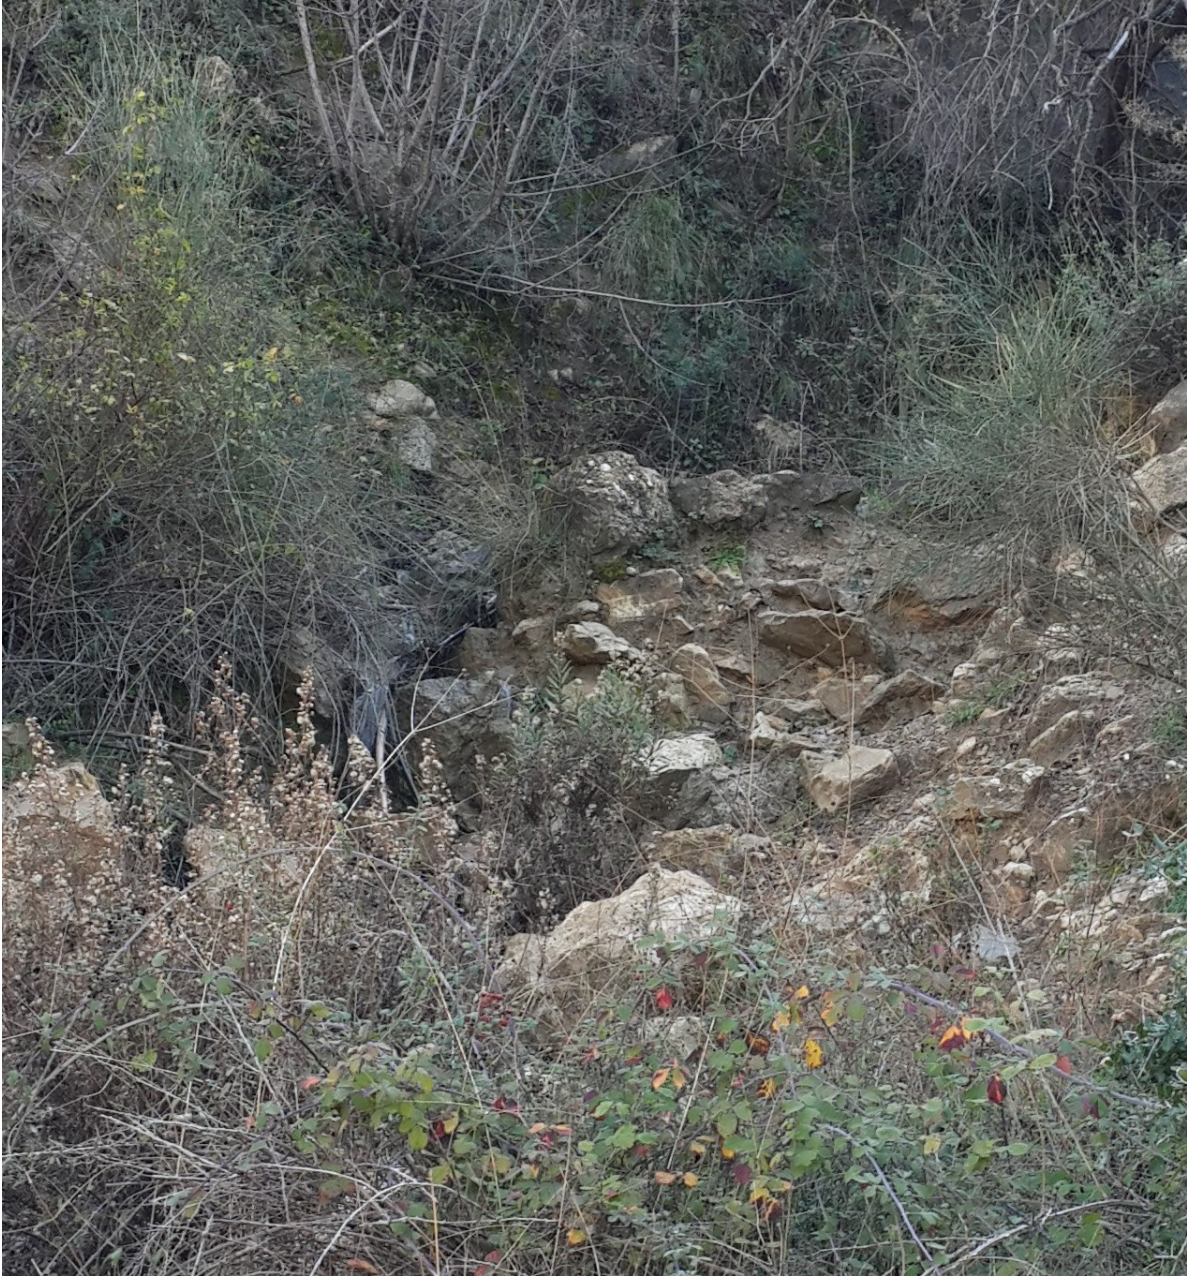
Figure A.5: Surface water runoff at the base of the cliff

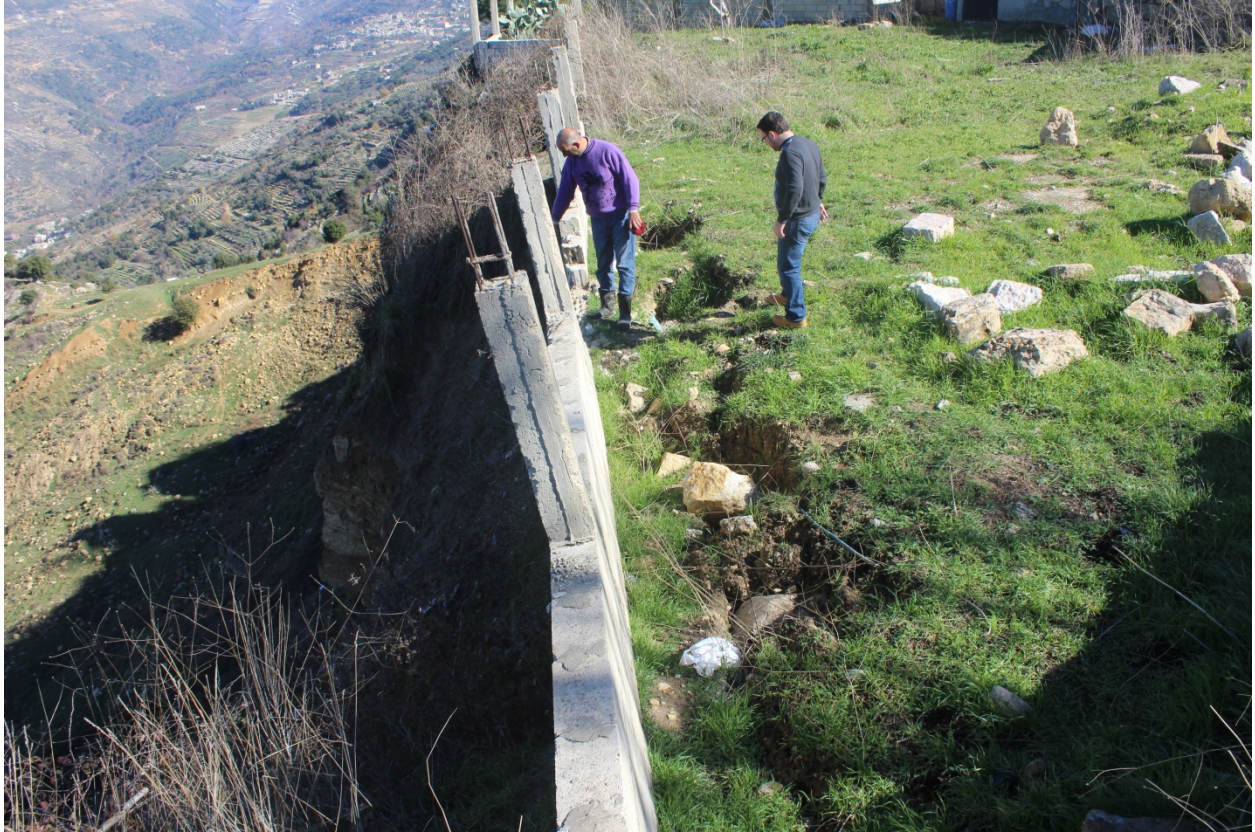
Figure A.6: Damage to backyard fence after 2015 landslide
