**Authors:** Youssef M.A. Hashash (UIUC), Binod Tiwari (CSF), Robb E. S. Moss (CalPoly), Domniki Asimaki (Caltech), Kevin B. Clahan (LCI), D. Scott Kieffer (TUGraz), Doug S. Dreger (UCB), Amy Macdonald (TT), Chris M. Madugo (PG&E), H. Benjamin Mason (OSU), Menzer Pehlivan (MRCE), Deepak Rayamajhi (OSU), Indra Acharya (TU) and Basanta Adhikari (TU).

## Executive Summary

The April 25, 2015 Gorkha (Nepal) Earthquake and its related aftershocks had a devastating impact on Nepal. The earthquake sequence resulted in nearly 9,000 deaths, tens of thousands of injuries, and has left hundreds of thousands of inhabitants homeless. With economic losses estimated at several billion US dollars, the financial impact to Nepal is severe and the rebuilding phase will likely span many years.

The Geotechnical Extreme Events Reconnaissance (GEER) Association assembled a reconnaissance team under the leadership of D. Scott Kieffer, Binod Tiwari and Youssef M.A. Hashash to evaluate geotechnical impacts of the April 25, 2015 Gorkha Earthquake and its related aftershocks. The focus of the reconnaissance was on time-sensitive (perishable) data, and the GEER team included a large group of experts in the a

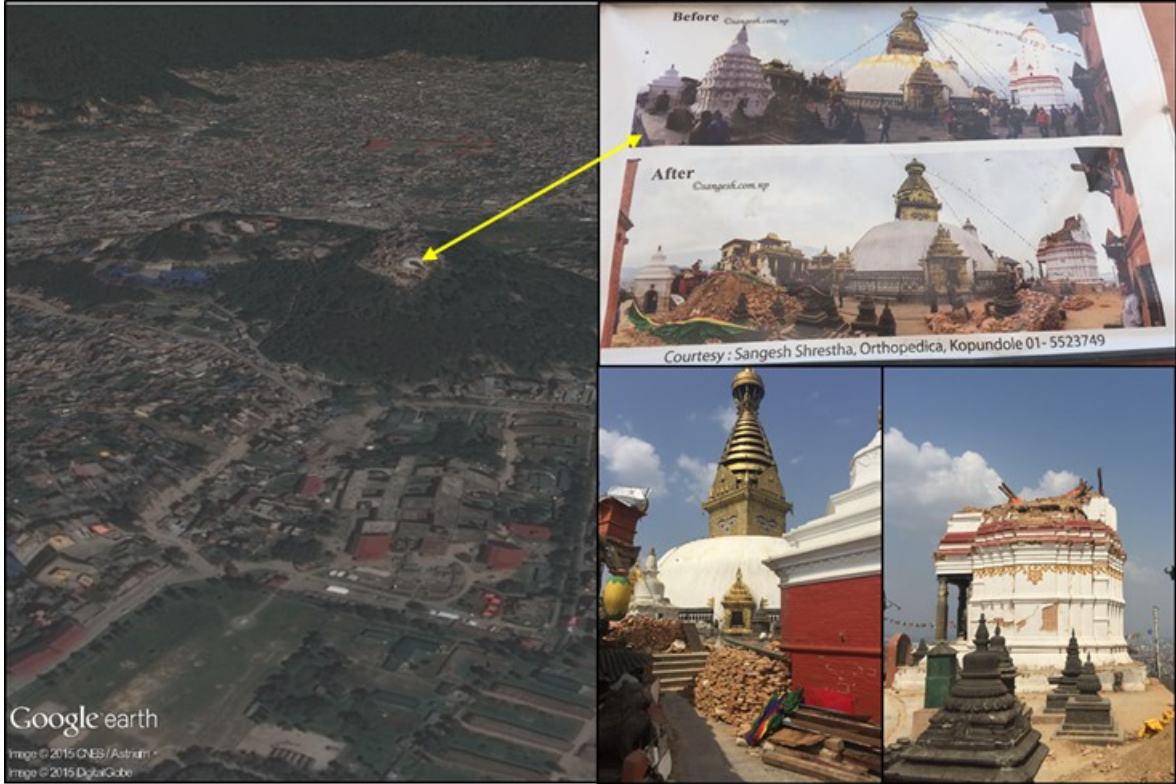
Figure 4-19 Damage in Swayambhu (Monkey) Temple (27.715270 N, 85.290231 E).

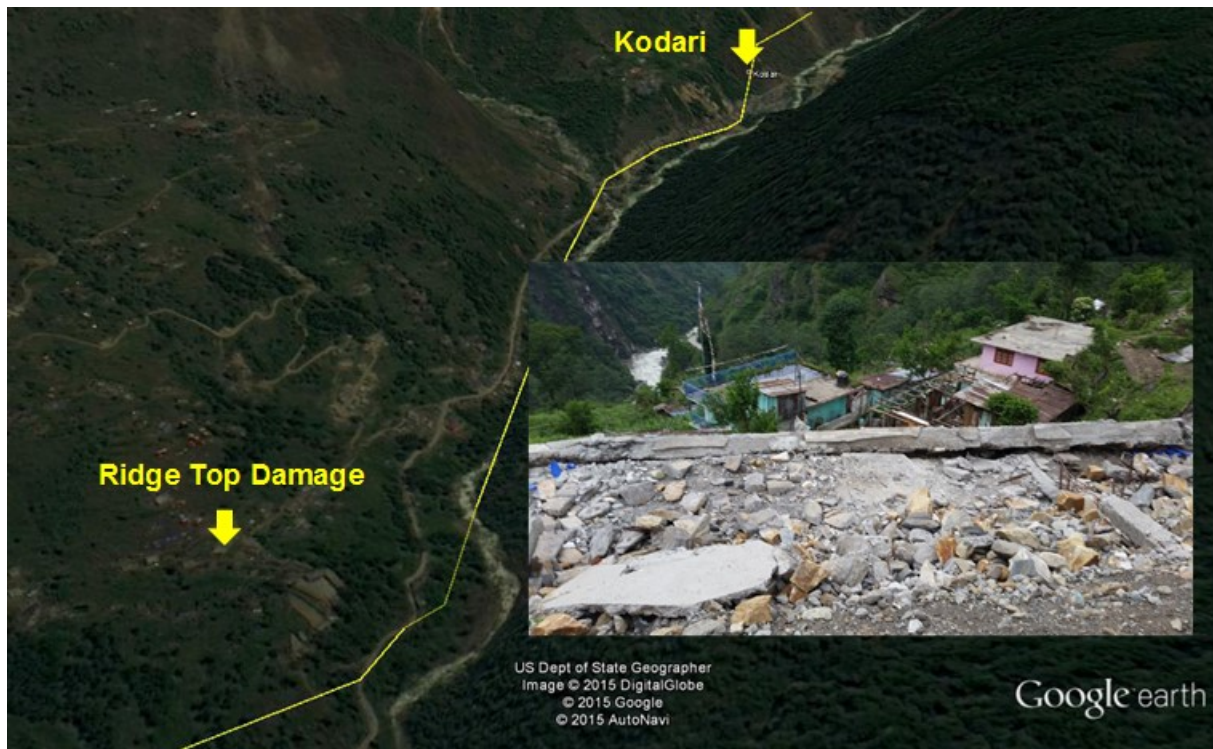
Figure 4-22 Ridge top damage and structure collapse, south of Kodari, near Chinese border (27 57' 31.9" N, 85 57' 17.7" E).

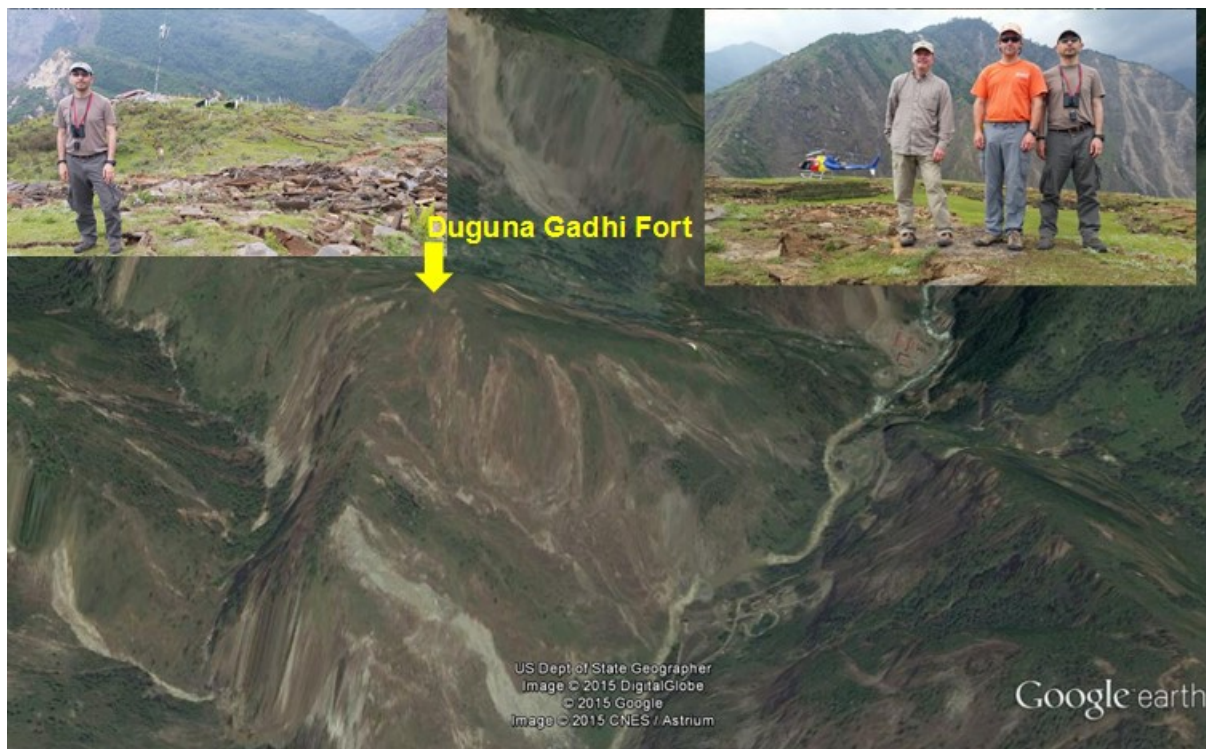
Figure 4-23 Shattered Ridge, Duguna Gadhi Fort (27 54' 59.4" N, 85 55' 2.38" E).

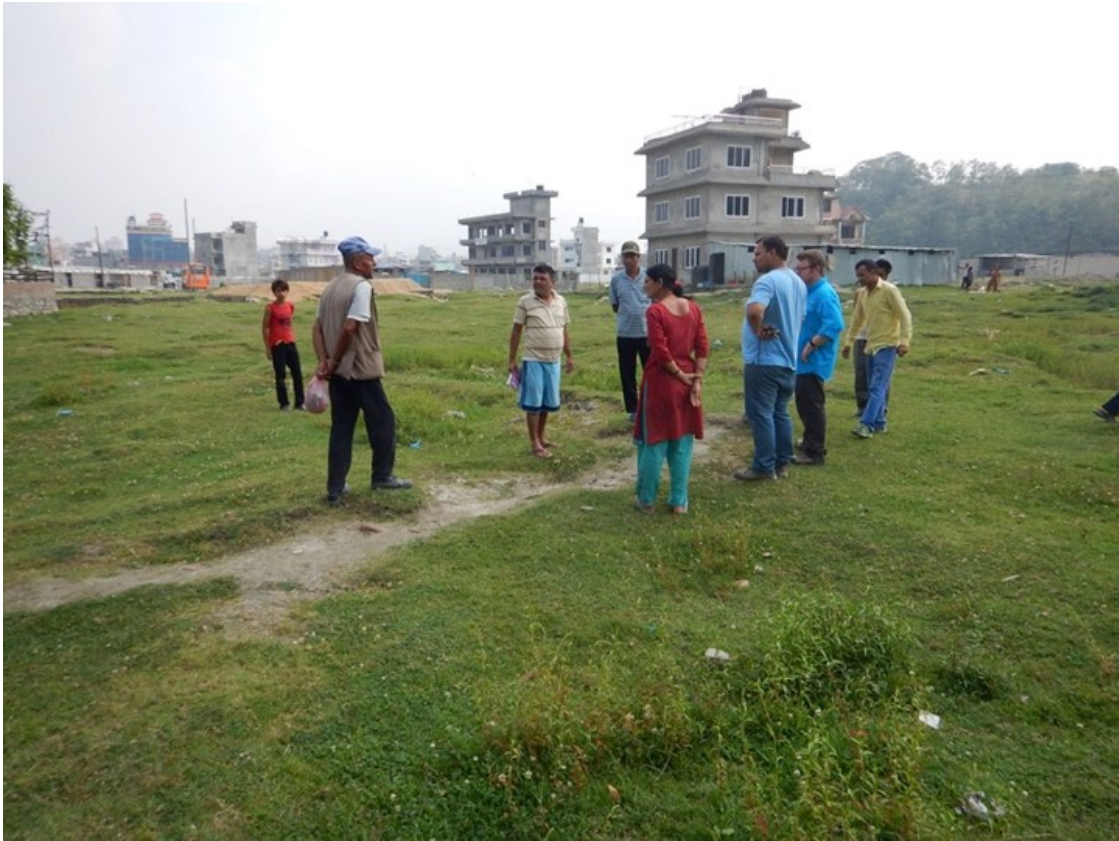
Figure 6-13. Location of liquefaction at Guheshwori (27.709253 N, 85.357553 E).

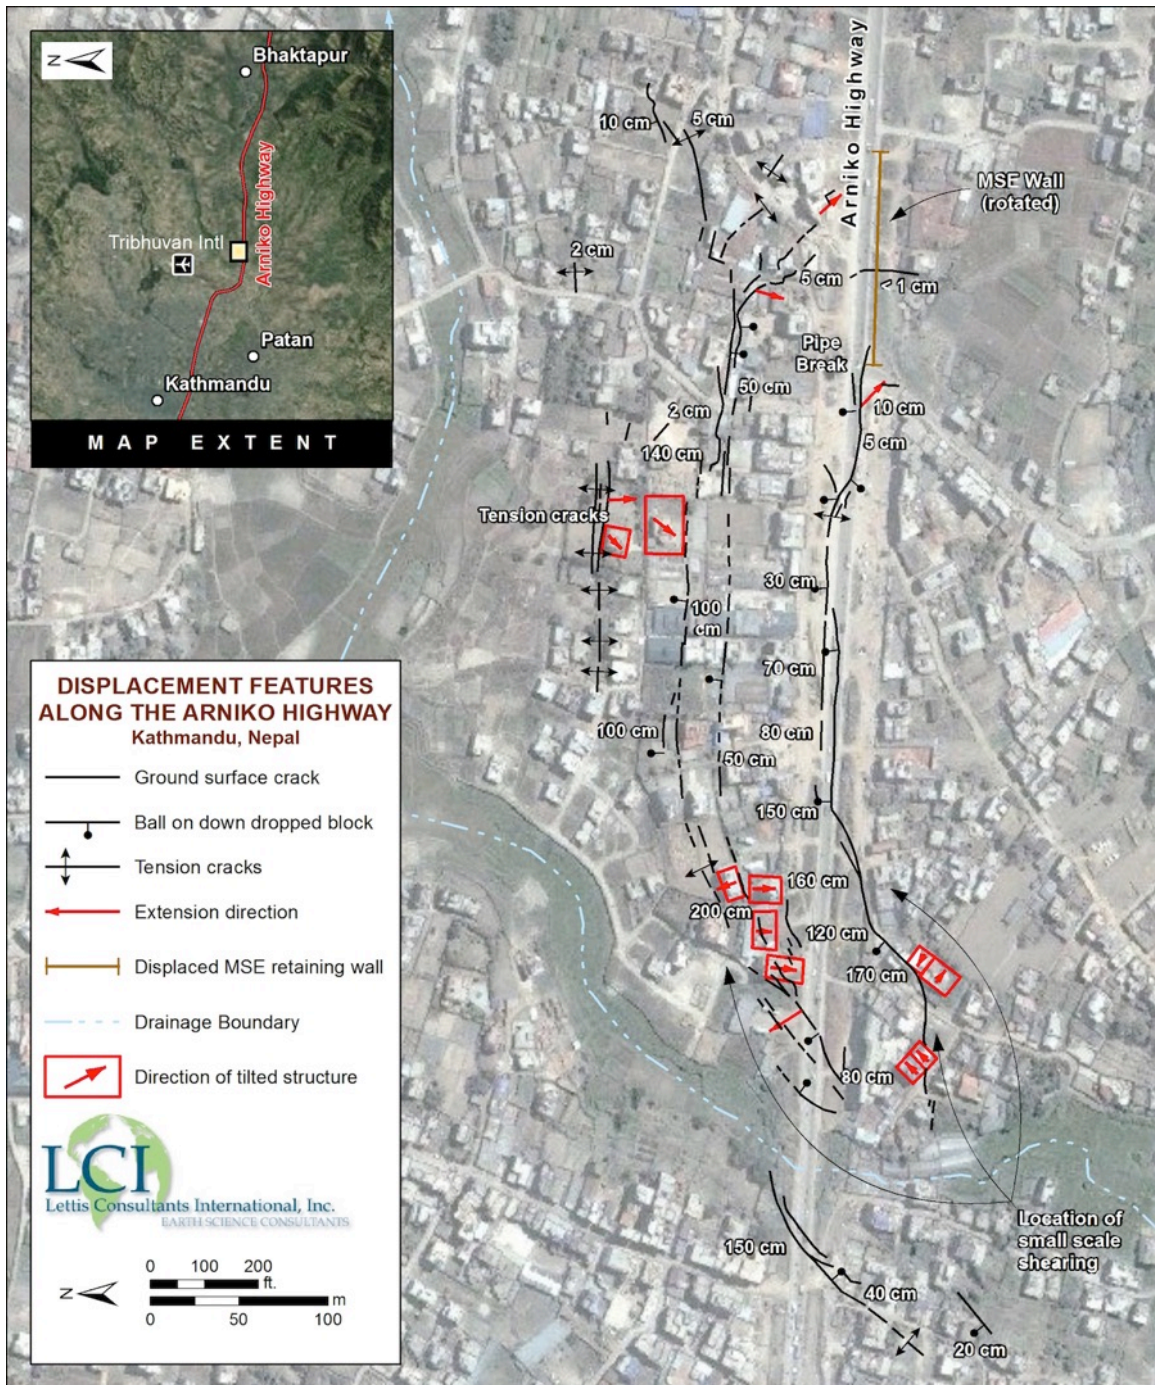
Figure 6-14. Cracks mapped at Lokanthali site (27.674816° 85.362646° and surrounding region). Vertical displacements on the order of 1m, horizontal displacements on the order of 0.5m, with fissure roughly 2 m deep.

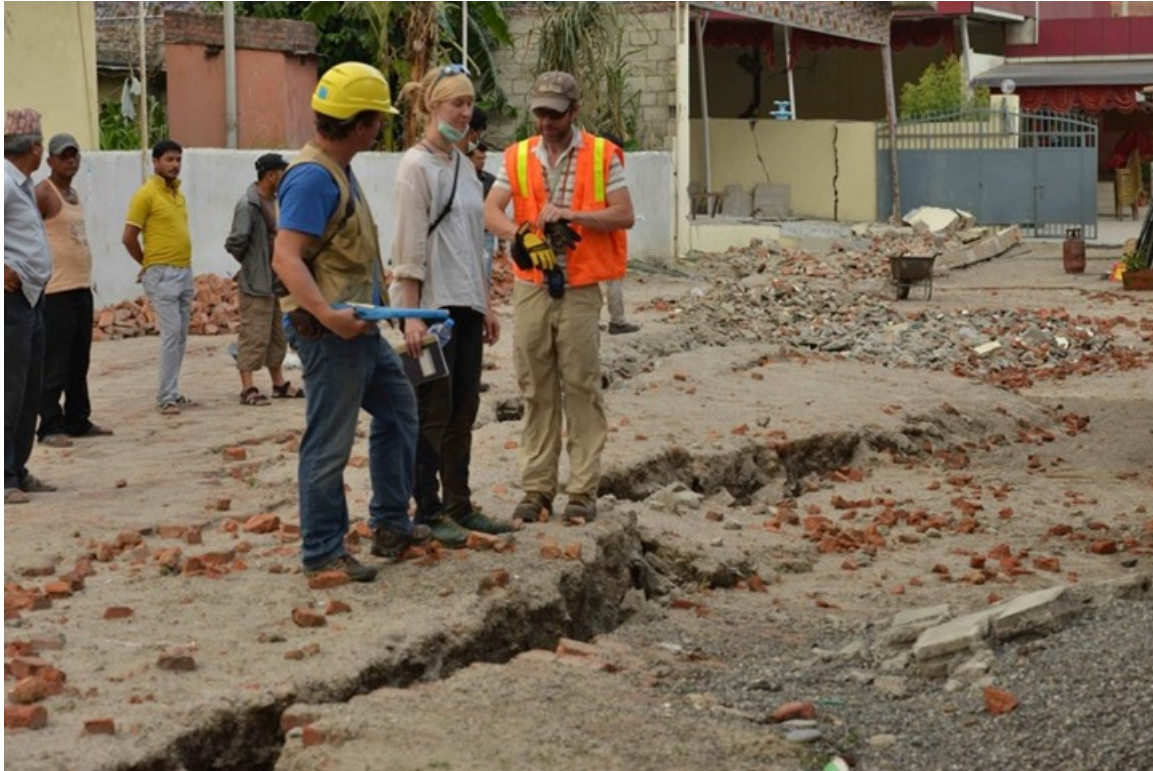
Figure 6-15 Cracks near the top of the rise in Lokanthali ( $27.674816^{\circ}$   $85.362646^{\circ}$  and surrounding region). Depth of cracks 2 to 3 m deep. Most of the deformation was reported to have occurred during the first aftershock, with only a small amount of deformation from the mainshock.

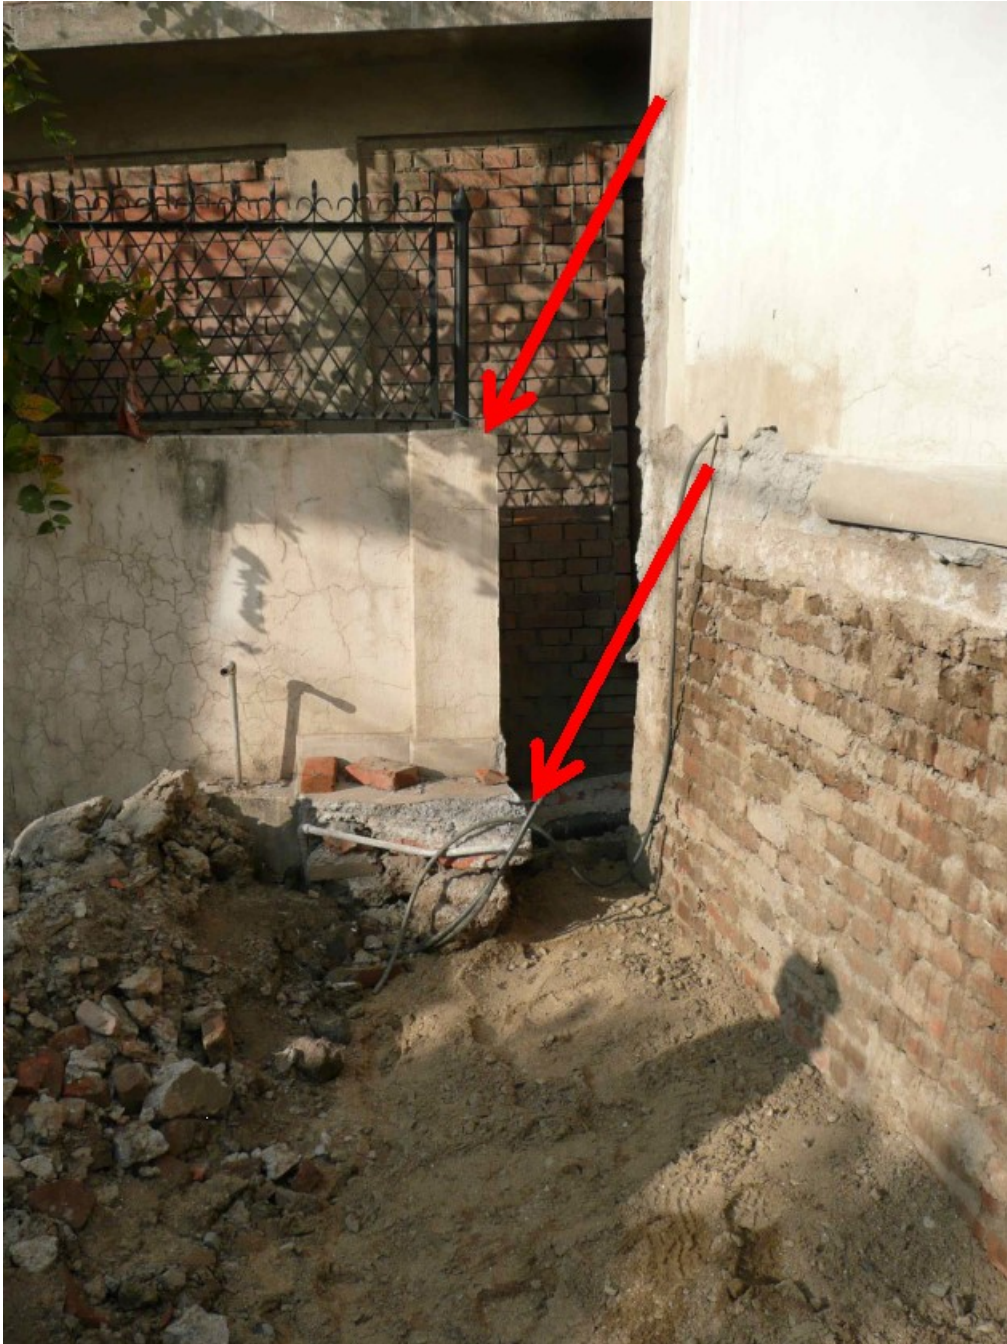
Figure 6-19. House on the hanging wall of the crack. The ground pulled away from the structure dropping upwards of 3/4 m and moving laterally 1/2 m. Before the earthquake the brick foundation was completely below the ground surface.

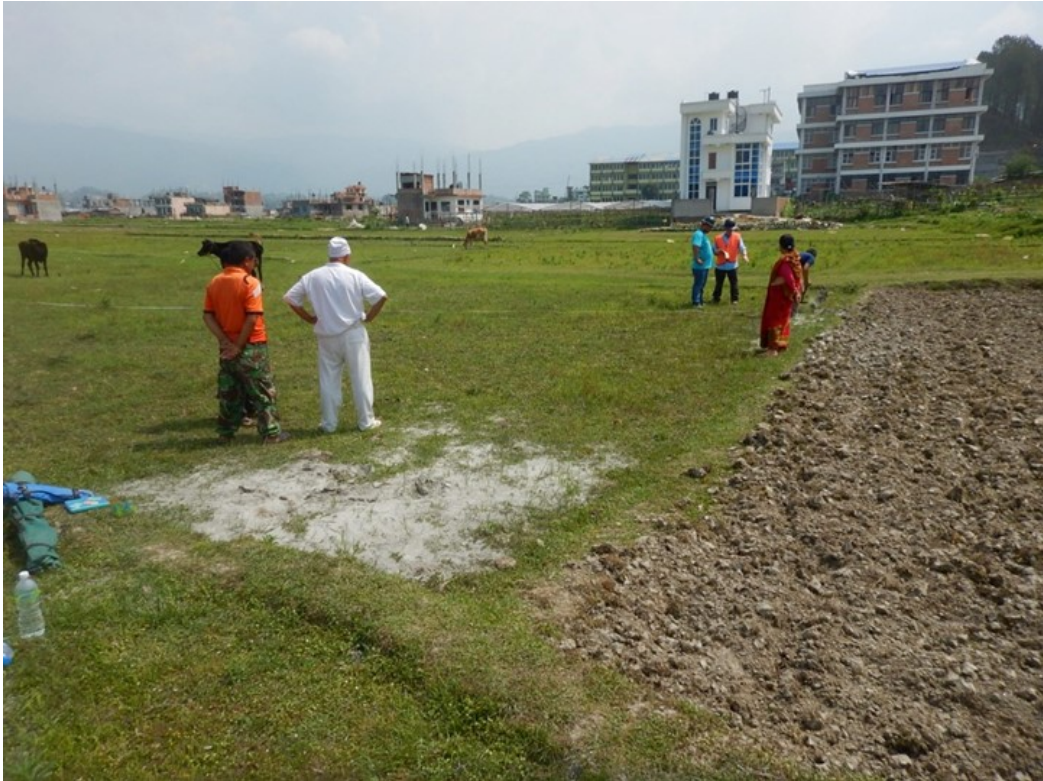
Figure 6-24. Sand boils in Changu Narayan (27.70943 N, 85.41397 E).

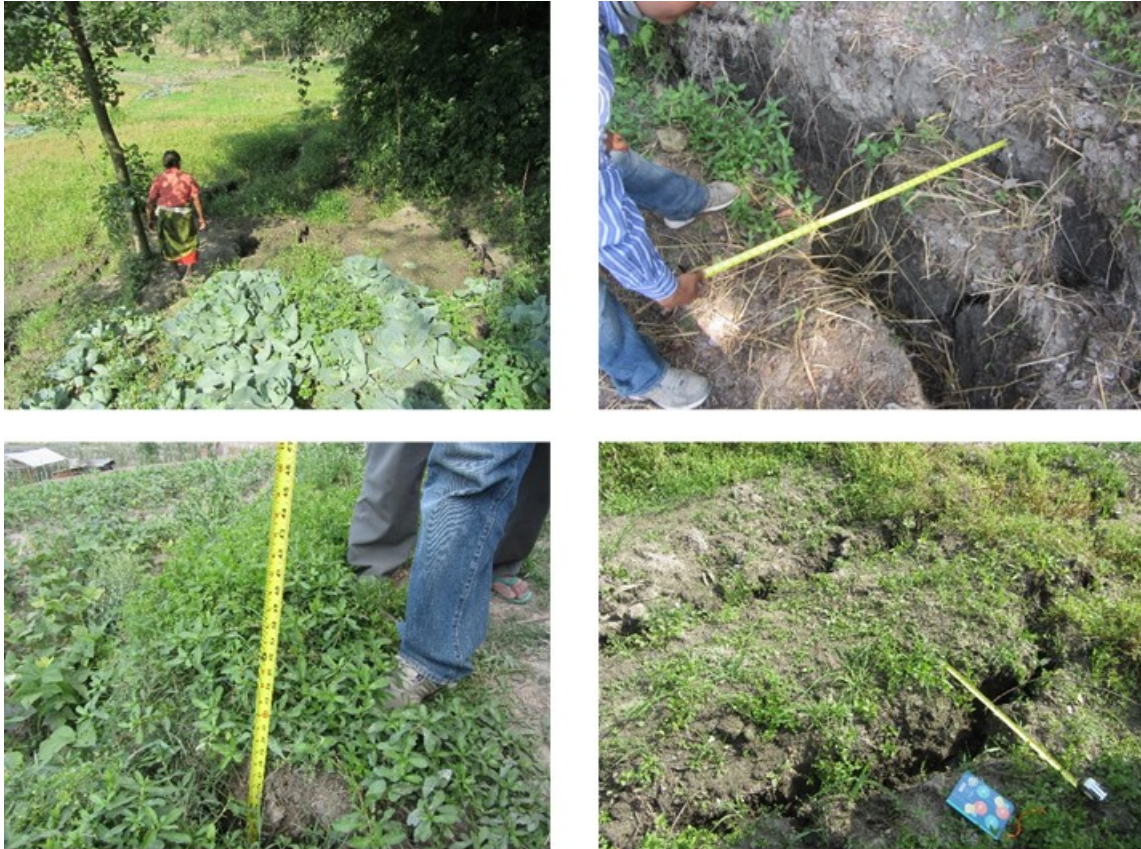
Figure 6-30 Observed surface cracks ~250m long, up to 0.8m wide, and up to 1.5m deep  
(Location: 27°40'42.20" N, 85°26'13.12" E)

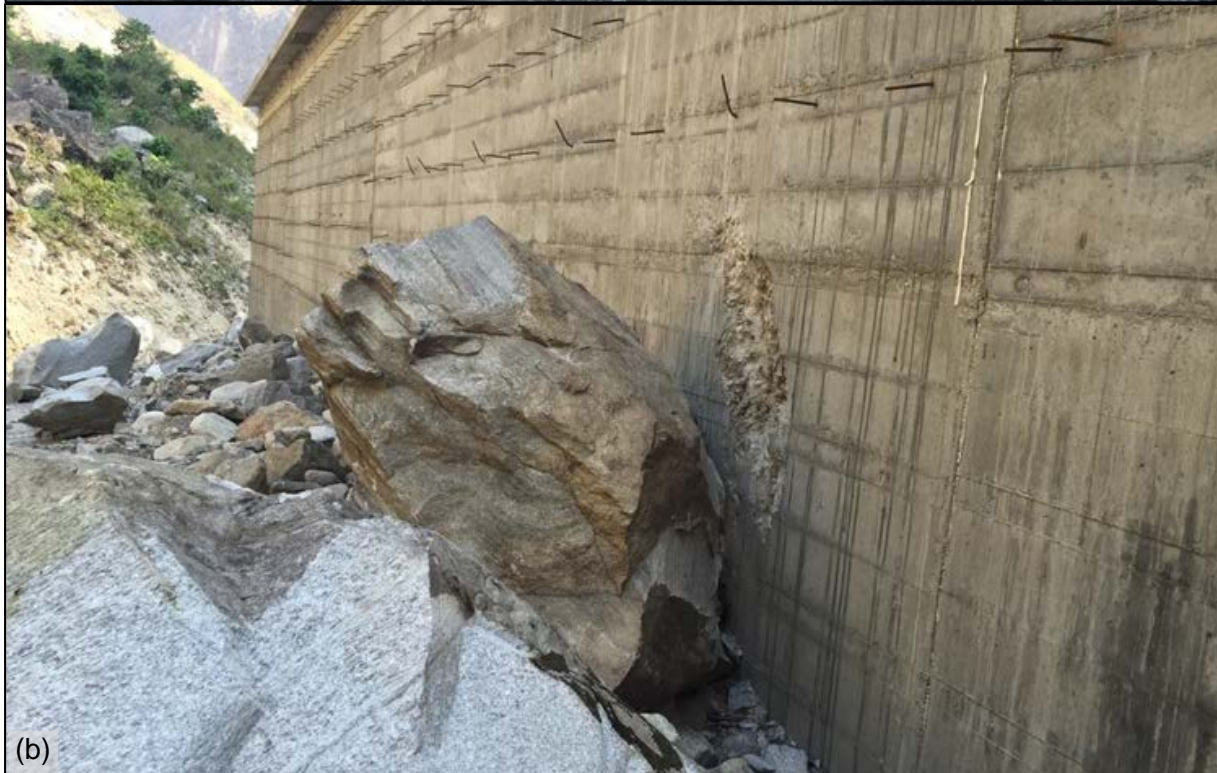
Figure 7-9 Sand trap under construction downstream of the headworks diversion dam were impacted by rockfall from above. Damaged observed was not consequential. (a) 28°3'41.77" N, 85°12'24.74" E, (b) 28°3'40.03" N, 85°12'23.69" E

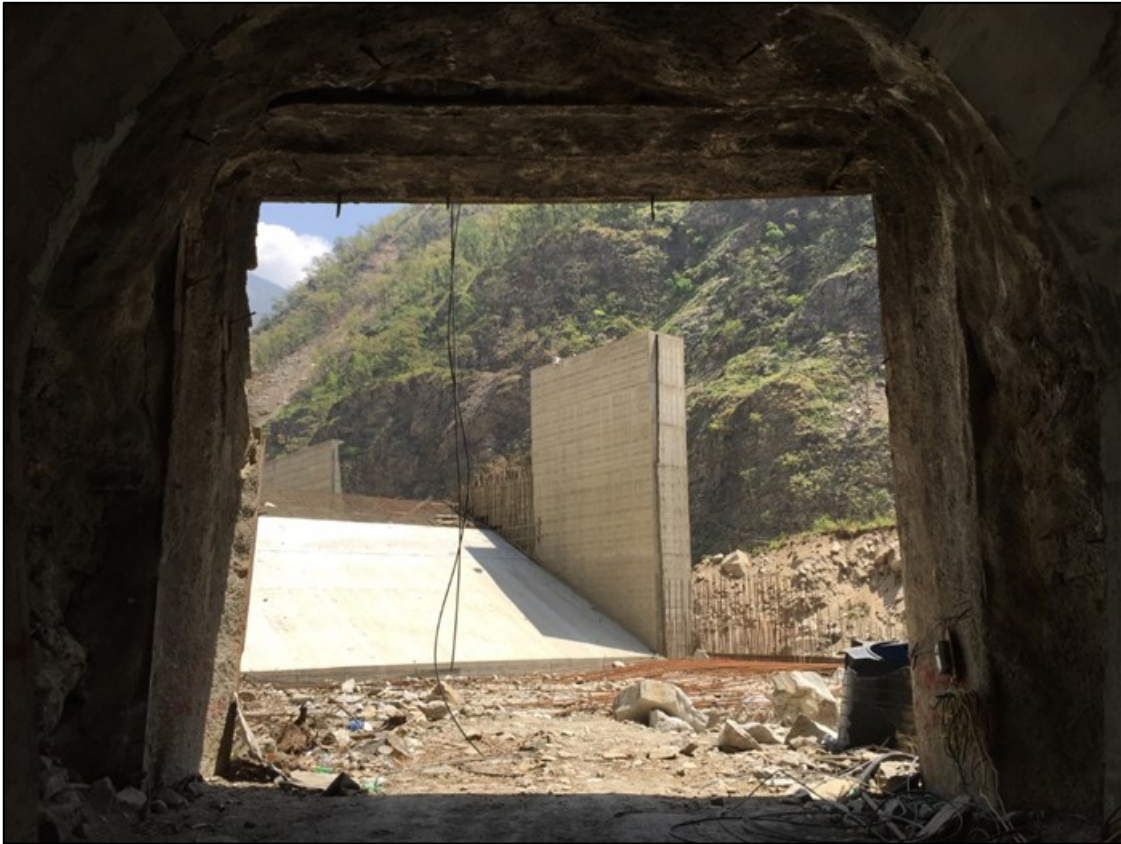
Figure 7-10 Scattered rockfall debris observed outside portal entrance with risk of continued rock fall evident. View is upstream toward dam (not shown) (28°3'36.20" N, 85°12'24.21" E).

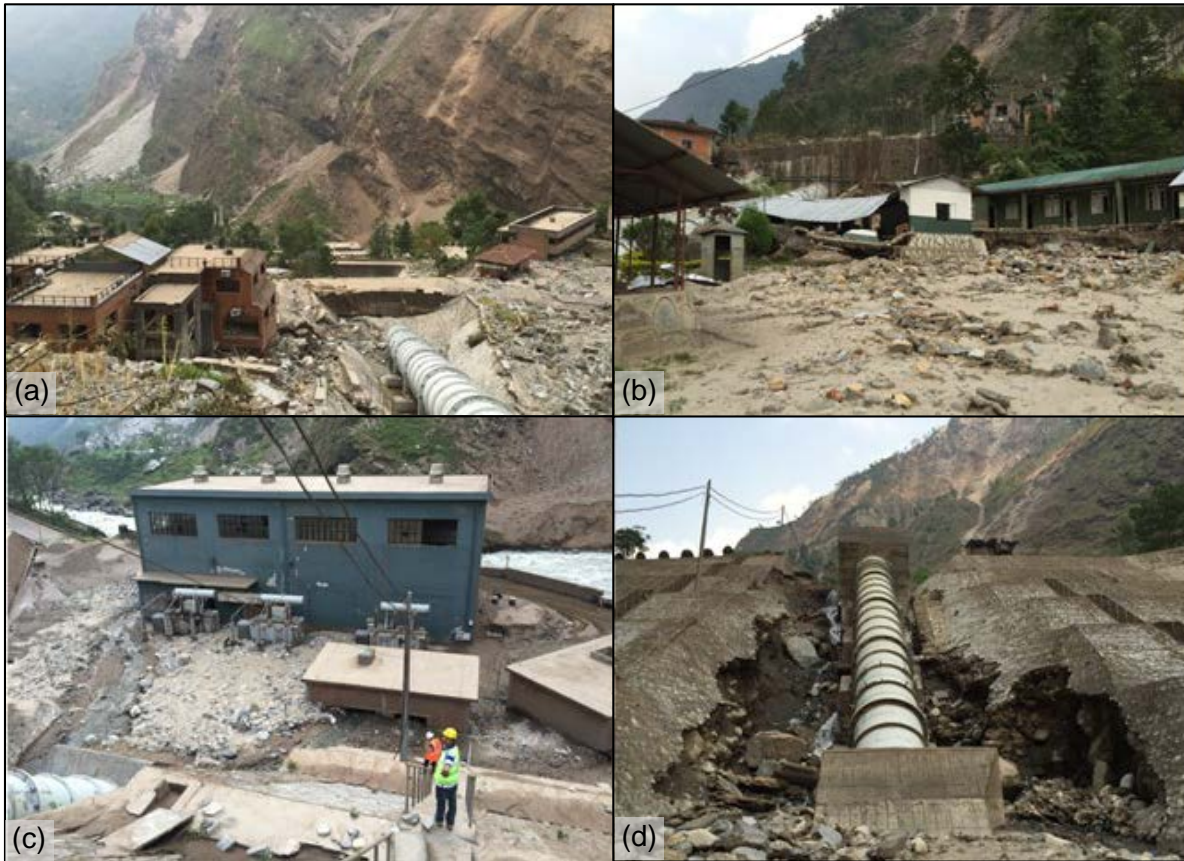
Figure 7-17 (a) Debris flow damage (27°54'45.77" N, 85°55'38.00" E), (b) Debris flow damage the workers colony (27°54'44.47" N, 85°55'32.87" E ), (c) powerhouse, showing debris that has accumulated to the top of doorways in the powerhouse area (27°54'45.67"N, 85°55'28.23"E ), (d) penstock liner (27°54'45.32" N, 85°55'27.15" E)

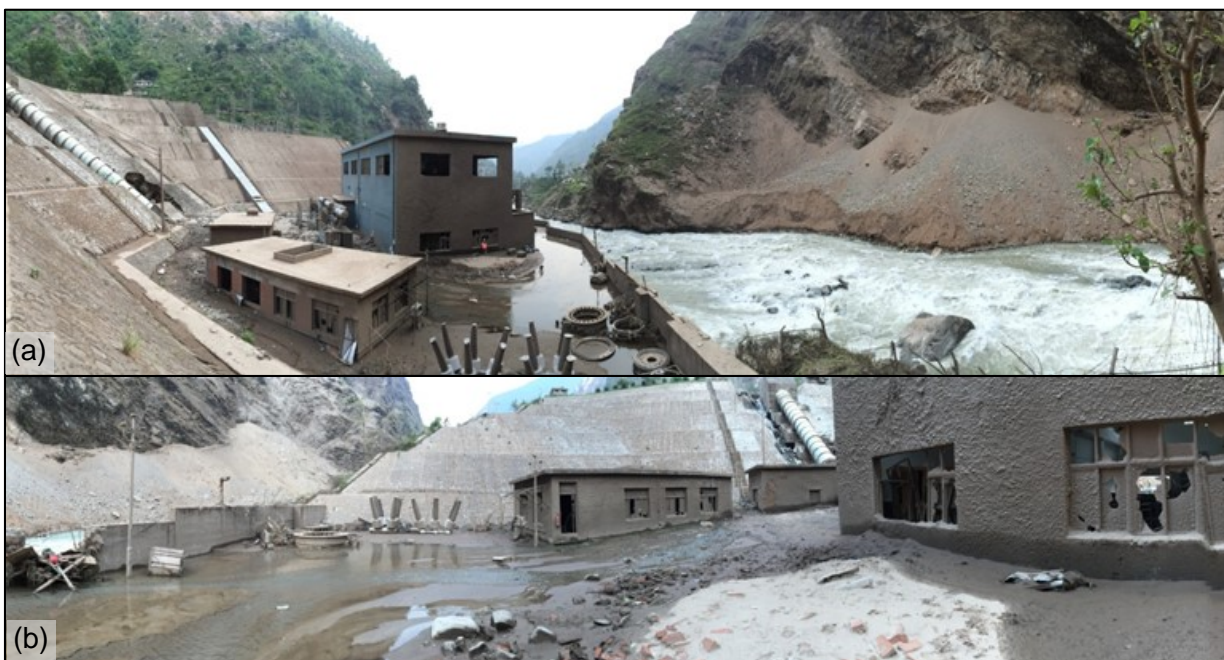
Figure 7-18 A debris plume and water from the impact of the rock fall across the river is hypothesized to have broken windows and resulted in the silt coating on river-facing walls of the powerhouse (contrast blue walls facing away from river with brown, silt coated walls)

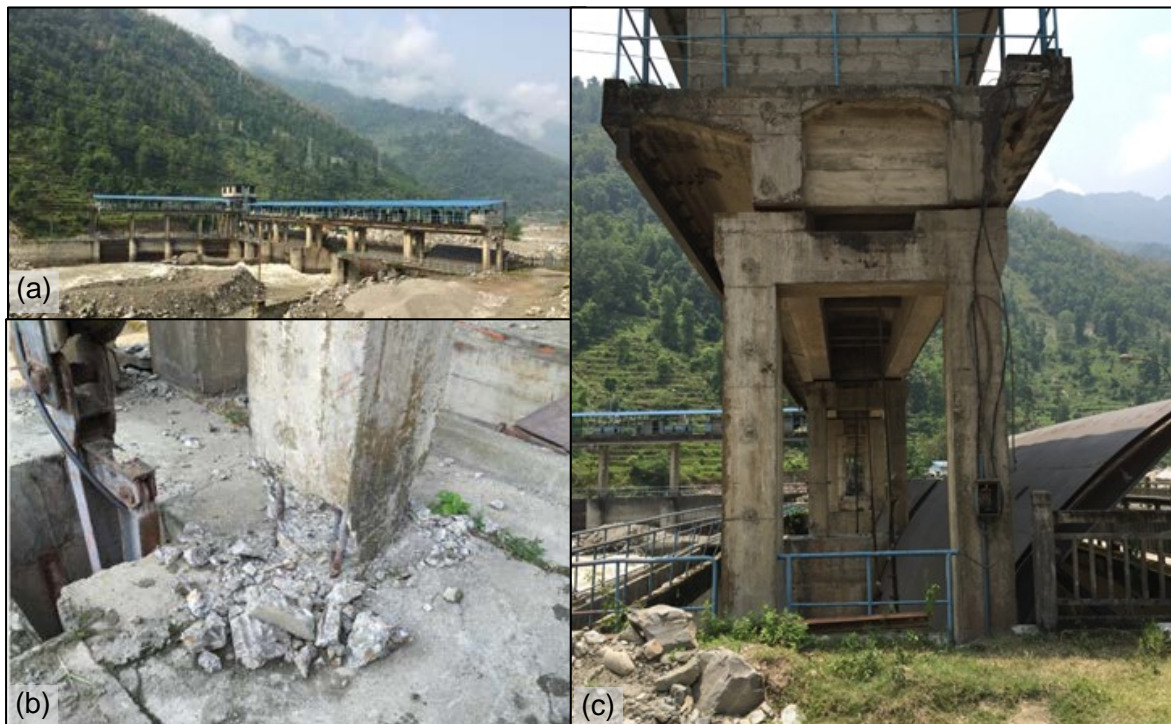
Figure 7-19 (a) Headworks damaged by June 2014 landslide and the 2015 earthquake (27°45'30.24" N, 85°52'5.39" E), (b) Concrete spalling expected to be as a result of earthquake induced shaking (27°45'26.85" N, 85°52'3.33" E), and (c) Headworks structure shifted to the right ) on top of the beam column base structure ( 27°45'29.40" N, 85°52'3.25" E)

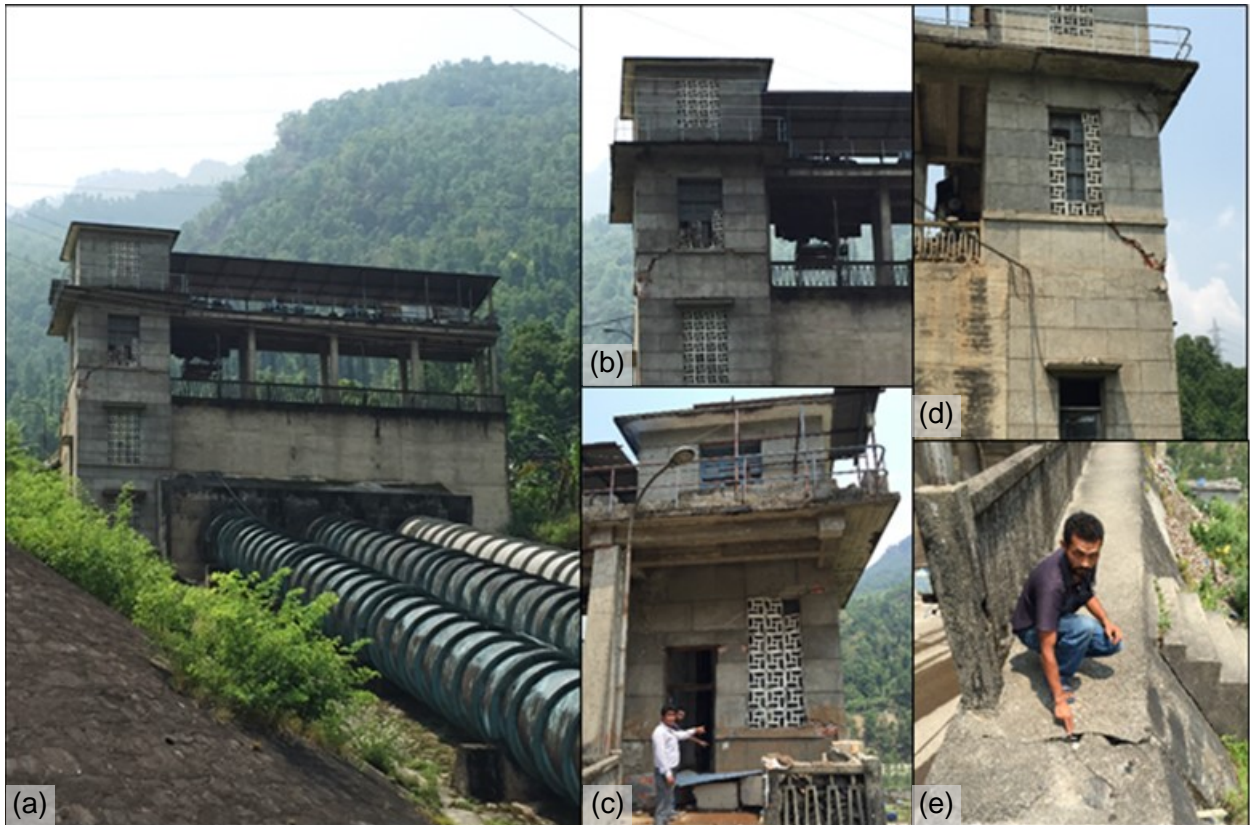
Figure 7-21 Structural damage observed in the intake structure of Sunkoshi powerhouse. Significant shear cracks were observed in the upper structure after the May 12<sup>th</sup> M 7.3 aftershocks. No significant damage was observed in the penstock ( $27^{\circ}45'10.66''\text{N}$ ,  $85^{\circ}50'17.70''\text{E}$ ).

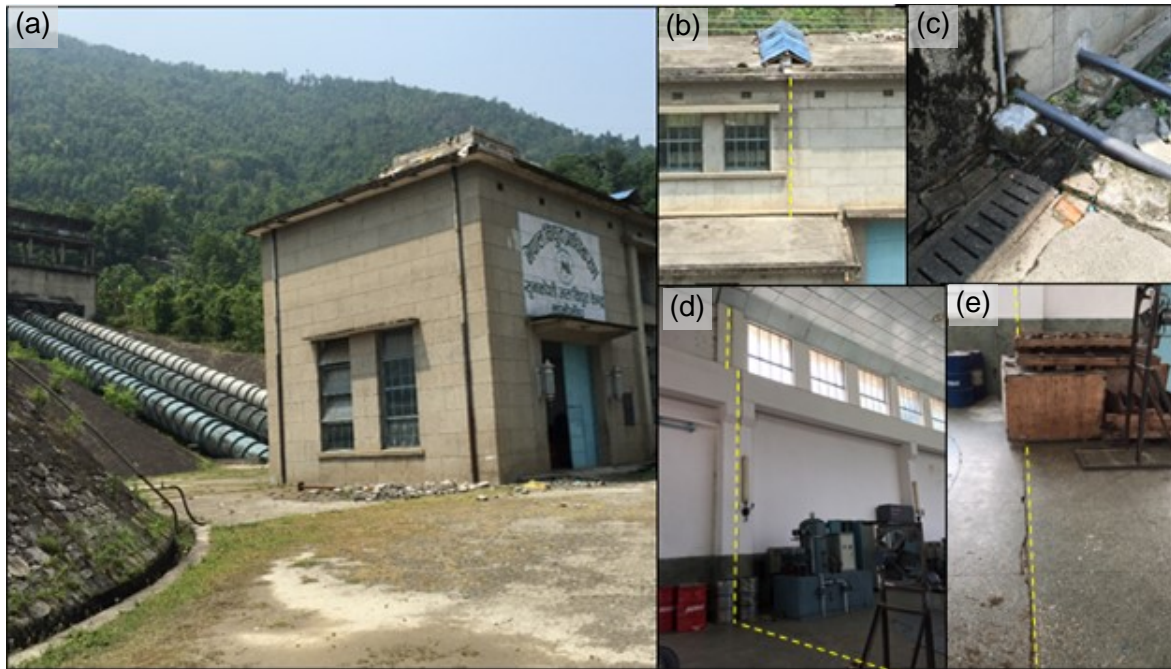
Figure 7-22 A continuous crack running through the walls and the floor is observed in the powerhouse structure. This observed crack can be potentially due to the differential settlement across the power plant structure, which can be further supported by the cracks and slight vertical offset observed in the pavement shown on the upper left side (7-21 27°45'13.96"N, 85°50'17.26"E).

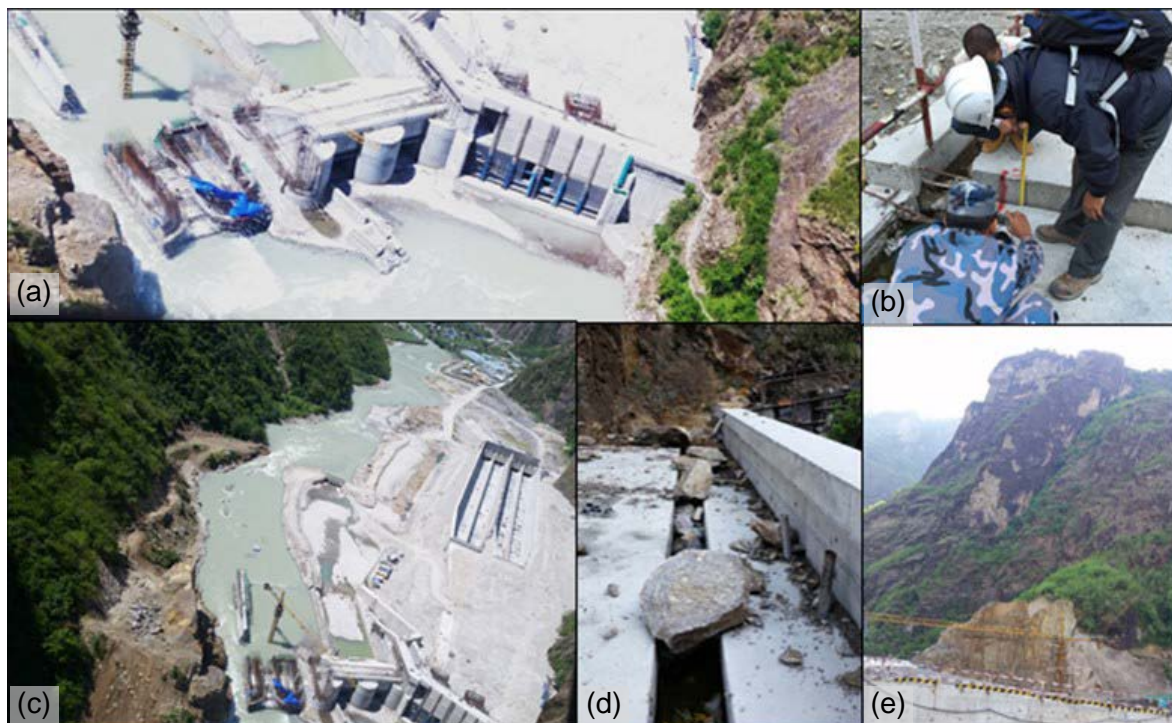
Figure 7-24 Damages observed at the Upper Tamakoshi Powerplant. (a) Aerial image of the headworks, (b) the settlement at the headworks, (c) breached cofferdam, (d) rockfalls, (e) steep slopes at the abutments.(27 55' 29.8" N, 86 12' 46.4" E)

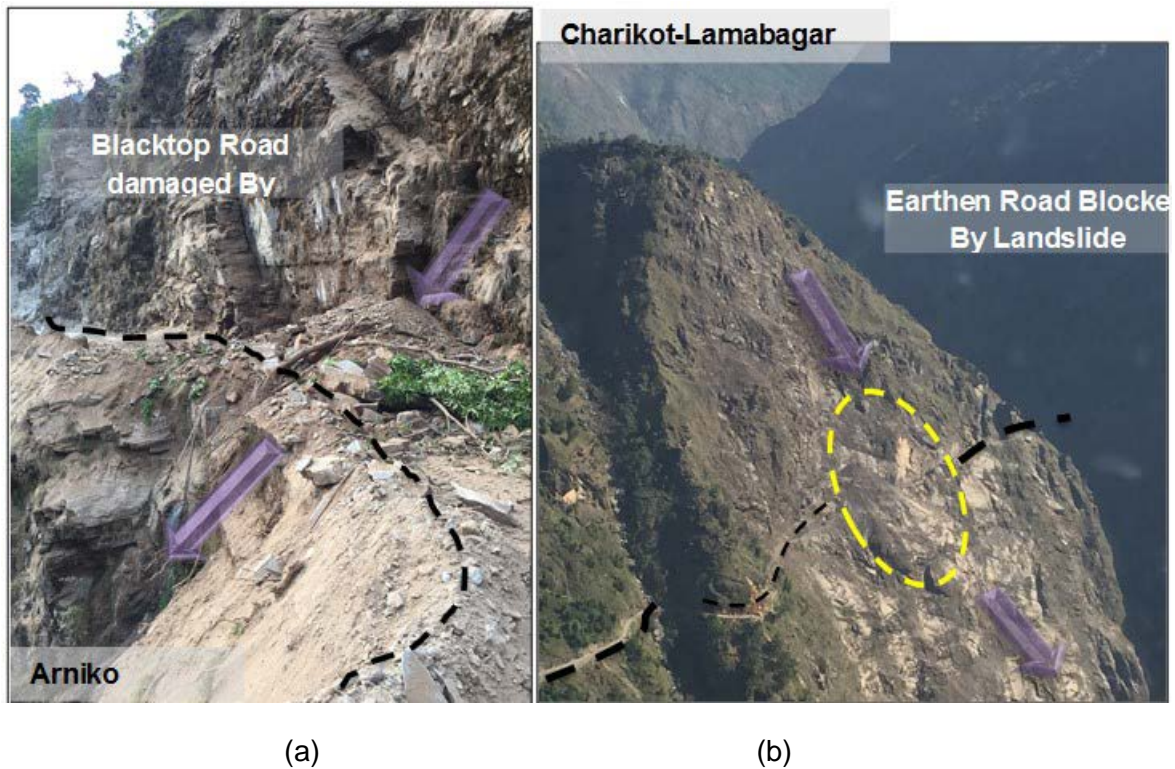
Figure 8-2 Interruptions and damage on roadways caused by the earthquake-induced landslides, (a) 27 52' 15.9"N 85 53' 15.9"E, (b) 27 52' 19.1"N 86 13' 20.7"E.

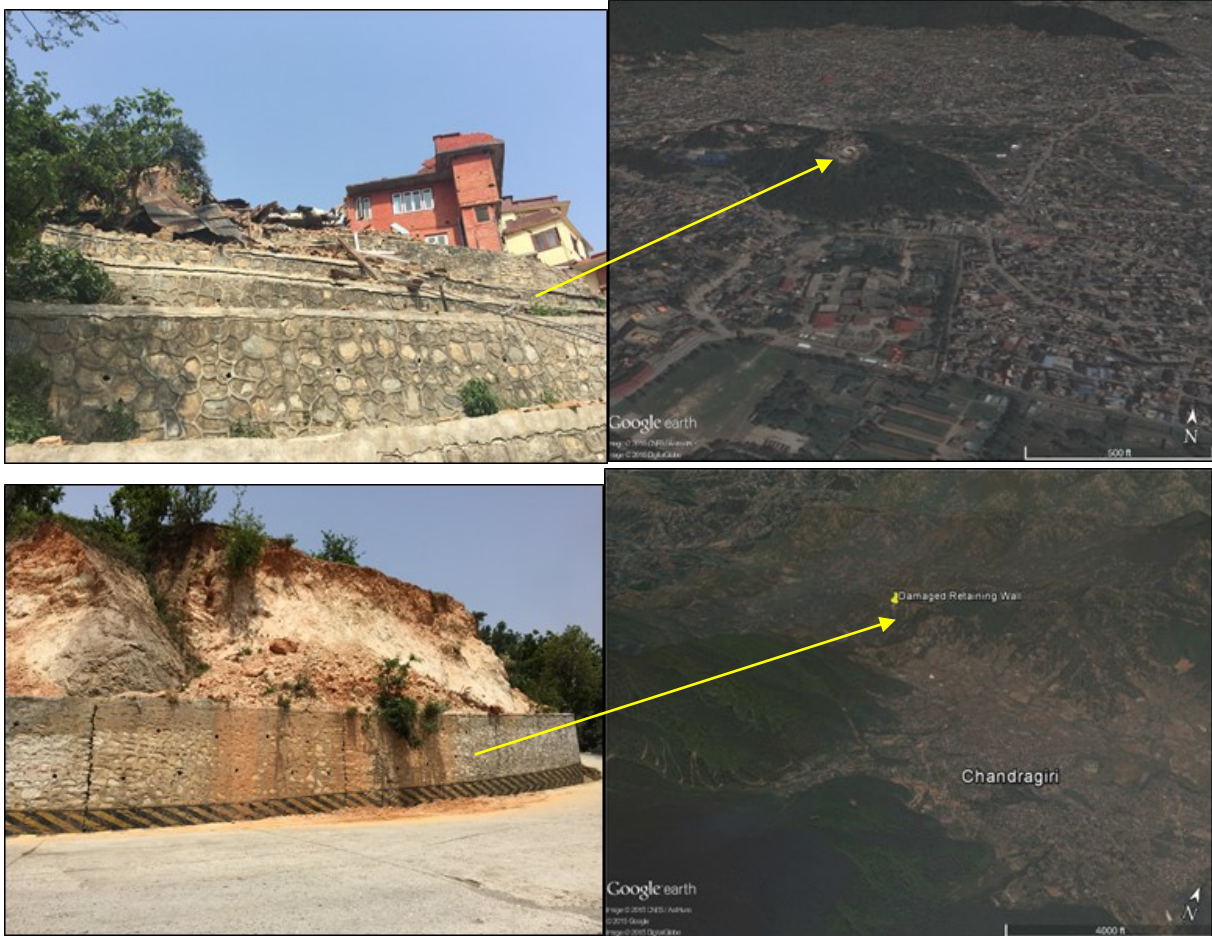
Figure 8-17 Retaining wall damage observed at the ridges (a) around Monkey Temple, Kathmandu (27 42' 54"N 85 17' 23.5"E) (b) around western basin edge of Kathmandu valley (27 42' 51.5"N, 85 11' 59.7"E).

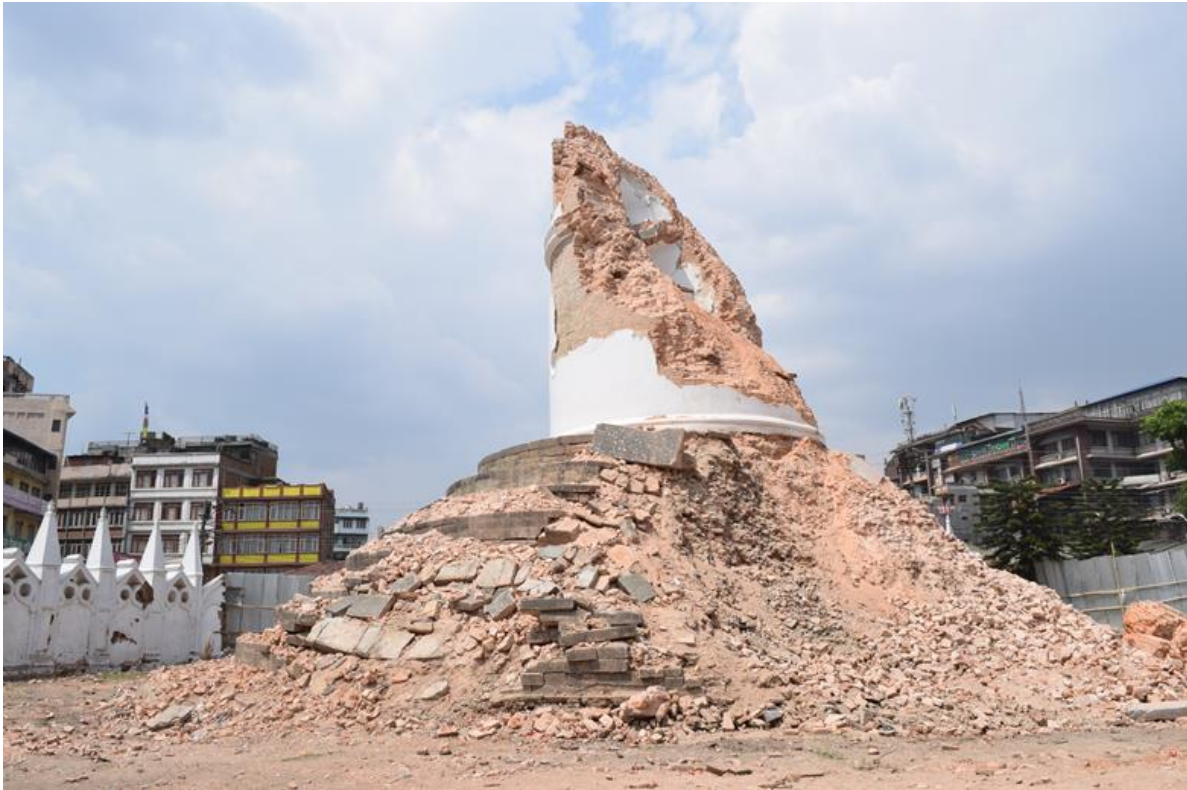
Figure 9-1 Seven story tall Bhimshen Tower collapsed due to earthquake shaking ( $27^{\circ}42' 2.23''$  N,  $85^{\circ}18'43.11''$  E).

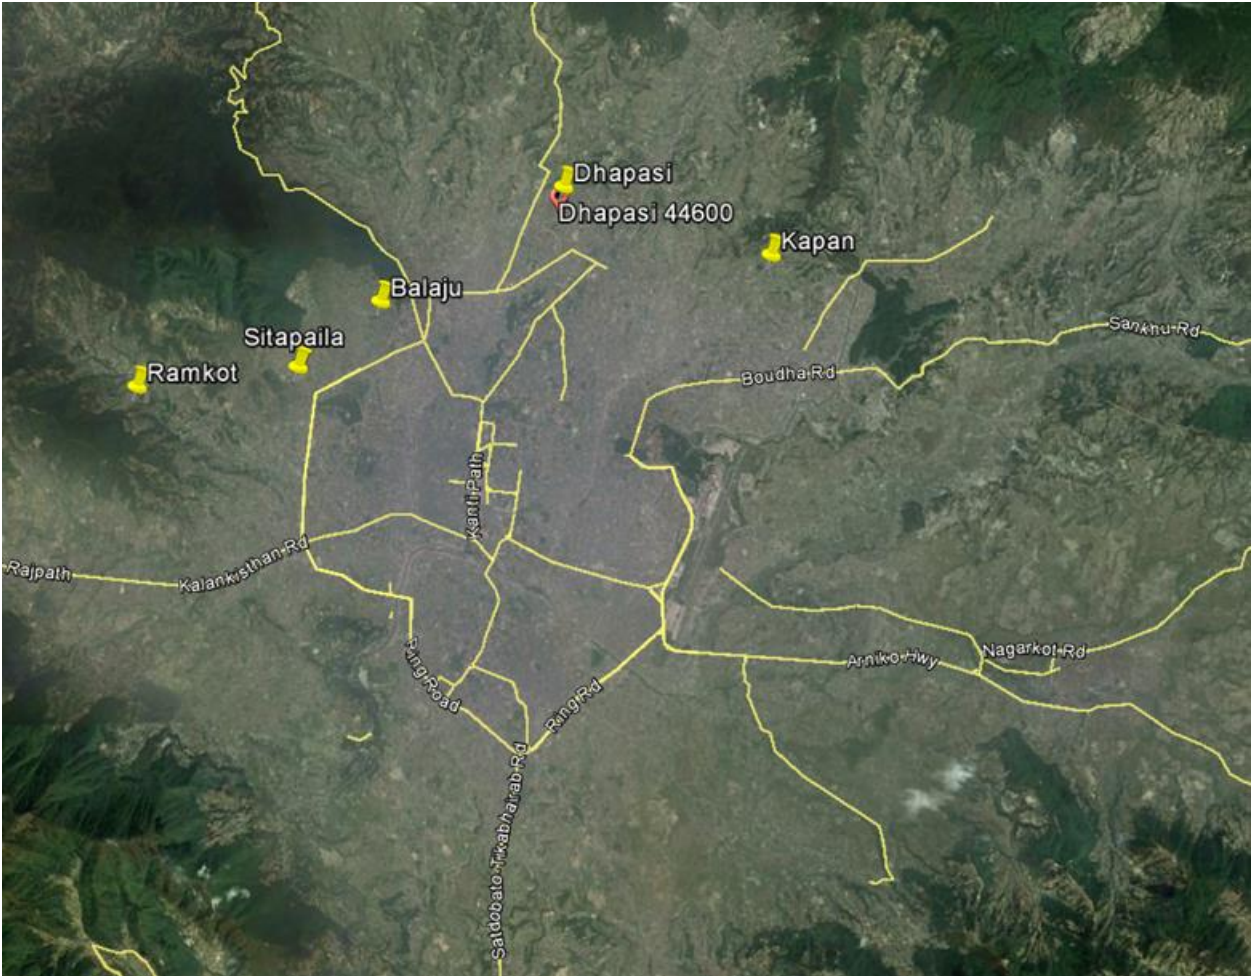
Figure 9-2 Major structural damage observed at Kathmandu Valley

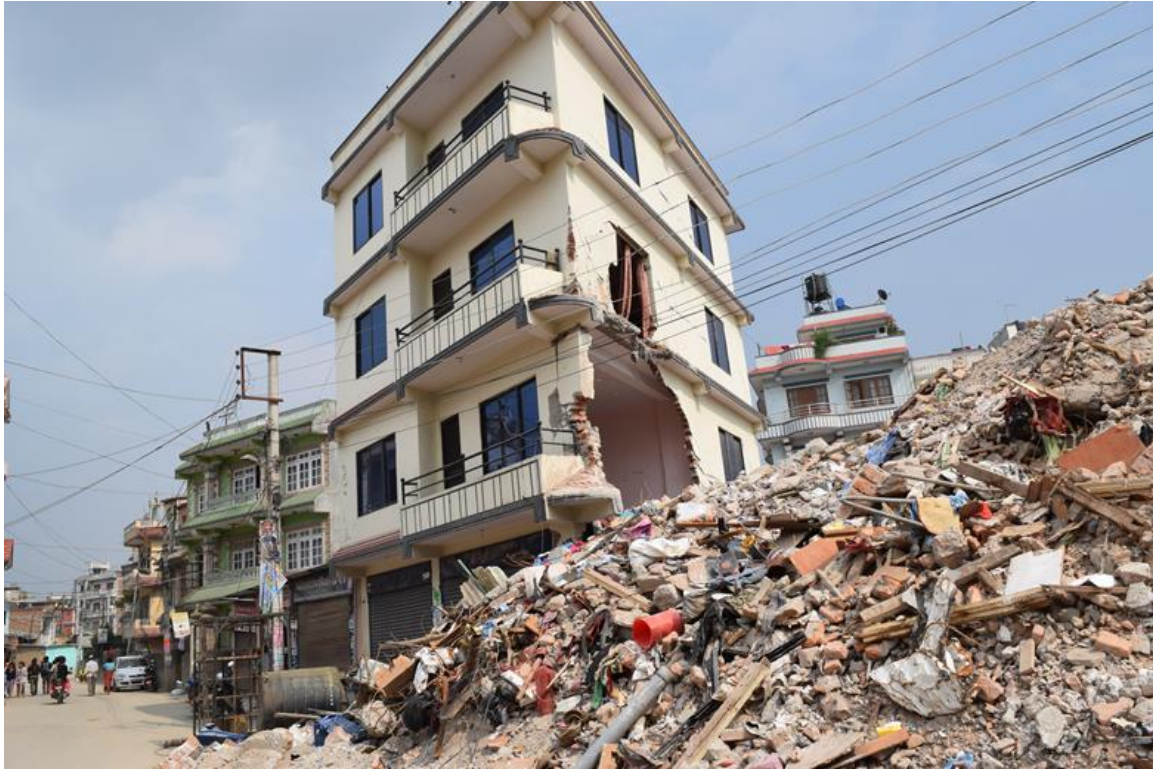
Figure 9-3 A 5.5 story building collapsed at Kapan after the ground shaking due to the  $M_w$ 7.8 Gorkha Earthquake. A total of 11 people died at this building ( $27^{\circ}43'30.0''$  N,  $85^{\circ}21'54.89''$  E).
