**Authors:** Youssef M.A. Hashash (UIUC), Binod Tiwari (CSF), Robb E. S. Moss (CalPoly), Domniki Asimaki (Caltech), Kevin B. Clahan (LCI), D. Scott Kieffer (TUGraz), Doug S. Dreger (UCB), Amy Macdonald (TT), Chris M. Madugo (PG&E), H. Benjamin Mason (OSU), Menzer Pehlivan (MRCE), Deepak Rayamajhi (OSU), Indra Acharya (TU) and Basanta Adhikari (TU).

## Executive Summary

The April 25, 2015 Gorkha (Nepal) Earthquake and its related aftershocks had a devastating impact on Nepal. The earthquake sequence resulted in nearly 9,000 deaths, tens of thousands of injuries, and has left hundreds of thousands of inhabitants homeless. With economic losses estimated at several billion US dollars, the financial impact to Nepal is severe and the rebuilding phase will likely span many years.

The Geotechnical Extreme Events Reconnaissance (GEER) Association assembled a reconnaissance team under the leadership of D. Scott Kieffer, Binod Tiwari and Youssef M.A. Hashash to evaluate geotechnical impacts of the April 25, 2015 Gorkha Earthquake and its related aftershocks. The focus of the reconnaissance was on time-sensitive (perishable) data, and the GEER team included a large group of experts in the a

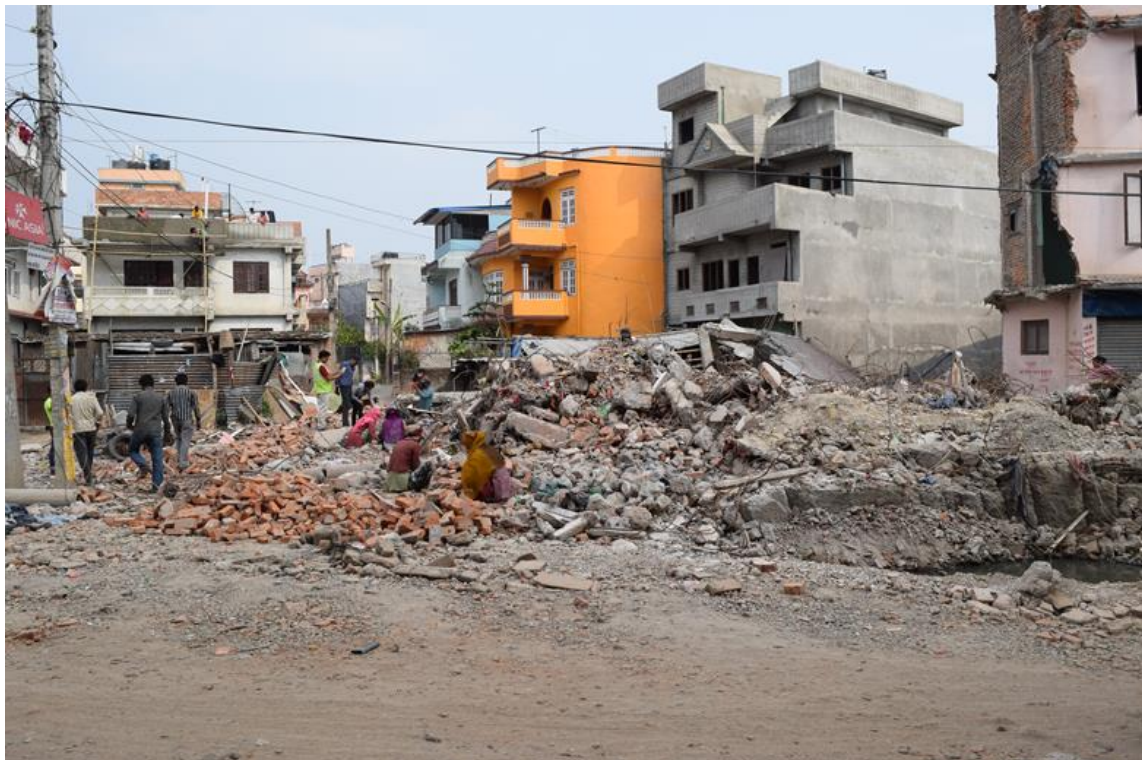
Figure 9-4 A 7 story building collapsed at Kapan after the ground shaking due to the  $M_w$ 7.8 Gorkha Earthquake. A total of 40 people died at this building ( $27^{\circ}43'26.15''$  N,  $85^{\circ}21'30.75''$  E).

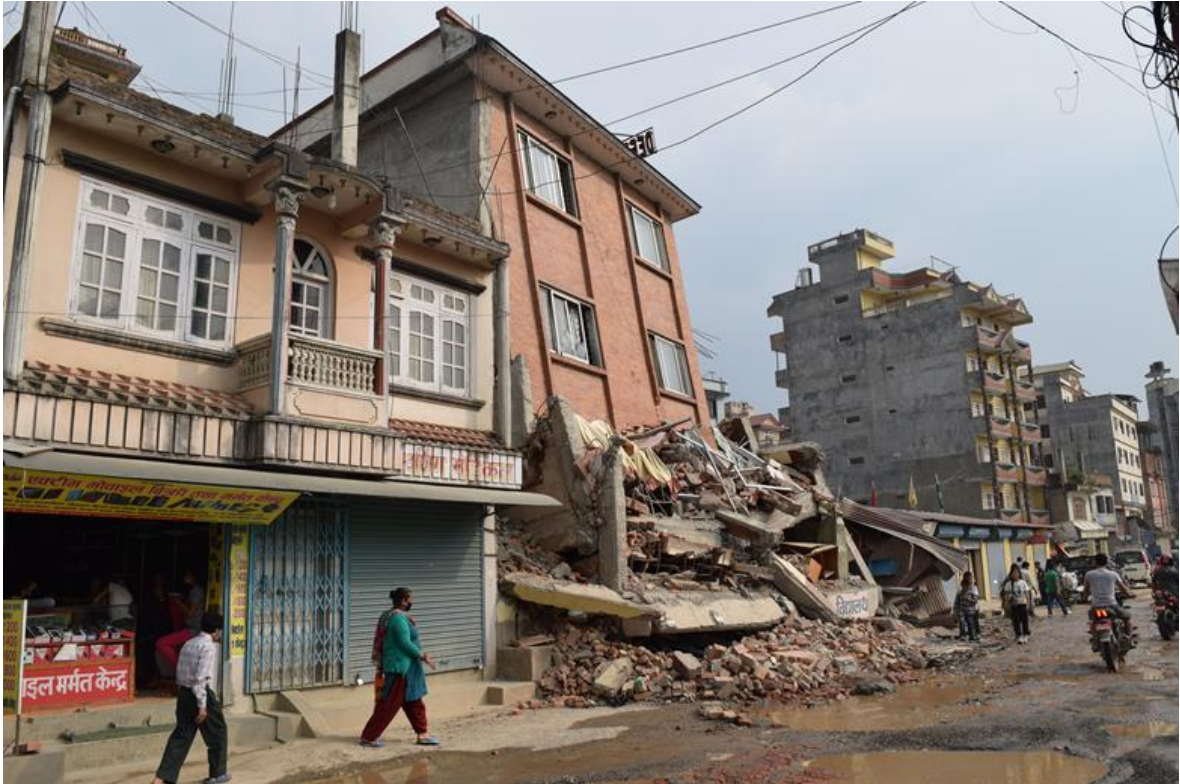
Figure 9-7 Structural damage of a RCC frame structure at Gogabu Bus Park near Balaju (27°44'7" N, 85°18'29" E).

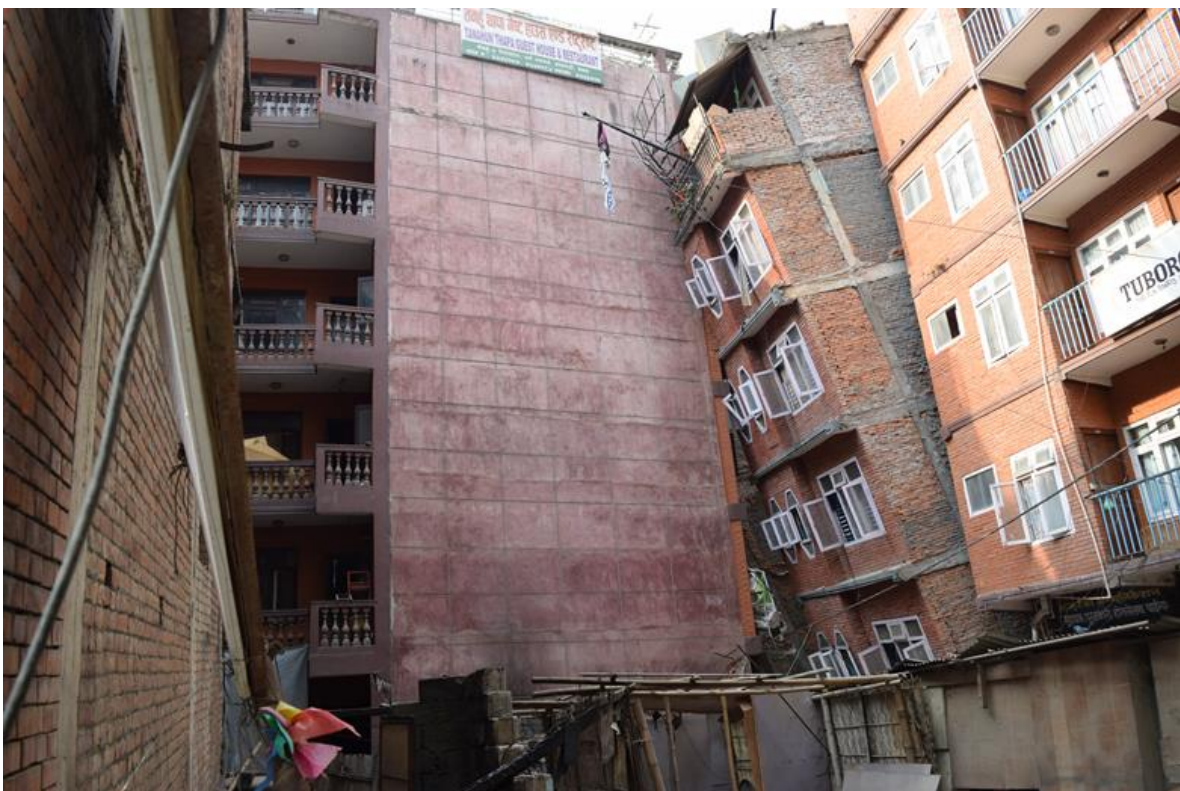
Figure 9-8 Soft story collapse of a six story building near Gogabu Bus Park. Three buildings were completely damaged in the neighborhood that killed over 20 people (27°44'06" N, 85°18'32" E).

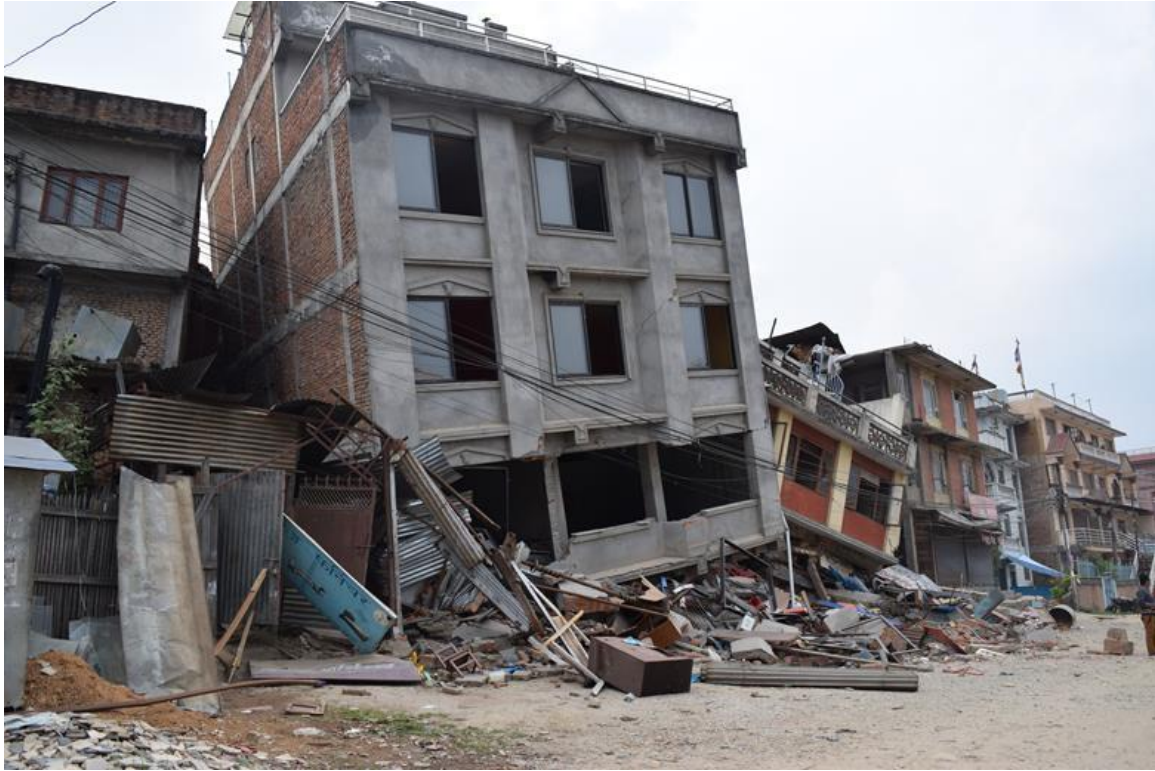
Figure 9-13 Five buildings collapsed along the ridge line at Sitapaila area near Ring Road at Swayambhunath. One building at the rightmost part of the picture was not damaged ( $27^{\circ}42.7'0''$  N,  $85^{\circ}17'0''$  E).

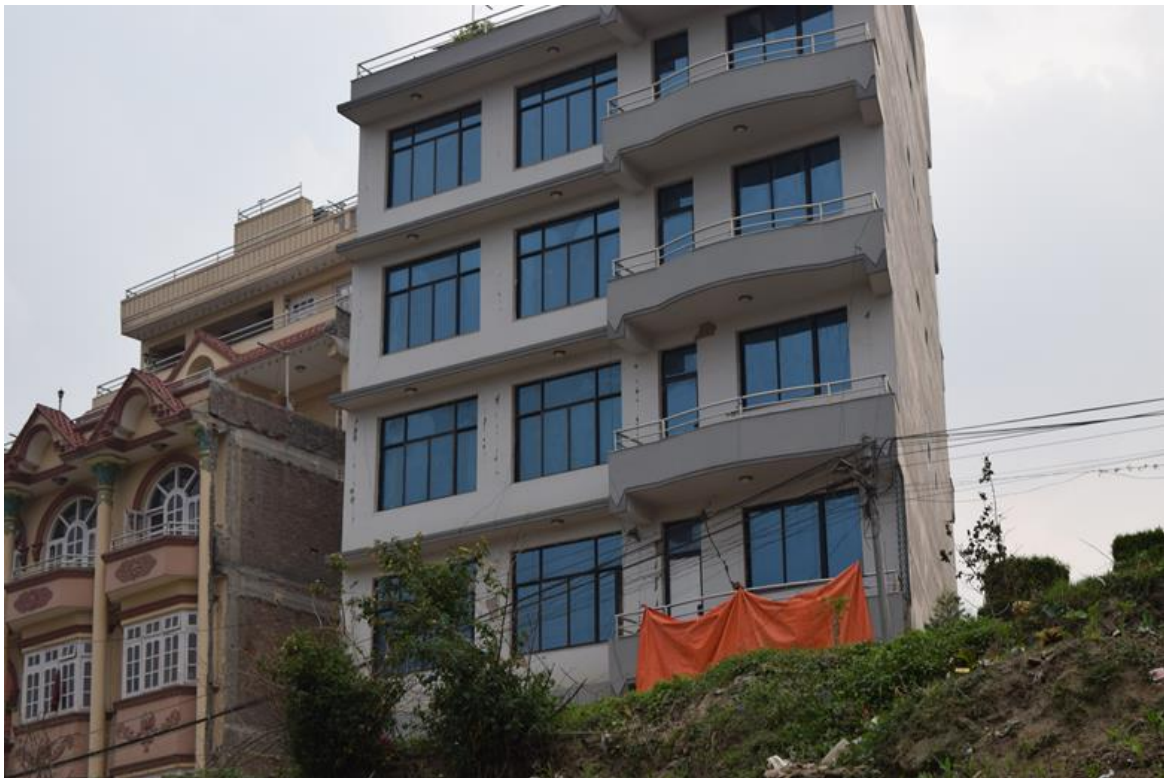
Figure 9-14 Recently constructed buildings at Sitapaila height also sustained significant damage although did not collapse ( $27^{\circ}42'51''$  N,  $85^{\circ}16'58''$  E).

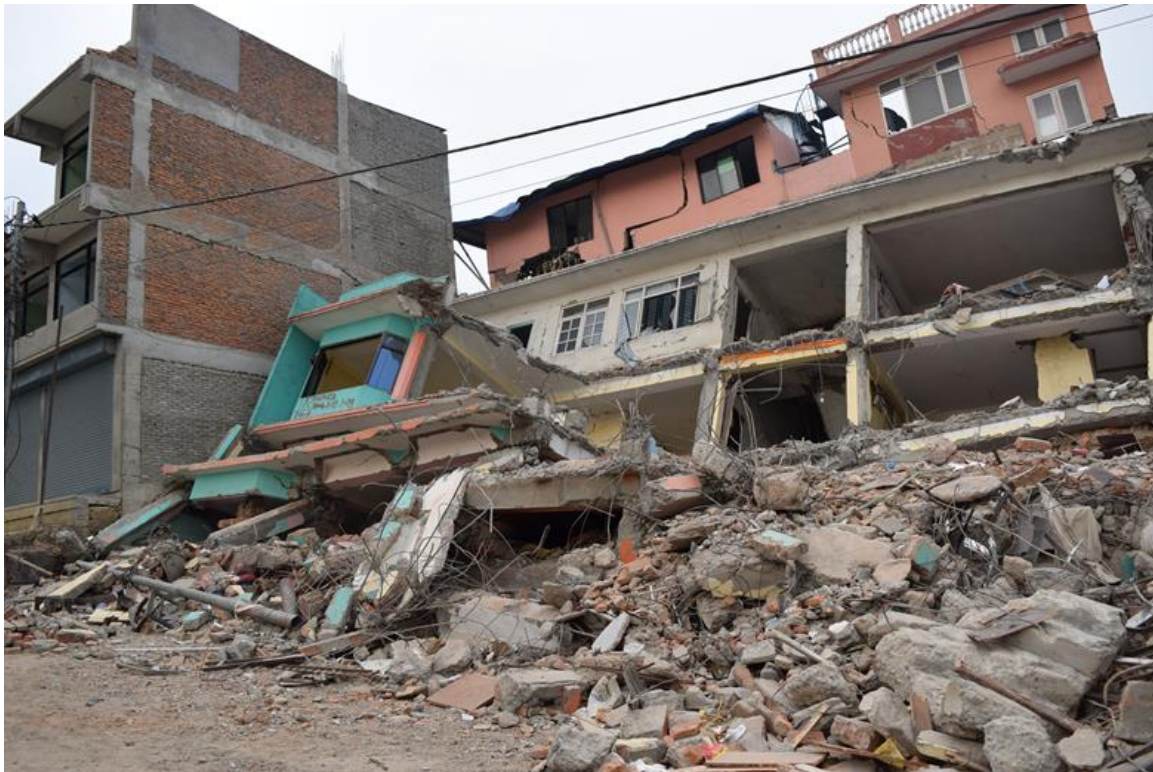
Figure 9-15 Collapse of two multi story buildings at Sitapaila killed over 20 people (27°42.7'0"N, 85°17'0"E).

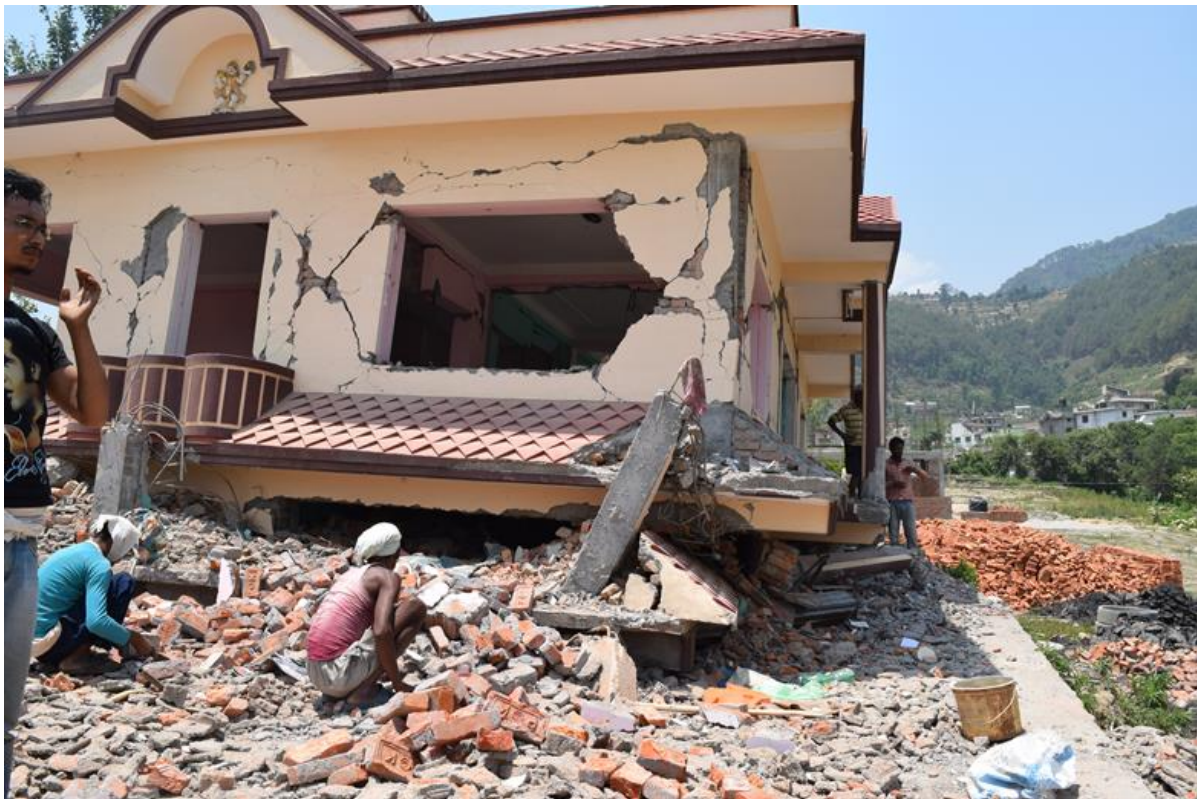
Figure 9-17 Typical modern building collapse pattern at Ramkot, Kathmandu.

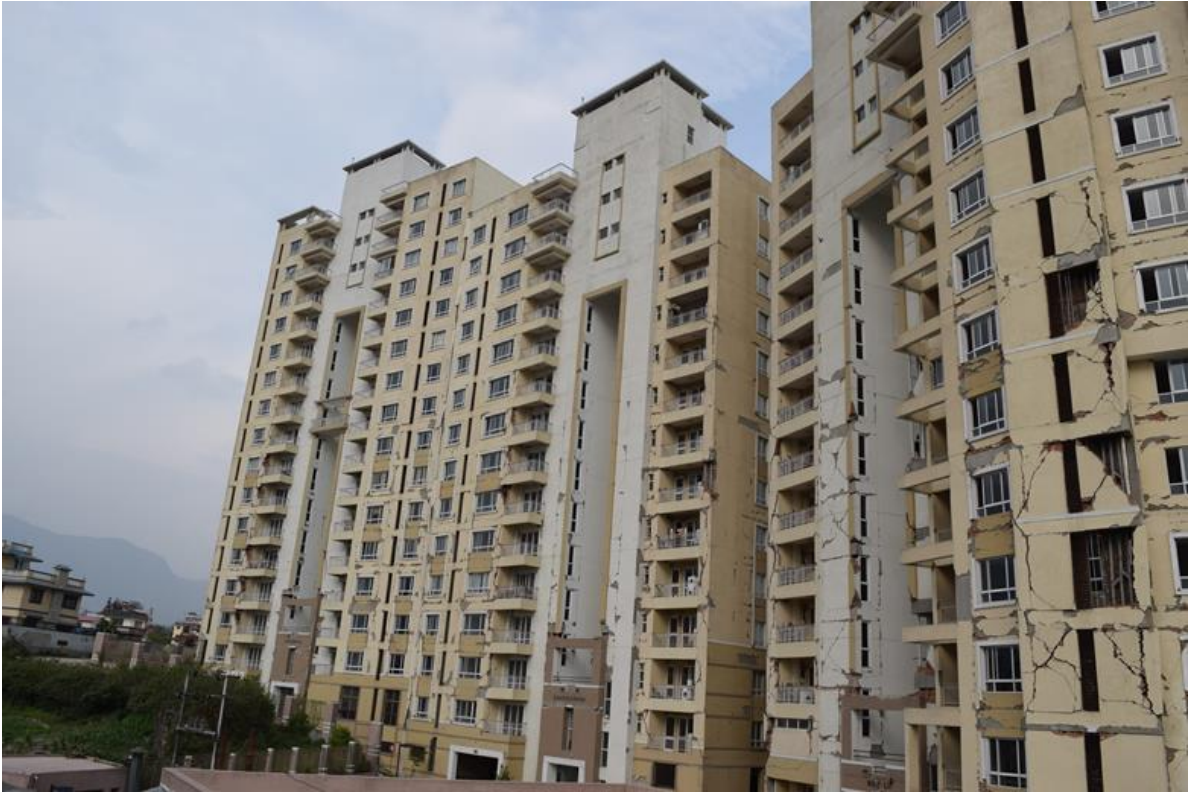
Figure 9-18 Structural damage to the park Horizon Apartment Building at Dhapasi due to the strong ground motion. Eye witness said that the buildings were pounding due to story drift due to ground shaking.

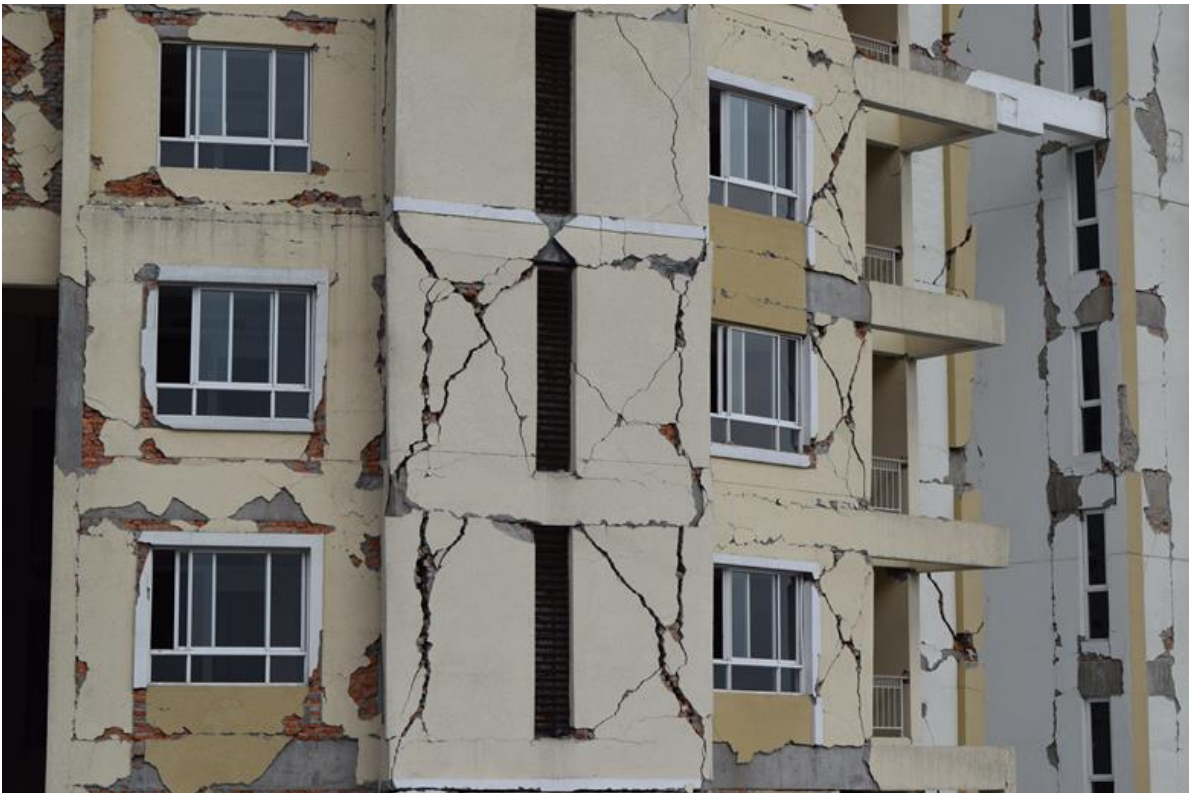
Figure 9-19 Close view of the structural damage (27°44.4'0"N, 85°19.4'0"E).

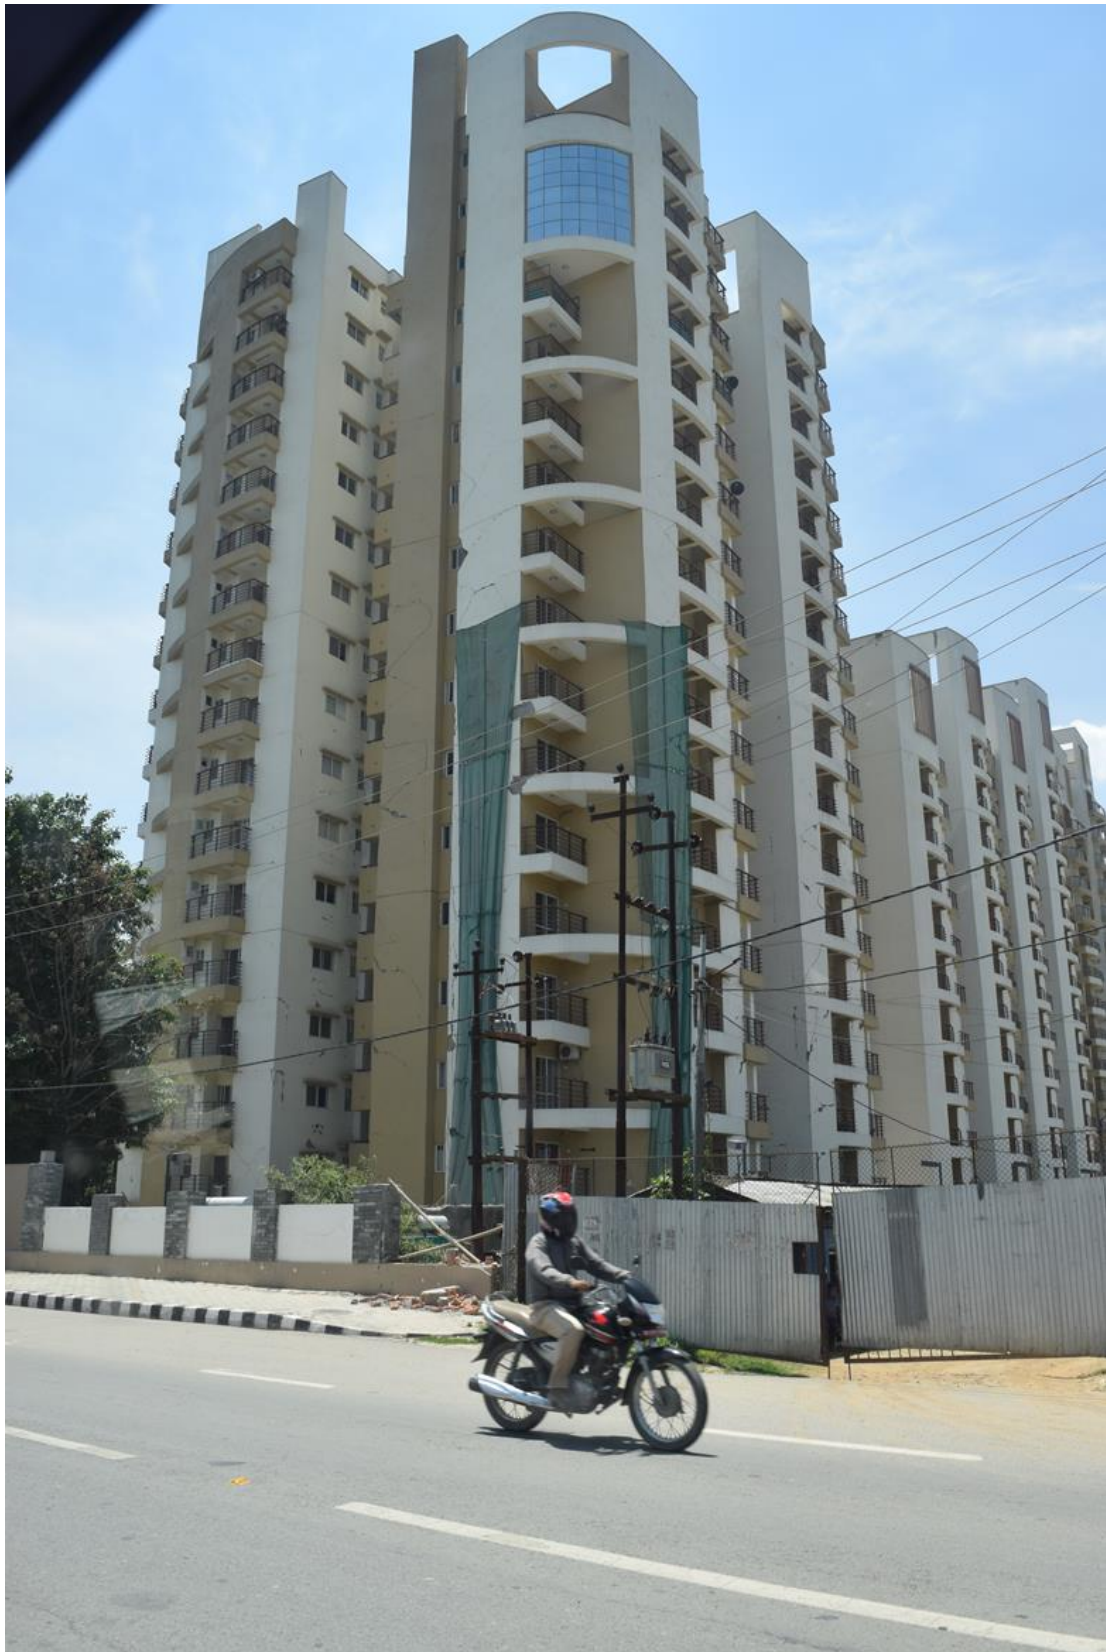
Figure 9-22 A high rise apartment building at Hattiban, Lalitpur. This building also sustained some major damage due to the earthquake.

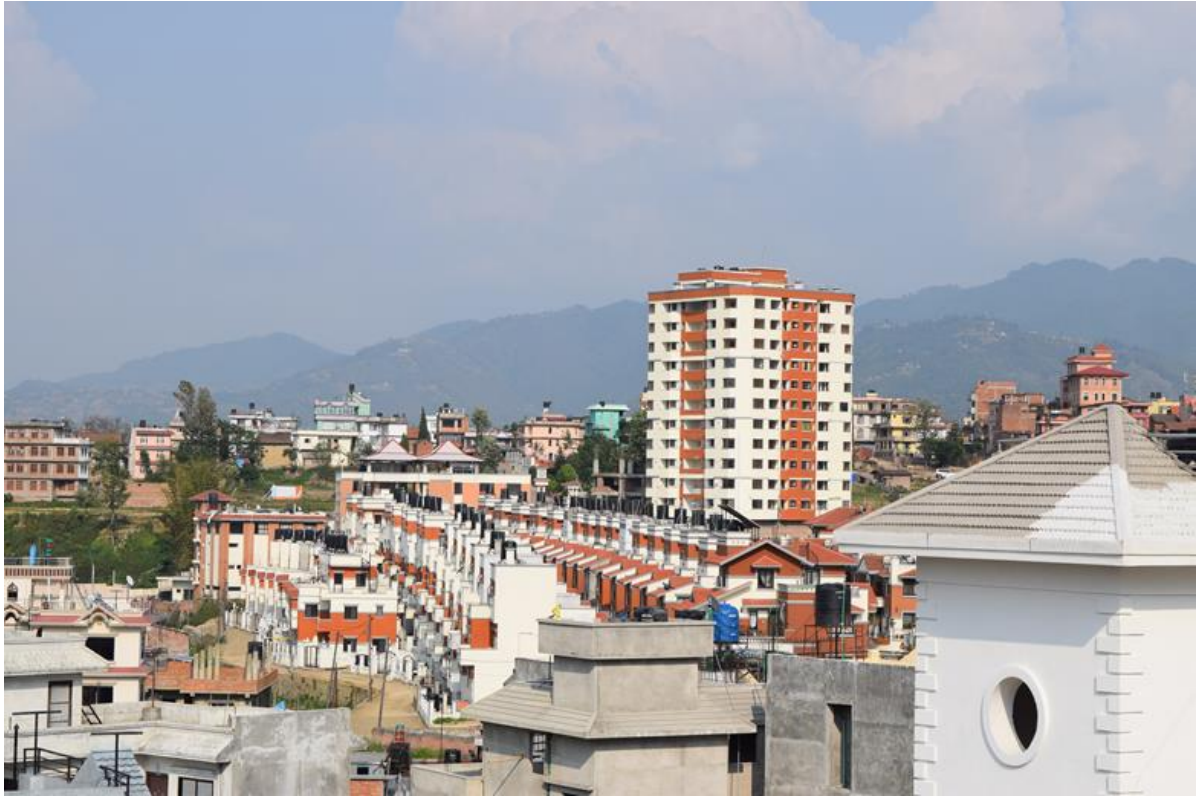
Figure 9-23 High rise apartment complex at Hattiban that sustained some damage due to earthquake shaking ( $27^{\circ}38'59''$  N,  $85^{\circ}19'46''$  E).

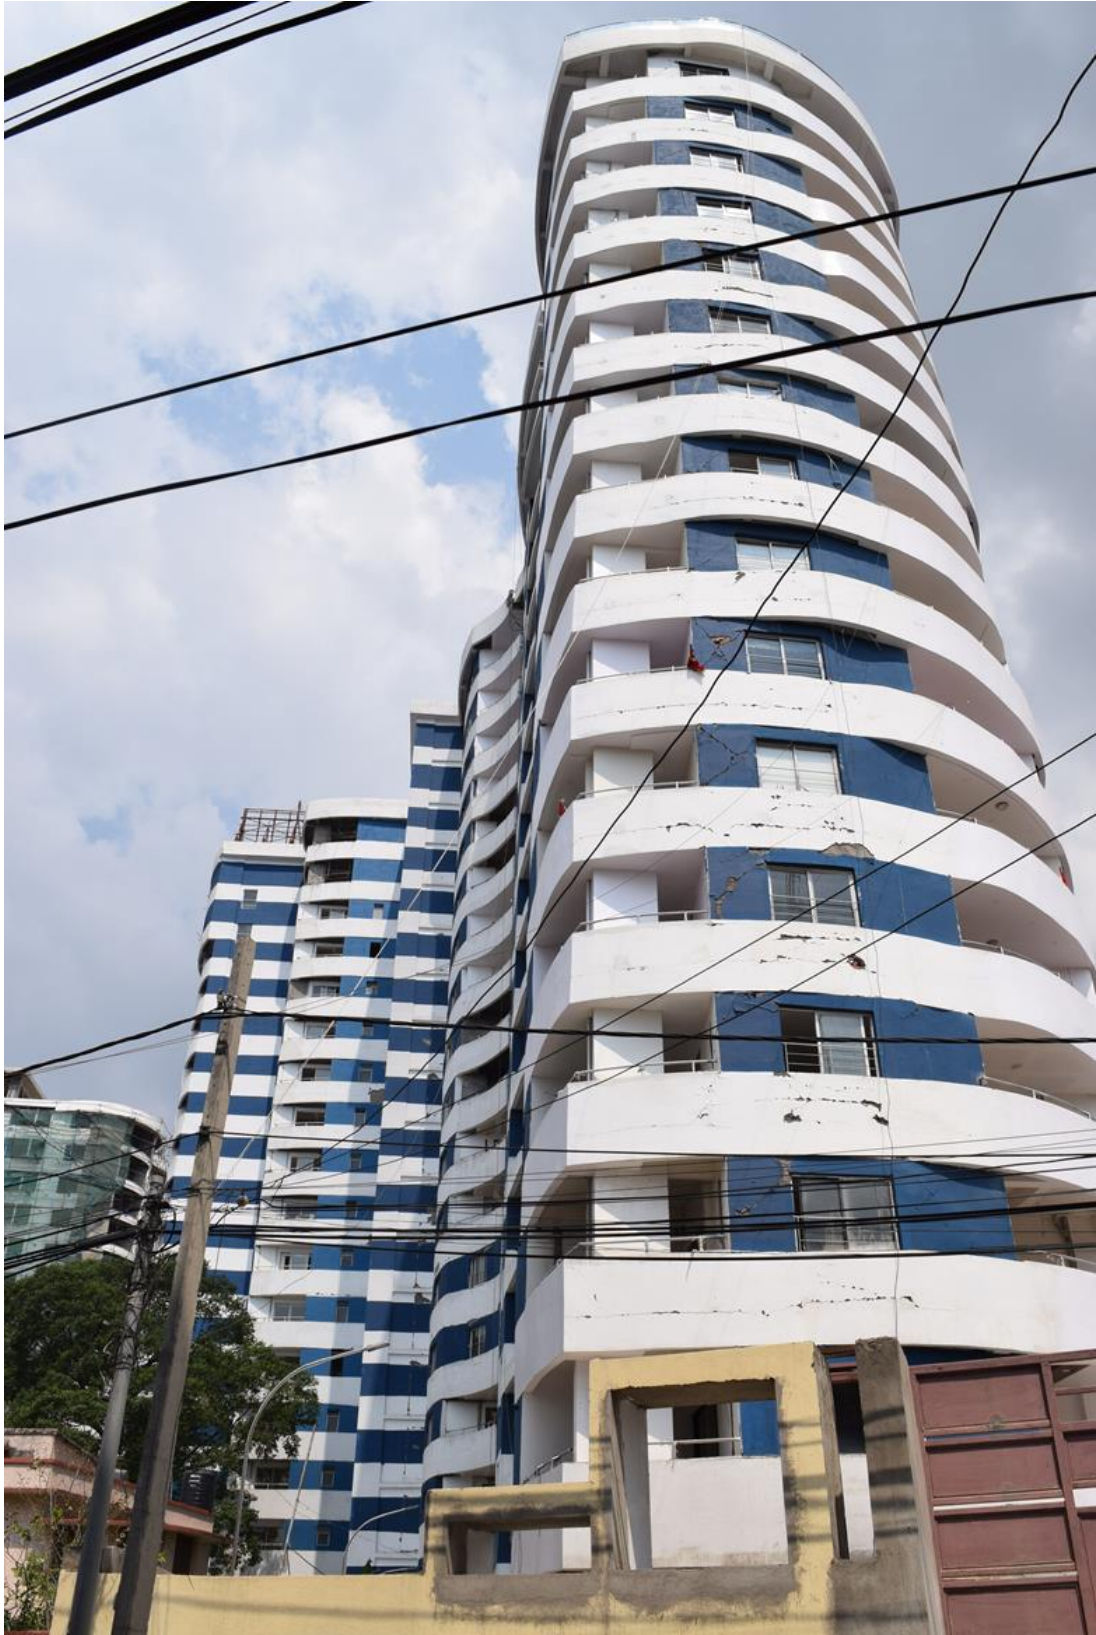
Figure 9-25 Damage observed at an apartment complex in Kalikasthan ( $27^{\circ}42'13''$  N,  $85^{\circ}19'38.3''$  E).

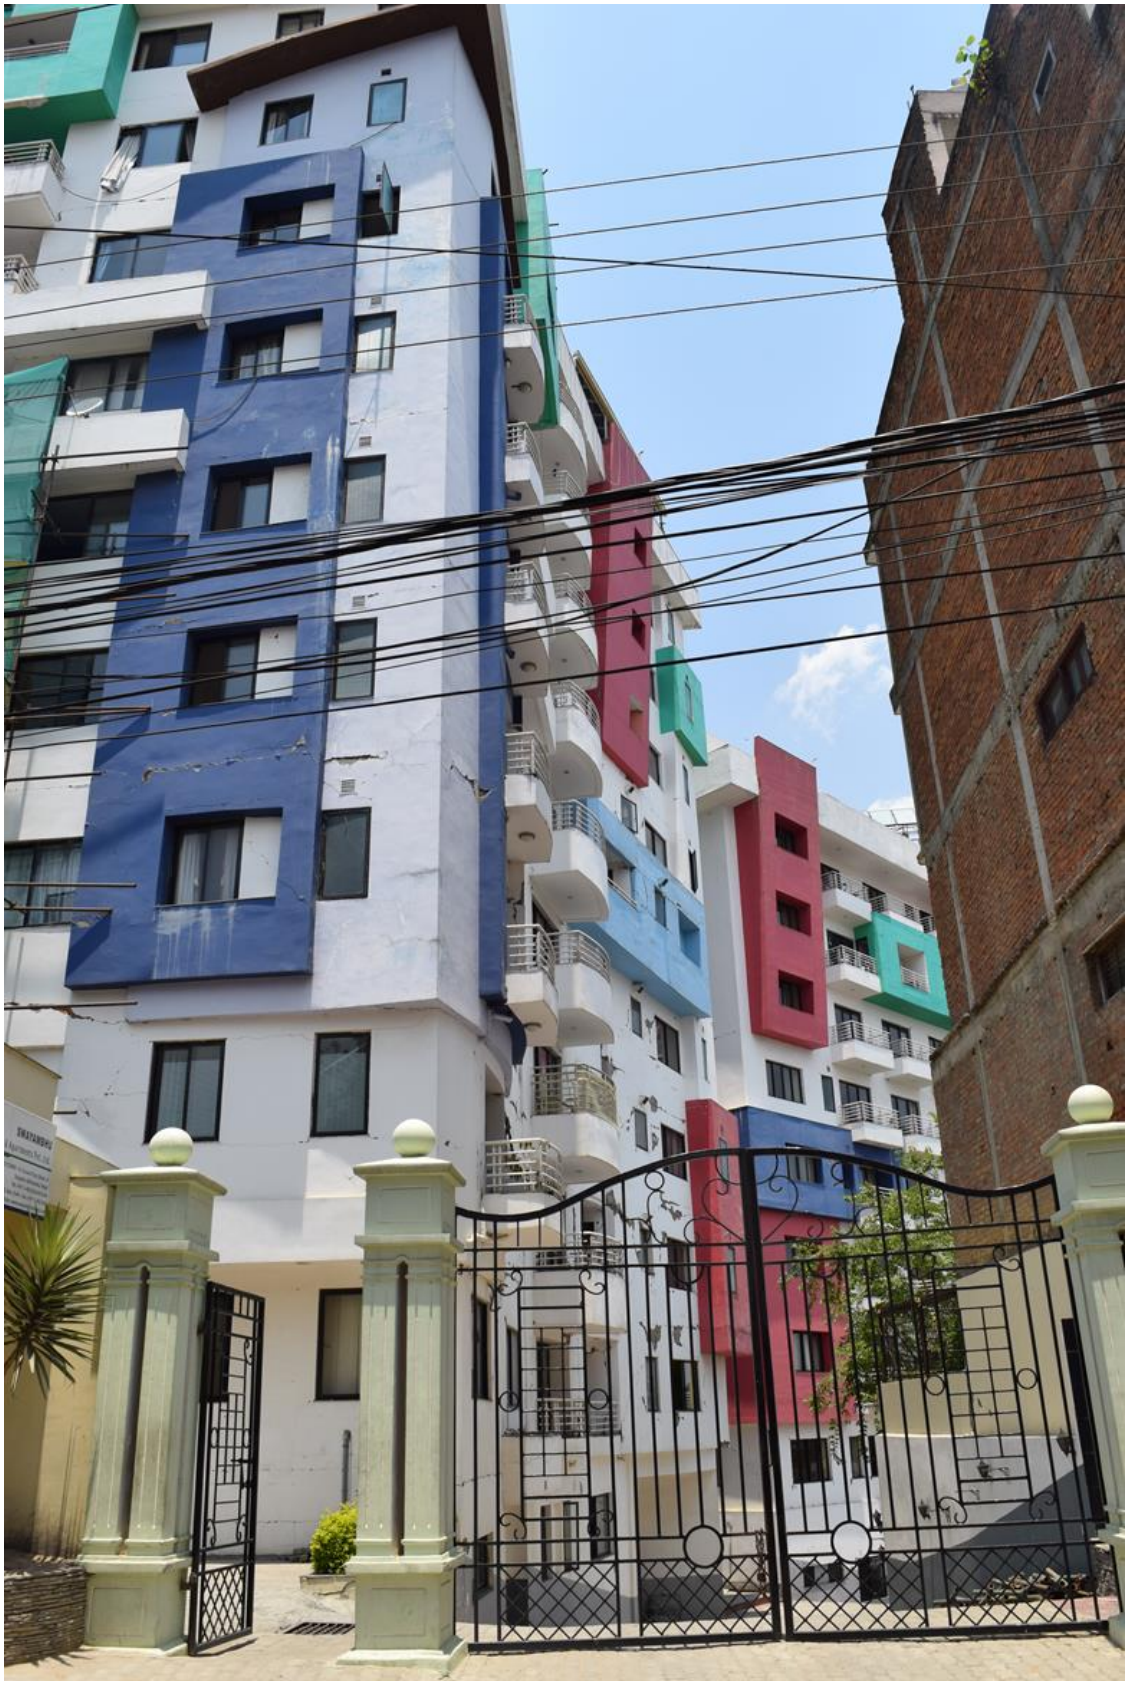
Figure 9-26 Damage observed at an apartment complex in Sitapaila

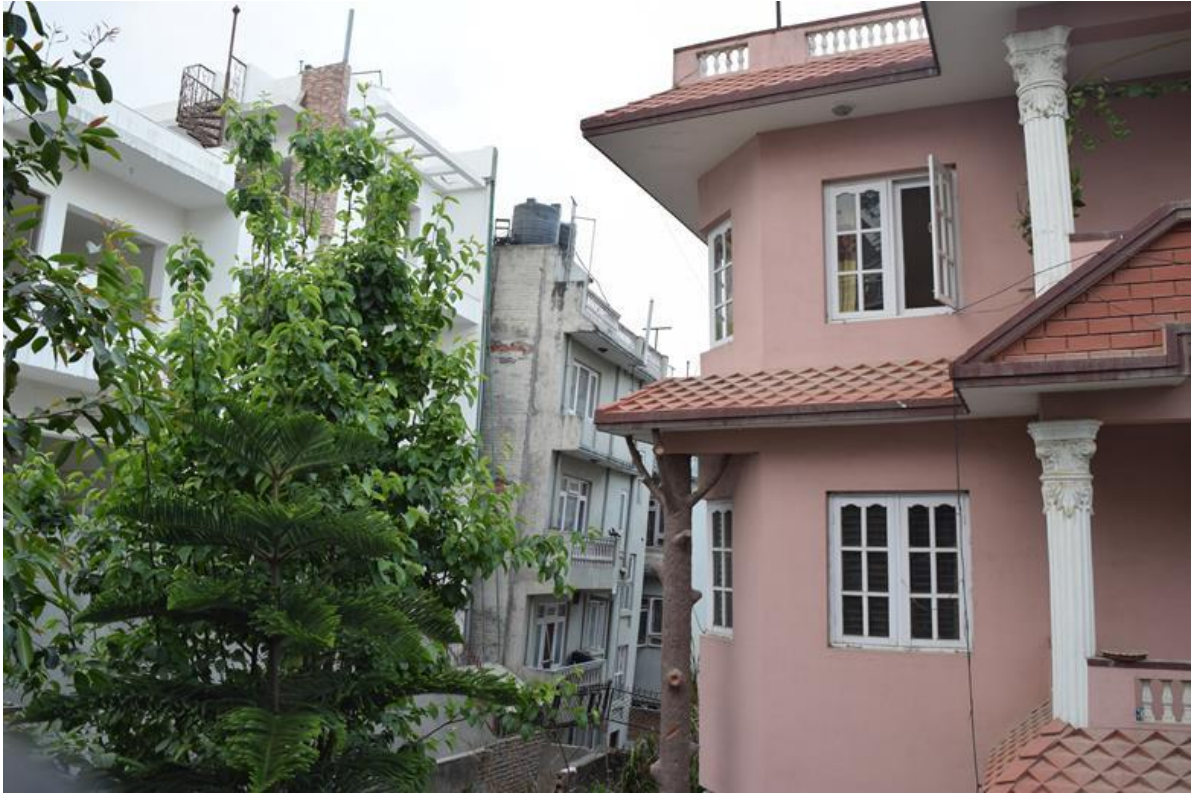
Figure 9-29 Buildings tilted at Lokanthali area (opposite side of the one presented in Figure 9-28) due to ground failure ( $27^{\circ}40'25.83''$  N,  $85^{\circ}21'44.3''$  E).

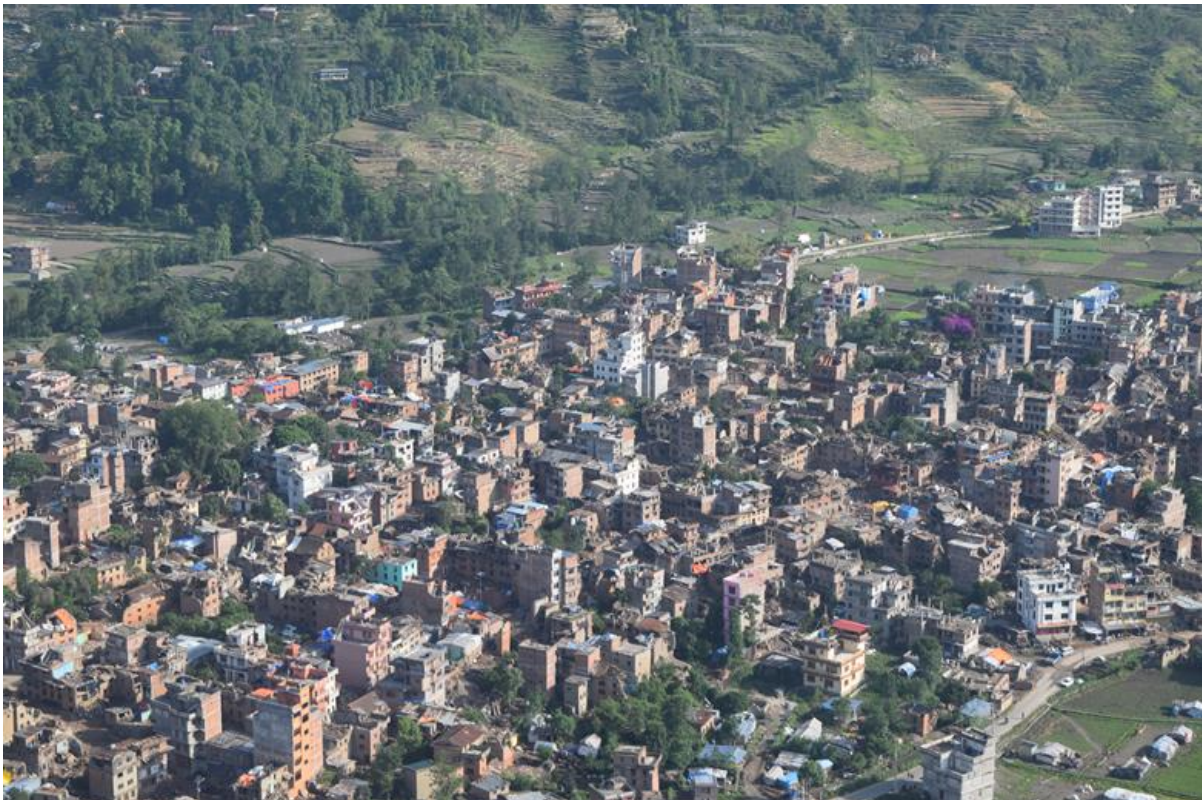
Figure 9-31 Aerial view of damage in Bhaktapur

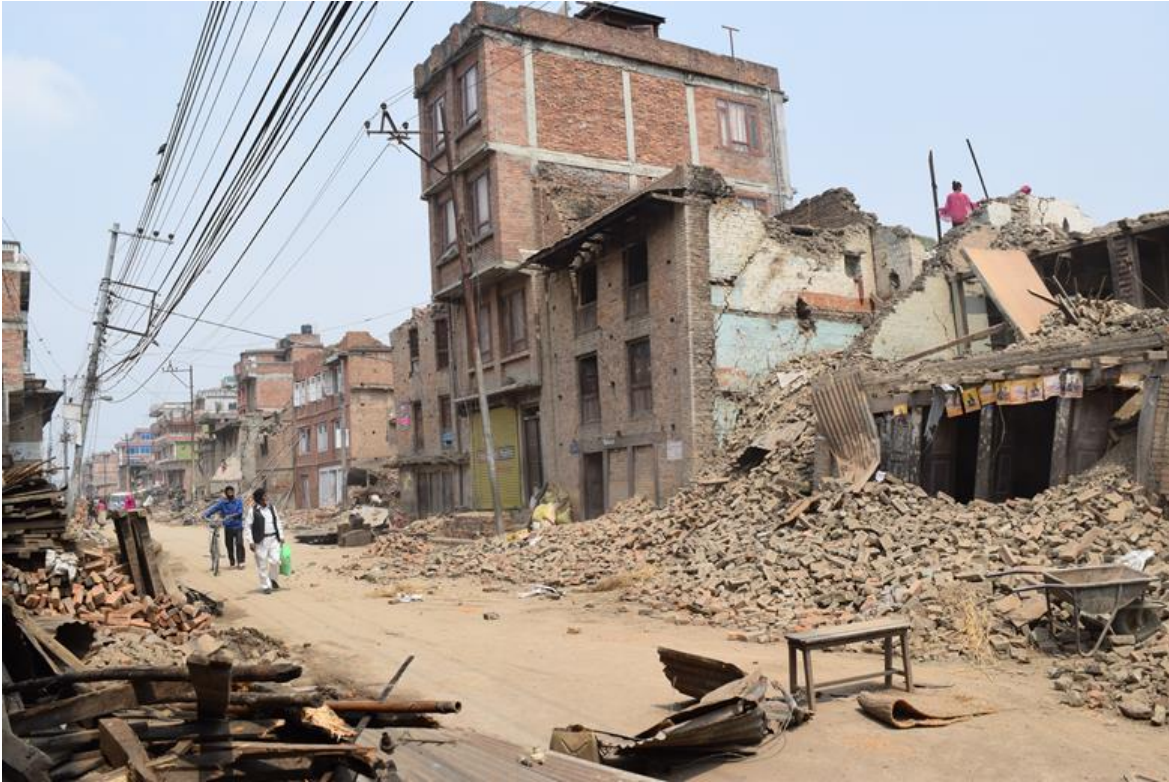
Figure 9-32 Unreinforced brick masonry in mud mortar at Bhaktapur collapsed due to ground shaking whereas the modern RCC structures did not sustain much damage (27°40'33.64" N, 85°24'26.18" E).

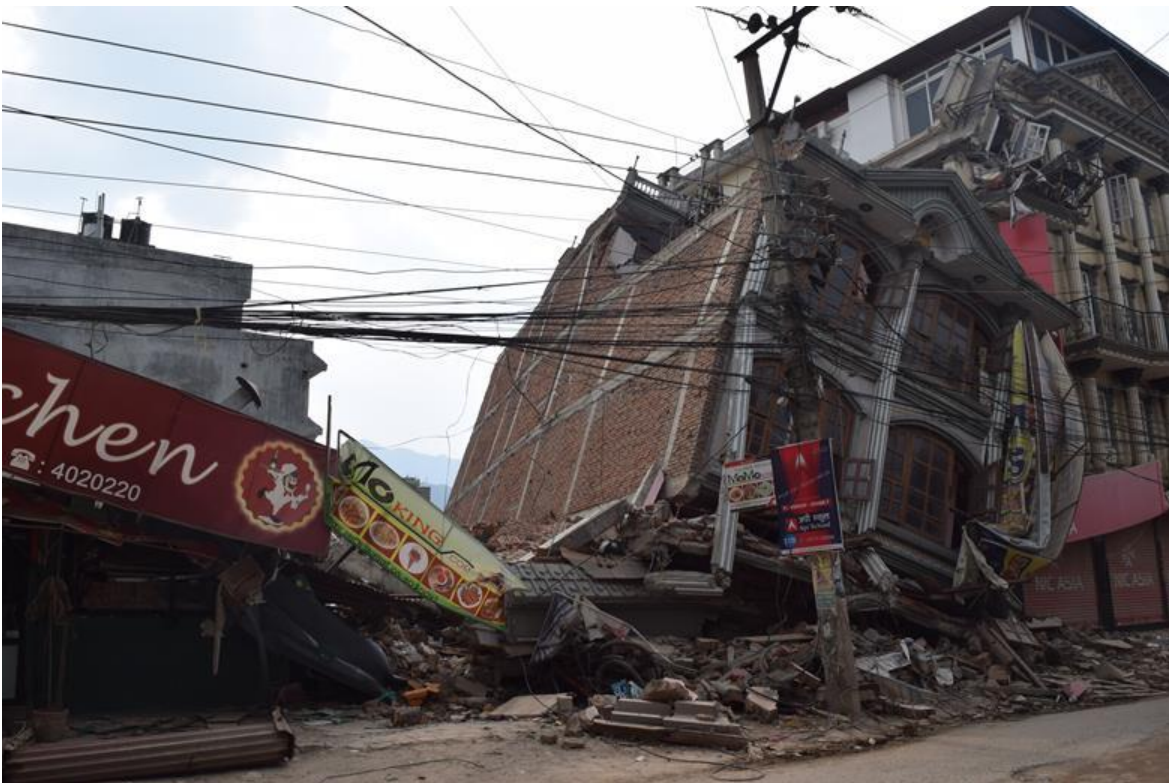
Figure 9-33 A four and half story RCC frame structure collapsed at Samakoshi, Kathmandu (27°43'49" N, 85°18'52" E).

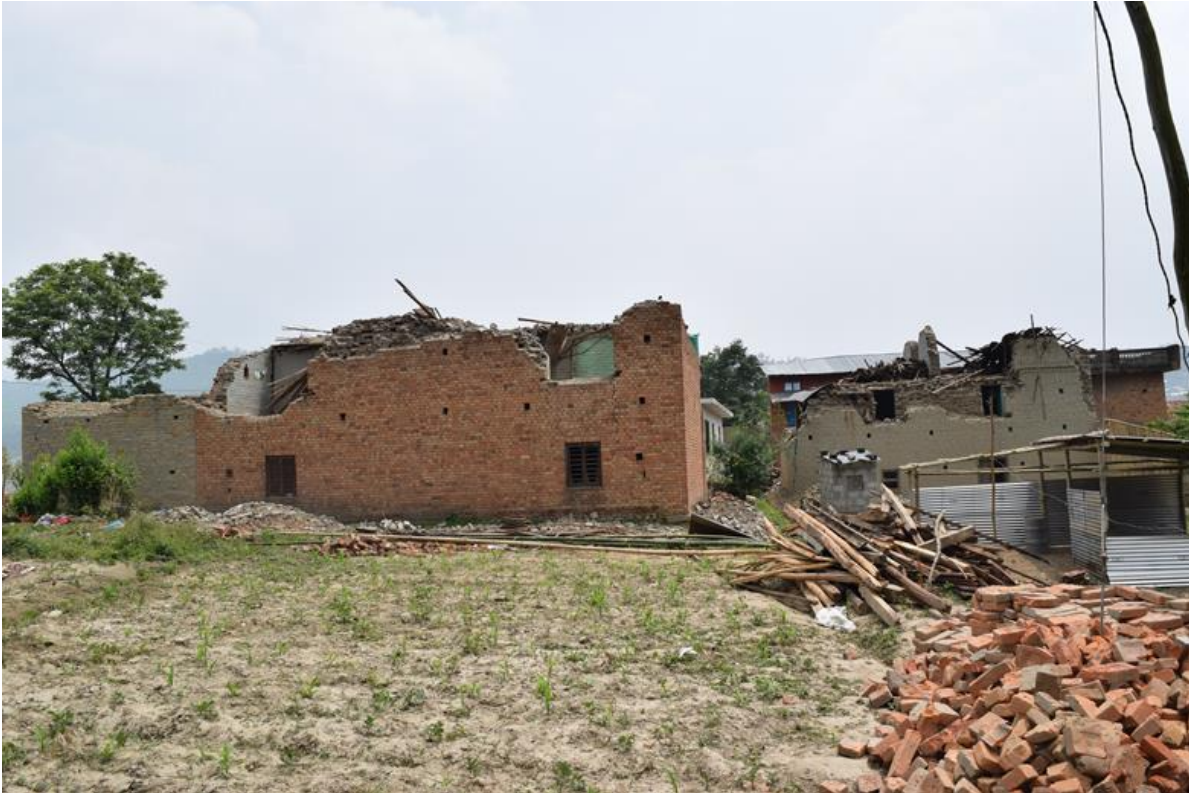
Figure 9-34 Old buildings with unreinforced brick masonry at Indrayeni Village got damaged due to ground shaking (27°43.7'0" N, 85°26.2'0" E).

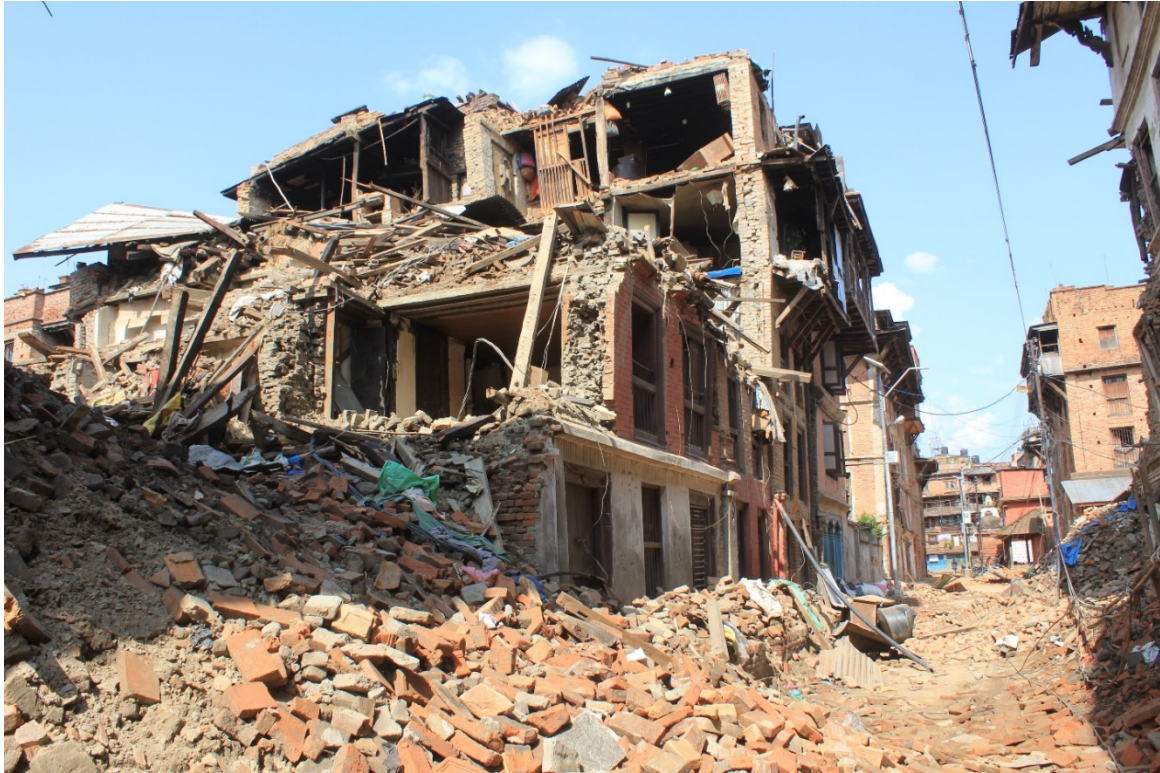
Figure 9-35 Collapsed unreinforced masonry building in Bhaktapur following the Gorkha earthquake (27° 40' 21.64" N; 85° 25' 58.24" E).

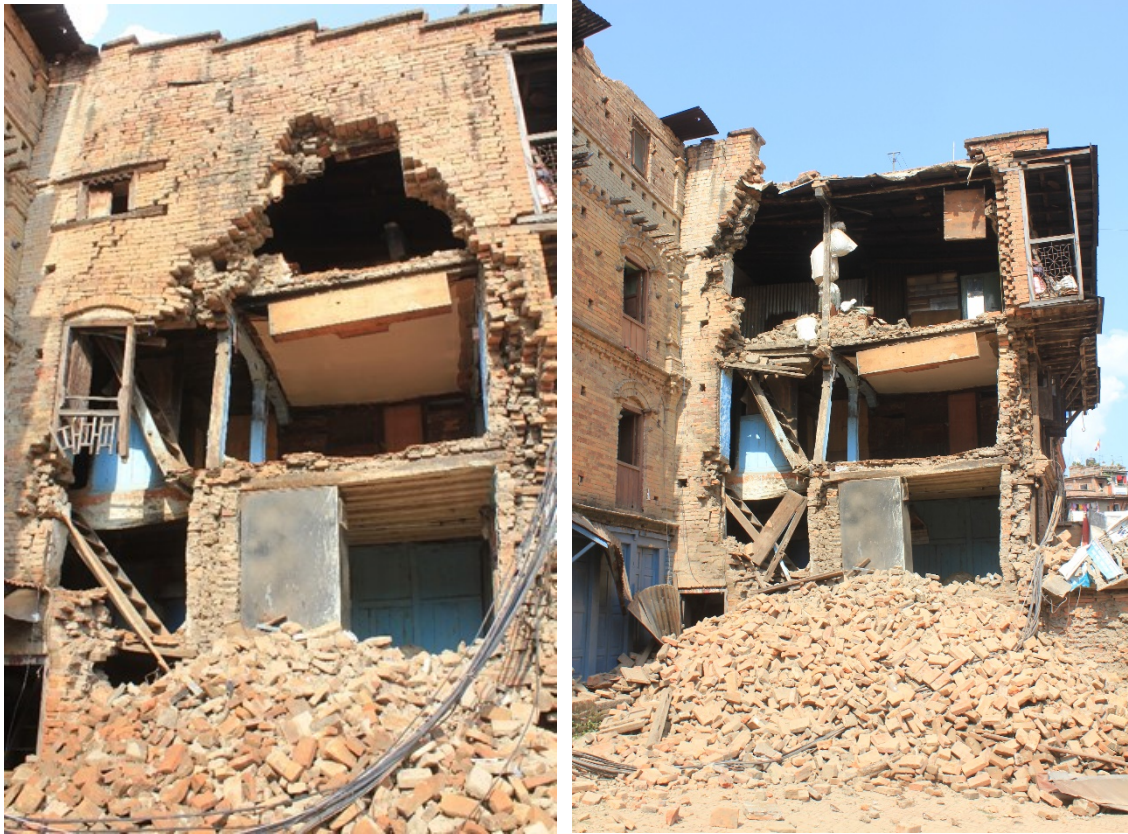
Figure 9-37 Photos on left taken May 11, 2015 and photo on right taken after the May 12, 2015  $M_w$  7.3 aftershock. Already damaged unreinforced masonry building experienced additional collapse ( $27^{\circ} 40' 21.15''$  N;  $85^{\circ} 25' 56.23''$  E).

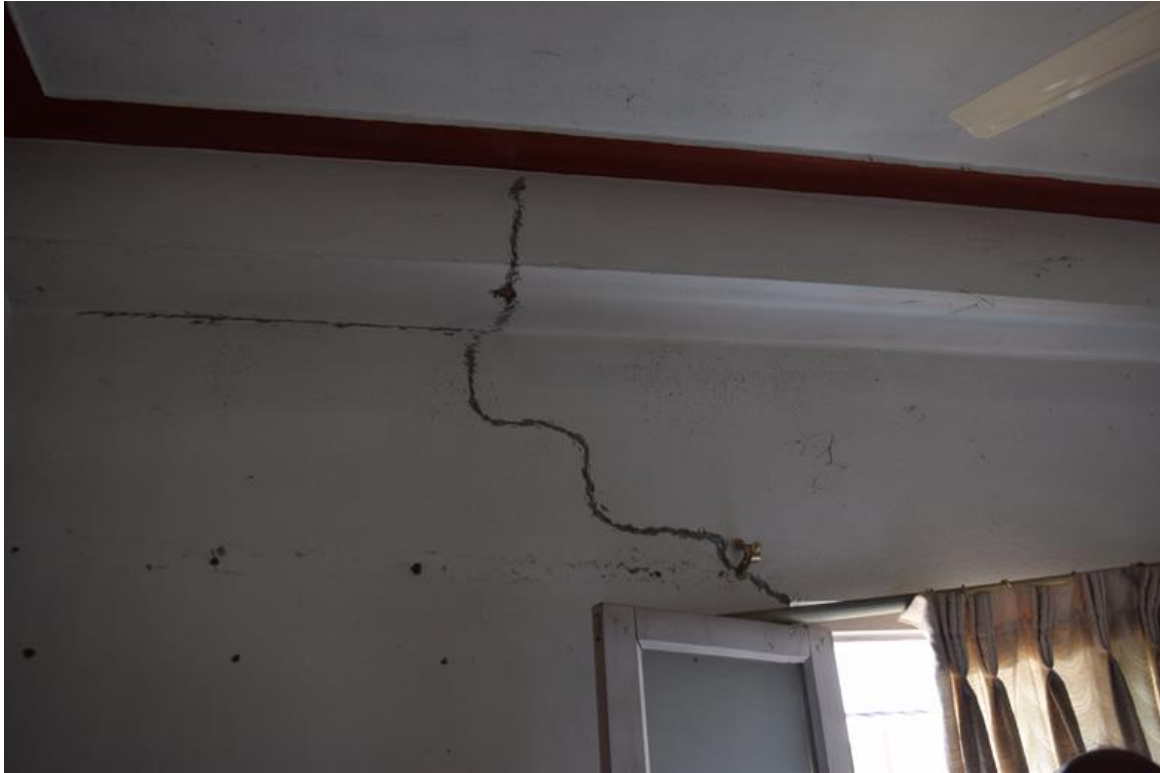
Figure 9-39 Structural damaged observed in a high school building at Pokhara.
