**Authors:** Youssef M.A. Hashash (UIUC), Binod Tiwari (CSF), Robb E. S. Moss (CalPoly), Domniki Asimaki (Caltech), Kevin B. Clahan (LCI), D. Scott Kieffer (TUGraz), Doug S. Dreger (UCB), Amy Macdonald (TT), Chris M. Madugo (PG&E), H. Benjamin Mason (OSU), Menzer Pehlivan (MRCE), Deepak Rayamajhi (OSU), Indra Acharya (TU) and Basanta Adhikari (TU).

## Executive Summary

The April 25, 2015 Gorkha (Nepal) Earthquake and its related aftershocks had a devastating impact on Nepal. The earthquake sequence resulted in nearly 9,000 deaths, tens of thousands of injuries, and has left hundreds of thousands of inhabitants homeless. With economic losses estimated at several billion US dollars, the financial impact to Nepal is severe and the rebuilding phase will likely span many years.

The Geotechnical Extreme Events Reconnaissance (GEER) Association assembled a reconnaissance team under the leadership of D. Scott Kieffer, Binod Tiwari and Youssef M.A. Hashash to evaluate geotechnical impacts of the April 25, 2015 Gorkha Earthquake and its related aftershocks. The focus of the reconnaissance was on time-sensitive (perishable) data, and the GEER team included a large group of experts in the a

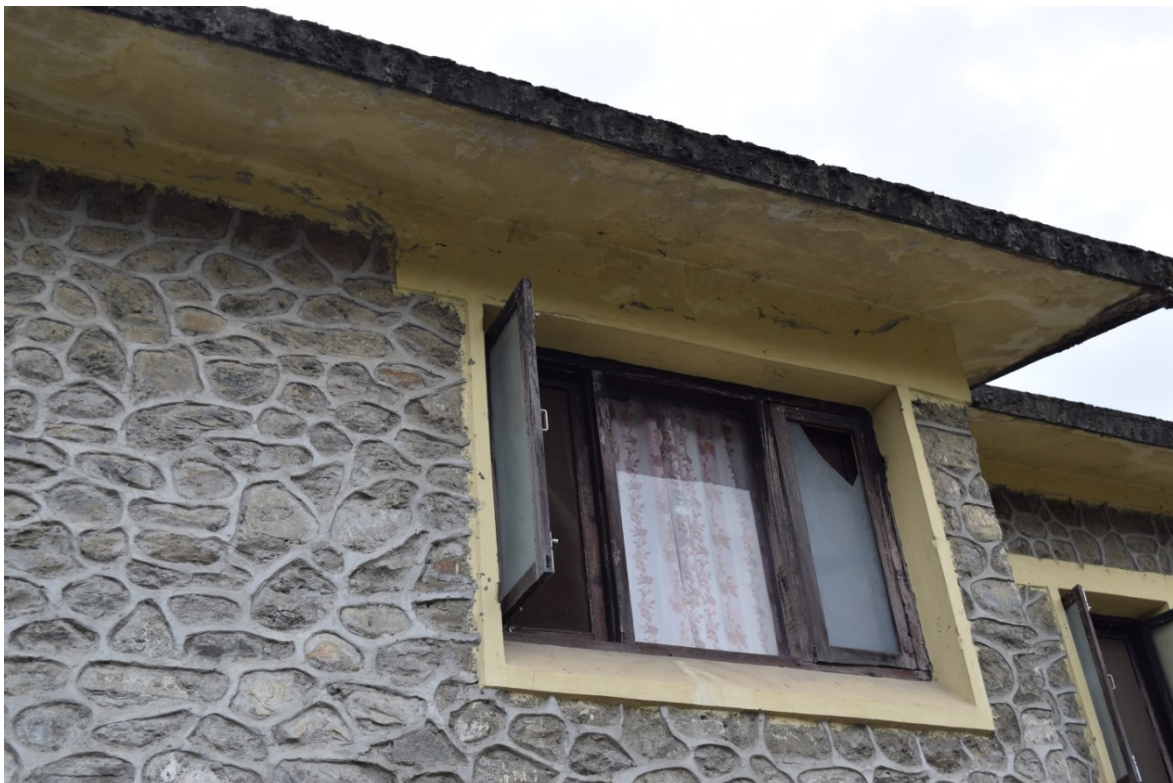
Figure 9-40 Damage to stone masonry walls under heavy roof at the staff quarter of Western Region Campus of the Institute of Engineering.

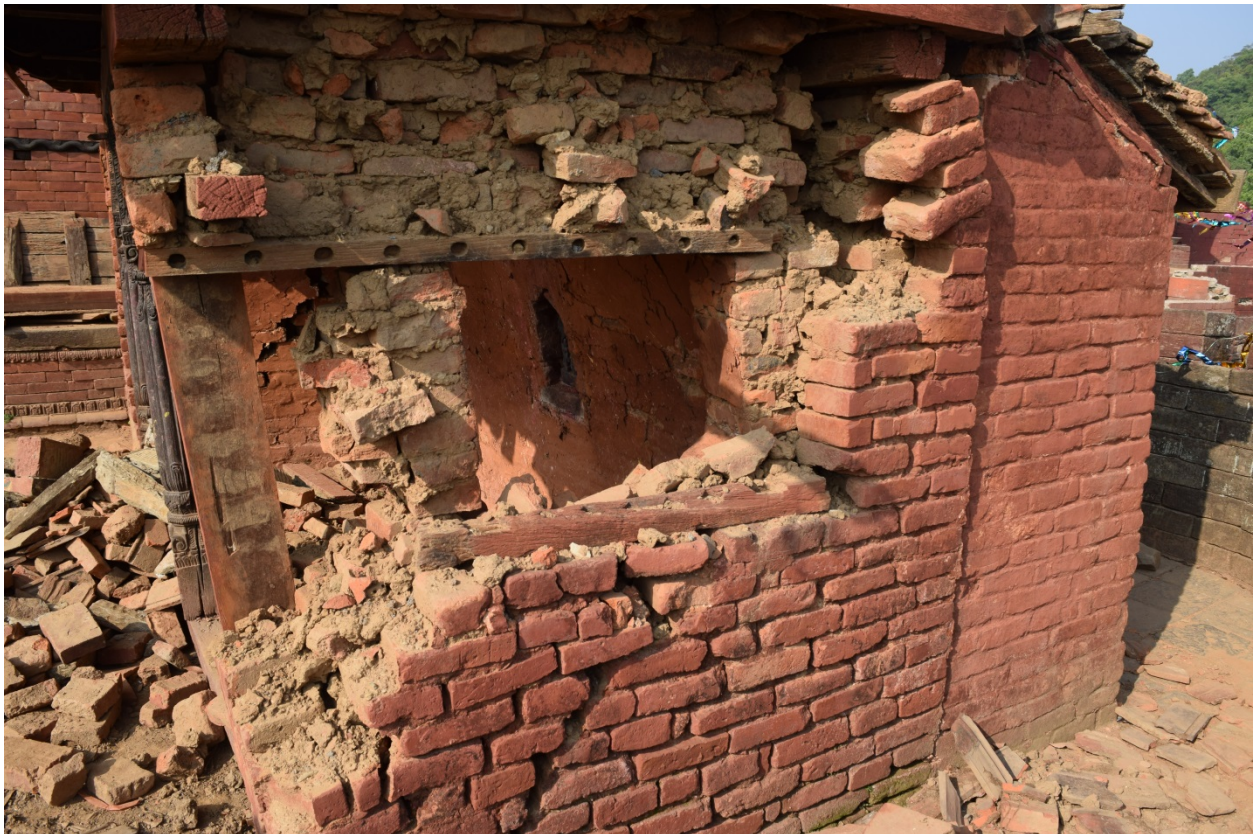
Figure 9-44 Damage to Gorakhnath Temple walls due to the earthquake shaking (28°0.217'0" N, 84°38.3'0" E).

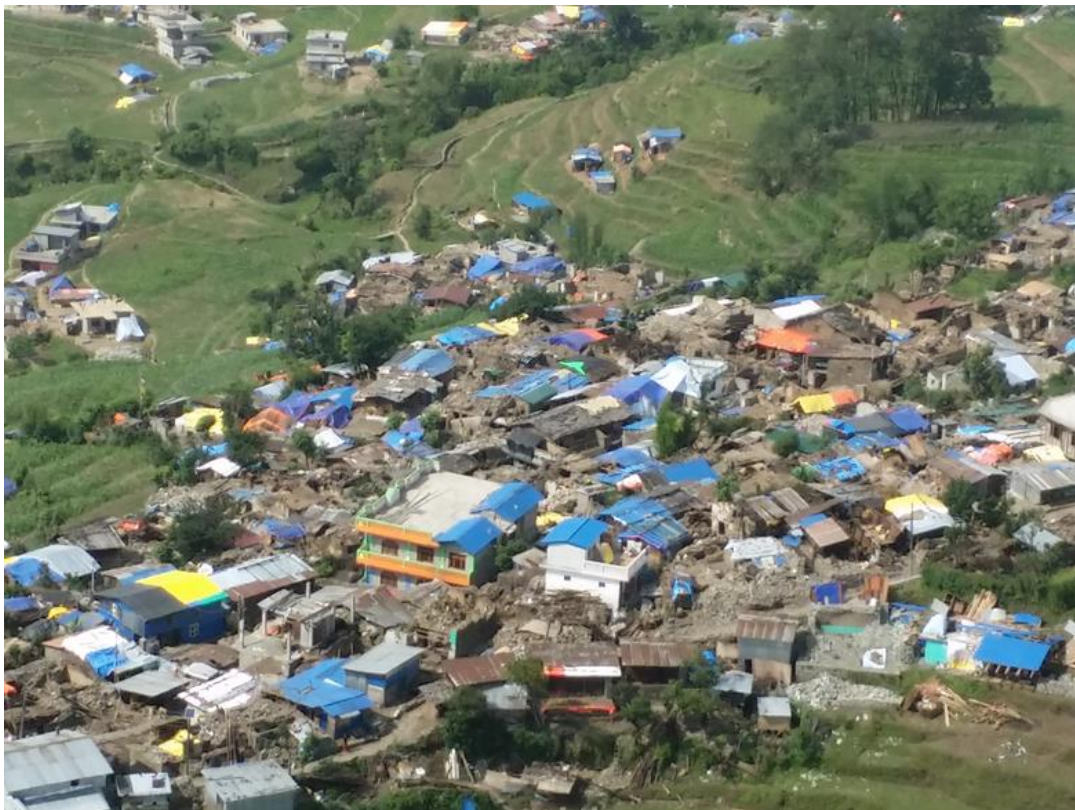
Figure 9-48 Closer look at the earthquake damage to stone masonry and RCC buildings.

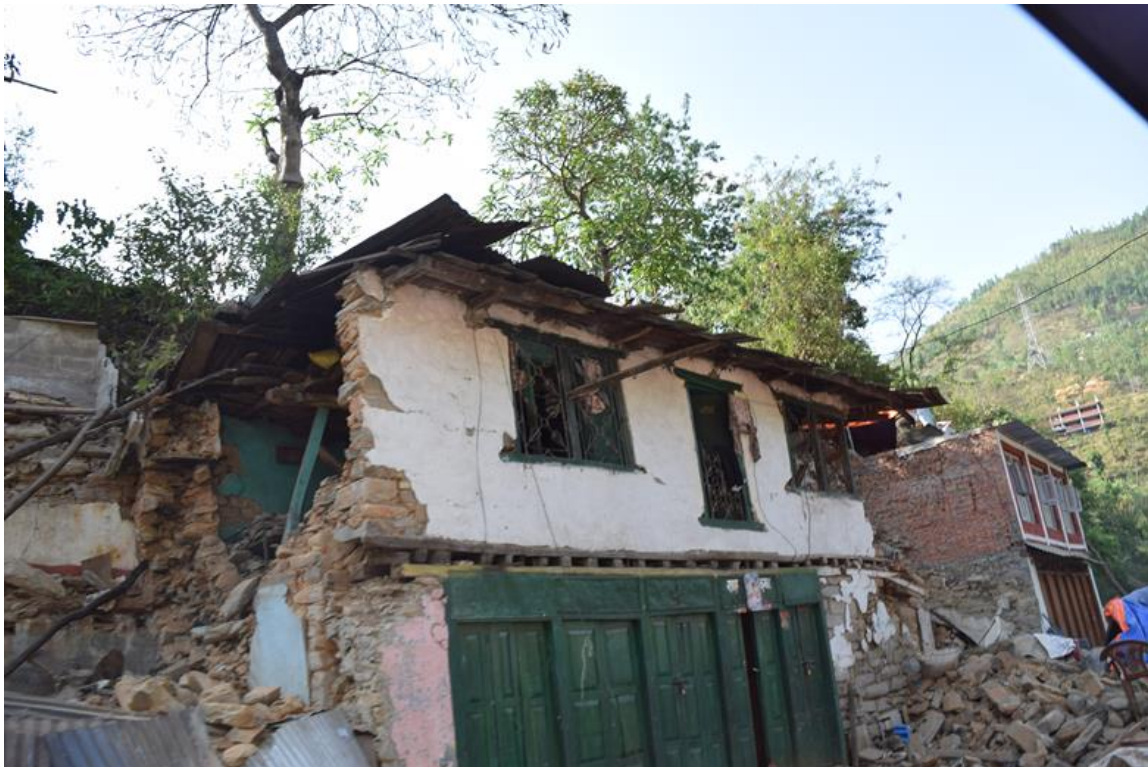
Figure 9-53 Old unreinforced masonry buildings sustained massive damage while modern buildings performed relatively better at Dolalghat, Kavre District, along Araniko Highway.

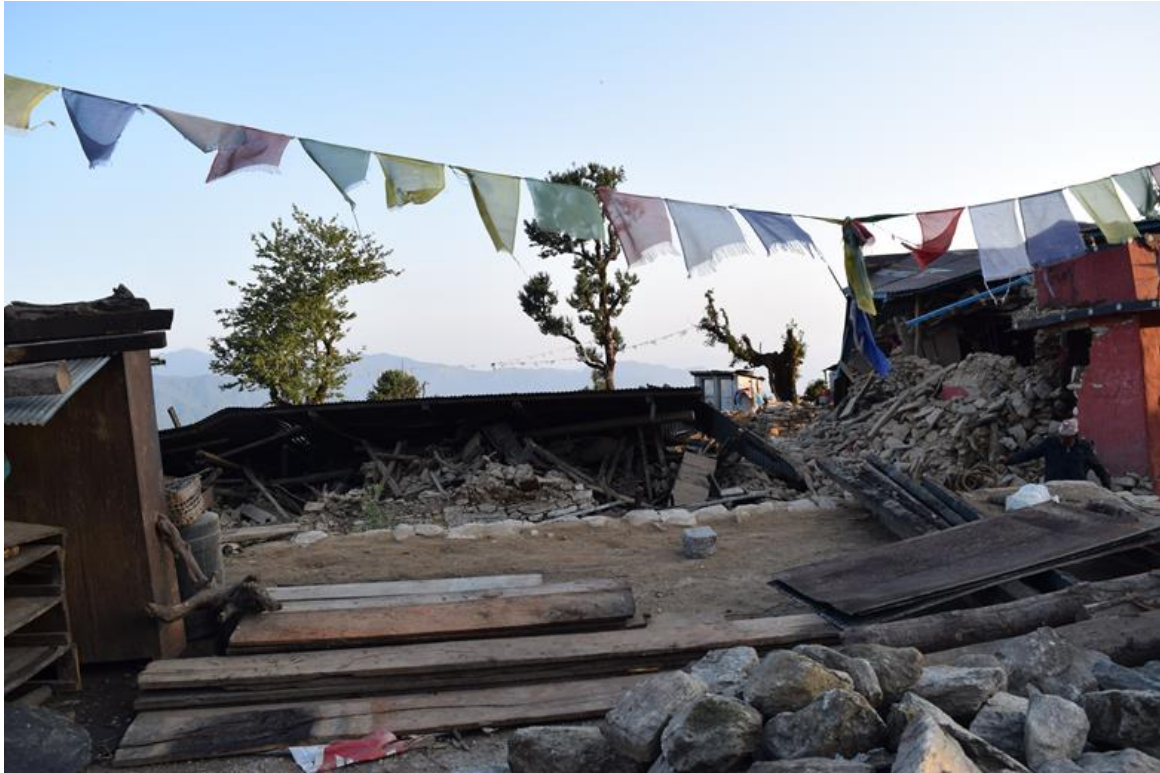
Figure 9-54 Several old unreinforced masonry buildings collapsed in Mude, Dolakha.

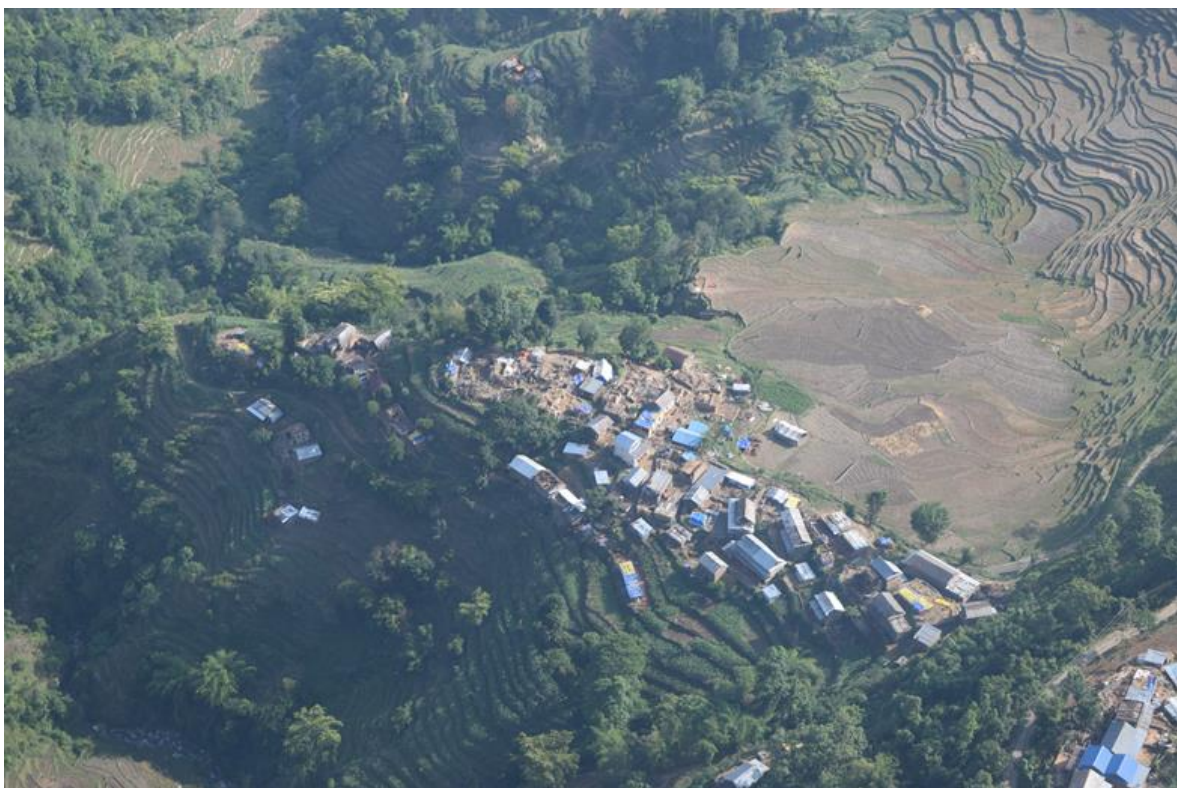
Figure 9-57 Aerial view of building damage at a ridge in Sindhupalchowk – aerial way to Lamabagar.

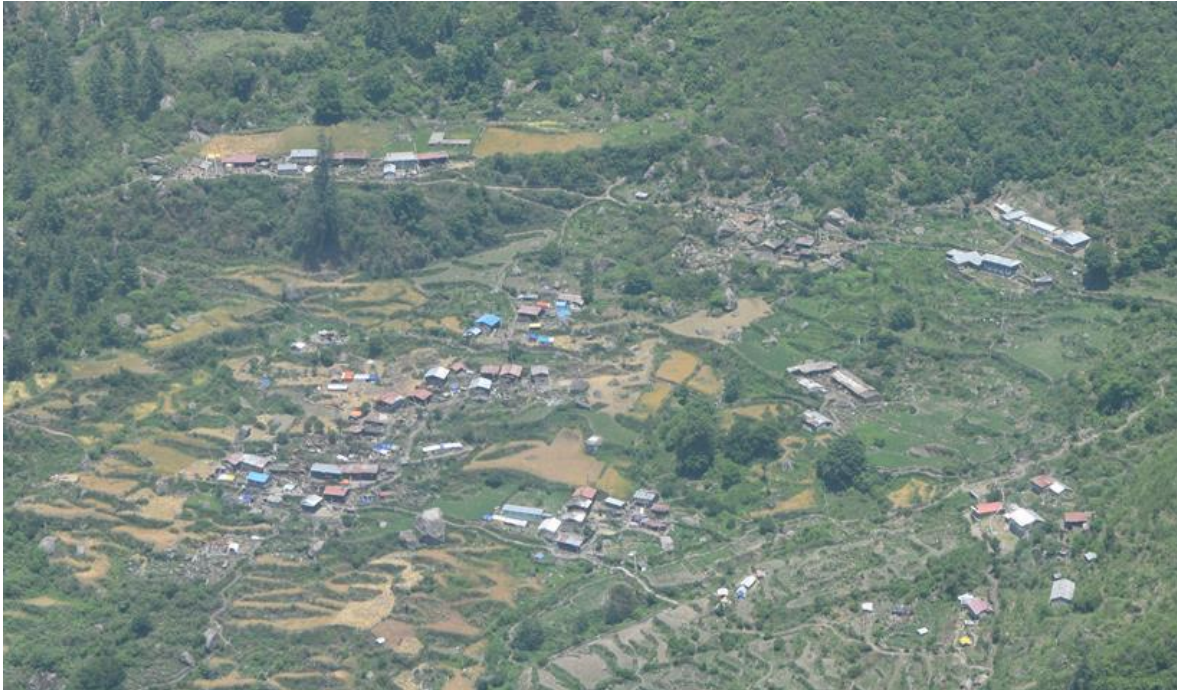
Figure 9-61 Building damage due to seismic shaking near Rasuwagadi of Rasuwa district.

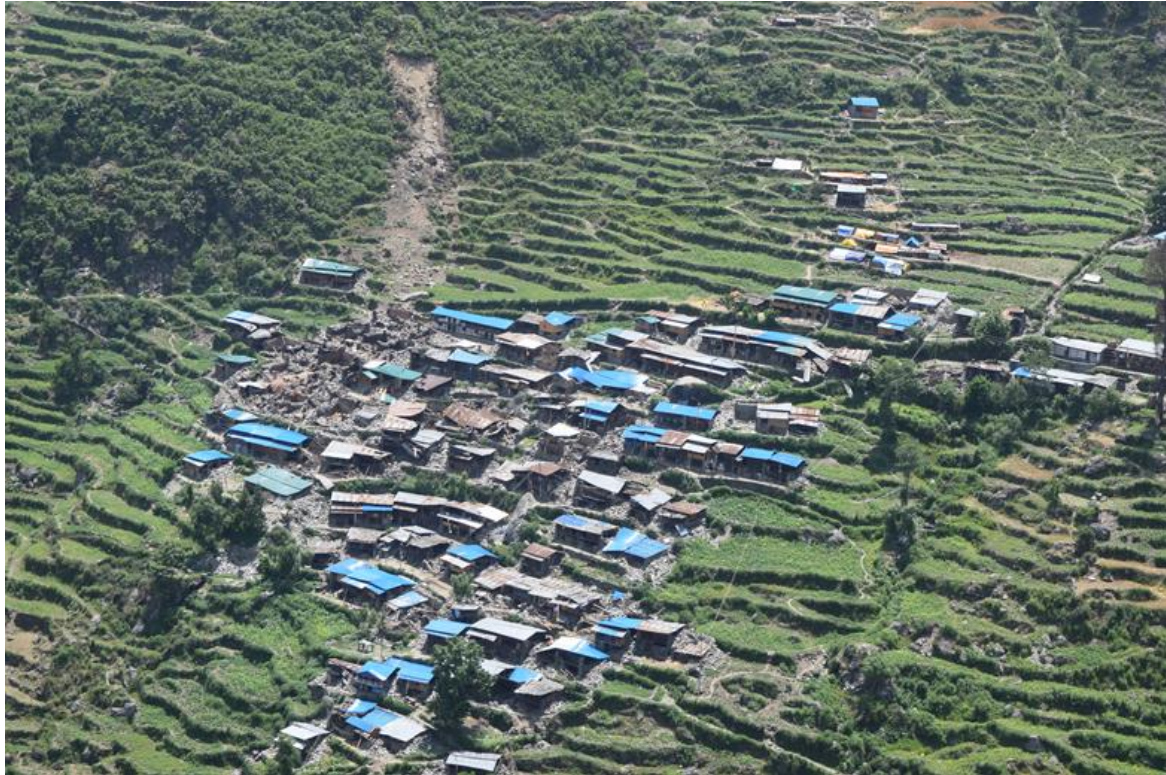
Figure 9-62 Building damage at a village near Rasuwagadi in Rasuwa District due to earthquake shaking and earthquake induced landslides.

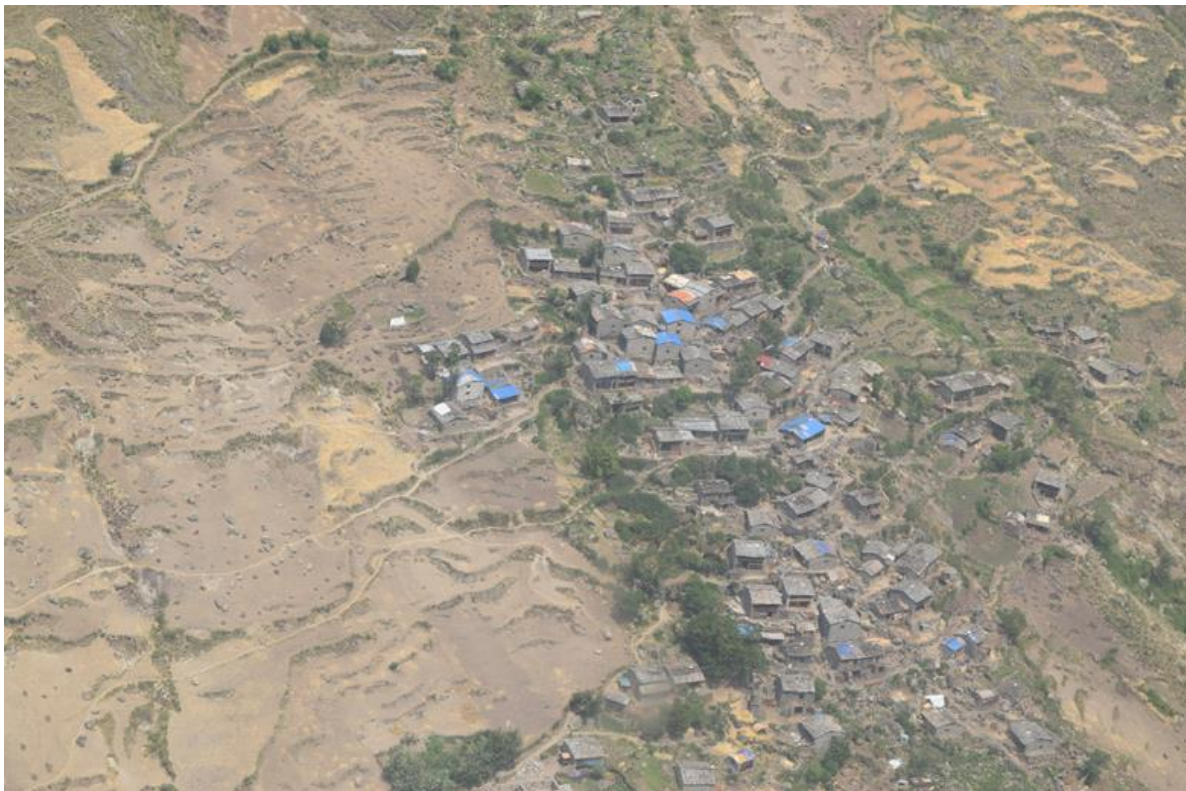
Figure 9-69 A village near Prok of Gorkha was devastated due to the seismic induced damage of unreinforced masonry structures.
