SUPPLEMENTAL TO SURFACE FAULT RUPTURE ASSOCIATED WITH THE M6.0 SOUTH NAPA EARTHQUAKE OF AUGUST 24, 2014

National Science Foundation (NSF)
Geotechnical Extreme Events Reconnaissance (GEER)

B.1 Preliminary Observations of Surface Cracking Within the Epicentral Area of the M6.0 South Napa Earthquake of August 24, 2014

Prepared by Keith Kelson¹ C.E.G., and John Wesling² C.E.G.

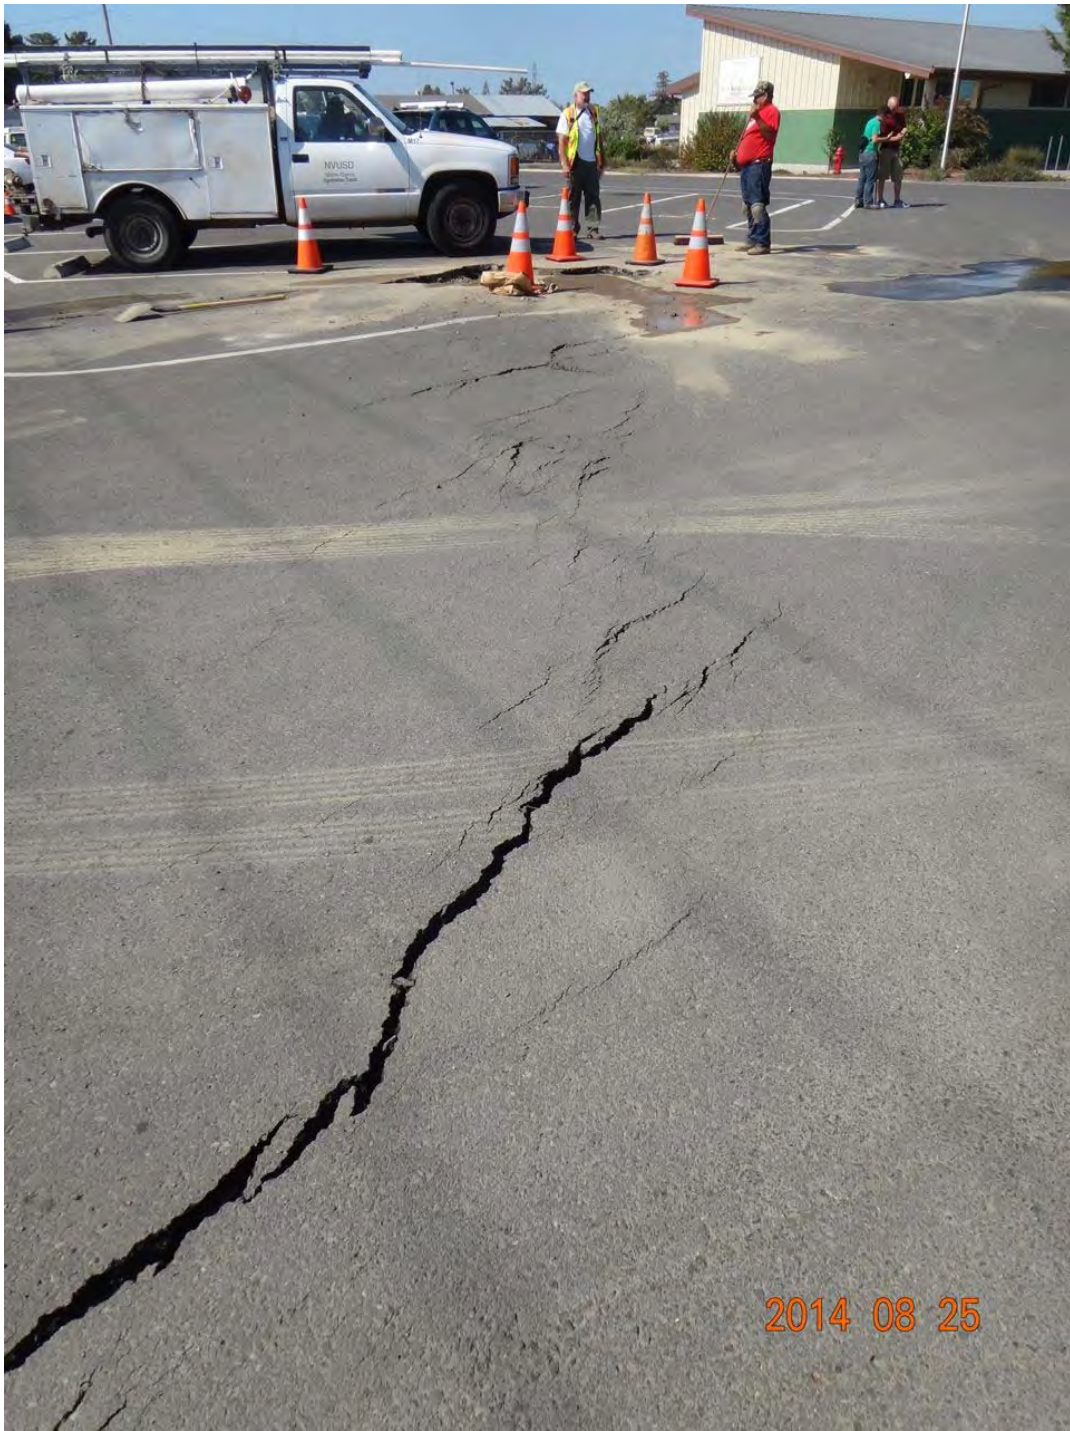
Figure 4. Surface fault rupture at Stone Bridge School (2.7 km NW of epicenter), showing left-stepping pattern of transtensional cracking within asphalt parking lot. View to north-northwest. Overall fault zone strikes 340, cracks strike about 020 to 040. [NSF-GEER; GPS N38.2436 W122.3212; 08/25/14: 3:38 pm]

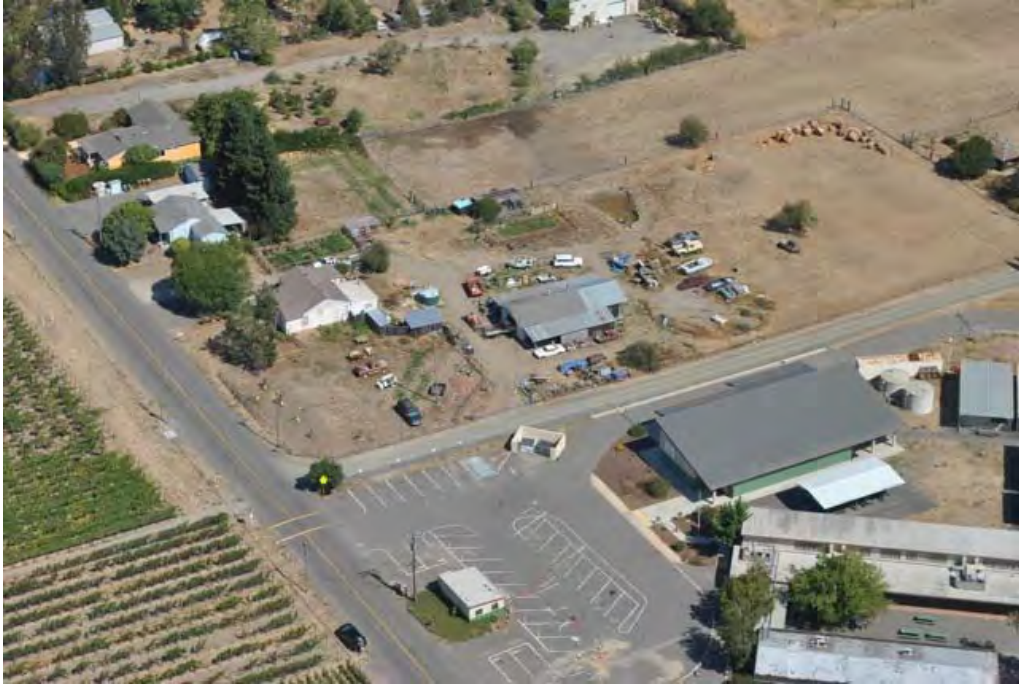
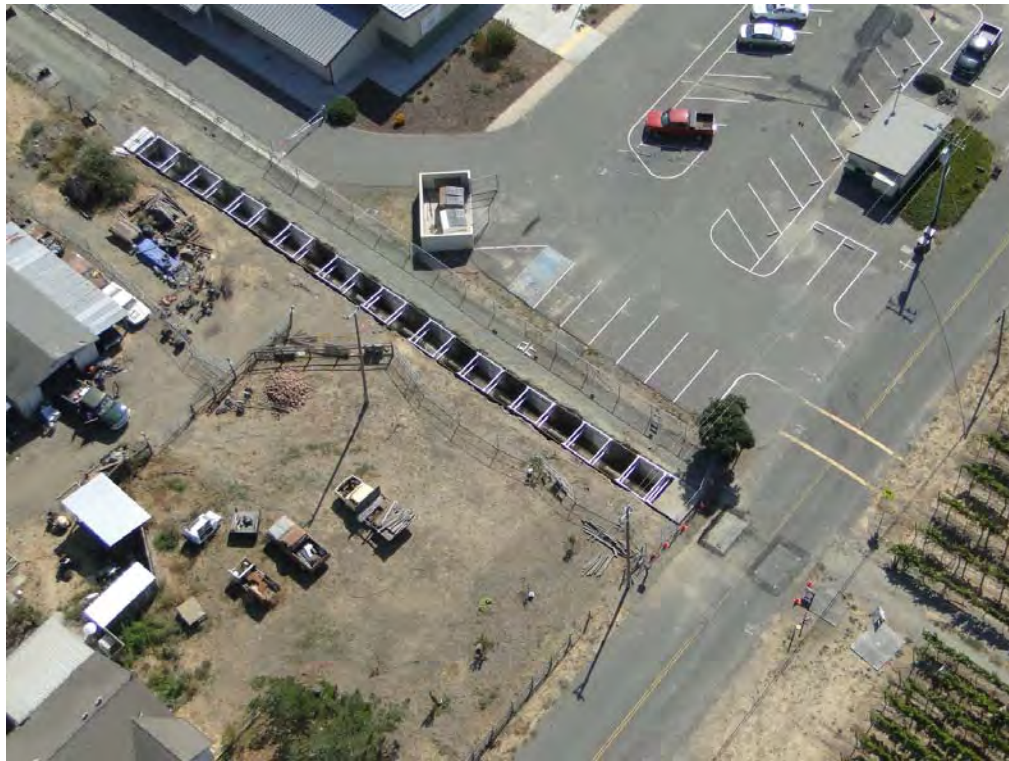
Figure 5. Oblique aerial photographs of the Stone Bridge School parking lot (Figure 4). Upper photo taken on August 27, 2014; 12:01 pm); view to northwest; cracks extend northwestward from parking lot into adjacent yard. Lower photo taken (by L. Harder, Sept 1; near-vertical) showing pipeline trench excavation along southern border of yard adjacent to school parking lot. [NSF-GEER; school lot: GPS N38.2436 W122.3212]

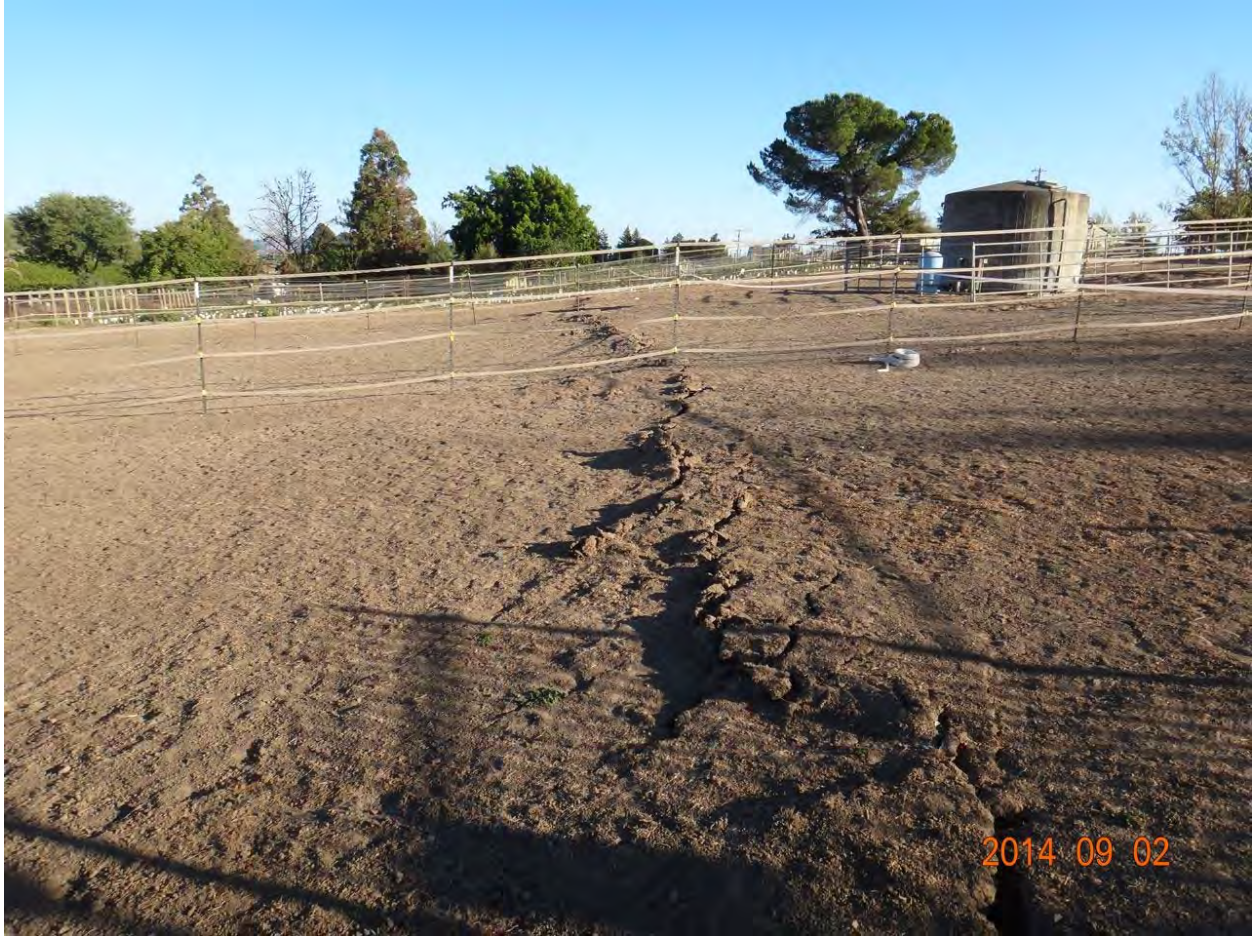
Figure 6. Surface fault rupture at horse corral west of Cuttings Wharf Road (3.9 km NW of epicenter), showing left-stepping pattern of transtensional cracking across compacted dirt slope. View to south-southeast. Individual cracks have as much as 5 cm lateral offset. [NSF-GEER; GPS N38.2536 W122.3262; 09/02/14: 6:07 pm]

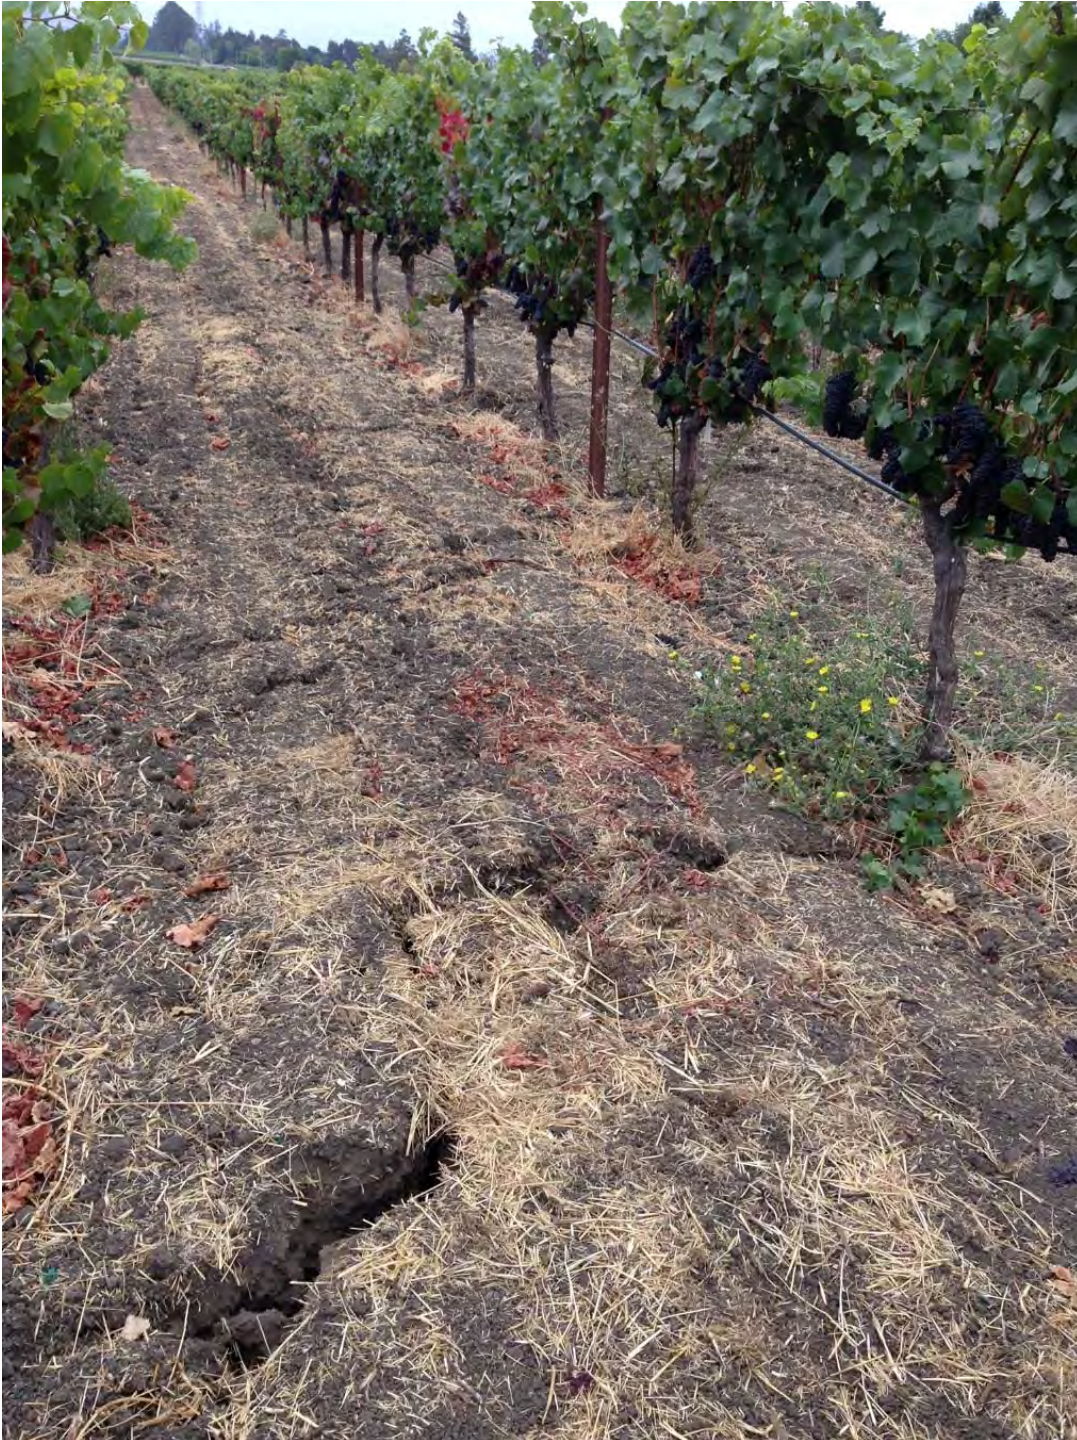
Figure 8. Surface fault rupture at vineyard directly south of Highway 12 and east of Cuttings Wharf Road (4.1 km NW of epicenter), showing left-stepping pattern of transensional cracking within vineyard. View to south. [NSF-GEER; GPS N38.2557 W122.3270; 08/25/14: 9:49 am]

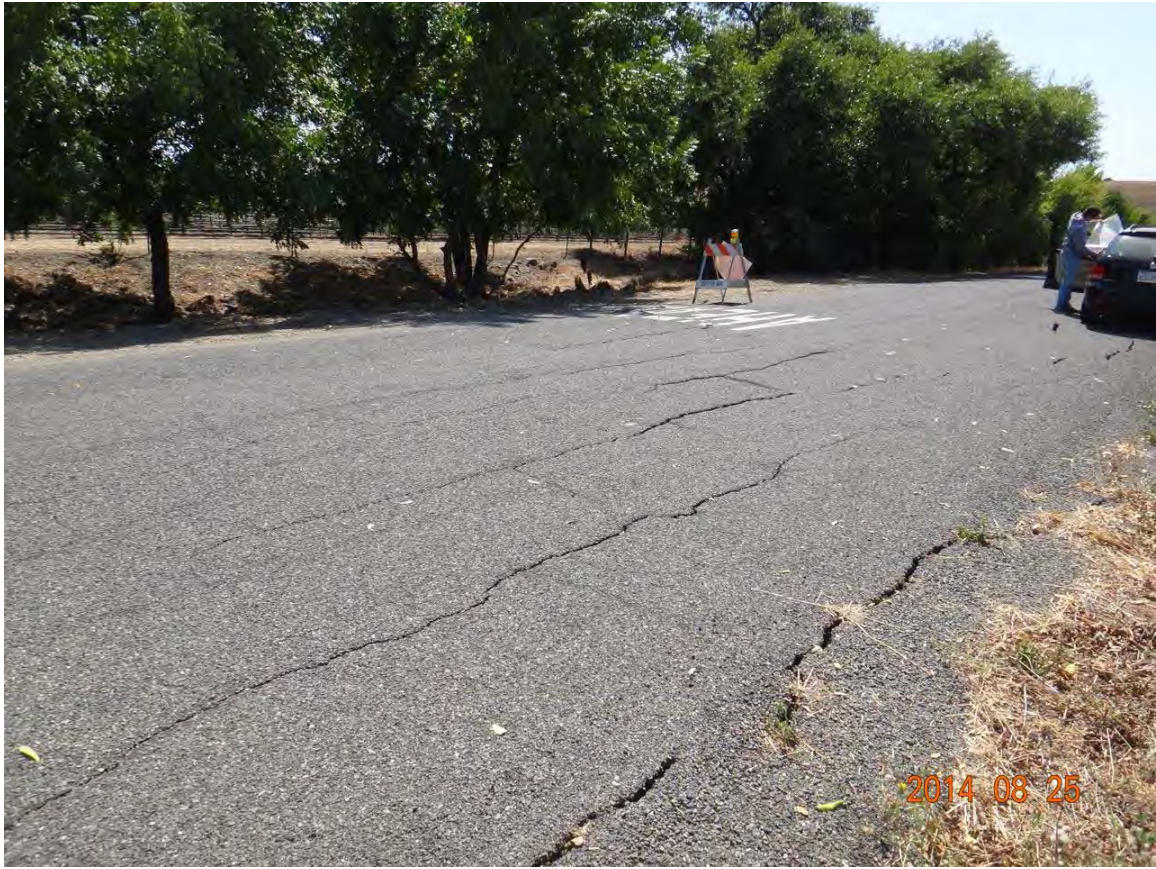
Figure 9. Surface fault rupture at Henry Road (6.2 km NW of epicenter), showing left-stepping pattern of transtensional cracking across asphalt. View to southeast. Offset across most prominent crack within this zone is as much as 6 cm, but offset across entire zone measure in adjacent vineyard is about 40 cm [NSF-GEER; GPS N38.2732 W122.3366; 08/25/14: 1:45 pm]

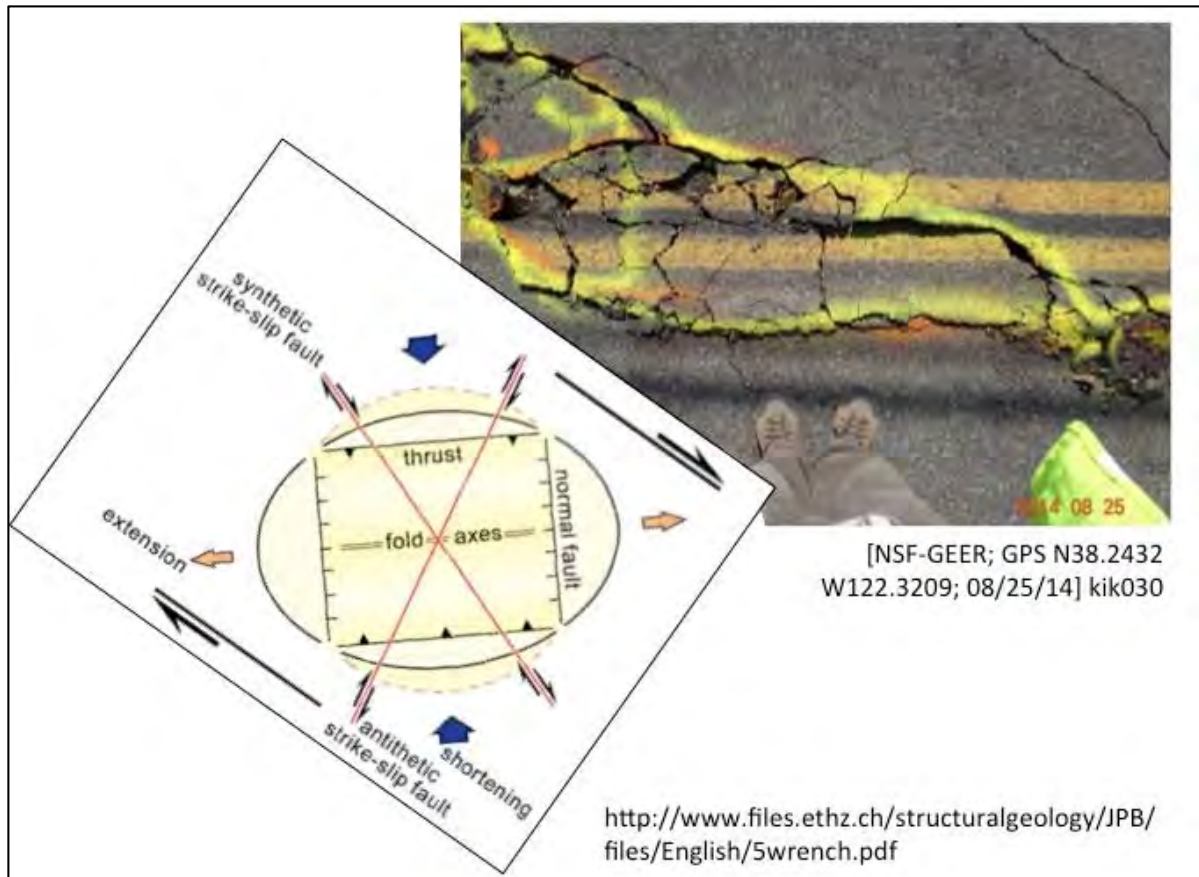
Figure 11. Surface deformation of the centerline of Los Carneros Road (2.5 km NW of epicenter), showing complex, small-scale deformation in ductile asphalt. View is vertical. Deformation is consistent with textbook models of pure shear. [NSF-GEER; GPS N38.2432 W122.3209; 08/25/14: 3:32 pm]

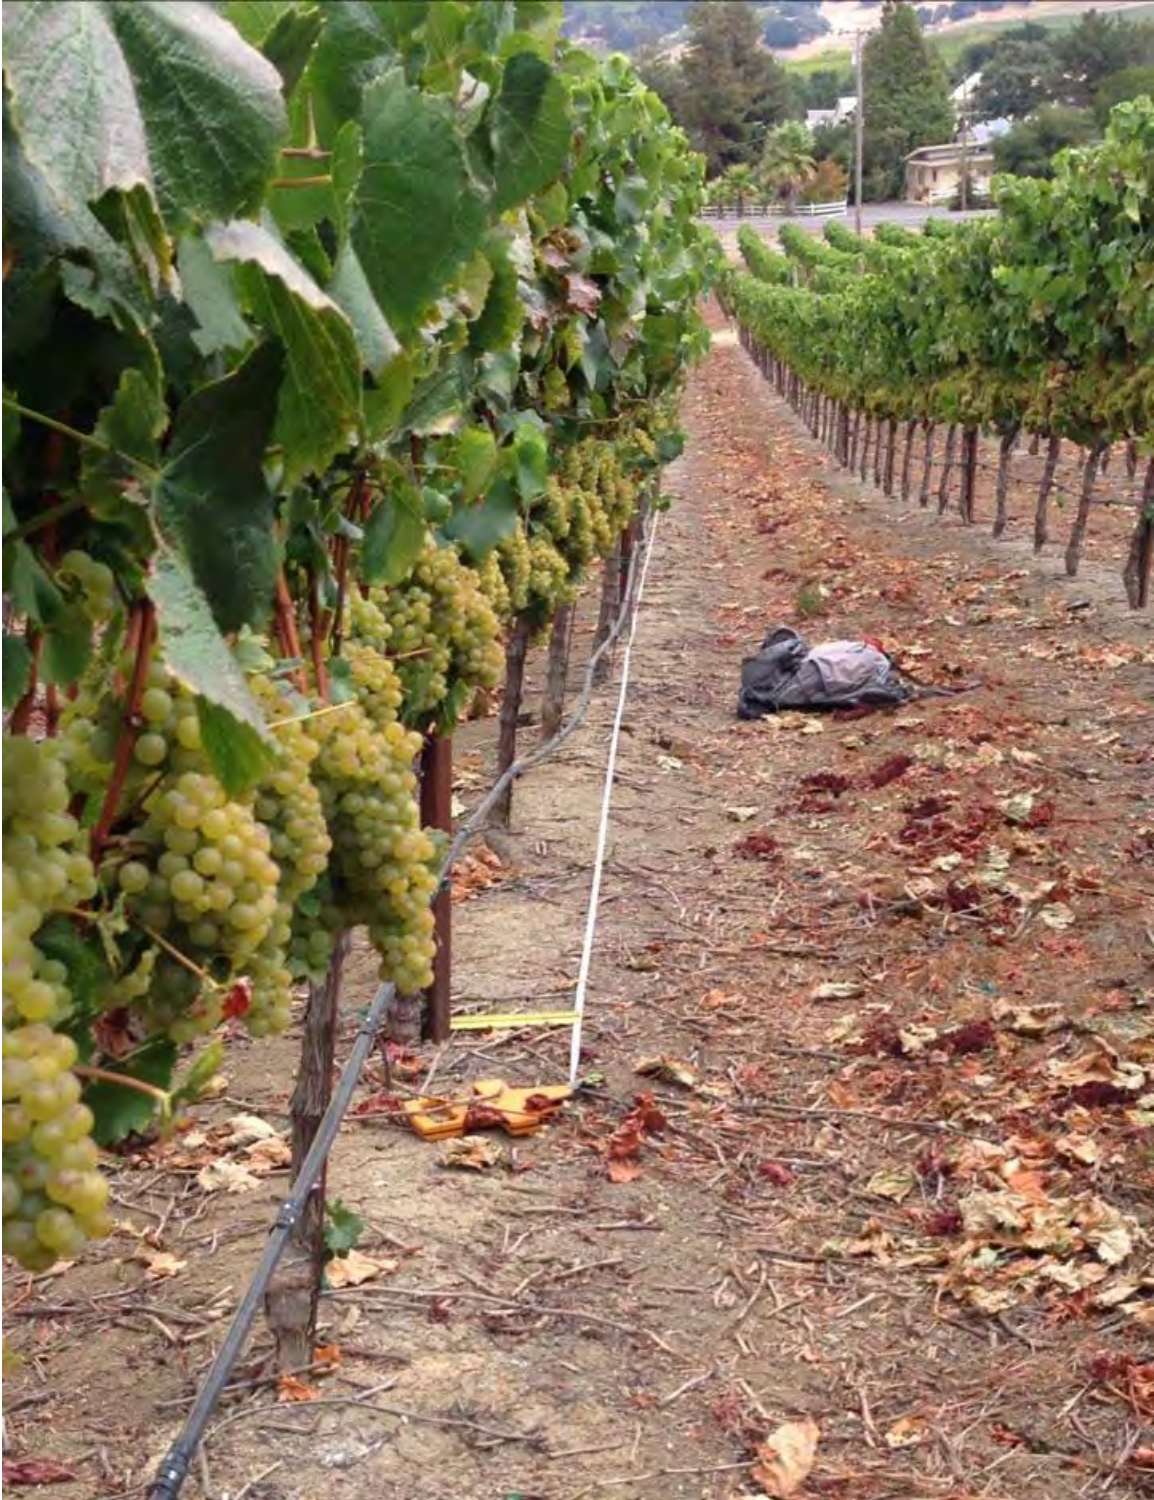
Figure 15. Surface fault rupture at southern part of Clos du Val Vineyard near Old Sonoma Road (5.6 km NW of epicenter), showing measurement alignment along azimuth 058. Yellow engineer's scale is located west of fault zone, showing 20 to 25 cm of apparent lateral offset. Tape was aligned at base of metal stakes east of fault zone. [NSF-GEER; GPS N38.2669 W122.3341; 08/25/14: 11:19 am].

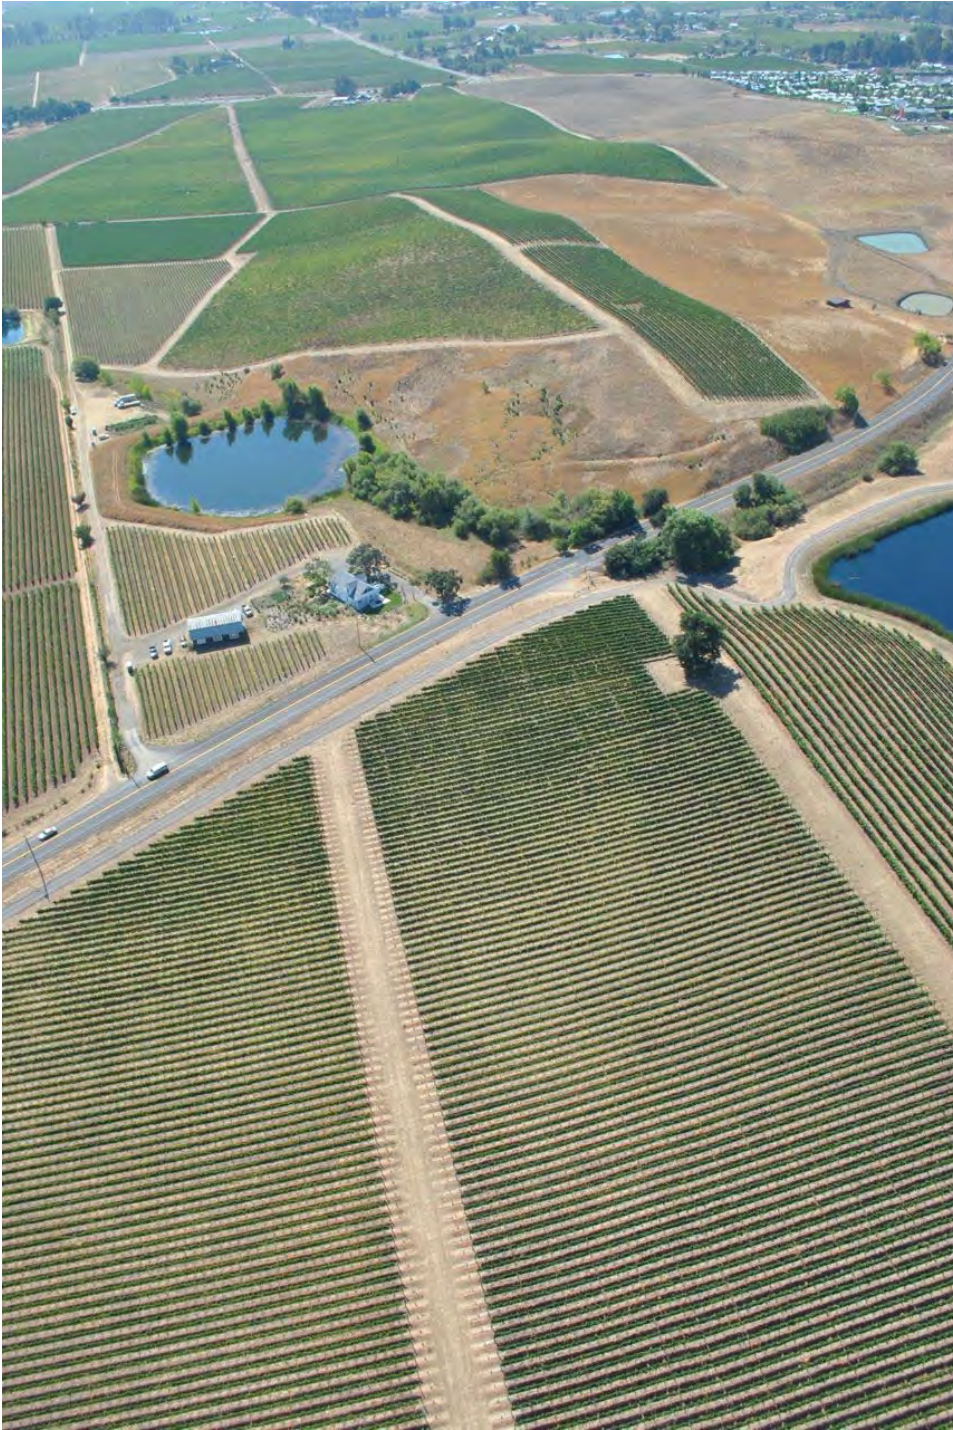
Figure 17. Oblique aerial view looking southeast along rupture toward the vineyard sites measured in Figures 11 and 12, in southern part of Clos du Val Vineyard near Old Sonoma Road (5.6 km NW of epicenter). Note prominent tonal lineament through vineyard north of Old Sonoma Road, which coincides with the 2014 surface rupture. [NSF-GEER; GPS N38.268 W122.334; 08/27/14: 12:07 pm]

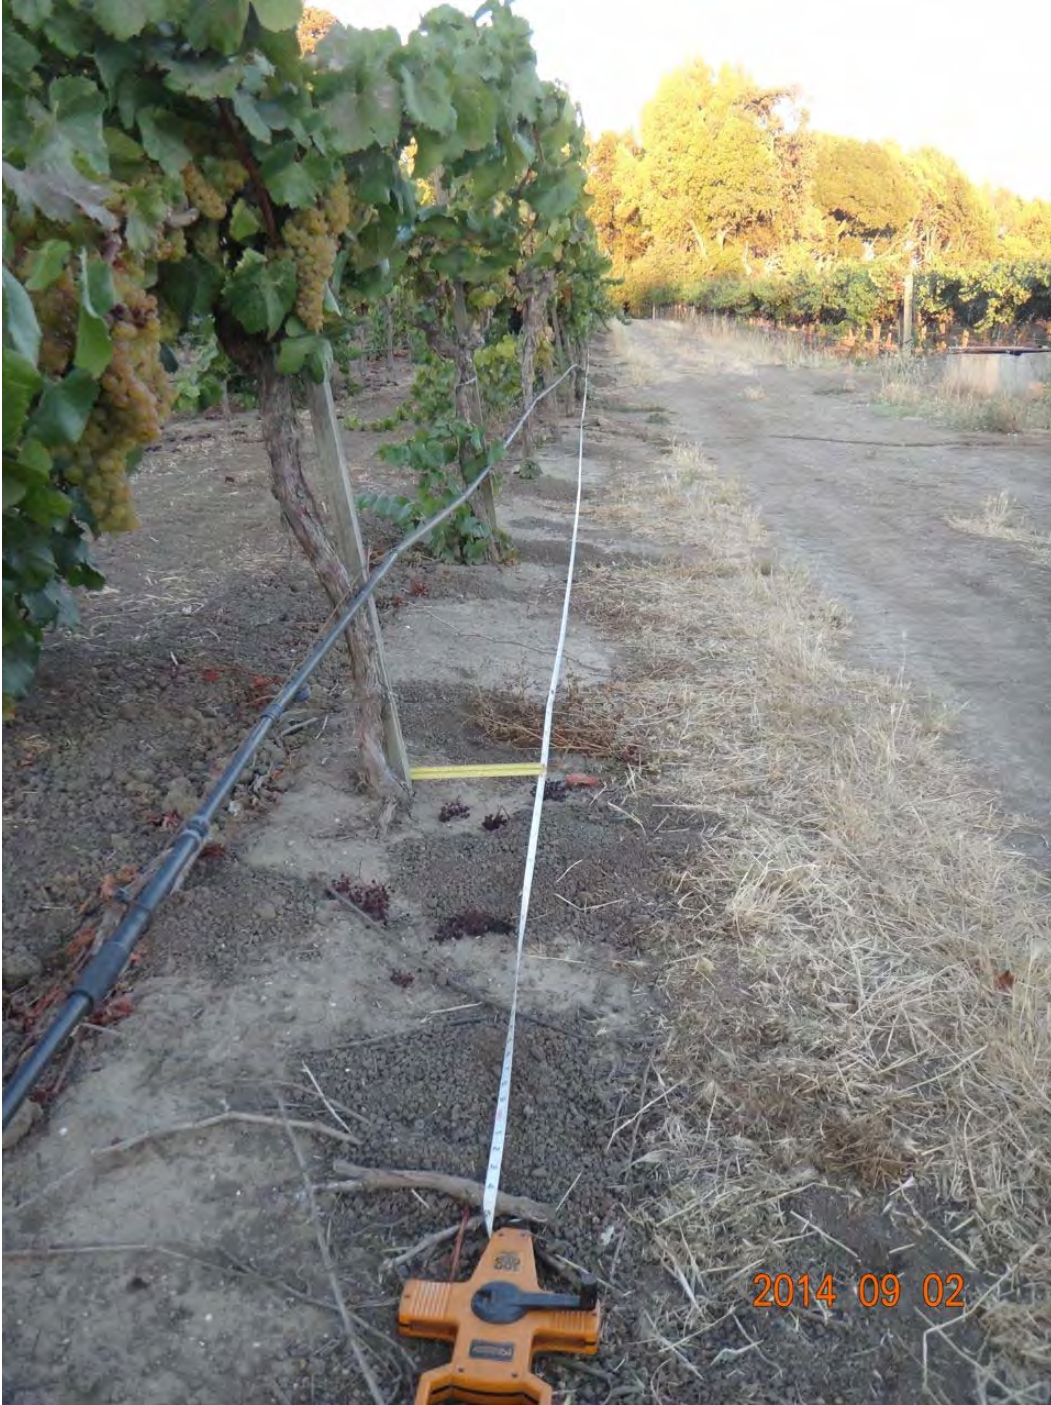
Right-lateral offset of 20 to 25 cm also was measured at a site located south of Las Amigas Road, about 1.2 km north of the epicenter (Poseidon Vineyard, Figure 18). This measurement was made on September 2 (1800 hrs); qualitatively, the amount of deformation was noticeably greater than that observed during a prior visit by the GEER team on August 25. Similar to the sites described above, the fault rupture included a 5-m-wide zone of extensional cracks, arranged in an

Figure 18. Surface fault rupture at Poseidon Vineyard south of Las Amigas Road (1.2 km NW of epicenter), showing measurement alignment along azimuth 090. Yellow engineer's scale is located west of fault zone, showing 20 to 25 cm of apparent offset. [NSF-GEER; GPS N38.2314 W122.3153; 09/02/14: 7:17 pm]

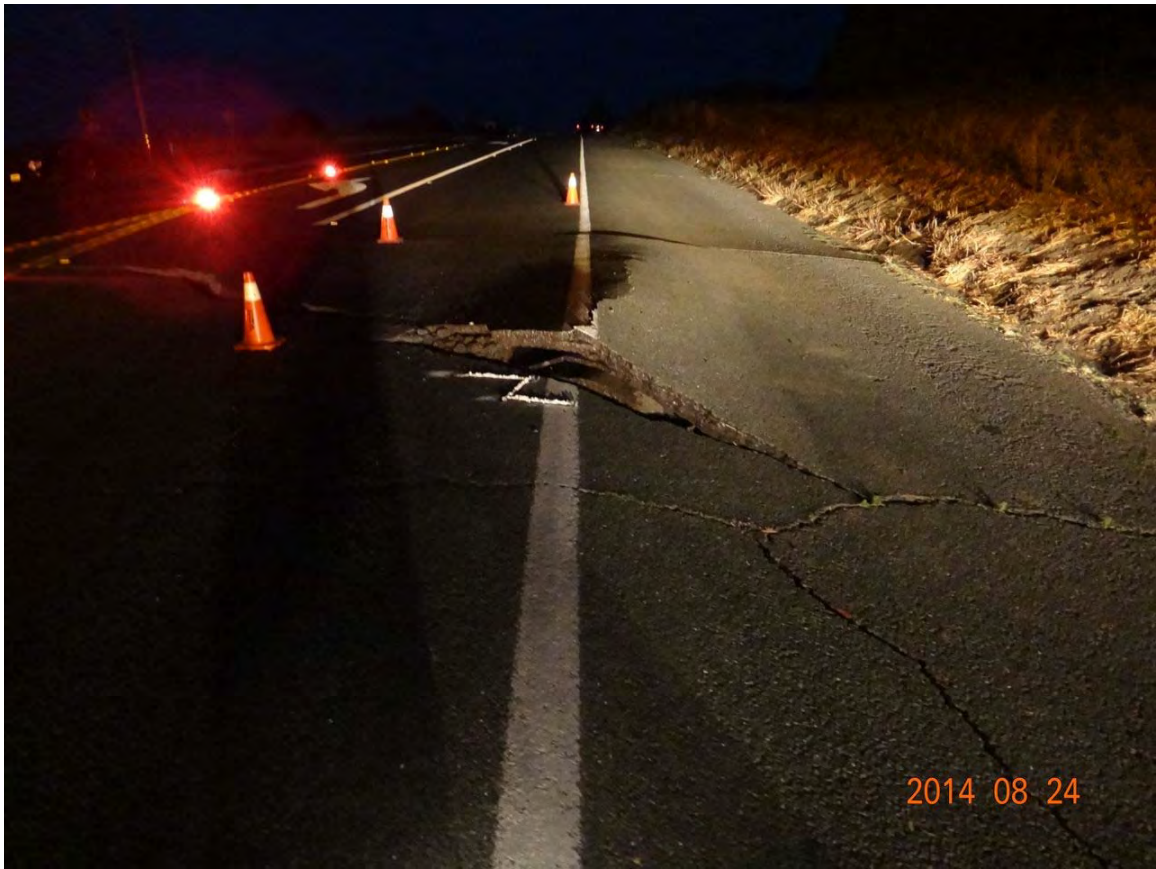
Figure 19. Surface fault rupture at Highway 12 (4.2 km NW of epicenter), showing buckling of asphalt on northern margin and minor lateral offset. Taken at 0554 local time, this photograph precedes road repairs. [NSF-GEER; GPS N38.256 W122.327; 08/24/14: 5:54 am]

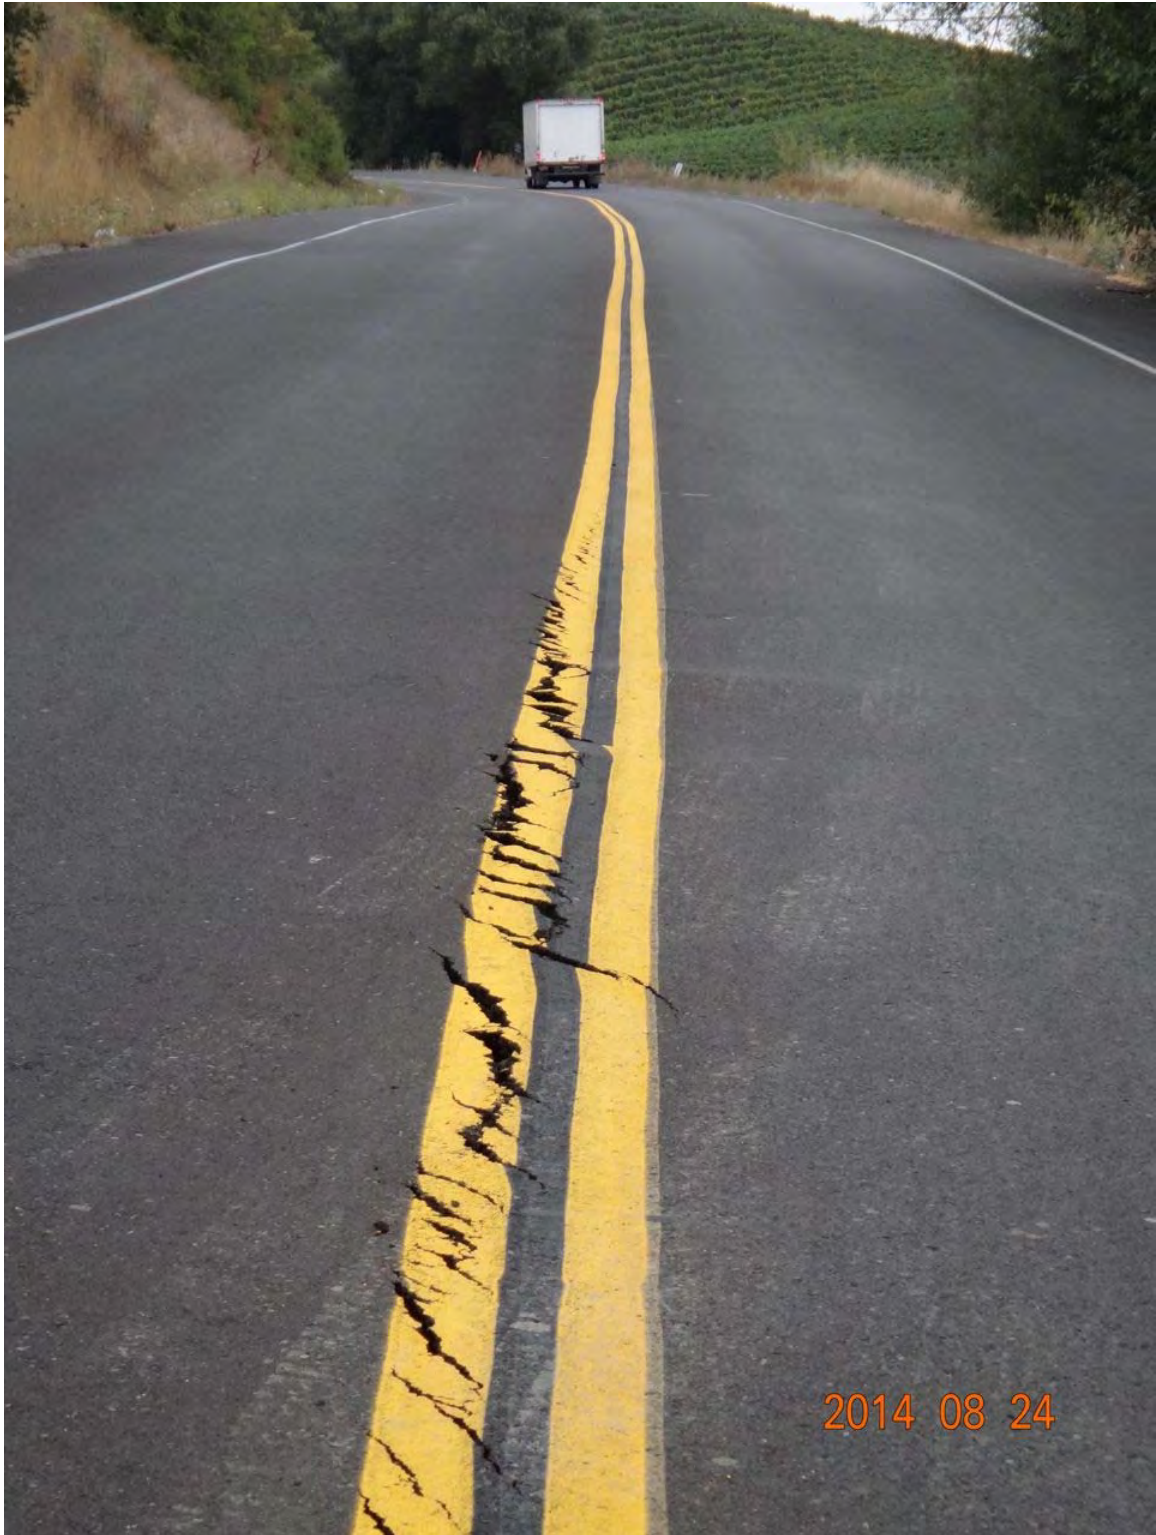
Post-earthquake surface deformation is also shown by observation of only minor deformation of Old Sonoma Road in the early hours of August 24 (Figure 22). At 0730 on August 24, a series of *en echelon* cracks had developed in the centerline striping of the road, with only minor offset and vertical uplift (Figure 23). Within 27 hours, this deformation was more distinct, and involved several centimeters of uplift across the road. The roadway was repaired soon thereafter, and there have been no subsequent notes on deformation at this fault crossing.

Figure 22. Surface deformation at Old Sonoma Road (5.4 km NW of epicenter, photograph taken at 0730, about 4 hours after main shock). Compare with photograph in Figure 23 [NSF-GEER; GPS N38.2659 W122.3338; 08/24/14: 7:34 am].

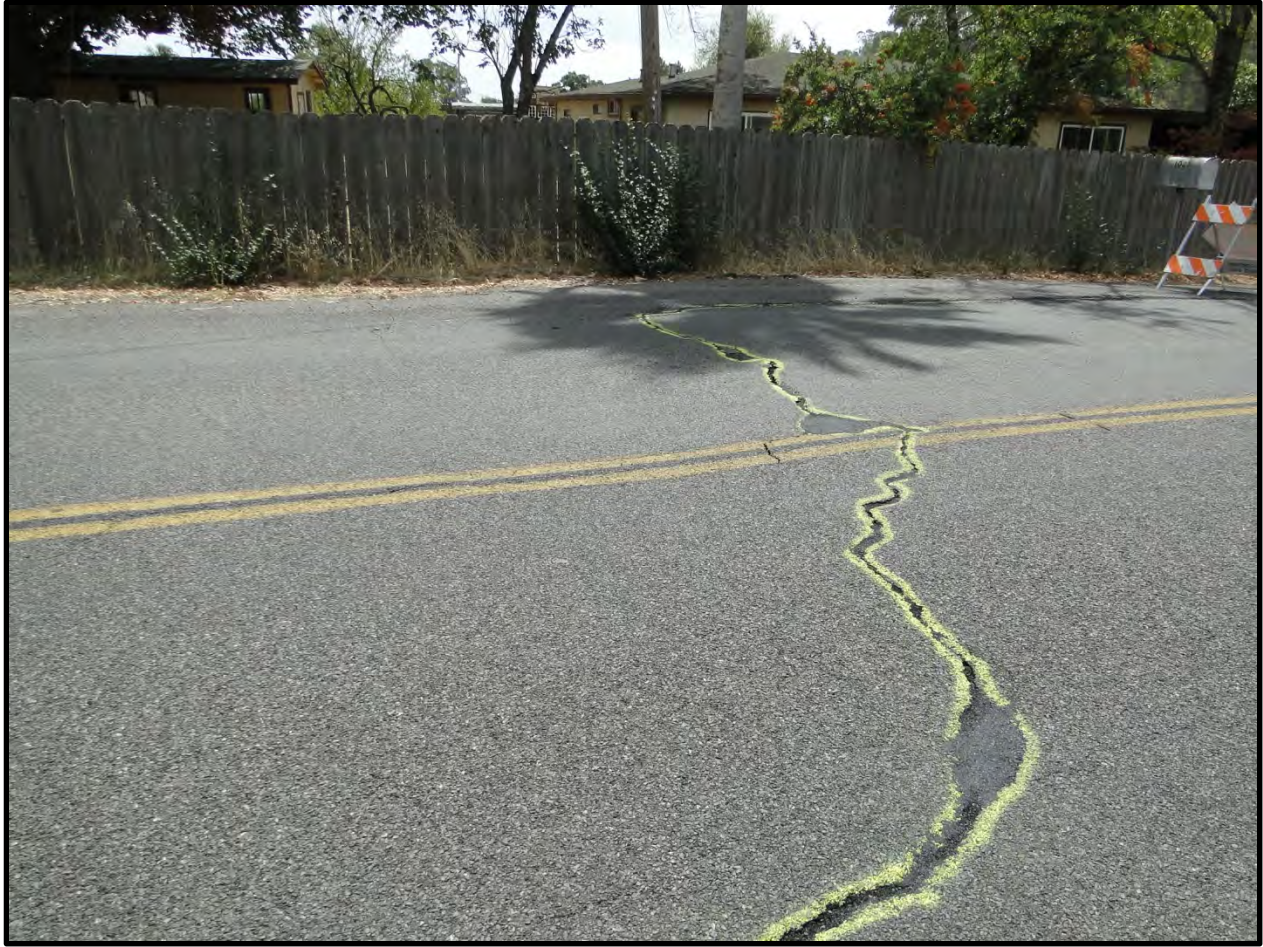
- 2) **Point B4, Congress Valley Road (N38° 17.057', W122° 19.471')** – In this area, ground cracking associated with Alignment B extended across Congress Valley Road, through the front fence of the property, through the property, and then across Old Sonoma Road. Selected photographs are as follows:
- Figure 3 presents a photograph of the cracked Congress Valley Road
 - Figures 4 and 5 present photographs of the wooden front fence on the property indicating approximately 8 to 12 centimeters of vertical displacement (west side up) and about 5 to 8 centimeters of right lateral displacement as a result of ground cracking.
 - Figures 6 and 7 present photographs of ground cracking between the Congress Valley Road property owner front fence and Old Sonoma Road (Point B5).

Figure 3: Photograph of cracking across Congress Valley Road in front of residence – looking southerly (Point B4)
[NSF-GEER; Napa, CA; N 38.284 W 122.325; Harder, L. F.; 08/29/14]

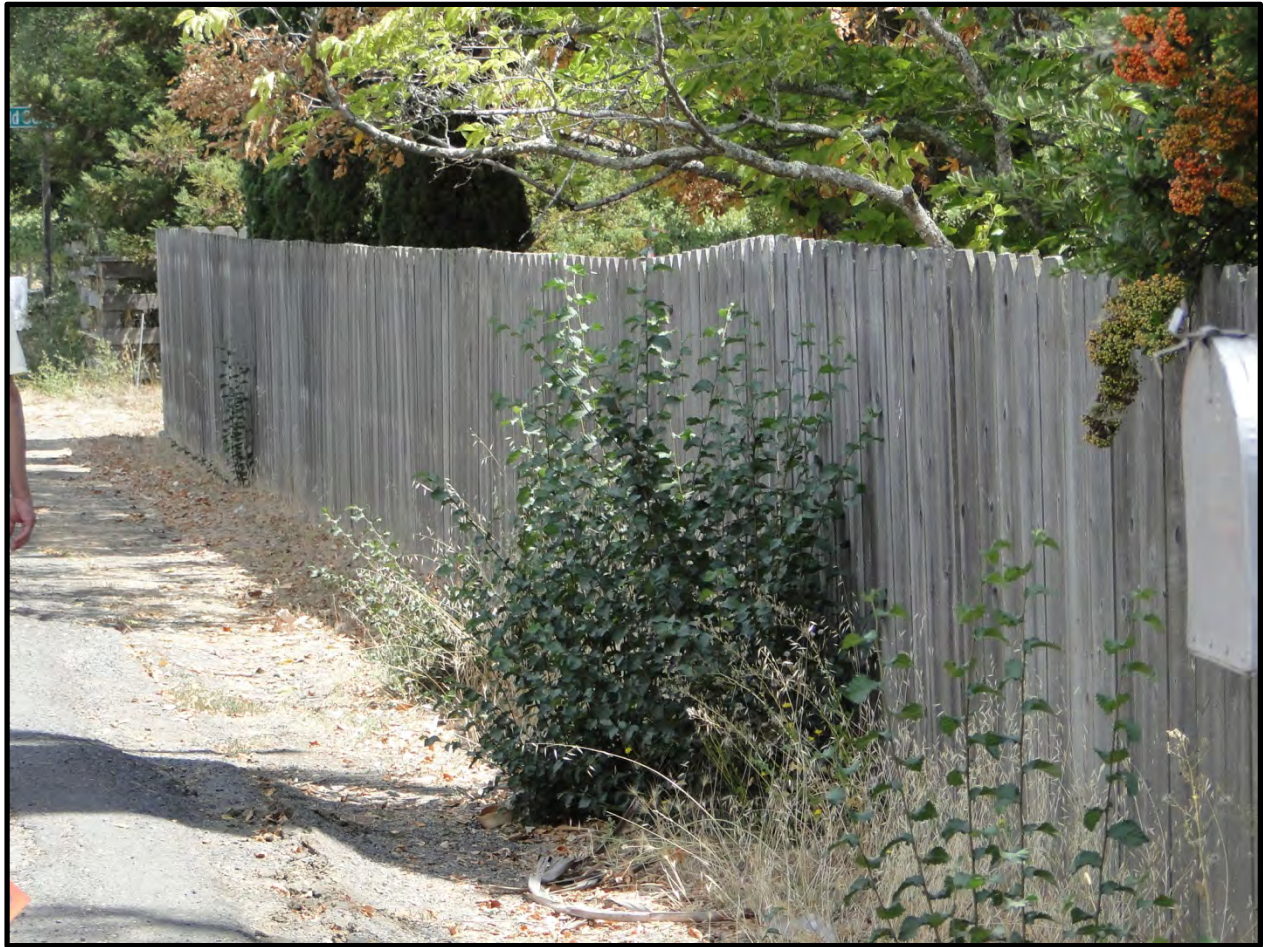
Figure 4: Photograph of wooden fence displaced by ground cracking in front of residence
(Congress Valley Road, Point B4) – looking easterly
– vertical fence displacements across ground cracking are approximately
8 to 12 centimeters with west side up
[NSF-GEER; Napa, CA; N 38.284 W 122.325; Harder, L. F.; 08/29/14]

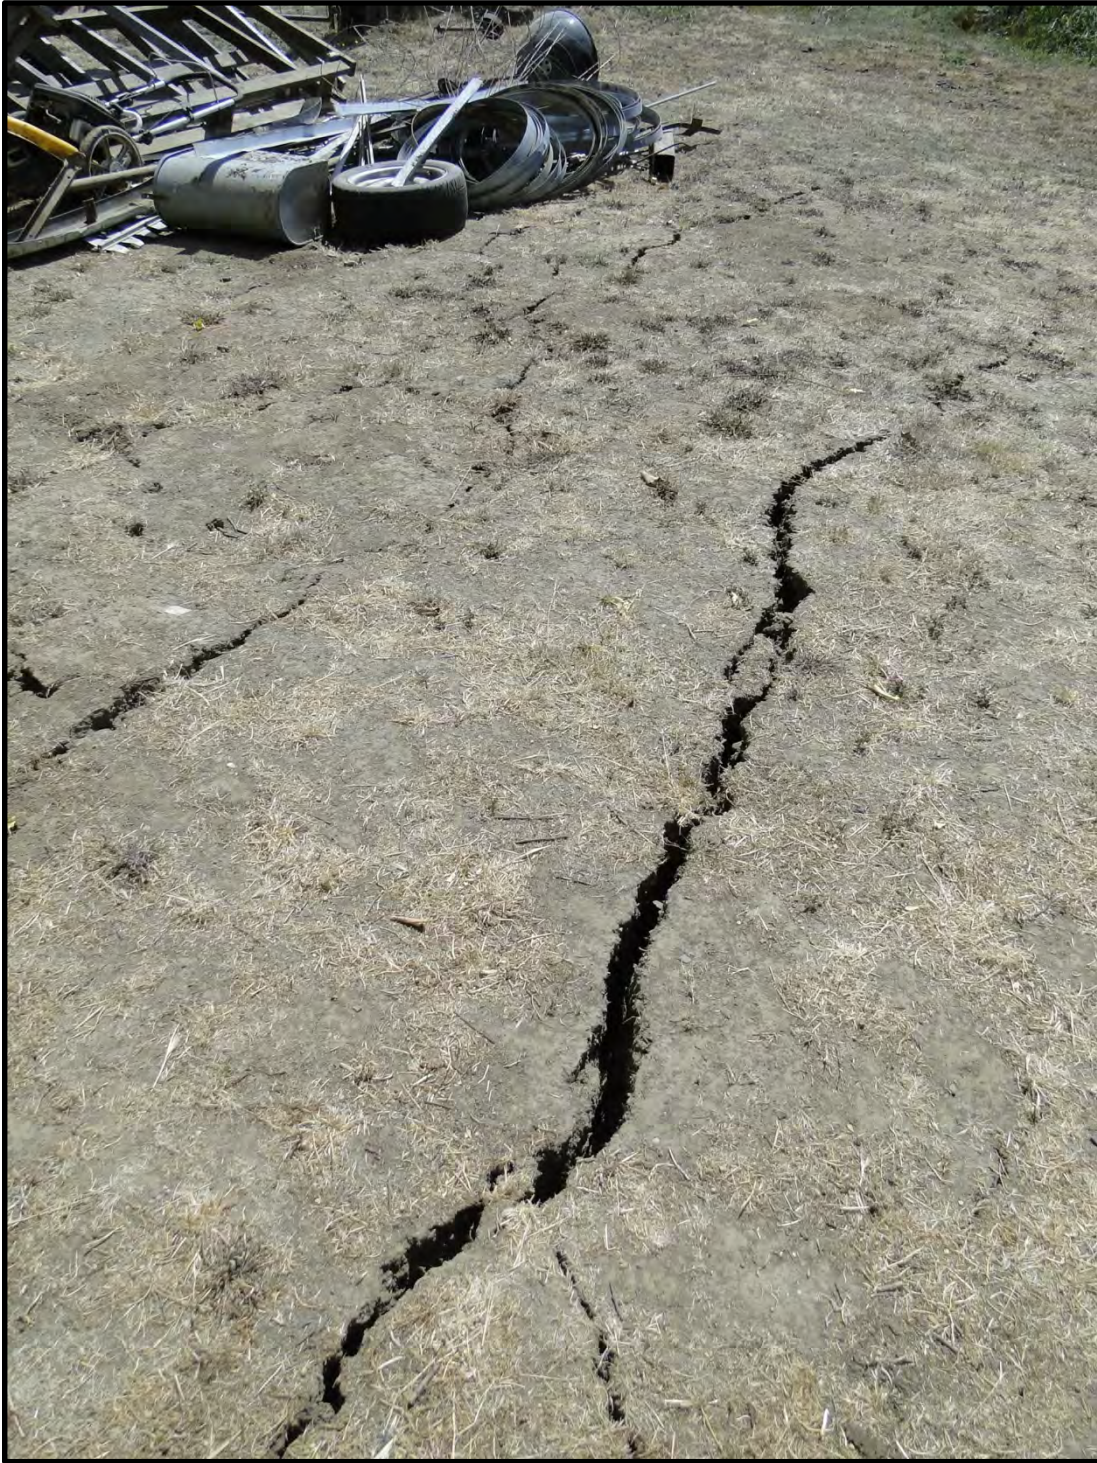
Figure 6: Photograph of ground cracking on property
(Congress Valley Road, Point B4) – looking southerly between front wooden fence
and towards damaged Old Sonoma Road (Point B5)
[NSF-GEER; Napa, CA; N 38.284 W 122.325; Harder, L. F.; 08/29/14]

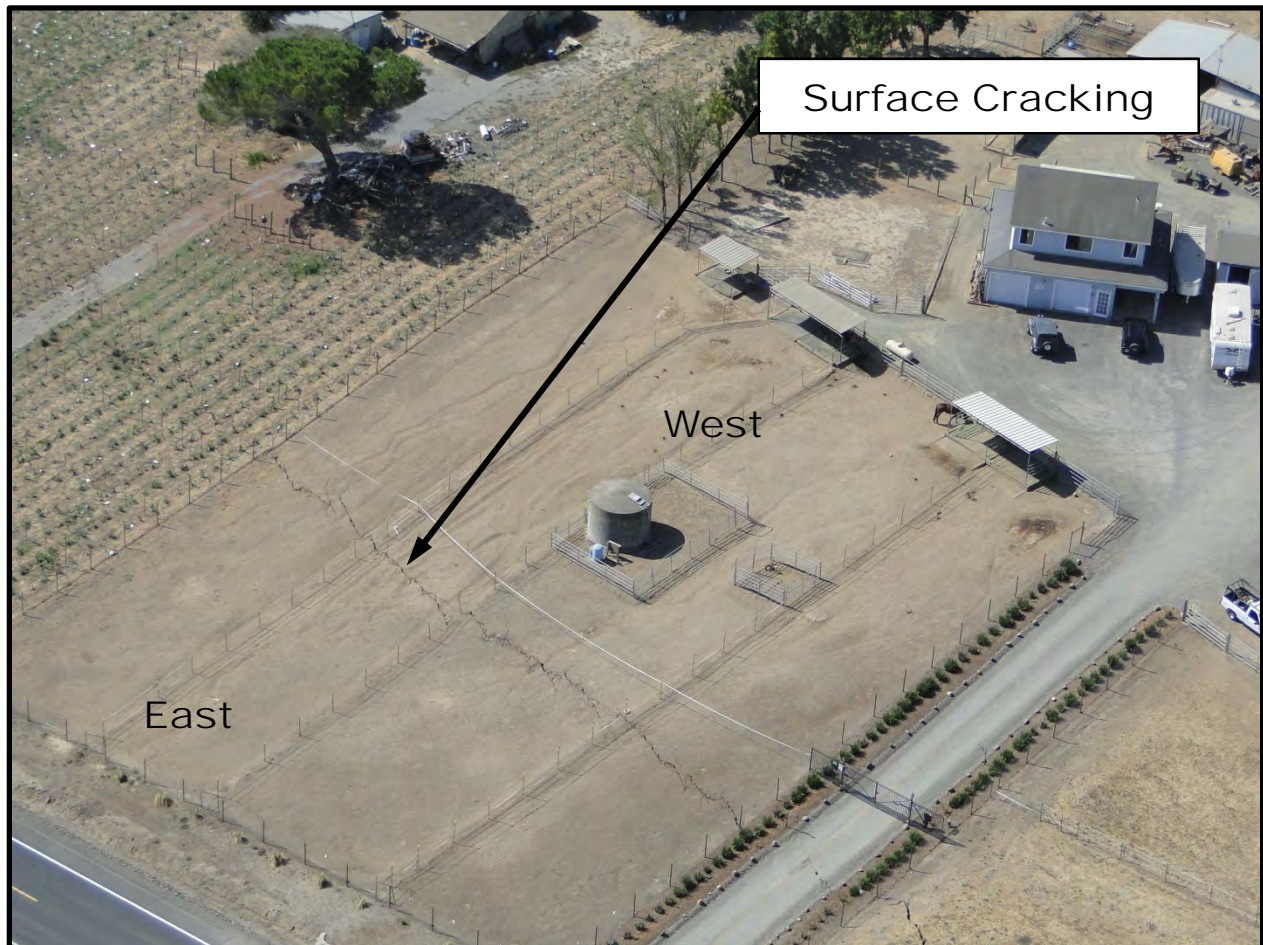
Figure 8: Aerial photograph of linear ground cracking in horse pasture along Cuttings Wharf Road south of Highway 12/121 (Point A10) – looking towards the southwest [NSF-GEER; Napa, CA; N 38.253 W 122.326; Harder, L. F.; 09/01/14]
