SUPPLEMENTAL TO SURFACE FAULT RUPTURE ASSOCIATED WITH THE M6.0 SOUTH NAPA EARTHQUAKE OF AUGUST 24, 2014

National Science Foundation (NSF)
Geotechnical Extreme Events Reconnaissance (GEER)

B.1 Preliminary Observations of Surface Cracking Within the Epicentral Area of the M6.0 South Napa Earthquake of August 24, 2014

Prepared by Keith Kelson¹ C.E.G., and John Wesling² C.E.G.

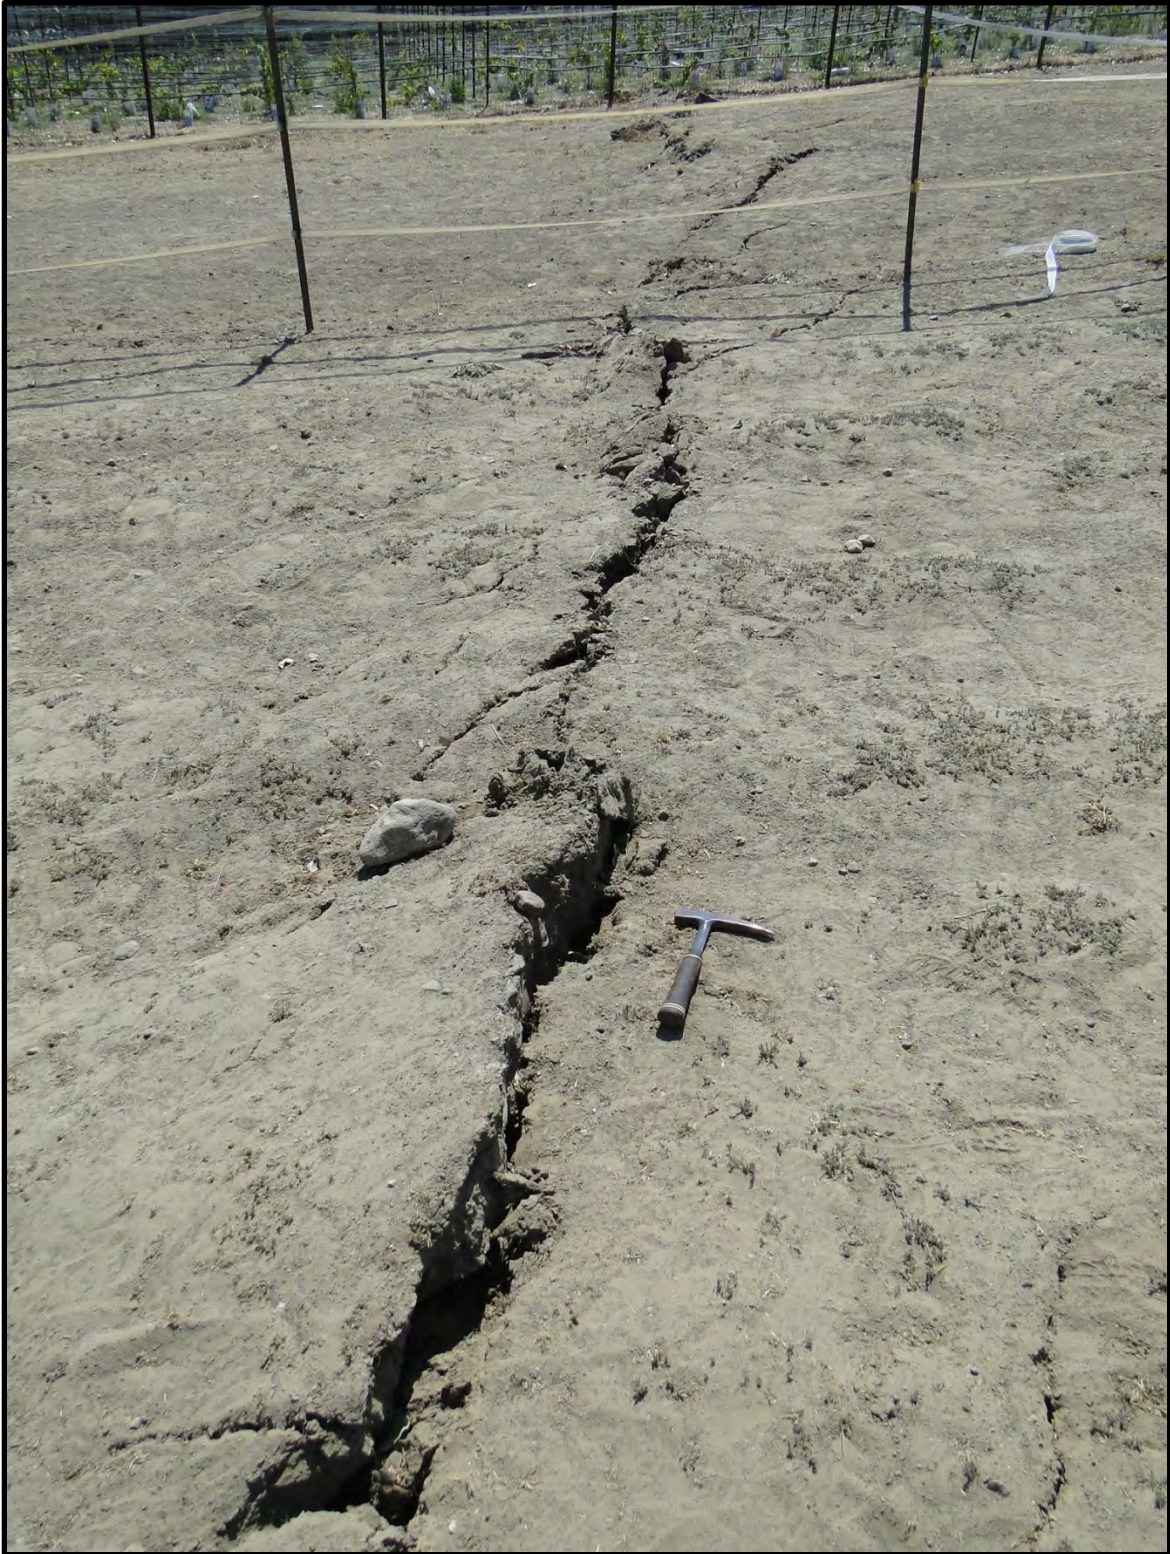
Figure 9: Photograph of linear ground cracking in horse pasture along Cuttings Wharf Road south of Highway 12/121 (Point A10) – view looking towards the southeast [NSF-GEER; Napa, CA; N 38.253 W 122.326; Harder, L. F.; 09/01/14]

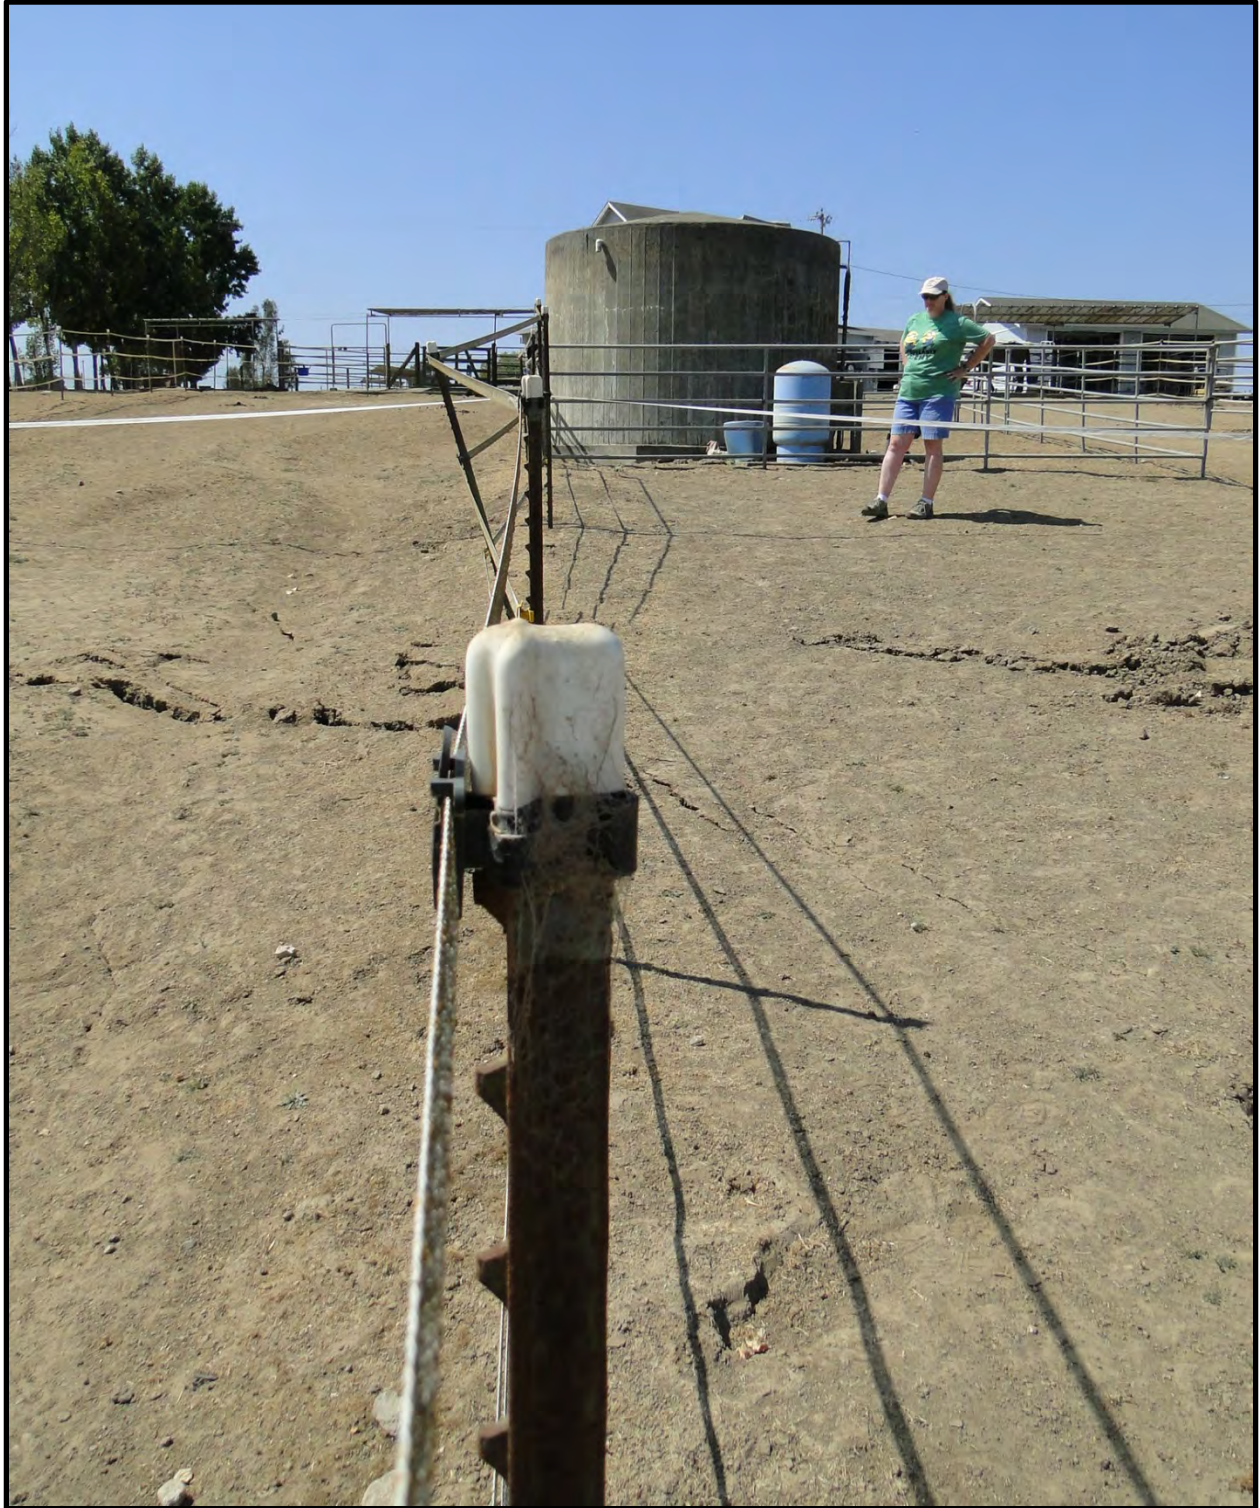
Figure 10: Photograph of electrical fence in horse pasture along Cuttings Wharf Road south of Highway 12/121 (Point A10) with approximately 4 centimeters of right lateral offset induced by ground cracking – view towards the west
[NSF-GEER; Napa, CA; N 38.253 W 122.326; Harder, L. F.; 09/01/14]

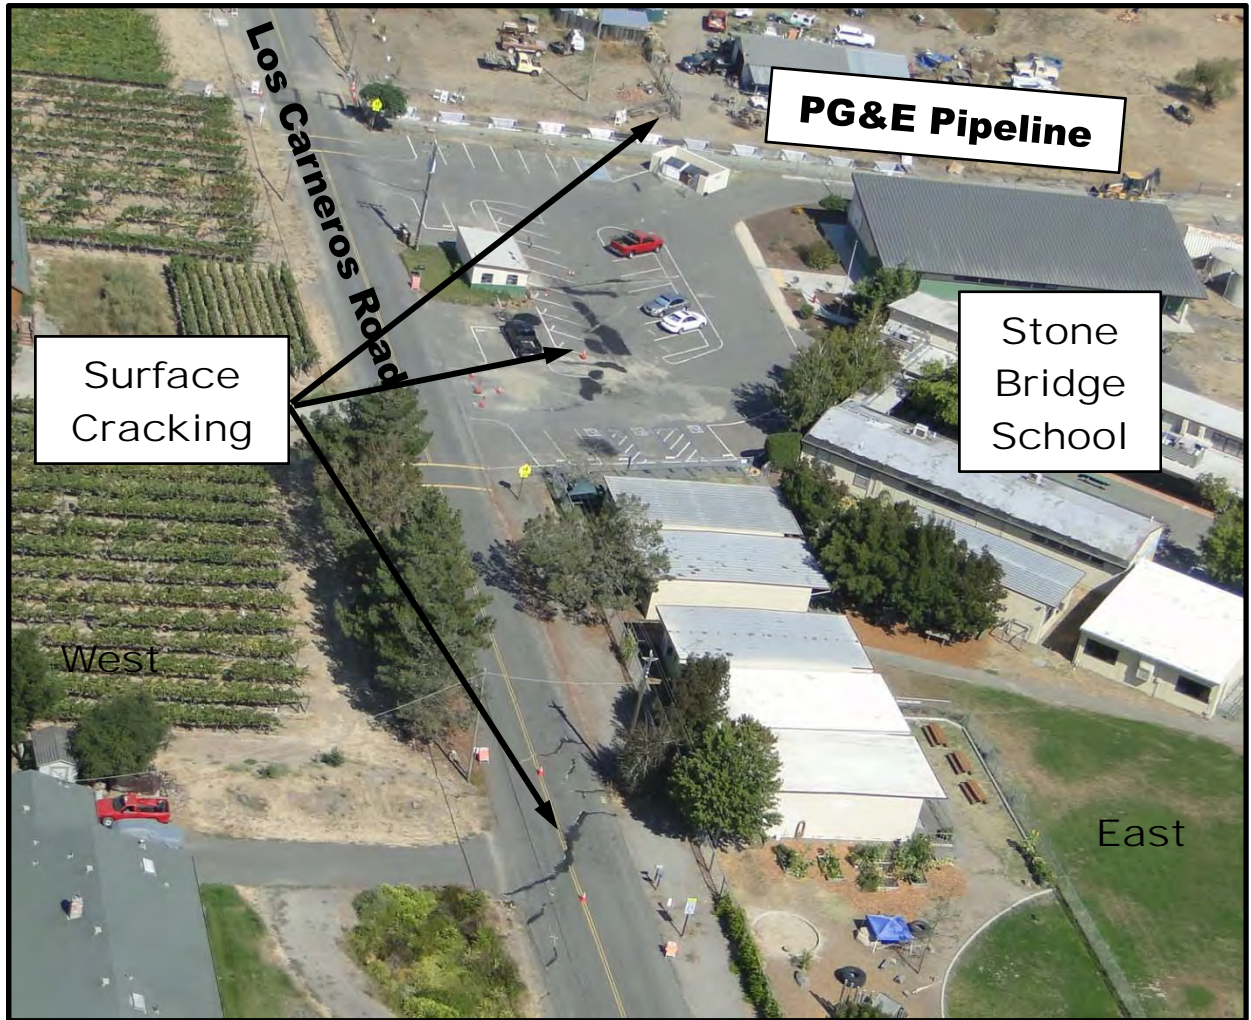
Figure 11: Aerial photograph of linear ground cracking across Los Carneros Road near Stone Bridge School (Point A12) – view looking towards the northeast
[NSF-GEER; Napa, CA; N 38.243 W 122.321; Harder, L. F.; 09/01/14]

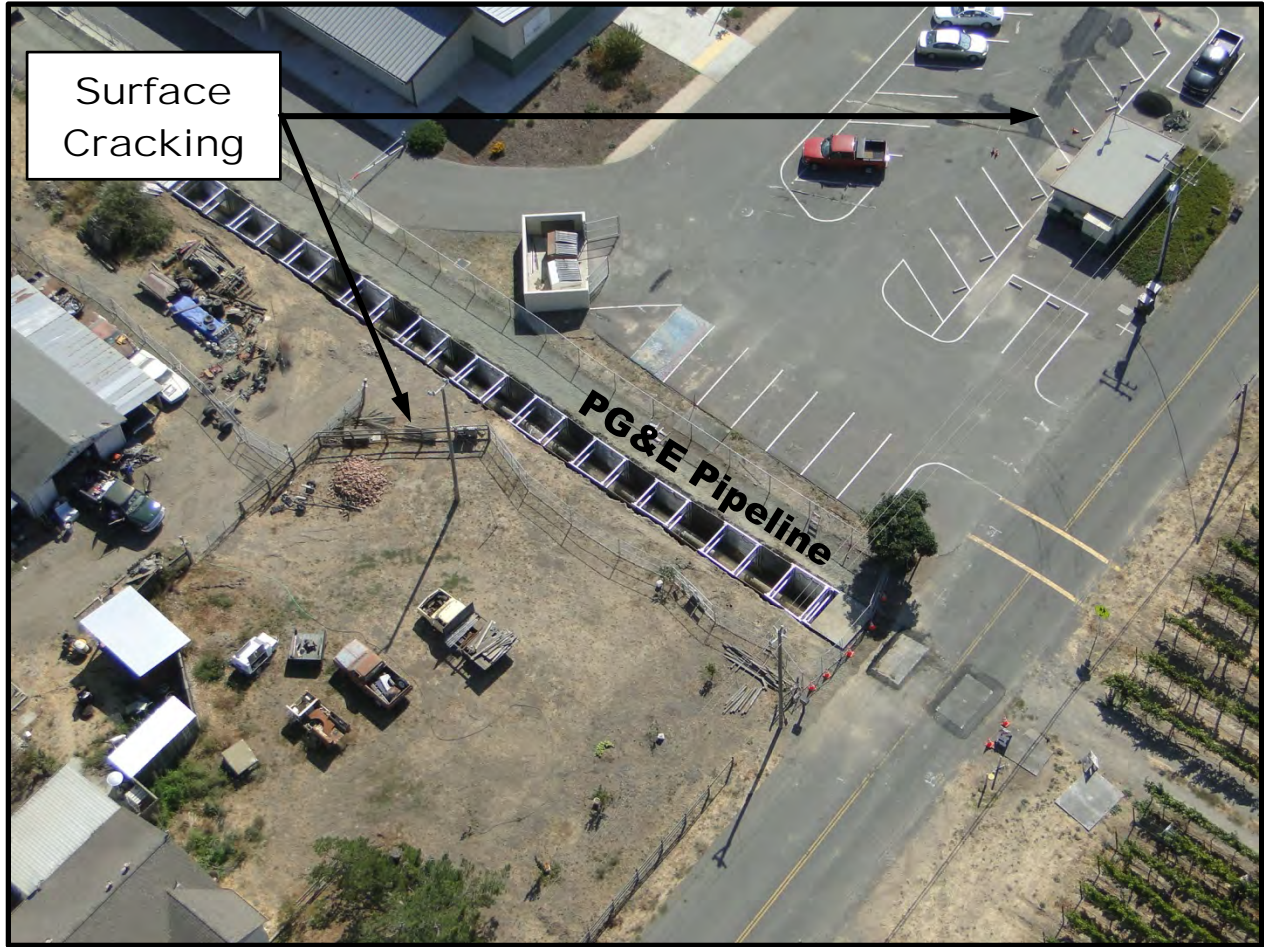
Figure 12: Aerial photograph of ground cracking crossing PG&E natural gas pipeline on Los Carneros Road near Stone Bridge School (Point A12)
– view looking towards the southeast
[NSF-GEER; Napa, CA; N 38.243 W 122.321; Harder, L. F.; 09/01/14]

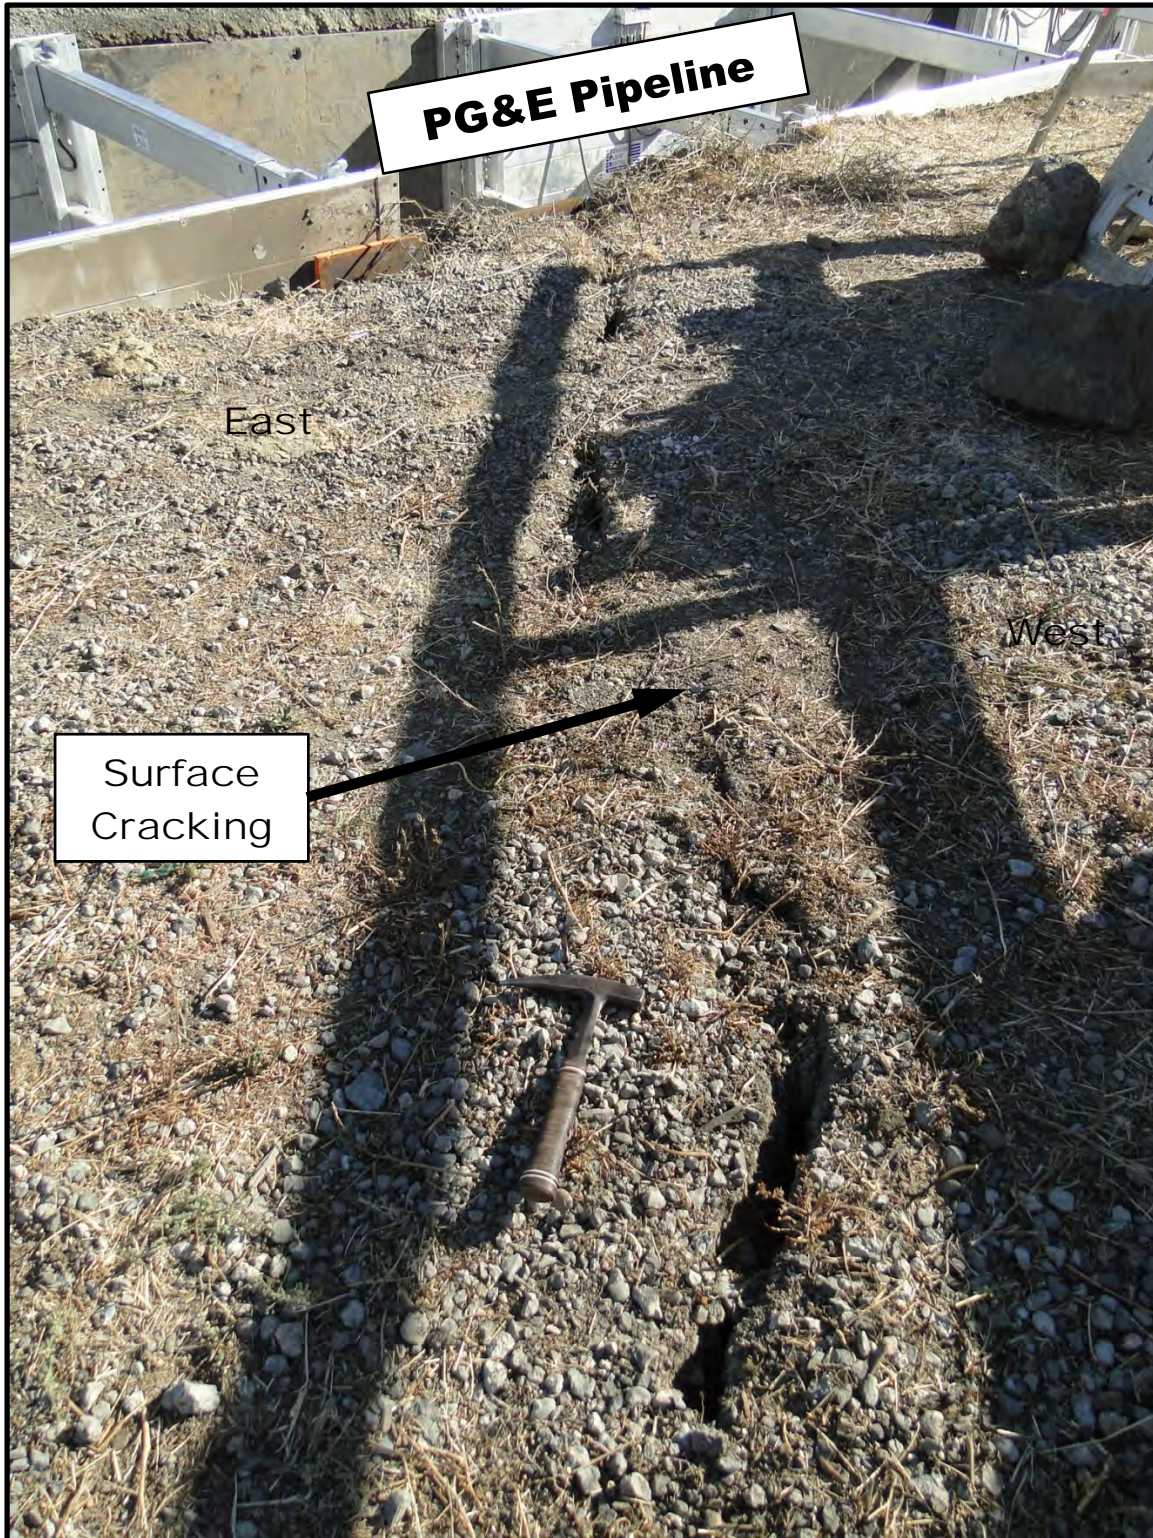
Figure 13: Photograph of linear ground cracking crossing PG&E natural gas pipeline near Los Carneros Road/Stone Bridge School (Point A12)
– view looking towards the southwest from northern side of pipeline
[NSF-GEER; Napa, CA; N 38.243 W 122.321; Harder, L. F.; 09/01/14]

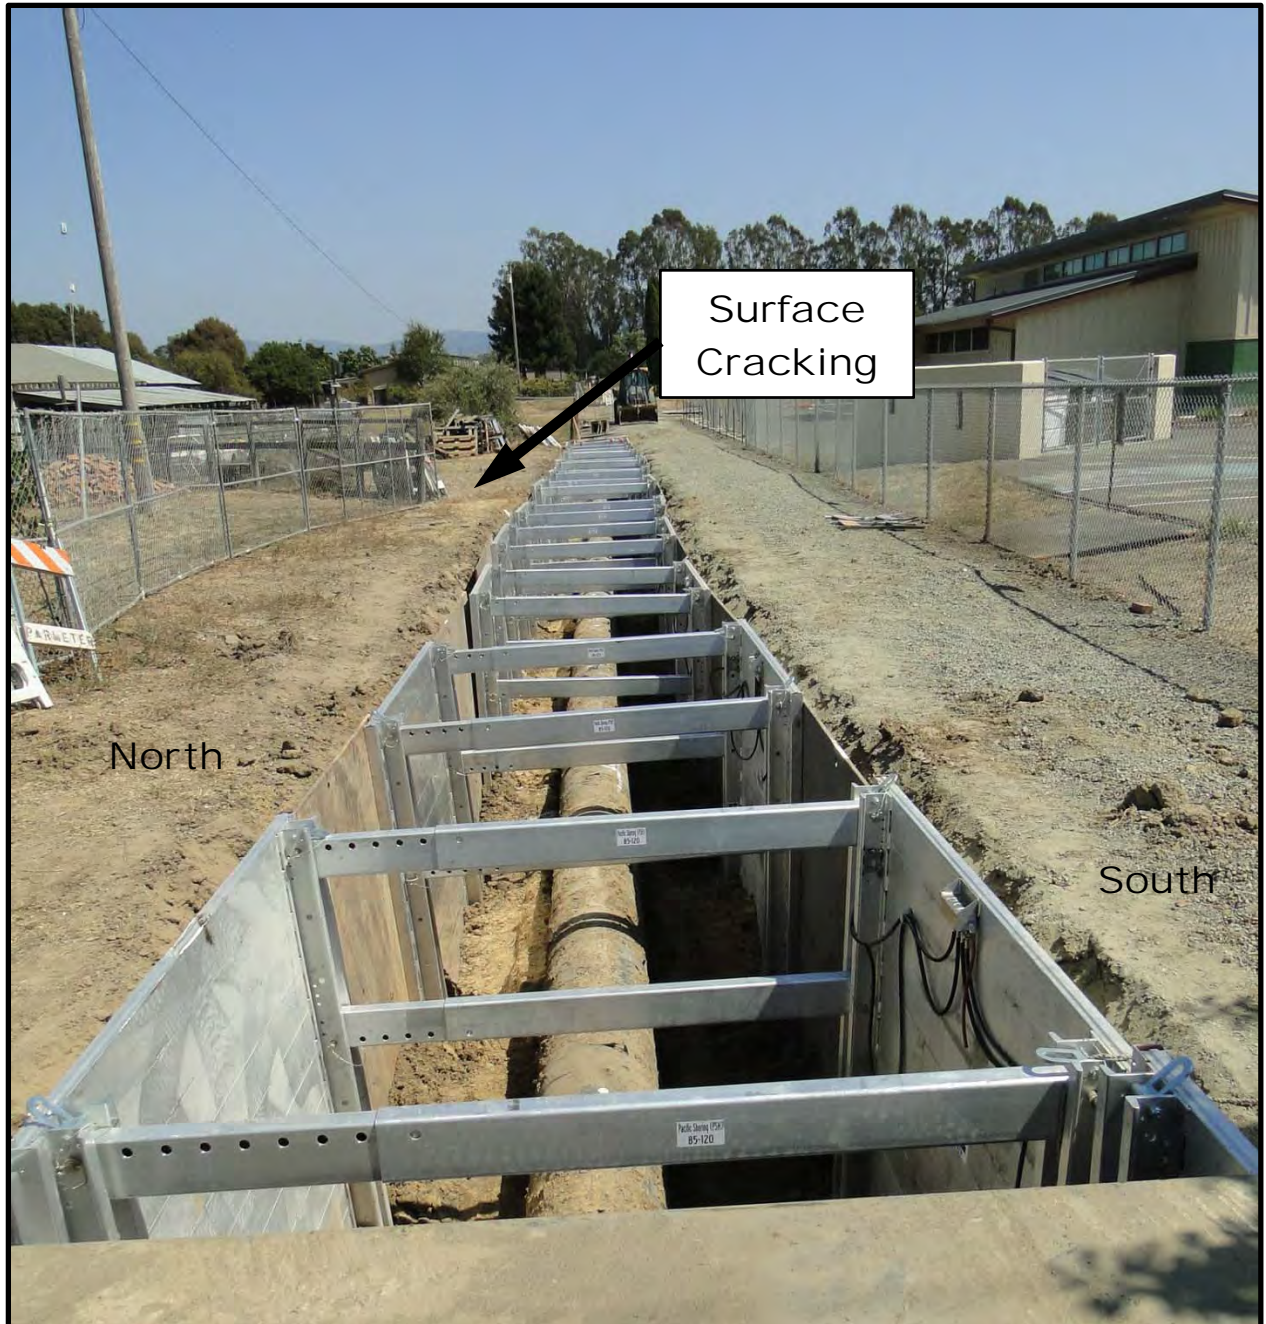
Figure 14: Photograph of excavated and shored PG&E natural gas pipeline crossing Los Carneros Road near Stone Bridge School (Point A12) – view looking towards the east towards alignment of ground cracking [NSF-GEER; Napa, CA; N 38.243 W 122.321; Harder, L. F.; 09/01/14]

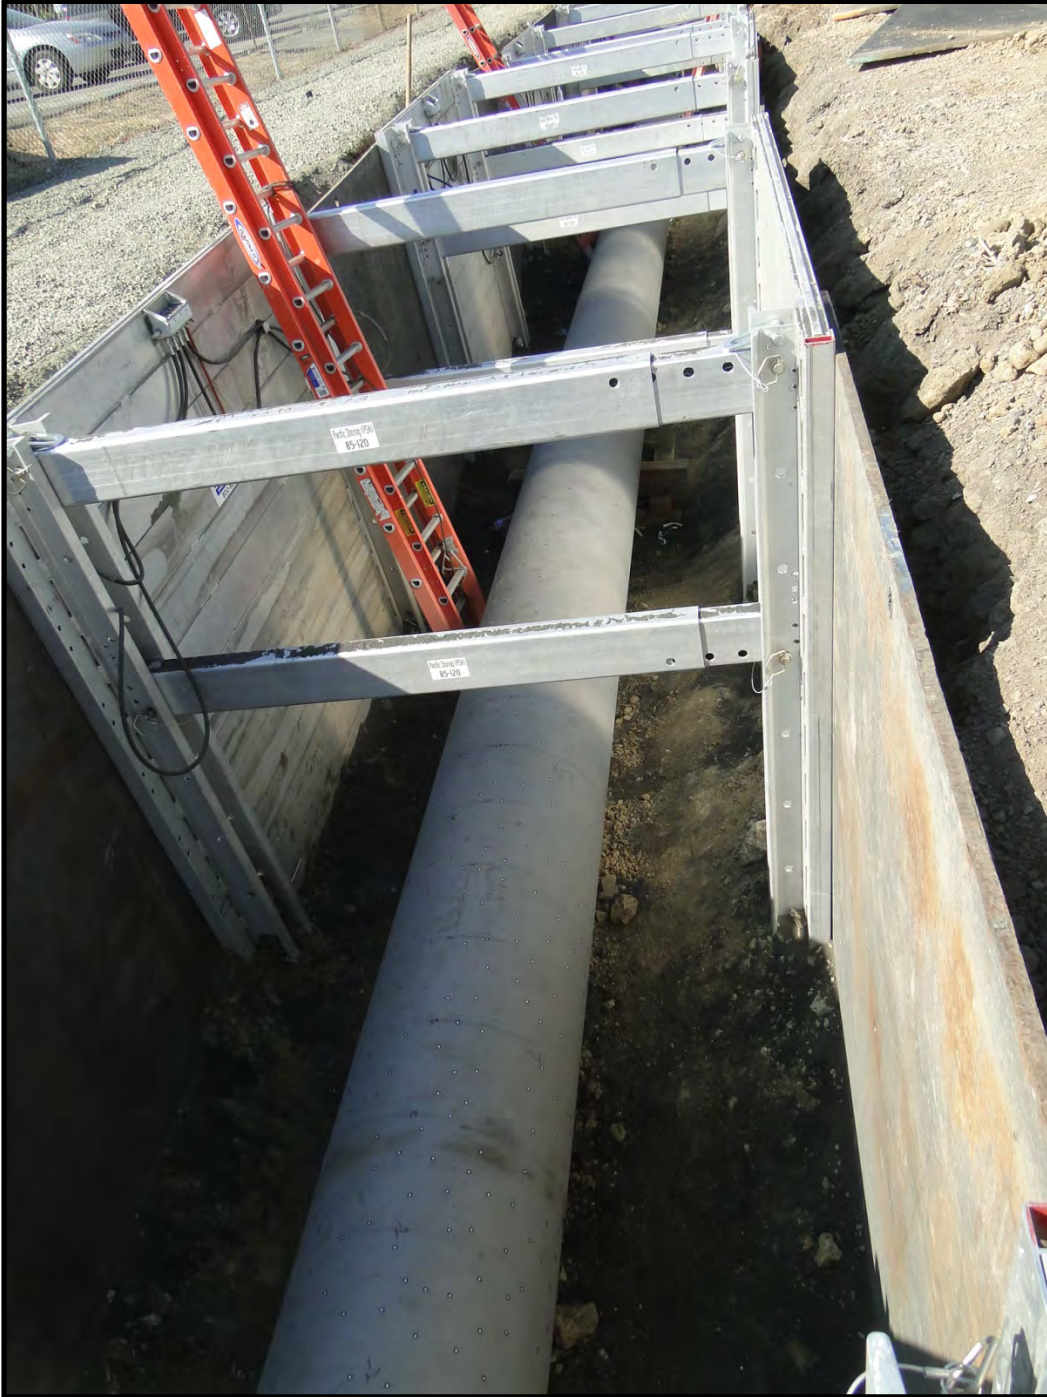
Figure 15: Photograph of unwrapped/tested PG&E natural gas pipeline crossing Los Carneros Road near Stone Bridge School (Point A12) – view looking towards the west [NSF-GEER; Napa, CA; N 38.243 W 122.321; Harder, L. F.; 09/07/14]

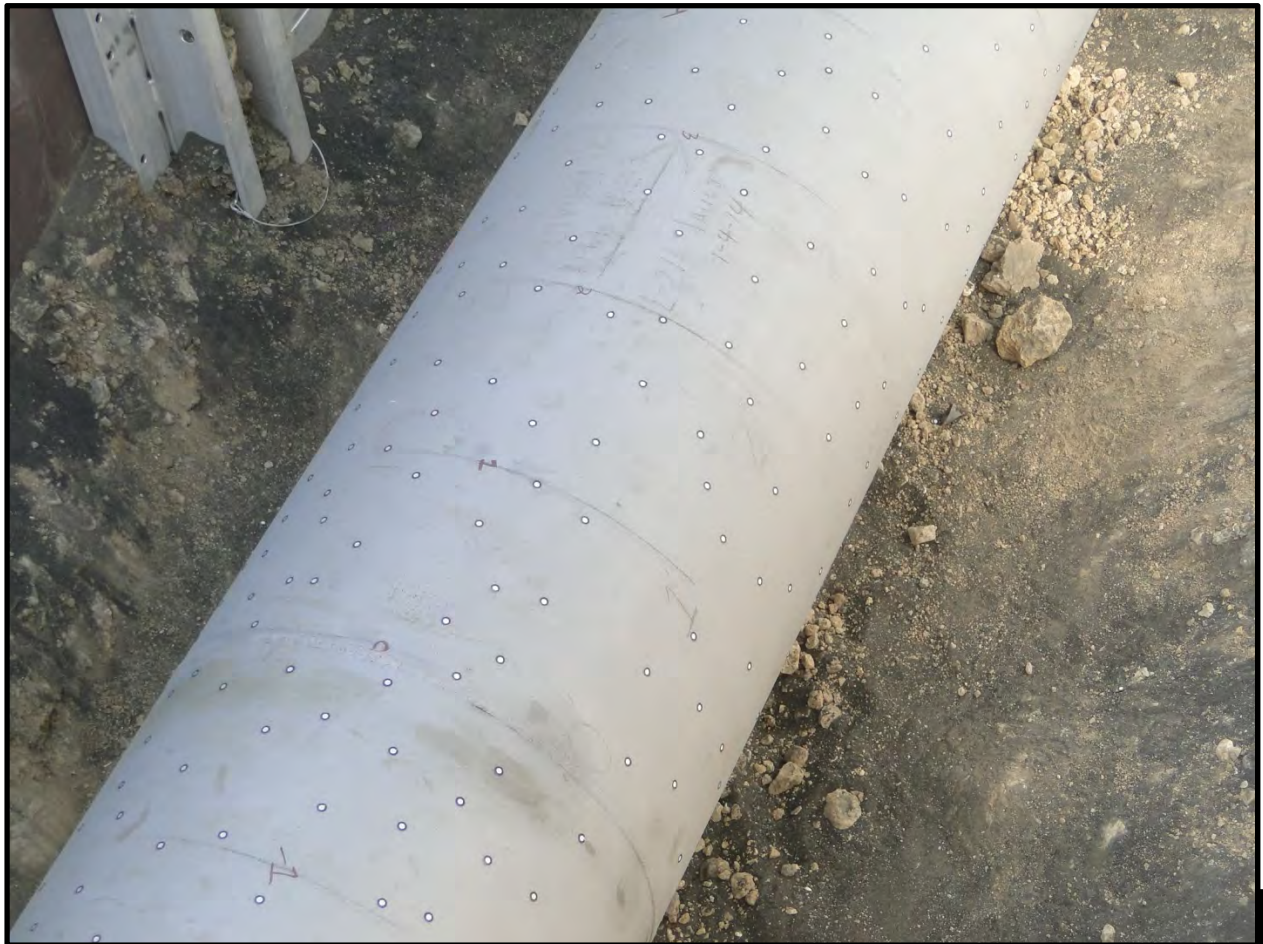
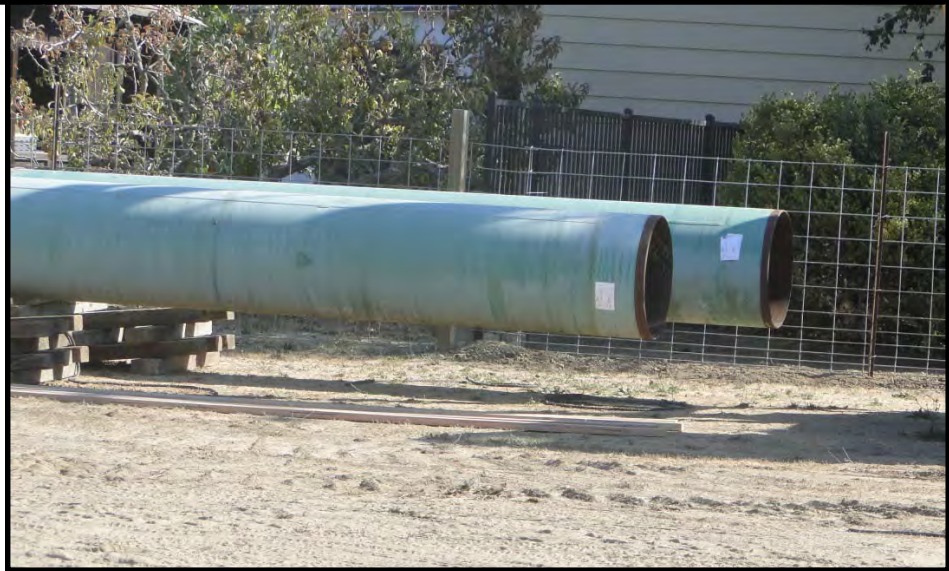
Figure 16: Close-up view of unwrapped/tested PG&E natural gas pipeline crossing Los Carneros Road near Stone Bridge School (Point A12) – note also photograph of replacement pipe on site waiting to be installed [NSF-GEER; Napa, CA; N 38.243 W 122.321; Harder, L. F.; 09/07/14]

- Residents reported that the cracking had worsened in the days following the main shock on August 24th, perhaps as a result of aftershocks.
- The principal damage observed was pavement cracking, which frequently had been fitted with temporary emergency repairs to provide for interim use. Where the surface cracking ran through residential structures, homes commonly experienced damage, and in some cases were restricted for occupancy. In many developed areas where ground cracking extended, notably the Brown's Valley area to the north, various utilities such as water mains were damaged and required emergency and/or interim repairs. South of State Highway 12/Highway 121 where the ground cracking crossed the alignment of a Pacific Gas and Electric natural gas pipeline, the pipeline was depressurized and, while no overt damage was reported after being inspected, a segment of the pipe was set to be replaced with a new pipe having a larger thickness.

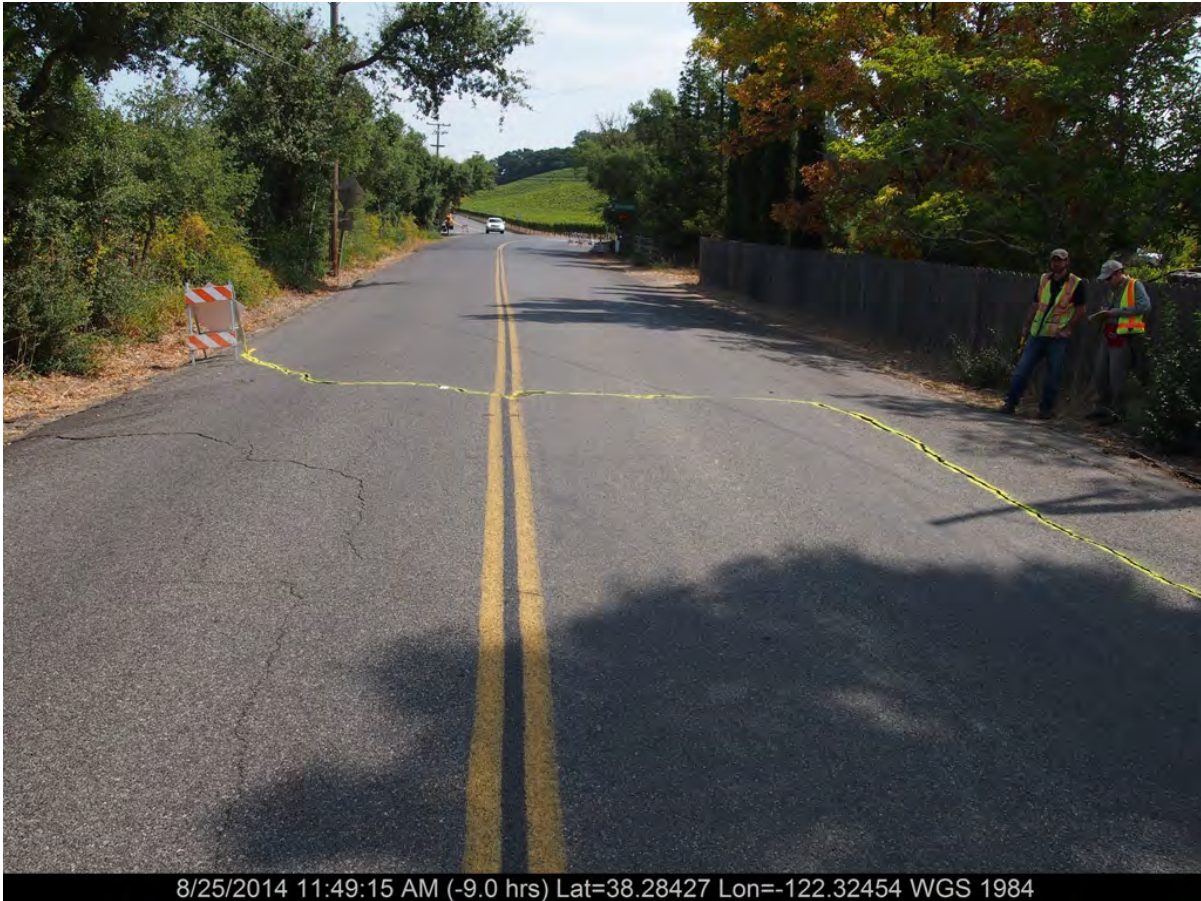
Figure 1. Photograph showing cracking in paved road surface perpendicular and parallel to NE-SW oriented Congress Valley Rd. [NSF-GEER; N38.2842, W122.3245; 08/25/14; 11:49 AM]

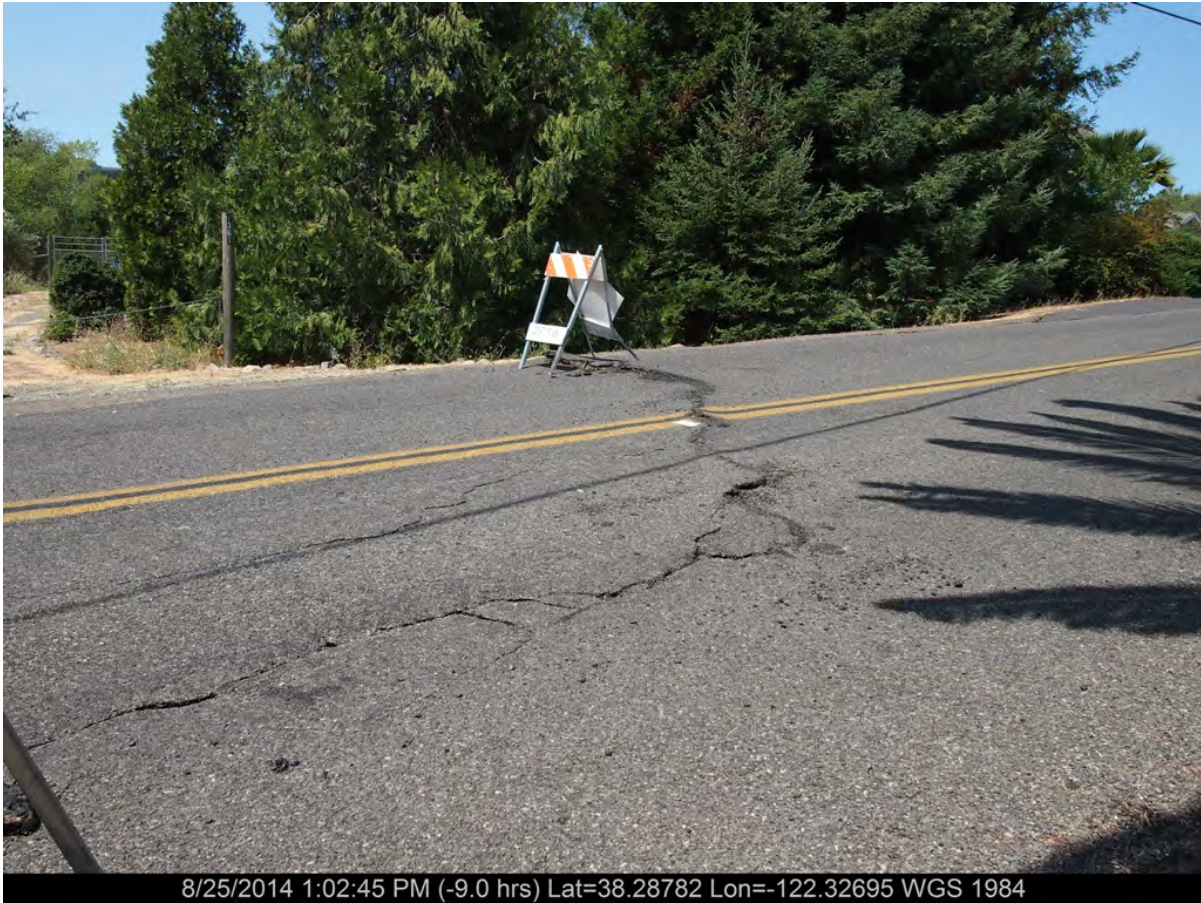
Figure 3. Photograph showing cracking in paved surface of N-S oriented Thompson Rd. [NSF-GEER; N38.2878, W122.3269; 08/25/14; 1:02 PM]

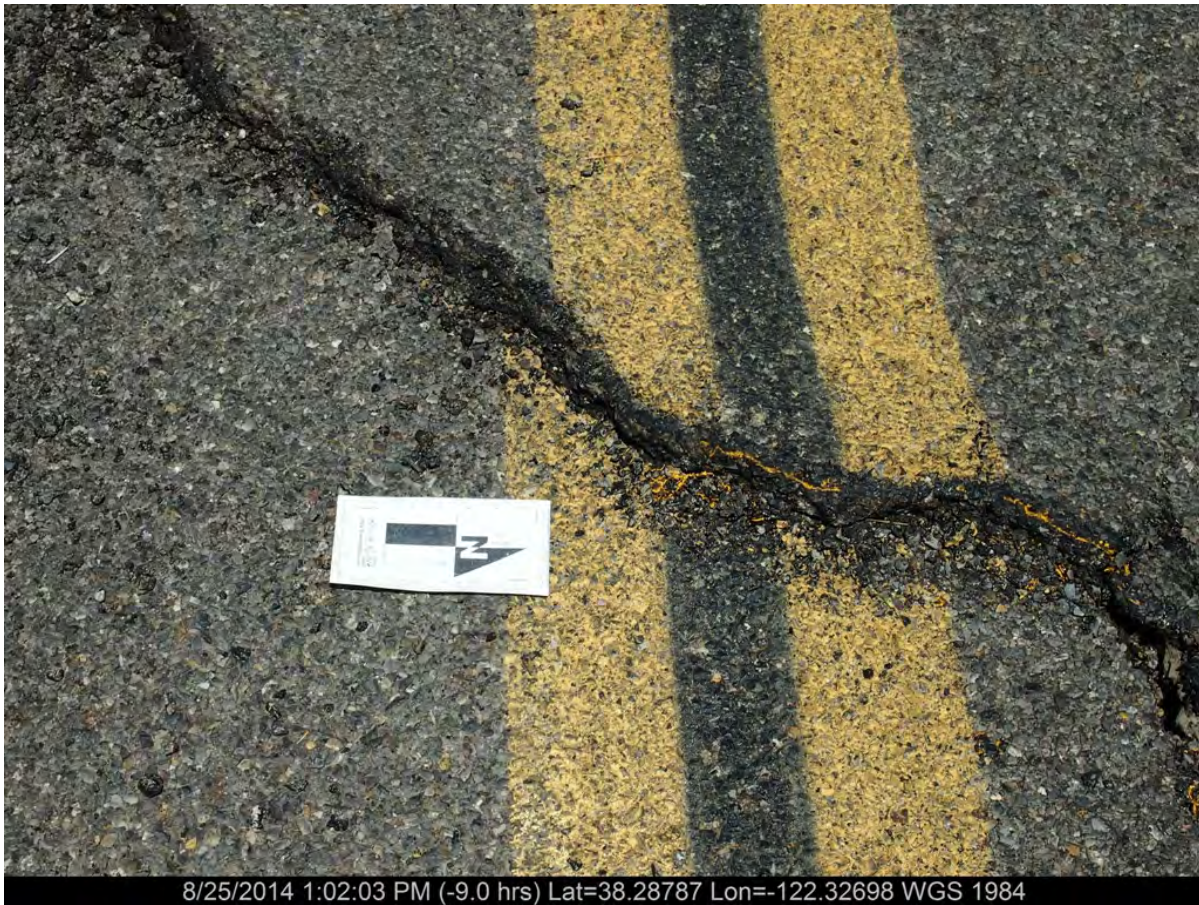
Figure 4. Photograph showing approximately 5 cm apparent right lateral separation of eastern margin of Thompson Ave. centerline. [NSF-GEER; N38.2878, W122.3269; 08/25/14; 1:02 PM]

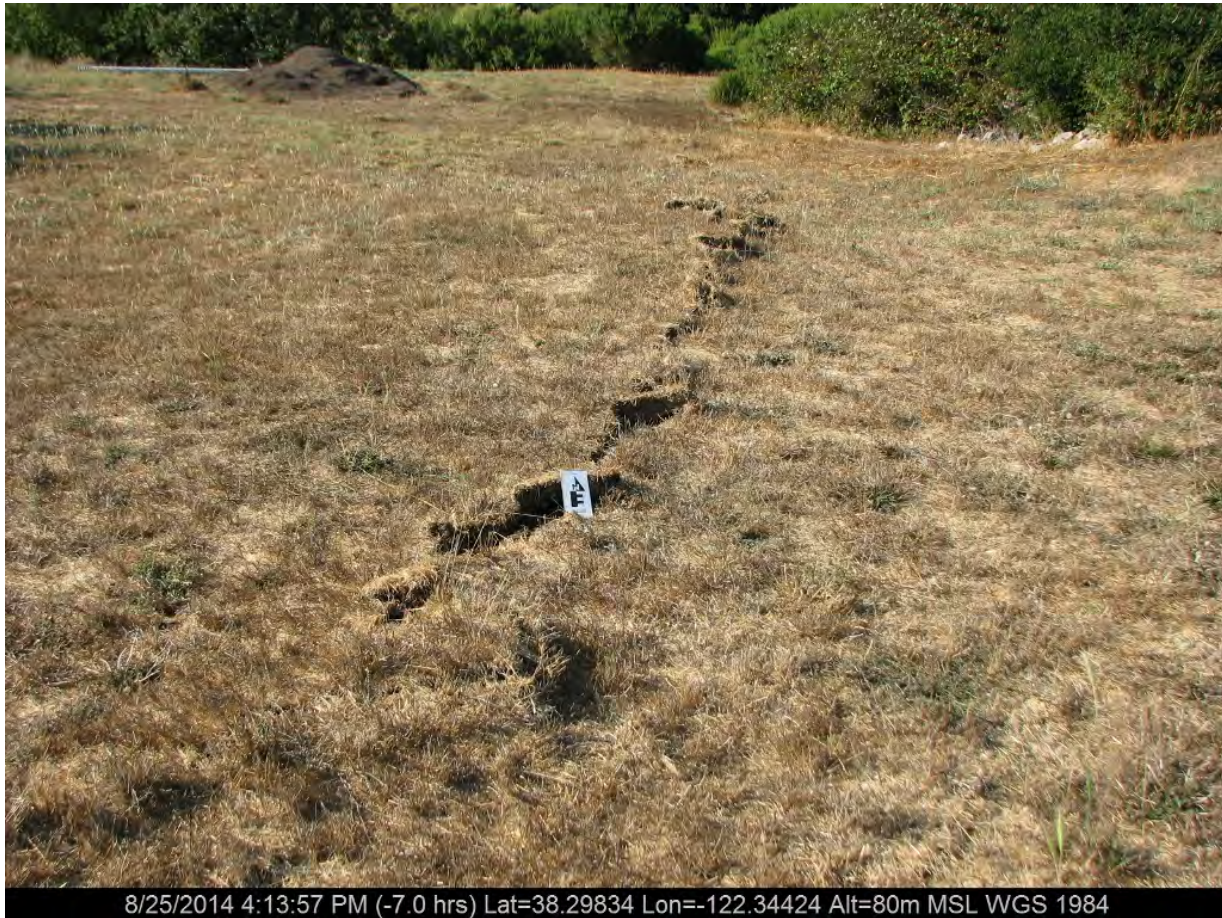
Figure 5: Photograph showing linear deformation of ground surface in natural ground surface / graded lot as linear mole track. Deformation apparently confined to zone appx.1-2 m wide and extends appx.50-60 m. [NSF-GEER; N38.2983, W122.3442; 08/25/14; 4:13 PM]

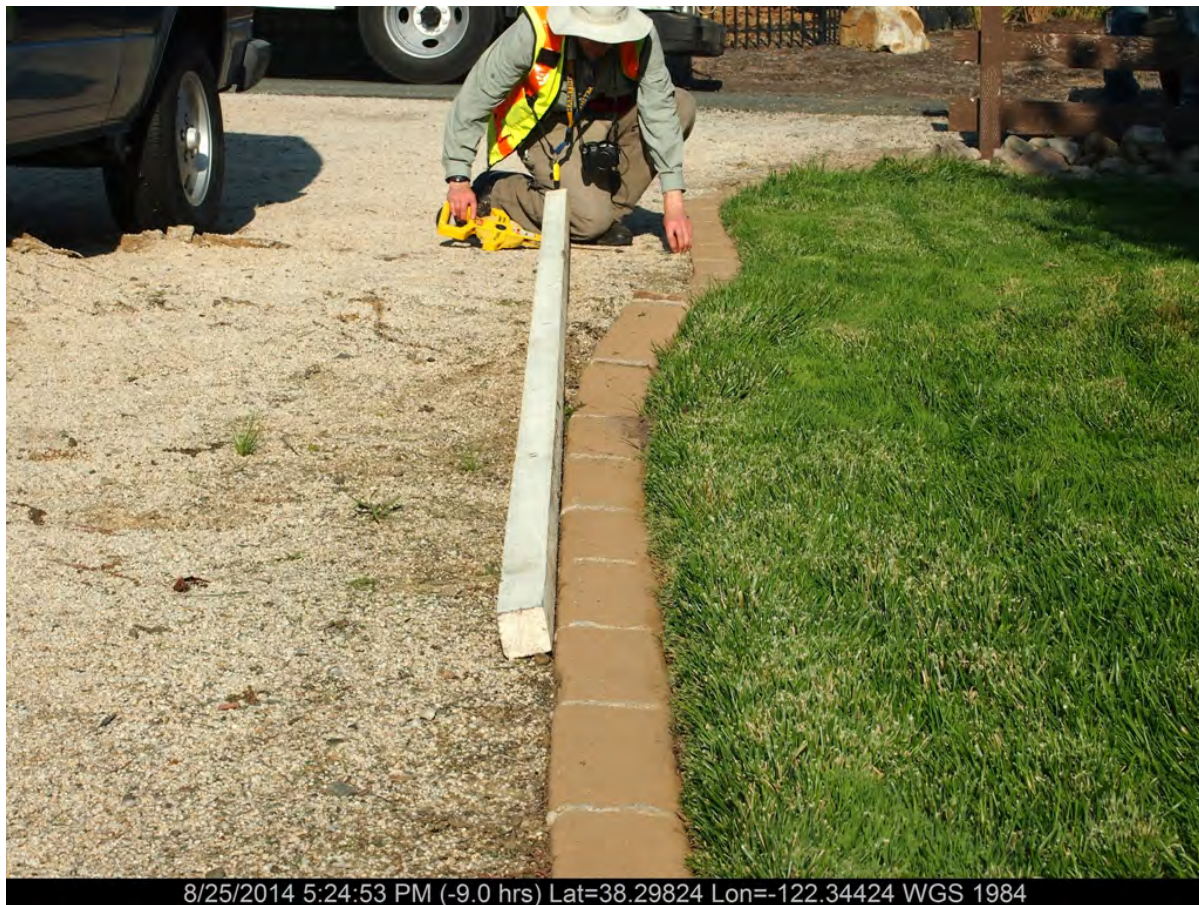
Figure 6. Photograph showing right lateral displacement of aligned bricks at southern margin of crushed granite driveway on Leaning Oak Rd. Measured a maximum of 1.1ft (appx.33) cm of right-lateral displacement. [NSF-GEER; N38.2982, W122.3442; 08/25/14; 4:26 PM]
