## Appendix C: Effects of Surface Fault Rupture on Infrastructure

Numbering of the Appendix C contents for individually mapped houses are denoted with an “H##” that represents the house reference number. The first figure for each house includes a site map (Figure C-H##-1); subsequent figures numbers are photographs associated with the house. As an example, the second photo for house no. 7 would be: “Figure C-H07-3.”

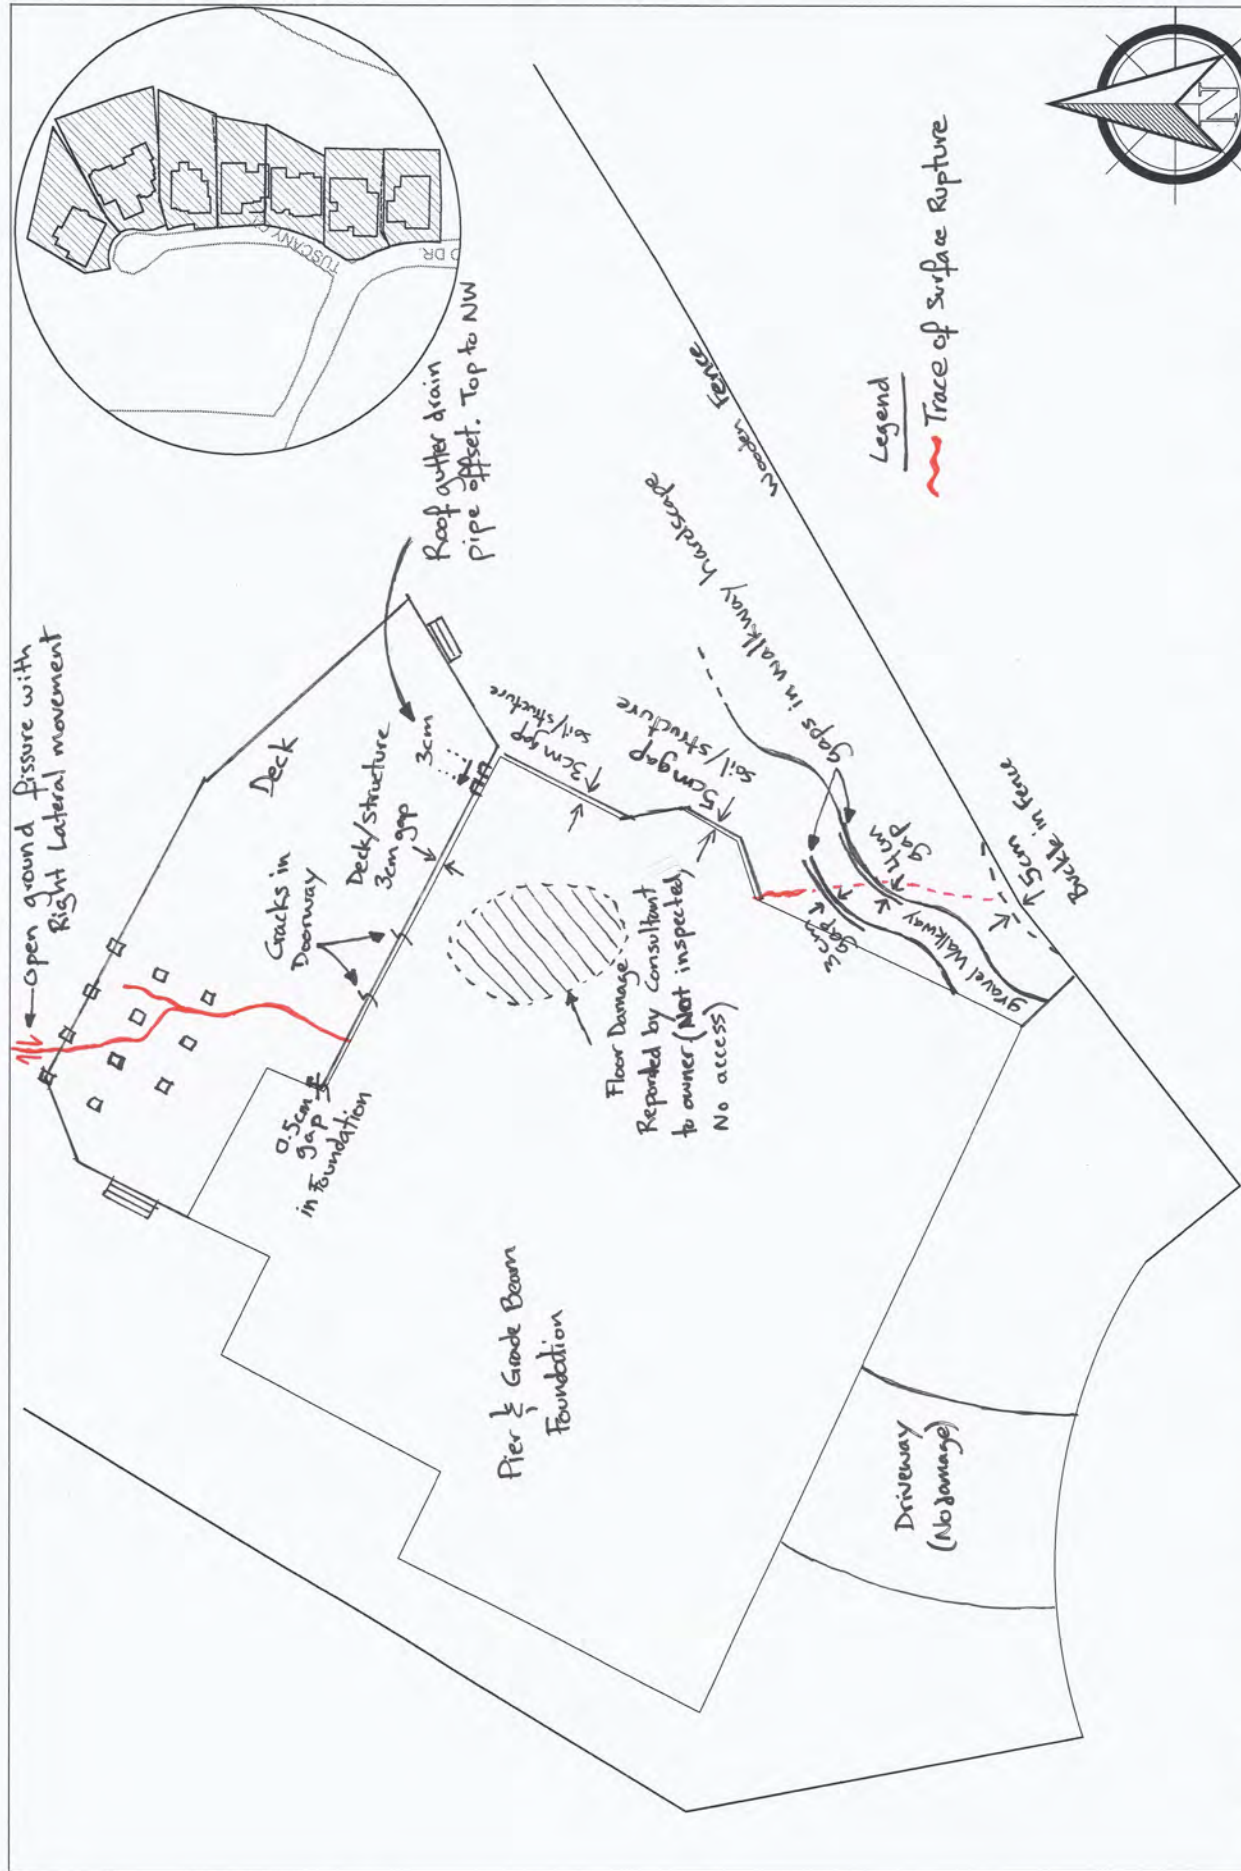
Open ground fissure with Right Lateral movement

Roof gutter drain pipe offset. Top to NW

gaps in walkway hardscape

Floor Damage Reported by Consultant to owner (Not inspected, No access)

Back in fence

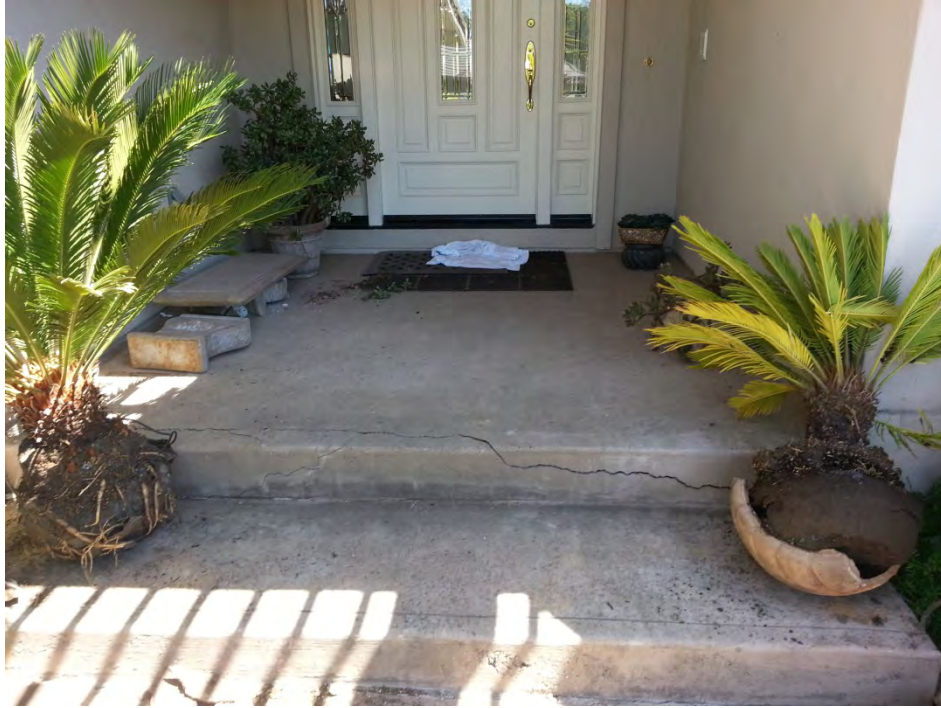
Figure C-H02-2: East looking view of crack extending through walkway and garage. [NSF-GEER; N 38.3133 W 122.3431; 08/28/14 12:46]

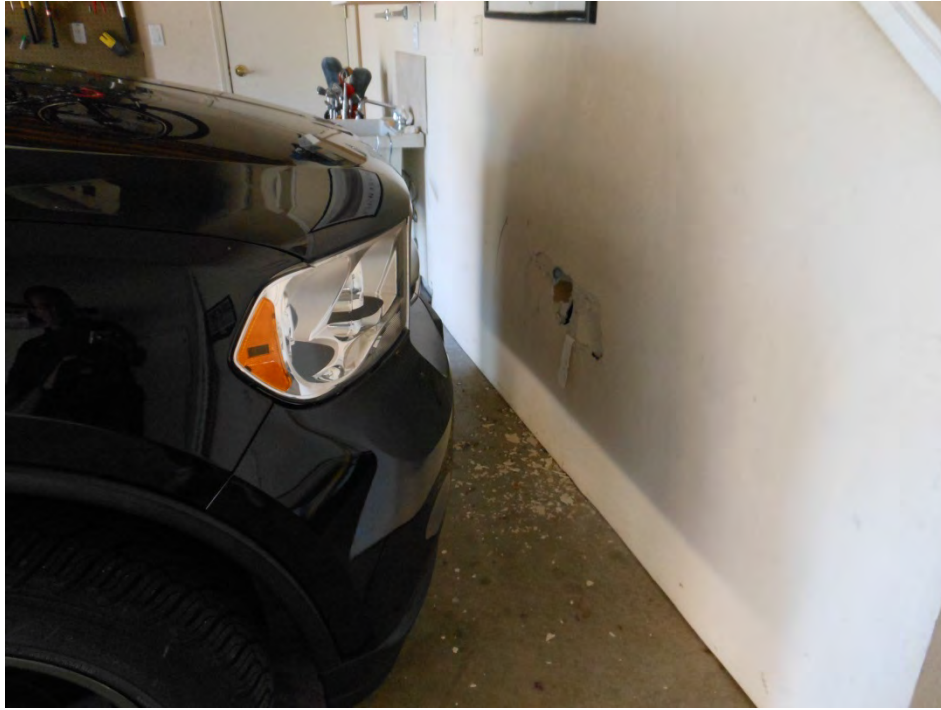
Figure C-H03-4: Vehicle thrown E-W into wall. [NSF-GEER; N 38.3131 W 122.3431; 08/28/14]

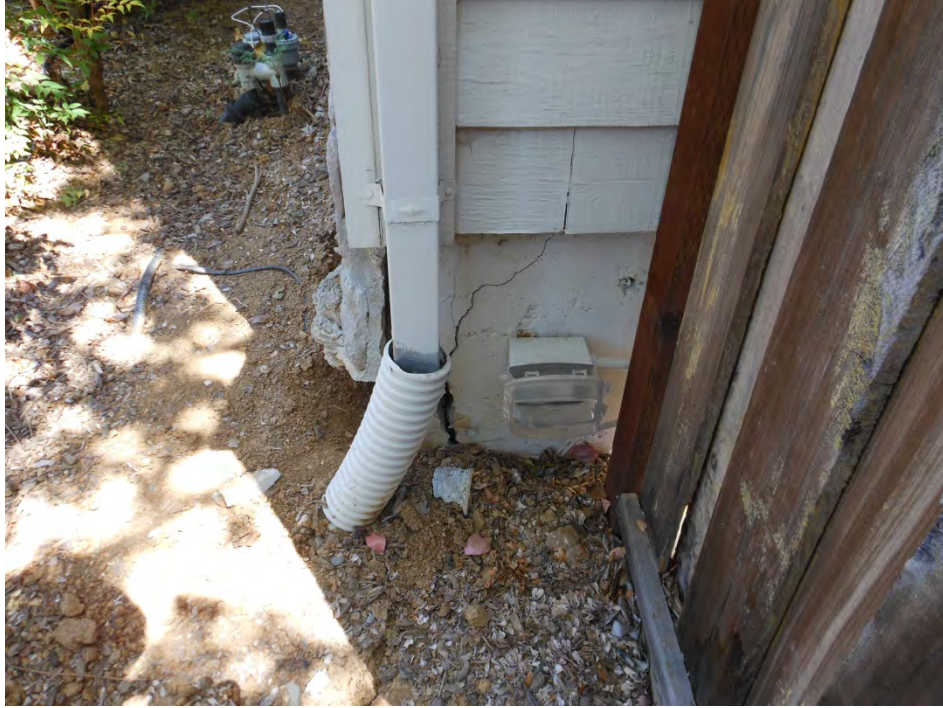
Figure C-H04-4: Cracked foundation. [NSF-GEER; N 38.3128 W 122.3431; 08/28/14]

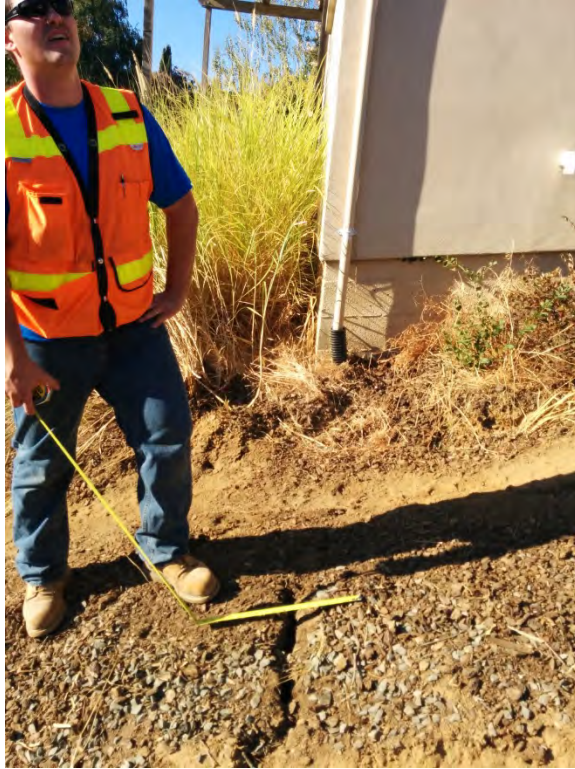
Figure C-H06-2: Soil fissure looking North. [NSF-GEER; N 38.3124 W 122.3431; 08/28/14, 17:31]

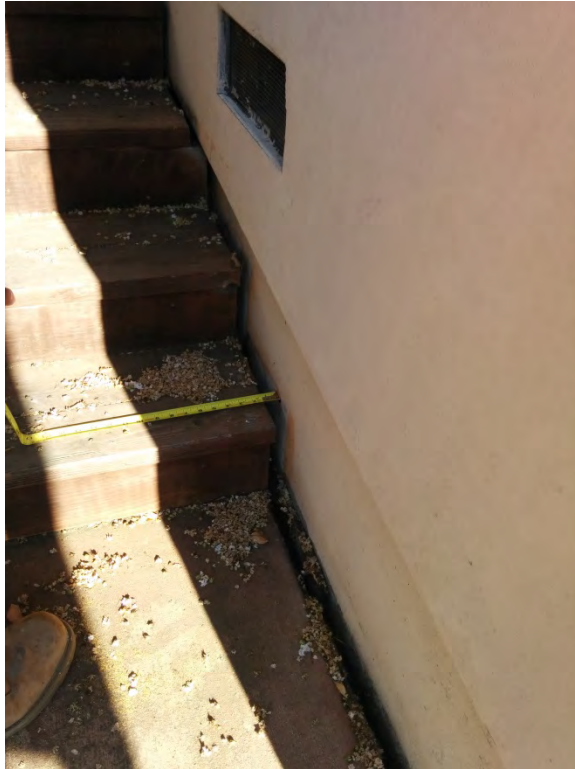
Figure C-H06-3: Staircase displaced from structure. [NSF-GEER; N 38.3124 W 122.3431; 08/28/14]

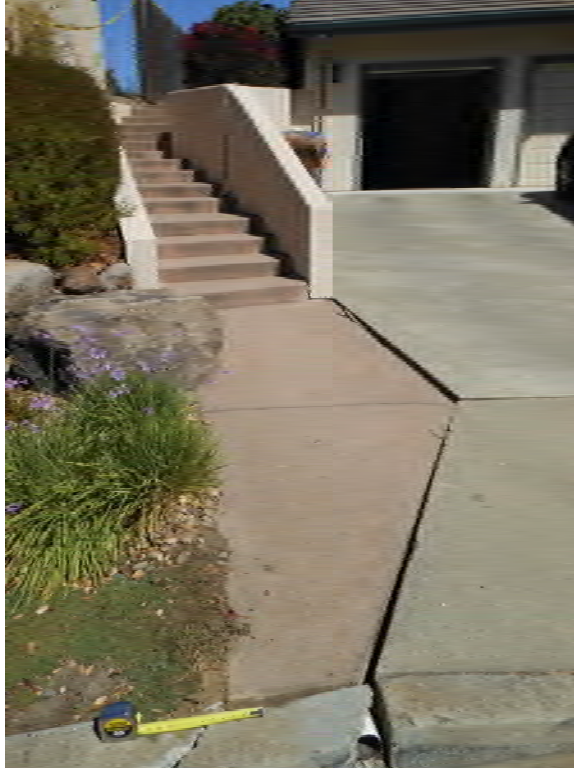
Figure C-H07-2: Crack extending along stair case and joint. [NSF-GEER; N 38.3122 W 122.3432; 08/28/14]

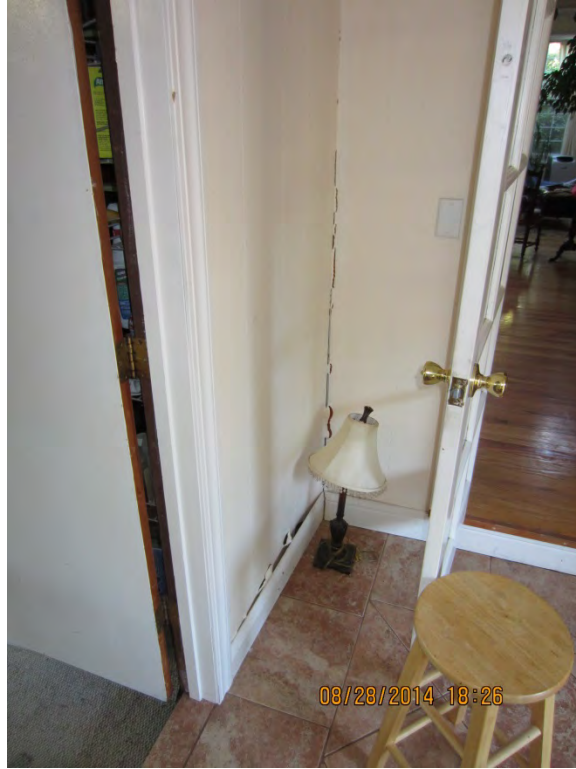
Figure C-H14-2: Crack along boundary with new construction. [NSF-GEER; N 38.3082 W 122.3427; 08/28/14, 18:26]

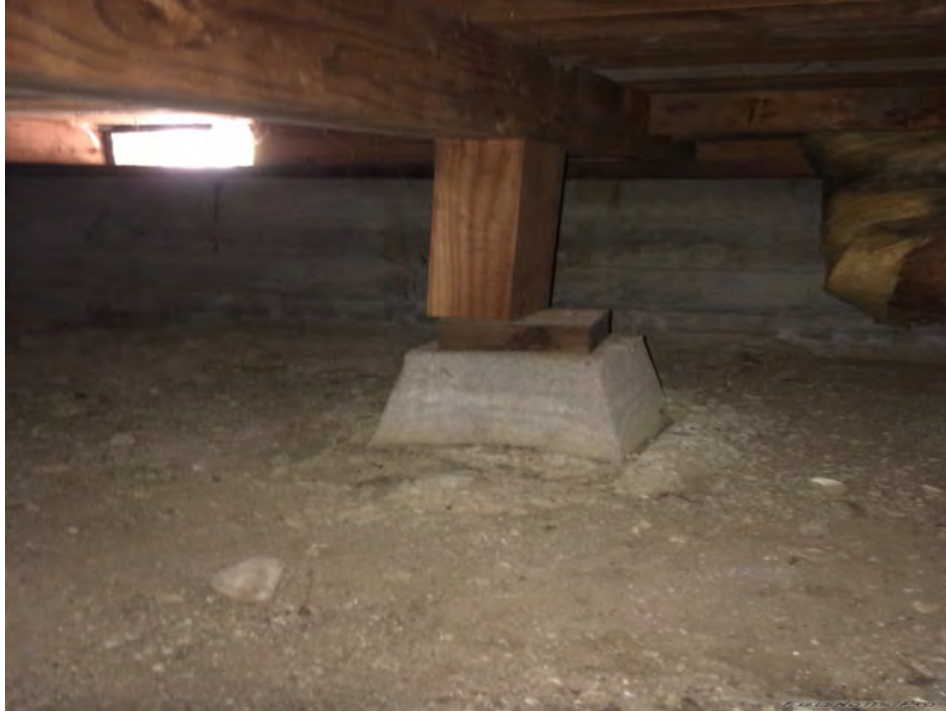
Figure C-H15-2: Shifted wooden column. The column was shifted towards west. [NSF-GEER; N 38.3061 W 122.3427; 08/29/14 10:02]

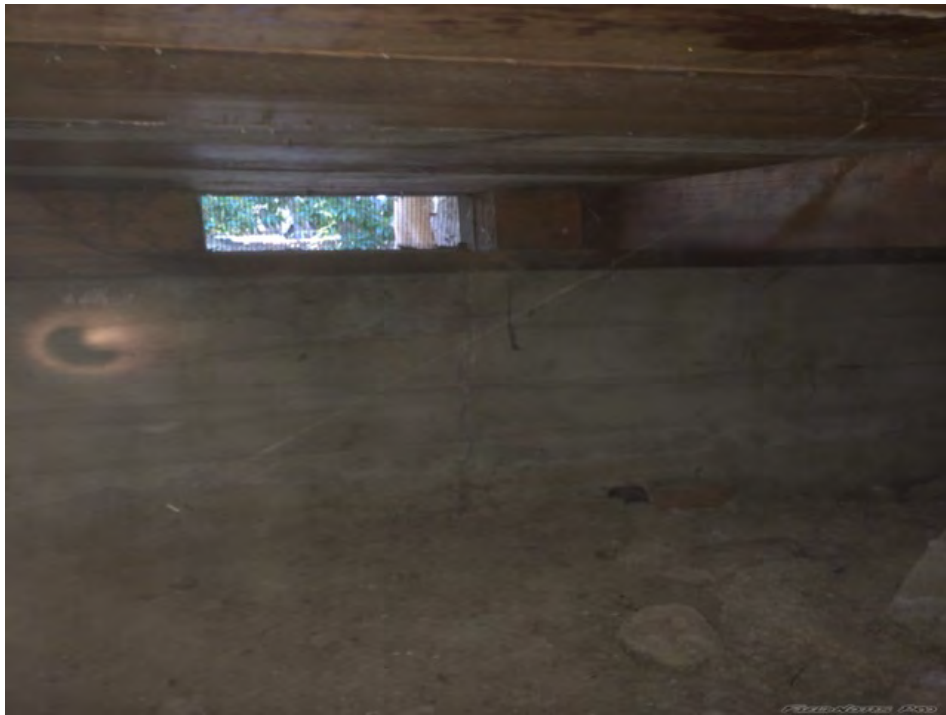
Figure C-H15-3: Crack in the perimeter foundation wall [NSF-GEER; N 38.3066 W 122.3427; 08/31/14 10:02]

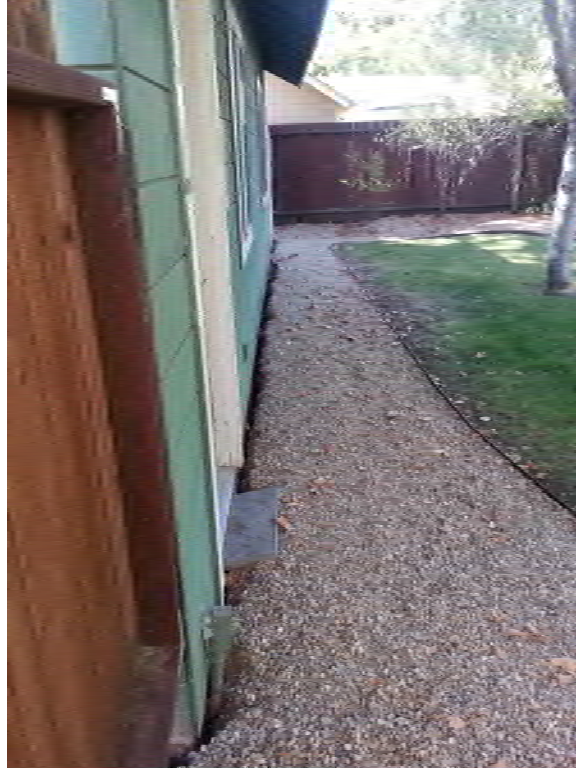
Figure C-H21-2: Open fissure along detached garage causing settlement to the right (West) [NSF-GEER; N 38.3052 W 122.3369; 08/28/14, 10:09]

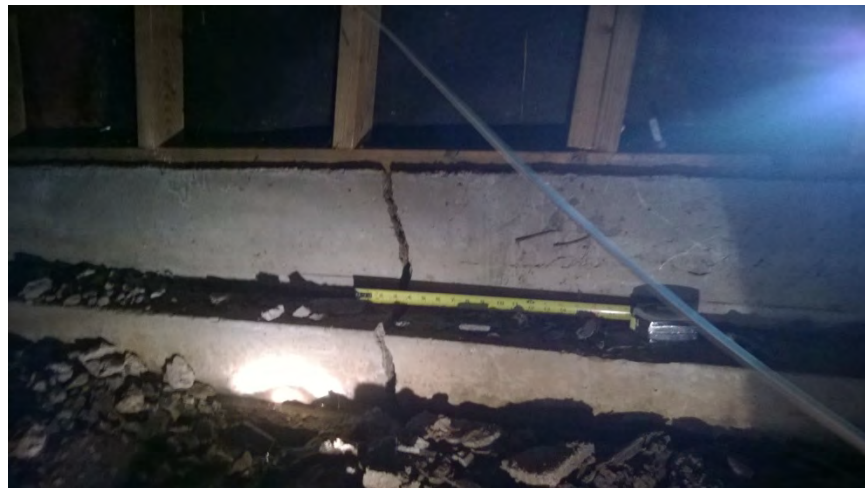
Figure C-H21-3: Strip footing crack and tilted cripple wall (E-W) [NSF-GEER; N 38.3052 W 122.3369; 08/28/14, 10:15]

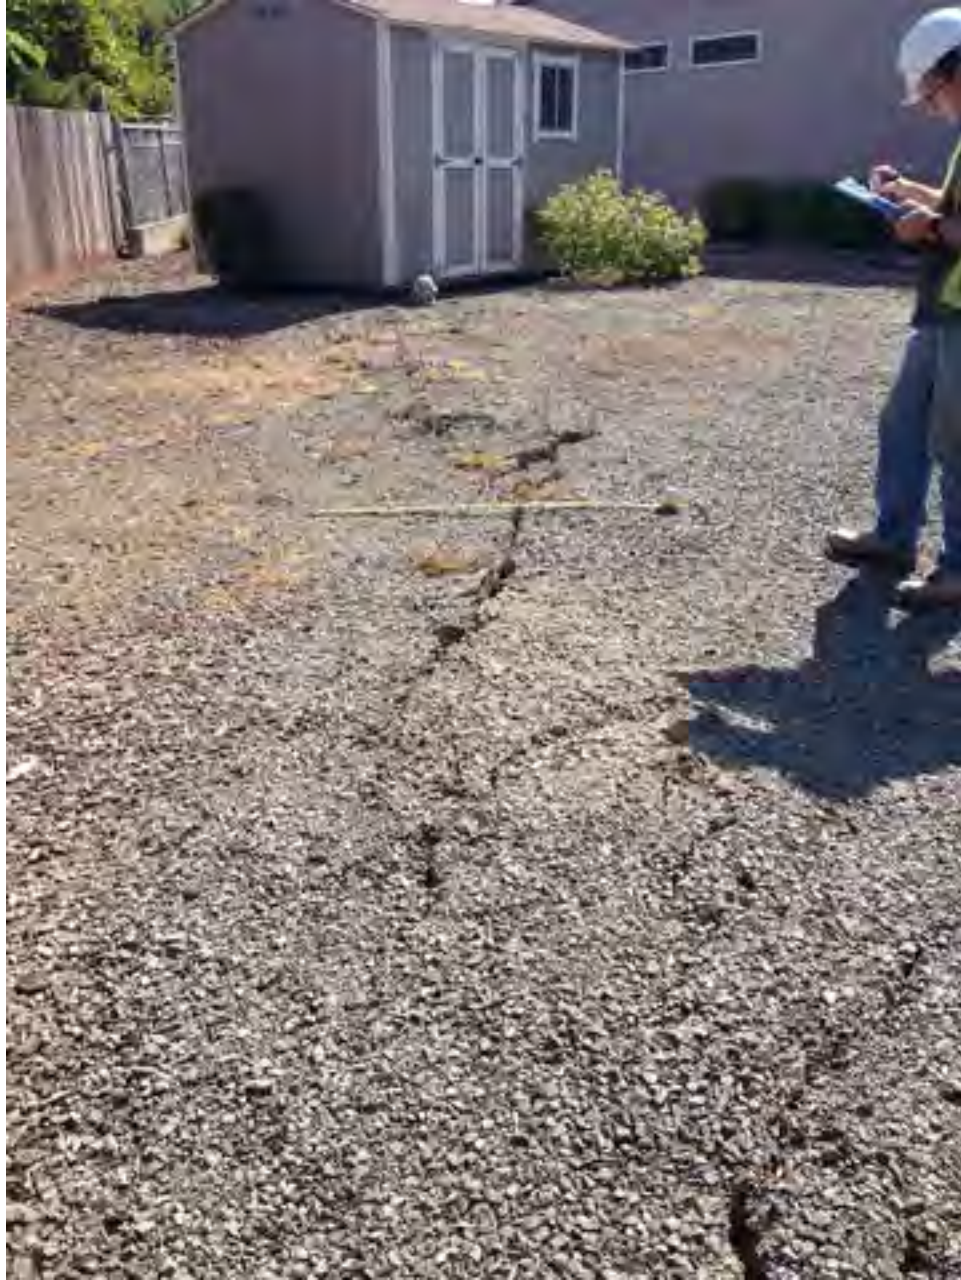
Figure C-H23-2: Ground surface rupture in side-yard  
[NSF-GEER; N 38.3045 W 122.3427; 08/25/14 15:24]

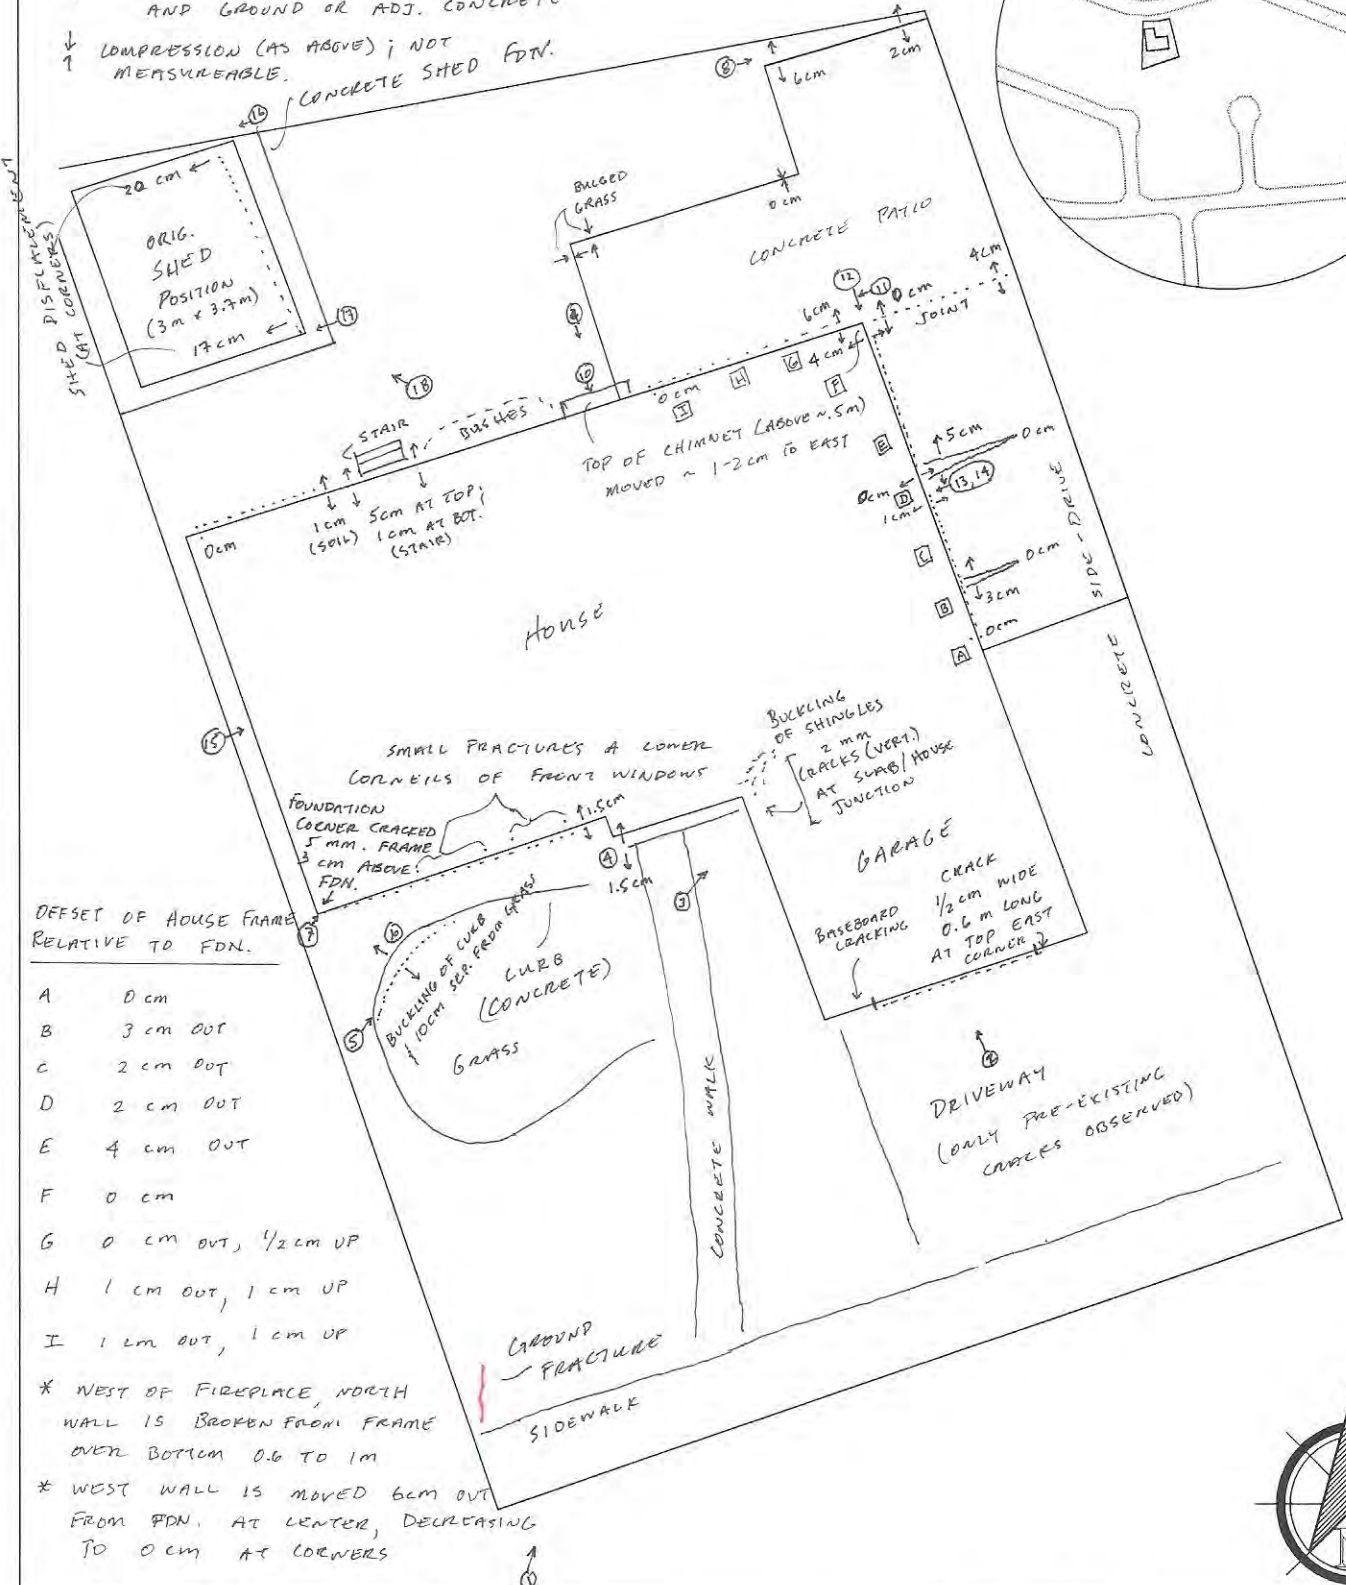
OFFSET OF HOUSE FRAME RELATIVE TO FDN.

- A 0 cm
- B 3 cm OUT
- C 2 cm OUT
- D 2 cm OUT
- E 4 cm OUT
- F 0 cm
- G 0 cm OUT, 1/2 cm UP
- H 1 cm OUT, 1 cm UP
- I 1 cm OUT, 1 cm UP

- \* WEST OF FIREPLACE, NORTH WALL IS BROKEN FROM FRAME OVER BOTTOM 0.6 TO 1m
- \* WEST WALL IS MOVED 6cm OUT FROM FDN. AT CENTER, DECREASING TO 0cm AT CORNERS

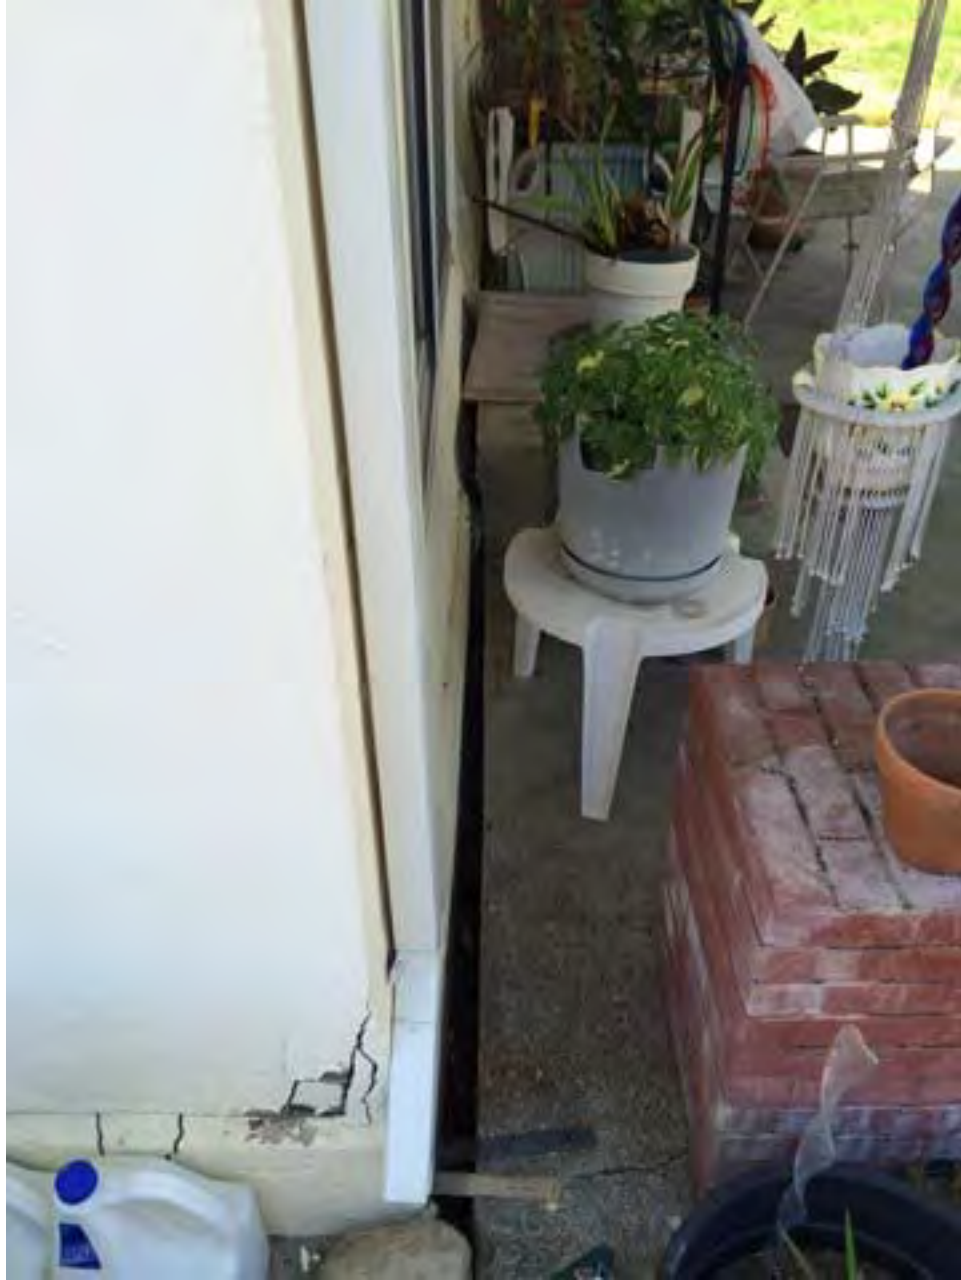
Figure C-H24-2: Displacement of patio slab relative to structure foundation; cracking of corner [NSF-GEER; N 38.3041 W 122.3429; 08/25/14 13:18]

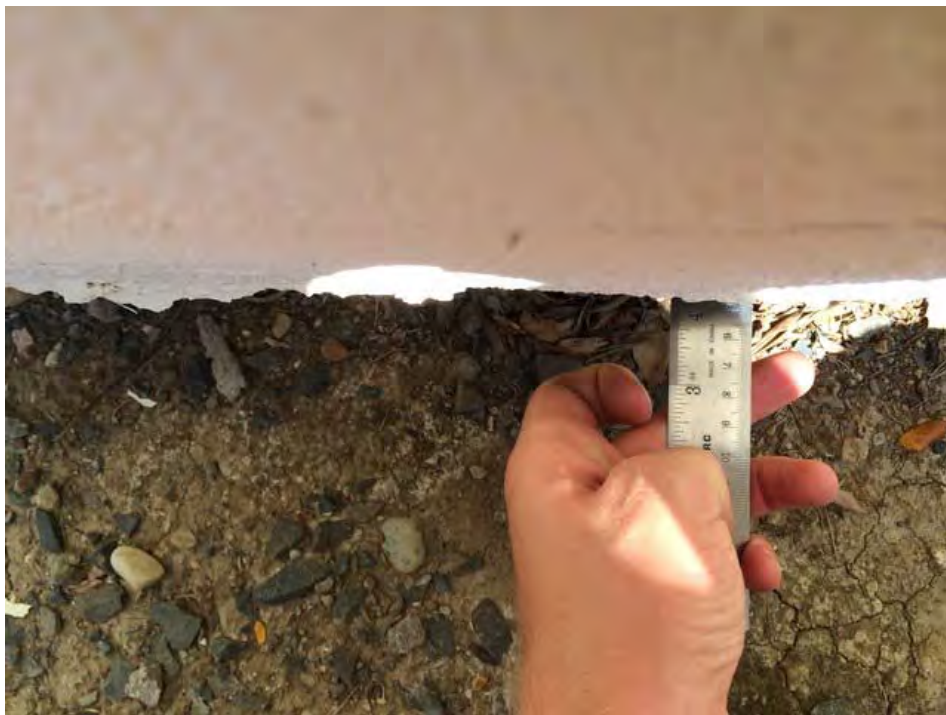
Figure C-H24-4: Offset of wall frame relative to foundation (view from top) [NSF-GEER; N 38.3040 W 122.3431; 08/25/14 14:15]

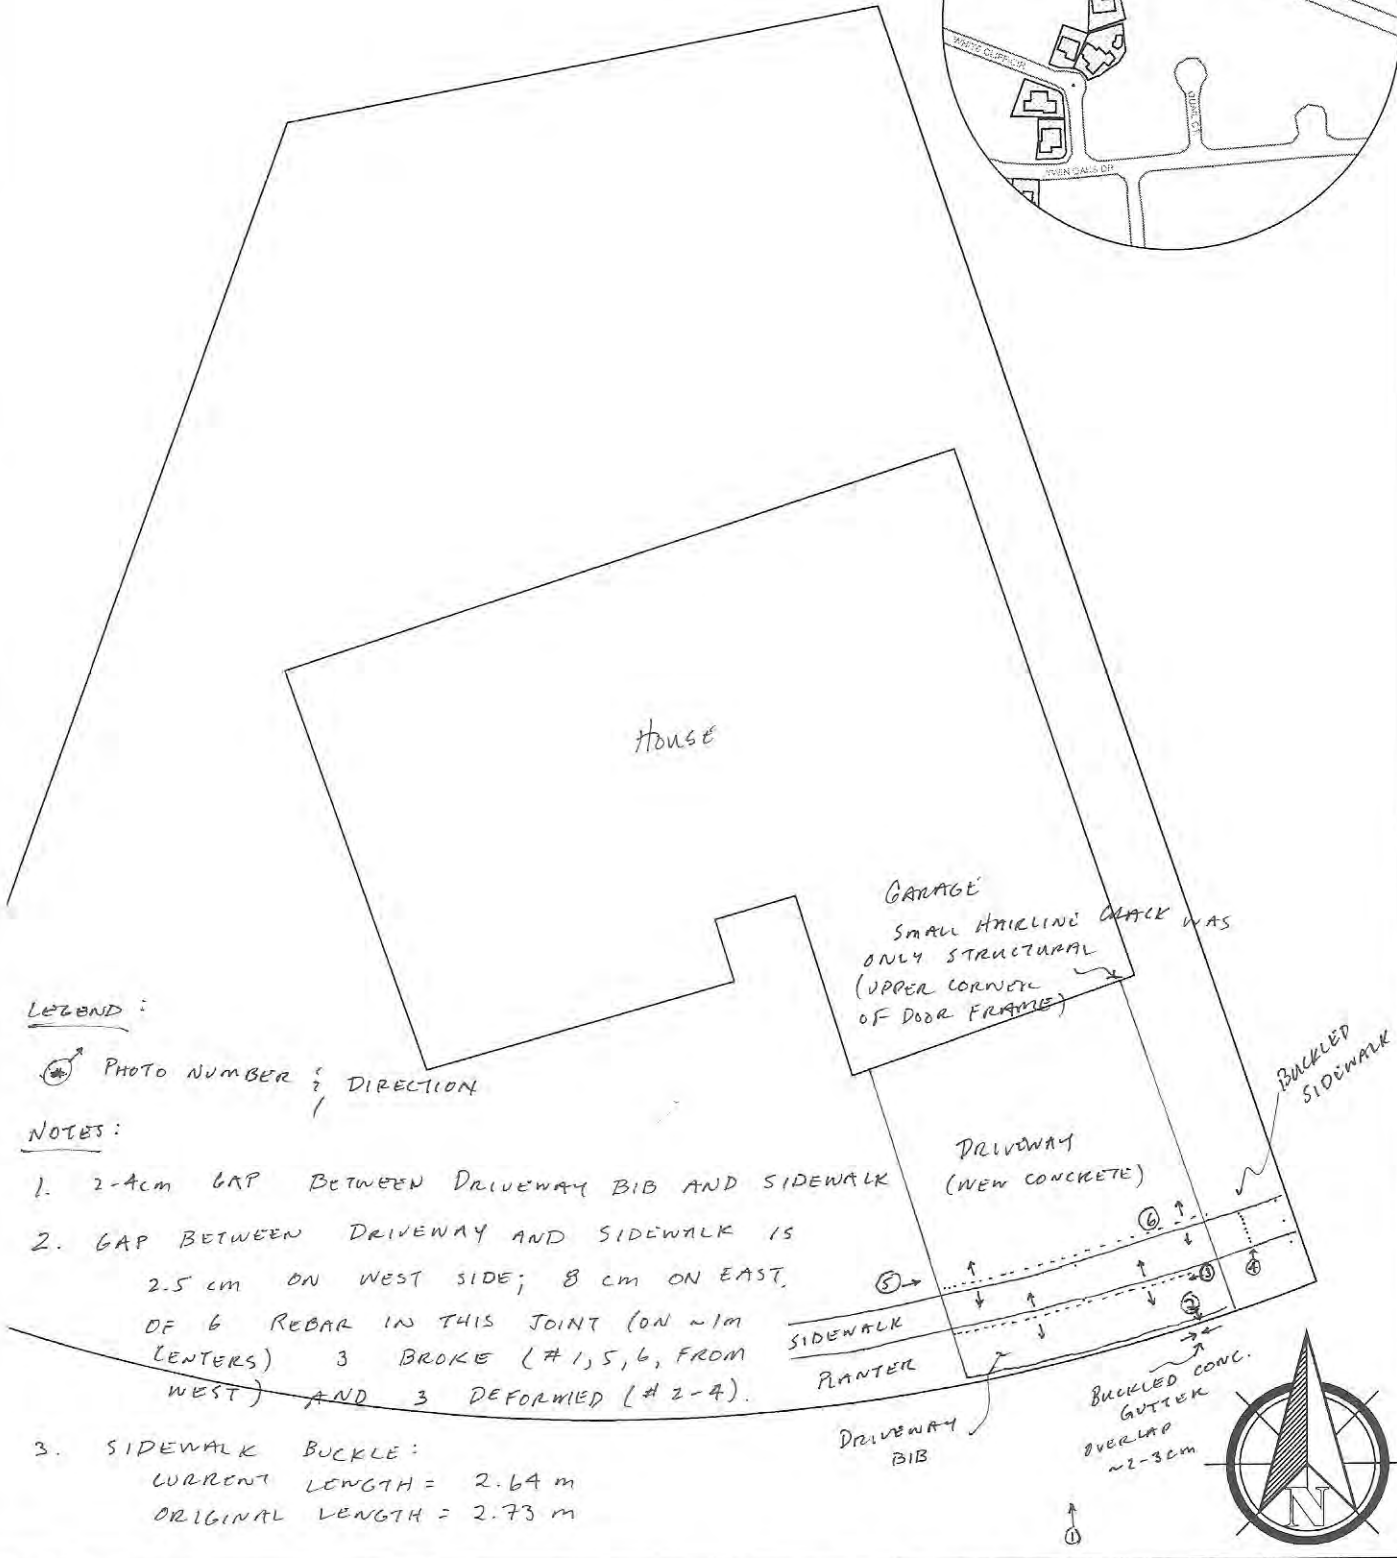
1. 2-4cm GAP BETWEEN DRIVEWAY BIB AND SIDEWALK
2. GAP BETWEEN DRIVEWAY AND SIDEWALK IS 2.5 cm ON WEST SIDE; 8 cm ON EAST. OF 6 REBAR IN THIS JOINT (ON ~1m CENTERS) 3 BROKE (#1,5,6, FROM WEST) AND 3 DEFORMED (#2-4).
3. SIDEWALK BUCKLE:  
 CURRENT LENGTH = 2.64 m  
 ORIGINAL LENGTH = 2.73 m

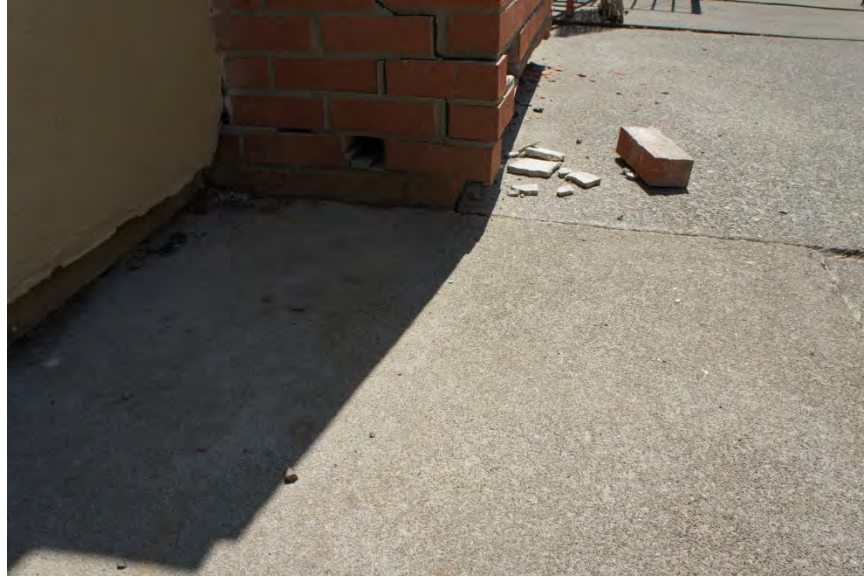
Figure C-H27-2: Structure shifted off of foundation. [NSF-GEER; N 38.3036 W 122.3432; 08/25/14 13:15]

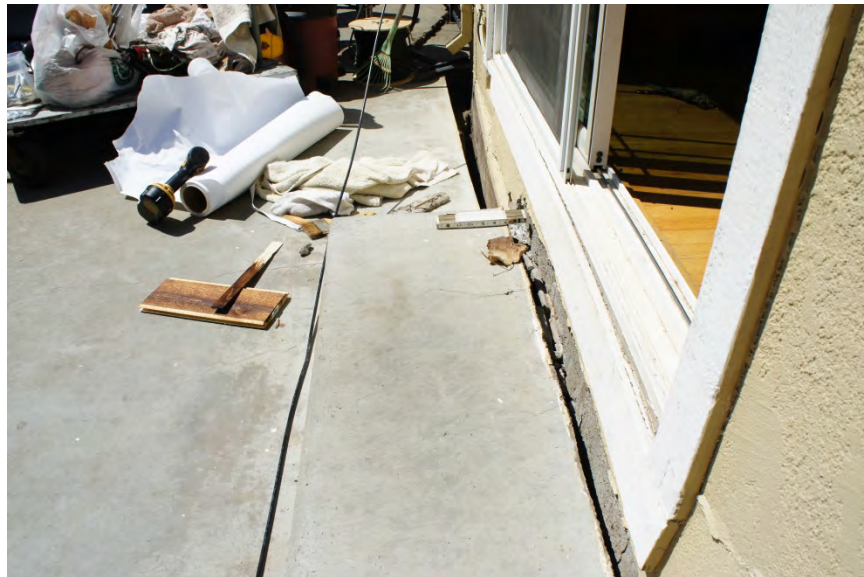
Figure C-H27-3: Gap between structure and patio. [NSF-GEER; N 38.3036 W 122.3432; 08/25/14 13:28]

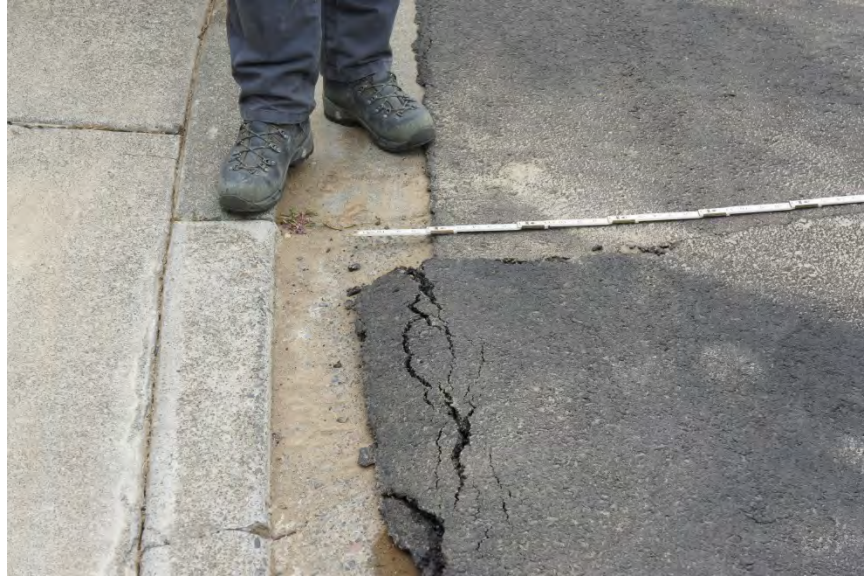
Figure C-H28-H29-2: Compression between asphalt and curb showing right lateral movement. [NSF-GEER; N 38.3033 W 122.3434; 08/25/14 09:29]

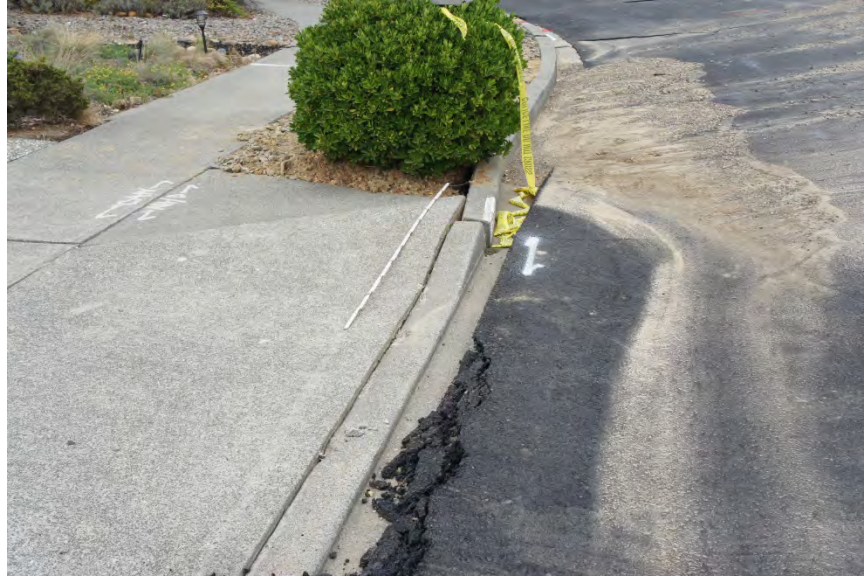
Figure C-H30-2: Compression between asphalt and curb showing. [NSF-GEER; N 38.3029 W 122.3435; 08/25/14 09:15]

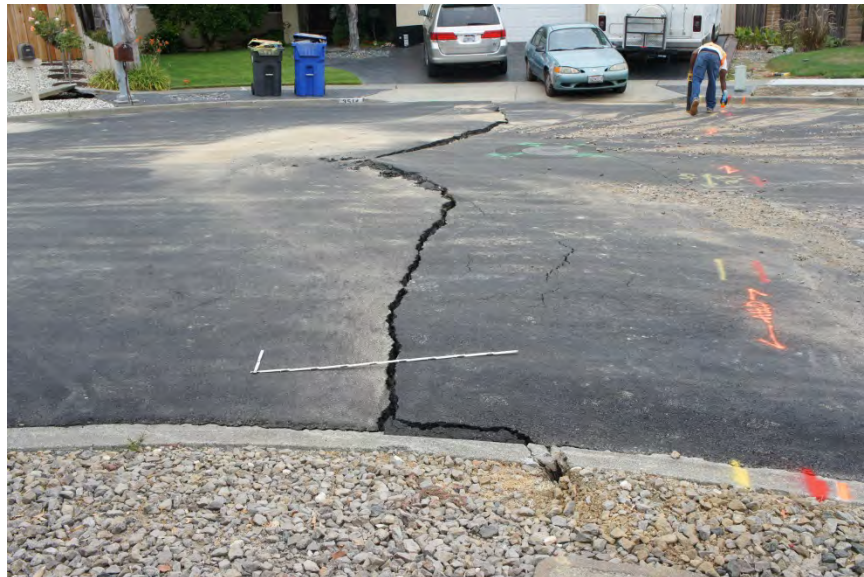
Figure C-H30-3: Severe cracking across White Cliff Circ. [NSF-GEER; N 38.3029 W 122.3435; 08/25/14 09:17]

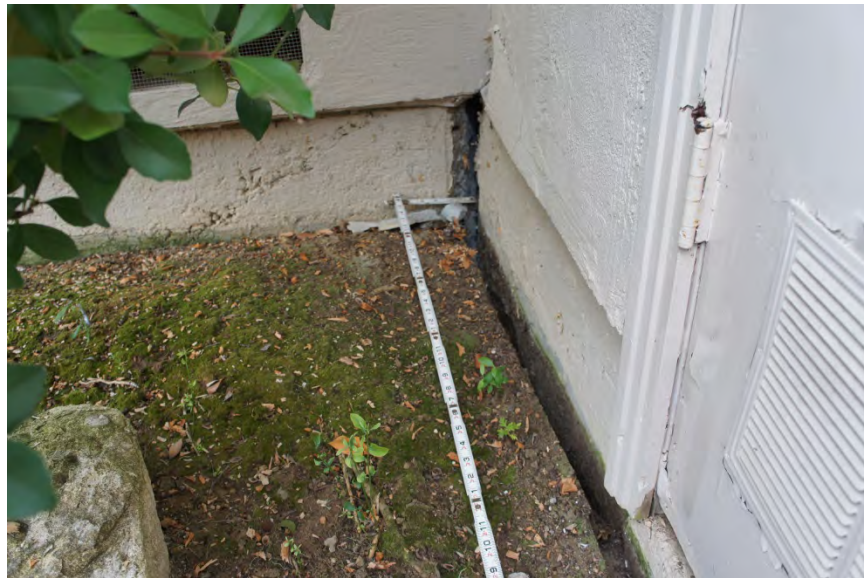
Figure C-H31-3: Structure shifted on foundation and foundation crack [NSF-GEER; N 38.3027 W 122.3436; 08/25/14 10:22]

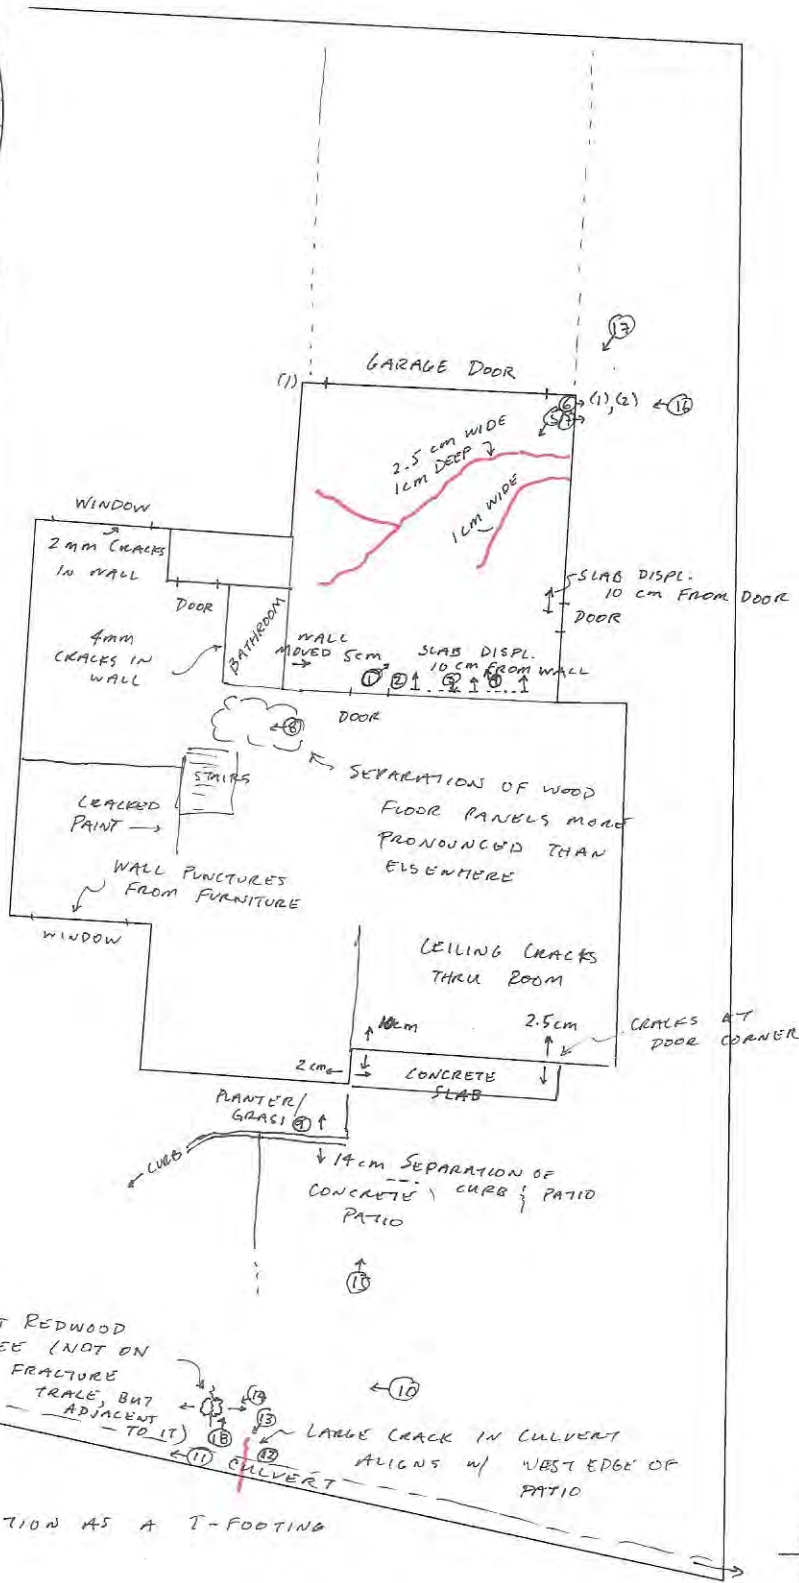
1. GARAGE WALLS SUPP. ON GRADE BEAMS SEPARATE FROM GARAGE SLAB.
2. BEAM UNDER N.E. GARAGE WALL CORNER ROTATE OUT TO STREET AT TOP  $\sim 7^\circ$
3. FRACTURED GARAGE SLAB SLOPES DOWN TO NORTHWEST
4. NO DAMAGE ON SECOND FLOOR
5. GAP BETWEEN CROWN MOLDING & WALL UP TO 2mm THROUGHOUT HOUSE (1st Floor)
6. APPROX. 5-15 cm OFFSET OF 1st STORY SHINGLE FLASHING AND 2nd FLOOR OUTER WALL.
7. OWNER DESCRIBED FOUNDATION AS A T-FOOTING ON "A FEW" PIERS.

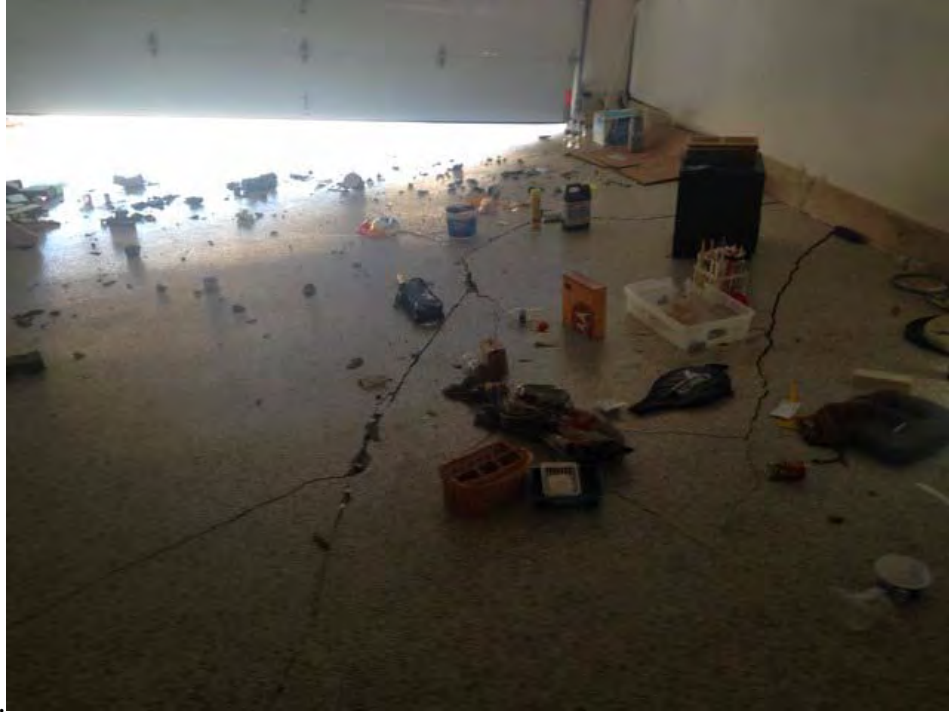
Figure C-H32-2: Garage slab cracking [NSF-GEER; N 38.3024 W 122.3436; 08/27/14 11:33]

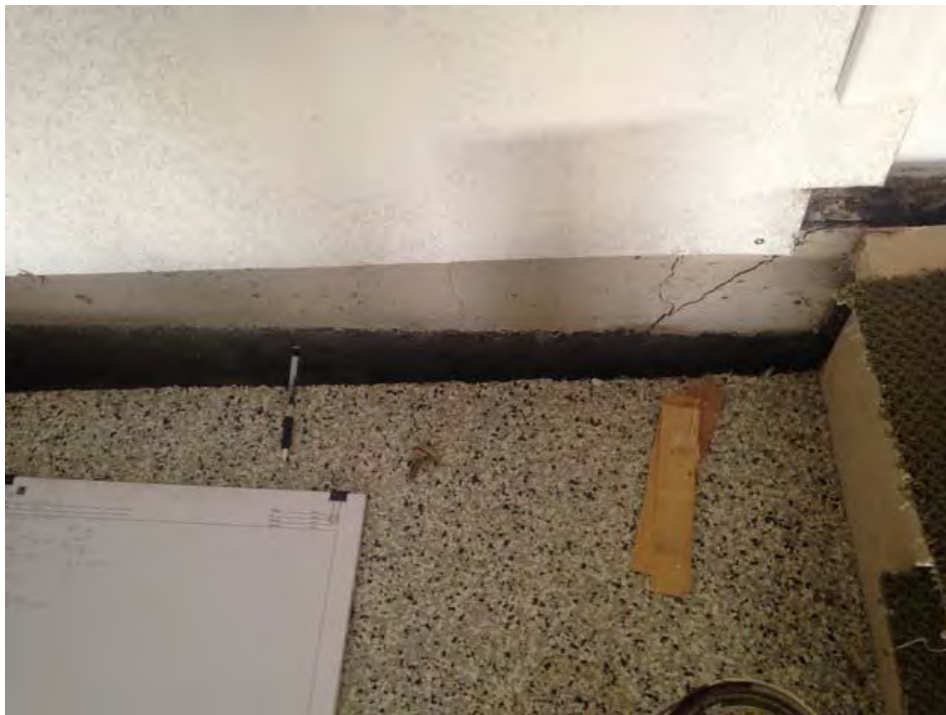
Figure C-H32-3: Separation of garage slab and wall [NSF-GEER; N 38.3022 W 122.3438; 08/27/14 11:33]

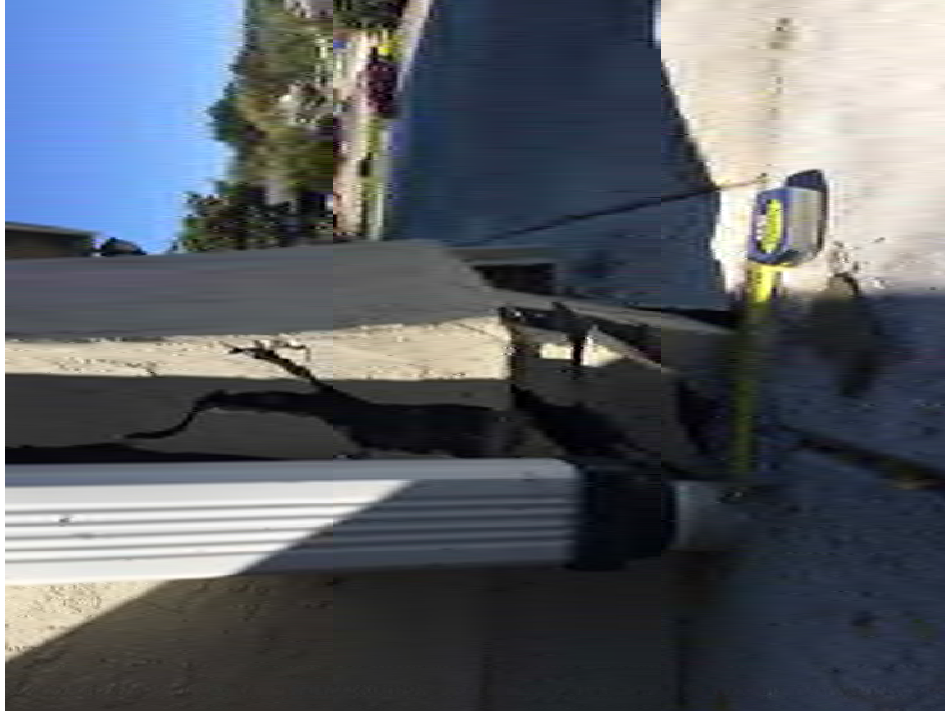
Figure C-H32-4: Damage to strip footing at garage corner [NSF-GEER; N 38.3023 W 122.3438; 08/27/14 11:47]
