## Appendix C: Effects of Surface Fault Rupture on Infrastructure

Numbering of the Appendix C contents for individually mapped houses are denoted with an “H##” that represents the house reference number. The first figure for each house includes a site map (Figure C-H##-1); subsequent figures numbers are photographs associated with the house. As an example, the second photo for house no. 7 would be: “Figure C-H07-3.”

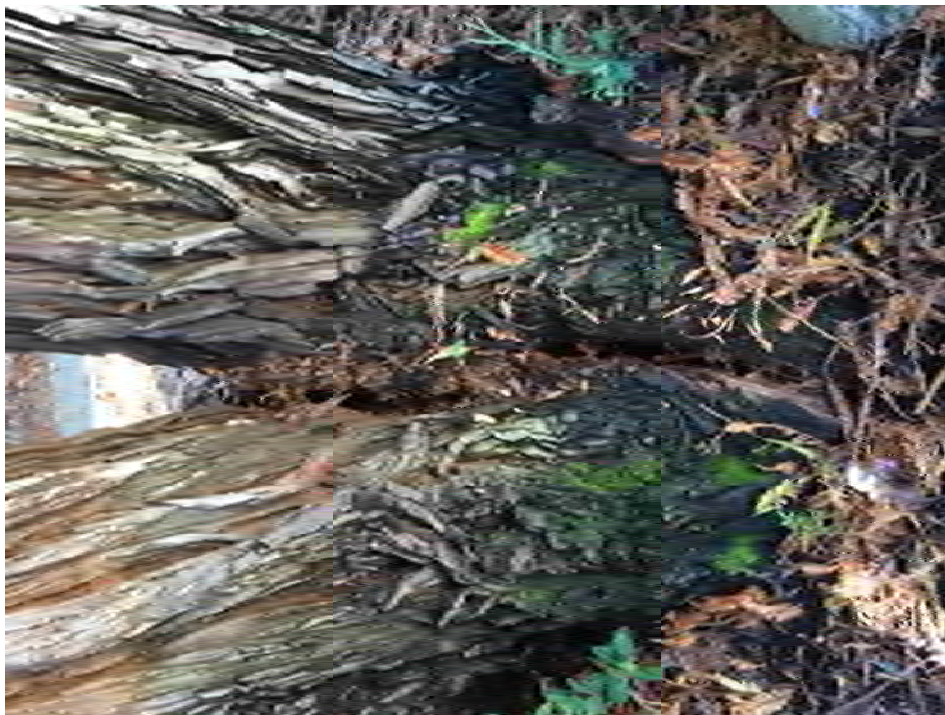
Figure C-H32-5: Split tree trunk adjacent to rupture alignment [NSF-GEER; N 38.3021 W 122.3439; 08/27/14 15:13]

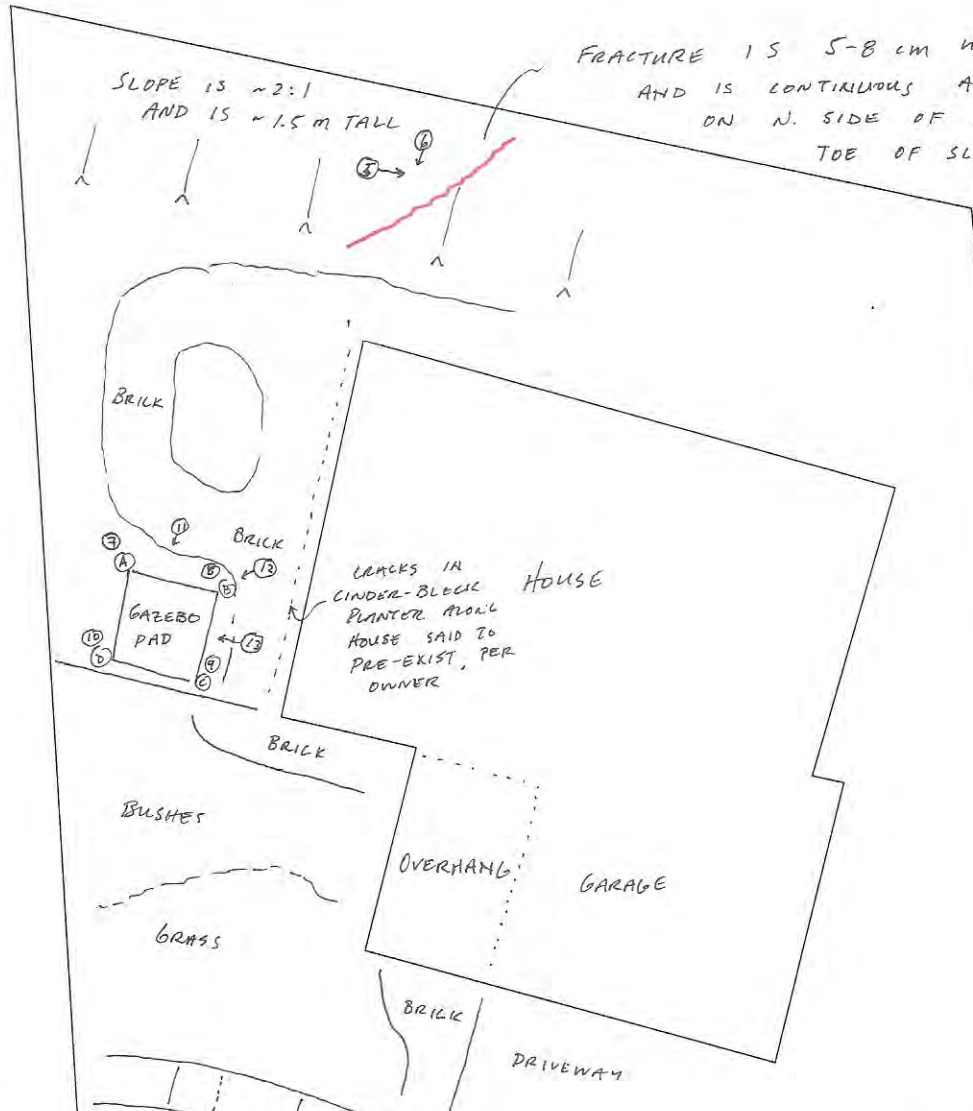
FRACTURE IS 5-8 cm WIDE, 18-20 cm DEEP AND IS CONTINUOUS ACROSS DIRT SLOPE ON N. SIDE OF PROPERTY (I.E., TOP TO TOE OF SLOPE).

SLOPE IS ~2:1 AND IS ~1.5 m TALL

CRACKS IN CINDER-BLOCK PLANTER AROUND HOUSE SAID TO PRE-EXIST, PER OWNER

GRASS BULGE TO SOUTH OF BUCKLE

BUCKLED SIDEWALK  
CURB SEPARATED 5.5cm FROM ASPHALT

"GAZEBO" IS A WOOD TRELLIS SUPPORTED BY 4 4"x4" BEAMS ~2m HIGH. MOVEMENT OF EACH BEAM IS SUMMARIZED IN THE TABLE BELOW:

CORNER	$\Delta X$ (cm)	$\Delta Y$ (cm)
A	25	11
B	33	22
C	14	20
D	4	0

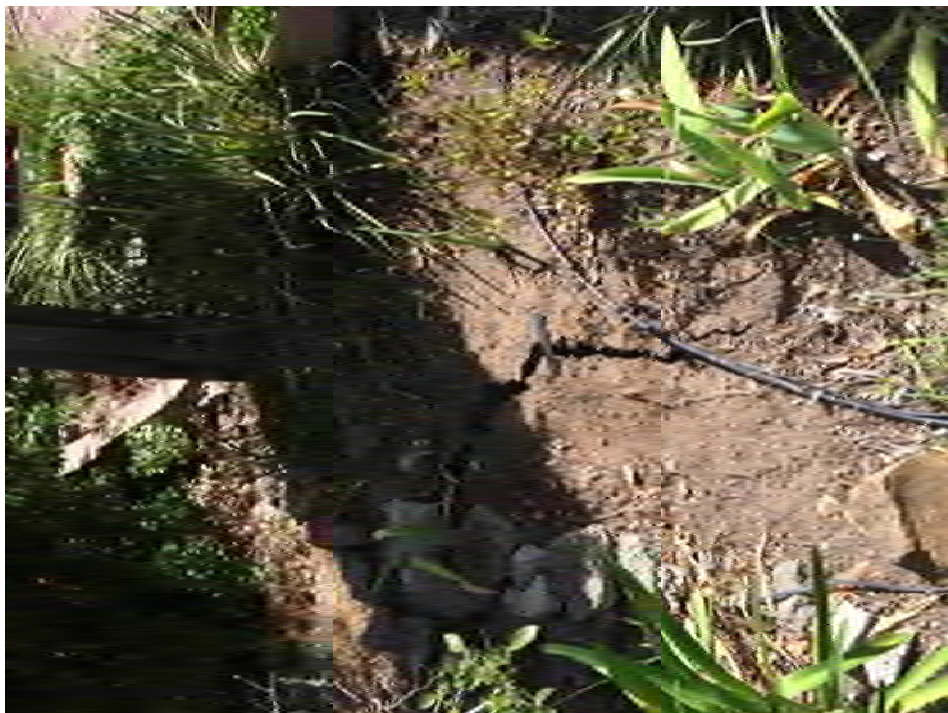
Figure C-H33-3: Fracture along backyard slope [NSF-GEER; N 38.3020 W 122.3439; 08/25/14 11:22]

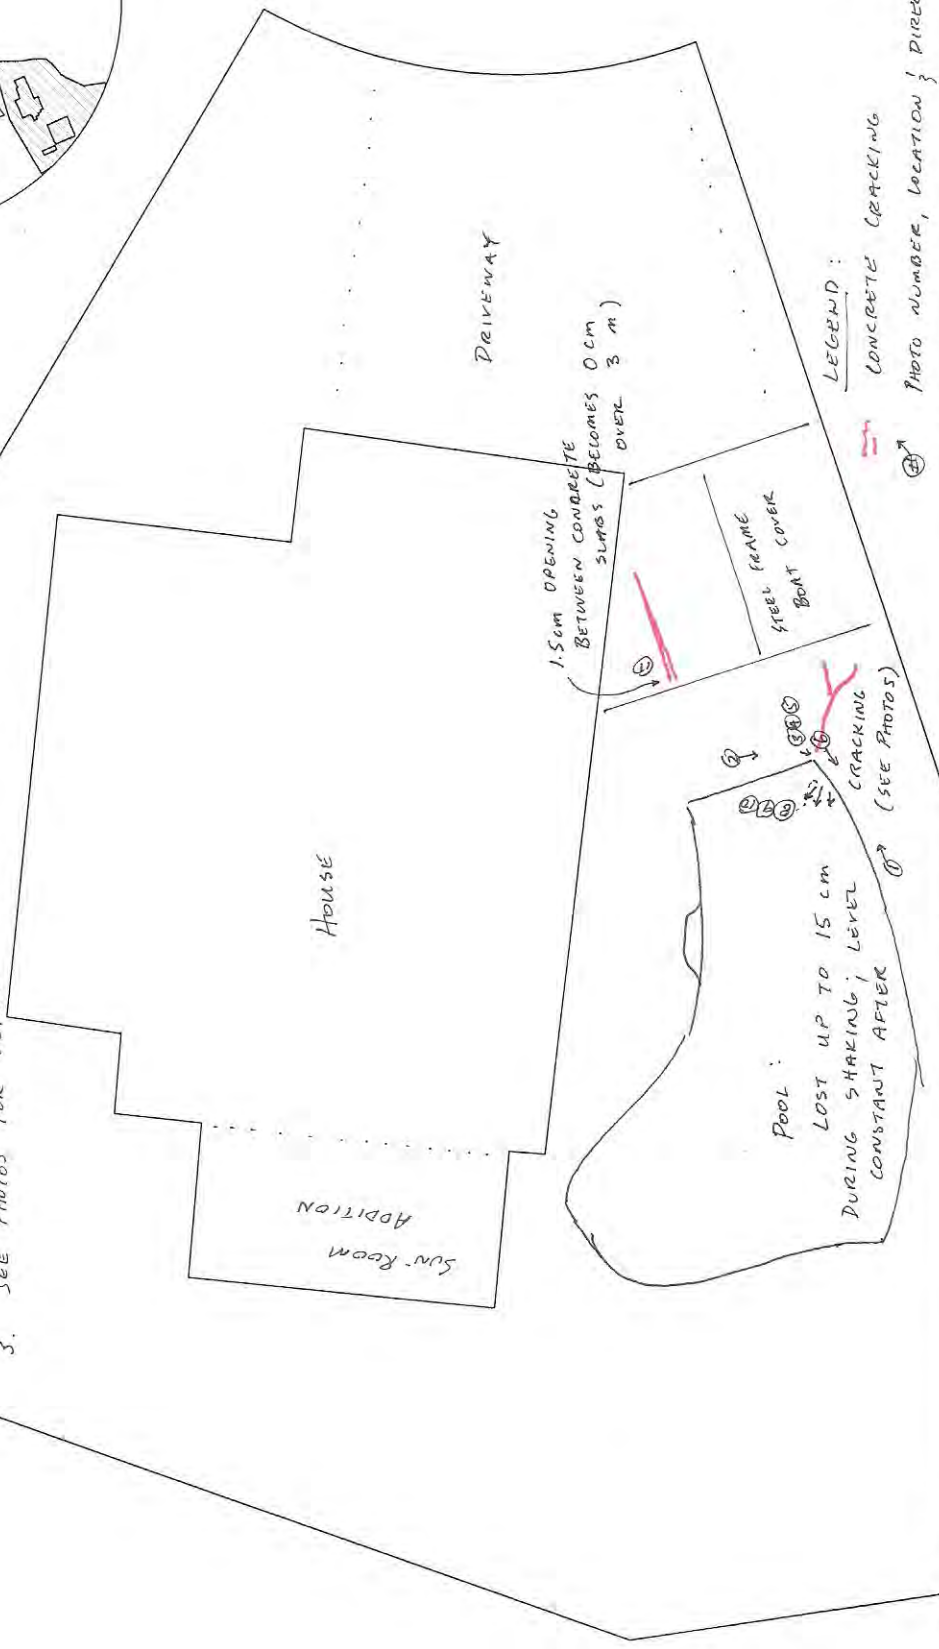
1. POOL CONCRETE BORDER CRACKED OVER 15m ALONG SOUTHEAST CORNER
2. SLAB LIFTED 4cm AND WAS OFFSET 1.5 cm HORIZONTALLY
3. SEE PHOTOS FOR DETAIL

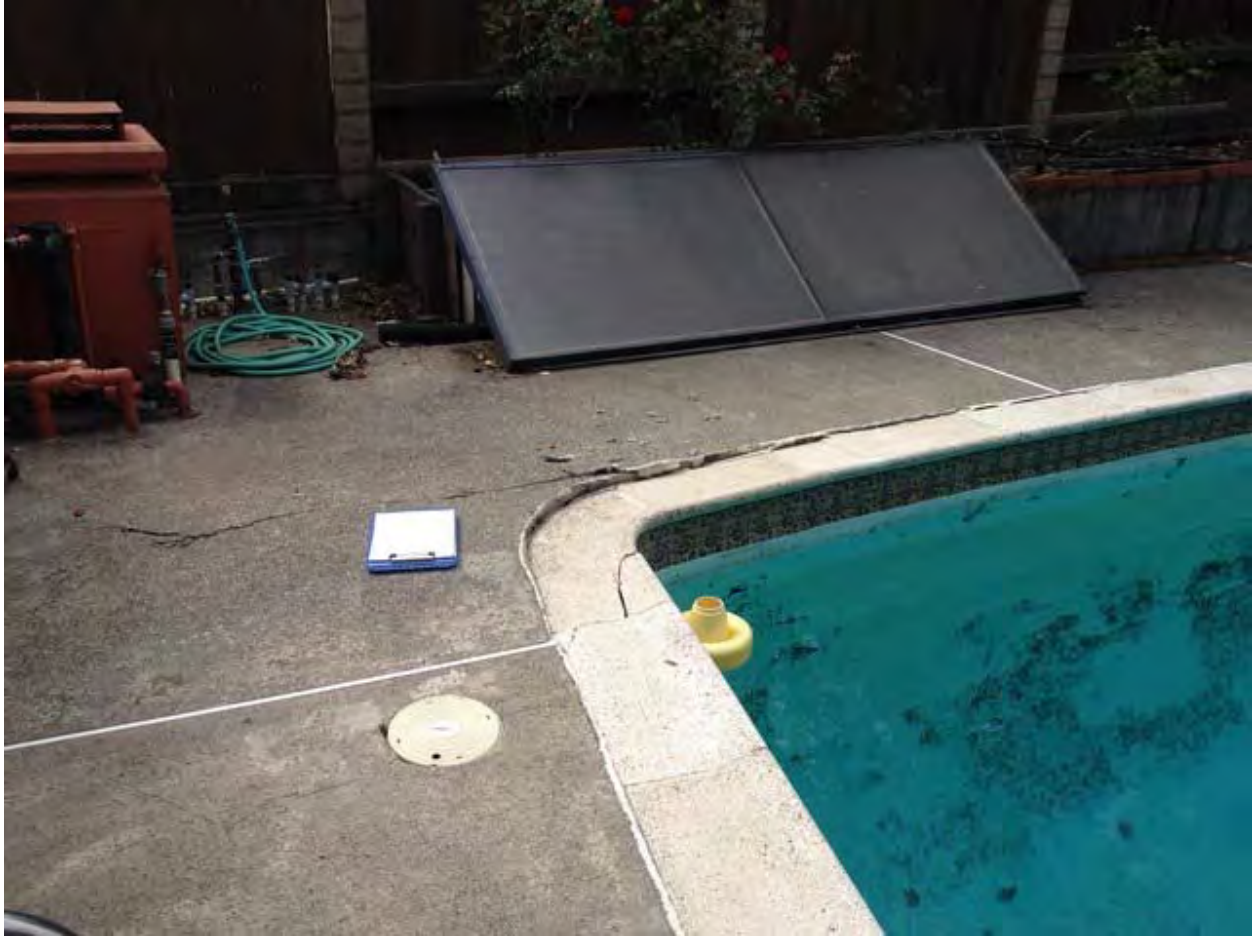
Figure C-H34-2: Concrete cracking at edge of pool

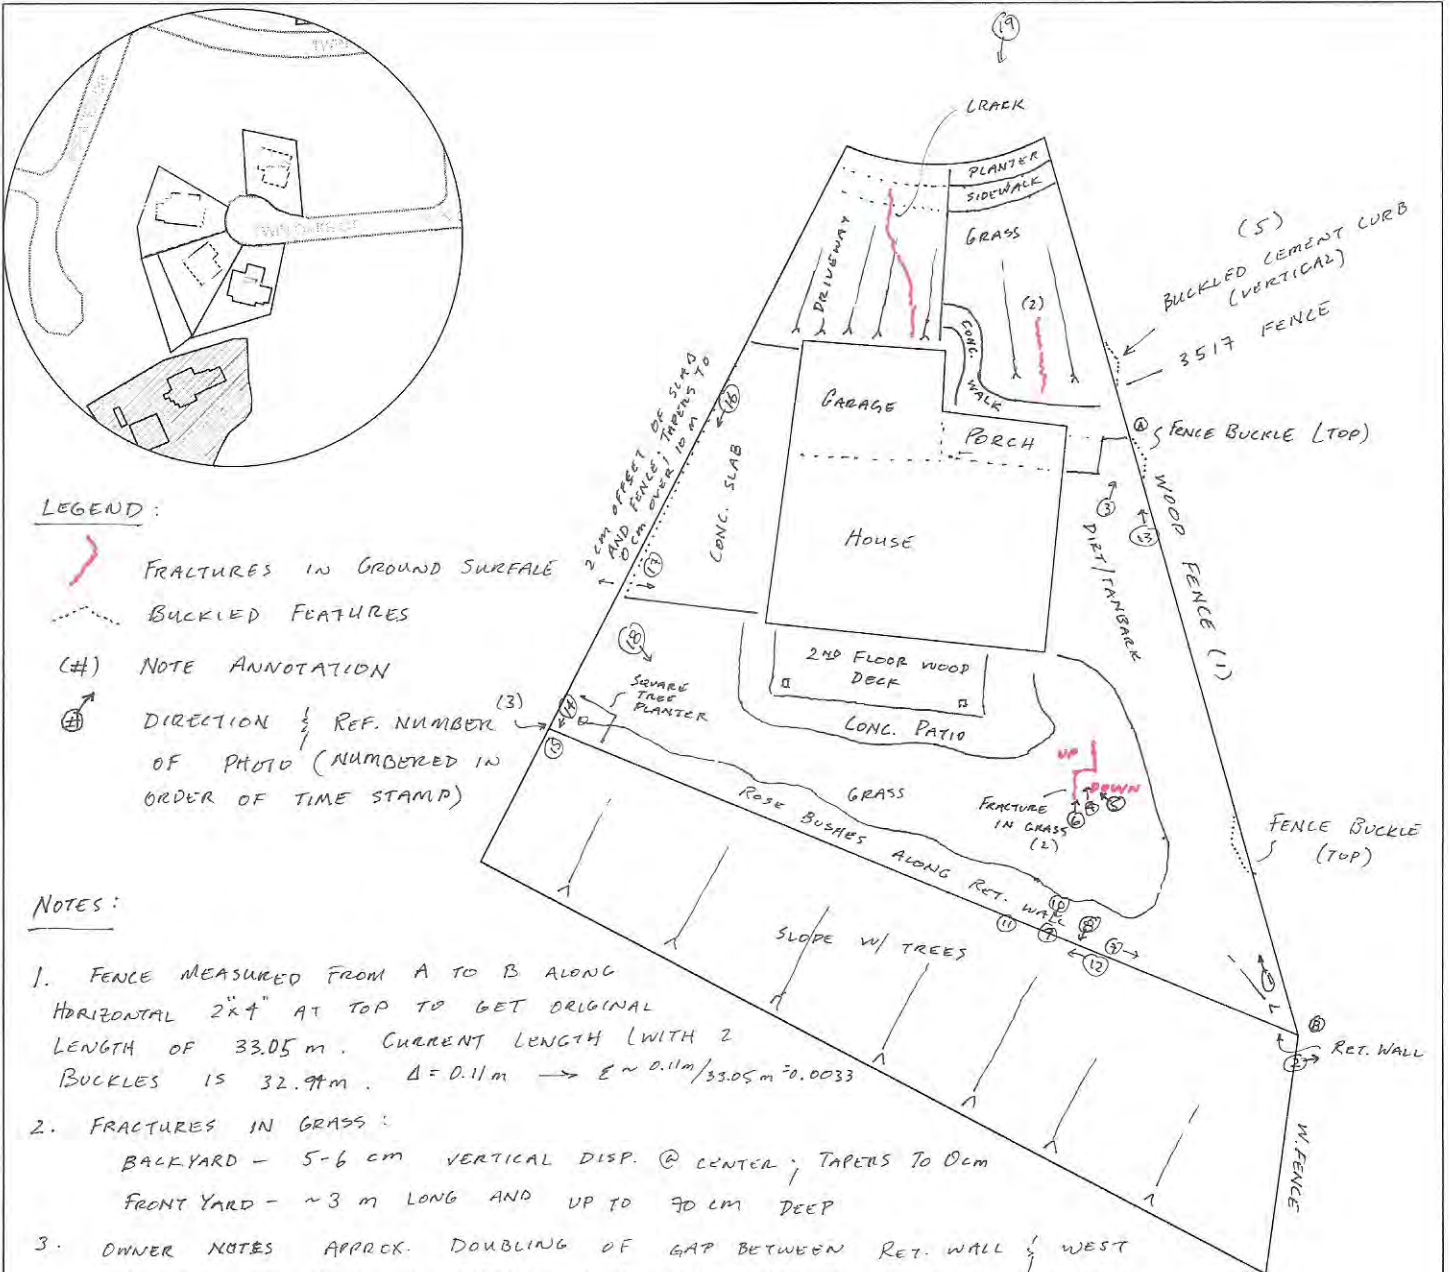
1. FENCE MEASURED FROM A TO B ALONG HORIZONTAL 2"x4" AT TOP TO GET ORIGINAL LENGTH OF 33.05 m. CURRENT LENGTH (WITH 2 BUCKLES) IS 32.94 m.  $\Delta = 0.11 \text{ m} \rightarrow E \approx 0.11 \text{ m} / 33.05 \text{ m} = 0.0033$
2. FRACTURES IN GRASS:
  - BACKYARD - 5-6 cm VERTICAL DISP. @ CENTER; TAPERS TO 0cm
  - FRONT YARD - ~3 m LONG AND UP TO 70 cm DEEP
3. OWNER NOTES APPROX. DOUBLING OF GAP BETWEEN RET. WALL & WEST FENCE; AT TIME OF MEASUREMENT, GAP WAS 8 cm AT BOTTOM, 10 cm AT TOP; WALL IS ~80 cm HIGH
4. RETAINING WALL IS 20 cm THICK UNREINFORCED LINDERBLOCK COATED WITH GUNNITE AND CONTAINS 2 BREAKS FOR STAIRS AT ~1/3 & 2/3 THROUGH IT'S 41.8 m LENGTH. THERE IS A 1 cm GAP BETWEEN WALL TOP AND RETAINED SOIL FOR THE ENTIRE SOUTHEASTERN HALF. CRACKS (VERTICAL) ARE SUMMARIZED IN THE FOLLOWING TABLE:

LENGTH (FROM S.E. END)	MAX. CRACK THICKNESS	WALL HEIGHT
4.01 m	8 mm	40 cm
6.10 m	10 mm	30 cm
8.84 m	5 mm	29 cm
11.1 m	8 mm	80 cm
15.1 m	5 mm	80 cm
20.2 m	4 mm	80 cm

5. BUCKLED CURB MEASURED 210 cm ORIGINAL LENGTH (128 cm & 82 cm PIECES) AND 203 cm CURRENT LENGTH.

20.2 m to ~30 m 6 HAIRLINE CRACKS; 80cm HIGH TO END

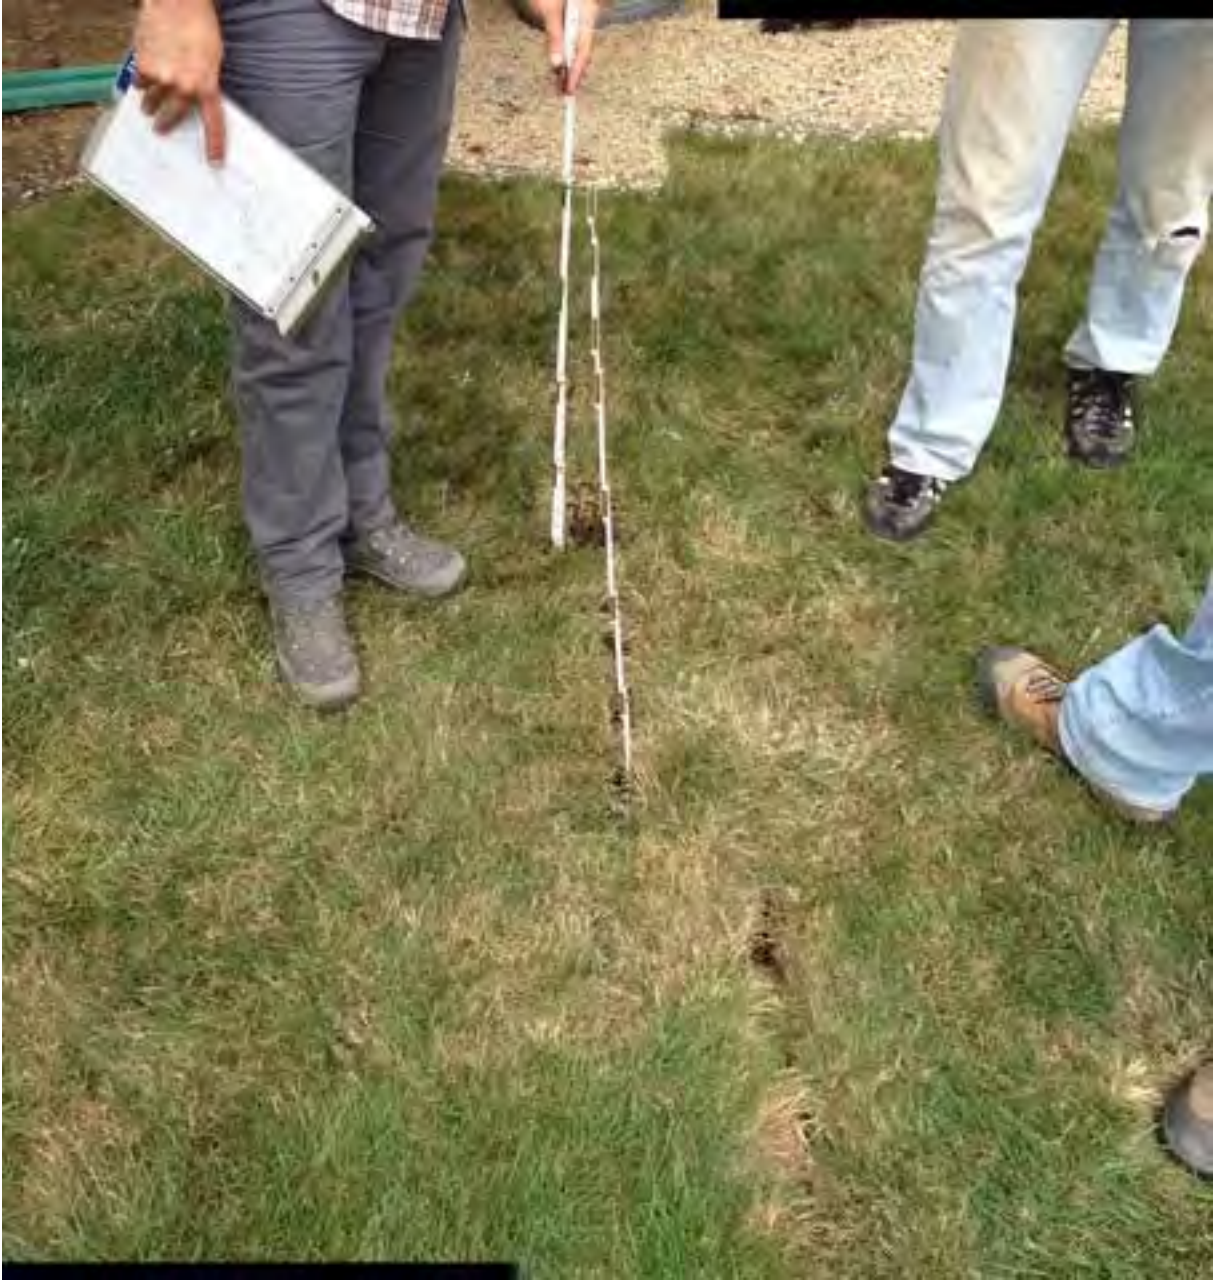
Figure C-H35-2: Fracture in grass [NSF-GEER; N 38.3015 W 122.3440; 08/25/14 10:49]

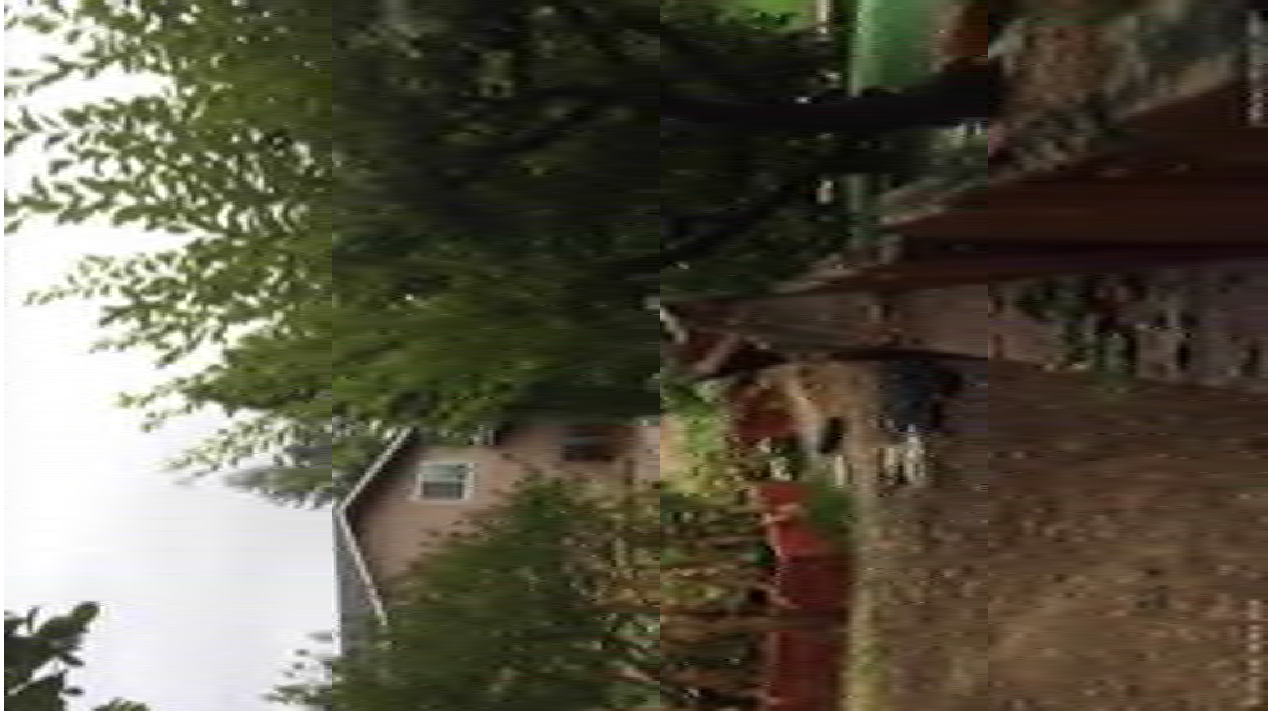
Figure C-H35-3: Buckled wood fence [NSF-GEER; N 38.3015 W 122.3440; 08/25/14 10:55]

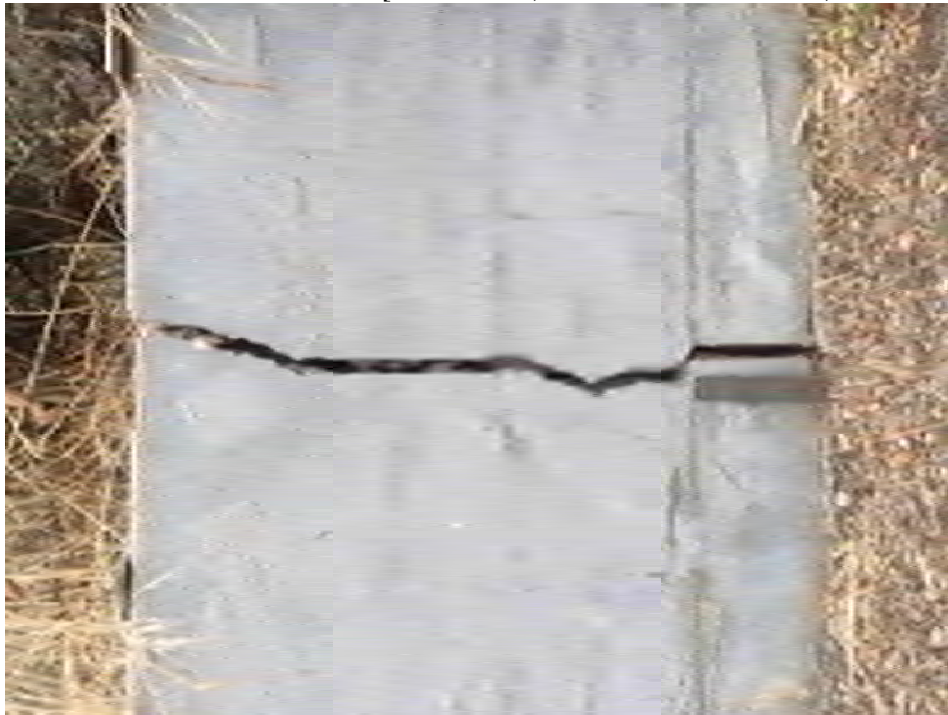
Figure C-H35-4: Retaining wall crack [NSF-GEER; N 38.3015 W 122.3440; 08/25/14 10:58]

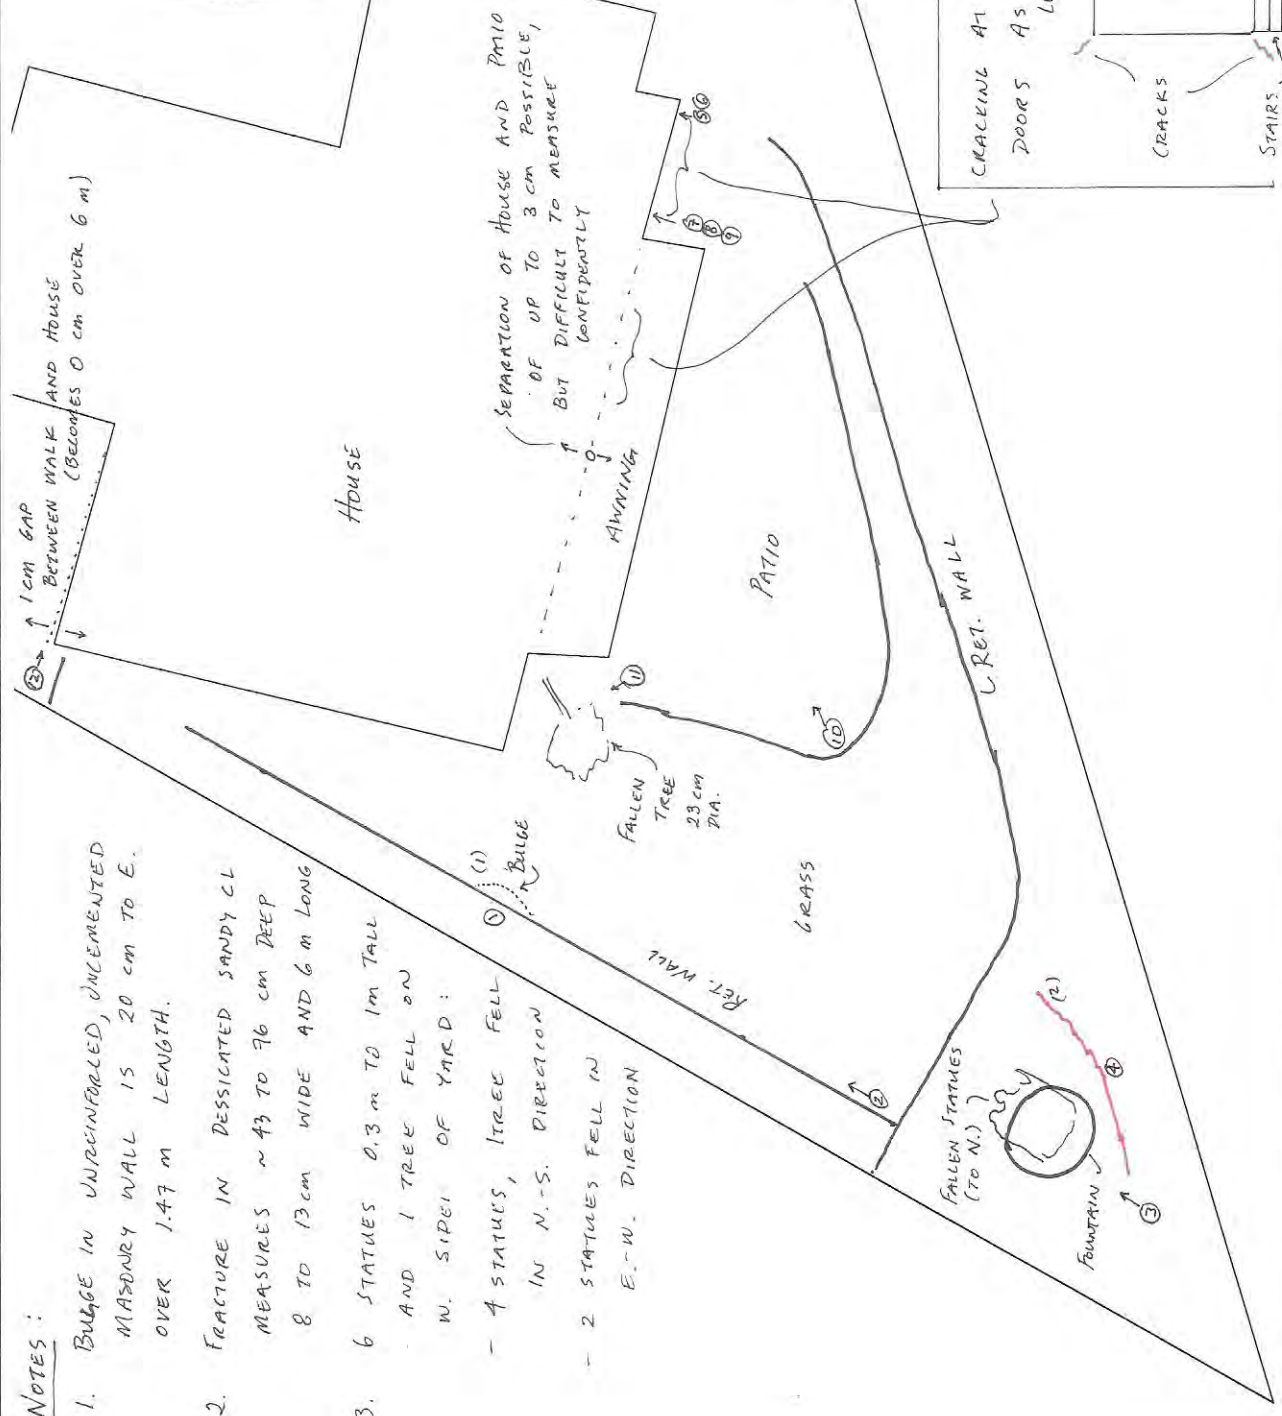
1. BULGE IN UNREINFORCED, UNCEMENTED MASONRY WALL IS 20 cm TO E. OVER 1.47 m LENGTH.
2. FRACTURE IN DESICCATED SANDY CL MEASURES ~43 TO 76 cm DEEP 8 TO 13 cm WIDE AND 6 m LONG
3. 6 STATUES 0.3 m TO 1 m TALL AND 1 TREE FELL ON N. SIDE OF YARD:  
 - 4 STATUES, TREE FELL IN N.-S. DIRECTION  
 - 2 STATUES FELL IN E.-W. DIRECTION

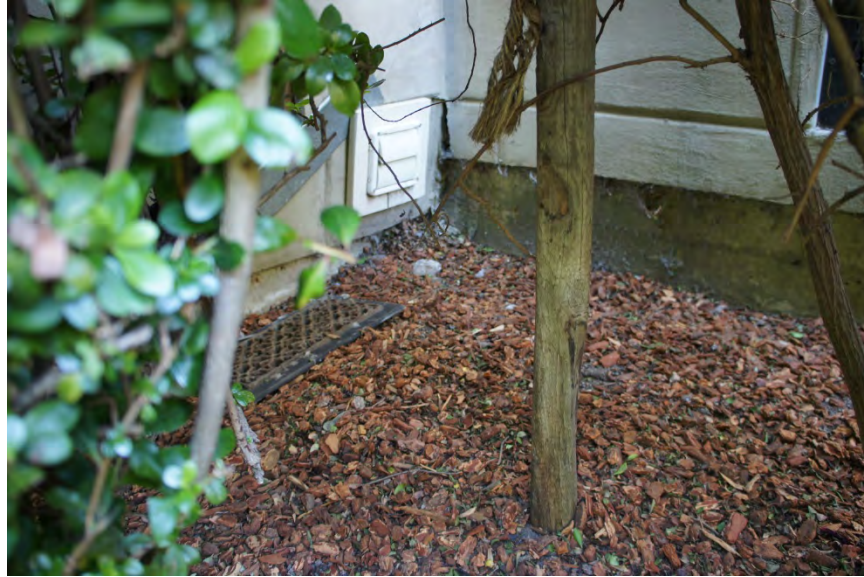
Figure C-H37-2: Cracked and settling strip footing [NSF-GEER; N 38.3011 W 122.3442; 08/25/14 11:41]

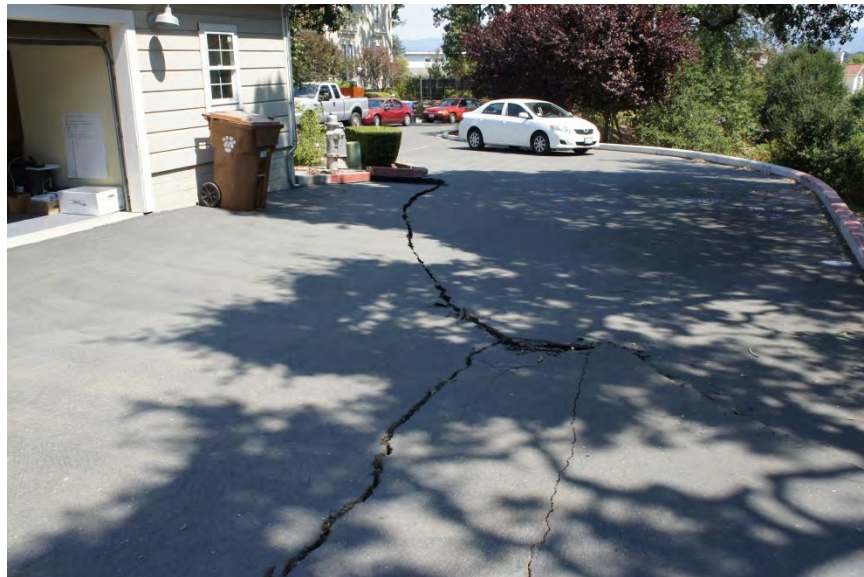
Figure C-H37-3: Open cracks in pavement [NSF-GEER; N 38.3011 W 122.3442; 08/25/14 11:36]

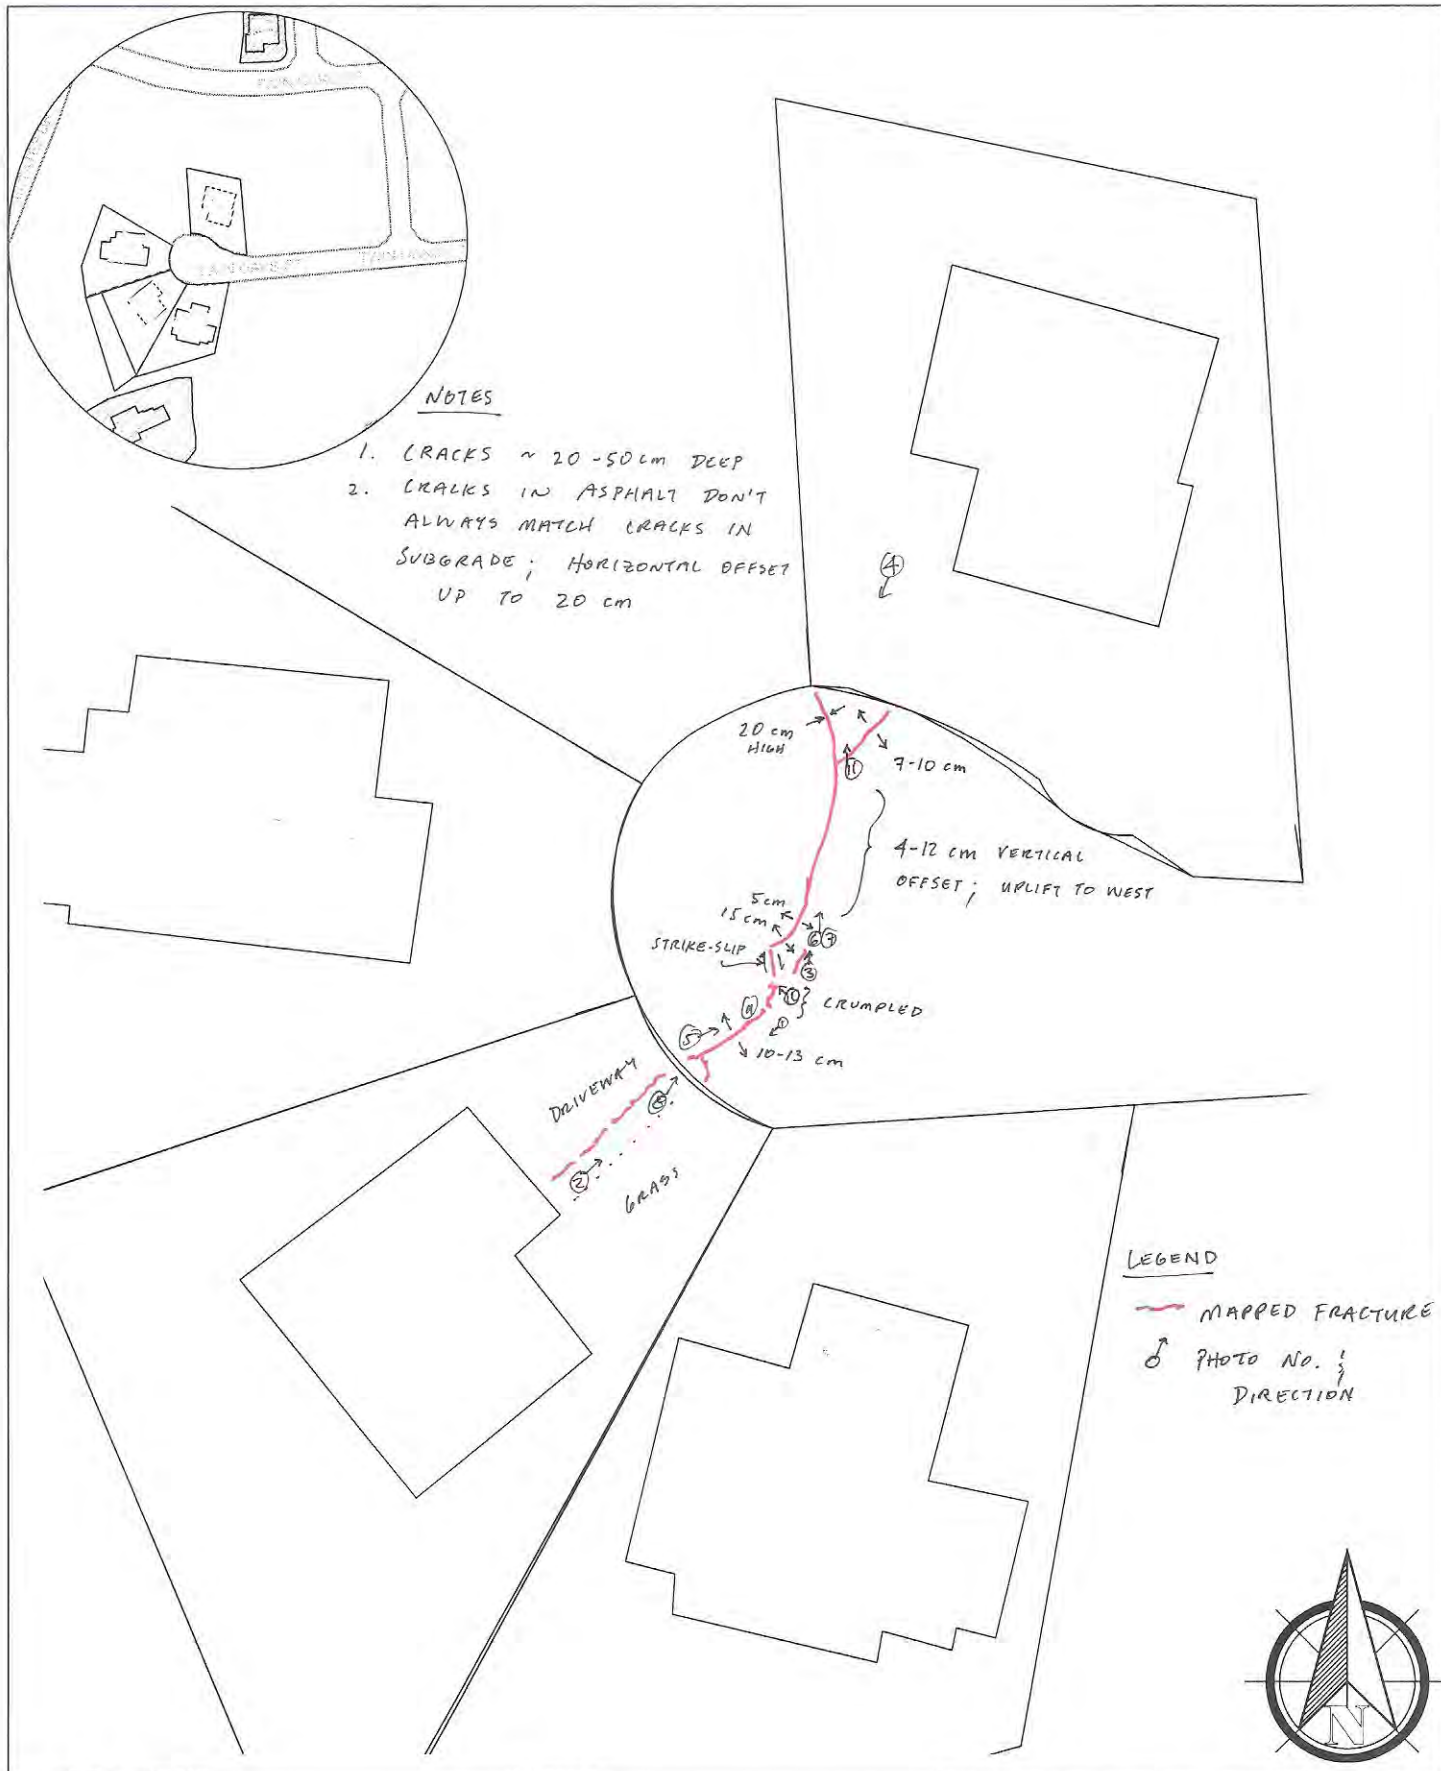
1. CRACKS ~ 20-50 cm DEEP
2. CRACKS IN ASPHALT DON'T ALWAYS MATCH CRACKS IN SUBGRADE; HORIZONTAL OFFSET UP TO 20 cm

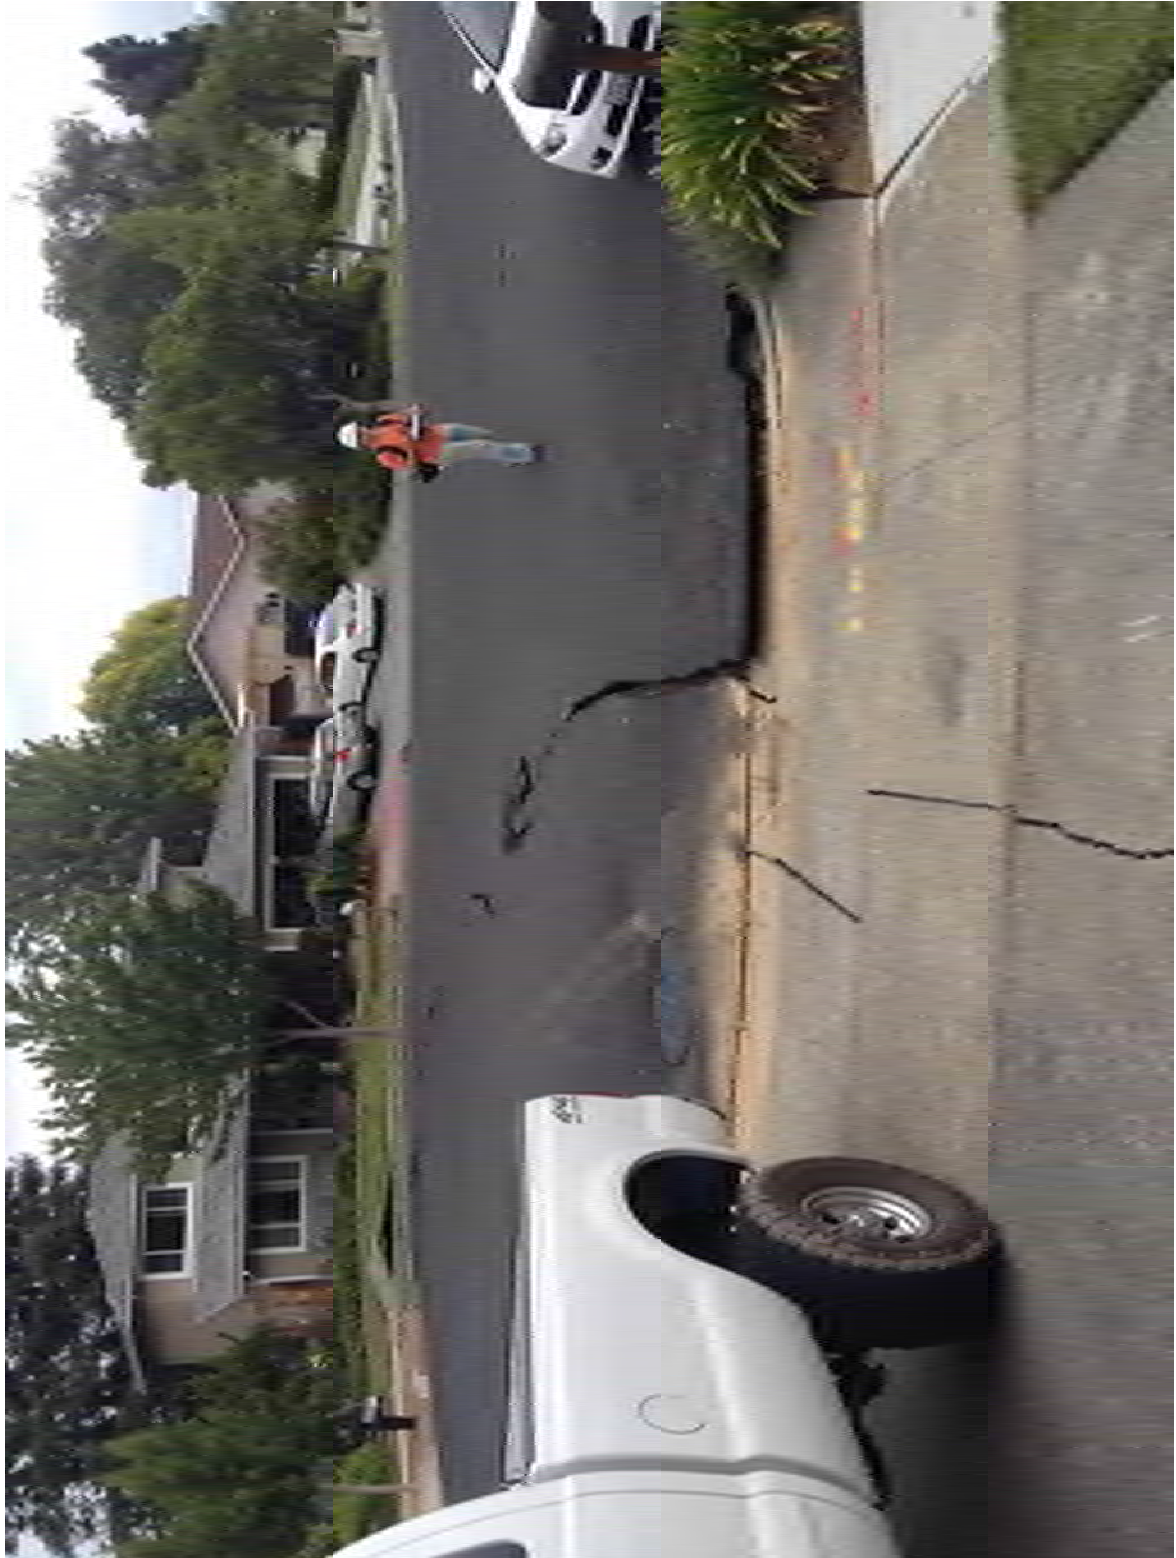
Figure C-P1-2: General view of fracturing [NSF-GEER; N 38.3016 W 122.3441; 08/25/14 10:24]

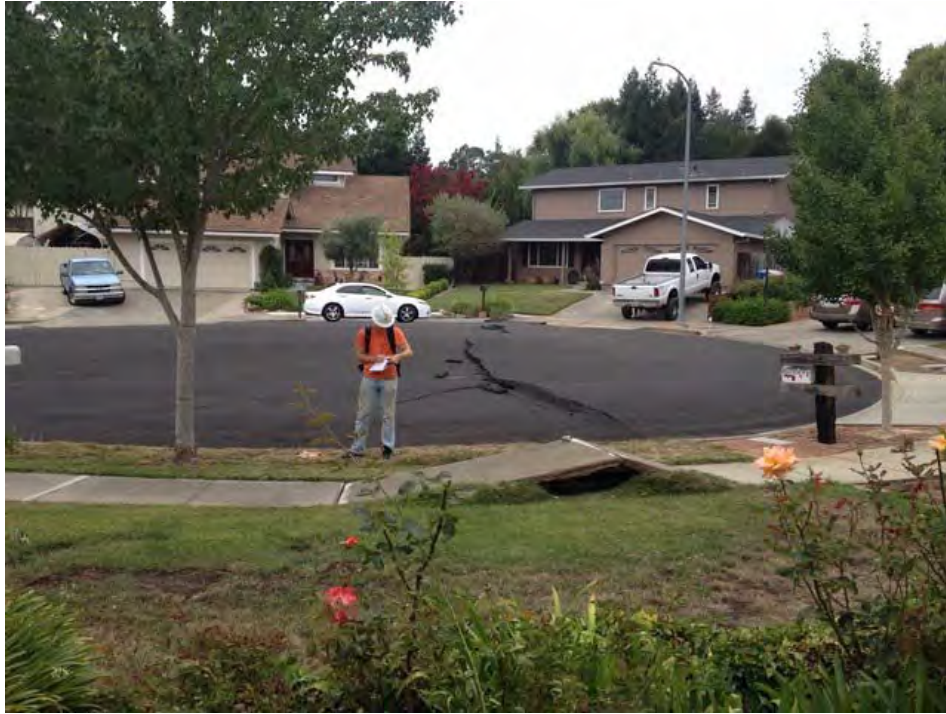
Figure C-P1-3: General view of fracturing [NSF-GEER; N 38.3018 W 122.3437; 08/25/14 10:42]

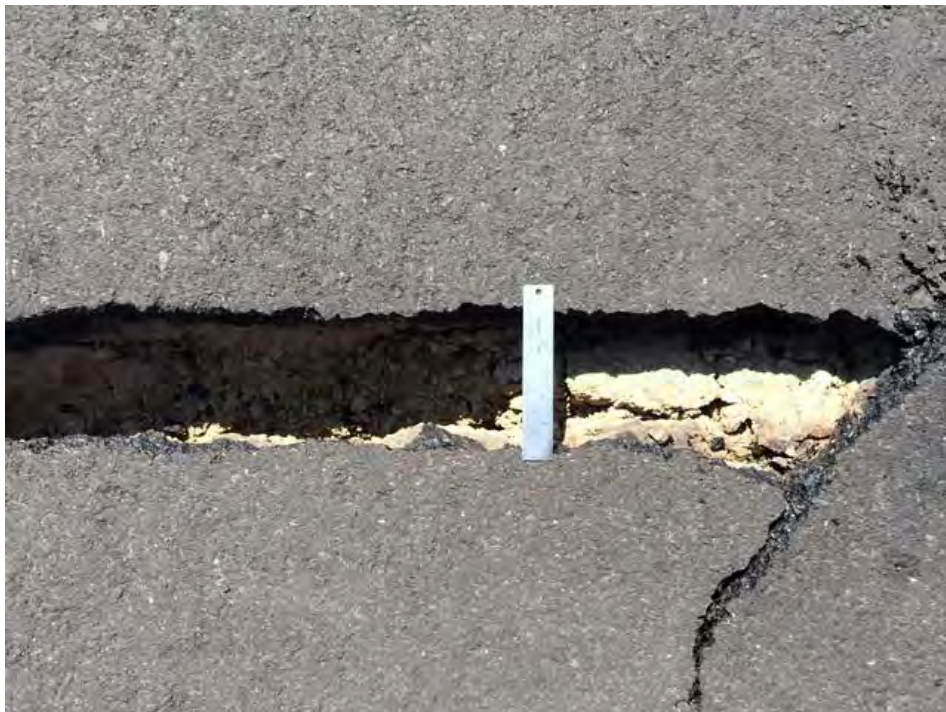
Figure C-P1-4: Asphalt fracture [NSF-GEER; N 38.3017 W 122.3440; 08/25/14 11:33]

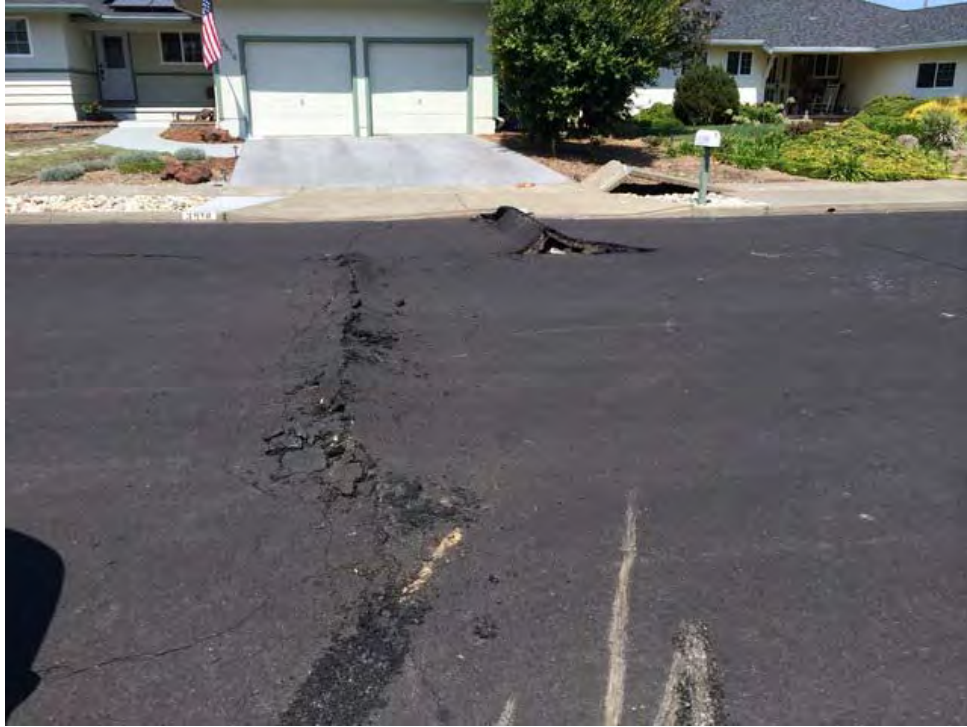
Figure C-P2-2: General view of fracturing [NSF-GEER; N 38.3038 W 122.3441; 08/25/14 13:18]

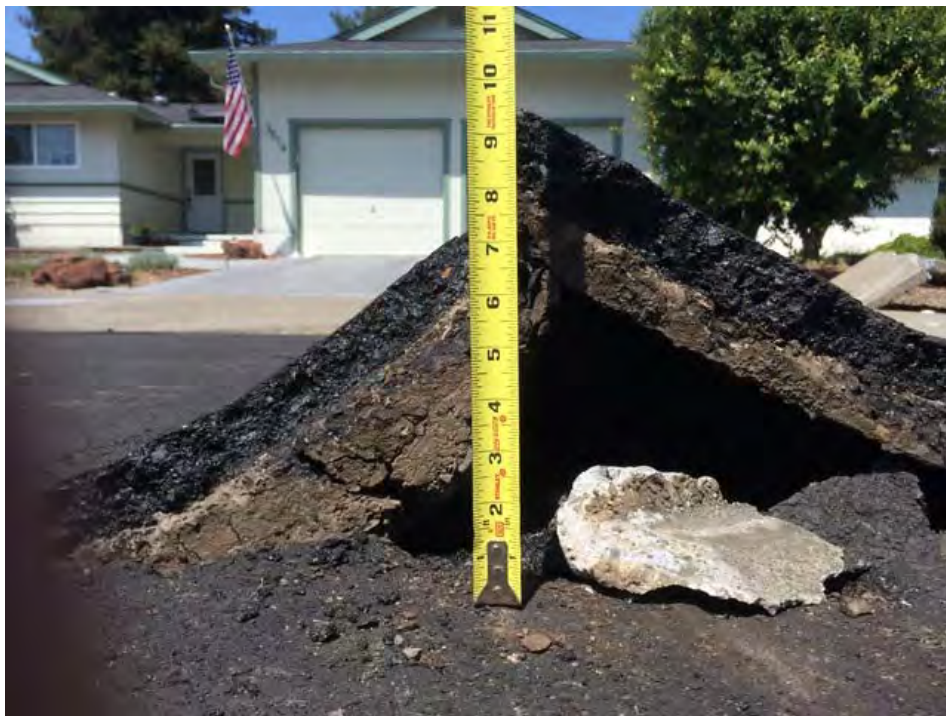
Figure C-P2-3: Asphalt buckling from end [NSF-GEER; N 38.3038 W 122.3430; 08/25/14 13:20]
