APPENDIX E: Non-Near-Fault Ground Performance Observations

List of Figures

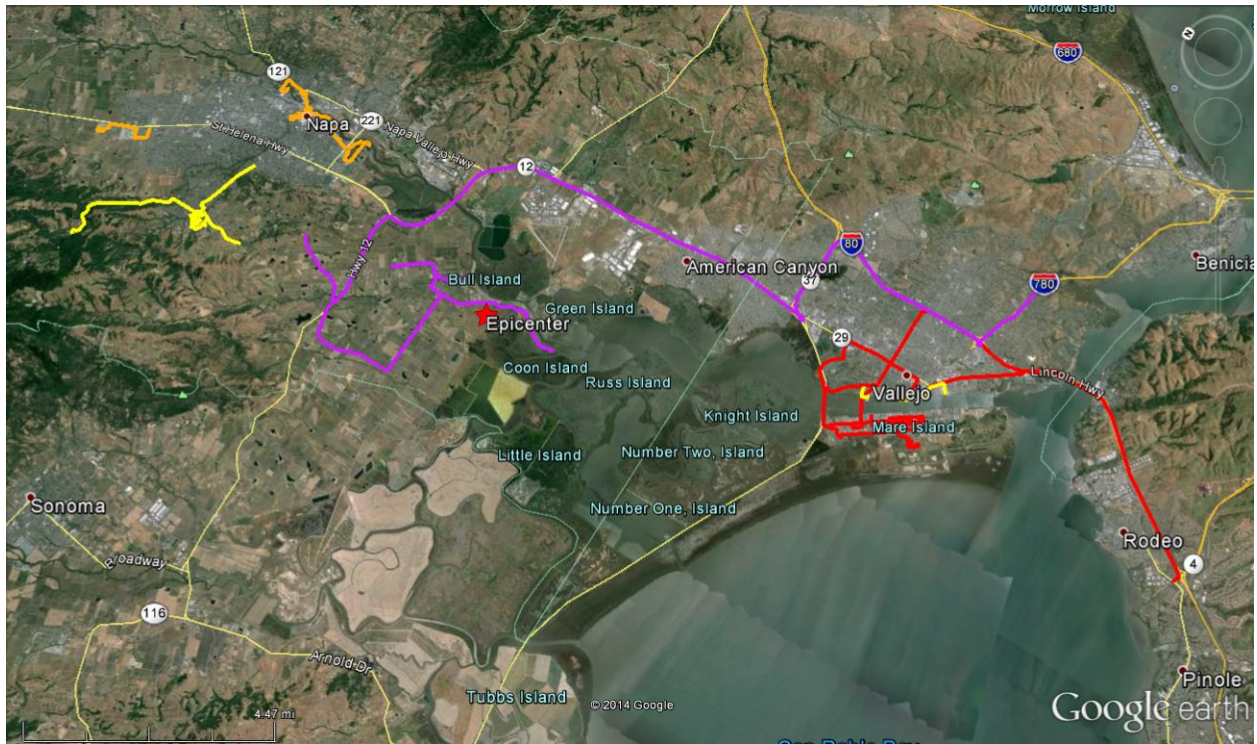
Figure E.1: GPS Track for all GEER teams outside near-fault region [NSF-GEER; 08/24/14]

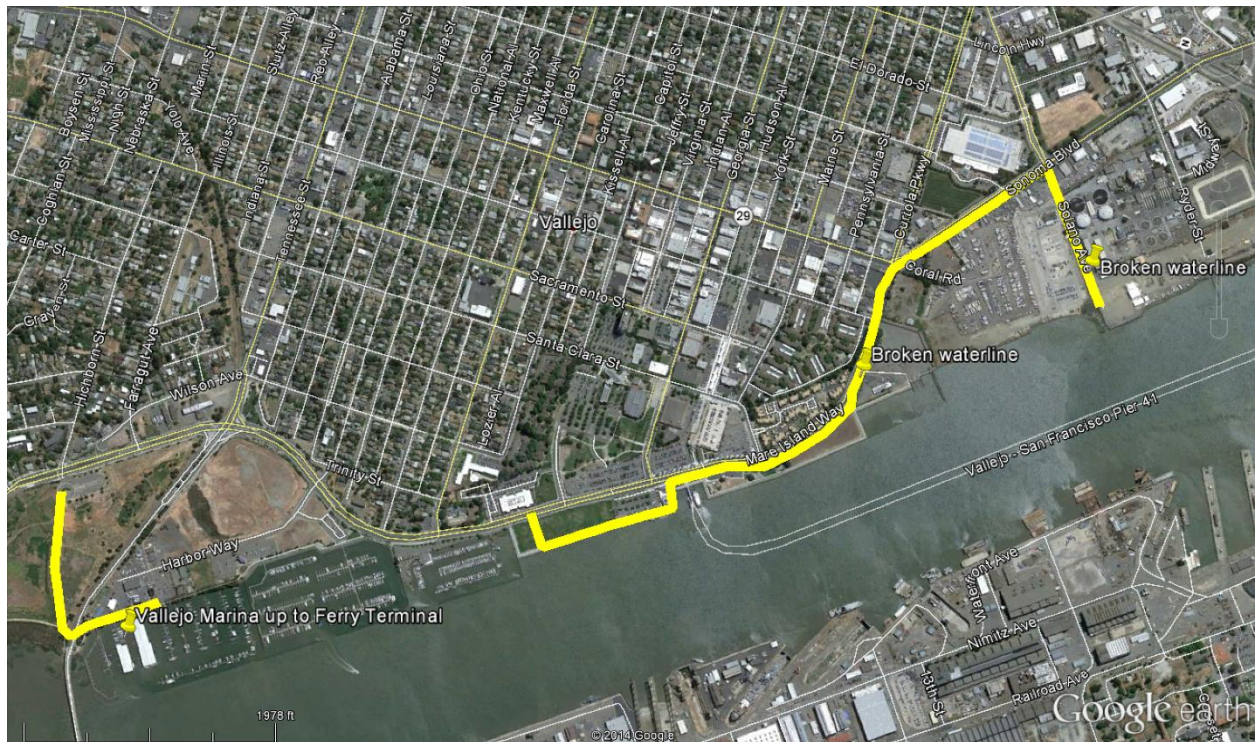
Figure E.5: Vallejo Waterfront Observation Locations [NSF-GEER: Gardner and Markham; 08/24/14]

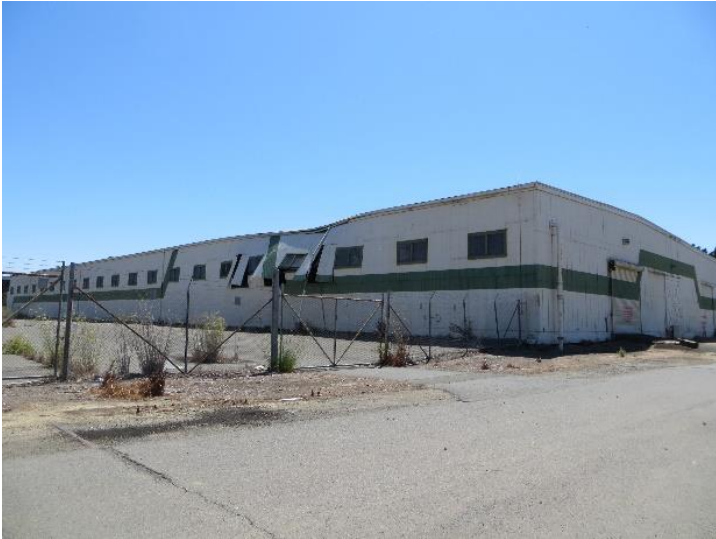
Figure E.6: Corrugated siding damage [NSF-GEER; GPS N38.111 W122.282; 08/24/14; 13:53]

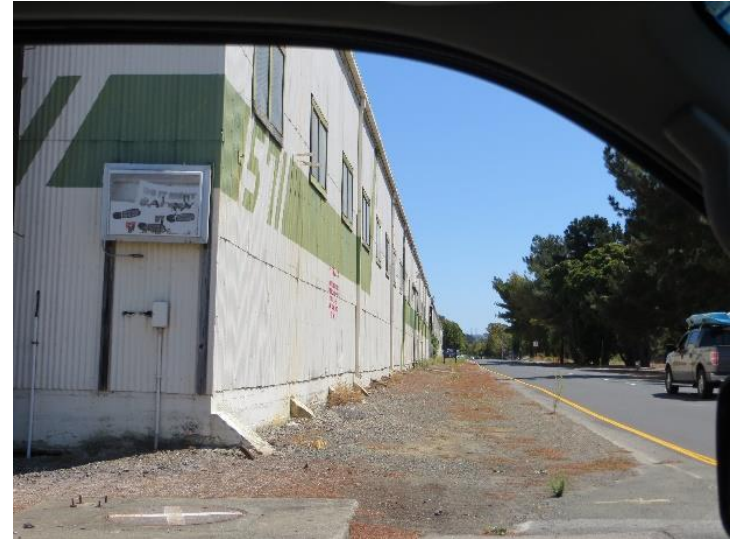
Figure E.7: Corrugated siding, no damage [NSF-GEER; GPS N38.110 W122.283; 08/24/14; 13:54]

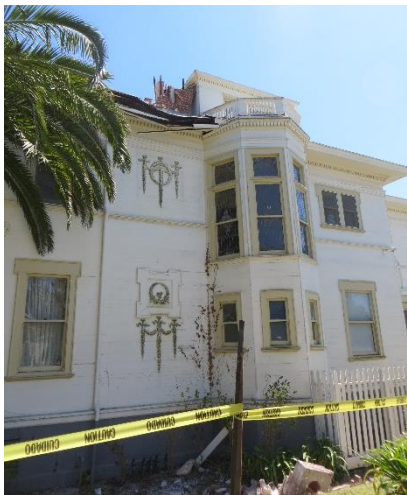
Figure E.8: Brick chimney damage [NSF-GEER; GPS N38.100 W122.274; 08/24/14; 14:13]

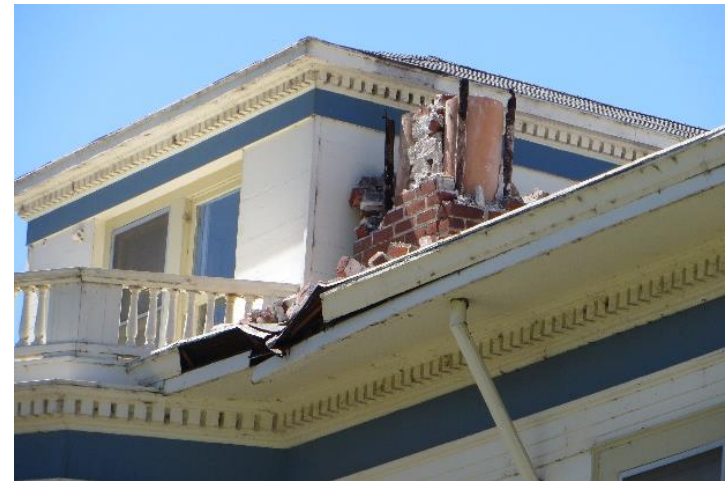
Figure E.9: Brick chimney damage [NSF-GEER; GPS N38.099 W122.273; 08/24/14; 14:19]

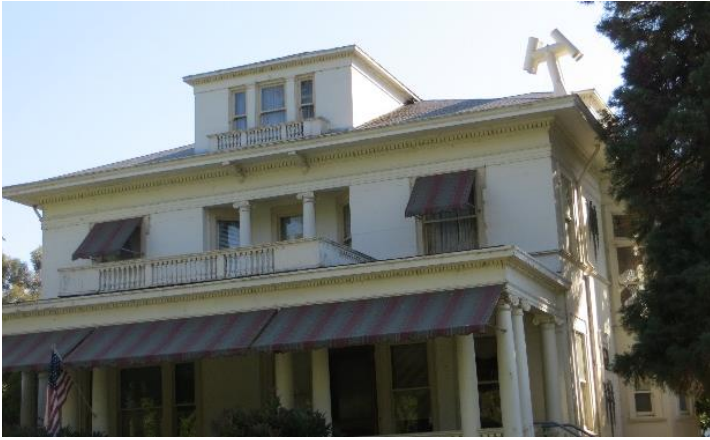
Figure E.10: Metal chimney, no damage [NSF-GEER; GPS N38.097 W122.272; 08/24/14; 17:06]

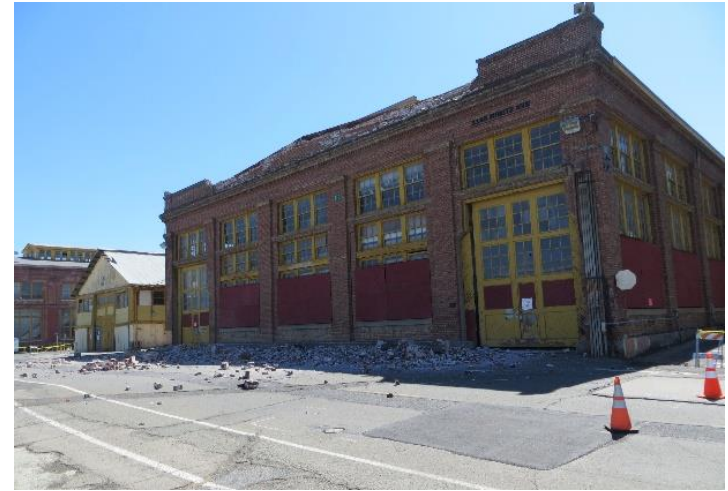
Figure E.11: Brick facade damage [NSF-GEER; GPS N38.097 W122.268; 08/24/14; 14:43]

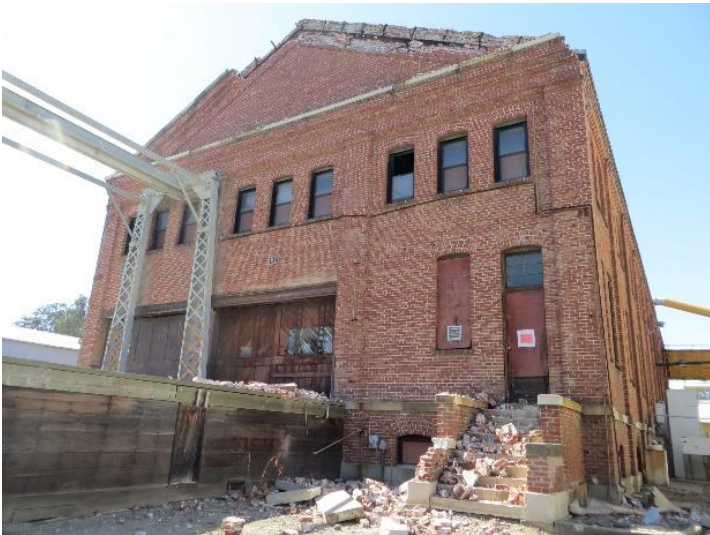
Figure E.12: Brick facade damage [NSF-GEER; GPS N38.095 W122.268; 08/24/14; 15:38]

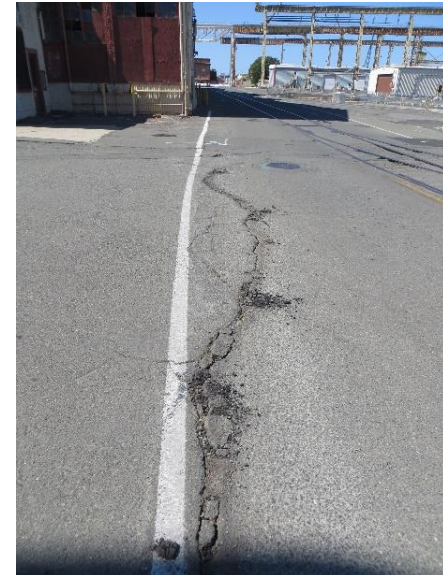
Figure E.13: Possible earthquake damage [NSF-GEER; GPS N38.098 W122.269; 08/24/14; 14:37]

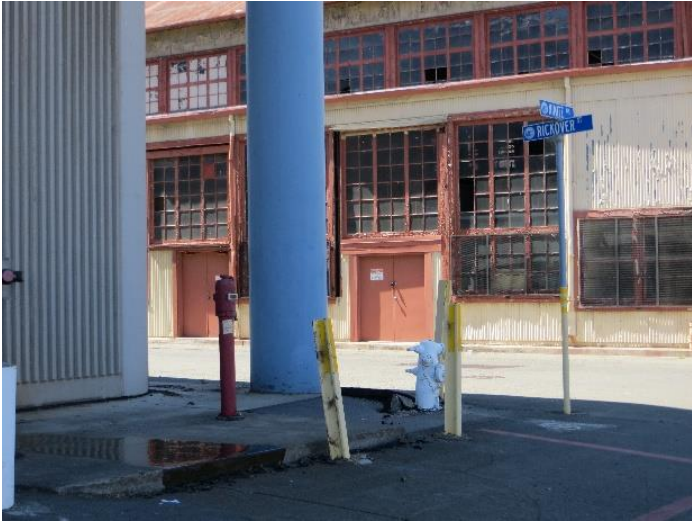
Figure E.14: Pavement damage at hydrant [NSF-GEER; GPS N38.098 W122.269; 08/24/14; 14:39]

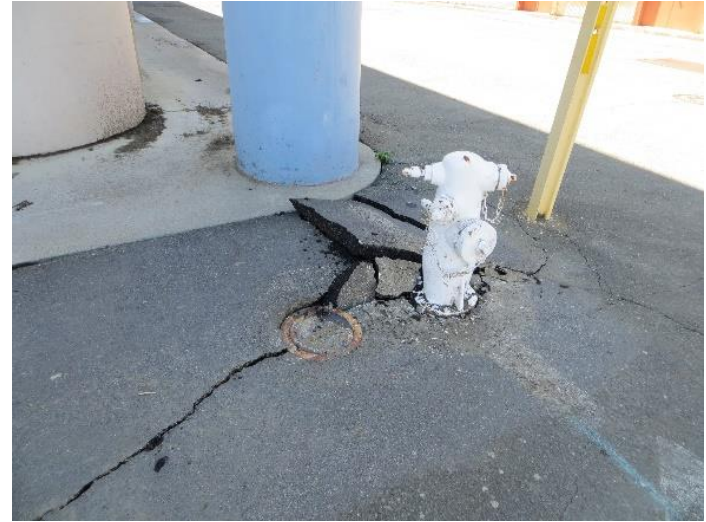
Figure E.15: Pavement damage at hydrant [NSF-GEER; GPS N38.098 W122.269; 08/24/14; 14:37]

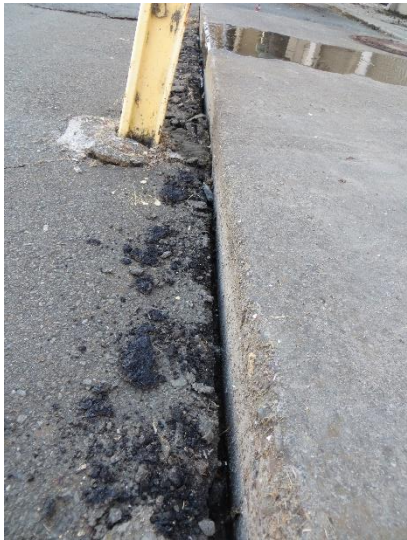
Figure E.16: Pavement damage along concrete [NSF-GEER; GPS N38.098 W122.269; 08/24/14; 14:38]

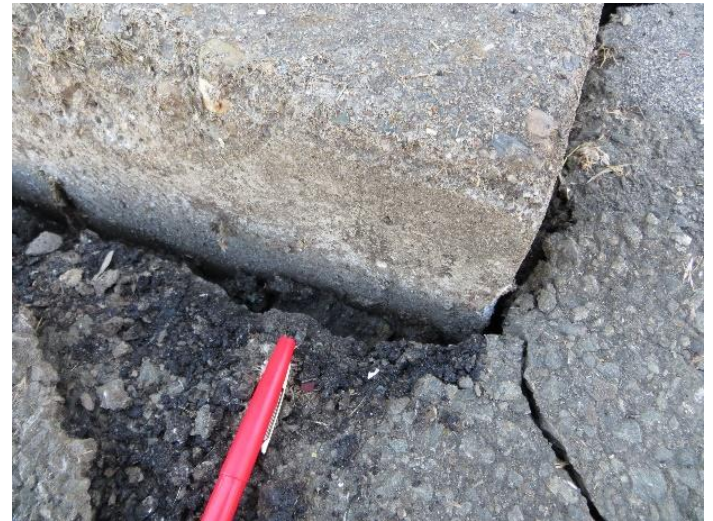
Figure E.17: Pavement damage at concrete corner [NSF-GEER; GPS N38.098 W122.269; 08/24/14; 14:38]

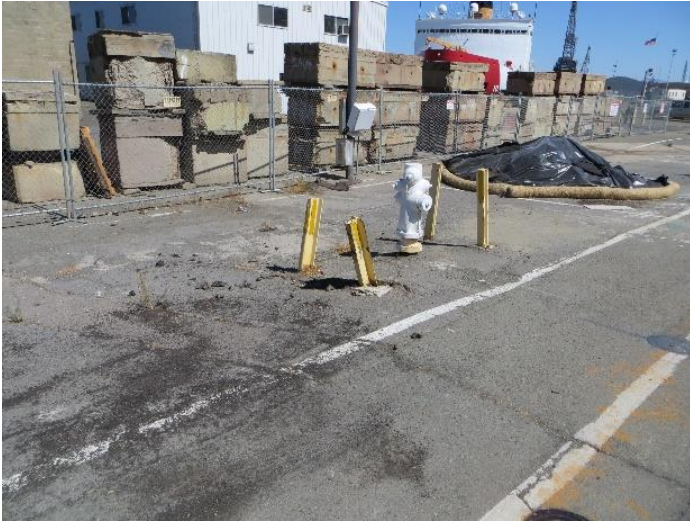
Figure E.18: Hydrant, no damage [NSF-GEER; GPS N38.097 W122.268; 08/24/14; 14:51]

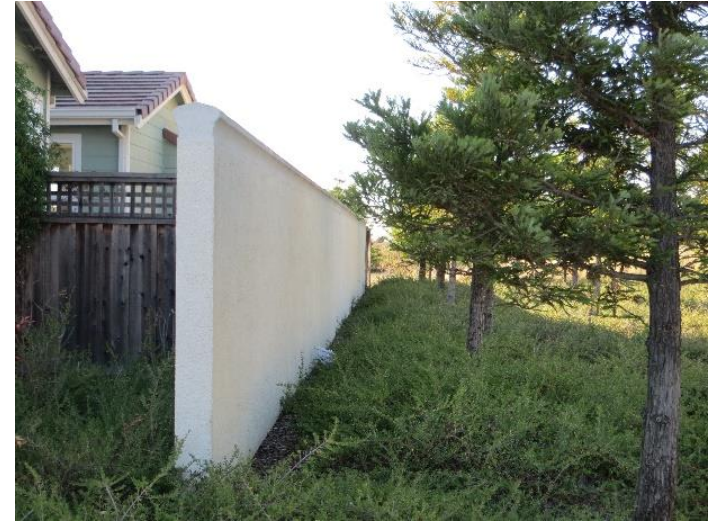
Figure E.19: Soundwall alignment, no deformation [NSF-GEER; GPS N38.096, W122.276; 08/24/14; 17:31]

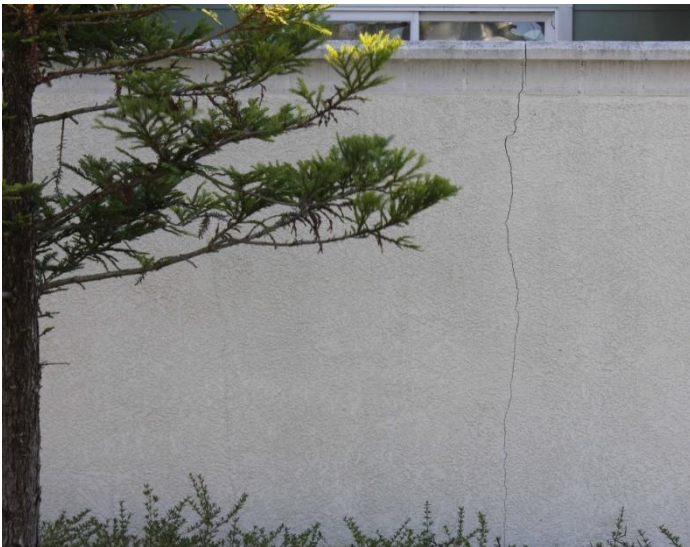
Figure E.20: Soundwall, minor crack [NSF-GEER; GPS N38.096 W122.276; 08/24/14; 17:31]

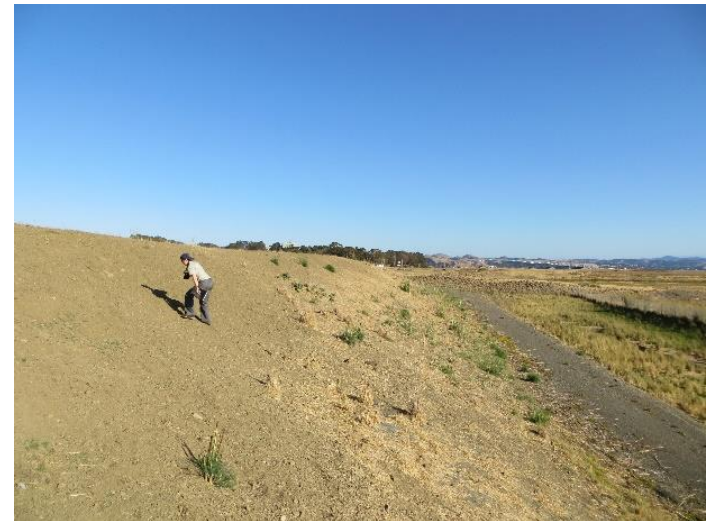
Figure E.21: Surcharge slope, no damage [NSF-GEER; GPS N38.092, W122.277; 08/24/14; 17:49]

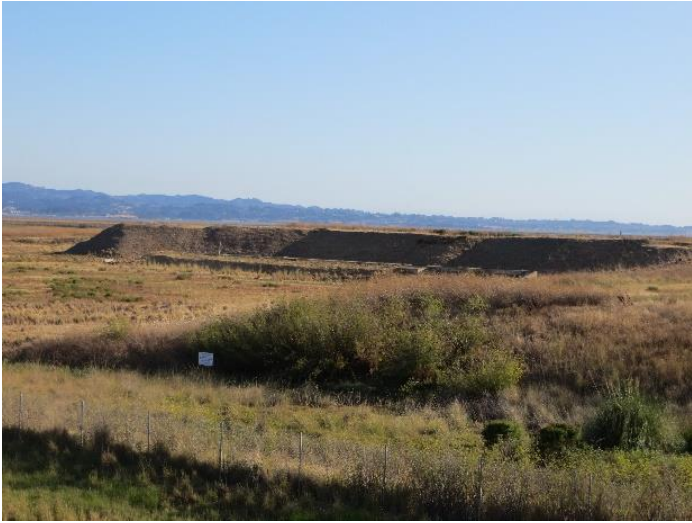
Figure E.22: Slope, no damage [NSF-GEER; GPS N38.092 W122.277; 08/24/14; 17:50]

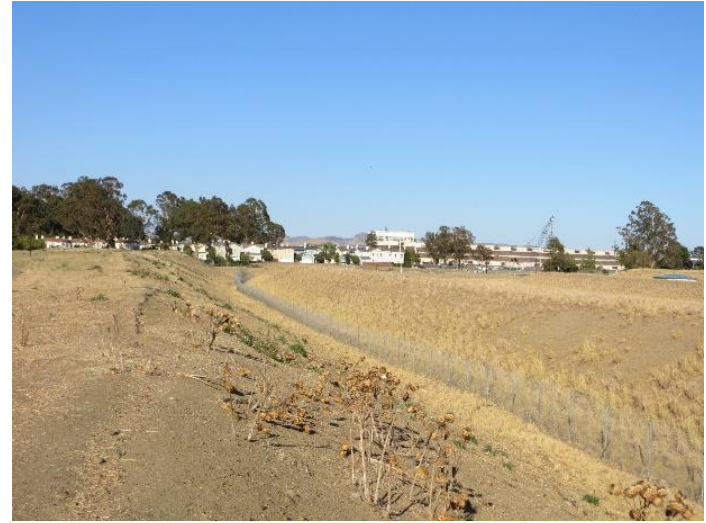
Figure E.23: Slopes, no damage [NSF-GEER; GPS N38.092 W122.277; 08/24/14; 17:53]

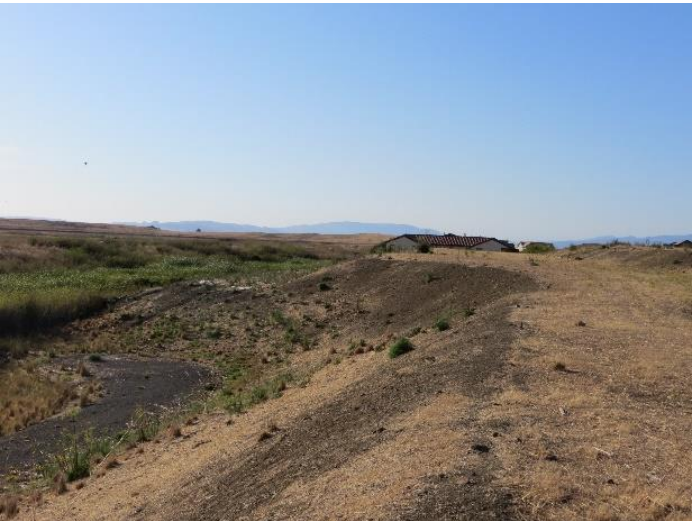
Figure E.24: Surcharge slope, no damage [NSF-GEER; GPS N38.092 W122.277; 08/24/14; 17:51]

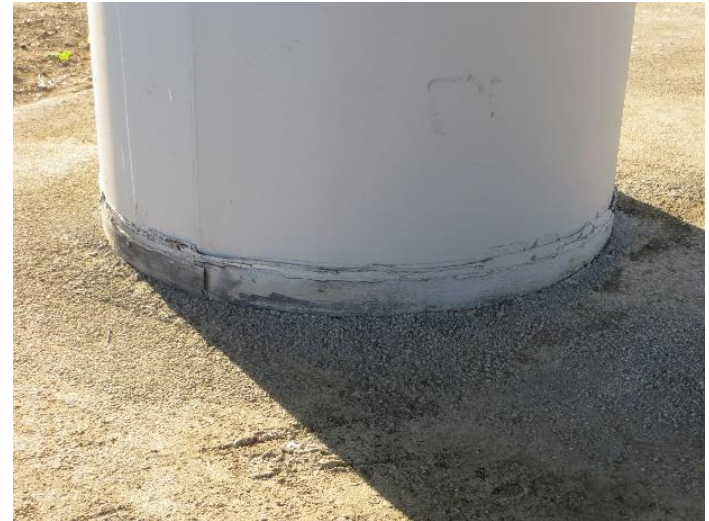
Figure E.25: Highway 37 Bridge pier, no damage [NSF-GEER; GPS N38.122 W122.276; 08/24/14; 18:24]

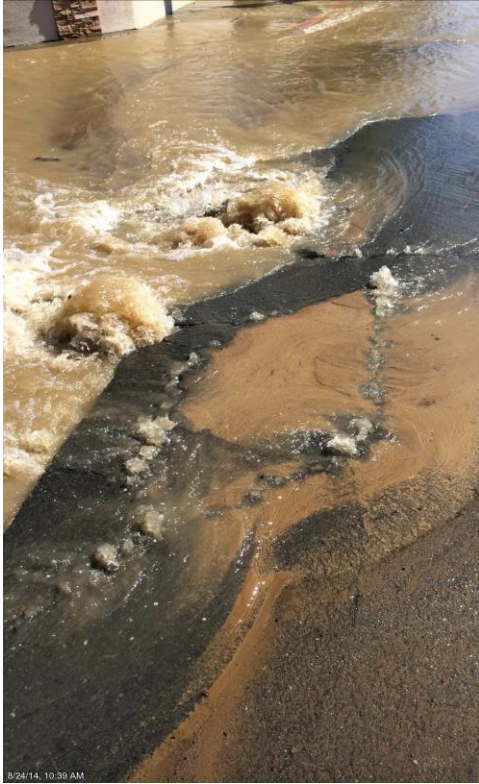
Figure E.26: Water main break at Napa Valley Mobile Home Park [NSF-GEER; N 38.3465 W -122.330; 08/24/14 10:39]

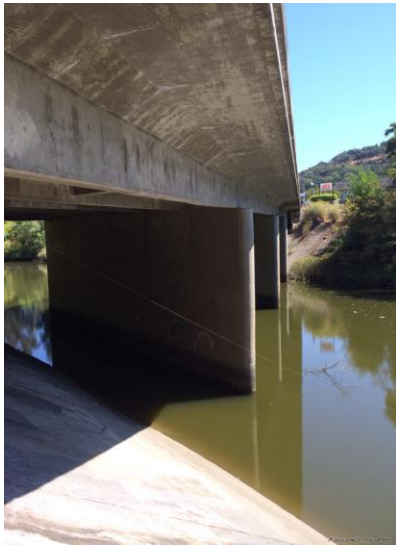
Figure E.29: Lincoln Bridge. No damage was observed. [NSF-GEER; N 38.311 W -122.278; 08/25/14 12:02]

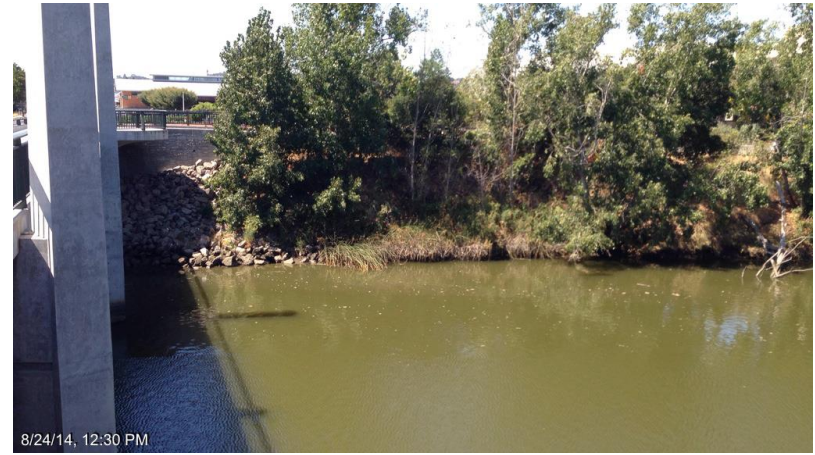
Figure E.30: 1st St. Bridge. No damage observed. [NSF-GEER; N 38.3023 W -122.2794; 08/25/14 12:26]

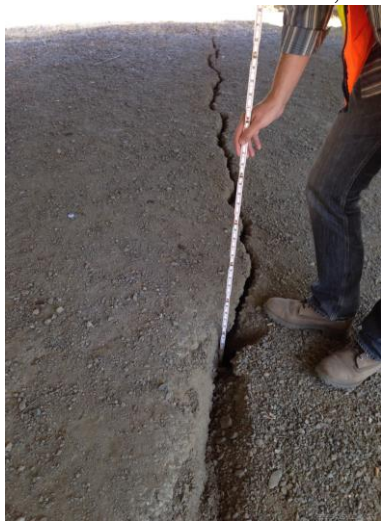
Figure E.31: Railroad Bridge. Crack observed in the interface between the North abutment foundation and the soil. [NSF-GEER; N 38.3002 W -122.282; 08/25/14 12:41]

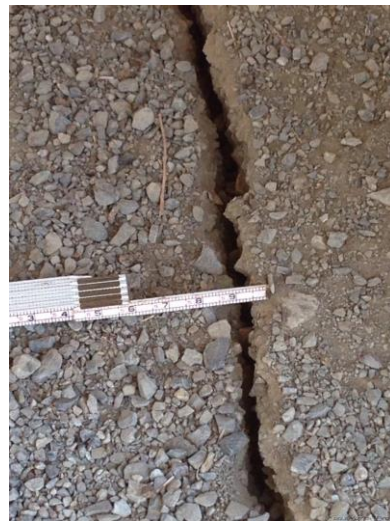
Figure E.32: Railroad Bridge. Crack observed in the interface between the South abutment foundation and the soil. [NSF-GEER; N 38.2995 W -122.2821; 08/25/14 13:28]

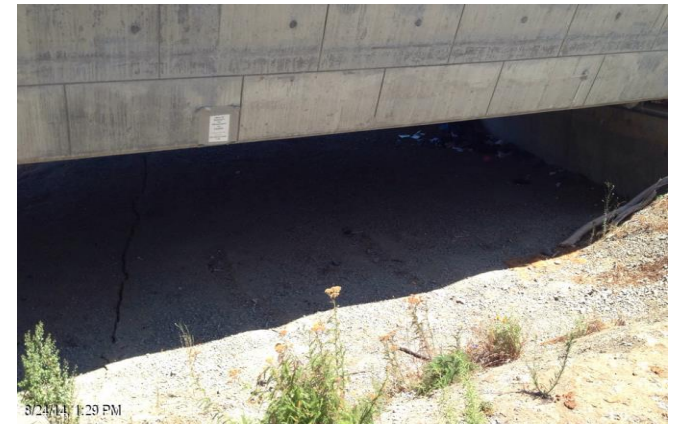
Figure E.33: Railroad Bridge. Crack observed in the interface between the South abutment foundation and the soil. [NSF-GEER; N 38.2995 W -122.2821; 08/25/14 13:28]

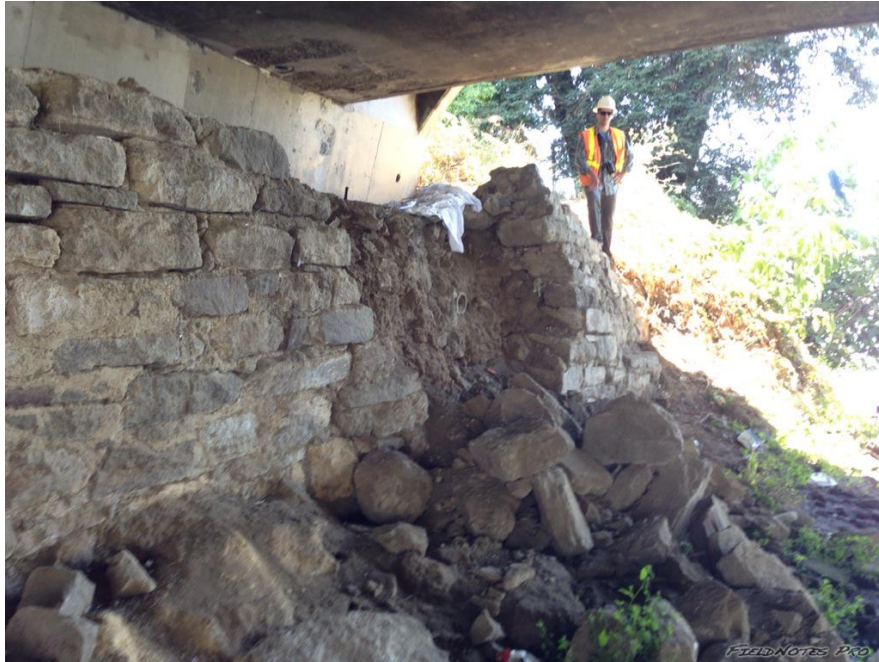
Figure E.34: Failure of the stone retaining wall in South abutment of Soscol Bridge [NSF-GEER; N 38.2994 W -122.282; 08/24/14 13:44]

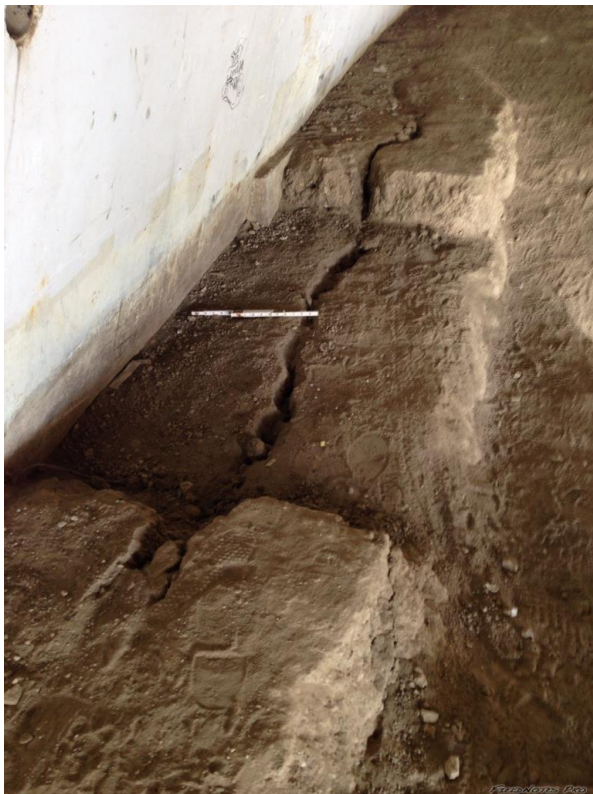
Figure E.35: Crack parallel to the River in North abutment of Soscol Bridge [NSF-GEER; N 38.2997 W -122.283; 08/24/14 13:09]

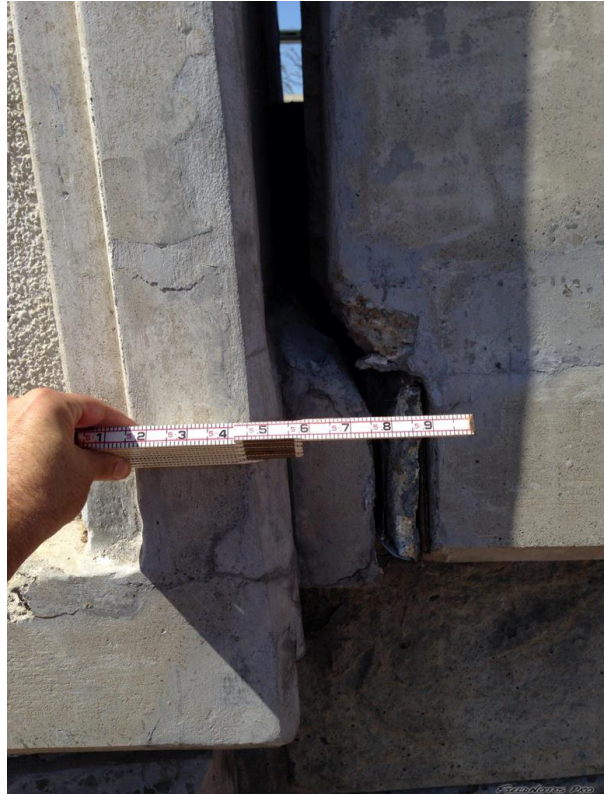
Figure E.36: Movement of the deck in 3rd St. Bridge East abutment [NSF-GEER; N 38.2981 W -122.284; 08/24/14 14:44]

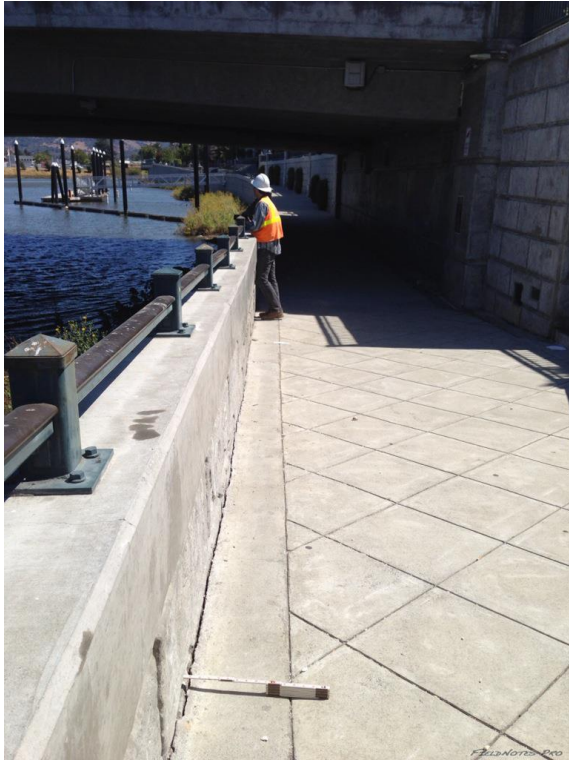
Figure E.37: Crack parallel to the River in West abutment of 3rd St. Bridge [NSF-GEER; N 38.2980 W -122.2840; 08/24/14 14:44]

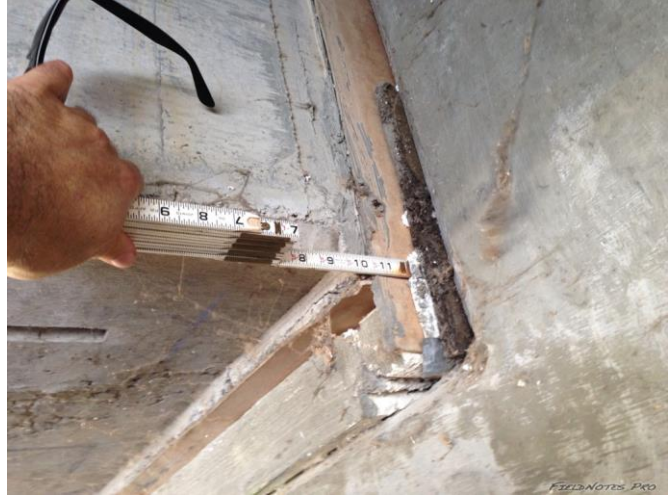
Figure E.38: of the deck in 3rd St. Bridge East abutment [NSF-GEER; N 38.2981 W -122.284; 08/24/14 14:44]

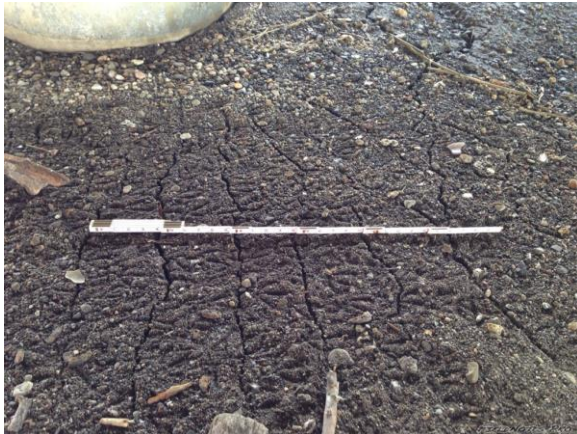
Figure E.39: Ground cracking due to liquefaction in Napa River point bar below 3rd St. Bridge, between the two columns of the eastern pier. [NSF-GEER; N 38.2980 W -122.2840; 08/24/14 14:44]

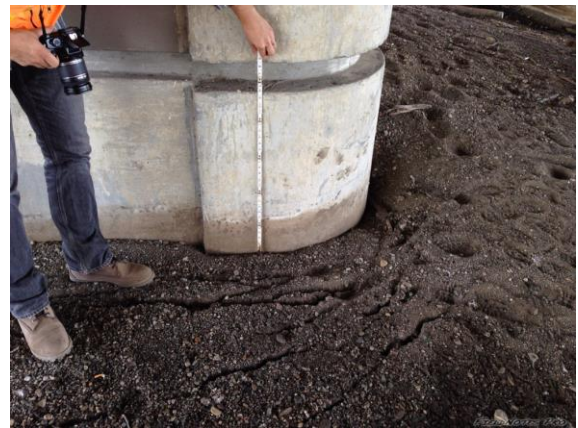
Figure E.40: Ground cracking and settlement due to liquefaction in Napa River point bar below 3rd St. Bridge [NSF-GEER; N 38.2980 W -122.2840; 08/24/14 14:44]

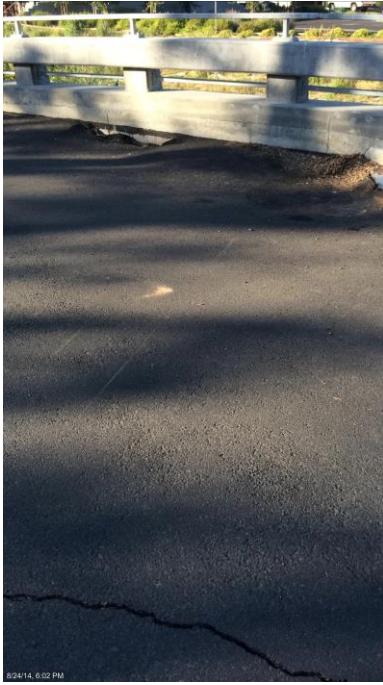
Figure E.41: Settlement of backfill near the retaining wall in the Pedestrian Bridge [NSF-GEER; N 38.3003 W -122.2881; 08/24/14 17:58]

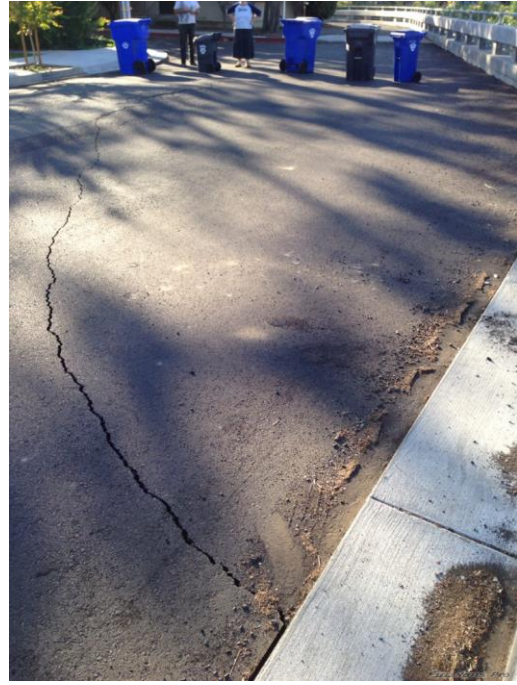
Figure E.42: Crack in pavement behind the retaining wall in the Pedestrian Bridge [NSF-GEER; N 38.3003 W -122.2881; 08/24/14 17:58]

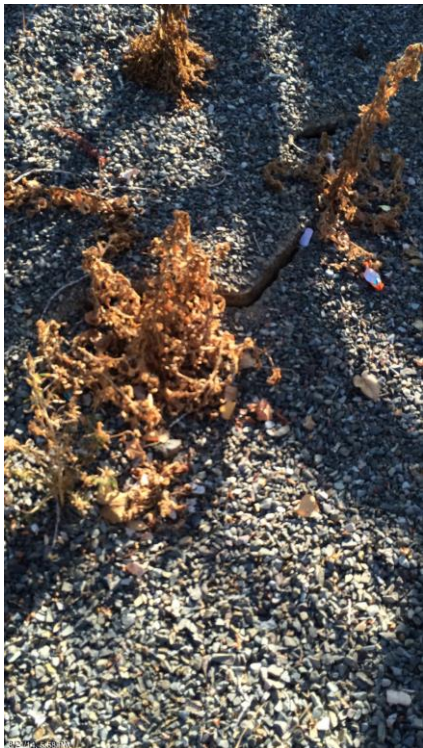
Figure E.43: Crack along sheet pile wall behind the retaining wall in the Pedestrian Bridge [NSF-GEER; N 38.3003 W -122.2881; 08/24/14 17:58]

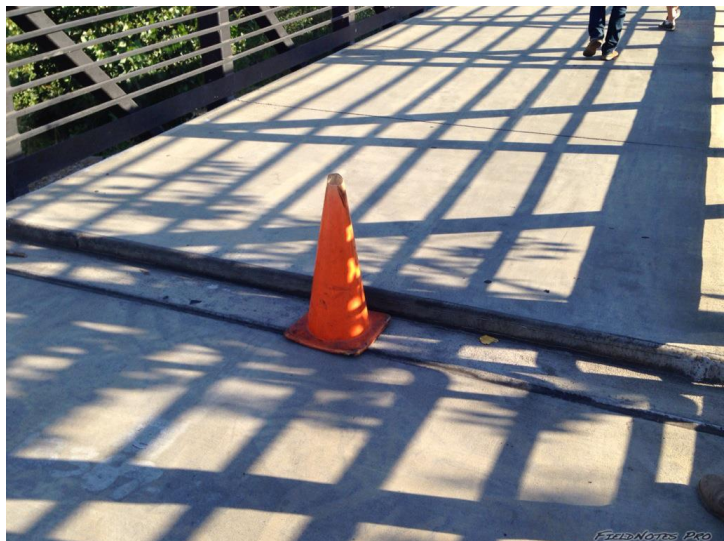
Figure E.44: Step between bridge's deck and access ramp in North abutment. [NSF-GEER; N 38.3003 W -122.2881; 08/24/14 17:58]

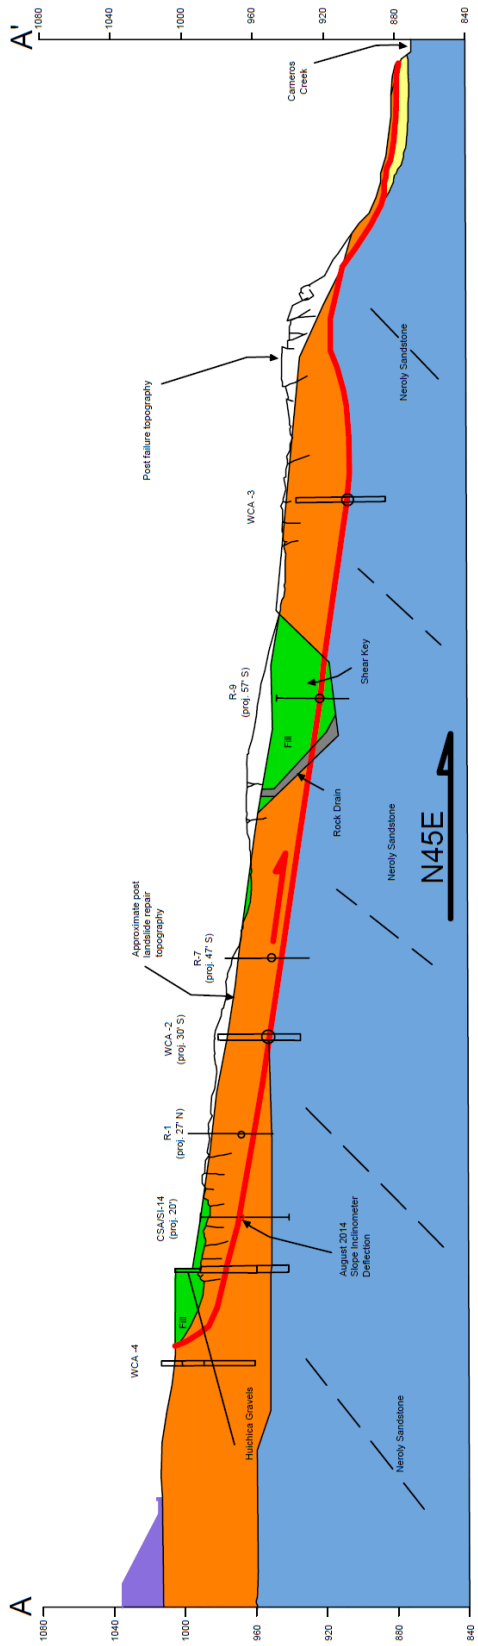
Figure E.45: Napa winery cross-section
