Appendix F: Performance of Dams and Levees

Preliminary reconnaissance efforts of dams and levees were made by GEER team members between August 24 and September 7, 2014 following the main shock. Reconnaissance efforts included several flights in a California Highway Patrol (CHP) helicopter over several dams and levee reaches to look for any major damage from the air. No significant damage was observed at any of the areas viewed from the air. These efforts were then followed up by ground investigations in areas where higher accelerations were thought to have been sustained, notably in the central Napa area and in Vallejo. Again, no major damage was observed at any of the dams or levee reaches visited by GEER team members. The majority of damage observed on either dams or levees consisted of relatively small longitudinal cracks either on the dam/levee crest, or in one location along the landside toe of a small dike on Green Island. New cracking associated with the earthquake, or any other damage, was often not observed at all. Where present, the cracking was commonly less than a few millimeters in width. The largest crack observed was on the crest of Lake Marie Dam and was only about

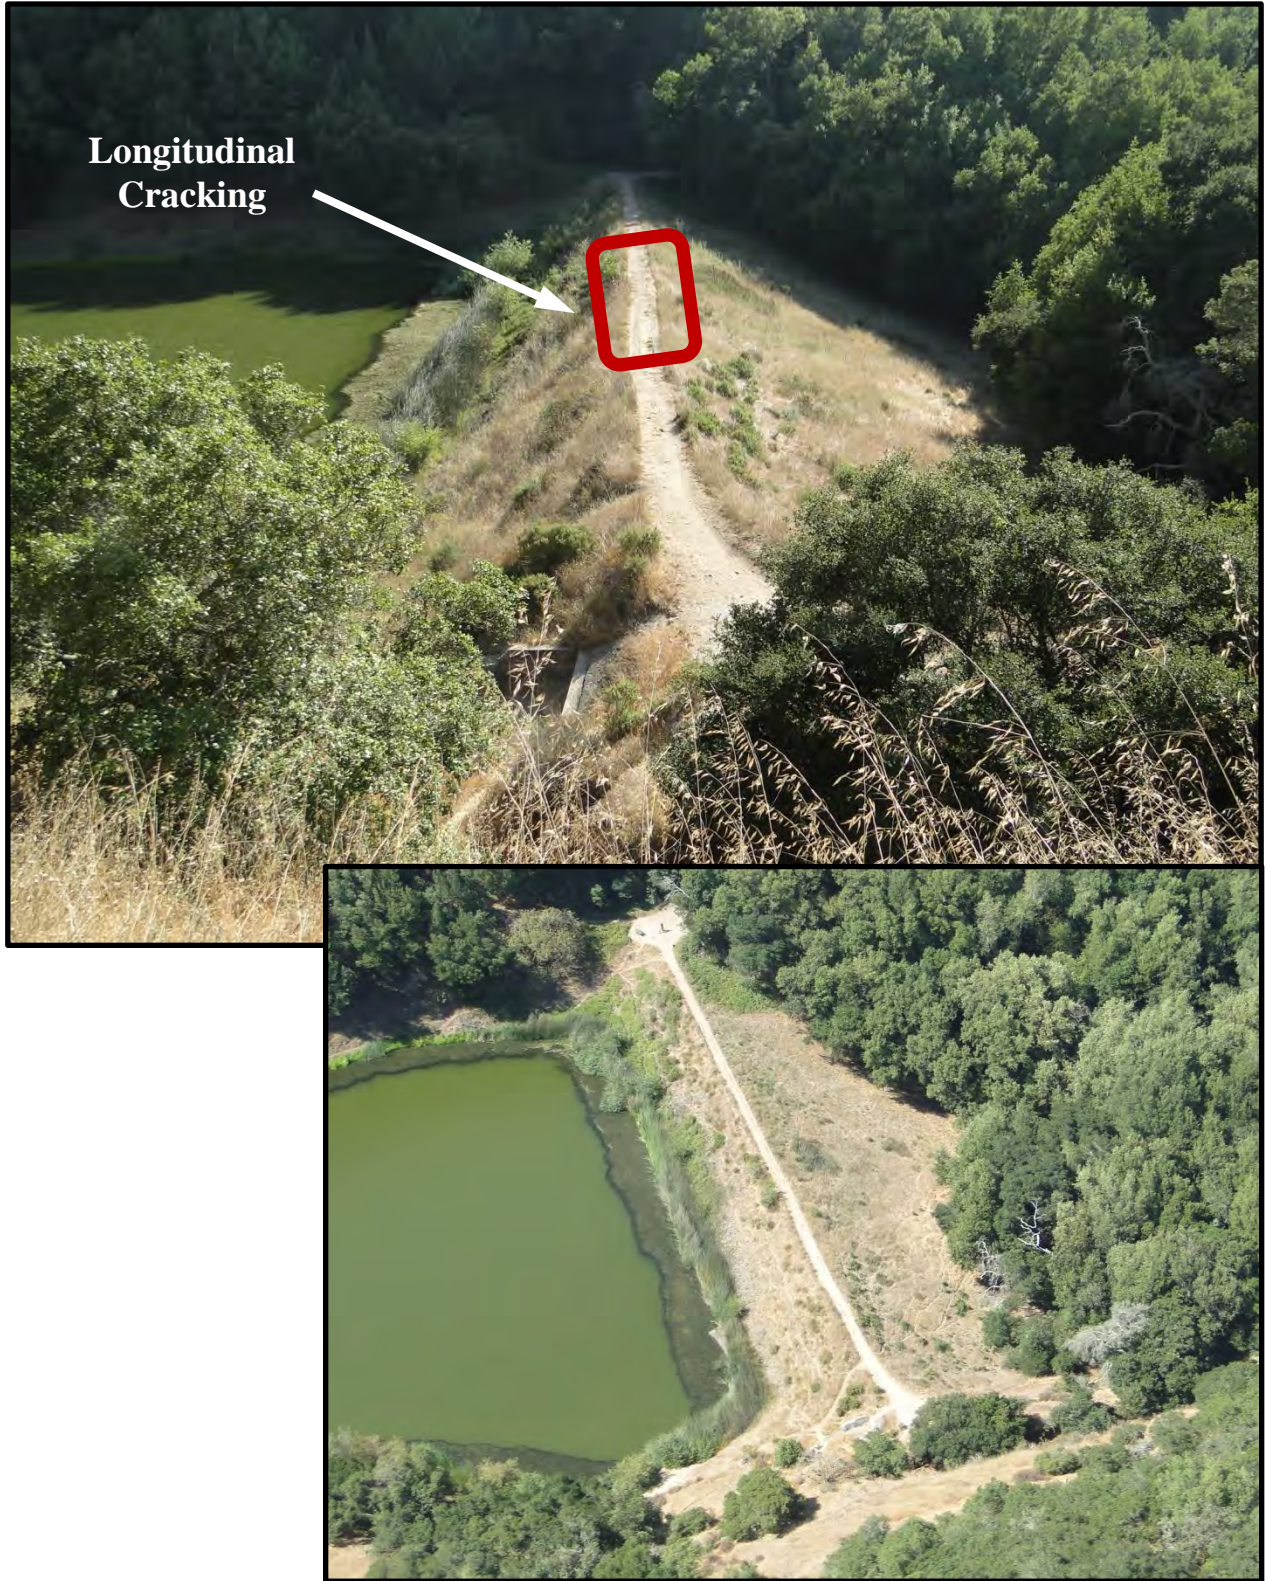
Lake Marie Dam was approximately 8.0 kilometers away from the energy source associated with the South Napa Earthquake and is estimated to have sustained a peak ground acceleration of about 0.19g based on nearby strong motion instruments. DSOD personnel inspected the dam during the same day as the earthquake and noted only a longitudinal crack in the upstream portion of the dam crest. The crack ran approximately 17 meters in length along the left central portion of the dam (see Figure F-2 for general location) and had a maximum width of about 2½ centimeters (see Figure F-3). Figures F-3 and F-4 present photographs taken by DSOD and by the GEER team of the cracking. The cracking may be related to movement of the upstream rock wall reportedly placed on the upstream edge of the dam crest in 1931. The cracking is considered minor, but DSOD staff report that they may require the cracking to be remediated.

Figure F-2: Ground and aerial photographs of Lake Marie Dam looking southeast
[NSF-GEER; Napa, CA; N38.260 W 122.230; Harder, L. F.; 09/01/14]

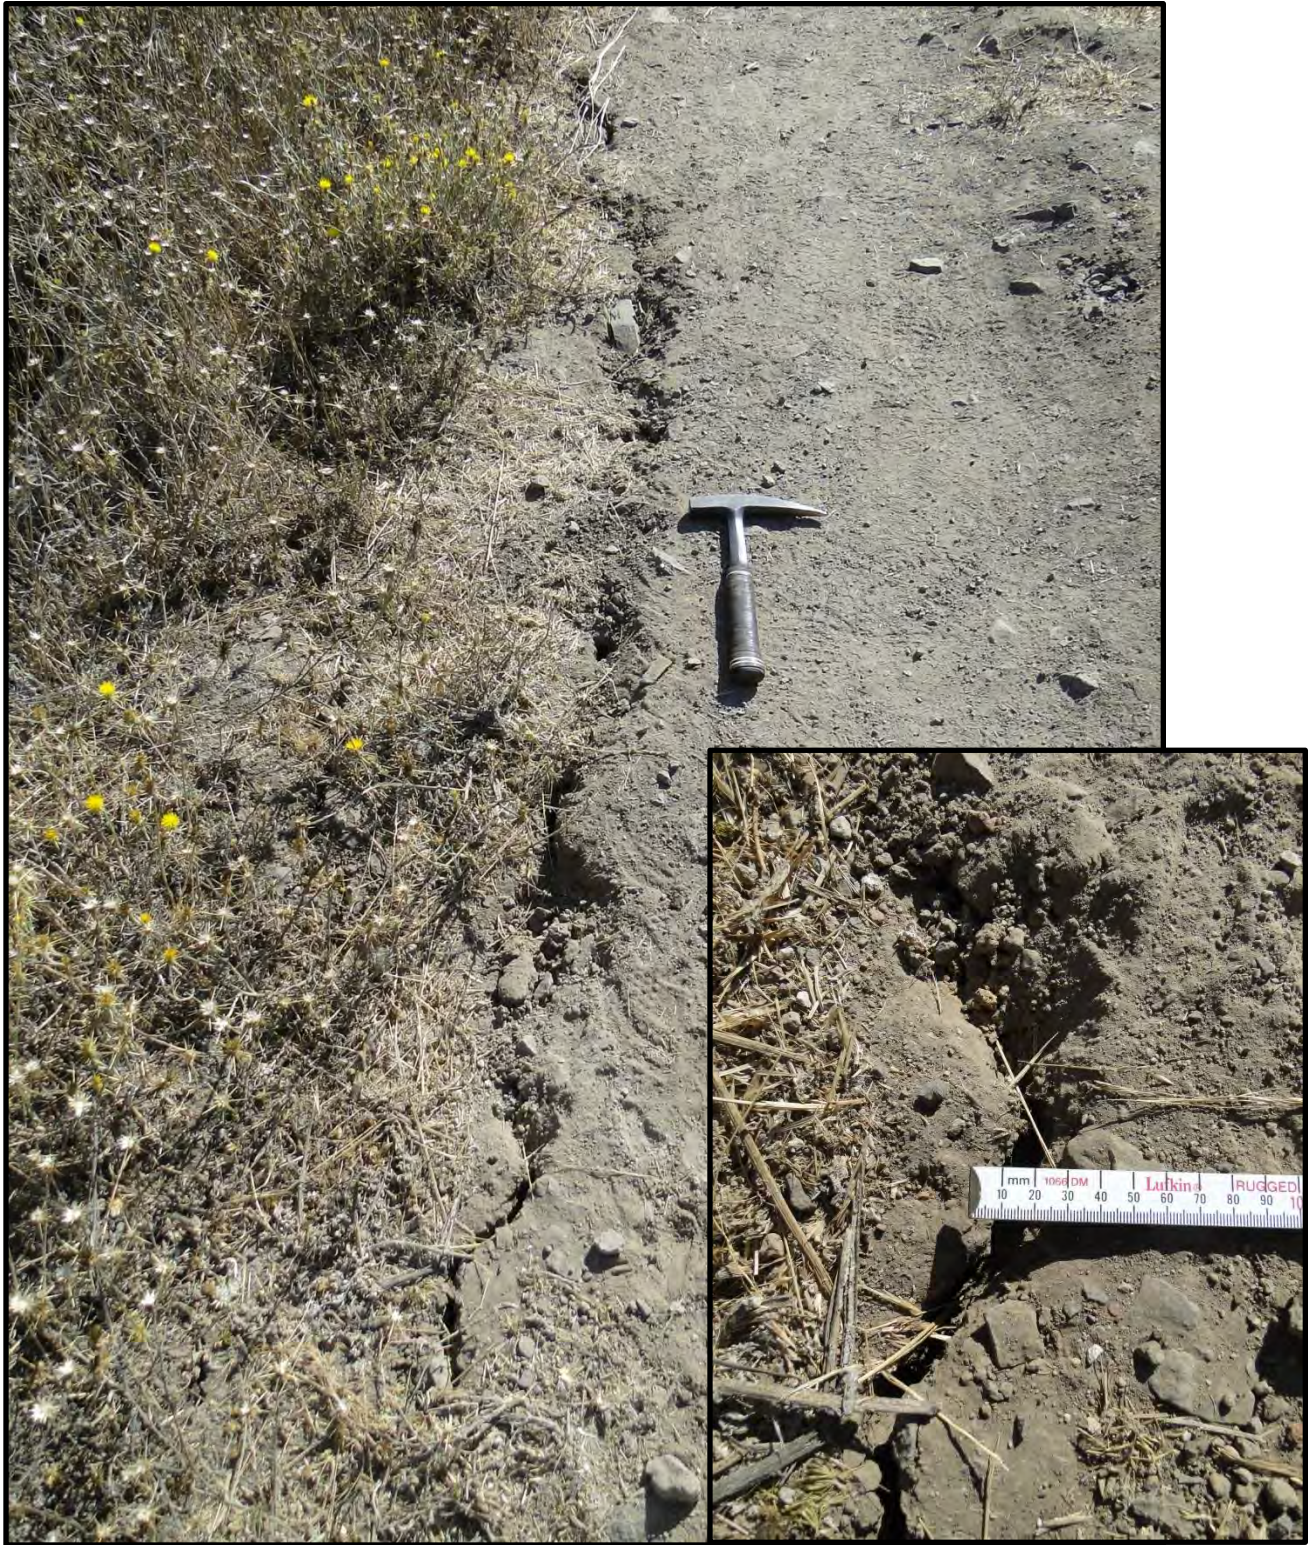
Figure F-4: Photograph of cracking on the upstream edge of the crest of Lake Marie Dam looking southeast [NSF-GEER; Napa, CA; N38.260 W 122.230; Harder, L. F.; 09/01/14]

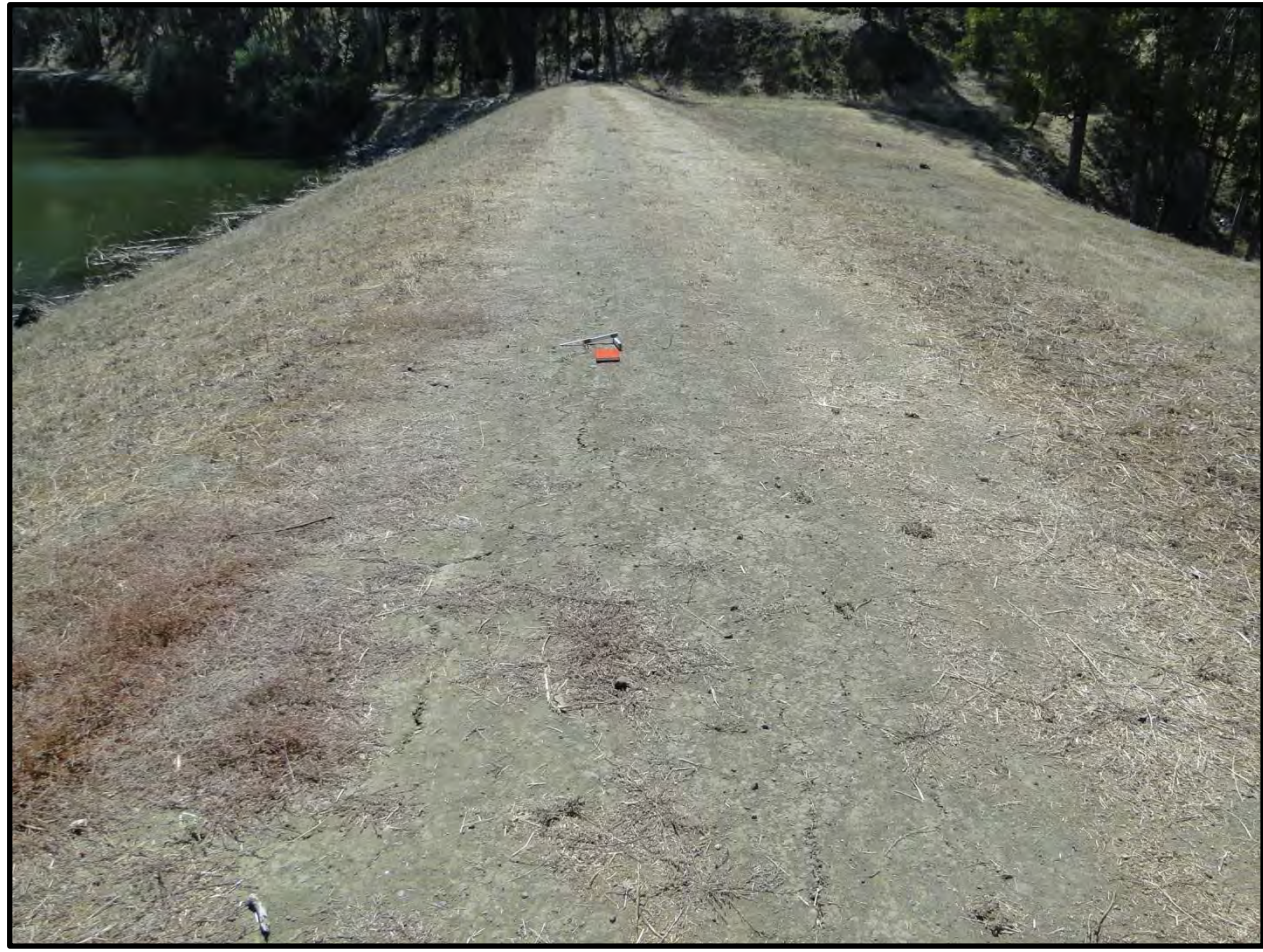
Lake Chabot Dam was approximately 11 kilometers away from the energy source associated with the South Napa Earthquake and is estimated to have sustained a peak ground acceleration of about 0.30g based on nearby strong motion instruments. A member of the GEER team inspected the dam on August 27th and found only minor longitudinal cracking less than 2 centimeters in

Figure F-6: Photograph of minor longitudinal cracking on the crest of Lake Chabot Dam looking southeast [NSF-GEER; Napa, CA; N38.141 W 122.241; Harder, L. F.; 08/27/14]

width on the dam crest (see Figures F-6 and F-7). Much of this cracking may have been associated with pre-existing longitudinally-dominated shrinkage cracks that simply opened up during the shaking. At the time of the August 27th inspection, the reservoir was approximately 4½ meters below the dam crest. A relatively new reinforced concrete spillway on the right abutment of the dam appeared to be undamaged.

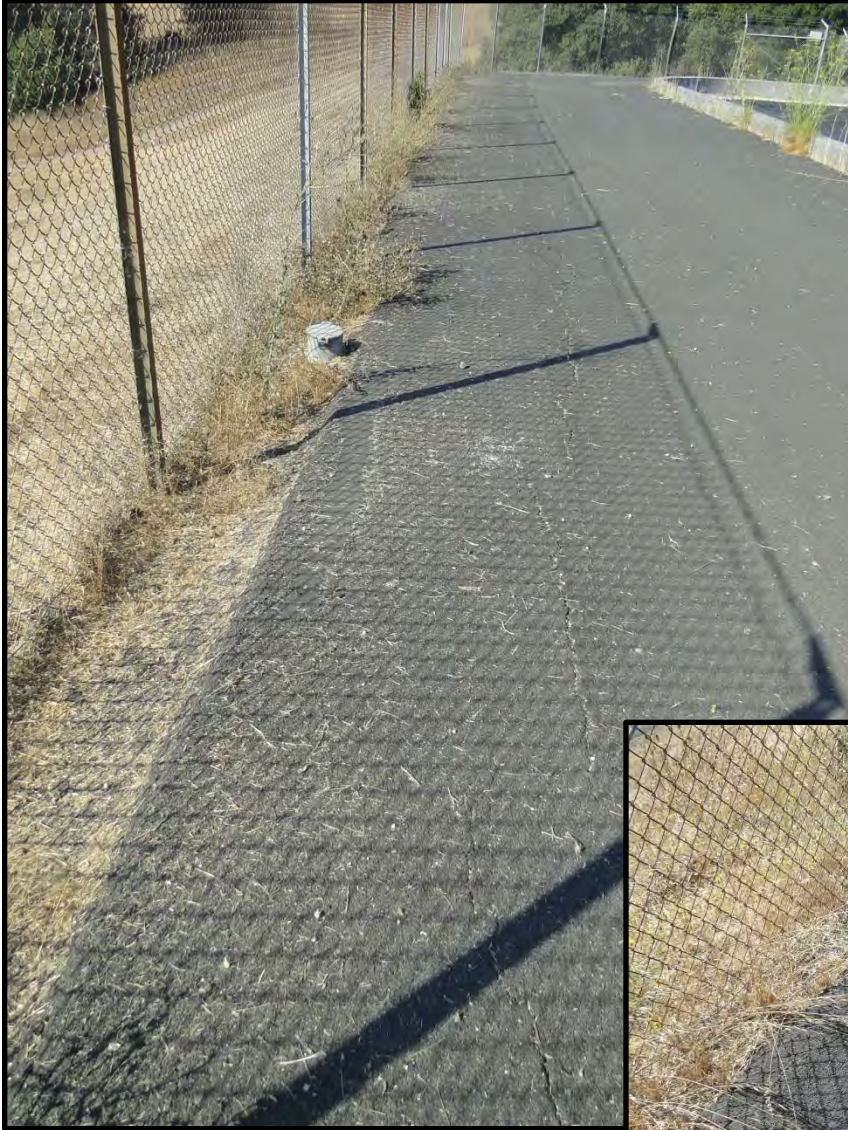
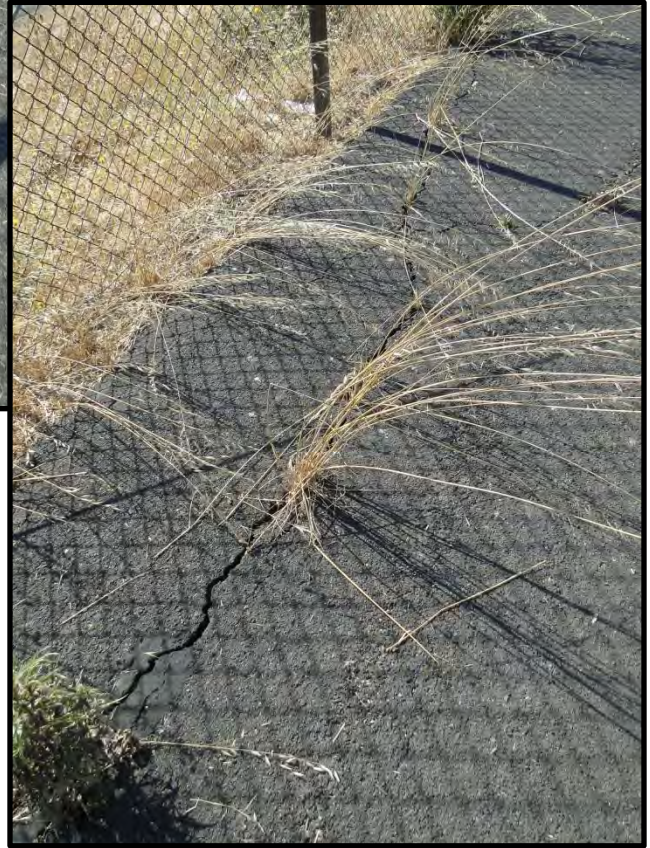
Summit Reservoir Dam was approximately 10.4 kilometers away from the energy source associated with the South Napa Earthquake and is estimated to have sustained a peak ground acceleration of about 0.25g based on nearby strong motion instruments. A member of the GEER team inspected the dam on August 27th and found that the dam appeared to have little to no damage. The only distress noted was relatively minor longitudinal cracking, principally located near the downstream edge of the asphalt-paved crest of the main dam section. These cracks were generally only a few millimeters in width with a maximum opening on the order of a centimeter. However, it was clear that these were pre-existing cracks as weeds were growing in them and asphalt mastic had previously been poured over them in the past in an attempt to seal them up. Figure F-9 illustrates some of the minor cracking noted. It is thought that at most, the effect of the earthquake was to perhaps slightly widen the pre-existing cracks.

Figure F-9: Photographs of pre-existing longitudinal cracks on the crest of the maximum section of Summit Reservoir Dam
[NSF-GEER; Napa, CA; N38.153 W 122.225; Harder, L. F.; 08/27/14]

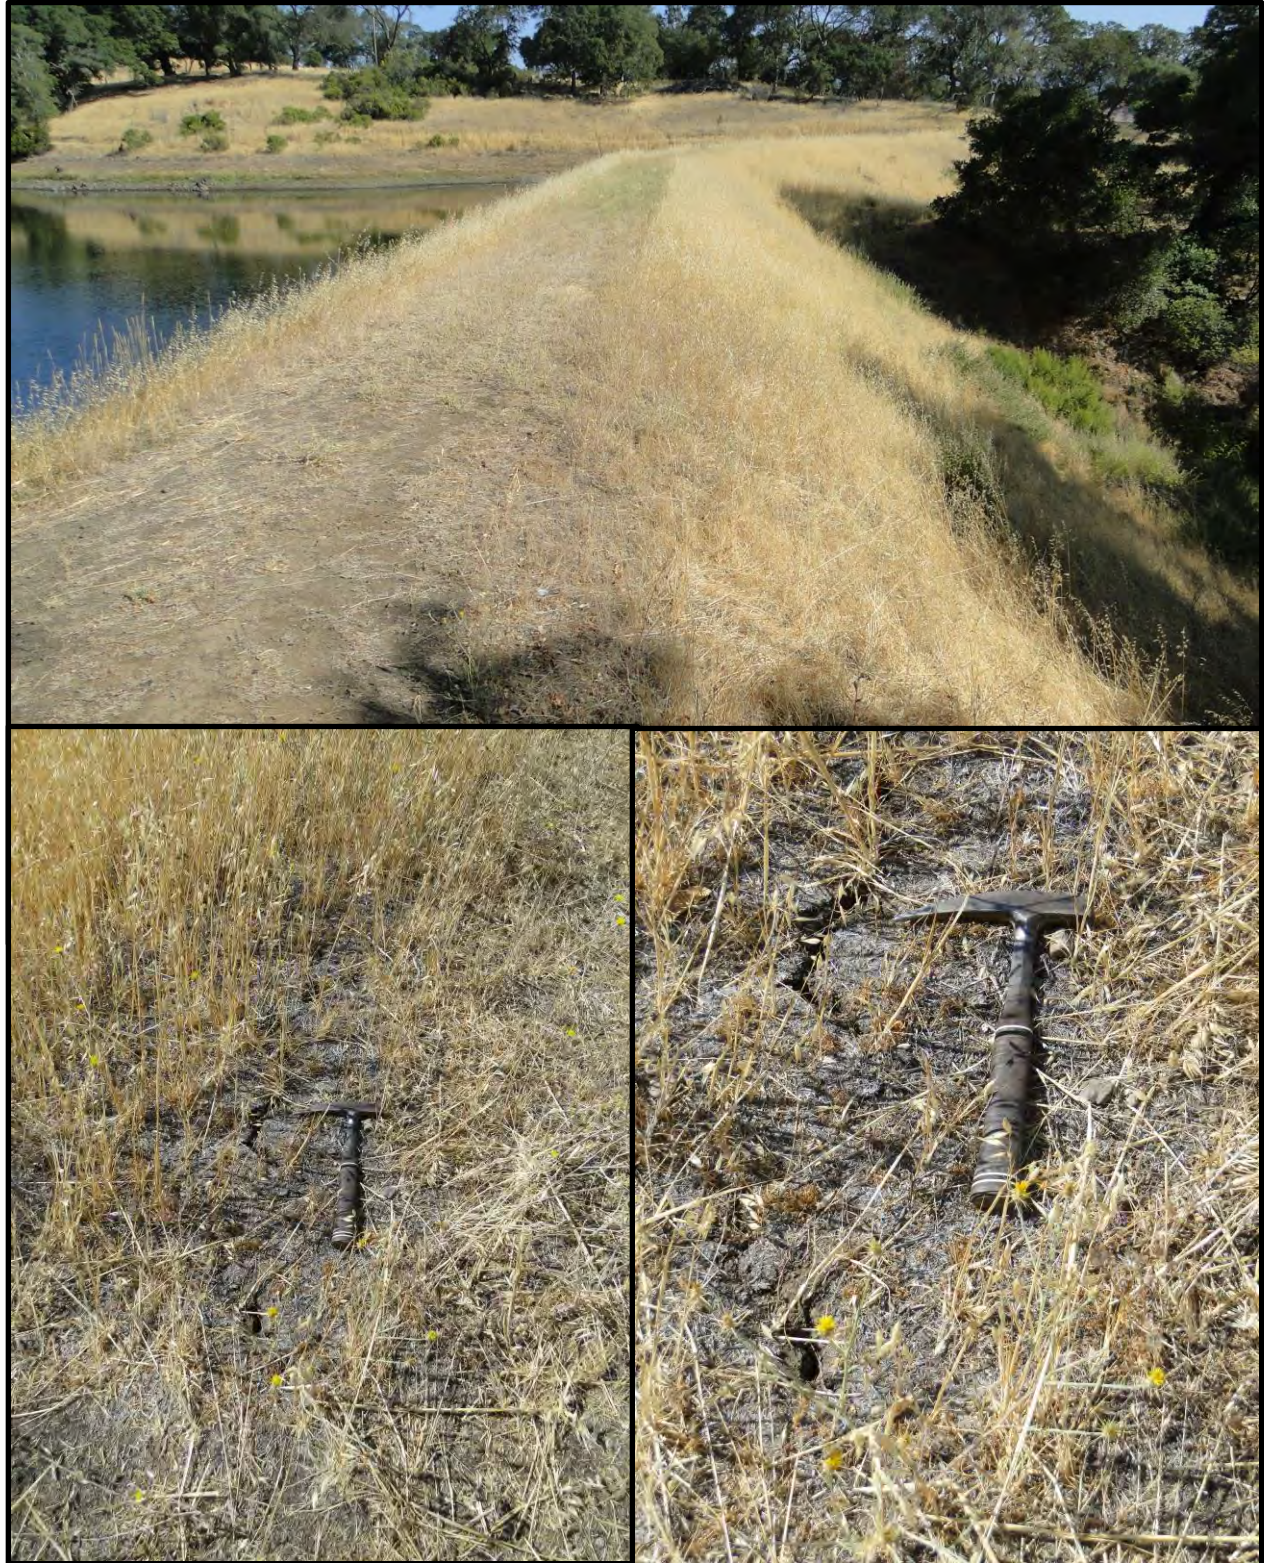
Municipal Dam was approximately 15.6 kilometers away from the energy source associated with the South Napa Earthquake and is estimated to have sustained a peak ground acceleration of only about 0.07g based on nearby strong motion instruments. A member of the GEER team inspected the dam on August 27th and found that the dam appeared to have little to no damage. The only distress noted was relatively minor, intermittent longitudinal cracking, principally located near the downstream edge of the dam's crest. These cracks were generally only a few millimeters in width with a maximum opening on the order of a centimeter. Most of these cracks appeared to be pre-existing shrinkage cracks that had simply opened up following the earthquake. On the left abutment near the downstream toe of the dam, seepage was flowing in the groin area to the creek below. However, the seepage obviously pre-existed the earthquake as there were numerous green grasses and brush growing in the seepage area. Figure F-10 presents views of the dam and the small cracking observed.

Figure F-10: Photographs of Municipal Dam and longitudinal cracks observed along the downstream edge of the crest of Municipal Dam
[NSF-GEER; Napa, CA; N38.298 W 122.144; Harder, L. F.; 08/27/14]

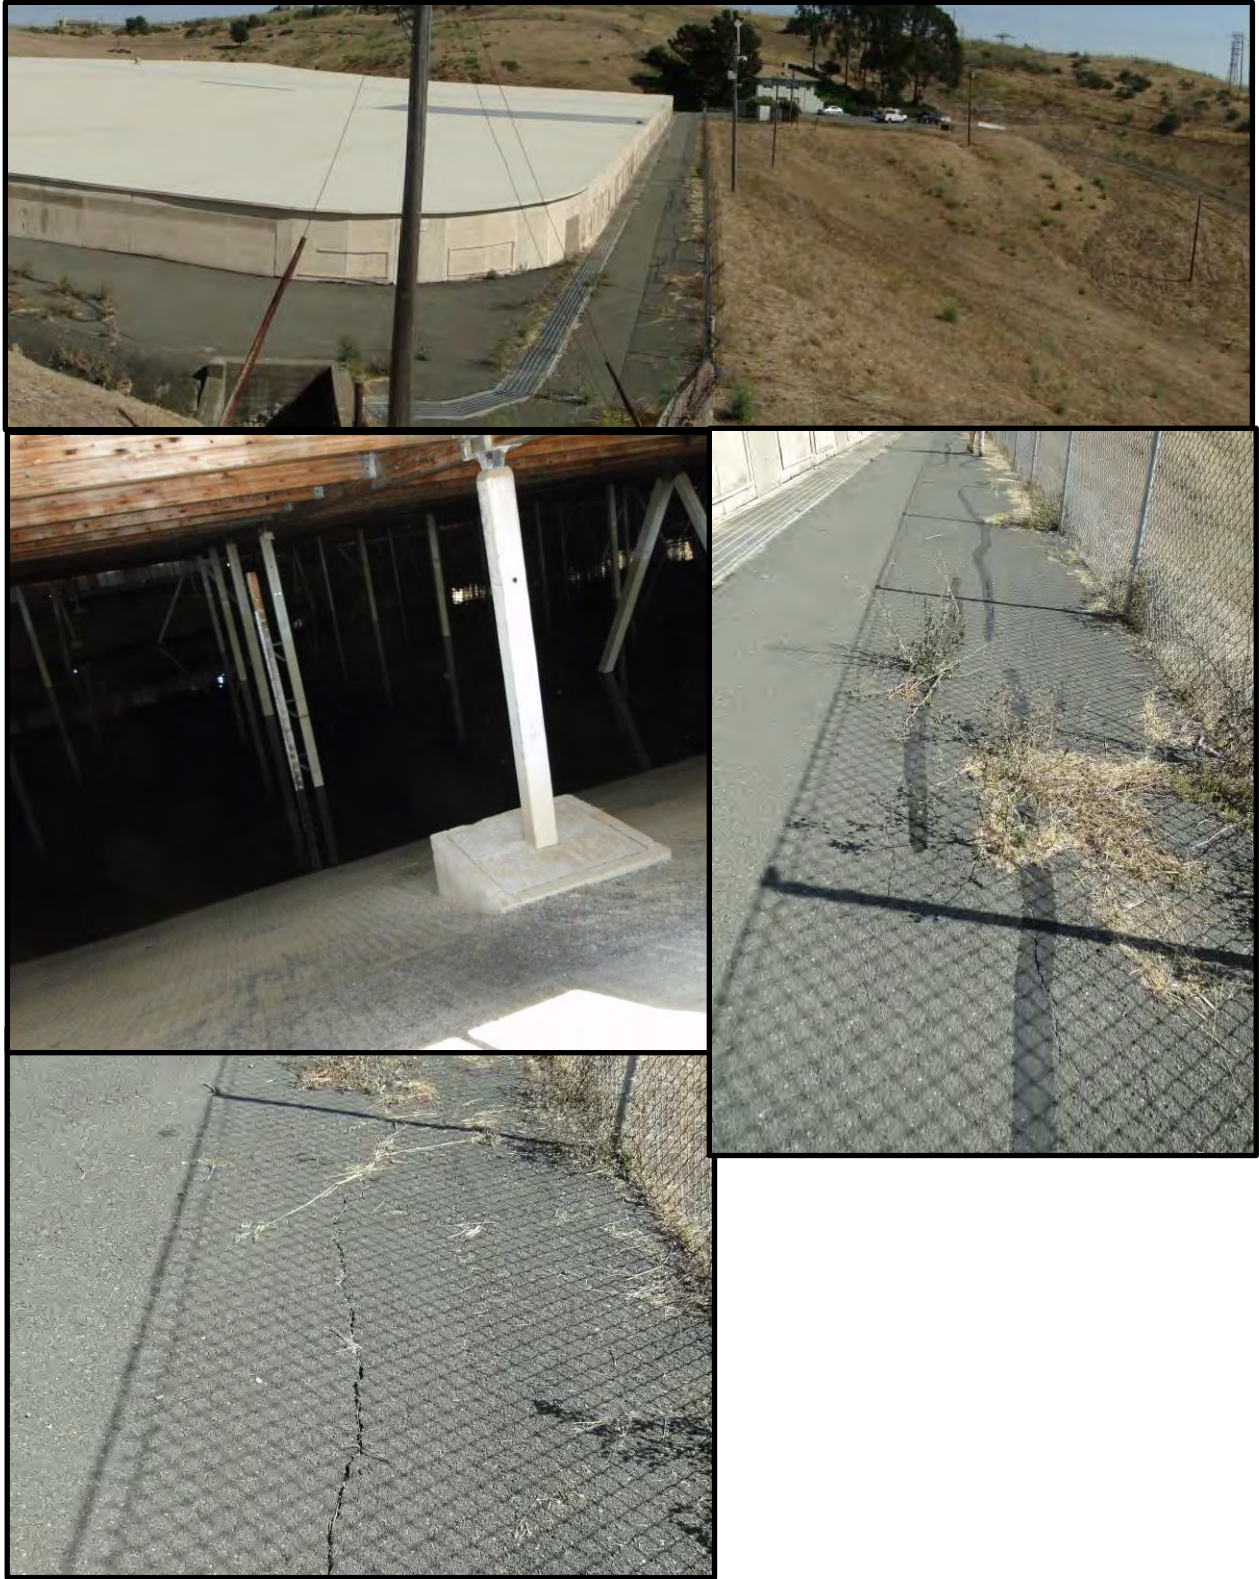
Swanzy Lake Dam was approximately 17.4 kilometers away from the energy source associated with the South Napa Earthquake and is estimated to have sustained a peak ground acceleration of about 0.30g based on nearby strong motion instruments. A member of the GEER team inspected the dam on August 27th and found that the dam appeared to have little to no damage. At the time of the August 27th inspection, the reservoir appeared to be approximately 3½ meters below the asphalt crest of the dam. The only distress noted was relatively minor longitudinal cracking, principally located near the downstream edge of the asphalt-paved crest of the main dam section. These cracks were generally only a few millimeters in width with a maximum opening on the order of a centimeter. However, it was clear that these were pre-existing cracks as weeds were growing in them and asphalt mastic had previously been poured over them in the past in an attempt to seal them up. Figure F-13 illustrates a view of the dam and some of the minor cracking noted. It is thought that at most, the effect of the earthquake was to perhaps slightly widen the pre-existing cracks.

Figure F-13: Photographs of Swanzy Dam and minor longitudinal cracking
[NSF-GEER; Napa, CA; N38.077 W 122.227; Harder, L. F.; 08/27/14]

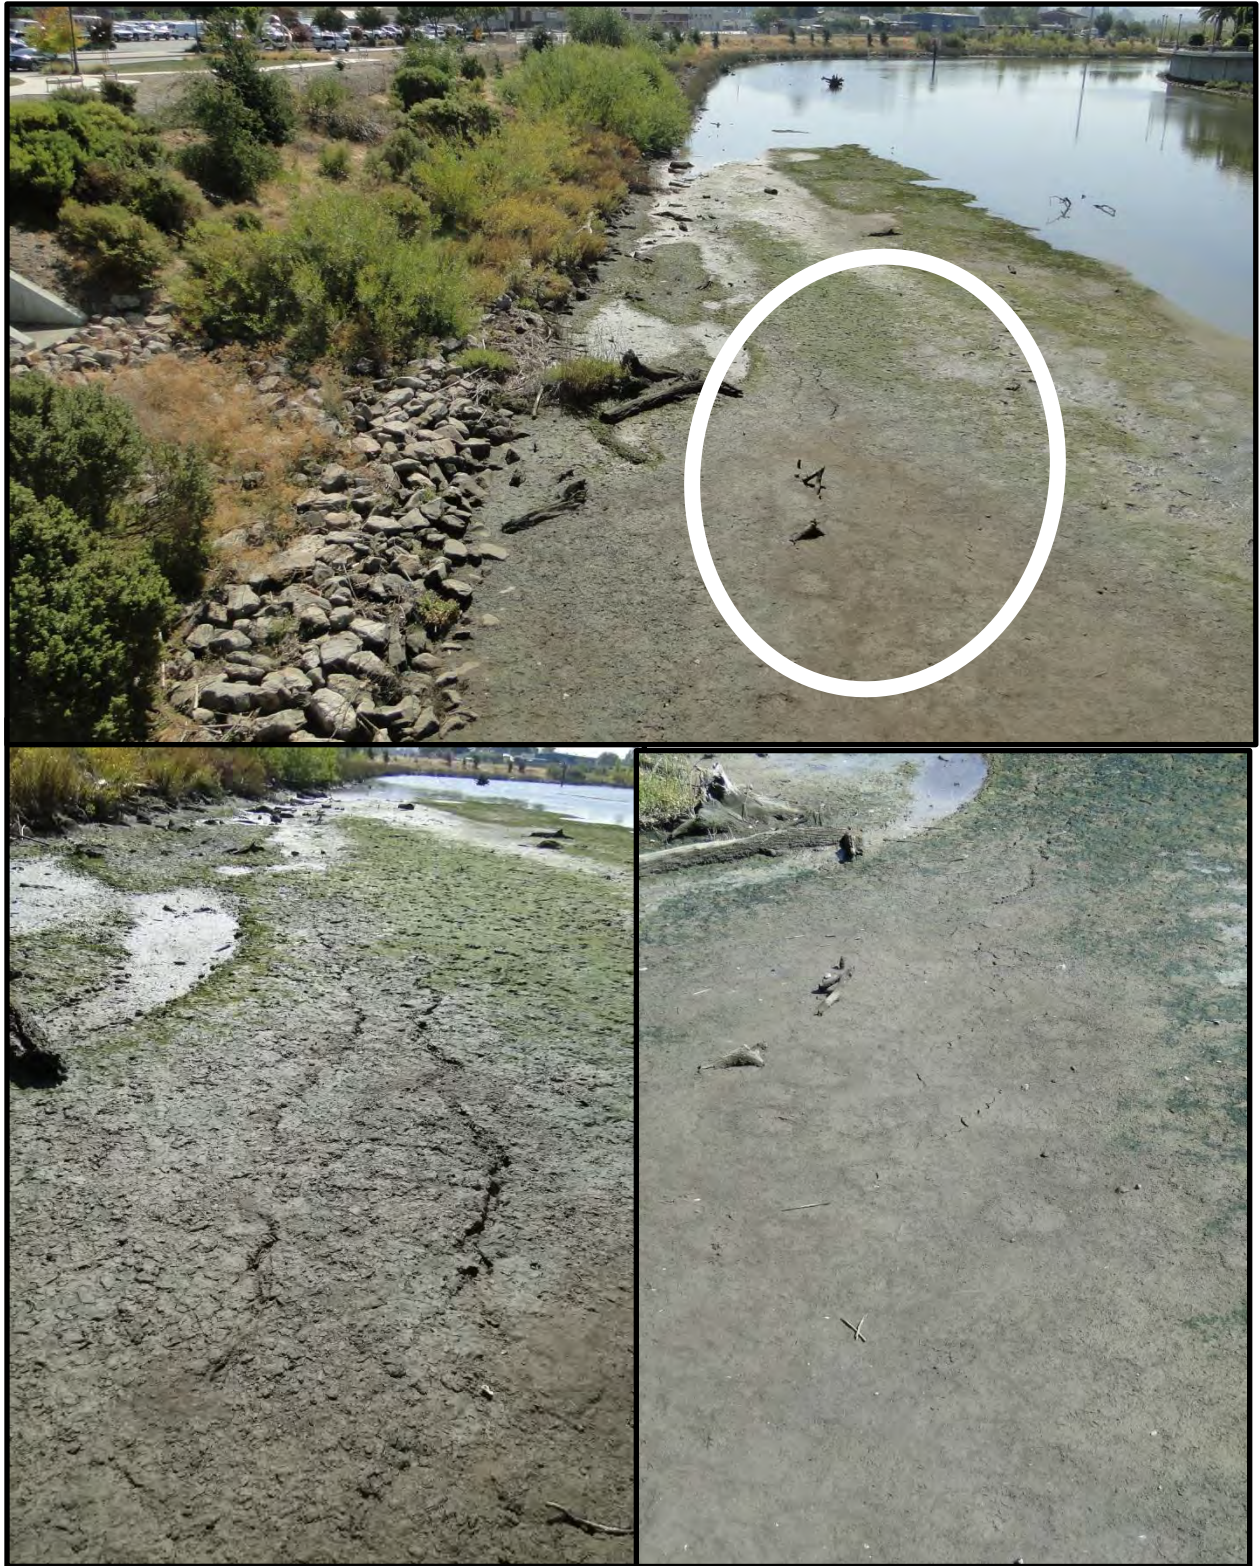
Downstream of the Third Street Bridge, remnant cracking and sand boils were observed in the sand/mud bar along the left (east) bank of the river and was suggestive that river sediments had liquefied during the earthquake (see Figures F-17 and F-18). The crack openings here were estimated to have a maximum width of approximately 2 centimeters. However, the adjacent riverbank appeared undamaged and there was no sign of cracking or lateral spreading on the concrete and gravel walkways above.

Figure F-18: Remnant cracking and sand boils in sand bar along left bank of Napa River looking downstream from Third Street Bridge
[NSF-GEER; Napa, CA; N38.298 W 122.283; Harder, L. F.; 09/04 and 09/07/14]

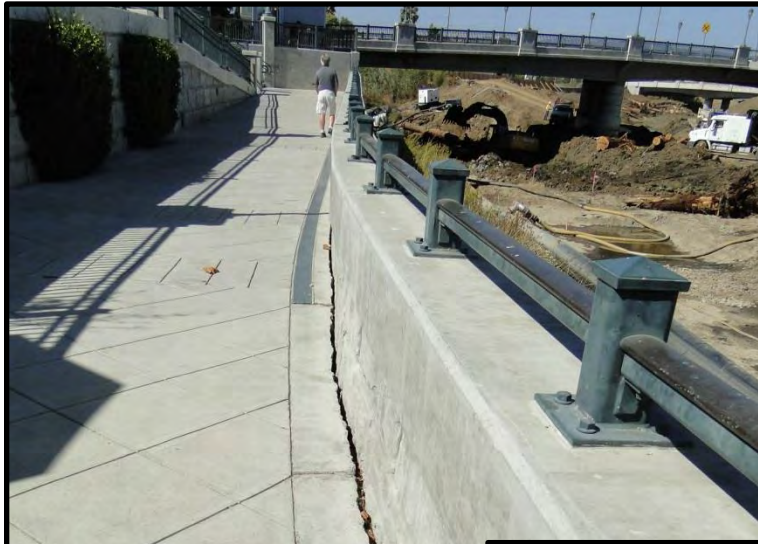
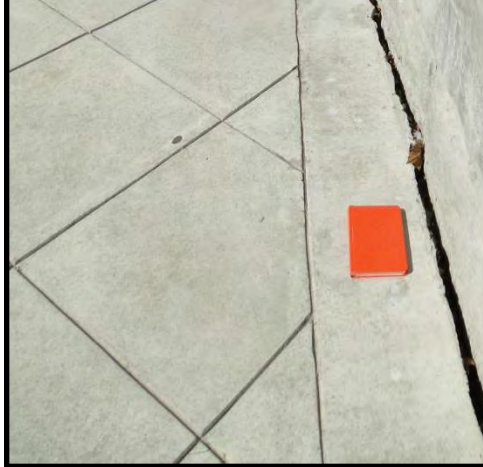
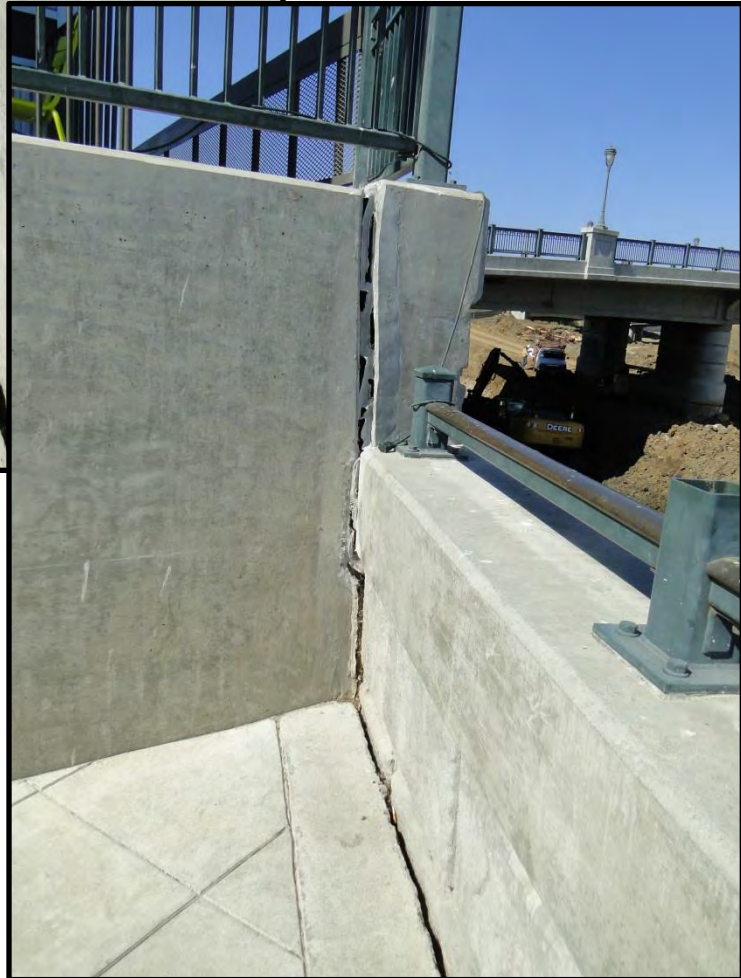
On the right (west) side of the river, the recently constructed large reinforced concrete floodwalls appeared to have performed well overall. However, the concrete deck slab behind the walls sustained minor cracking and had pulled away from the floodwalls by as much as 3 centimeters (see Figure F-19). In addition, a lateral retaining wall supporting part of a restaurant had settled approximately 3 centimeters relative to the wall (see Figure F-19).

Figure F-19: Separation of concrete slab and retaining wall from Napa River floodwall along right bank of Napa River looking upstream from Third Street Bridge [NSF-GEER; Napa, CA; N38.299 W 122.285; Harder, L. F.; 09/04/14]

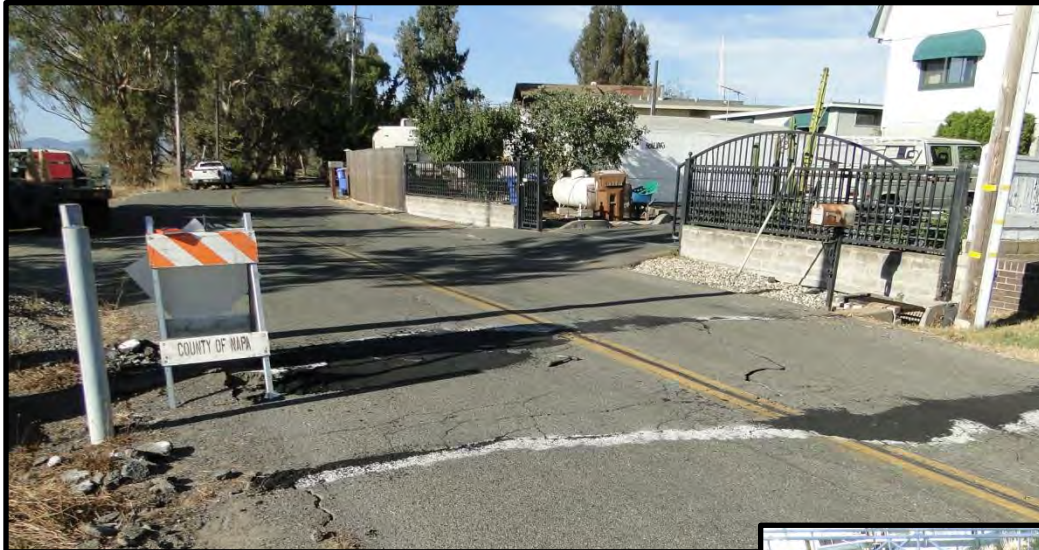
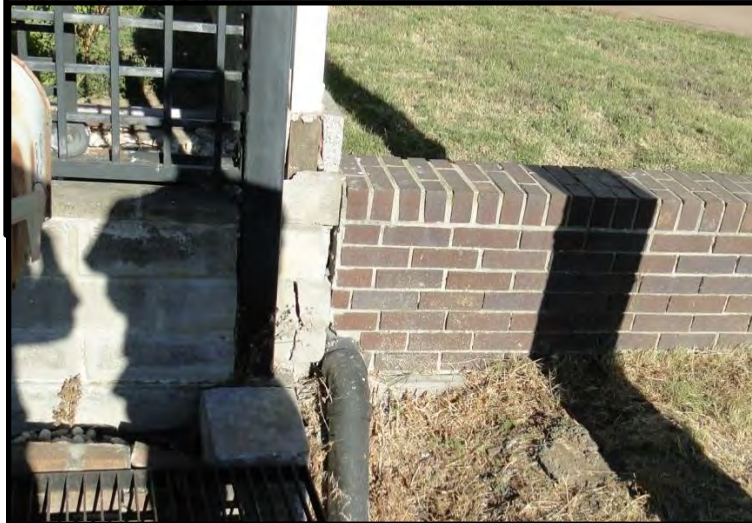
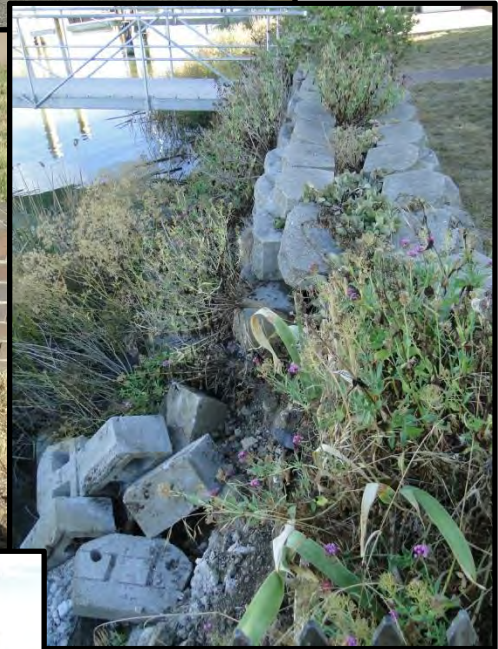
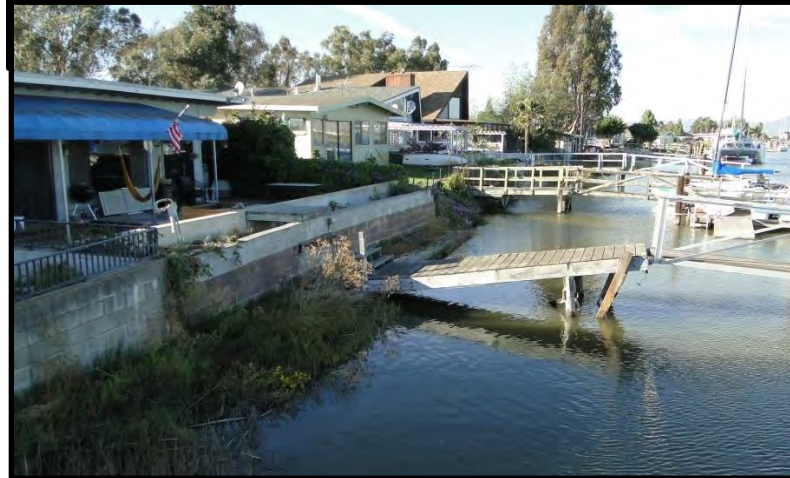
In one location along Milton Road, ground cracking was observed across the asphalt pavement. This cracking continued to a fractured low cinderblock wall (see Figure F-21). At the back of the residence on the waterside portion of the levee, the dock and floodwall had been damaged. It was not clear if the cracking and damage were associated with shaking or ground displacements associated with a continuation of the fault rupture south of the epicenter. The shaking must have been significant as a large water tank moved off its concrete pad and sheared its connection with the residence (see Figure F-22). However, no damage was observed on the levee embankment itself.

Figure F-21: Photographs of cracked asphalt pavement on Milton Road, cracked cinderblock retaining wall, and damage to waterside floodwall/boat dock on Edgerley Island south of the epicenter [NSF-GEER; Napa, CA; N38.198 W 122.316; Harder, L. F.; 09/01/14]

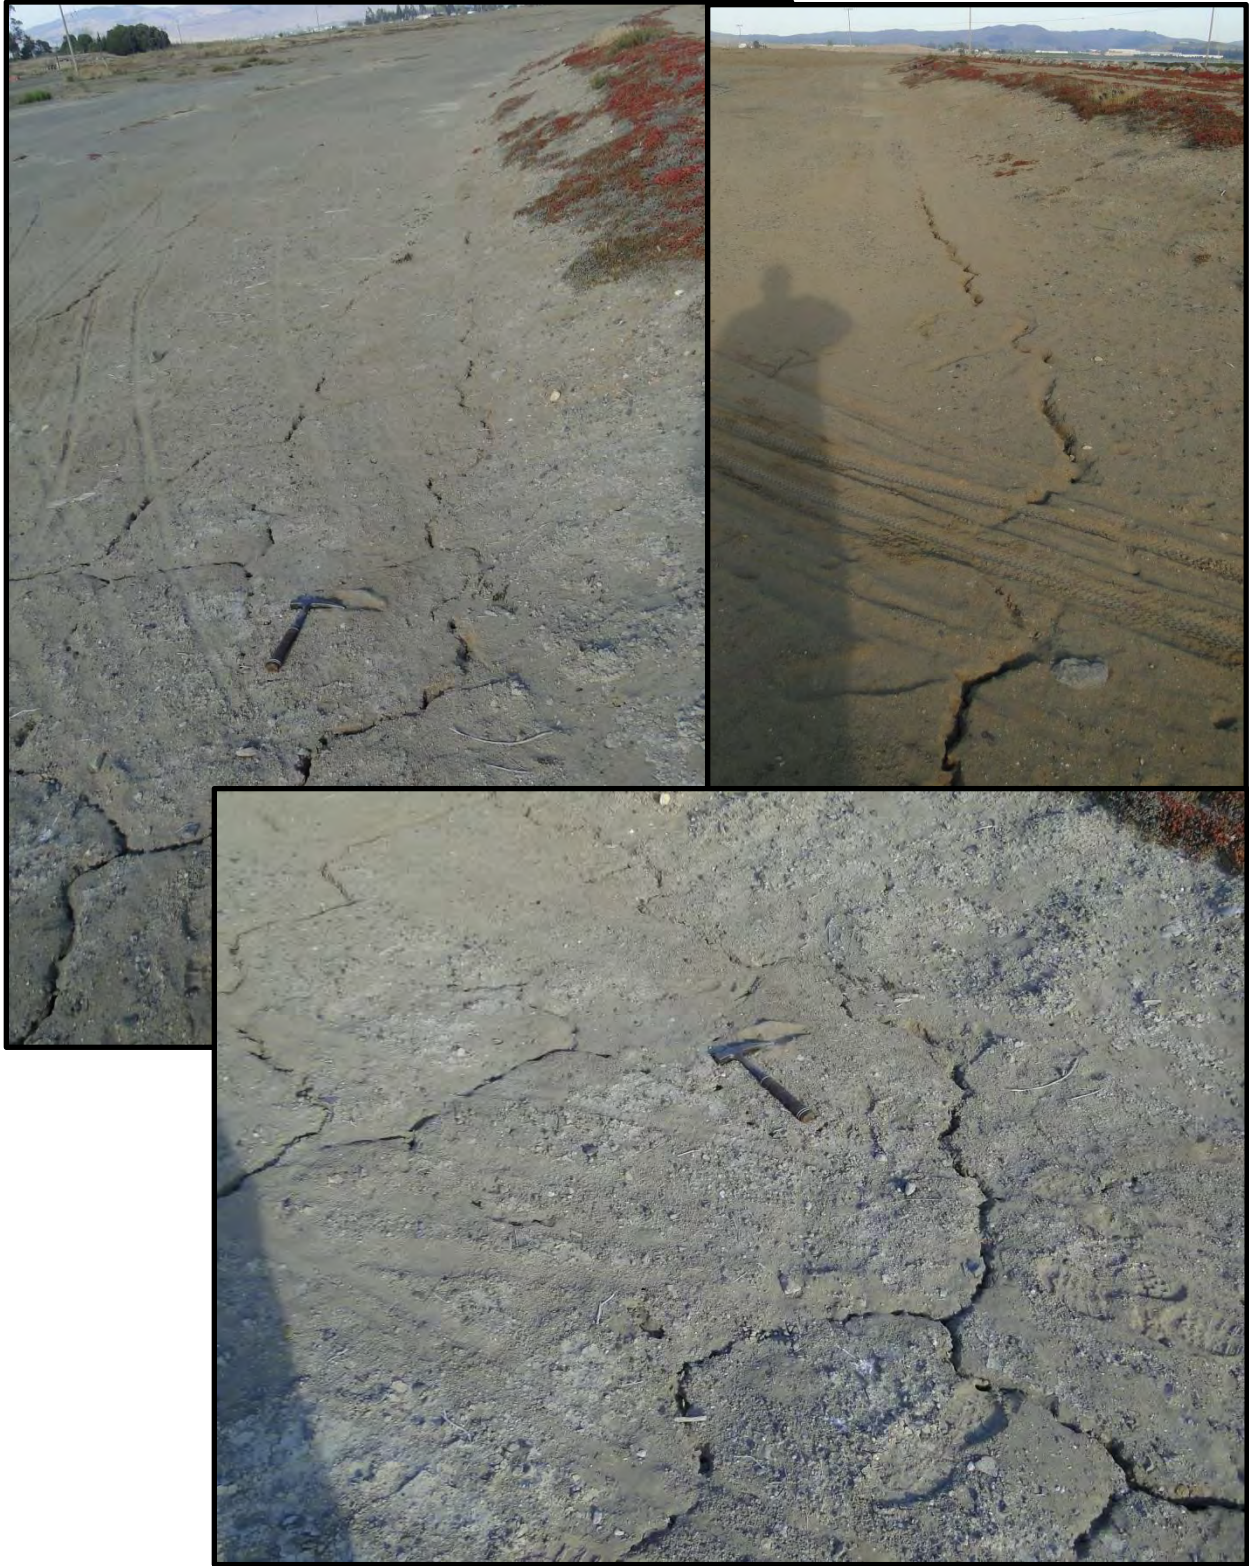
Along the western edge of Green Island along mud flats east of the left (east) bank of the Napa River and south of the epicenter there are small retaining dikes that previously retained brine waters in salt ponds (see location in Figure F-20). The area has largely been converted into an environmental restoration and recreation area, but many of the retaining ponds for the salt ponds remain in place. No significant damage was observed by the GEER team for the majority of the dikes visited on foot, and no damage was observed during the aerial reconnaissance. However, near the very western tip of the island, approximately 100 meters of longitudinal cracking was observed near the landside toe of the dike. The largest cracks were approximately 2½ centimeters in width, and, while longitudinal, appeared to have enlarged from shrinkage cracks. In addition, there appeared to be sandy ejecta along the cracks, but this was not definitive as the observations were made on September 4th, approximately 10 days after the earthquake (see Figure F-23).

Figure F-23: Photographs of longitudinal cracking and apparent ejecta along landside toe of salt pond retaining dike on western edge of Green Island south of the epicenter [NSF-GEER; Napa, CA; N38.201 W 122.302; Harder, L. F.; 09/04/14]
