3 SURFACE FAULT RUPTURE ASSOCIATED WITH THE M6.0 SOUTH NAPA EARTHQUAKE OF AUGUST 24, 2014

Tim Dawson (CGS), Keith Kelson (USACE), John Wesling (OMR), Ken Hudnut (USGS), and Dan Ponti (USGS)¹

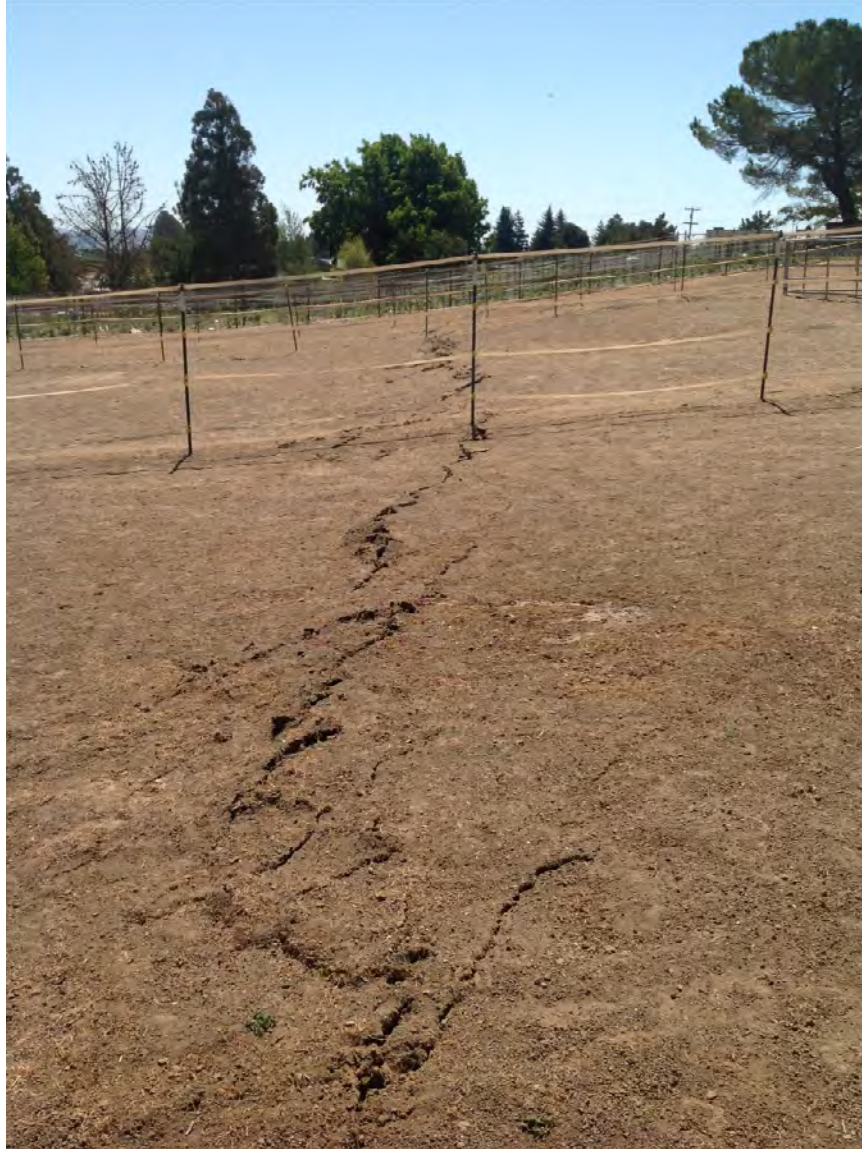
Figure 3-5. Left-stepping pattern of surface fault rupture crossing horse corral near Cuttings Wharf Road. Note variation in width of zone. Offset at this location was initial on the order of ~10 - 20 cm, although offsets later grew due to afterslip. [NSF-GEER; GPS: 38.2555°, -122.3270°; 08/24/2014]

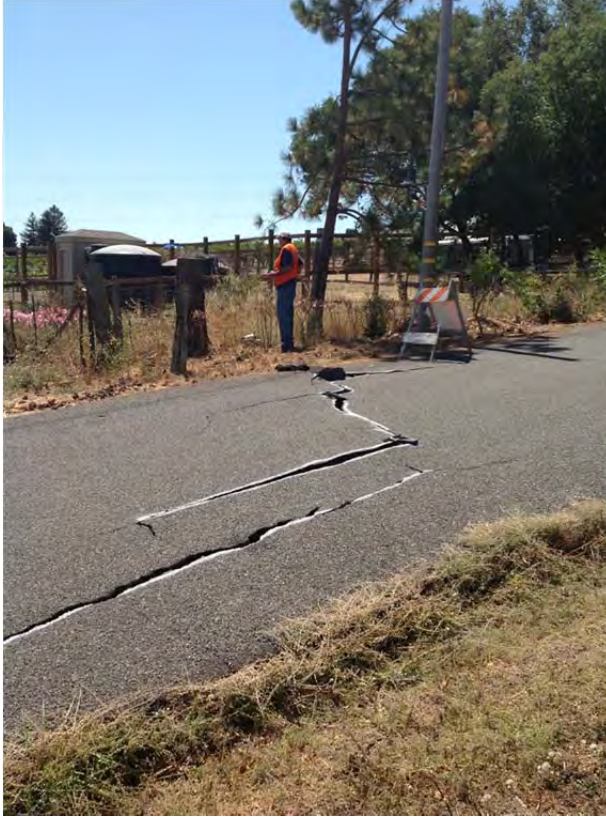
Displacements along the surface rupture are predominantly right-lateral and amounts are variable along strike, both in the near-field (on the order of tens of meters perpendicular to strike), as well as along the entire length of the rupture, as shown on [Figure 3-4](#). The rupture is highly variable in terms of expression at the surface, but is typically expressed as a zone of *en echelon* left-stepping fractures ([Figure 3-5](#)) varying from less than a meter in width to tens of meters, or more, wide. The expression of surface rupture varies where the fault crosses paved roads, in some cases being complex, with some fractures oriented nearly orthogonal to the orientation of the fault trace ([Figures 3-6a-b](#)) and others oriented along strike.

Figure 3-6a-b. Photos showing complexity of surface rupture as it crosses paved roads: 3-6a shows a broad zone, with fractures oriented nearly orthogonal to trend of fault at Middle Avenue [NSF-GEER; GPS: 38.2517°, -122.3251°; 08/24/2014]. The expression in 3-6b is narrower and fault-parallel, located where fault crosses Los Carneros Ave [NSF-GEER; GPS: 38.2431°, -122.3207°; 08/24/2014].

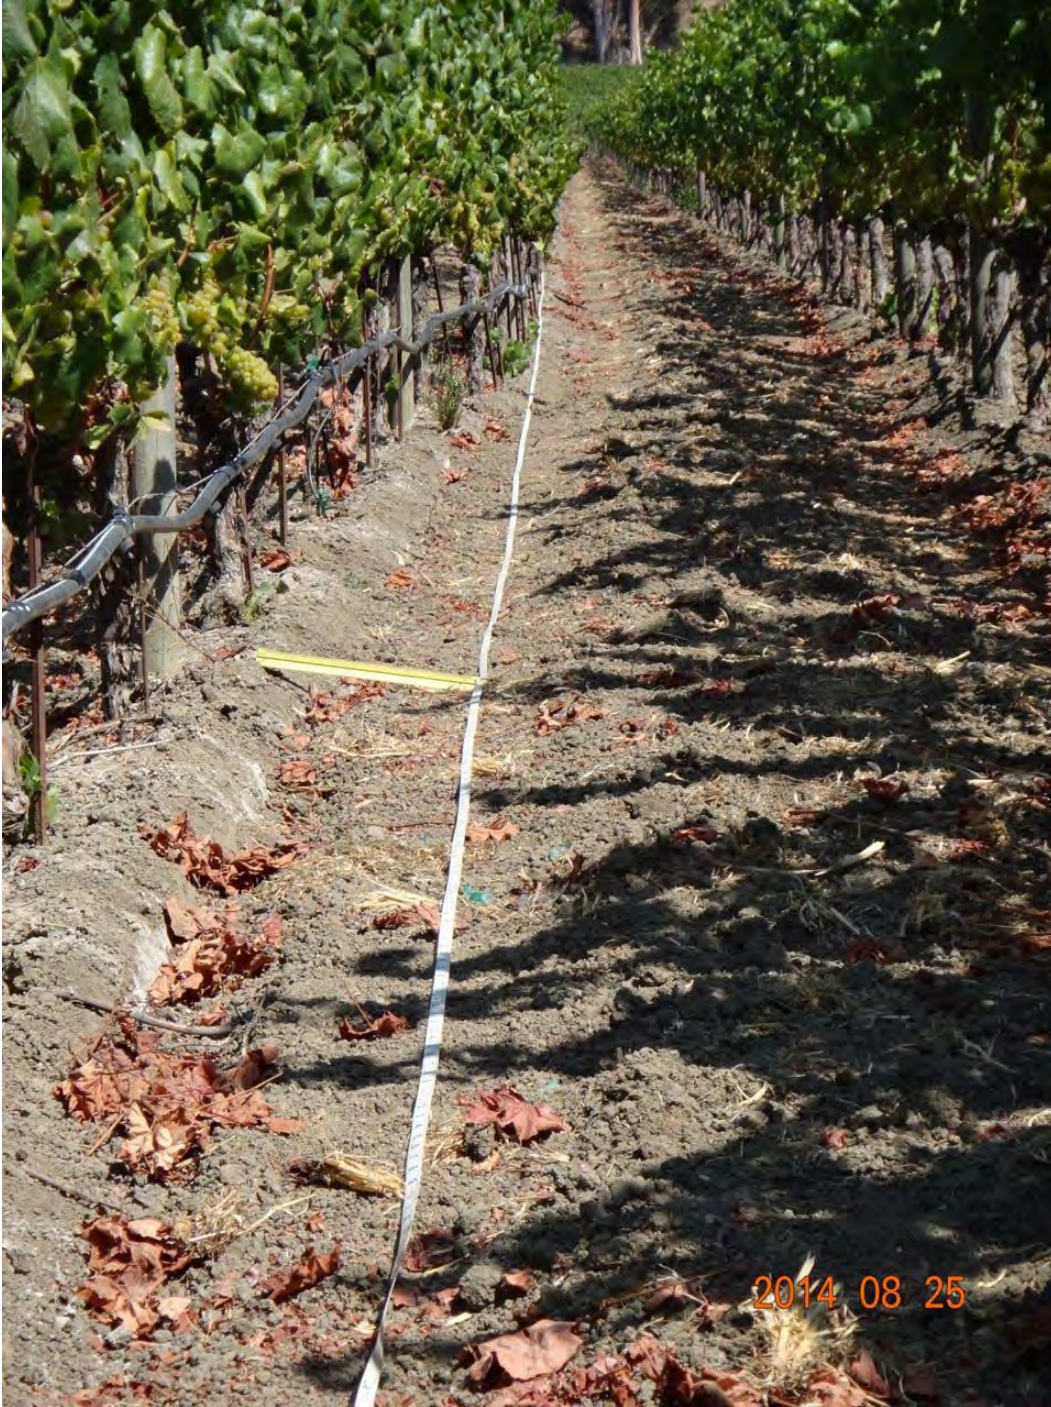
Figure 3-7. Surface fault rupture at northern part of Clos du Val Vineyard near 2121 Buhman Avenue (6.7 km NW of epicenter), showing measurement alignment along azimuth 090. Yellow engineer's scale shows measurement of 40 to 45 cm from base of thick wooden post; tape placed along southern edge of wooden posts aligned on east side of fault zone. [NSF-GEER; GPS 38.2776, -122.3377; 08/25/14: kik027]

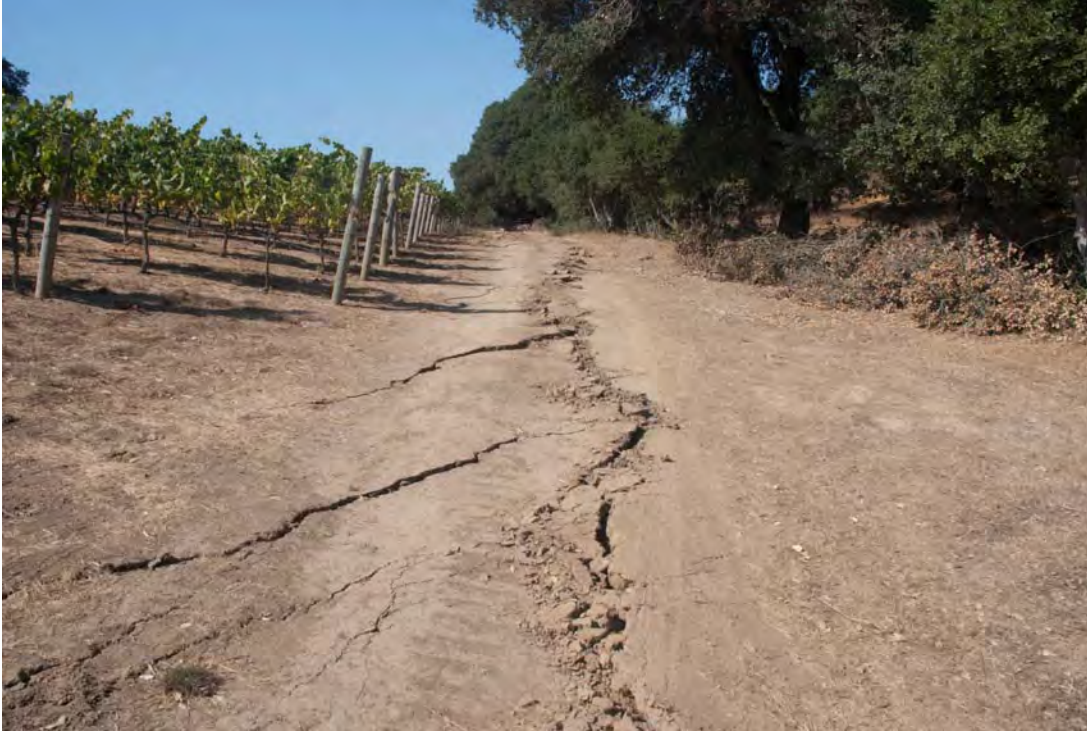
Near the intersection between Buhman and Congress Valley Roads, surface rupture has not been completely mapped, although surface rupture in the area has been inferred based on a lineament interpreted from the UAVSAR. To the north the rupture is strongly expressed on the Buhman Ranch Property, west of Buhman Road ([Figure 3-8](#)), with right-lateral offsets in the range of 40-45 cm.

Figure 3-8. Rupture west of Buhman Avenue. Right-lateral displacement was on the order of 40 cm, with a small amount (~12 cm) of up-on-the-west vertical displacement. [NSF-GEER; GPS: 38.2924°, -122.3432°; 08/25/2014]

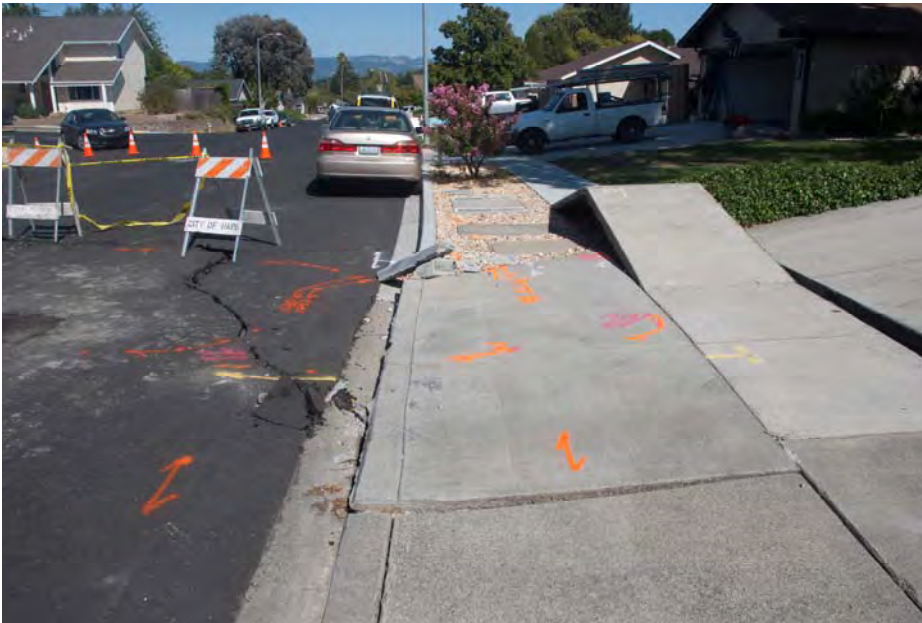
Within Browns Valley, fault offset is in the range of 10 – 20 cm ([Figure 3-3](#)), as the fault steps to the east. The Browns Valley area is developed, consisting largely of residential units, and the fault cuts numerous cultural features including roads, sidewalks and residential structures ([Figures 3-9](#)). At the latitude of Browns Valley Road, a subparallel, northwest trending fault (herein referred to as the Eastern Strand) is approximately 500 meters east of the principal rupture (labeled Western Strand on [Figure 3-2](#)), and has a subordinate amount of right-lateral displacement, typically 2-8 cm ([Figure 3-10](#)). North of Browns Valley, the eastern and western strands merge in the vicinity of the Hendry Winery, located south of Alston Park. The northern end of the field-verified rupture has been traced as far as the northern boundary of Alston Park ([Figure 3-11](#)), and likely continues for a least several kilometers more, which will be confirmed as field teams continue to map the rupture.

Figure 3-9. Surface rupture disrupting sidewalks and curb on Twin Oaks Drive in Napa. Right-lateral displacement was on the order of 10 – 20 cm at this location [NSF-GEER; GPS 38.3024°, -122.3438°; 08/26/2014]

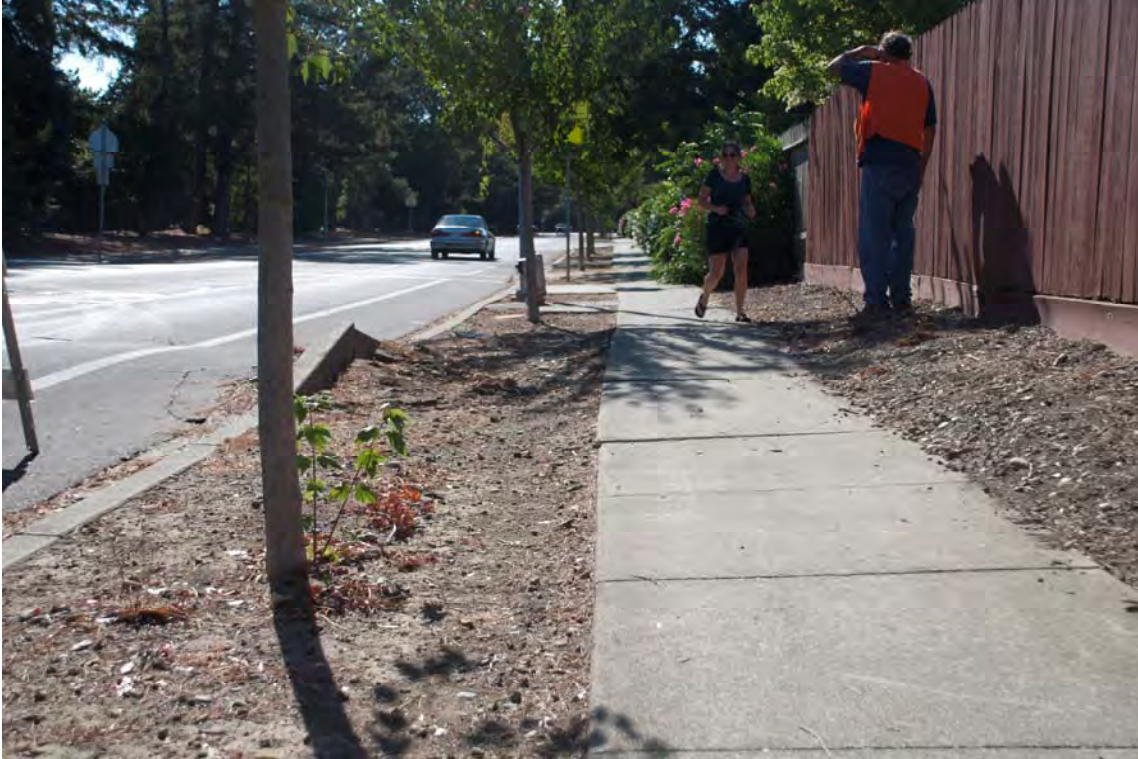
Figure 3-10. Surface rupture forming moletrack on asphalt road, tented concrete curb and displaced sidewalk in right-lateral sense on Partrick Road along eastern strand of the surface rupture. Right-lateral offset is on the order of between 5 - 10 cm. [NSF-GEER; GPS 38.3069°, -122.3374°; 08/24/2014]

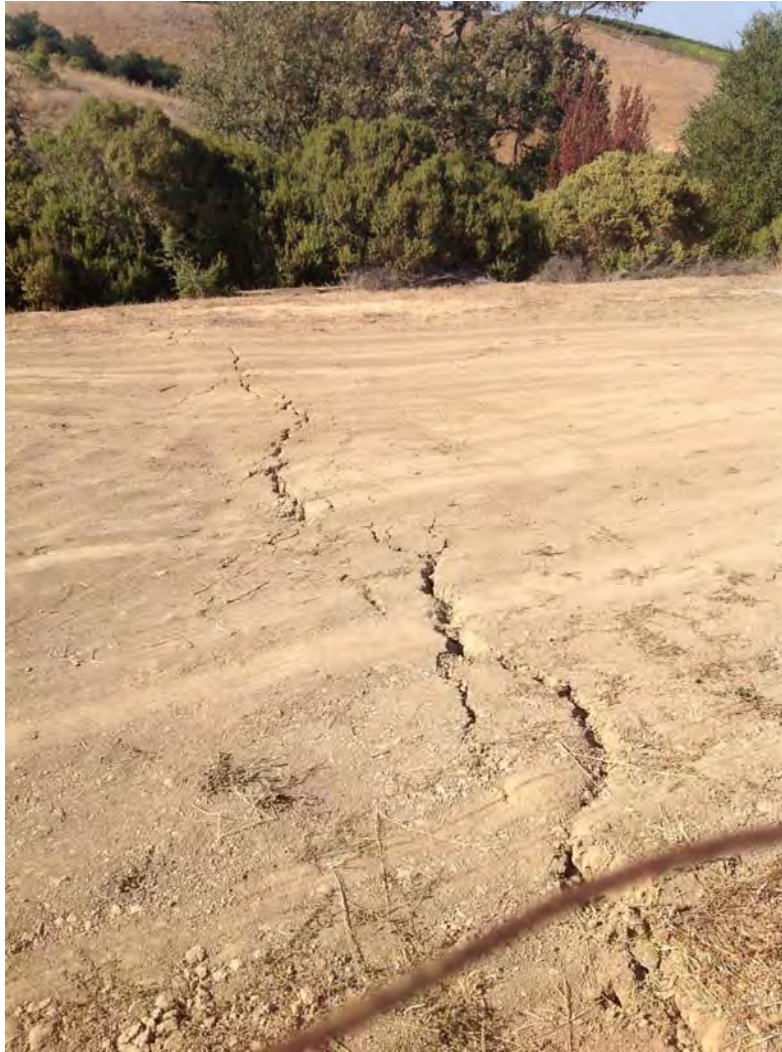
Figure 3-11. Surface rupture near northern boundary of Alston Park. Note left-stepping pattern of extensional cracking, suggestive of right-lateral displacement, which was about 4-5 cm at this location. [NSF-GEER; GPS 38.3263°, -122.3459°; 09/01/2014]

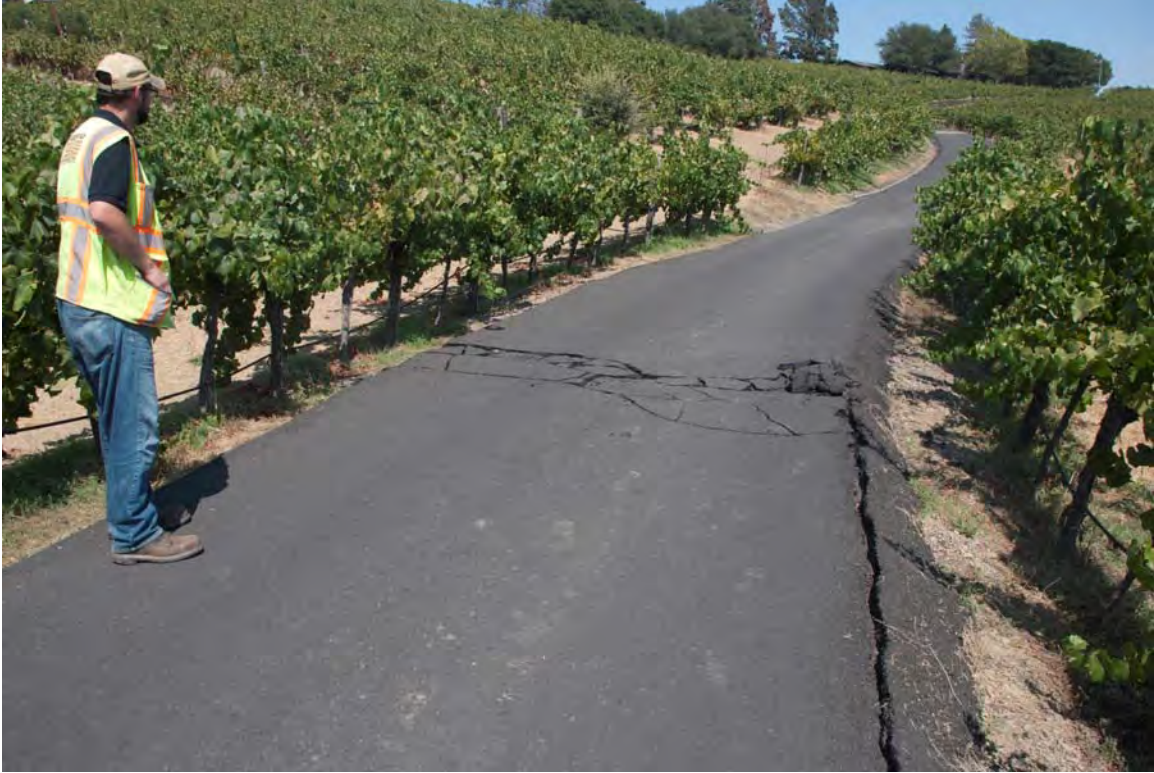
Figure 3-12. Shattering of asphalt along southern part of eastern strand on driveway near Thompson Road. Rupture was difficult to see in soil on either side of driveway, but obvious on asphalt. Right-lateral offsets were around 5 cm in this area, although difficult to measure at this location [GEER-NSF; GPS: 38.2866°, -122.3259°; 8/25/2014].

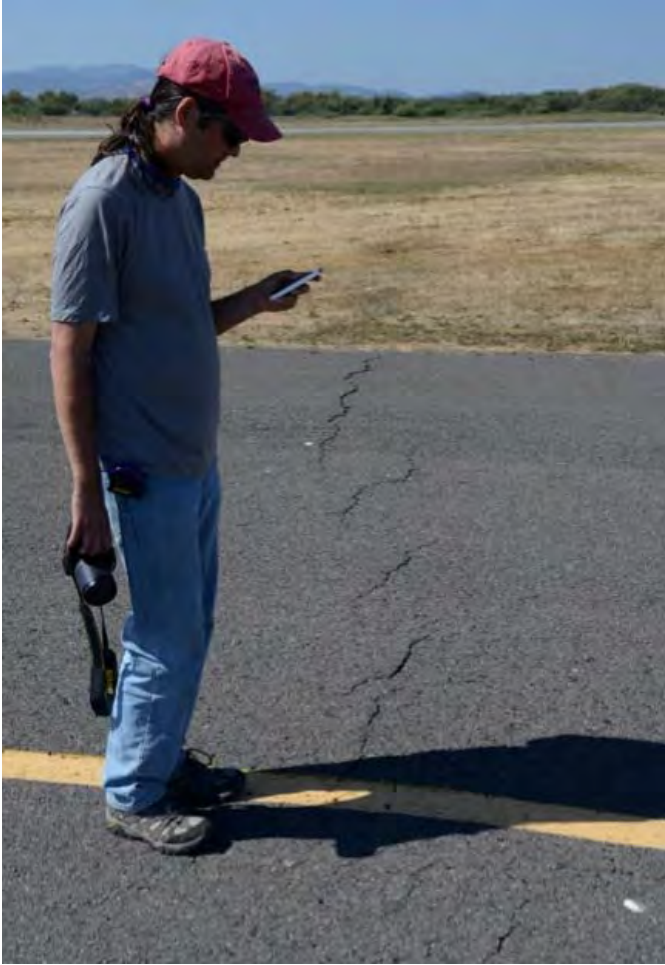
South of Cuttings Wharf, previously mapped traces of the West Napa fault step about 2 km to the east, and trend from the Napa County Airport to the southeast through American Canyon. Minor surface rupture and offset was observed on Taxiways “C” and “E” at the Napa County Airport, expressed as warping and left-stepping, *en echelon* cracking in the asphalt, suggestive of right-lateral movement (Figure 3-13). The surface rupture is coincident with the mapped trace of the West Napa fault (Bryant, 2000; Wesling and Hanson, 2008), which is expressed at the airport as a low scarp and is visible in aerial imagery as a vegetation lineament adjacent to the taxiway (Figure 3-13). At the time of this writing, the origin of the airport deformation is not known, and could be related to either surface rupture or triggered slip. On August 27, 2014, evidence of surface rupture or triggered slip was not present across Green Island Road, or across features south of Green Island Road. An aerial overflight on August 27 showed an absence of perceptible ground cracking along the eastern banks of the Napa River, south of Green Island Road. Subsequent analysis of the UAVSAR data suggested the presence of possible surface deformation in this area, but this has not yet been field checked.

Figure 3-13. Left-stepping en-echelon fractures without measurable displacement but of likely tectonic origin observed crossing only one of several runways at the Napa County Airport and located on the previously mapped section of the West Napa fault. Note vegetation lineament in grass, on trend with cracks on taxiway. [NSF-GEER; GPS: 38.2127°, -122.2814°; 8/27/2014].

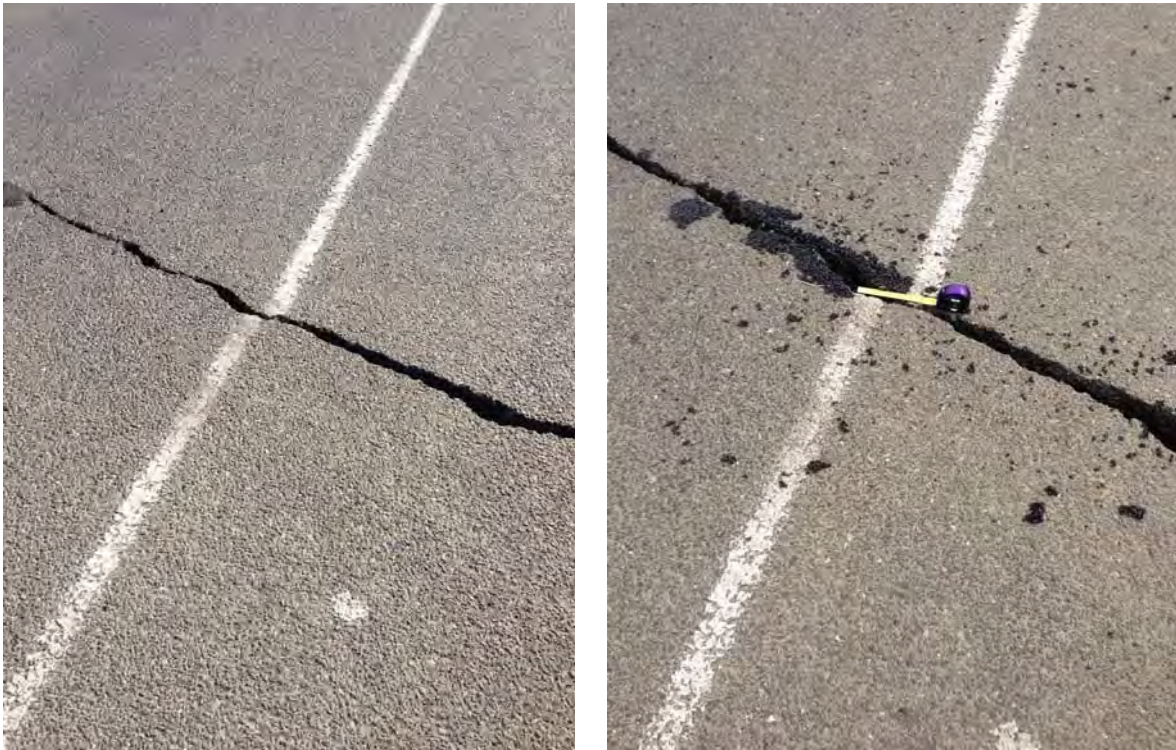
Afterslip was documented within the first 24 hours and was expressed as the continued development of the rupture on the ground and the growth through time of observed offsets on roads and other cultural features (Figure 3-14). The USGS was able to establish four alignment arrays across the fault in order to monitor afterslip. Although results are not yet available, based on episodic field observations, afterslip appears to be common in the primary, 7-km-long epicentral part of the rupture. Little to no offset was observed within a few hours of the main shock at some locations that exhibited as much as 20 cm of right-lateral slip 48 hours after the mainshock. From qualitative observations made by the field teams, the majority of afterslip occurred within about 36 to 48 hours of the main shock, and the amount of afterslip was probably in the range of about 30 - 60% of the total slip. Additional time-series analyses of imagery and digital topographic data, using repeat mobile LiDAR, campaign and continuous GPS data acquired by the USGS, may provide information to define the pattern, timing, and amount of afterslip along the various sections of the surface rupture.

Figure 3-14. Offset painted stripe on the side of Highway 12 is shown by these two photos taken approximately 24 hours apart on Aug. 24, 2014 and Aug. 25, 2014. The fracture opening is narrower and the paint stripe offset by a lesser amount on the day of the earthquake. During the ensuing day, the fracture grew and the offset of the paint stripe increased. The increase of offset along the surface rupture of an earthquake has been observed in previous earthquakes. What is different in the case of the South Napa earthquake is that in this case, afterslip in the first day after the earthquake was rapid, but then afterslip appeared to stop in the following days. In the southern half of the surface rupture zone, the initial evidence for rapid afterslip was pronounced, whereas in the northern portion there was little to no afterslip [NSF-GEER; GPS: 38.2559°, -122.3272°; 08/24/2014 and 08/24/2014.
