4 EFFECTS OF SURFACE FAULT RUPTURE ON INFRASTRUCTURE

The preliminary reconnaissance efforts performed by GEER on August 24, 2014 (the day of the M6 South Napa earthquake) noted significant damage to infrastructure due to ground rupture in the areas northwest of the earthquake epicenter. While infrastructural damage in lightly populated areas was limited to roadways, boundary barriers or isolated structures, damage in heavily populated areas was extensive. The West Napa residential neighborhoods in the vicinity of Browns Valley Road and Buhman Avenue, herein referred to as the Browns Valley area (BVA), were observed to have been particularly affected by ground rupturing and intense seismic shaking. Located approximately 10 km north of the epicenter, the BVA experienced what was suspected to be surface fault rupture from Oak Rock Ln (southern end of this segment) to Redwood Rd (northern end), and west of Browns Valley Rd. and Buhman Rd. Although many residents in close proximity of the fault experienced significant damage to personal property from intense ground shaking, most of the structural damage was observed in conjunction with surface fault rupture. This section summarizes the

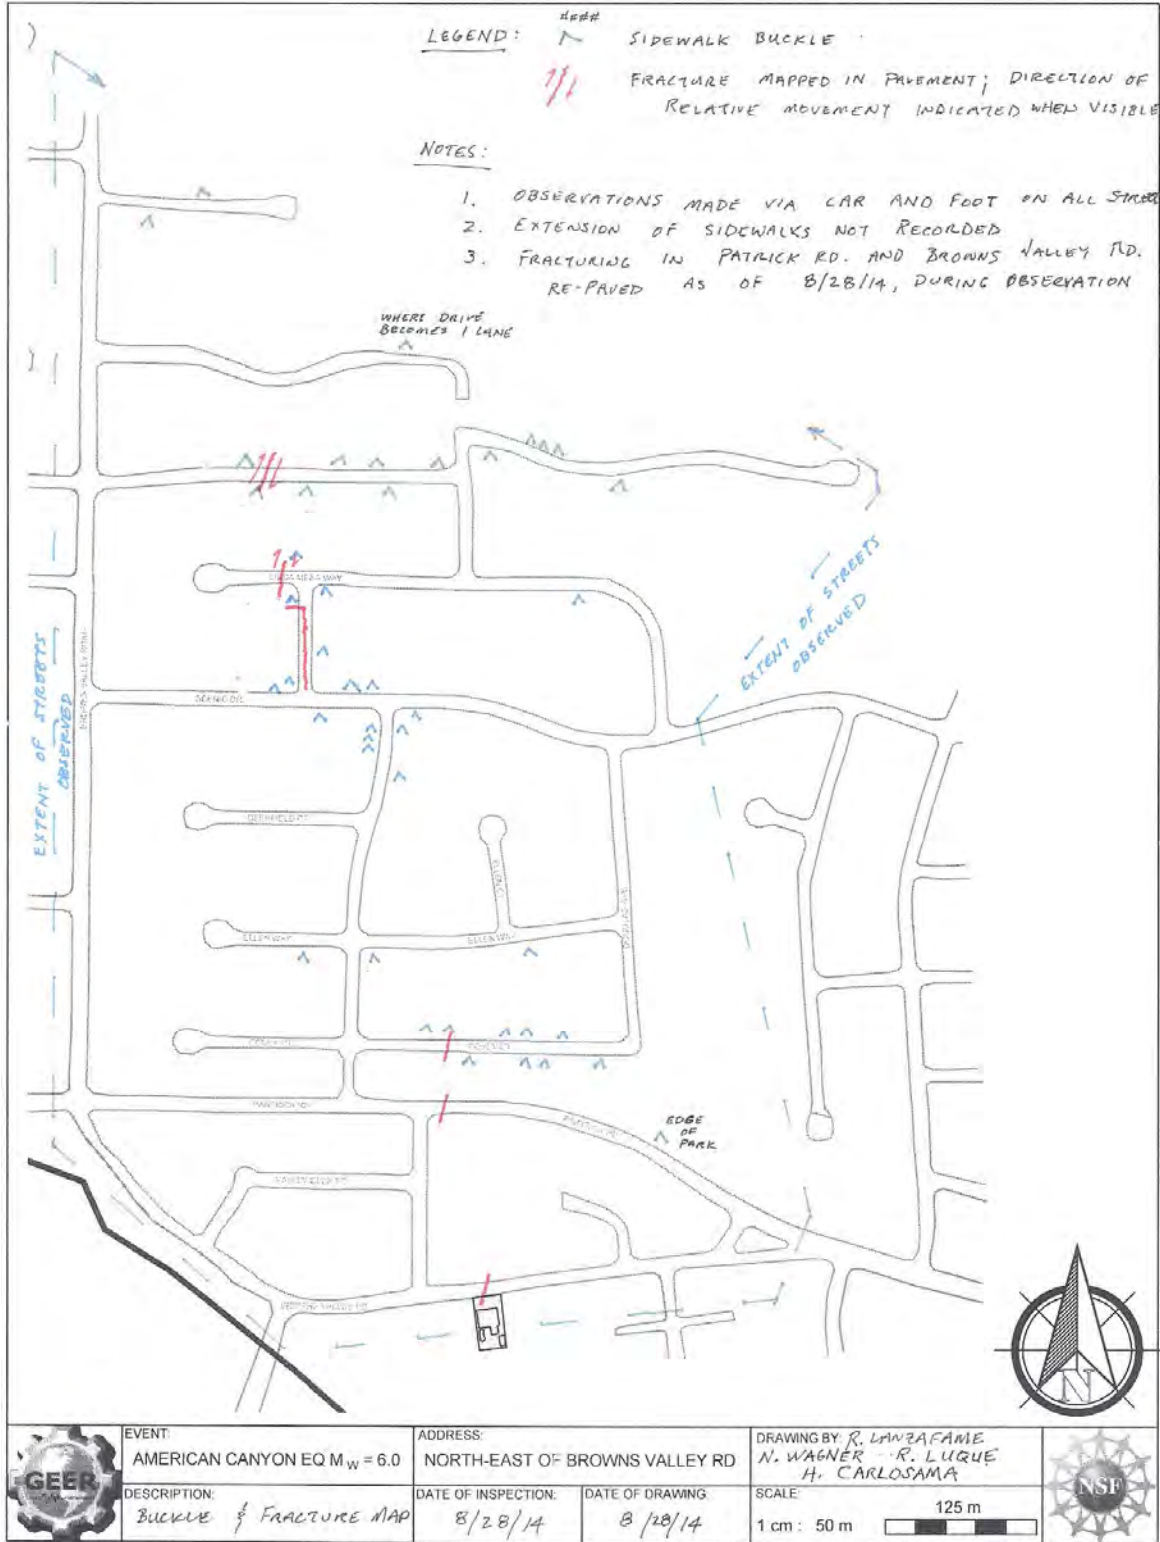
Figure 4.2 Map of surficial damage in the Browns Valley Area 2, Northeast of Browns Valley. [NSF-GEER; H. Carlosama, R. Luque, R. Lanzafame, N. Wagner; 09/12/2014]

was conducted on foot along roads and sidewalks and consisted of locating the general characteristics of ruptured asphalt pavement and buckled sidewalks. Asphalt cracking was drawn at approximate scale and the residential properties that were entered were identified. In some cases the asphalt pavement had already been repaired by the date of the reconnaissance.

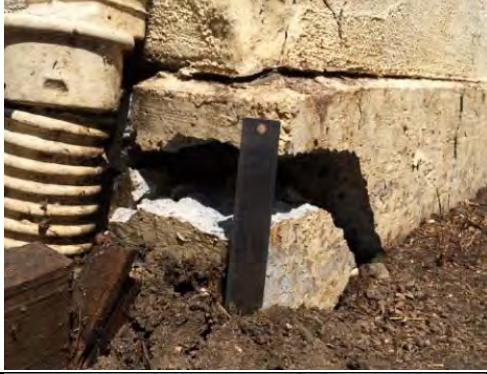
<p>Cracking of concrete and masonry structures</p>	
<p>Foundations</p> <p>Primarily consisted of cracking of reinforced concrete strip footings or grade beams; visible from outside residence or within crawlspace.</p> <p>Photo reference: [NSF-GEER; N 38.3040 W 122.3430; 08/25/14 13:47]</p>

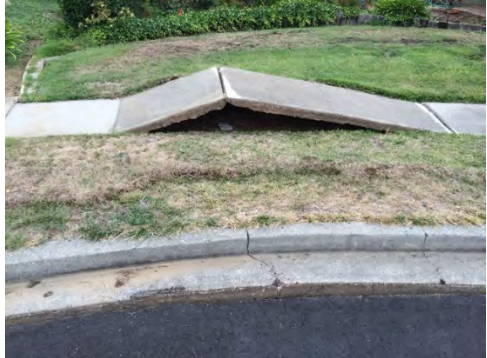
<p>Concrete (non-foundation)</p> <p>Typically consisted of new fractures within garage concrete slabs, driveways, patio slabs, planter edges and other concrete structures, which were sometimes reinforced.</p> <p>Photo reference: [NSF-GEER; N 38.3024 W 122.3436; 08/27/14 11:33]</p>	 
<p>Sidewalk/curb buckling</p> <p>Buckling of sidewalks, curbs or other linear concrete structures due to compressive forces during fault rupture displacement or seismic shaking.</p> <p>Photo reference: [NSF-GEER; N 38.3018 W 122.3439; 08/25/14 10:38]</p>

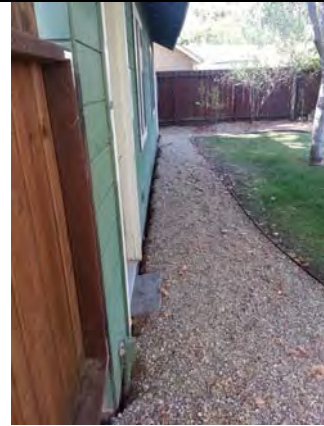
Settlement

Detached garage on strip footings and slab-on-grade. Structure settled west (i.e., right) approximately 5 cm due to surface fault rupture along edge of footing.

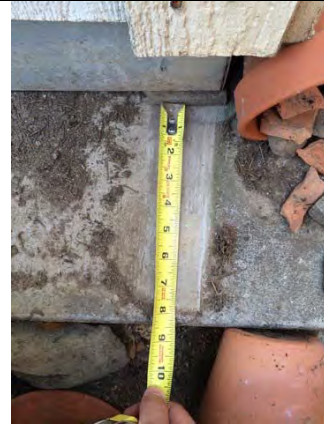
Light structures

Displacement of light structures was measured where evidence of movement provided confirmation of displacement length.

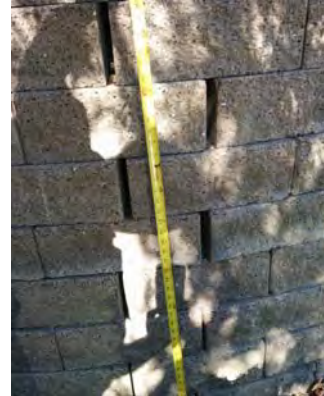
Retaining walls

Separation of masonry blocks due to surface displacement in 1.5 - m tall landscape retaining wall.

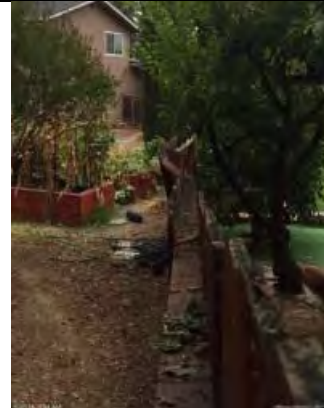
Compression of fences

Fences were compressed in several cases; in one case a local strain measurement was obtained by measuring before and after length.

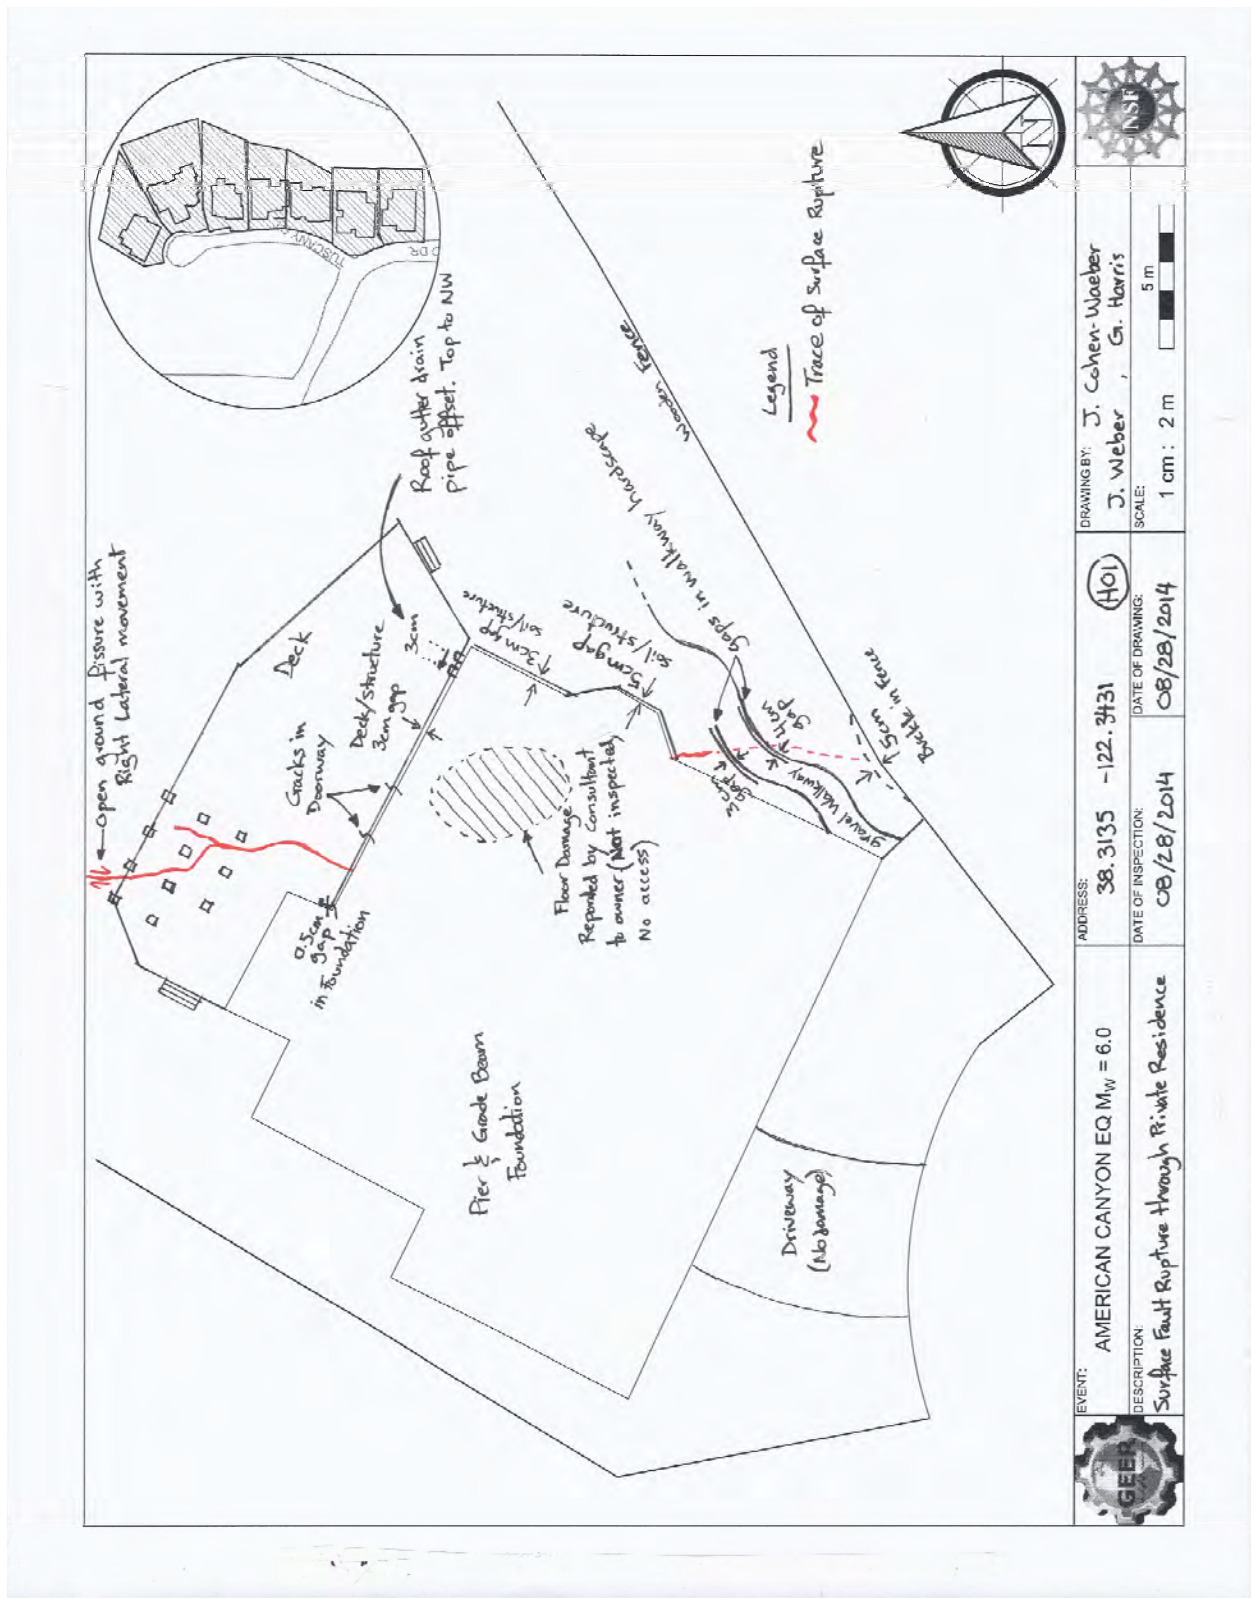
Figure 4.3 Map of Structural Performance, Northwest Browns Valley.
 [NSF-GEER; J.Cohen-Waeber, J. Weber, G. Harris; 08/28/2014]

In the case of H01, the site's geotechnical consultant allowed access to the property where surface rupture was observed to cross through the NE corner of the residence. Surface rupture was observed from a buckle in the wooden fence along the property's southern boundary, northward through displaced hardscape and under the structure. The rupture surface re-appeared along the north end of the residence from beneath the structure as a 3 cm open soil fissure with approximately 1 cm of right lateral displacement. Up to 5 cm of displacement was observed in the NE corner of the structure from gaps between the perimeter foundation and surrounding landscape. Damage to the northern external façade of the structure included approximately 0.5 cm cracks extending from the corners of the door frame, a roof beam apparently detached from the structure's wall, and a cracked foundation (approximately 0.5 cm). The consultant also reported damage to the floor boards within the structure which could be seen from the exterior though access to the structure was not possible to determine the cause.

The performance of pier foundations under surface fault rupture conditions is an important question. Of the 8 investigated properties constructed on pier and grade beam foundations, the property at location H01 experienced the most damage. The surface rupture trace appears to have sheared the NE corner of the structure by passing between piers. Though it was not possible to enter the home, significant foundation and structural damage was visible from the exterior.

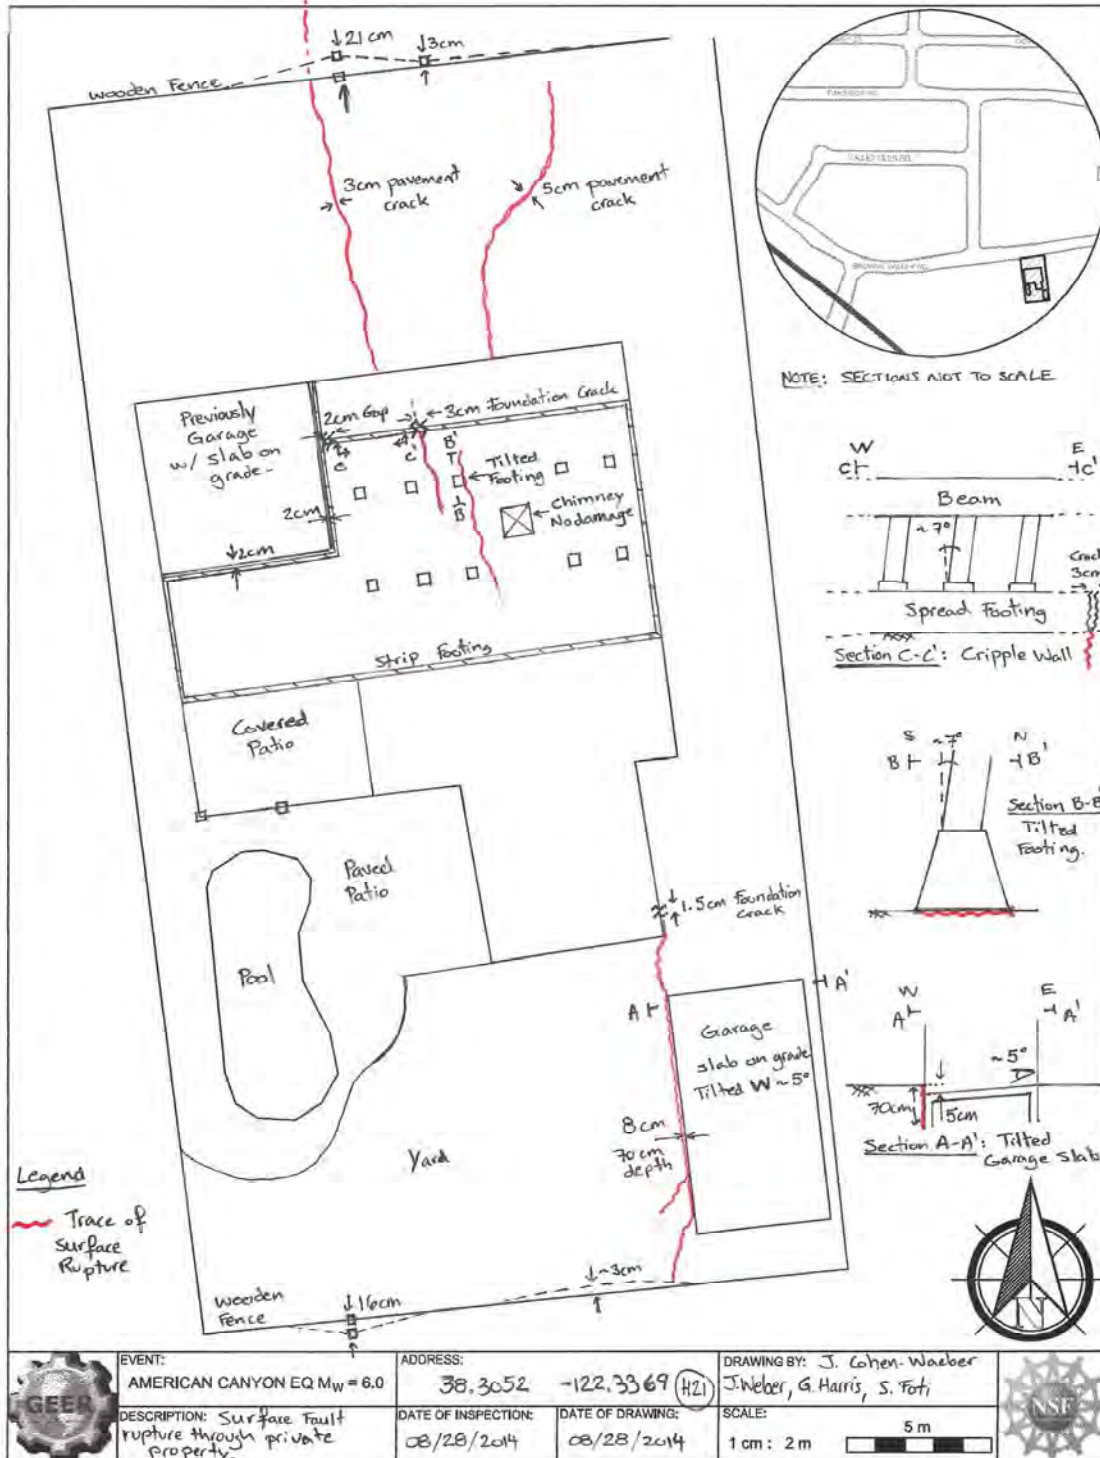
Figure 4.3 Map of Structural Performance, Northwest Browns Valley. [NSF-GEER; J.Cohen-Waeber, J. Weber, G. Harris; 08/28/2014]

In a similar fashion to H01, the residence at H21 experienced significant damage due to the surface rupture progressing directly through the structure. Along the southeast end of the property, an open fissure 8 cm wide and up to 70 cm deep cut adjacent to the West wall of a detached garage, causing the slab-on-grade building to tilt slightly to the West. The rupture was further pronounced to the North in the building crawl space by large open soil fissures. A 3 cm wide crack and several small gaps within the northern most perimeter strip footing were clearly a result of the ground rupture, also causing the structure's cripple wall to rack approximately 7 degrees to the East. North of the residence, the surface rupture was further pronounced through the paved driveway. Additionally, both wooden fences along the southern and northern property boundaries were buckled, with displaced fence posts up to 16 and 21 cm, respectively.
