5 GROUND DEFORMATION IN THE VERY NEAR FAULT REGION

5.1 Introduction

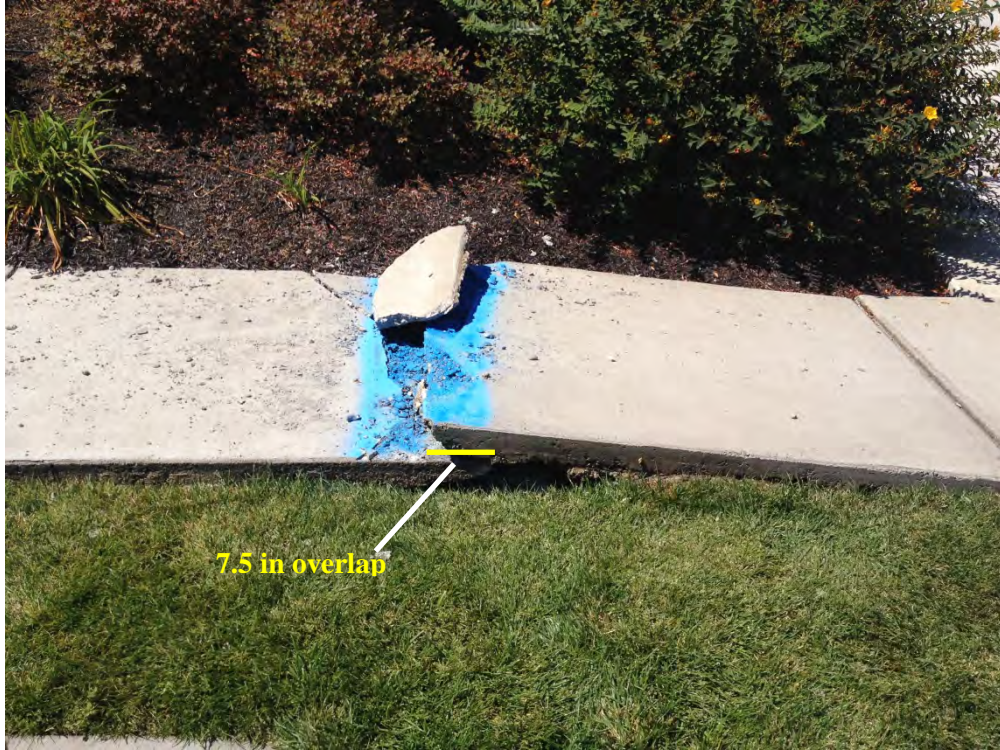
In some locations, compression in the sidewalk pavement manifested as an overlap instead of a buckled section. In such cases the overlap was measured and recorded as the compression in the zone. The measurement for an overlapping compression zone is shown in Figure 5.4 below. In cases where both gaps and overlaps were observed, the gaps were subtracted from the overlap measurement and this value was recorded as the compression in the zone. The measurement for an overlapping compression zone with a gap is shown in Figure 5.5 below.

Figure 5.4: Measuring an overlapped compression zone in sidewalk pavement [NSF-GEER; N 38.3065 W 122.3454; 8/28/2014 14:00]

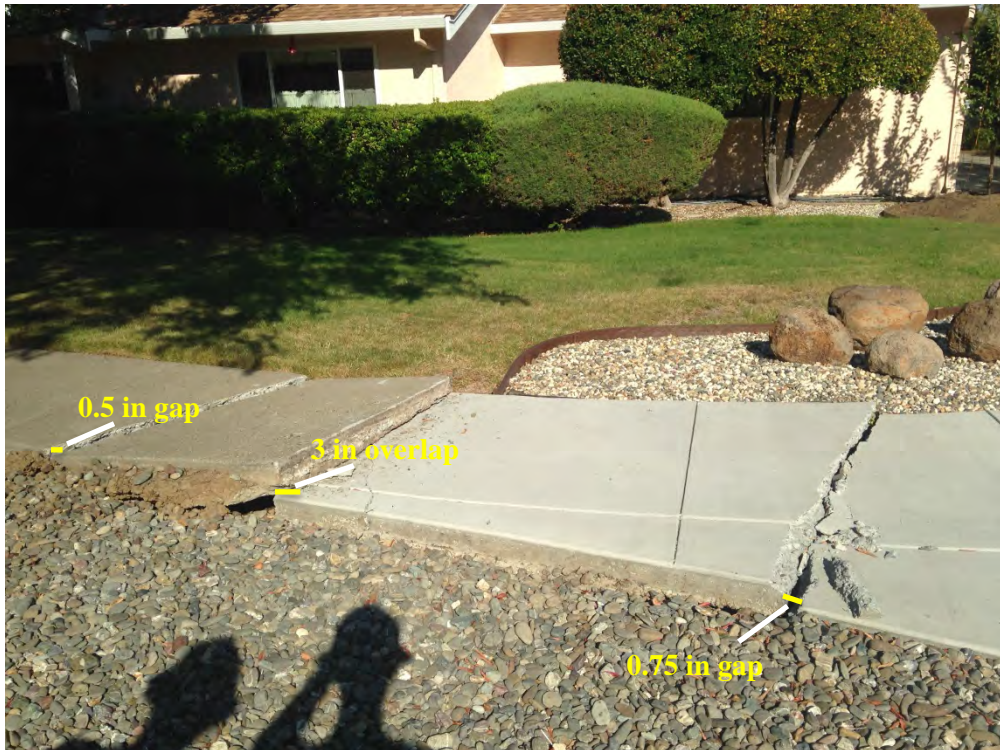
Figure 5.5: Measuring an overlapped compression zone with a gap in sidewalk pavement [NSF-GEER; N 38.3047 W 122.3459; 8/26/2014 16:52]

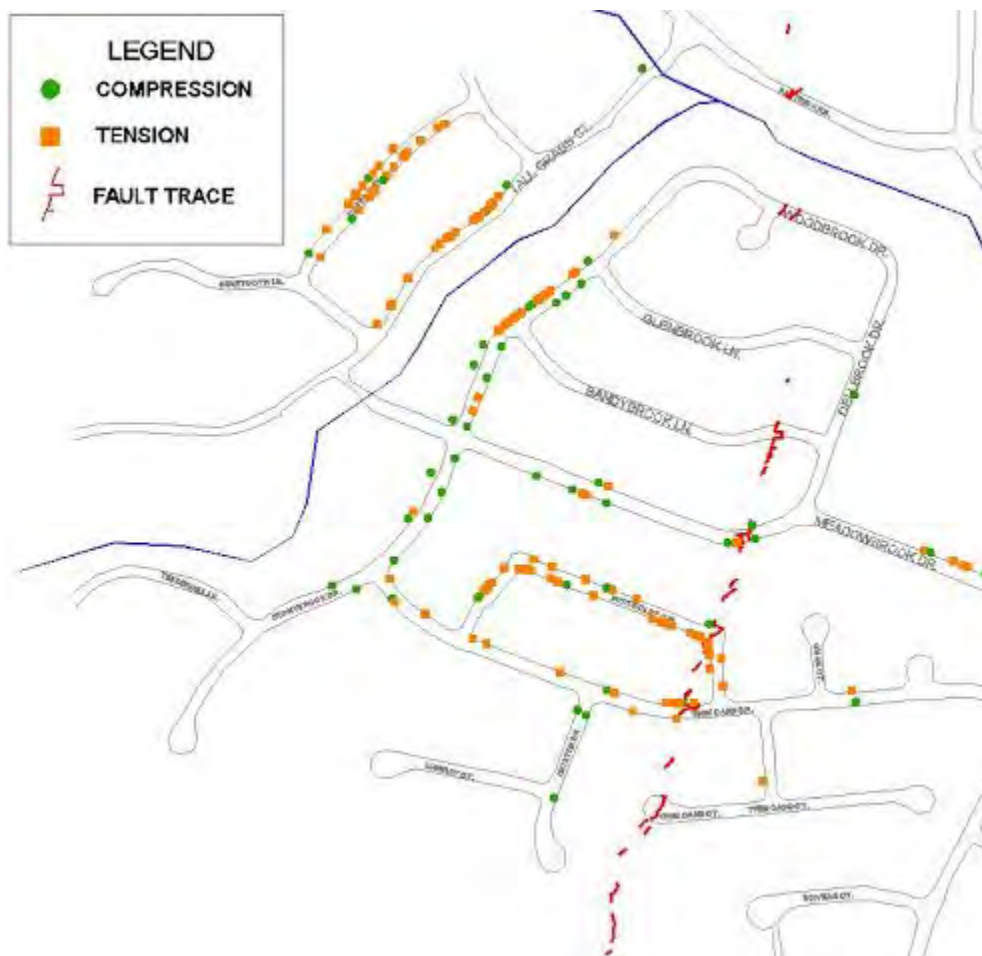
Ground strain was computed over each 25 meter segment by adding the measured extension cracks (positive) and compression zones (negative) to the measured segment length to obtain the original segment length. This became the “gage length” of the strain measurement. Then, the difference between the measured and the estimated original length was divided by the estimated original length to obtain the decimal strain, which was converted to a percent strain. Additionally, the average strain for each sidewalk section as a whole was computed in a similar manner by considering all measured extension cracks and compression zones added to the total length of the segments of a single sidewalk. The results of the average strain over each total sidewalk are shown in Table 5.1 and Table 5.2 below for sidewalks parallel and perpendicular to the fault, respectively. The measurements and computations for individual segments are shown in Appendix D. A schematic showing the approximate location of each extension crack and compression zone is shown in Figure 5.6 below.

Figure 5.6: Observed and measured tension (orange) and compression (green) locations; produced in AutoCAD; [NSF-GEER; Luque, R.; Wagner, N.; processed 9/5/14]

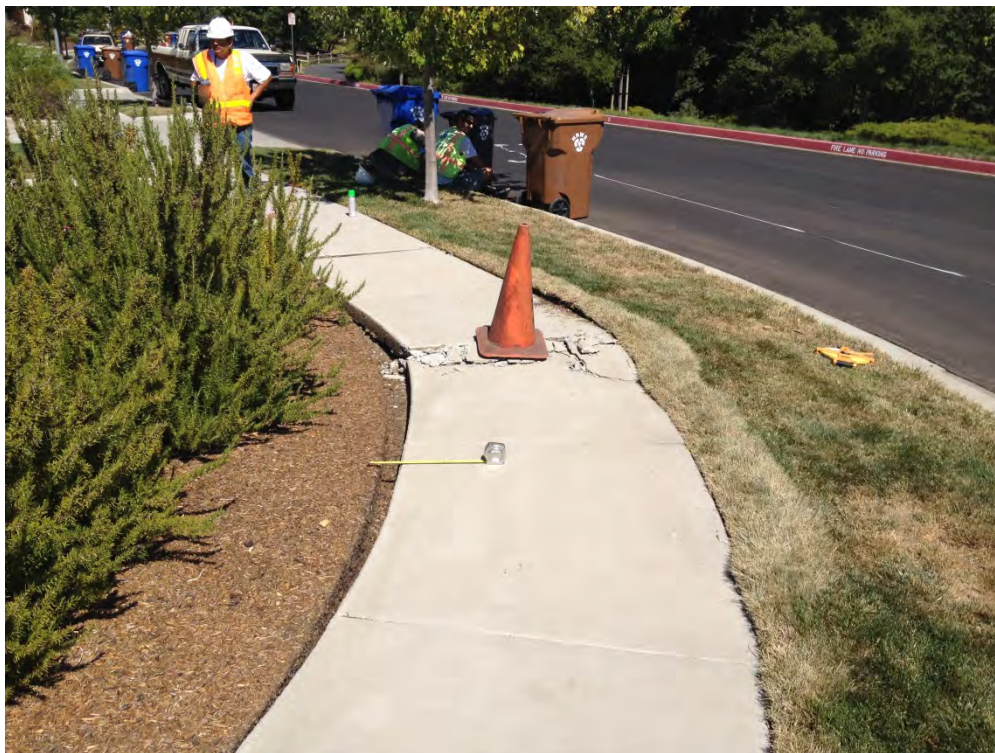
Compression features in the curb strip were observed at various locations adjacent and perpendicular to the sidewalk pavement. Two of the compression features (Figure 5.7 and Figure 5.8) are located across from the creek running parallel to the fault trace through the neighborhood. In these cases the sidewalk pavement moved laterally toward the free face of the creek. Additionally, it was noted that the compression feature in Figure 5.7 occurred at the end of the bend at a corner.

Figure 5.7: Crushed section in pavement parallel to fault with compression features in curb strip perpendicular to fault, across from creek [NSF-GEER; N 38.3055 W 122.3467; 8/28/2014 14:30]

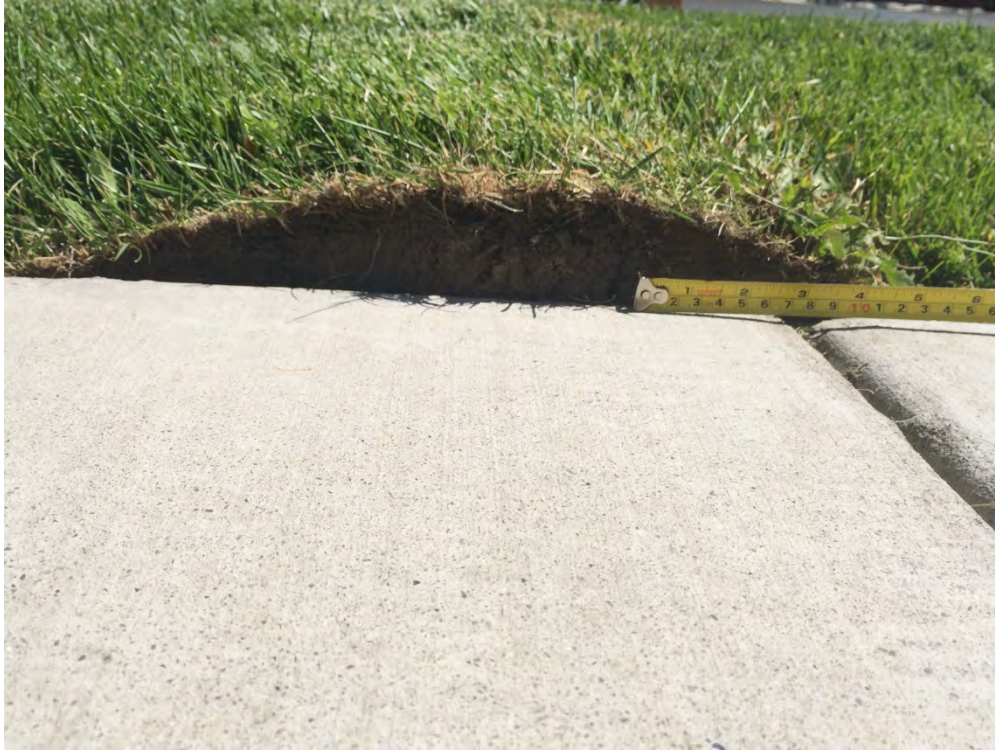
Figure 5.8: Compression feature in curb strip perpendicular to fault, across from creek [NSF-GEER; N 38.3065 W 122.3455; 8/28/2014 13:52]

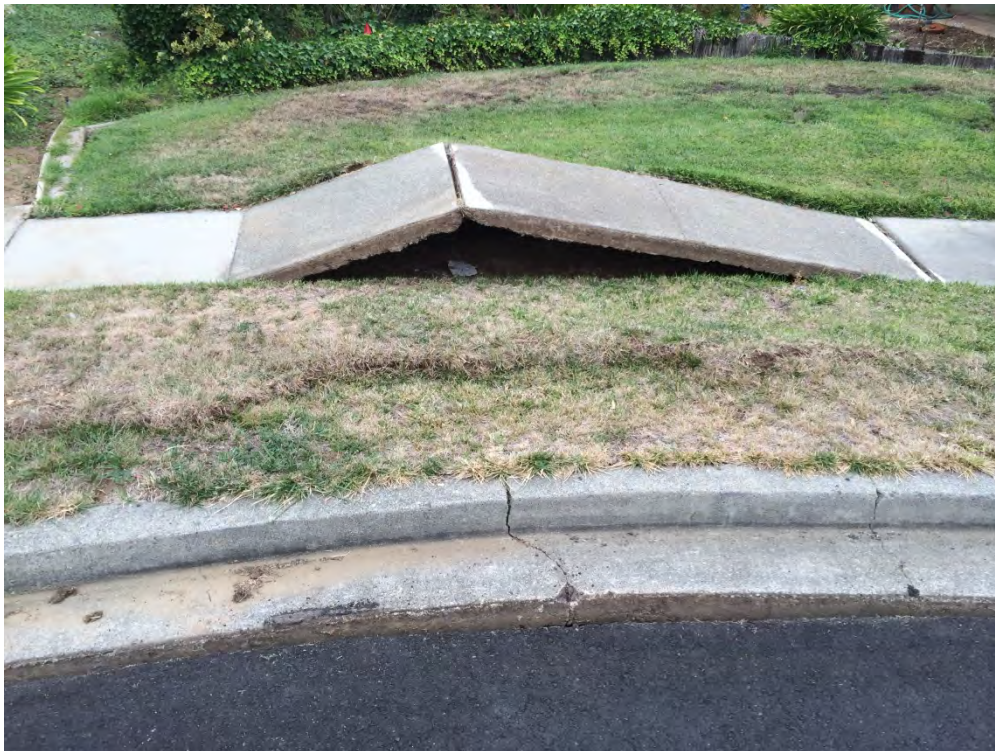
One of the compression features was located near the fault trace adjacent to a buckled compression zone in a sidewalk perpendicular to the fault trace (Figure 5.9). The compression feature is parallel to the fault trace. It was noted that there was separation between the asphalt and the curb in line with the compression feature in the curb strip.

Figure 5.9: Buckled section in pavement perpendicular to fault with compression features in curb strip and lawn parallel to fault, near observed fault trace [NSF-GEER; N 38.3018 W 122.3439; 8/25/2014 10:38]

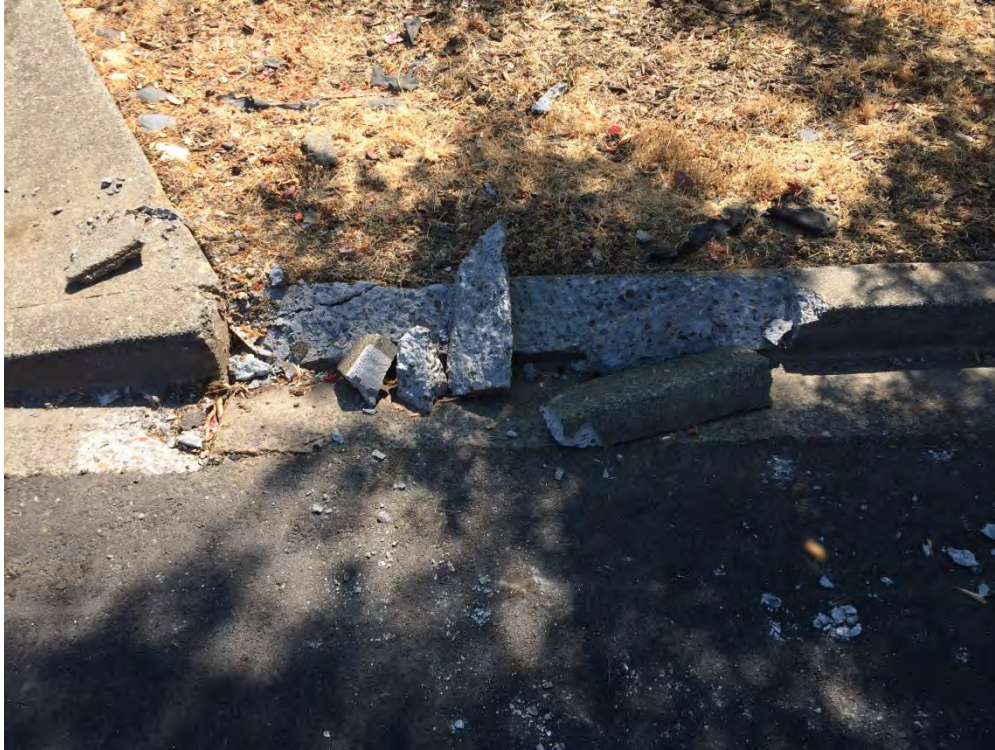
Damaged curbs were observed throughout the neighborhood along roads both parallel and perpendicular to the fault trace. The damage included crushing (Figure 5.11), extension cracks (Figure 5.12) and buckling failures (Figure 5.13). In general, the damaged curbs were not directly adjacent to the buckled compression zones in the sidewalk pavement. However, the curbs were not included in the detailed surveying because in most cases the broken pieces were missing or could not be reconstructed into the original configuration.

Figure 5.11: Crushed curb perpendicular to fault trace [NSF-GEER; N 38.3035 W 122.3411; 8/25/2014 14:47]

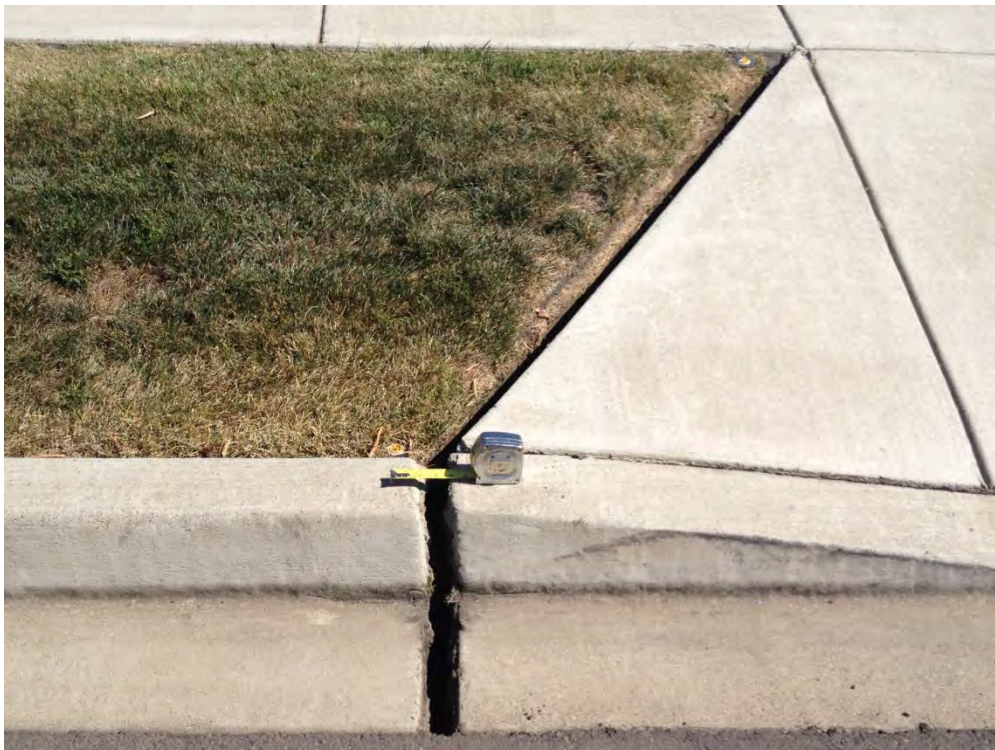
Figure 5.12: Extension crack in curb parallel to fault trace [NSF-GEER; N 38.3066 W 122.3475; 8/28/2014 15:08]

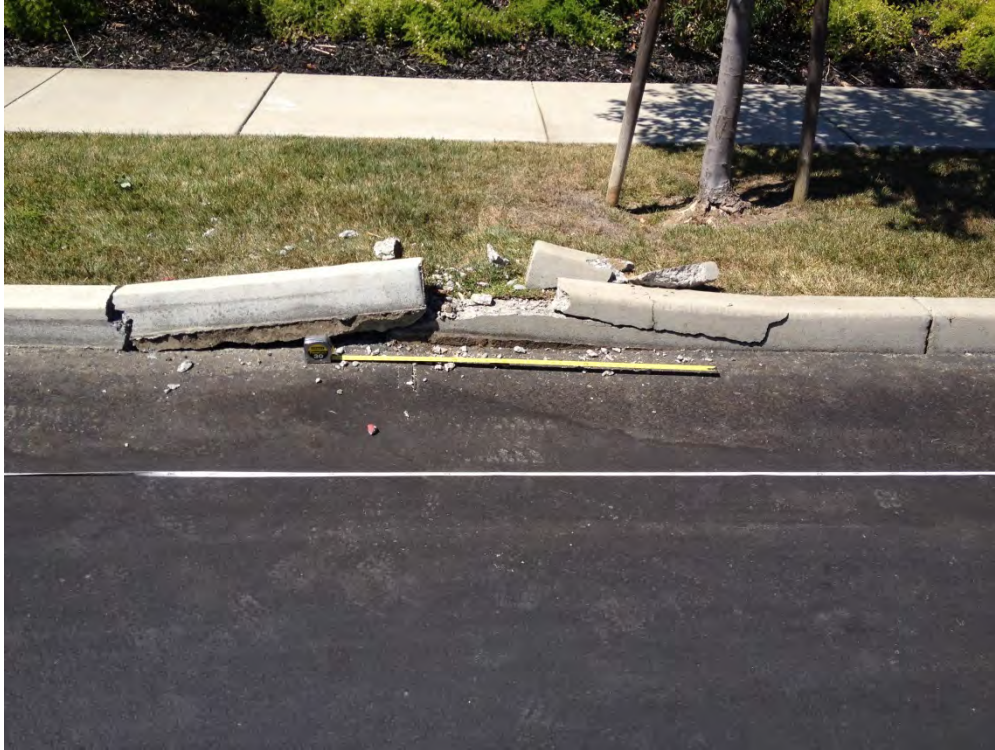
Figure 5.13: Buckled curb parallel to fault trace [NSF-GEER; N 38.3073 W 122.3443; 8/28/2014 13:41]

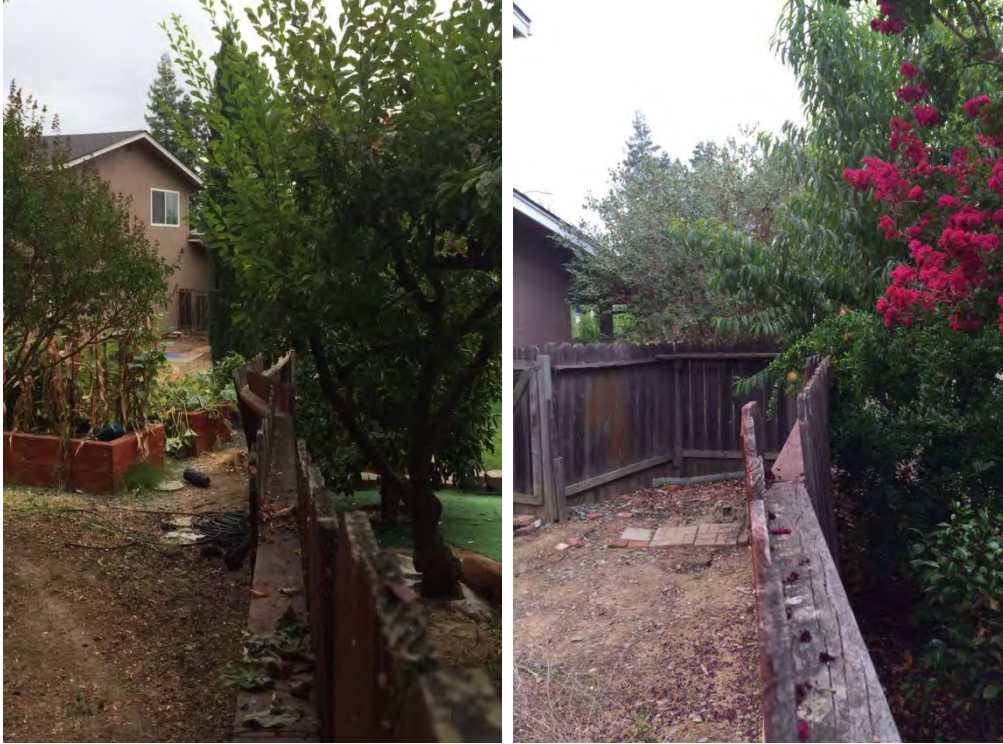
In addition to calculating strains in sidewalk pavement, strain was computed for a section of fence running parallel and adjacent to the fault trace (Figure 5.14). To compute the strain, the horizontal boards at the top of the fence were measured in segments to obtain an estimate of the original length of the fence. Then, the ground along the base of the fence was measured to obtain an estimate of the new length of the fence. The data and computations are shown in Table 5.3 below. Note that the average strain in the fence is the same order of magnitude as the average strain in the sidewalk pavement for roads crossing the fault trace (Table 5.1 and Table 5.2).

Figure 5.14: Buckled section of fence of the surveyed fence [NSF-GEER; N 38.3015 W 122.3442; 8/25/2014 09:57]
