6 PERFORMANCE OF GROUND AND BURIED UTILITIES

6.1 Introduction

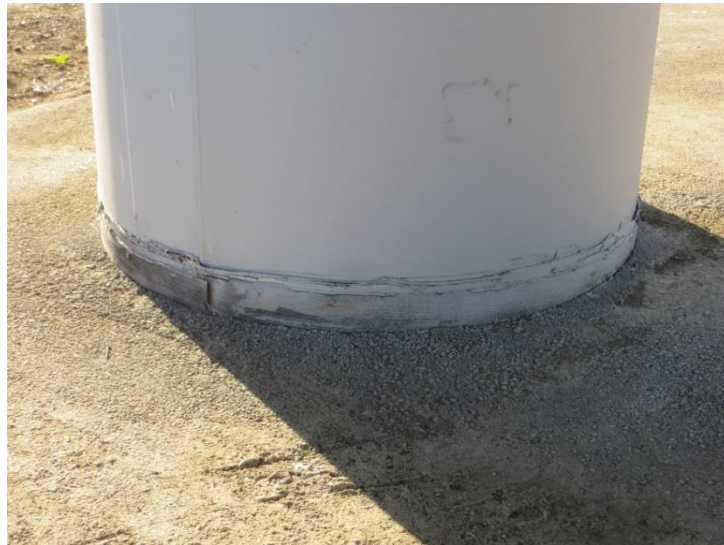
No significant damage was observed along the Highway 37 Bridge alignment. The bridge was observed from vantage points at the east and west abutments and from a vehicle while crossing. The eastern abutment was observed in greater detail (Figure 6.2). There was an absence of ground cracking and ground deformation, indicating good performance of the ground at the site.

Figure 6.2: Highway 37 Bridge pier with no significant ground damage; [NSF-GEER; Mare Island, Vallejo, CA; GPS N38.122 W122.276; 08/24/14; 18:24]

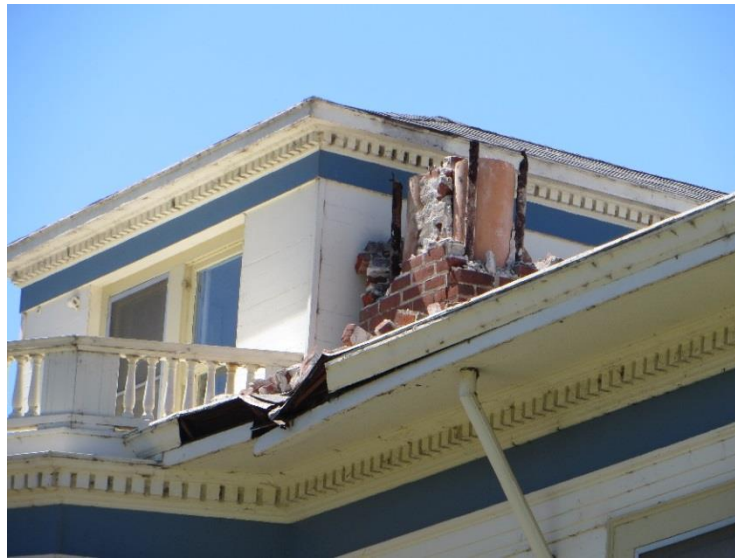
While investigating the occurrence of ground deformation, the GEER team members observed the performance of some structures. Brick chimneys were observed to have fallen from a number of the historic structures on Walnut Avenue (Figure 6.3), many formerly used as Officer's Quarters by the Navy. Of the 19 structures along Walnut Avenue, 5 had metal chimneys with no visible damage, 11 had brick chimneys with some degree of damage, 2 had brick chimneys with no visible damage, and 1 had no visible chimney or damage. Observations of external structural damage are summarized in Table E.1 in Appendix E.

Figure 6.3: Brick chimney damage; [NSF-GEER; Mare Island, Vallejo, CA; GPS N38.099 W122.273; 08/24/14; 14:19]

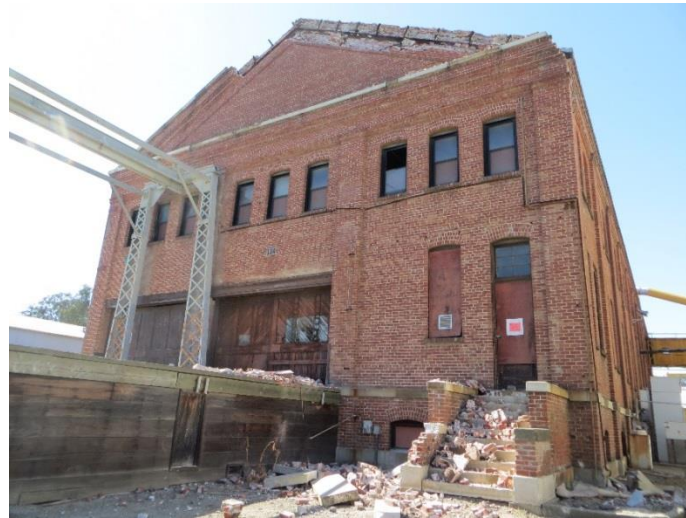
Several buildings along the historic Mare Island waterfront, opposite the dry docks on the west side of Nimitz Avenue were observed to have brick façade or corrugated siding damage (Figure 6.4). The buildings consist of mix of industrial and commercial buildings and warehouses, formerly associated with the Mare Island Naval Base and now under civilian use, owned and leased by LMI. Cracks were observed along corner columns and around windows of some brick structures. No signs of collapse were evident, though some buildings were blocked off and red-tagged pending structural inspection. Several buildings also had broken glass windows although it was unclear by observation which instances were due to earthquake damage. Deformation of rollup doors was evident on one of the waterfront structures. Ground

deformation was not widespread, but was observed in localized pockets near one of the larger, more modern structures. Observations of external structural damage are summarized in Table E.2 in Appendix E.

Figure 6.4: Brick facade damage; [NSF-GEER; Mare Island, Vallejo, CA; N38.095 W122.268; 08/24/14; 15:38]

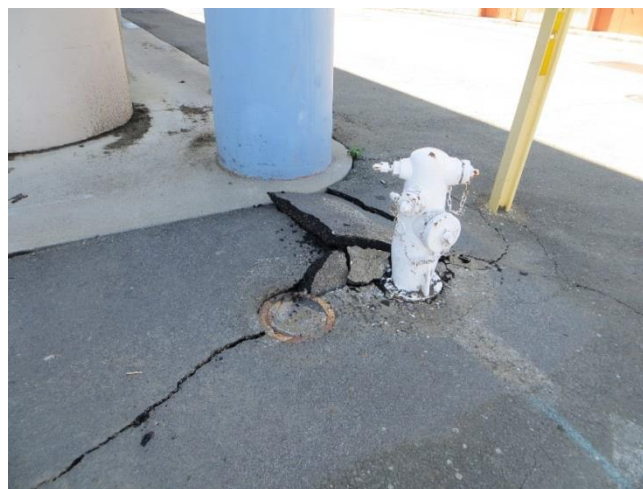
Deformed pavement was visible in localized areas around structures of the historic core (e.g., Figure 6.5). Paving stones along sidewalks and walkways along Walnut Avenue appeared to be slightly out of place. Evidence of persistent ground rupture in the vicinity of Mare Island was not observed by GEER team members, nor was evidence of significant ground rupture reported by representatives of LMI, who inspected much of the island with representatives of the City of Vallejo and ENGEO Incorporated, their engineering consultant. Linear east west running berms associated with the Navy's former firing range were viewed from a nearby vantage point and ground rupture was not apparent.

Figure 6.5: Pavement damage at hydrant; [NSF-GEER; Mare Island, Vallejo, CA; GPS N38.098 W122.269; 08/24/14; 14:37]

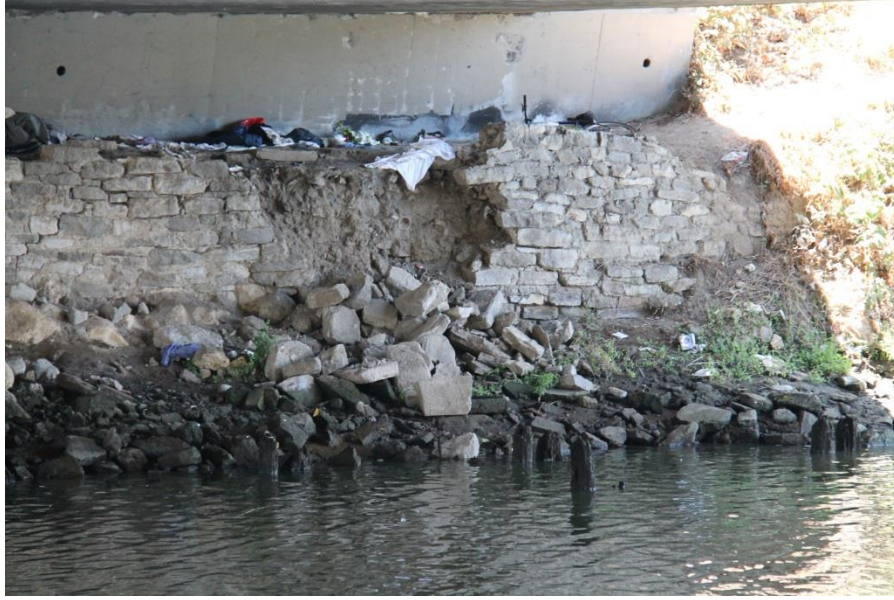
These two bridges cross the Napa River in a NS direction. They showed similar cracking at the interface between the foundation of the abutments and the adjacent soil. The cracks were primarily oriented parallel to the sloped free face. At the south abutment of Soscol Bridge an old masonry retaining wall failed, as shown in Figure 6.6. The Soscol Ave. pavement also settled with respect to the South end of the bridge deck.

Figure 6.6: Failure of masonry retaining wall below the south abutment of Soscol Bridge [NSF-GEER; N 38.2997 W -122.2834; 08/24/14 13:09]

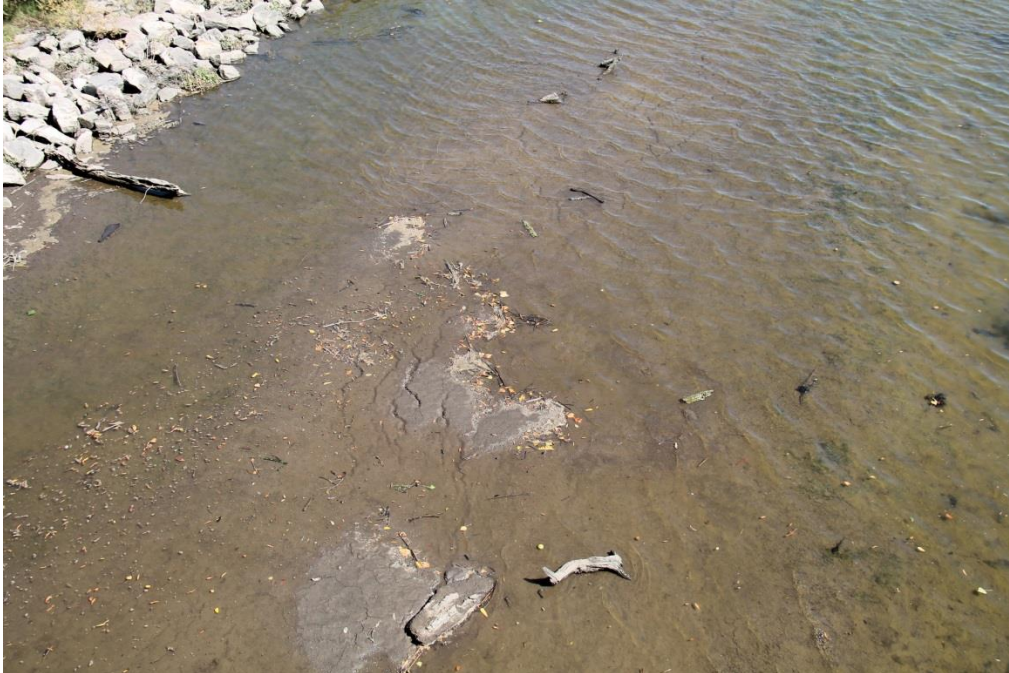
- Between the eastern pier of the bridge and the East abutment a natural sand deposit has formed (Point Bar). Minor liquefaction-induced ground deformation was observed in this area. Ground cracking and sand boils observed on the east bank of the river, south of the 3rd Street Bridge. On August 24th, the area photographed was under 15 to 30 cm of water. Dry conditions at these locations allowed for closer inspection, revealing signs of liquefaction and sand boils as discussed in Section 7.5.1.
- Ground cracking parallel to the shore to the south and north of the bridge
- Around 5 cm of horizontal displacement of the deck at each abutment
- Separation of approximately 2 cm between concrete walkway and adjacent floodwalls below the west abutment

Figure 6.7: Ground cracking and submerged sand boils due to liquefaction in Napa River point bar, east bank, south of 3rd St. Bridge [NSF-GEER; N 38.2980 W -122.2830; 08/24/14 14:44]

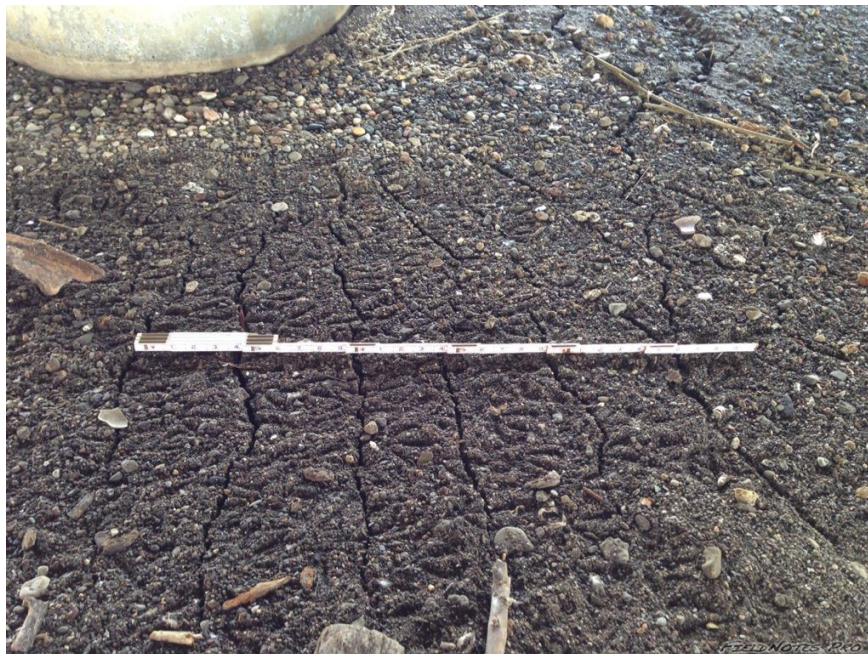
- Settlement of soils around the western column on the order of 5 cm and 25 cm. Around the columns of the pier, cracks spaced every 25 cm to 30 cm were observed in a radial pattern

Figure 6.8: Ground cracking due to liquefaction in Napa River point bar below 3rd St. Bridge, between the two columns of the eastern pier. [NSF-GEER; N 38.2980 W -122.2840; 08/24/14 14:44]

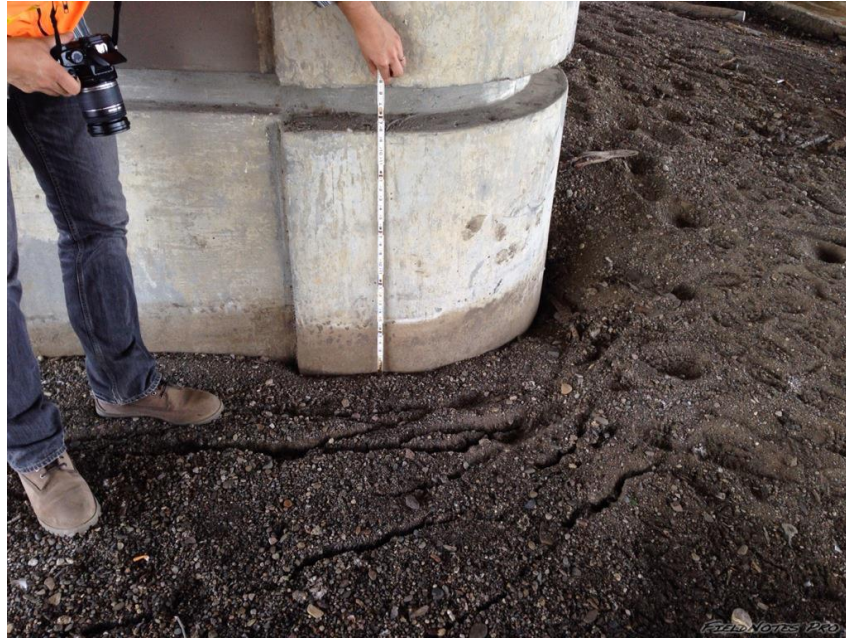
Figure 6.9: Ground cracking and settlement due to liquefaction in Napa River point bar below 3rd St. Bridge [NSF-GEER; N 38.2980 W -122.2840; 08/24/14 14:44]

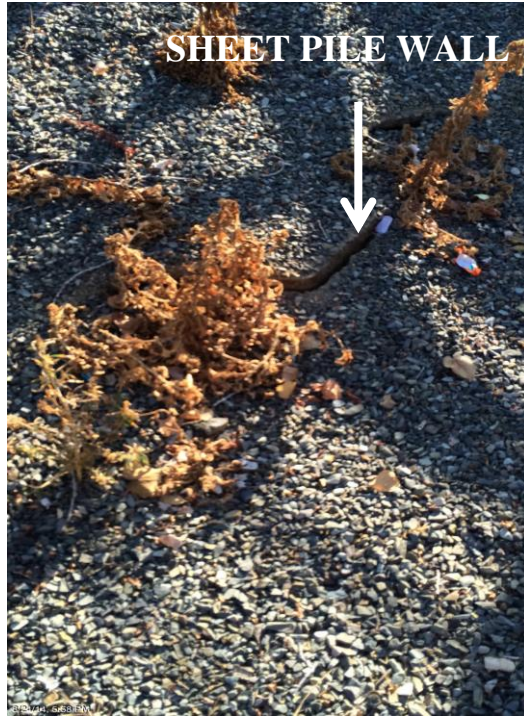
A pedestrian bridge crosses the Napa Creek in a SW-NE direction, from Coombs St. (SW) to Clinton St. (NE). It consists of a single steel beam supported by 2 reinforced concrete abutments. Along the SW side of the bridge, on Coombs St., parallel to the creek (NW-SE direction), there is a retaining wall of approximately 3 m in height. This retaining wall supports the North end of Coombs Street, pedestrian bridge South abutment and a house. A large crack was observed parallel to the retaining wall and about three meters behind the wall face. The crack was observed at the interface between the soil and a sheet pile wall (Figure 6.10). At the north of Coombs St. a crack was observed indicating the deformation of the backfill, which was also confirmed by 30 cm of settlement of the pavement adjacent to the retaining wall. Figure 6.11 shows the pavement crack, and Figure 6.12 shows the settlement in the pavement. At the NW end of the bridge, the deck was observed to be 15 cm above the bridge access ramp. Also in the parking lot located N of the abutment, tension cracks were found parallel to the creek.

Figure 6.10: Crack along sheet pile wall behind the retaining wall in the Pedestrian Bridge [NSF-GEER; N 38.3003 W -122.2881; 08/24/14 17:58]

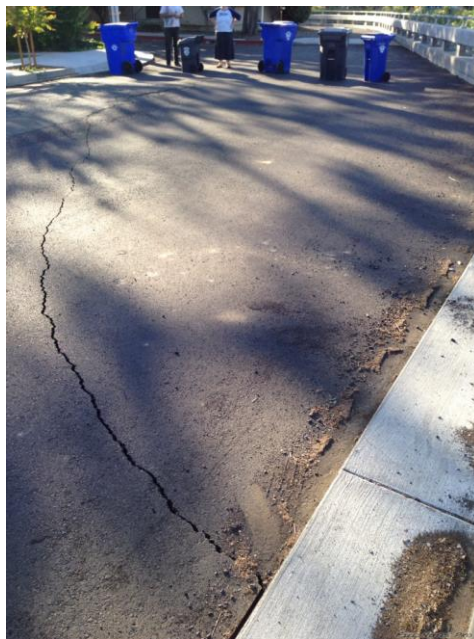
Figure 6.11: Crack in pavement behind the retaining wall in the pedestrian bridge [NSF-GEER; N 38.3003 W -122.2881; 08/24/14 17:58]

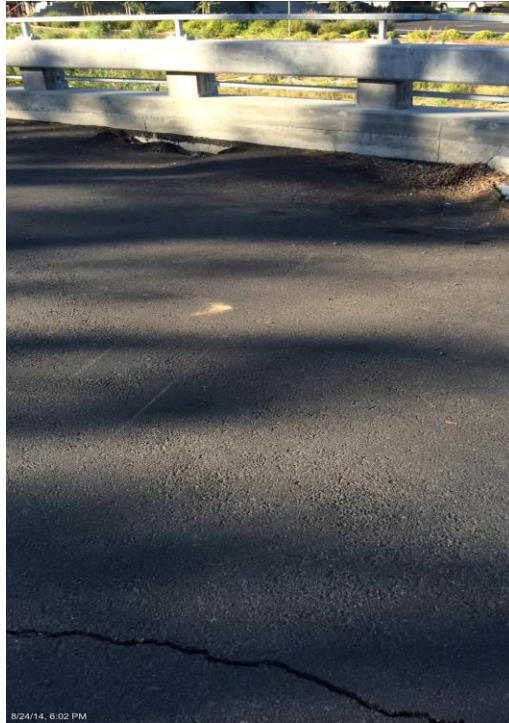
Figure 6.12: Settlement of backfill near the retaining wall in the pedestrian bridge [NSF-GEER; N 38.3003 W -122.2881; 08/24/14 17:58]

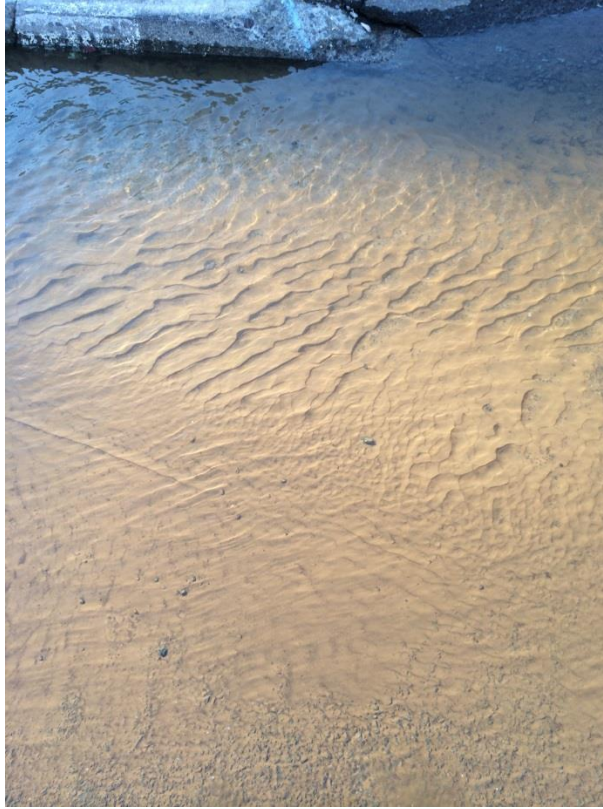
Several water main breaks were reported on the day of the earthquake in Downtown Napa. The GEER members in Downtown Napa documented three of them, one on Arroyo Dr. and two on Brown St. Arroyo Dr. is located just north of the NW abutment of the Pedestrian Bridge and is oriented parallel to the Napa Creek. The water main break occurred where recent trench work was apparent. The pavement around the break is also uneven with a large depression towards the East. According to the residents this depression occurred during recent construction along the Napa Creek. The other two water main breaks were observed on Browns St., at its intersection with Napa St. and Caymus St. All of these water line breaks ejected trench sand to the ground surface. An example is shown on Figure 6.13.

Figure 6.13: Soil ejected from water main break in Arroyo Dr. [NSF-GEER; N 38.3008 W -122.2894; 08/24/14 16:34]
