## 7 PERFORMANCE OF DAMS AND LEVEES

### 7.1 Introduction

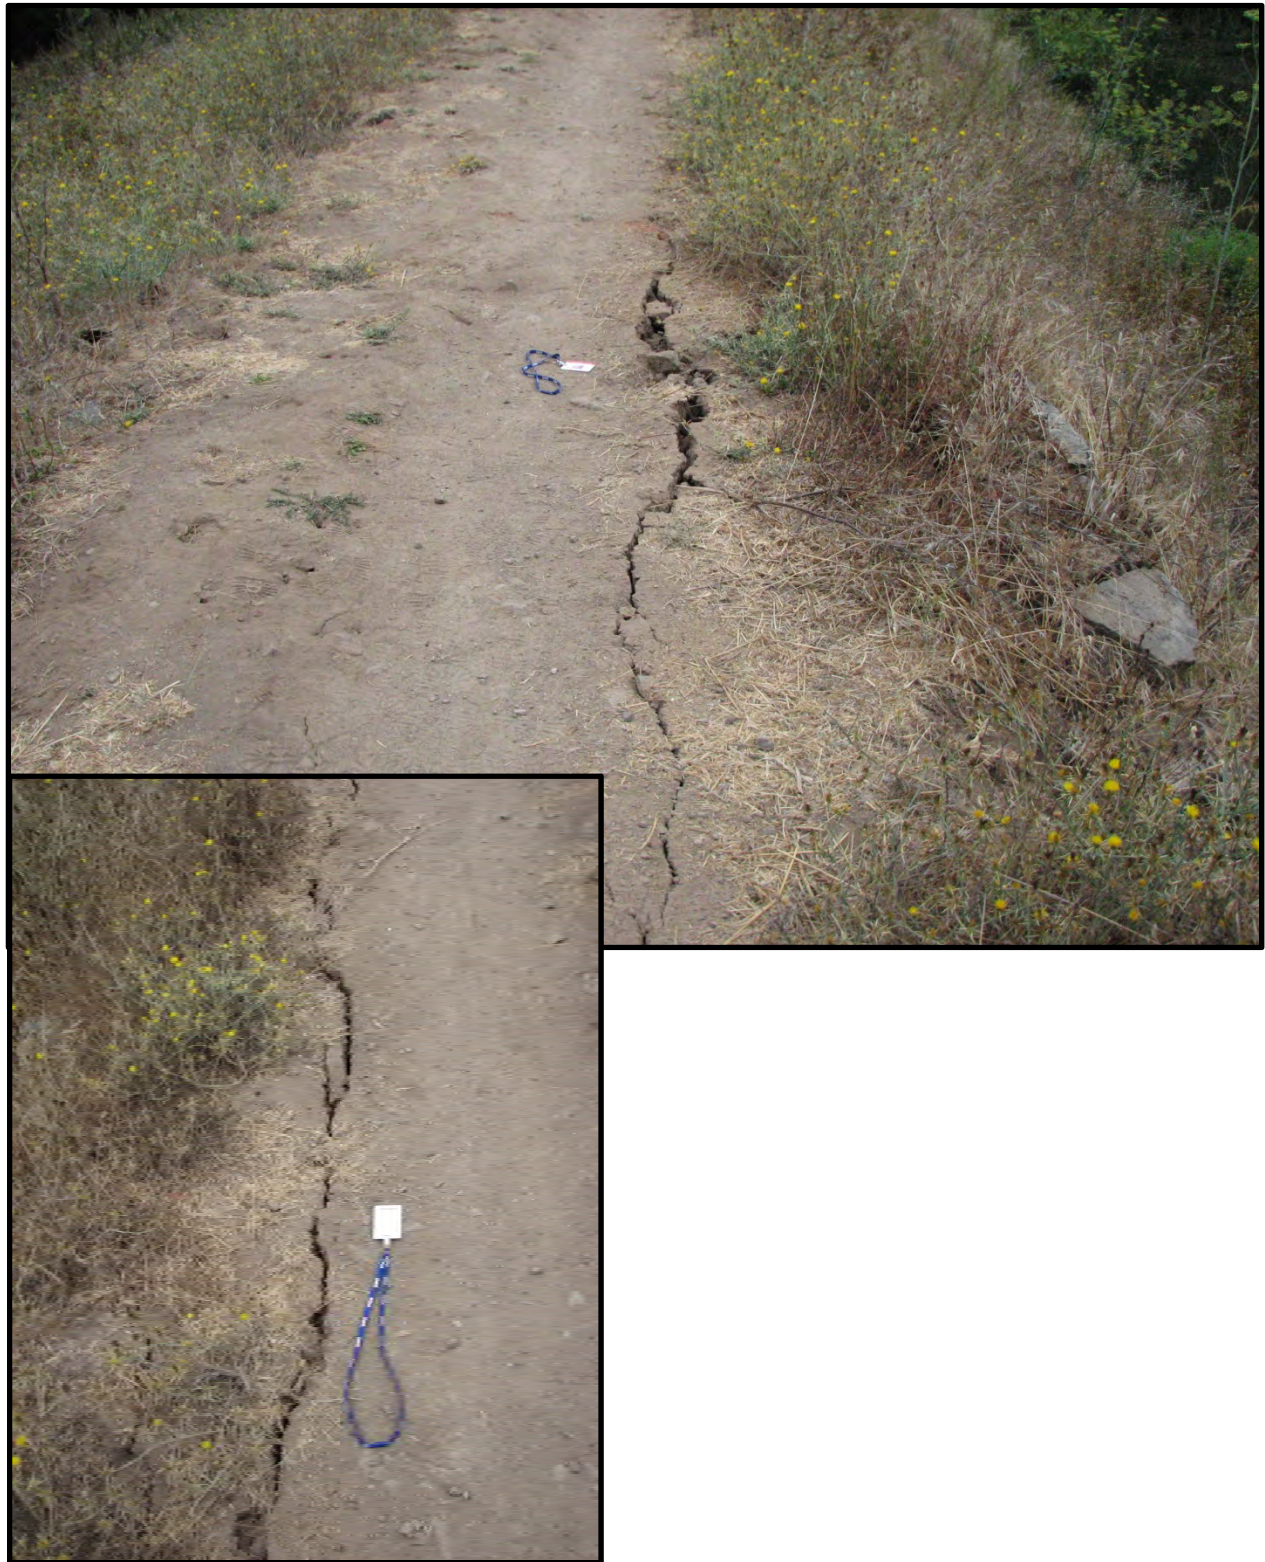
Lake Marie Dam was approximately 8.0 kilometers away from the energy source associated with the South Napa Earthquake and is estimated to have sustained a peak ground acceleration of about 0.19g based on nearby strong motion instruments. DSOD personnel inspected the dam during the same day as the earthquake and noted only a longitudinal crack in the upstream portion of the dam crest. The crack ran approximately 17 meters in length along the left central portion of the dam (see Figure 7-2 for general location) and had a maximum width of about 2½ centimeters (see Figure 7-3). Figures 7-3 and 7-4 present photographs taken by DSOD and by the GEER team of the cracking. The cracking may be related to movement of the upstream rock wall reportedly placed on the upstream edge of the dam crest in 1931. The cracking is considered minor, but DSOD staff report that they may require the cracking to be remediated.

Figure 7-3: Photographs of longitudinal cracking on the upstream edge of the crest of Lake Marie Dam [Napa, CA; N38.260 W 122.230; from DSOD files; 08/24/14]

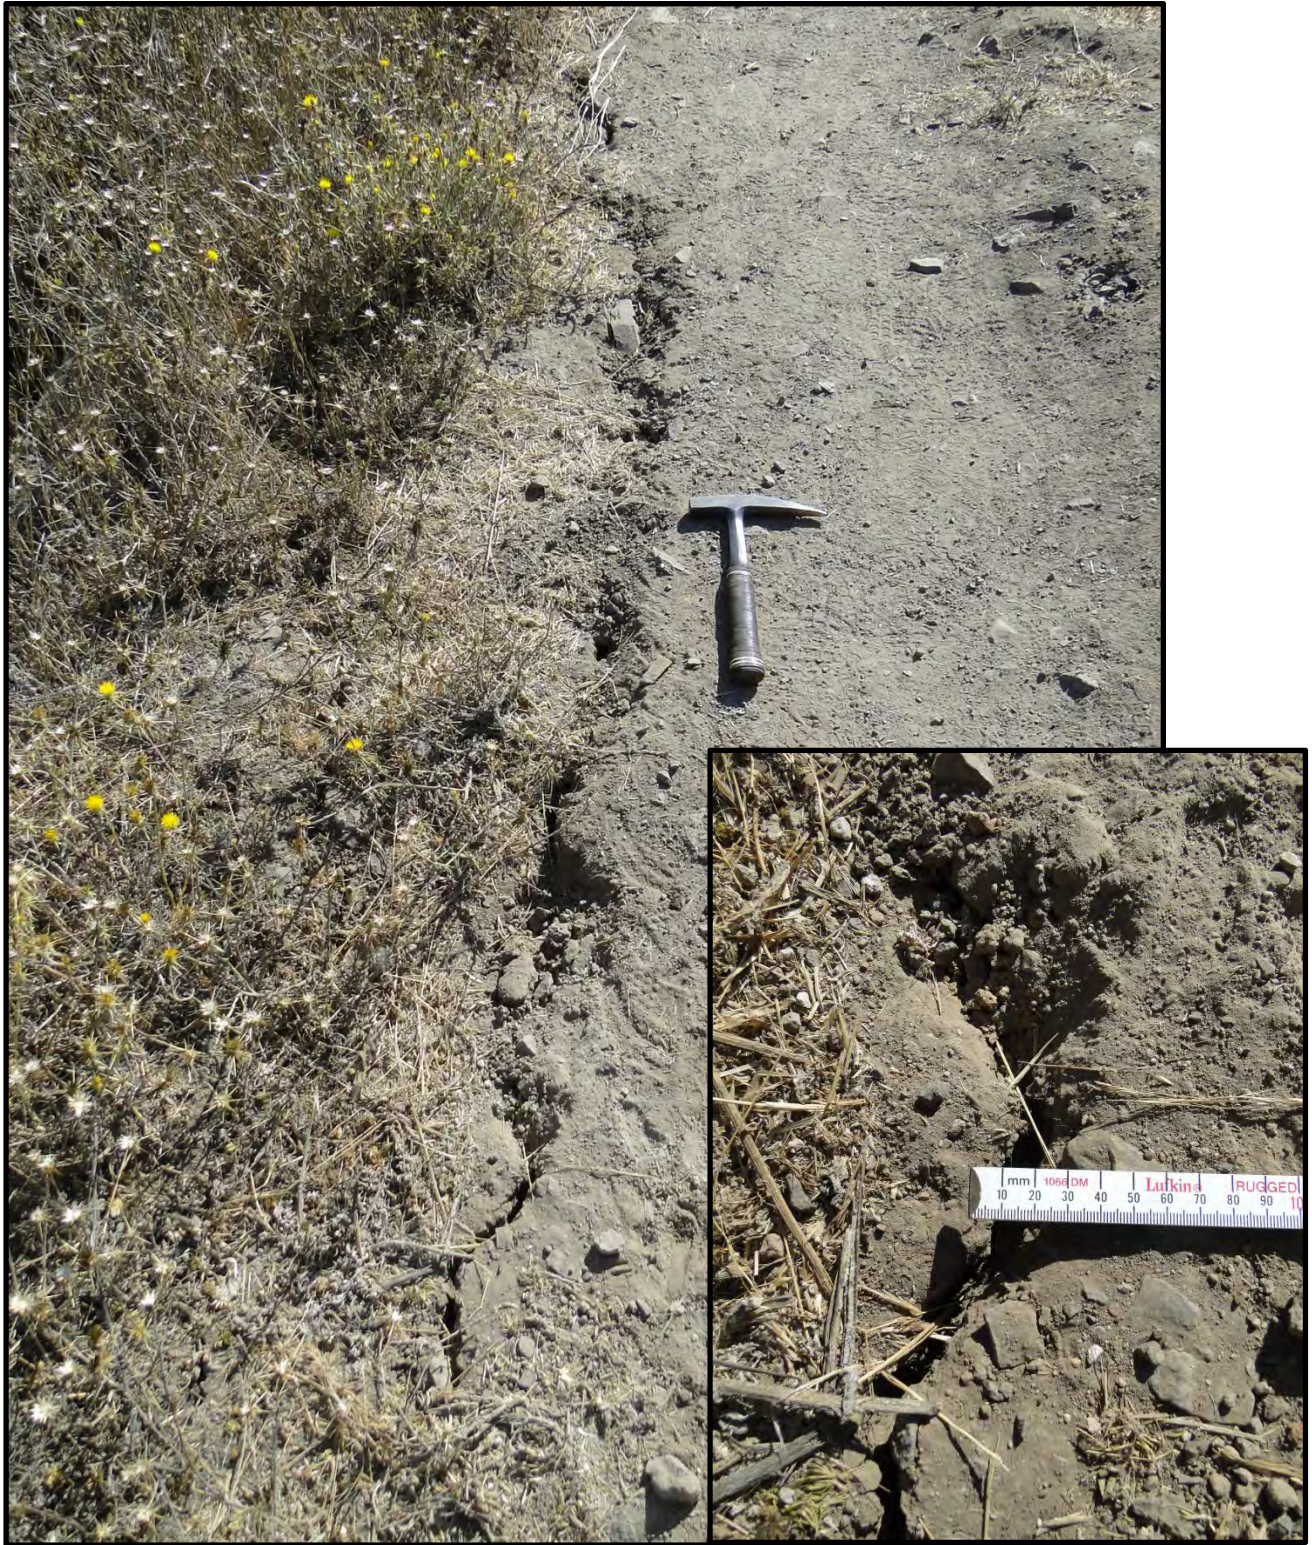
Figure 7-4: Photograph of longitudinal cracking on the upstream edge of the crest of Lake Marie Dam looking southeast [NSF-GEER; Napa, CA; N38.260 W 122.230; Harder, L. F.; 09/01/14]

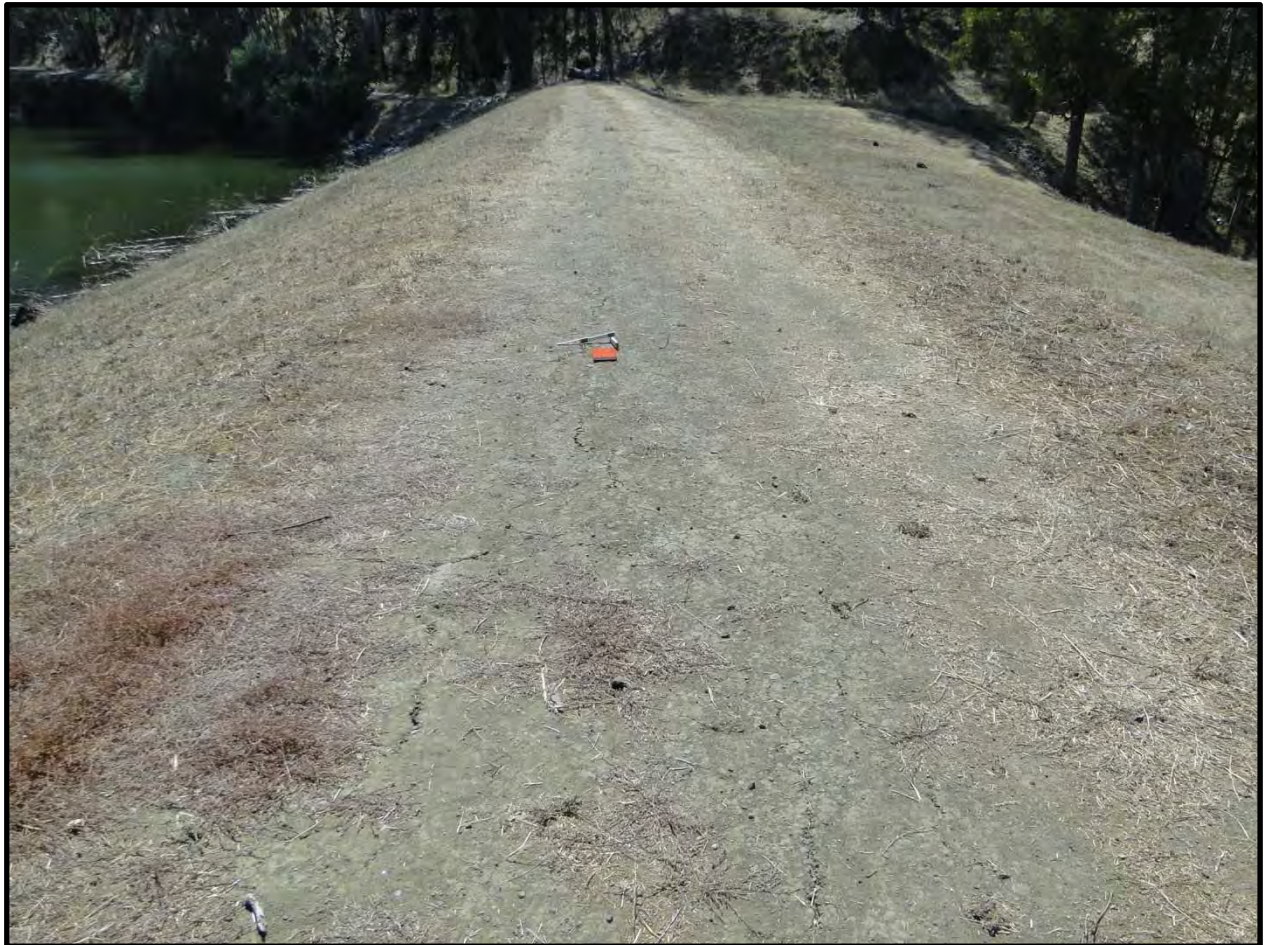
Lake Chabot Dam was approximately 11 kilometers away from the energy source associated with the South Napa Earthquake and is estimated to have sustained a peak ground acceleration of about 0.30g based on nearby strong motion instruments. A member of the GEER team inspected the dam on August 27<sup>th</sup> and found only minor longitudinal cracking less than 2 centimeters in

Figure 7-6: Photograph of minor longitudinal cracking on the crest of Lake Chabot Dam looking southeast [NSF-GEER; Napa, CA; N38.141 W 122.241; Harder, L. F.; 08/27/14]

width on the dam crest (see Figures 7-6 and 7-7). Much of this cracking may have been associated with pre-existing longitudinally-dominated shrinkage cracks that simply opened up during the shaking. At the time of the August 27<sup>th</sup> inspection, the reservoir was approximately 4.3 meters below the dam crest. A relatively new reinforced concrete spillway on the right abutment of the dam appeared to be undamaged.

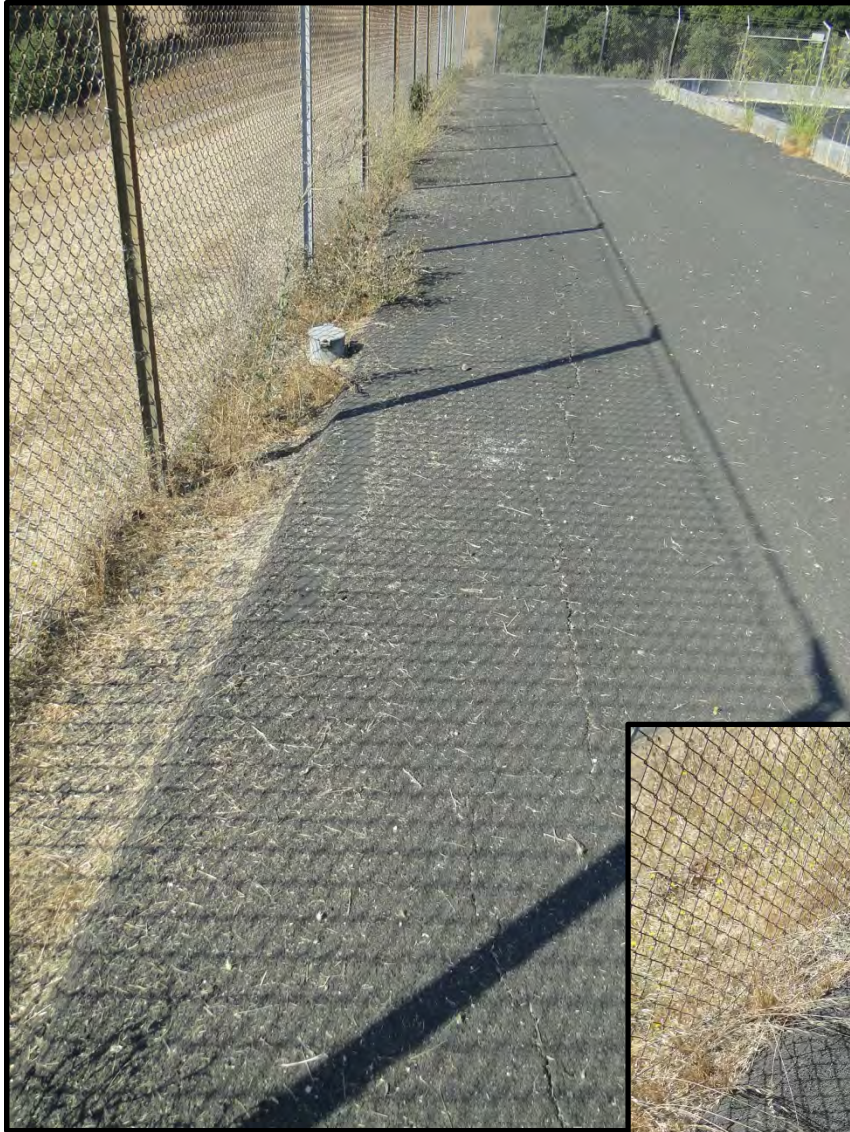
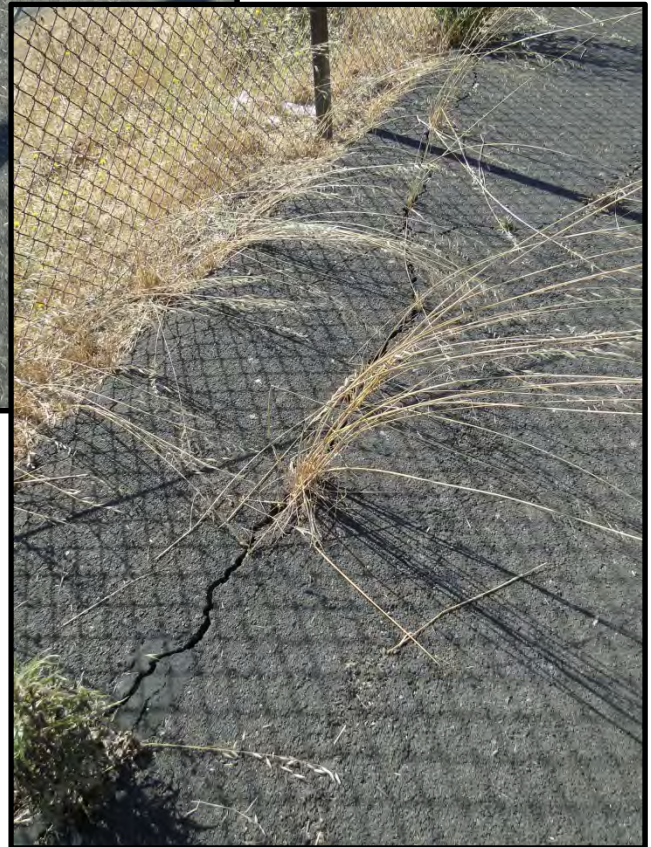
Summit Reservoir Dam was approximately 10.4 kilometers away from the energy source associated with the South Napa Earthquake and is estimated to have sustained a peak ground acceleration of about 0.25g based on nearby strong motion instruments. A member of the GEER team inspected the dam on August 27<sup>th</sup> and found that the dam appeared to have little to no damage. The only distress noted was relatively minor longitudinal cracking, principally located near the downstream edge of the asphalt-paved crest of the main dam section. These cracks were generally only a few millimeters in width with a maximum opening on the order of a centimeter. However, it was clear that these were pre-existing cracks as weeds were growing in them and asphalt mastic had previously been poured over them in the past in an attempt to seal them up. Figure 7-9 illustrates some of the minor cracking noted. It is thought that at most, the effect of the earthquake was to perhaps slightly widen the pre-existing cracks.

Figure 7-9: Photographs of pre-existing longitudinal cracks on the crest of the maximum section of Summit Reservoir Dam  
[NSF-GEER; Napa, CA; N38.153 W 122.225; Harder, L. F.; 08/27/14]

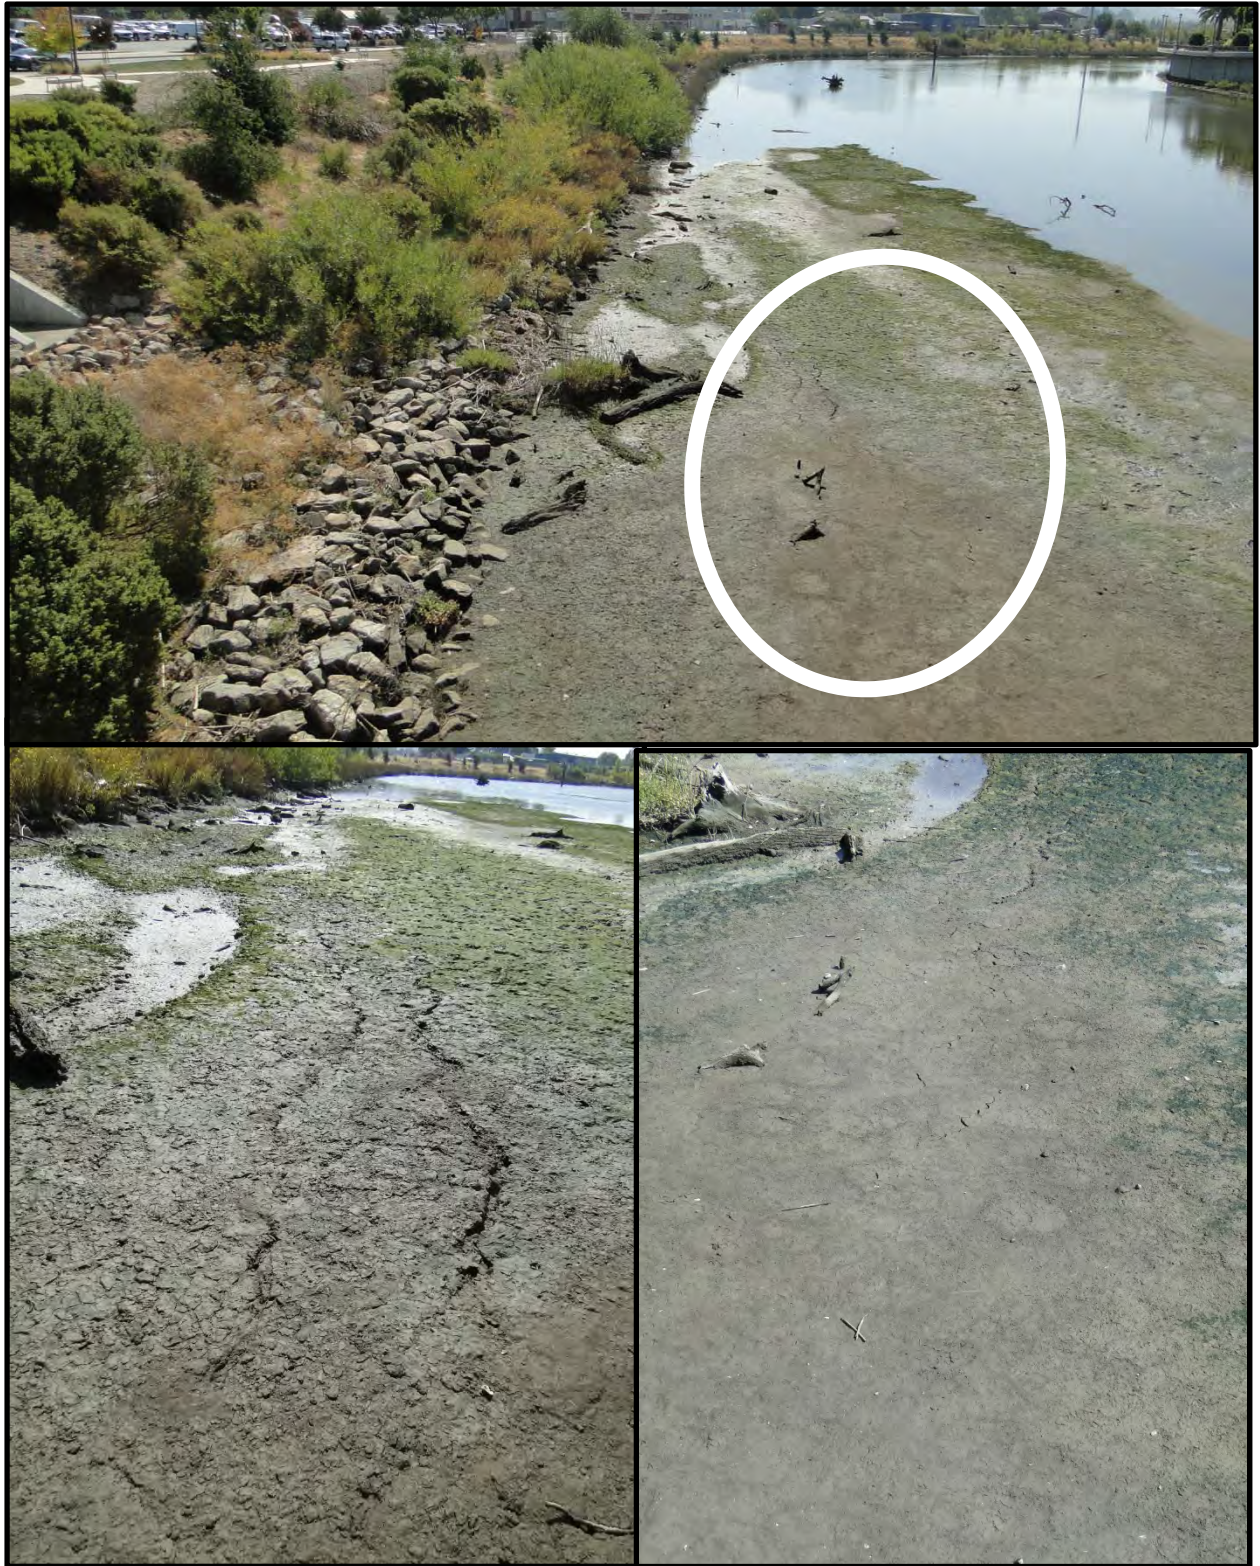
Downstream of the Third Street Bridge, remnant cracking and sand boils were observed in the sand/mud bar along the left (east) bank of the river and was suggestive that river sediments had liquefied during the earthquake (see Figures 7-12 and 7-13). The crack openings here were estimated to have a maximum width of approximately 2 centimeters. However, the adjacent riverbank appeared undamaged and there was no sign of cracking or lateral spreading on the concrete and gravel walkways above.

Figure 7-13: Remnant cracking and sand boils in sand bar along left bank of Napa River looking downstream from Third Street Bridge  
[NSF-GEER; Napa, CA; N38.298 W 122.283; Harder, L. F.; 09/04 and 09/07/14]

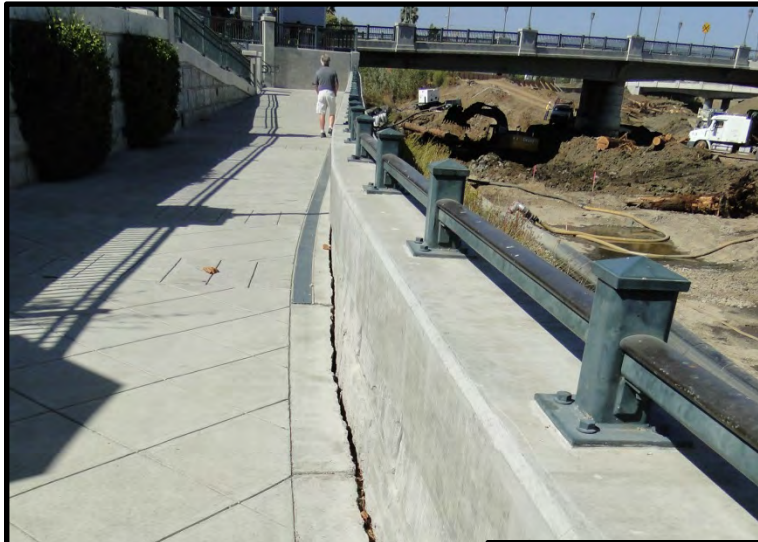
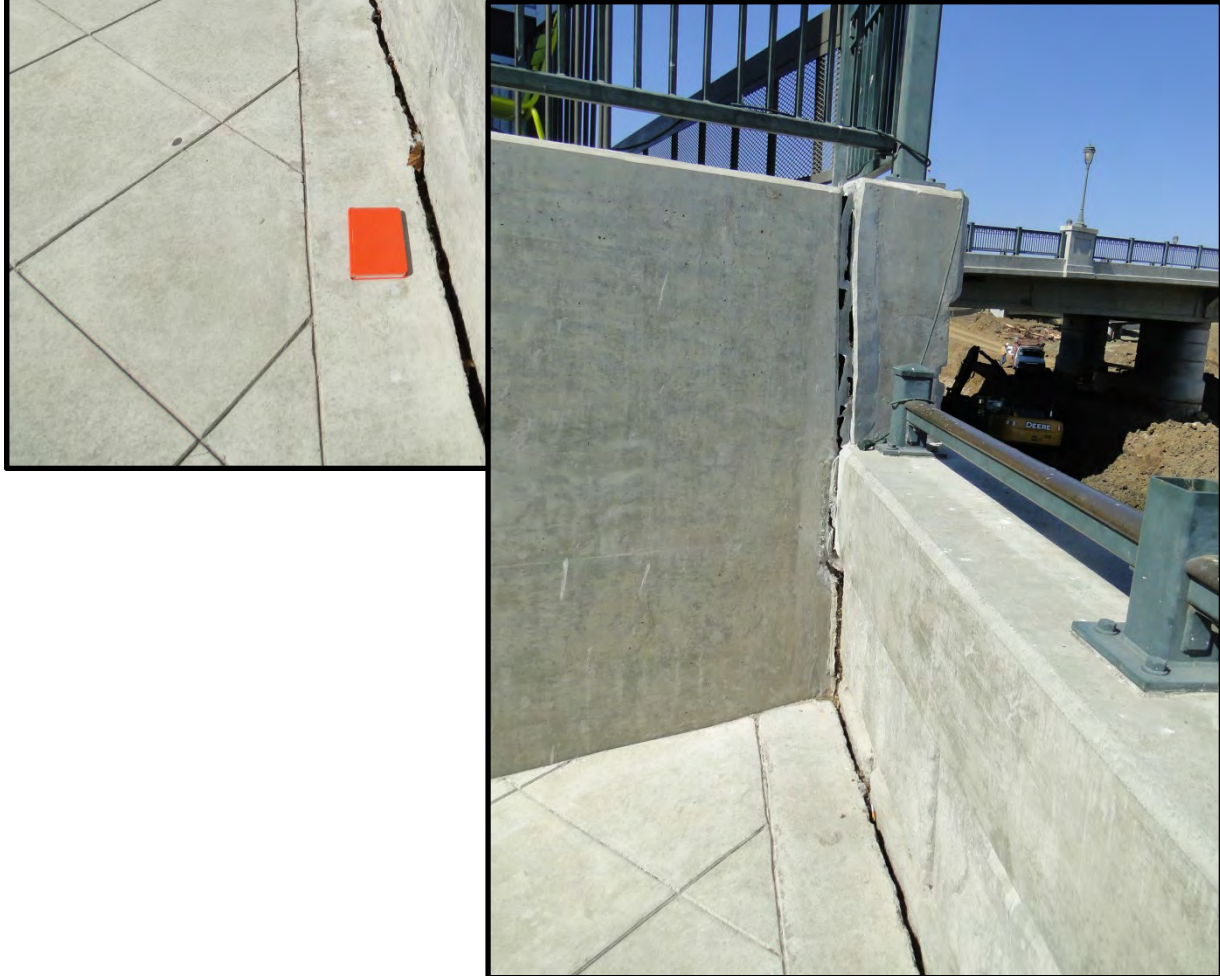
On the right (west) side of the river, the recently constructed large reinforced concrete floodwalls appeared to have performed well overall. However, the concrete deck slab behind the walls sustained minor cracking and had pulled away from the floodwalls by as much as 3 centimeters (see Figure 7-14). In addition, a lateral retaining wall supporting part of a restaurant had settled approximately 3 centimeters relative to the wall (see Figure 7-14).

Figure 7-14: Separation of concrete slab and retaining wall from Napa River floodwall along right bank of Napa River looking upstream from Third Street Bridge [NSF-GEER; Napa, CA; N38.299 W 122.285; Harder, L. F.; 09/04/14]

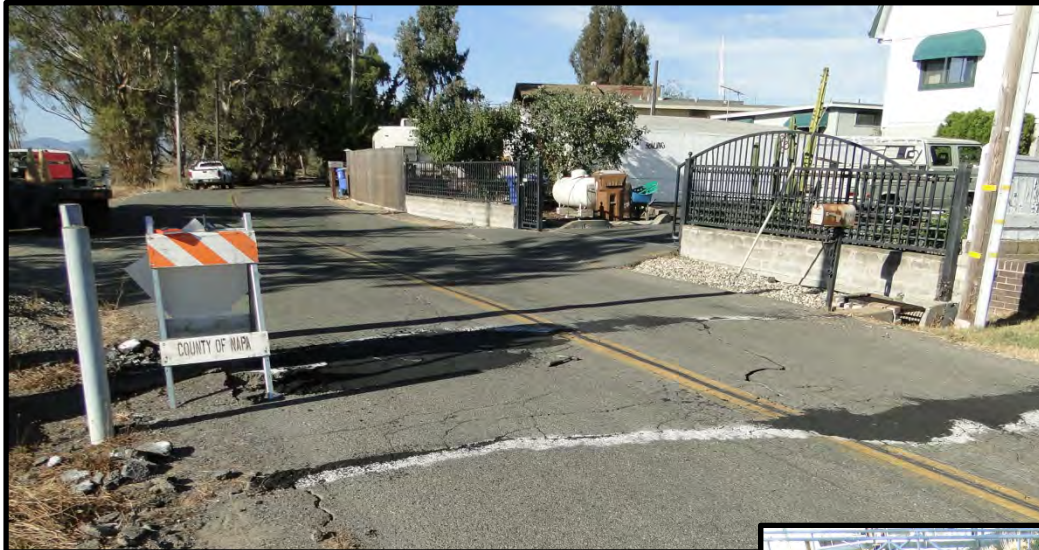
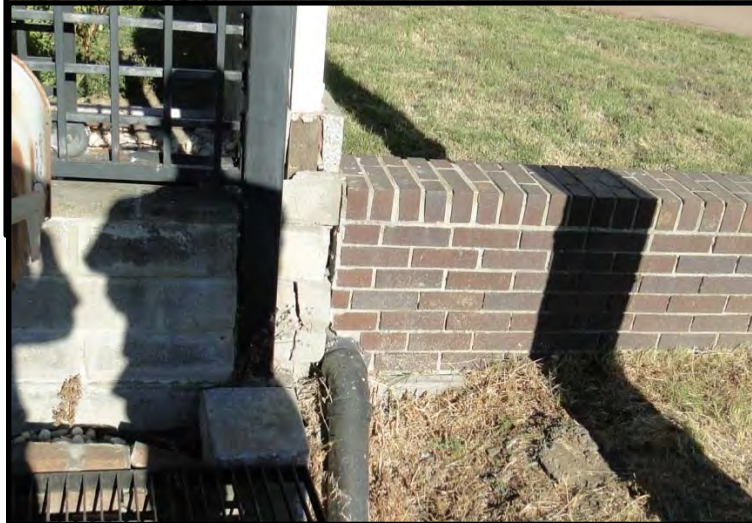
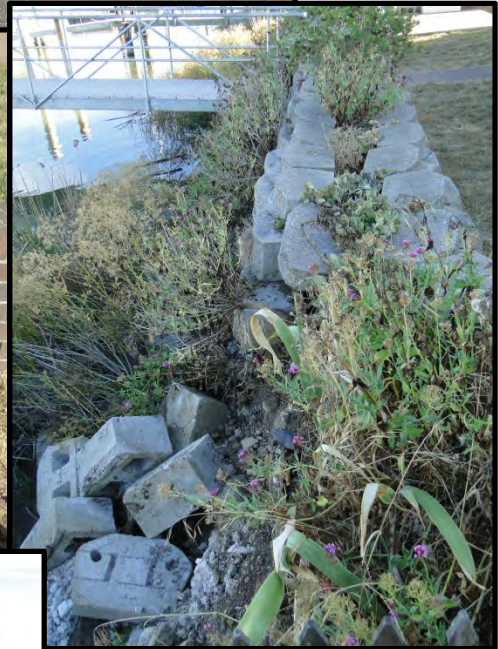
In one location along Milton Road, ground cracking was observed across the asphalt pavement. This cracking continued to a fractured low cinderblock wall (see Figure 7-16). At the back of the residence on the waterside portion of the levee, the dock and floodwall had been damaged. It was not clear if the cracking and damage were associated with shaking or ground displacements associated with a continuation of the fault rupture south of the epicenter. The shaking must have been significant as a large water tank moved off its concrete pad and sheared its connection with the residence (see Figure 7-17). However, no damage was observed on the levee embankment itself.

Figure 7-16: Photographs of cracked asphalt pavement on Milton Road, cracked cinderblock retaining wall, and damage to waterside floodwall/boat dock on Edgerley Island south of the epicenter [NSF-GEER; Napa, CA; N38.198 W 122.316; Harder, L. F.; 09/01/14]

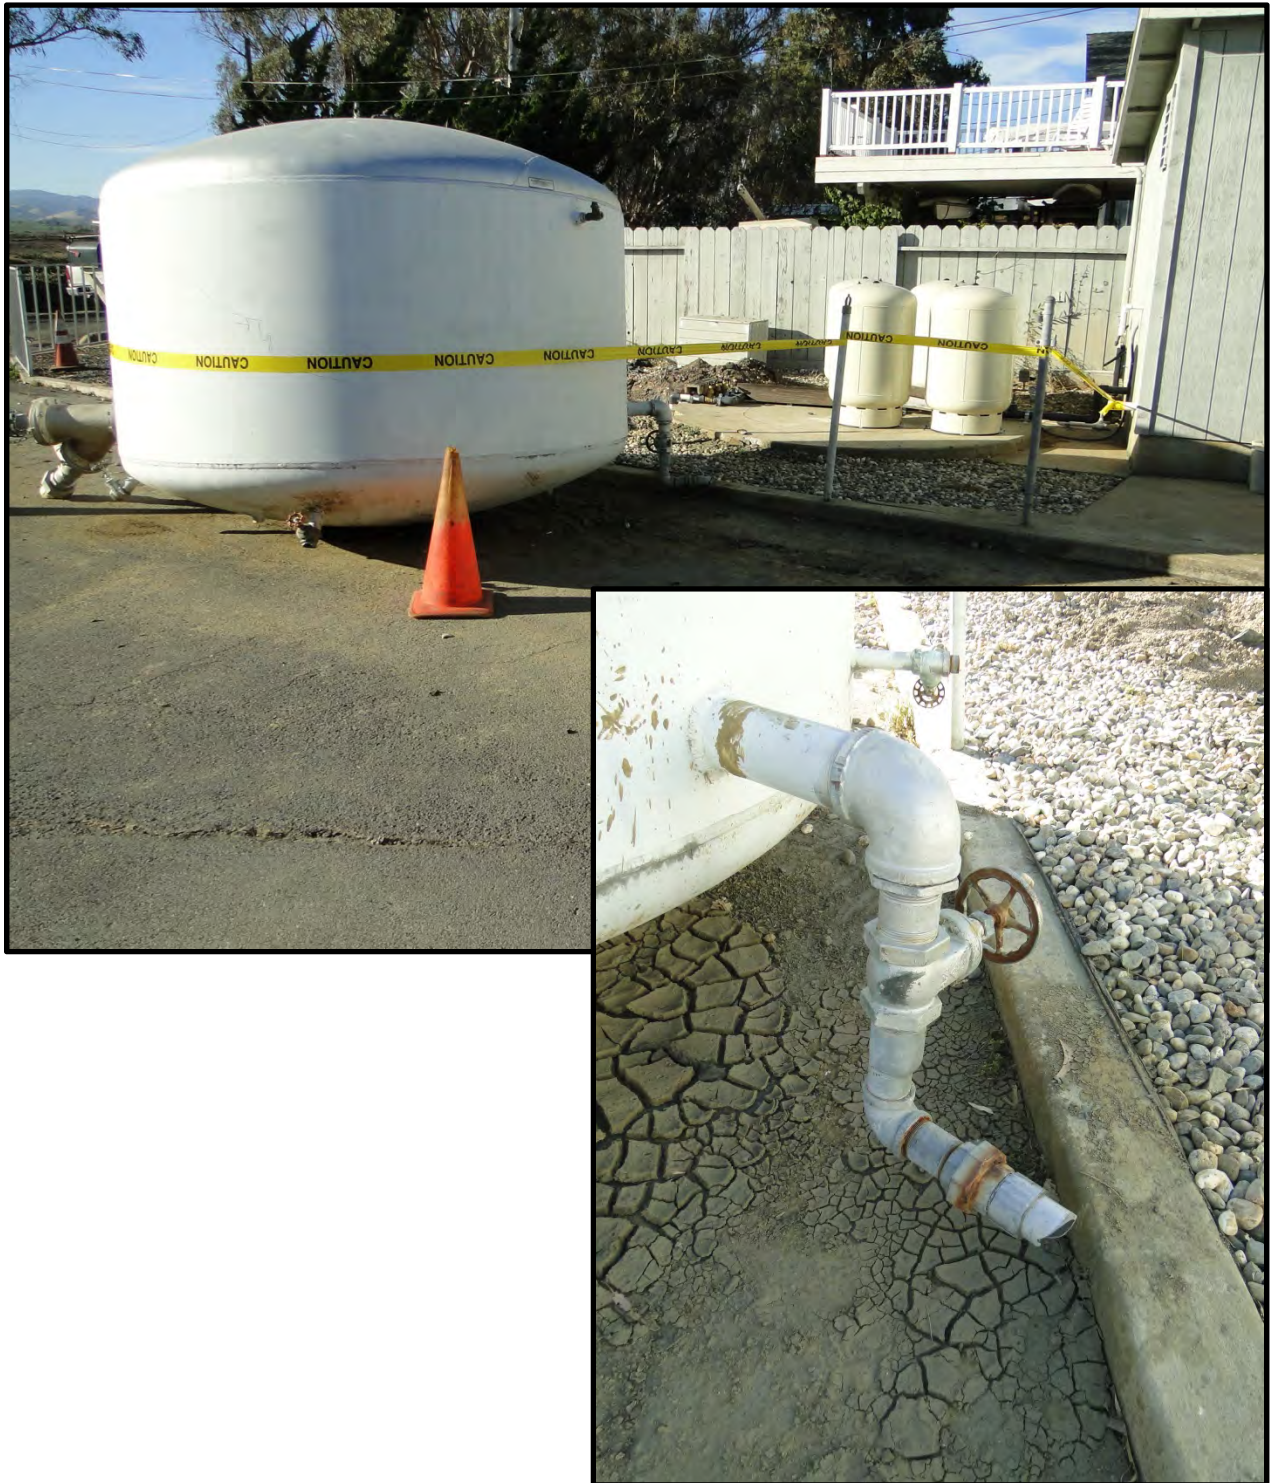
Figure 7-17: Photographs of displaced water tank moved off its concrete pad and sheared pipe connection – note replacement tanks on pad in its place - on Edgerley Island south of the epicenter [NSF-GEER; Napa, CA; N38.198 W 122.316; Harder, L. F.; 09/01/14]

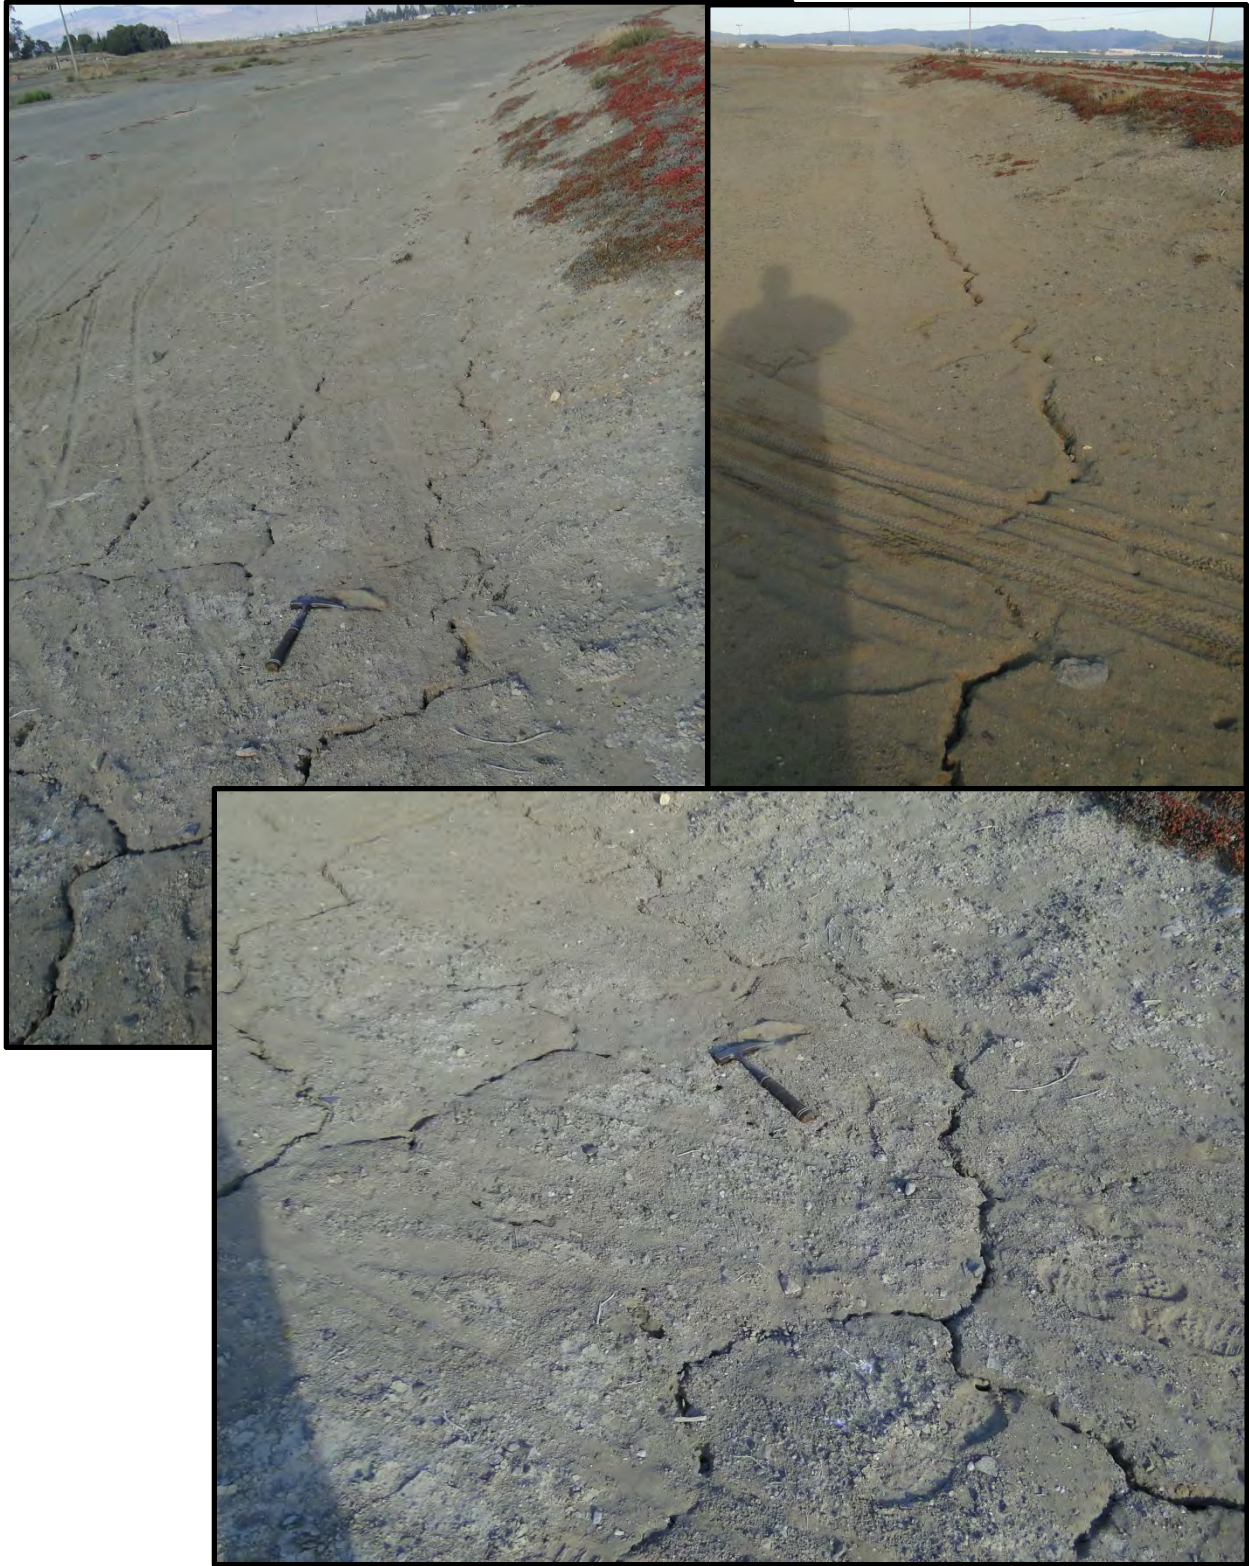
Along the western edge of Green Island along mud flats east of the left (east) bank of the Napa River and south of the epicenter there are small retaining dikes that previously retained brine waters in salt ponds (see location in Figure 7-15). The area has largely been converted into an environmental restoration and recreation area, but many of the retaining ponds for the salt ponds remain in place. No significant damage was observed by the GEER team for the majority of the dikes visited on foot, and no damage was observed during the aerial reconnaissance. However, near the very western tip of the island, approximately 100 meters of longitudinal cracking was observed near the landside toe of the dike. The largest cracks were approximately 2½ centimeters in width, and, while longitudinal, appeared to have enlarged from shrinkage cracks. In addition, there appeared to be sandy ejecta along the cracks, but this was not definitive as the observations were made on September 4<sup>th</sup>, approximately 10 days after the earthquake (see Figure 7-18).

Figure 7-18: Photographs of longitudinal cracking and apparent ejecta along landside toe of salt pond retaining dike on western edge of Green Island south of the epicenter [NSF-GEER; Napa, CA; N38.201 W 122.302; Harder, L. F.; 09/04/14]

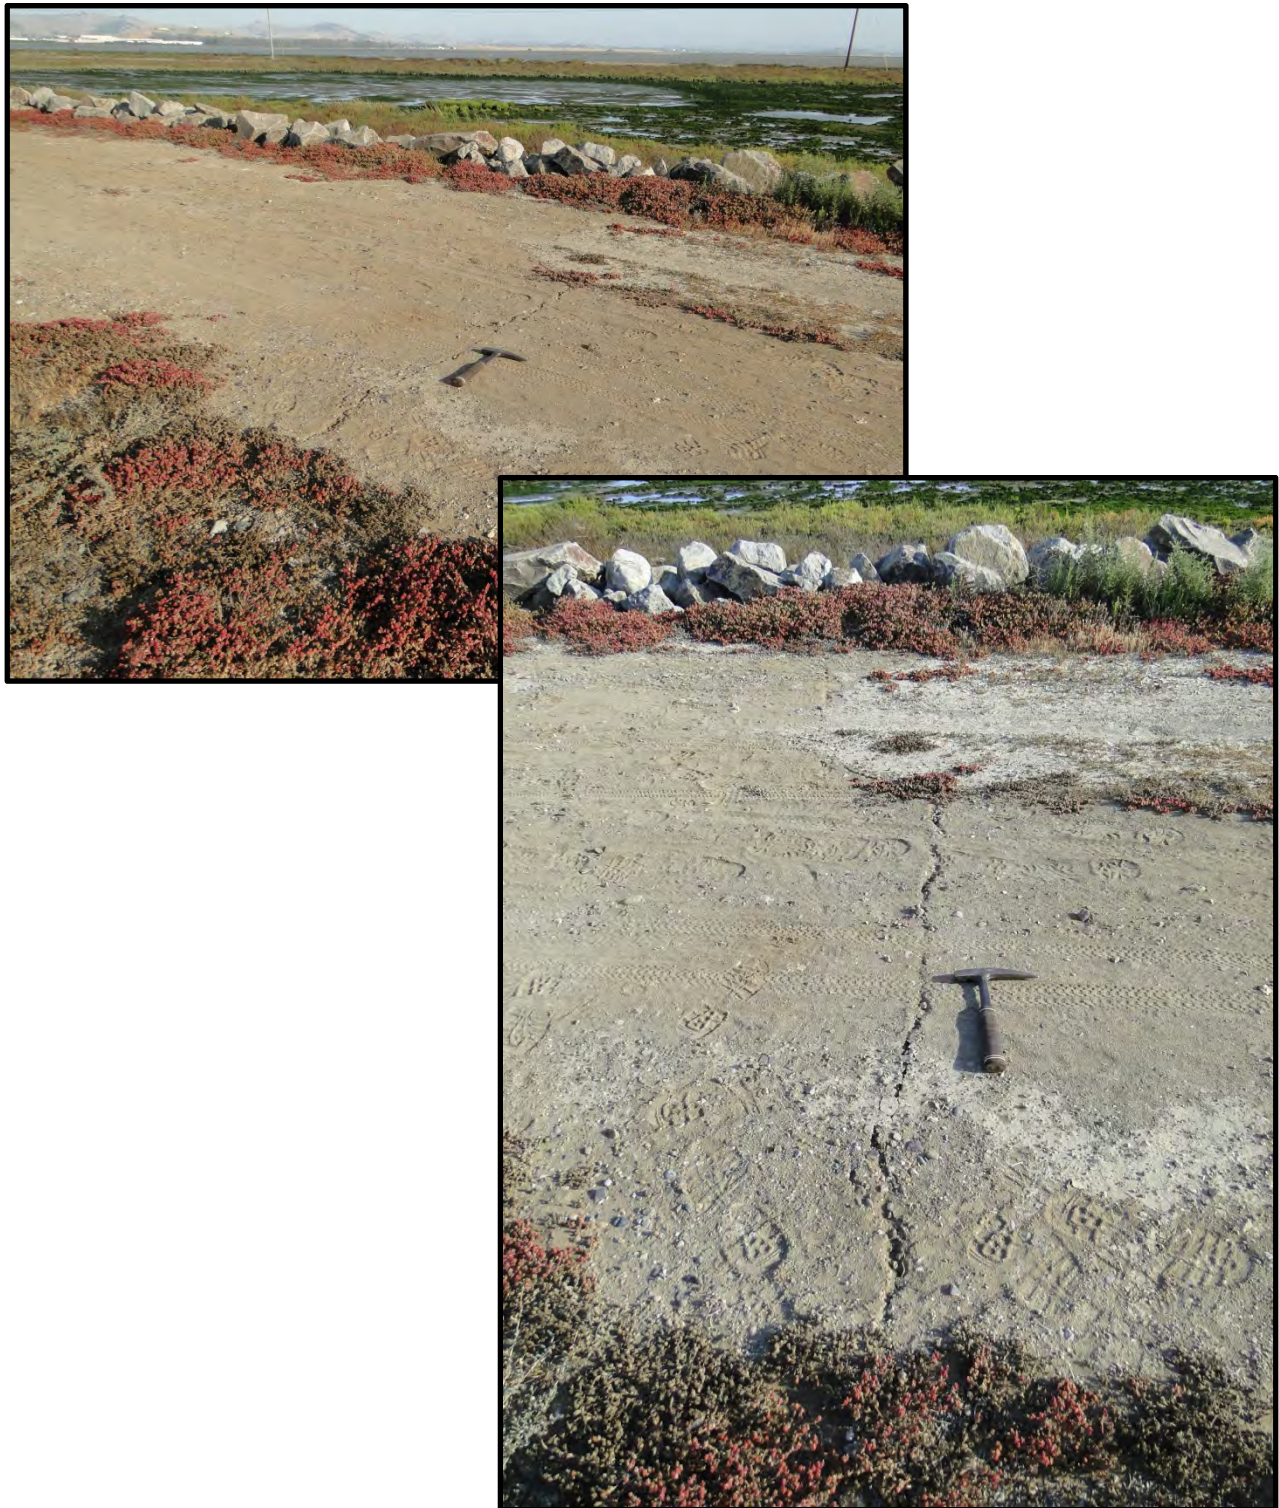
The retaining dike at this location was approximately 2 meters high and had crown widths on the order of 3 meters. In addition to the longitudinal cracking, four transverse cracks approximately 2 to 4 millimeters in width also crossed the levee in this 100-meter reach (see Figure 7-19). It is likely, but not definitive that the cracking was associated with a limited amount of liquefaction in the foundation in this area.

Figure 7-19: Photographs of transverse cracking on crown of salt pond retaining dike on western edge of Green Island south of the epicenter  
[NSF-GEER; Napa, CA; N38.201 W 122.302; Harder, L. F.; 09/04/14]
