Engineering Impacts of the August 4, 2020 Port of Beirut, Lebanon Explosion

A report of the NSF-Sponsored Geotechnical Extreme Event Reconnaissance Association in
Collaboration with the American University of Beirut

Report GEER-070: <https://doi.org/10.18118/G6C96C>

February 4 2021

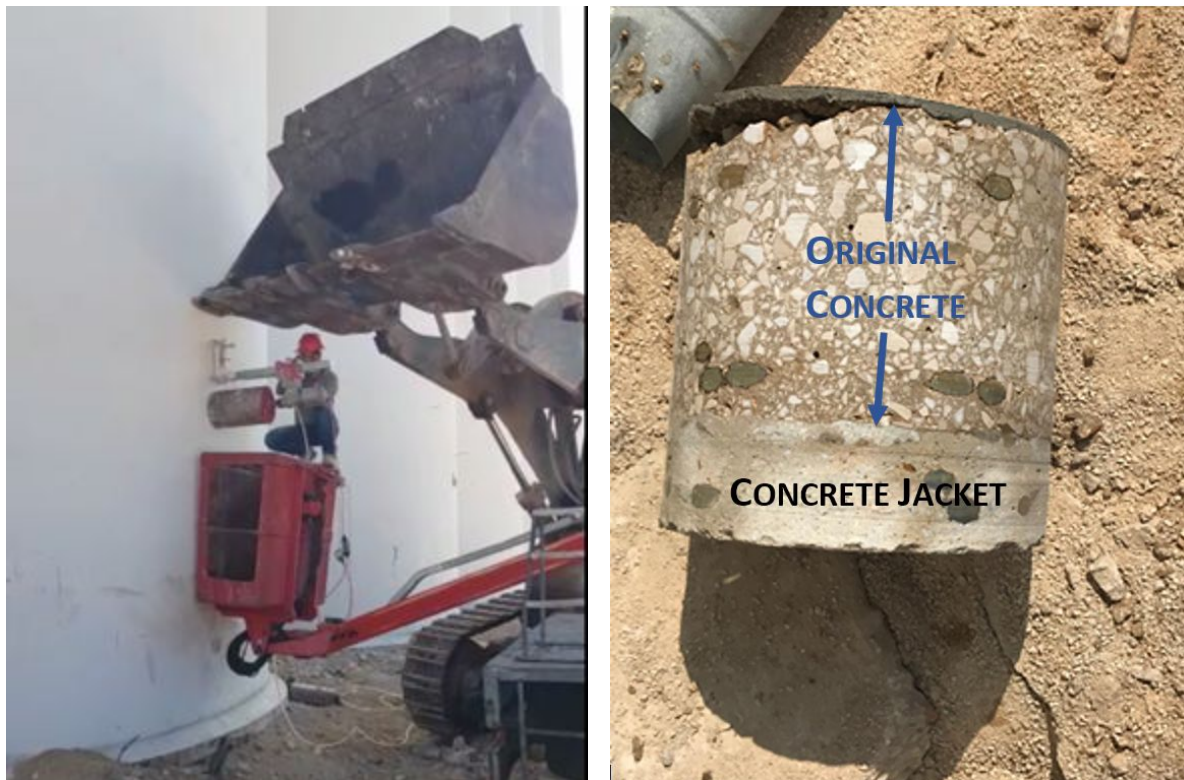
In the late 1990s a comprehensive structural assessment was conducted on the silos. Significant deterioration of the 17-18 cm thick outer concrete silos shells was observed, mostly due to exposure to the humid and salty seafront environment and subsequent carbonation. The damage was addressed/mitigated by constructing a 12 cm thick reinforced concrete jacket onto the inner walls of the outer/exposed silos. This strengthening measure played a role in conditioning/improving their response to the blast on 4 August 2020. Figure 3.9 presents images taken in the aftermath of the explosion showing the process of coring through one of the western cells. The original concrete along with the 12 cm newly placed jacket can be clearly seen.

Figure 3.9. Coring through one of the “intact” cells. Note the improvised protection from falling debris from the damaged silo roof. The original concrete and the inner concrete jacket can be clearly seen in the recovered 30 cm core.

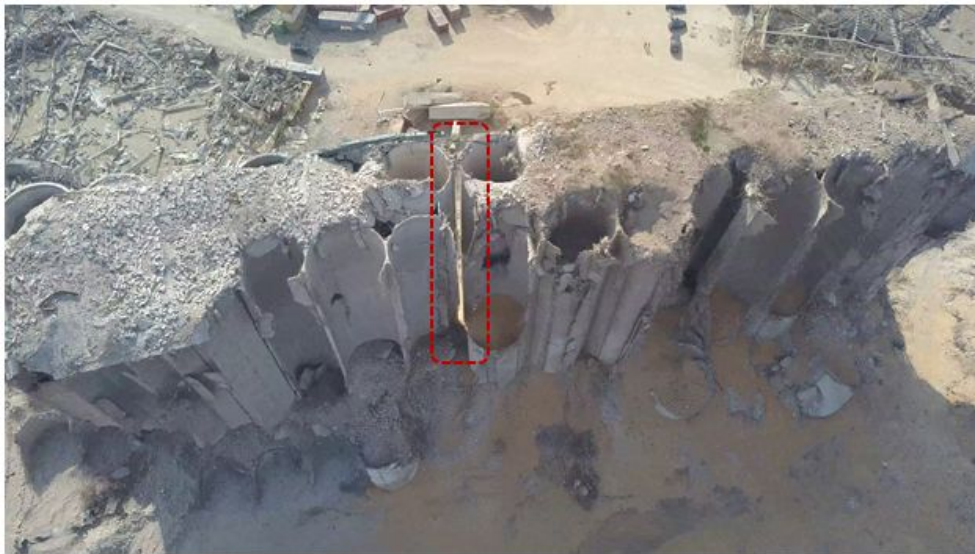
Figure 3.13. Image taken from a drone looking towards the west. The red box shows the interface between Phases I and II of the silo construction, where the construction gap was revealed by the damage.

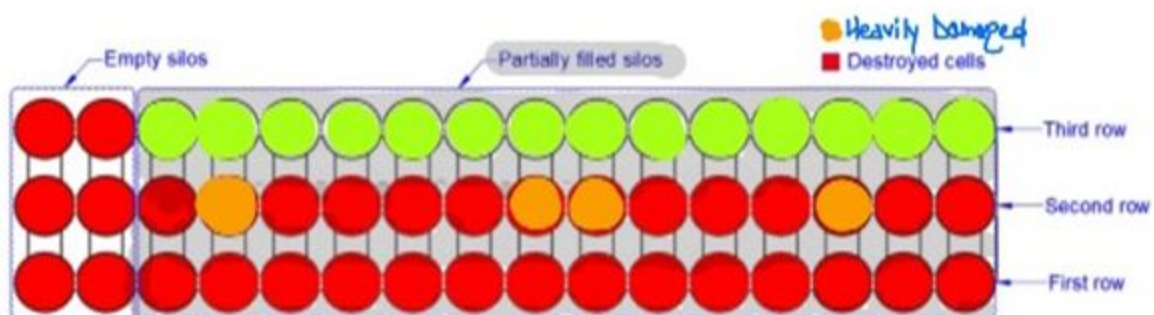
Figure 3.14. Schematic of damage levels observed on site. The top of the figure represents the western-cells furthest from the blast point.

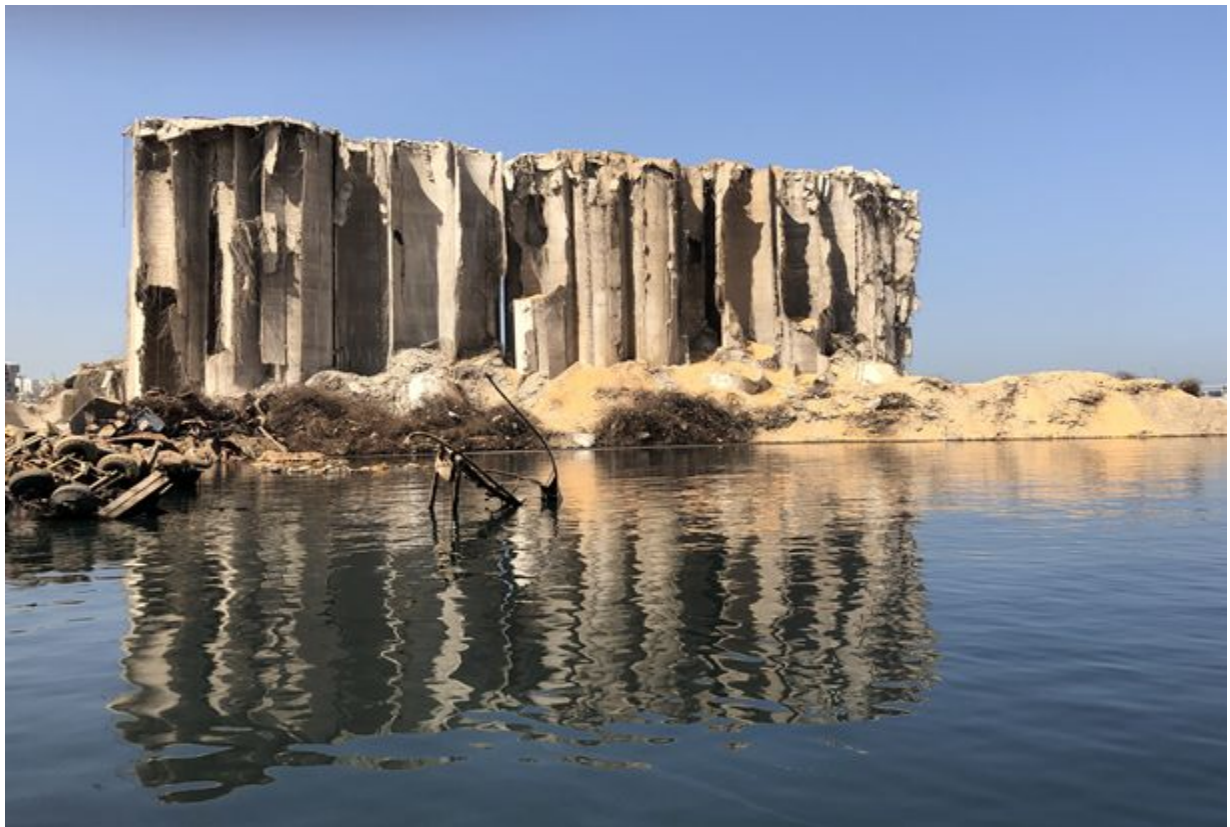
Figure 3.16. Frontal view of silos looking towards the west. Picture taken from Quay 10. ($33^{\circ}54'6.35''\text{N}$; $35^{\circ}31'16.19''\text{E}$).

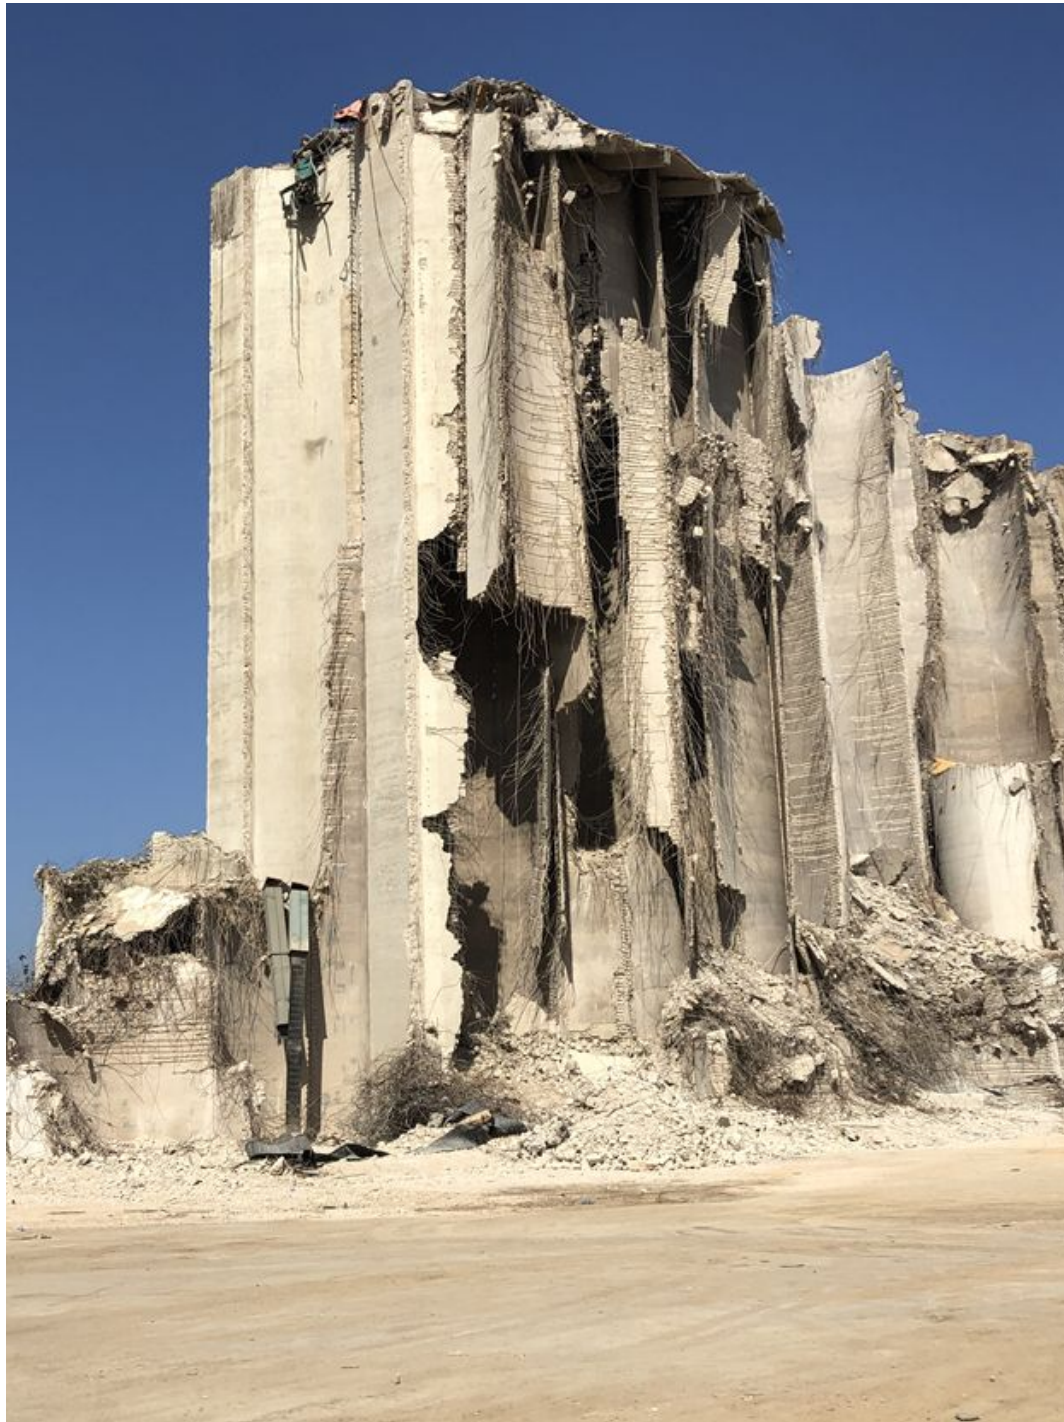
Figure 3.17. Close-up view of the destroyed and severely damaged silos that were empty at the time of the 4 August 2020 explosion (33°54'0.51"N; 35°31'7.35"E).

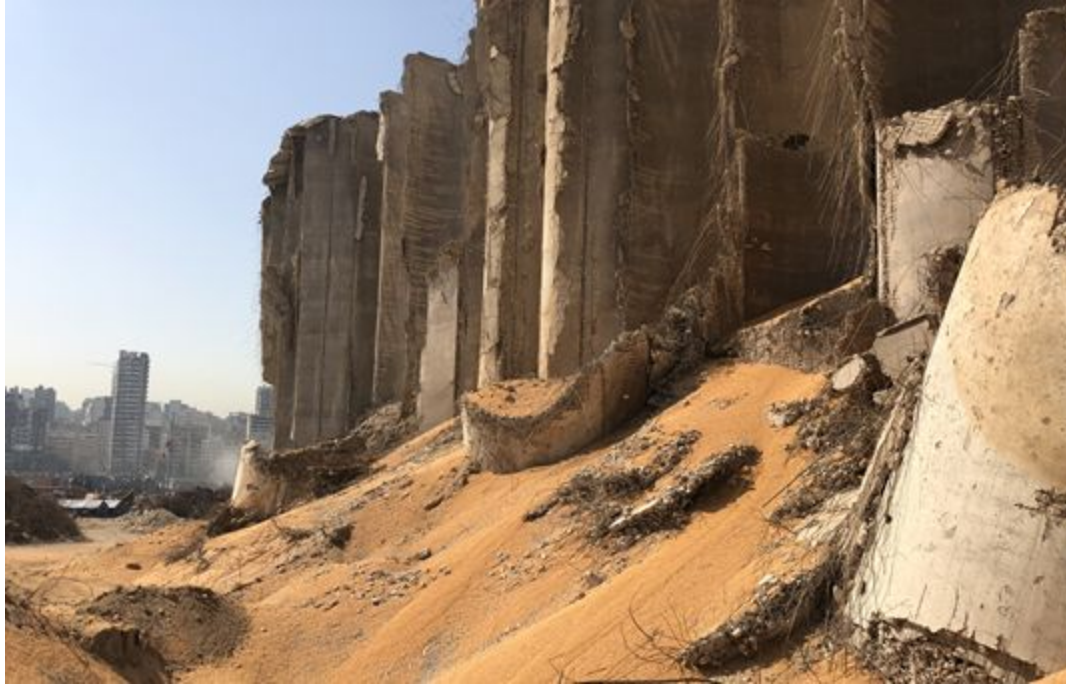
Figure 3.18. Picture taken from the seaside close to Quay 8 looking south towards the city ($33^{\circ}54'6.97''\text{N}$; $35^{\circ}31'6.54''\text{E}$) . Note the mounds of grain (corn in this case) potentially contributing to structure stability.

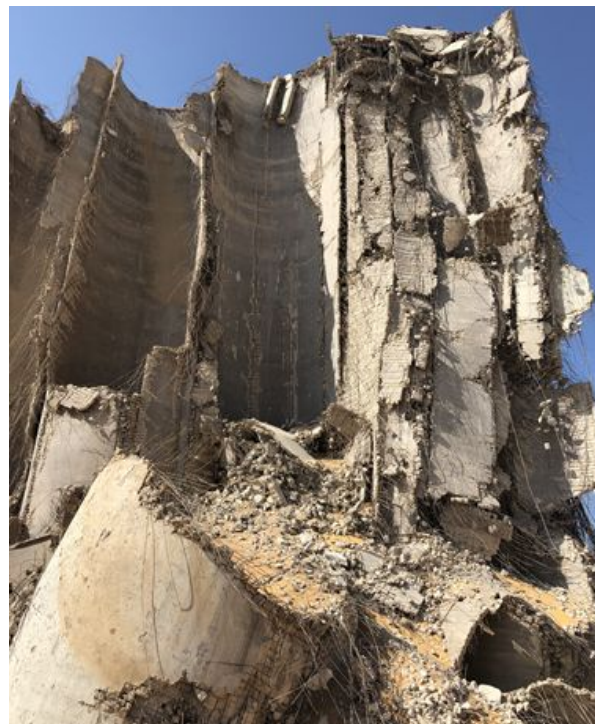
Figure 3.19. Complete failure/crushing of the concrete and collapse of the shell structures ($33^{\circ}54'6.61''\text{N}$; $35^{\circ}31'5.43''\text{E}$).

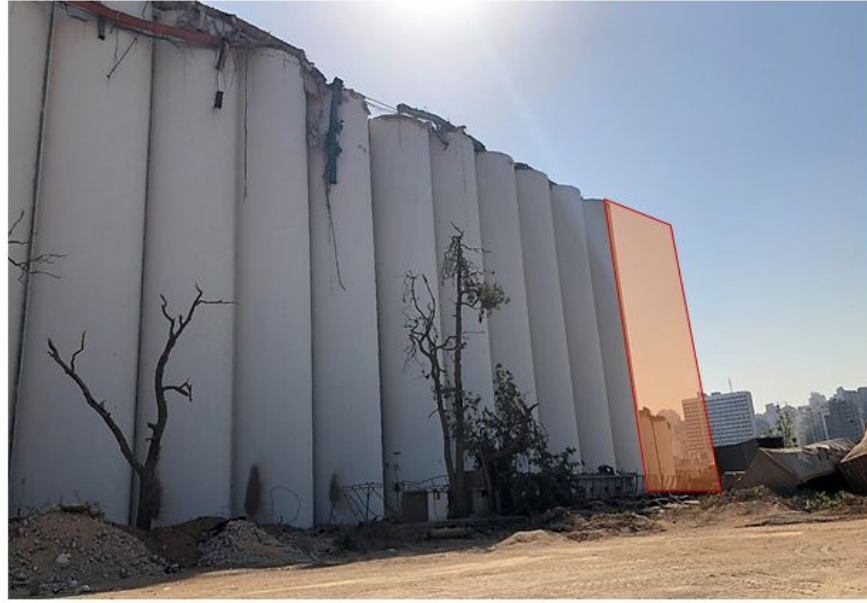
Figure 3.20. View of the third row of silos (of Phases I and II) on the opposite side of the explosion source. The location of the last two columns of silos (Phase III) is shaded in the image; those silos are completely destroyed and not visible in the picture. (33°54'5.31"N; 35°31'3.38"E).

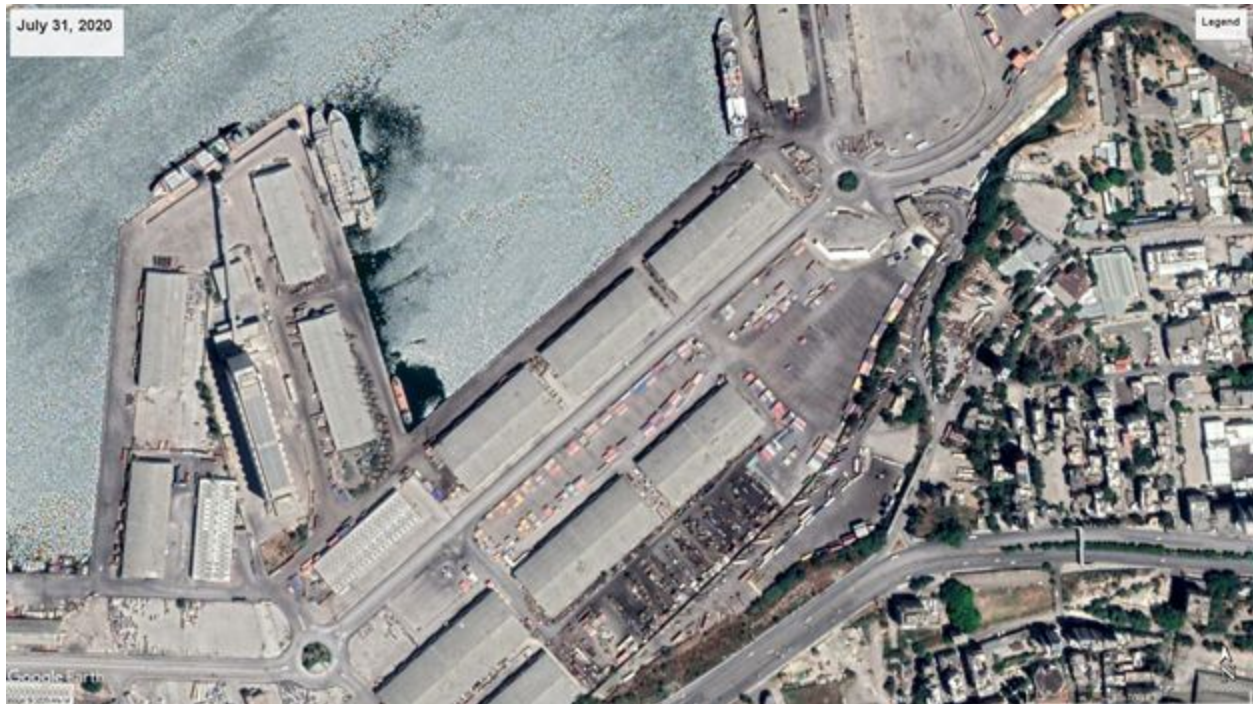
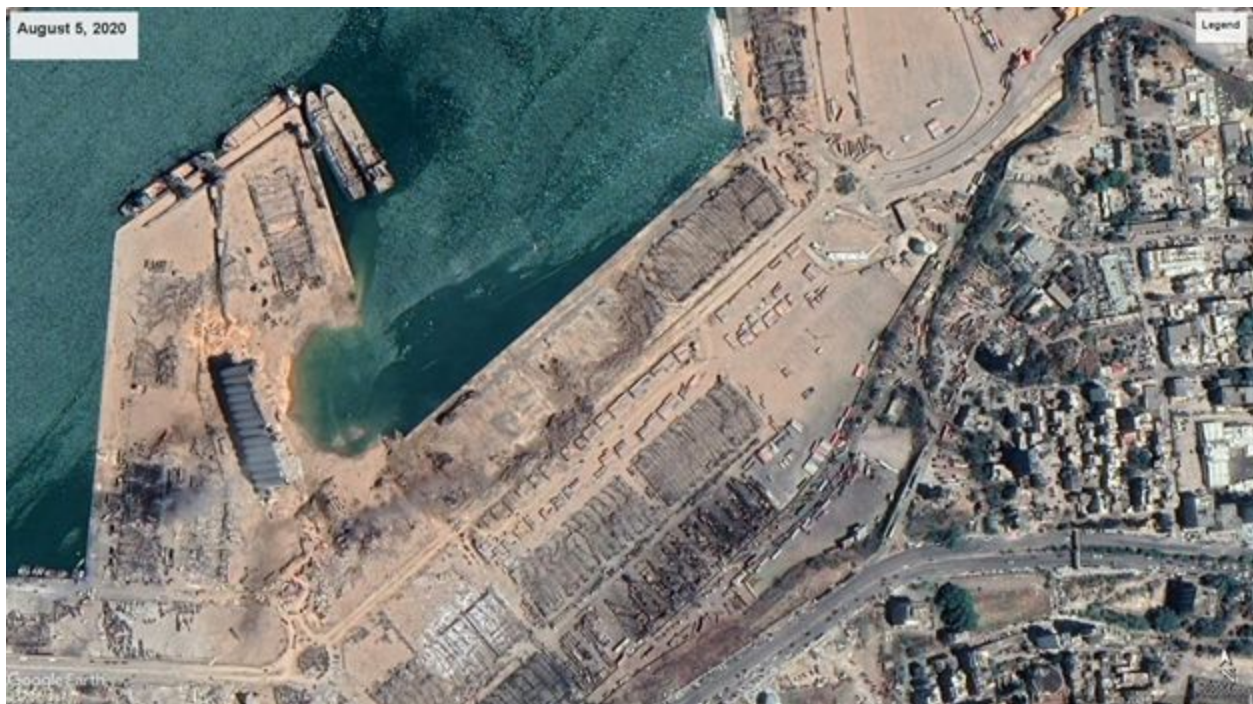
One of the most compelling features revealed by reconnaissance following the explosion is the almost 120m diameter crater left at the location of the blast source. This, along with the remnants of the silos have come to symbolize the intensity and ferocity of the energy released. Figure 3.22 includes before and after aerial view images of Hangar 12 and the crater.

Figure 3.22. Aerial views of ground zero (Hangar 12) prior to (31 July 2020) and immediately following (4 August 2020) the explosion (Google Earth).

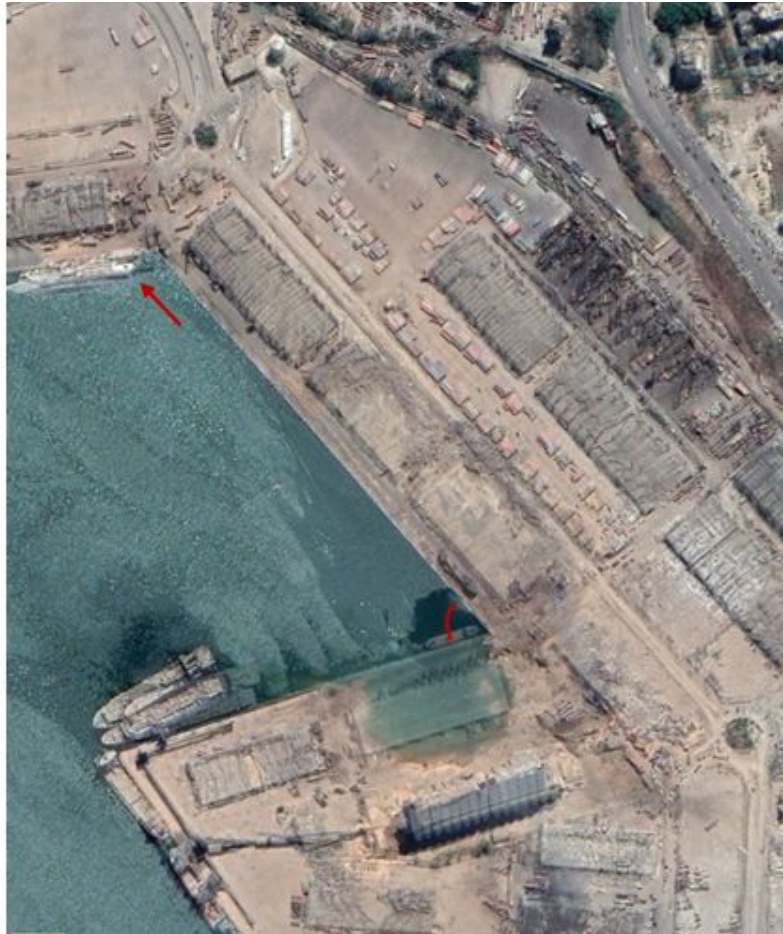
In Figure 3.23, we superimpose the before and after images to provide a clearer view of the extent of the crater and related damage to docked vessels. Some of these vessels capsized, whereas a lighter ship was carried across Basin 3 and made landfall on an adjacent dock.

Figure 3.23. Superimposed Google Earth (™) images from 31 July 2020 and 5 August 2020. Straight arrow on the east side of Basin 3 shows the location of a capsized vessel (the Orient Queen). Curved arrow shows the before- and after-blast positions of a vessel washed up onto Quay 10 by the blast.

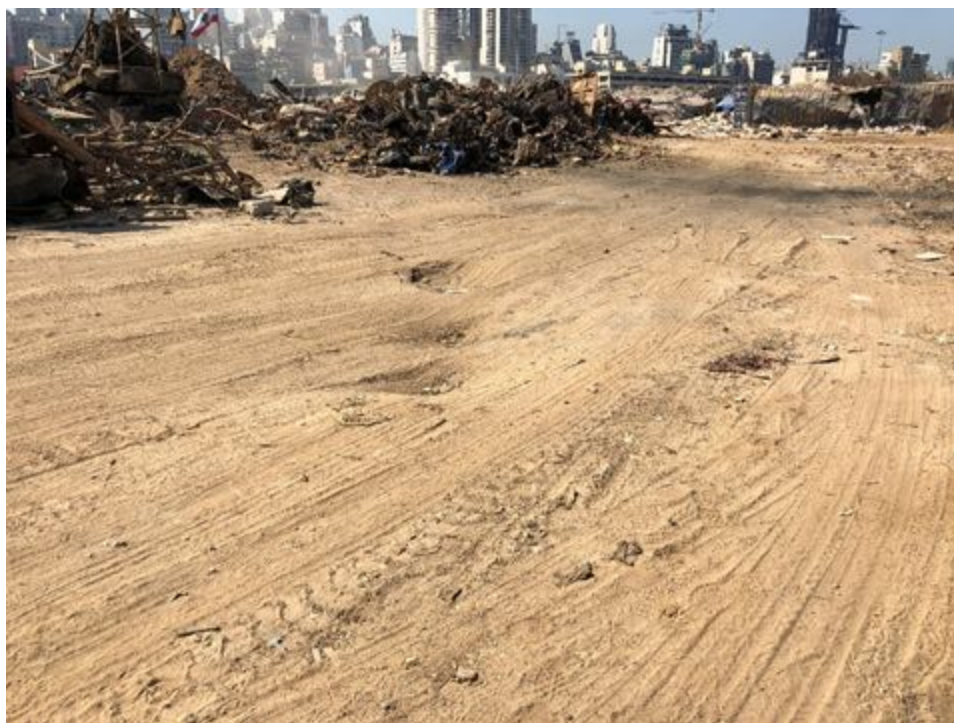
Figure 3.30. Ground deformation and mini-cratering exposed by truck traffic and possible resulting from loosening and/or shifting of the fill below. (33°54'0.86"N; 35°31'9.30"E).

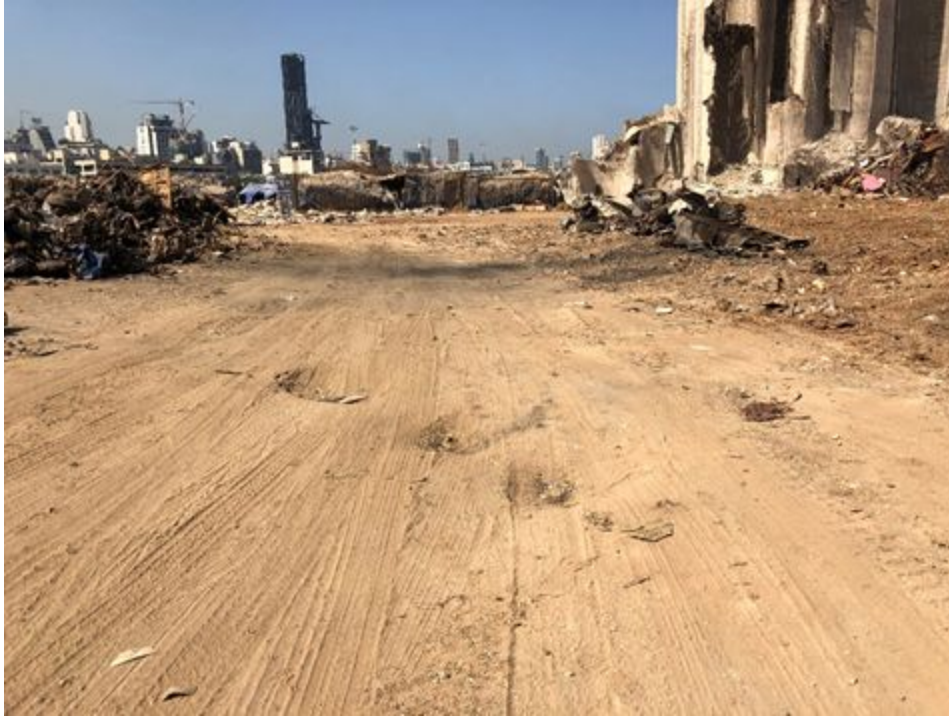
Figure 3.31. Surface expressions similar to Figure 3.30 at a location close-by. ($33^{\circ}54'1.09''\text{N}$; $35^{\circ}31'7.59''\text{E}$).

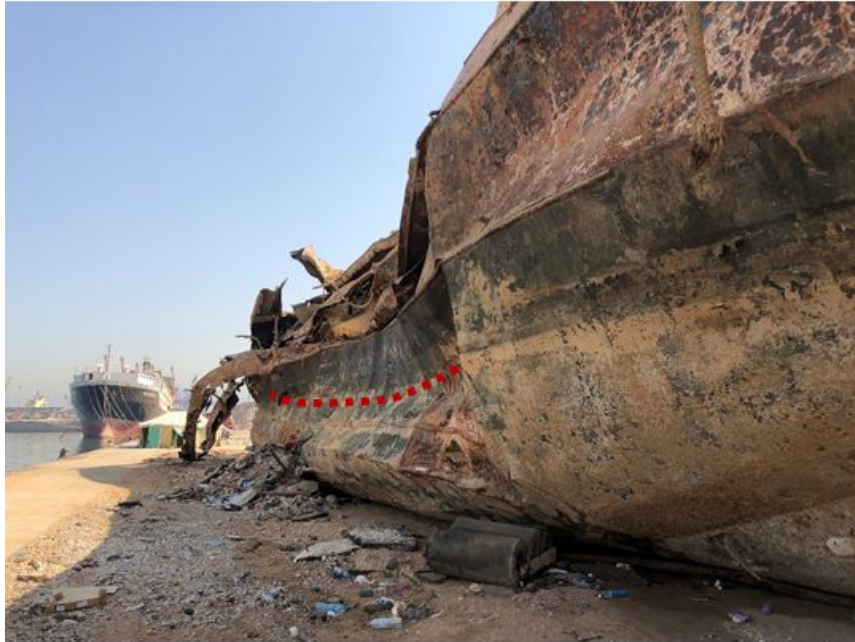
Figure 3.35. Closer view of the vessel with evidence of the indentation caused by the pressure wave. (33°54'4.13"N; 35°31'12.74"E).

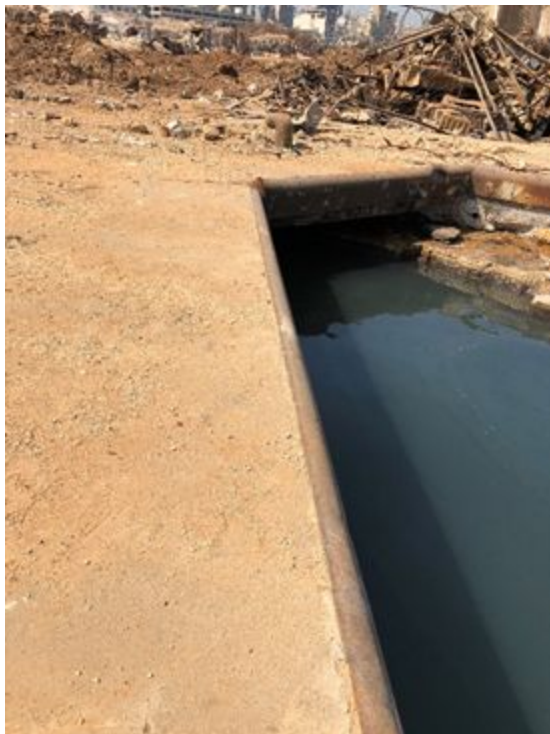
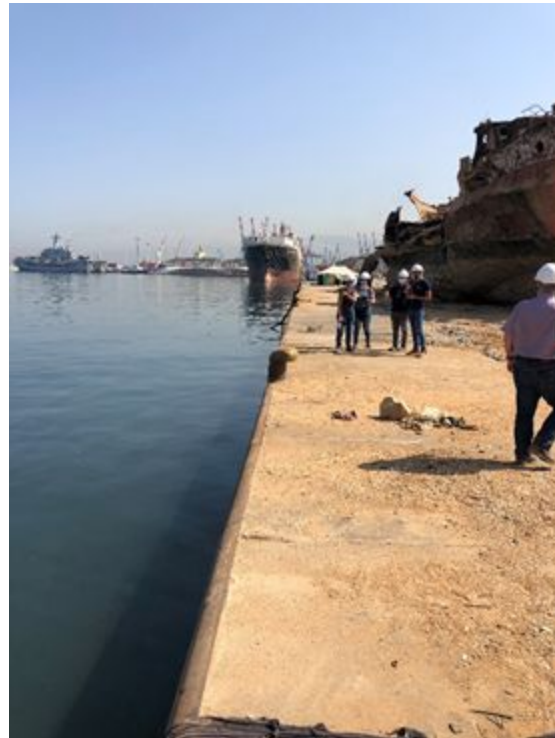
Figure 3.36. No evidence of damage to the western section of Quay 10. Alignment and level of the top quay slab in this section is intact (Location of these images is indicated by the red lines on Figure 3.29) (33°54'4.23"N; 35°31'15.04"E).

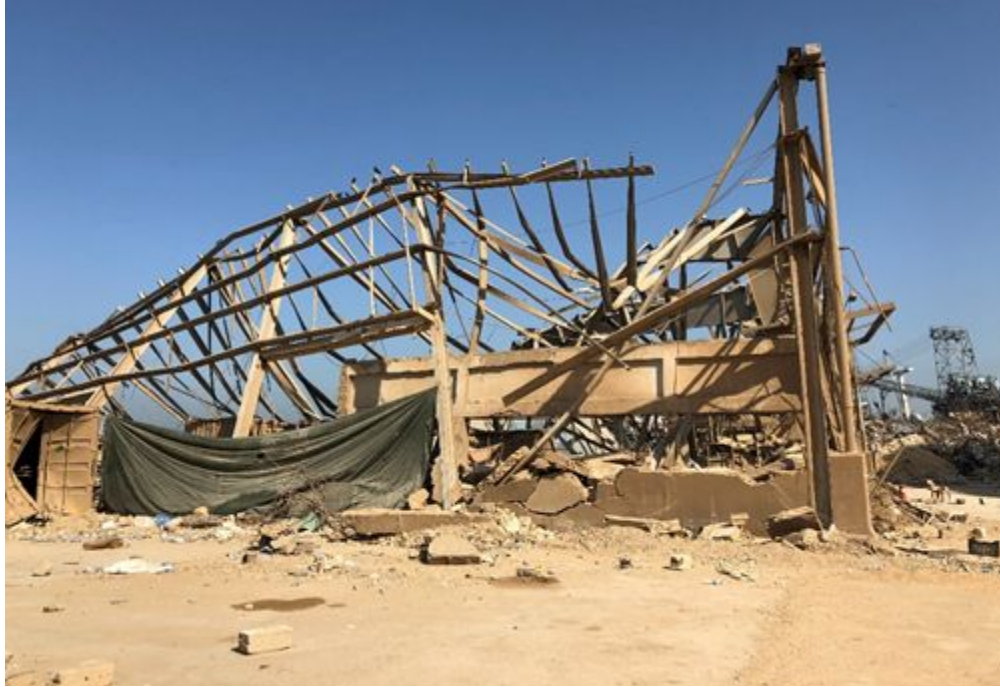
Figure 3.37. Typical damage done to steel structures throughout the Port. All suffered either this level of damage or worse (extent evident in Figure 3.29) (33°54'4.23"N 35°31'15.04"E).

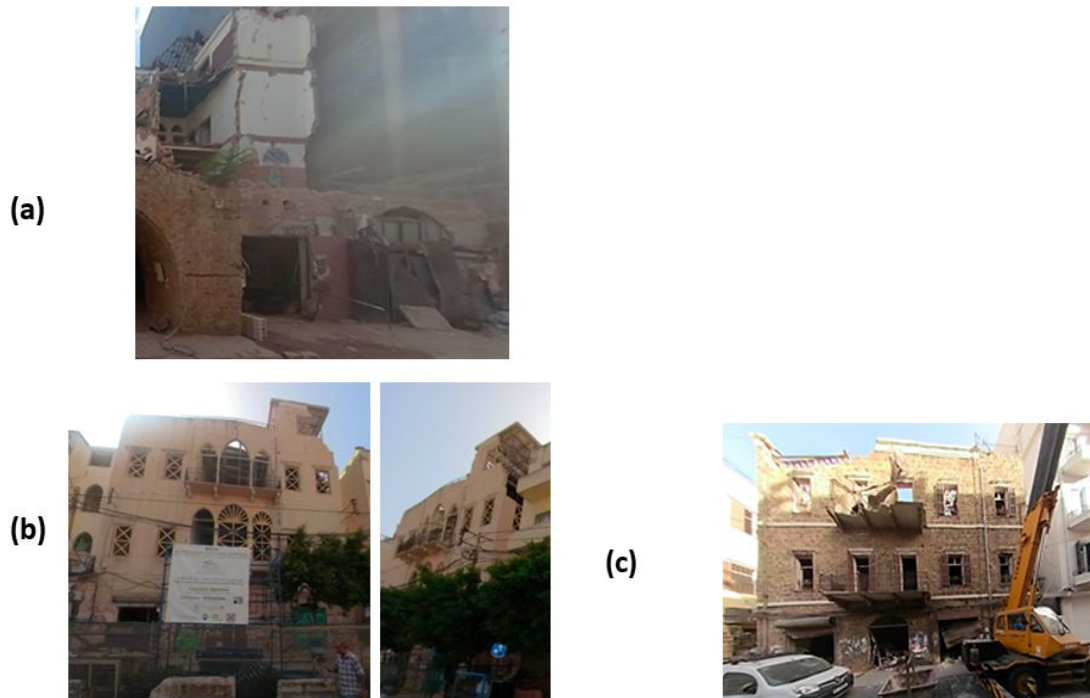
Figure 4.6. Heavily damaged stone masonry buildings classified based on 360 photos: (a) building SM1 (33.8952° N, 35.5202° E), D4-D5; (b) building SM2 (33.8956° N, 35.5223° E), D4; and (c) building SM3 (33.8953° N, 35.5172° E), D3-D4.

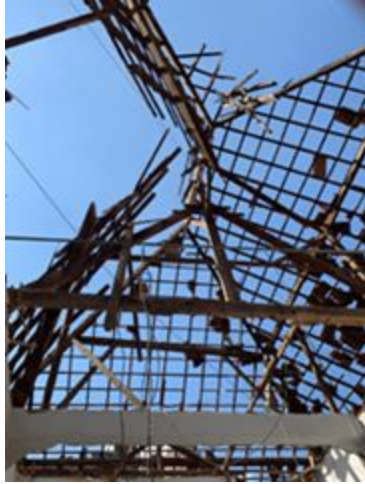
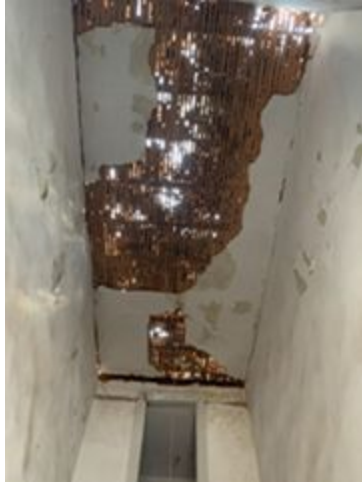
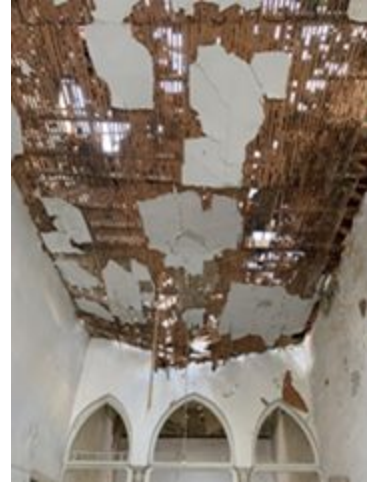
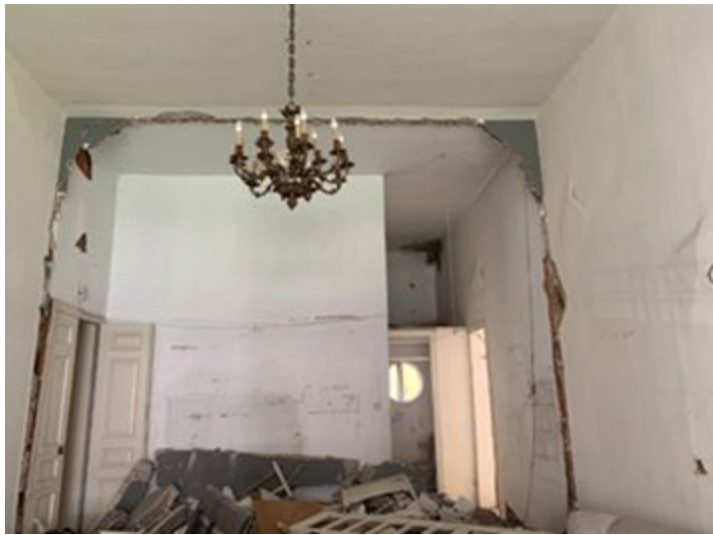
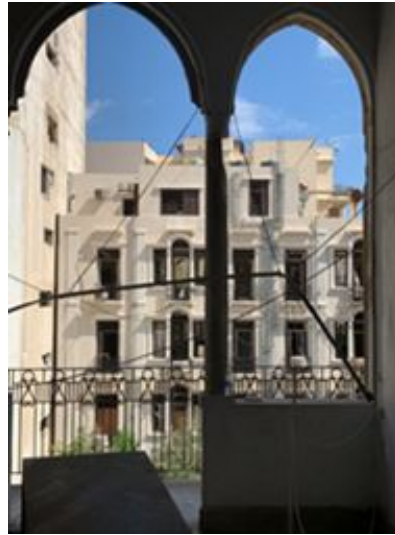
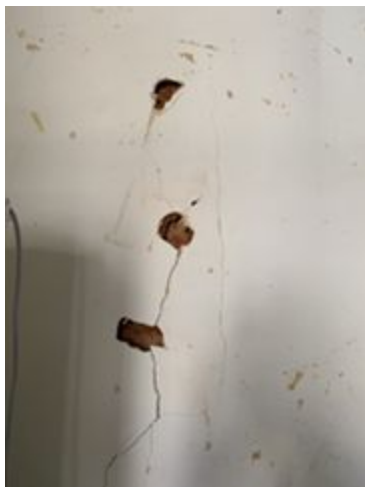
Figure 4.7. Partially collapsed (D4) stone masonry building SM4 (33.8948° N, 35.5161° E).

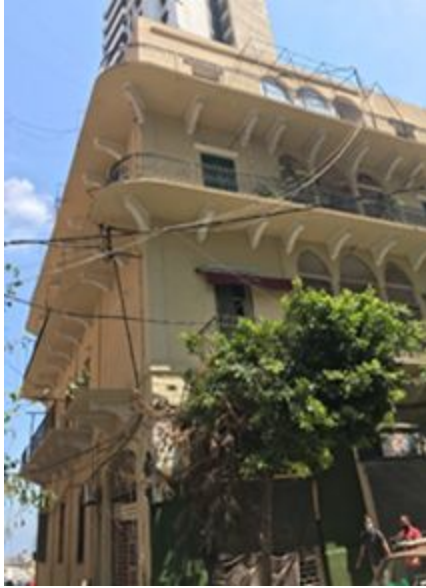
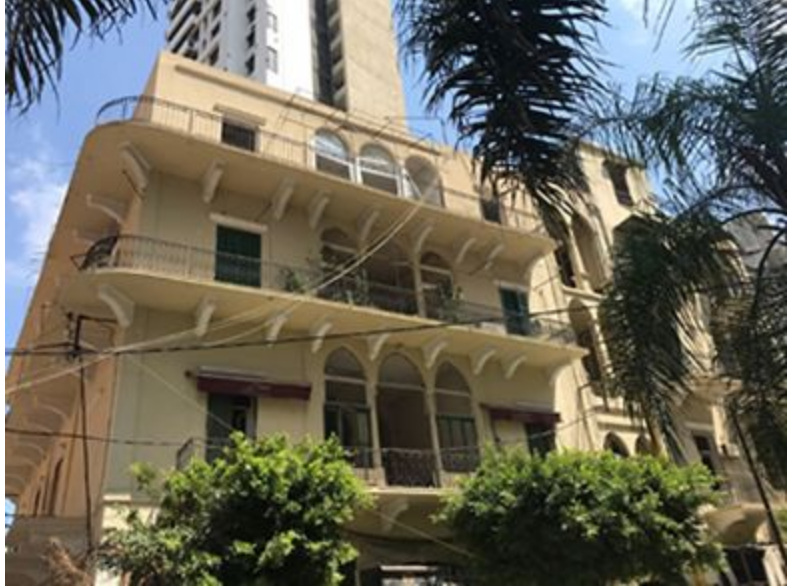
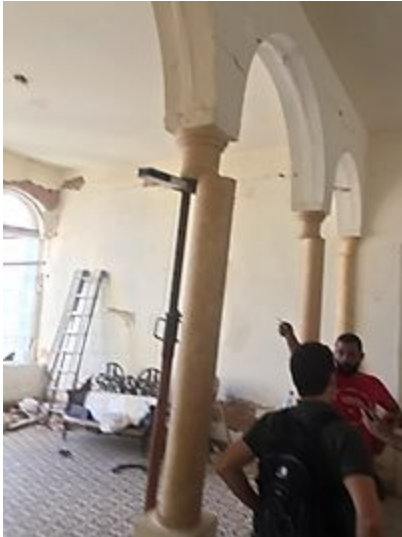
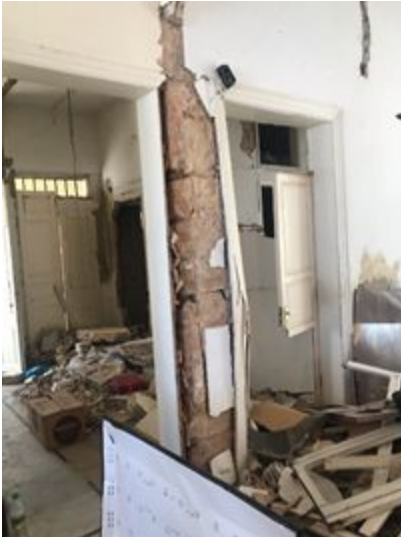
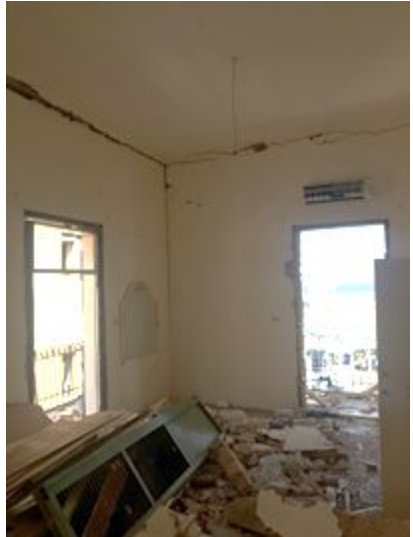
Figure 4.9. Heavily damaged (D3) stone masonry building SM6 (33.8958° N, 35.5192° E).

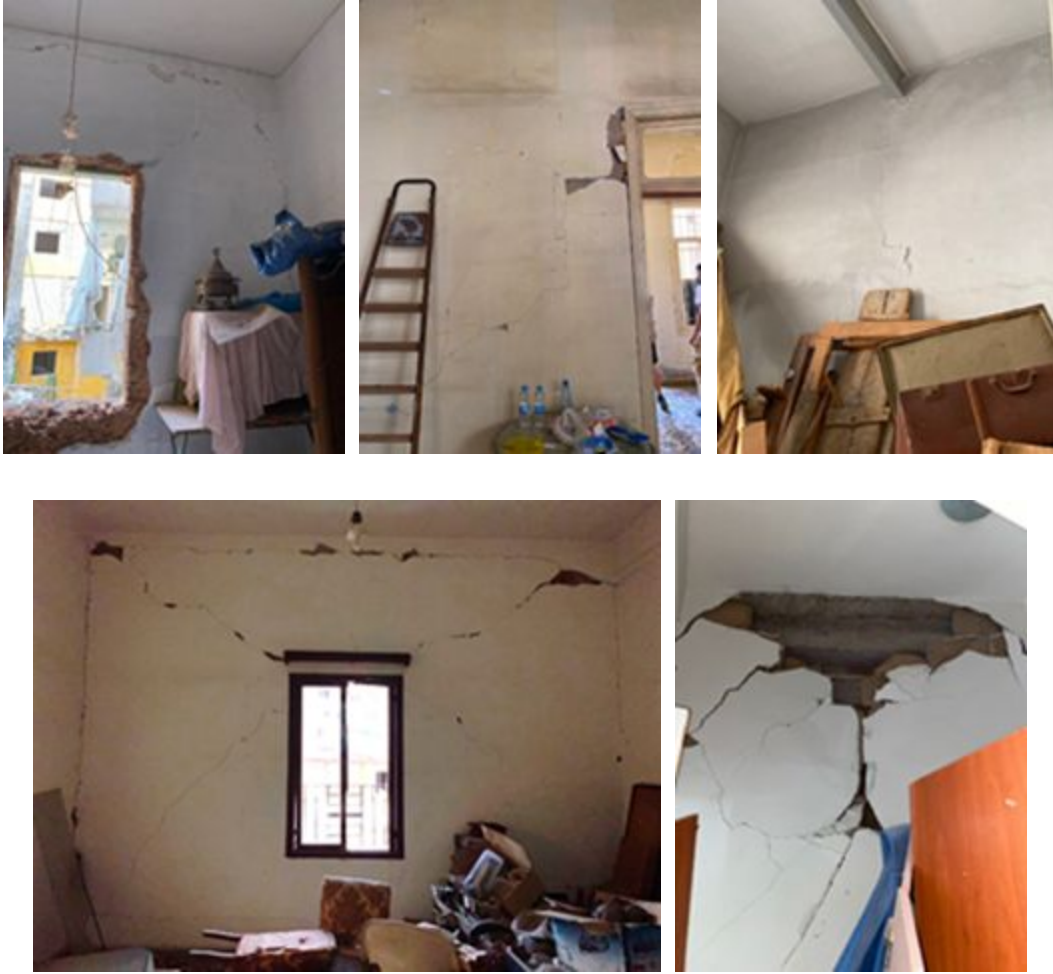
Figure 4.10. Another example of a heavily damaged (D3) stone masonry building SM7 (33.8954° N, 35.5214° E).

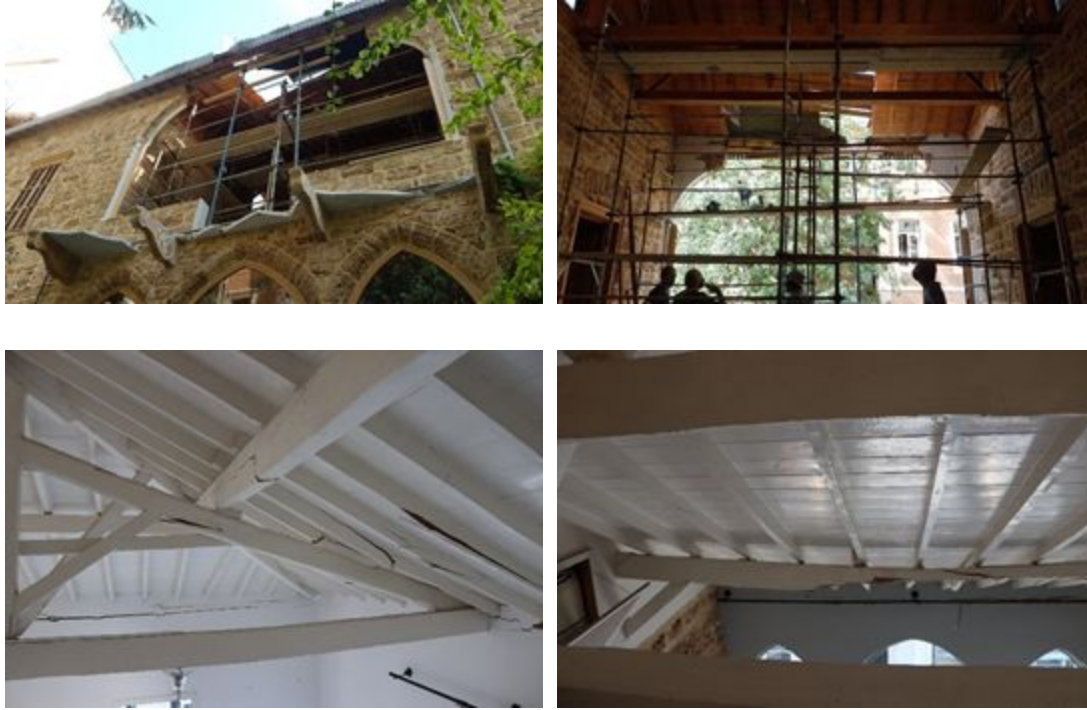
Figure 4.11. Example observations from moderately damaged (D2) stone masonry buildings: SM8 (33.8946° N, 35.5126° E) (top) and SM9 (33.8949° N, 35.5122° E) (bottom).

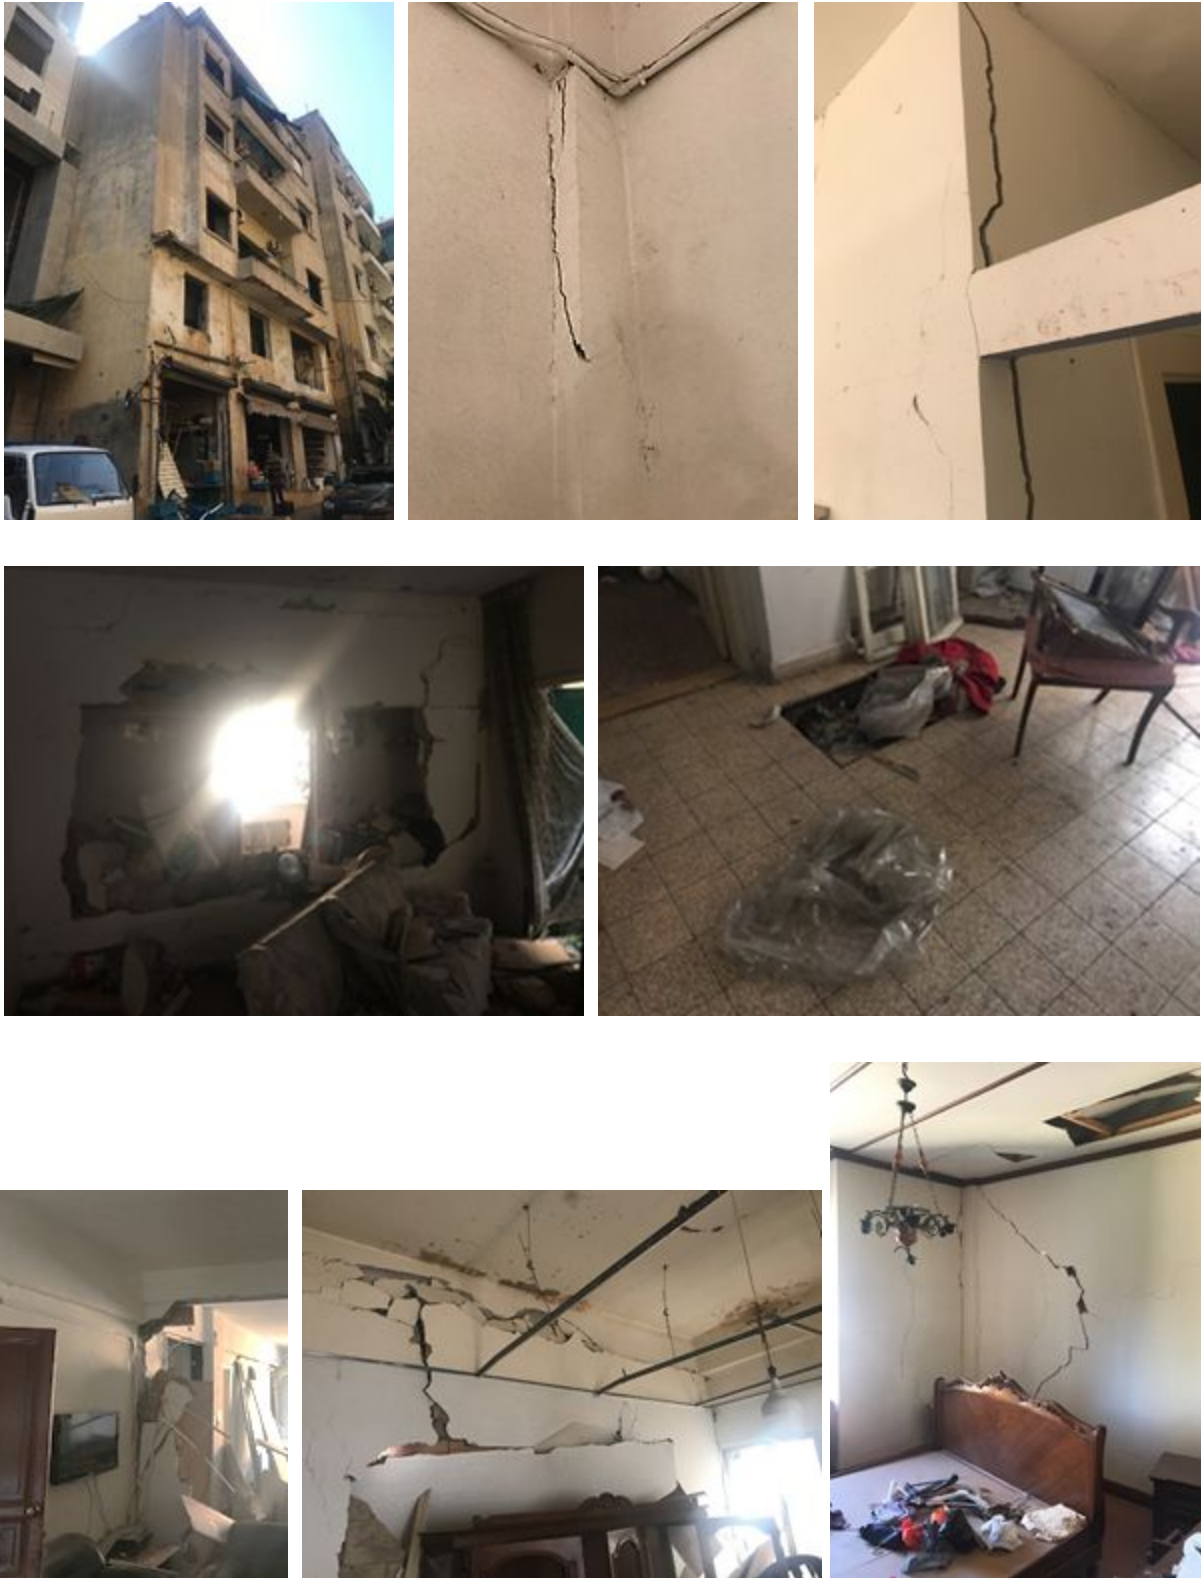
Figure 4.12. Heavily damaged (D3) older reinforced concrete building RC1 (33.8958° N, 35.5199° E).

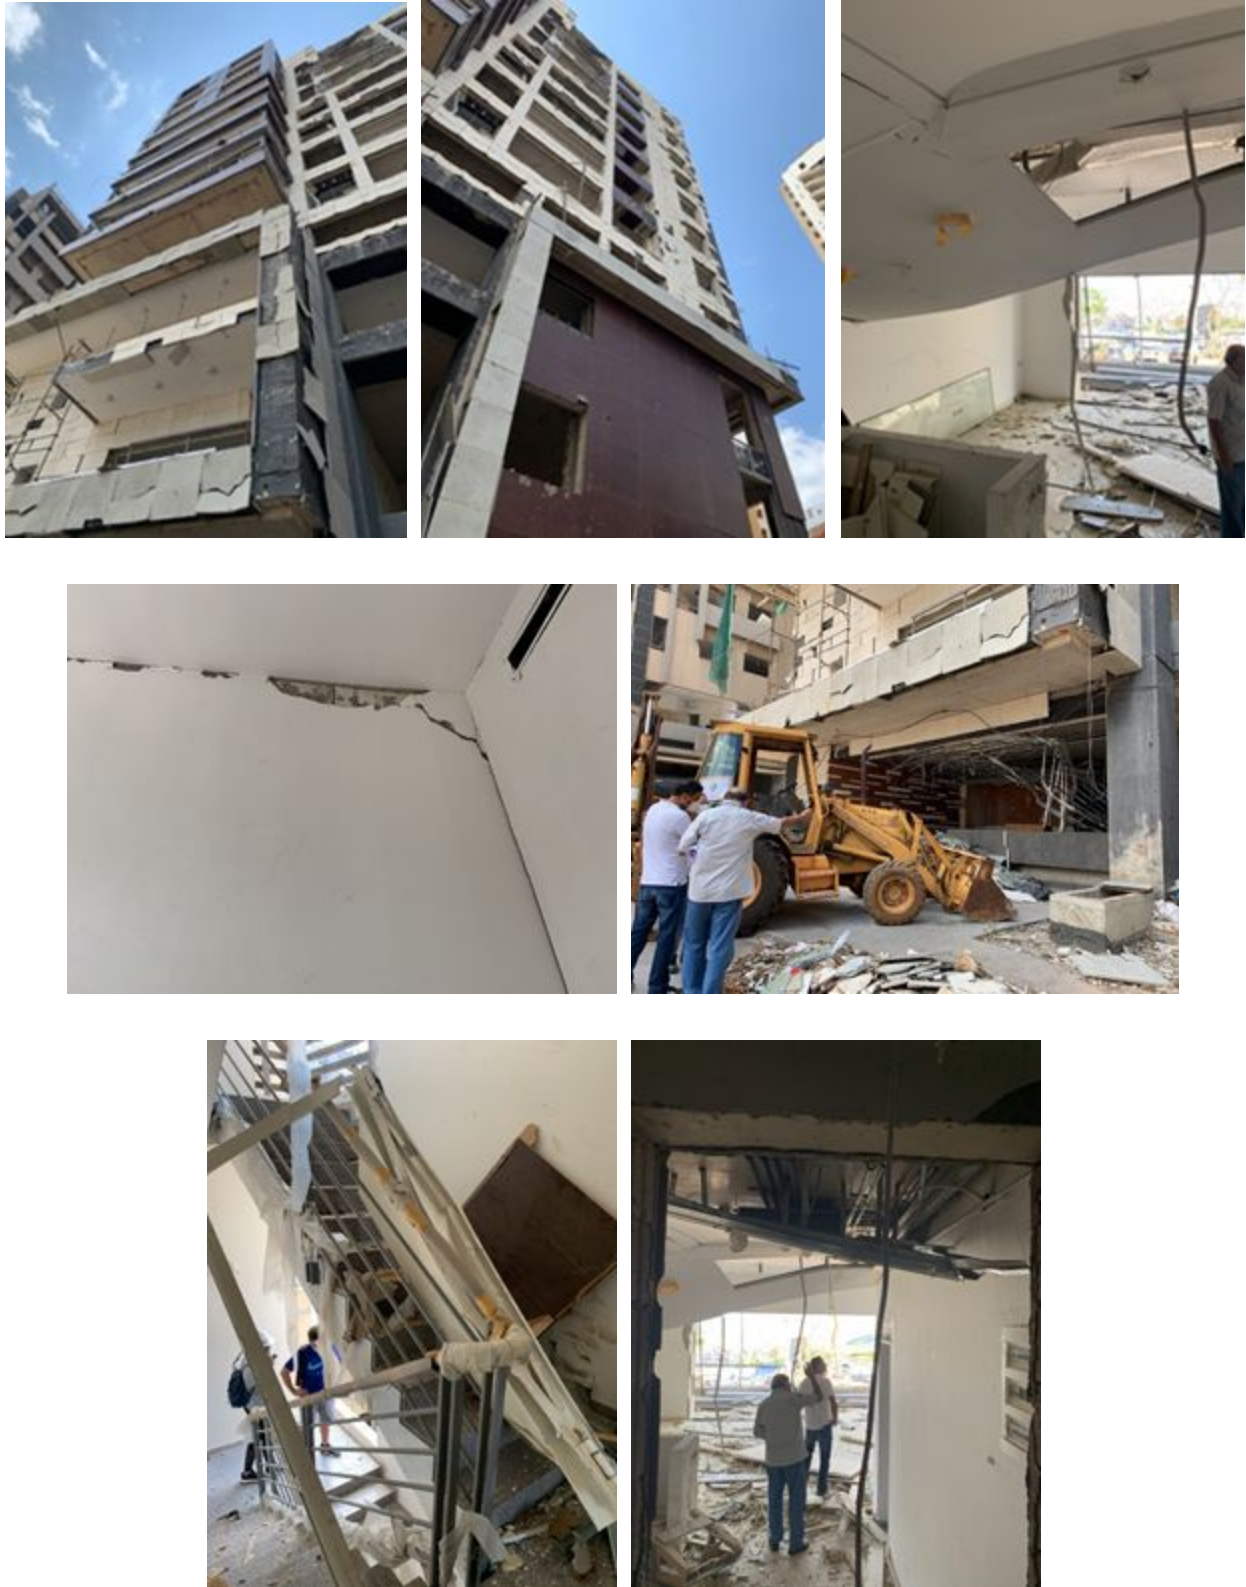
Figure 4.13. Moderately damaged (D2) new reinforced concrete building RC2 (33.8960° N, 35.5198° E).
