Engineering Impacts of the August 4, 2020 Port of Beirut, Lebanon Explosion

A report of the NSF-Sponsored Geotechnical Extreme Event Reconnaissance Association in
Collaboration with the American University of Beirut

Report GEER-070: <https://doi.org/10.18118/G6C96C>

February 4 2021

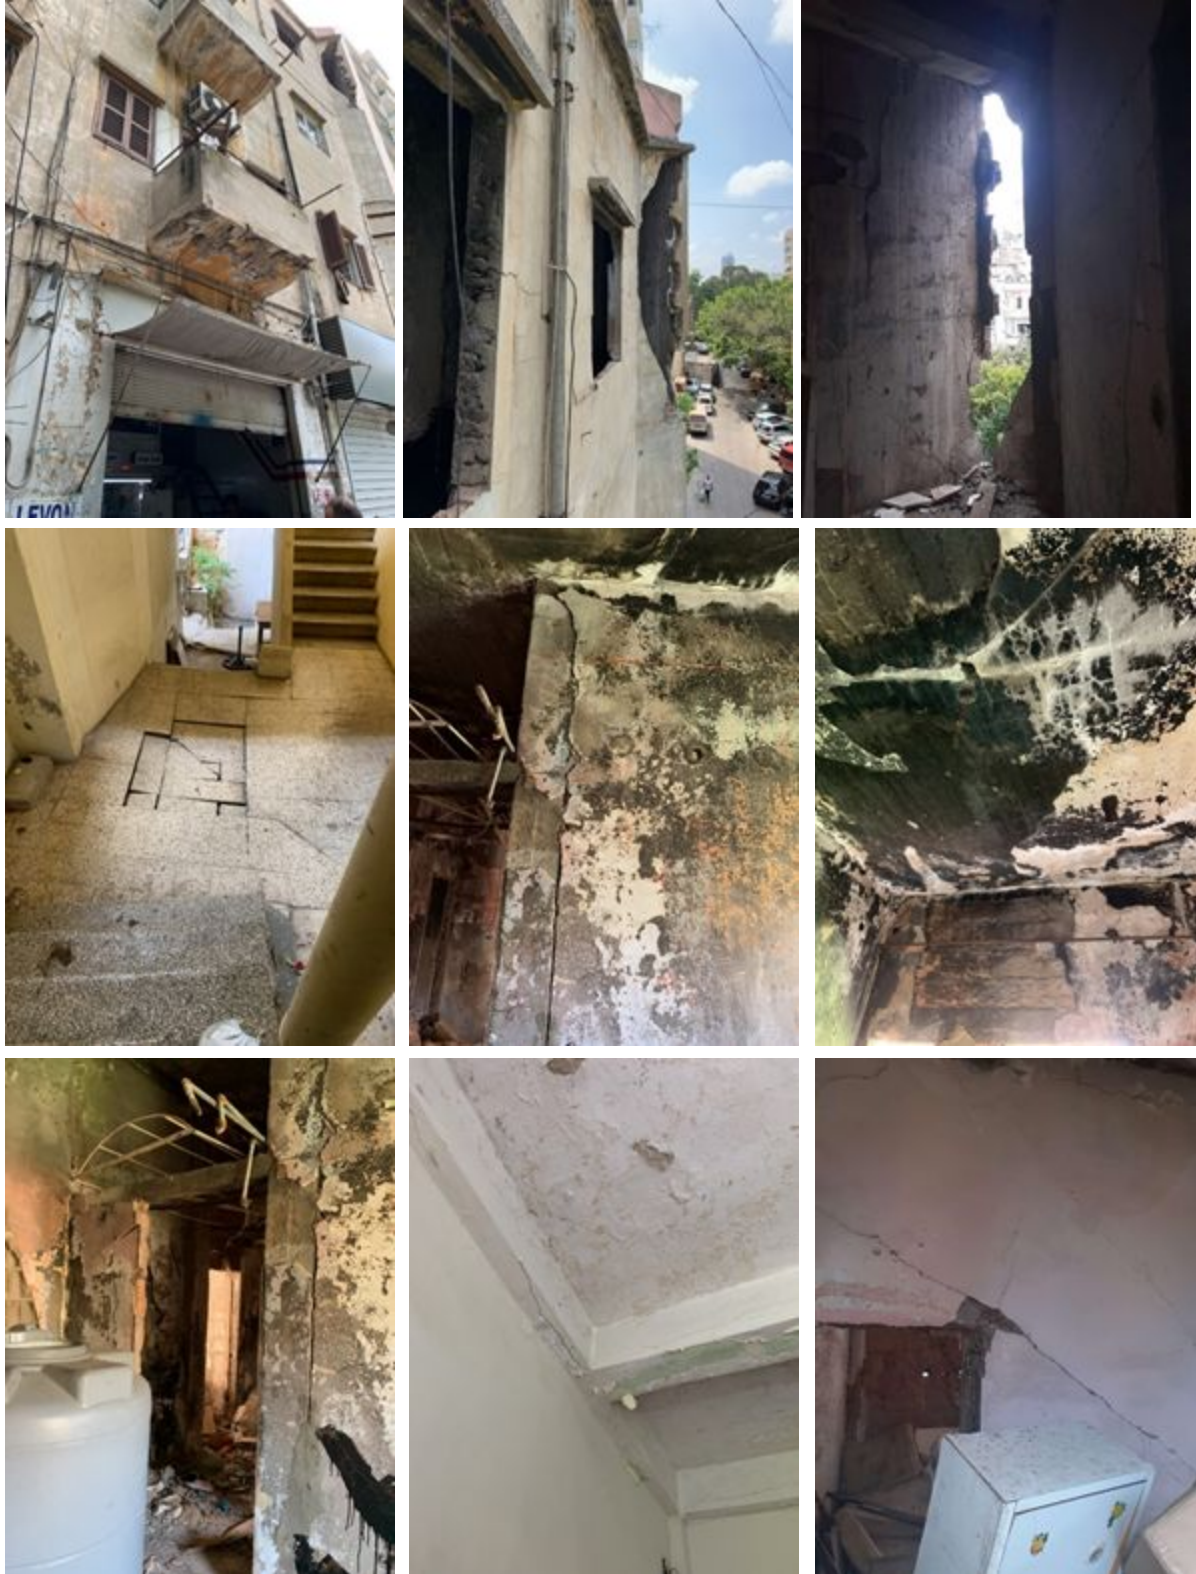
Figure 4.14. Heavily damaged (D3) older reinforced concrete building RC3 (33.8949° N, 35.5335° E) in poor condition before the blast.

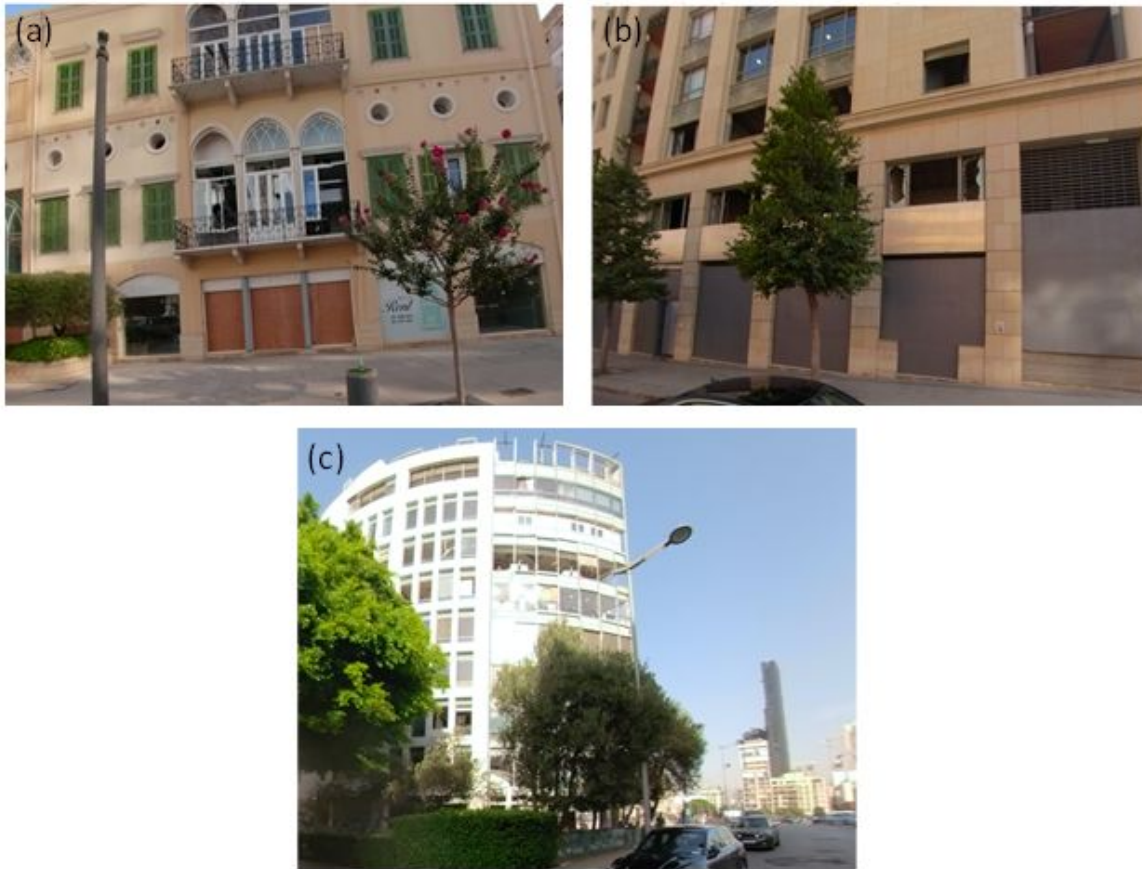
Figure 4.17. Example of façade damage levels (a) Wxx-1: damage to windows only, (b) Wxx-2: damage to windows and frames, and (c) Wxx-3: complete blow-out of frames.
