Geotechnical Extreme Events Reconnaissance

Geotechnical Reconnaissance:
The 28 September 2018 M7.5 Palu-Donggala, Indonesia Earthquake

(Version 1.0; 3 April 2019)

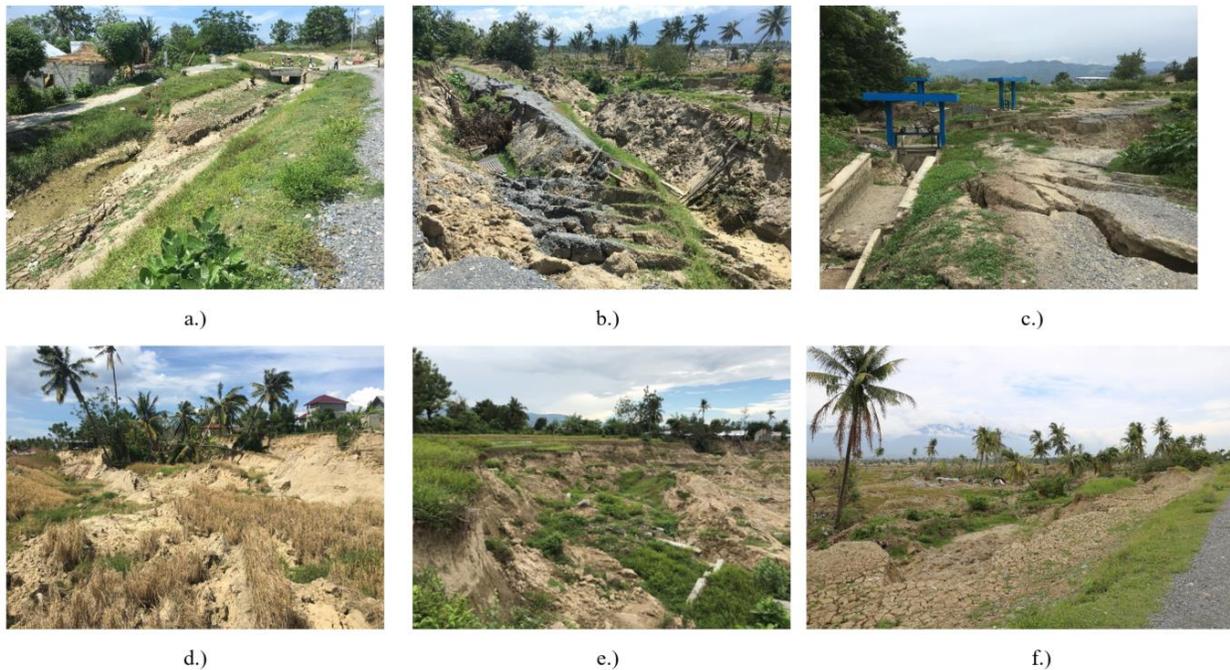
water in the canal was previously controlled by two sluice gates in the northeast corner of the slide, where the irrigation canal transitioned from an unlined system to a concrete-lined channel. Figure 3.7c illustrates the damage to the lined canal, sluice gates, and the lateral extension and vertical displacement of blocks in the northeastern corner of this site. The lined portion of the channel extending into the footprint of the slide was destroyed and buried beneath debris.

Figure 3.7. Observations in Zone A: a.) cracking in the irrigation canal (-0.93791, 119.92157); b.) collapse of canal walls near head scarp (-0.93832, 119.92154); c.) damage and vertical displacement of gates in northeast corner of slide where the canal turns and runs east to west (-0.936019, 119.920635); d.) back-rotated blocks near head scarp at the center of the slide (-0.938349, 119.921008); e.) back-rotated blocks and head scarp in northeast corner of the slide (-0.93623, 119.92018); f.) overlooking back-rotated block field in the southeast corner of the slide (0.94071, 119.92258).

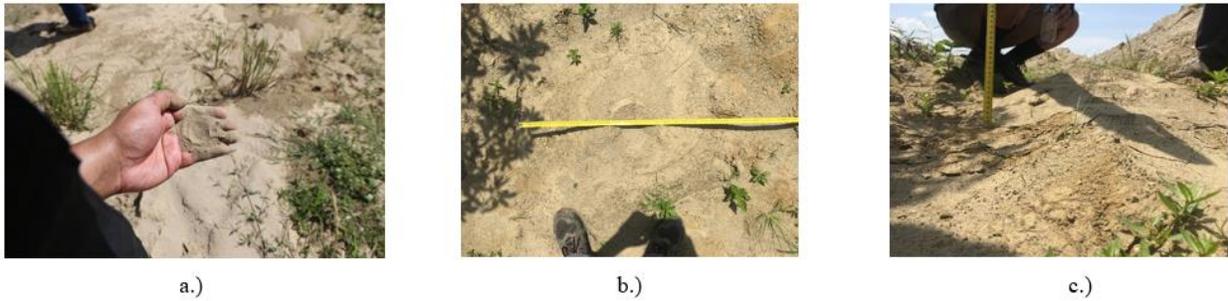
Figure 3.8. Sand boils: a.) typical sand boil ejecta (-0.93850, 119.92092); b-c.) representative height and width of typical sand boils found preserved between blocks (-0.938503, 119.920425).

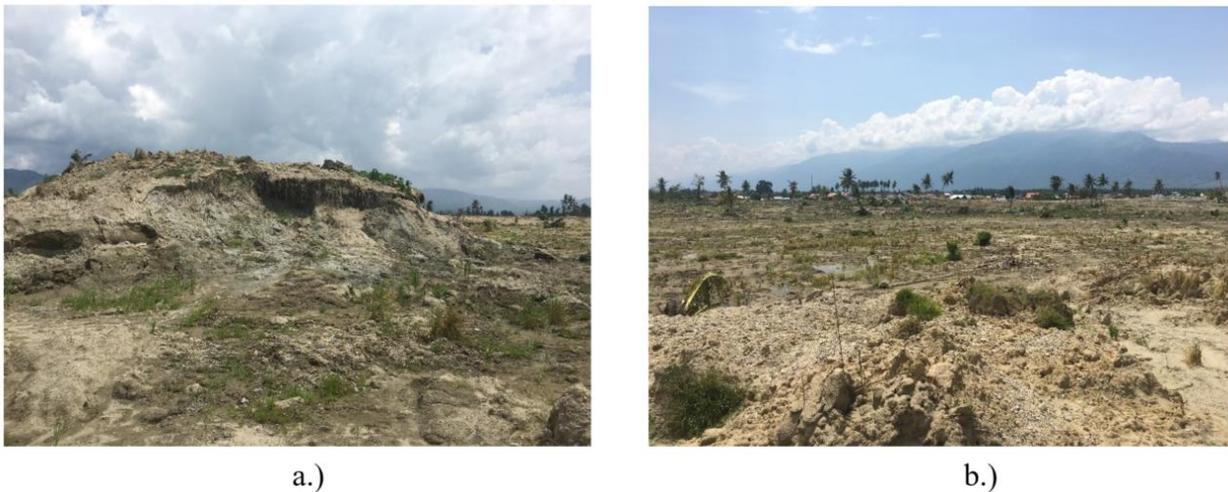
Figure 3.9. Zone B: a.) relatively large block/mound in this zone with limited vegetation and a shape that is not as well-defined as blocks in Zone A (-0.939489, 119.917507); b.) debris flow deposits and mounds in the foreground of picture near the margin of Zone C, which forms an elevated plain at the boundary of these two zones (-0.939664, 119.918263).

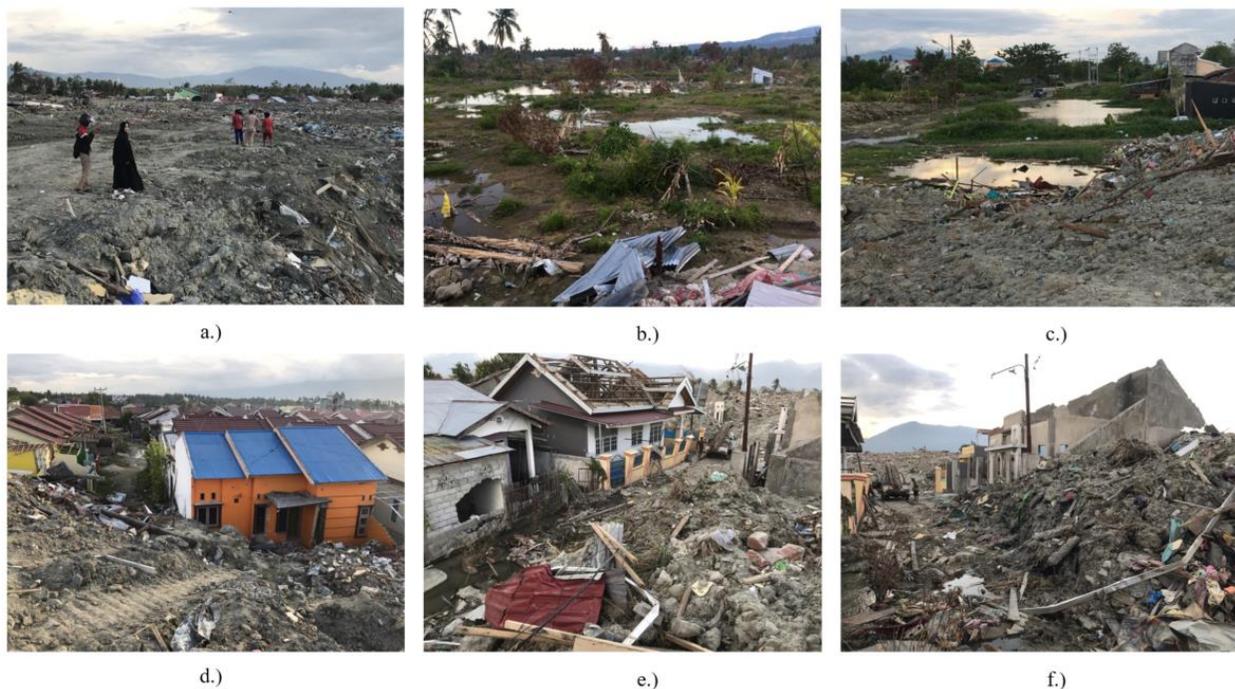
Figure 3.12. Zone E: a.) reworked areas in the center of the zone where earthwork has made morphological features unrecognizable (-0.93952, 119.90387); b.) flooded areas on the northern margins of Zone E (-0.94672, 119.90939); c.) flooded are on the southern margin of Zone E (-0.94090, 119.91040); d-f.) area along the southern margins of Zone E4 where debris flows infiltrated adjacent neighborhoods (-0.94072, 119.90413; -0.94141, 119.90977; -0.94150, 119.9068).

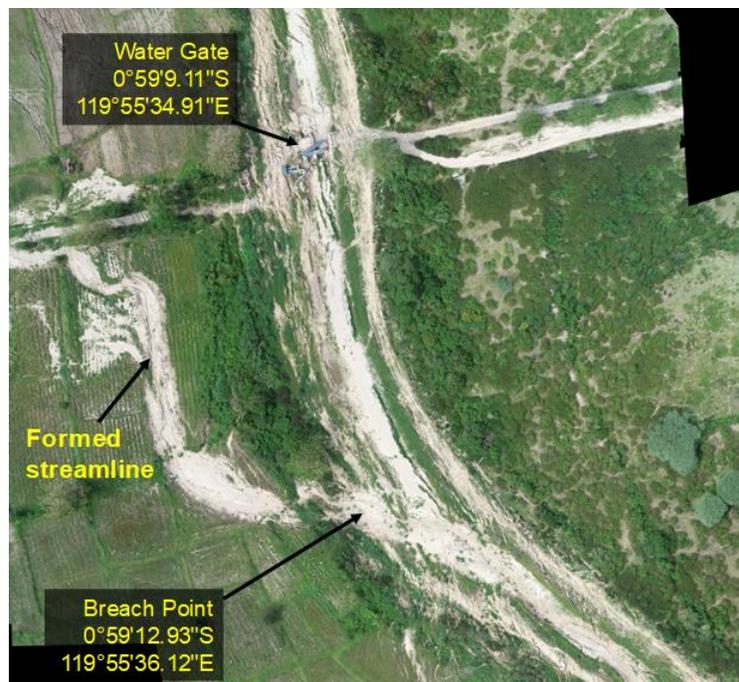
Figure 3.15. Aerial view of destroyed water gate and breach point captured by drone.

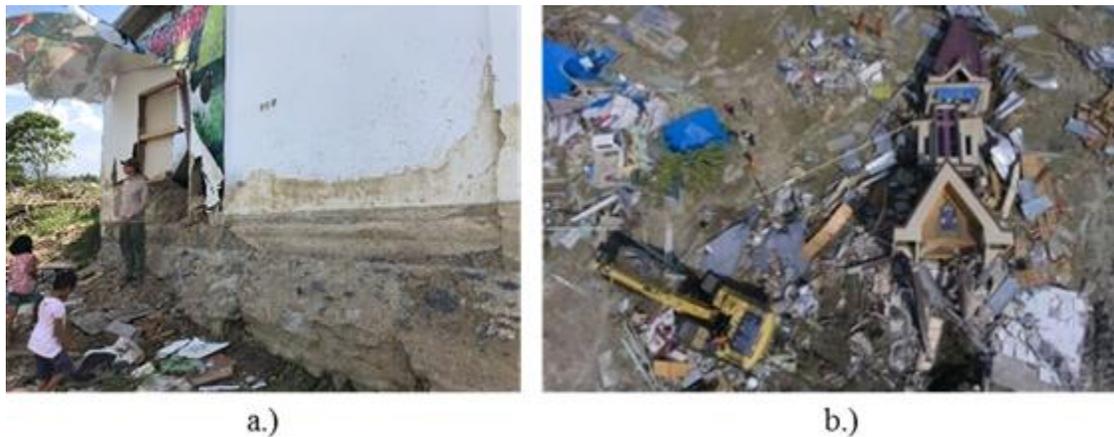
Figure 3.18. (a) Final location of the Patra Poultry Market (-0.98786, 119.90844), which displaced approximately 1,230 m ; (b) final location of the Pusklat GPID Patmos Jono Oge (-0.98942, 119.91007), which displaced approximately 1,080 m (image from Antara Foto 2018).

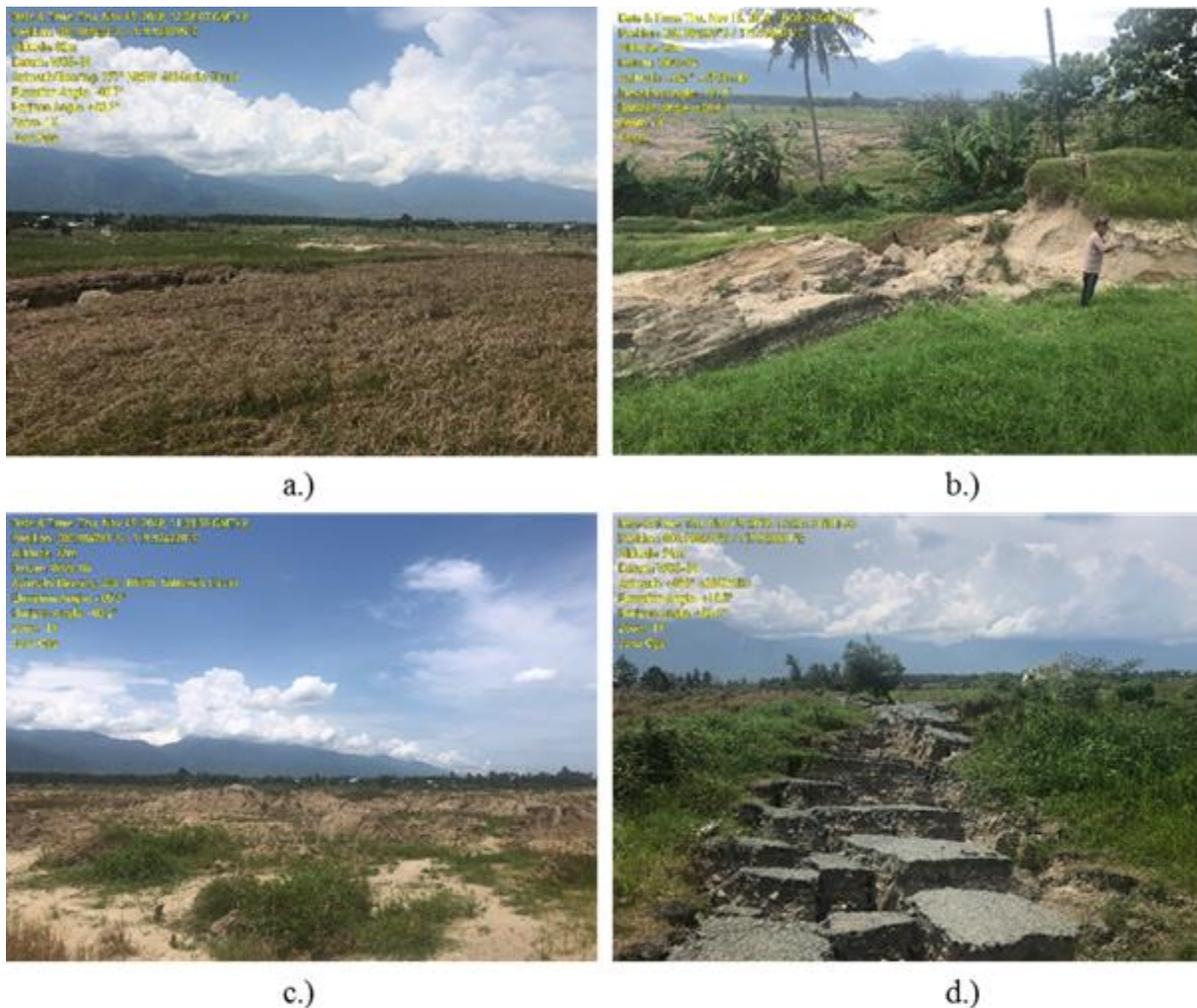
Figure 3.19. Zone A: (a) View of an intact rice paddy and the head scarp of the flowslide at Jono Oge (-0.98540, 119.92580); (b) intersection of the head scarp with the canal (-0.98423, 119.92607); (c) formation of rotated blocks and extensional cracks in the area of the canal breach (note the sand deposited by the subsequent flooding; -0.98478, 119.92423); (d) damage to a road along the southern edge of the flowslide (0.98623, 119.92383).

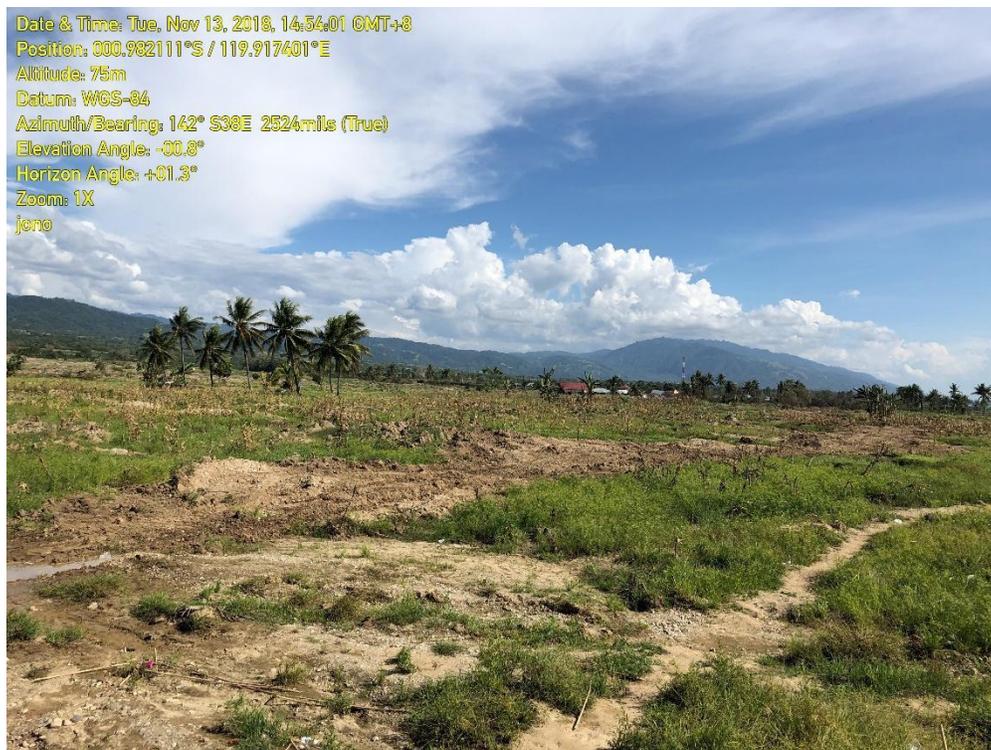
Figure 3.20. Zone B: Zone B consists of rafted blocks that moved into the main failure area after the soil in this area was displaced (-0.98211, 119.91760).

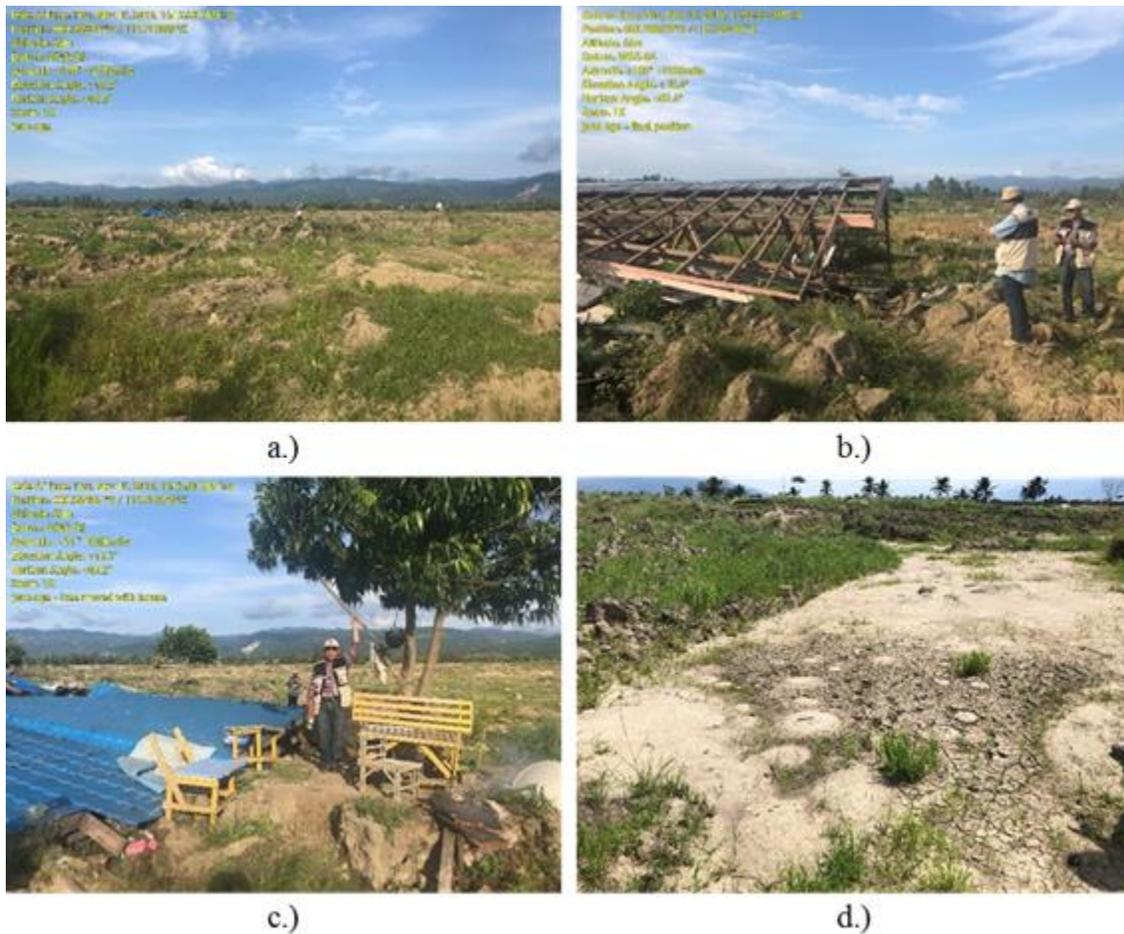
Figure 3.21. Zone C: (a) Much of Zone C was low-lying and areas between blocks were often saturated (-0.98539, 119.91938); (b) collapsed structure located in Zone C (-0.98364, 119.92071). The metal roofing was removed after the earthquake; (c) collapsed structure and tree, which had moved approximately 470 meters on a relatively intact block of crust (-0.98436, 119.91995); (d) cluster of sand boils between two blocks of crust (-0.98410, 119.92163). Note the pen on one of the sand boils in the foreground is approximately 15 cm long.

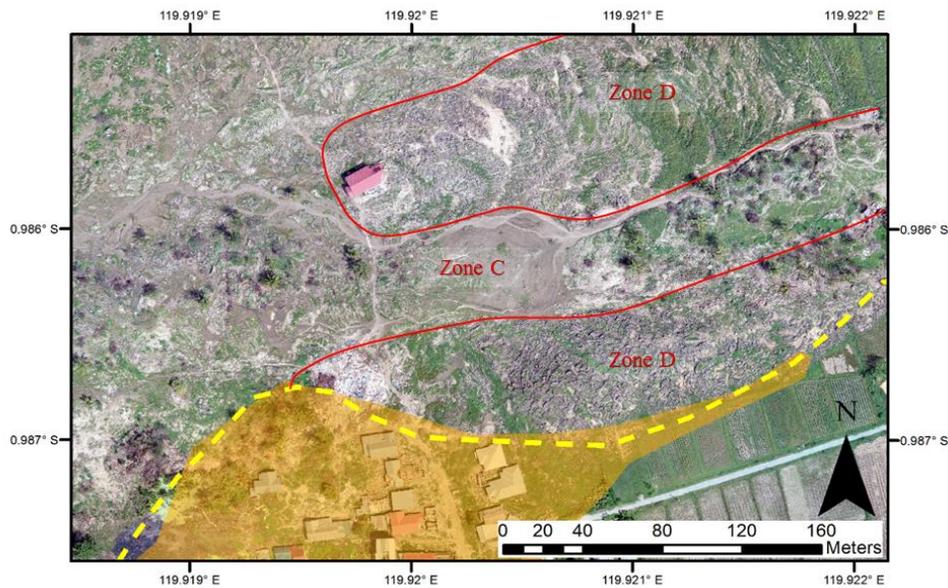
Figure 3.22. Drone imagery of the secondary failure zone along the southern edge of the flowslide at Jono Oge.

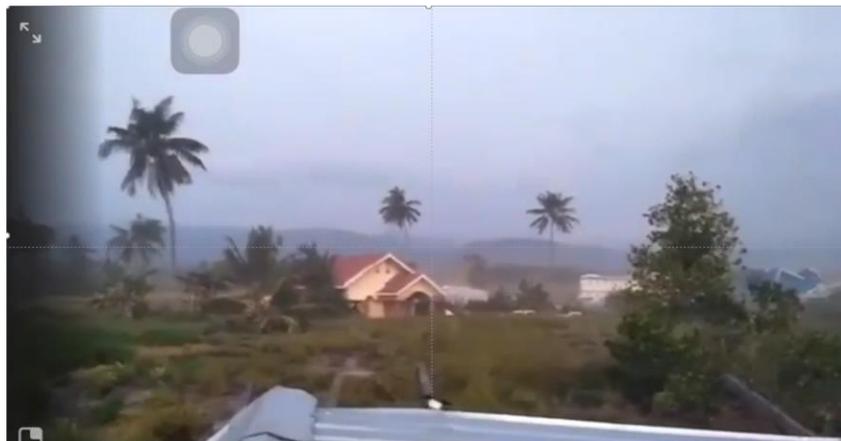
Figure 3.23. Screenshot of a video recorded during the initial failure. The person recording the video is standing on the roof of a building, which is moving. The red roofed house in the video is not moving and is located at -0.98579, 119.91965. The buildings behind the red roofed house have not moved at the time the video was recorded, but were displaced by a secondary failure.

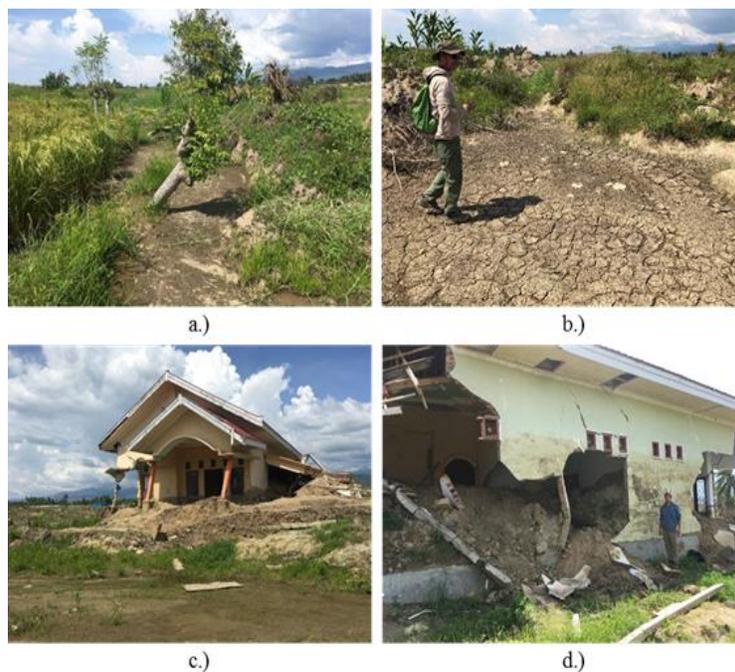
Figure 3.24. Zone D: (a) Tree in between two intact blocks of rice paddies (-0.98554, 119.22403); (b) small sand boils in a low-lying area between blocks of crust (-0.98483, 119.92223); (c) view of the red roofed house looking northeast (-0.98595, 119.91951); (d) damage to the side of the red roofed house looking southwest (-0.98566, 119.91973). The person in the photo is approximately 1.87 meters tall.

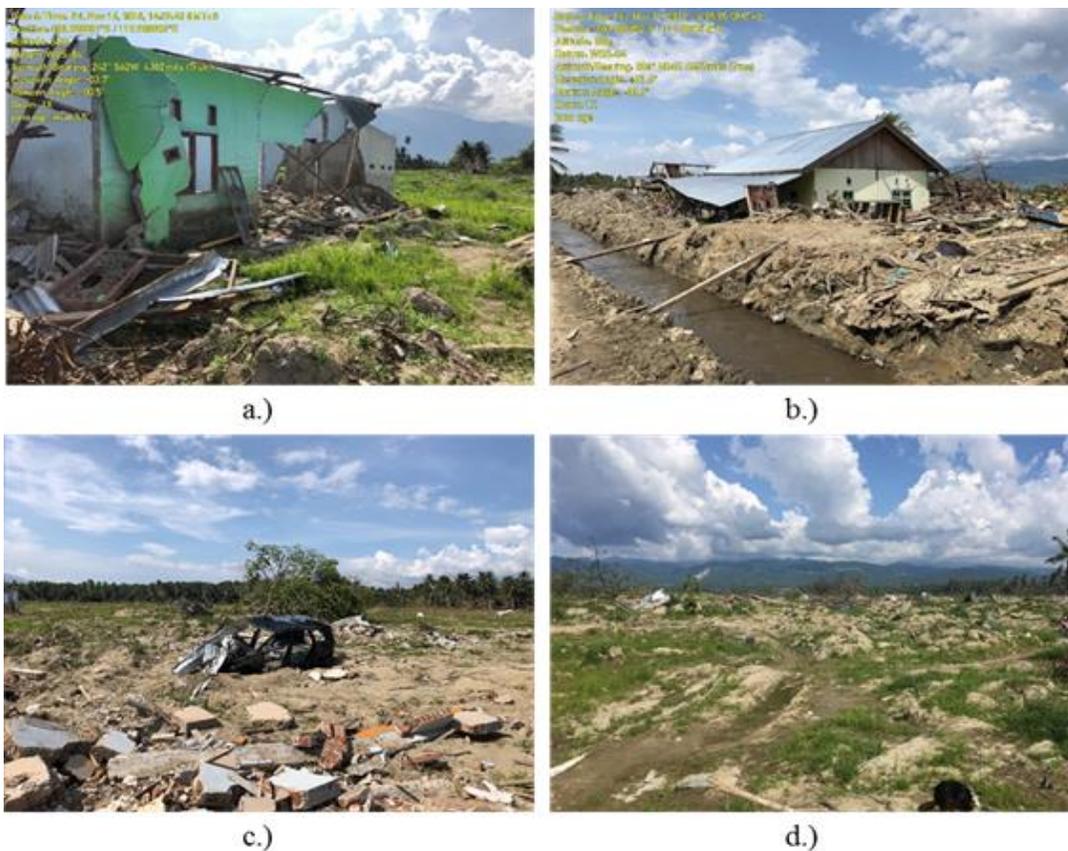
Figure 3.25. Zone E: (a) Structure damaged by the flowslide deposits (-0.98898, 119.90891); (b) Existing structure surround by debris and soil deposited by the flowslide at Jono Oge (-0.98985, 119.90922); (c) A vehicle damaged by the flowslide (-0.98838, 119.90895); (d) debris, blocks of crust and trees within the deposition area of the flowslide (-0.98893, 119.90881).

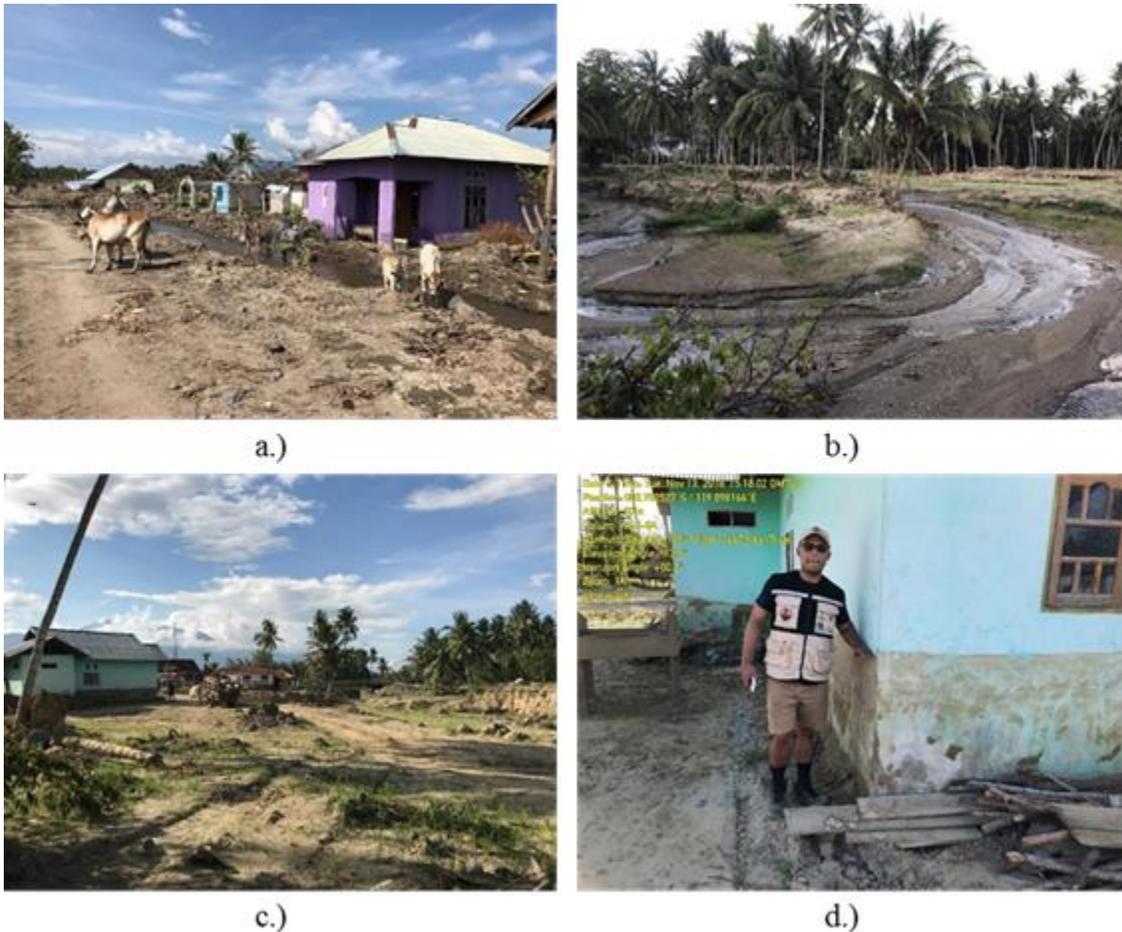
Figure 3.27. (a) Mudflow deposits filled the streets, but left structures undamaged near the margins of the slide (-0.99025, 119.90926); (b) mudflow deposits within the river channel (-0.98440, 119.90143); (c) mudflow deposits left the river channel and flooded the surrounding community after reaching a bridge (-0.98279, 119.89848); (d) height of the mudflow on one of the homes near the bridge (-0.98253, 119.89817). The person in the photo is approximately 1.75 meters tall.

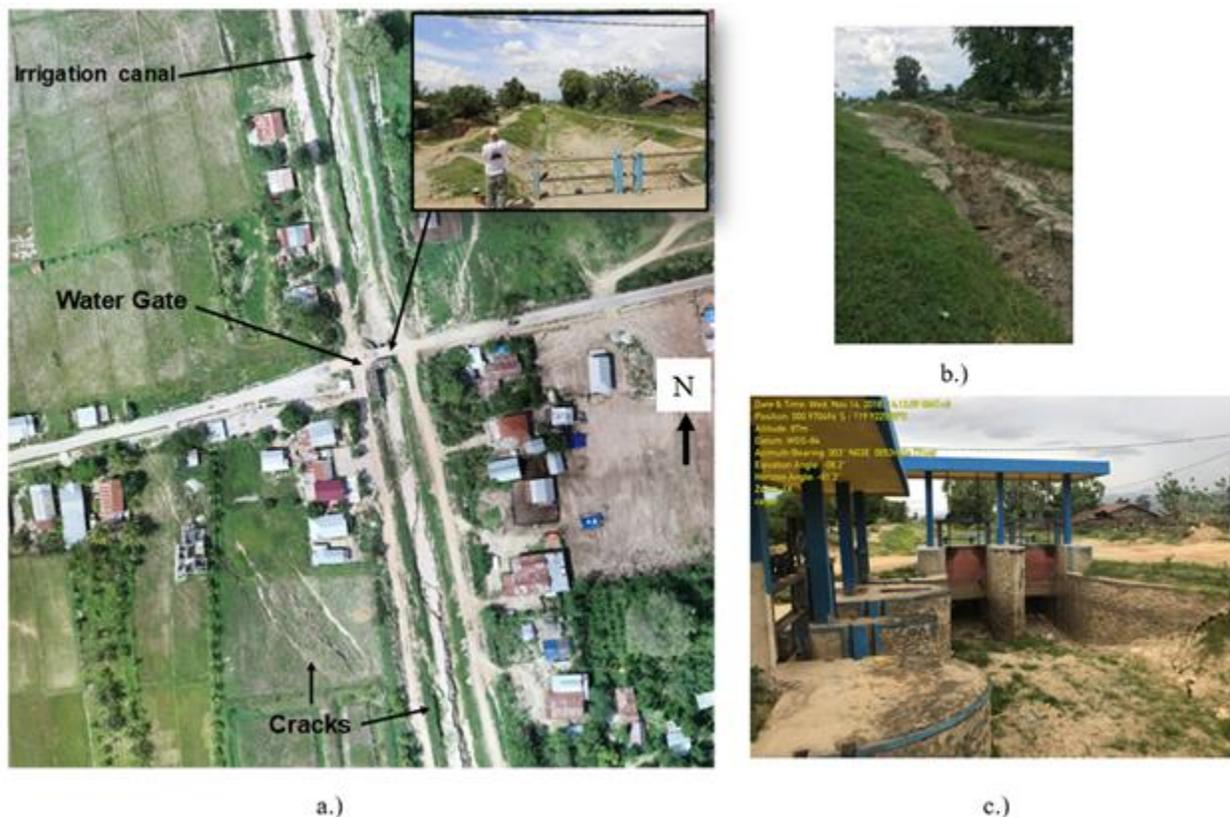
Figure 3.33. a.) Aerial view of cracking in irrigation canal; b.) crack in canal (-0.96974, 119.92249); c.) sluice gate that remained largely intact (-0.970496, 119.922598).

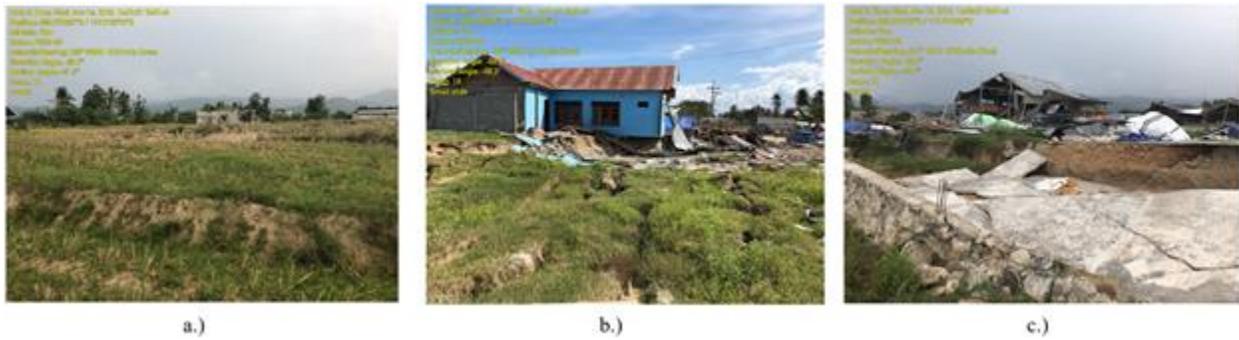
Figure 3.34. a.) Lateral extension of ground in fields above (east) of the main road (-0.970407, 119.918776); b.) damage to residential structure and laterally extended ground near main road (-0.970327, 119.916775); c.) damage to residential structure and partial scarp development near main road (-0.971073, 119.919248).

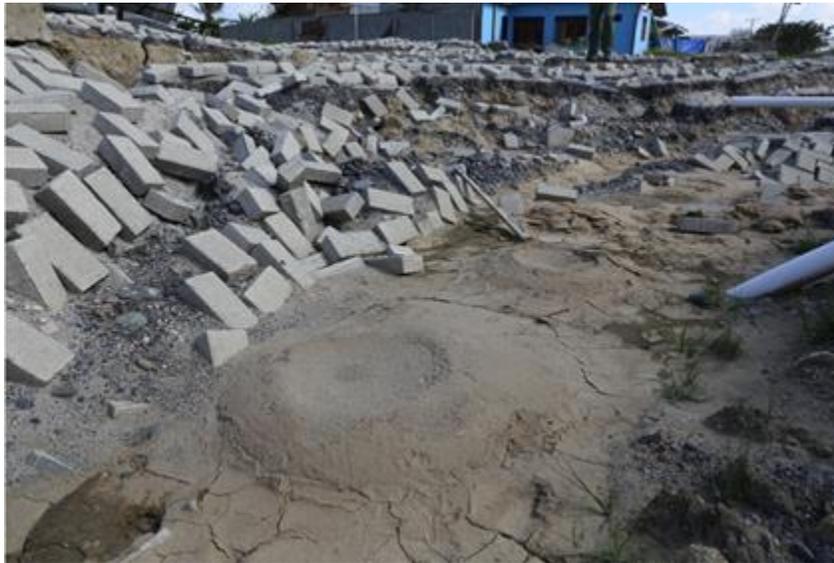
Figure 3.35. Sand boils between laterally extended ground above (east) of the main road (-0.970349, 119.916787).

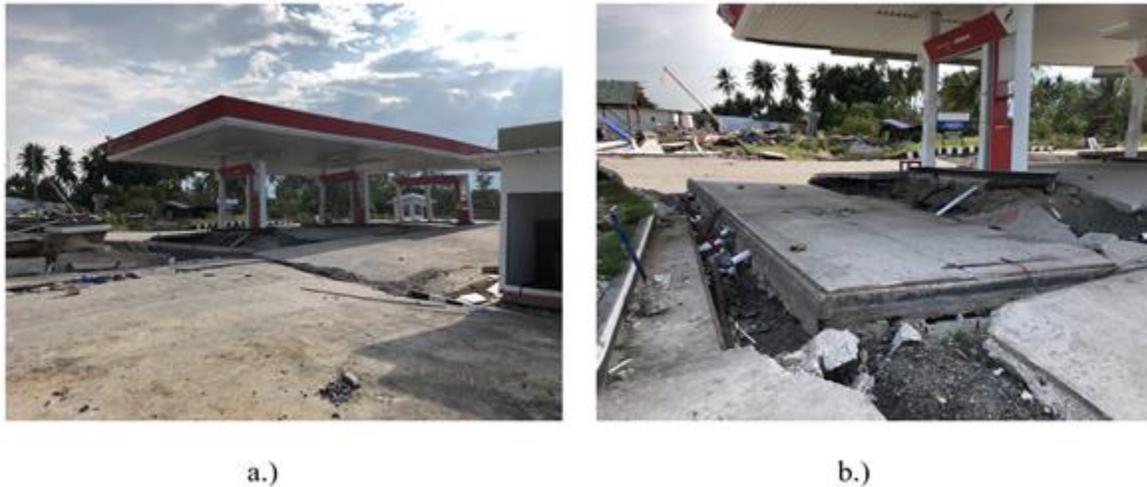
Figure 3.36. Damaged gas station on western side of main road: a.) view of facility (-0.970627, 119.916465); b.) splitting and cracking of concrete pavement (-0.970753, 119.916406).

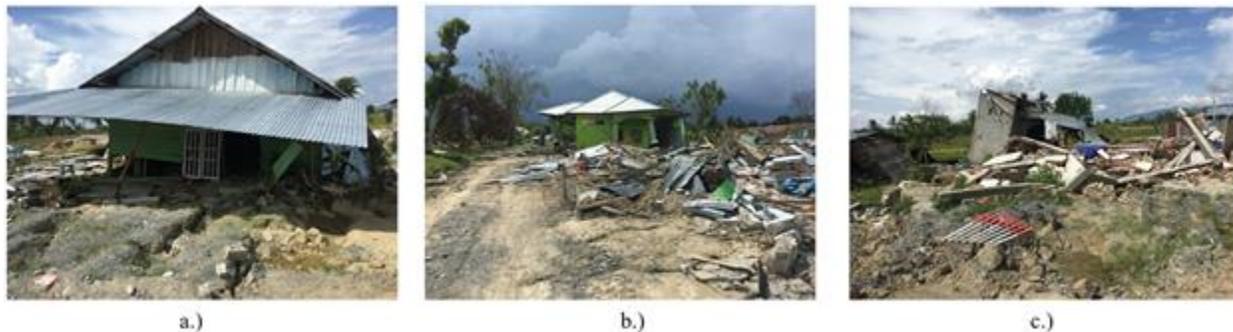
Figure 3.37. Damaged structures in Zone B: a.) laterally extended ground and collapsed home (0.97051, 119.91515); b.) partially collapsed mosque and repaired access road left (-0.97050, 119.91492); c.) collapsed structures and rafted blocks in the foreground (-0.97037, 119.91531).

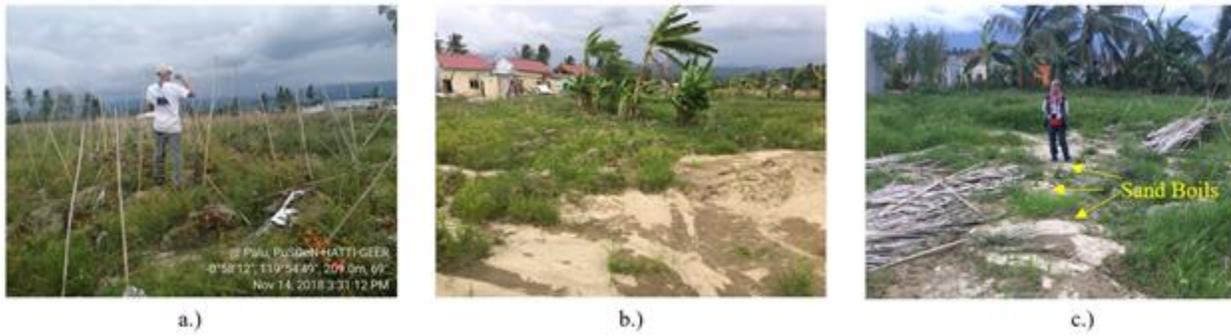
Figure 3.38. Area uphill and adjacent to sheared housing complex: a.) laterally extended and partially disintegrated blocks and mounds in field above housing complex (-0.97000, 119.91361); b.) extent of heavily reworked and disintegrated debris flow and rafted trees near margin of Zones B and C (-0.97034, 119.91374); c.) partially eroded sand boils near margin of debris flow deposits in Zone B (-0.97030, 119.91360).

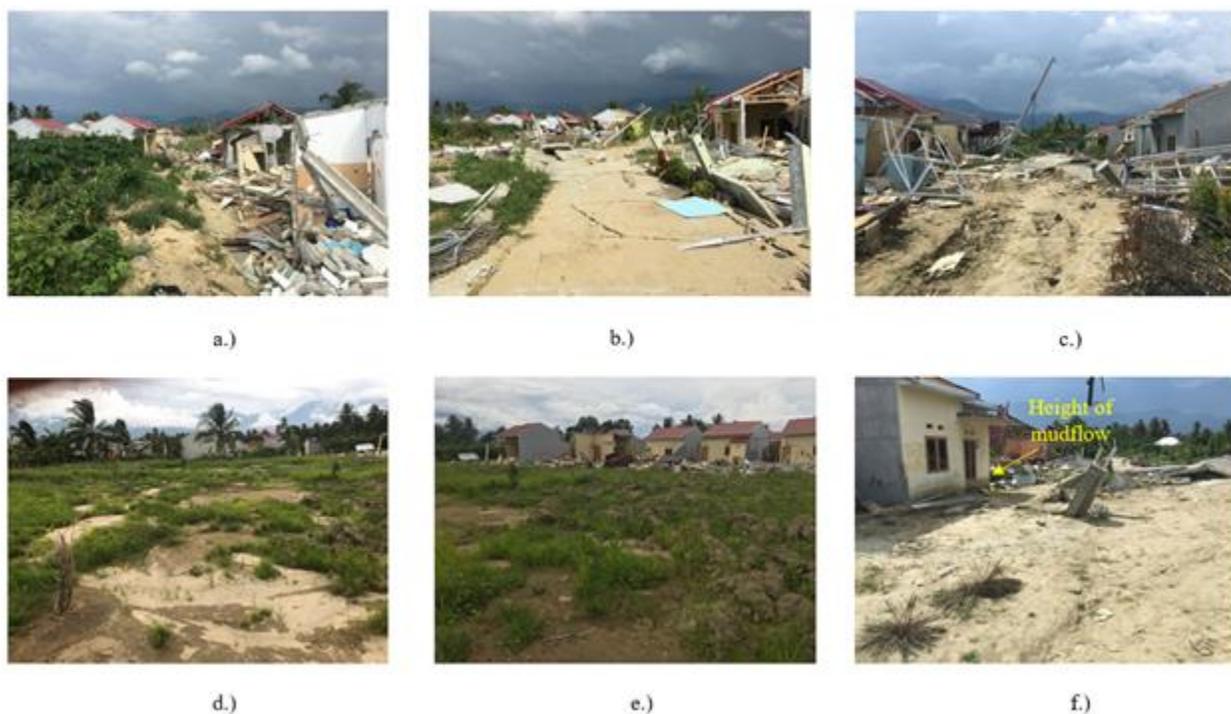
Figure 3.39. Housing complex in Zone C: a.) view of split housing complex that slid around papaya tree field (-0.97025, 119.91304); b.) east-facing view showing rotated and uplifted street with papaya tree field still visible to the left (-0.97039, 119.91268); c.) view of destruction and evidence of compression and uplift in street in lower portion of apartment complex (-0.97069, 119.91304); d.) western view behind separated portion of housing complex showing sand boils and margin of debris flow and disintegrated blocks to the right (-0.97034, 119.91380); e.) west-northwest view of upper portion of housing complex with margin of debris flow and disintegrated blocks (-0.97036, 119.91375); f.) height of mudflow through lower portion of housing complex (-0.97040, 119.91292).

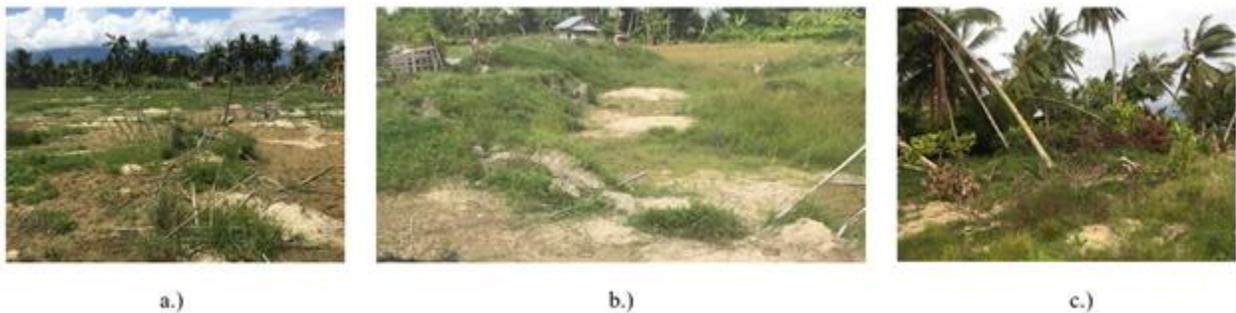
Figure 3.40. Zone D: a.) sand boil field and heavily reworked and disintegrated debris (-0.97100, 119.91171); b.) compression ridge near margin of Zones C and D (-0.97048, 119.91188); c.) forward-rotated trees near toe of slide (-0.97091, 119.91104).

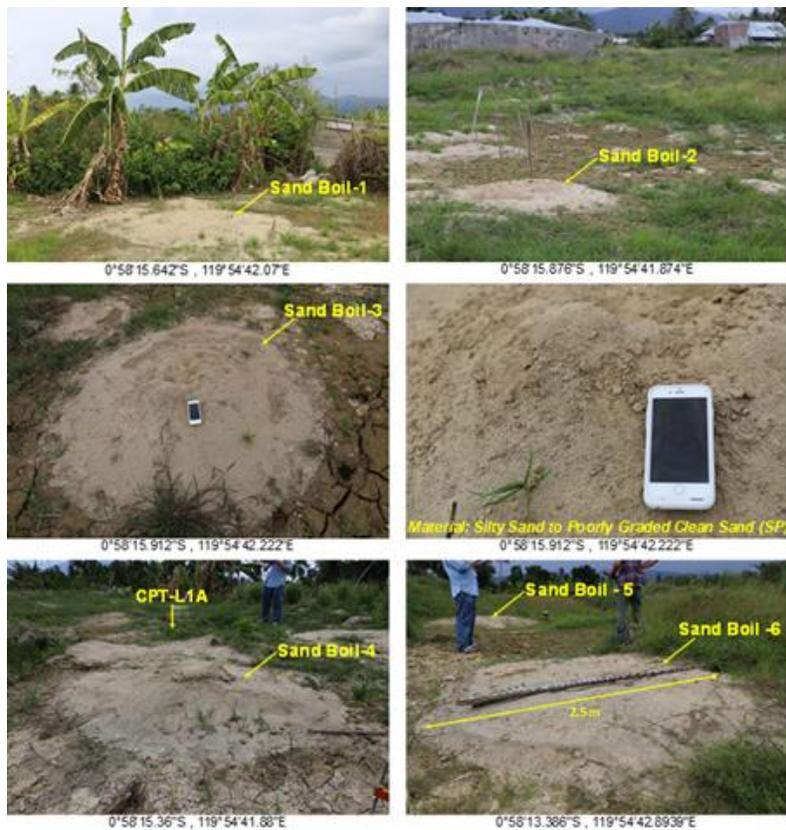
Figure 3.41. Sand boil field near the eastern margin of Zone D.

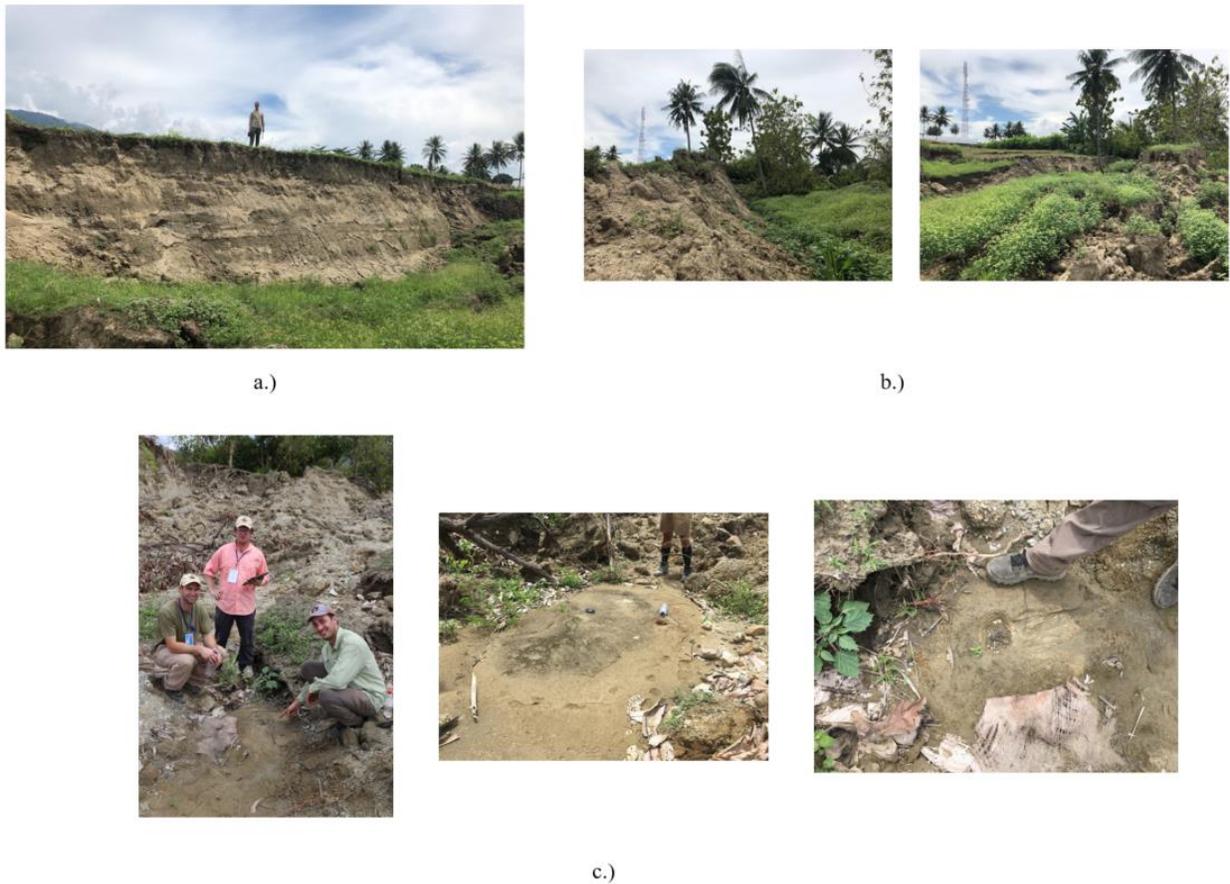
Figure 3.46. Zone B1: a.) head scarp (-1.149536, 119.924125); b.) back-rotated blocks (-1.149580, 119.924053); c.) sand boils (-1.49620, 119.923225).

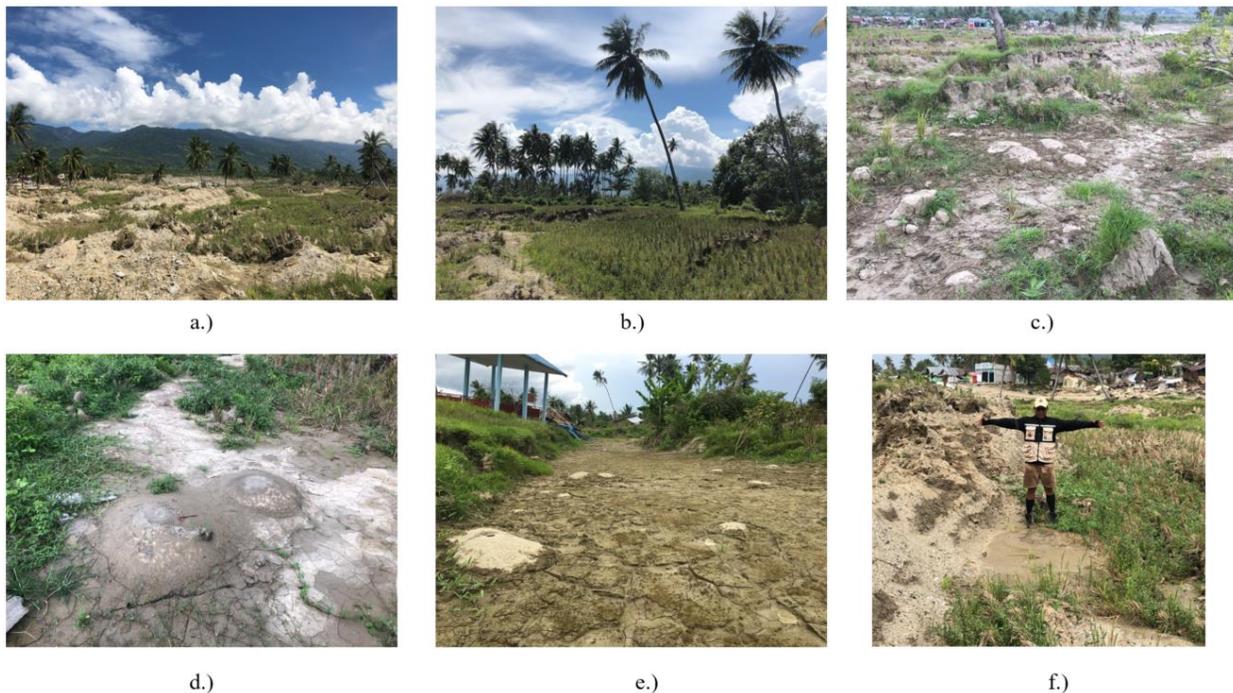
Figure 3.47. Zone C: a.) view facing southeast of back-rotated blocks (-1.146946, 119.919843); b.) view facing south of back rotated blocks (-1.146946, 119.919843); c.) view facing southeast of back-rotated blocks and sand boils (-1.146575, 119.919432); d.) sand boils (-1.146419, 119.920662); e.) sand boils near margins of Zone C and D (-1.146422, 119.919374); f.) large sand boil (-1.147622, 119.921125).

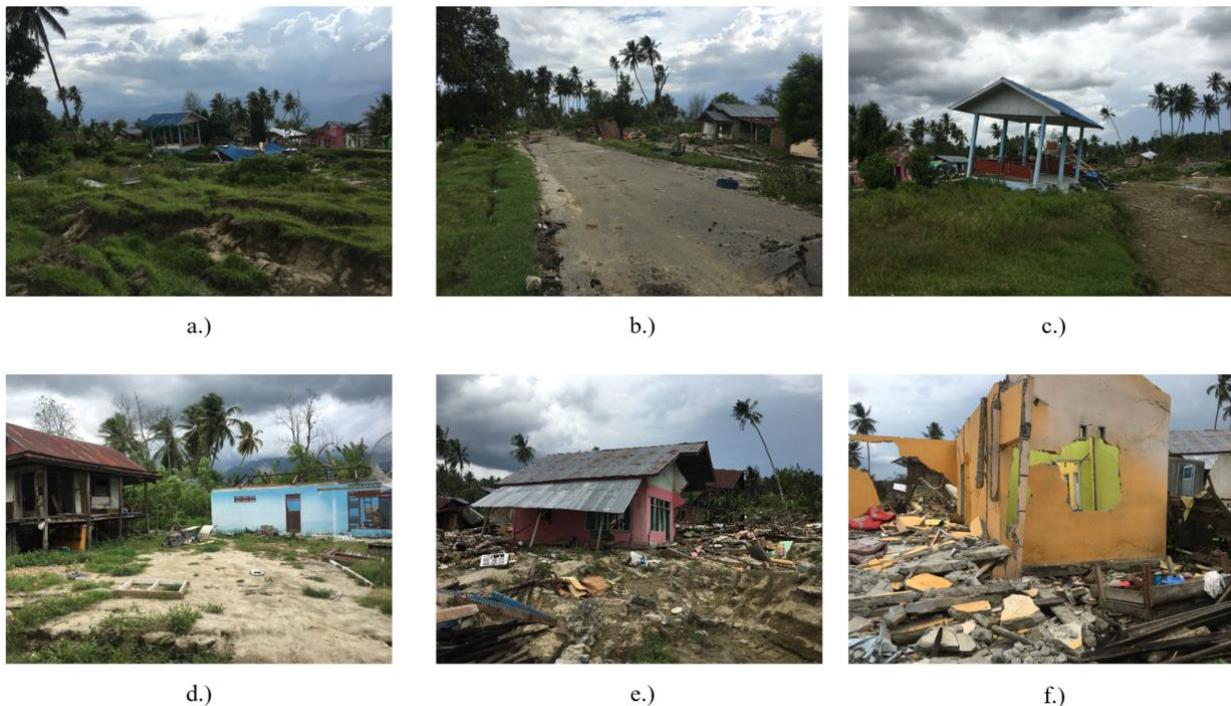
Figure 3.48. Zone D: a.) block compression and uplift near northern margin of zone C (-1.145940, 119.919559); b.) relatively intact portion of road and apparent closure of crack on left side (-1.146440, 119.919162); c.) notable difference in elevation immediately adjacent to depression in zone C (-1.146422, 119.919289); d.) relatively intact residential homes near the center of the zone D (-1.146385, 119.919055); e.-f.) greater distress and collapse of structures near the northwestern margins of zone D (-1.145904, 119.919079 and -1.145963, 119.918827).

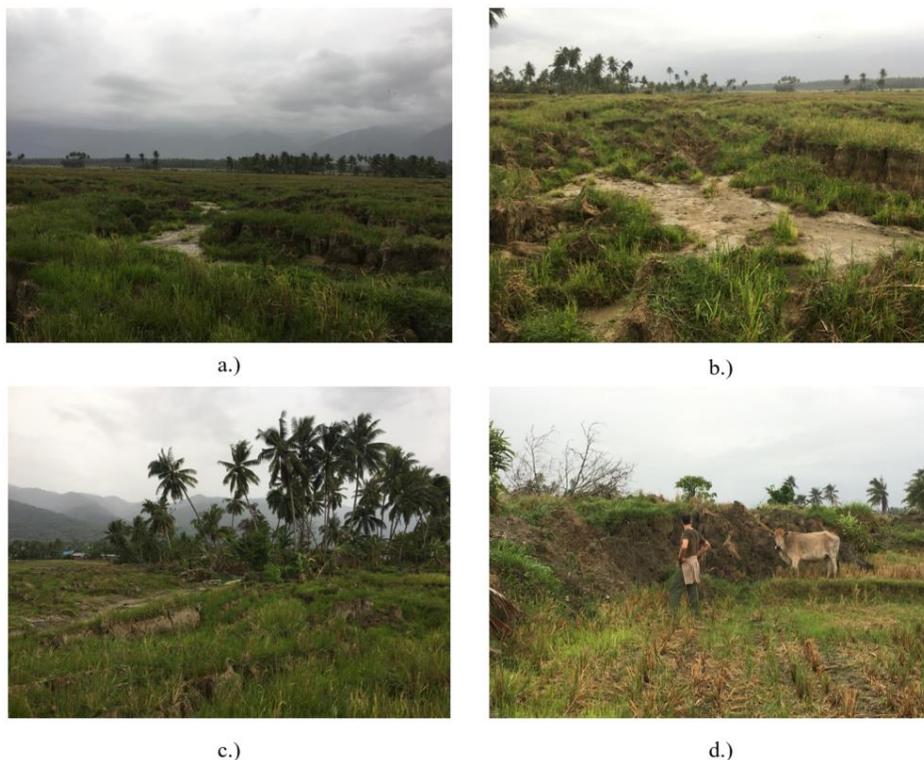
Figure 3.49. Zone E: a.) runout block field and seam of previously liquefied sediment in seam between blocks (-1.144891, 119.917555); b.) sediment in depressed seam between blocks (-1.14496, 119.91769); c.) forward-rotated and uplifted collision blocks near the terminus of the slide (-1.144893, 119.917708); d.) thickness of debris at the terminus of the slide (-1.144651, 119.915743).

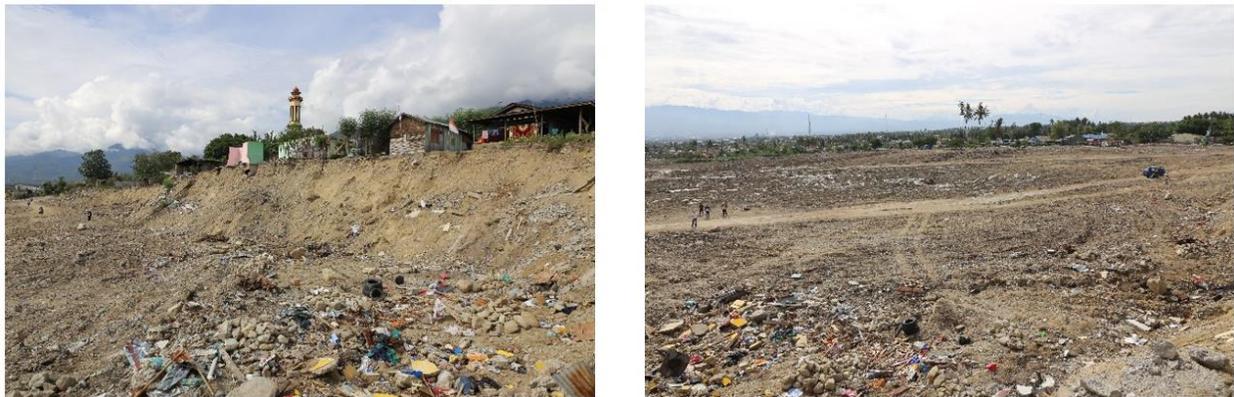
Figure 3.52. Photos of the scarp of the Balaroa landslide (left -0.906689° , 119.839557°) and of the slide area (right, -0.906687° , 119.839372°) after clean-up had occurred.

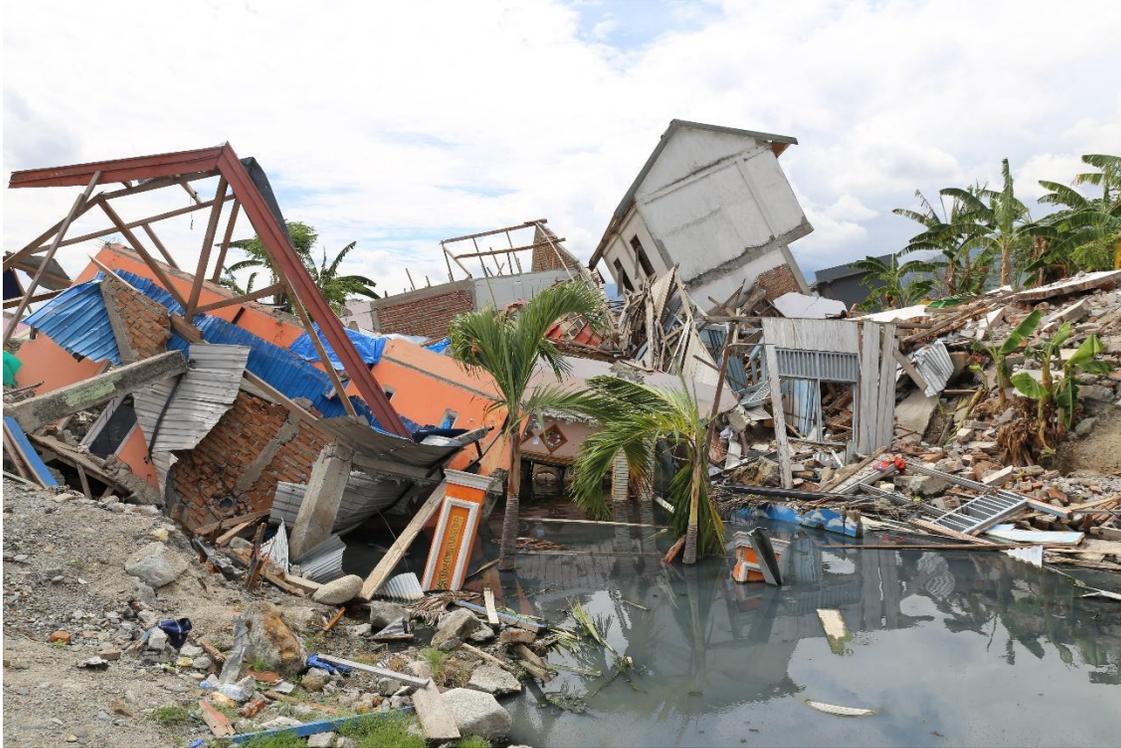
Figure 3.54. Toe of the Balaroa landslide, showing multiple structures stacked on top of each other (-0.904367, 119.846528).
