Preliminary Report on Engineering and Geological Effects of the July 2019 Ridgecrest Earthquake Sequence

A report of the NSF-Sponsored Geotechnical Extreme Event Reconnaissance Association

Report GEER-064: <https://doi.org/10.18118/G6H66K>

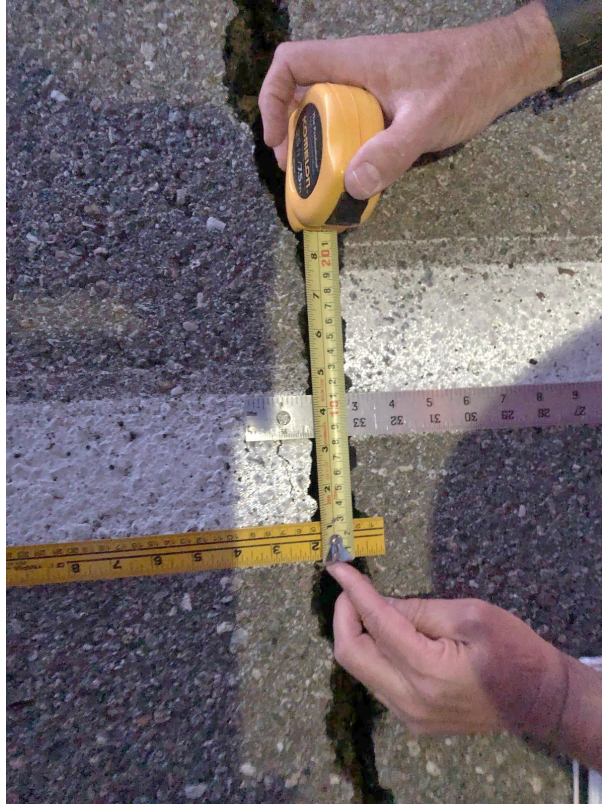
On the evening of July 4 2019, Janis Hernandez (CGS), Kelly Blake (US Navy), and Ken Hudnut (USGS) arrived at the Highway 178 crossing of the cross fault rupture. Prior to their visit, a 165 m wide zone containing four distinct fractures and several minor cracks was found to have $N80E \pm 2$ degrees orientation where rupture crossed the highway. The team was joined by Ben Brooks (USGS) and others. Between the two teams working independently to estimate total displacement across the zone, an estimate of 40-50 cm of left-lateral offset was obtained. On one strand of this fault zone, the white painted stripe on the south side of Hwy. 178 was offset by 8.9 cm (see Fig. 3).

Figure 3. Measuring a fault offset on Highway 178 following the **M6.4** earthquake on July 4, 2019. (Credit: Kelly Blake, US Navy. Public domain). Here, the fault breaks crossed the highway nearly perpendicular to the orientation of the highway, probably because the road surface was relatively strong and was easily able to de-couple from the road bed. The overall orientation of the fault zone at this site is about N 50 E (see Fig. 2) but the fractures crossing the road were measured at N 80 E (Lat./Long. 35.6442, -117.5356).

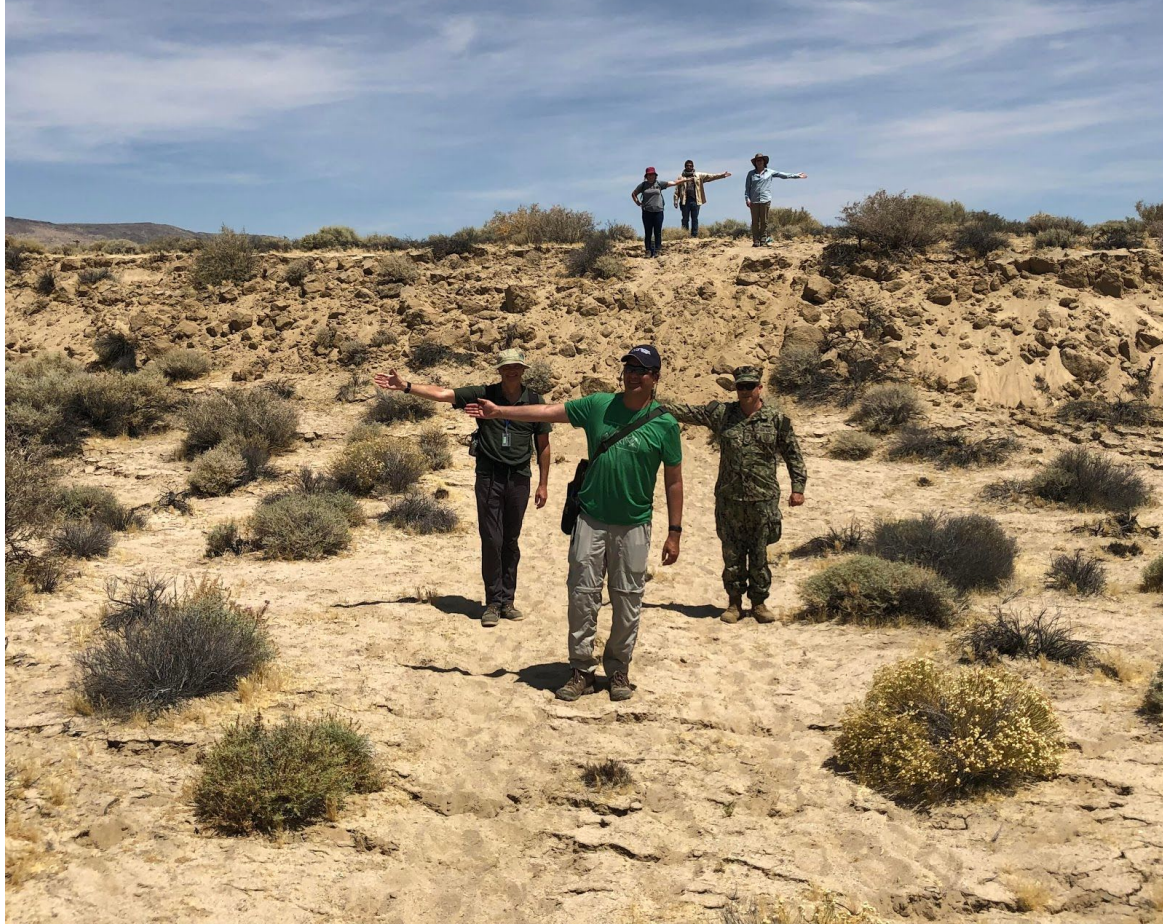
Figure 5. All six people are standing on a surface that was nearly flat prior to the **M7.1** earthquake, and here the fault rupture offset the ground surface vertically by one to two meters, forming a fault scarp. The lateral offset of about 3 to 4 m shifted a dirt road set of tracks to the right (see Fig. 9 for additional details at this site). On each of the sides of the fault, three people are marking the same three features that have been offset; the center line of the road and each of the tire tracks. All are pointing to indicate the tectonic sense of right-lateral fault motion. (Credit; Photo by John Foster, US Navy; public domain).

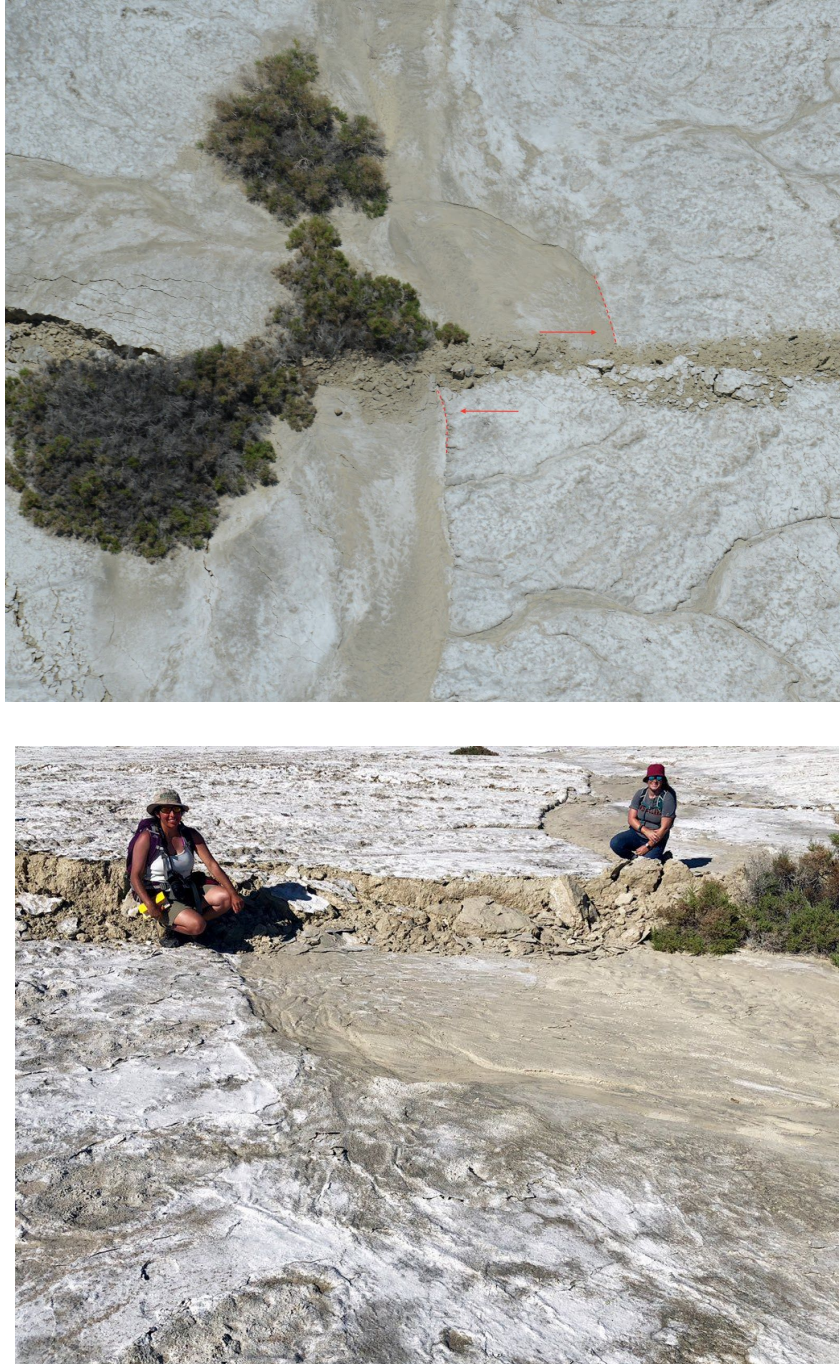
- Both major splays of the rupture cross the major NS base access road and disrupted the pavement. The main strand of the rupture then enters the playa at its NW edge at CGS FID 585. From the NW side of the playa to the SE side of the playa, the main rupture continues for 3.5 km and it is over this section of the rupture that the largest surface displacements were observed. Within the NW edge of the China Lake playa, 0.6 km to the SE of CGS FID 585, we encounter offsets of 3.75 ± 0.2 m (USGS FID 975). Further along by 0.7 km, we encounter 4.2 ± 0.10 m offset (USGS FID 875), which is the maximum observed slip (Figure 6).

Figure 6. (a) Aerial and (b) ground view of a 4.20 m right-lateral offset on the dry China Lake bed. In Part (b) the offset is measured by Belle Philobosian (USGS) and Kelly Blake (NAWSCL Geothermal Program Office). Photographer in (b) was at the upper right of the photo in (a). The channel margin sharply demarcates the salt-crusted white surface of the pre-incisional dry lake bed surface from the fresh fine-grained deposits in the wide flat channel thalweg. This feature provides a reference allowing measurement of a displacement vector with small errors (approx. ± 10 cm). This is considered the maximum offset measurement (Credits: (a) Ken Hudnut, USGS, public release; (b) Brian Olson, CGS).

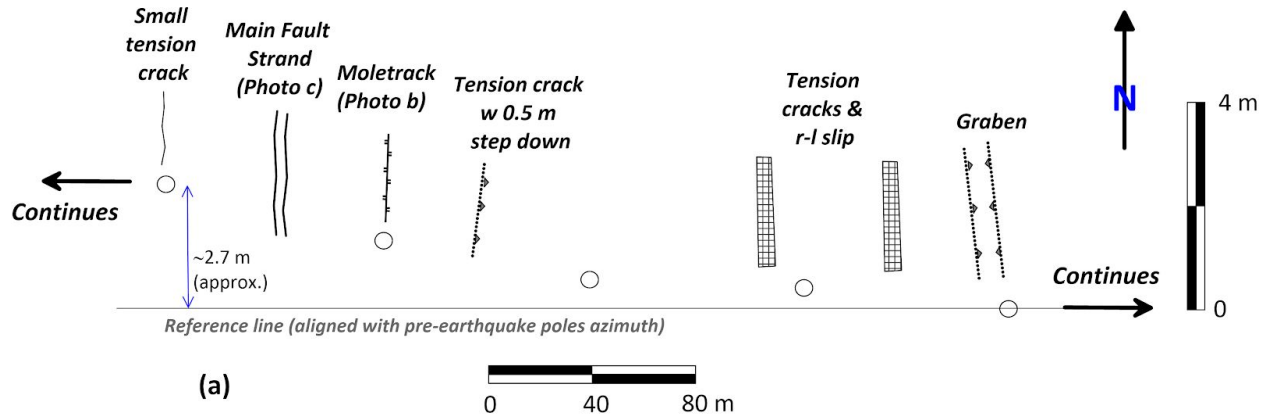
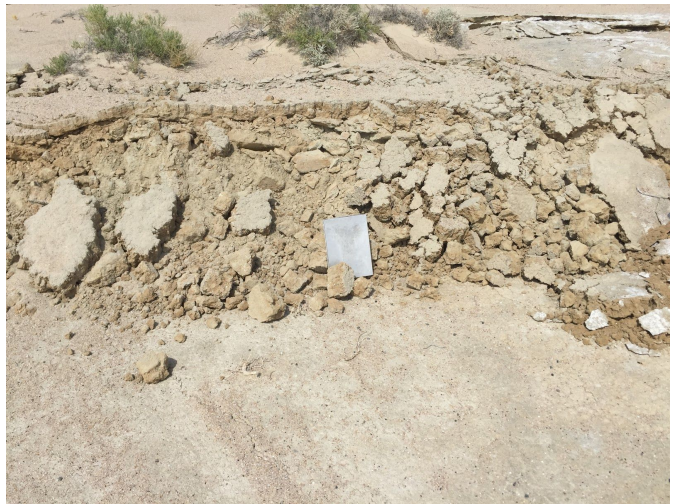
- A prominent power line that runs EW across the southern margin of the playa is offset 2.7 m right laterally, based on field mapping and later confirmed by truck-mounted lidar (Figure 7) The width of the fault rupture zone near the power lines, measured as the maximum distance between ground cracks observed perpendicular to the fault in this area, is approximately 320 m. Interestingly, a few hundred meters north of this location, the main fault strand narrows to only a few meters.

Figure 7. (a) Field mapping of line of power poles offset by surface rupture near the southern margin of the playa and ground deformations in dirt road immediately north of poles. The mapping indicates features over the full width of the fault zone. The utility pole locations are approximate from field mapping; more accurate surveying has been undertaken by USGS and will be published separately. (b) Moletrack photo at location labeled on map. (c) Photo of main strand near road crossing.

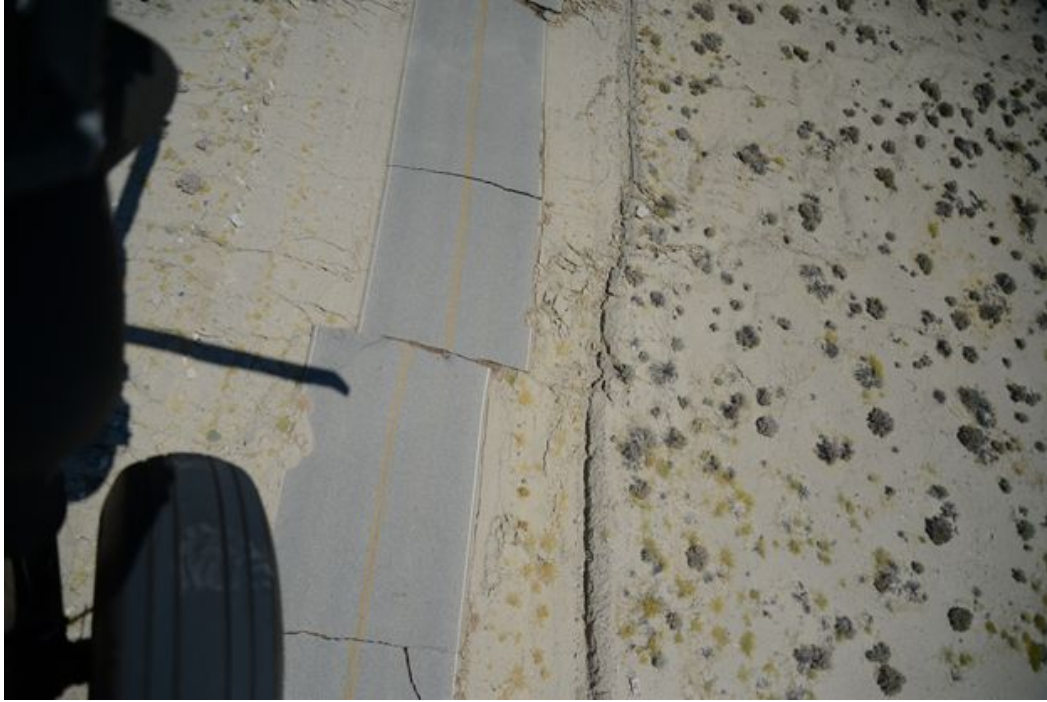
Figure 8. Helicopter overflight viewing access road fault offset. The CGS and USGS, along with National Guard and Navy personnel, view road damage showing 2.5 ± 0.2 m of right-lateral motion along the primary rupture associated with the magnitude 7.1 event. This offset access road was broken by the mainshock fault rupture about 800 m southeast of the China Lake playa (Credit: Ken Hudnut, USGS. Public domain)

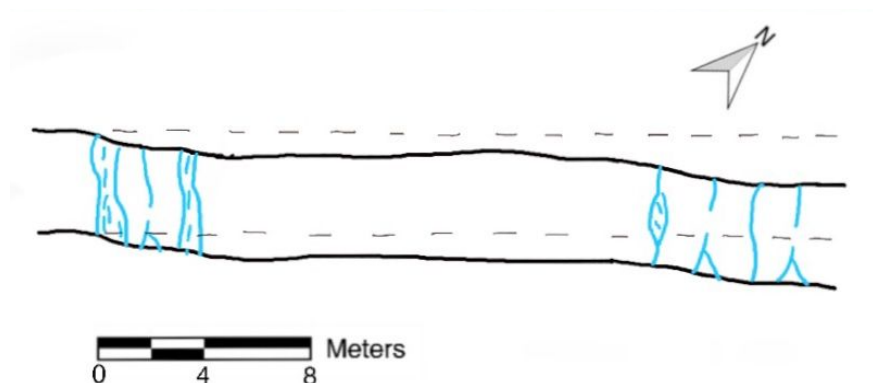
- Proceeding SE from the access road shown in Fig. 8 by 0.16 km, the rupture then encountered an abandoned railroad line between USGS FID 872 and 967. The railroad bed has been offset 1.8 m right-laterally. The pattern of rupture in the railroad ballast fill was mapped as shown in Figure 9, with an approximate width of 30 m

Figure 9. Map of railroad embankment with cumulative offset of 1.8 m. The embankment is of offset on two distinct strands of the fault, with an overall width of the rupture zone of about 30 m.

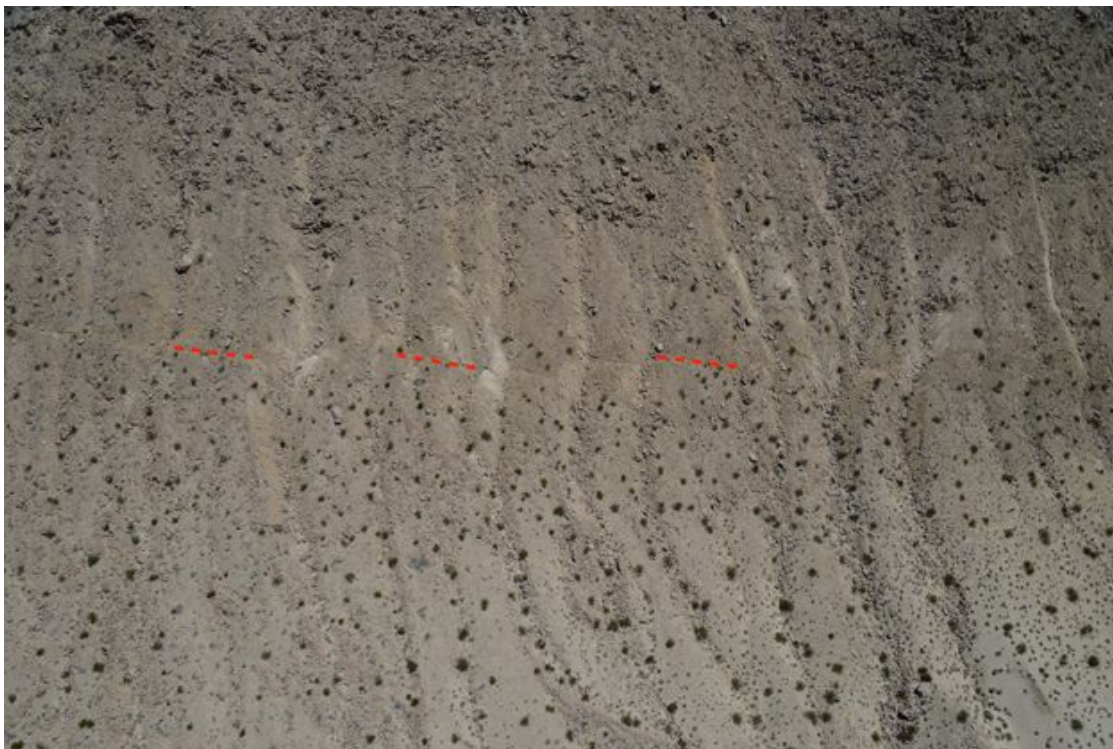
Figure 10. A series of nearly parallel and sharply incised small drainage gullies occur along a NW-SE oriented ridge line that lies from 1 km to 3 km southeast of the offset access road shown in Fig. 8. The roughly twenty such gullies shown in this photo are referred to as the “offset gullies”. The short dashed red line segments indicate the location of the mainshock fault surface rupture, which forms a bench as the fault cuts across this hillside, nearly perpendicular to these gullies. With high-resolution topography from the air photos already collected, and potentially from the airborne lidar in the future, geologists expect to be able to precisely measure fault slip variation along this section of the fault. Slip is known to diminish from approx. 1.8 m at the abandoned railroad tracks down to less than one meter at the SE end of the ridge where these gullies were found. So, it is expected that these gullies will afford a way to quantify the reduction in slip from NW to SE along this 2 km long section of the fault.

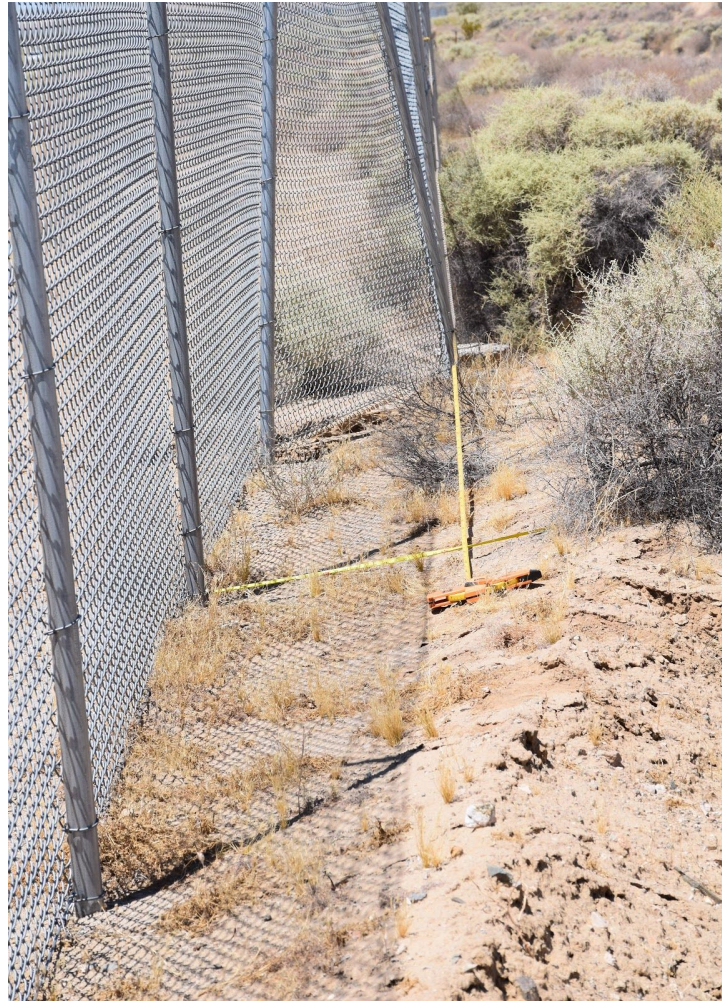
Figure 11. Offset fence line at southern Salt Wells Valley, just north of highway 178. The fence offset is 70 ± 5 cm right-lateral sense. (photo by Jason R. Patton, CGS; Lat./Long. 35.6495, -117.4828)

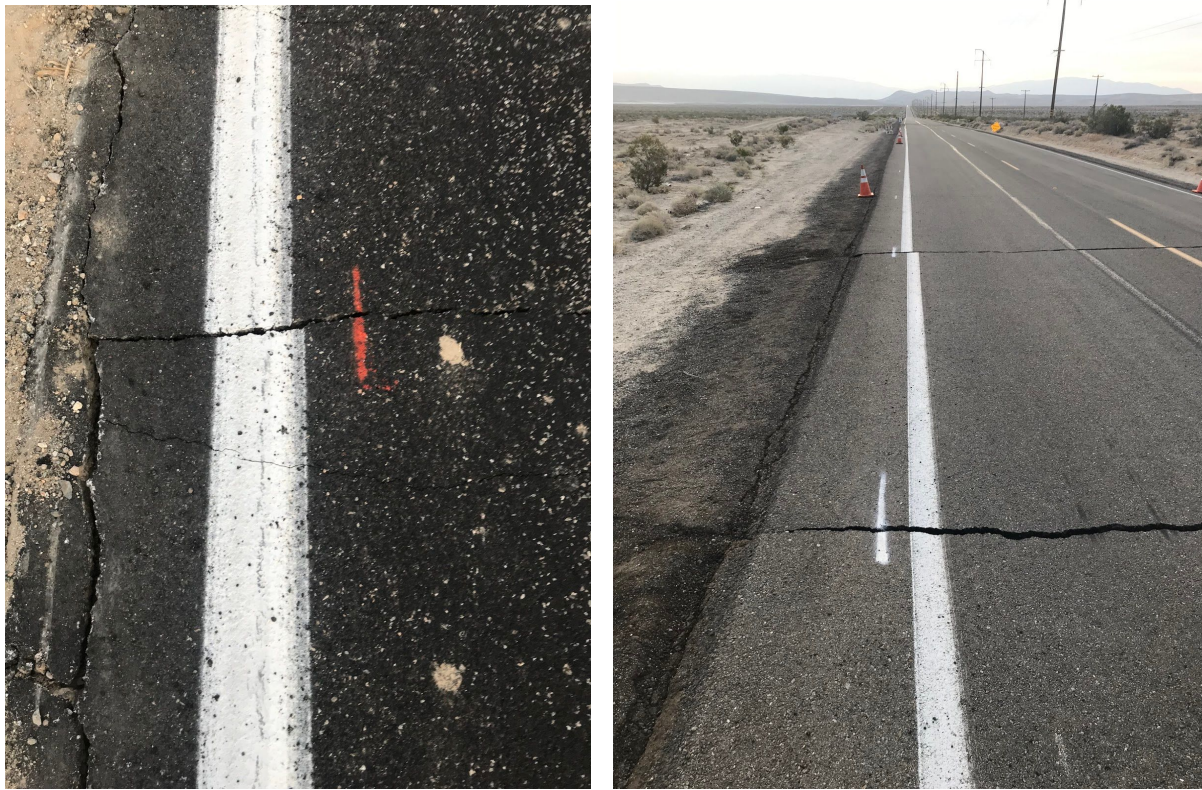
Figure 13. Pavement of Highway 178 offset by **M6.4** event fault rupture (shown by white lines) and short painted lines used to monitor afterslip. Locations: Left 35.649, -117.4824 (red line), Right 35.6441, -117.537 (white line). Photo credits: Ben Brooks, USGS

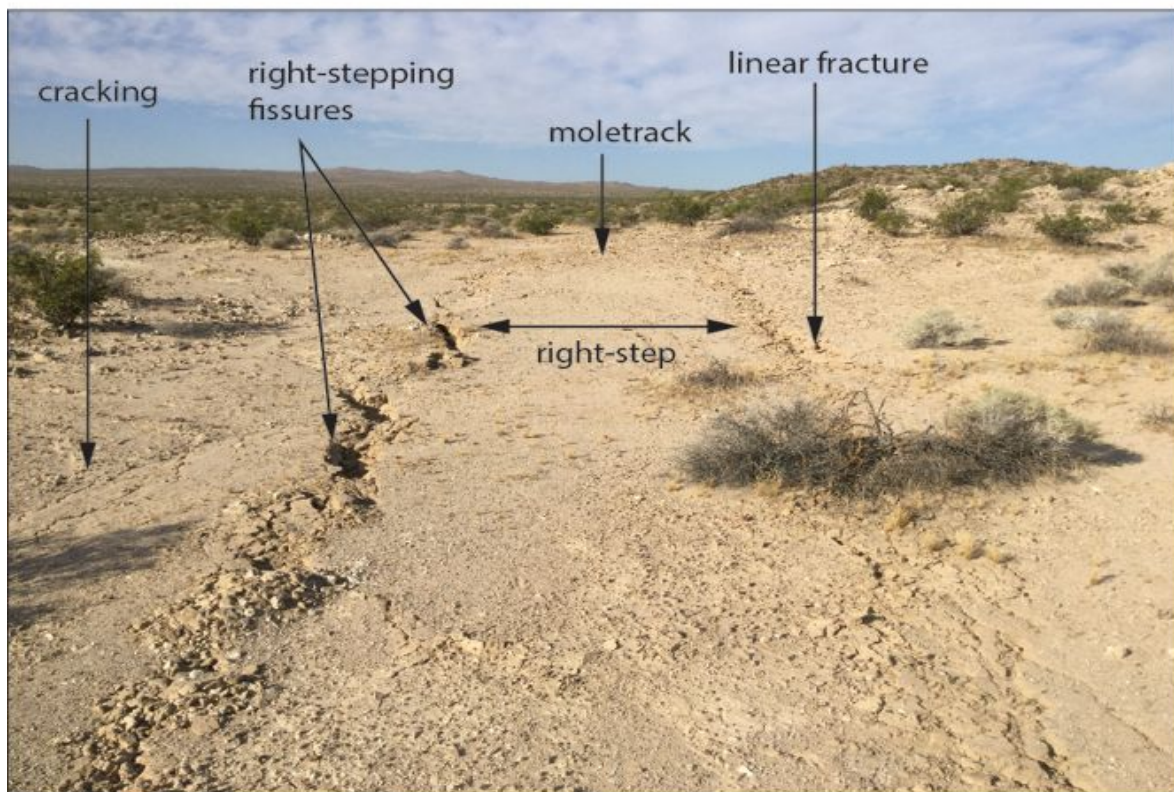
Figure 14. Typical right-stepping and overlapping surface cracks generated by the **M6.4** rupture southwest of Highway 178. View to southwest. (Lat./Long. 35.6413, -117.5391). Photo credit: Rich Koehler.

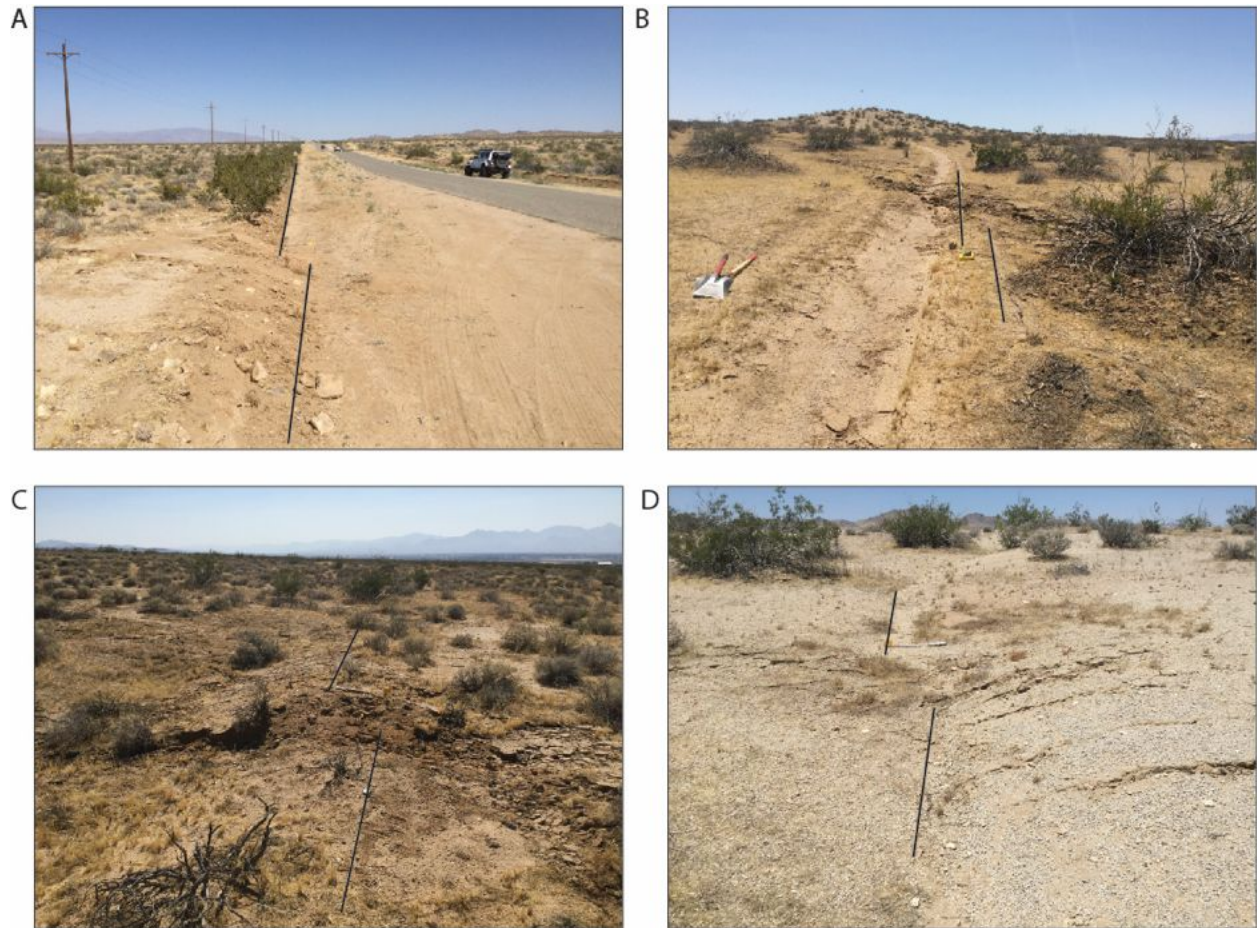
Figure 15. Observed left-lateral offsets along the **M6.4** rupture (black lines) including (A) 60 cm displacement of Randsburg Wash road, view east (Lat./Long. 35.6178, -117.5734), (B) 37 cm displacement of a motorcycle track along a dirt road, view west (Lat./Long. 35.6312, -117.5563), (C) 60 cm displacement of the crest of an erosional swale, view northwest (Lat./Long. 35.6155, -117.5758), and (D) 45 cm displacement of a wash gully, view northwest (Lat./Long. 35.6336, -117.5522). Photo credit: Rich Koehler.

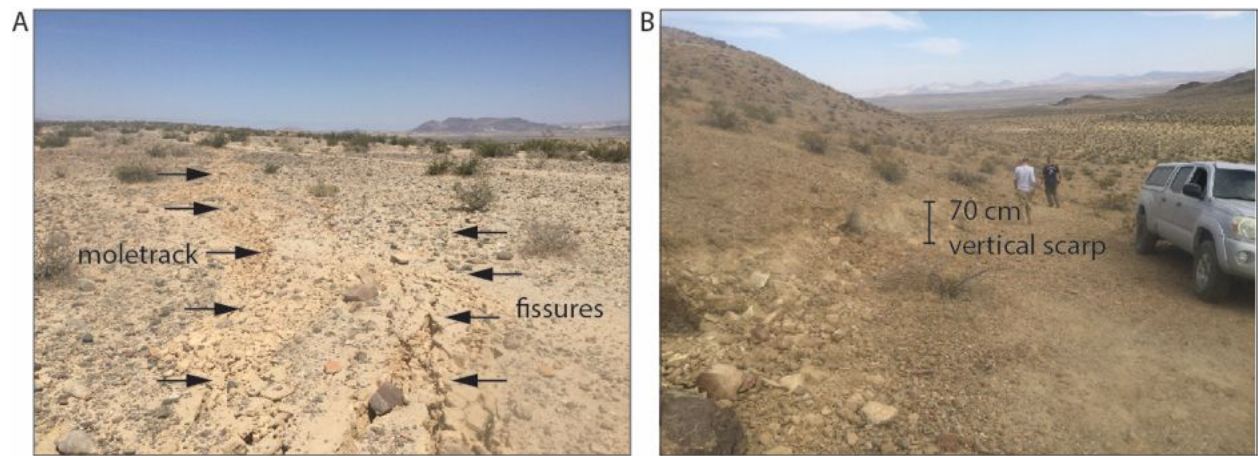
Figure 16. (A) Left-stepping fissures and moletracks (Lat./Long. 35.6380, -117.4546), and (B) vertical scarp (Lat./Long. 35.6217, -117.4277) within the Spangler Hills. Photo credit: Rich Koehler

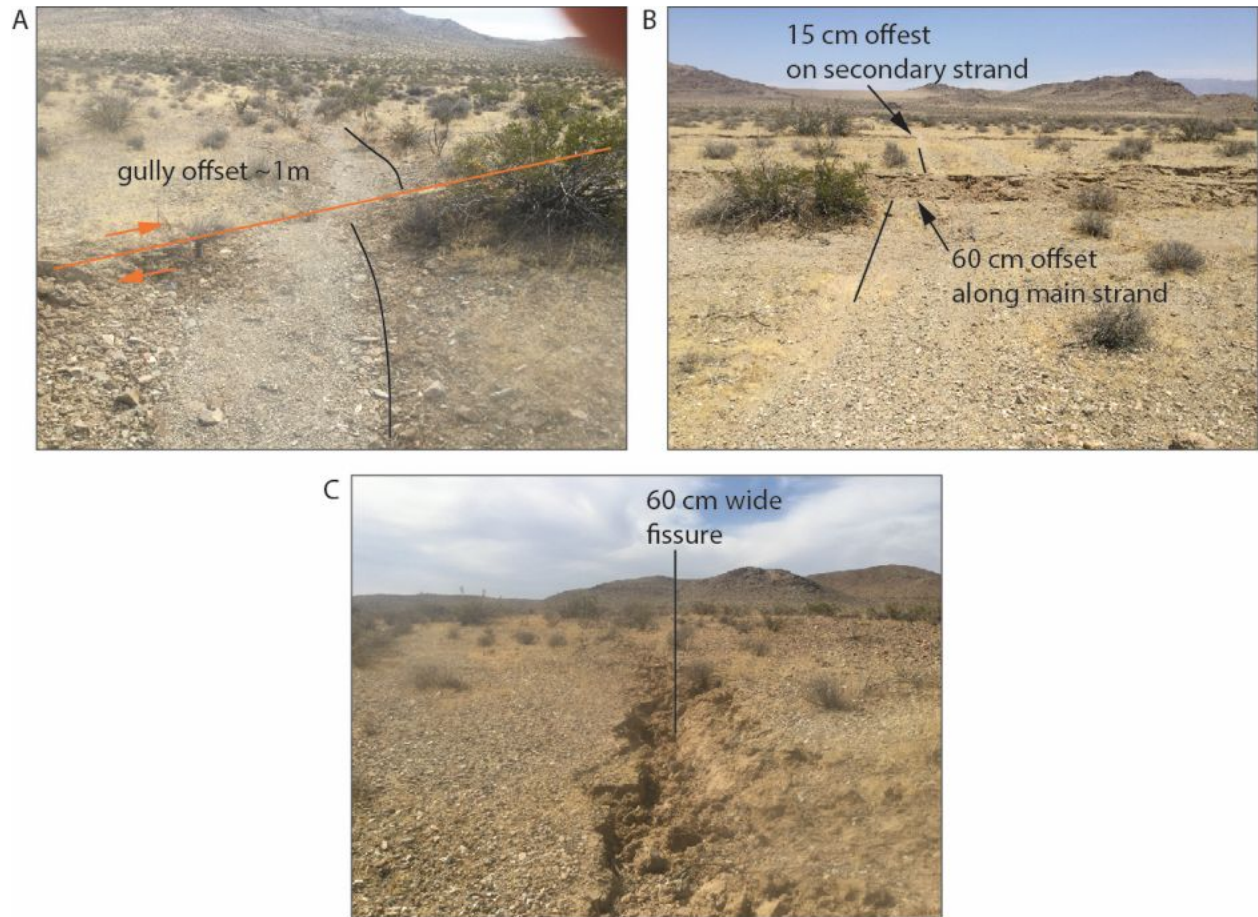
Figure 17. Photographs of the rupture where it cuts an alluvial fan on the southeast flank of the Spangler Hills including (A) ~1 m right-lateral offset of a gully (Lat./Long. 35.6172, -117.4236), (B) right-laterally offset dirt road, 60 cm across main strand and 15 cm across parallel subsidiary strand (Lat./Long. 35.6022, -117.4069), and (C) a large fissure (Lat./Long. 35.6171, -117.4227). Photo credit: Rich Koehler.

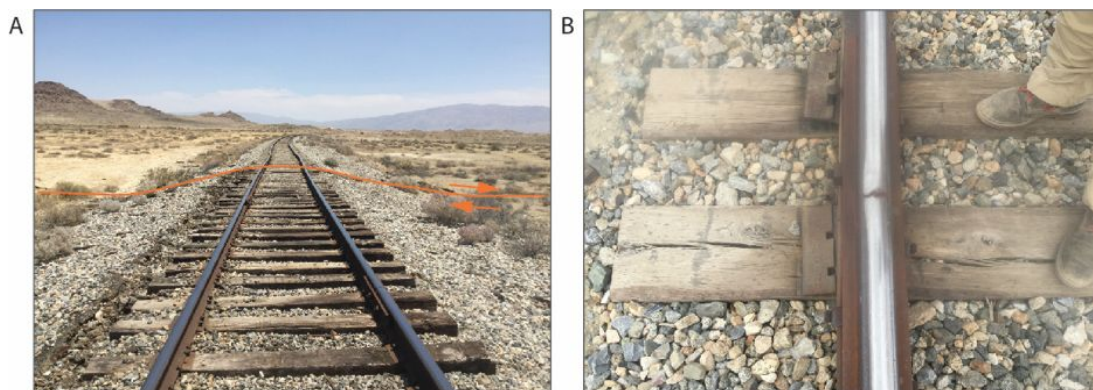
Figure 18. (A) Right-laterally offset rail bed and bent tracks along the main rupture trace (Lat./Long. 35.5944, -117.4004) and (B) kinked tracks and jostled rail spikes along a secondary trace (Lat./Long. 35.5872, -117.4141). Photo credit: Rich Koehler.

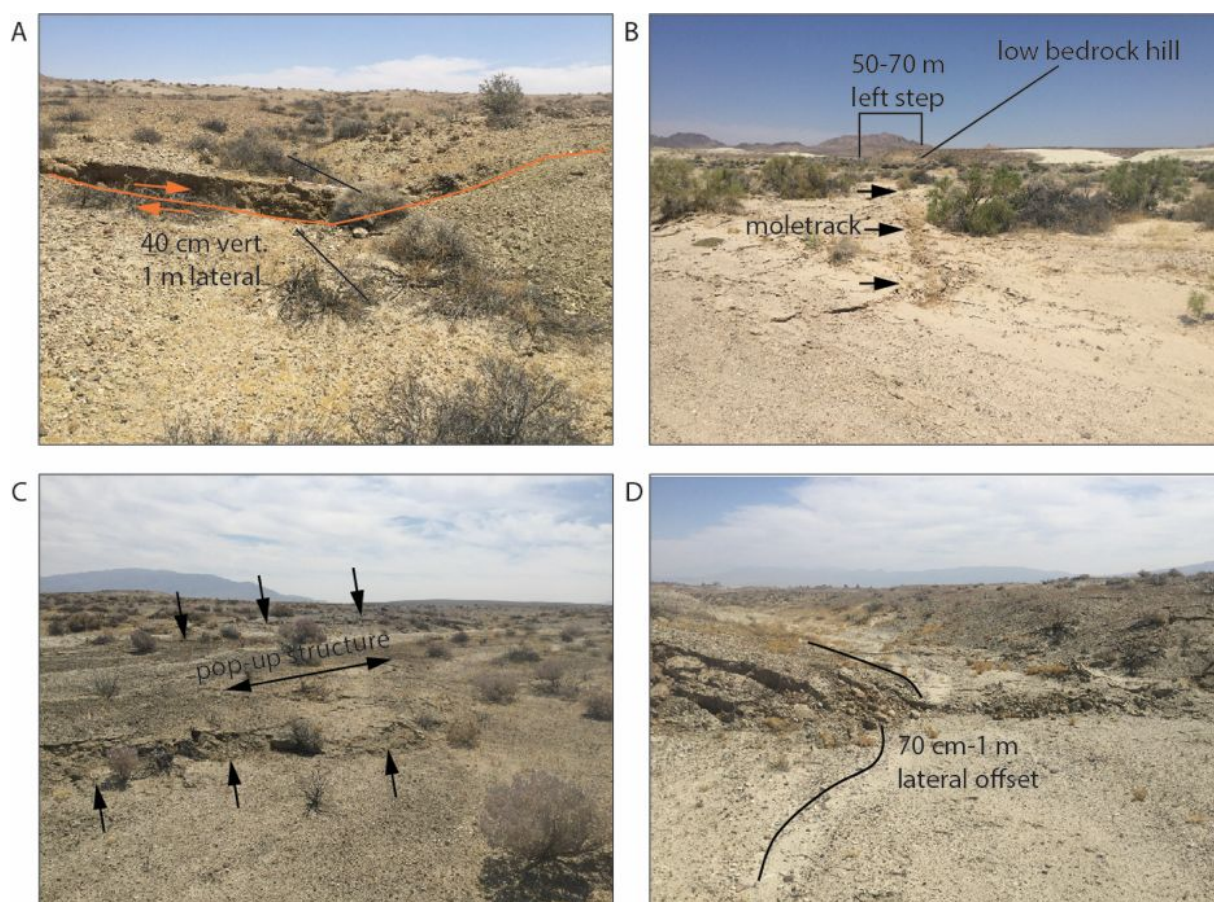
Figure 19. Photographs of the **M7.1** rupture south of the Trona railway. (A) 1 m right lateral and 40 cm vertical displacement of small drainage, view northeast (Lat./Long. 35.5917, -117.3978), (B) moletrack projecting northwest into 50-70 m wide stepover in rupture trace (Lat./Long. 35.5869, -117.3903), (C) left stepping scarps in active wash connected by pop-up structure, view west (Lat./Long. 35.5856, -117.3889), and (D) right-laterally displaced channel margin (70 cm-1 m), floor of active wash displaced vertically up on NE about 30 cm, view NE (Lat./Long. 35.5826, -117.3845). Photo credit Rich Koehler.

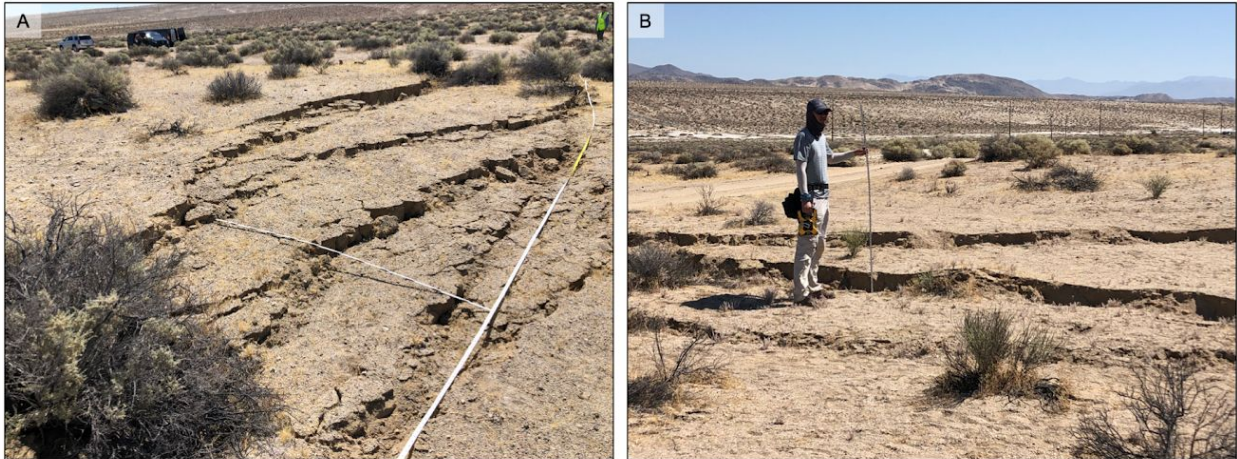
Figure 20. Photographs of the **M7.1** rupture taken the day after the rupture, July 6 (A, 35.6470, -117.4801) and on July 11 (B, 35.6457, -117.4790). Photo A was taken just south of the dirt road, Photo B was taken just north; the fault traces generally exhibit similar features. Although not taken exactly at the same location, the two pictures illustrate the typical degradation of features from people visiting the site within a span of 4 days. Photos by Christine Goulet.

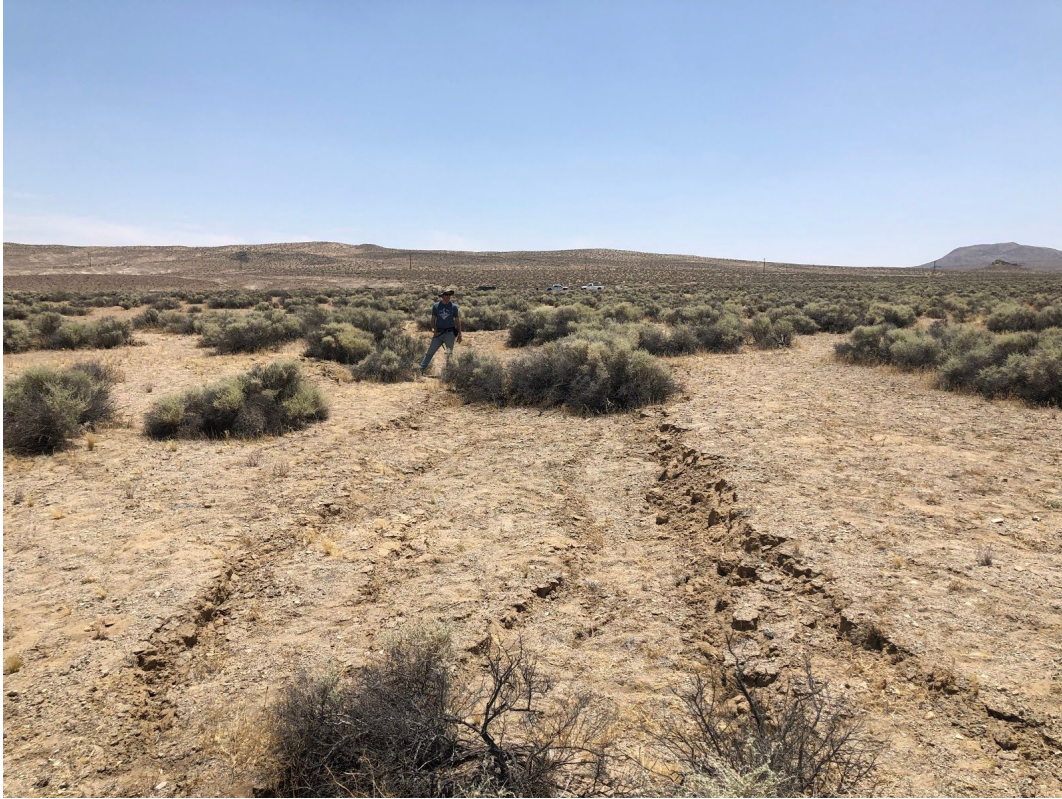
Figure 22. Fault rupture from the **M7.1** event south of Highway 178 showing a 3 m band of concentrated deformation (35.6483, -117.4813). Photo credit Christine Goulet.

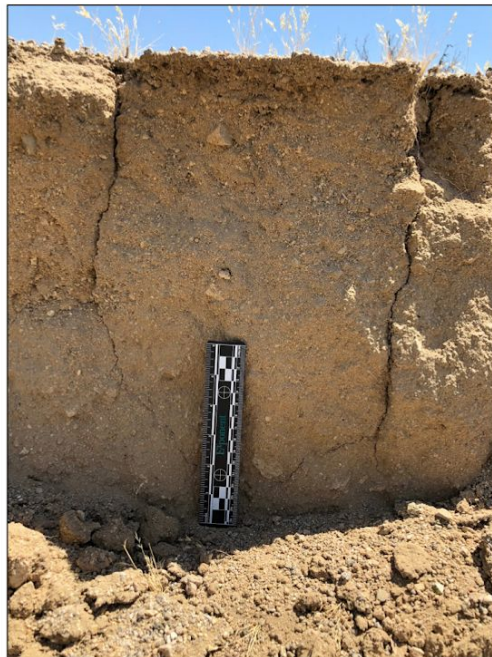
Figure 23. Fault rupture from the **M7.1** event showing 40 cm of apparent vertical offset at a location approximately 146 m south of Highway 178 (35.6470, -117.4802). Photo credit Sean Ahdi.

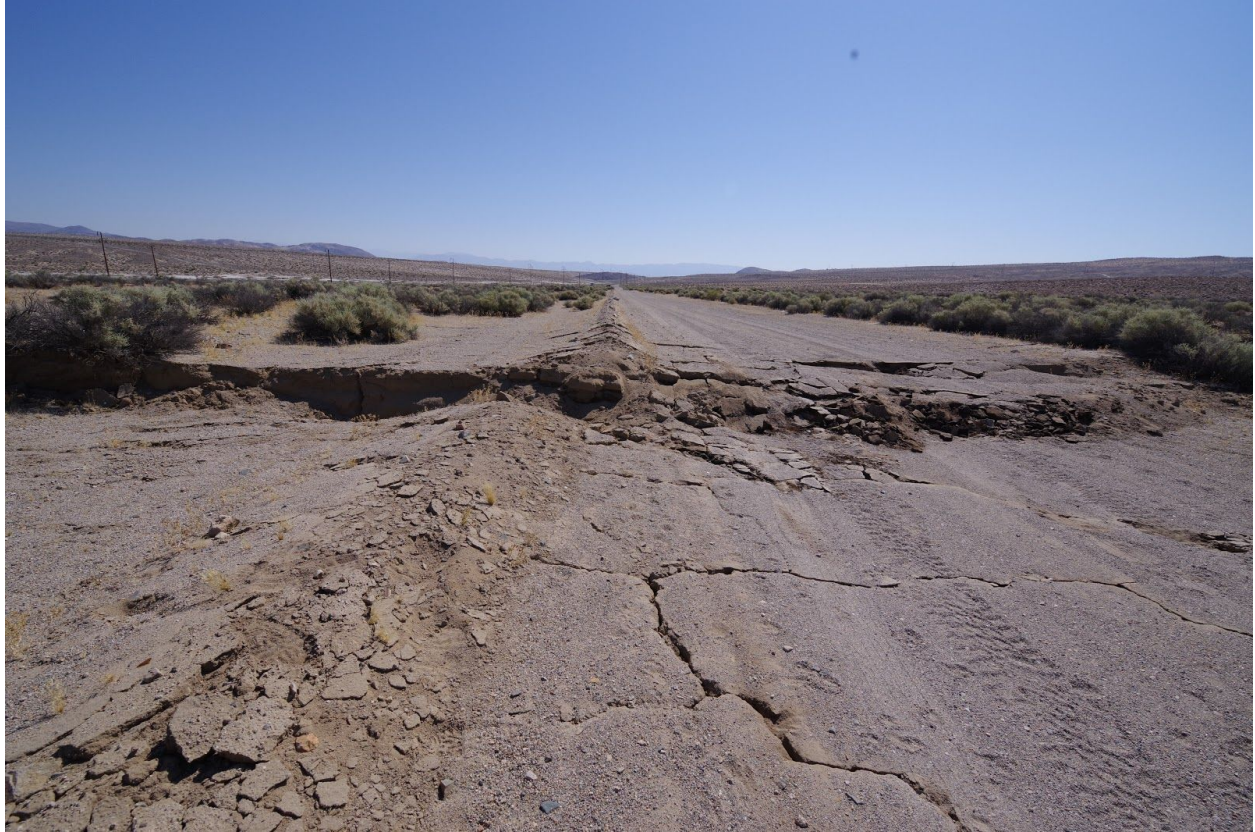
Figure 24. Fault rupture from the **M7.1** event showing at a road crossing south of Highway 178 (35.6468, -117.4800). Photo credit Scott Brandenburg.

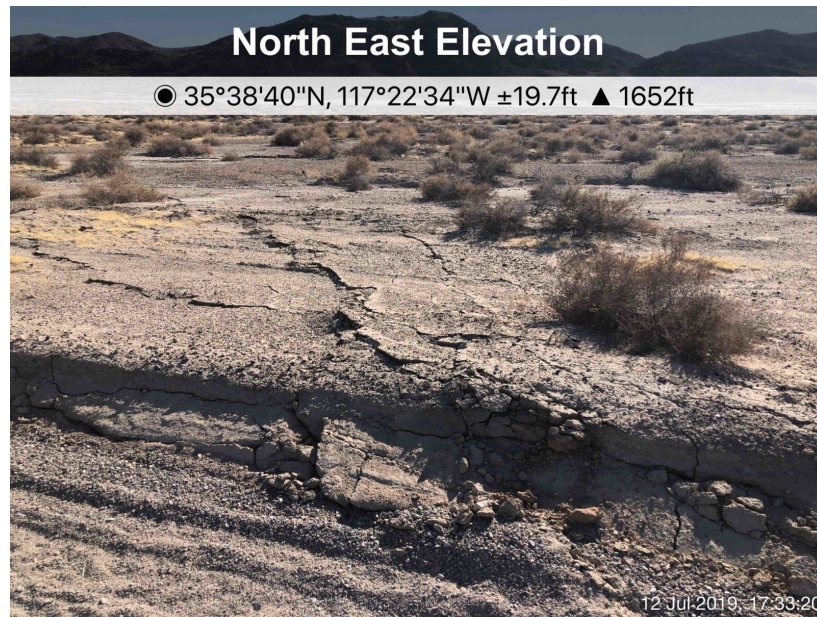
Figure 27. Example of cracks observed along Pinnacles Road. This specific picture was taken at zone 3 and shows where the cracks cut the Pinnacles Road.

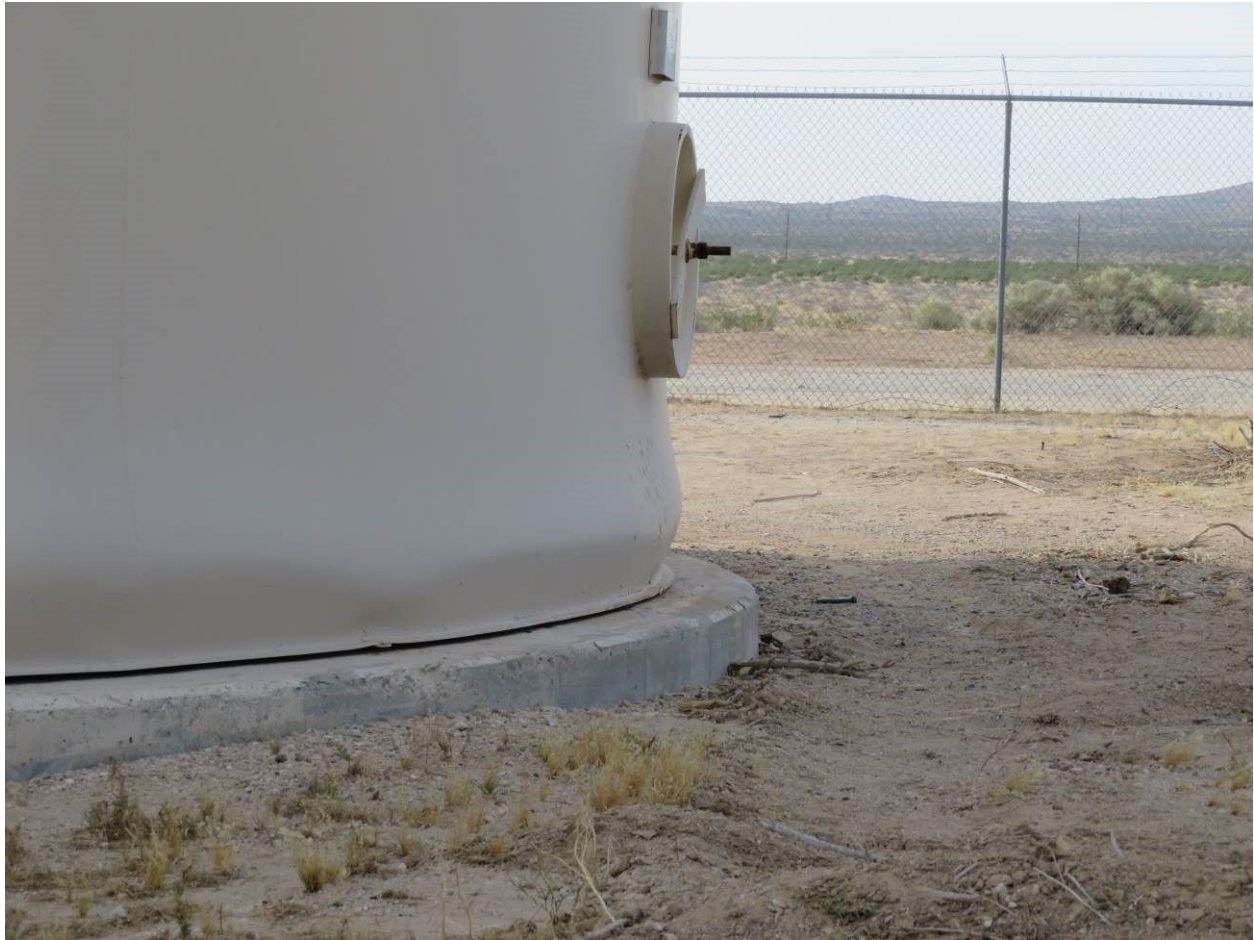
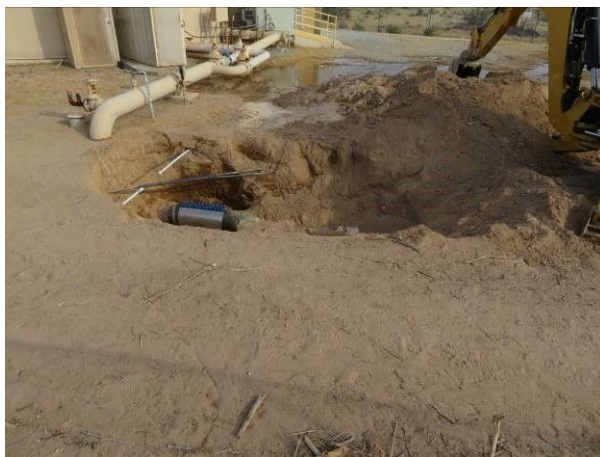
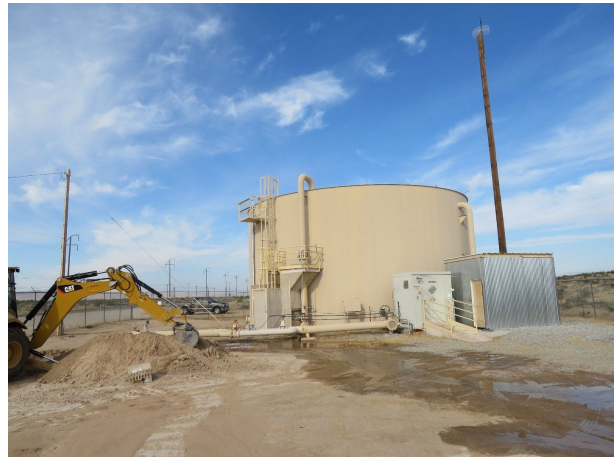
Figure 28. Hilltop Tank elephant foot buckle, pipe repair and continued leaking (35.6260, -117.5916).

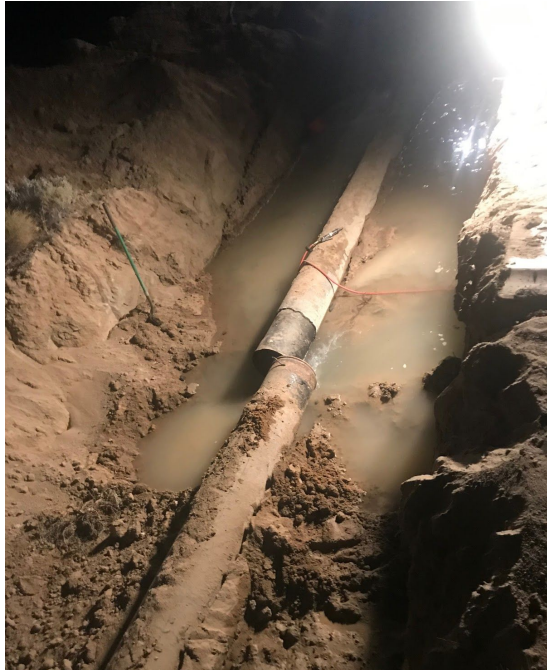
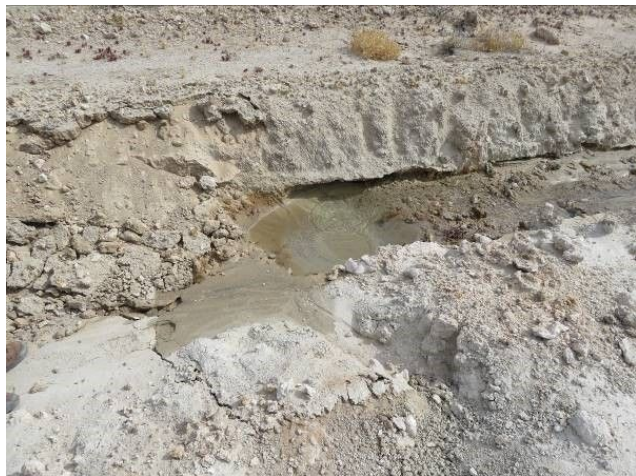
Figure 29. Pipeline damage at **M6.4** surface rupture crossing. (a) broken pipeline at west side of rupture zone photographed before repair on 7/4/2019 (B. Brooks, USGS). (b) repaired pipeline at west side of fault zone. (c) repaired pipeline at east side of fault zone. (d) leak within fault zone after **M7.1** earthquake. (35.6443, -117.5369)

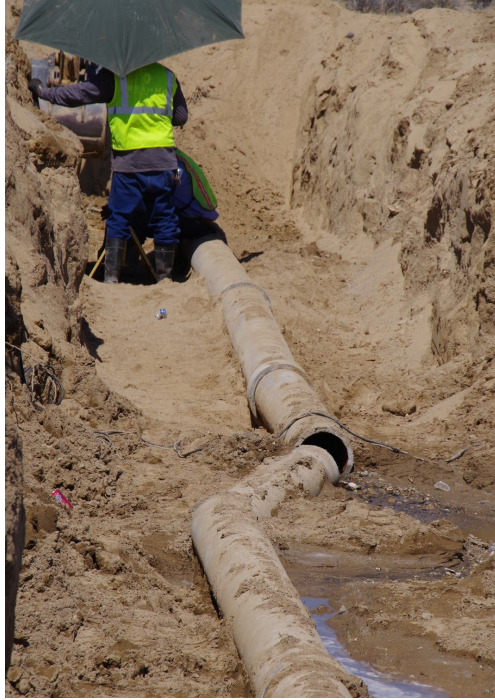
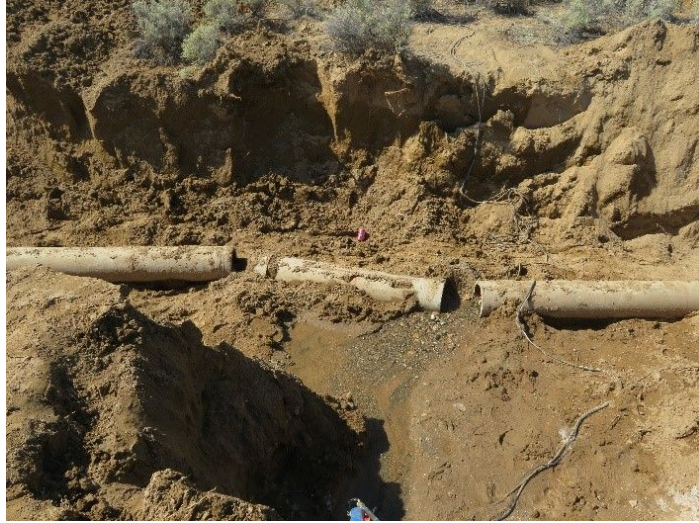
Figure 30. Offset of buried concrete segmented pipeline crossing the **M7.1** surface fault rupture. (35.6492, -117.4822).

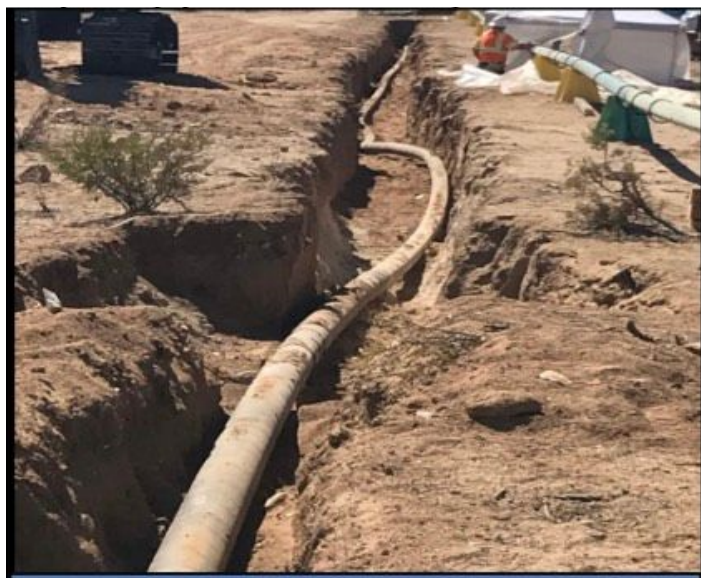
Figure 31. Deformed section of 10.75 inch steel gas pipeline following excavation at crossing of **M7.1** fault rupture. The surface rupture width in this area was approximately 0.5 m. Photo from PG&E.
