Preliminary Report on Engineering and Geological Effects of the July 2019 Ridgecrest Earthquake Sequence

A report of the NSF-Sponsored Geotechnical Extreme Event Reconnaissance Association

Report GEER-064: <https://doi.org/10.18118/G6H66K>

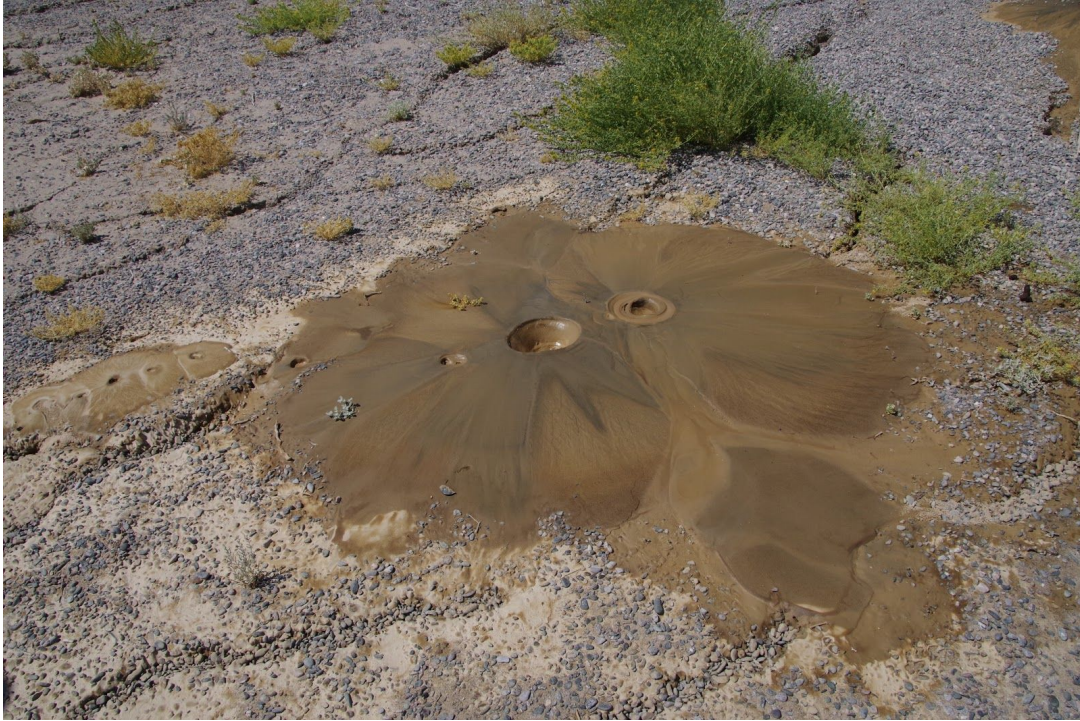
Figure 34. Sand boil near margin of Searles Lake in Trona. Photo by Scott Brandenburg, (35.7573, -117.3776).

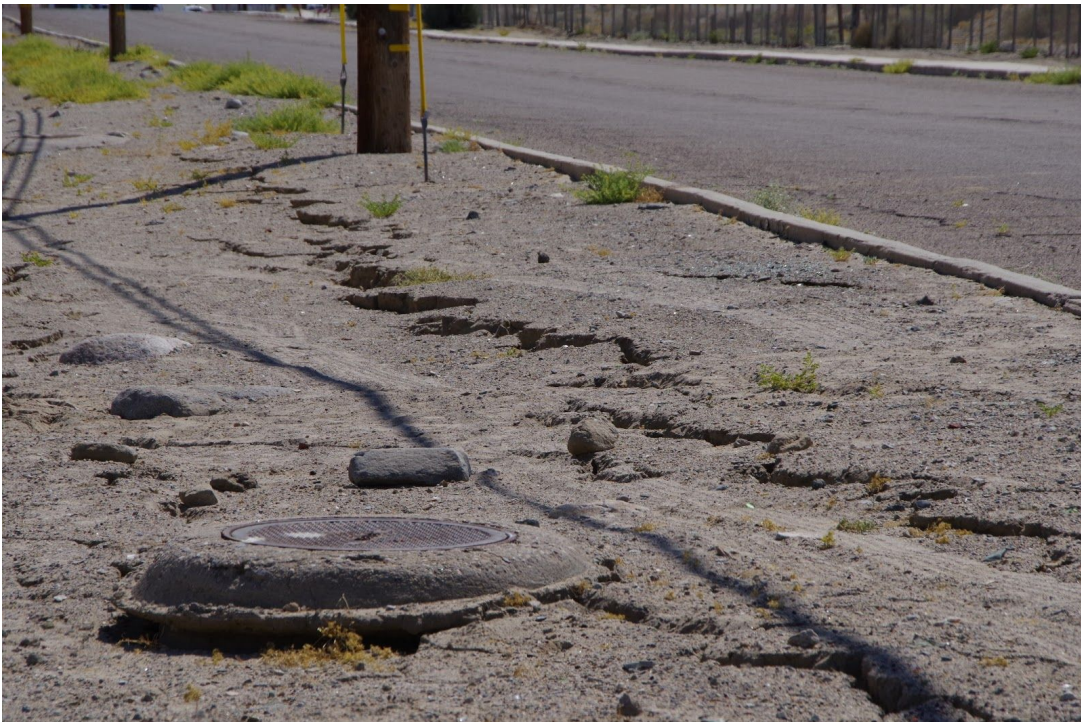
Figure 35. Ground cracks due to liquefaction-induced lateral spreading in Trona. Photo by Scott Brandenburg, (35.7626, -117.3731).

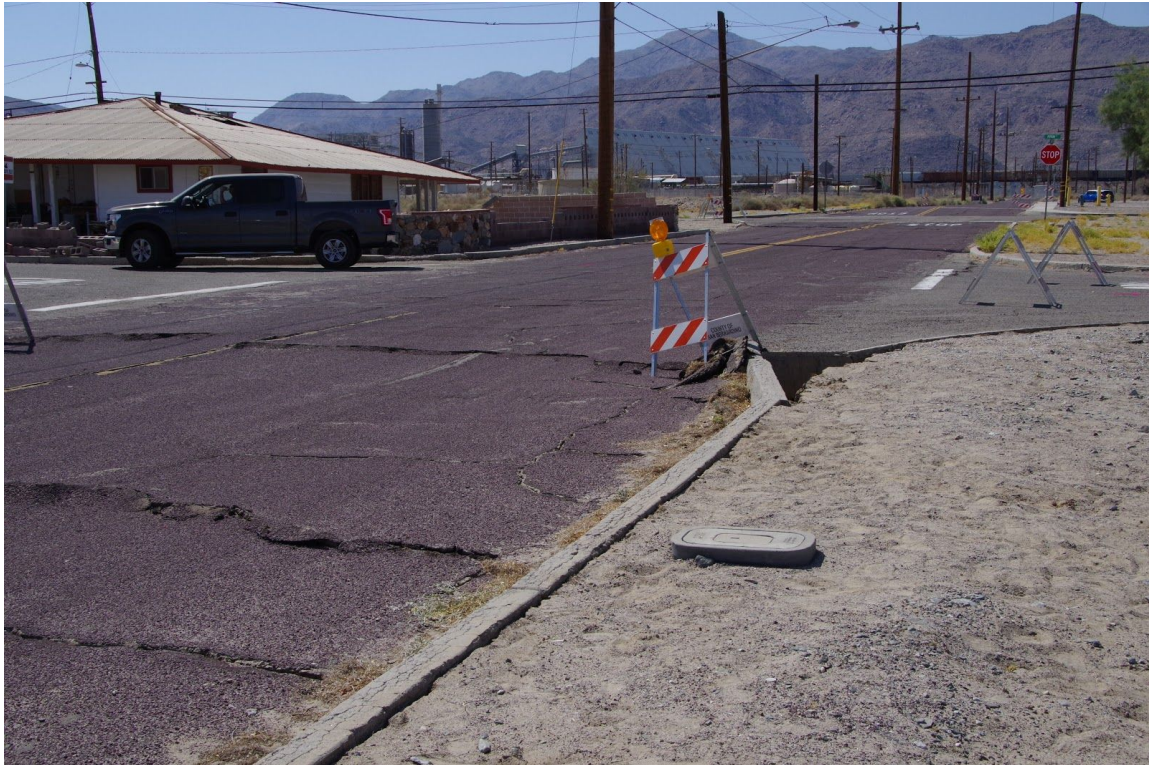
Figure 36. Ground compression, including buckled curb, due to liquefaction-induced lateral spreading in Trona. Photo by Scott Brandenburg, (35.7623, -117.3725).

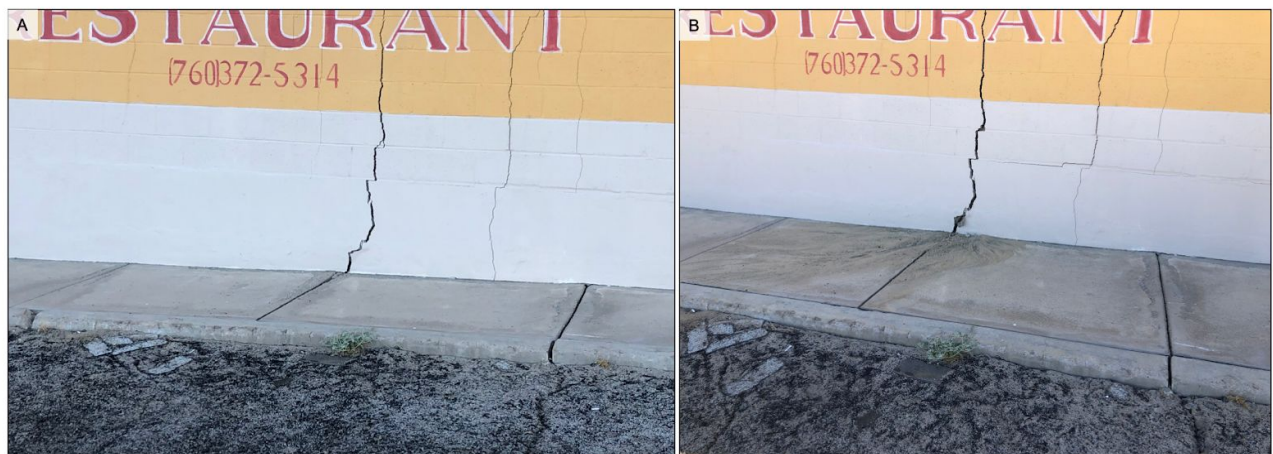
Figure 37. Esparza Restaurant building in Trona that exhibited cracked walls, (A) After the **M6.4** earthquake and before the **M7.1** and (B) after the **M7.1** earthquake. Following the **M7.1** earthquake, the horizontal and vertical cracks widened, the roof showed damage and a sand boil appeared at the base of the crack shown in the photo. Photos by Christine Goulet (35.7595, -117.3757).

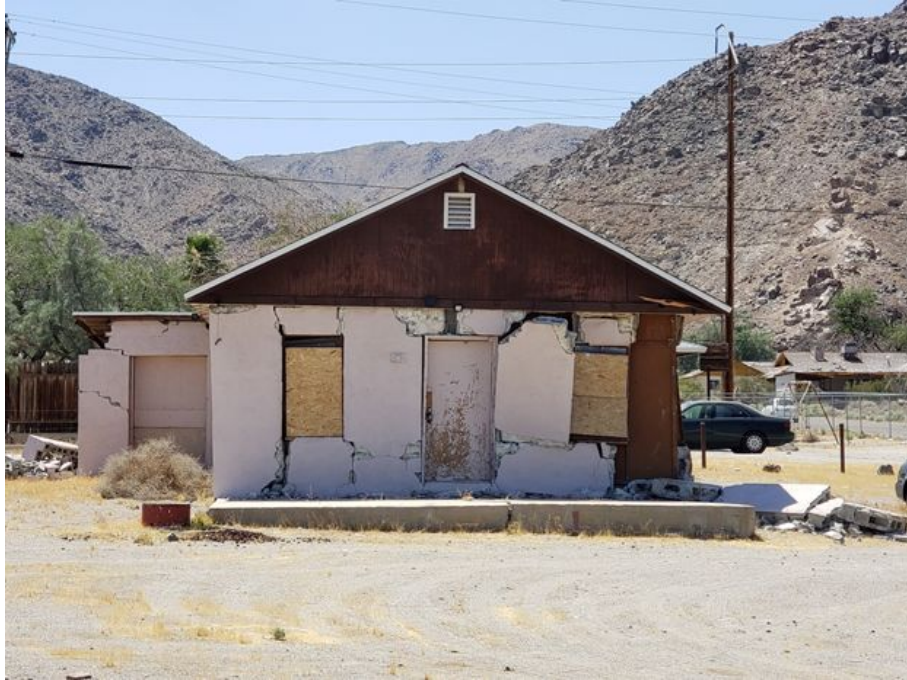
Figure 43. Example of more heavily damaged Structure A1 in vicinity of liquefaction – induced ground cracking (upon alluvial fan deposits – see canyon visible behind structure). (35.7457, -117.3964)

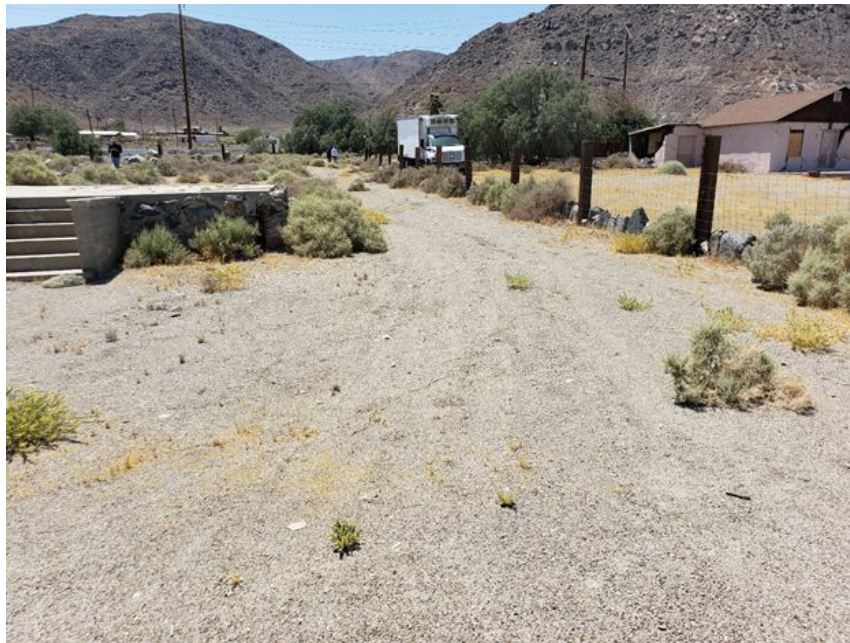
Figure 44. Example of liquefaction-induced lateral spreading ground cracking in vicinity of Structure A1 (at right of photograph). (35.7454, -117.3963)

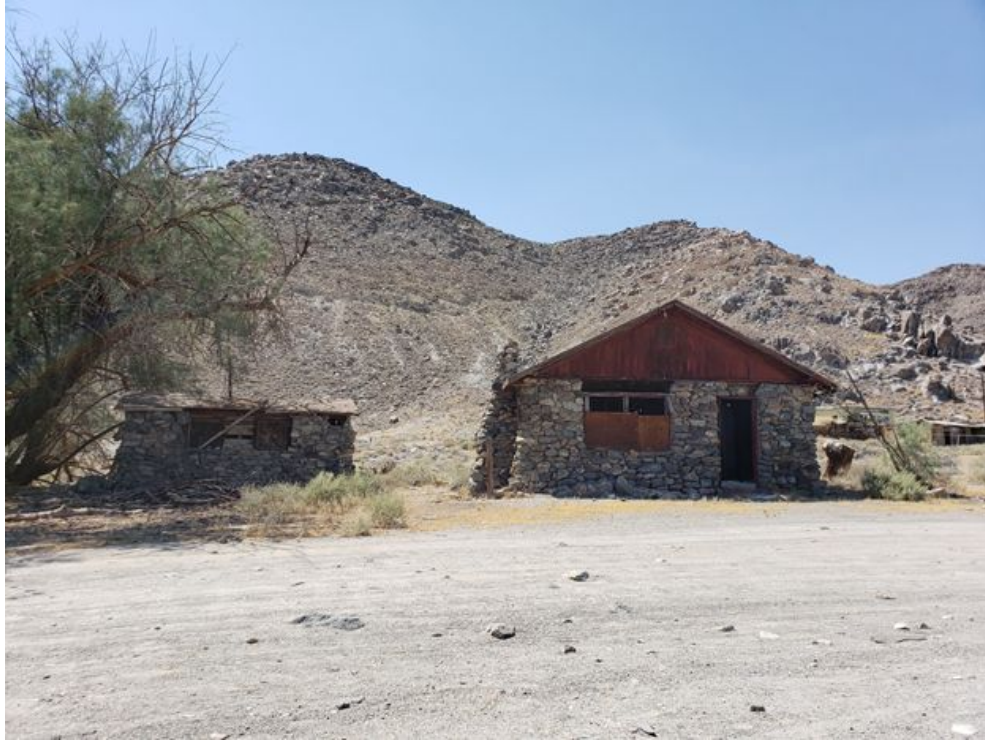
Figure 45. Example of less-heavily damaged Structure A2, not in vicinity of liquefaction – induced ground effects (at base of mountain). (35.7484, -117.3988)

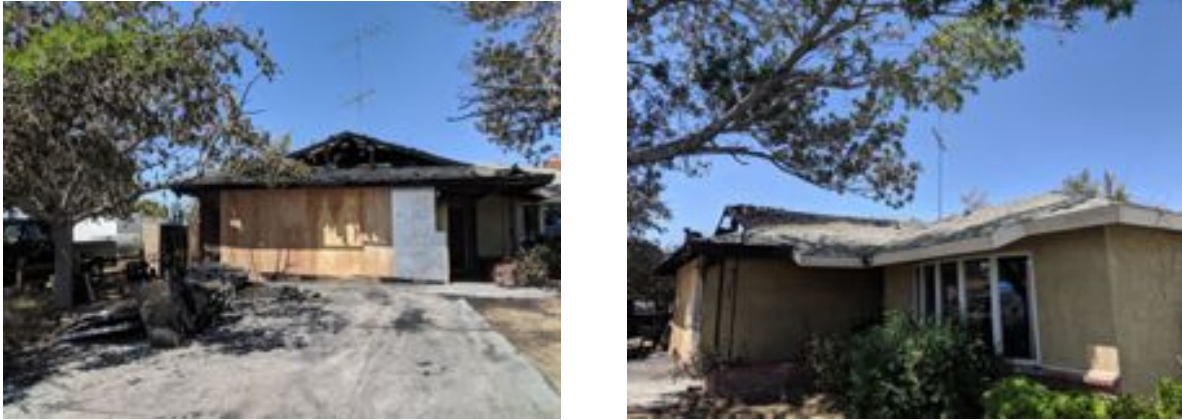
Figure 46. Damaged wood-frame house due to gas leak fire in Ridgecrest (35.6202, -117.6612) Photo credit: Farzin Zareian

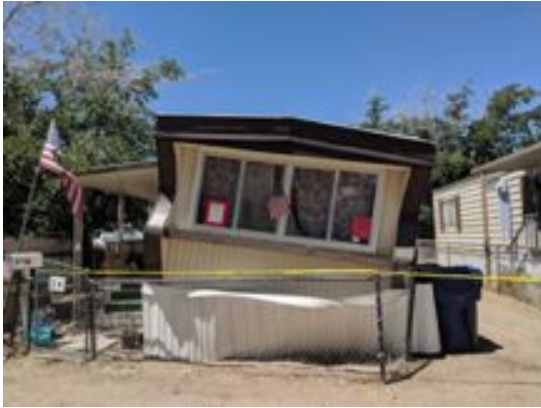
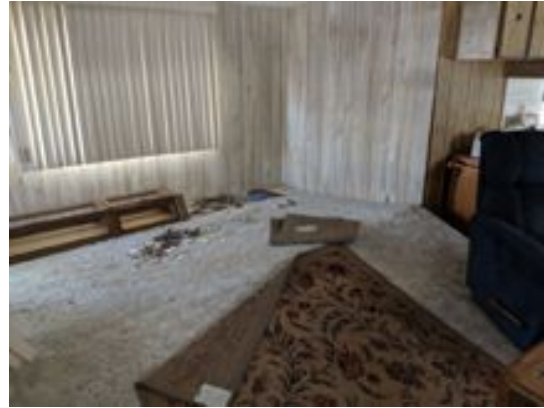
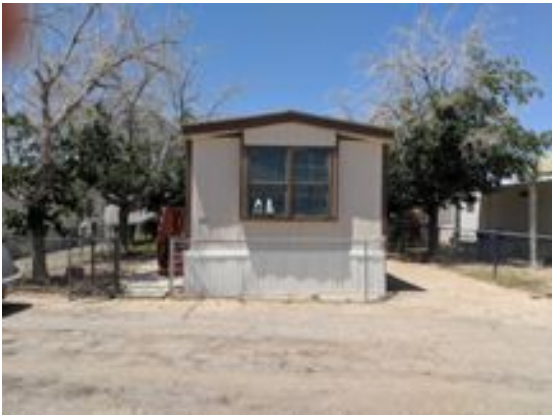
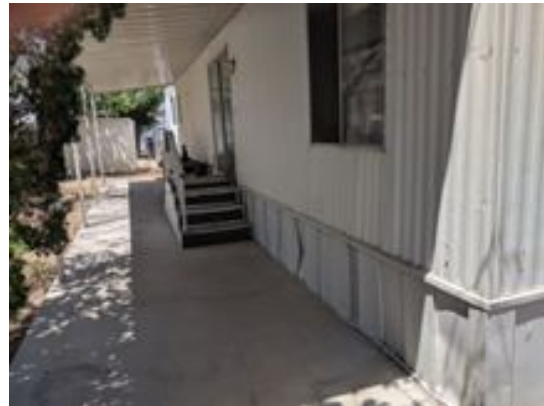
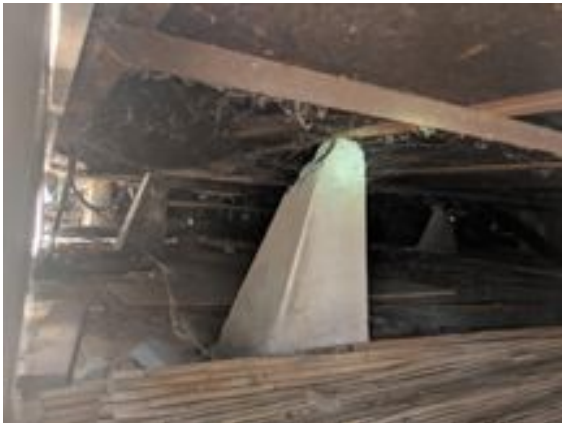
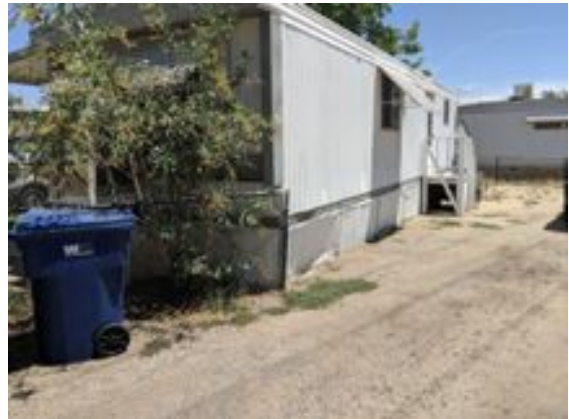
Figure 47. Damaged mobile homes in Ridgecrest after M6.4 event (35.6444, -117.6733) Photo credit: Farzin Zareian

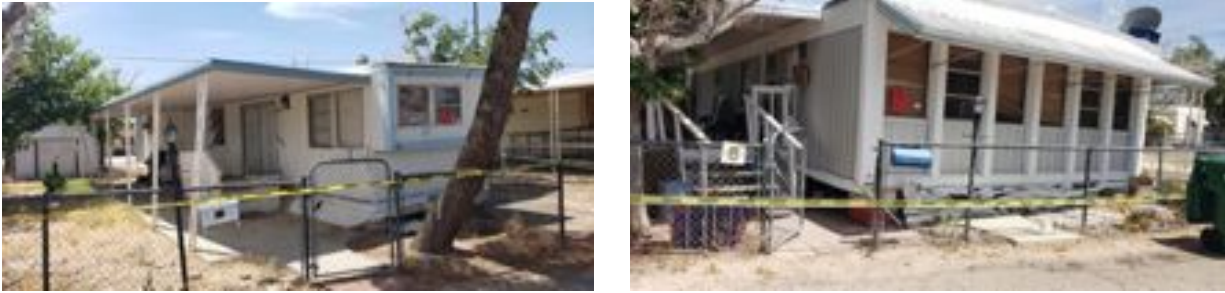
Figure 48. Collapsed mobile homes in Ridgecrest after M7.1 event (35.6444, -117.6733) Photo credit: Jawad Fayaz

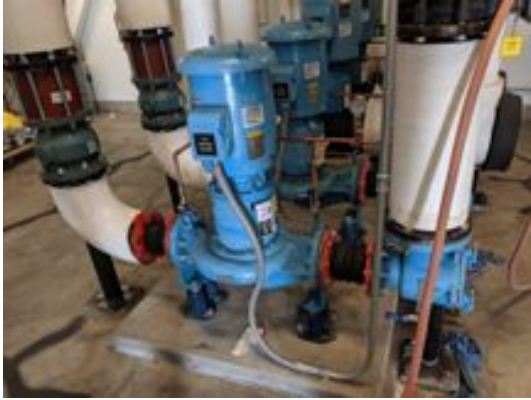
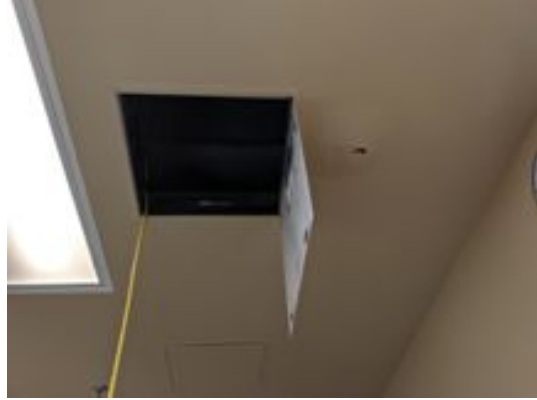
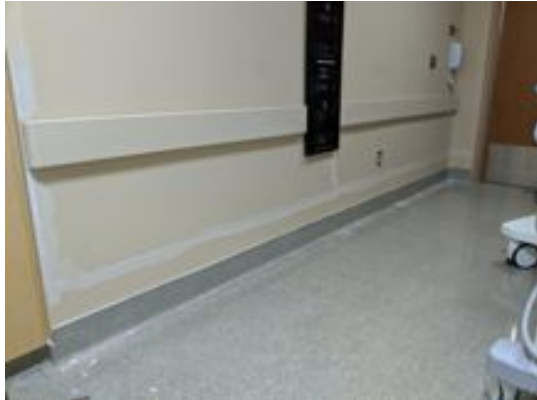
Figure 49. Damages to Ridgecrest Regional Hospital after the **M6.4** event (35.6410, -117.6707) Photo credit: Farzin Zareian

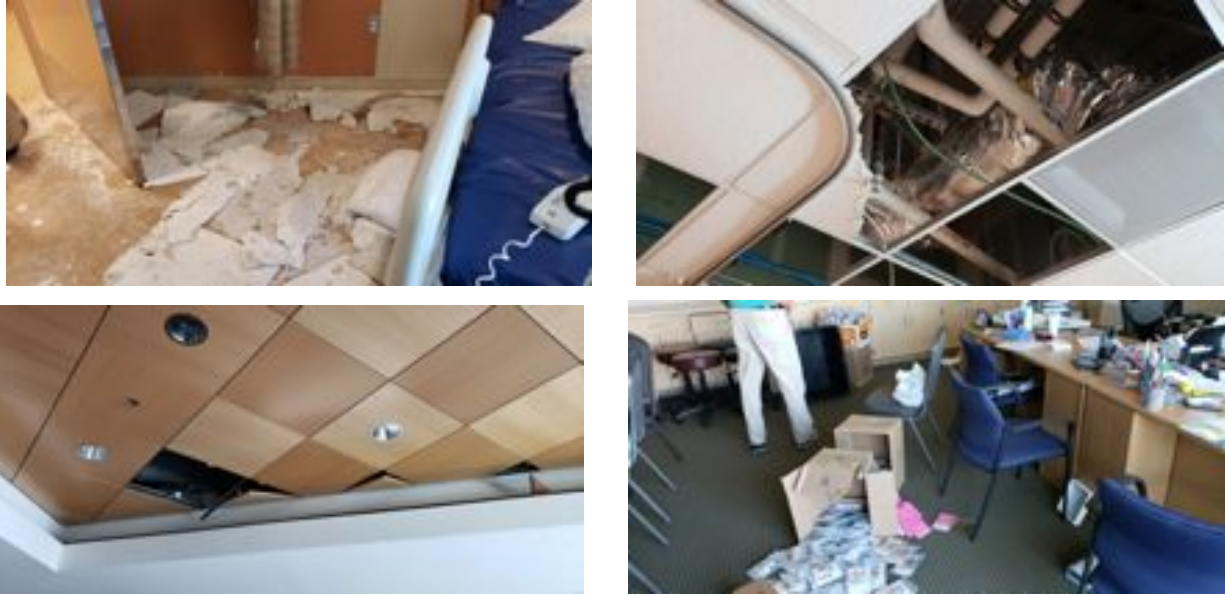
Figure 50. Damages to Ridgecrest Regional Hospital after the M7.1 event (35.6410, -117.6707) Photo credit: Jawad Fayaz

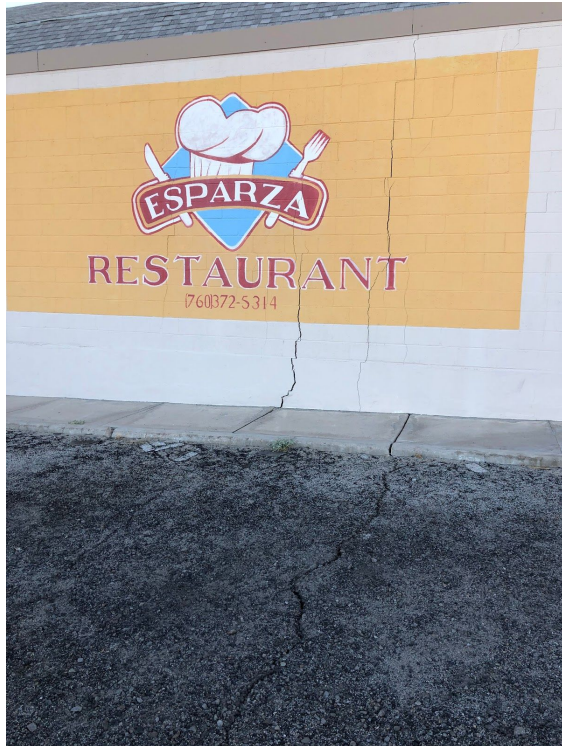
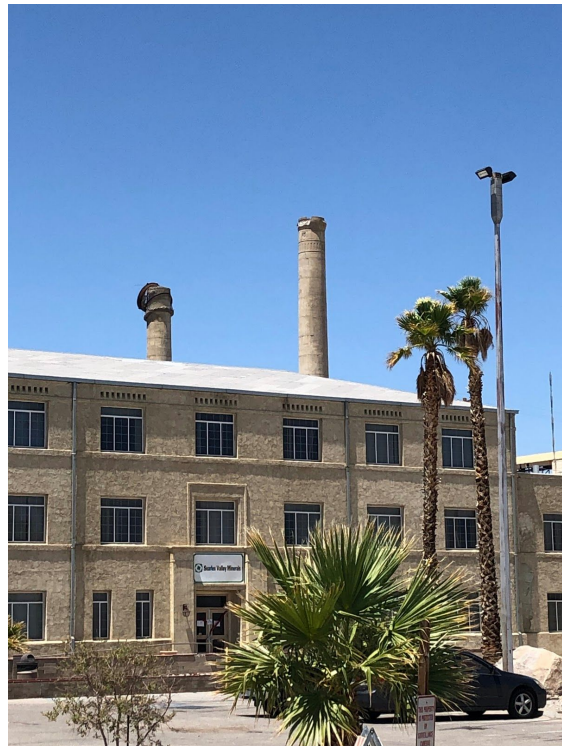
Figure 51. Damages to Masonry components after the M7.1 event (a: 35.7595, -117.7357, b: 35.7592, -117.3766, c: 35.7595, -117.7357, d: 35.6444, -117.6720) Photo credit: Christine Goulet and Jawad Fayaz

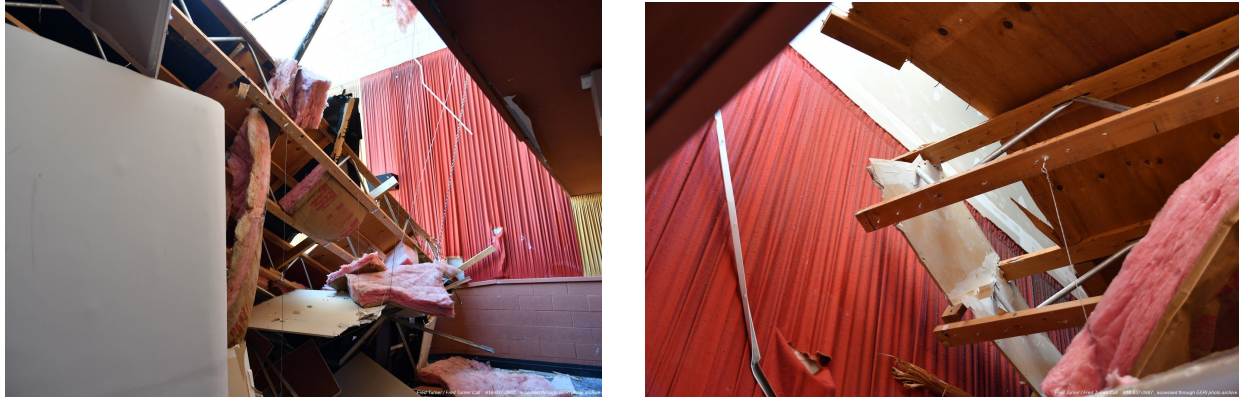
Figure 52. Observation of collapsed roof in Ridgecrest Cinema after **M7.1** event (35.6499, --117.6715)
Photo credit: Fred Turner

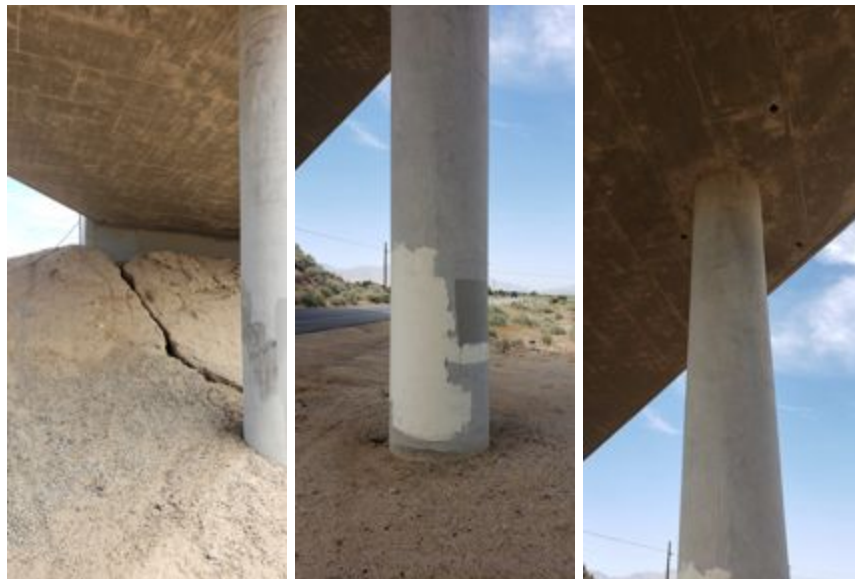
Figure 53. Observation of Ridgecrest – US-395/Brown Road Bridge after **M7.1** event (35.6696, -117.8187)
Photo credit: Jawad Fayaz

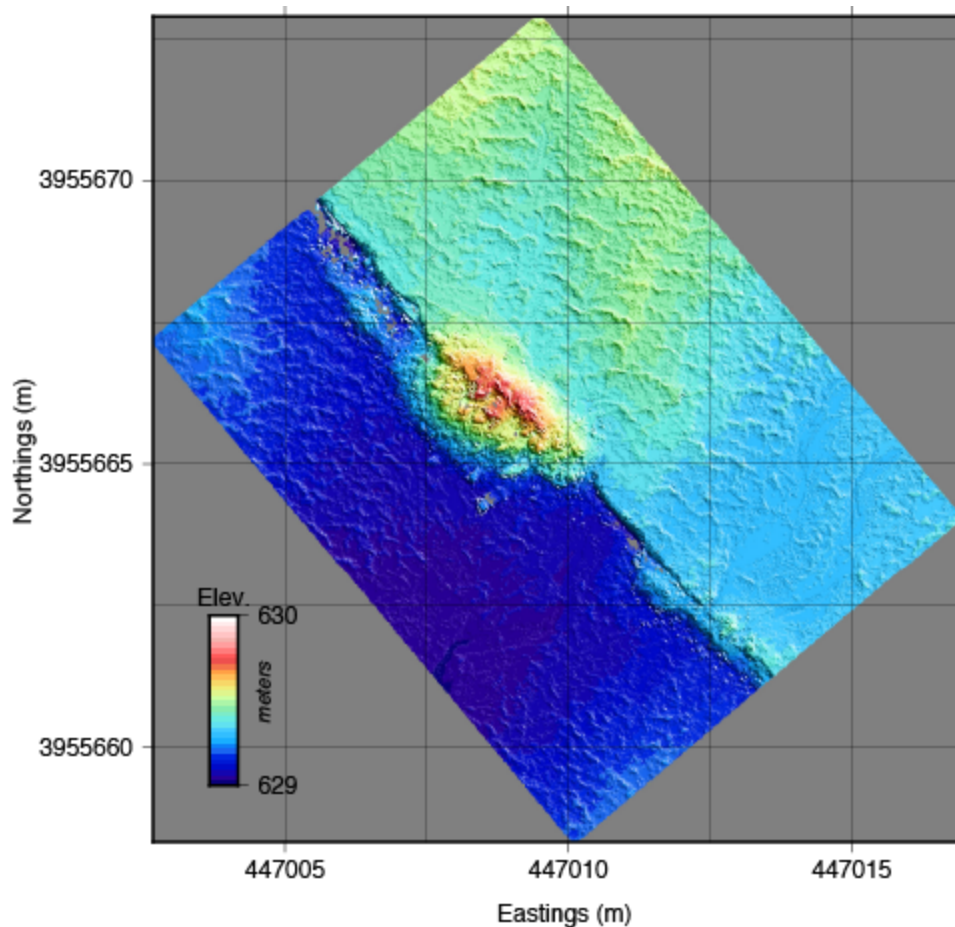
Figure 57. Example of USGS mobile lidar digital elevation model (DEM). DEM grid size is 2.5cm. The example shows the principal rupture on China Lake offsetting right-laterally, by approx. 1 m, a preexisting sand dune. Additionally the DEM shows vertical relief on the fault scarp on the order of ~25 cm. Grid graticules are 2.5 meters.
