CHAPTER 8 Geotechnical Observations

GEER/EERI/ATC Cephalonia, Greece 2014 Report Version 1

8.1 Site Effects

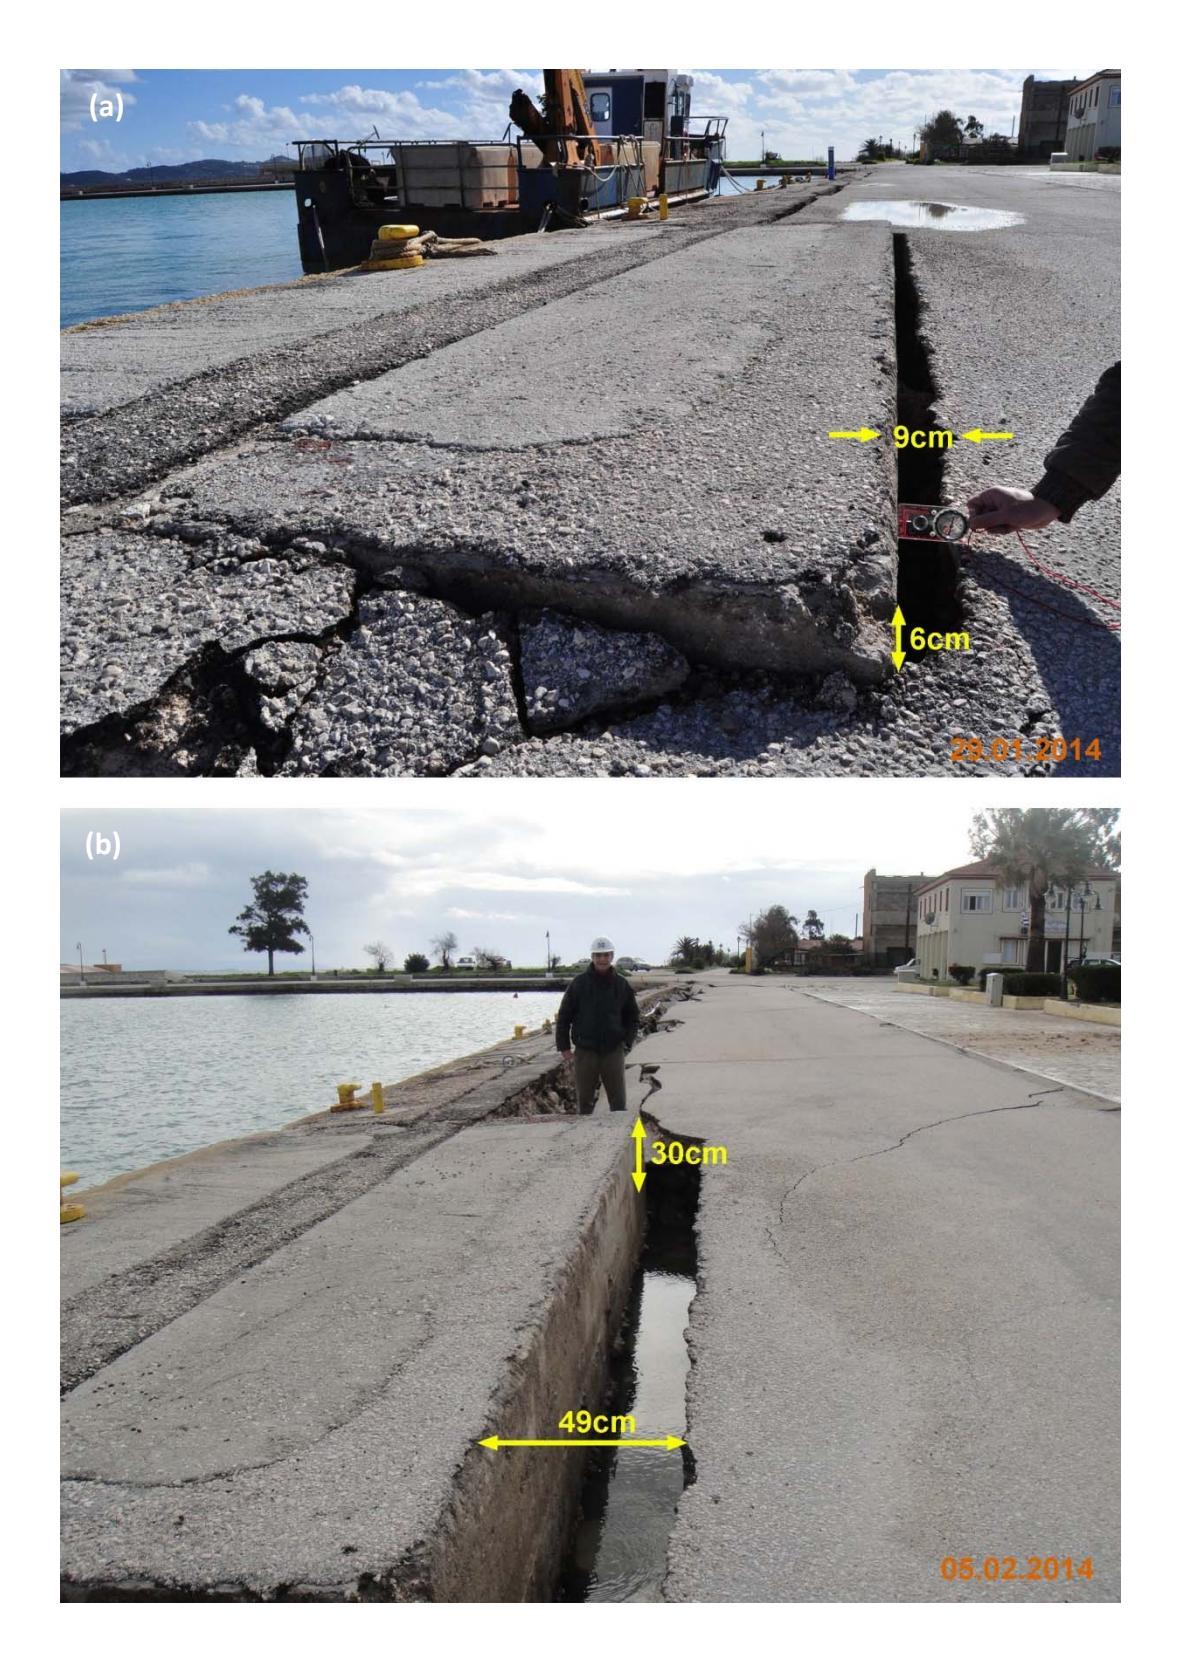
Figure 8.2.3 shows an example of damage due to liquefaction and lateral spreading in Lixouri's quay wall following Event 1 (Fig. 8.2.3a) and following Event 2 (Fig. 8.2.3b). As shown in Fig. 8.2.3, at this location the horizontal displacement was 9 cm and vertical displacement was 6 cm after Event 1 (Fig. 8.2.3a). After Event 2, horizontal and vertical displacements increased to 49 cm and 30 cm, respectively (Fig. 8.2.3b). Many sites that were liquefied in Event 1 re-liquefied during Event 2 along the Lixouri waterfront. Figure 8.2.4 illustrates an example from the Lixouri port's main pier, which was practically undamaged following Event 1 (Fig. 8.2.4a), but suffered significant damage in some sections following Event 2 (Fig 8.2.4b).

Figure 8.2.3. Lixouri port movement following (a) Event 1 and (b) Event 2. (GPS coordinates 38.198767°, 20.439533°). George Athanasopoulos of UPatras is on the photo.

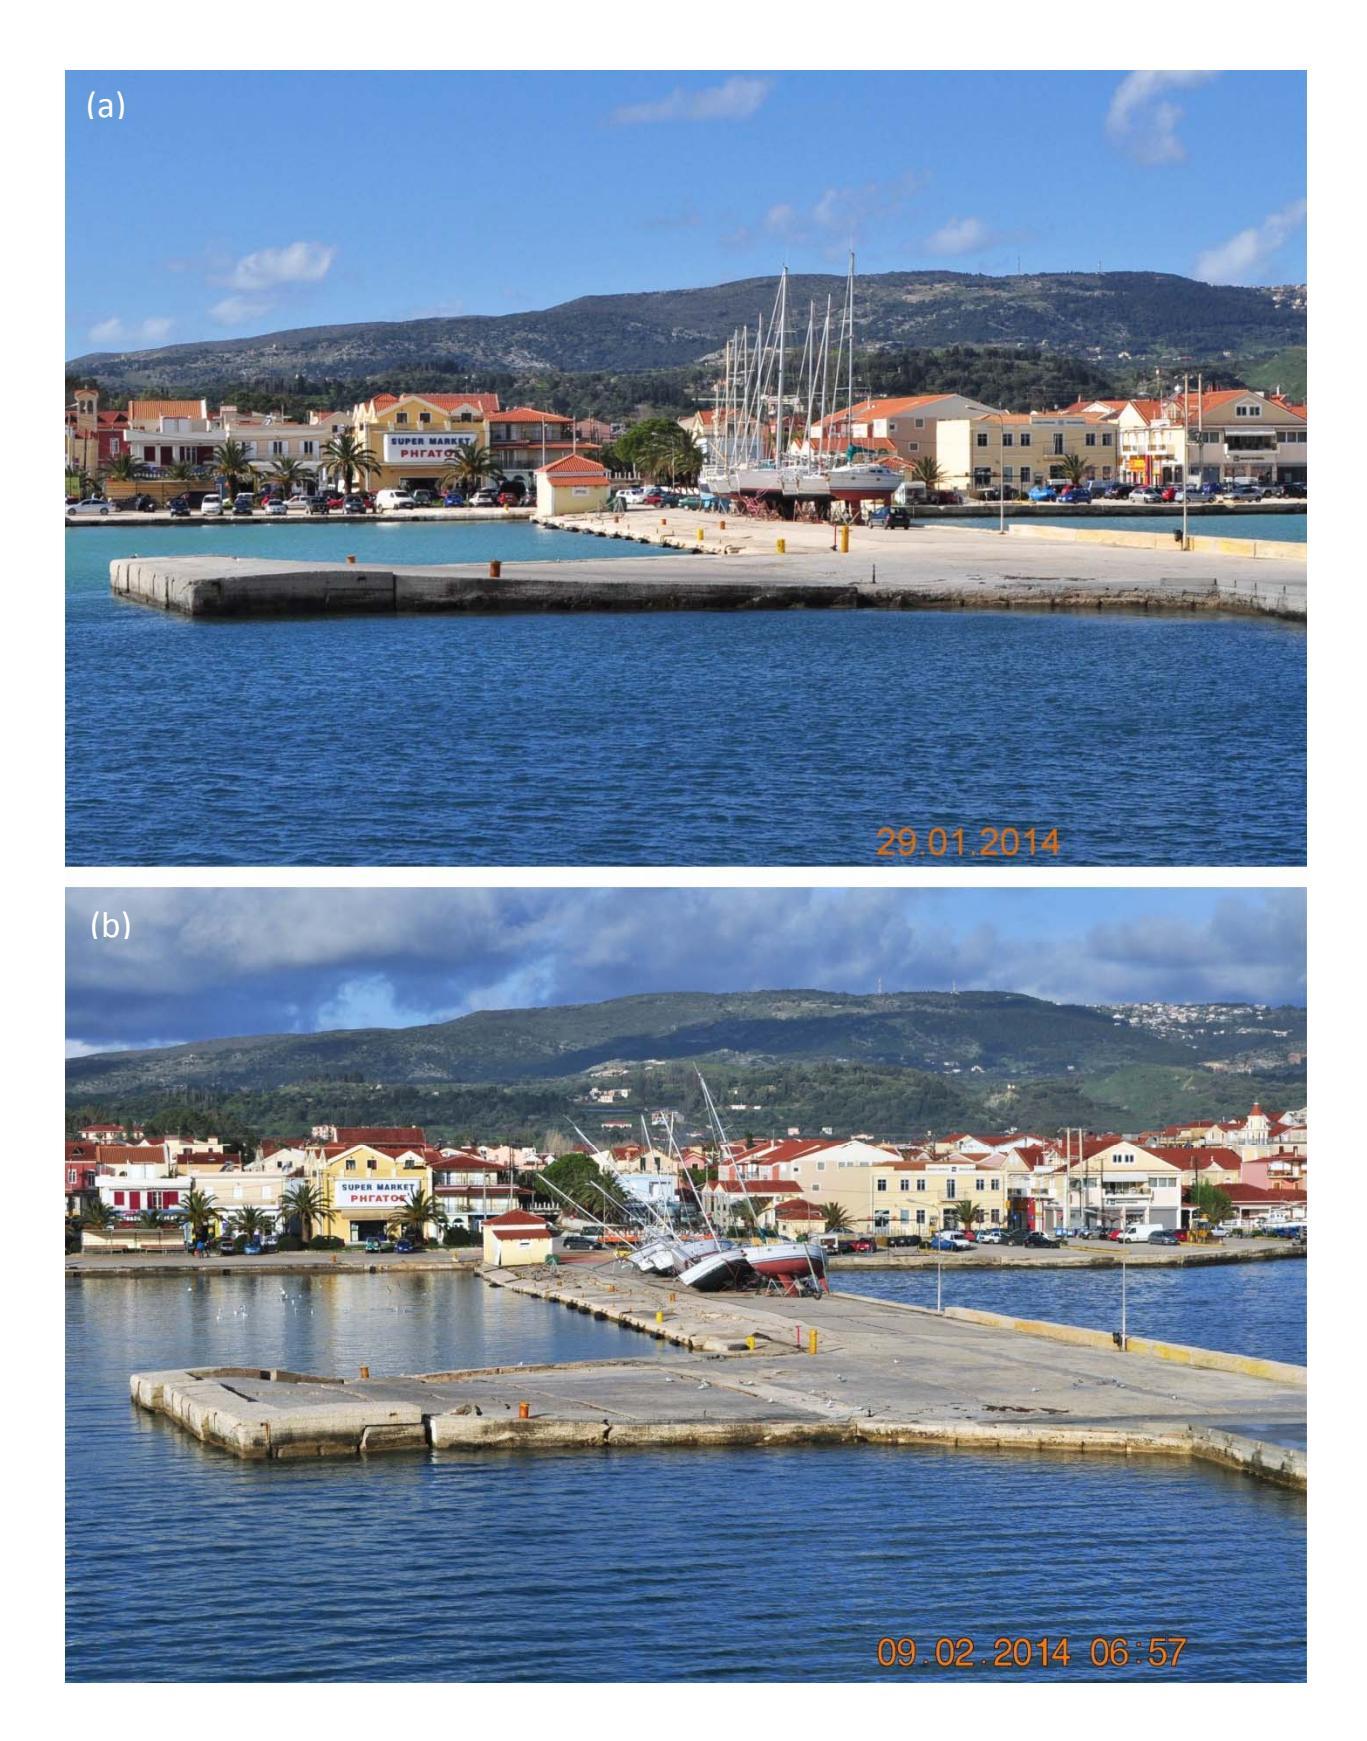
Figure 8.2.4. Damage to the main pier of Lixouri port, Davraga, following: (a) Event 1 and (b) Event 2 at (GPS coordinates 38.201500°, 20.441283°).

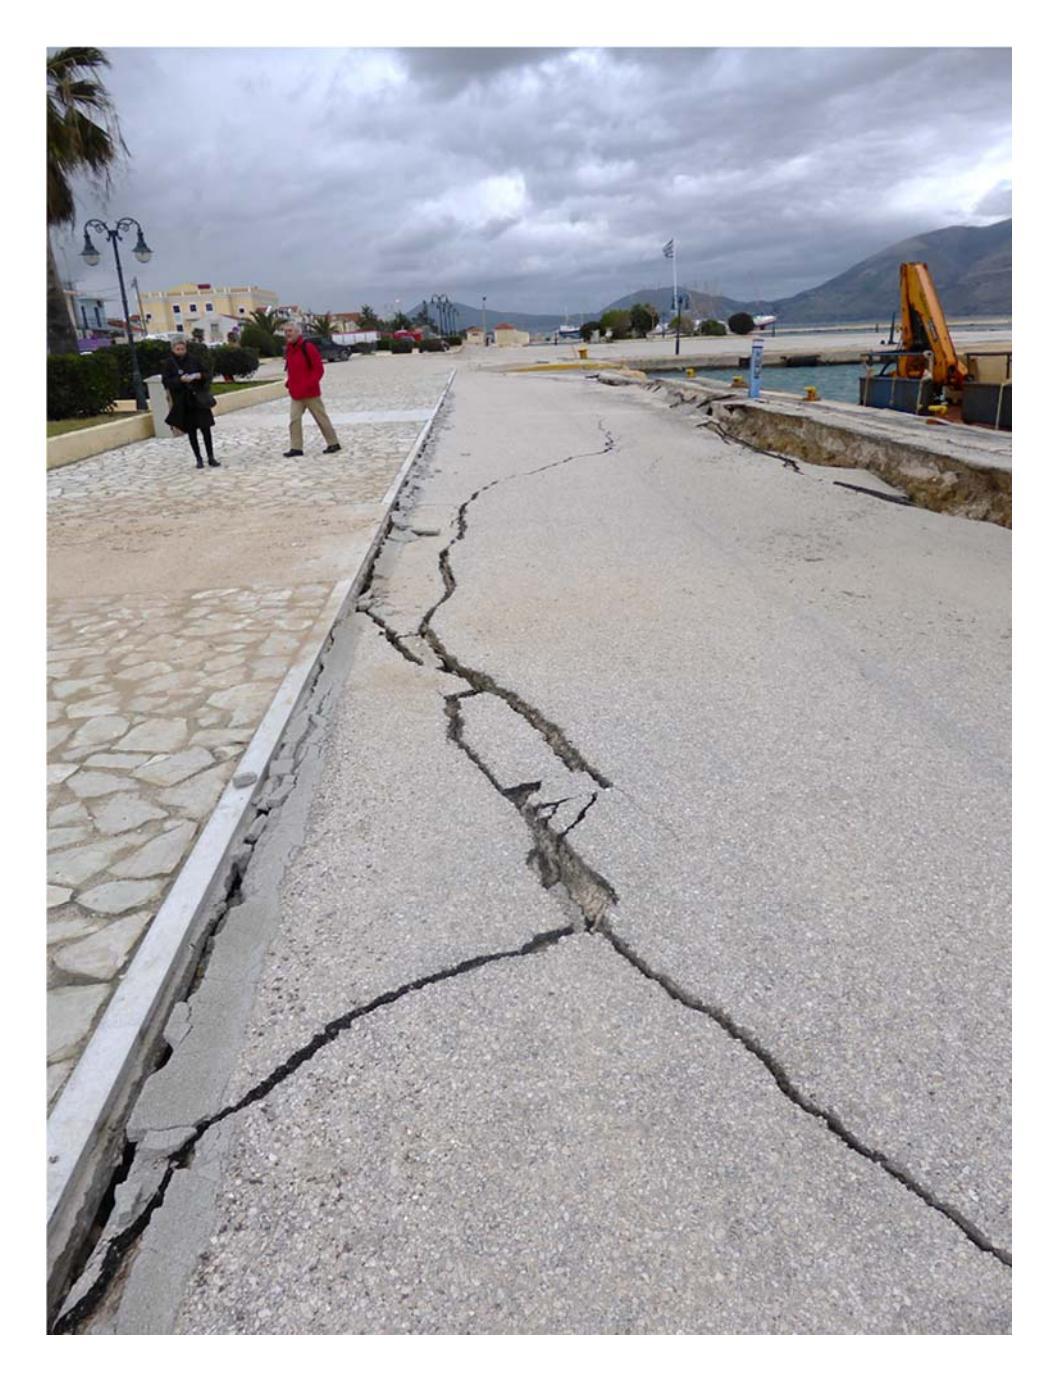
Figure 8.2.18. Cracks in the road behind the quay wall and liquefaction remnants on the sidewalk (GPS coordinates: 38.199166, 20.439444).

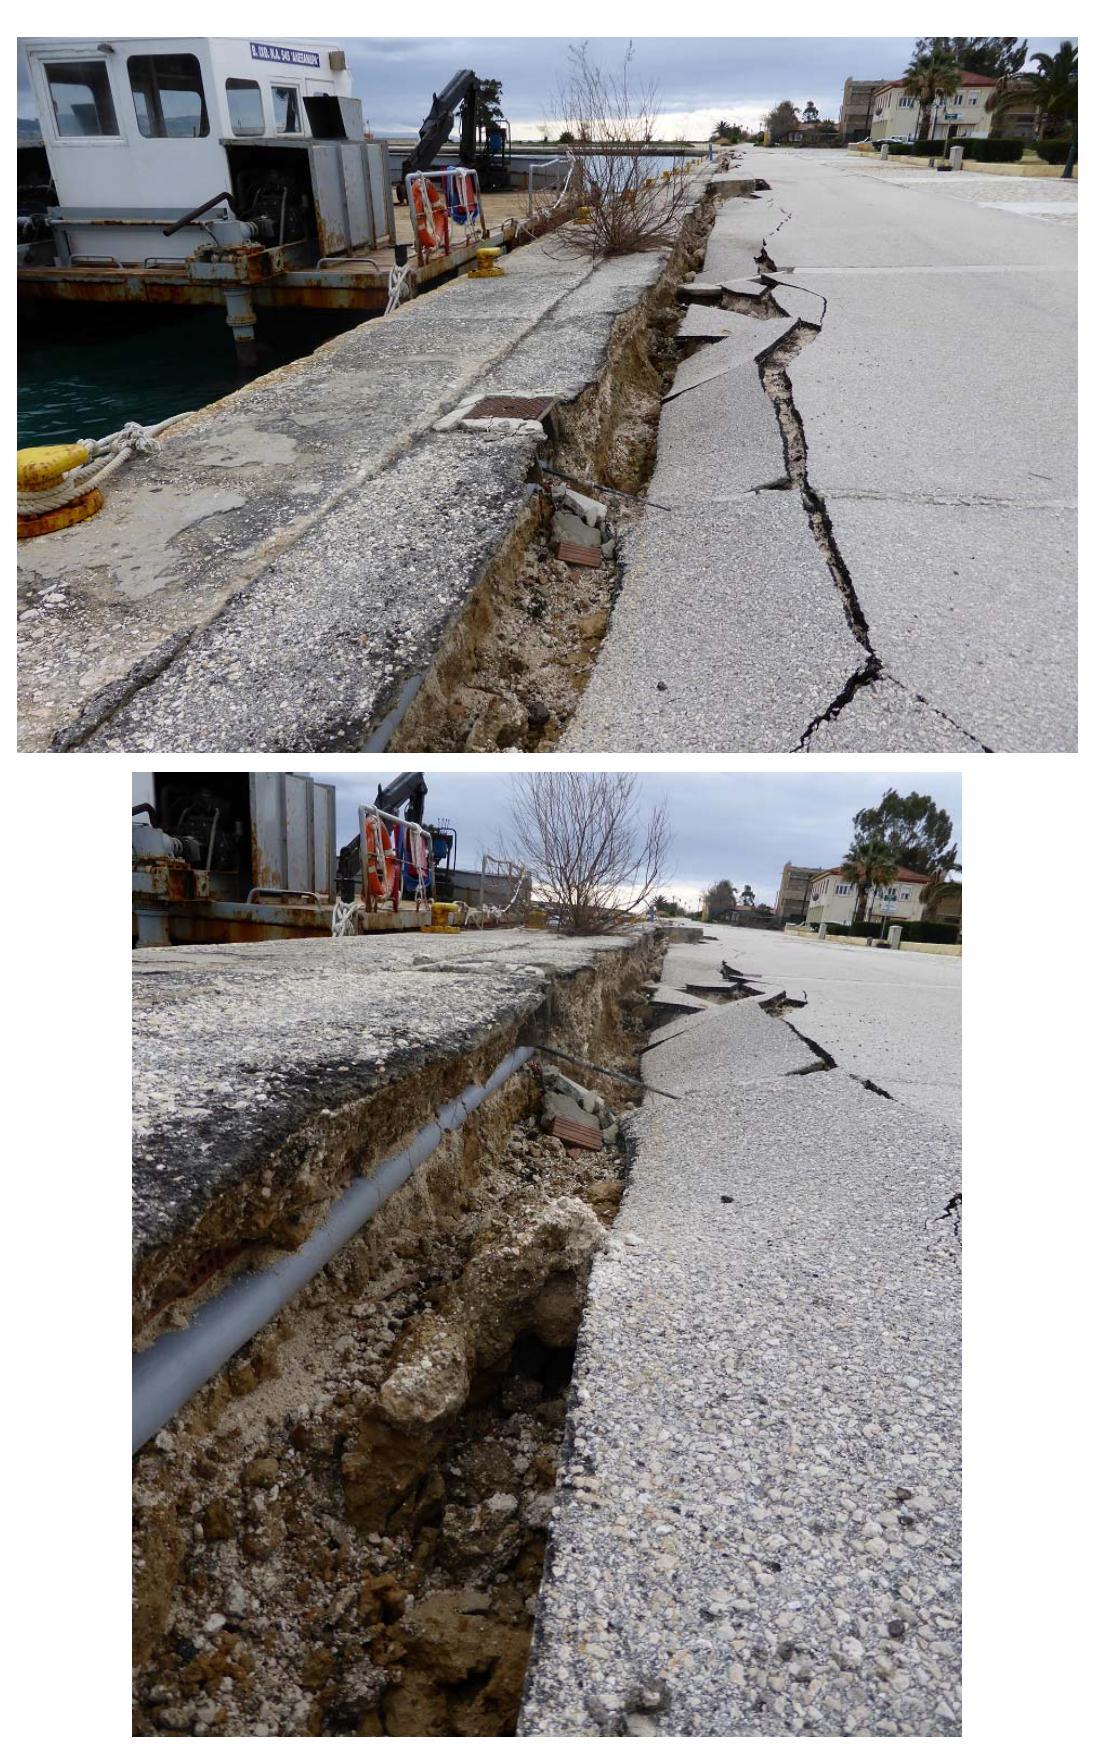
Figure 8.2.19. Vertical diaplacement behind quay wall exposing water network pipes (GPS coordinates: 38.199166, 20.439444).

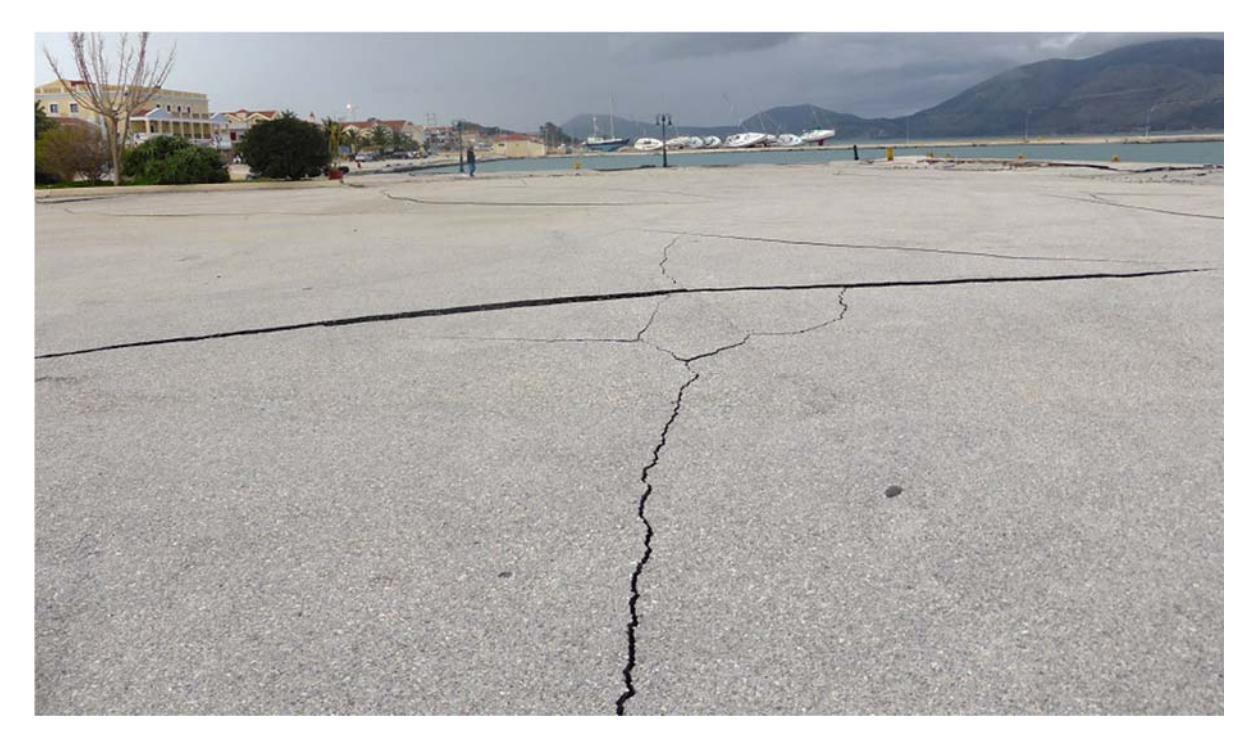
Figure 8.2.25. Cracks in the southern part of the Lixouri port (GPS coordinates: 38.199722, 20.439722).

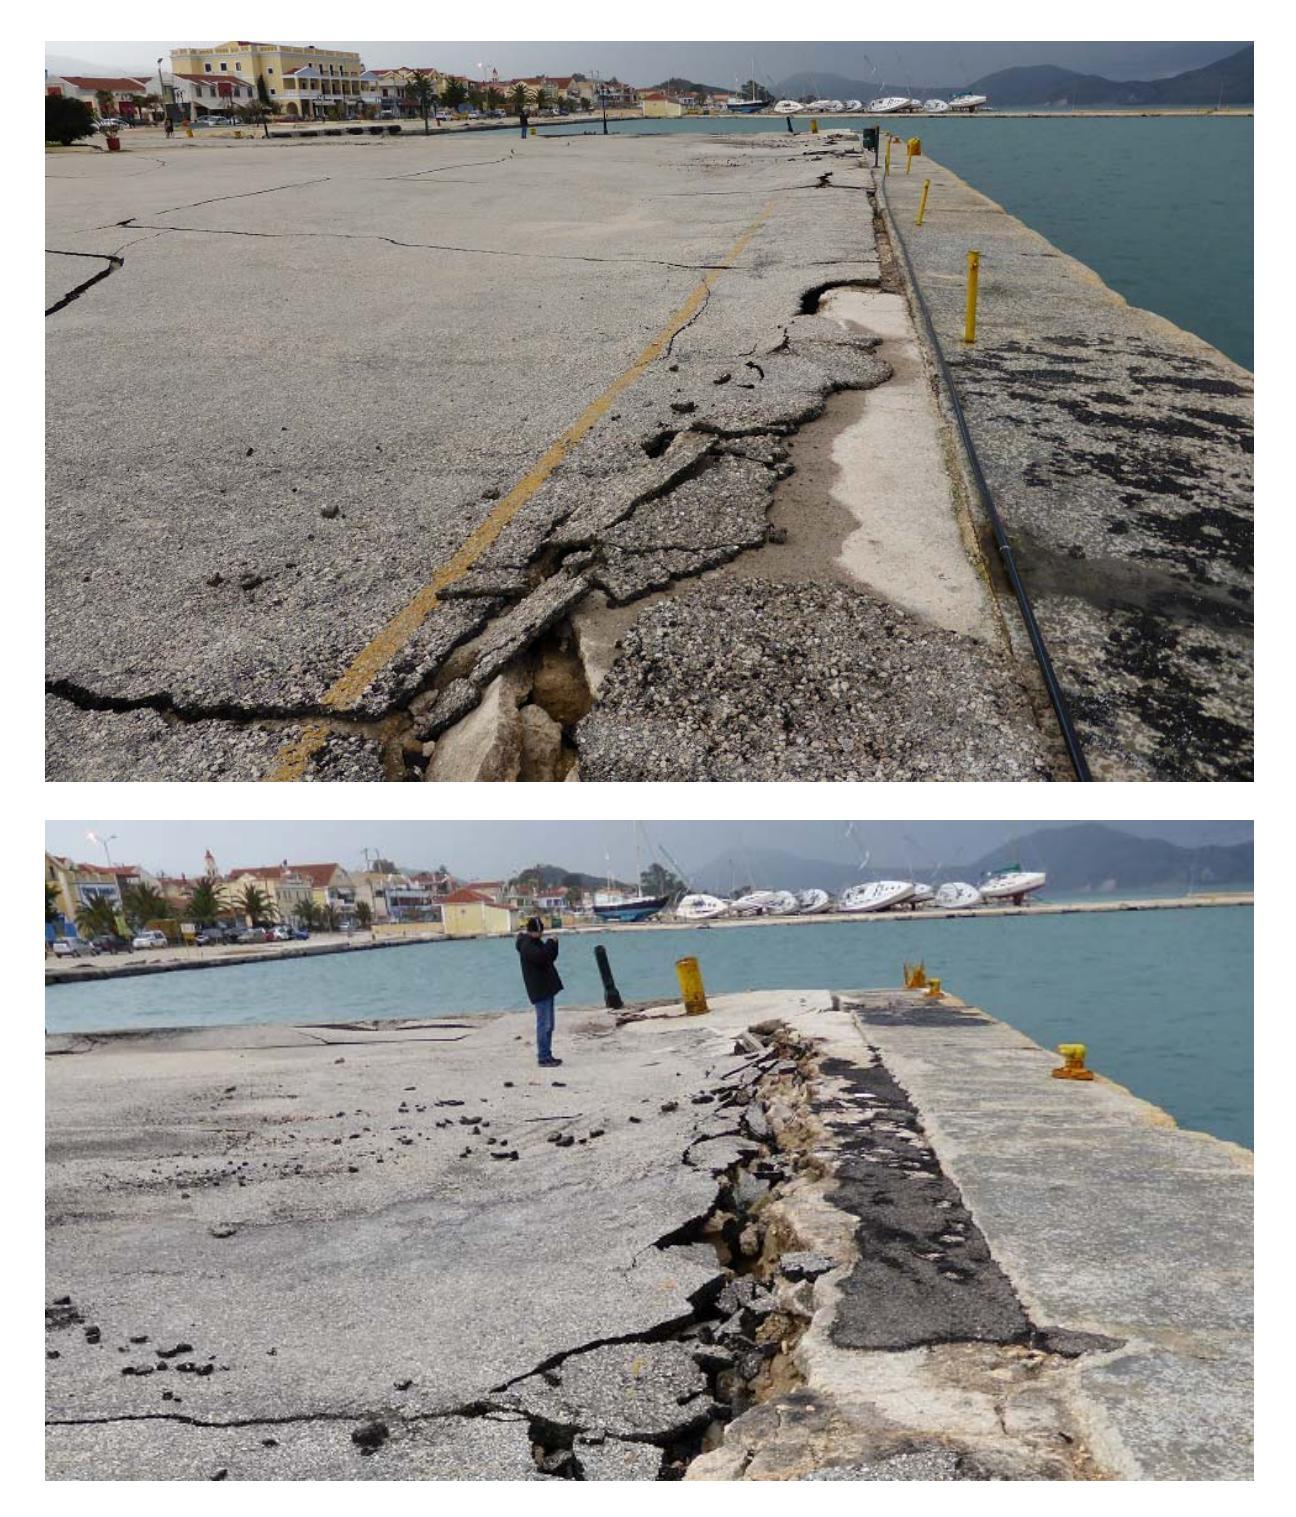
Figure 8.2.27. Uneven surface settlement due to lateral spreading and liquefaction of the wharf backfill (GPS coordinates: 38.199627, 20.440022).

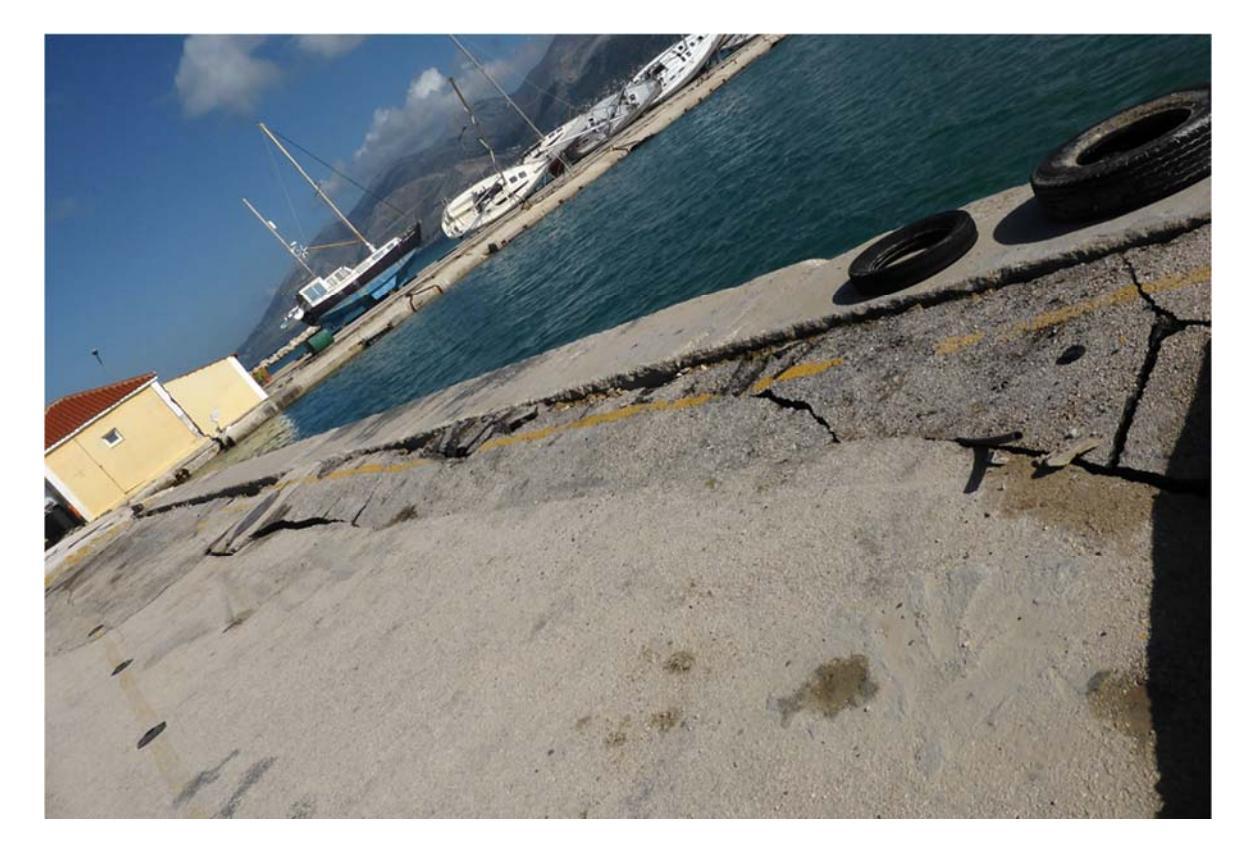
Figure 8.2.30. Cracks behind the wall and sand remnants of liquefaction ejecta (GPS coordinates: 38.201050, 20.439297).

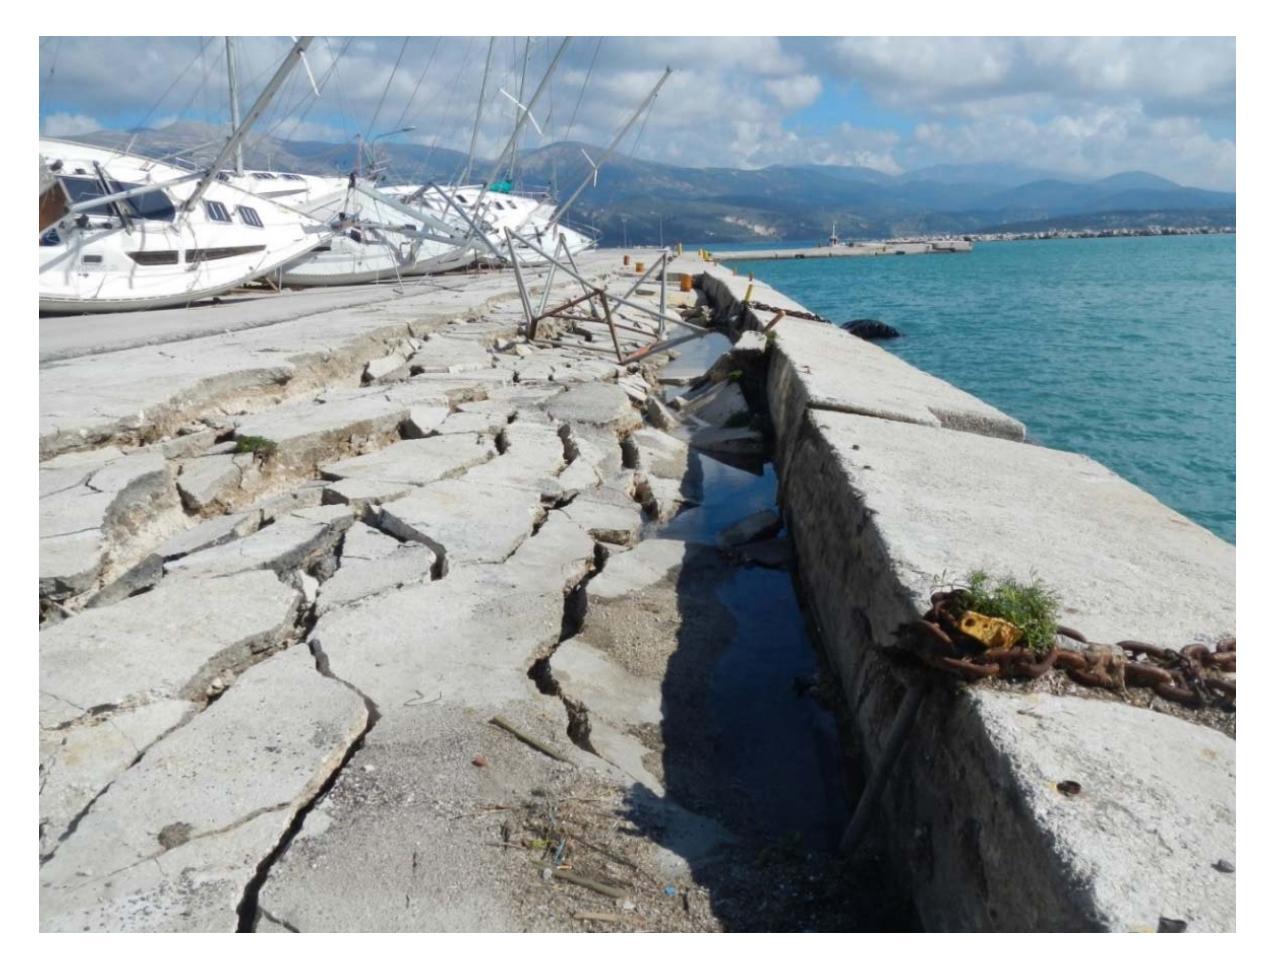
Images such as the one shown on Fig. 8.2.37 caught significant media attention. The main pier appeared to be largely undamaged following Event 1, but in some places suffered heavy damage during Event 2. The pier has been constructed in phases. As a result, different sections suffered variable levels of damage (Fig. 8.2.38 to 40), depending on the construction and geometric aspects of the pier. Surveying measurements have been performed and results are currently being processed by the UPatras team.

Figure 8.2.37. Example of liquefaction damage and lateral spreading at the most damaged section of the main pier (38°12'5.12"N, 20°26'22.40"E).

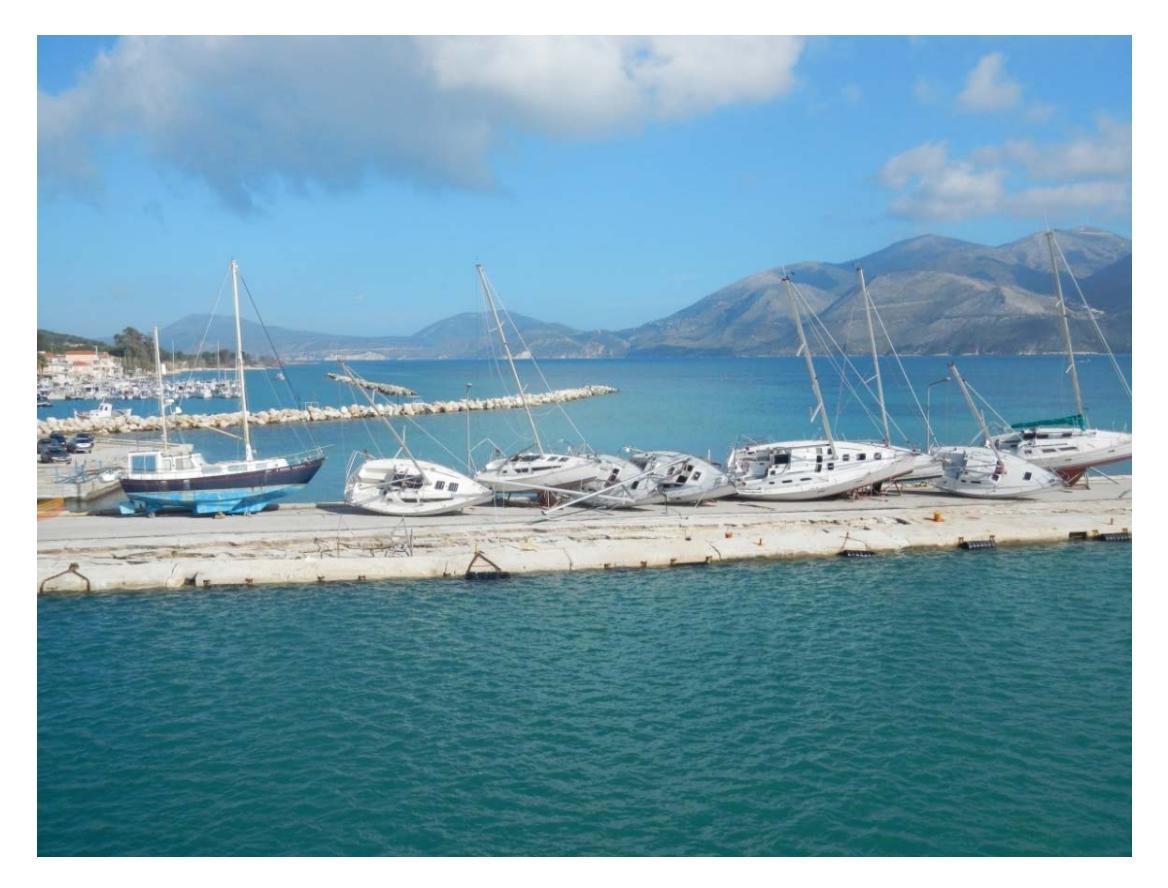
Figure 8.2.38. Most damaged section of the main pier (38°12'3.32"N, 20°26'22.92"E).

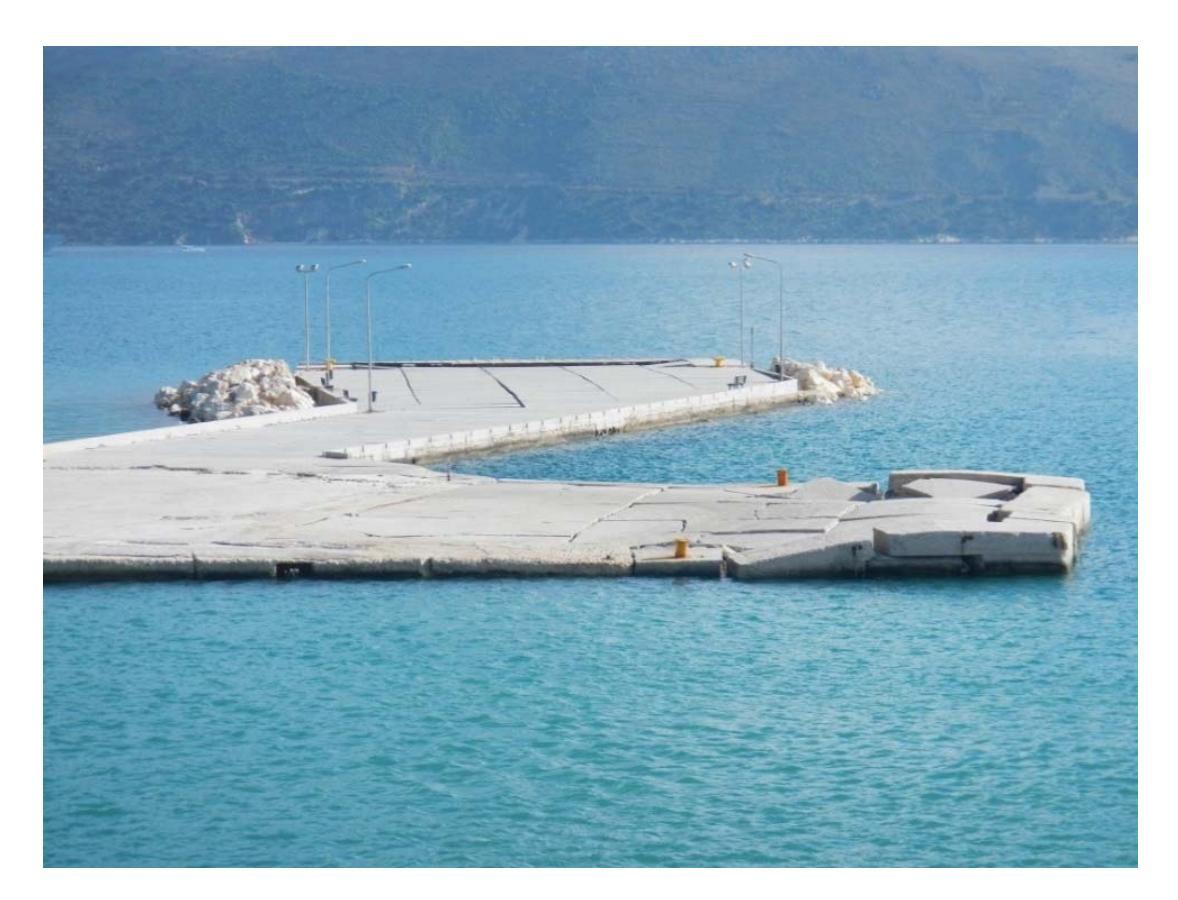
Figure 8.2.39. Another section of the damaged main pier (38°12'3.30"N, 20°26'23.02"E).

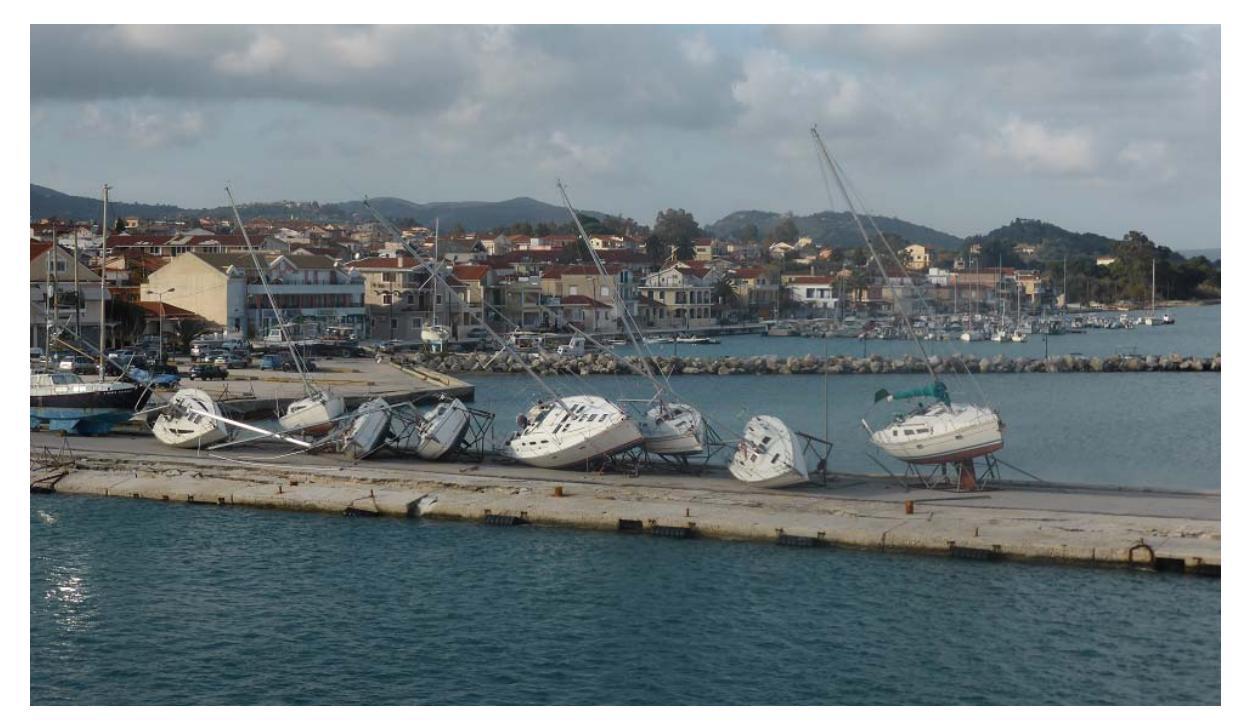
Figure 8.2.41. Damage of quay wall in Davraga pier. Sailboats overturned (GPS coordinates: 38.201050, 20.439297).

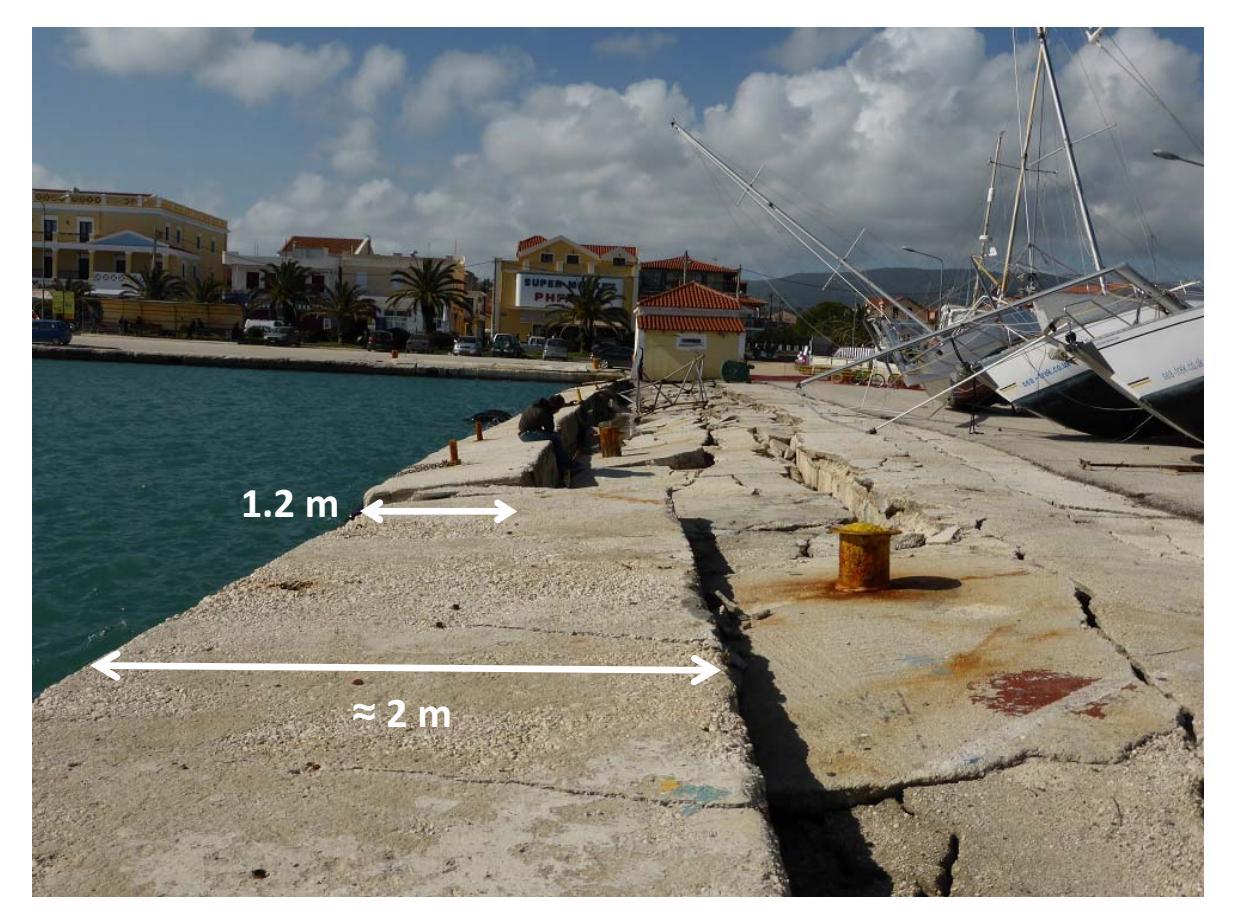
Figure 8.2.42. Lateral spreading and differential horizontal displacement along Davraga main pier wall. Note the different wall width shown with white arrows (GPS coordinates: 38.201436, 20.440202).

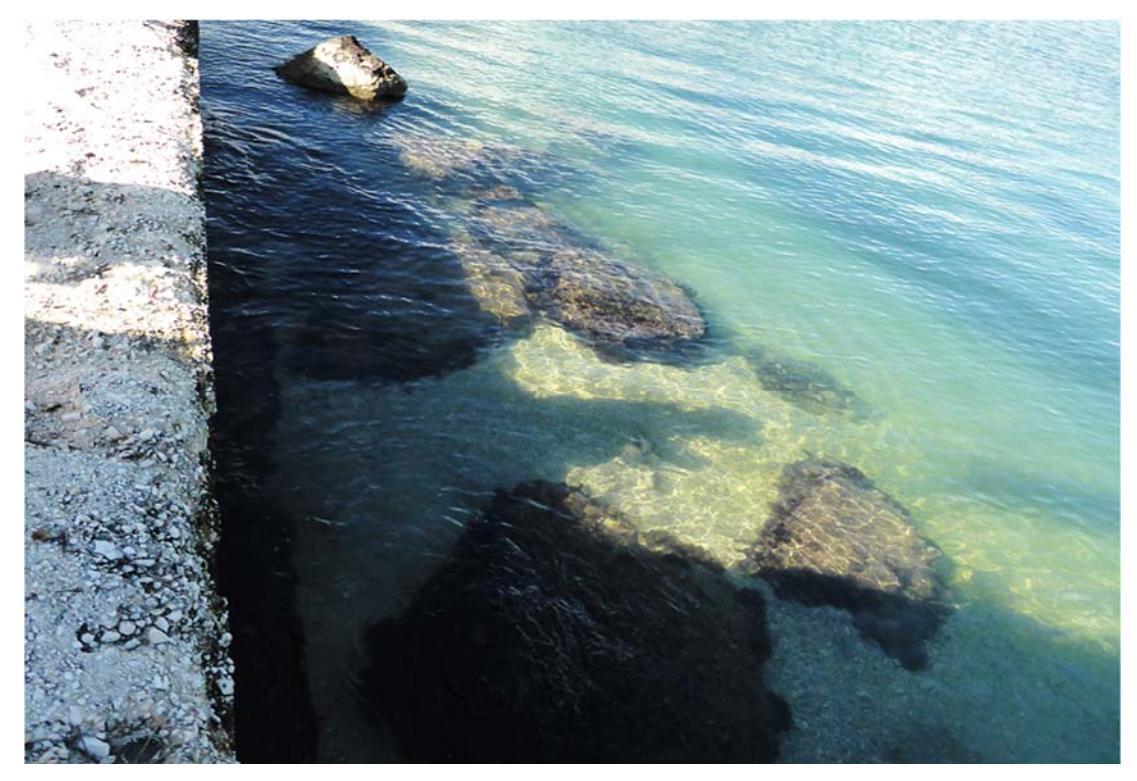
Figure 8.2.45. Southern side of main pier, the only side where damage was observed. Presence of large monoliths at the northern side had a positive effect by restricting lateral movement (GPS coordinates: 38.201666, 20.440000).

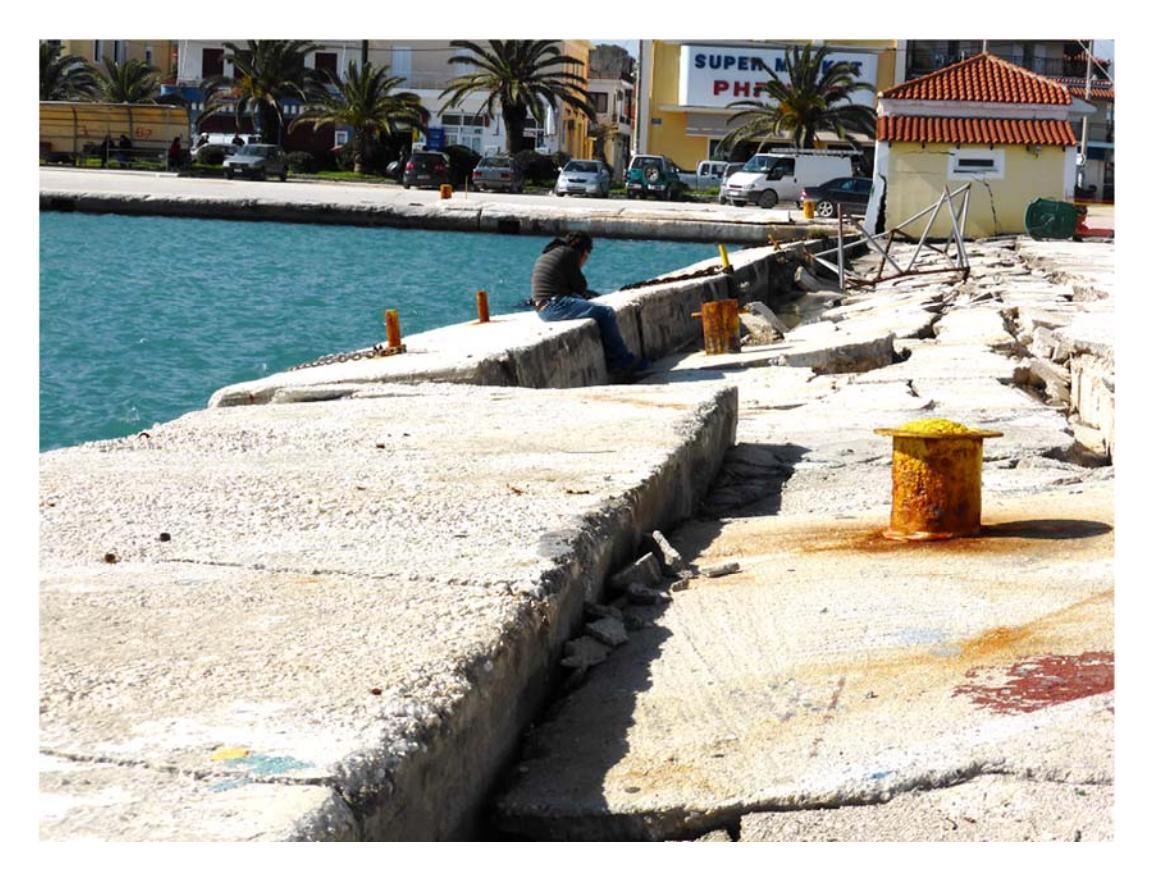
Figure 8.2.46. Lateral movement is greater behind the narrower wall of the main Lixouri pier (GPS coordinates: 38.201466, 20.440158).

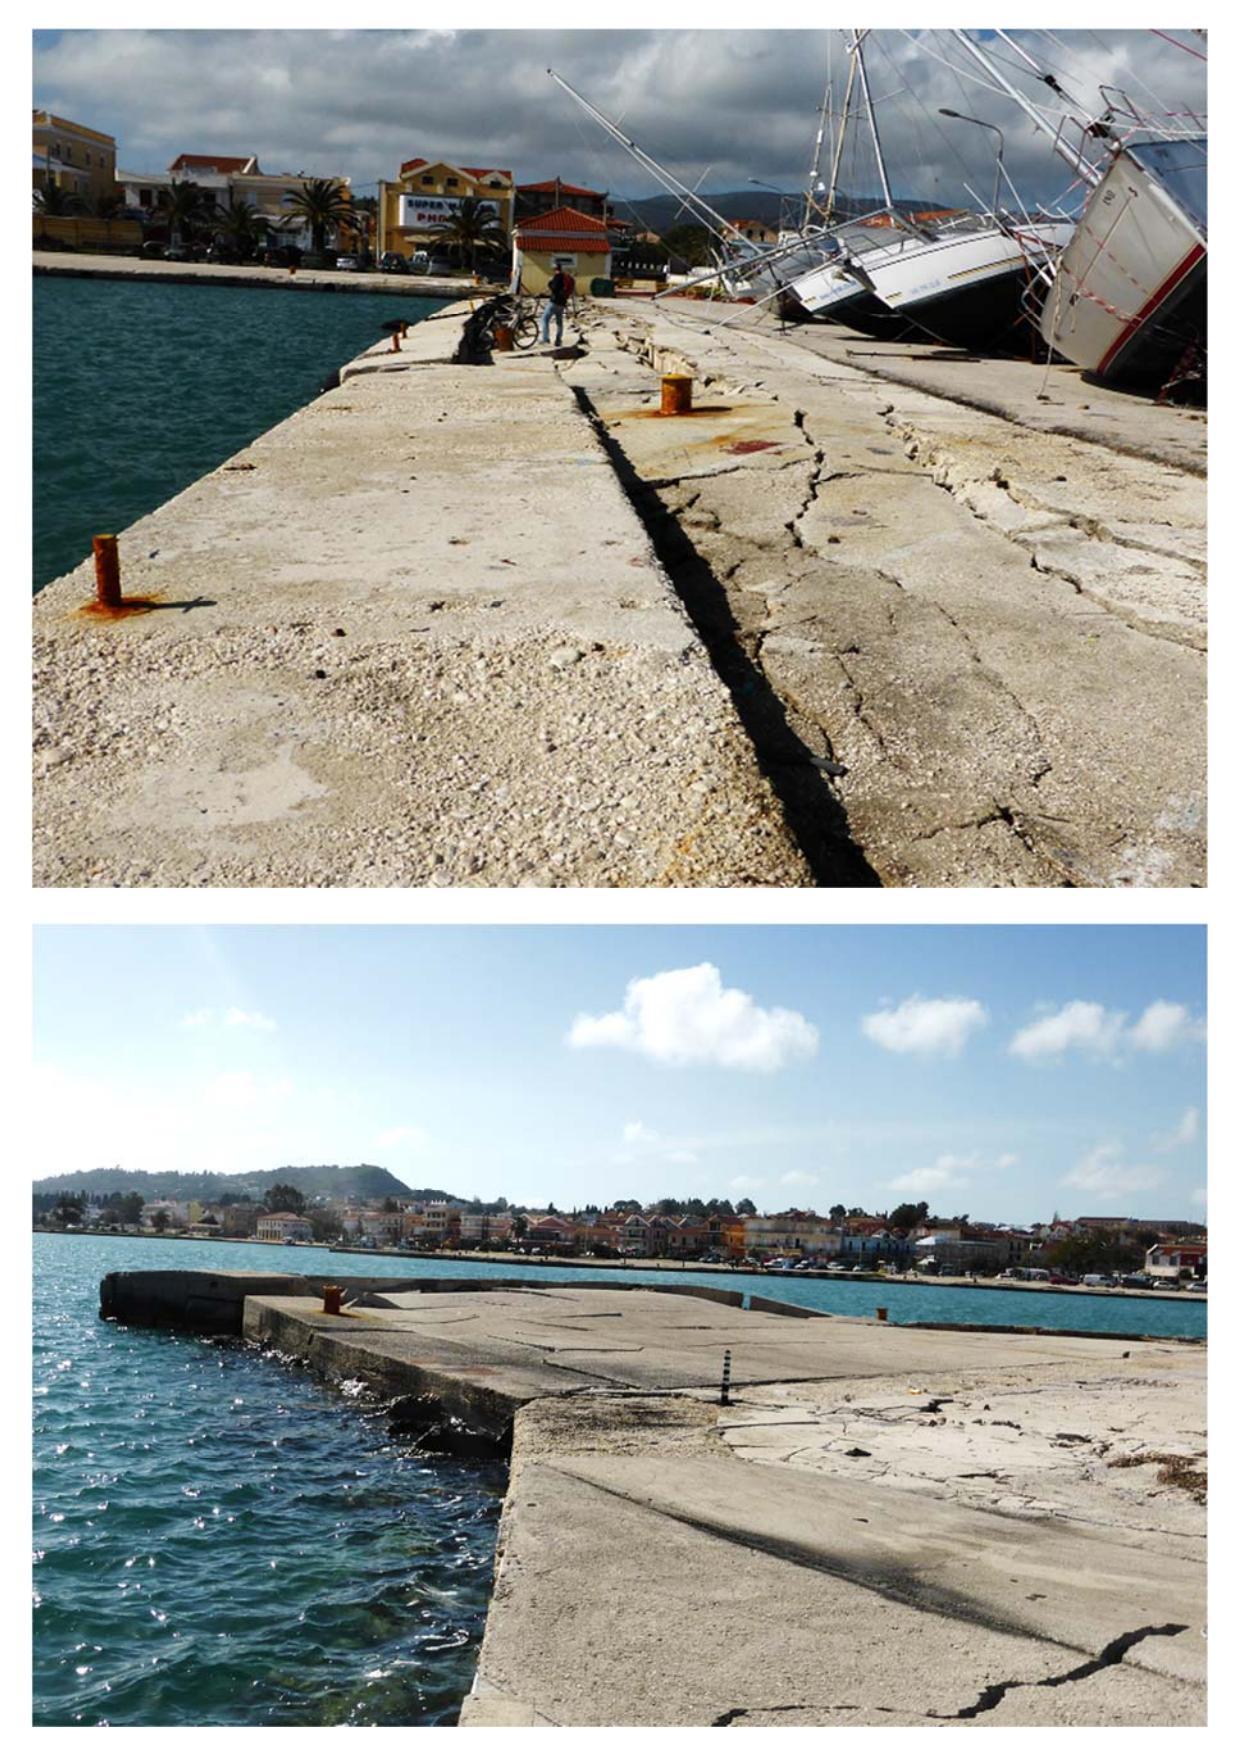
Figure 8.2.47. Cracks along main Lixouri pier dock surface (GPS coordinates: 38.201486, 20.441266).
