CHAPTER 8 Geotechnical Observations

GEER/EERI/ATC Cephalonia, Greece 2014 Report Version 1

8.1 Site Effects

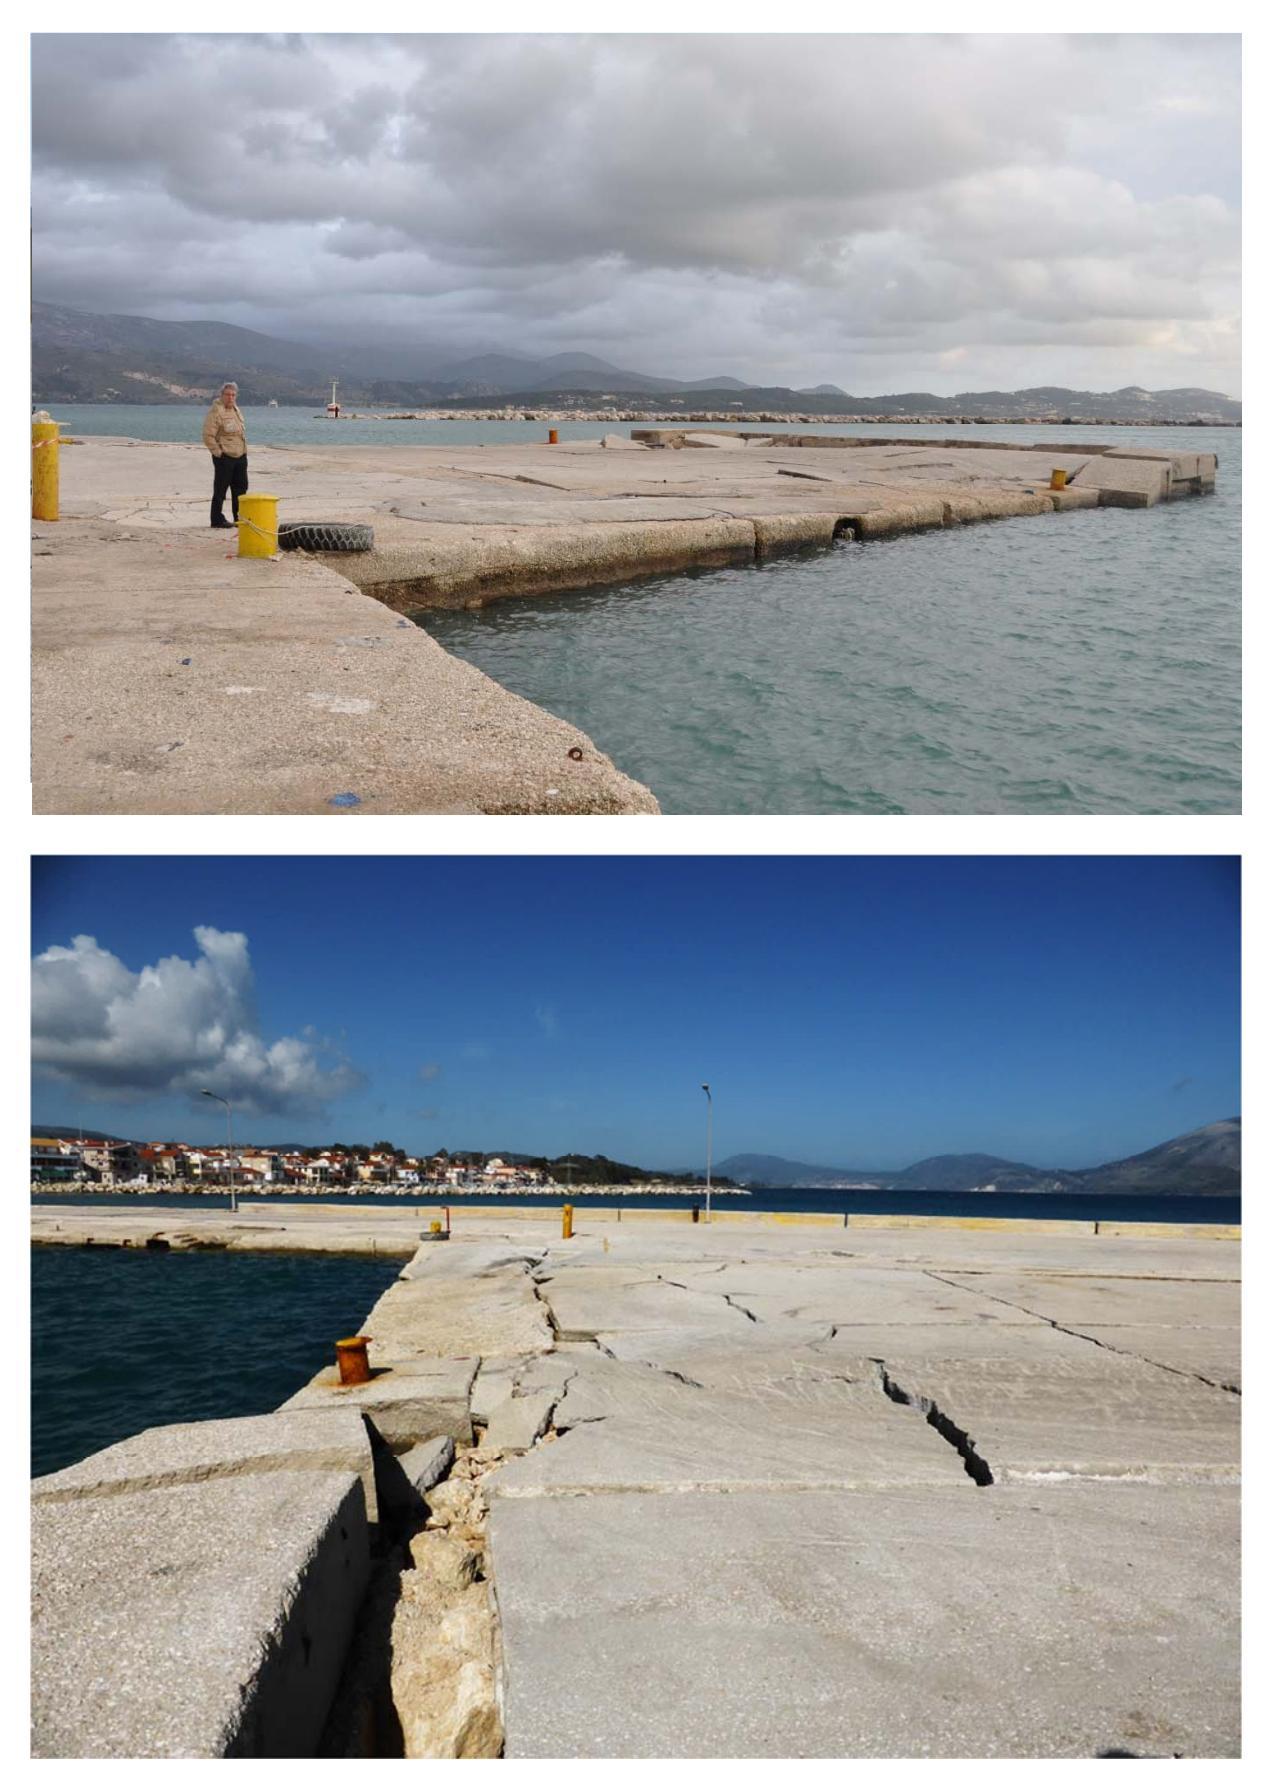
Figure 8.2.48. Rotation and lateral movement of main pier. Prof. G. Gazetas of NTUA shown on top photo (GPS coordinates: 38.201269, 20.440977).

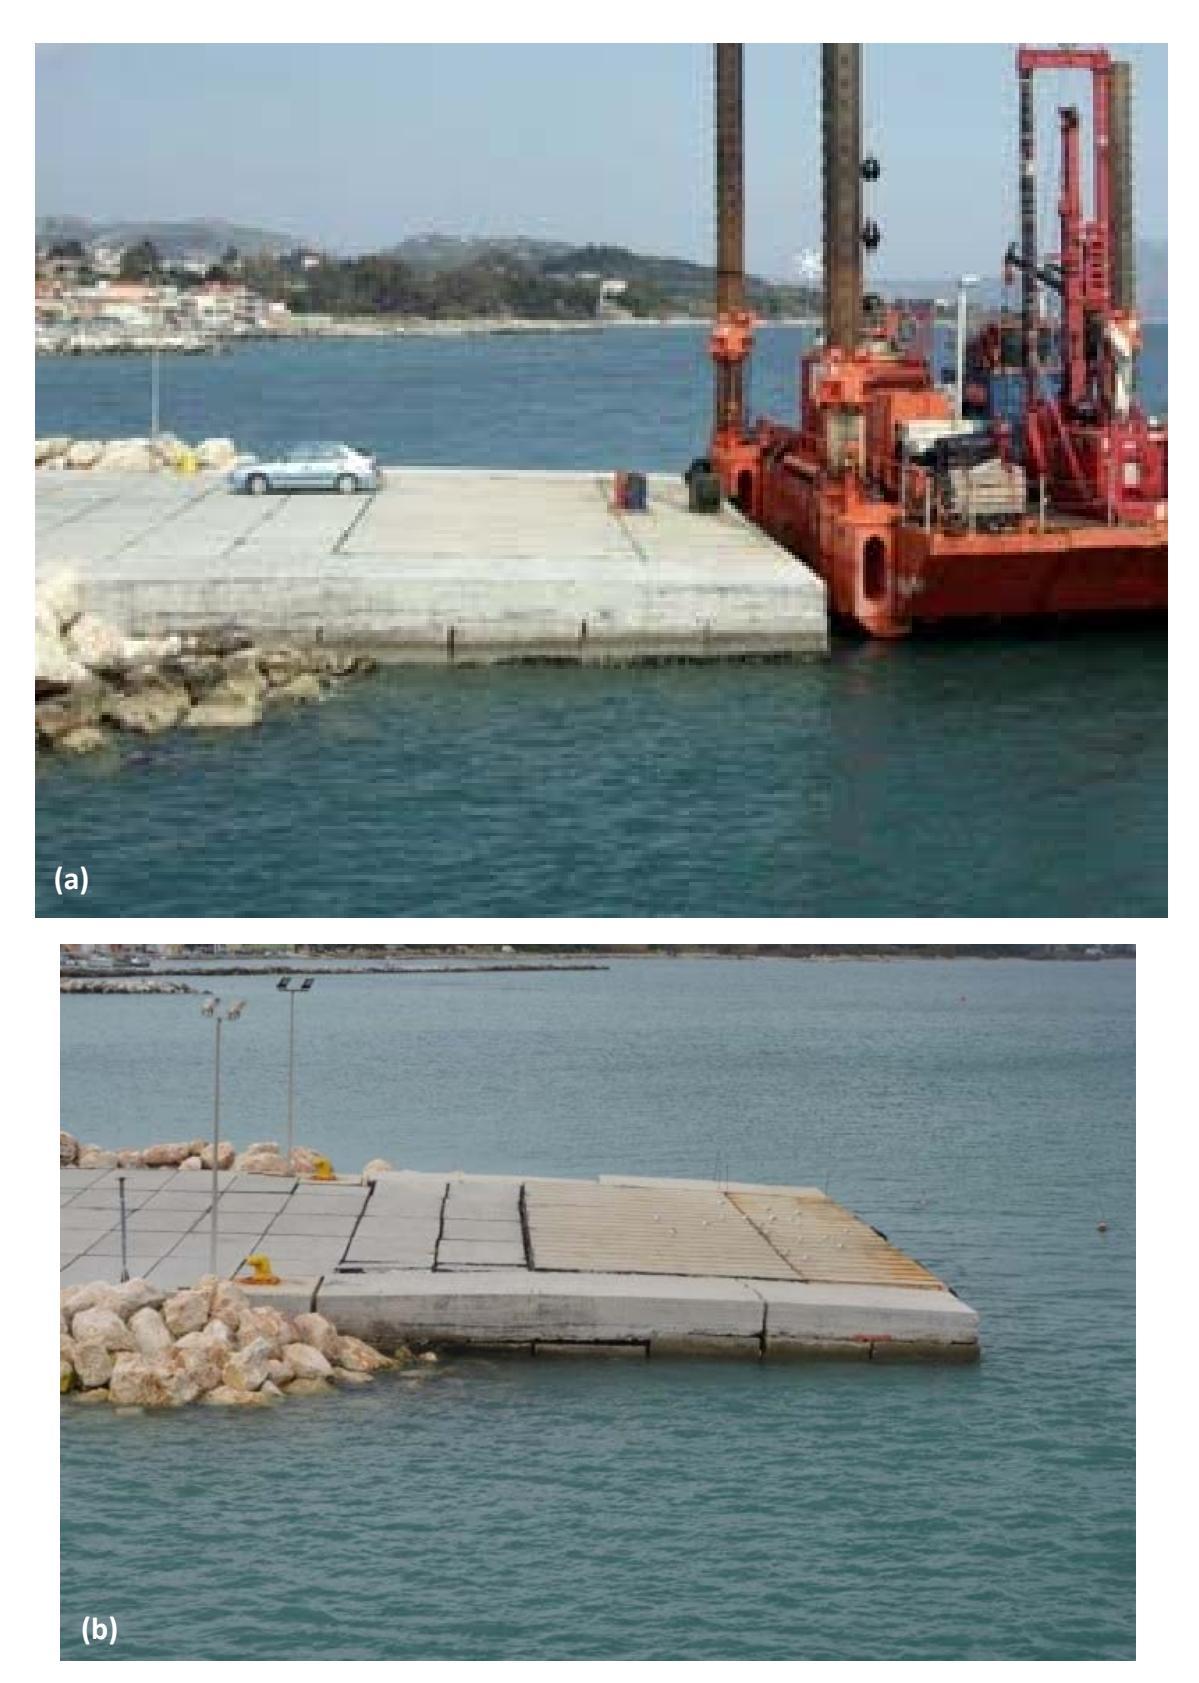
Figure 8.2.52. State of eastern most section of main pier of Lixouri port: (a) from 2011 archives, {<u>www.panoramio.com/photo/49466386?source=wapi&referrer=kh.google.com</u>} with jack up drilling vessel that reportedly caused pier damage, and (b) after the 2^{nd} event ($38^{\circ}12'6.14''N$, $20^{\circ}26'32.08''E$).

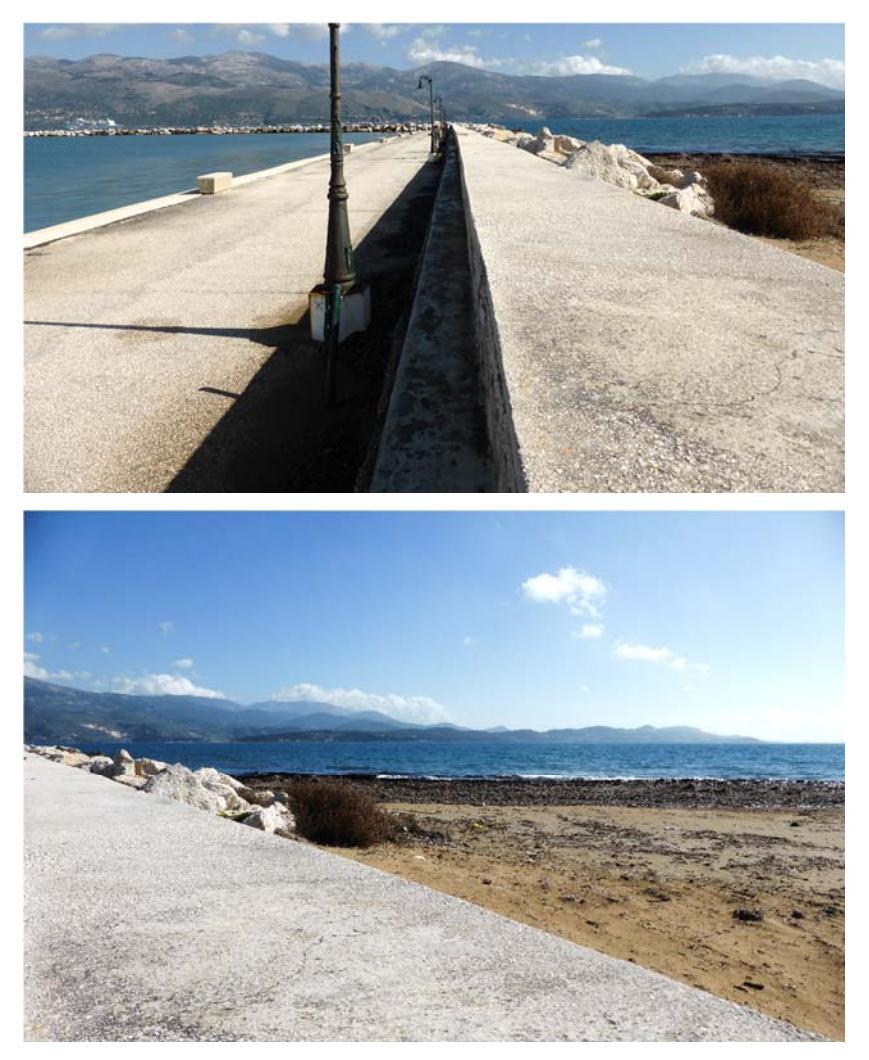
Figure 8.2.62. Land reclamation on the outer side of the southern marina prevented lateral displacements of the shallow quay wall. The ejected liquefied soil on the reclaimed land is abundant (GPS coordinates: 38.197944, 20.441044).

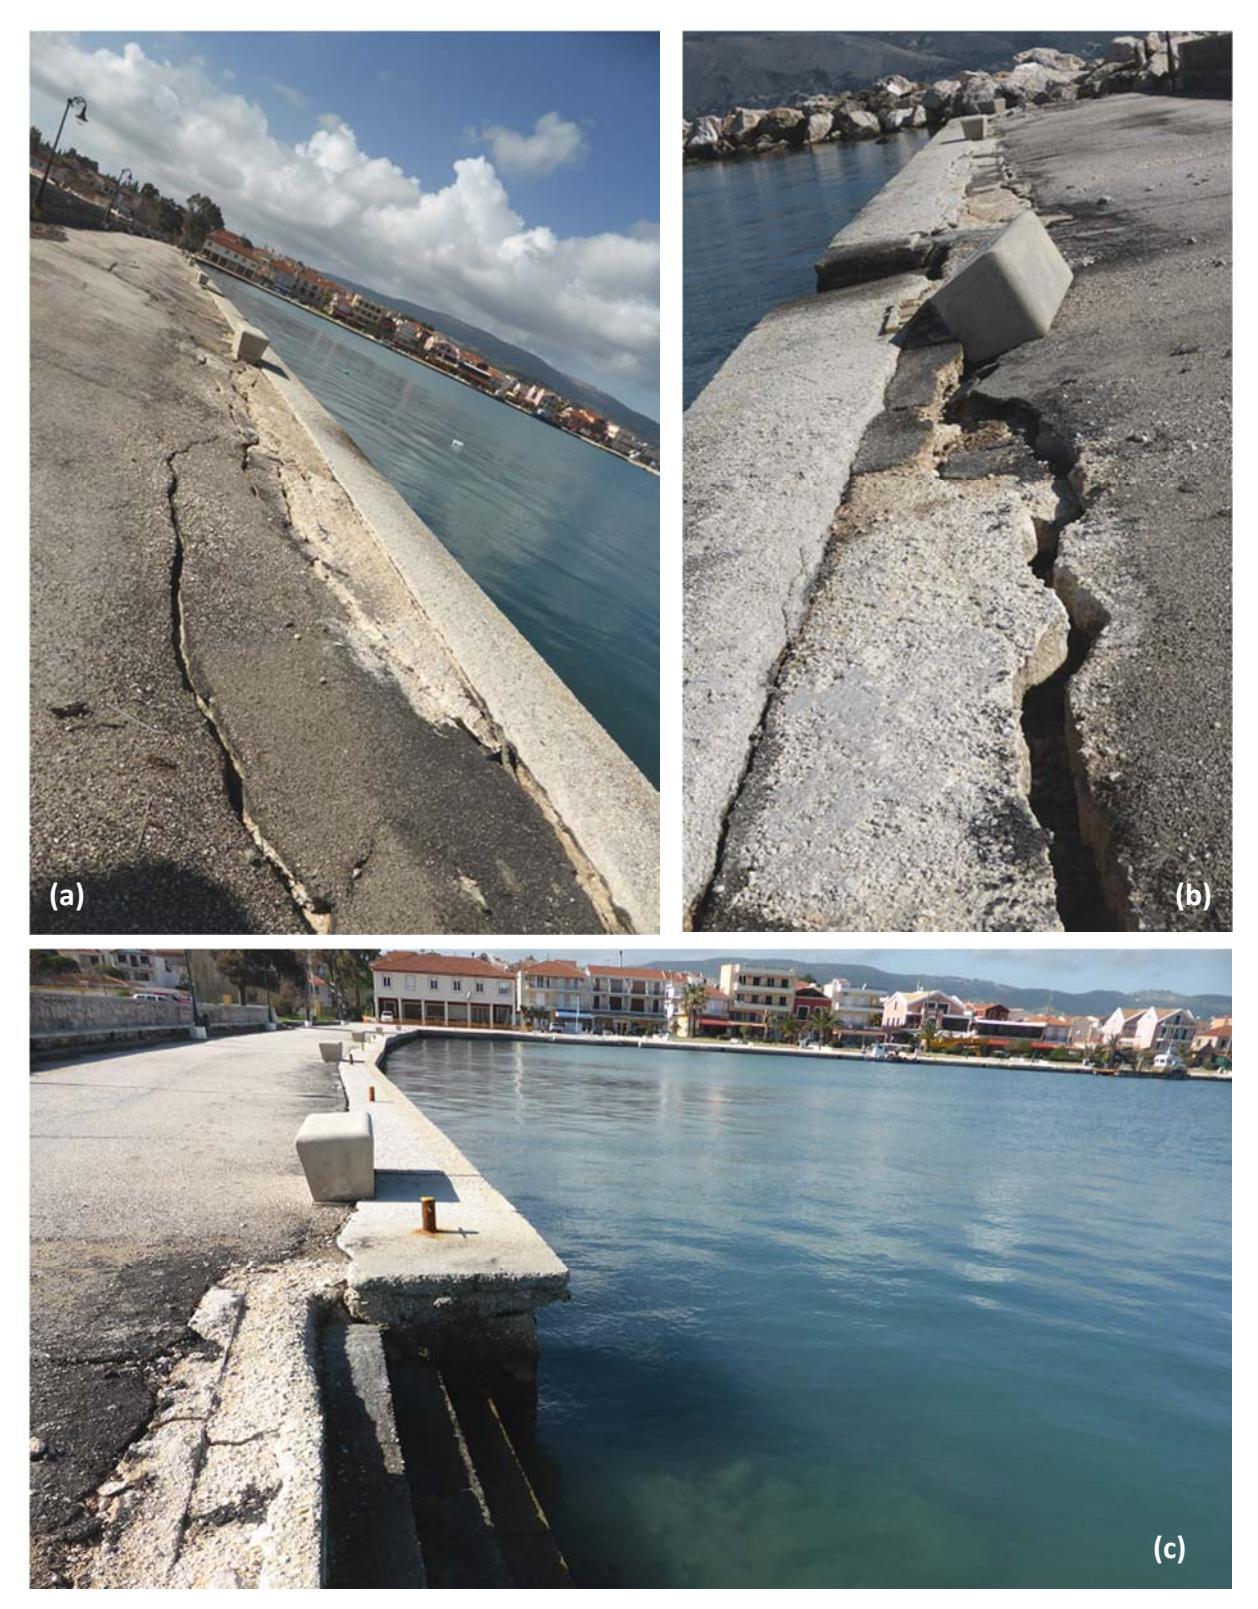
Figure 8.2.64. Detailed views of the south part of Lixouri port: (a) and (b) minor cracks behind the wall, (c) shallow water level (GPS coordinates: 38.198158, 20.442222).

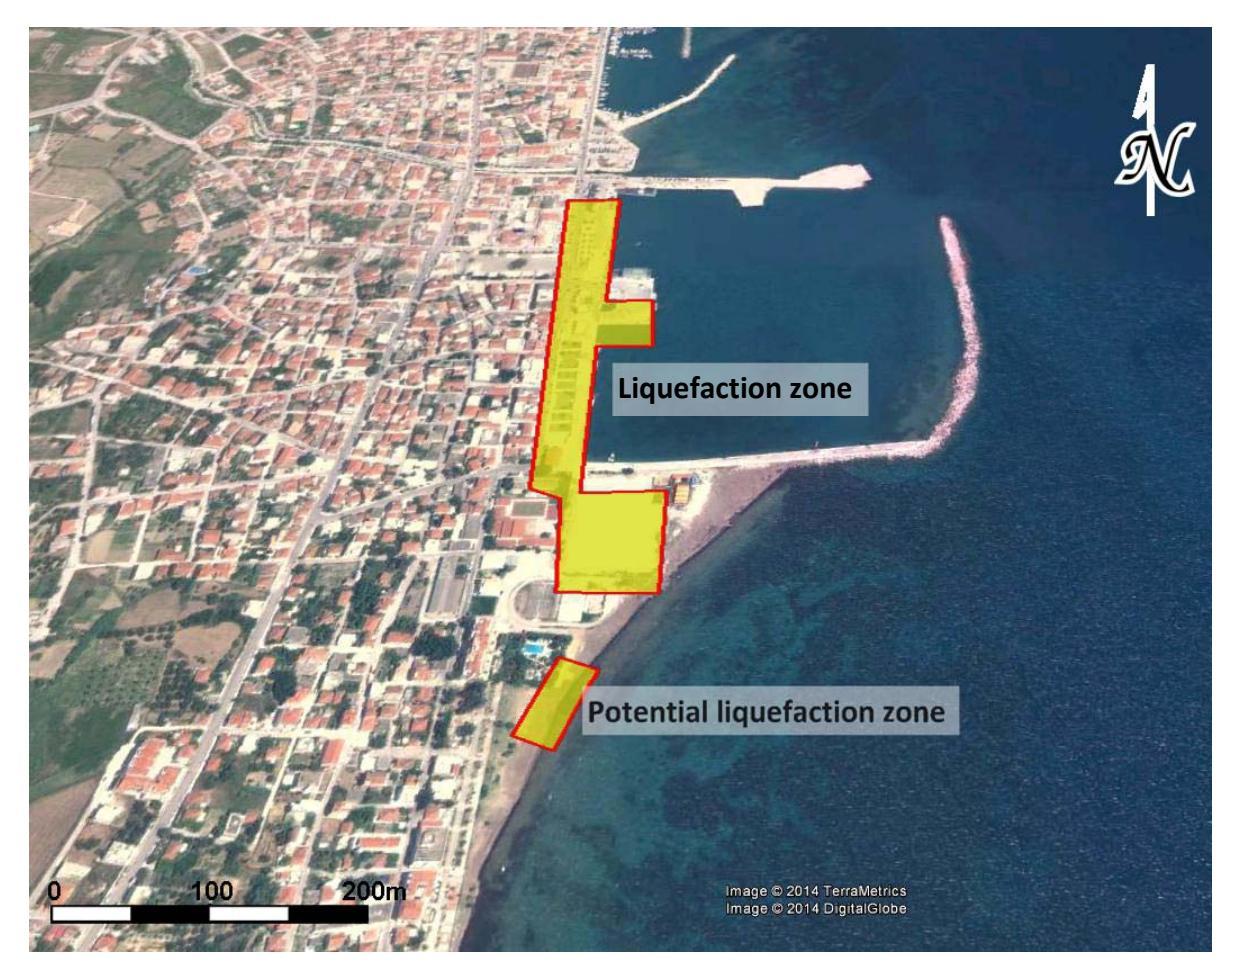
Some evidence of liquefaction was observed to the south of the port of Lixouri (Fig. 8.2.66), but is more limited. The limited number of liquefaction evidence may be attributed to a number of rainfall events that might have "washed away" the soil ejecta.

Figure 8.2.66. Liquefaction zones observed along Lixouri port (GPS coordinates 38.20°, 20.44°).

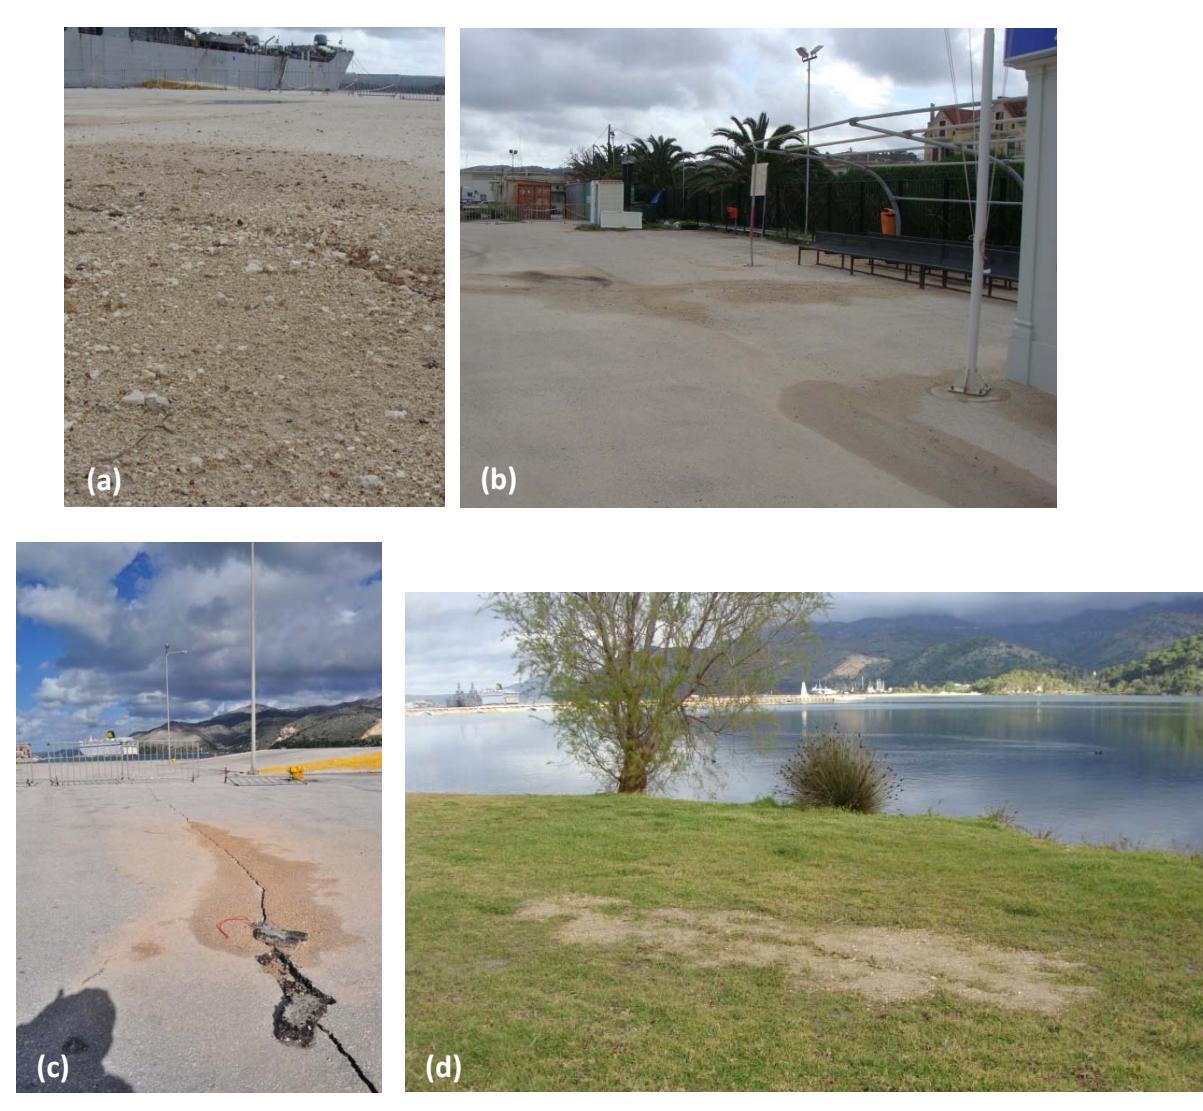
Figure 8.2.71. Examples of soil craters and ejecta along the waterfront of Argostoli port GPS coordinates a-(38.18105°, 20.48955°), b-(38.118118°, 20.48954°), c-(38.180752°, 20.489990°), d-(38.17118°, 20.49600°)].

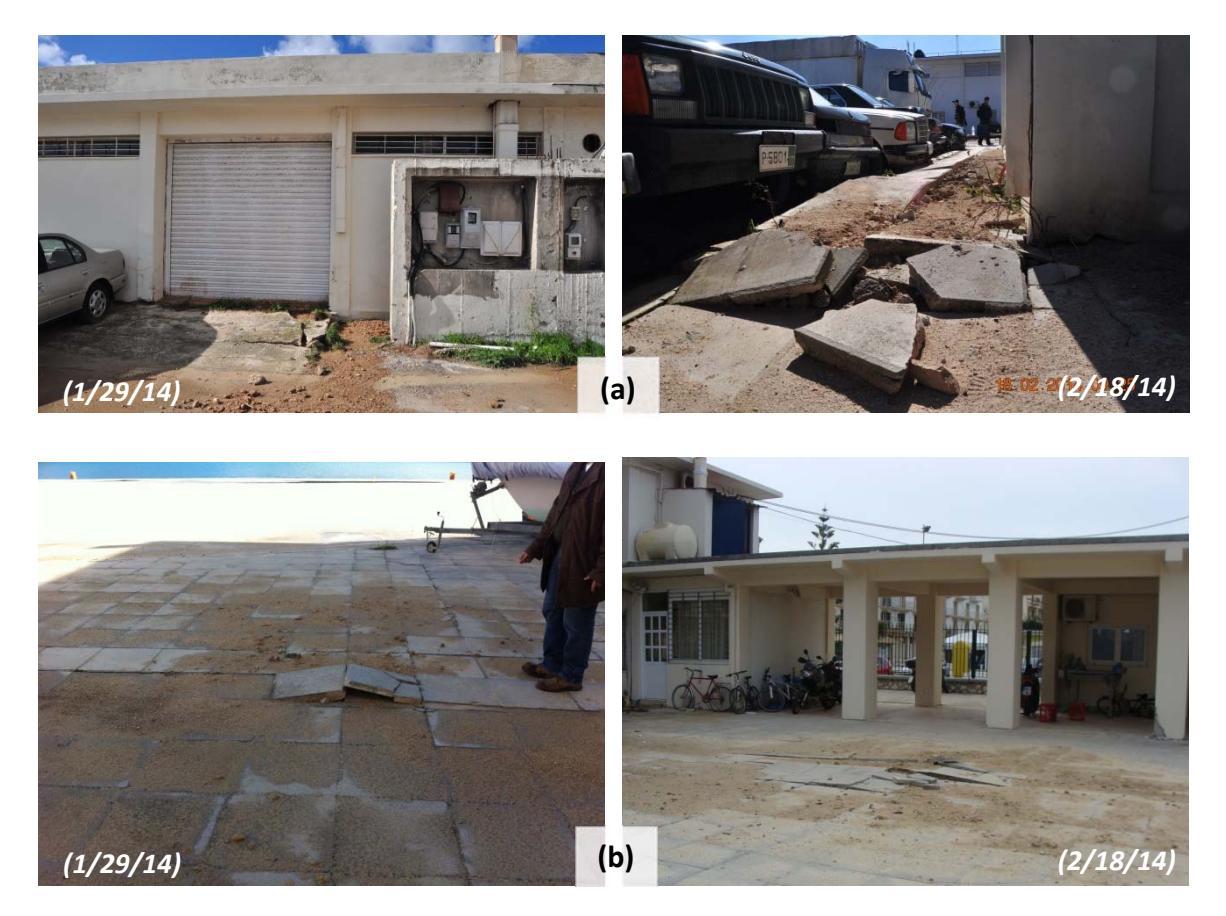
Figure 8.2.72. Ejecta material outside the Customs Building of Argostoli where the UPatras Geotechnical Engineering Laboratory strong motion station is located [GPS coordinates: a: (38.18010°, 20.48993°), b: (38.17998°, 20.48996°)].

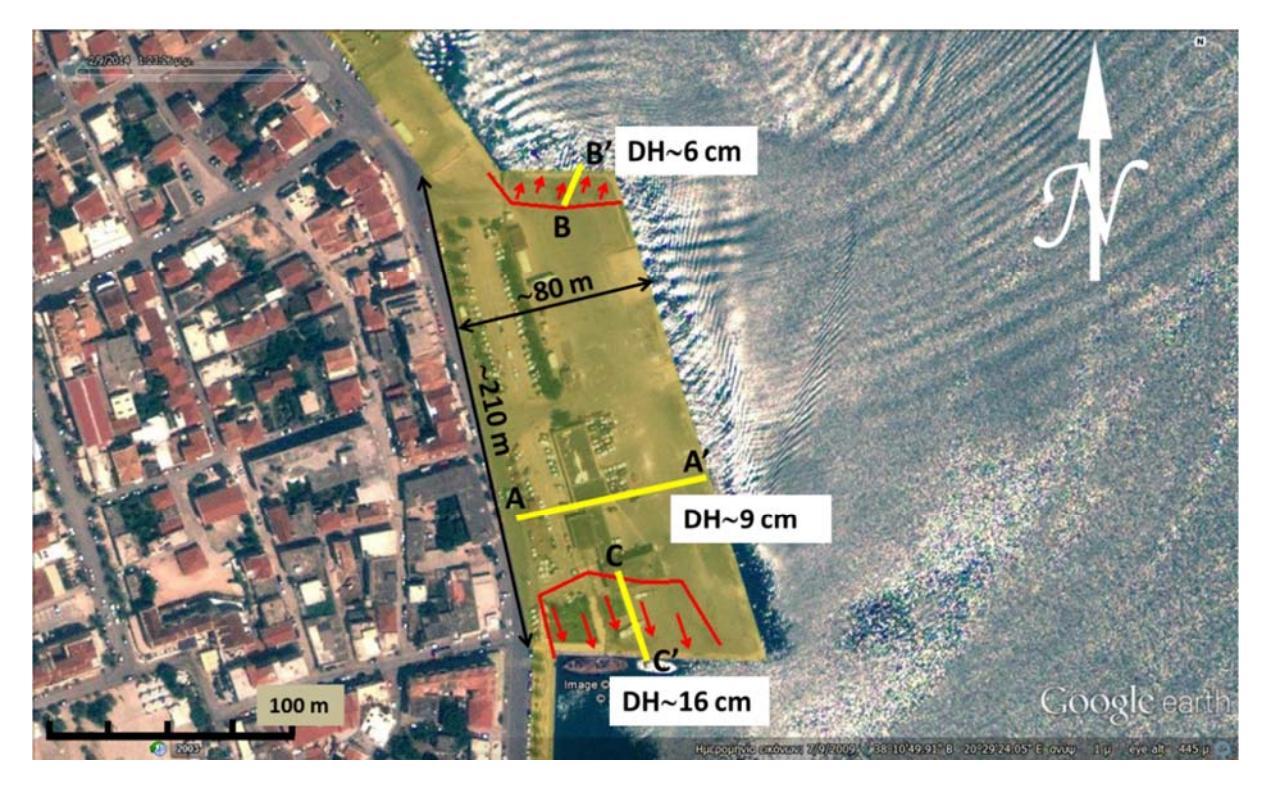
Figure 8.2.76. Google Earth photo of the central dock of Argostoli port. Red arrows indicate development of excessive cracking and lateral spreading.

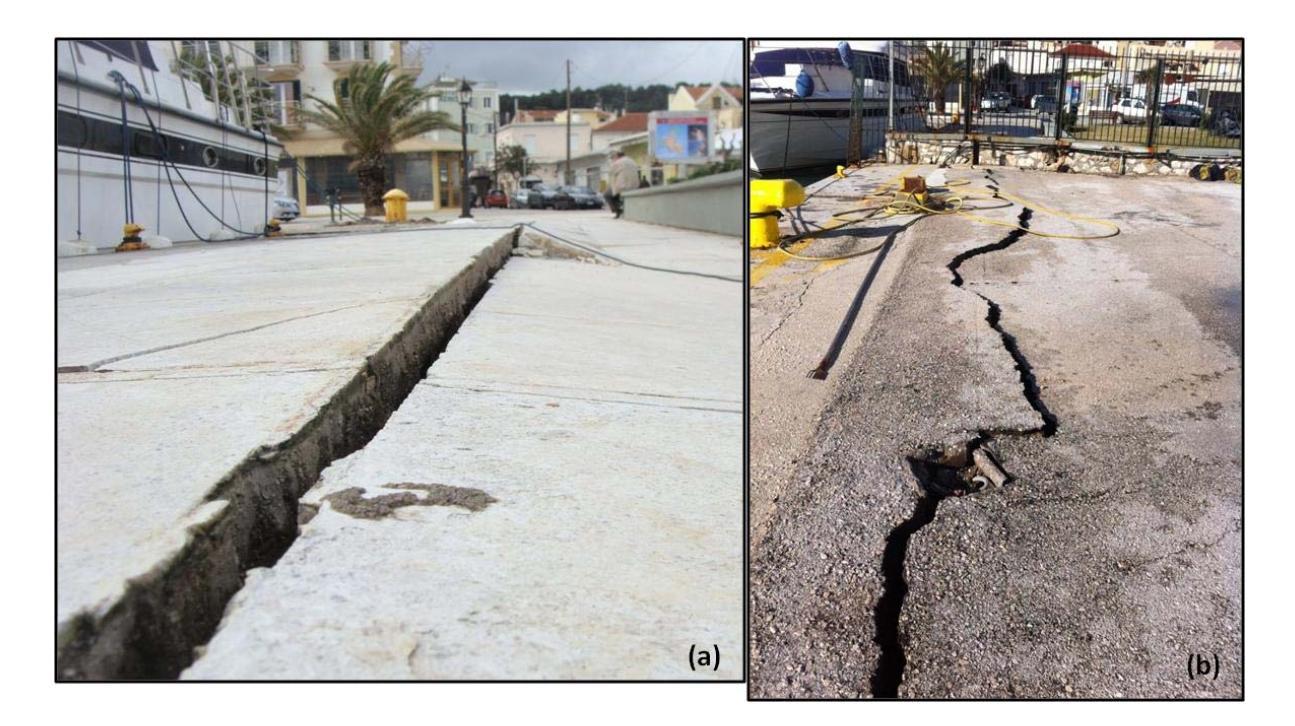
Figure 8.2.77. Quay wall at dock of Argostoli port: (a) wall outward movement and (b) cracks due to lateral spreading dated 2/9/14. GPS coordinates: a-(38.17955°, 20.48987°), b-(38.17955°, 20.49011°).

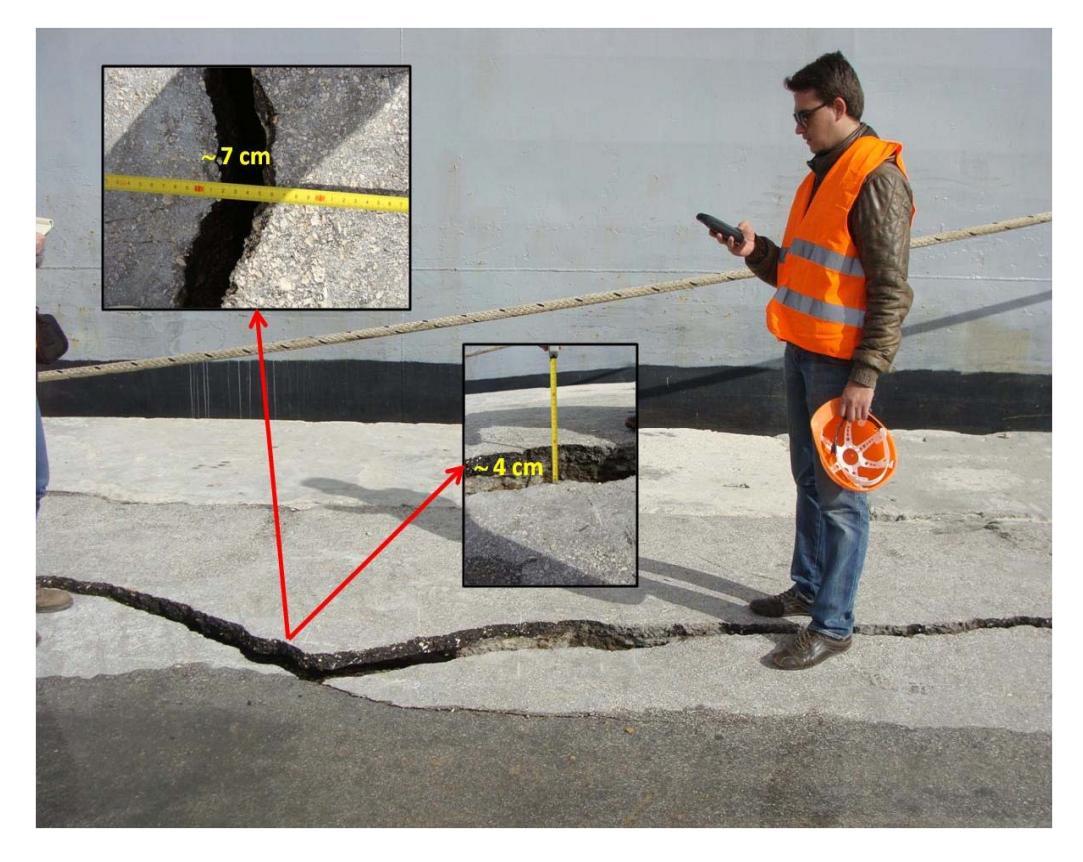
Figure 8.2.78. Outward movement of quay wall and vertical displacement in front of the main Argostoli port dock measured by Tasos Batilas of UPatras (GPS coordinates 38.18024°, 20.49034°, 9/2/2014).

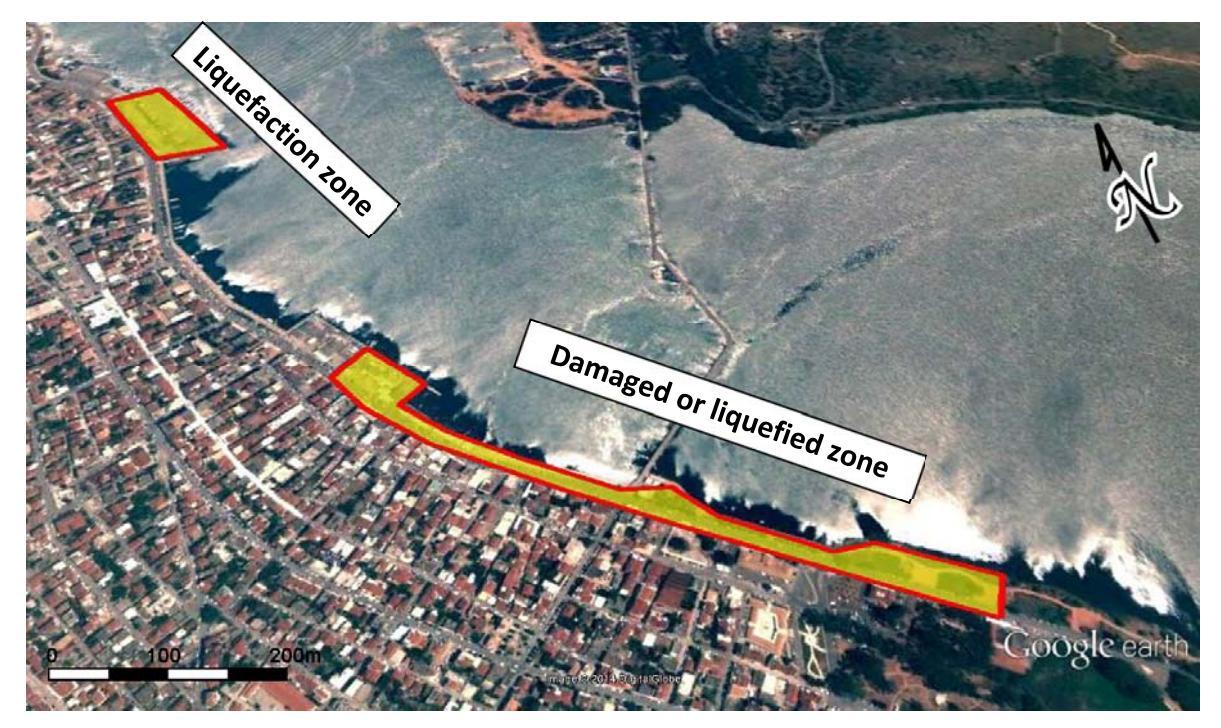
Figure 8.2.81. Liquefaction observations at Argostoli coastal area (GPS coordinates 38.17°, 24.49°).

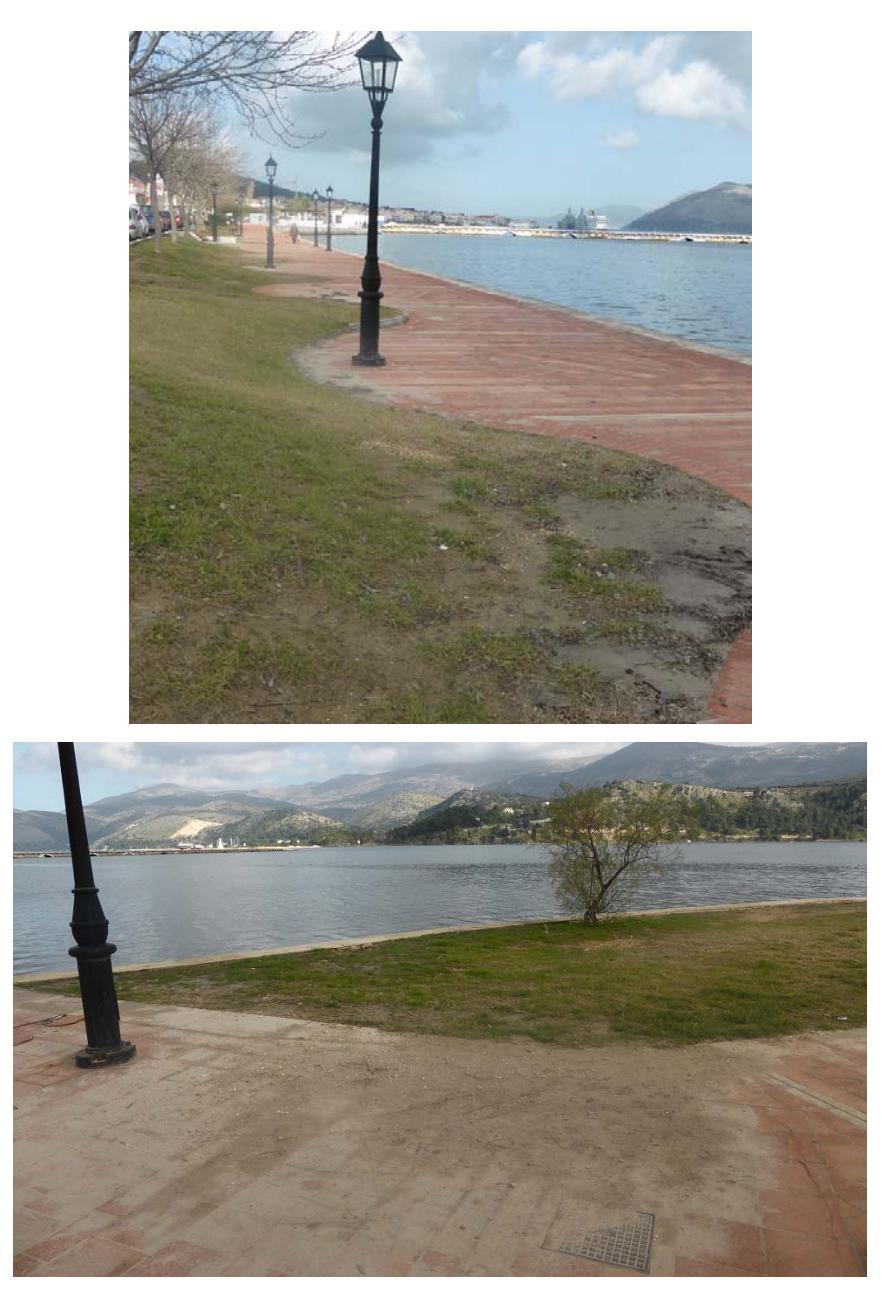
Figure 8.2.88. Visible evidence of soil liquefaction at southeast part of Argostoli port (GPS coordinates: 38.171197, 20.495725]

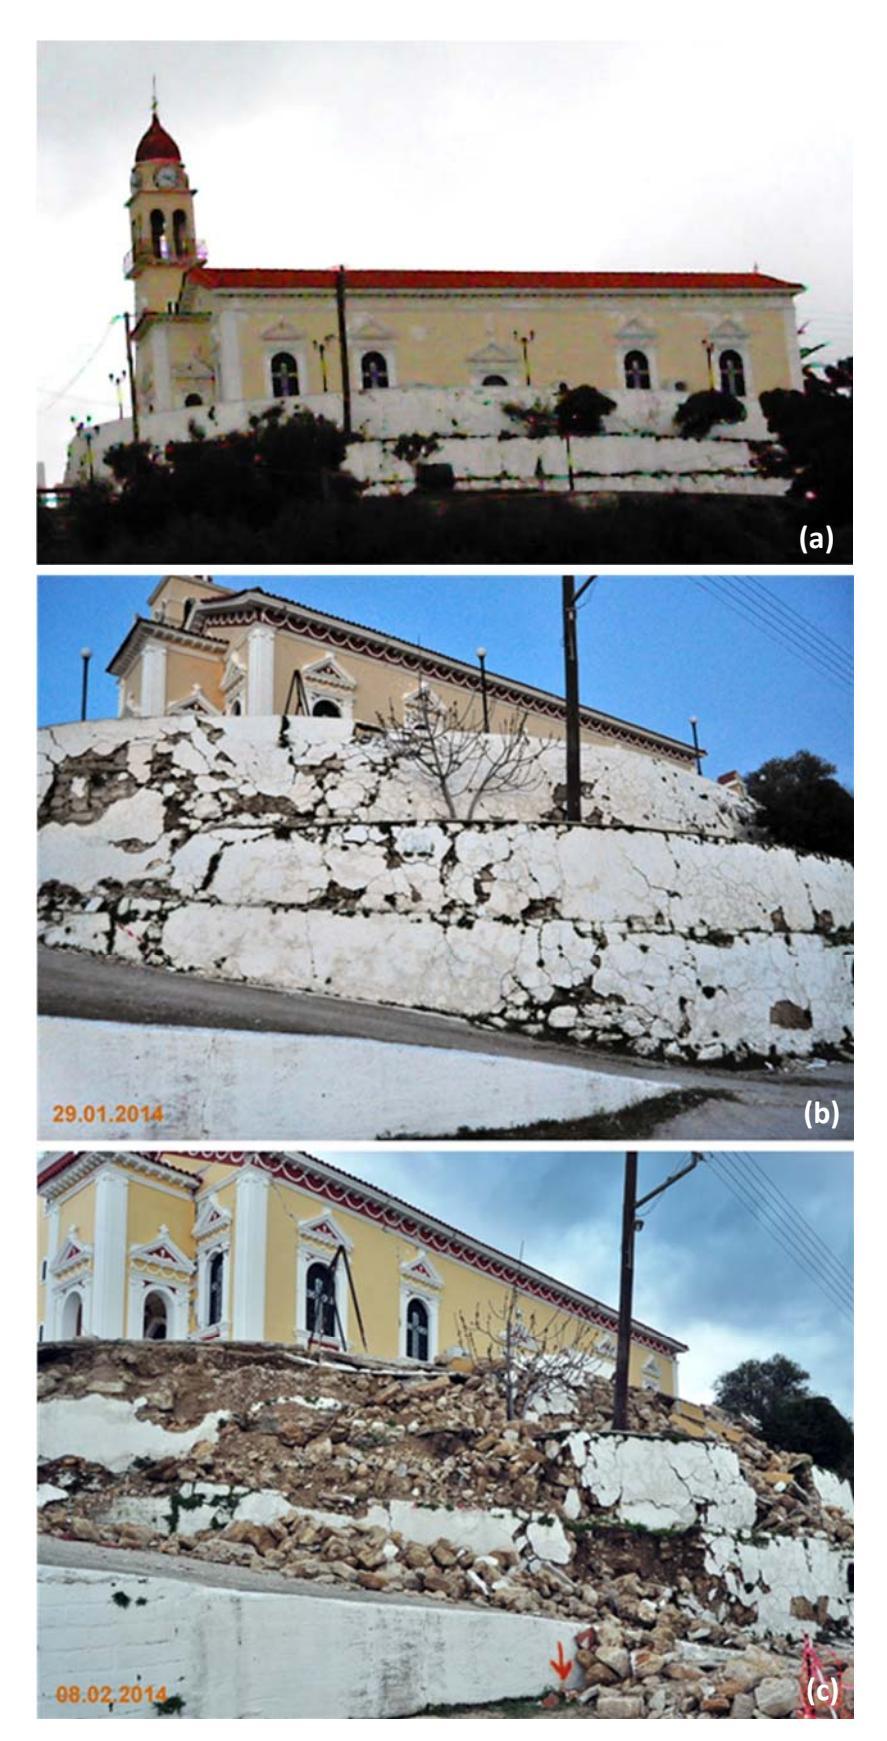
Figure 8.3.2. Retaining wall and historical church at Chavriata village: (a) before the 2 events, (b) following the 1st event; and (c) following the 2nd event; (38°10'57.52"N, 20°23'13.61"E). Photo (a) is from 2007 archives: <u>www.panoramio.com/photo/50007113?source=wapi&referrer=kh.google.com</u>

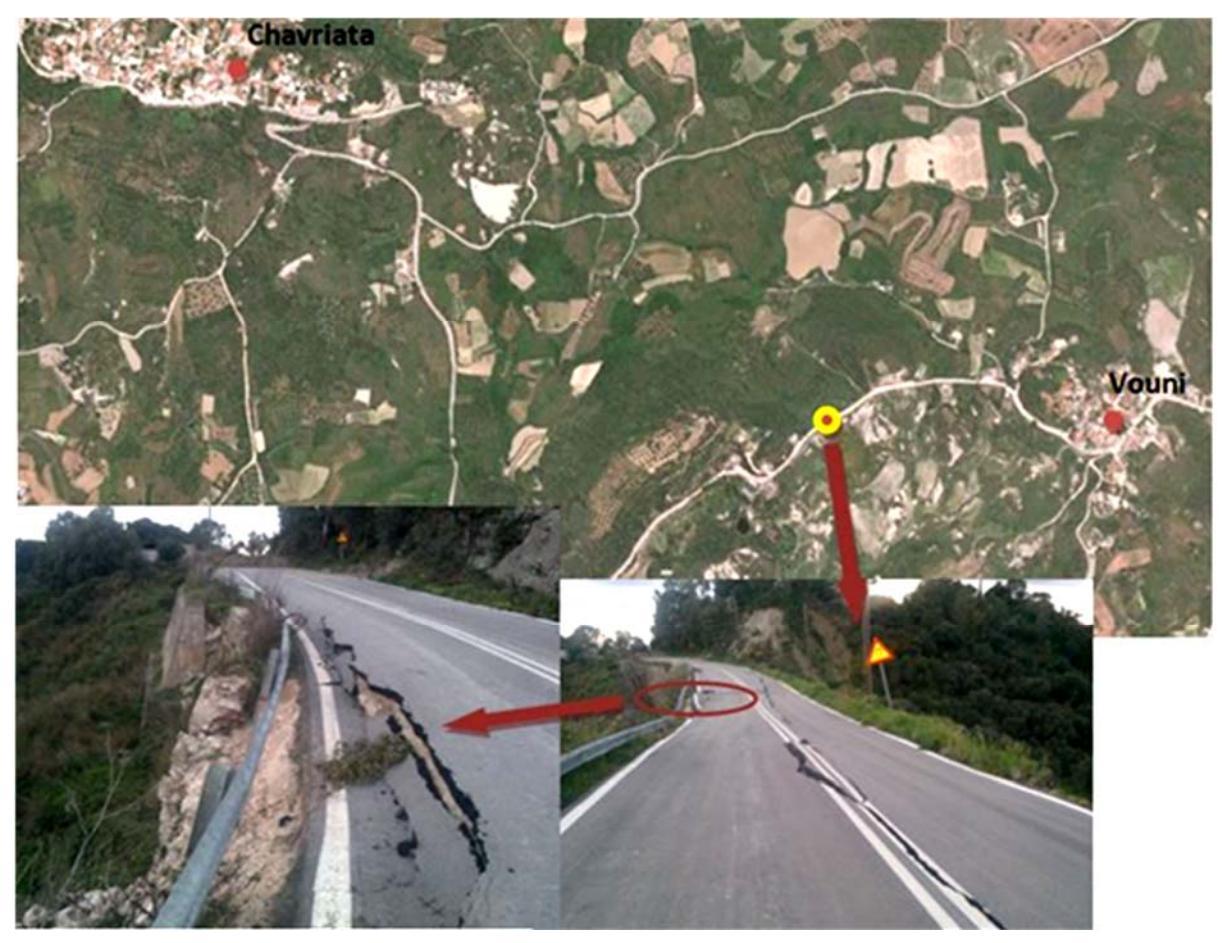
Figure 8.3.7. Extensive failure of stone masonry retaining wall followed by road embankment sliding failure with horizontal and vertical displacement. This major failure is on the roadway connecting the villages of Vouni and Chavriata (38.177692°N, 20.397458°E). The reinforced concrete retaining wall shown in yellow dotted circle suffered no damage although adjacent to the collapsed one.

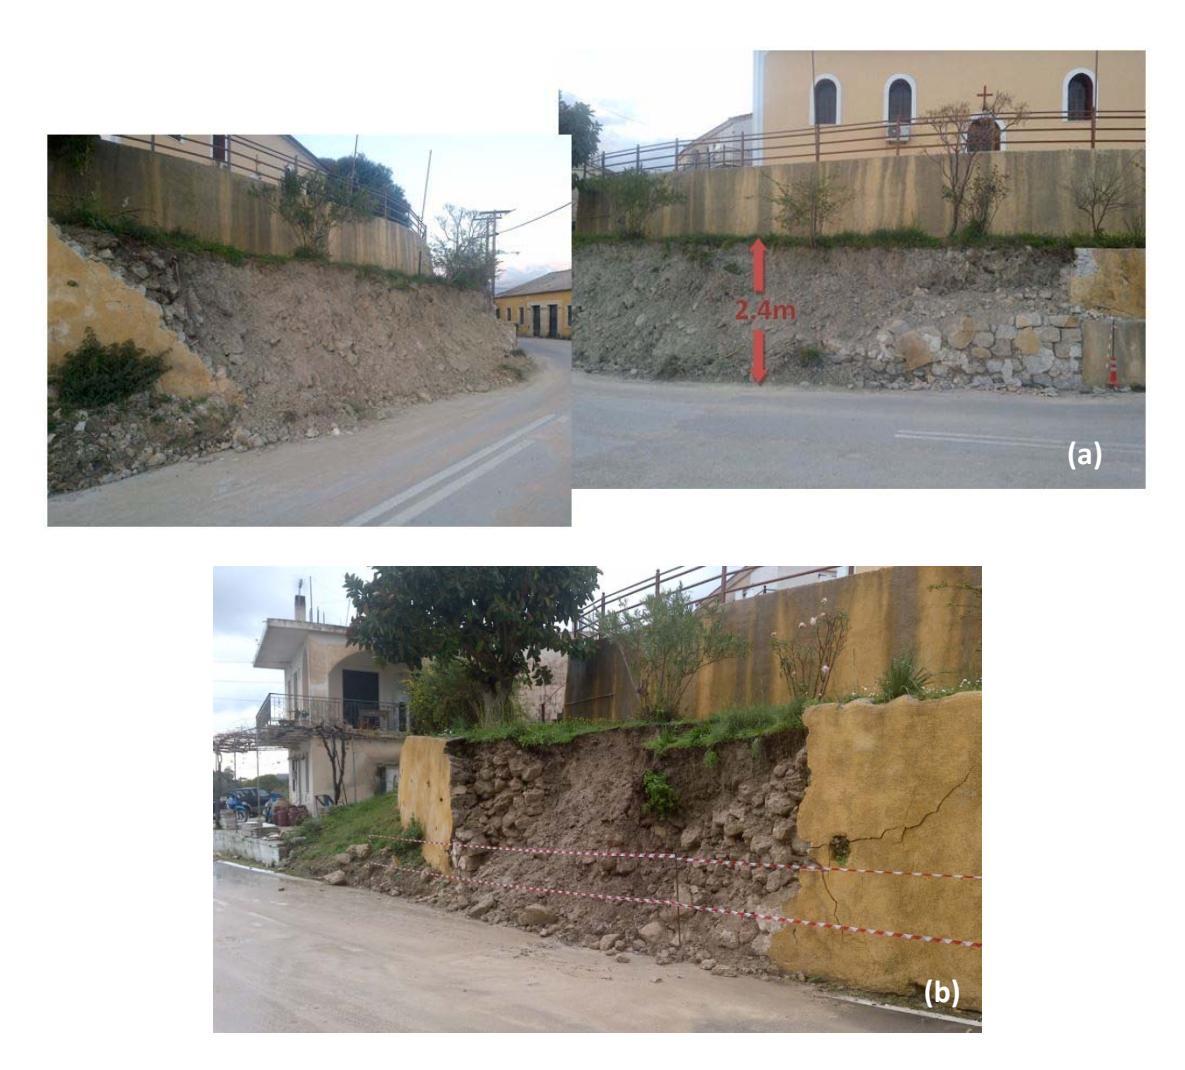
Figure 8.3.8: (a) Collapse of lower two levels of a three-level stone retaining wall supporting the bearing soil of a Vouni village church $(38.177578^{\circ} \text{ N}, 20.403477^{\circ} \text{ E})$ after the 2^{nd} event, and (b) partial collapse of the same wall following the 1^{st} event.

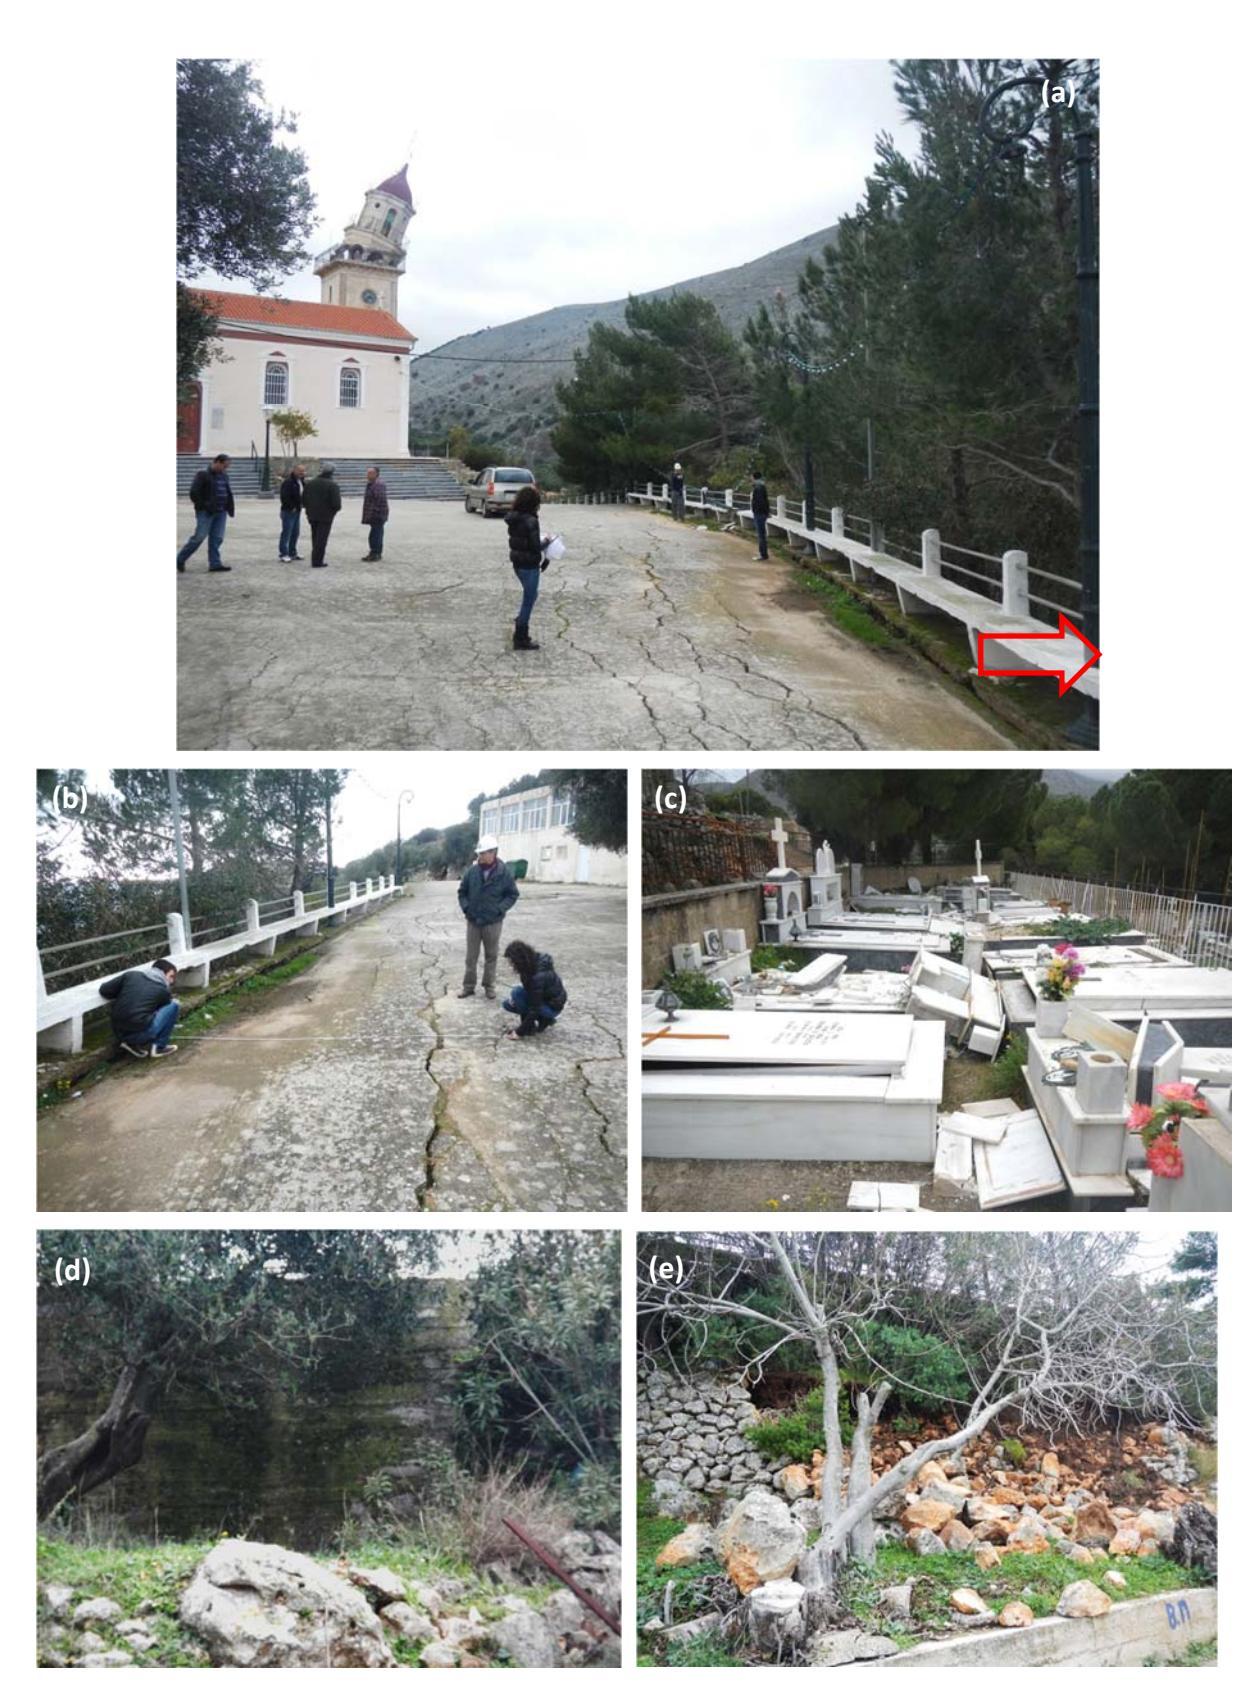
Figure 8.3.10. Damage at Kourouklata village church. (a) cracked ground in foreground with wall to the right and church in background; (b) ground deformations taken by Prof. G. Athanasopoulos, V. Kitsis and O. Theofilopoulou; (c) damage at cemetery behind the church; (d) concrete wall adjacent to masonry wall from lower elevation; and (e) view of wall damage (38°14'31.72"N, 20°28'25.40"E).
