CHAPTER 8 Geotechnical Observations

GEER/EERI/ATC Cephalonia, Greece 2014 Report Version 1

8.1 Site Effects

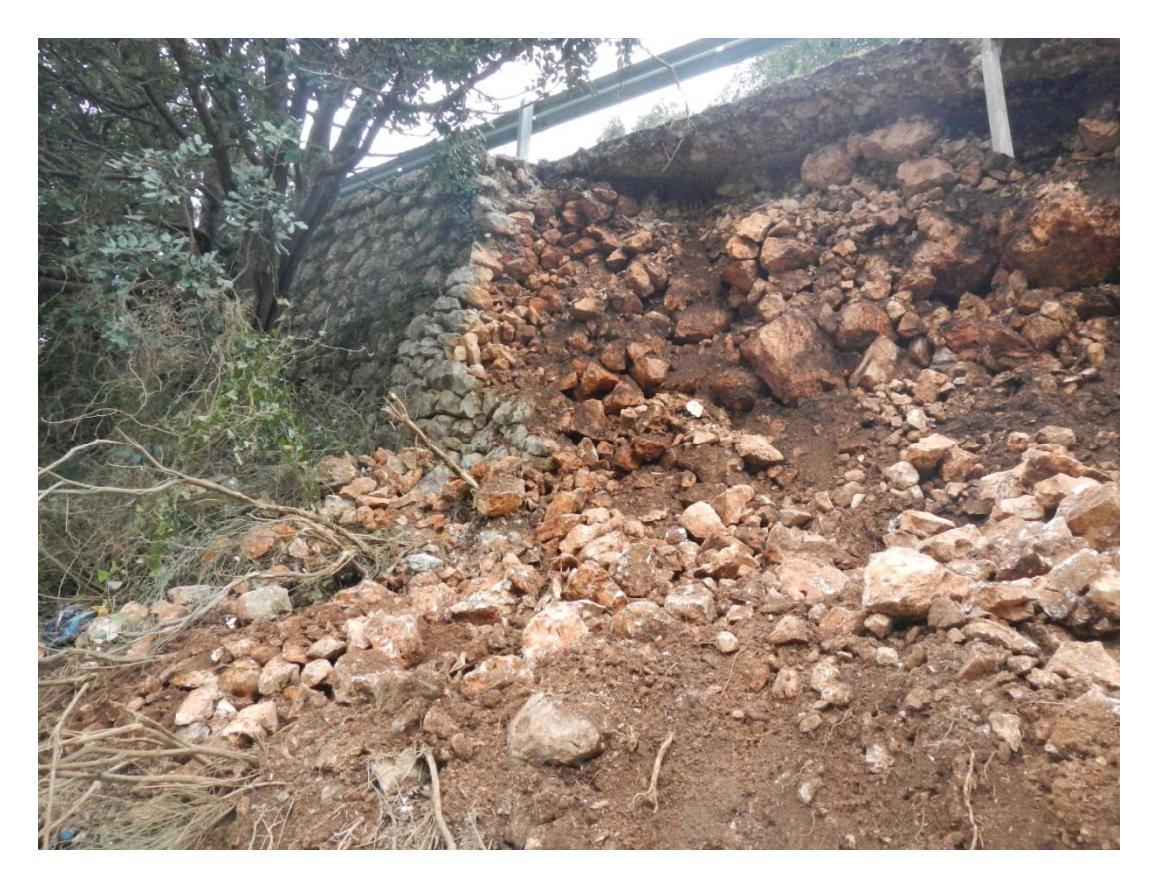
Figure 8.3.13. Masonry wall damage towards Kourouklata village. (38°14'26.29"N, 20°28'35.14"E)

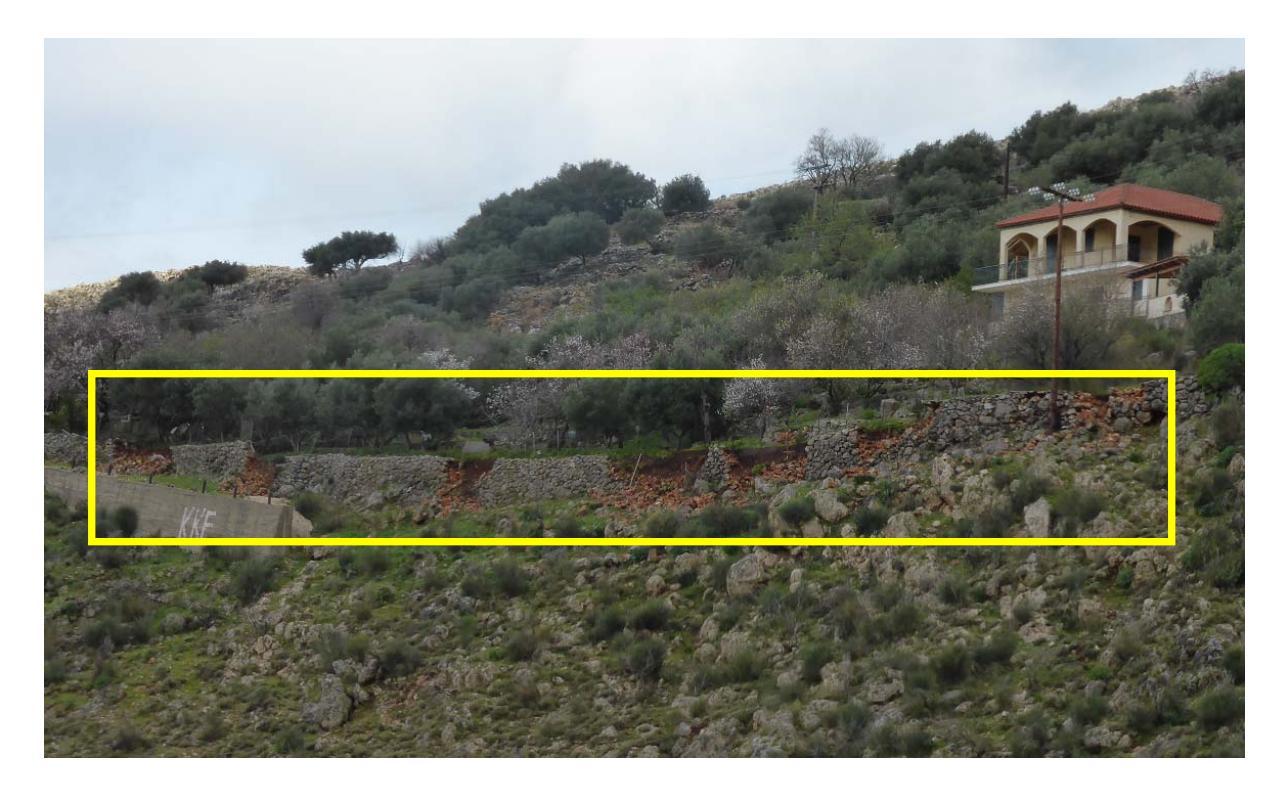
Figure 8.3.15. Retaining wall failures at several locations in Kourouklata village (38.241075N, 20.475602E).

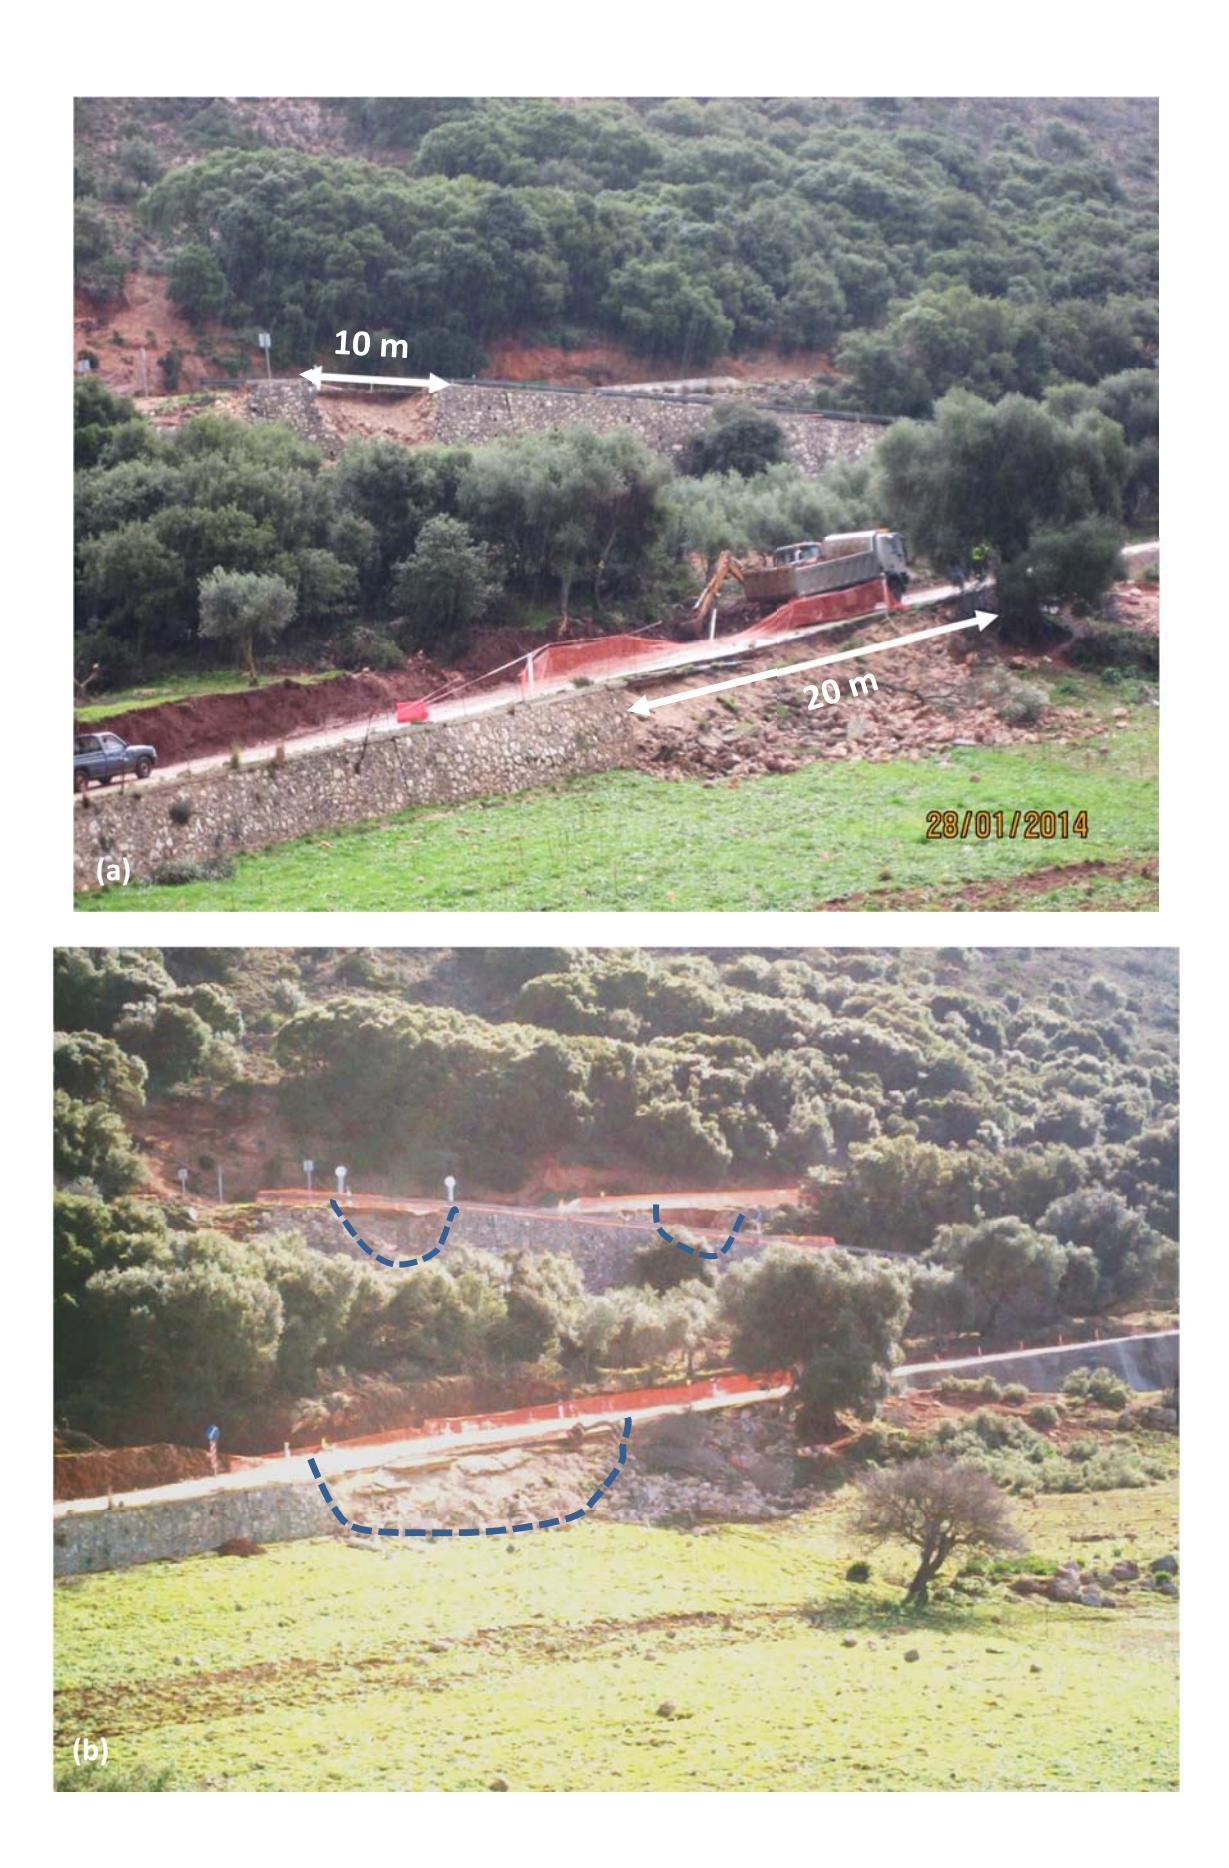
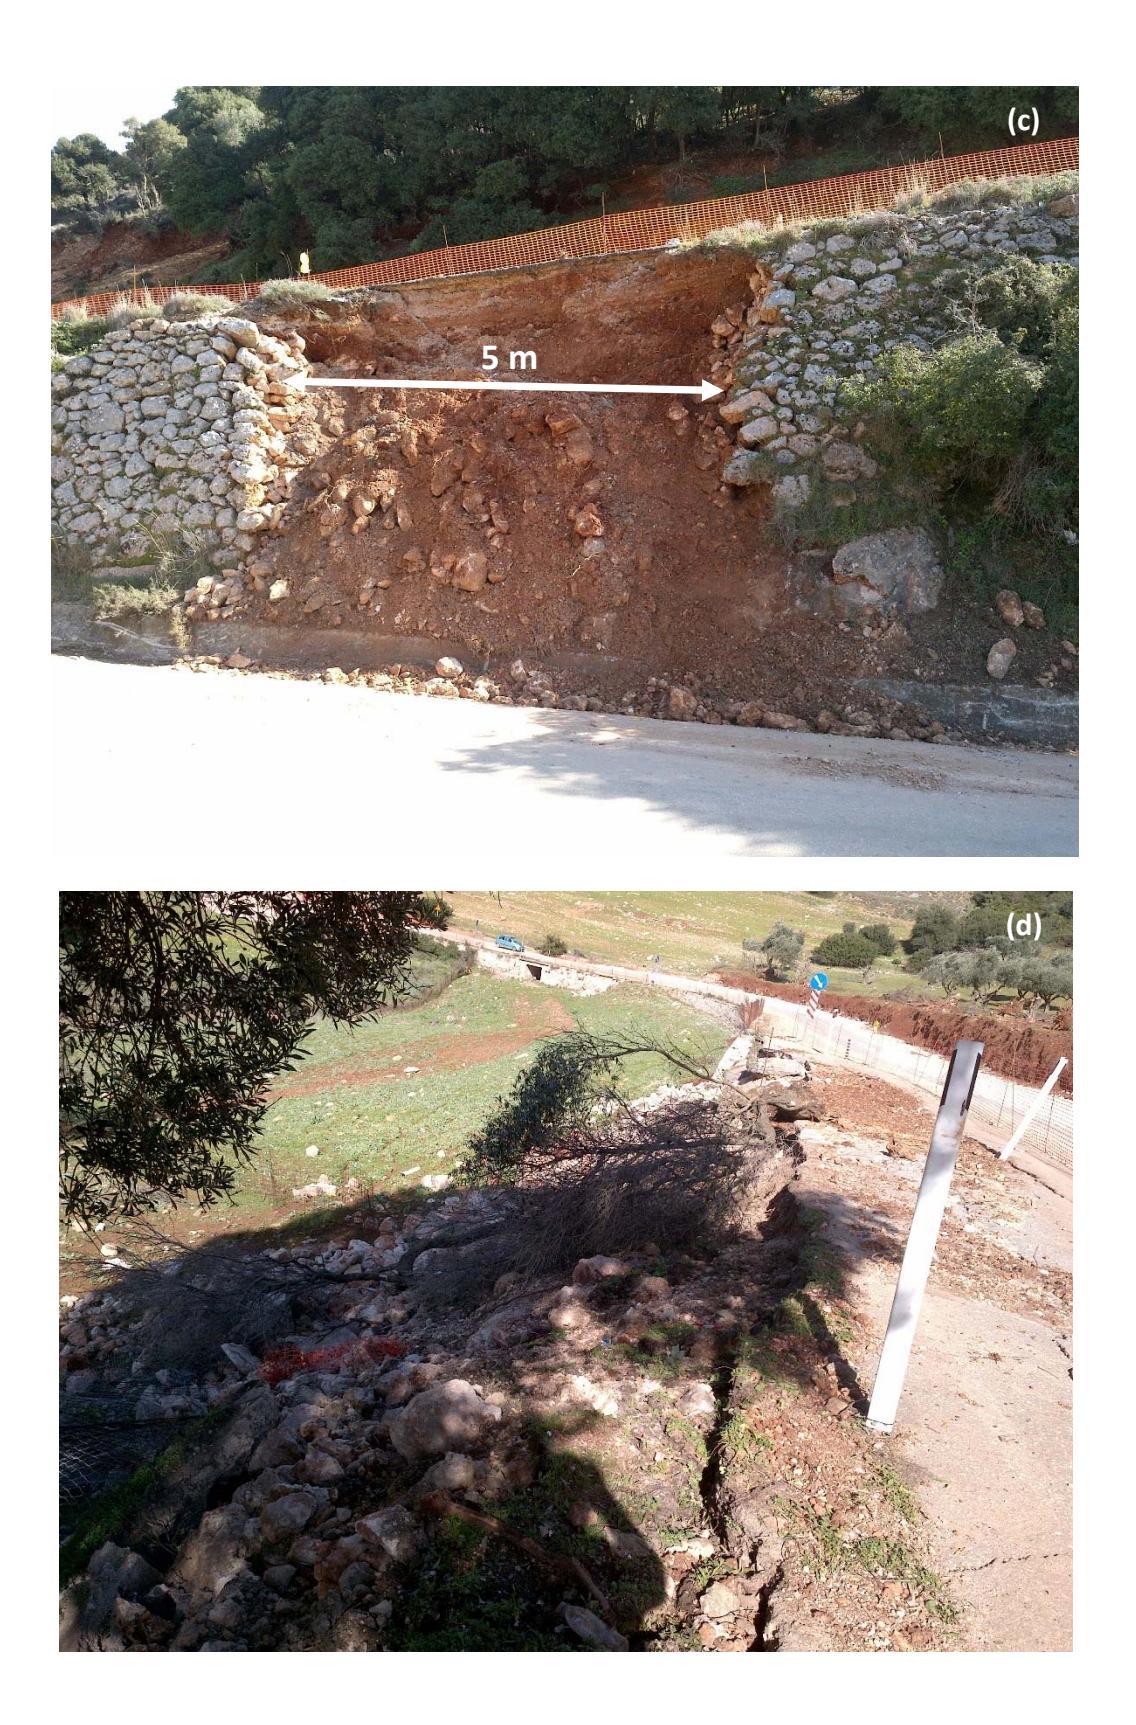
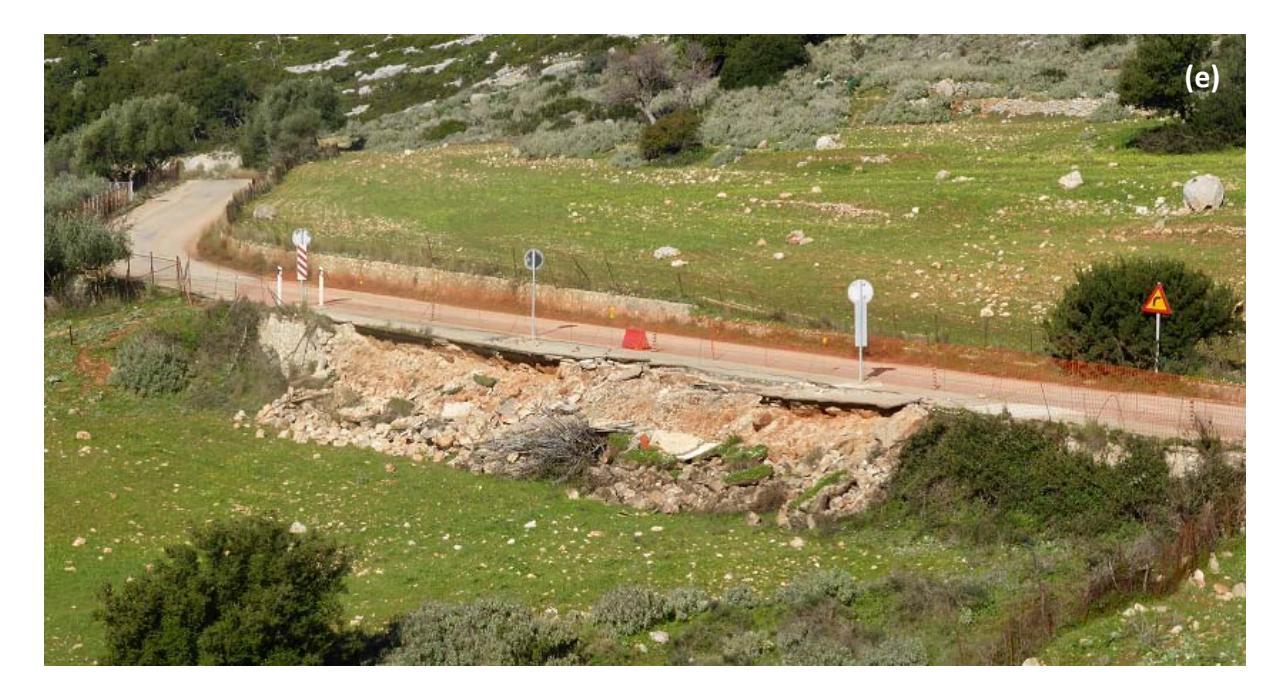
Figure 8.3.17. (a) Extensive failure of stone masonry retaining wall followed by road embankment settlement close to Atheras Village ($38.293224^{\circ}N$, $20.45217^{\circ}E$) after 1^{st} event; (b) failure at 3^{rd} wall location after 2^{nd} event with adjacent concrete sections undamaged; (c), (d), (e) failure details.

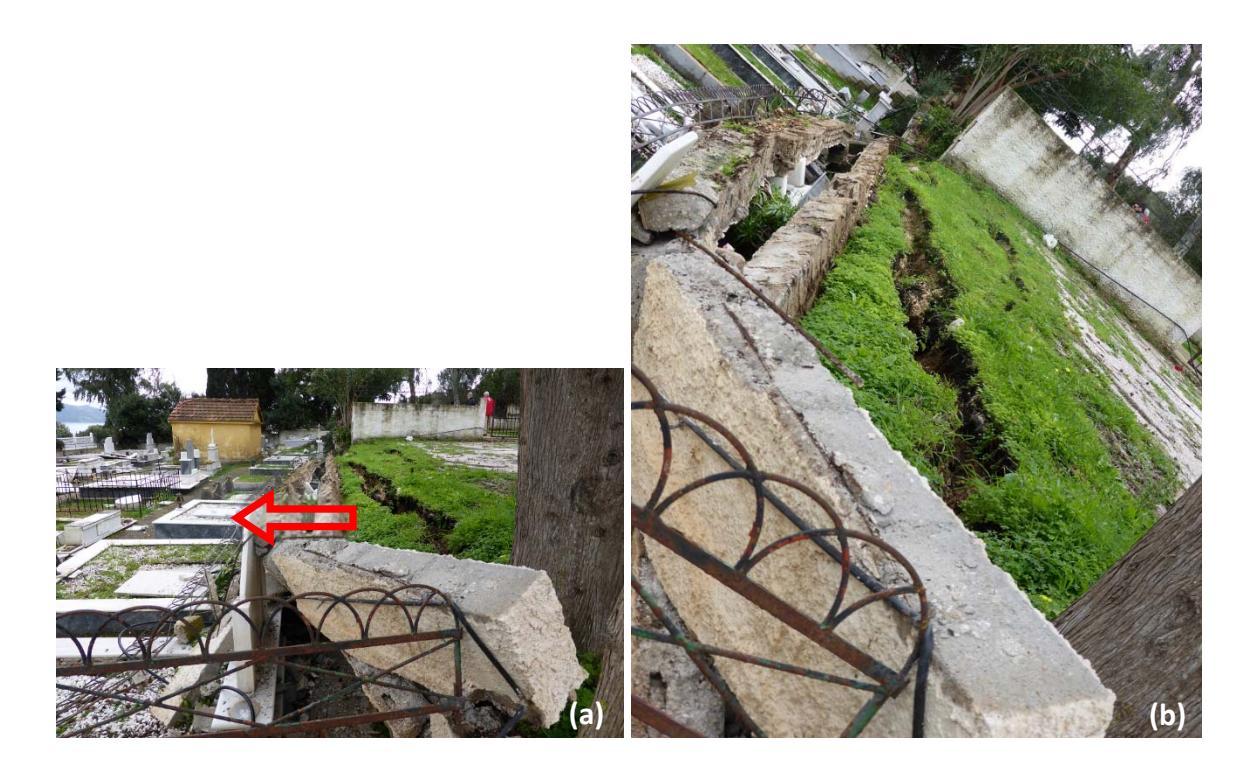
Figure 8.3.20. (a) View of stone/masonry retaining wall failure at the cemetery of Livadi village. (b) Close-up photo showing rotation of the wall face and tension cracks in the backfill (GPS coordinates: 38.255833, 20.420833).

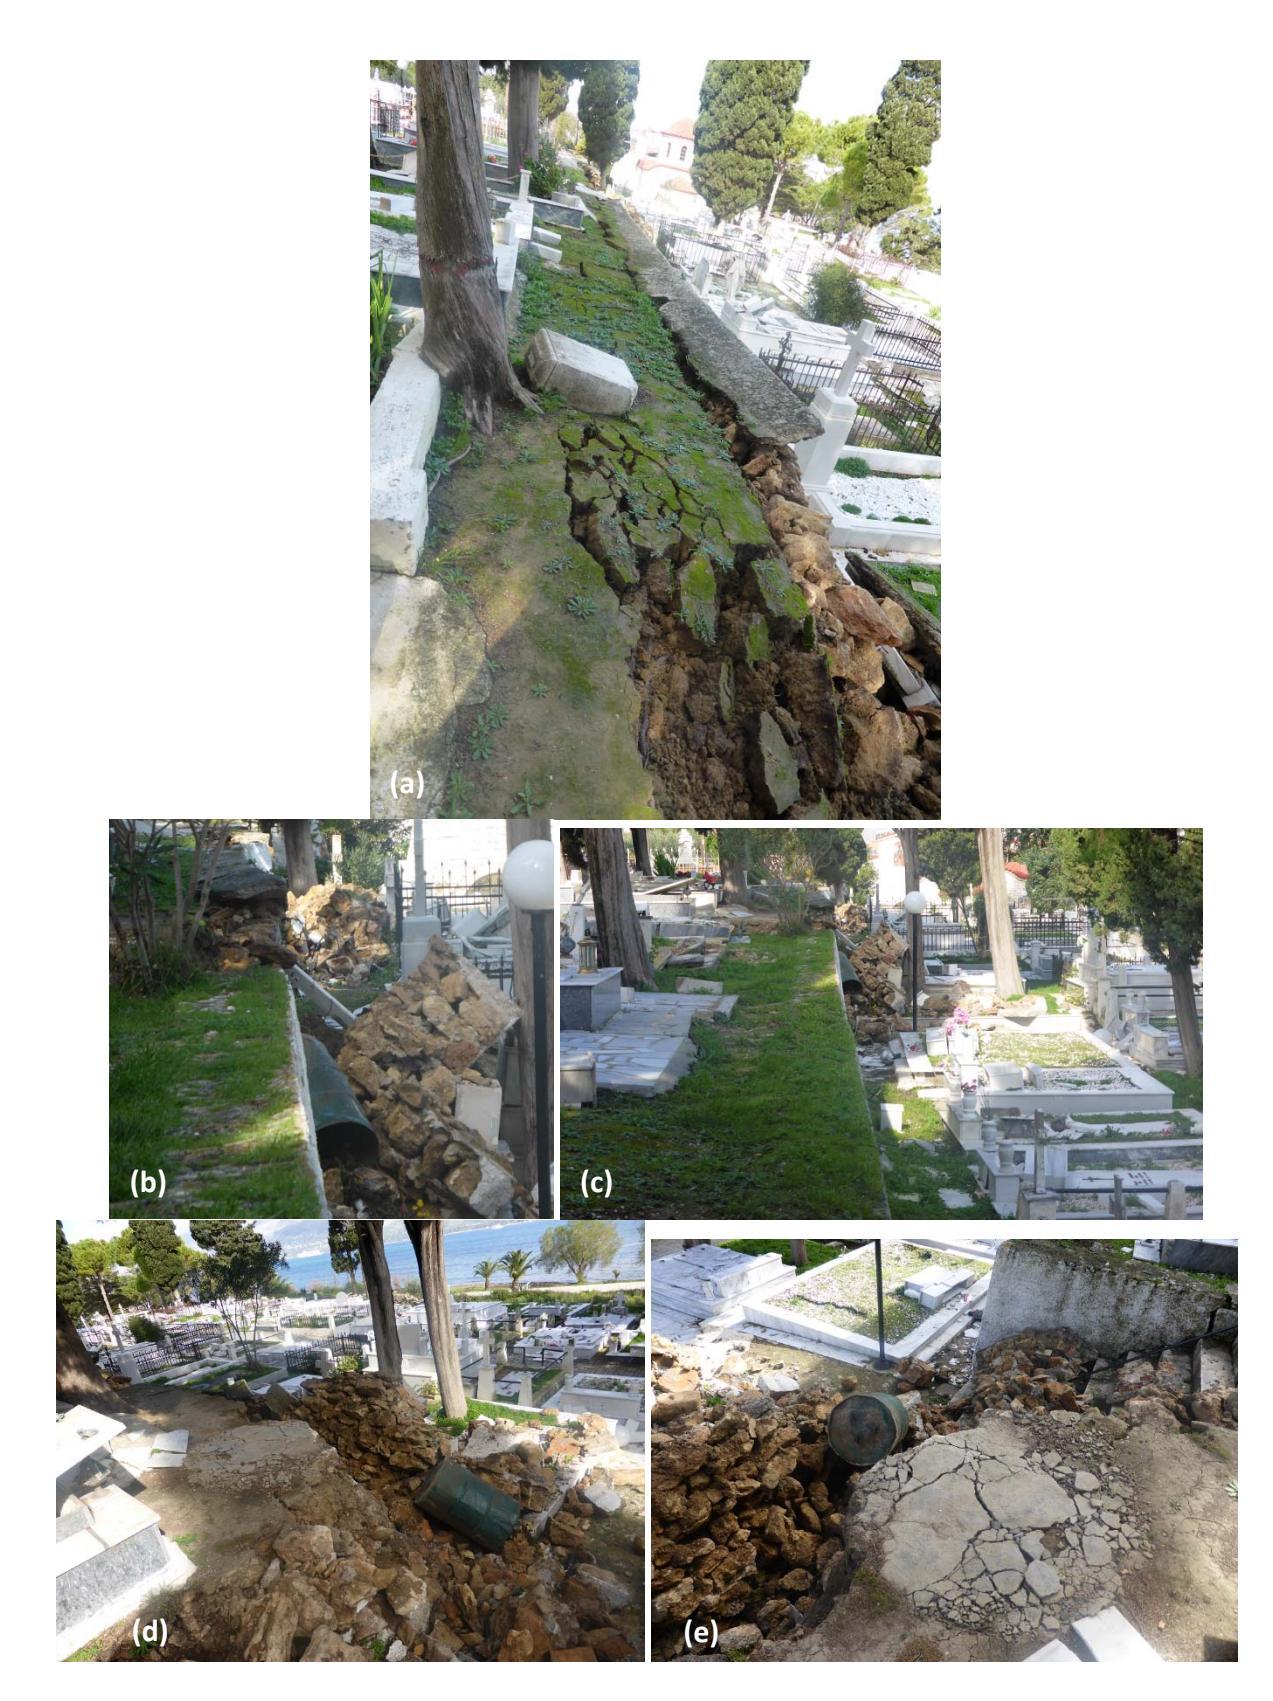
Figure 8.3.21. Collapsed retaining wall at cemetery of Lixouri with close up (b-c) side views (GPS coordinates: 38.192400, 20.438725); (d-e) top views (38.192433, 20.438725).

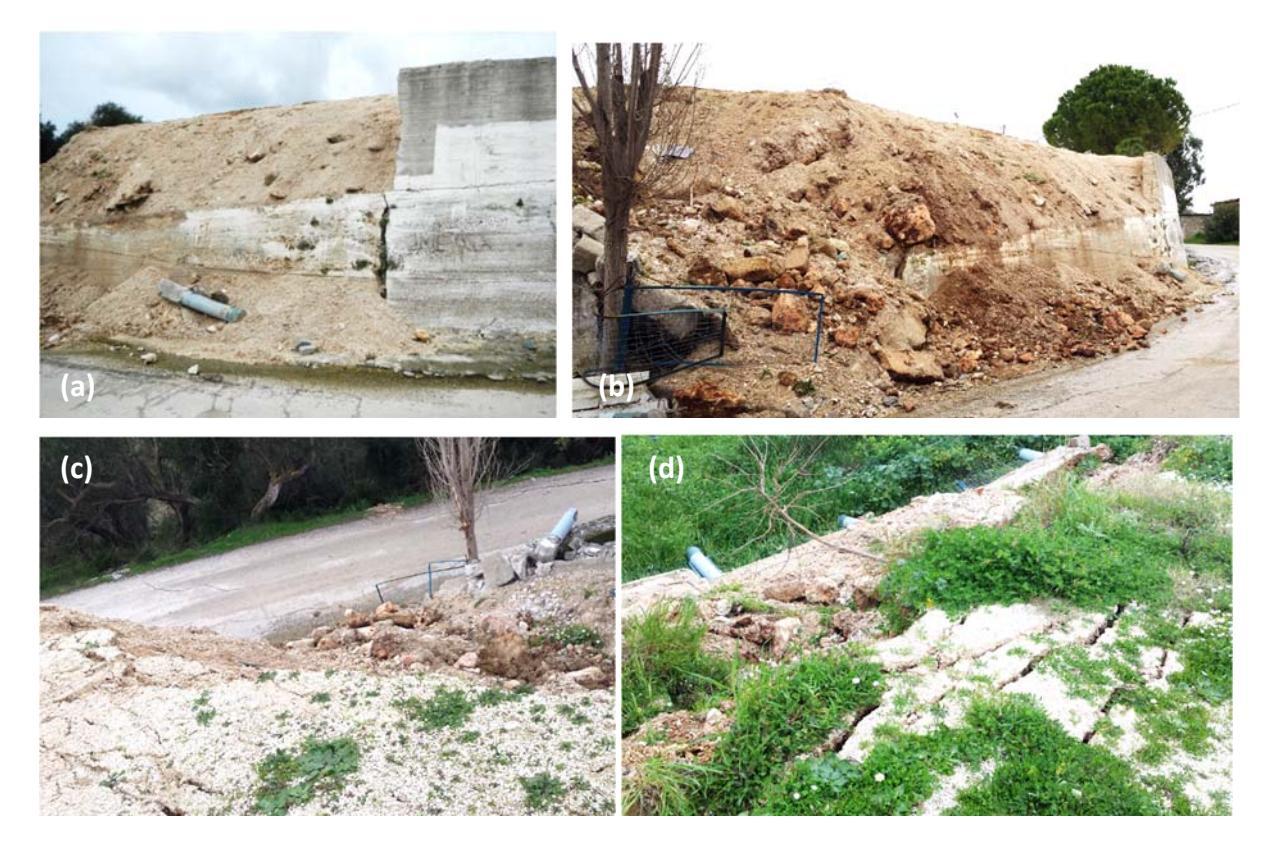
Figure 8.3.28. Failure of concrete retaining wall along a cold joint. The upper and lower portions of the wall appear to have been built at different times (38°11′0.07″N; 20°22′54.18″E); (a, b) side views; (c, d) top view with tensile cracks of soil surface at hill top where the strong motion station is located.

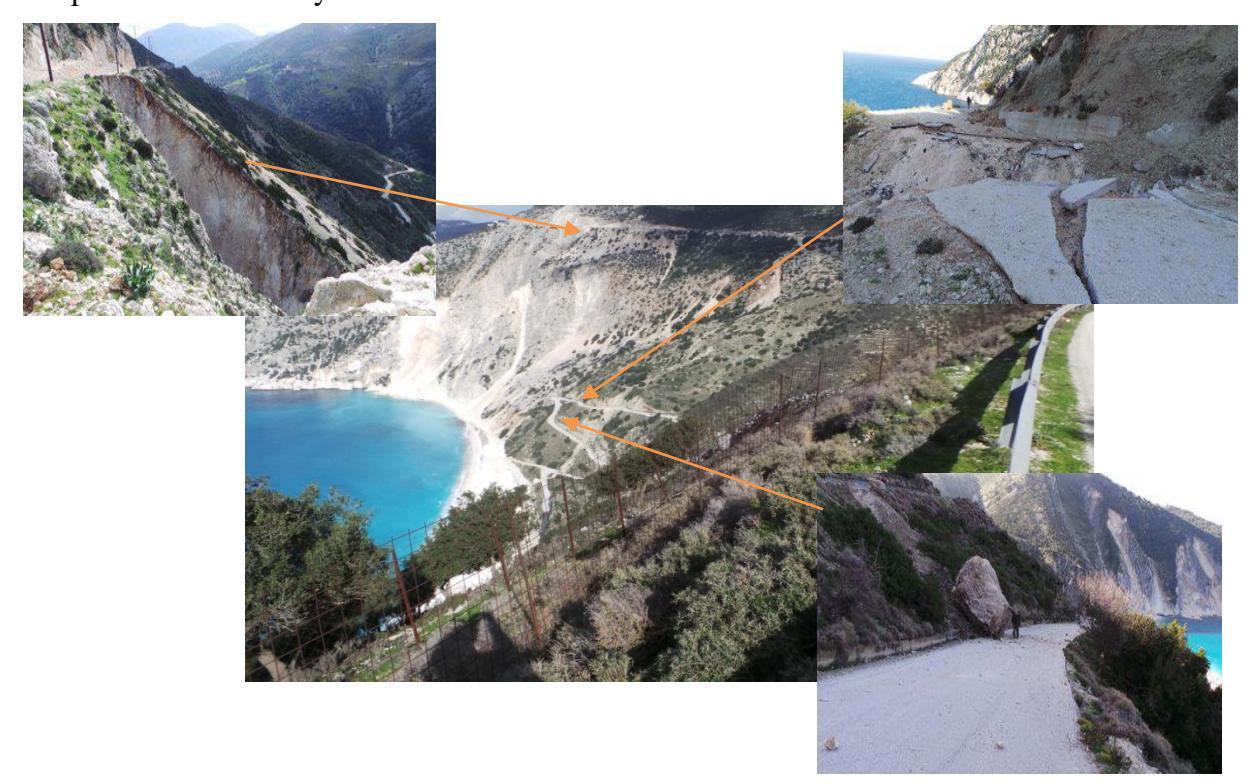
Figure 8.4.11. Northern cliffs and eastern slopes of Myrtos Bay. Major wedge failure, shallow rockslides and raveling; detachment and rolling down of the two major rock blocks with the associated road pavement damage (38.337833° N, 20.532317° E, UPatras, 2/10/14).

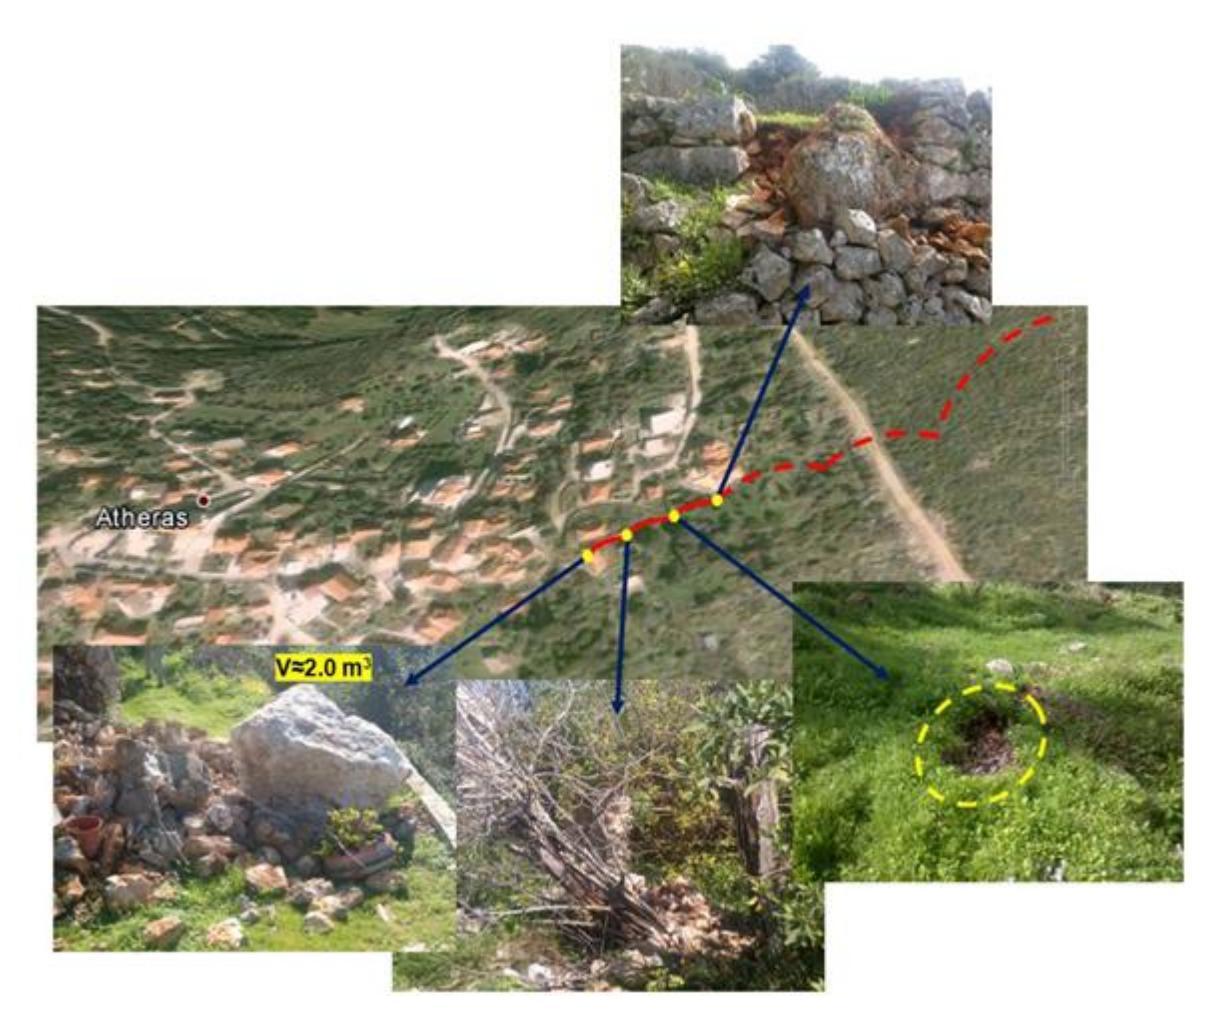
Figure 8.4.13. Possible trajectory of a limestone boulder of about 2 m³ that rolled over a natural slope and bounced at least 3 times, passing through a tile roof of a house in Athera village. Tracks of striking points where boulder bounced also shown (38.317365° N, 20.418548° E, DUTh team, 2/22/14).

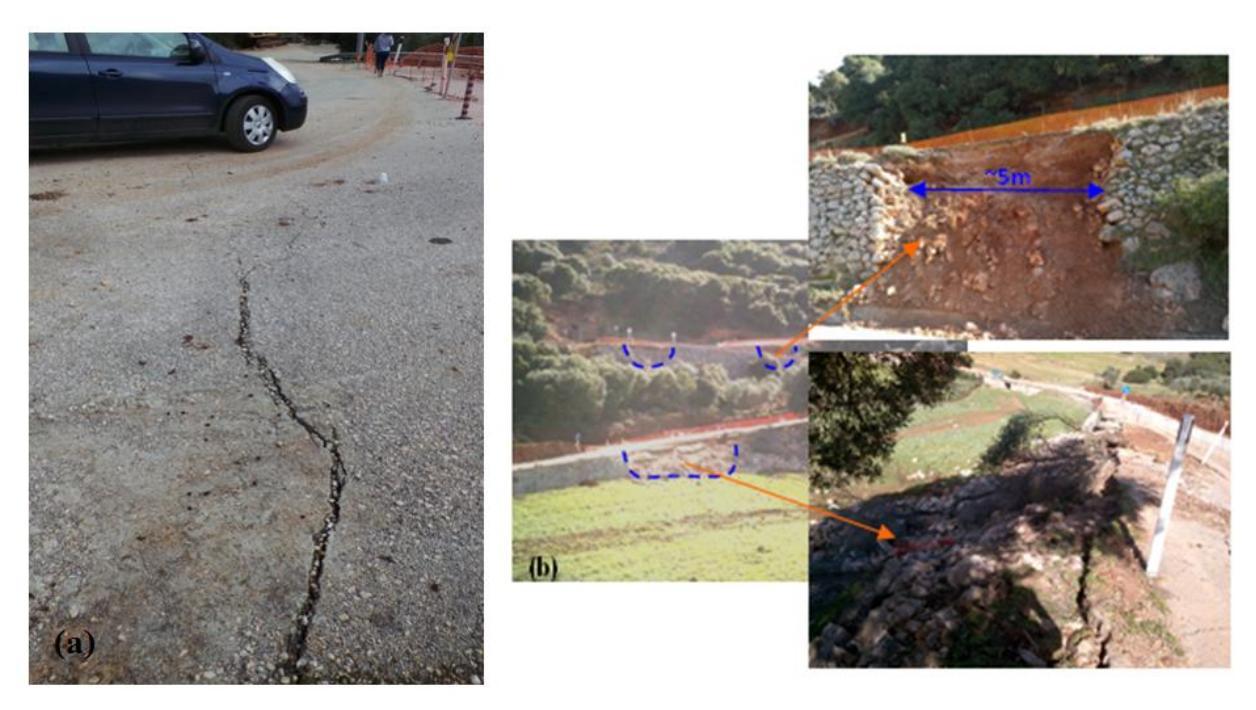
Figure 8.4.19. Area showing signs of incipient earth landslide failure. (a) Cracks on upper road pavement (UPatras) and (b) stone retaining walls destruction after the 1^{st} and 2^{nd} events (ITSAK), and soil displacements at the toe (coordinates 38.293224°N, 20.45217°E, date 2/8/14).

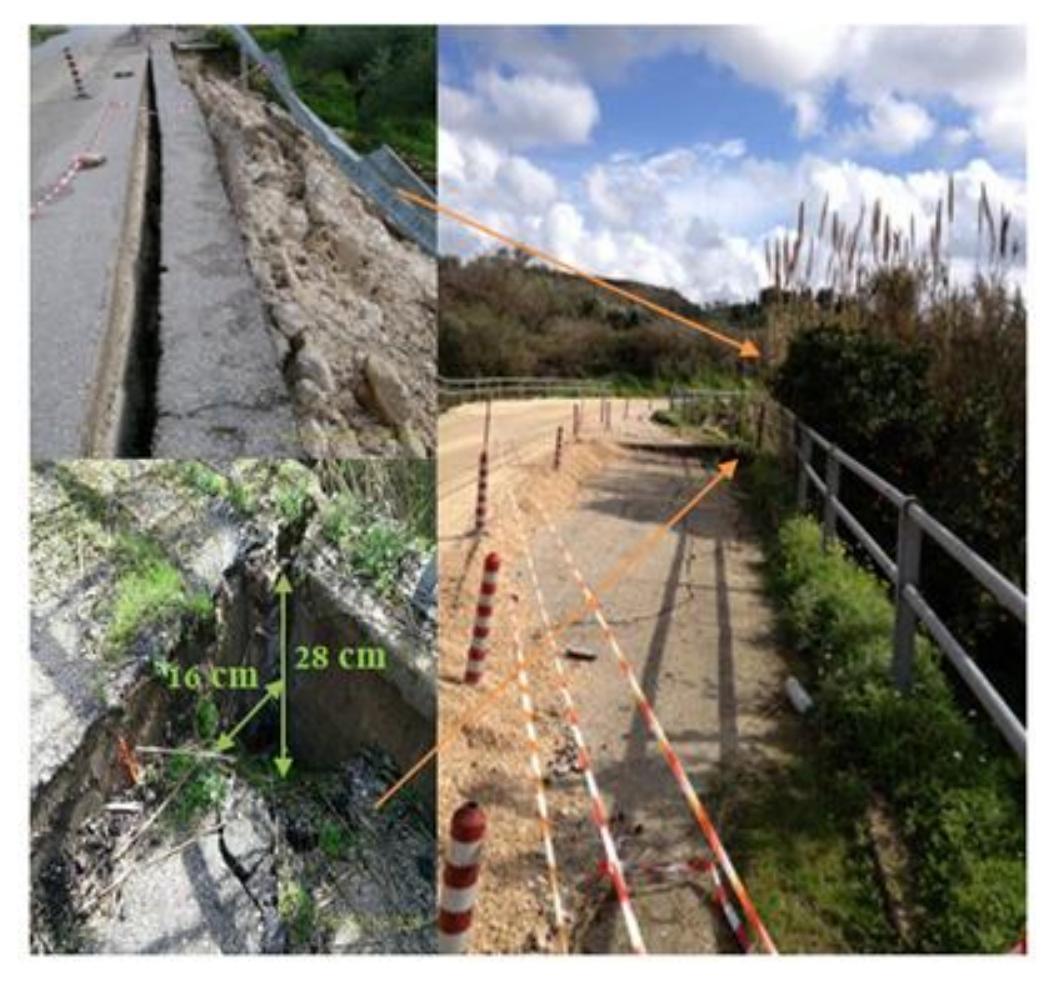
Figure 8.4.22. Road embankment settlement near bridge in Havdata (38.2028°N, 20.40445°E, UPatras team, 2/9/14).

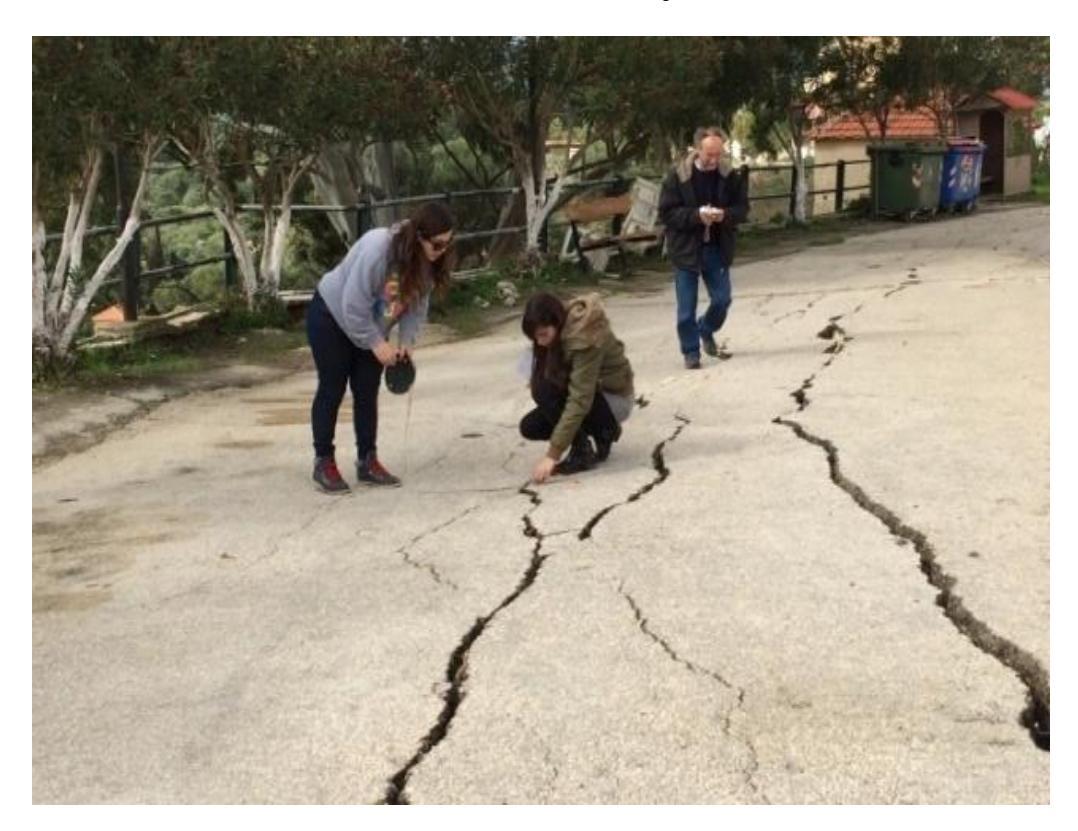
Figure 8.4.23. Road embankment settlement in Chavriata (38.182733°N, 20.384067°E, date 2/9/14). Measurements by UPatras team members Eva Agapaki, Elpida Katsiveli, and Costas Papantonopoulos.

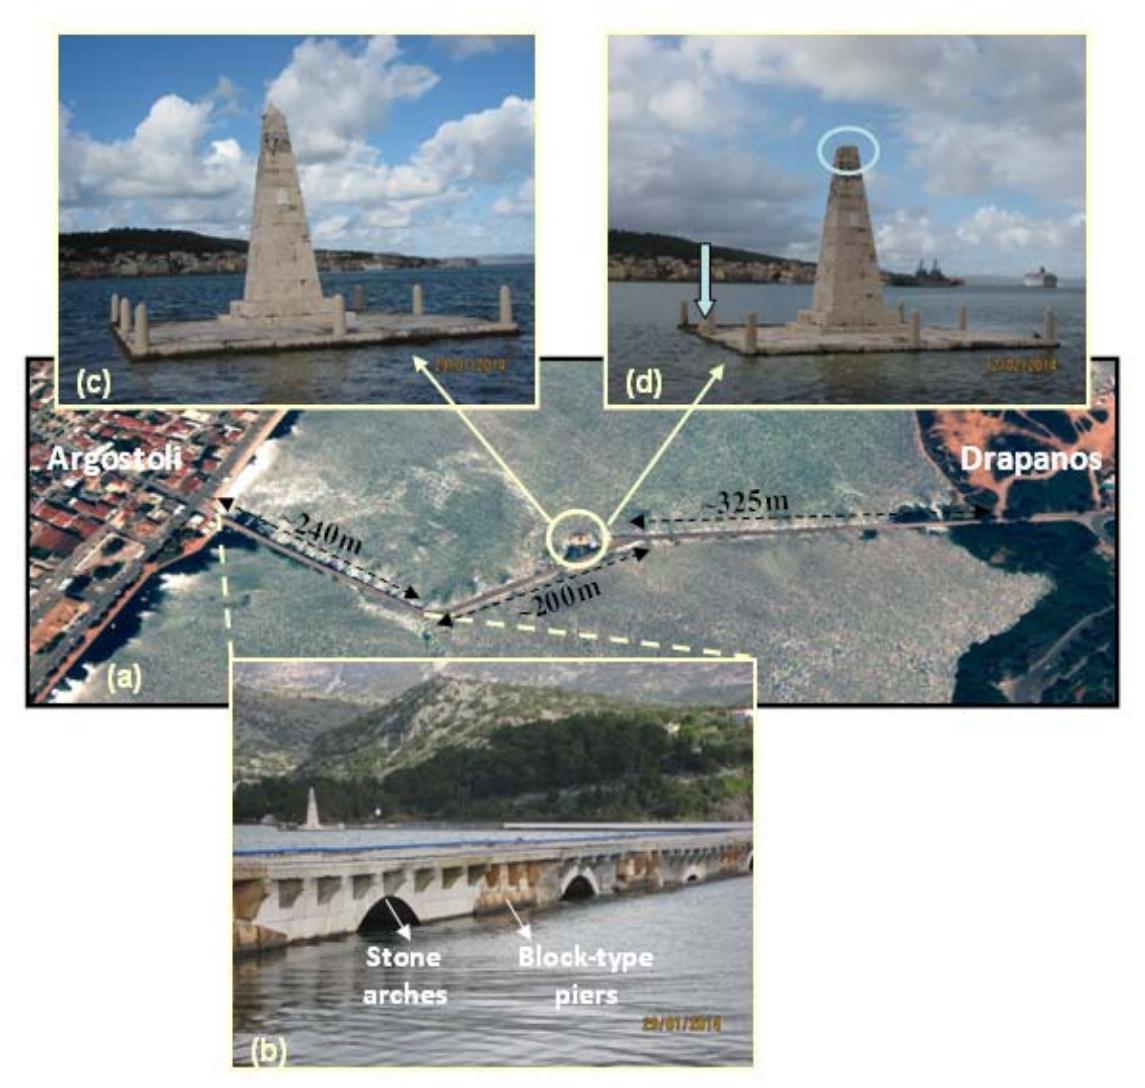
Figure 8.5.7. (a) Debosset bridge $(38^{\circ}10'26.25"N, 20^{\circ}29'45.59"E)$; (b) Rehabilitated bridge with no observed damage following the major events of 2014; (c) Multi-drum obelisk (Kolona) monument intact after the 1st event; and (d) Toppling of upper drum of the obelisk induced by the 2nd event.

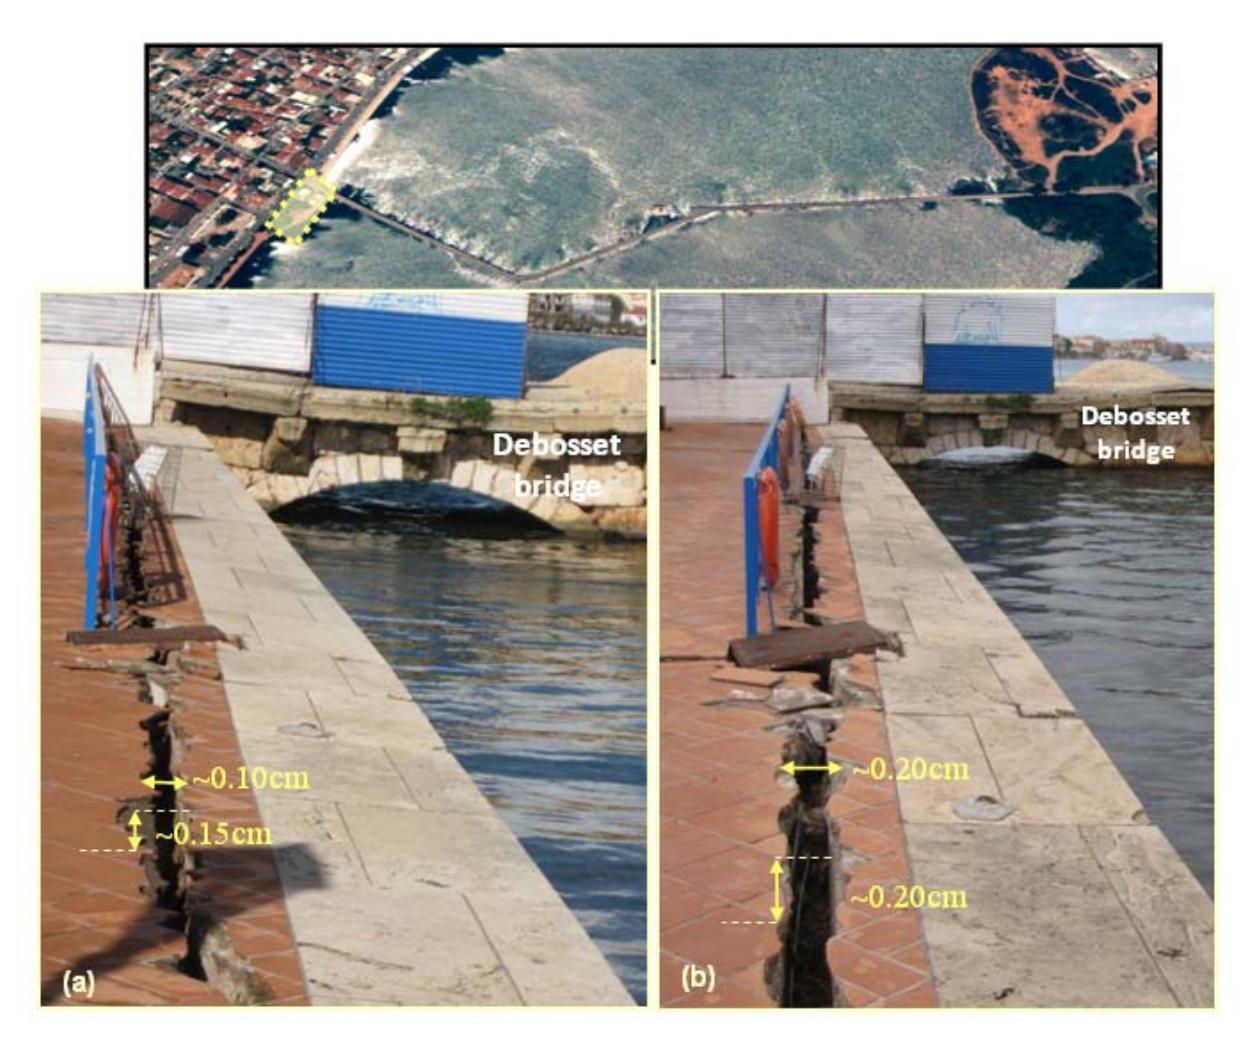
Figure 8.5.9. Observed failures adjacent to the Debosset bridge: permanent lateral displacement of the quay wall and settlement of the backfill induced by: (a) 1^{st} event, and (b) 2^{nd} event.

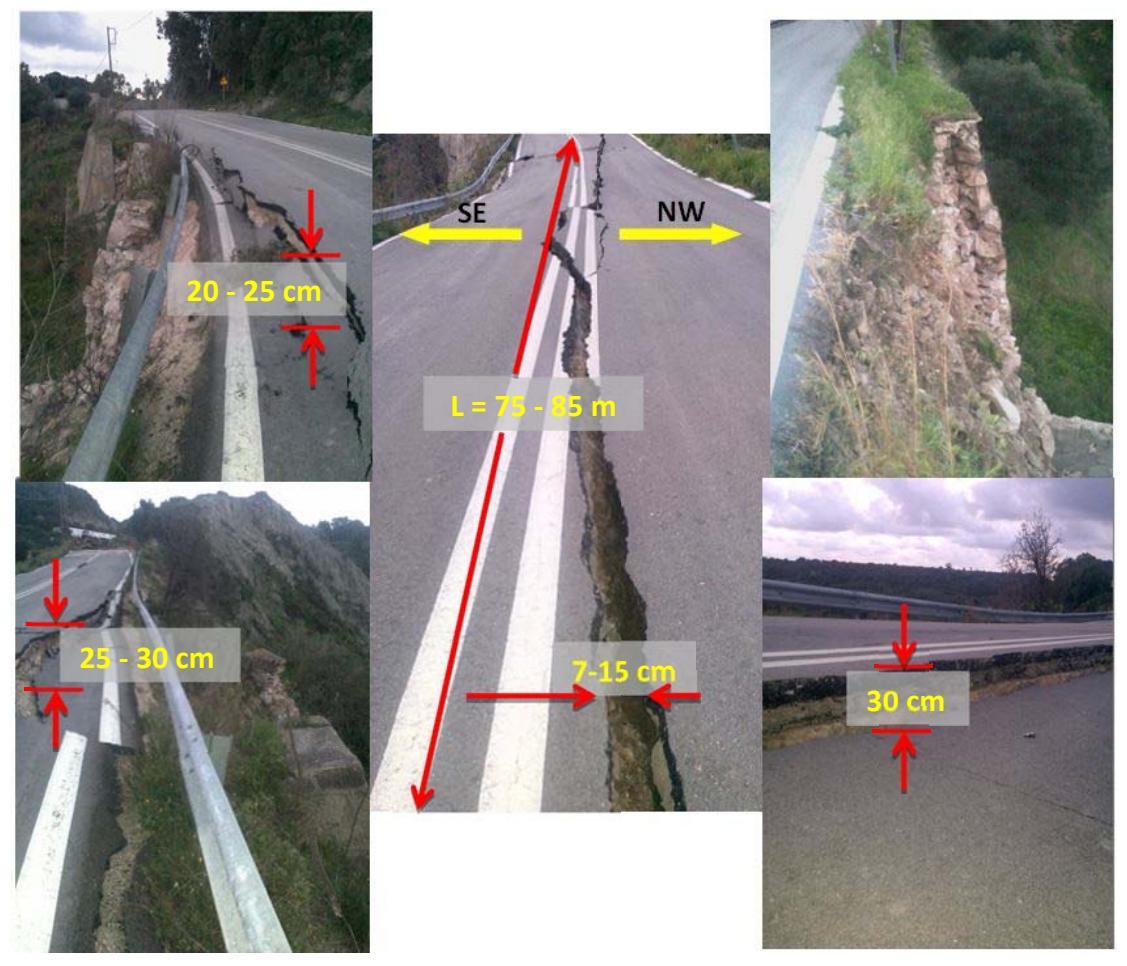
Figure 8.6.3. Location B ($38^{\circ}10'39.79"$ N, $20^{\circ}23'50.90"$ E) on the road connecting the Chavriata and Vouni villages. Severe road embankment damage was observed. Photos taken after the 2^{nd} event.

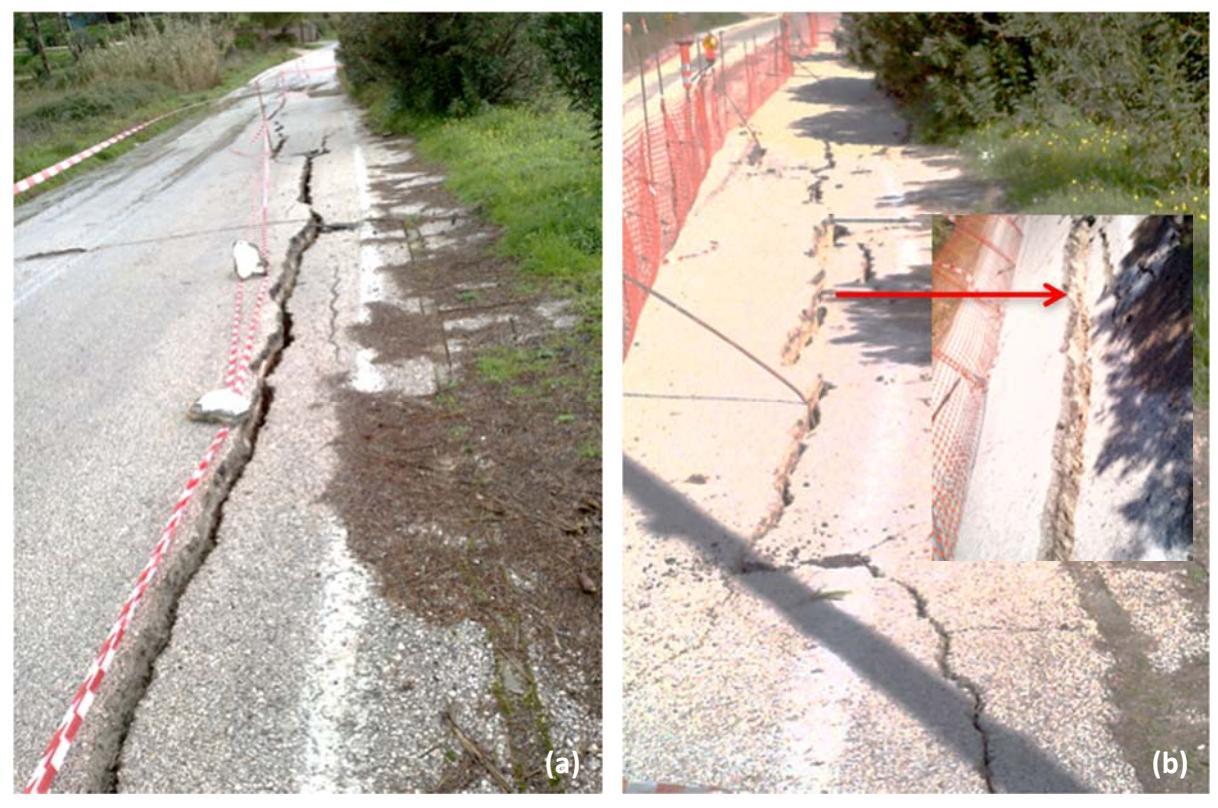
Figure 8.6.6. Cracks and settlements on the road embankment between Aghios Dimitrios and Livadi villages (38°14'17.17"N, 20°25'44.30"E): (a) after the 1st (left) and (b) the 2nd (right) event.

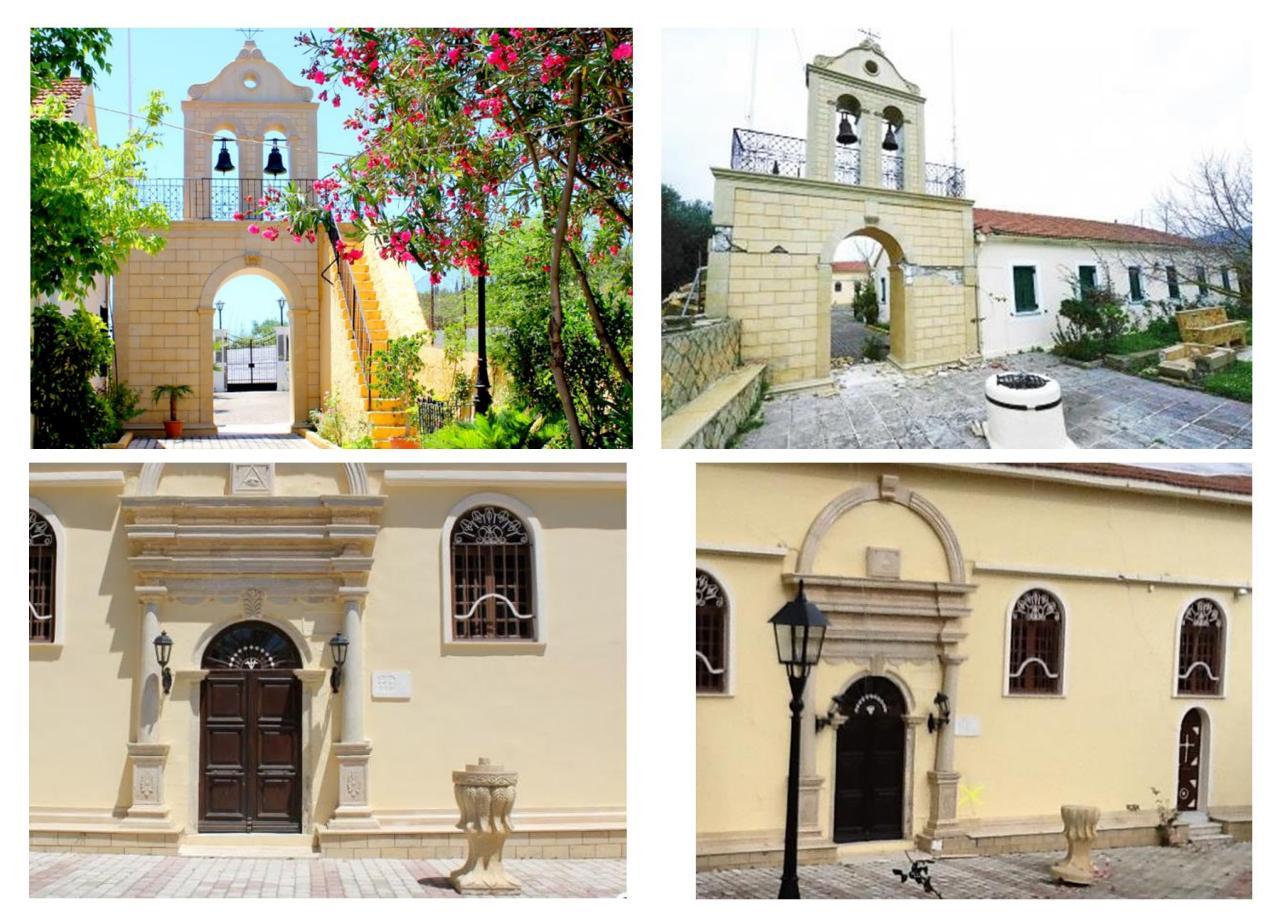
Figure 8.7.13. Comparison of the external and main gate of the Kechrionos Monastery prior (left) and after the 2014 earthquakes (right).
